Structural Evaluation Report
for existing one-story ground level commercial building

Property Address:
"Piano Shop"
907 Caroline St,
Key West, FL 33040

AD Job#: 1804-15
City of Key West P.O.: 086088

Artibus Design
April 2018

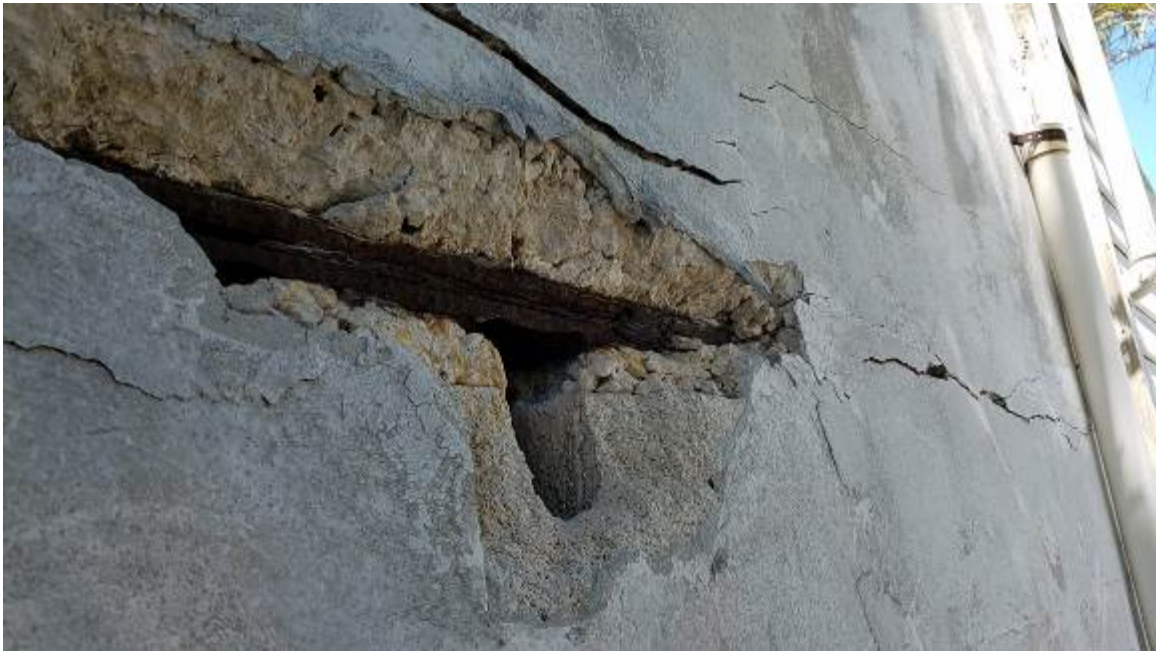
Figure 7. Same as above. Rear of the building right side. Large parts of the tie-beam collapsed, and damaged reinforcement exposed to the elements.

In my professional opinion, parts of the tie-beam with extensive damage and loose concrete chunks need to be secured by the means of removing loose elements and installation of heavy plywood sheathing. Such temporary shoring is required to minimize life and health safety of the building occupants and public.

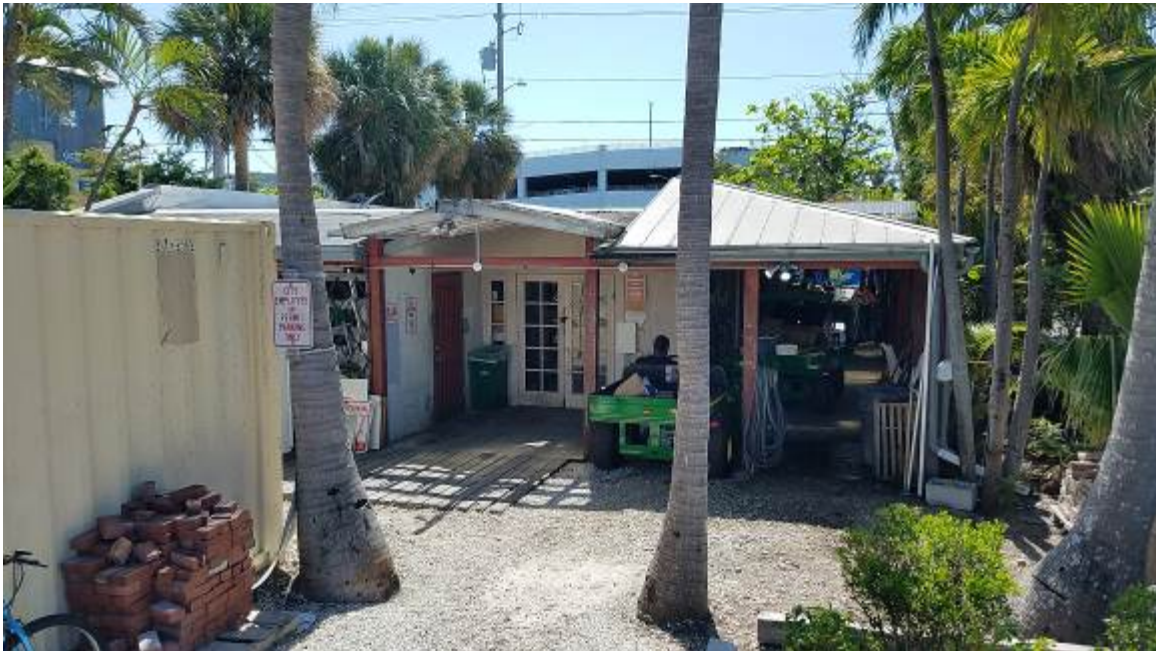
Figure 9. Rear elevation with pergola style and shed roof on the side. Rear of the shed is obstructed by storage container. Wood pergola and side roof are in poor shape but stable. Left side of the building is obstructed by the landscaping.

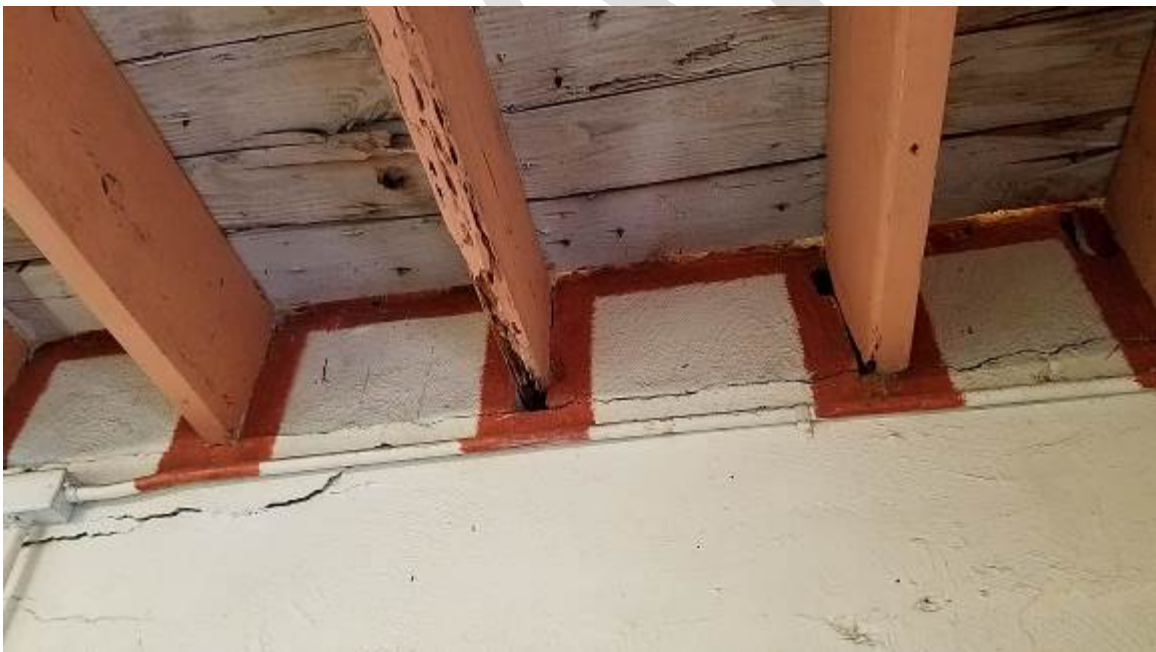
Figure 10. Maintenance shop - Interior view with damaged top of tie-beam and heavily damaged roof rafter. Damaged wood roofing deck. Please note electrical conduits along the tie-beam.

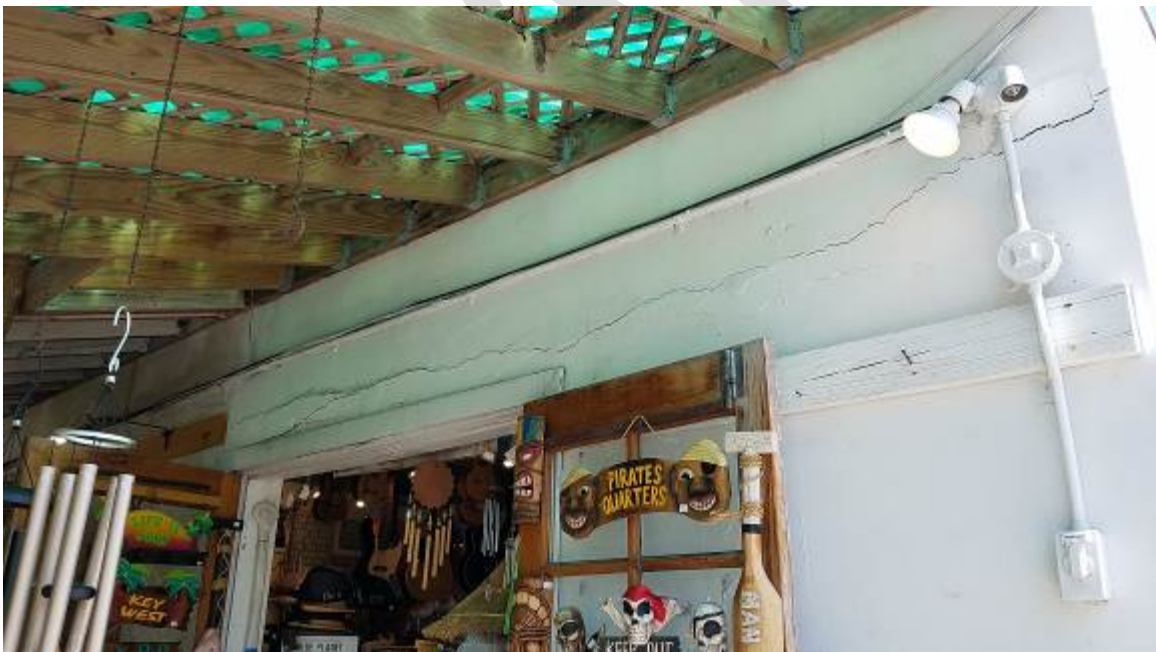
Figure 14. Heavy spalling damage above the side entrance into the gift shop. Large sections of concrete debris are unsecured and may fall creating life & health safety hazard. Roofing above with a patchwork of non-conforming improvements. More electrical components in the way of repairs.

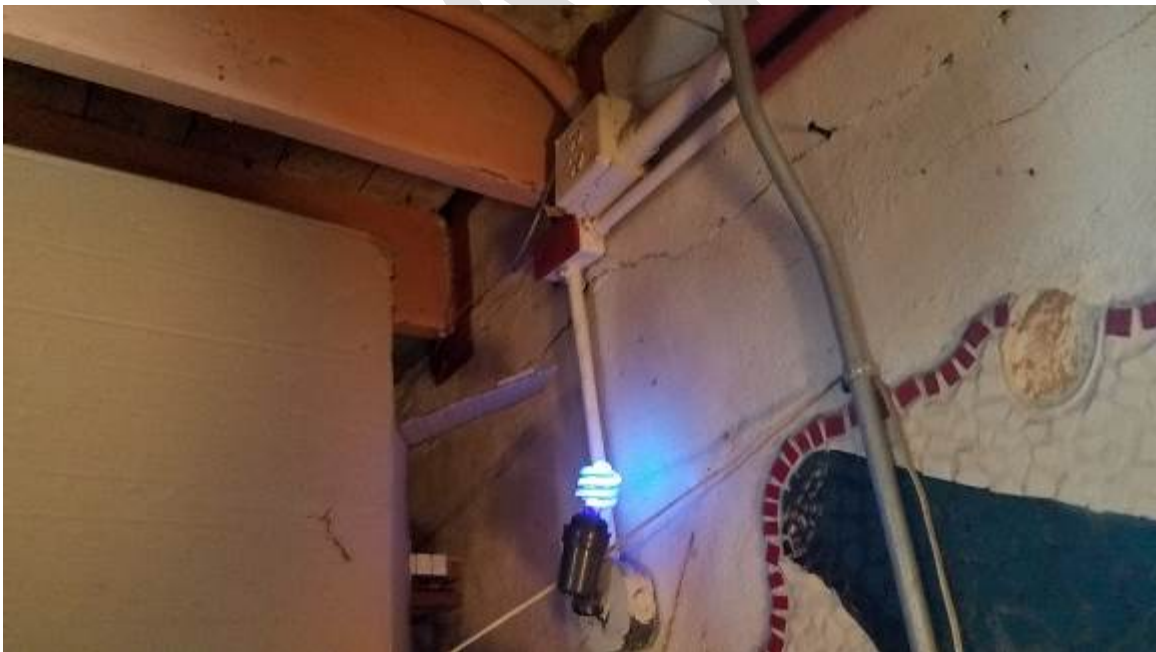
Figure 16. More electrical conduits, outlets and lights at the level of tie-beam and roof rafters requiring repairs.

Electrical distribution system will need to be replaced entirely – since most of the conduits are attached directly to the tie-beam or roof rafters to be repairs.
