STAFF REPORT

DATE: August 1, 2017

RE: **1300 Atlantic Boulevard (C.B. Harvey Rest Beach Park)
(permit application # T17-8522)**

FROM: Karen DeMaria, City of Key West Urban Forestry Manager

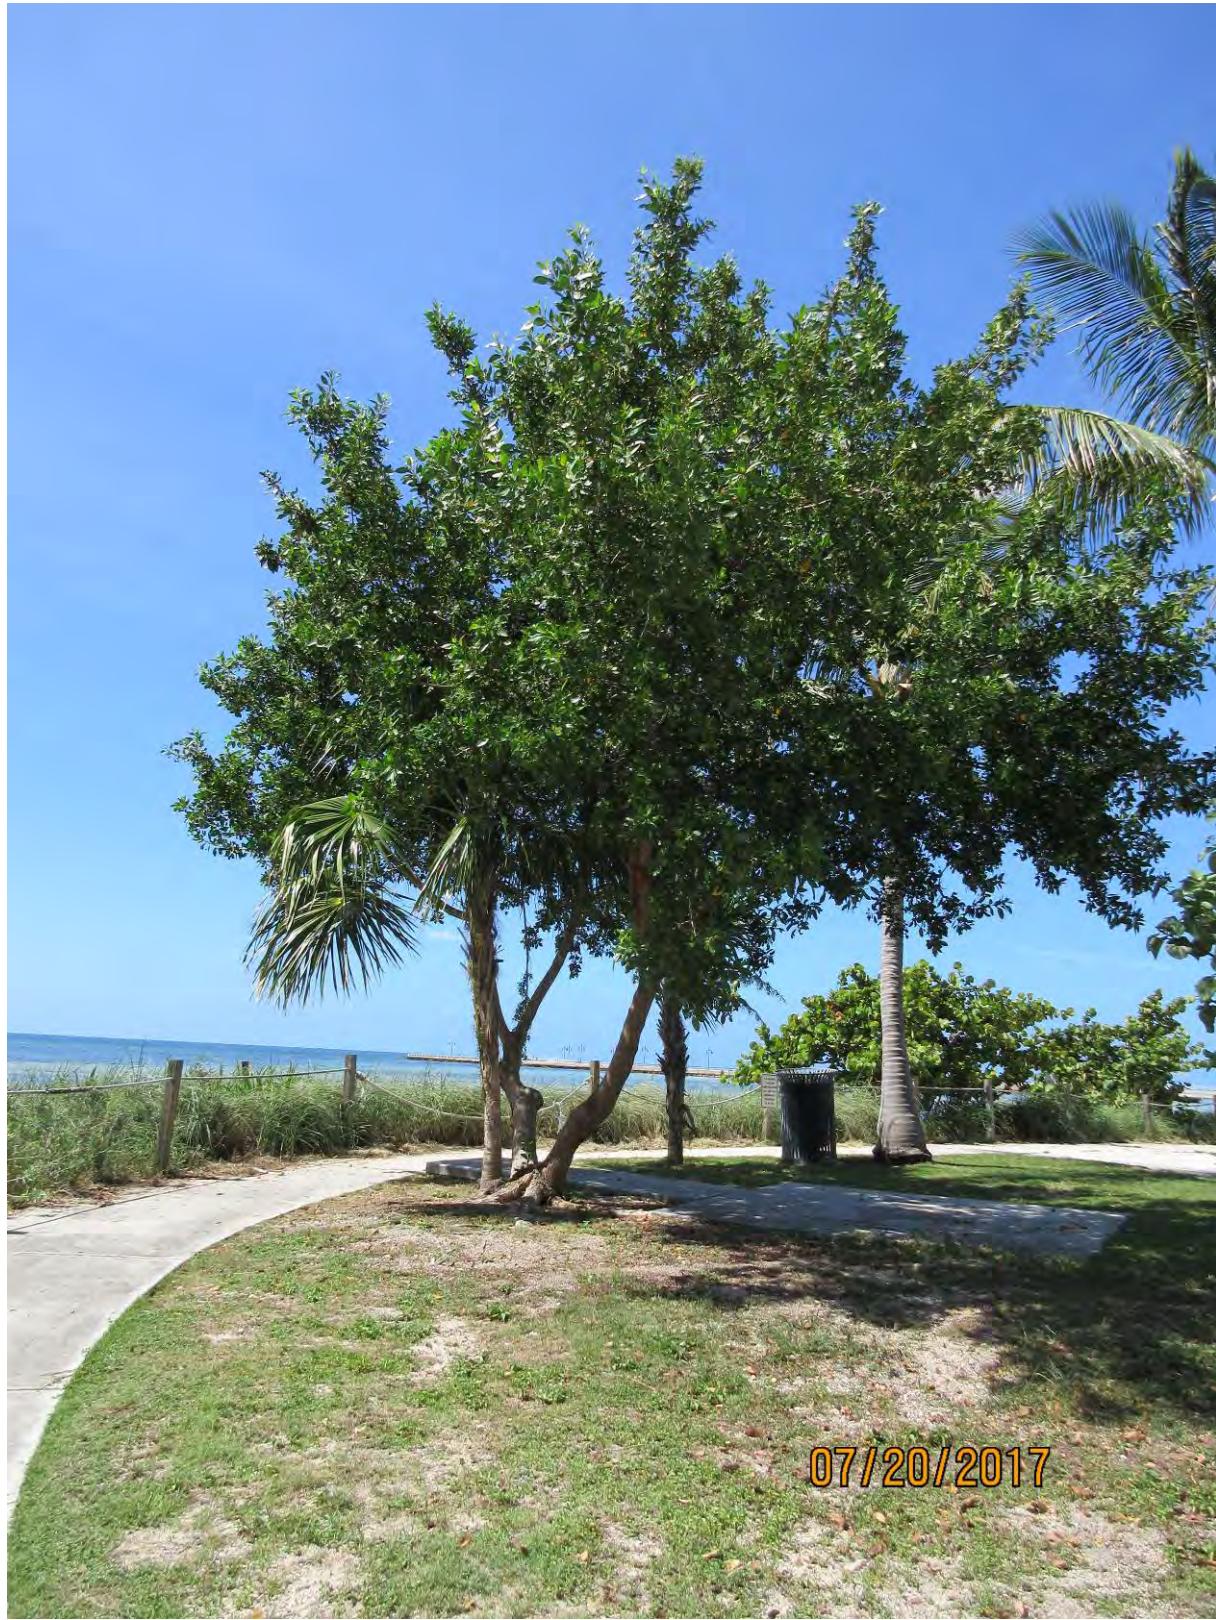
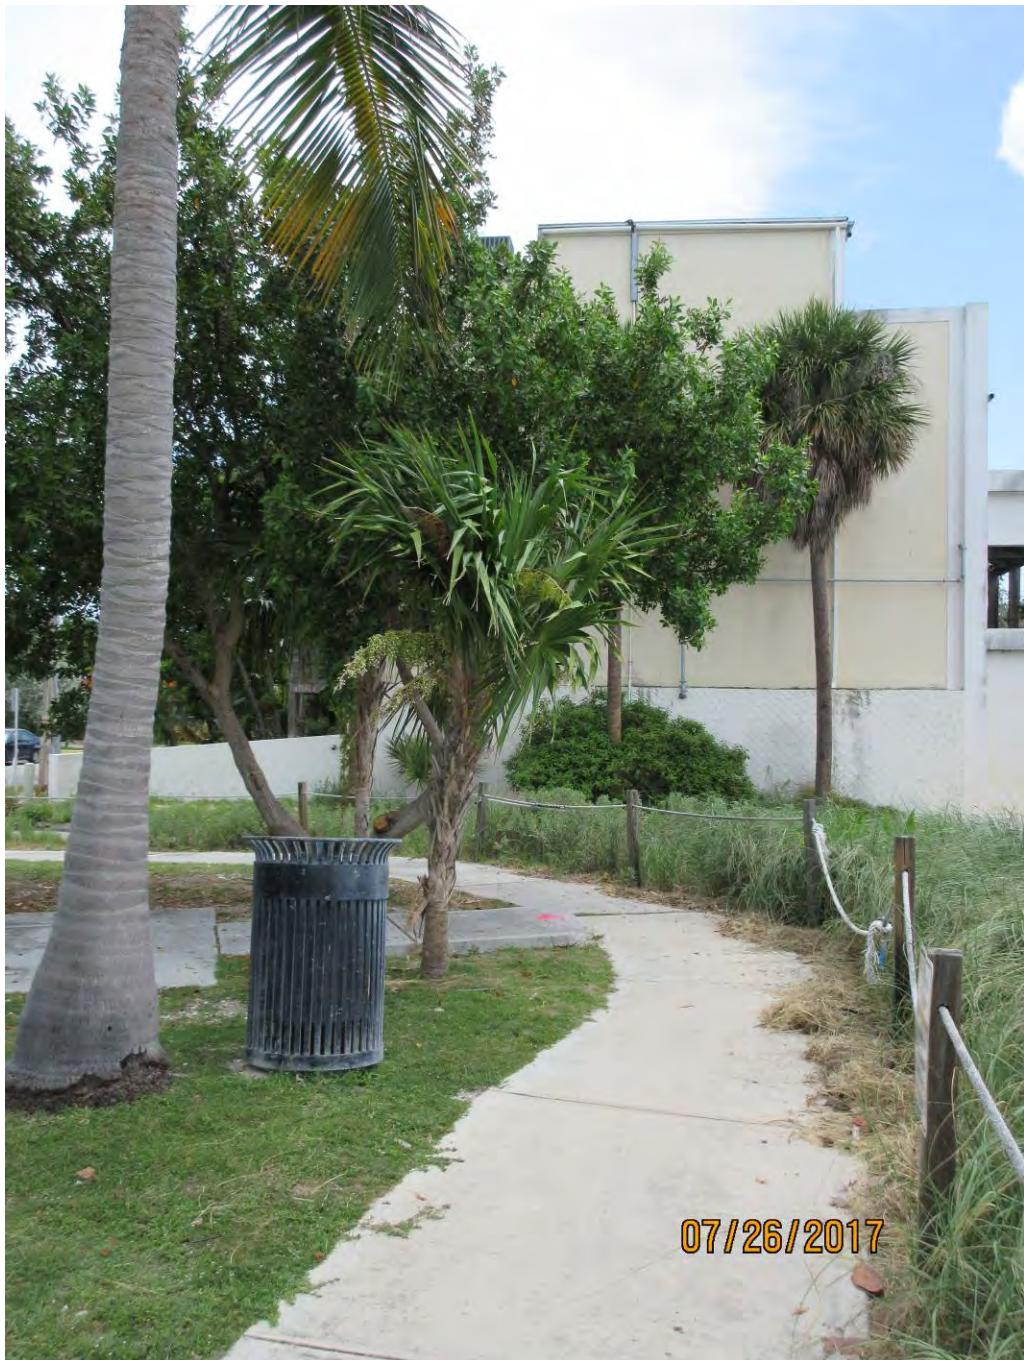
Tree #2A:

Diameter: 14.9"

Location: 90%

Species: 100% (on protected tree list)

Condition: 60% (fair, co-dominant trunks)

Total Average Value = 83%

Value x Diameter = 12.3 replacement caliper inches

NOTE: It might be possible to do a heavy maintenance trim on this tree to remove one of the main branches. A final decision will be made once site is staged for work.

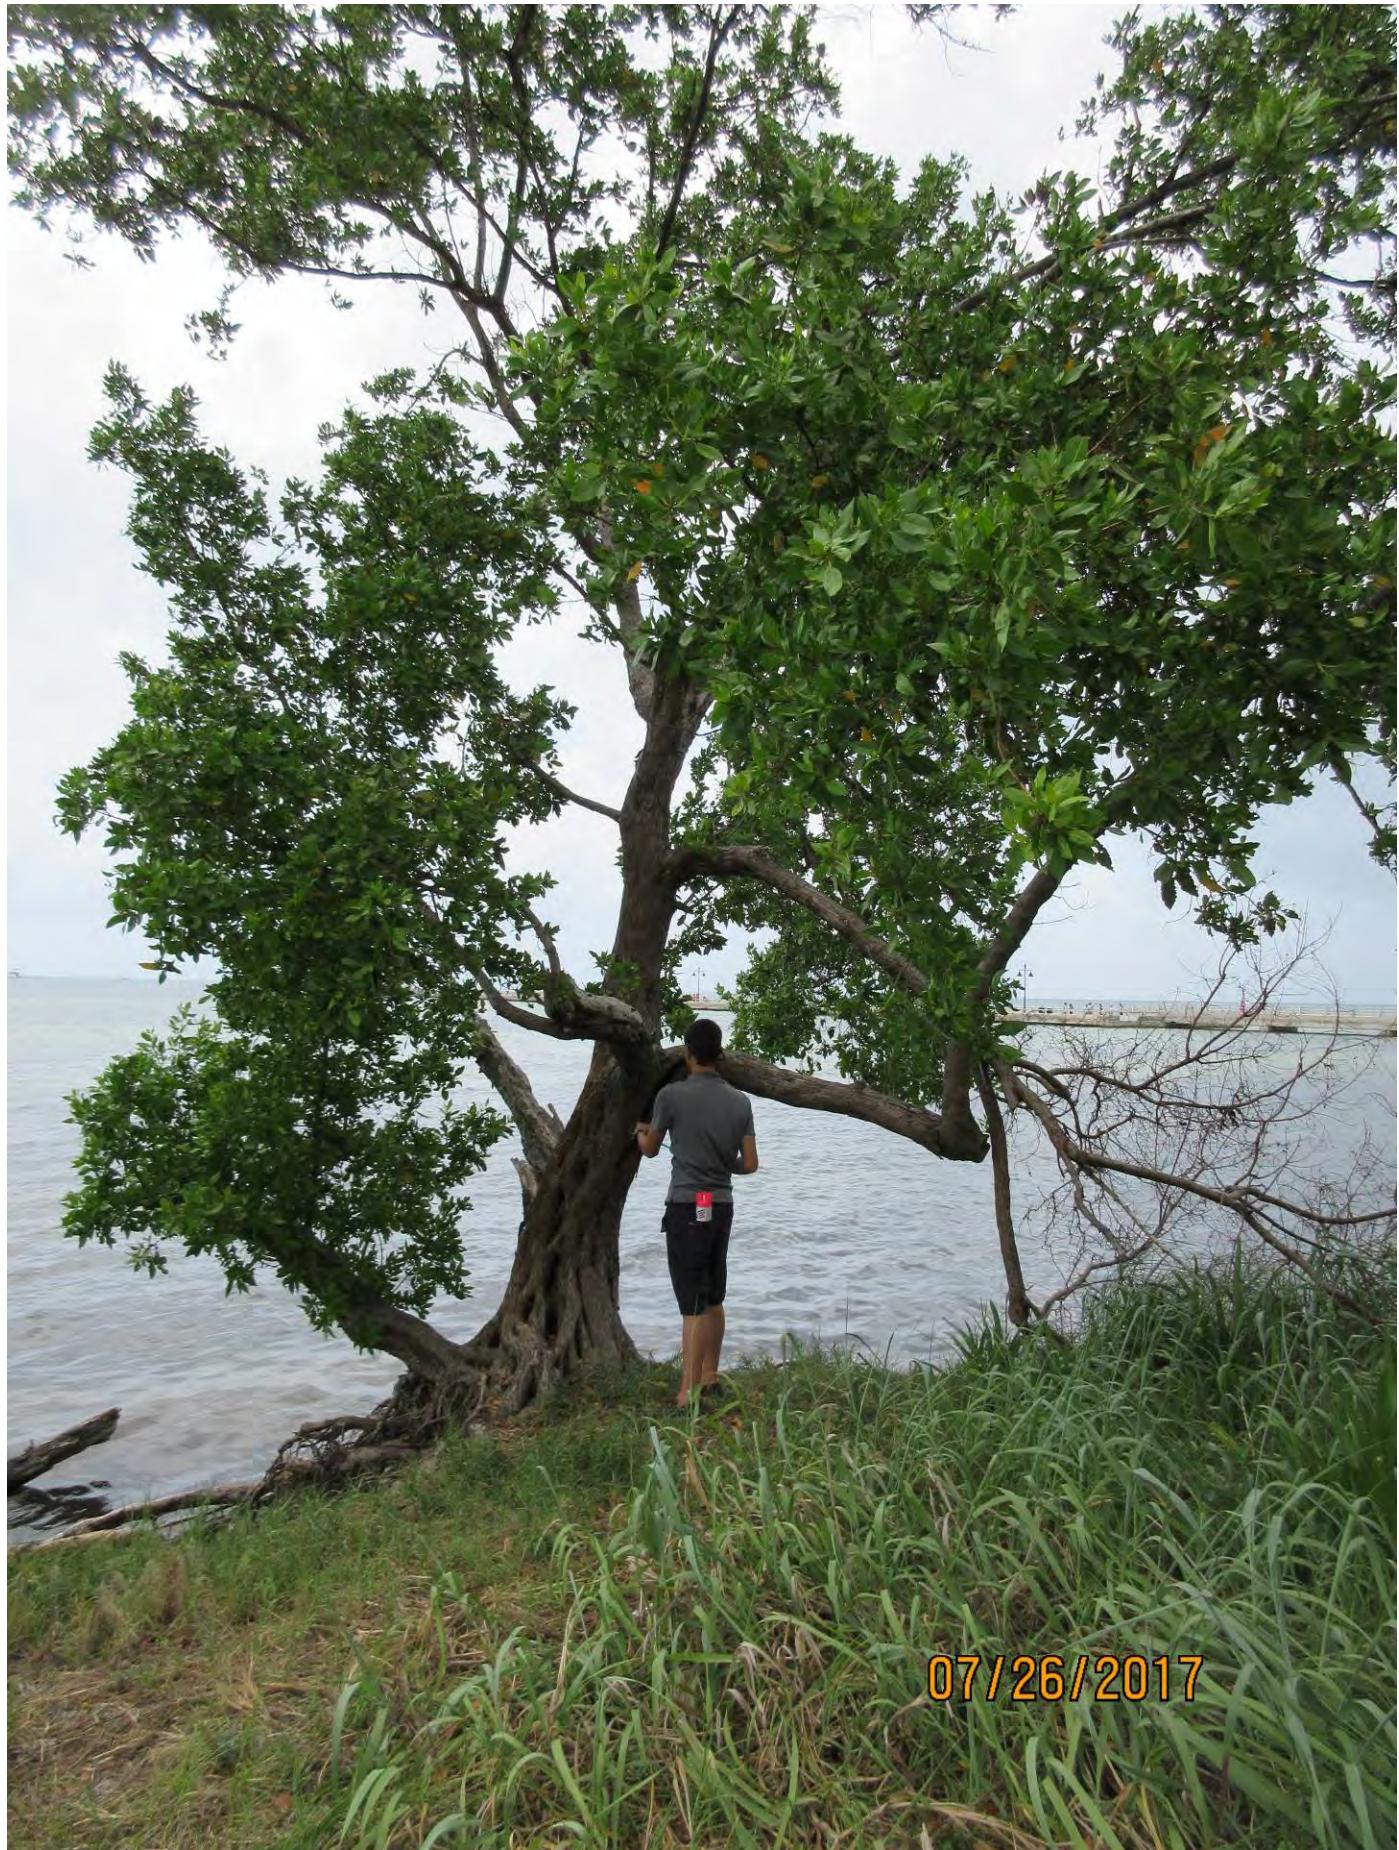
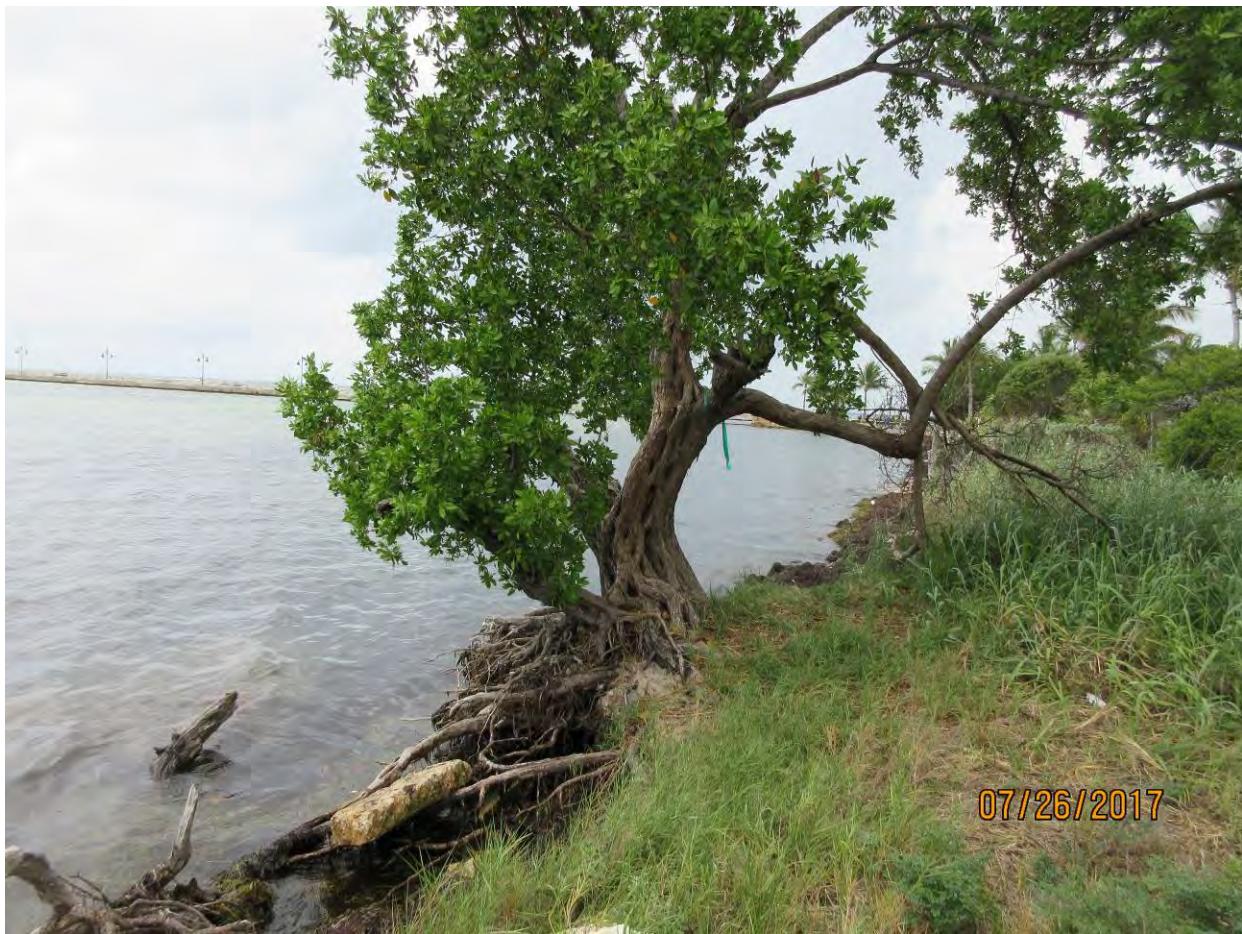
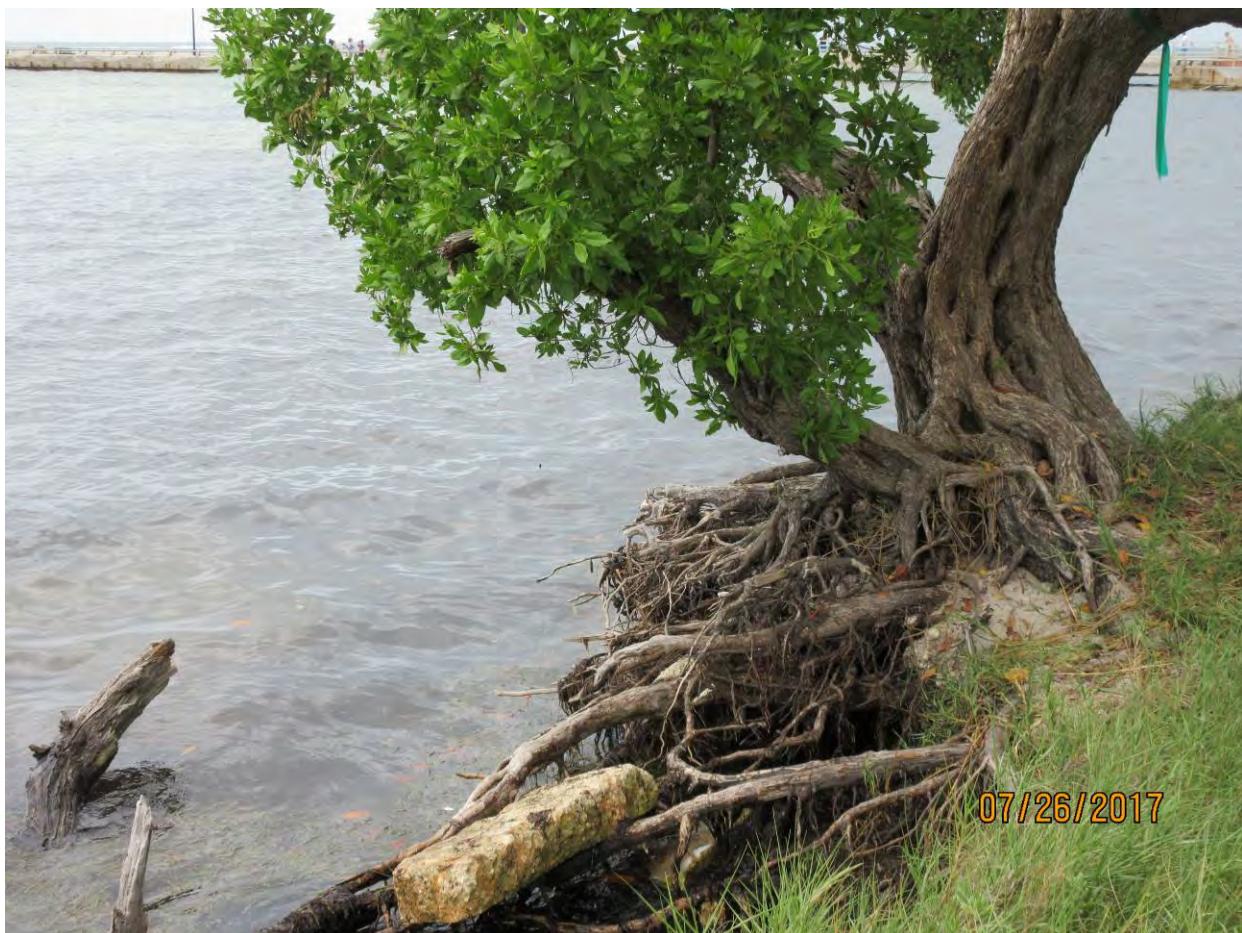
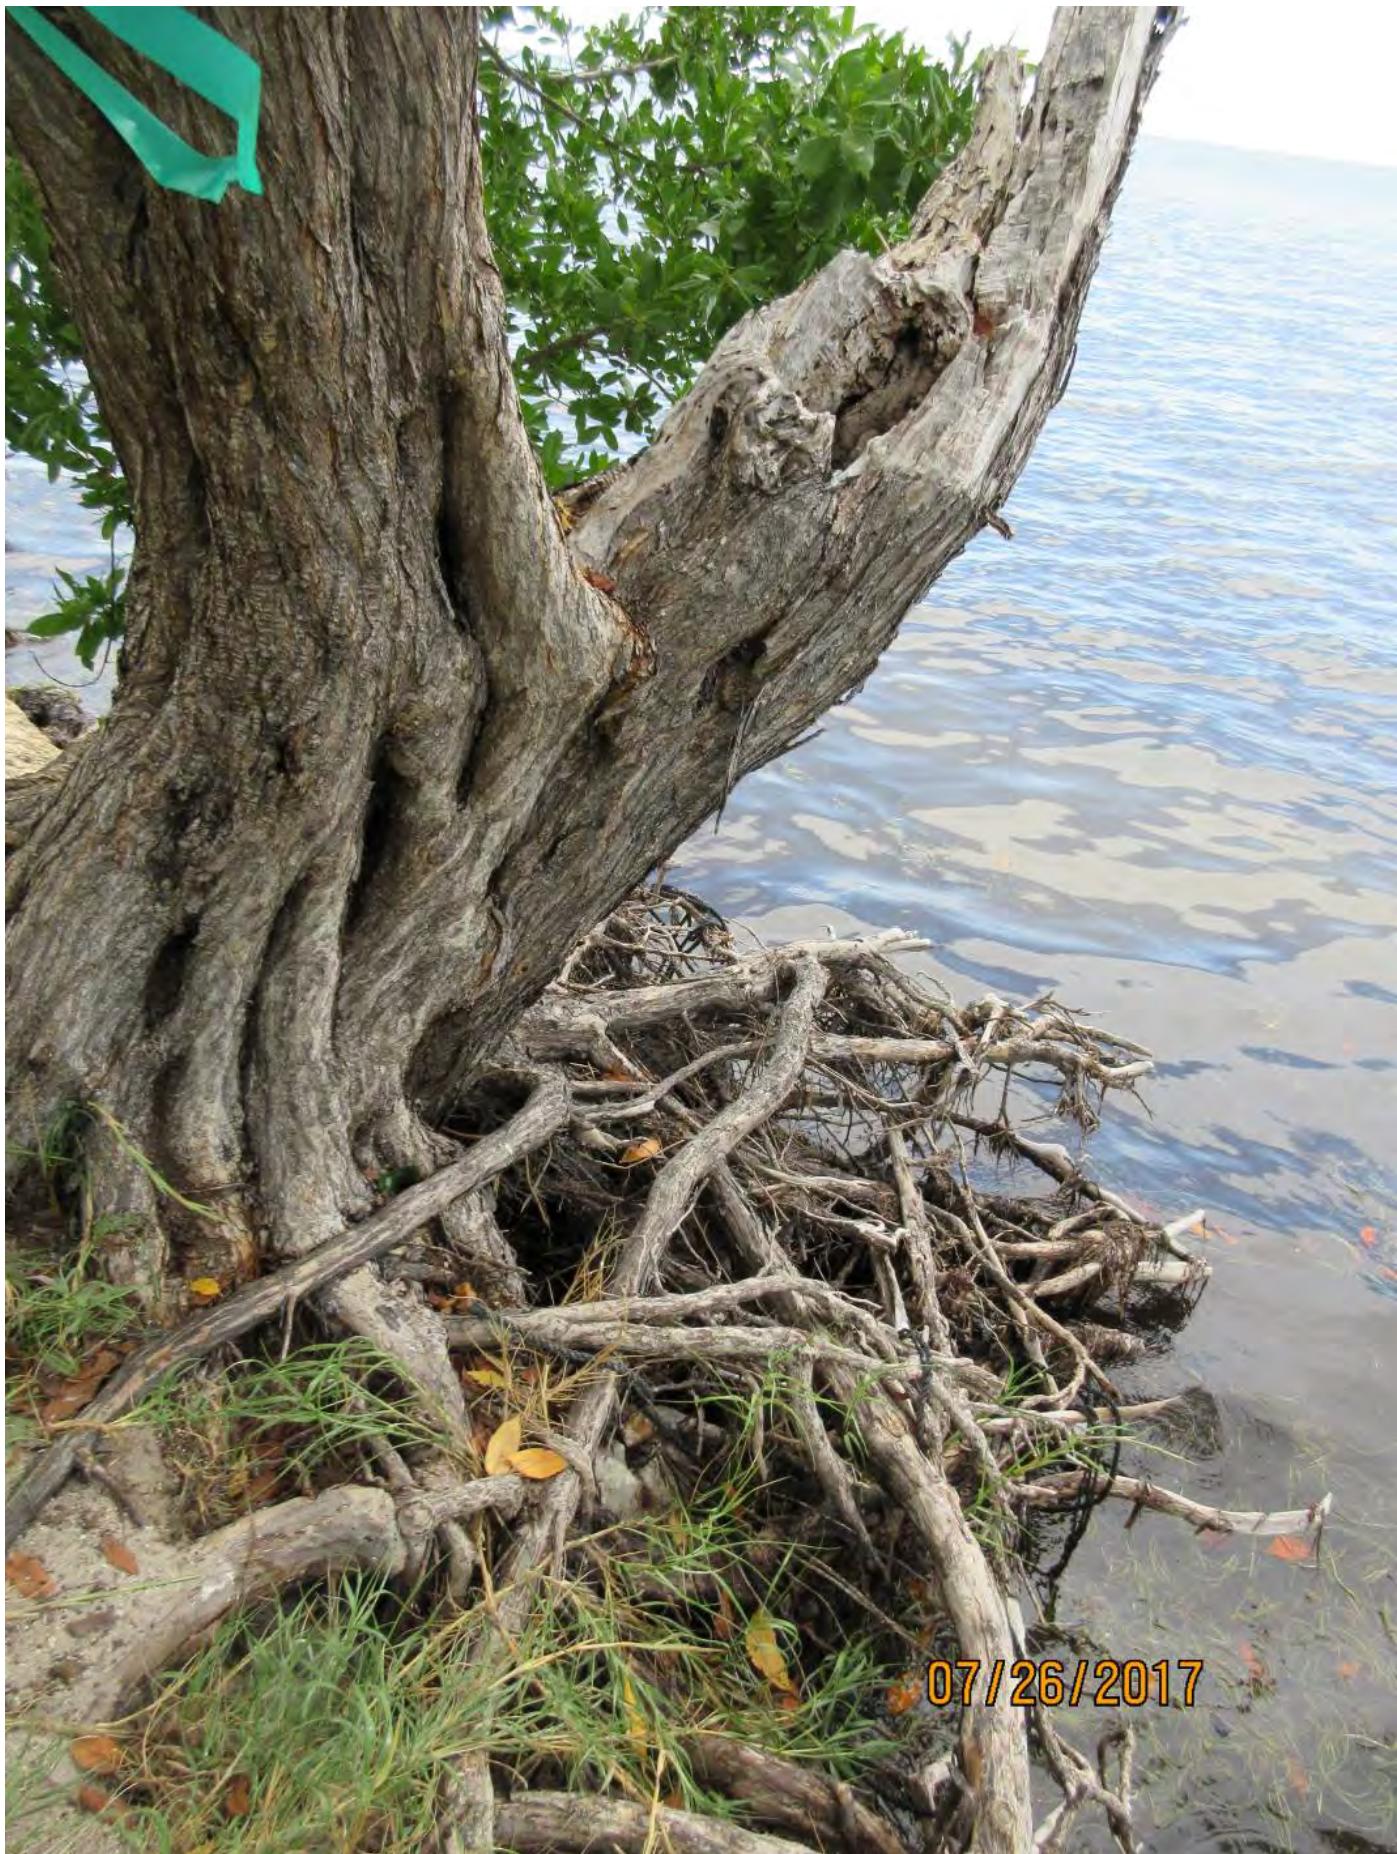
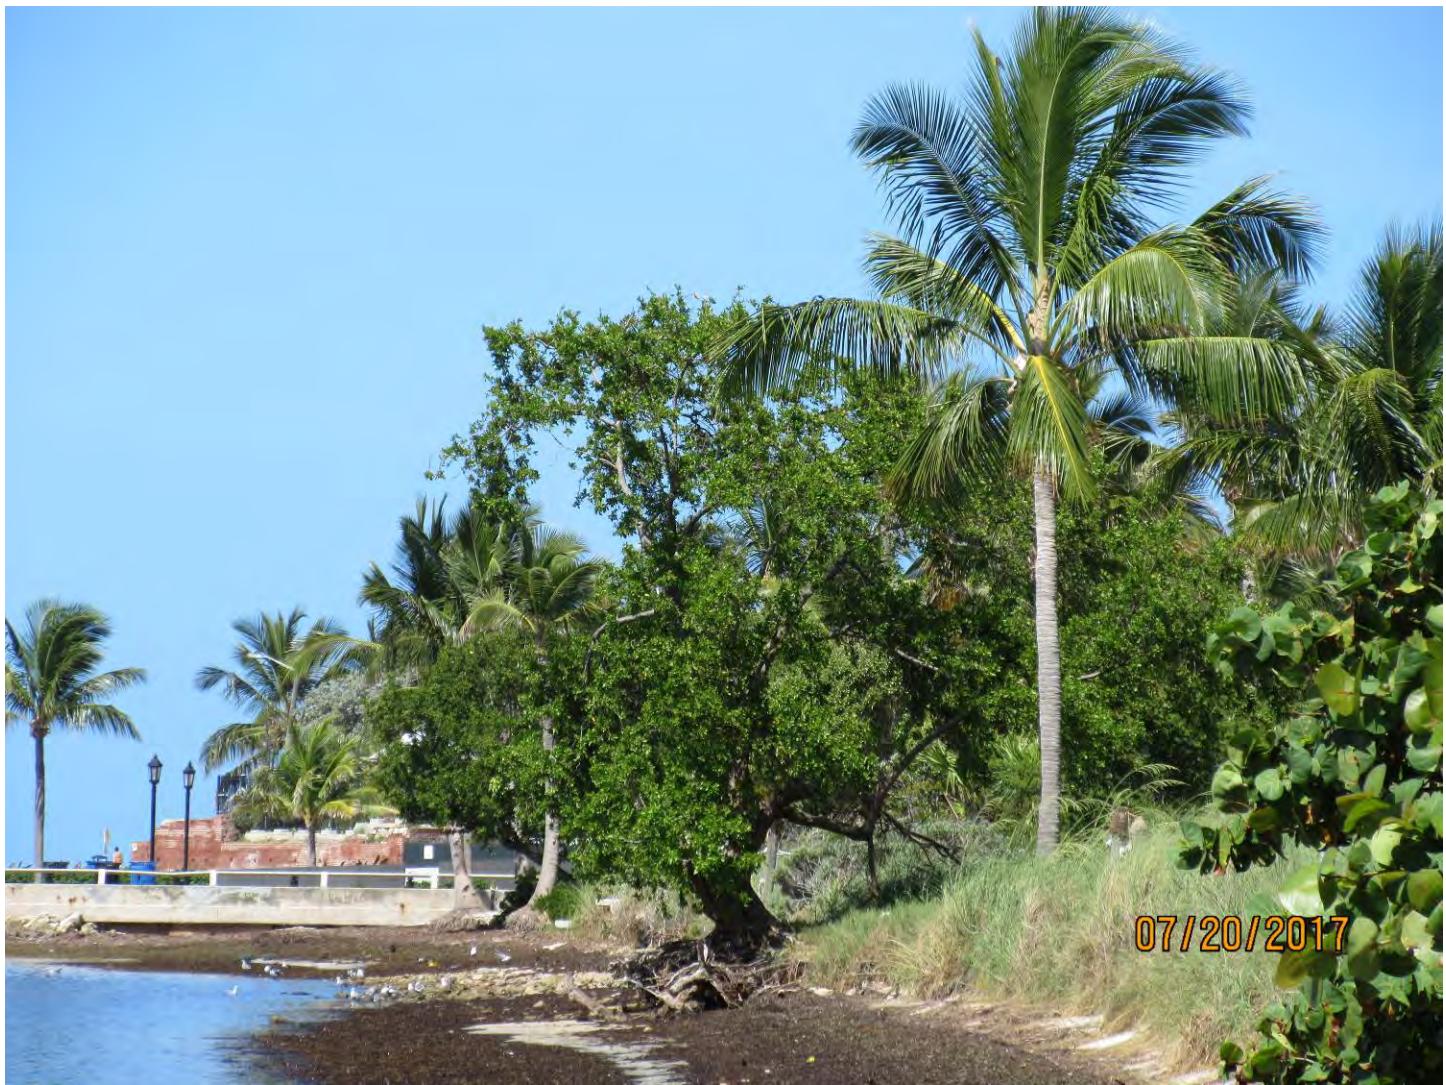
Tree#40:

Diameter: 20.3"

Location: 20% (on edge of mean high water line-in a year tree will be dead and in the water)

Species: 100% (on protected tree list)

Condition: 40% (poor, part of tree already dead due to salt water intrusion and bare root system)

Total Average Value = 53%

Value x Diameter = 10.7 replacement caliper inches

Recommend removal of tree.

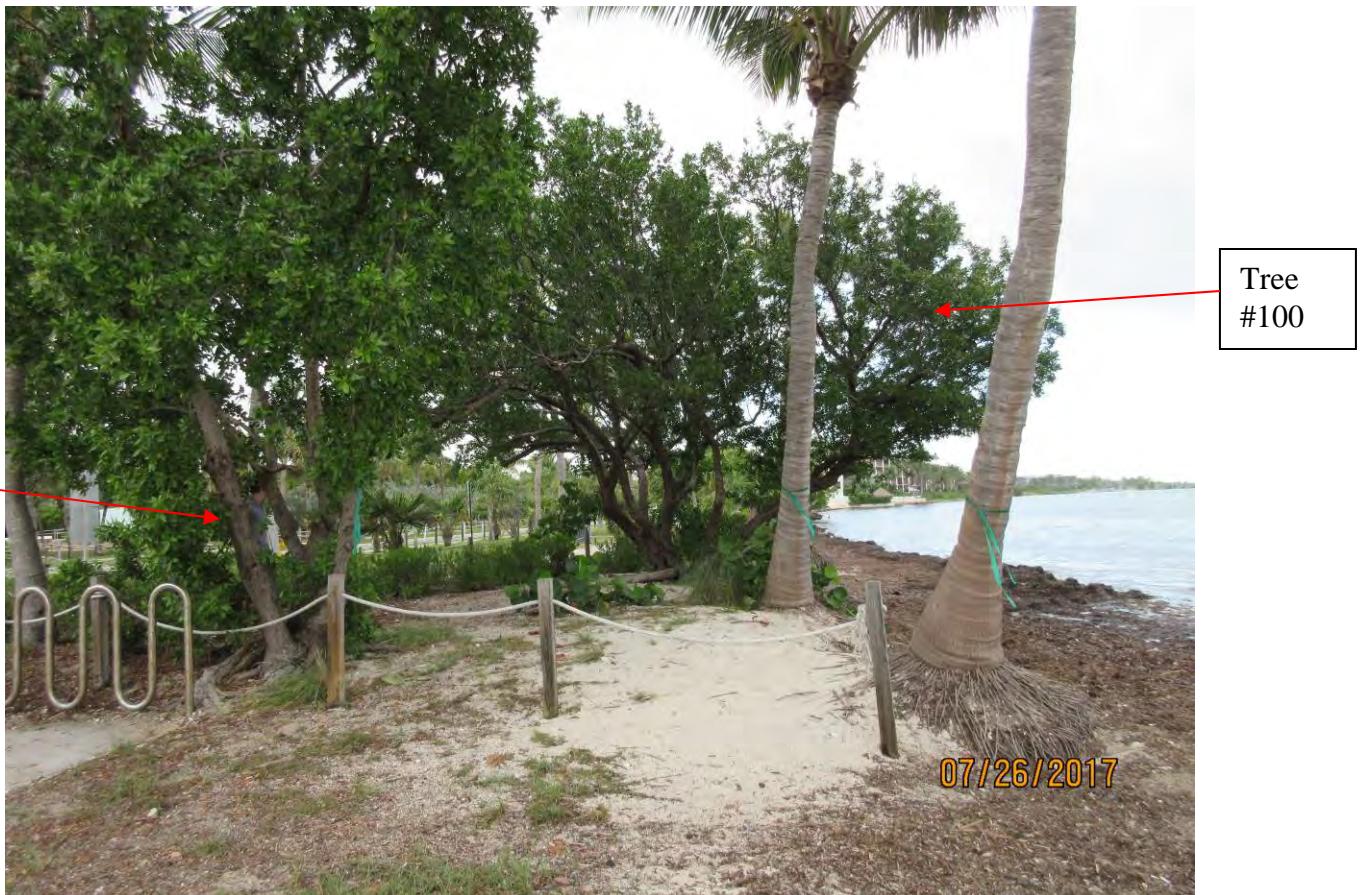
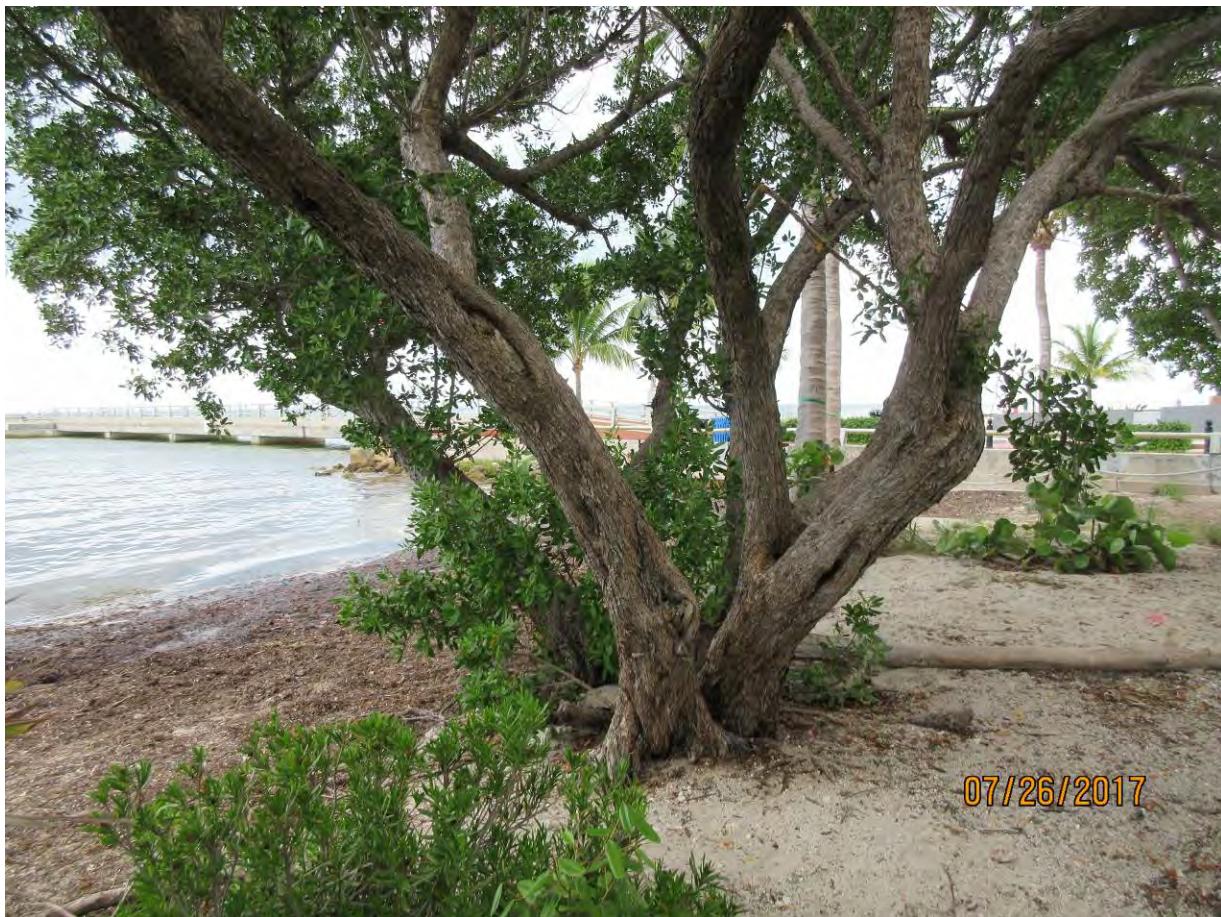
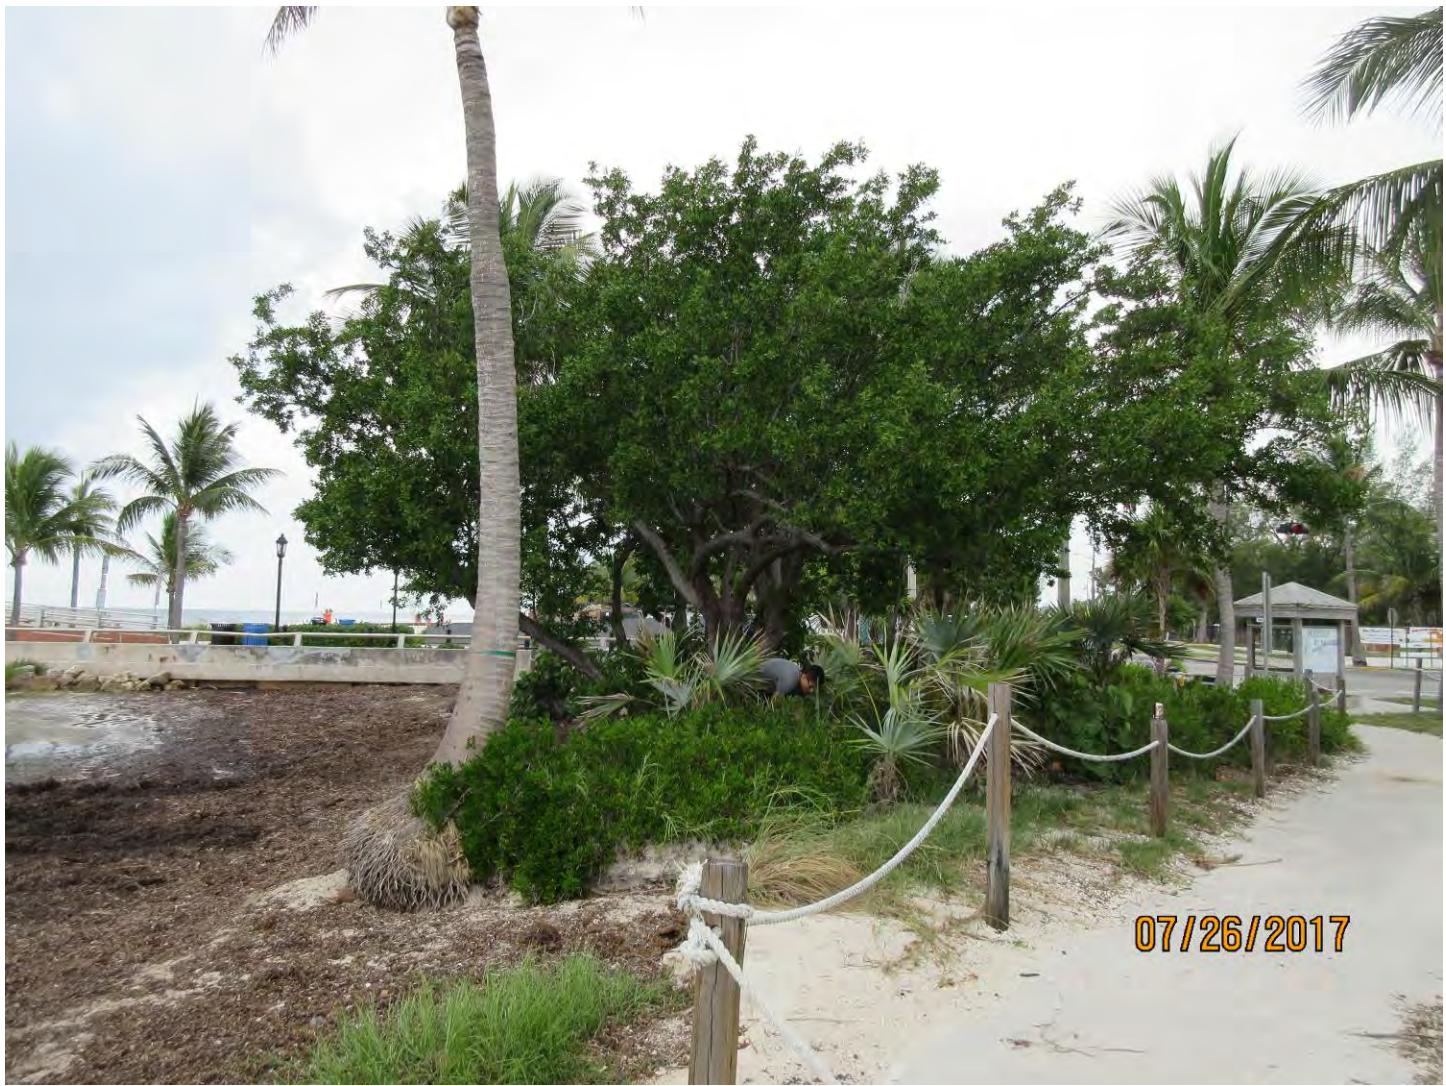
Tree# 100:

Diameter: 45.2"

Location: 90%

Species: 100% (on protected tree list)

Condition: 80% (multi trunked tree, typical dune shaped buttonwood)

Total Average Value = 90%

Value x Diameter = 40.6 replacement caliper inches

At the present time it appears that this tree is in the middle of the work area. It is not known at this time whether the tree can successfully be transplanted.
