STAFF REPORT

DATE: August 1, 2017

RE: **1300 Atlantic Boulevard (C.B. Harvey Rest Beach Park)
(permit application # T17-8522)**

FROM: Karen DeMaria, City of Key West Urban Forestry Manager

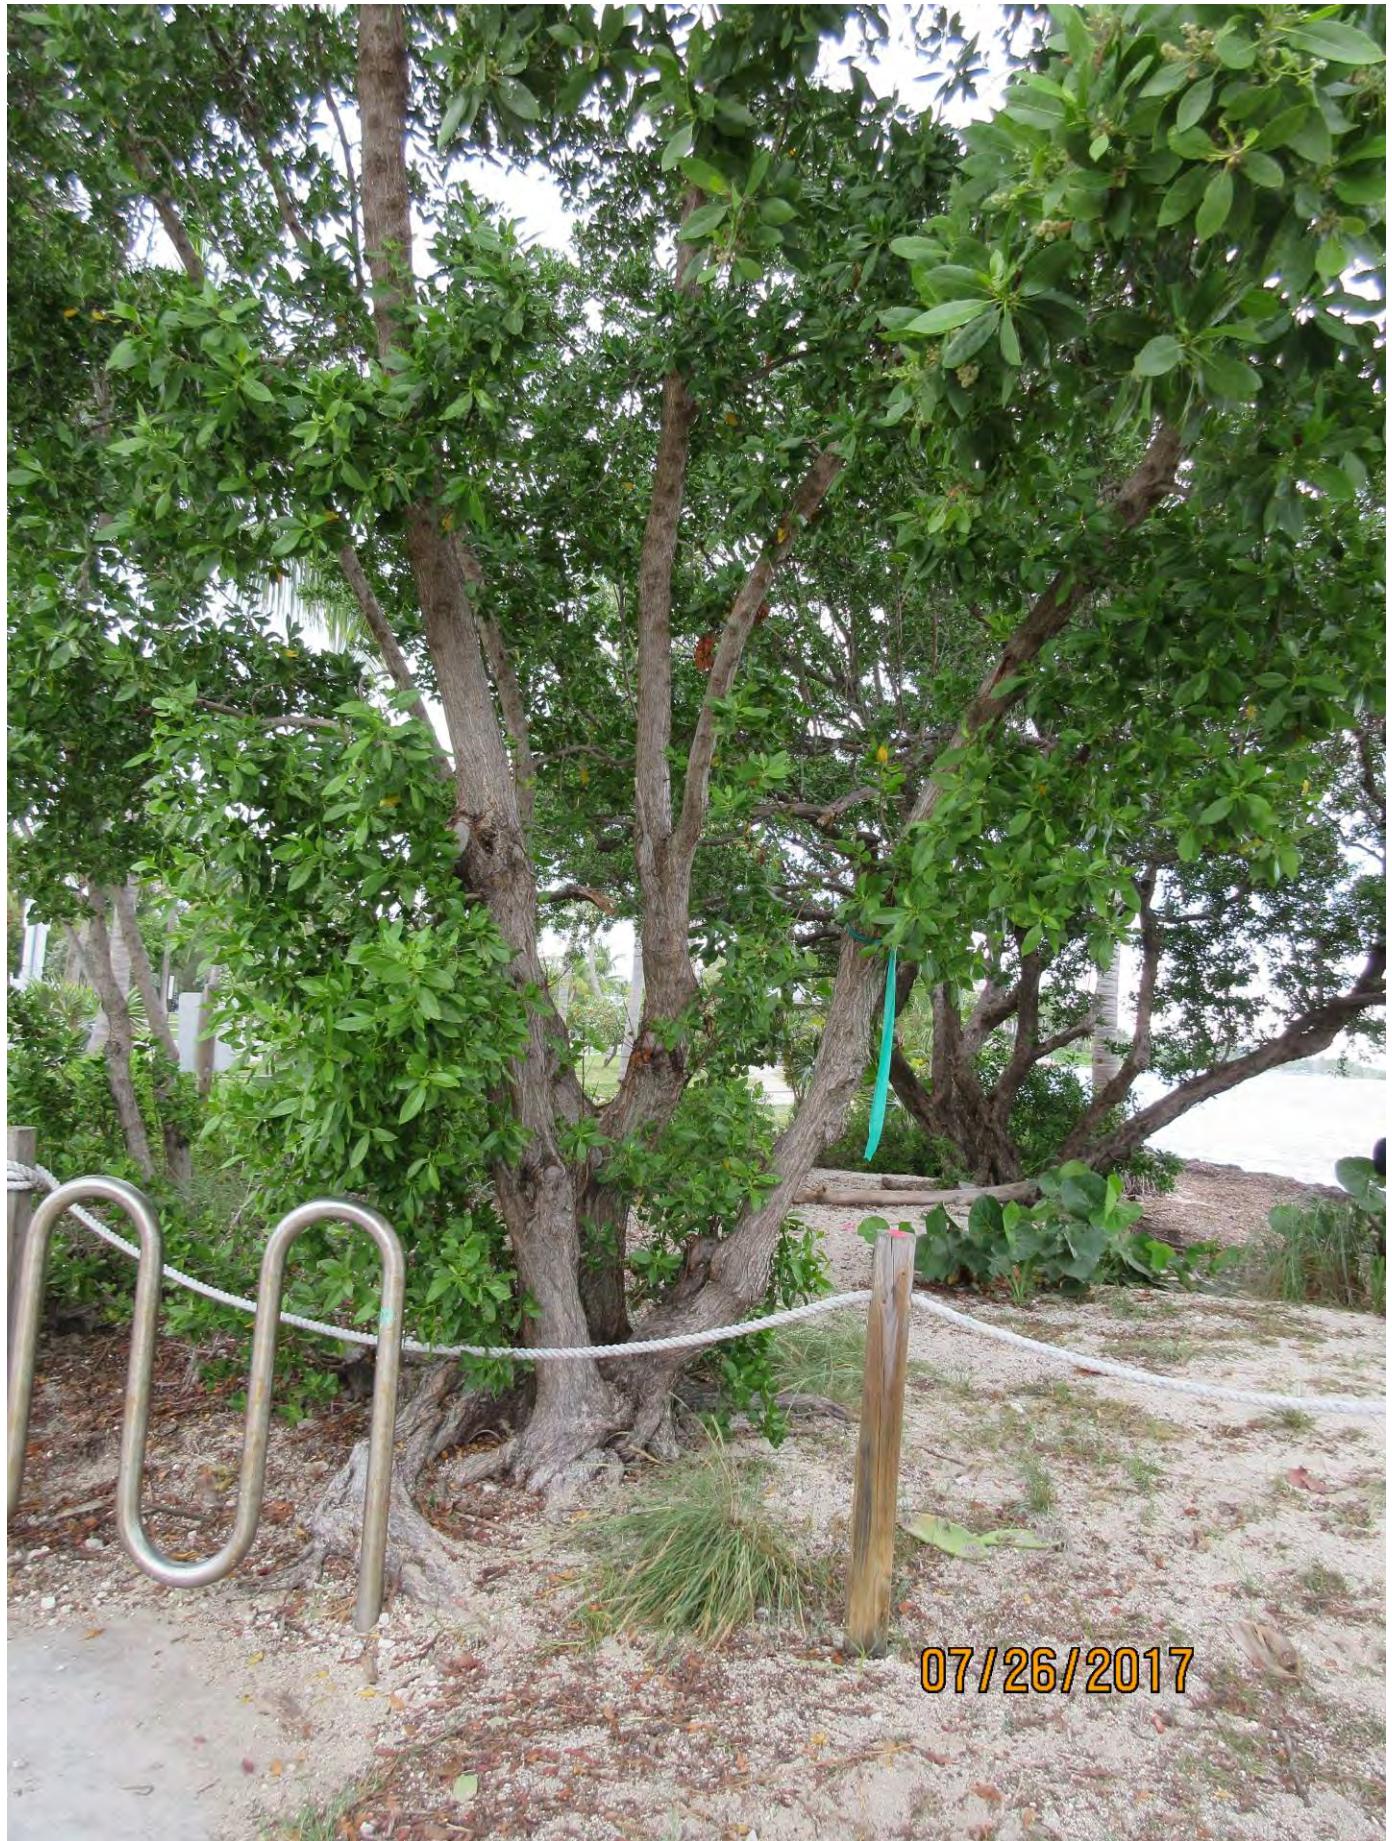
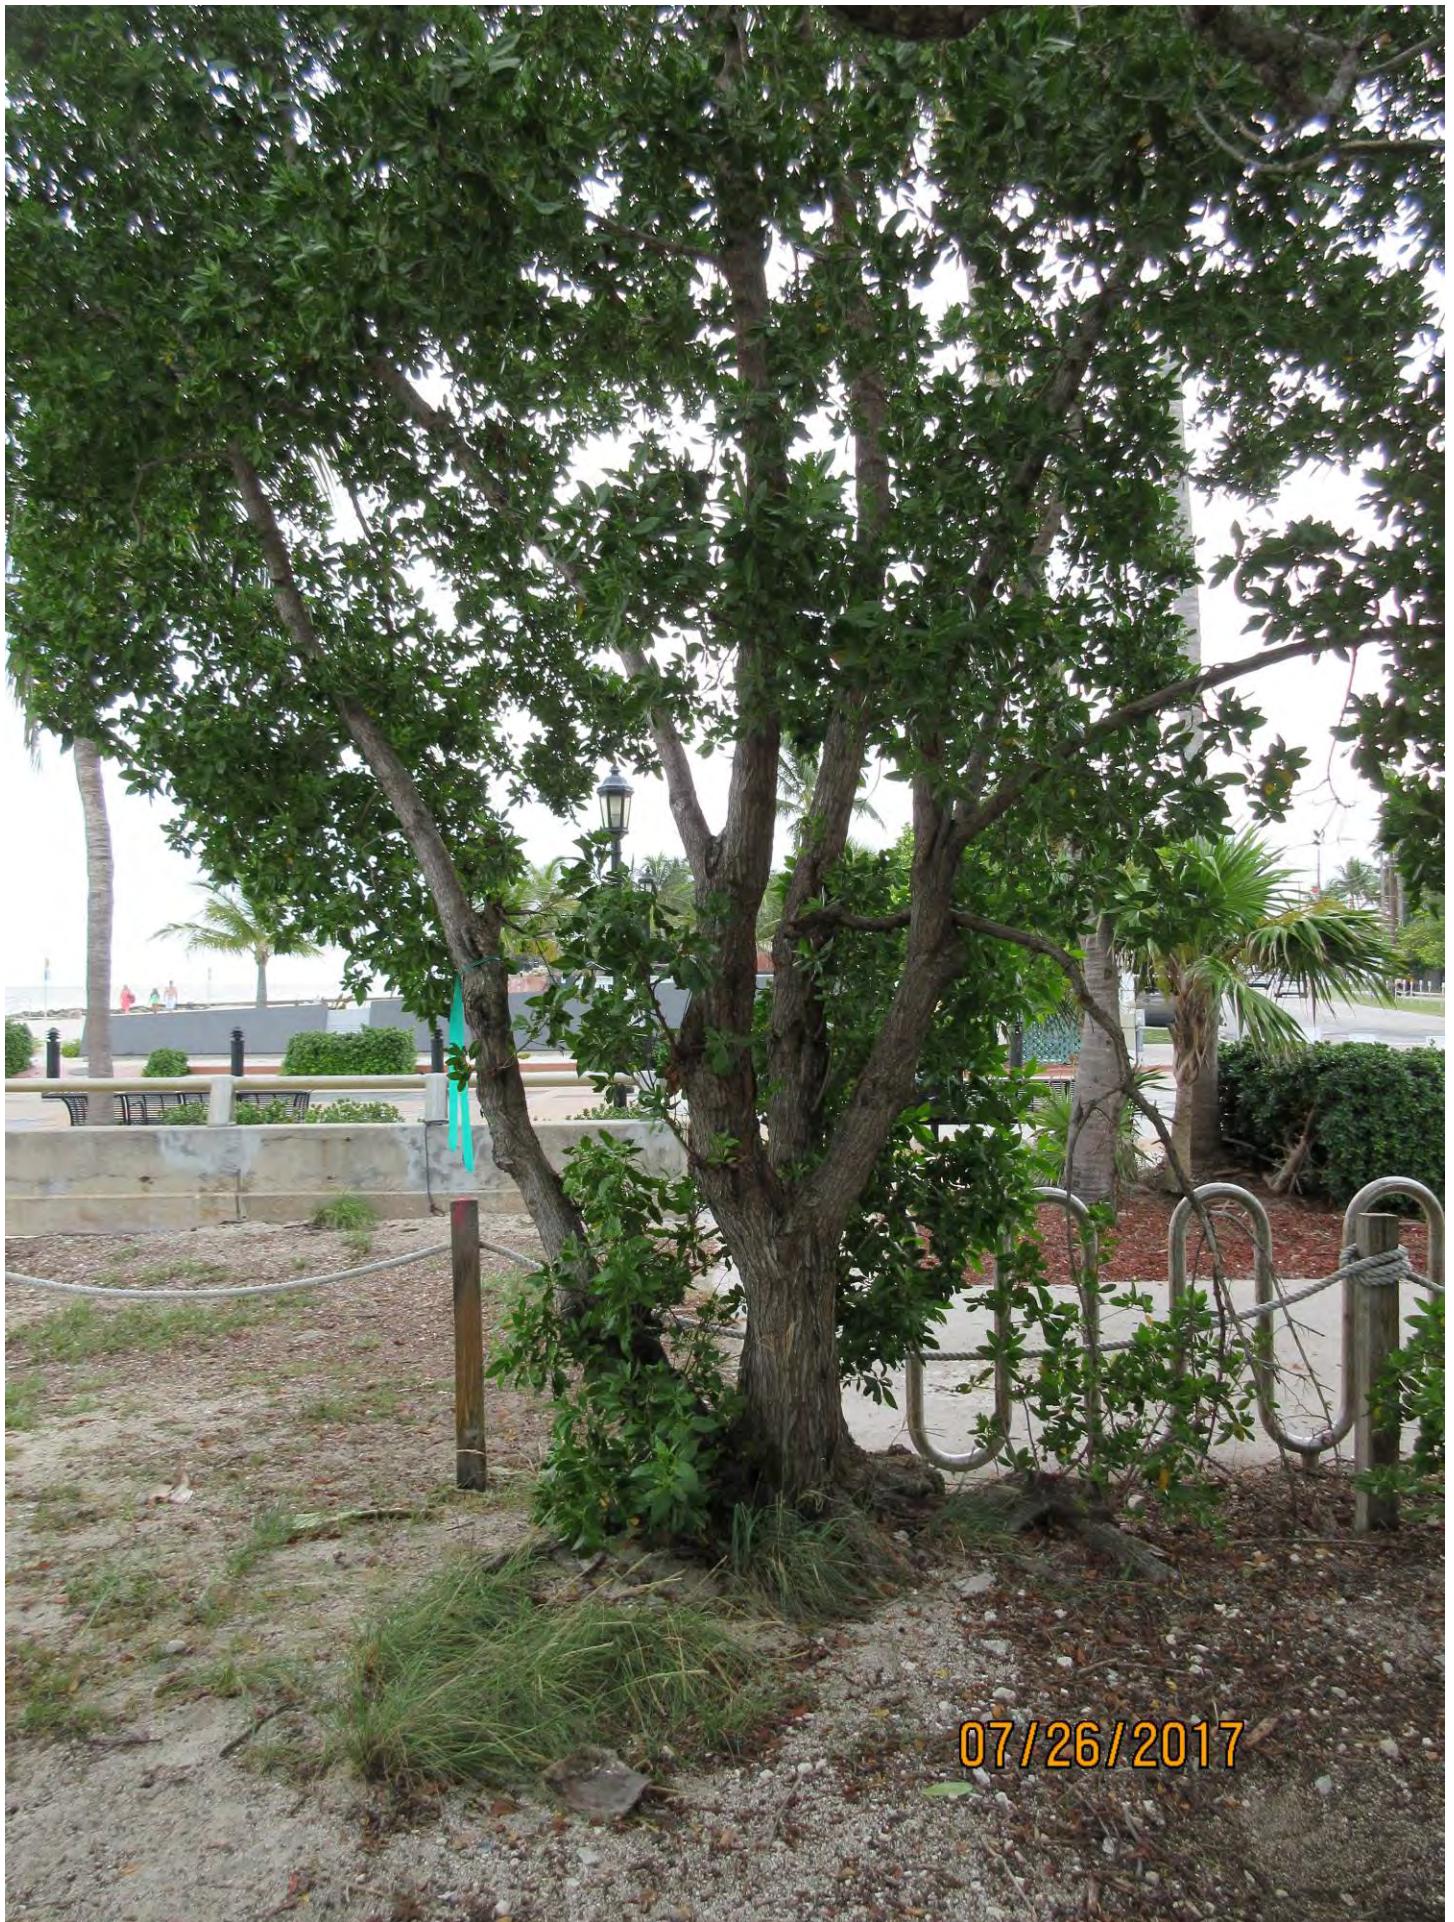
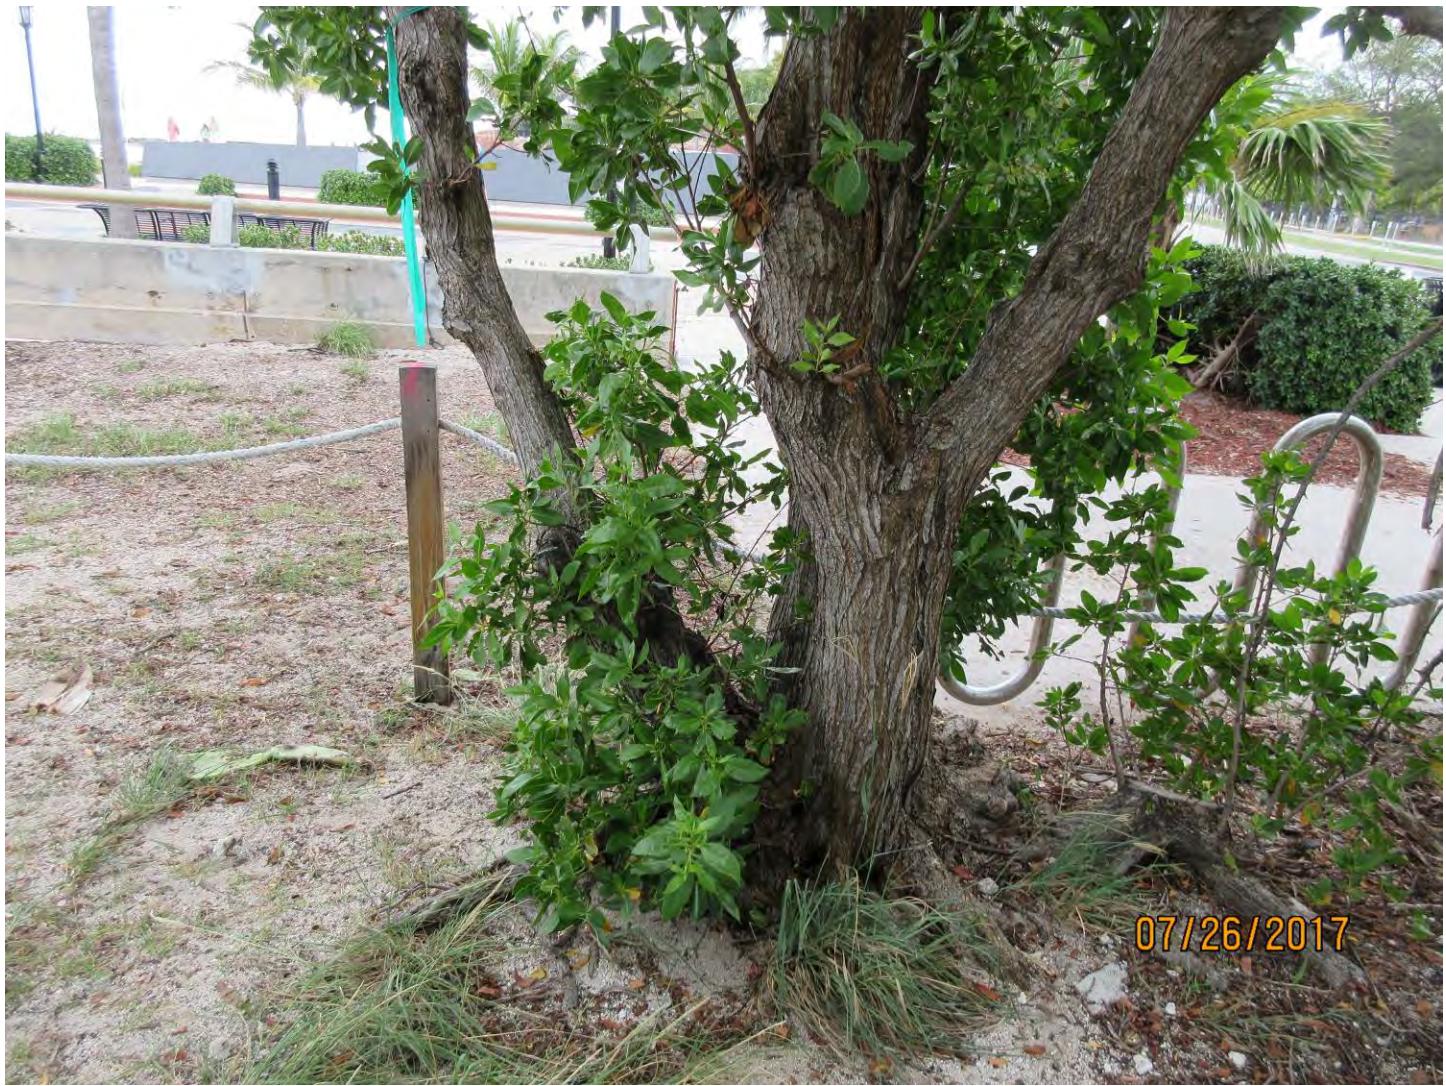
Tree #106:

Diameter: 22.9"

Location: 90%

Species: 100% (on protected tree list)

Condition: 80% (good, multitrunked tree)

Total Average Value = 90%

Value x Diameter = 20.6 replacement caliper inches

NOTE: It might be possible to do a heavy maintenance trim on the tree to remove one of the trunks. A decision will be made once site is staged for work.

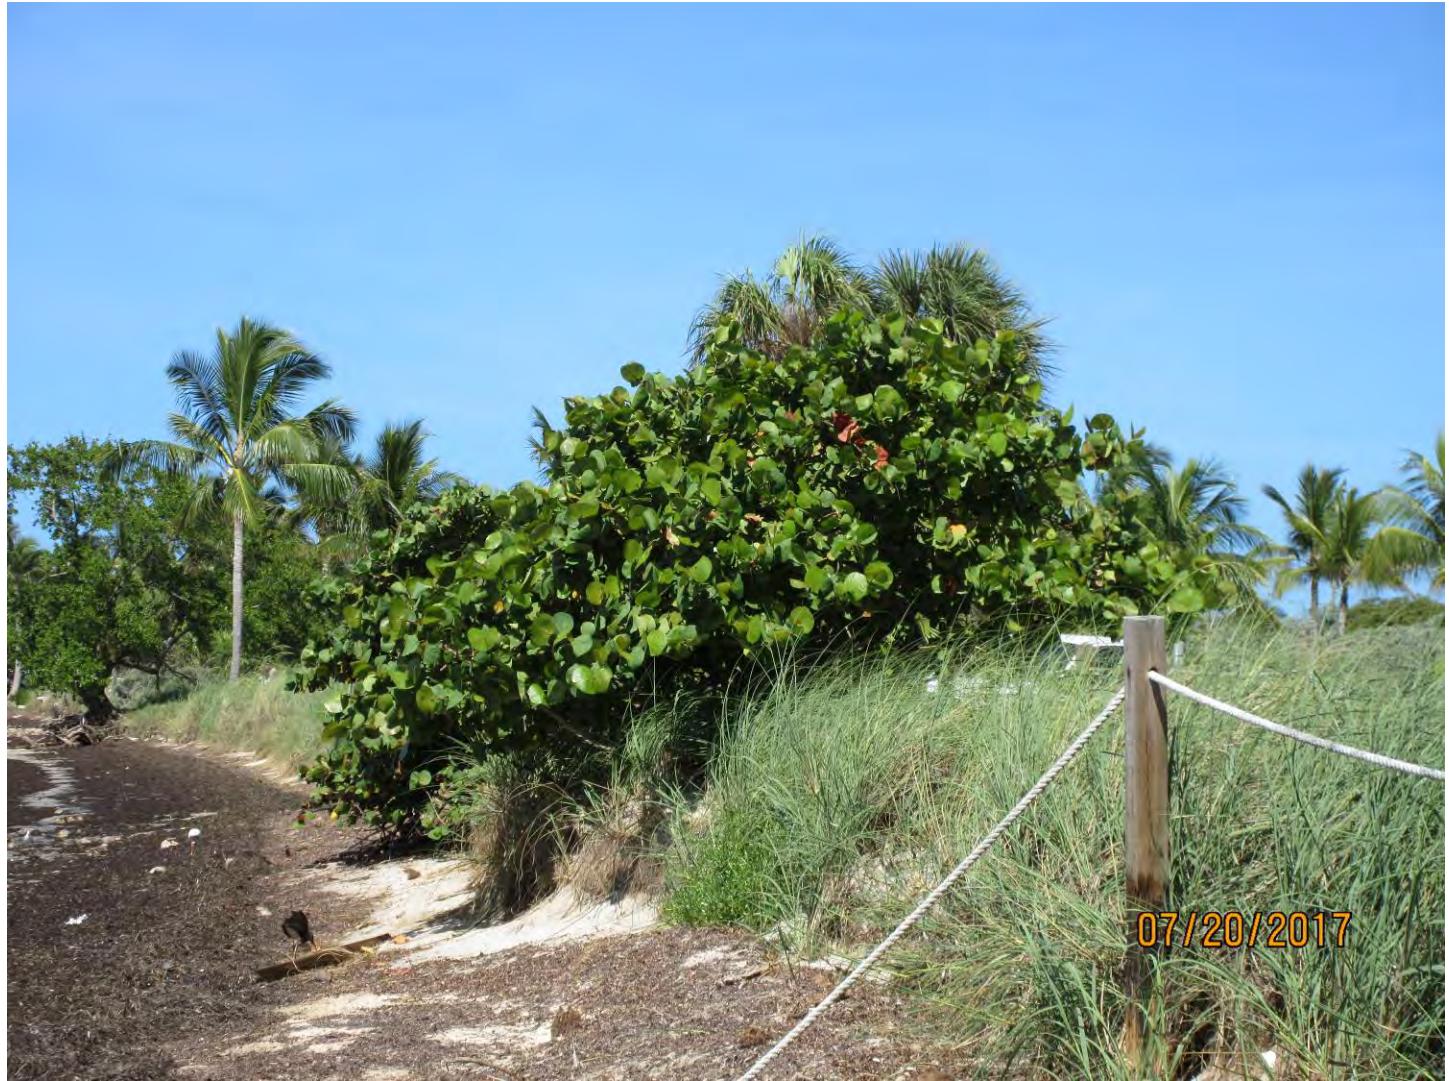
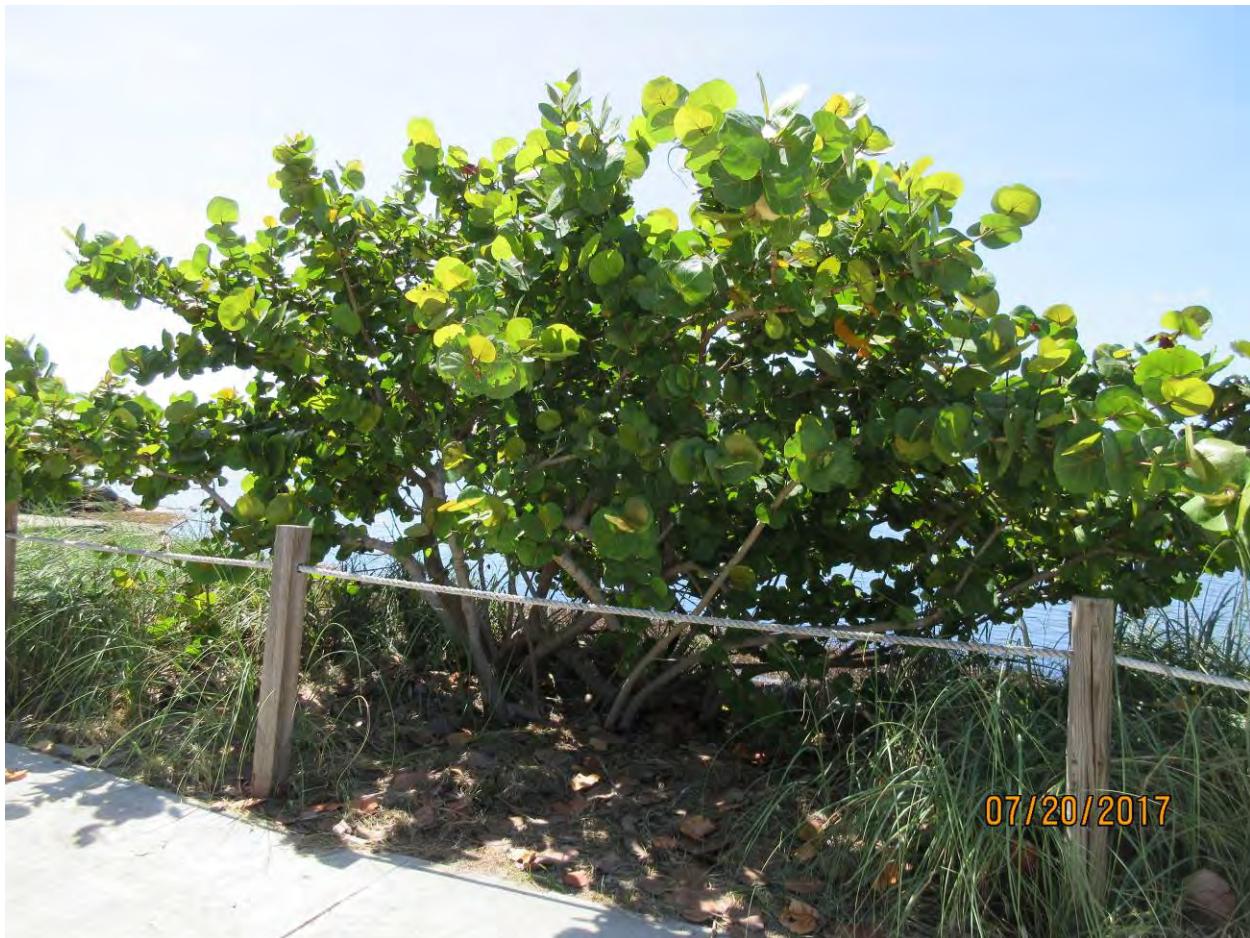
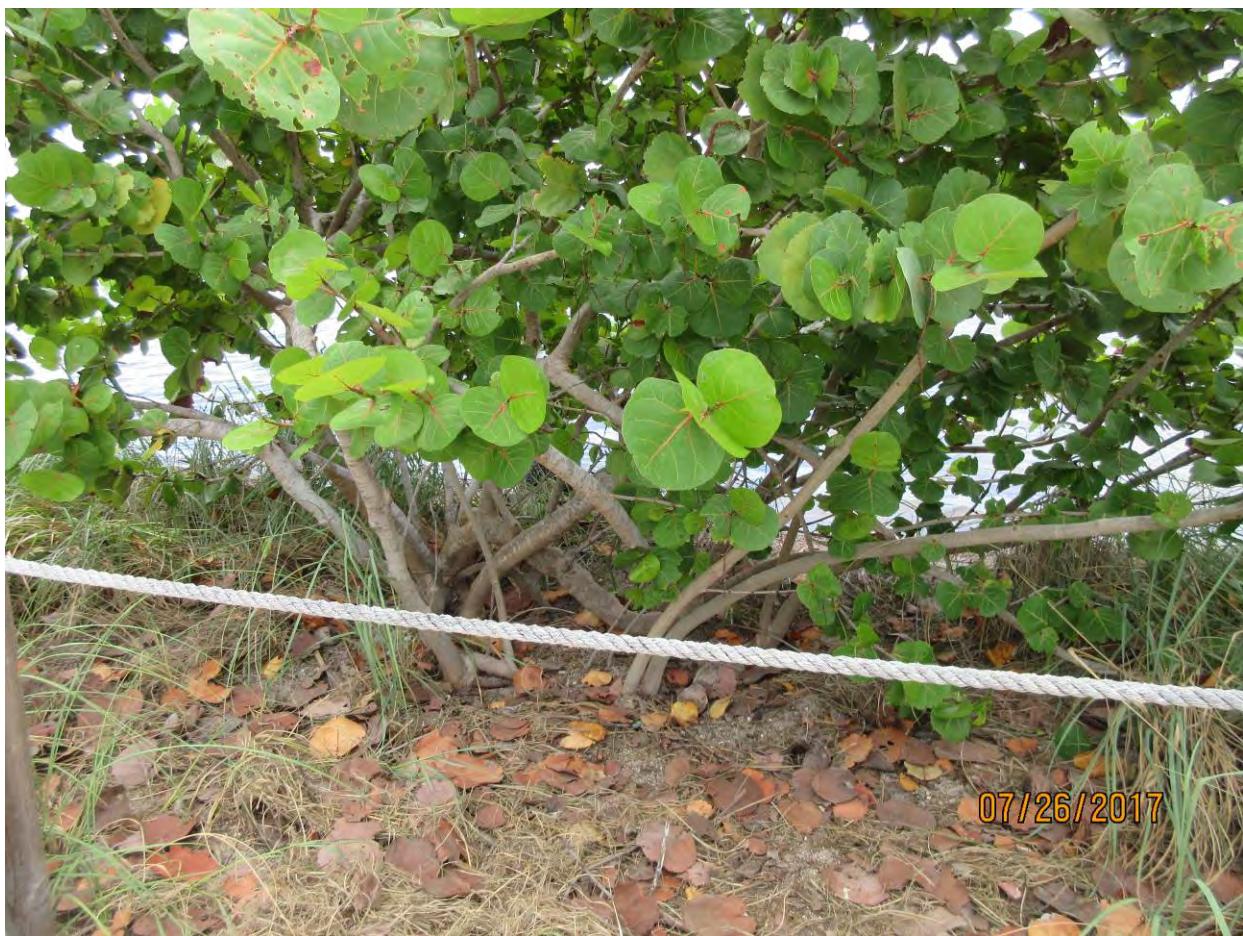
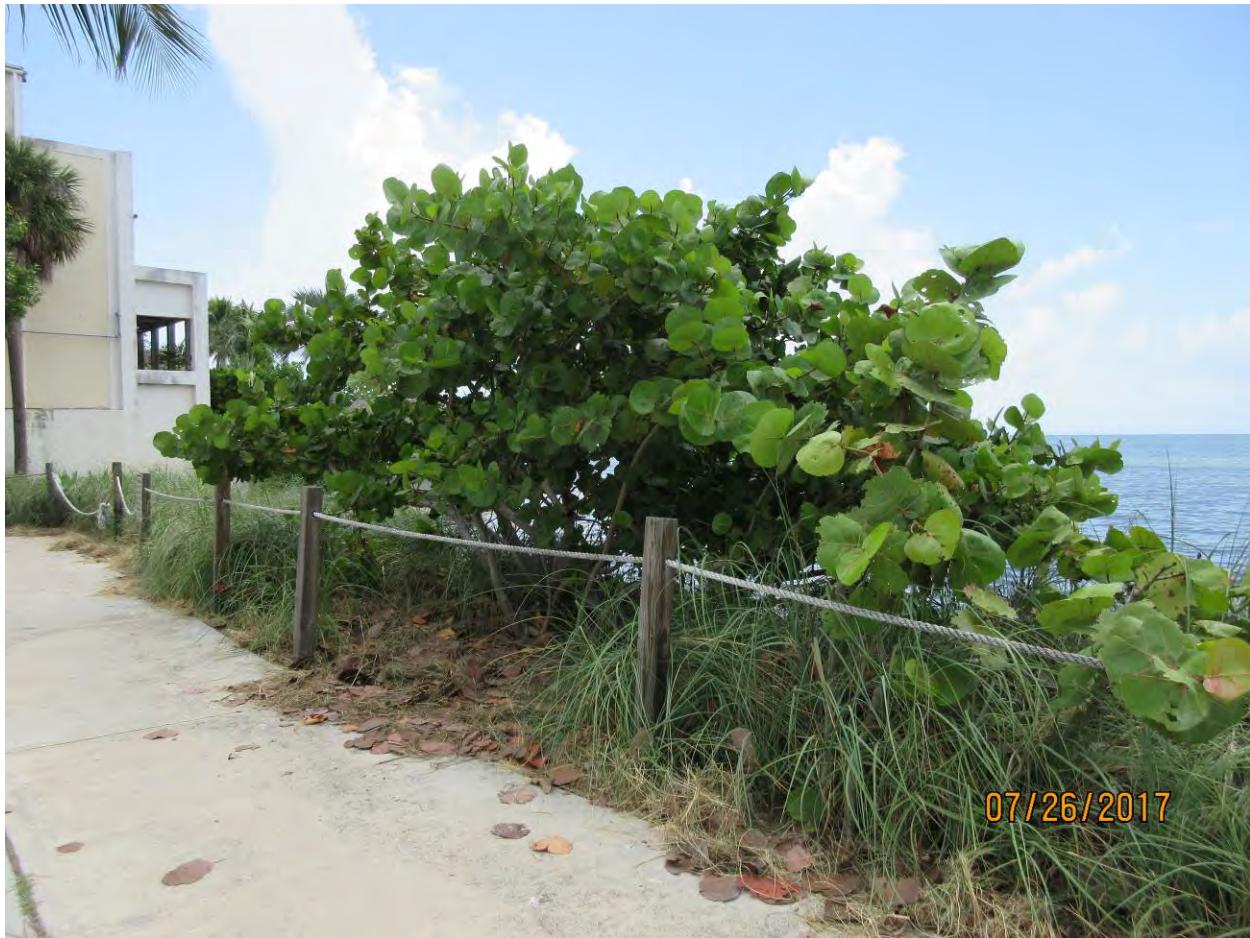
Tree #9:

Diameter: 16.5"

Location: 60% (on dune edge, continual erosion will expose roots and cause death of tree)

Species: 100% (on protected tree list)

Condition: 80% (good, sprawling tree structure-typical dune/beach tree)

Total Average Value = 80%

Value x Diameter = 13.2 replacement caliper inches

It appears that this tree is in the middle of the work area. It is not known at this time whether the tree can successfully be transplanted.

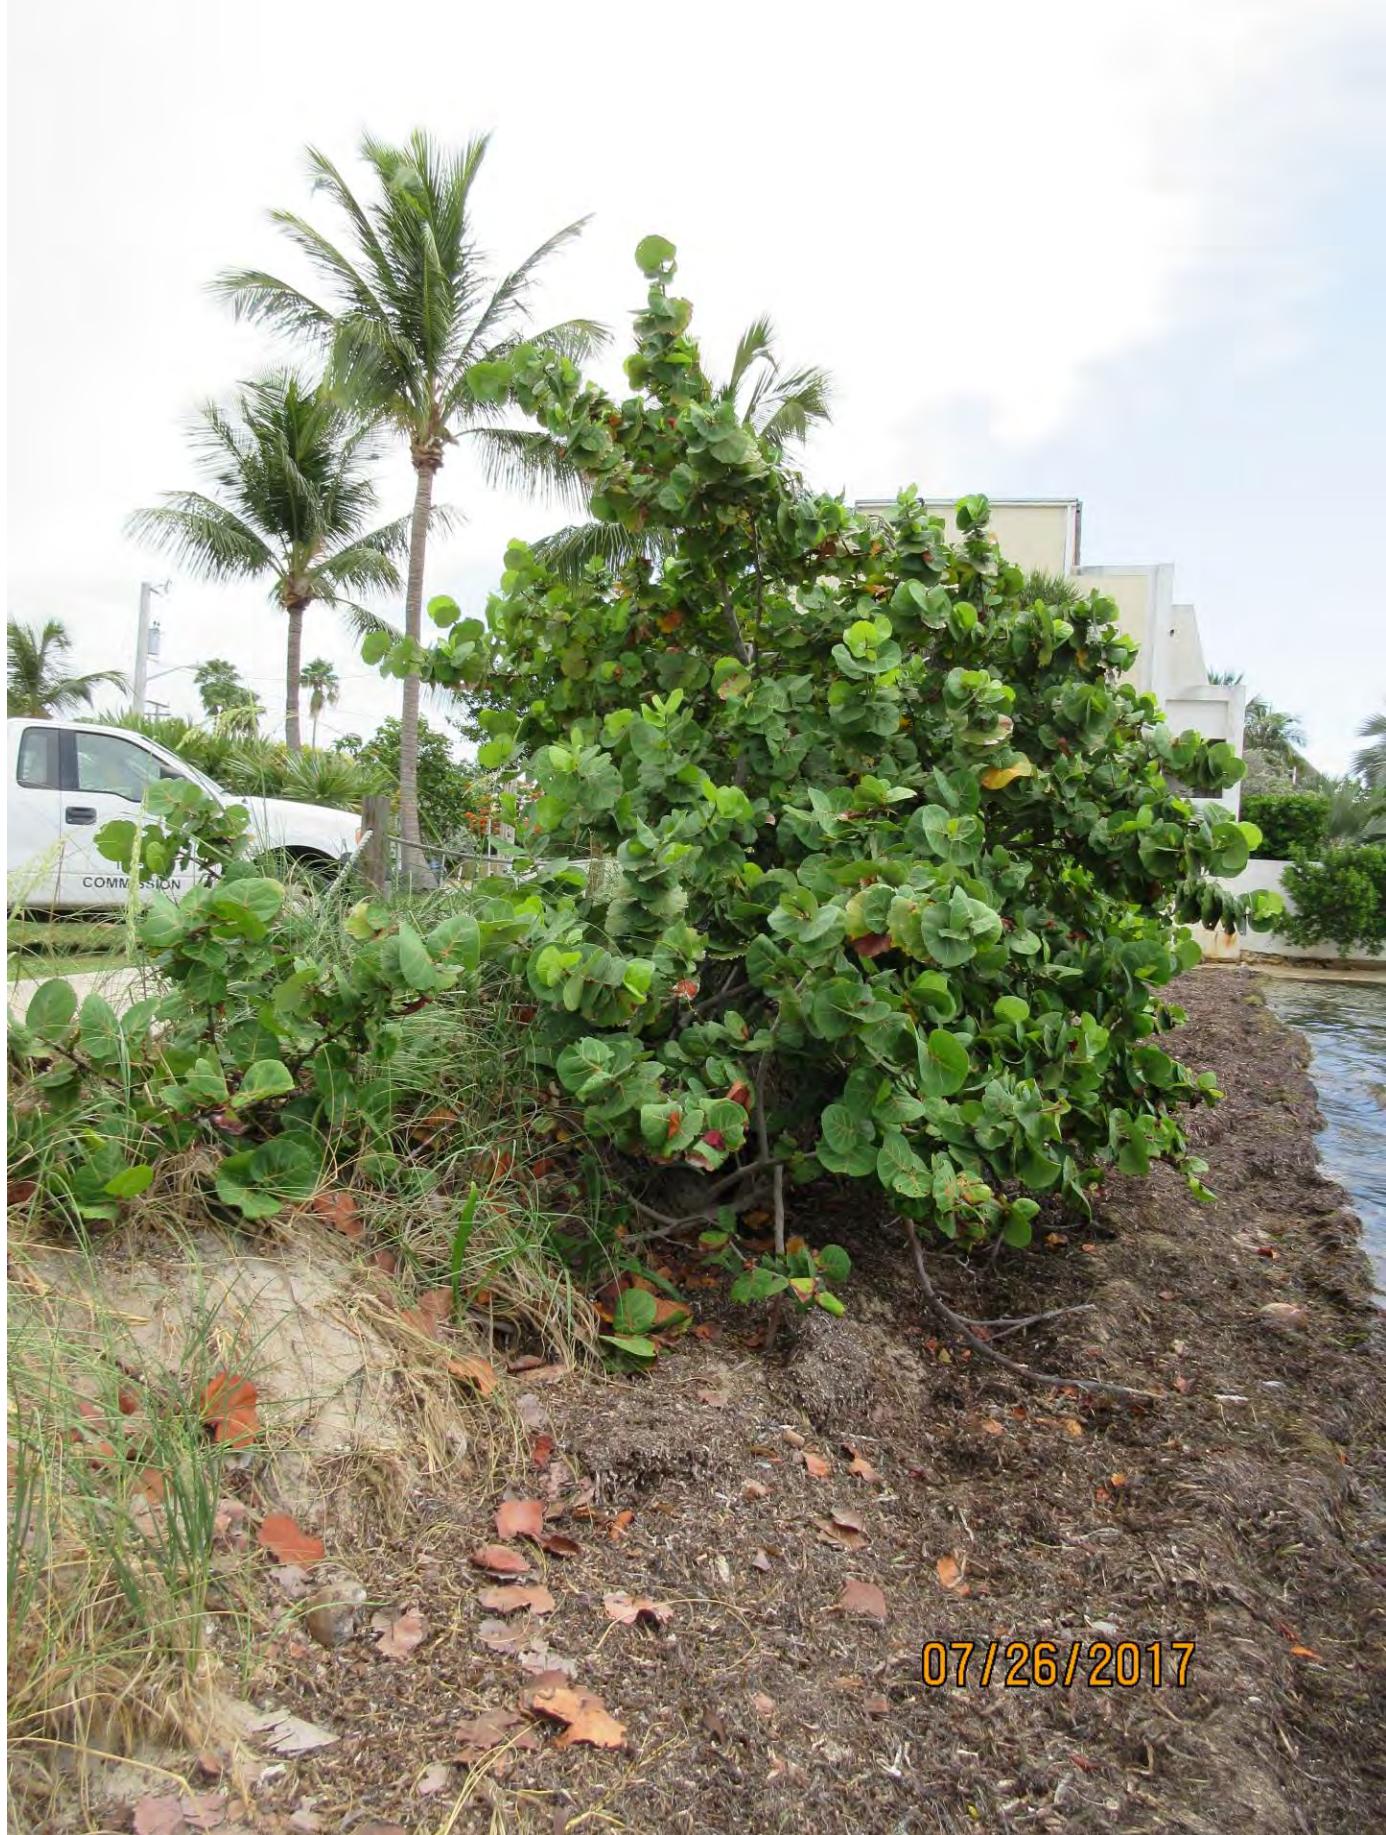
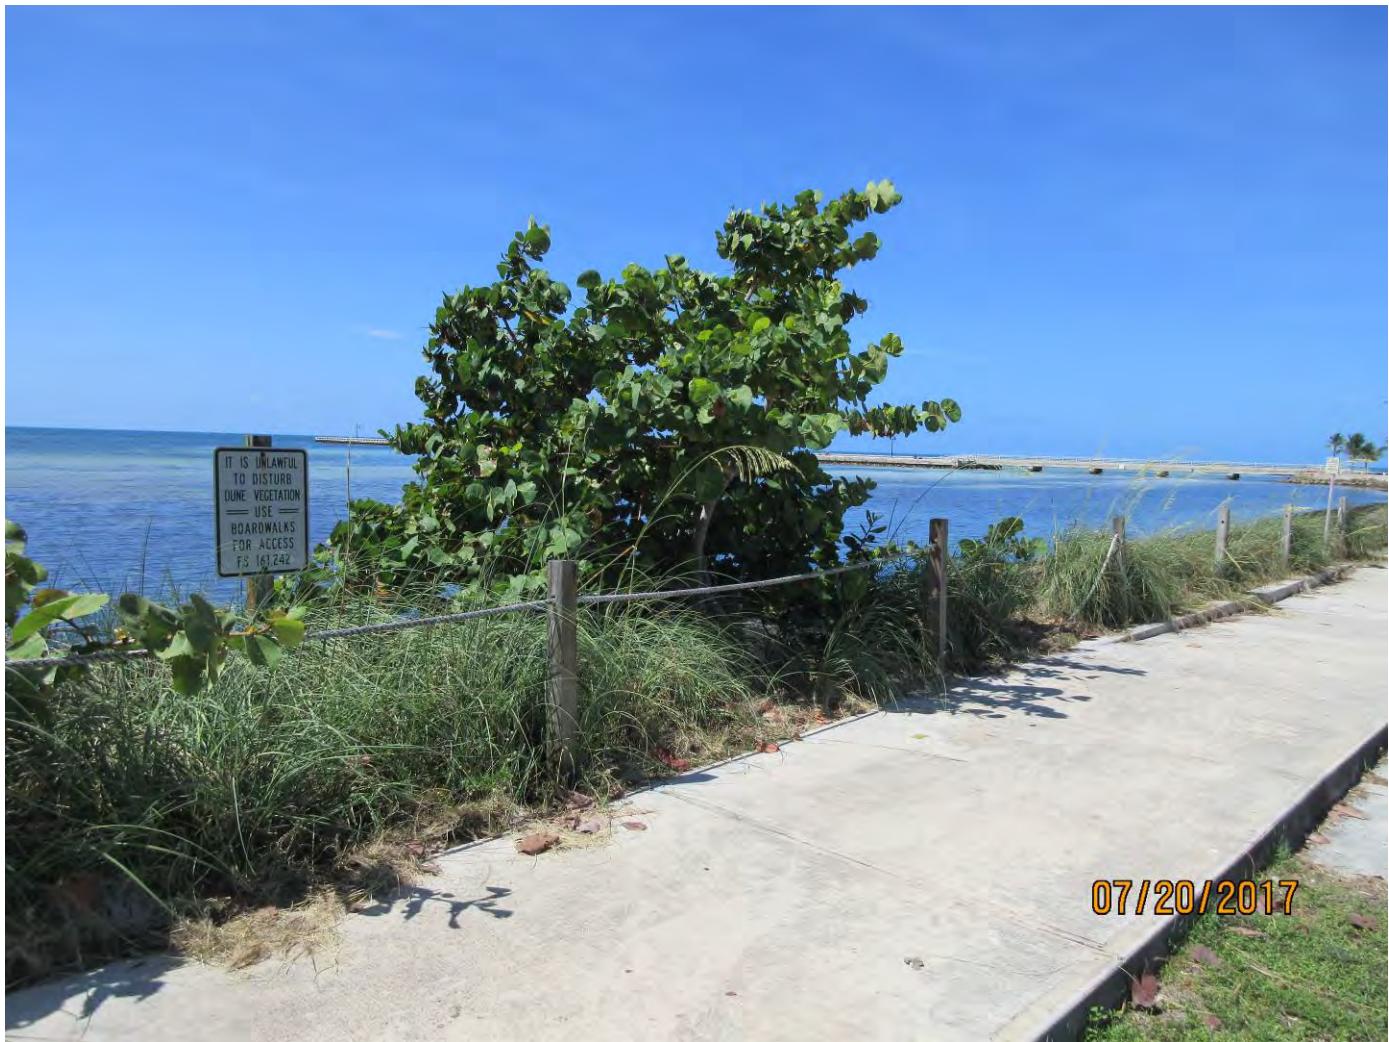
Tree#13:

Diameter: 12.7"

Location: 60% (on dune edge, continual erosion will expose roots and cause death of tree)

Species: 100% (on protected tree list)

Condition: 60% (fair, sprawling tree structure-typical dune/beach tree)

Total Average Value = 73%

Value x Diameter = 9.2 replacement caliper inches

It appears that this tree is in the middle of the work area. It is not known at this time whether the tree can successfully be transplanted.

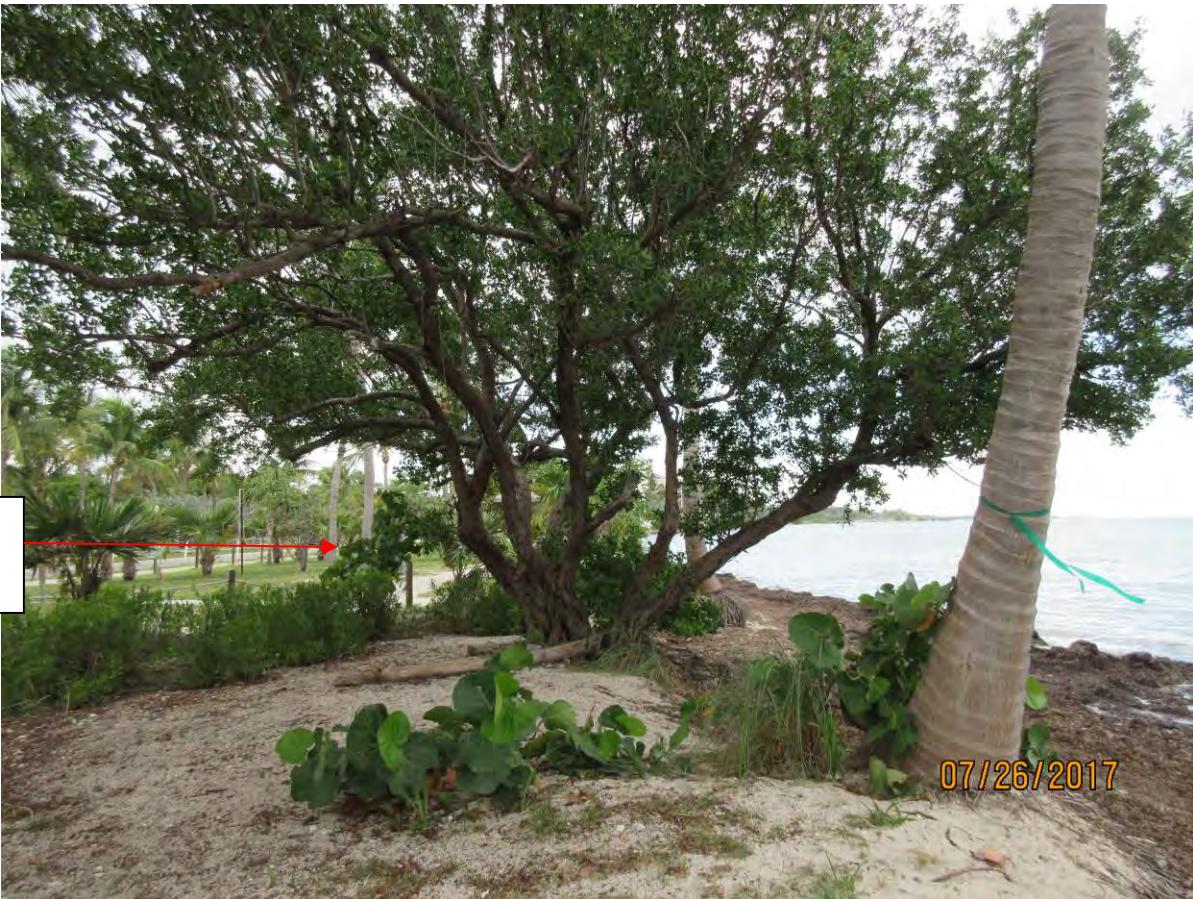
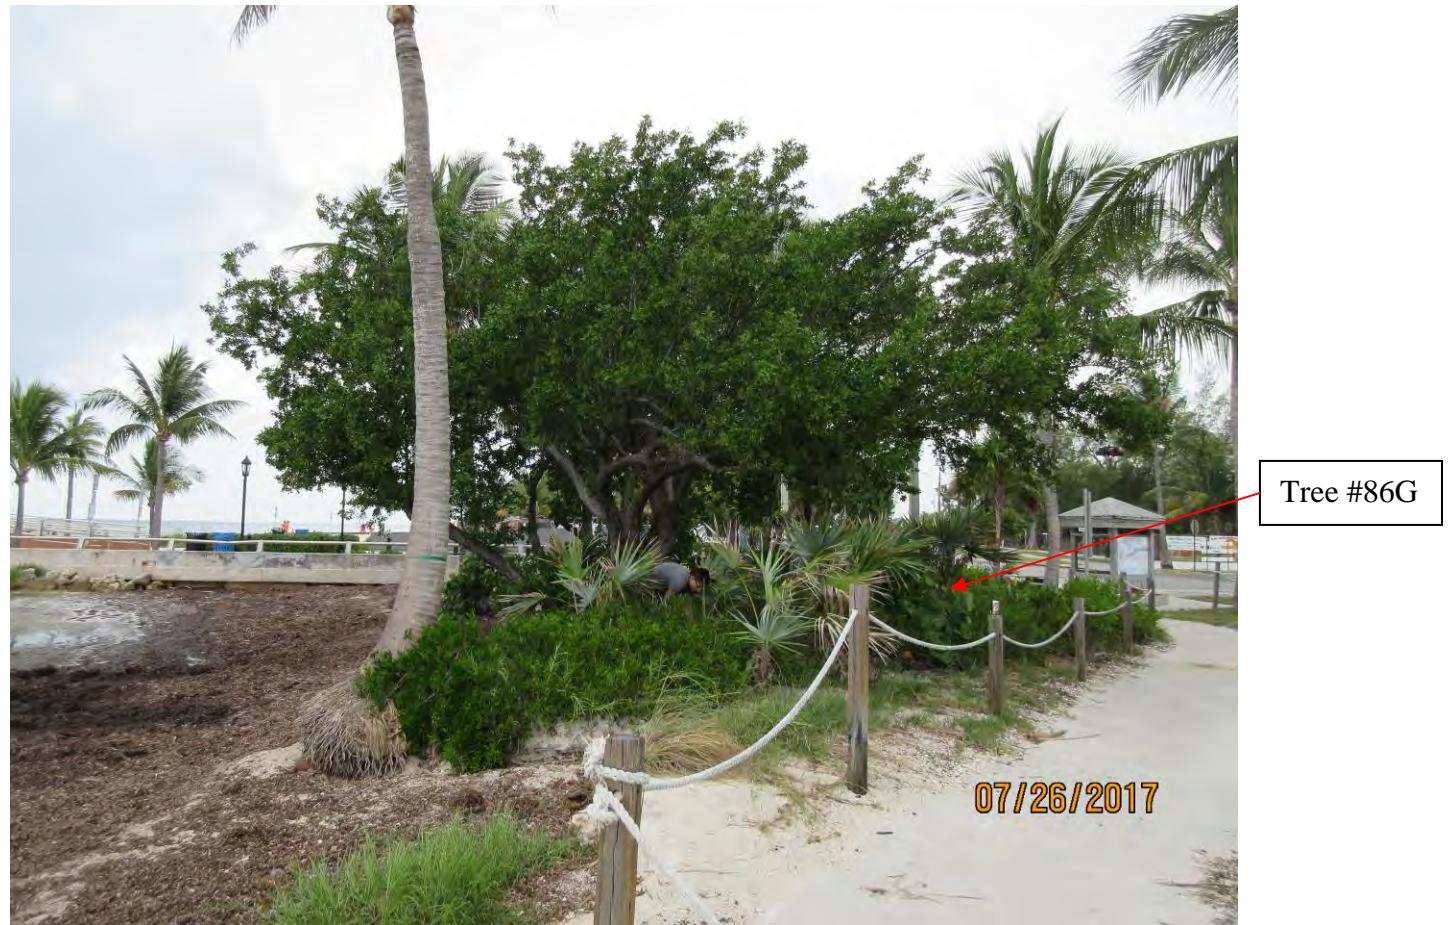
Tree #86G:

Diameter: 1"

Location: 90%

Species: 100% (on protected tree list)

Condition: 60% (fair, young tree)

Total Average Value = 83%

Value x Diameter = 0.83 replacement caliper inches

It appears that this tree is in the middle of the work area. It is not known at this time whether the tree can successfully be transplanted.

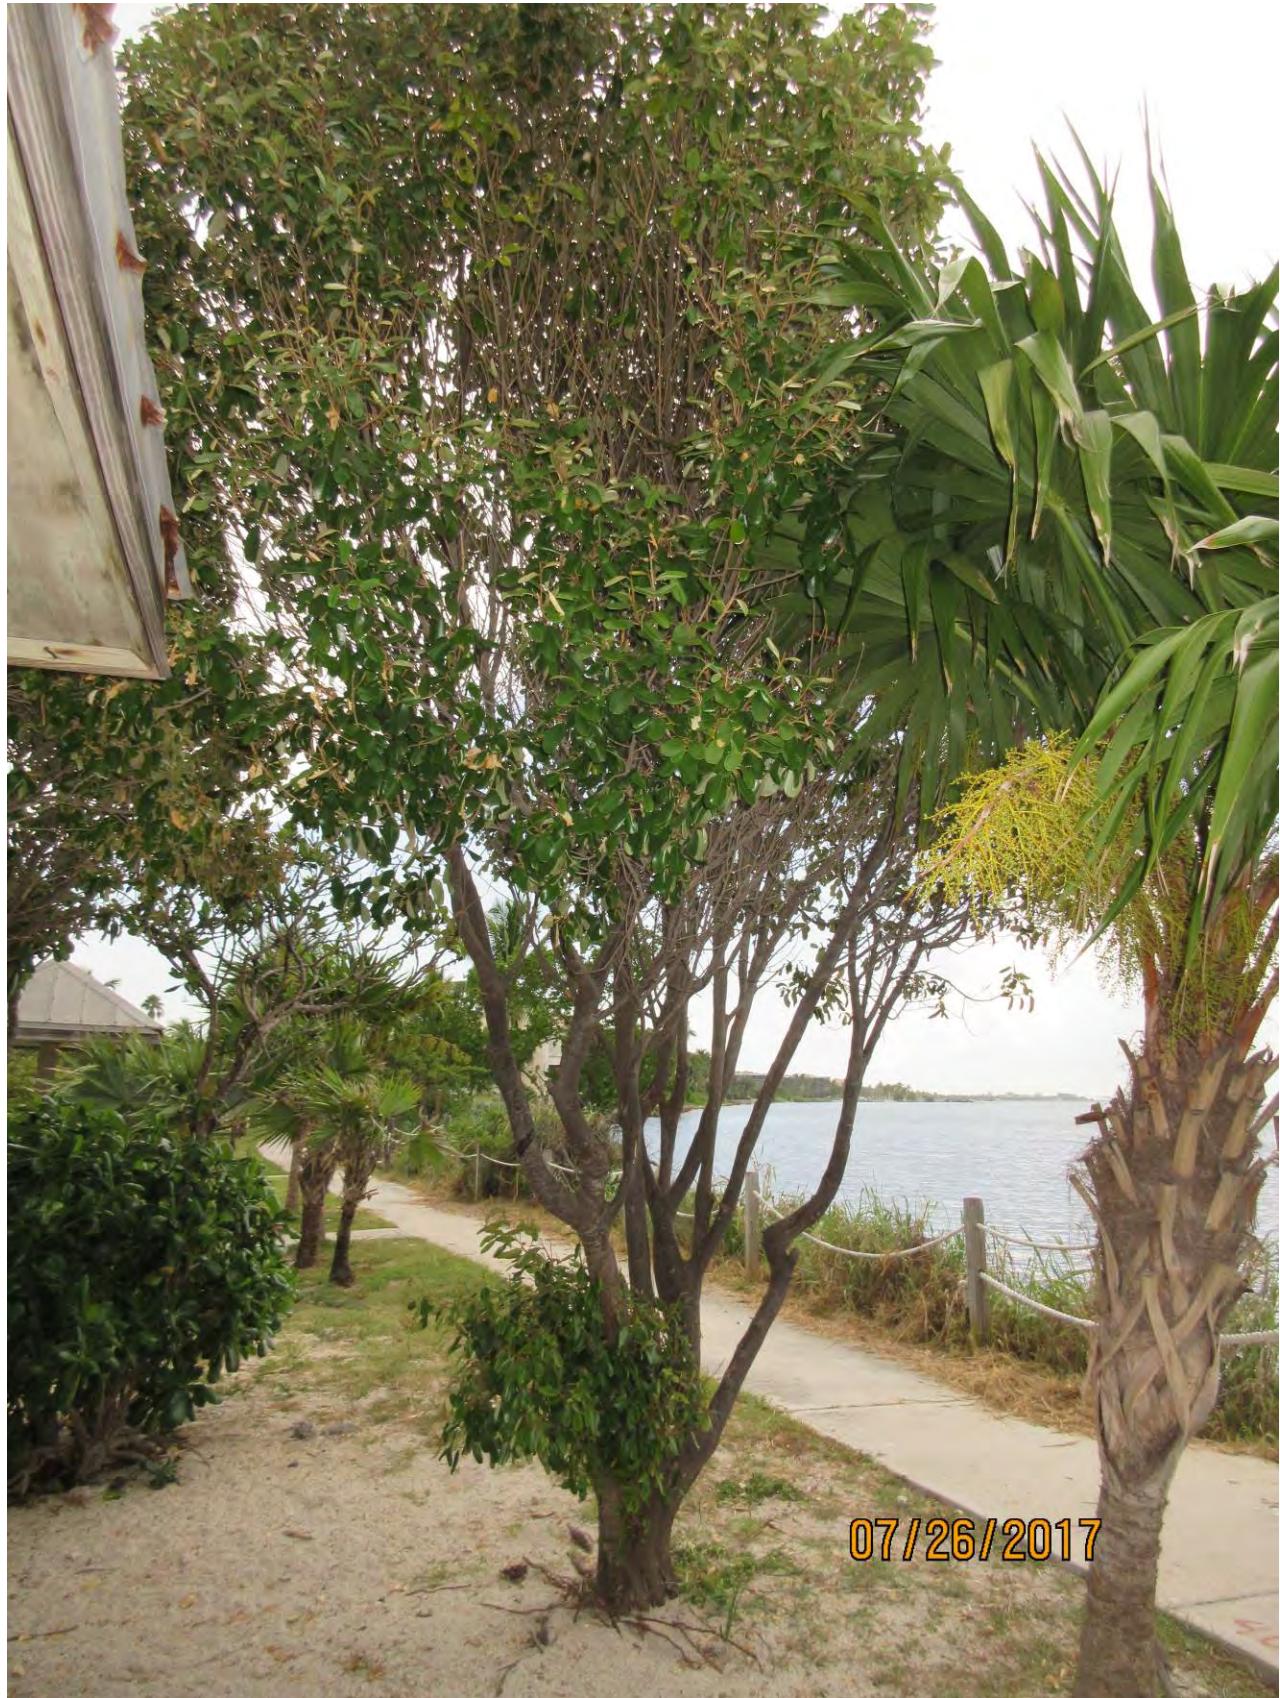
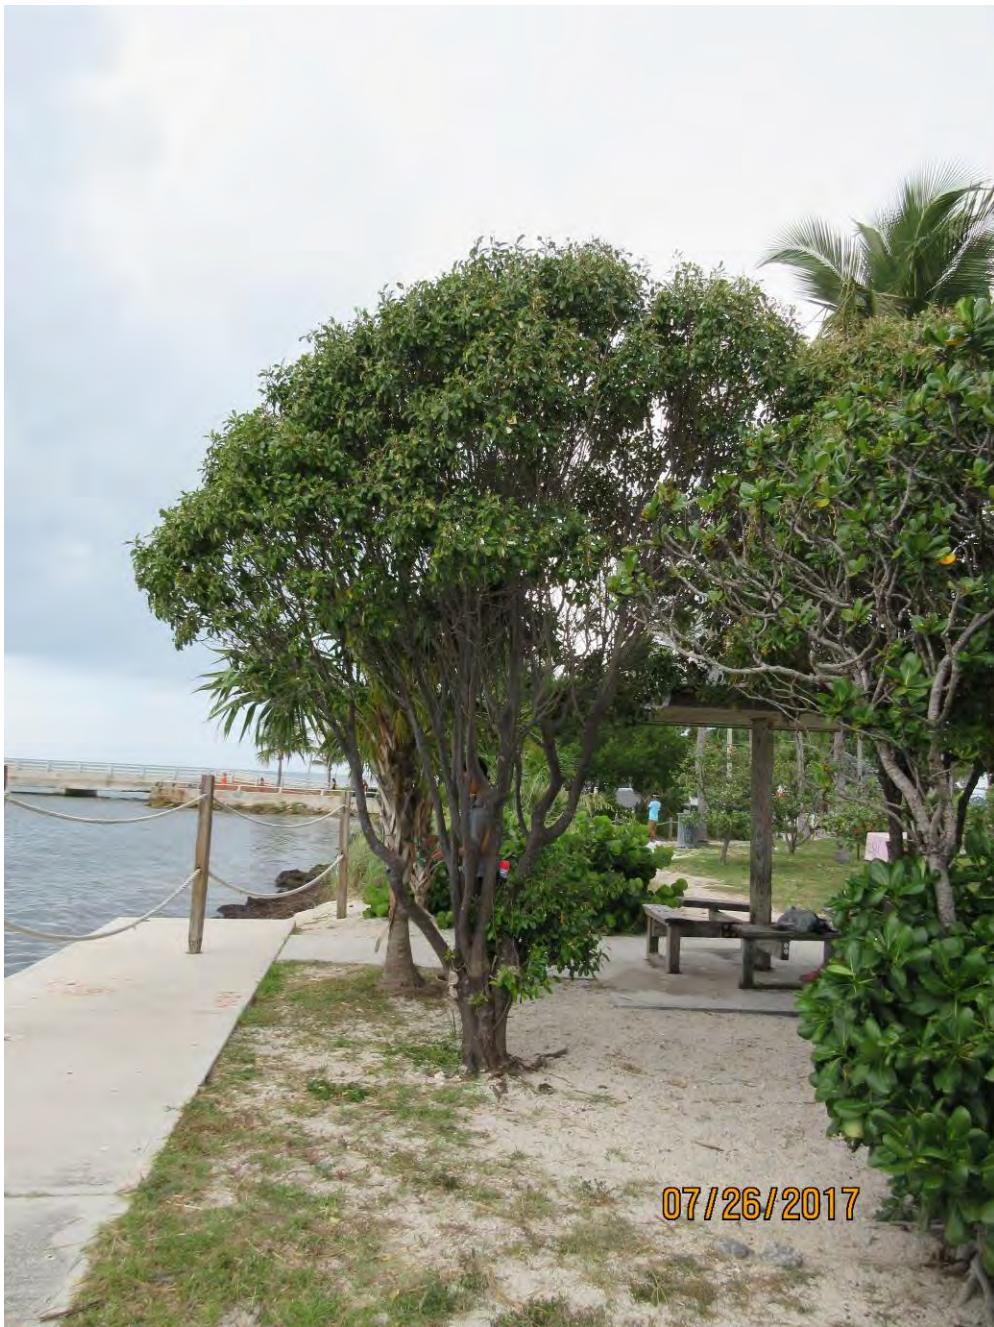
Tree #67:

Diameter: 21"

Location: 90%

Species: 100% (on protected tree list)

Condition: 80% (good)

Total Average Value = 90%

Value x Diameter = 11.3 replacement caliper inches

It appears that this tree is in the middle of the work area. It is not known at this time whether the tree can successfully be transplanted.
