STAFF REPORT

DATE: August 1, 2017

RE: **1300 Atlantic Boulevard (C.B. Harvey Rest Beach Park)
(permit application # T17-8522)**

FROM: Karen DeMaria, City of Key West Urban Forestry Manager

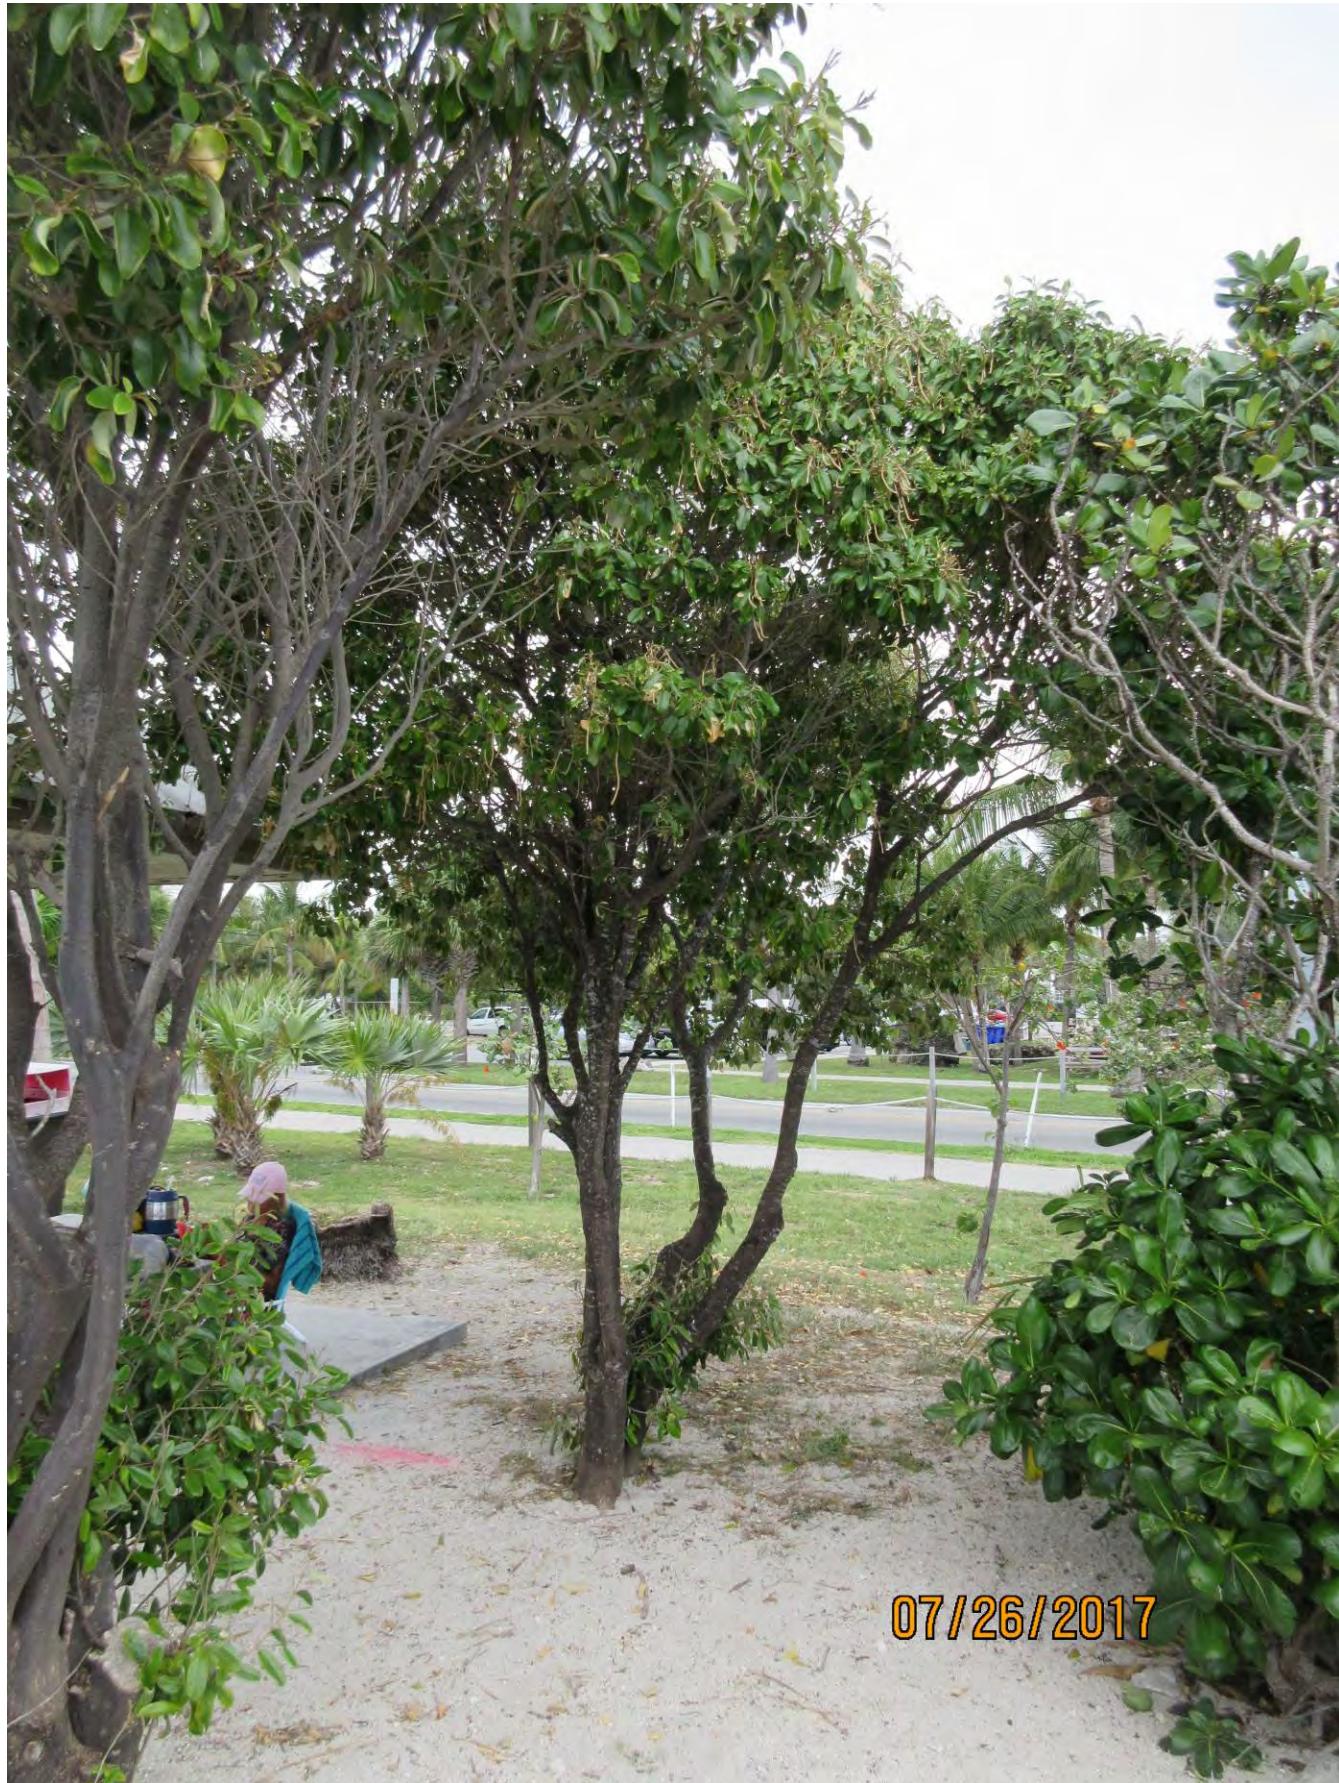
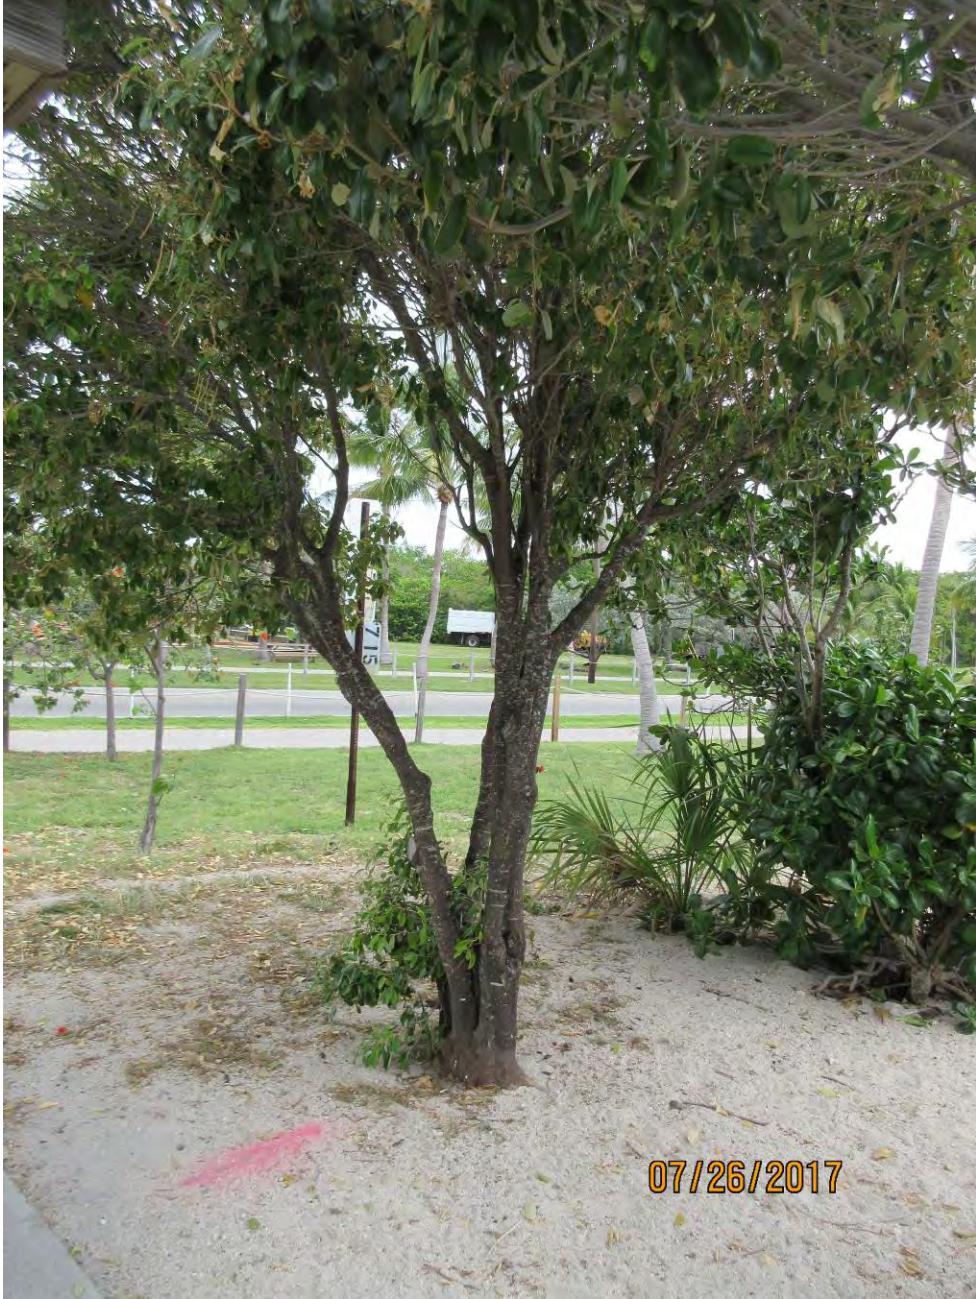
Tree #68:

Diameter: 15.6"

Location: 90%

Species: 100% (on protected tree list)

Condition: 70% (good)

Total Average Value = 86%

Value x Diameter = 13.4 replacement caliper inches

It appears that this tree is on the edge of the work area. It is not known at this time whether the tree can successfully be transplanted.

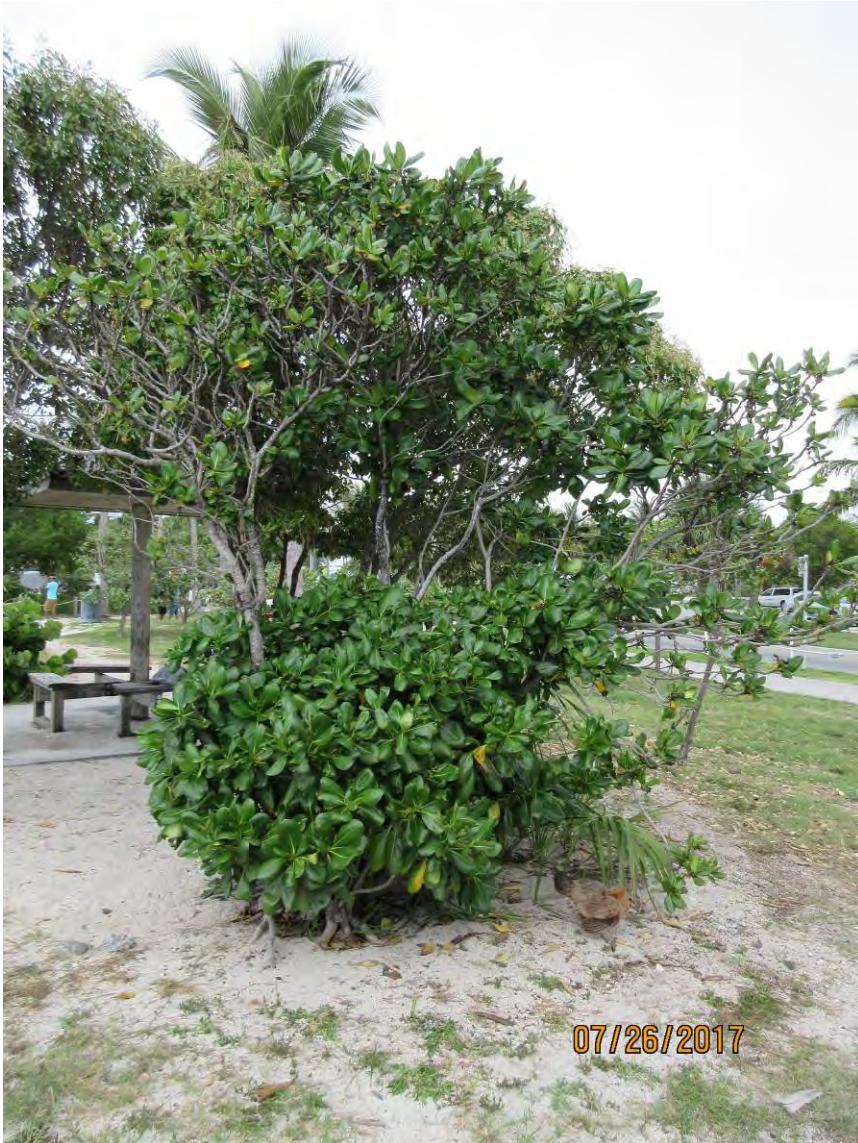
Tree #66:

Diameter: 8.5"

Location: 90%

Species: 100% (on protected tree list)

Condition: 70% (fair, sprawling tree)

Total Average Value = 86%

Value x Diameter = 7.3 replacement caliper inches

It appears that this tree is on the edge of the work area. It is not known at this time whether the tree can successfully be transplanted.

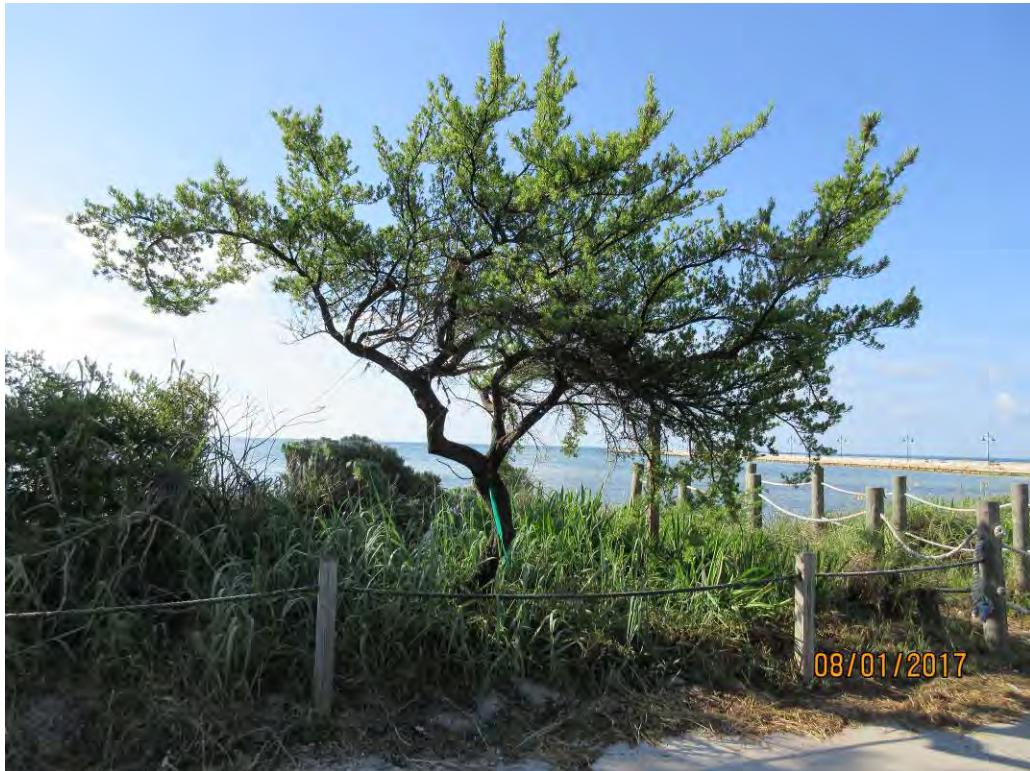
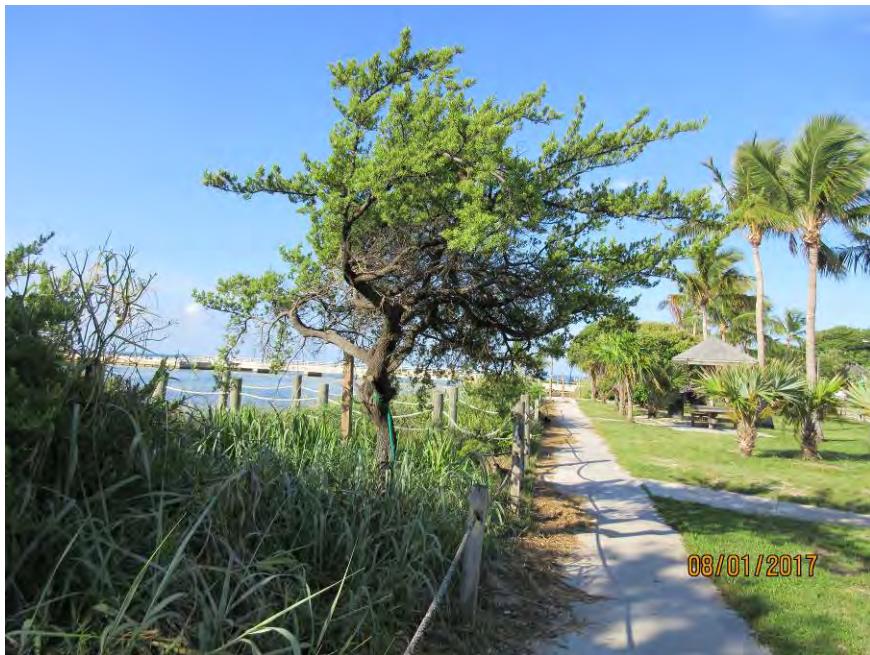
Tree #48:

Diameter: 7.3"
Location: 90%
Species: 100% (on protected tree list)
Condition: 70% (old specimen, some dead branches, single trunk with typical dune canopy structure)
Total Average Value = 86%
Value x Diameter = 6.2 replacement caliper inches

At the present time it appears that this tree is in the work area. It is not known at this time whether the tree can successfully be transplanted.
