Key West Historic Diesel Electric Plant Complex

Enid Torregrosa-Silva
Kelly Perkins

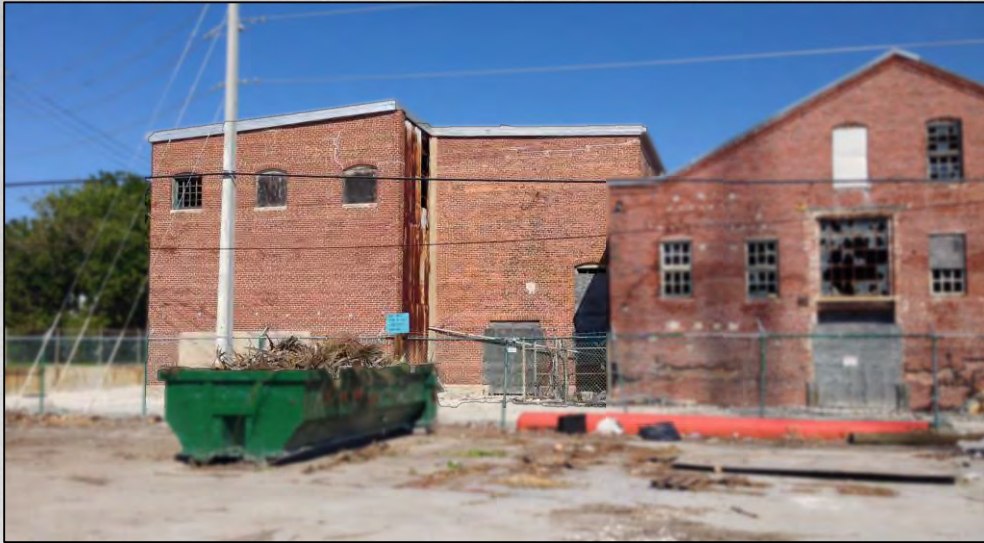
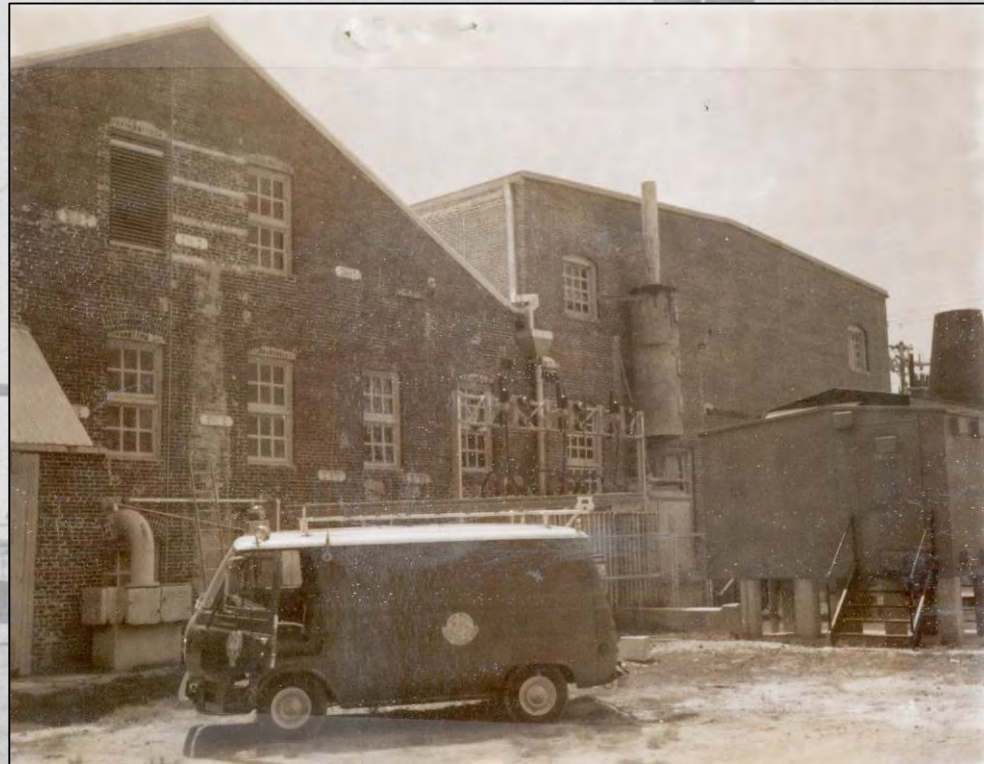
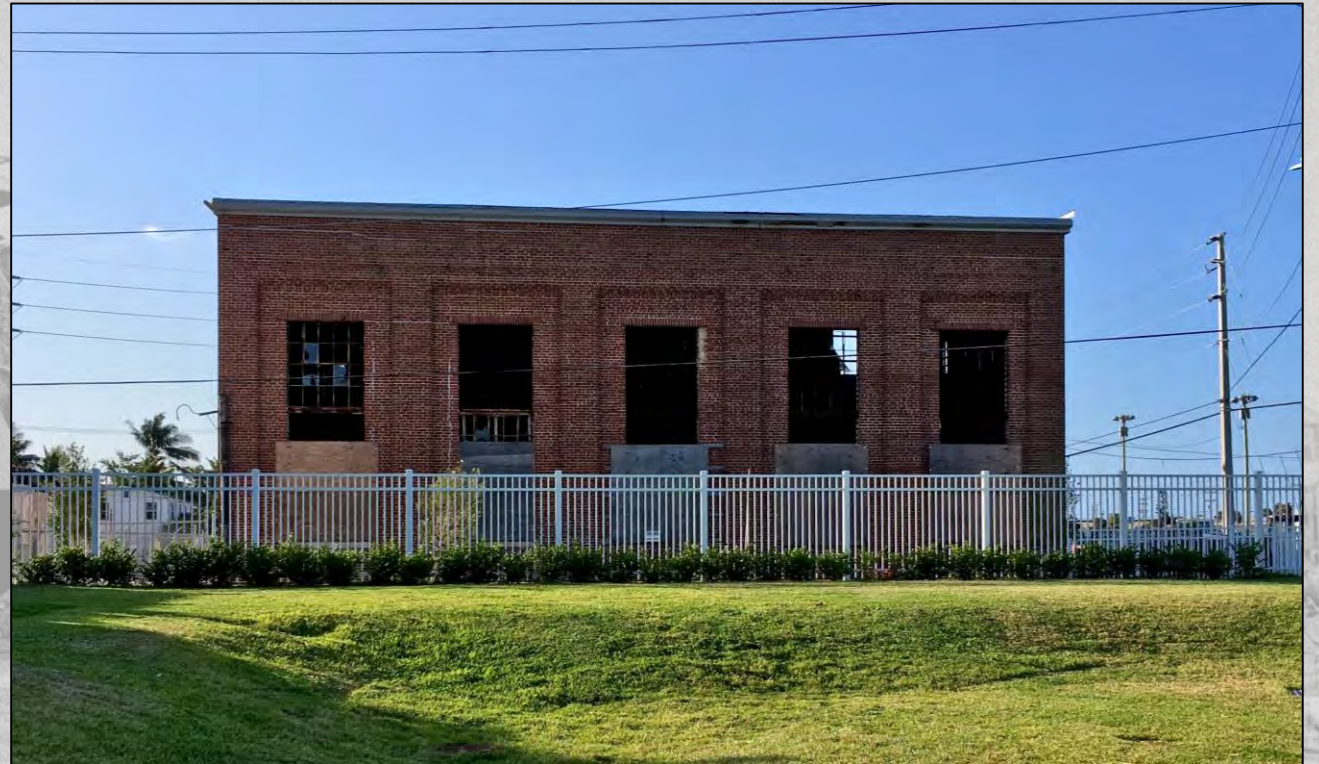
- First appears on the 1926 Sanborn map, meaning it was constructed between 1912 and 1926.
- Building 1 had the roof redone after Wilma hit in 2005, and is considered to be in the best condition according to the AES Structural Report. It was not condemned by Chief Building Official.

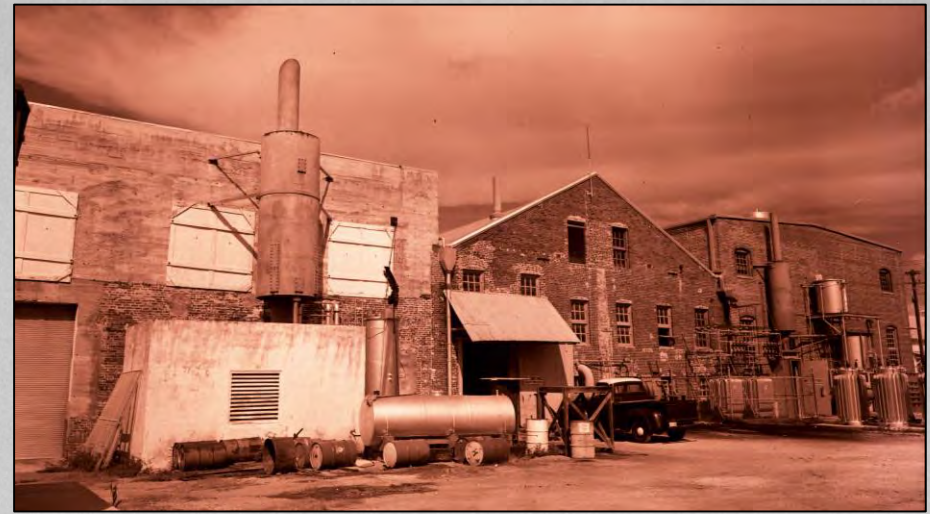
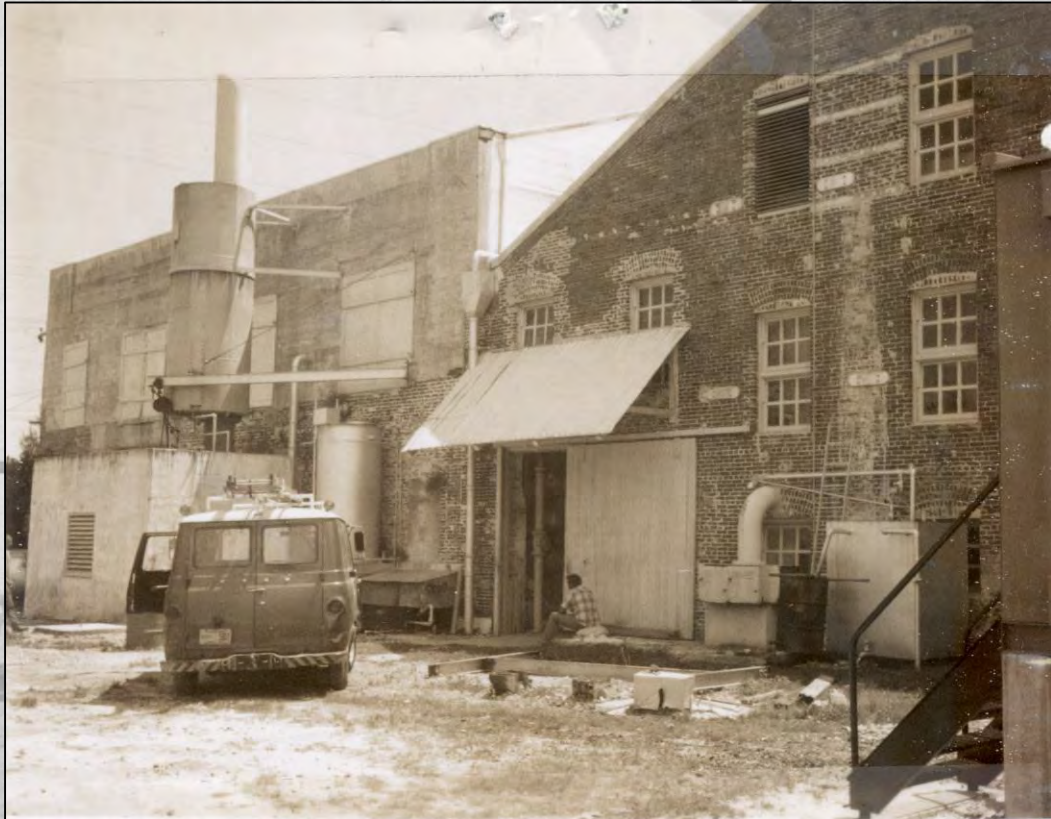
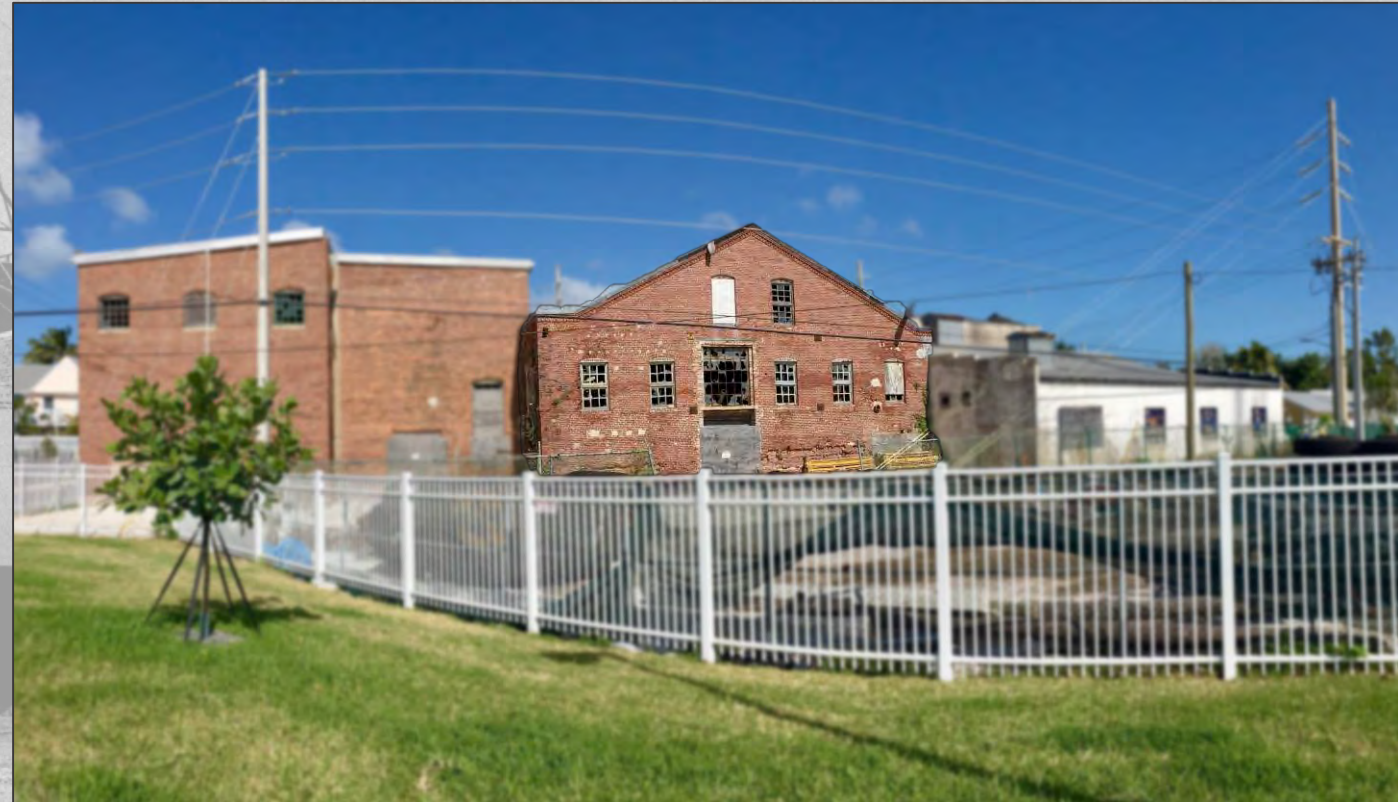
Building 2

- Part of the original complex, constructed in the 1880s.
- The building was considered to be in “much worse condition” than Building 1. It was not condemned by Chief Building Official.

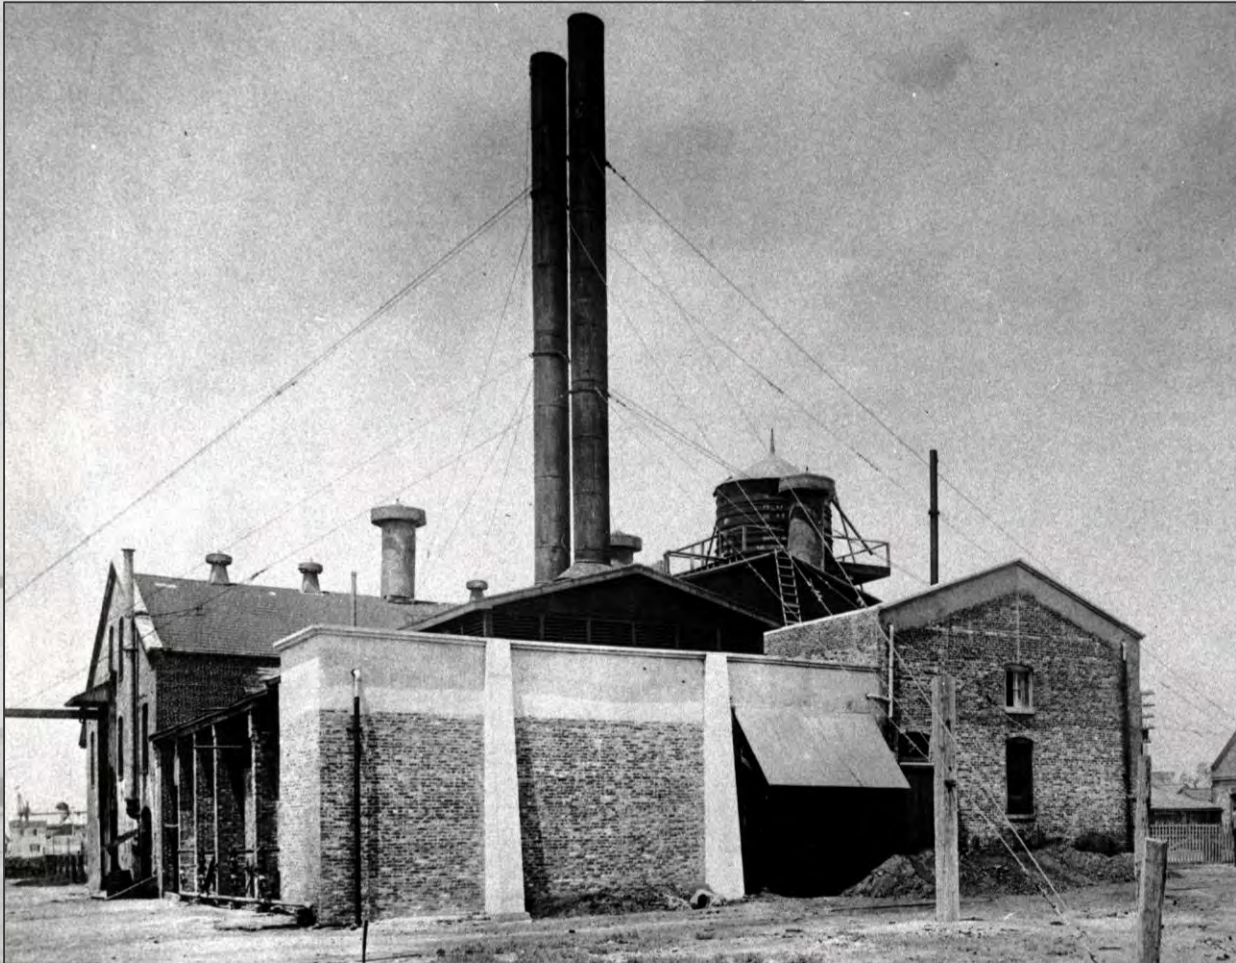
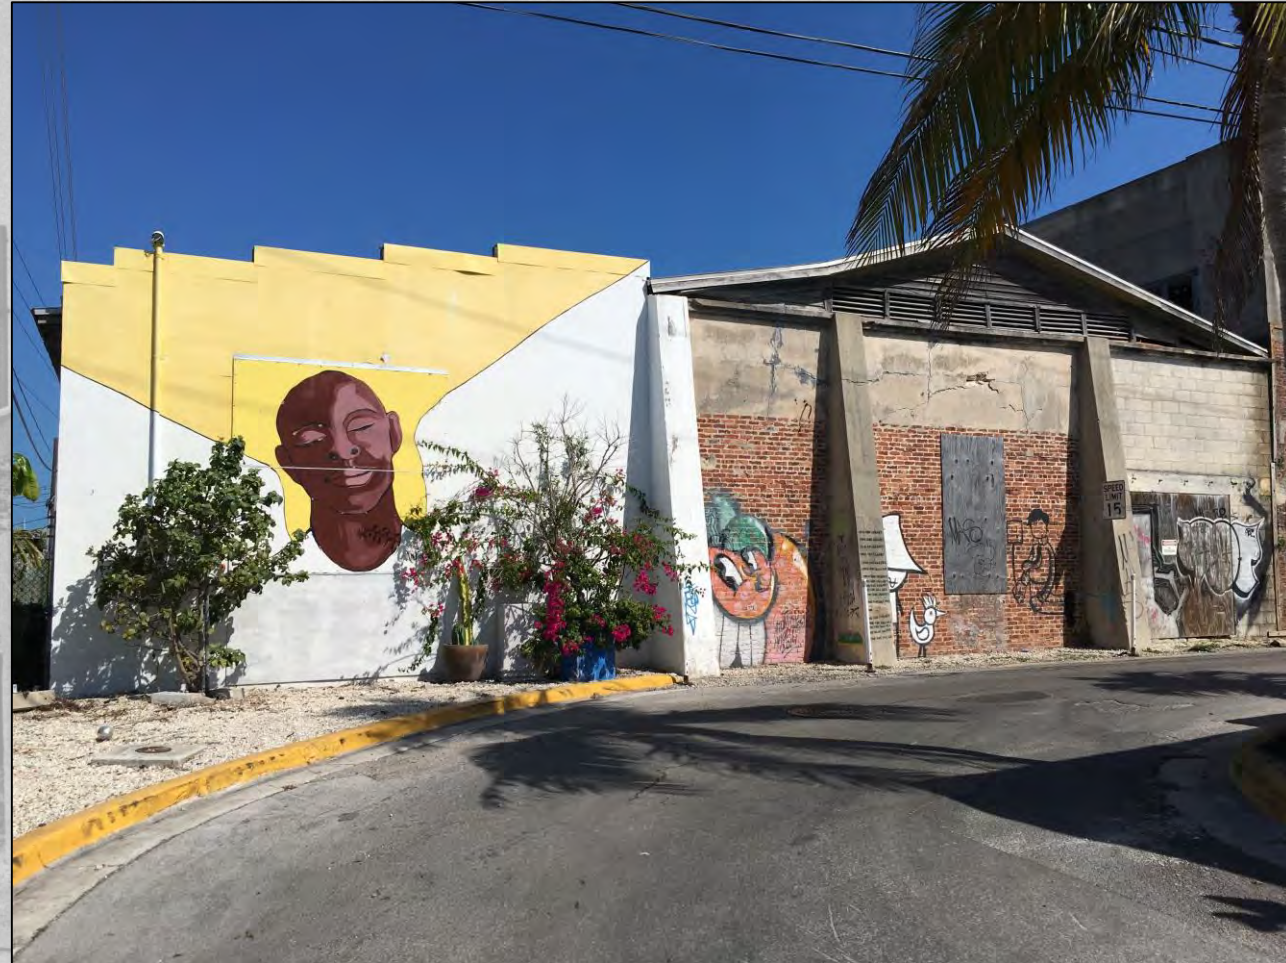
Building 3a

- In 1910, the new buttressed façade was constructed. The side of the building had a buttressed, brick wall as well. At some point, the roof was extended to be flush with the buttressed façade, and the right bay entrance was closed in with CMU.
- The AES Structural Report stated that Building 3 (including 3a and 3b) is in better condition than Building 2 and Building 4. It was condemned by the Chief Building Officer.

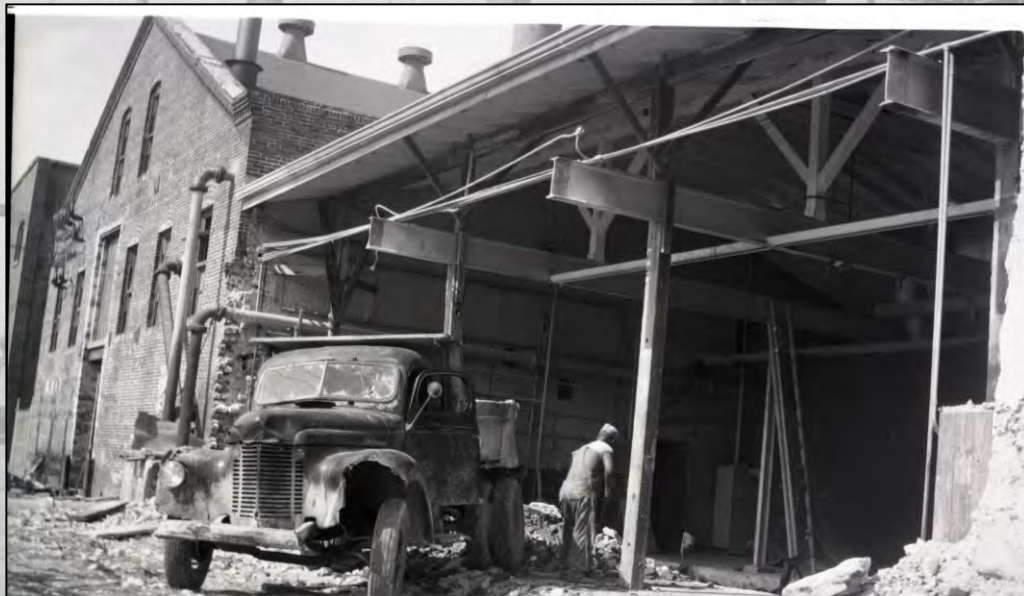
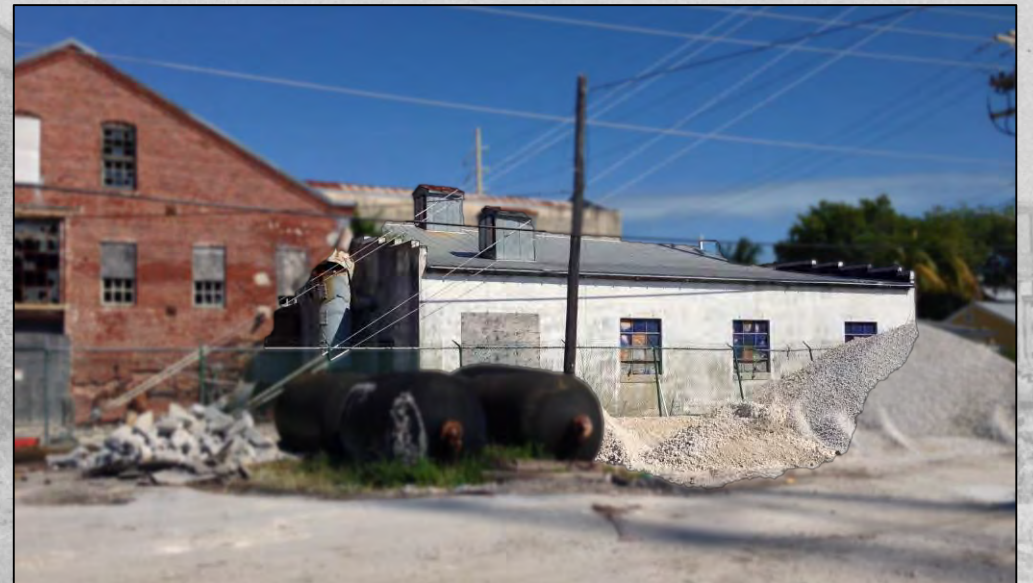
- Not part of the original complex. It was added onto Building 3a sometime in the mid-20th century, first appearing on the 1962 Sanborn map. It was built onto the existing Fort Street, severing the connection to Angela Street. The building is considered to be historic, as it is more than 50 years old.
- It should be determined which is more significant: this historic addition or the return of the Fort Street connection to Angela Street.
- The AES Structural Report stated that Building 3 (including 3a and 3b) is in better condition than Building 2 and Building 4. It was condemned by the Chief Building Officer.

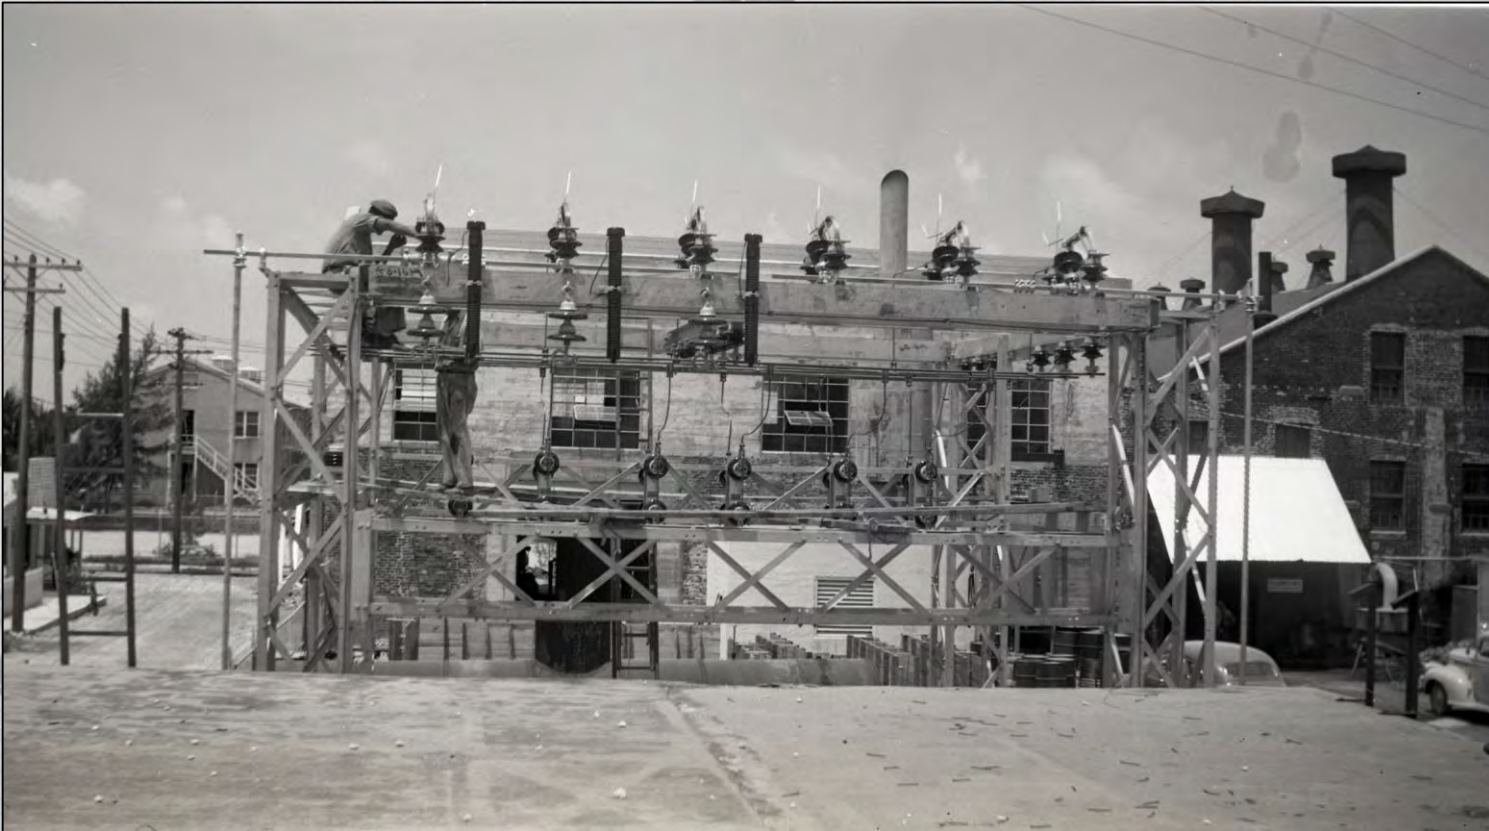
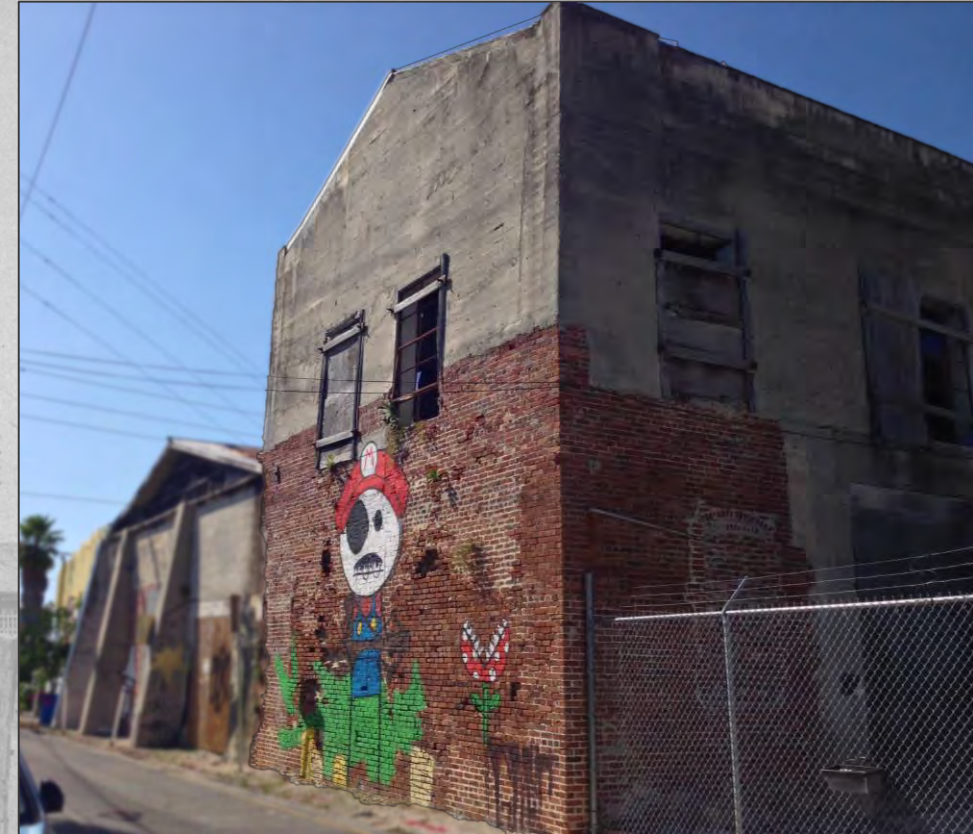
Building 4

- By the 1950s, building was expanded to a taller building using concrete as the material for the second floor. The concrete was poured with forms. The second story windows were steel with blue glass.
- Considered to be in the worst condition out of the four buildings in the AES Structural Report. It was condemned by the Chief Building Official.

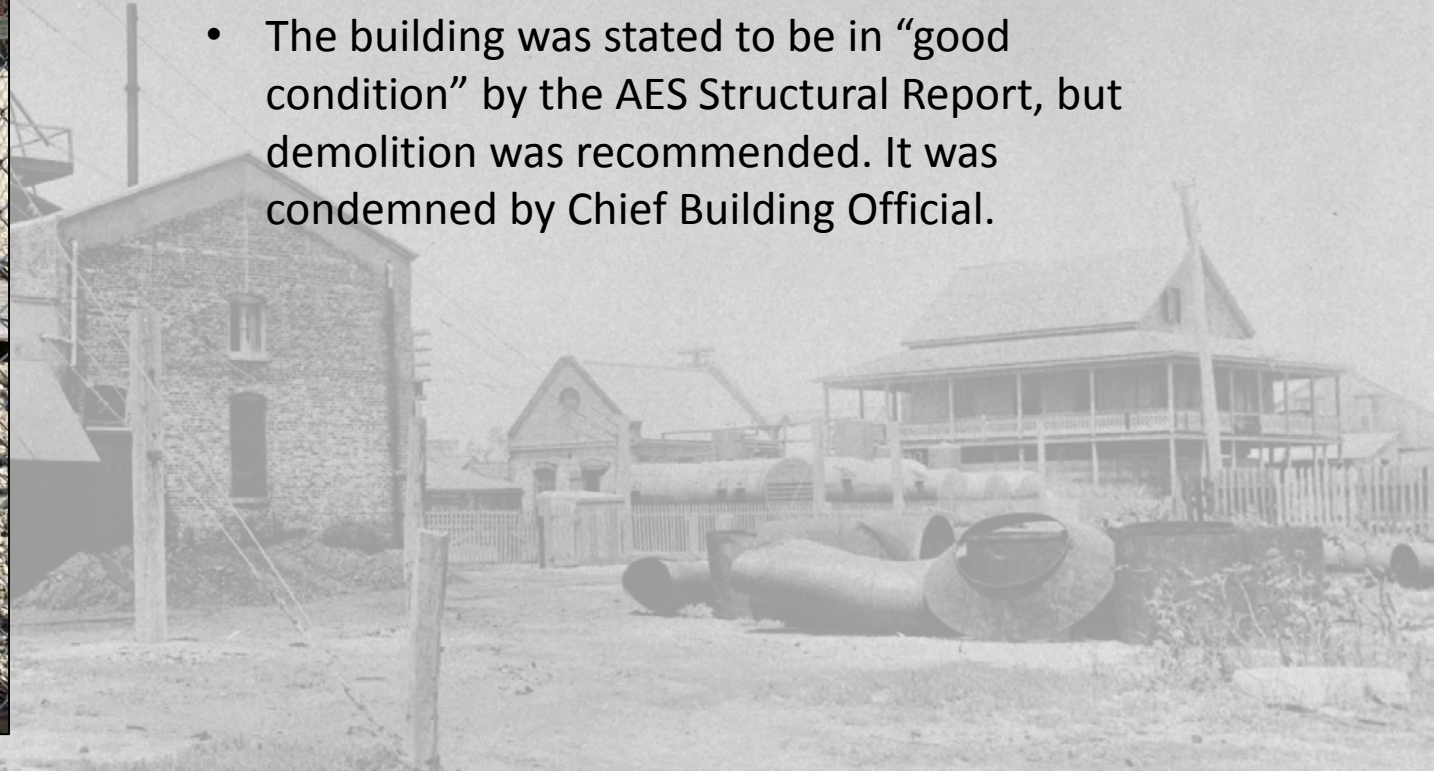
- Appears in a 1950s photograph of the complex, making it historic. It currently blocks eastern access of the complex.
- Staff finds no significance in this building.
- The building was stated to be in “good condition” by the AES Structural Report, but demolition was recommended. It was condemned by Chief Building Official.
