Key West Historic Diesel Electric Plant Complex

Enid Torregrosa-Silva
Kelly Perkins

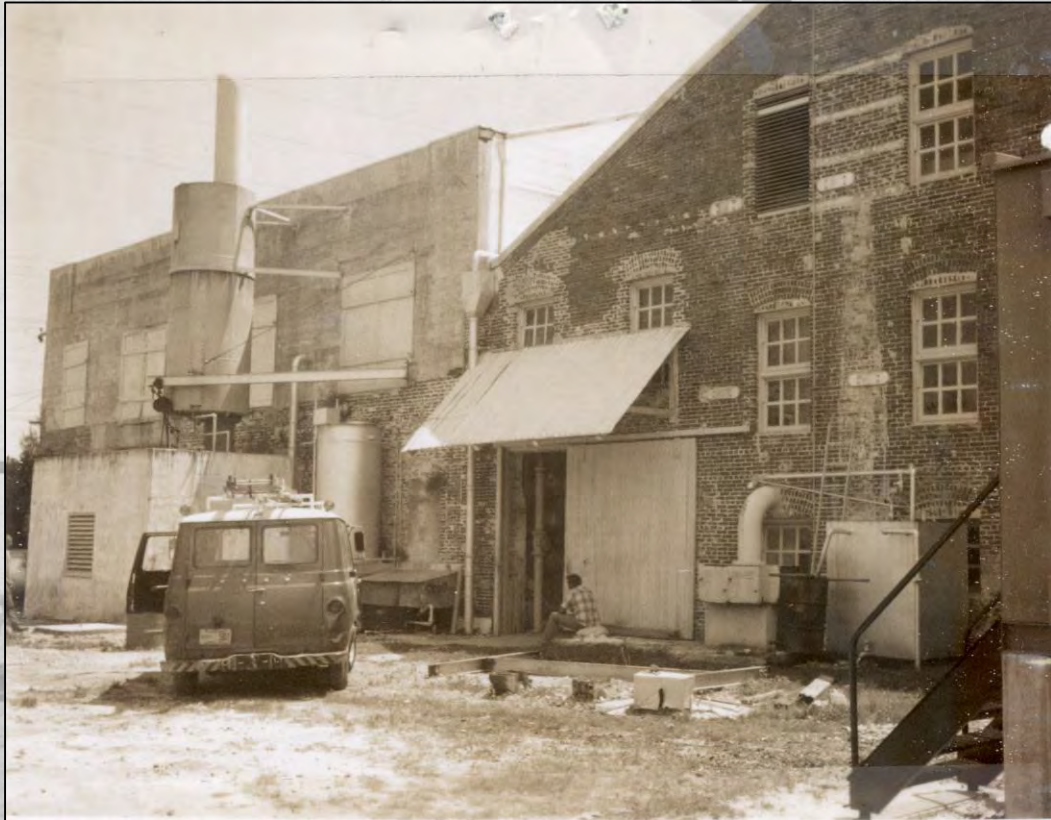
Building 2

- Part of the original complex, constructed in the 1880s.
- The building was considered to be in “much worse condition” than Building 1. It was not condemned by Chief Building Official.

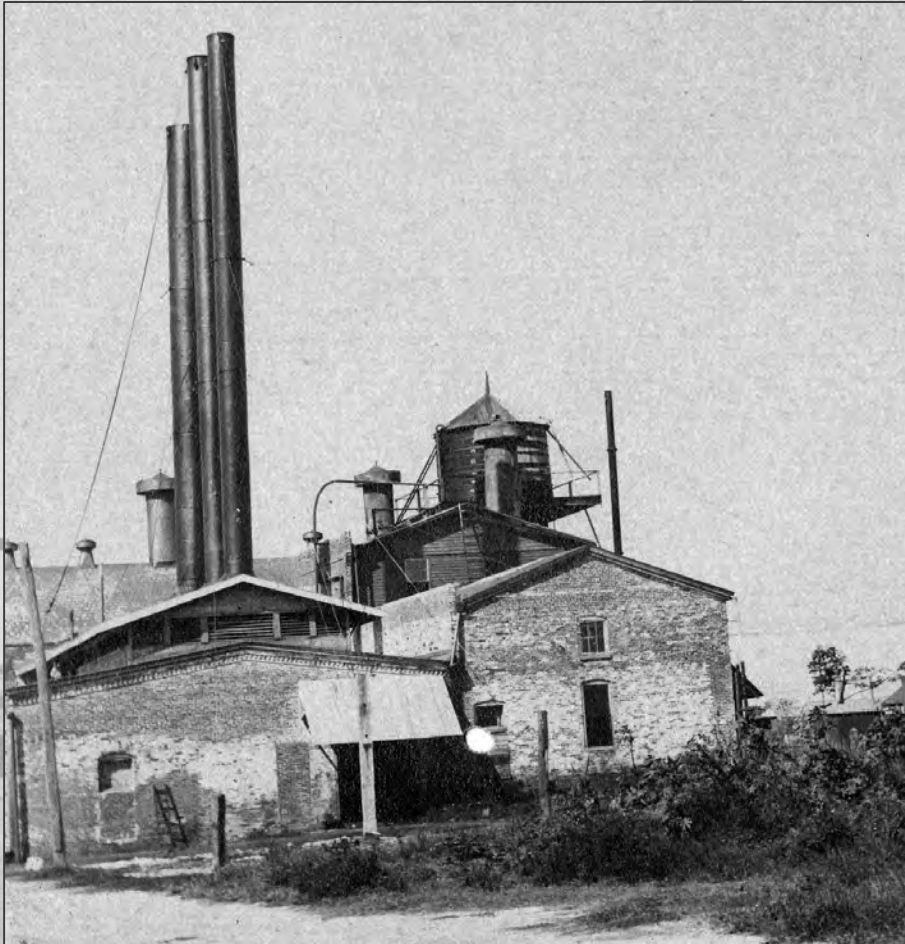
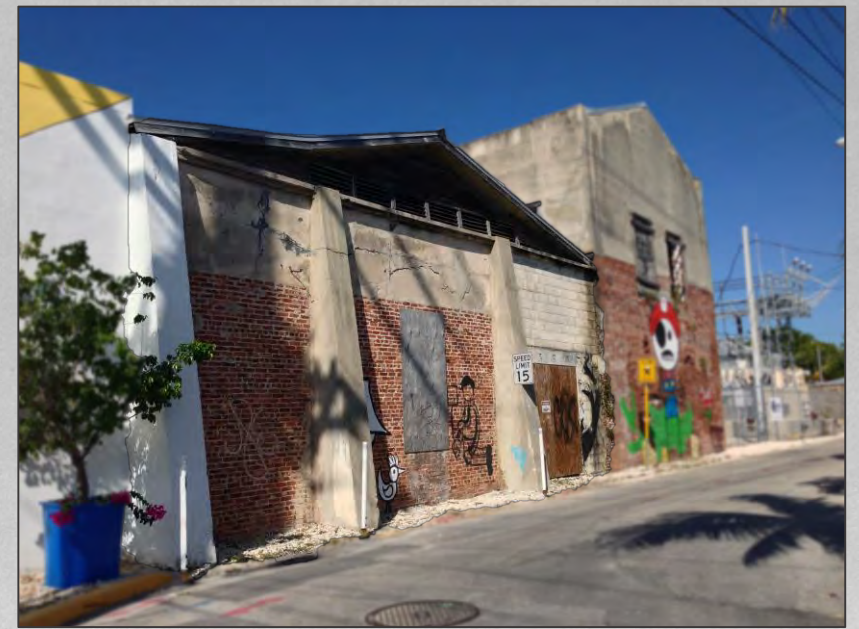
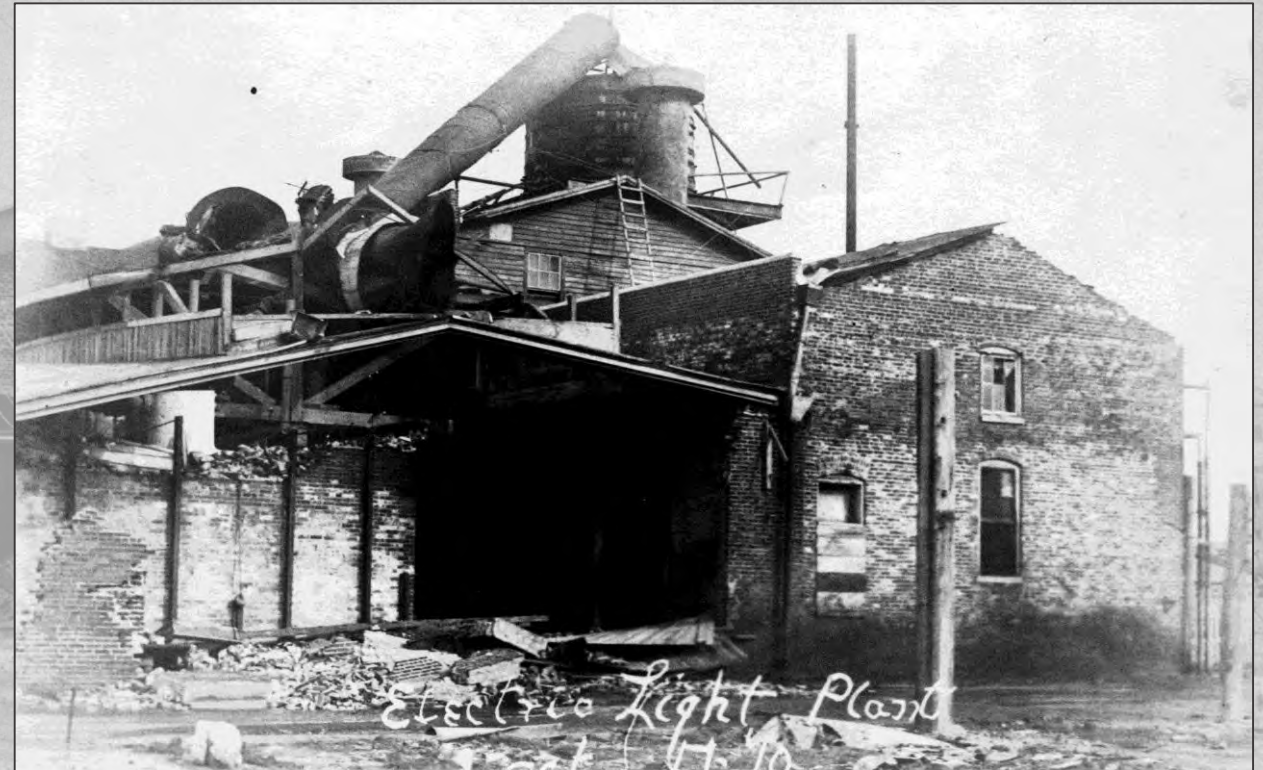
Building 3a

- Part of the original complex, first appearing on the 1892 Sanborn map.
- The building was originally a one story brick structure with classical detailing. The October 1909 hurricane destroyed the façade on Geraldine Street.

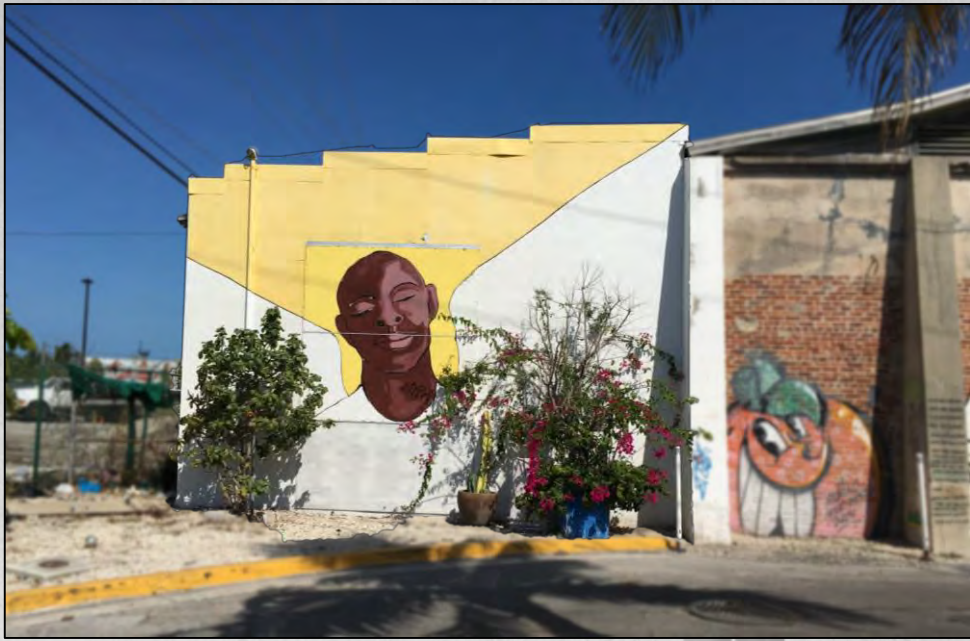
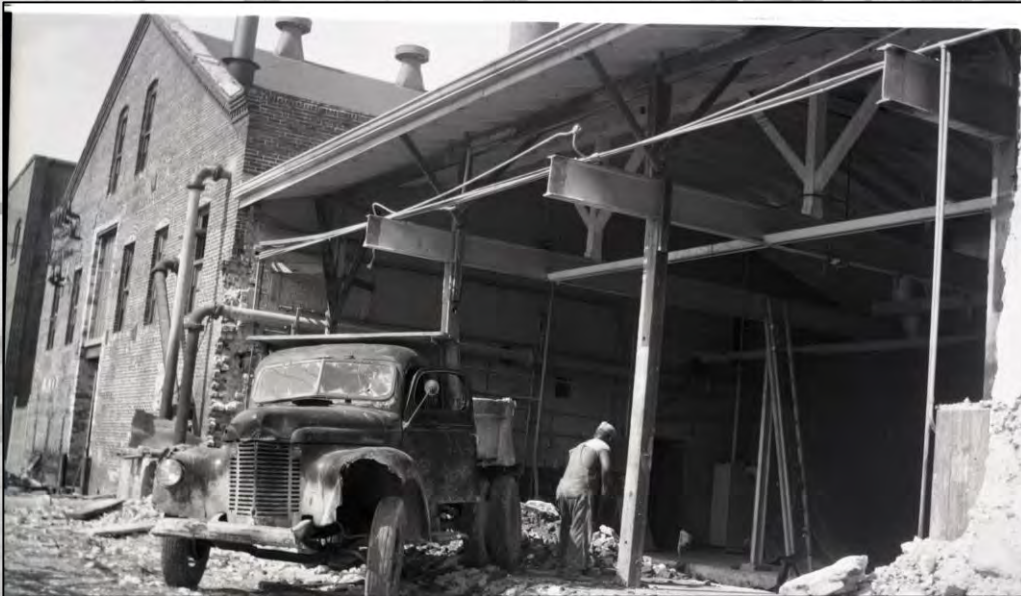
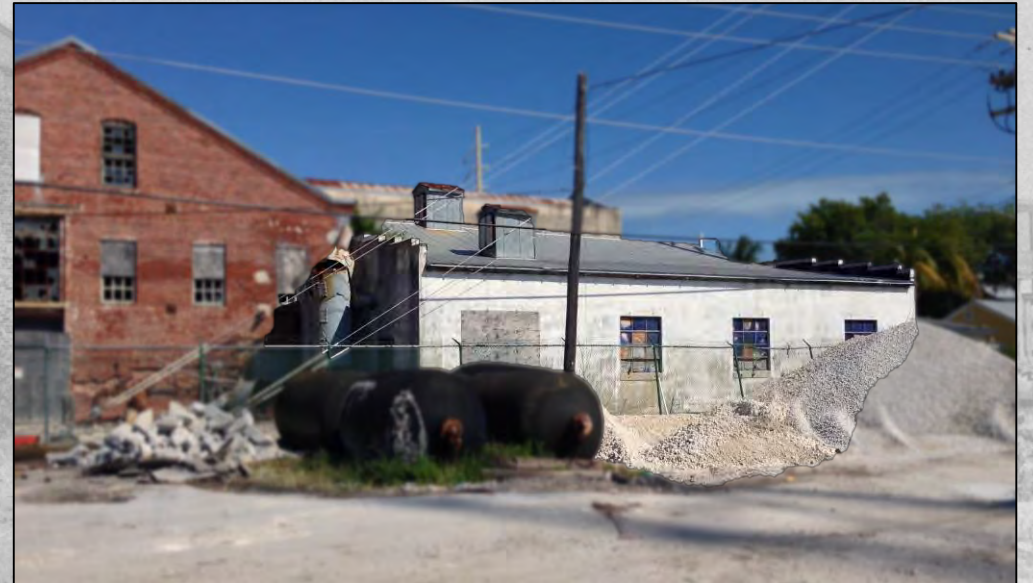
Building 3b

- Not part of the original complex. It was added onto Building 3a sometime in the mid-20th century, first appearing on the 1962 Sanborn map. It was built onto the existing Fort Street, severing the connection to Angela Street. The building is considered to be historic, as it is more than 50 years old.
- It should be determined which is more significant: this historic addition or the return of the Fort Street connection to Angela Street.
- The AES Structural Report stated that Building 3 (including 3a and 3b) is in better condition than Building 2 and Building 4. It was condemned by the Chief Building Officer.

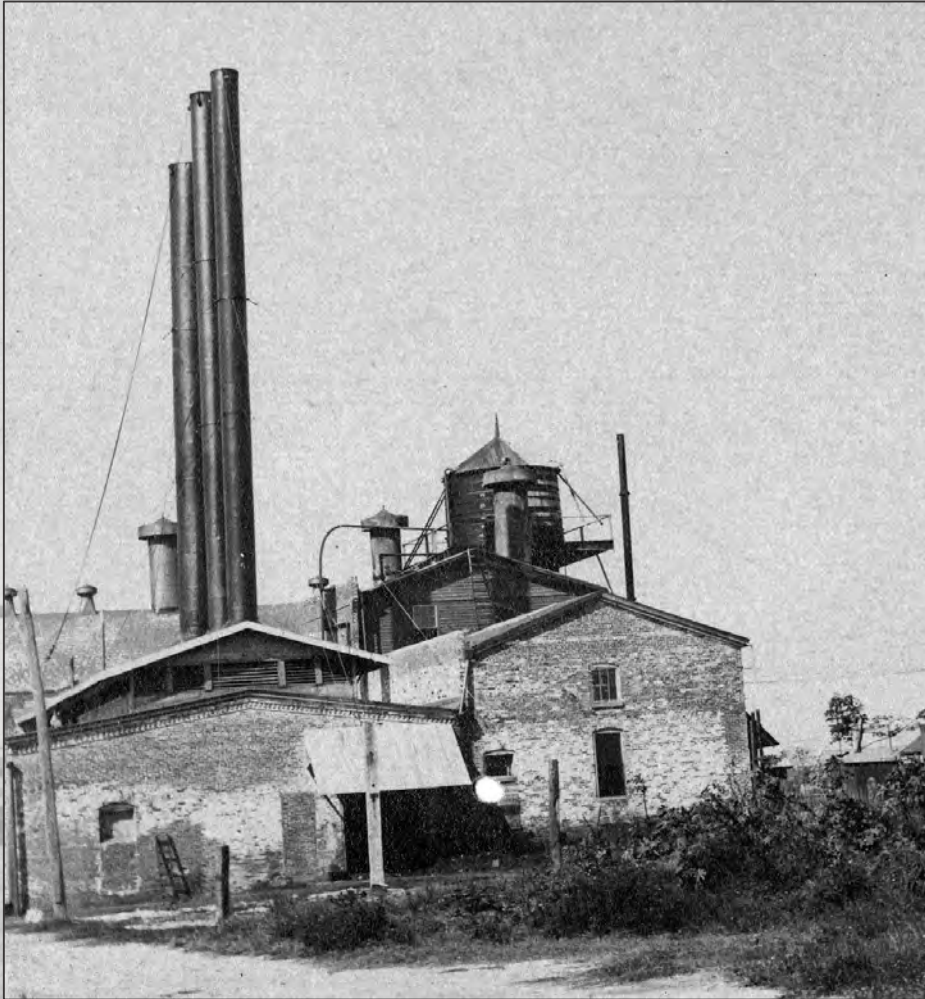
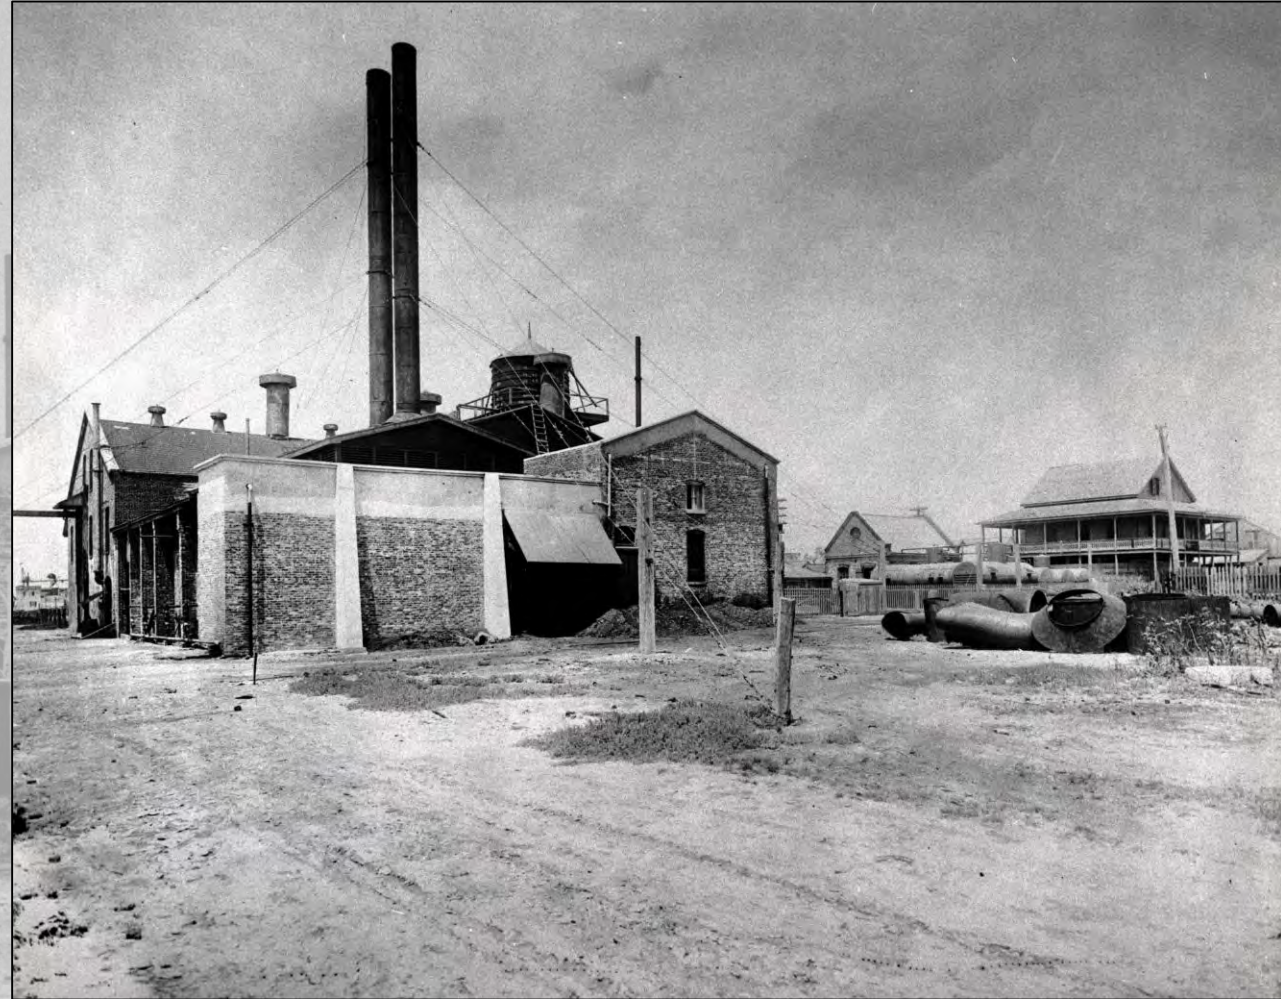
Building 4

- Constructed between 1892 and 1899. The structure was originally a shorter two-story building made entirely of brick with a rear wood structure that held a water tower and other equipment.
- The 1909 and 1910 Hurricanes destroyed the roof, and the structure was expanded with a steeper pitched roof in 1910.

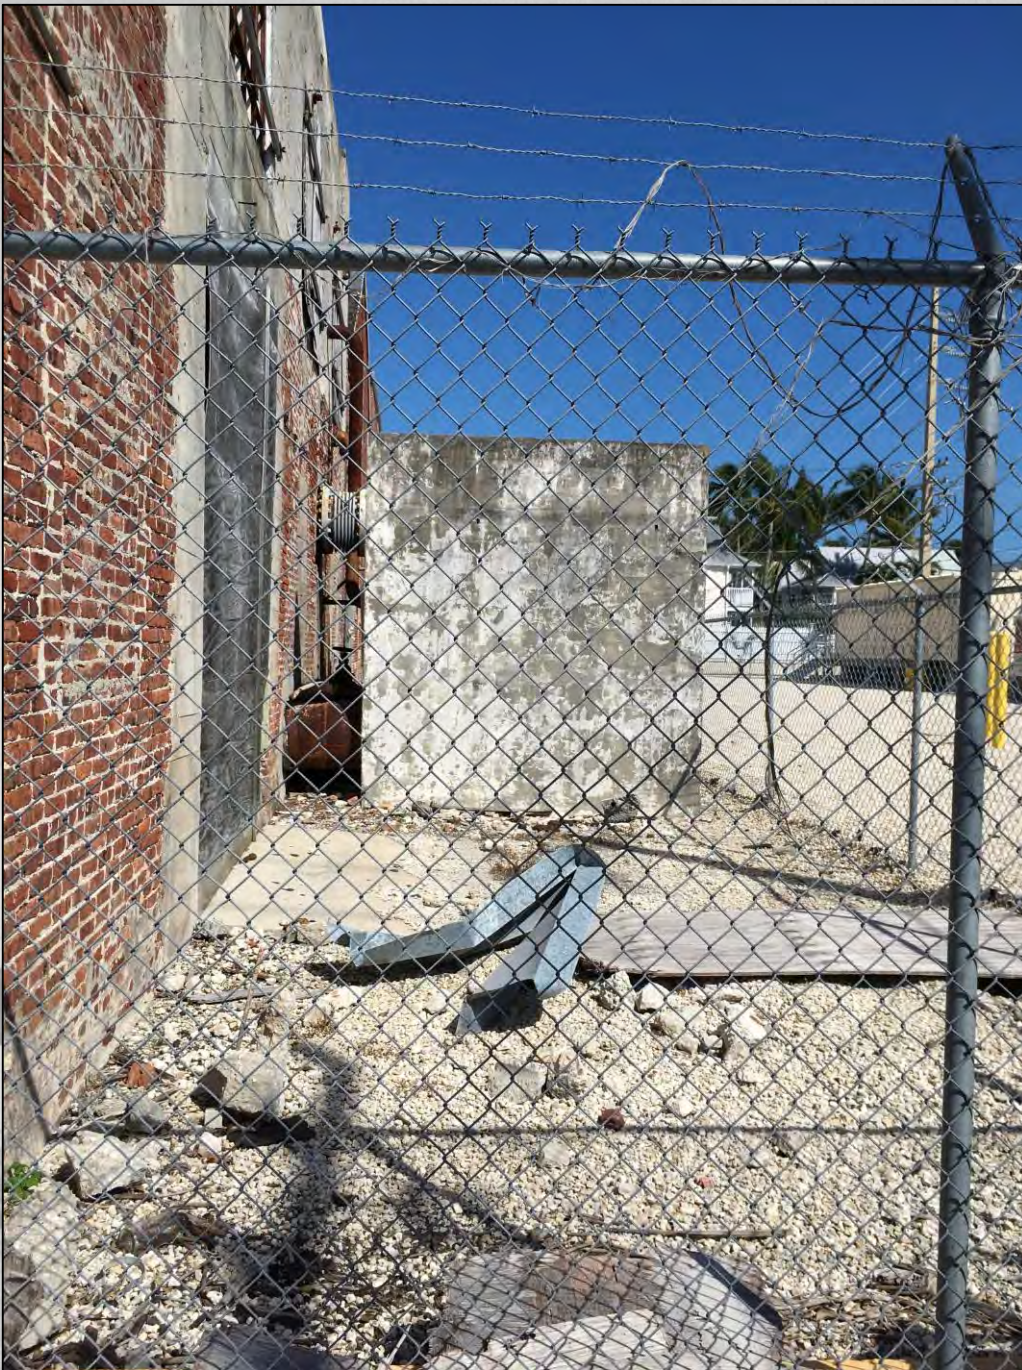
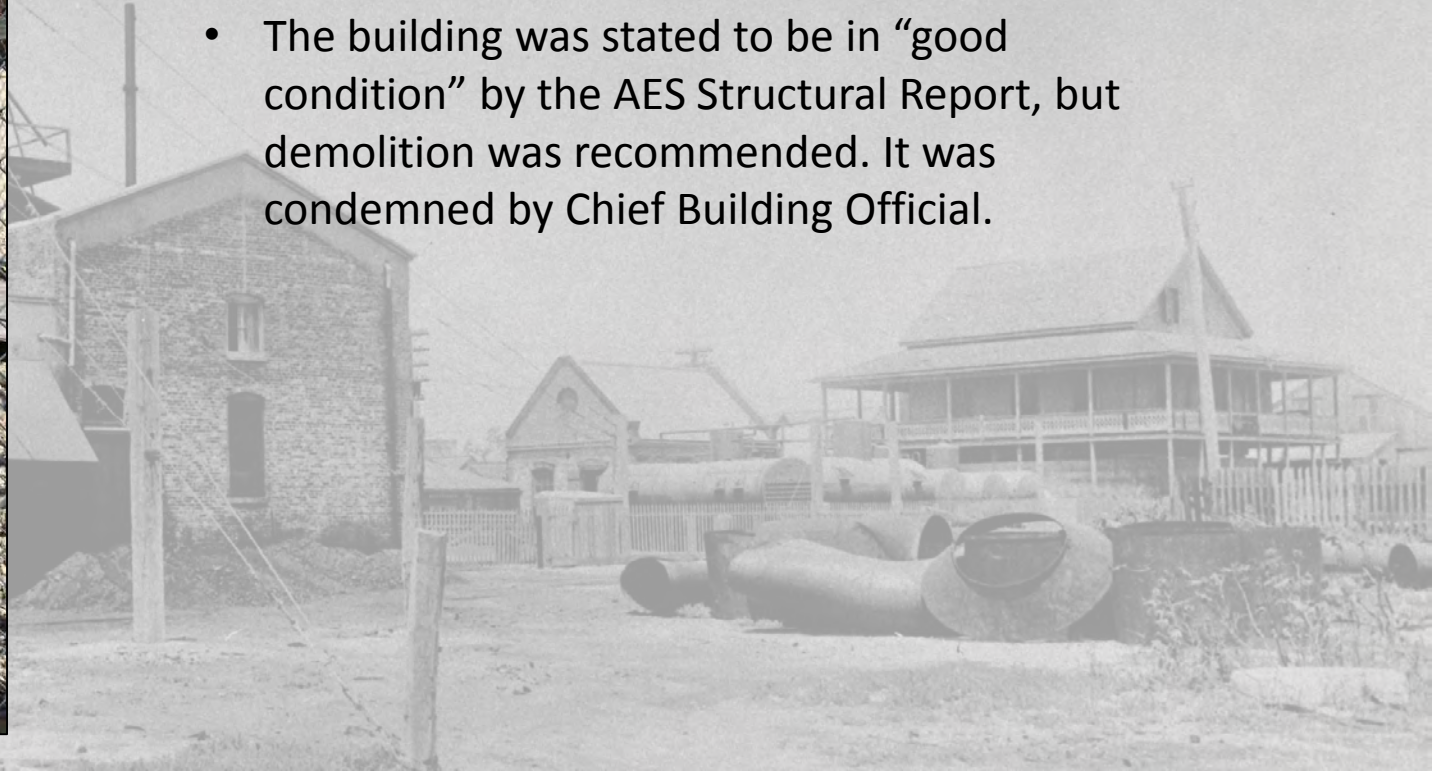
Building 5

- Appears in a 1950s photograph of the complex, making it historic. It currently blocks eastern access of the complex.
- Staff finds no significance in this building.
- The building was stated to be in “good condition” by the AES Structural Report, but demolition was recommended. It was condemned by Chief Building Official.

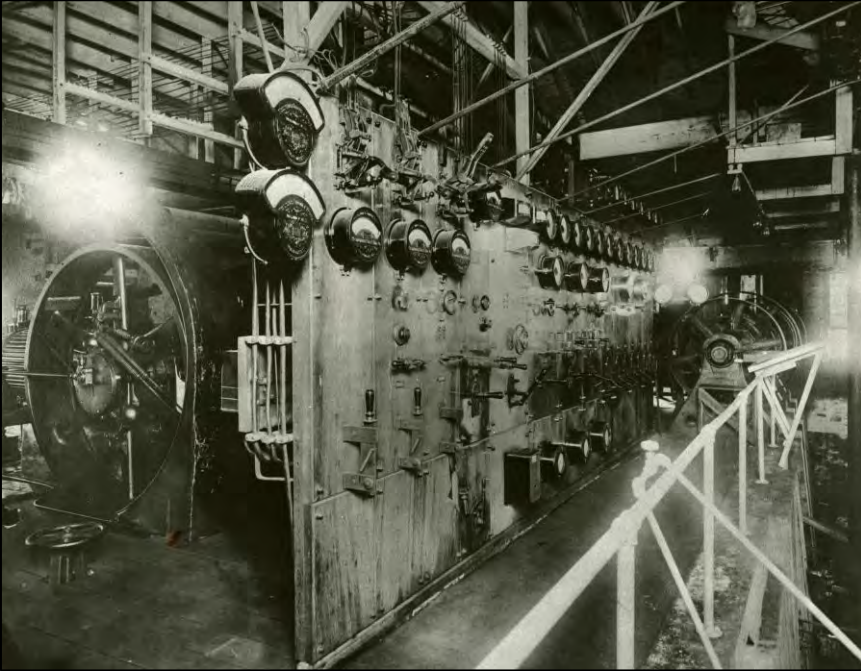
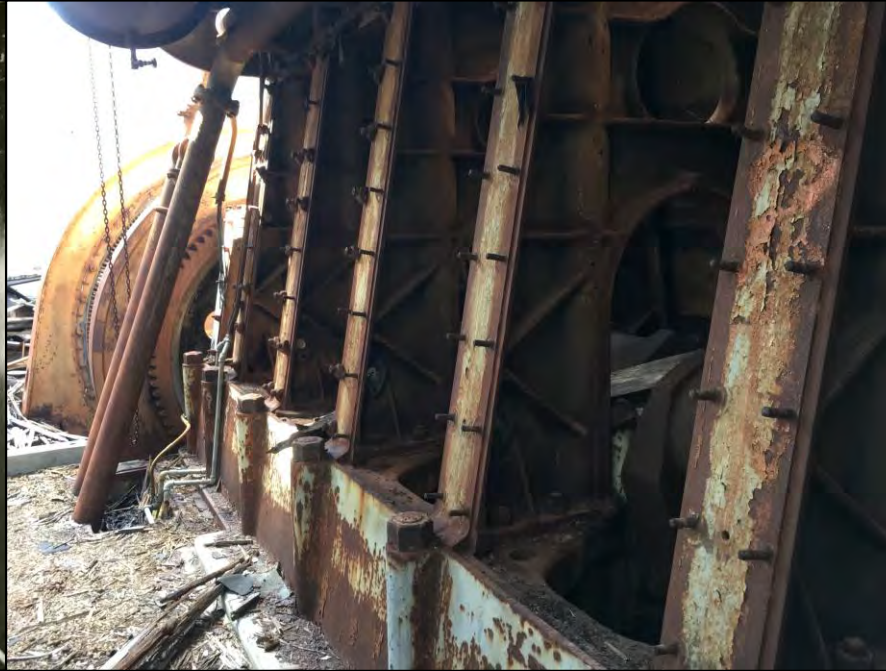
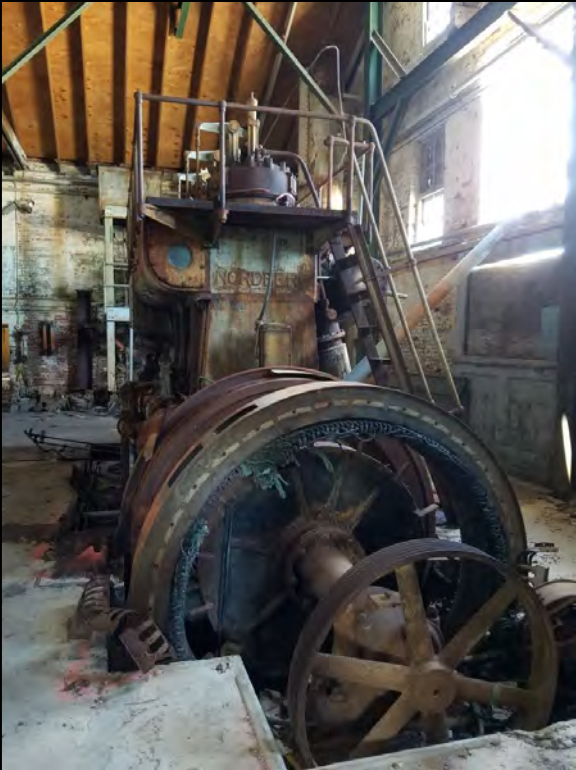
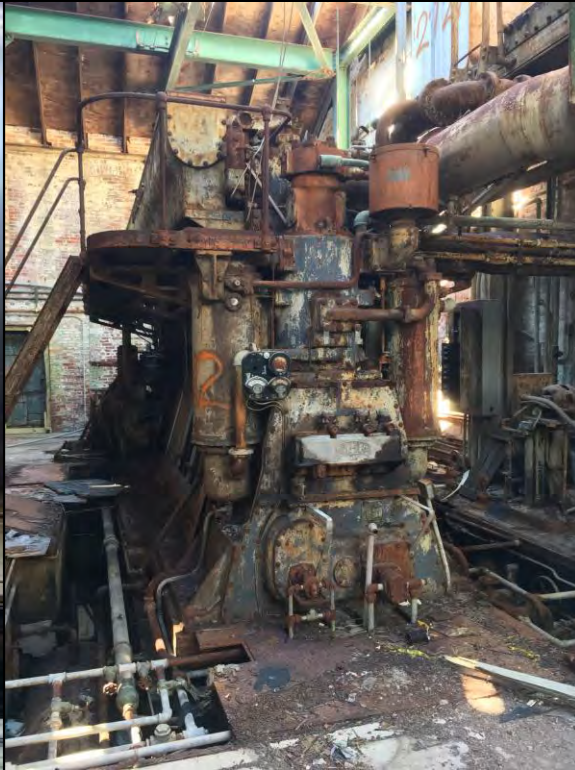
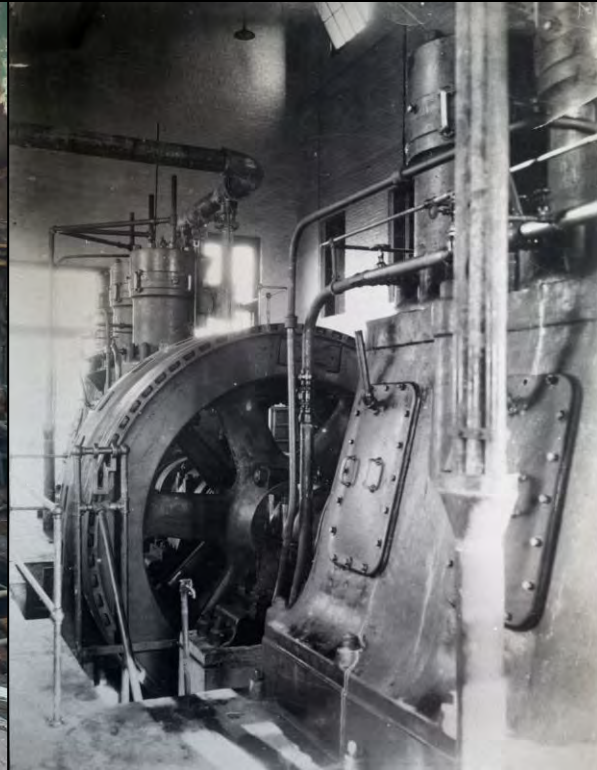
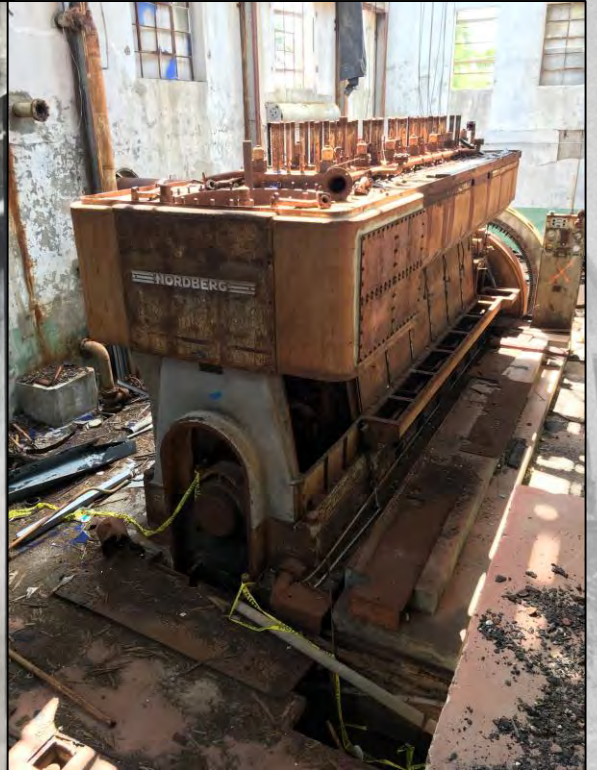
Machinery

- Building contains historic machinery, such as Nordberg and Busch-Sulzer engines.
- Nordberg Manufacturing Company has a collection in the Smithsonian.
