Structural Condition Assessment Key West Diesel Plant

Key West, Florida

> AES Project No. 316-048 August 3, 2016

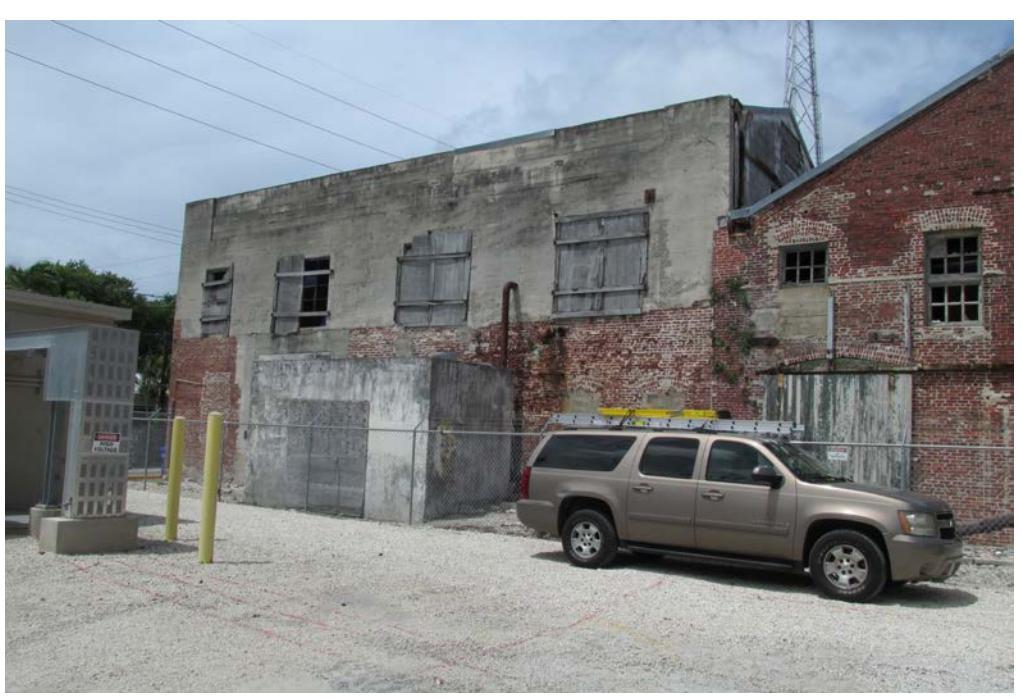
PHOTOGRAPH 5 (BUILDING IV AND V)

The abandoned Diesel Plant consists of four (4) connected one-story, buildings with the three (3) eastern buildings housing four (4) electric dynamos and the southwestern building having a lower roof that probably housed a shop and support spaces. The northernmost eastern building (Building I) houses one (1) dynamo and consists of a high new pre-engineered wood truss framed roof with plywood sheathing and metal roofing supported by perimeter multi-wythe brick walls and interior steel beams and columns (see Photographs 1 and 2). The easternmost center building (Building II) houses two (2) dynamos and consists of metal roofing on plywood sheathing, on wood joists and beams supported by heavy timber trusses and steel beams and columns that support crane beams (see Photographs 3 and 4). The heavy timber roof trusses are supported by perimeter multi-wythe brick walls. The southernmost eastern building (Building IV) houses one (1) dynamo and consists of metal roofing on wood joists and beams supported by heavy timber roof trusses are supported by perimeter multi-wythe brick walls. The southernmost eastern building (Building IV) houses one (1) dynamo and consists of metal roofing on wood sheathing on wood joists and beams supported by heavy timber trusses, and perimeter low multi-wythe brick walls and upper concrete walls (see Photographs 5 and 6).

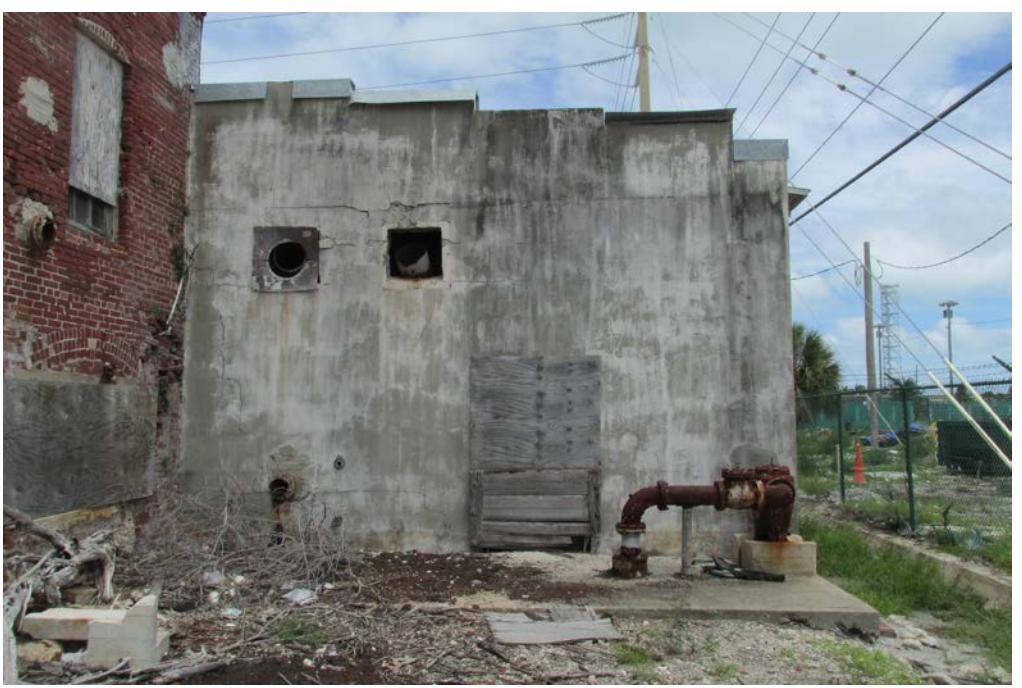
PHOTOGRAPH 9 (BUILDING III)

Below the roof structure is a gantry crane supported by a steel crane beam and steel columns independent of the perimeter brick walls. To the east of this building is an exterior concrete exhaust structure (Building V), which consists of a concrete roof slab with concrete parapets supported by concrete walls (see Photographs 7 and 8). The southwestern building (Building III) consists of metal roofing on wood sheathing on wood joists, and beams supported by interior steel beams and columns and perimeter multi-wythe brick walls, CMU walls and concrete walls (see Photographs 9 and 10).

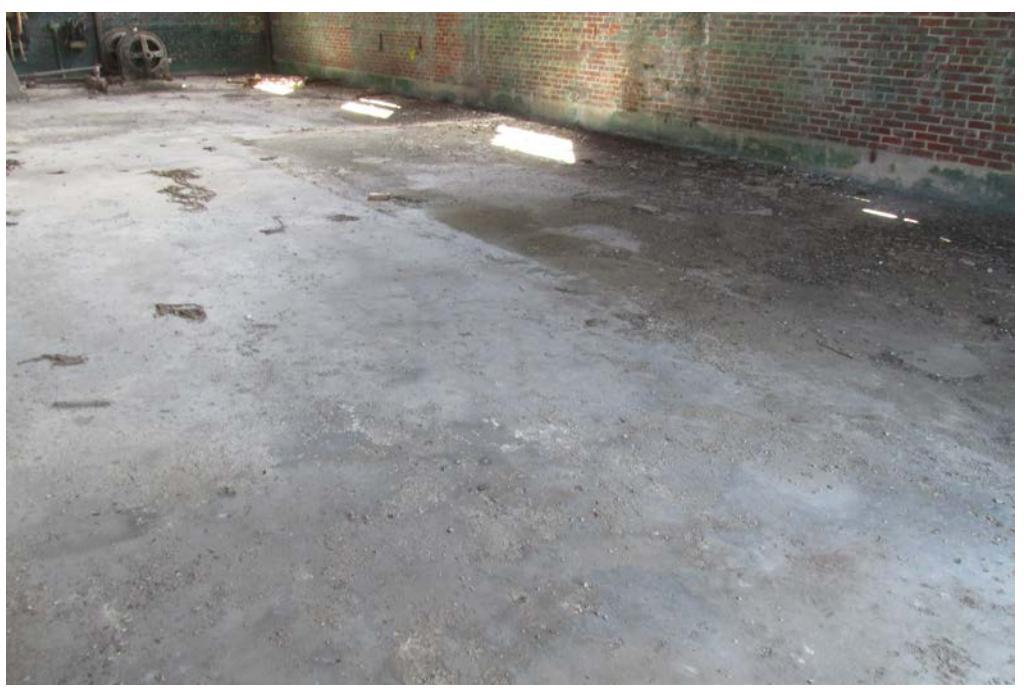
PHOTOGRAPH 14 (BUILDING I)

I. The northernmost, eastern building (Building I) has been recently re-roofed and the original wood structure supported by the steel beams and trusses have been replaced with plywood sheathing and wood trusses. The new roofing and roof structure is in excellent condition except that the roofing screws are not stainless steel and are corroding (see Photograph 12). The original steel beams, trusses and columns are in good condition with surficial corrosion except for one (1) column, which has a badly corroded base with more than 20% material loss (see Photograph 13). The slab on grade is cracked and uneven and there is a large crack at the interior door to the adjacent building, and several of the western window sills are spalled with corroded reinforcing and the remainder are cracked (see Photographs 14, 15 and 16).

Building I is in good condition with the exterior masonry requiring repair and several window lintels requiring replacement. The steel structure is in good condition with surficial corrosion except for one (1) column that needs reinforcement due to excessive corrosion at its base. All of the steel needs to be cleaned of corrosion and coated with a corrosion inhibiting coating. The slab on grade is cracked and uneven and is due for replacement. The exterior masonry requires repointing and all of the corroded embedments and steel lintels need to be cleaned of corrosion and coated with a corrosion inhibiting coating. The slab on grade is cracked and uneven and is due for replacement. The exterior masonry requires repointing and all of the corroded embedments and steel lintels need to be cleaned of corrosion and coated with a corrosion inhibiting coating. The deteriorated face brick needs to be removed and replaced and the vegetation in the wall cracks needs to be removed and the cracks repointed. At the western return metal panel wall, the badly corroded angle purlin needs replacement as well as the wall metal panels. The concrete spall in this wall also requires repair.

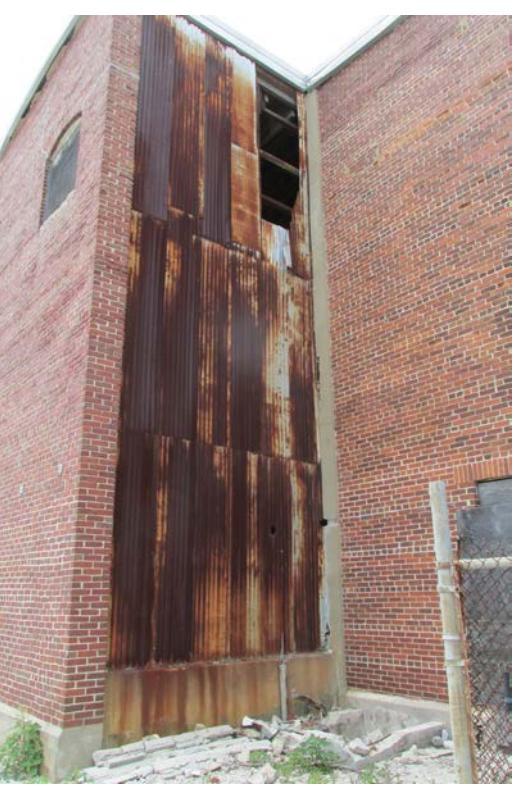
PHOTOGRAPH 27 (BUILDING I)

The exterior masonry walls are in good condition but there are numerous cracks, corroded embedments, deteriorated mortar, corroded lintels, deteriorated face brick, brick cracks with vegetation and random cracks in the concrete water table (see Photographs 17, 18, 19, 20, 21, 22 and 23). At the western return metal panel wall, there is a badly corroded angle purlin and a large column spall with corroded reinforcing and an area of missing metal wall panel (see Photographs 24, 25 and 26). The remaining metal panels are corroded and in poor condition (see Photograph 27).

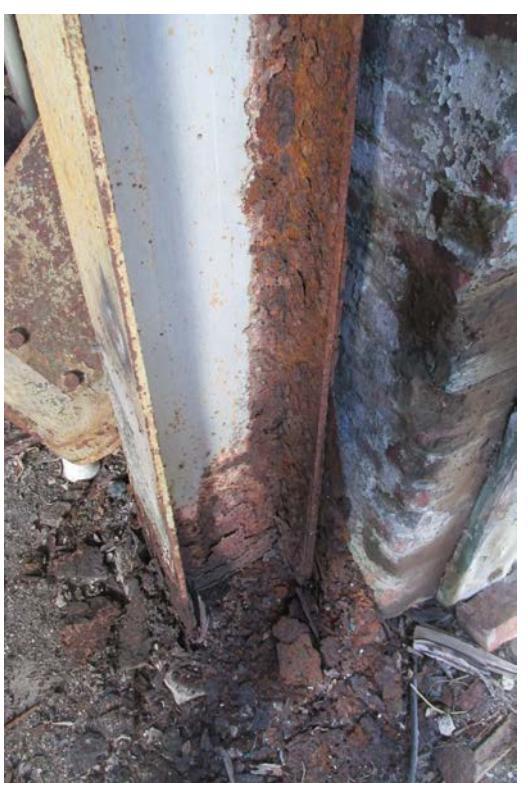
PHOTOGRAPH 29 (BUILDING II)

II. The eastern center building (Building II) is in much worse condition than the Building I with metal roofing in extremely poor condition with large areas of missing metal roofing and large areas of deteriorated roof decking (see Photograph 28). The roof wood structure is in good condition as well as the steel structure with surficial corrosion except for several badly corroded columns and post bases with more than 20% material loss (see Photographs 29 and 30).

The remainder of the buildings are in worse condition than Building I with Building IV being in the worst condition with a portion of missing roof. These buildings are stable but require new roofs with extensive roof sheathing replacement and some wood structure reinforcement and replacement. At the areas of missing and badly deteriorated roofing, these roofs could sustain significant damage in a severe wind event losing the remainder of their roofing and sheathing. In general, the steel structure is in good condition with surficial corrosion but several columns will need reinforcement due to excessive corrosion at their bases. All of the steel needs to be cleaned of corrosion and coated with a corrosion inhibiting coating. At Building IV, the wall opening with numerous loose and missing bricks and falling bricks needs to be shored or repaired immediately to prevent further deterioration of the wall. The exterior masonry walls are in good condition except for the northwest corner of Building II where there is a large area of missing brick that needs to be rebuilt. The remaining walls need to be repointed, deteriorated face brick removed and replaced and the vegetation in the wall cracks removed and the cracks repointed. Like Building I, all of the corroded embedments and steel lintels need to be cleaned of corrosion and coated with a corrosion inhibiting coating. In many of the arched brick openings, brick has been infilled with no lintel installed. This infill brick is being held in place by the mortar alone and in areas is cracking. This infill brick needs to be removed or steel lintels installed to support it. At Building II, the concrete platform is in poor condition with large spalls and the concrete carbonated to the reinforcing with the concrete containing high levels of chlorides. If it is the owner's desire to rehabilitate this platform when the concrete is repaired, it should be treated with a penetrating corrosion inhibitor or an active cathodic protection system installed. Due to the thickness of the platform walls, both will be expensive, therefore strong consideration should be taken for demolishing this platform. The exterior concrete walls and pits, except for Building V, are in poor condition requiring extensive repair. Like the Building II concrete platform, the concrete contains high levels of chlorides and once repaired, the walls should be treated with a penetrating corrosion inhibitor or an active cathodic protection system installed, and the exterior concrete coated with a penetrating sealer. The exterior pits and chutes are abandoned and should be cleaned of debris, the top of the deteriorated walls demolished to 8" below grade and filled with clean fill or stone. All of the interior trench and pit edge angles are in poor condition and badly corroded. All of the dynamo pits are full of water and breeding mosquitos. When the deteriorated dynamos are removed, the pits need to be pumped empty of water. The pits and trenches need to be dewatered, cleared of debris with the edge angles removed, and the pits and trenches filled with clean fill or stone with a concrete slab on grade placed, drilled and adhesived into the pit and trench walls level with the surrounding concrete slabs on grade. If any of the dynamos are kept for display, their pits should be pumped empty of water and filled and capped as described above.

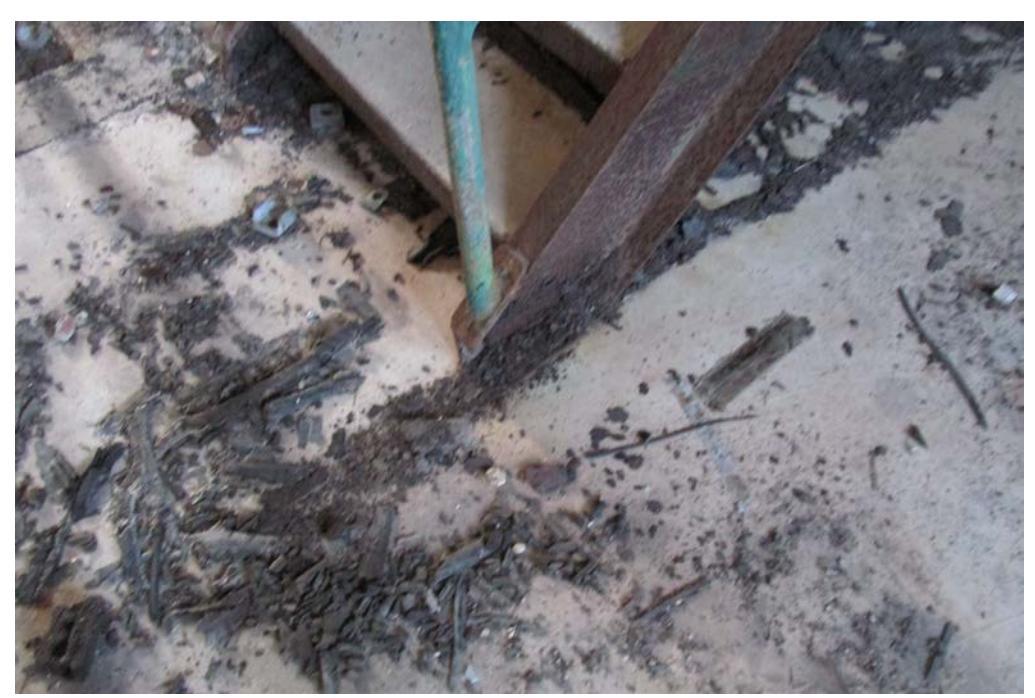
PHOTOGRAPH 31 (BUILDING II)

The stair to the concrete platform has badly corroded stair stringer bases with more than 20% material loss and the concrete platform has extensive large concrete spalls with exposed corroding reinforcing (see Photographs 31, 32 and 33). The exterior masonry walls are in good condition, but there are numerous cracks, corroded embedments, deteriorated mortar, deteriorated face brick, infilled arch brick with no lintel, large areas of missing brick, corroding lintels and brick cracks with vegetation (see Photographs 34, 35, 36, 37, 38 and 39).

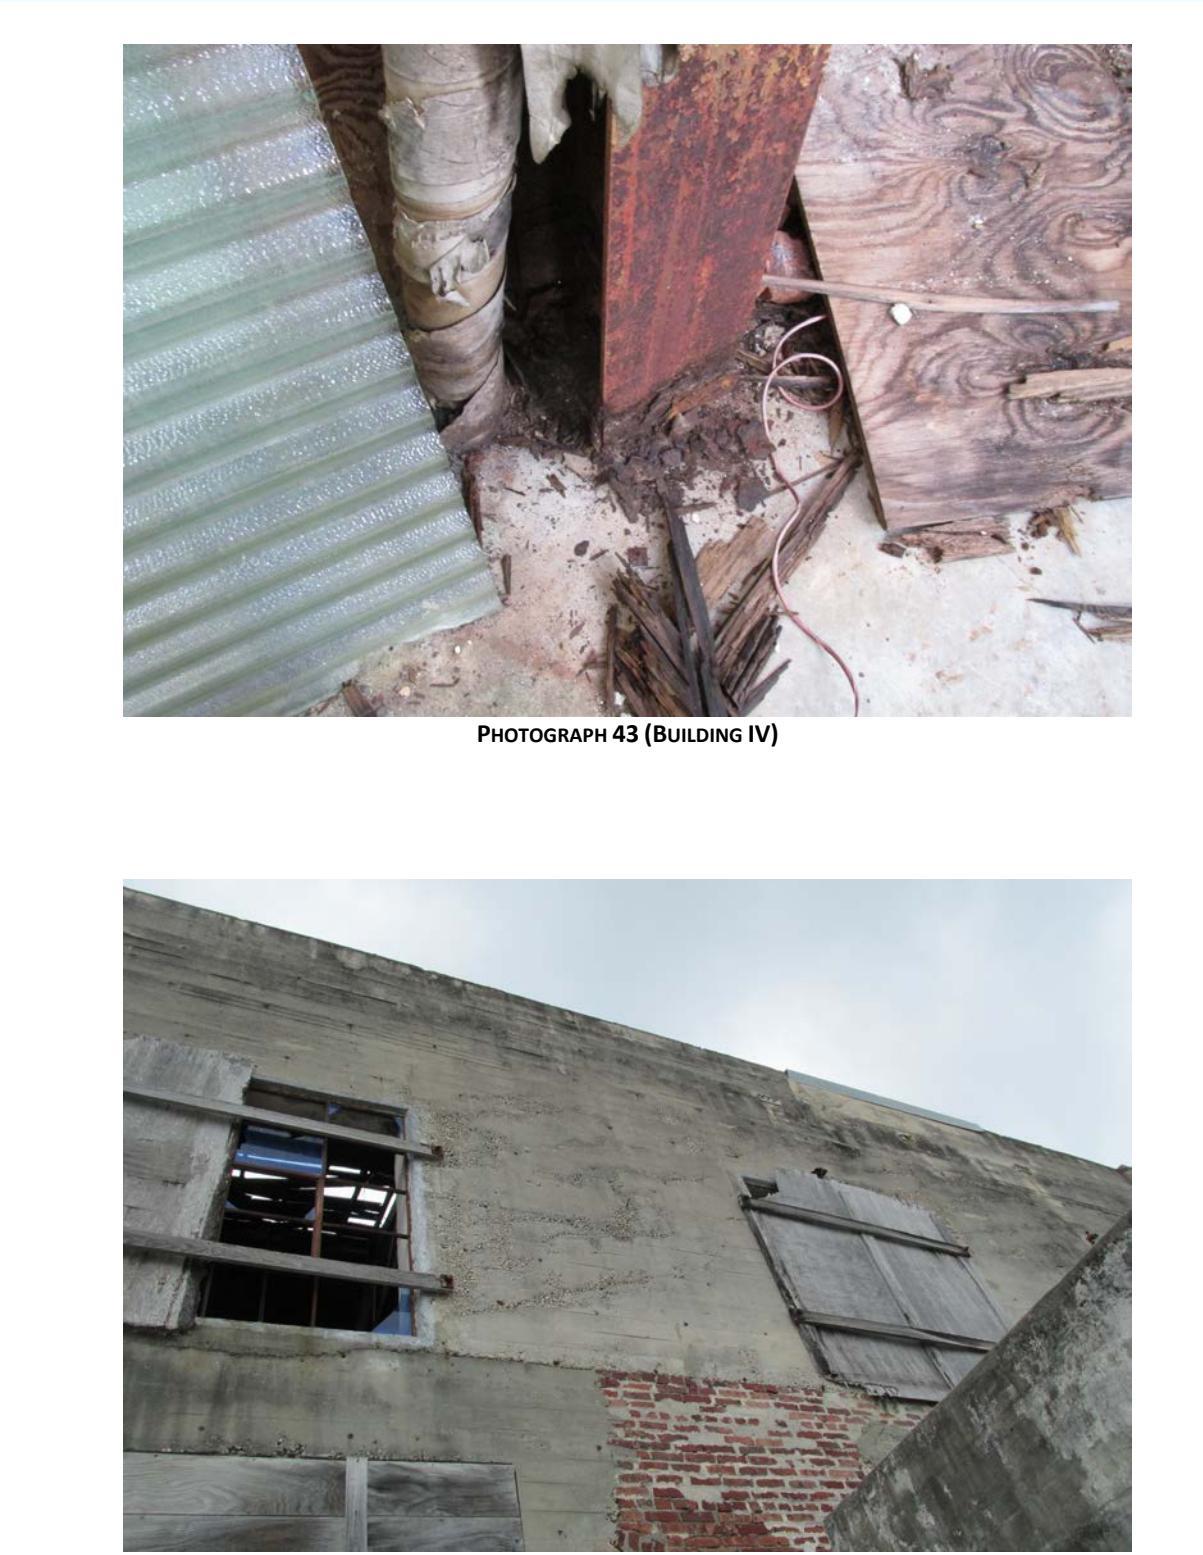
PHOTOGRAPH 44 (Building IV)

- IV. The southernmost eastern building (Building IV) is in worse condition than Building II with a large area of missing metal roofing and wood sheathing, a deteriorated bottom roof truss chord and a wall opening with numerous loose and missing bricks with bricks falling (see Photographs 40, 41 and 42). The wood roof joists are in poor condition but the wood trusses appear in good condition. The steel structure is in good condition with surficial corrosion but many of the steel column bases are severely corroded with more than 20% material loss (see Photograph 43). The exterior masonry walls are in good condition but there are numerous cracks, corroded embedments, deteriorated mortar and loose and missing face brick. The upper concrete walls have large areas of honey combed concrete and an area of spalled concrete with corroded reinforcing (see Photographs 44 and 45).

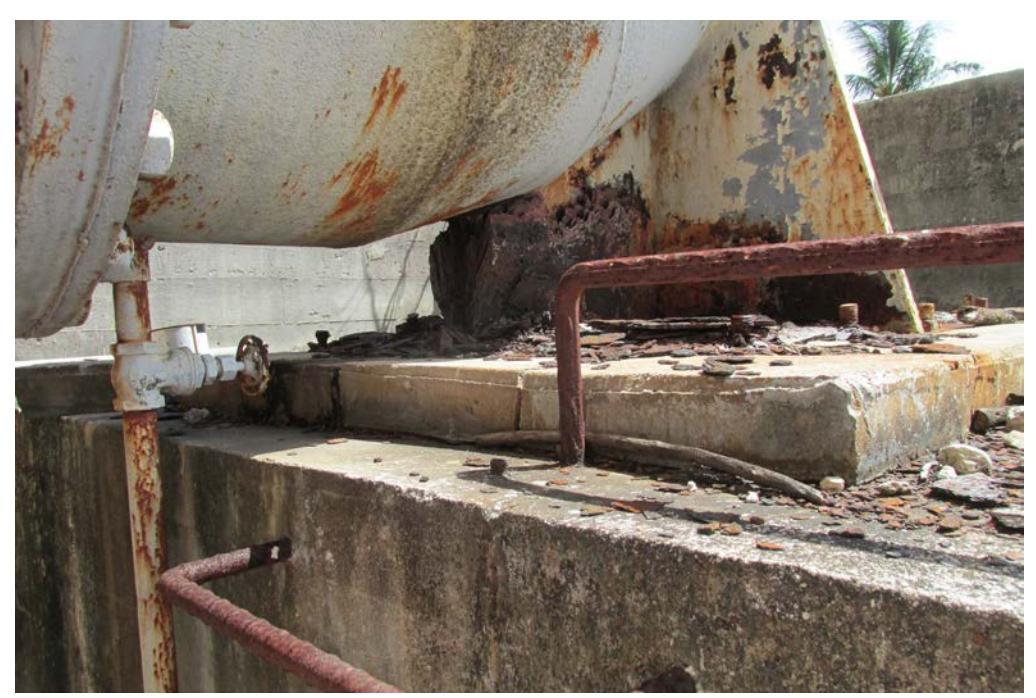
PHOTOGRAPH 51 (BUILDING V)

- V. The concrete exhaust building (Building V) is in good condition with corroded steel ladders; a badly corroded pipe support, a cracked housekeeping pad and a hairline crack in the roof parapet (see Photographs 50, 51, 52 and 53). The exterior pit and chute walls are in poor condition with cracked and spalling concrete with corroding reinforcing (see Photograph 54). All of the interior pits are full of water and breeding mosquitos. The interior trench and pit edge angles are in poor condition and badly corroded (see Photograph 55). All of the dynamos are in poor condition and badly corroded (see Photograph 56).
