BUILDING INSPECTION REPORT

631 Greene Street Fish House Key West, FL 33040

Client Name Key West Historic Seaport

Inspection Date: **04/24/2017** Inspection Time: 9:00 AM

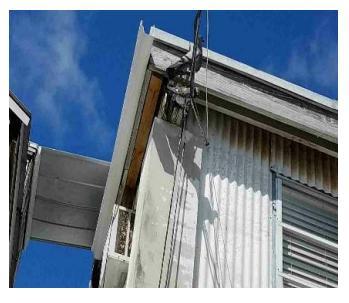
1.

Location: Exterior Right **System:** Roof **Condition:** Fascia wood is rotted **Explanation:** The condition of the fascia is such that wood rot and deterioration has occurred.

Impact Consequences: Rotted wood at fascias is an indication that the ability of the fascia to protect against water infiltration and pest entry has been compromised. All rotted and deteriorated wood at fascias should be removed and replaced. Failure to correct this condition may result in costly repairs to adjacent areas damaged as a result of loss of protection.

Recommended Action: Replace

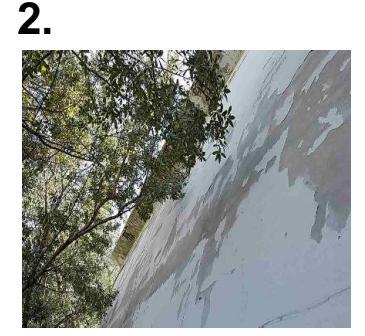
Location: Exterior Rear System: Roof Condition: Deteriorated Concrete Roof Deck

Explanation: The concrete roof deck is deteriorated. **Impact Consequences:** Deteriorated sections of the concrete roof deck should be refinished in order to increase life expectancy. **Recommended Action:** Repair or Replace Click here to find out more about this item

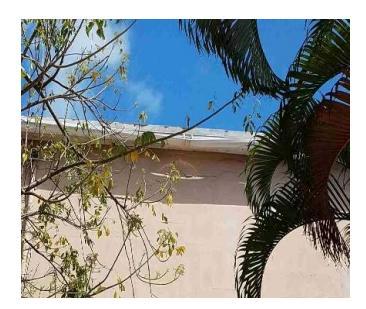
3.

Location: Exterior Front **System:** Roof **Condition:** Gutter is damaged **Explanation:** Damage is noted at the roof edge gutter. Damaged gutters may prevent the controlled drainage of water from roof areas as intended.

Impact Consequences: Gutters are a key component in the controlled drainage of run-off water away from the building exterior elements. Gutters that do not perform as intended may result in saturation of soils near the foundation which in turn can result in basement moisture or leakage issues. Repair should include repairing or replacing damaged sections of gutters and assuring that water freely flows and drains from the gutter.

Recommended Action: Repair or replace <u>Click here to find out more about this item</u>

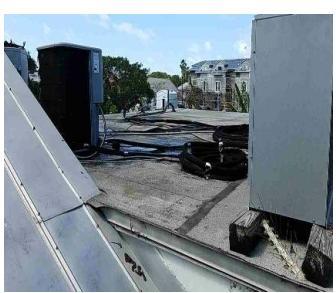
4.

Location: Exterior Front System: Roof Condition: Water ponding on roof surface is observed

Explanation: Active water ponding is observed on the roof surface. Poor roof surface drainage increases the risk of leakage and can reduce the life expectancy of the roof. **Impact Consequences:** Flat and low-slope roofs should be sufficiently sloped such that all water will drain from its surface. Water that ponds on the surface will add to the weight loading at the affected area which will over time enlarge this area and compound the problem. Leaks are most likely to occur at seams that are immersed in water. Correction to the roof surface profile is required. A roofing specialist should be consulted to assess for current condition and for requirements and costs for remedial action.

Recommended Action: Replace consult specialist

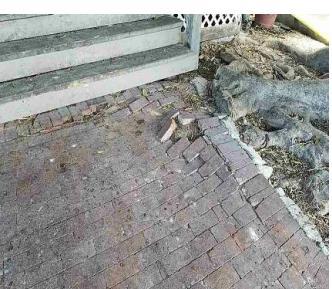
Location: Exterior Front **System:** Exterior **Condition:** Trip hazard(s) on walkway **Explanation:** Uneven surface conditions in the walkway present the risk of tripping for persons traversing the walkway.

Impact Consequences: Trip hazards are a safety concern requiring immediate attention.

Recommended Action: Repair Click here to find out more about this item

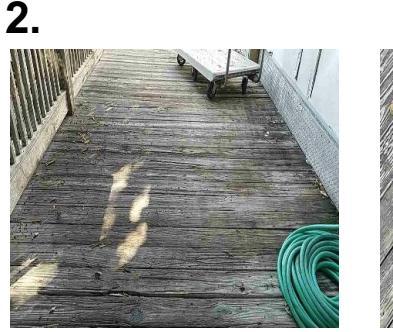
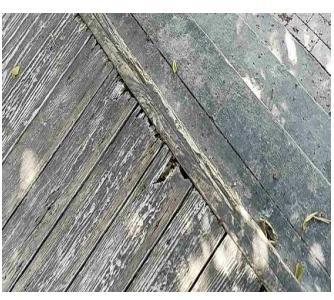
Location: Exterior Front **System:** Exterior **Condition:** Deck boards are deteriorated **Explanation:** Deck boards are deteriorated and are in need of replacement. **Impact Consequences:** The primary purpose of deck boards is to provide a sound and sturdy surface for foot traffic. Boards subject to rot and deterioration may break through and may result in fall hazards. Individual boards with end or excessive edge rot should be replaced; all boards should be capable of bearing traffic without excessive flexing. Where individual boards are deteriorated these boards should be replaced to reduce the risk of injury.

Recommended Action: Replace

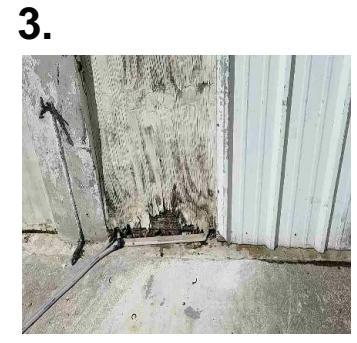
Location: Exterior Right System: Exterior Condition: Rot observed on wood elements

Explanation: Wood elements that display rot should be replaced

Impact Consequences: Rot in wood is an indication of excessive moisture and insufficient drying over time. Failing to replace the affected wood will most often result in further wood deterioration over time, and will often result in water damage to wall areas behind the wood elements. Rotting wood provides an attractive environment for insects. The cause(s) for the wood rot should be understood and corrected as part of the remedial actions, thus preventing future recurrence of this condition.

Recommended Action: Replace

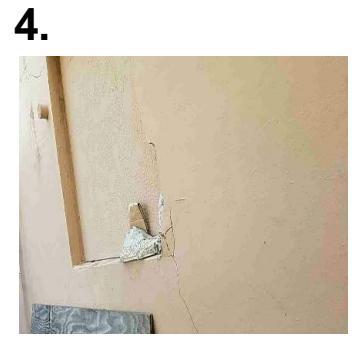
Location: Exterior Rear **System:** Exterior **Condition:** Foundation wall is damaged **Explanation:** An area of damage is noted in the foundation wall.

Impact Consequences: Damaged areas are susceptible to adverse conditions that may include deterioration of the foundation wall structural effects and water infiltration. As a minimum periodic examinations should be performed to observe for change and whether any adverse conditions are occurring. Advice from a foundation or structural specialist should be considered.

Recommended Action: Monitor; Consult Specialist Click here to find out more about this item

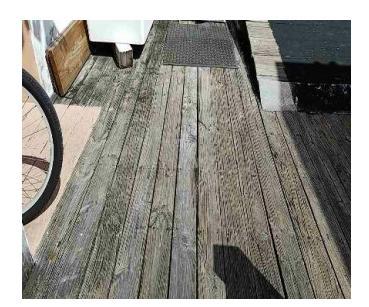
5.

Location: Exterior Front **System:** Exterior **Condition:** Deck surface is bouncy **Explanation:** When traversing the deck surface the deck surface has areas where noticeable bounce is observed.

Impact Consequences: Decking should provide a sound and sturdy surface for foot traffic. Bounce in the deck surface is an indication there is either insufficient support under the decking joist span is too great the deck boards are not adequately secured or there is insufficient end support at individual deck boards. Over time extra stress on the boards may result in premature deterioration and they may fracture and fail under load. To establish a safe and durable deck surface the cause of the bounce should be investigated and corrections applied to improve the sturdiness of the decking. Review by a framing contractor is suggested.

Recommended Action: Repair

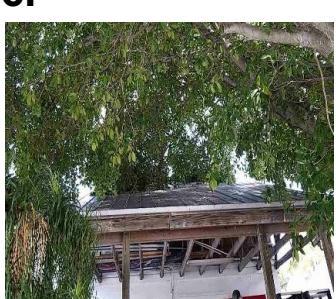
Location: Exterior Front System: Exterior Condition: Tree branches are too near to the roof surface

Explanation: Roof surfaces can be damaged by tree branches in close proximity to the roof cover.

Impact Consequences: Tree branches in contact with the roof surface will abrade the roof cover. Where the roof is heavily shaded by tree branches and leaves moss growth may occur as moisture is retained at the roof surface; flat roofs are particularly vulnerable to this condition as evaporation from the surfaces is restricted. Leaves and debris from trees will also clog the roof drainage system. Trees not only are buildings to many pests they also provide ready access to areas normally difficult for them to access such as roofs chimneys soffits vents etc. As a guide the maximum outermost branches of a mature tree should be no closer than 10Ft. (3m) from any surface of the building.

Recommended Action: Remove Click here to find out more about this item

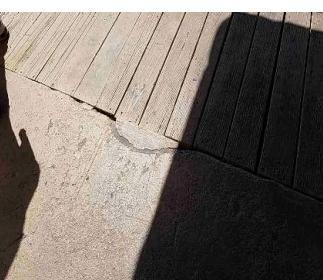
7.

Location: Exterior Front **System:** Exterior **Condition:** Trip hazard(s) on walkway **Explanation:** Uneven surface conditions in the walkway present the risk of tripping for

persons traversing the walkway. <u>Impact Consequences:</u> Trip hazards are a safety concern requiring immediate attention. <u>Recommended Action:</u> Repair <u>Click here to find out more about this item</u>

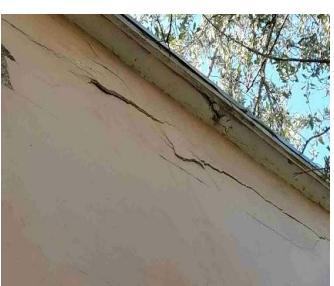
1.

Location: Exterior Rear **System:** Structure **Condition:** Exterior masonry wall has deteriorated mortar

Explanation: The mortar in the masonry wall is observed to be in a deteriorated condition. As mortar is a mixture of cement sand and water there is a broad range of performance characteristics of the mortar. As such the ability of the mortar to withstand the deteriorative effects of the conditions to which it is exposed will vary broadly. The current observed condition of the brick wall is such that the degree of deterioration warrants considerations for repair.

Impact Consequences: Mortar will deteriorate over time. When mortar deteriorates such that the mortar is cracked eroded or missing and such that further deterioration would reduce the integrity of the wall repairs should be performed. Minor repairs often involve pointing or removing and replacing areas of deteriorated mortar without disturbing the bricks. Where deterioration is more severe then more intensive work is required to repair the wall which often involves removing and rebuilding brickwork. Obviously the longer the delay in repairing the wall will increase the amount and expense of repair. Left uncorrected mortar deterioration can result in collapse of the masonry wall.

Recommended Action: Repair Click here to find out more about this item

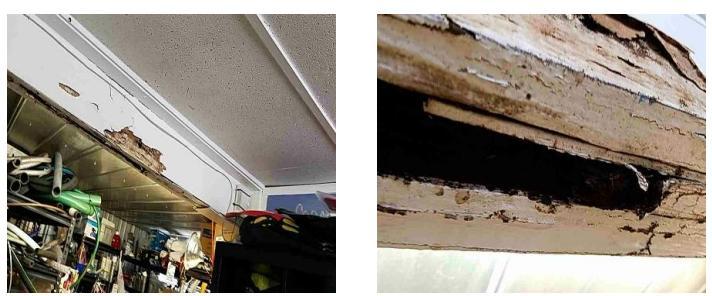
2.

Location: Storage **System:** Structure **Condition:** Deteriorated or Damaged Beams **Explanation:** Structural support beams are observed to be damaged or deteriorated. **Impact Consequences:** Deteriorated or damaged structural beams should immediately be reviewed by a qualified contractor for proper repairs.

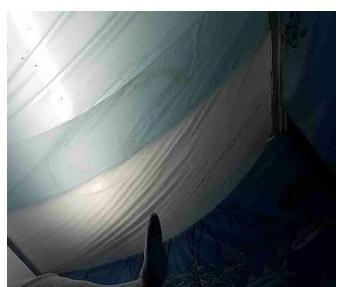
1.

Location: Museum **System:** Interior **Condition:** DRY Ceiling Stain Roof Leak **Explanation:** A stain on a ceiling surface is observed to test low for moisture content using moisture meters or thermal imaging camera. The source of the moisture intrusion is suspected to be from a past roof leak which may or may not have been repaired.

Impact Consequences: In observing the water staining the Inspector suspects the leak may have been from a past roof leak. The stained ceiling area should be replaced or repaired in order to provide a clean surface in which a reoccurrence of the problem may be readily visible. It should be noted that certain conditions may be required for the leak to activate such as heavy rains. Ongoing monitoring as part of routine maintenance of this area is recommended.

Recommended Action: Review

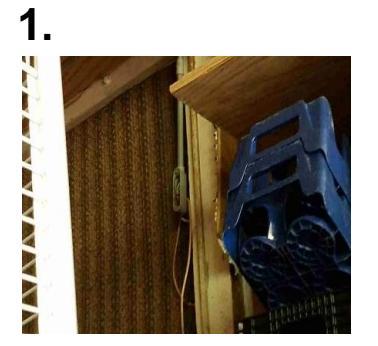
Location: Storage System: Electrical Condition: Damaged or Missing Cover Plate On Junction Box

Explanation: A protective cover plate is observed to be damaged or missing from an electrical junction box.

Impact Consequences: A cover plate for junction box is required to reduce the risk of electrical shock. A suitable cover plate should be immediately installed for safety. **Recommended Action:** Repair

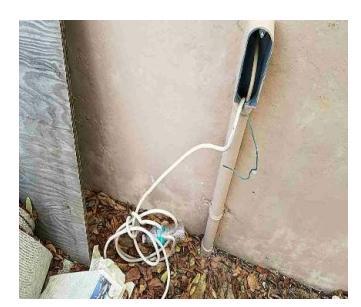
Location: Exterior Rear System: Electrical Condition: Unterminated active wiring observed

Explanation: Wires are observed to be not terminated in a protective box and this wiring is active.

Recommended Action: Repair

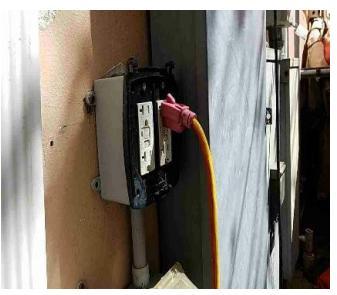
3.

Location: Exterior Front System: Electrical Condition: Damaged or Missing Cover of Exterior Electrical Outlet

Explanation: Electrical outlets installed in outdoor locations require protection from water entry and contaminants.

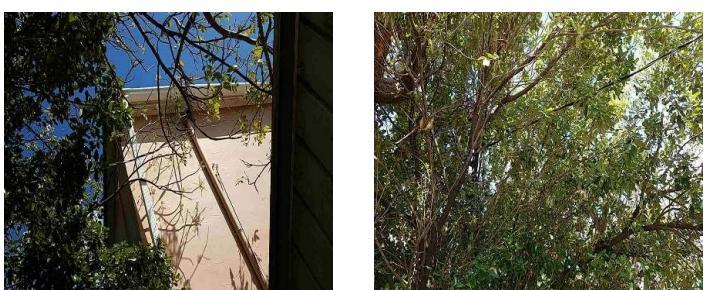
4.

Location: Exterior Front System: Electrical Condition: Tree Branches Too Near To Service Cable or Mast

Explanation: Clearance of the service cable or mast appears to be insufficient. **Impact Consequences:** Trees should be cleared away from the electrical service cable and entrance in order to prevent damage or hazards during high wind storms. Consult the local power company for proper correction.

Recommended Action: Adjust

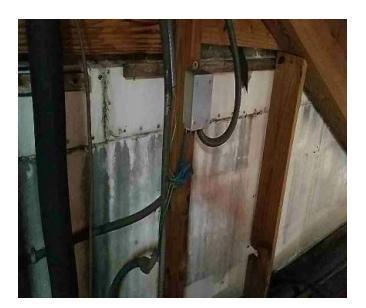
Location: Attic **System:** Electrical **Condition:** Conduit Not Properly Connected **Explanation:** The conduit as installed is not properly connected to a panel or junction box.

Impact Consequences: Connect the conduit to a junction box or panel in order to prevent damage to wiring and avoid electrical shock hazards. **Recommended Action:** Repair

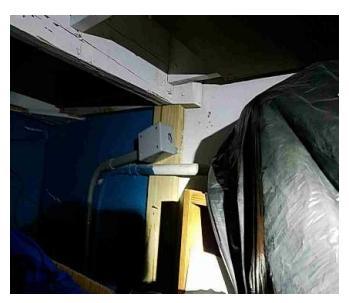
6.

Location: Museum System: Electrical Condition: Open Knock Outs Of Junction Box

Explanation: The junction box is observed to have missing or open knock outs. **Impact Consequences:** These openings are designed to allow distribution of wiring to other components. When not connected to a conduit the openings should be sealed in order to prevent hazards.
