STAFF REPORT

RE: 1109 Varela Street (permit application # T2019-0472)

FROM: Karen DeMaria, City of Key West Urban Forestry Manager

An application was received requesting the removal of (1) Mango tree. A site inspection was done and documented the following:

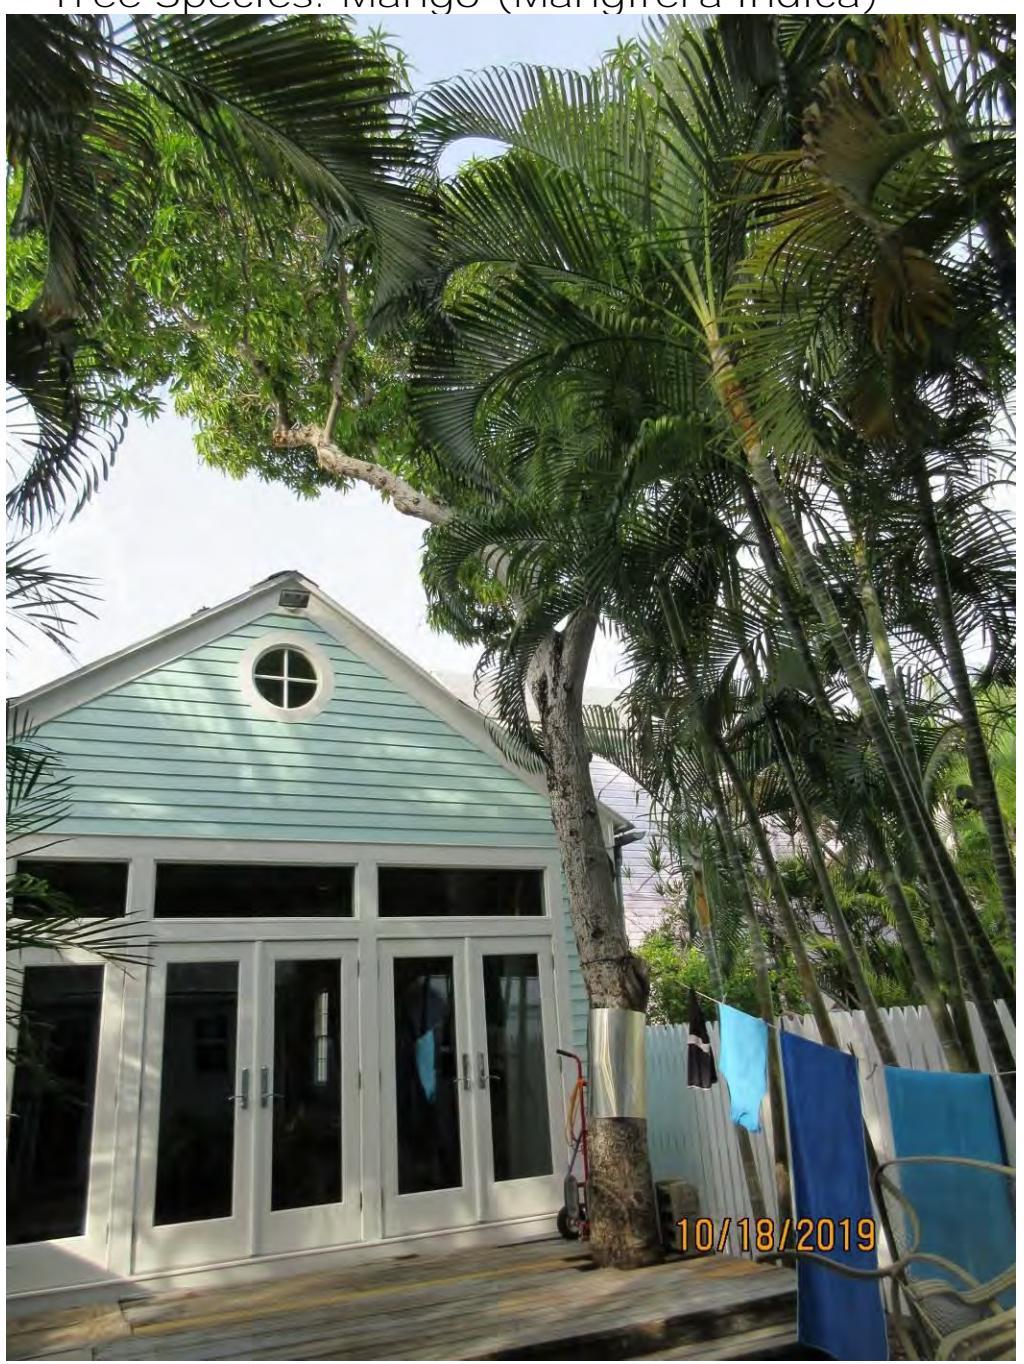
Photo of mango tree in back yard near structure

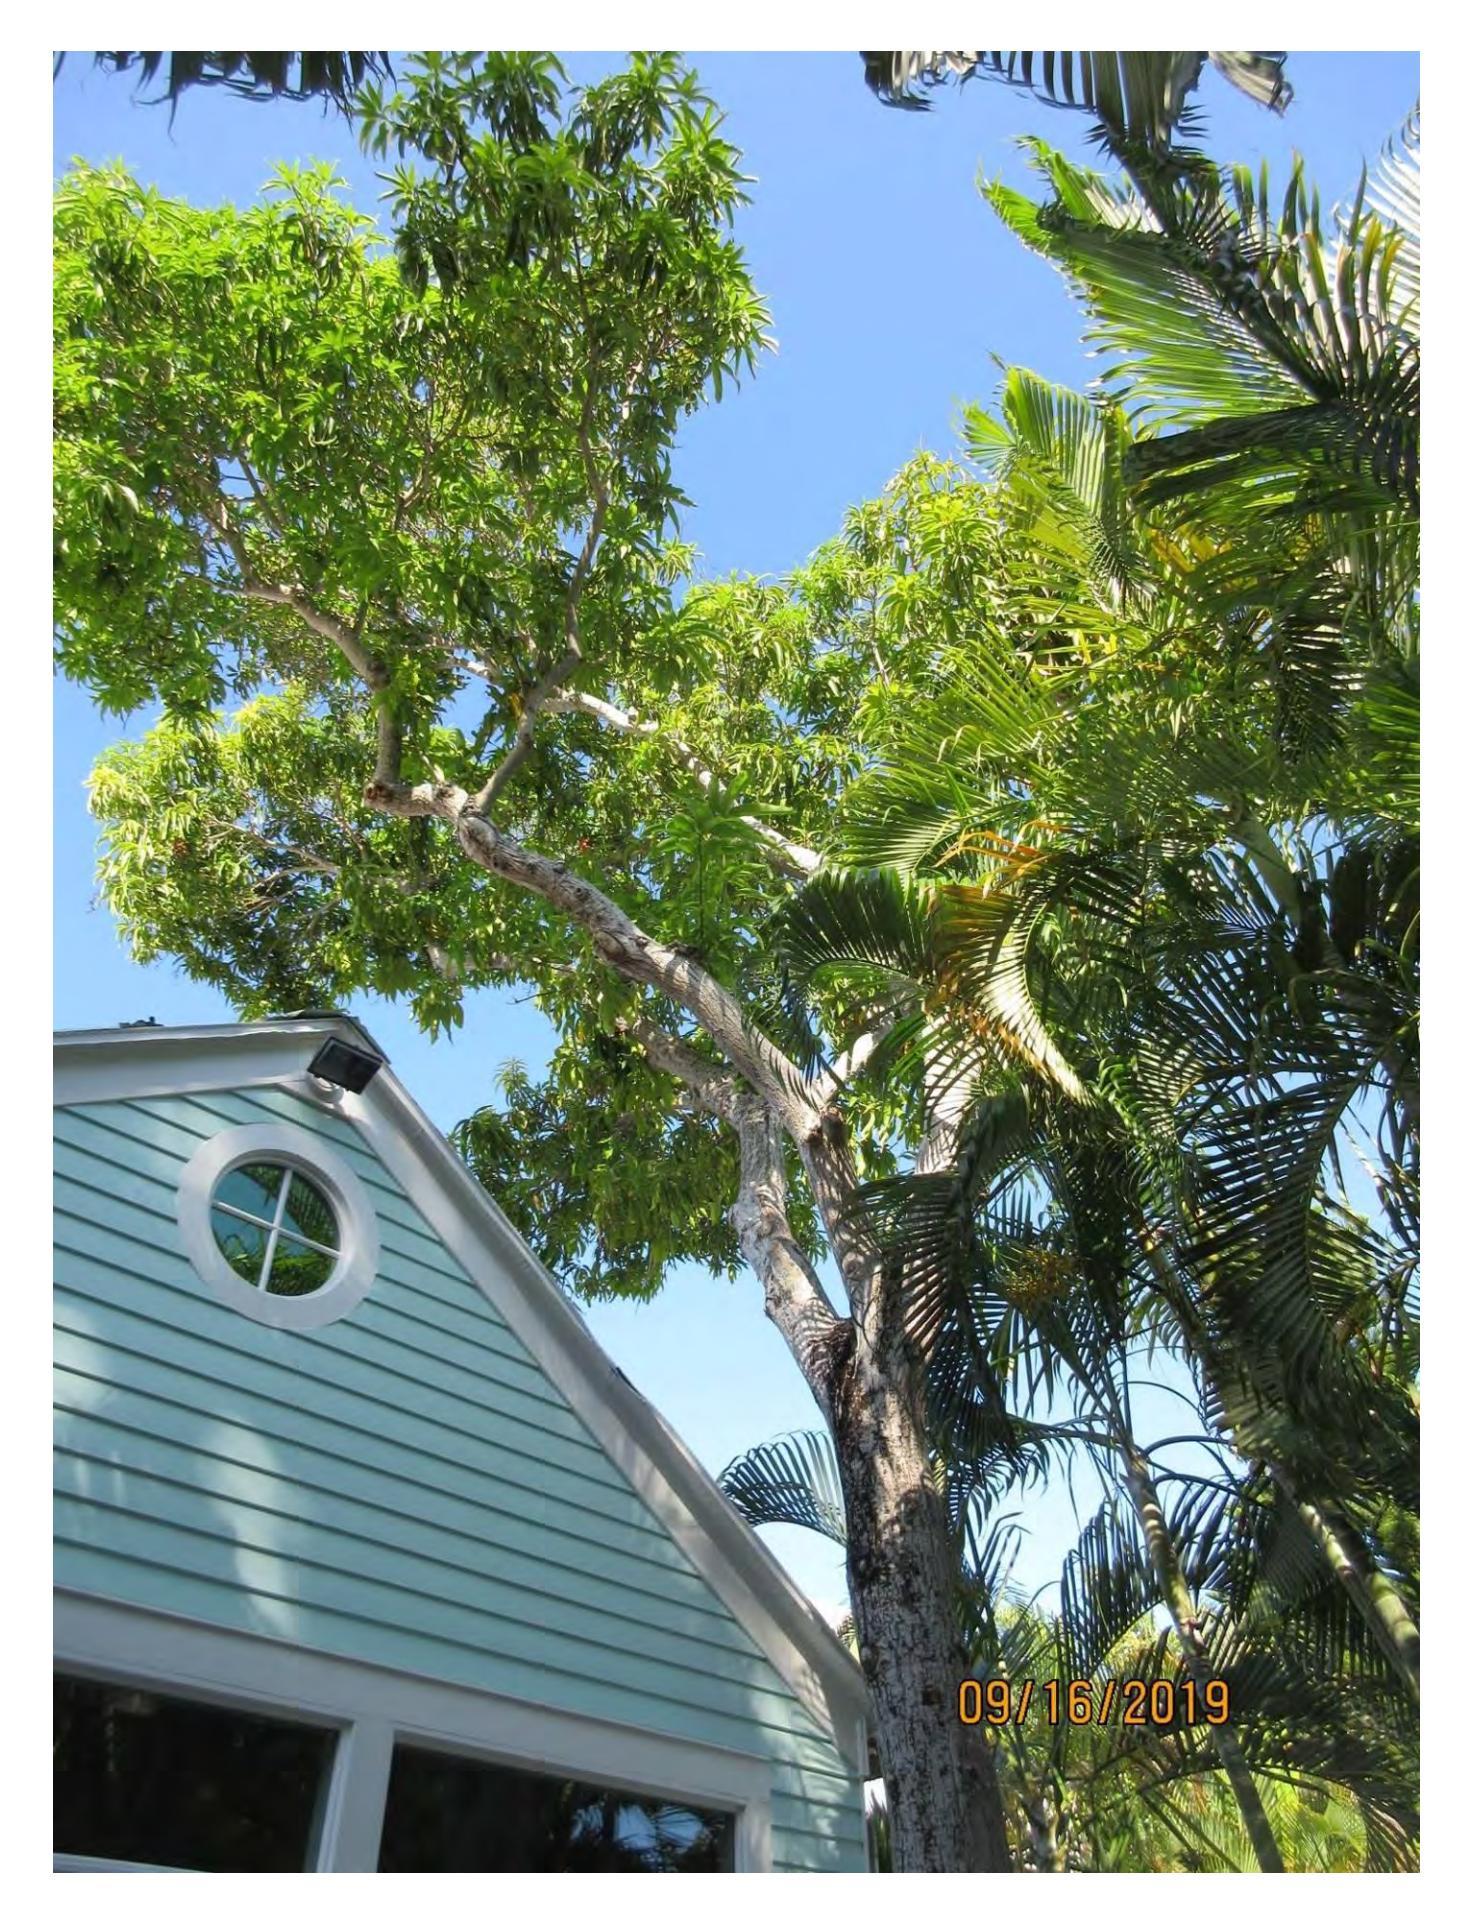
Photo of tree canopy over roof.

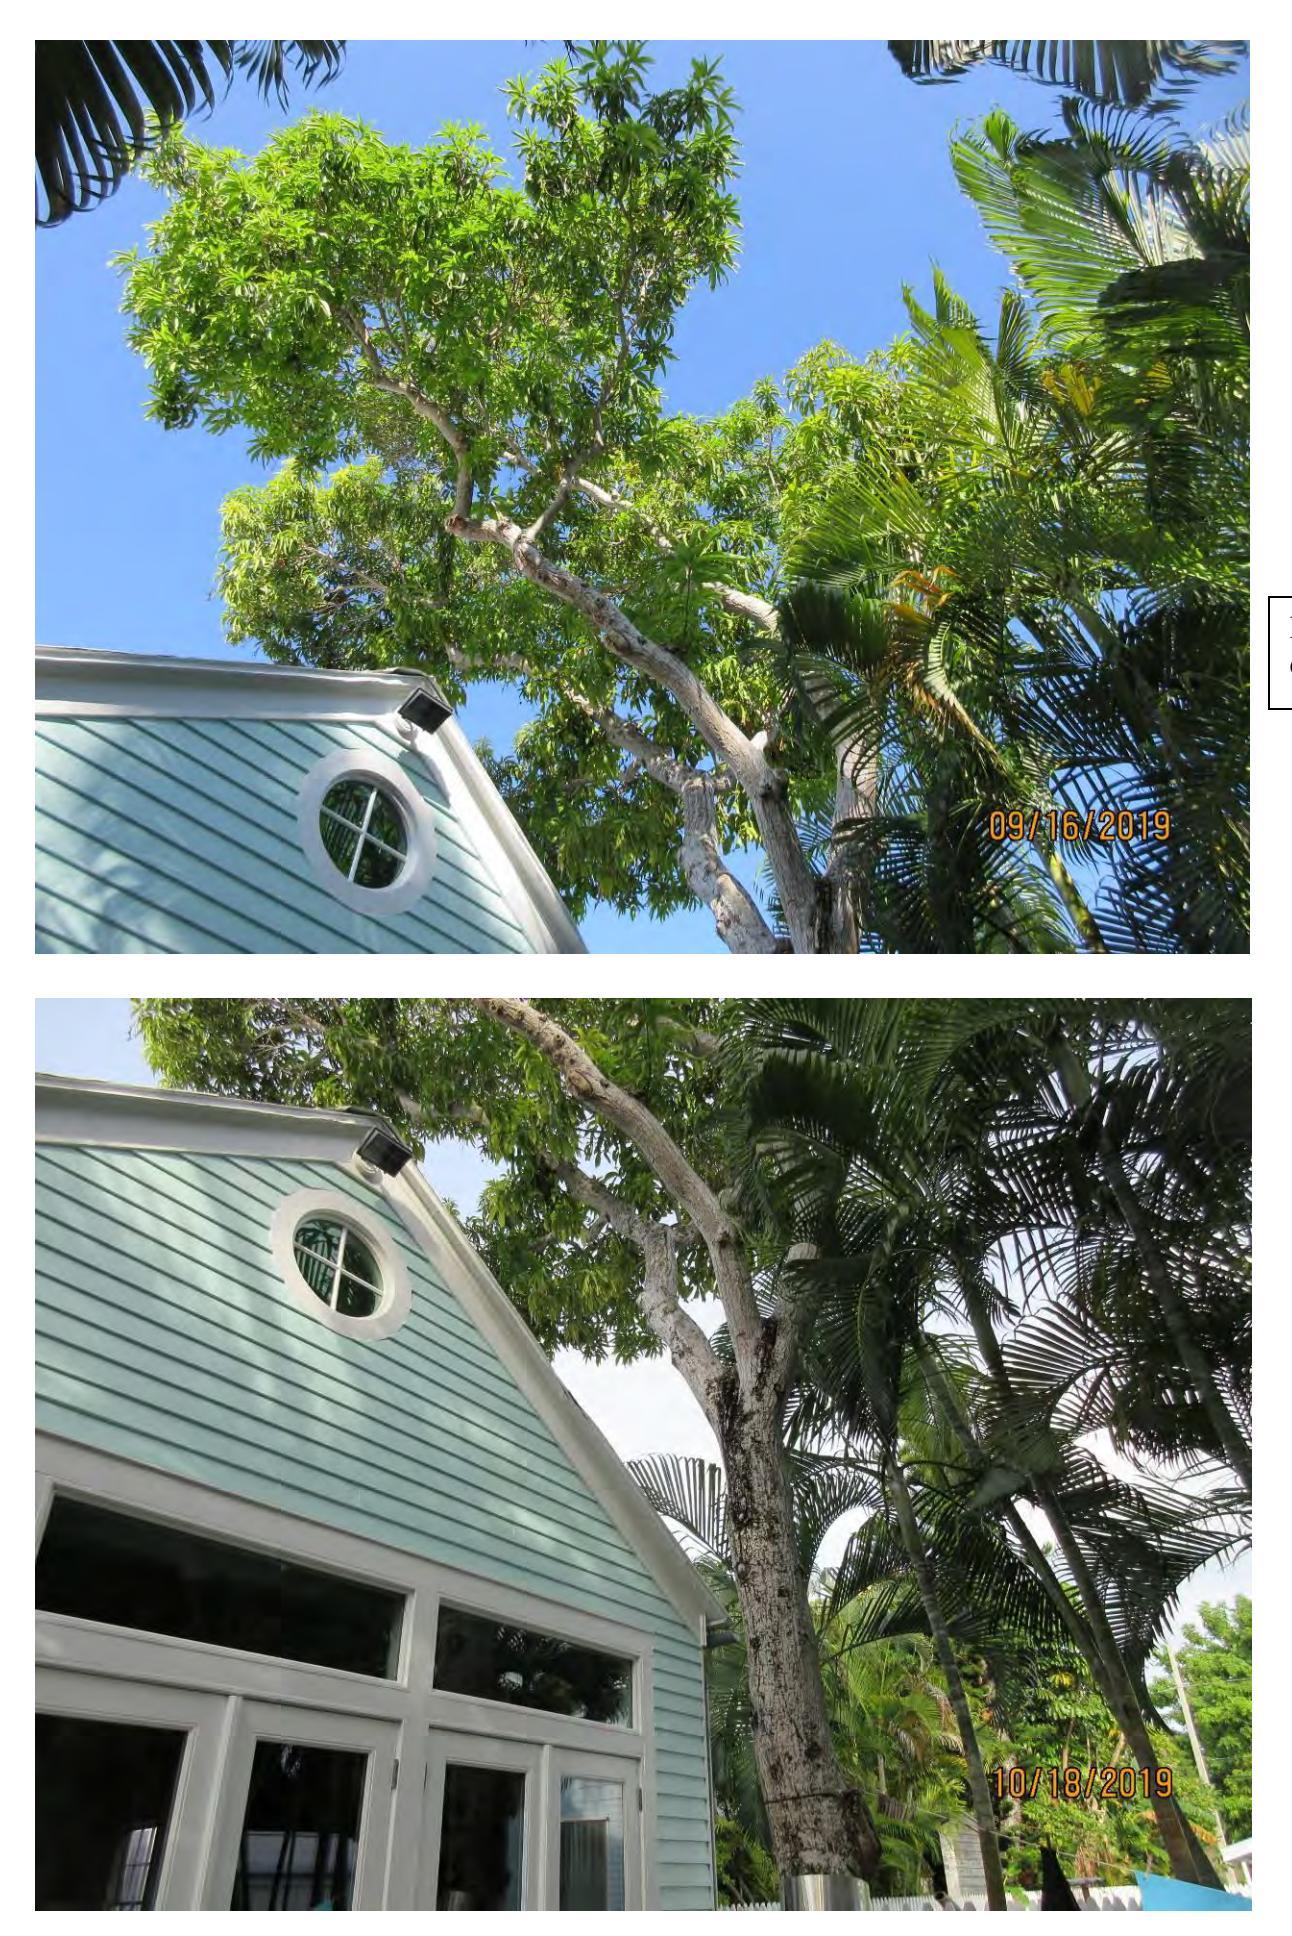
Photo of tree canopy, view 1.

Photo of tree trunk, view 1.

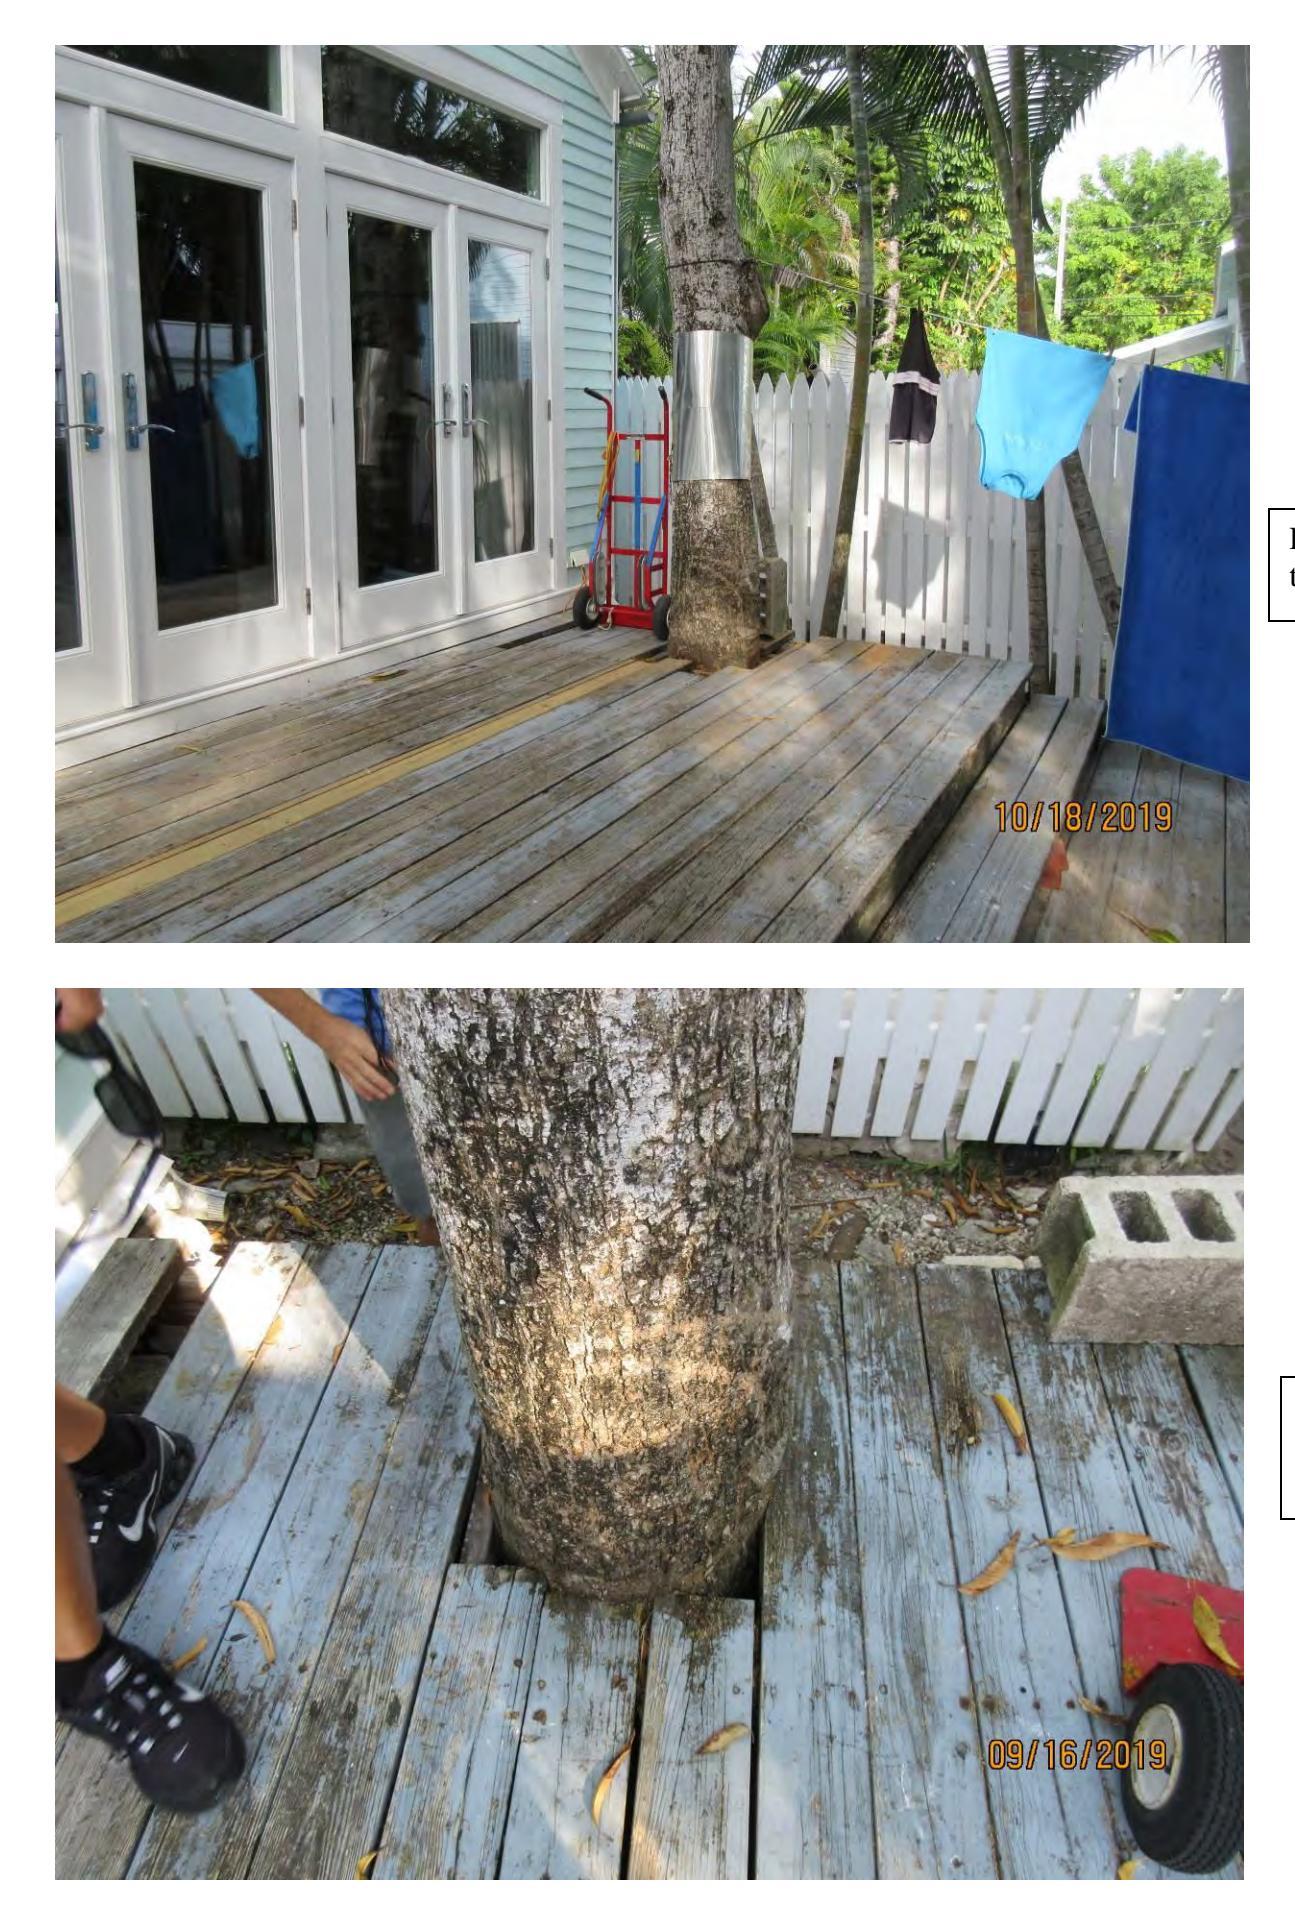
Photo of tree trunk, view 2.

Photo of tree trunk at deck area, view 1.

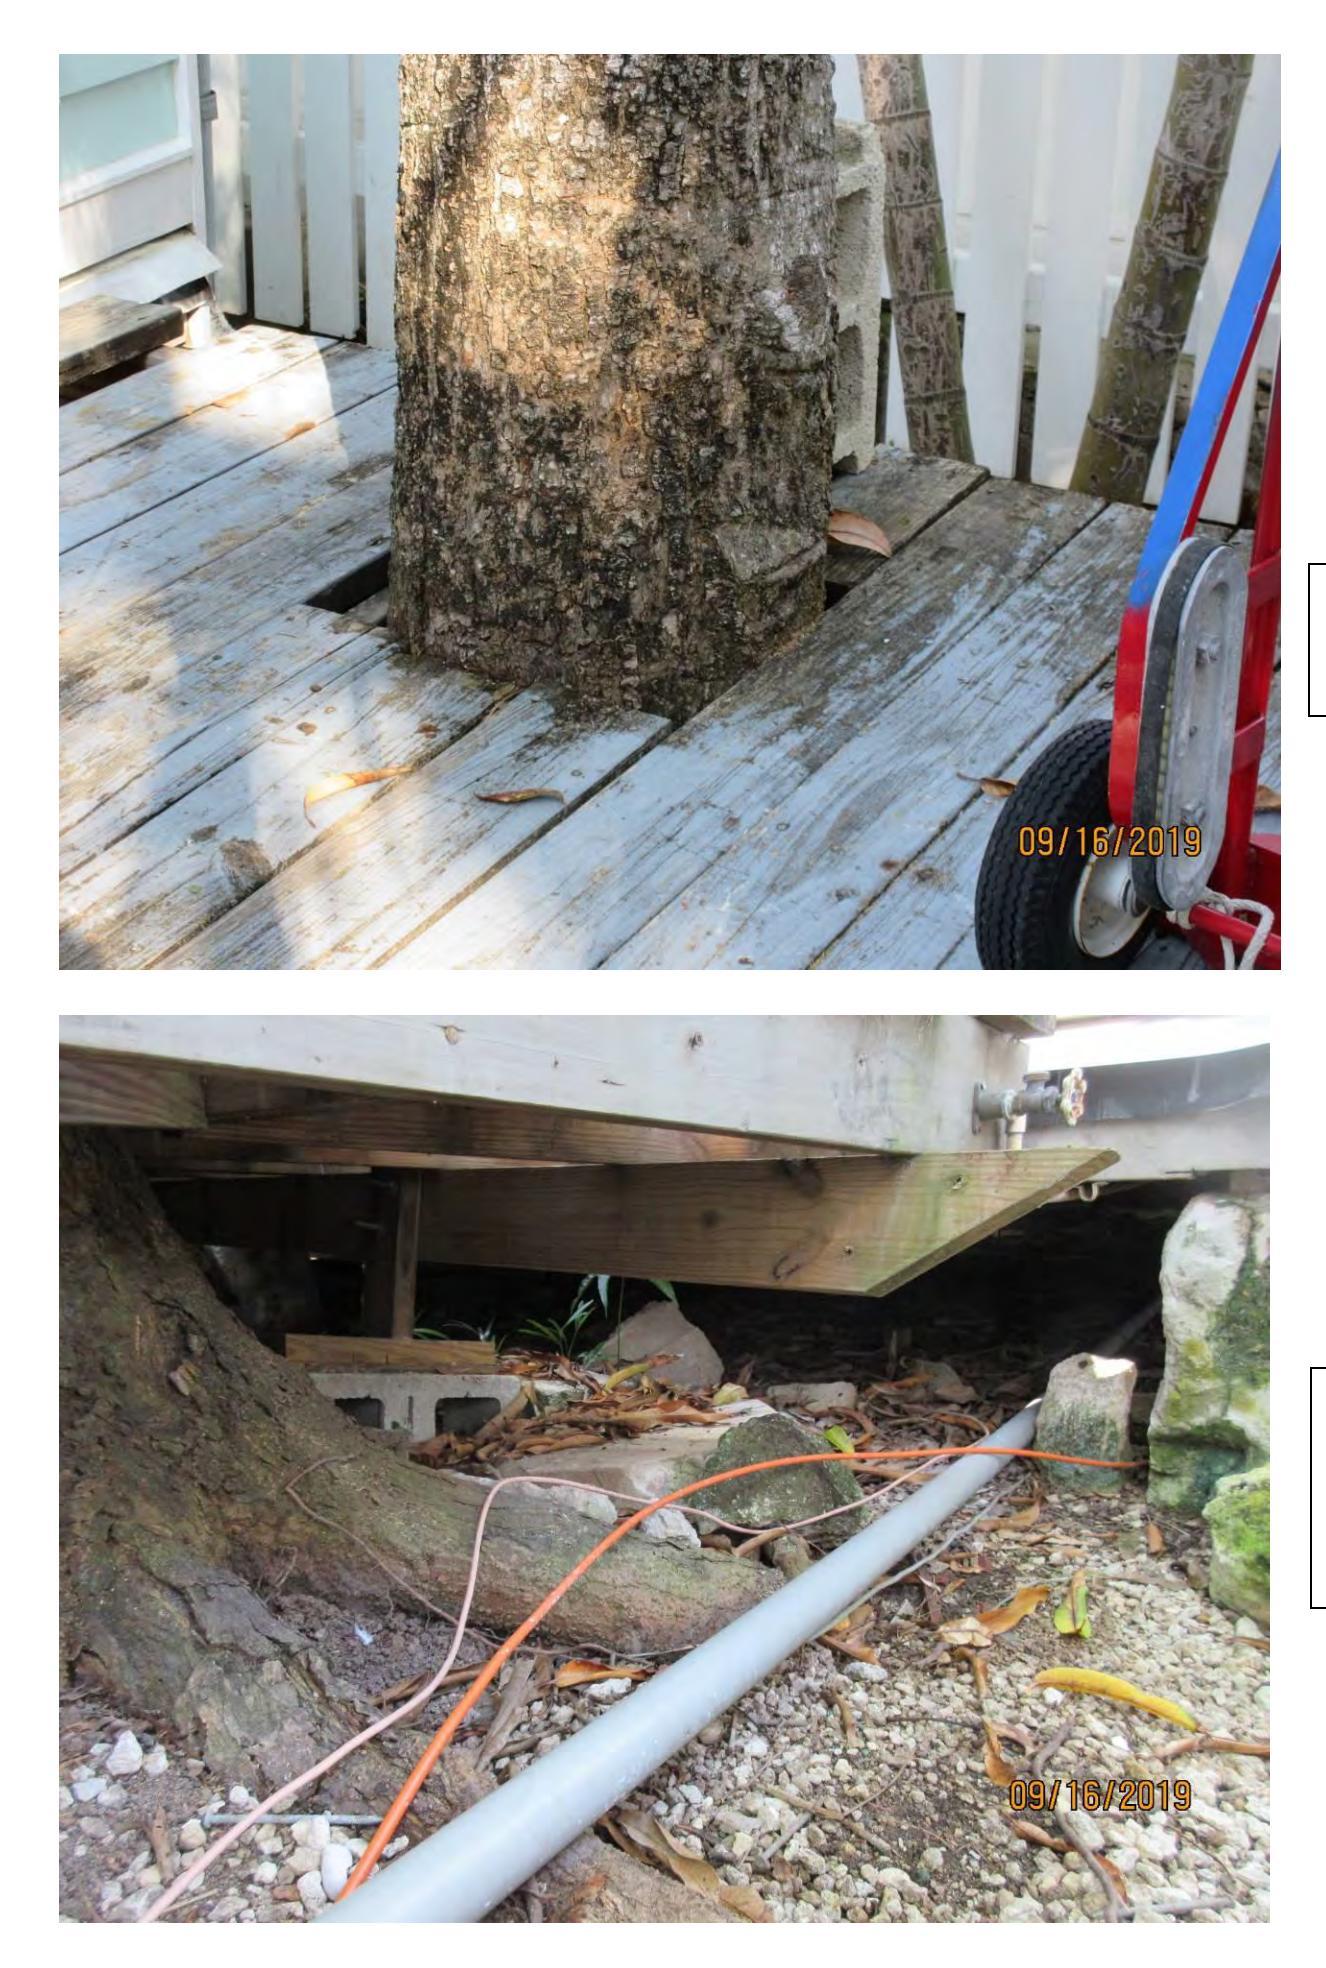
Photo of tree trunk at deck area, view 2.

Photo of base of tree and roots growing toward house footer, view 1.

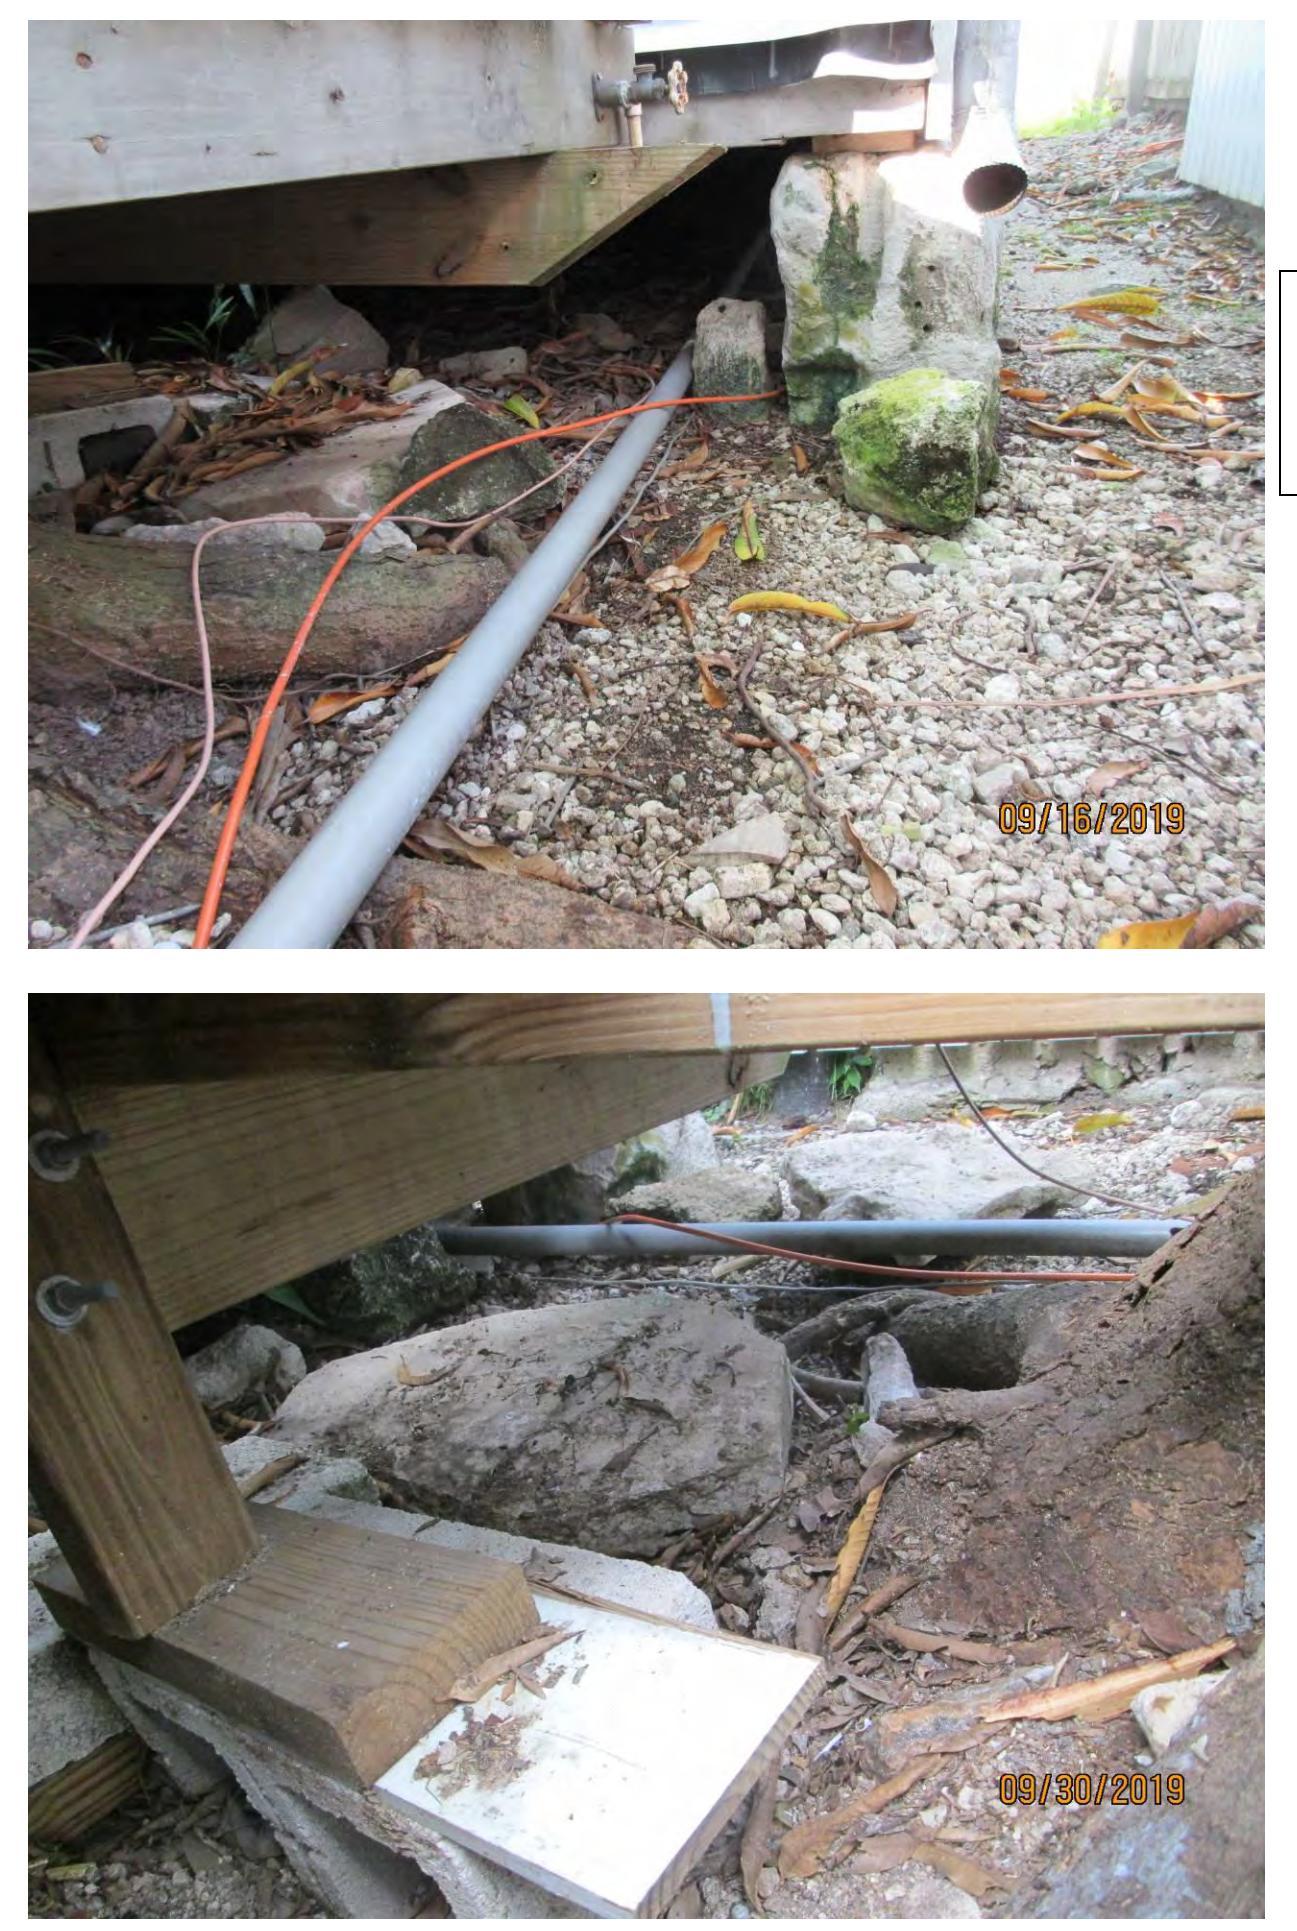
Photo of base of tree and roots growing toward house footer, view 2.

Photo of base of tree, showing root areas that had been uplifted in Hurricane Irma, view 1.

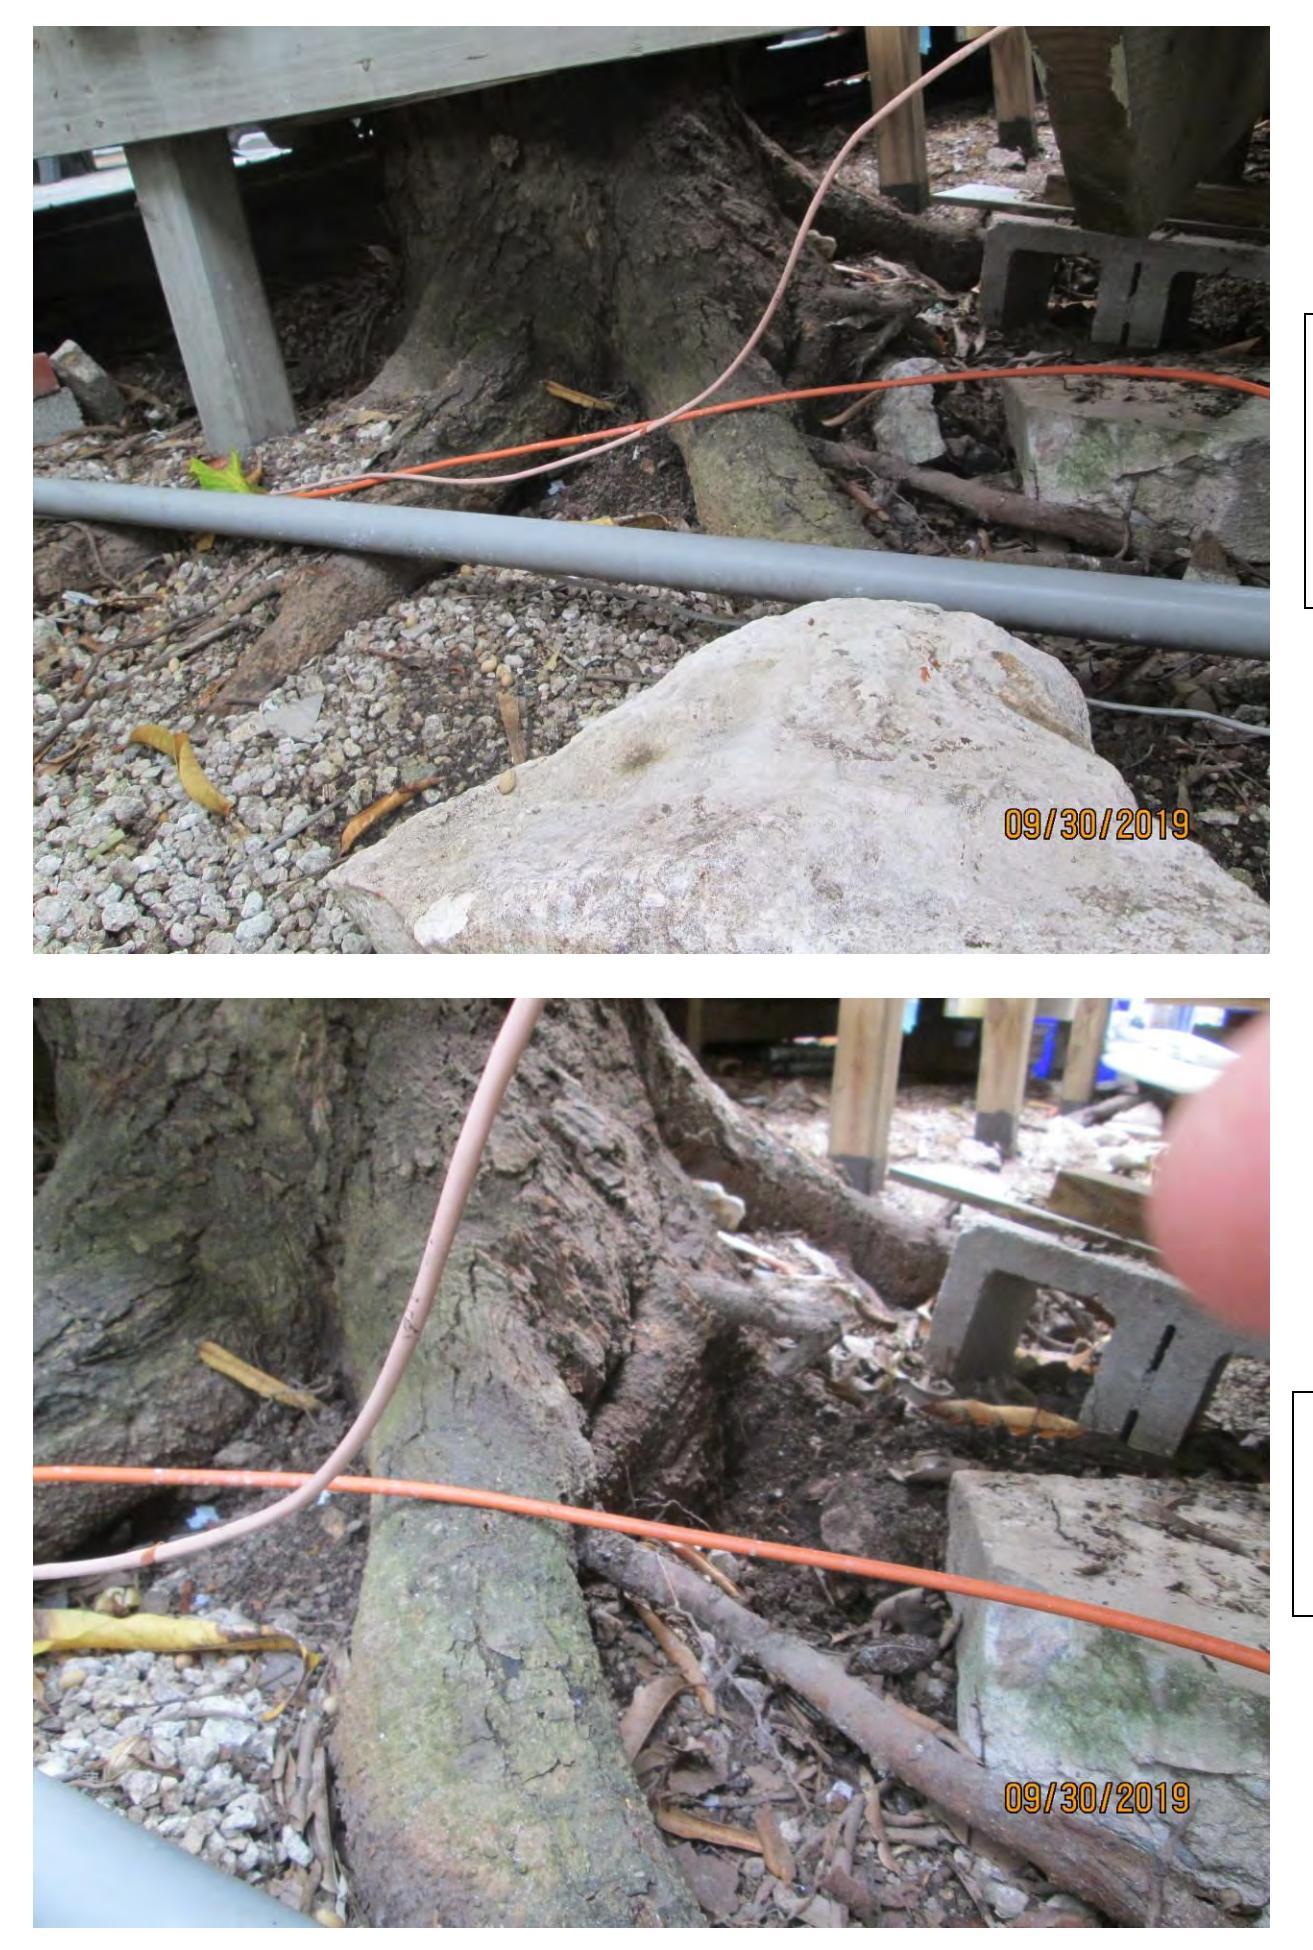
Photo of base of tree, showing root areas that had been uplifted in Hurricane Irma, view 2.

Photo of base of tree, showing root areas that had been uplifted, view 3.

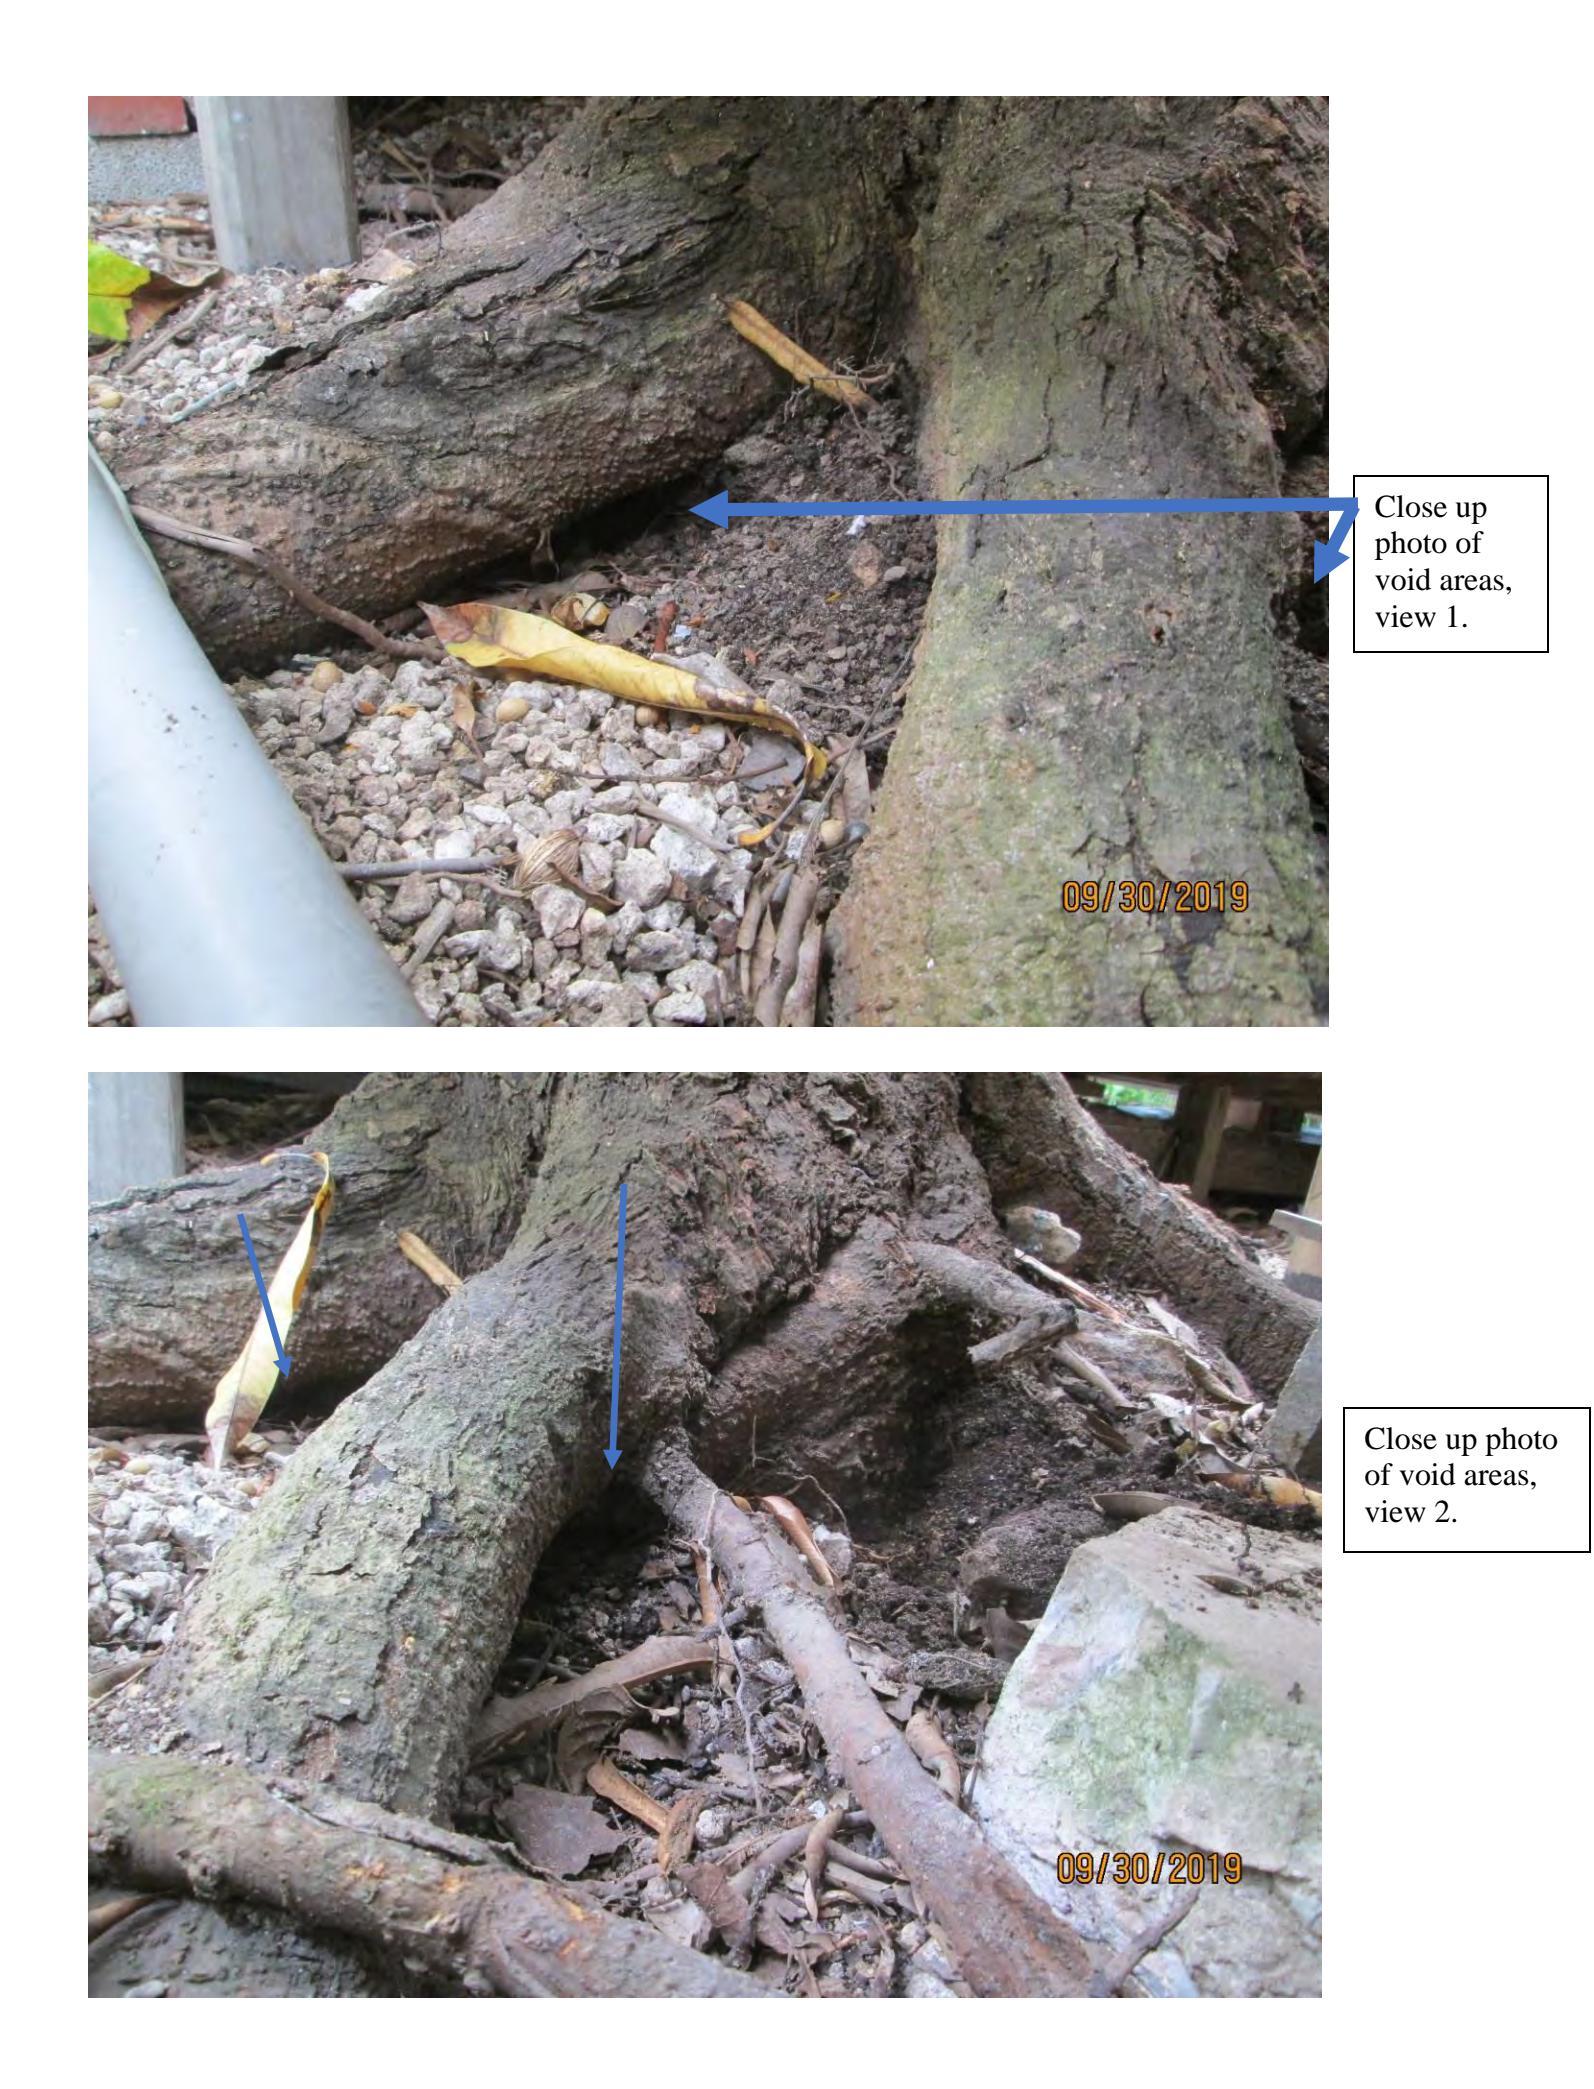
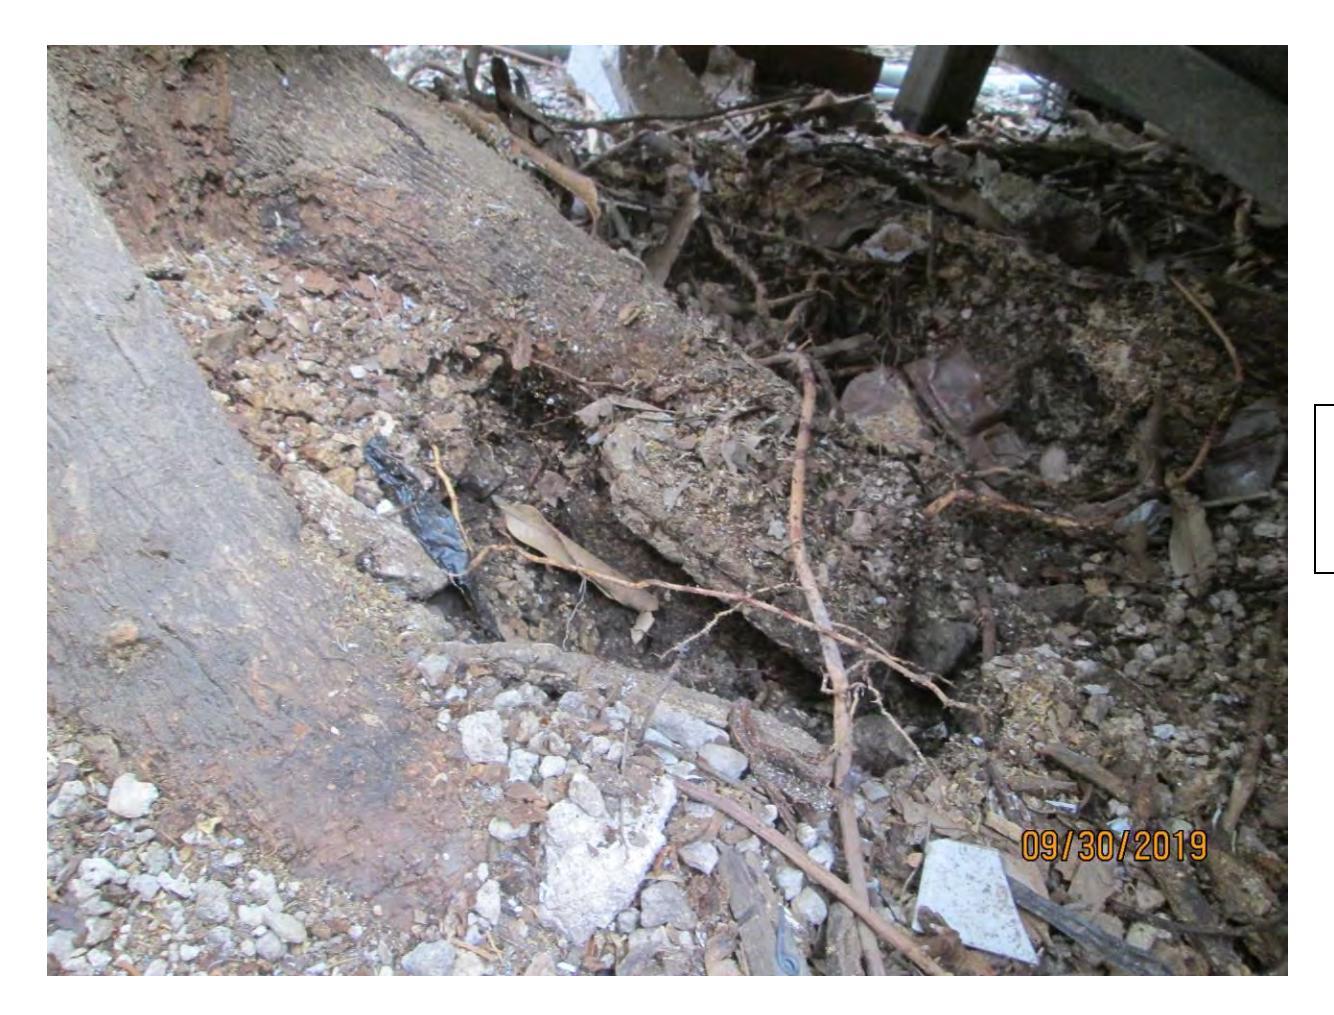
Close up photo of void areas, view 3.

Diameter: 14.9" Location: 50% (Back yard tree, deck built around it. Tree moved a lot and root system was uplifted during Hurricane Irma, close to house) Species: 100% (on protected tree list) Condition: 60% (Healthy canopy, root system with voids under main structural roots) Total Average Value = 70% Value x Diameter = 10.4 replacement caliper inches
