STAFF REPORT

RE: 1109 Varela Street (permit application # T2019-0472)

FROM: Karen DeMaria, City of Key West Urban Forestry Manager

An application was received requesting the removal of (1) Mango tree. A site inspection was done and documented the following:

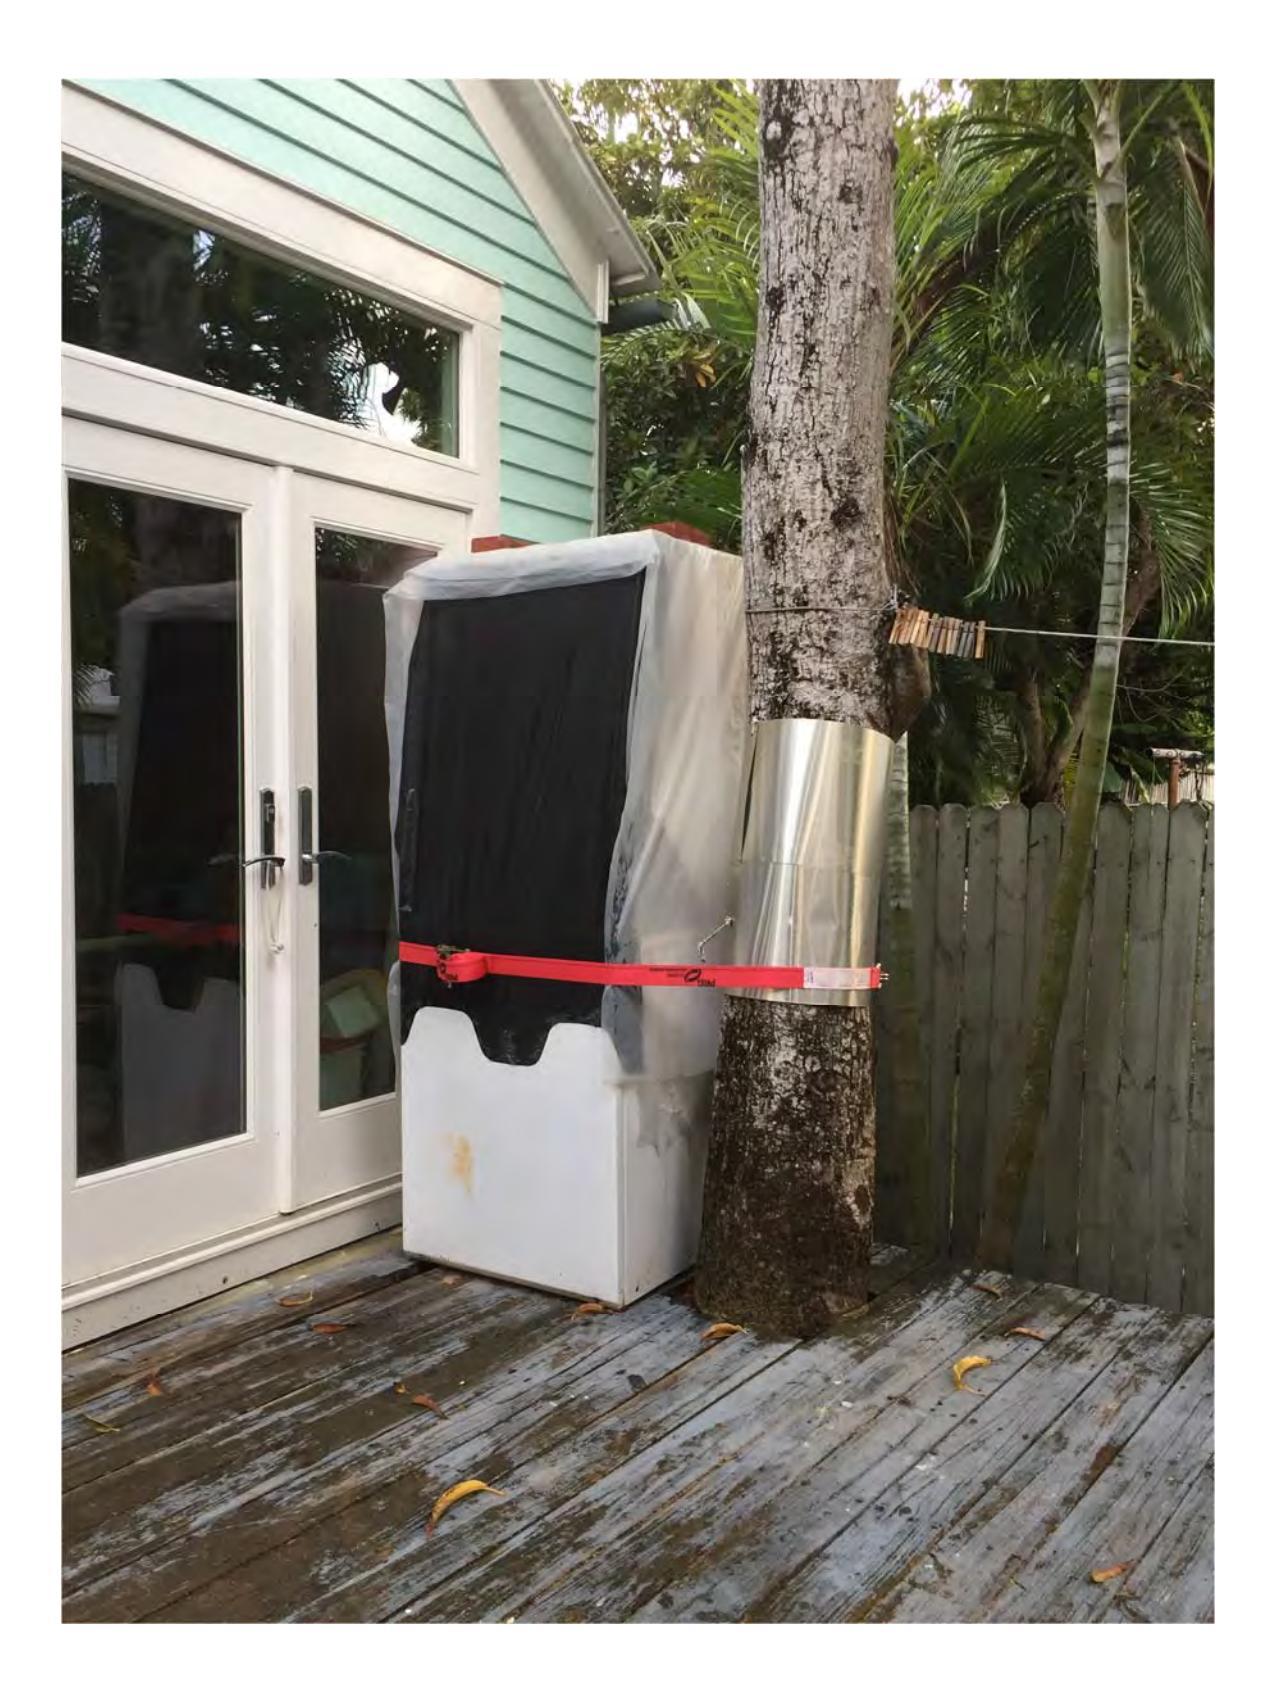
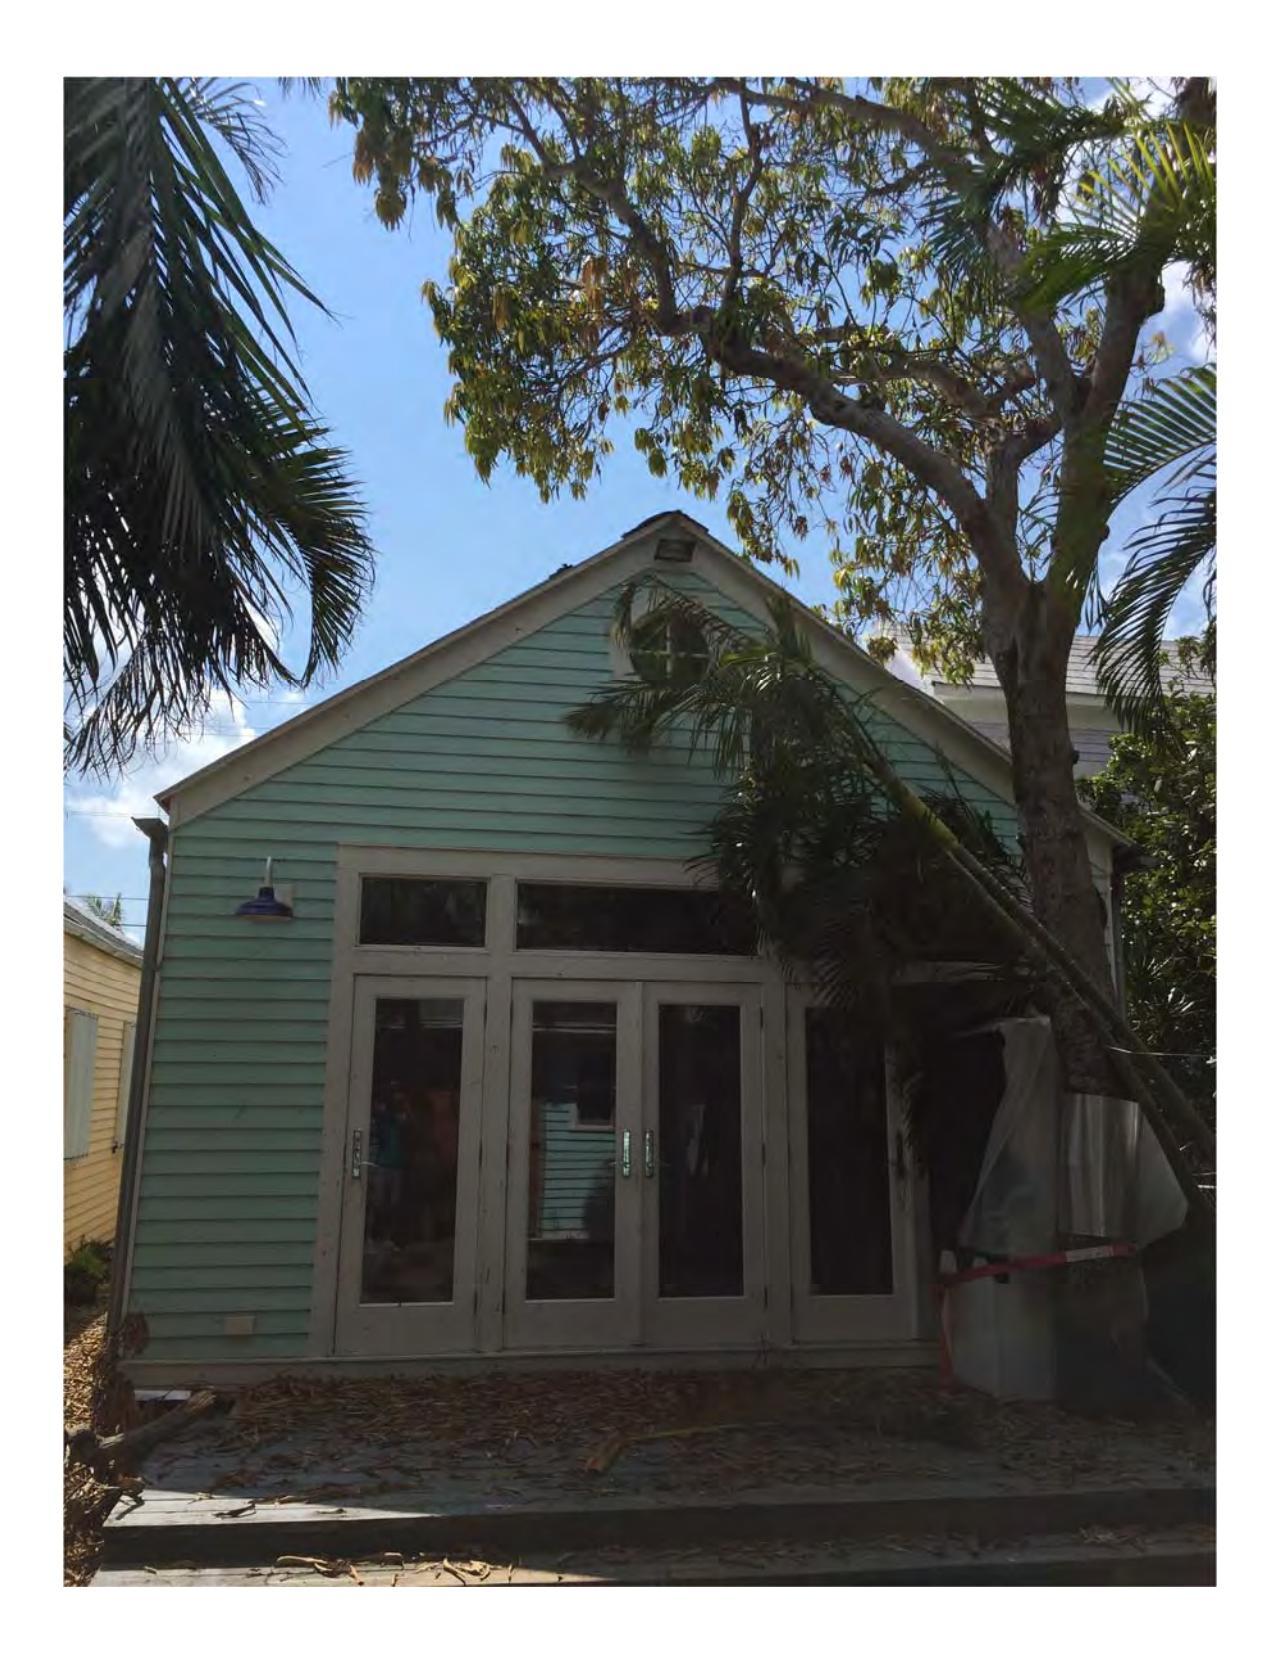
To add a little historical context as to why this root has become a problem after 30 or 40 years of growth, it is important to note that the tree was damaged by hurricane Irma; the storm pulled the whole tree about six inches out of the ground. We believe that several lucky coincidences are all that kept the tree from coming down entirely back then. First, the previous homeowners built a deck in the back yard around the tree (about 2' above grade). During the intervening 20-ish years, the tree grew thicker and actually came into solid contact with the deck surface as it filled that opening. My suspicion is that the two points of contact (the root system and the deck 2' above) created a situation such that the tree was less able to roll over with the wind (as did our neighbors' avocado tree 20' away). In addition, we had a stacked washer-dryer between the tree and the house, which we ratchet-strapped to the tree in the hope that the appliance wouldn't blow around the yard. Upon our return, we discovered the tree had lurched so violently during the storm that it smashed the unit into the house (destroying the dryer), and even dinged the edge of the roof 4' away. Thus between the washer-dryer and the deck, the tree was unable to fall over.

However, while the tree didn't go down, it was quite apparent that it had been pulled six inches out of the ground; there was significant scaring in the bark. Our arborist theorizes

I know you took a bunch of photos of the existing conditions, and I am including several more with this appeal to illustrate how Irma affected the tree (before the storm, after the storm, and a close-up of the bark damage). Please let me know what else you might need to proceed with our request.
