Tree Species: Mahogany (Swietenia mahogany)
Tree #172

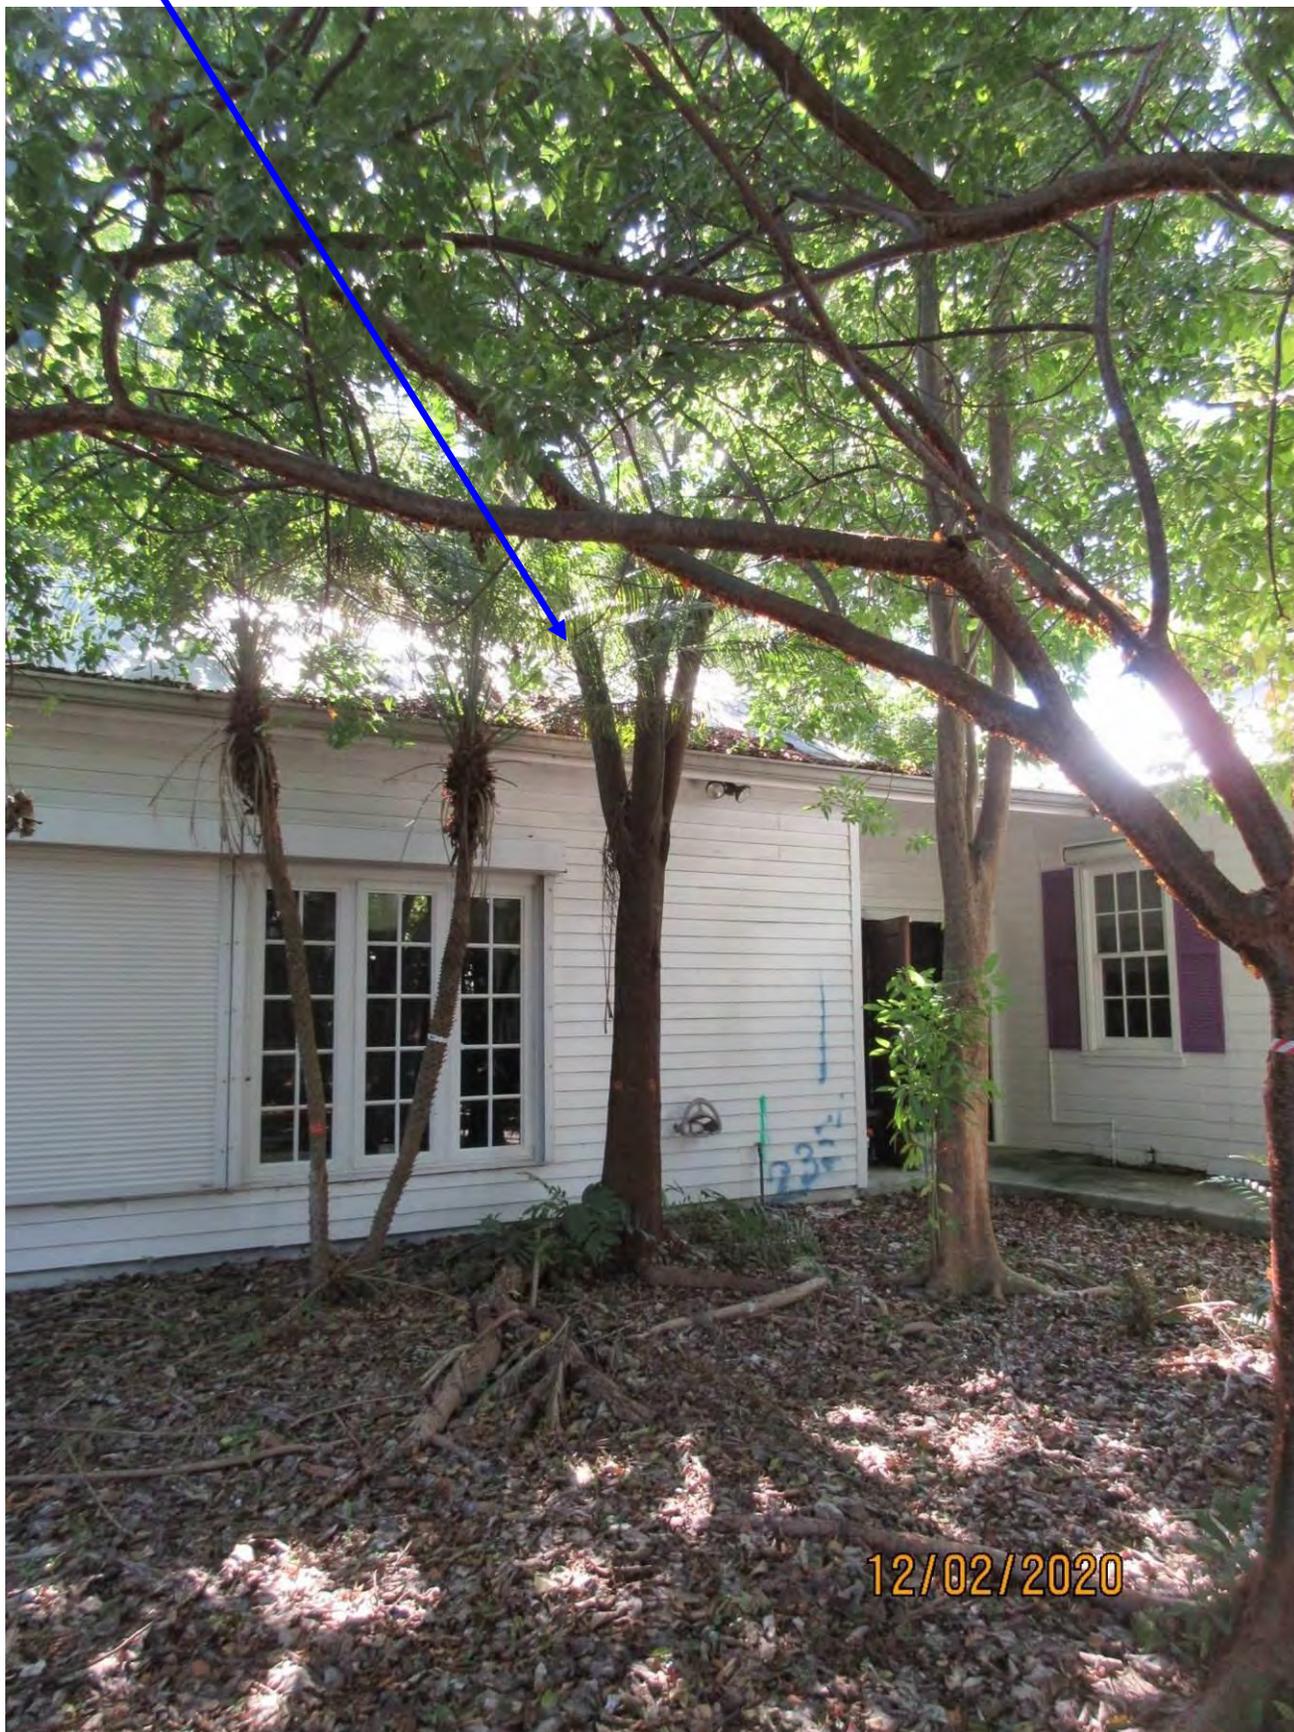
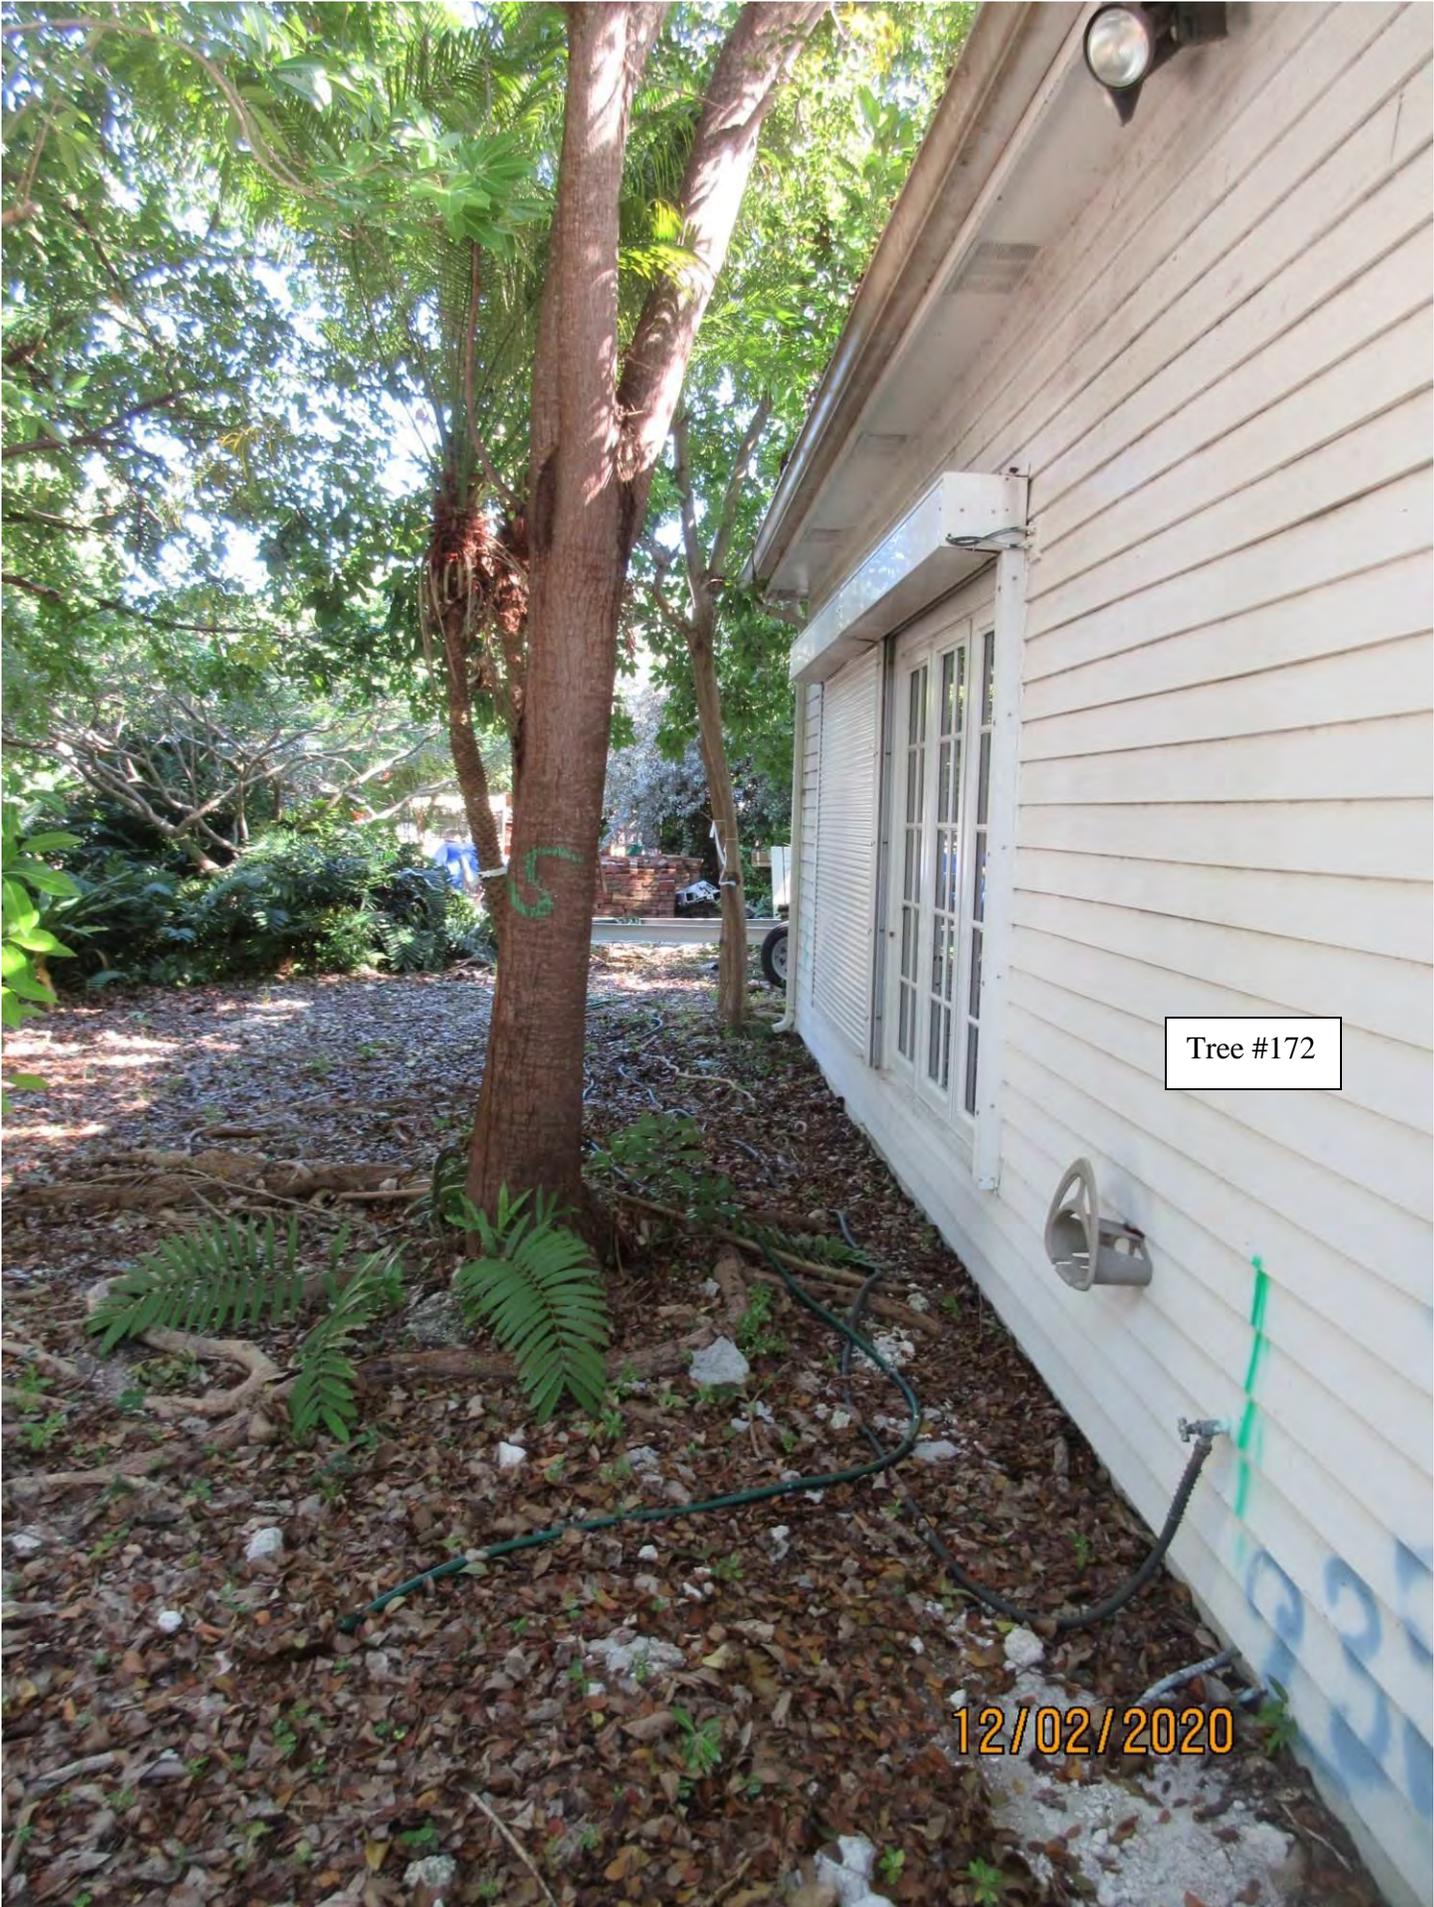
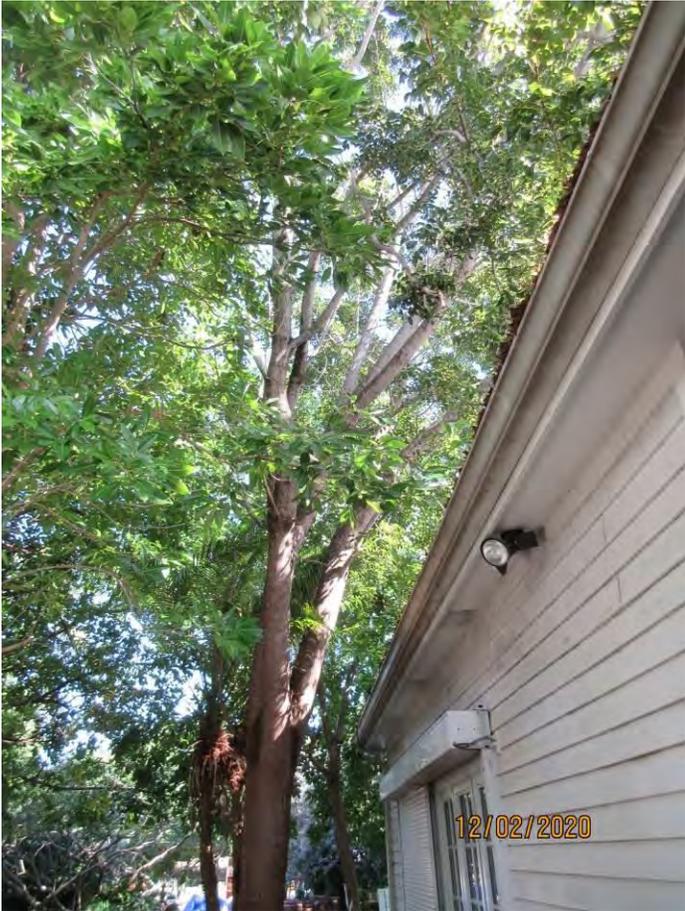
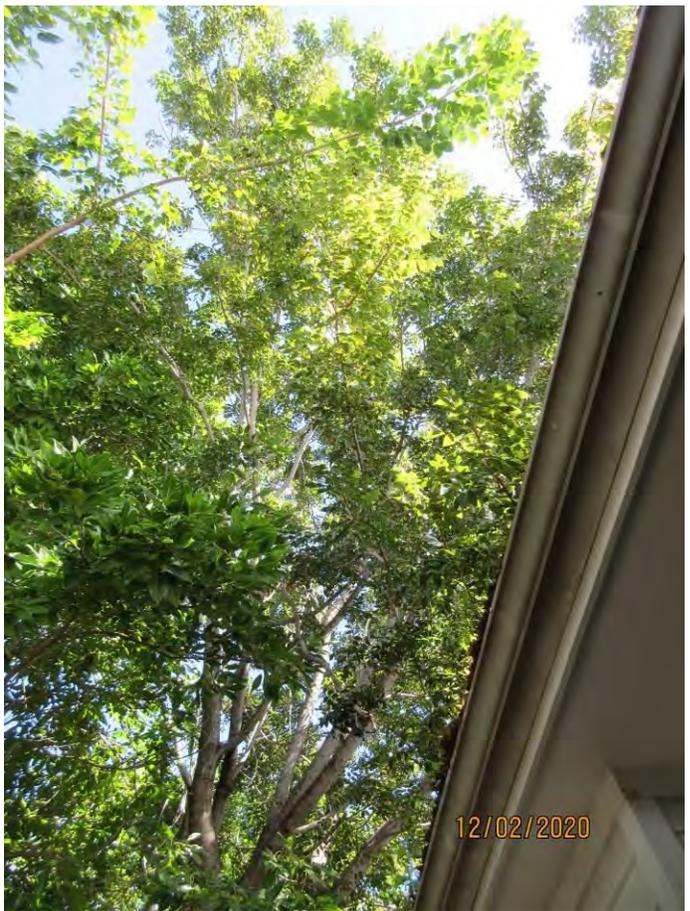
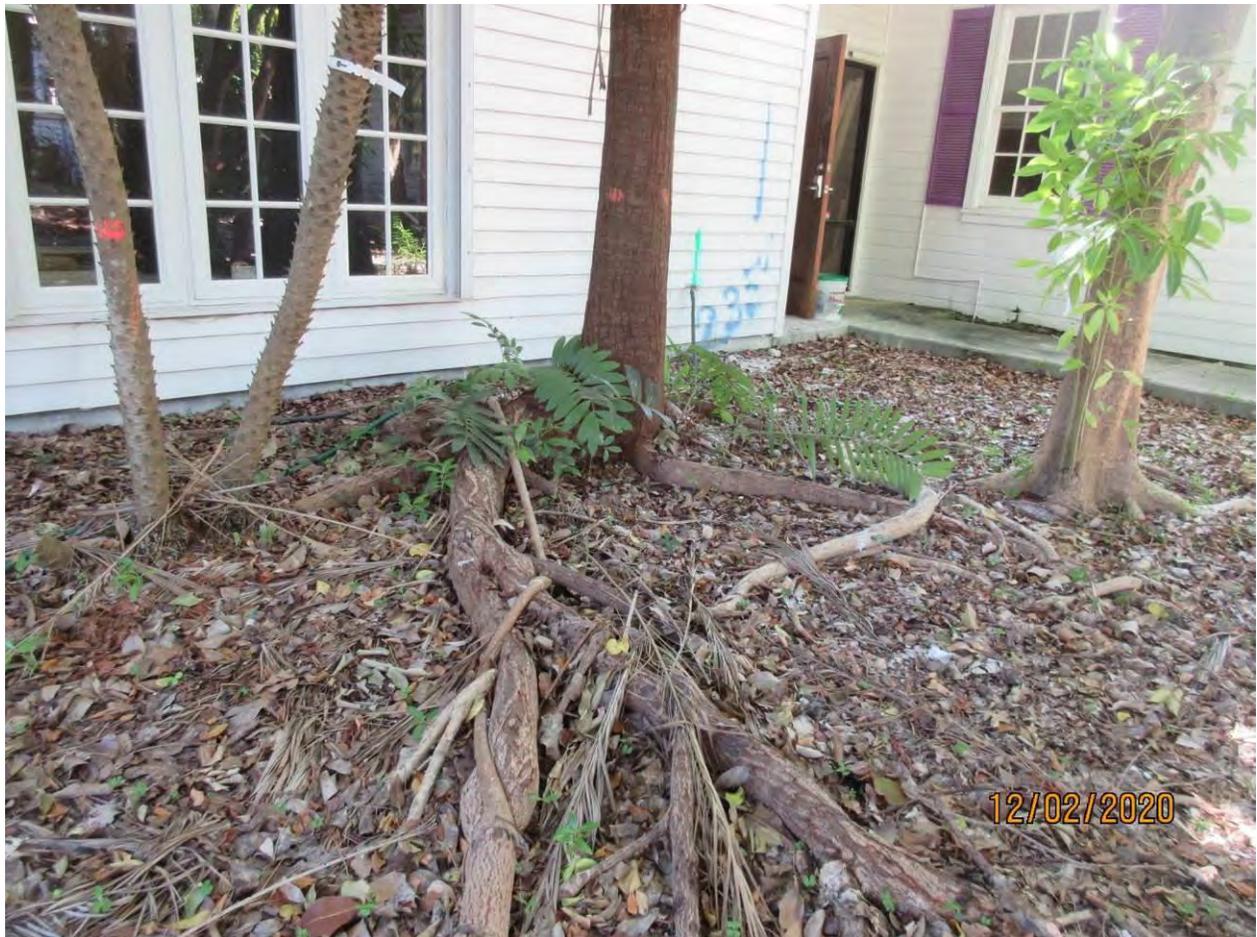
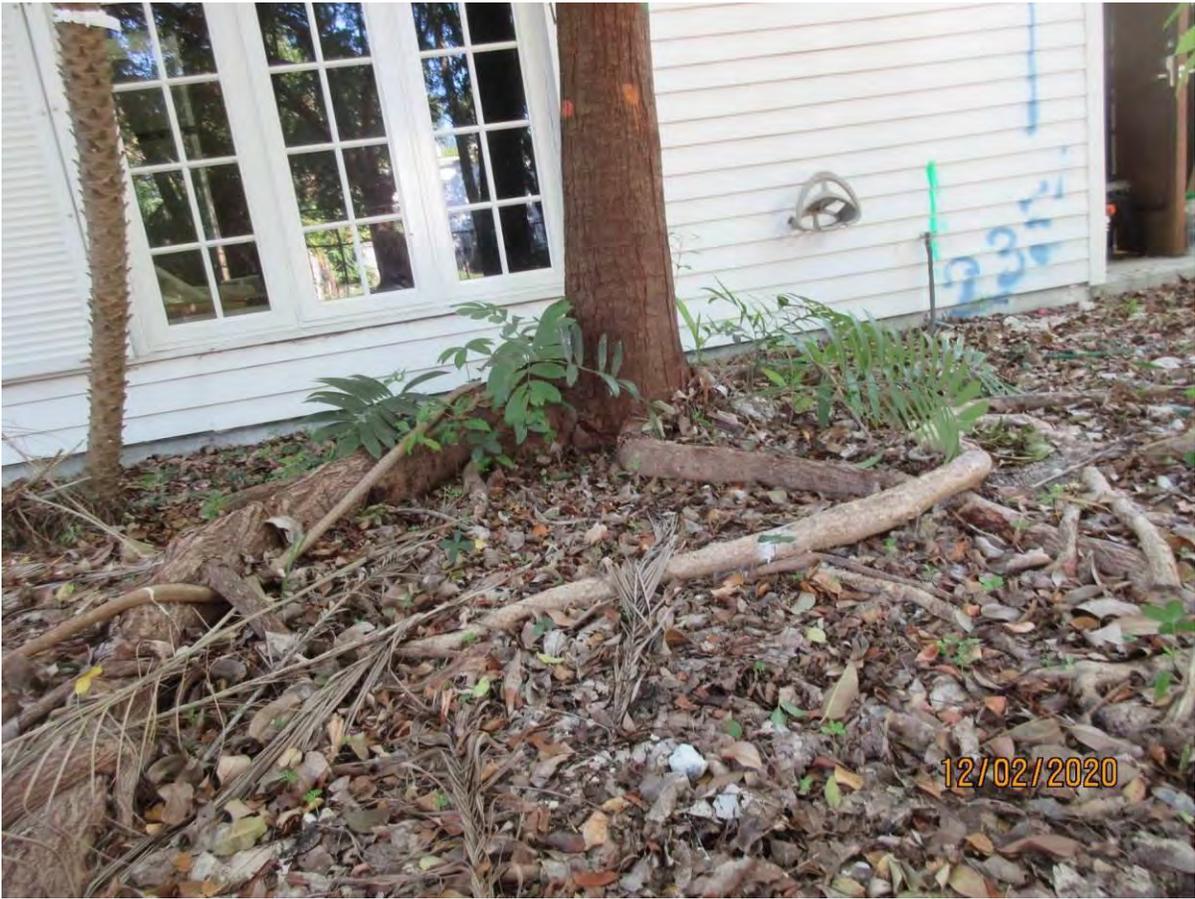
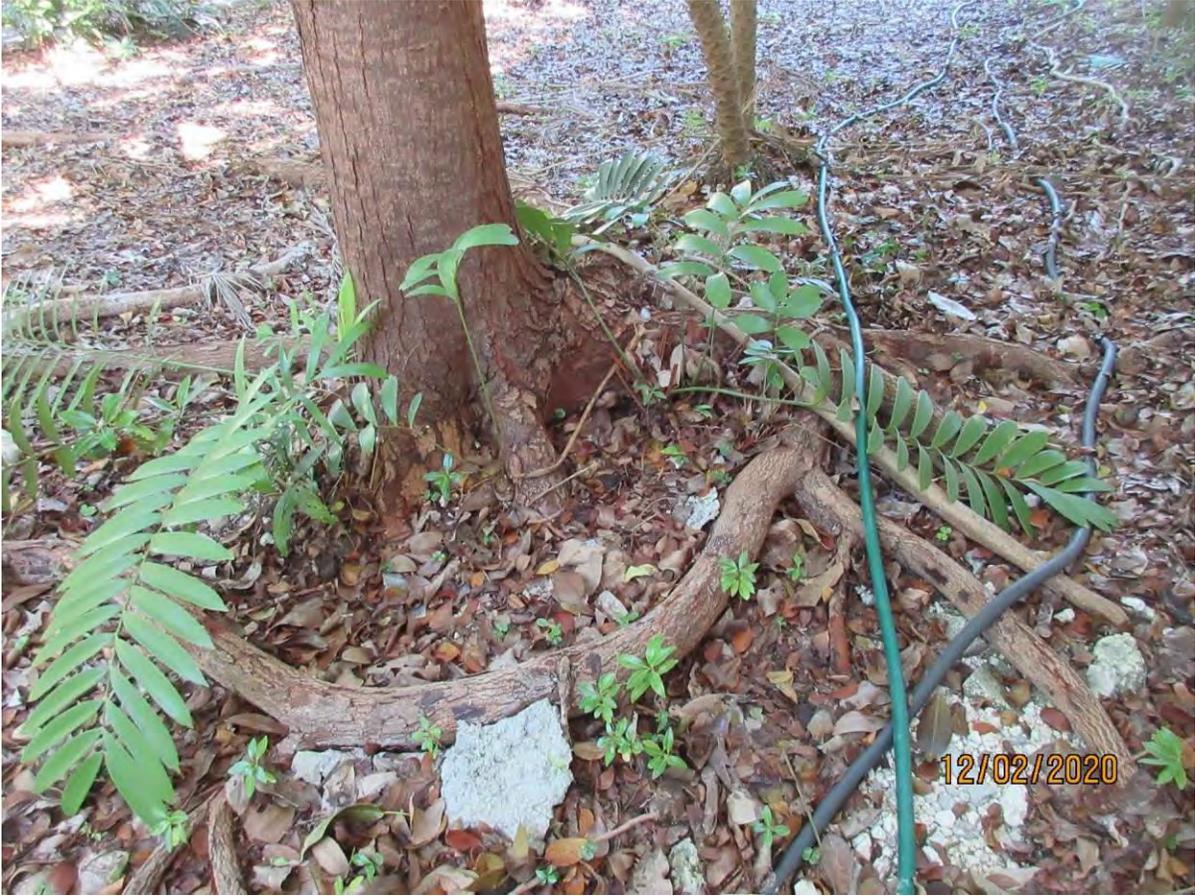
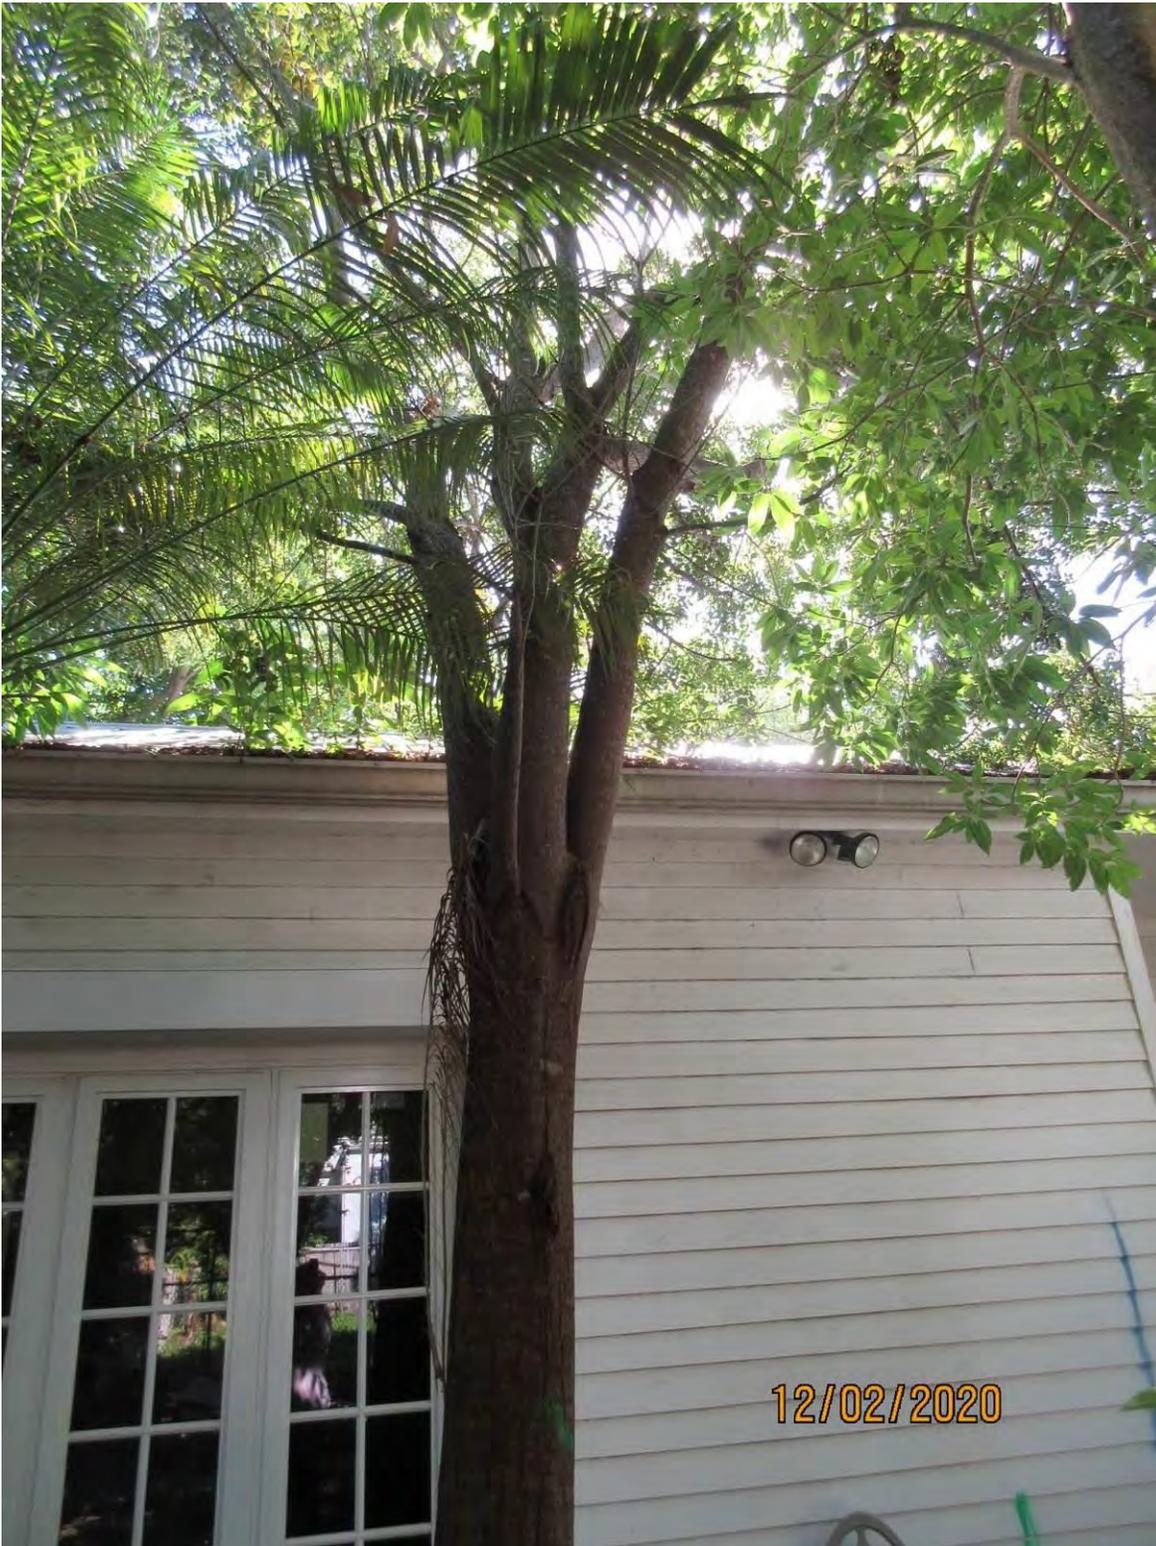
Tree #172

Location: 60% (growing close to existing structure)

Condition: 40% (poor root system-exposed surface roots, juncture of canopy branches will create included bark)

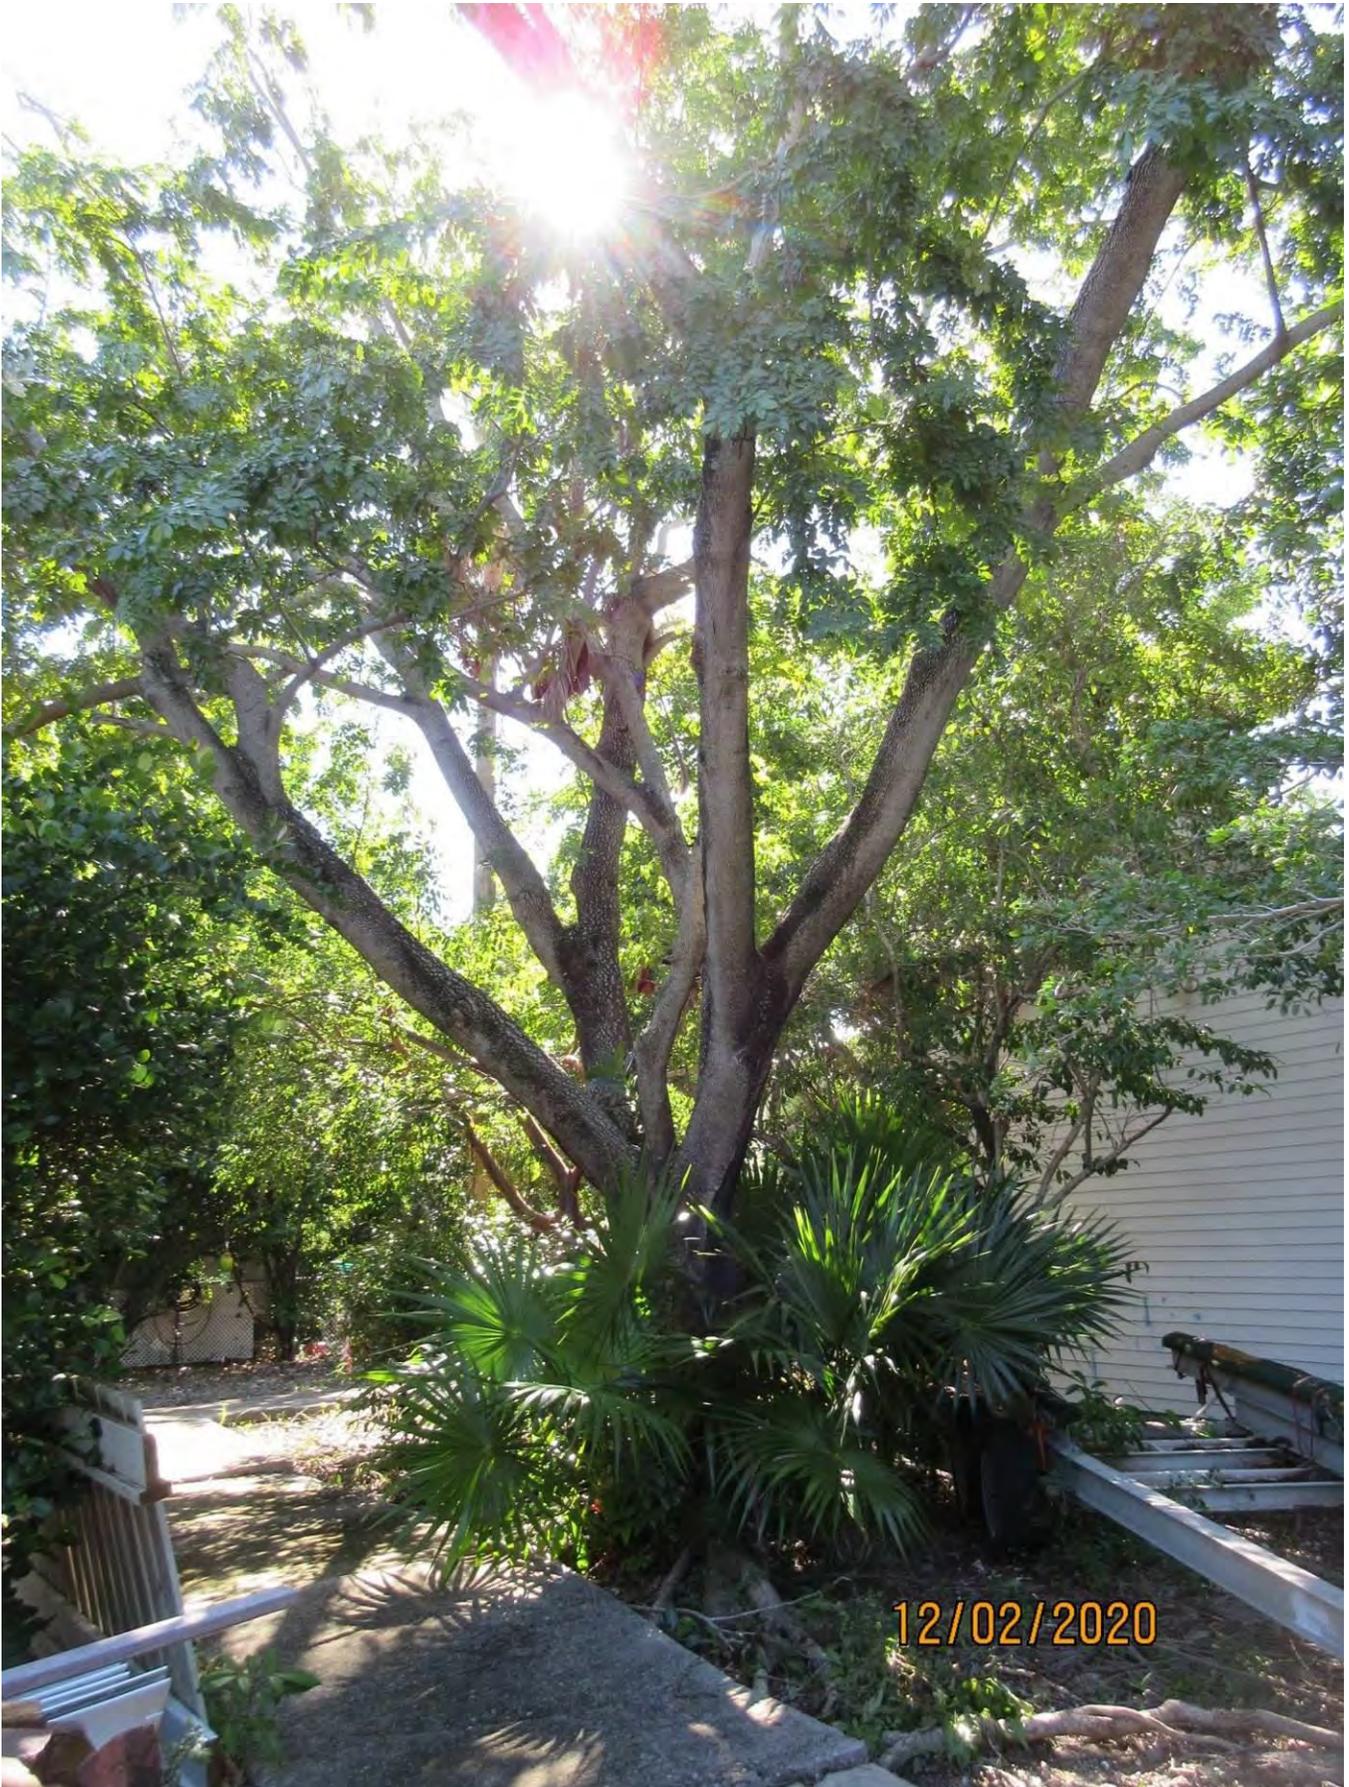
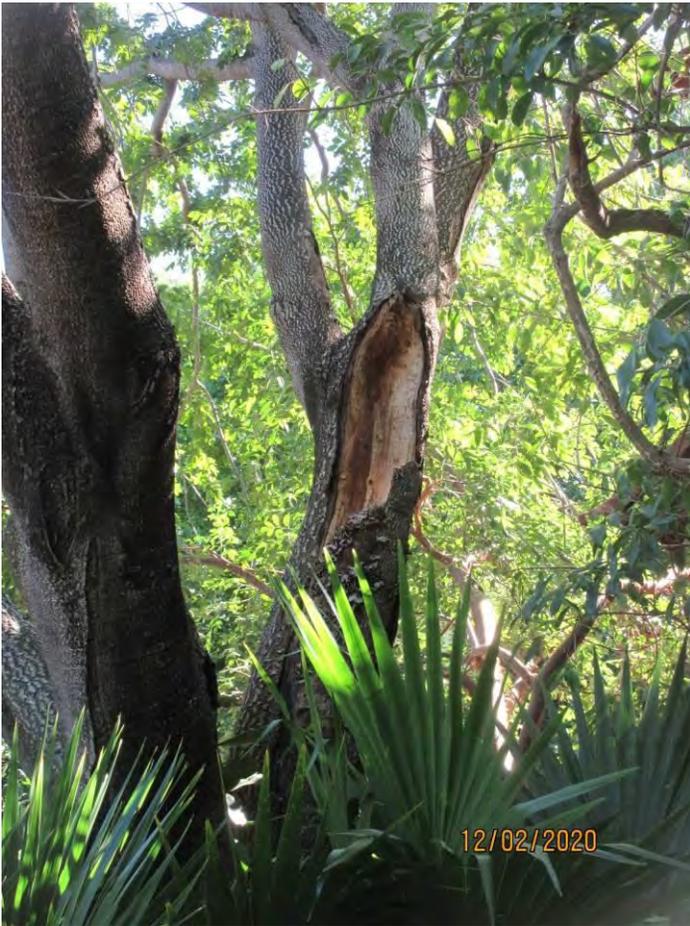
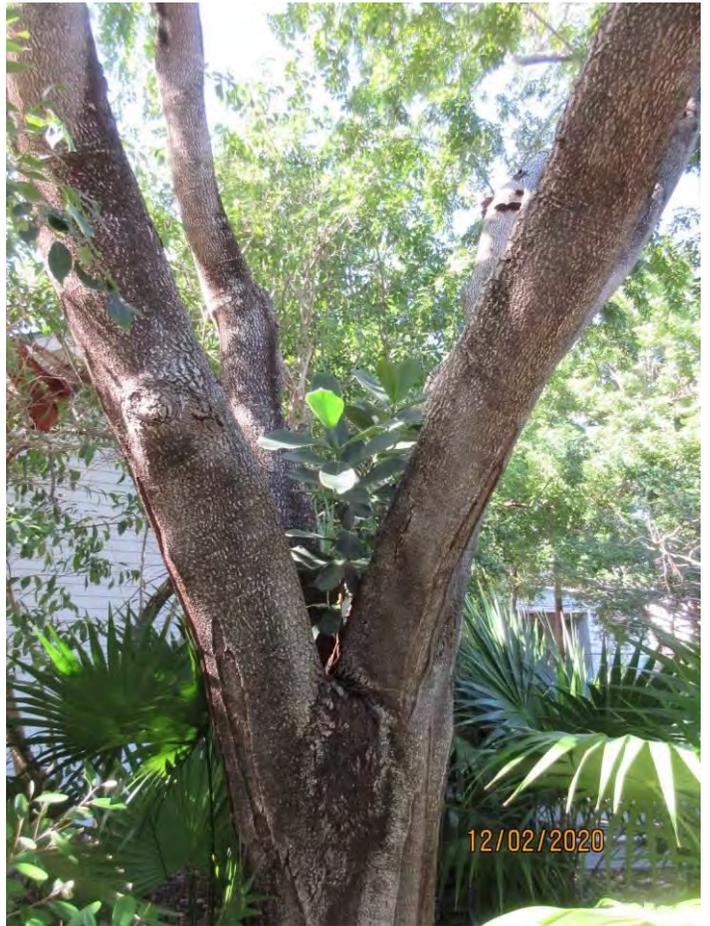
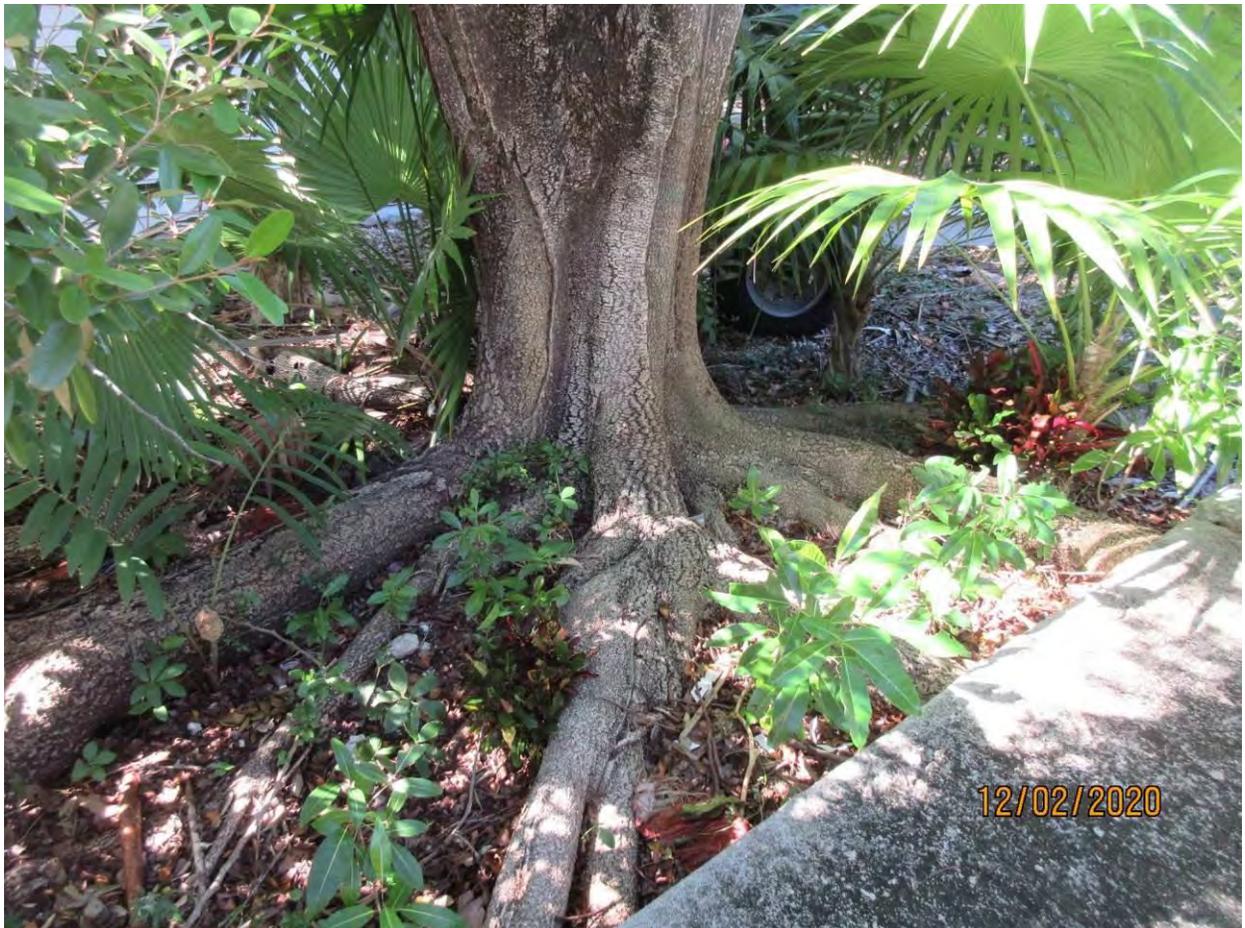
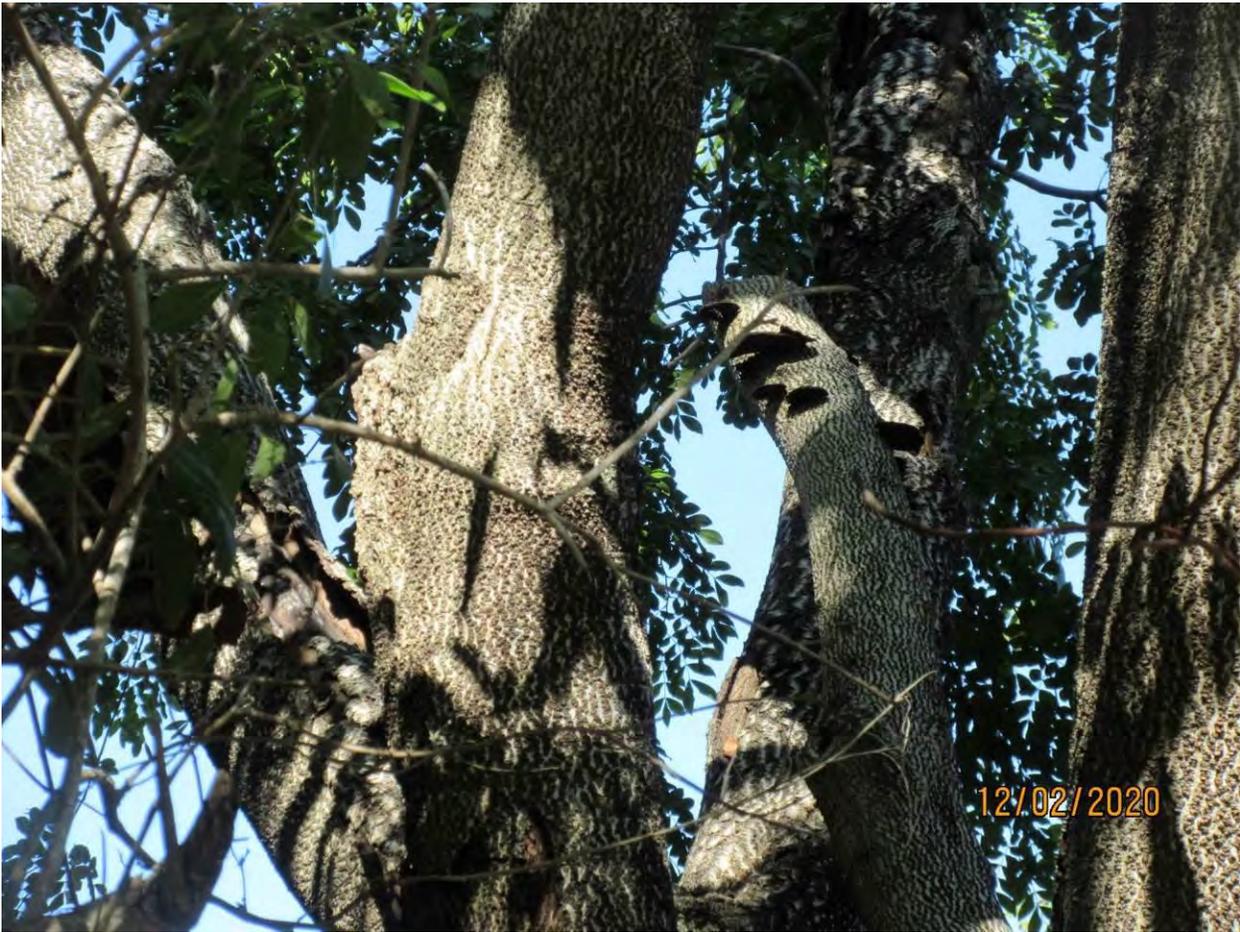
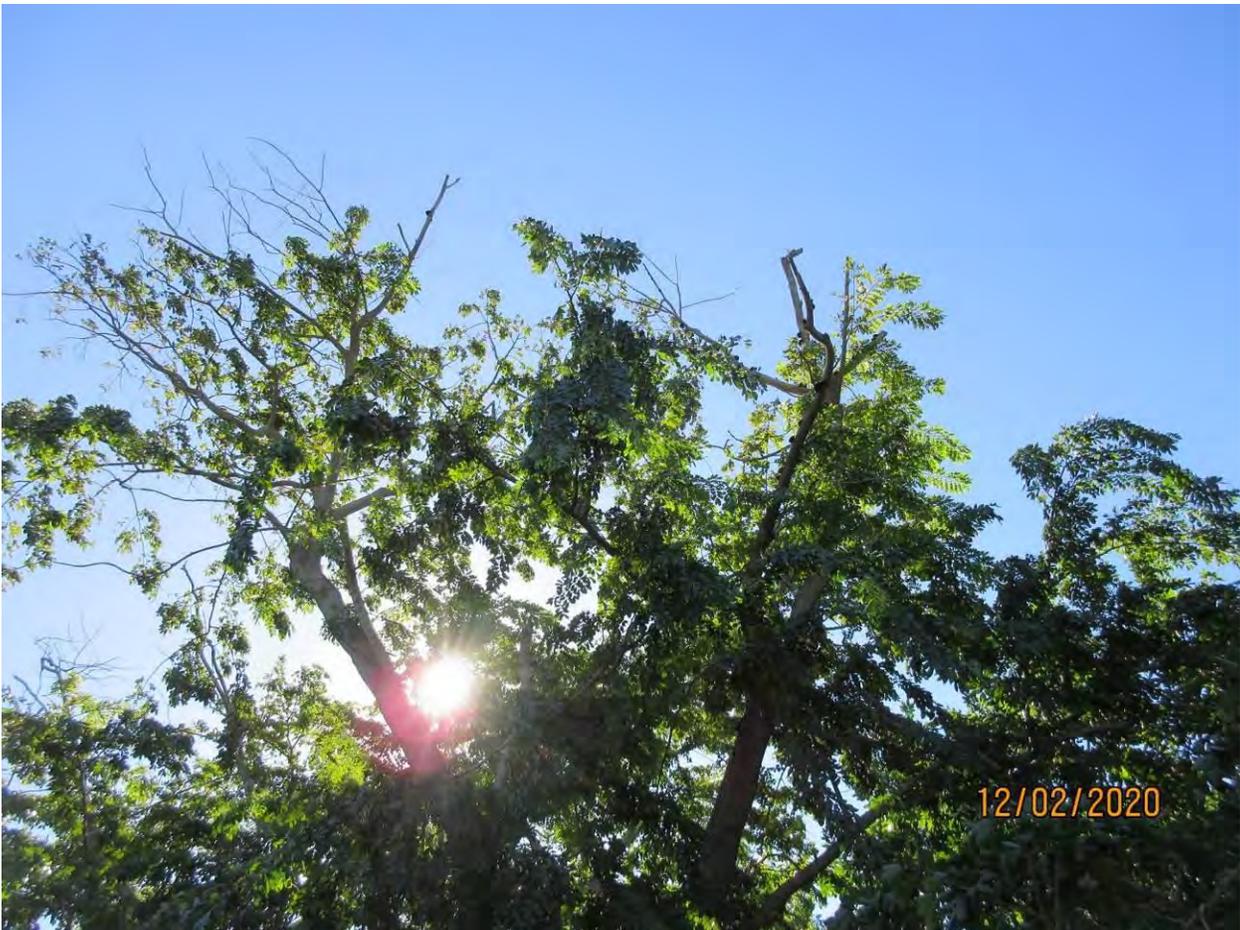
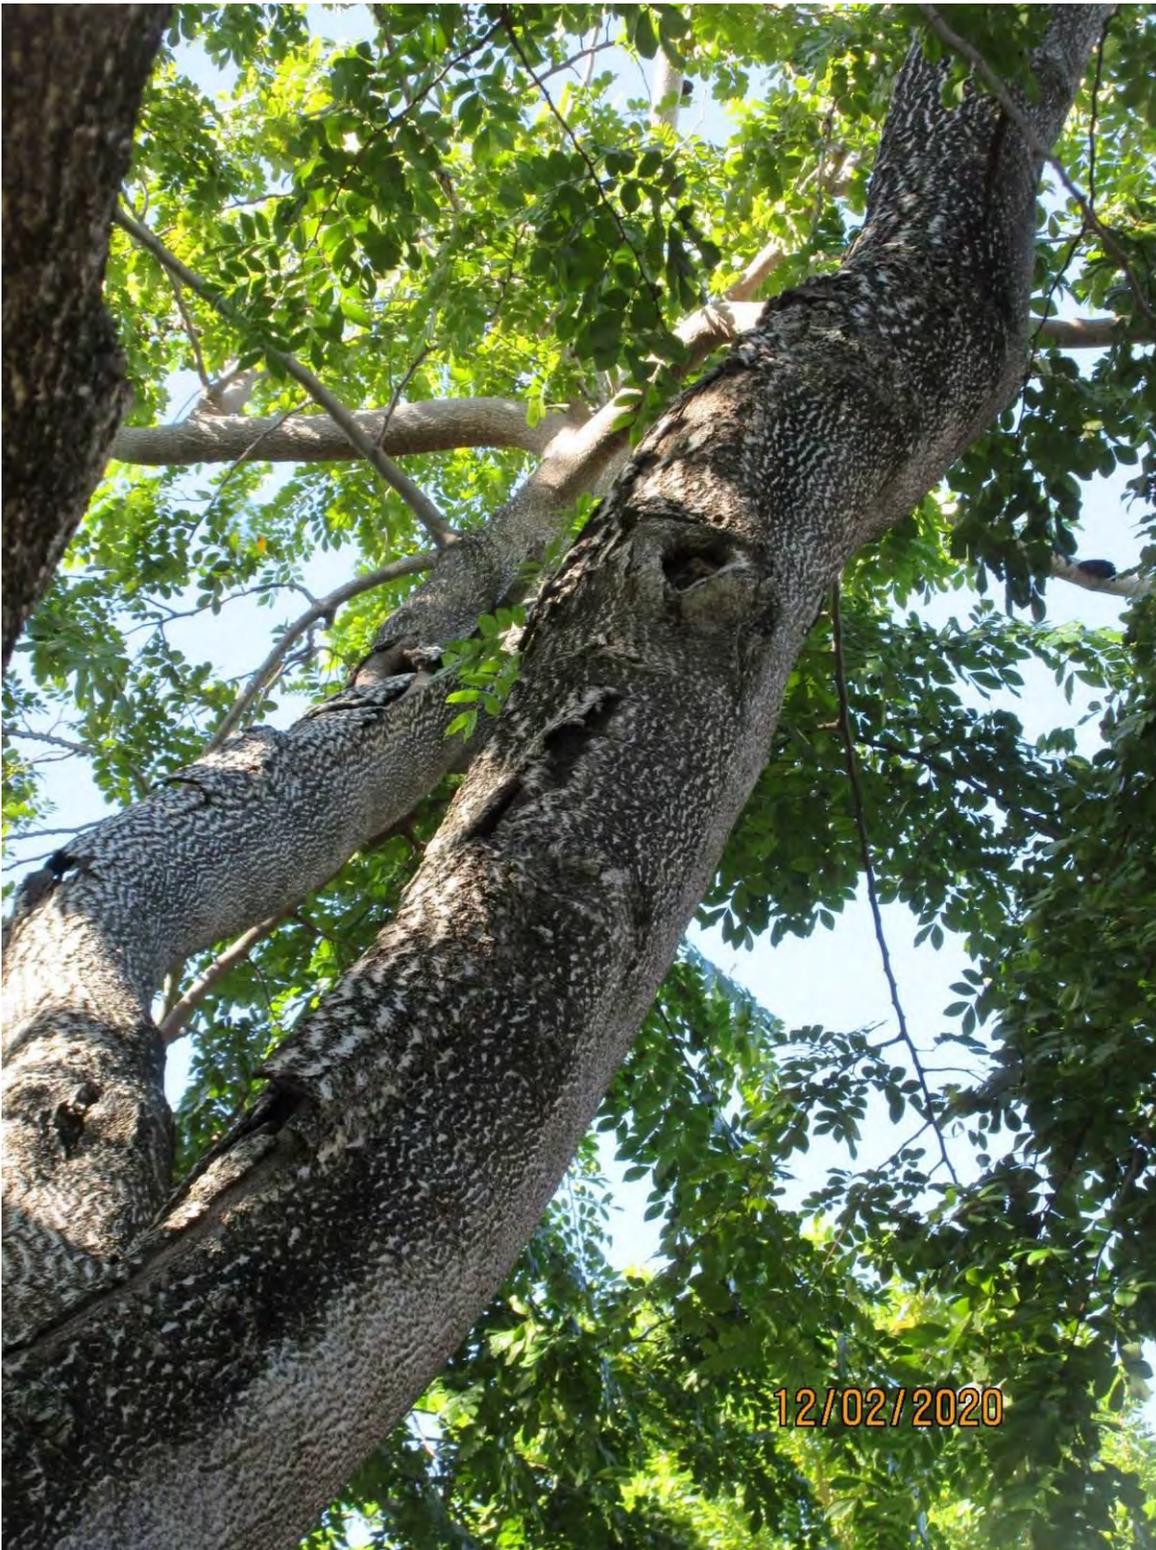
Tree Species: Raintree (*Samanea saman*) Tree #163

Location: 60% (roots impacting existing interior sidewalk)

Condition: 40% (poor, crown die back, decay in main trunk branches, mushroom conks)
