Tree Species: Mahogany (Swietenia mahogany)
Tree #172

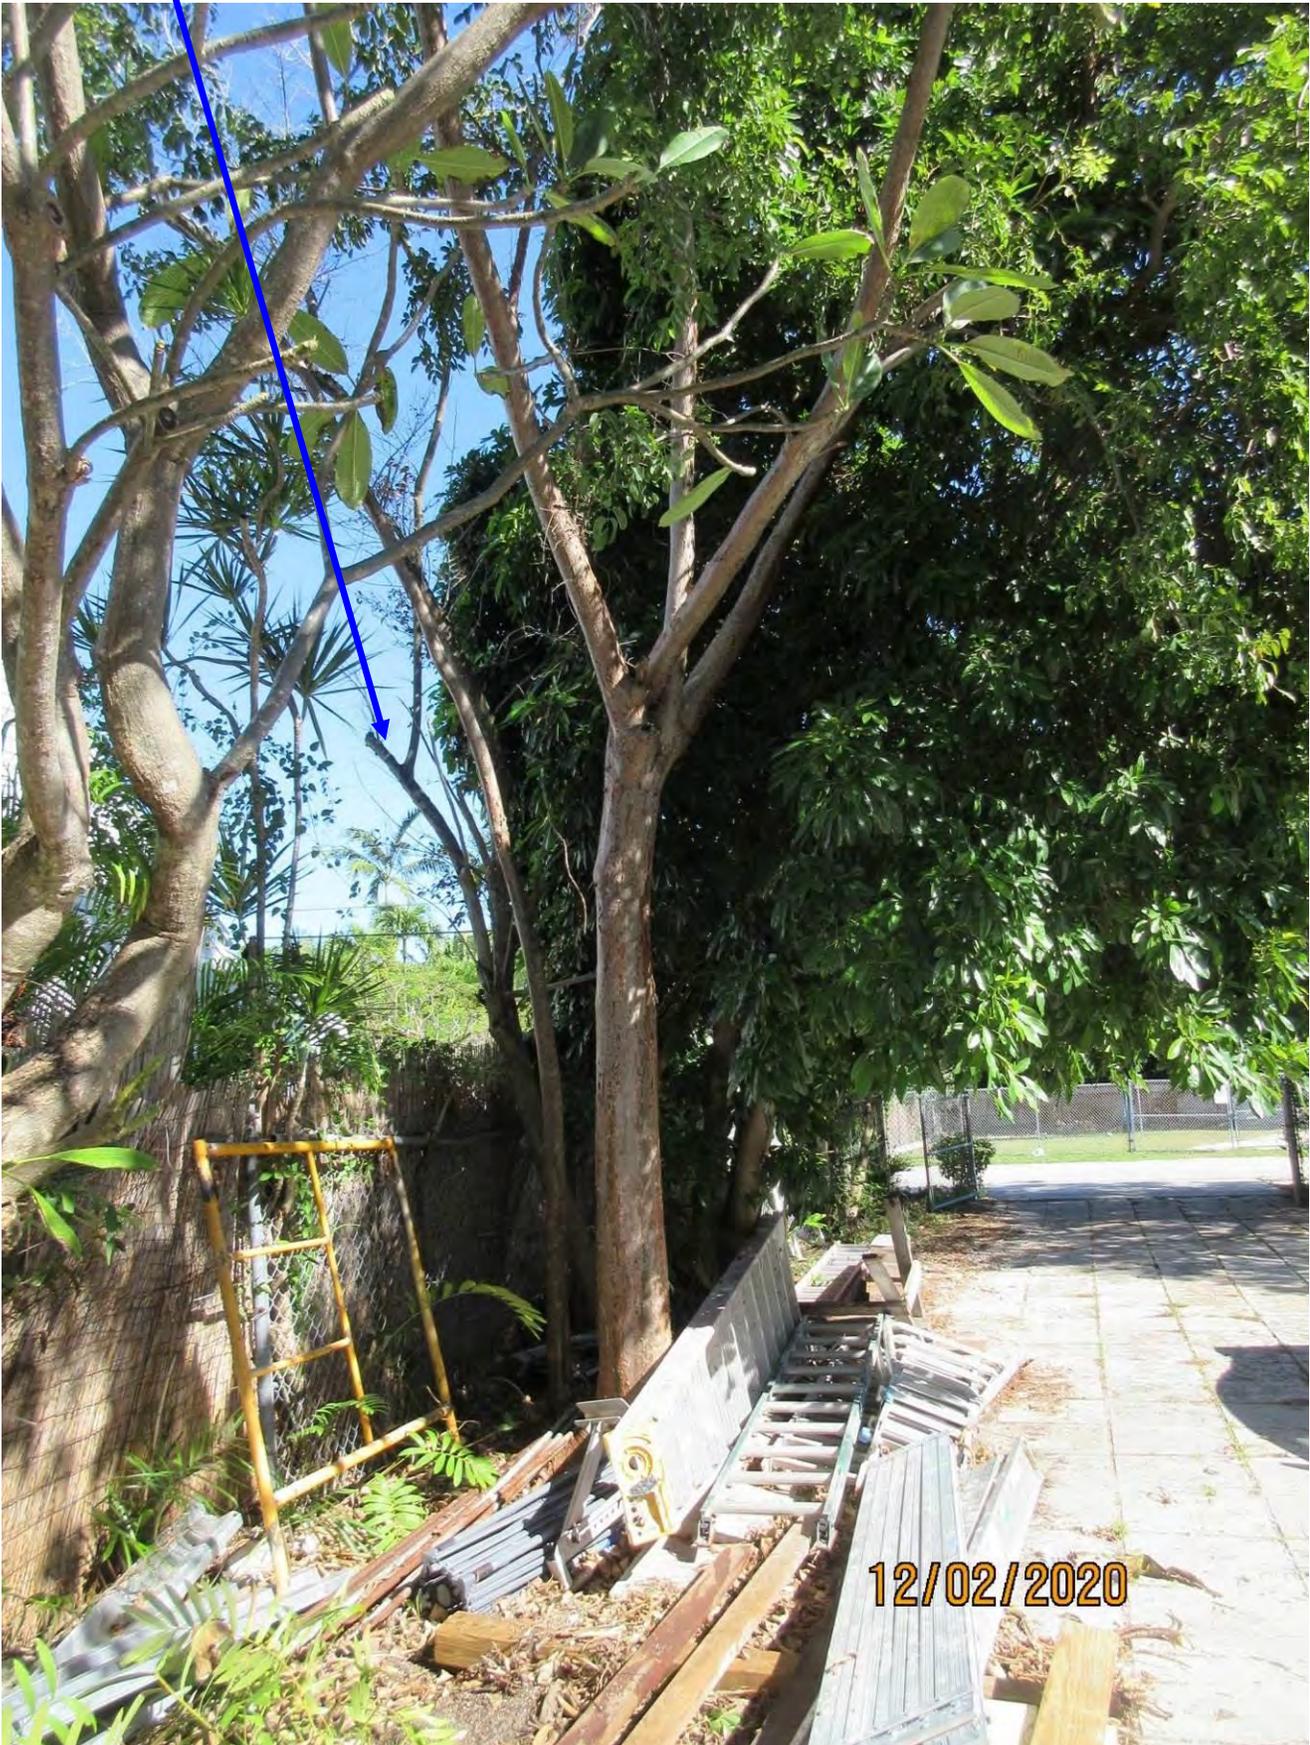
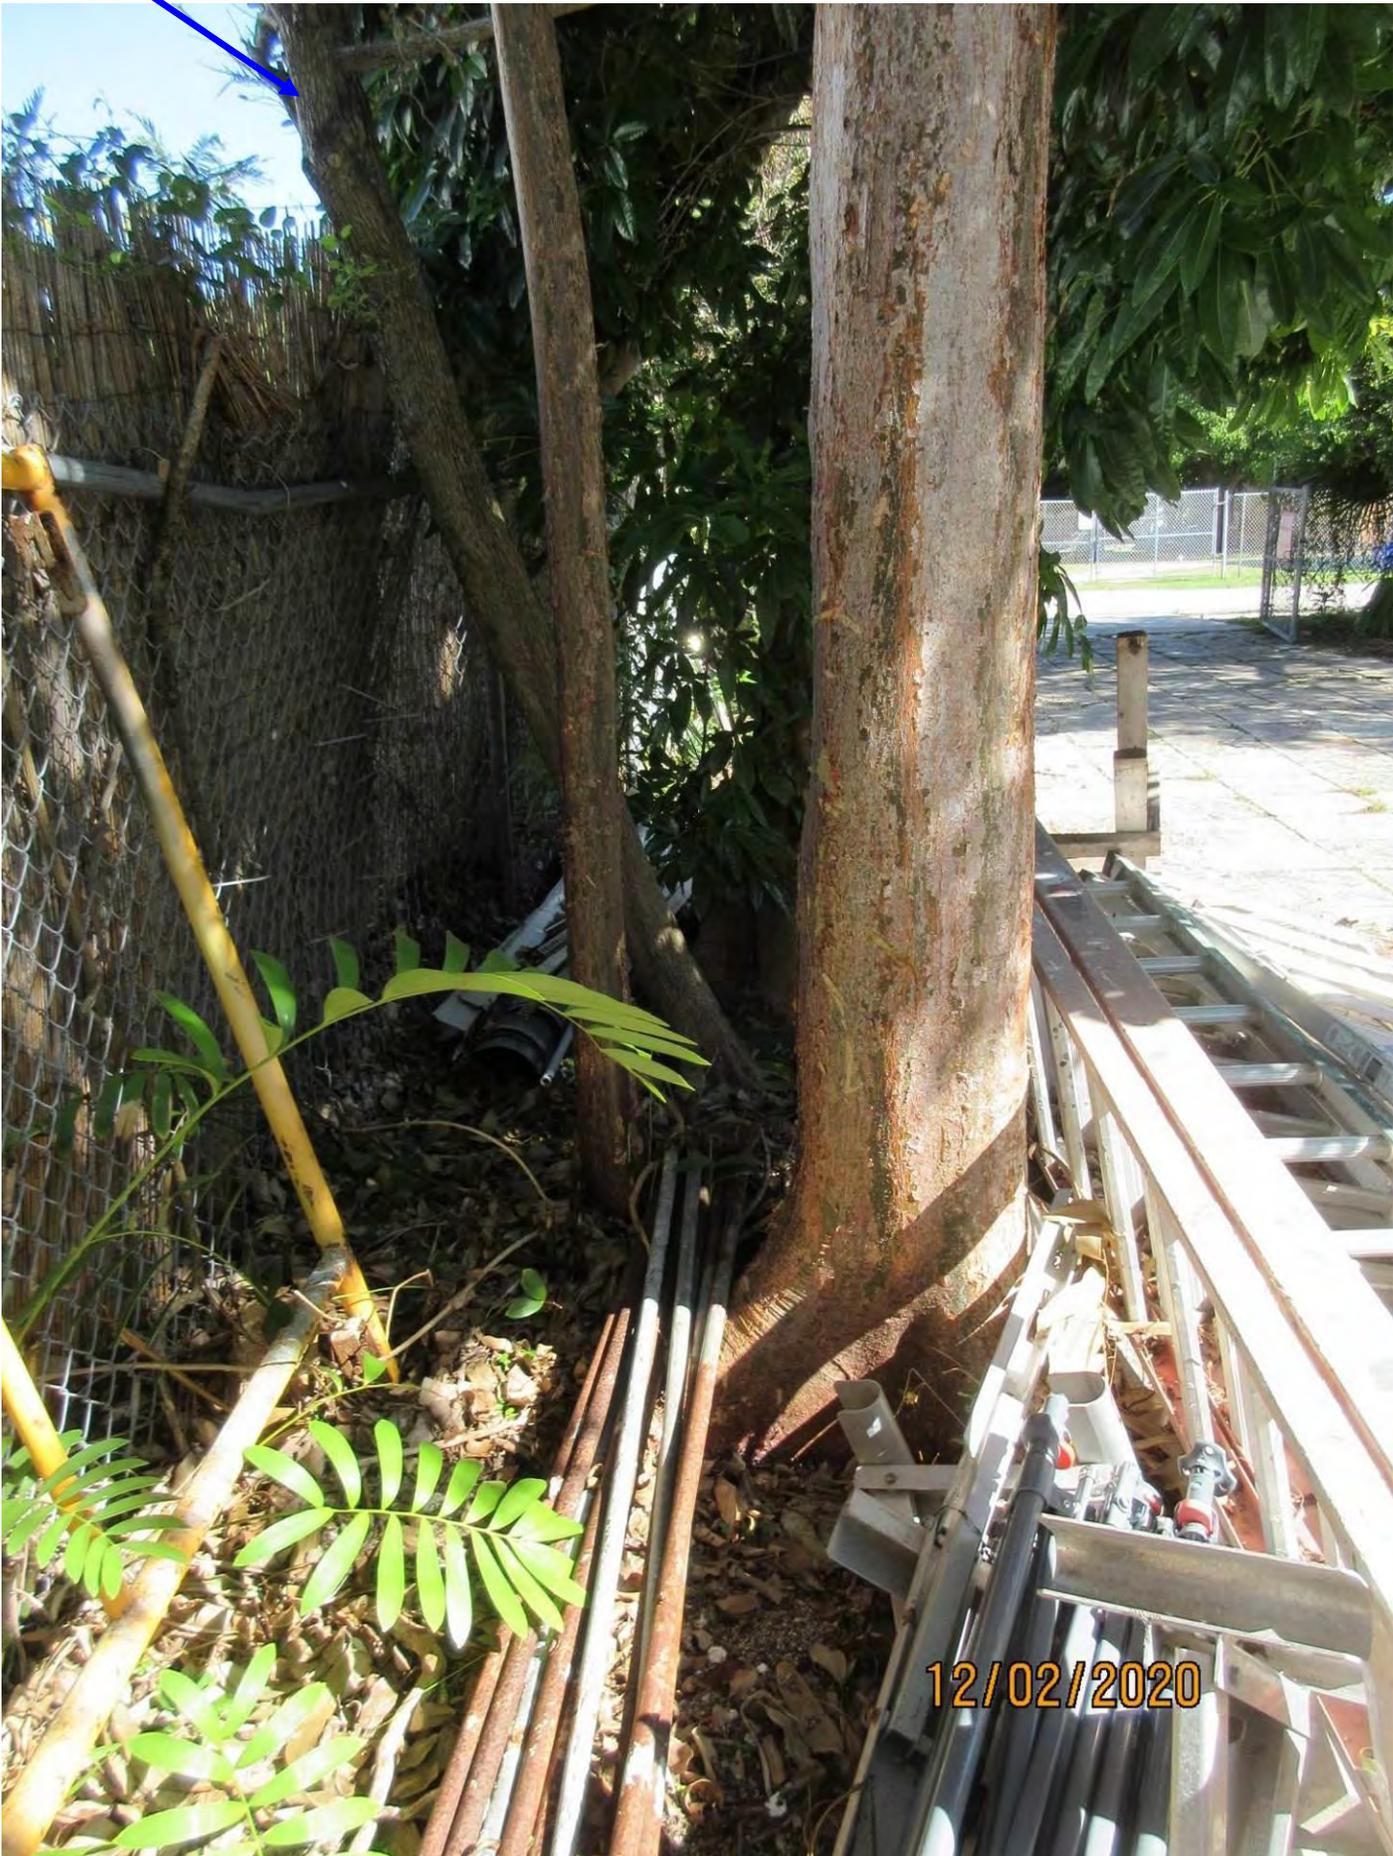
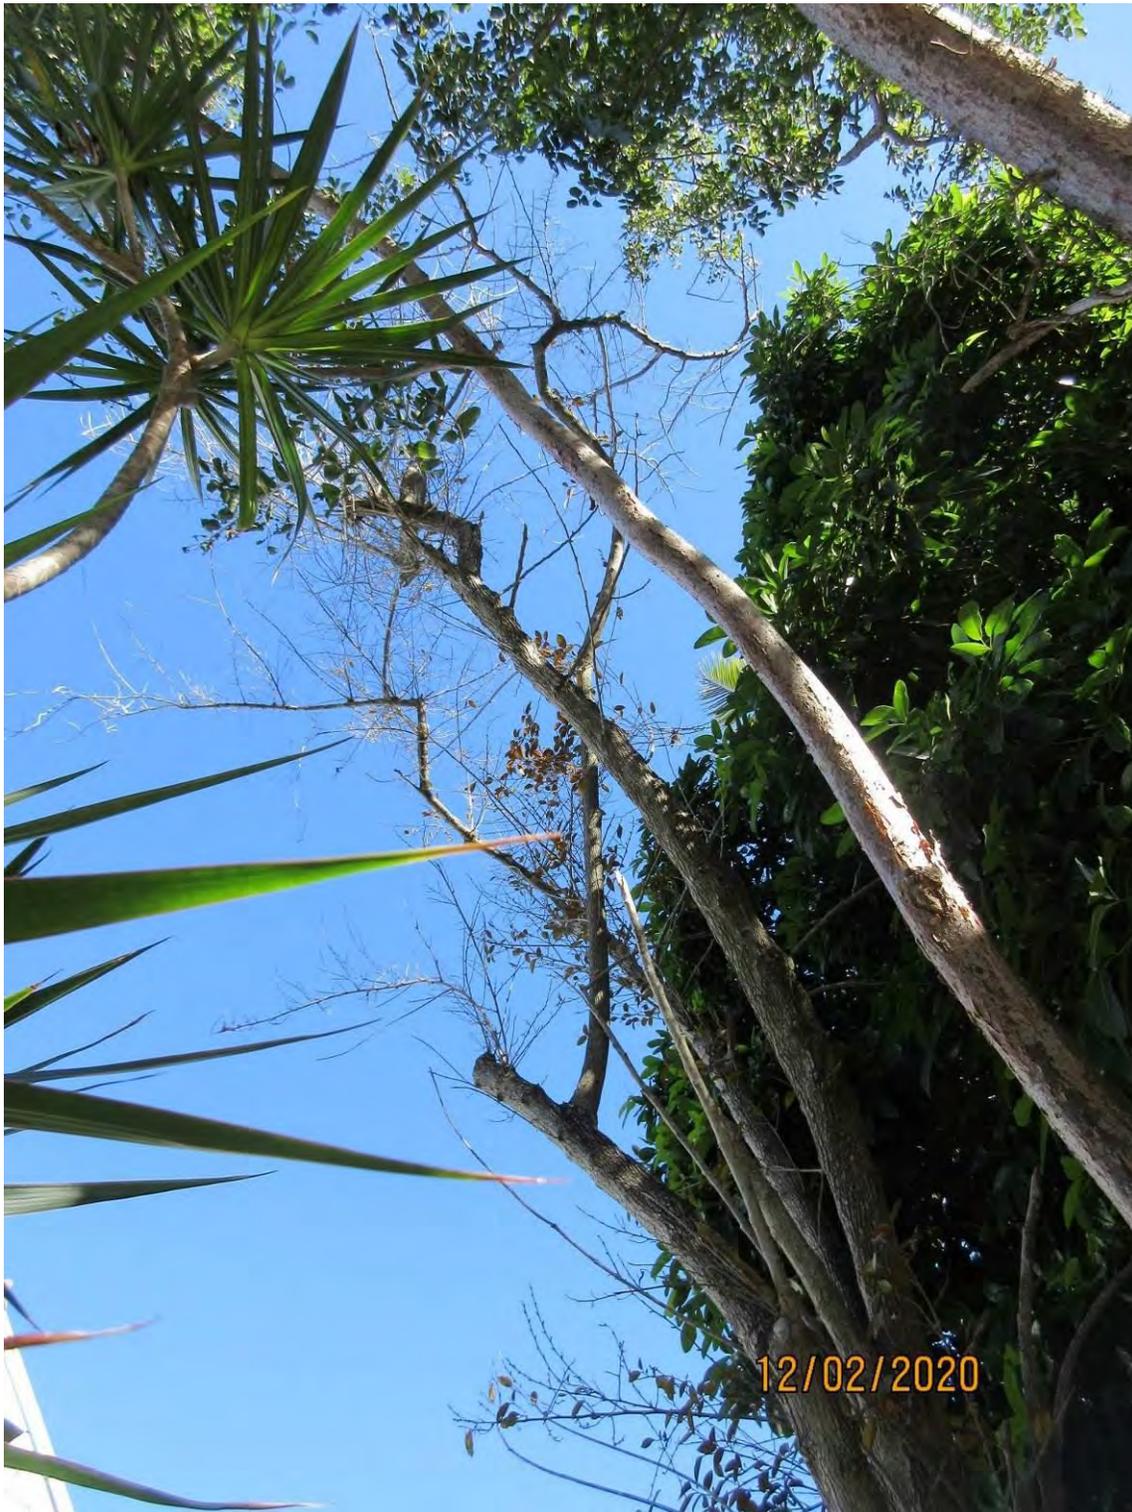
Tree #82

Location: 60% (growth impacted by adjoining canopy trees)

Condition: 30% (poor, most of canopy contains dead branches, low leaf count, trunk with growth lean toward neighboring property.)

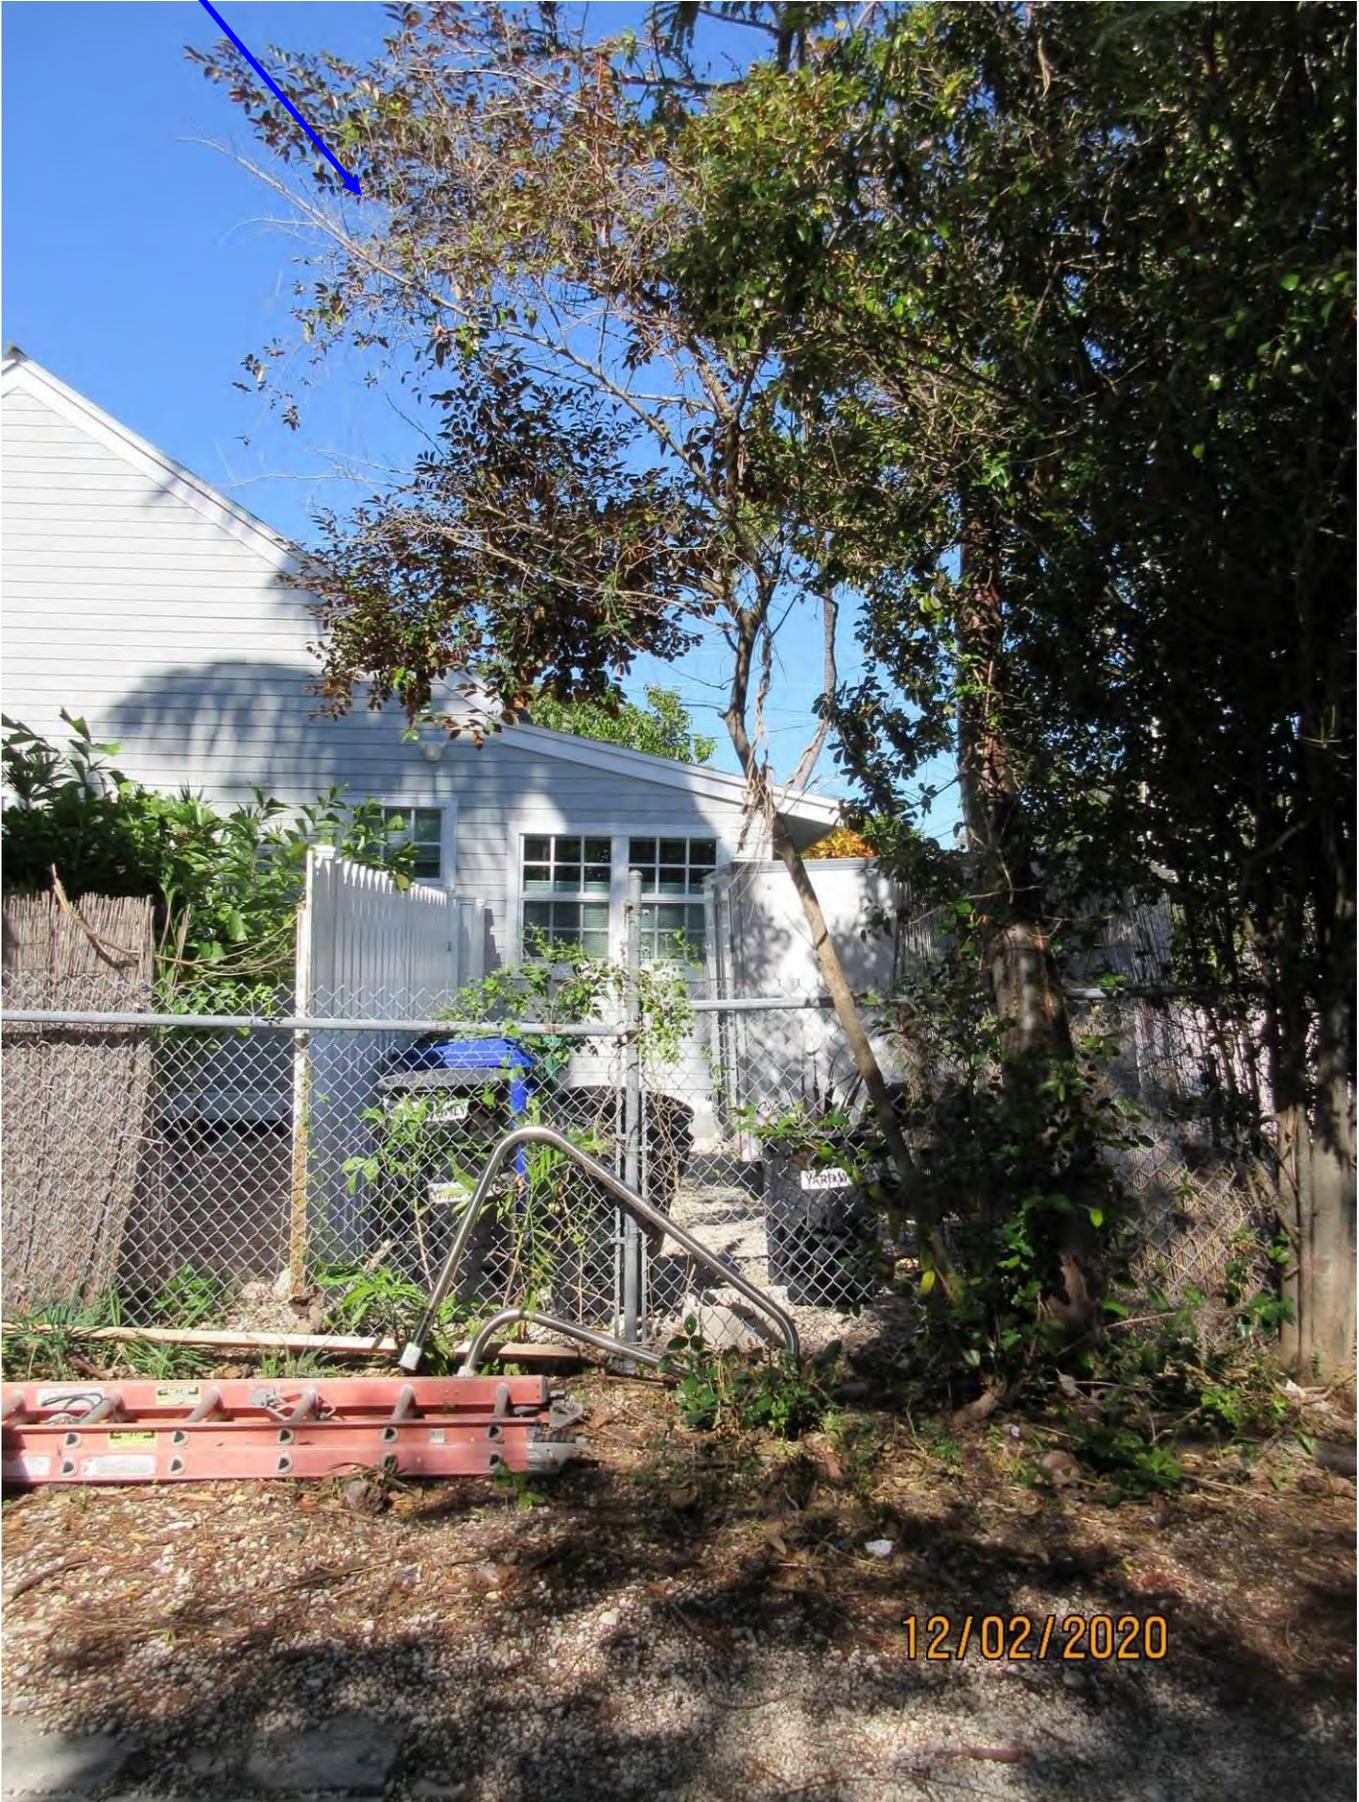
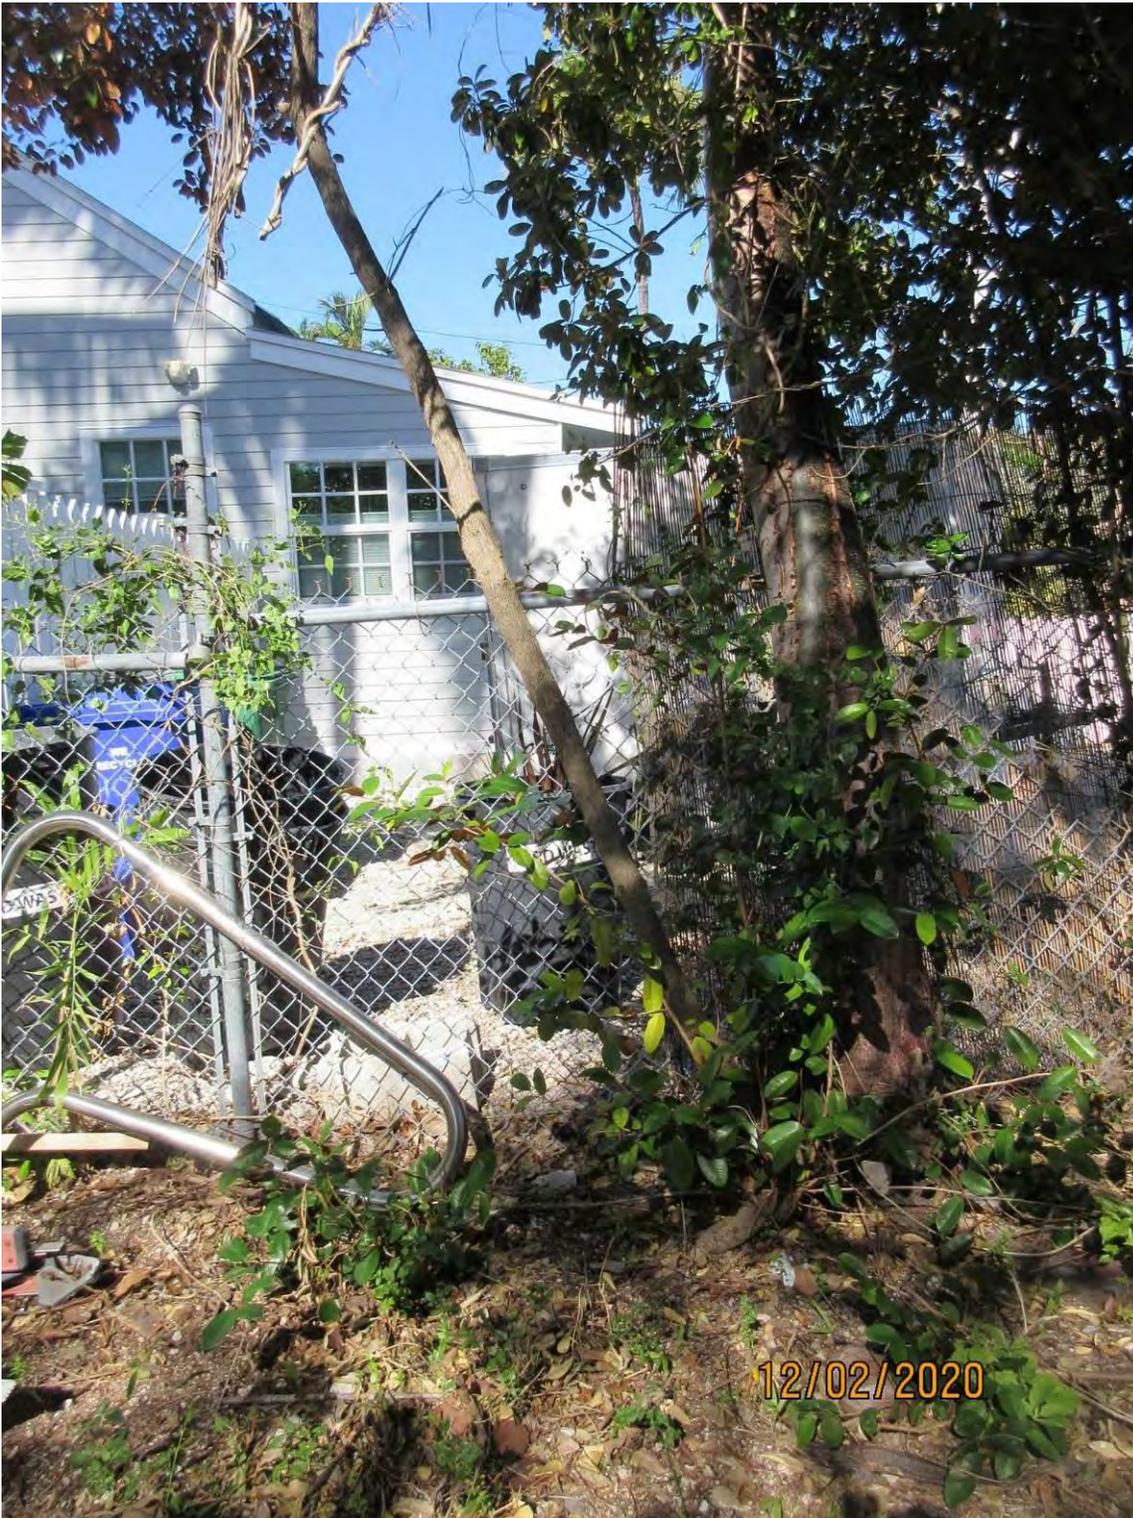
Tree #85

Location: 60% (some growth impacts from neighboring canopy tree, very close to fence line)

Condition: 50% (fair to poor, elongated trunk growth with lean, canopy with die back.)

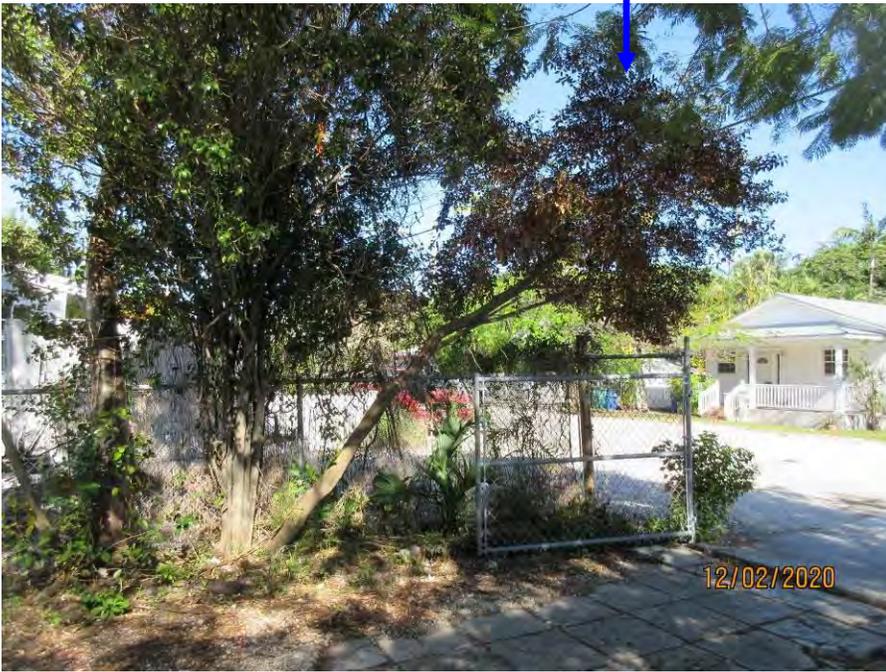
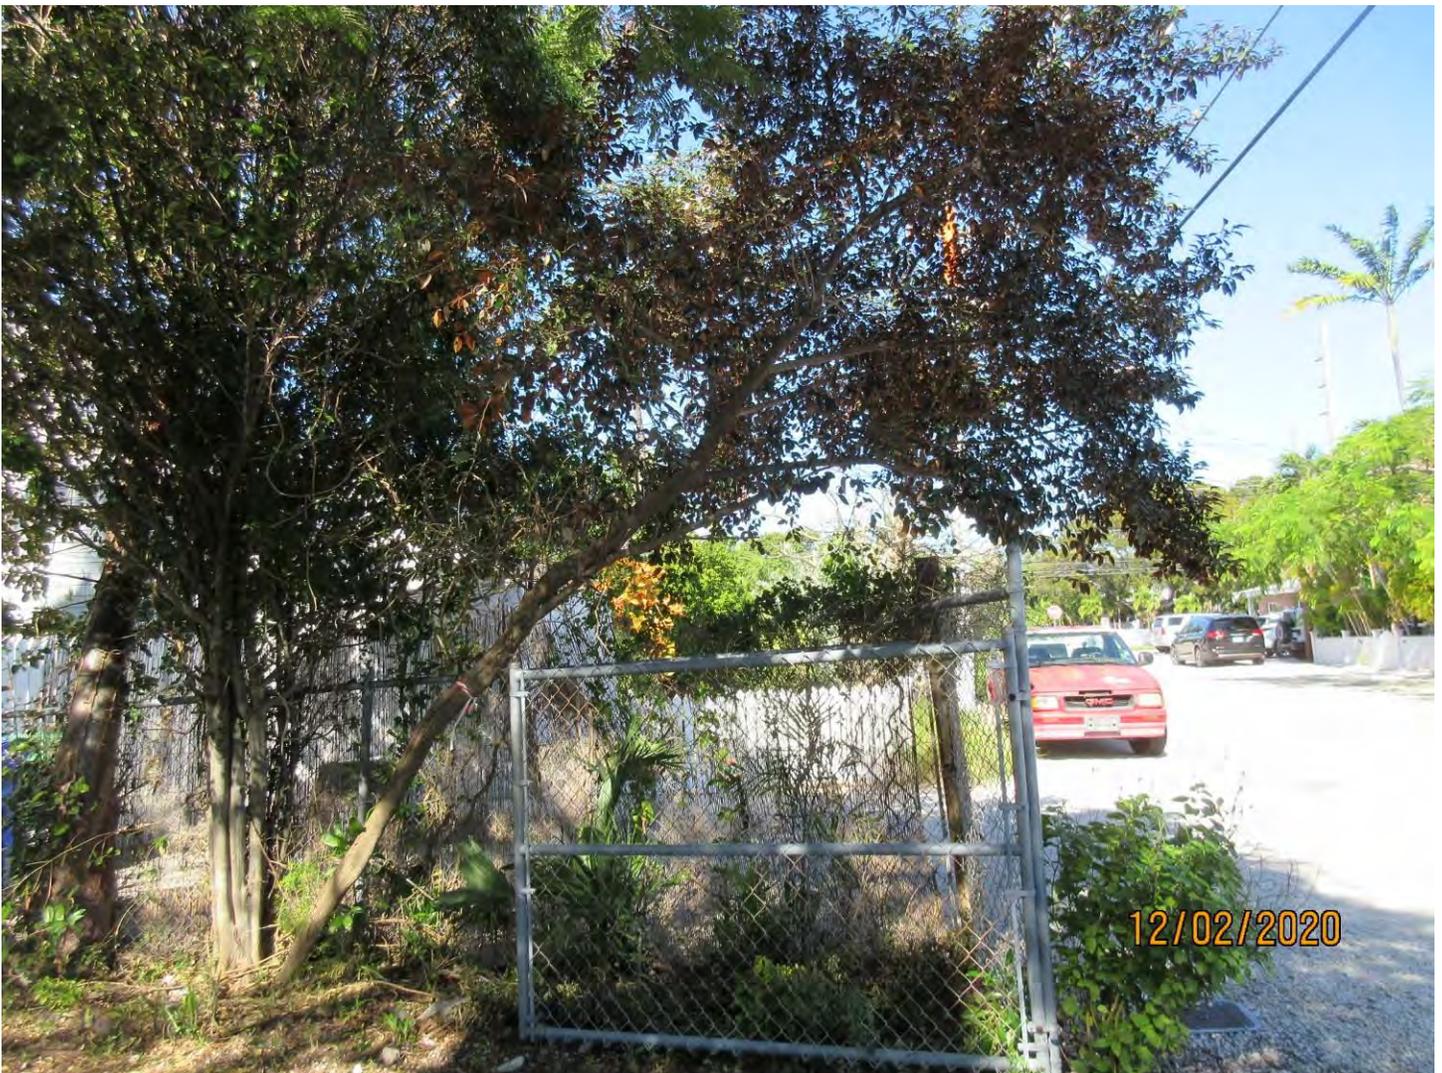
Tree #88

Diameter: 3.7"
Location: 60% (growing at base of Jamaican caper tree close to fence line)
Species: 100% (on protected tree list)
Condition: 50% (healthy looking canopy, heavy 45 degree growth lean)
Total Average Value = 70%
Value x Diameter = 2.5 replacement caliper inches

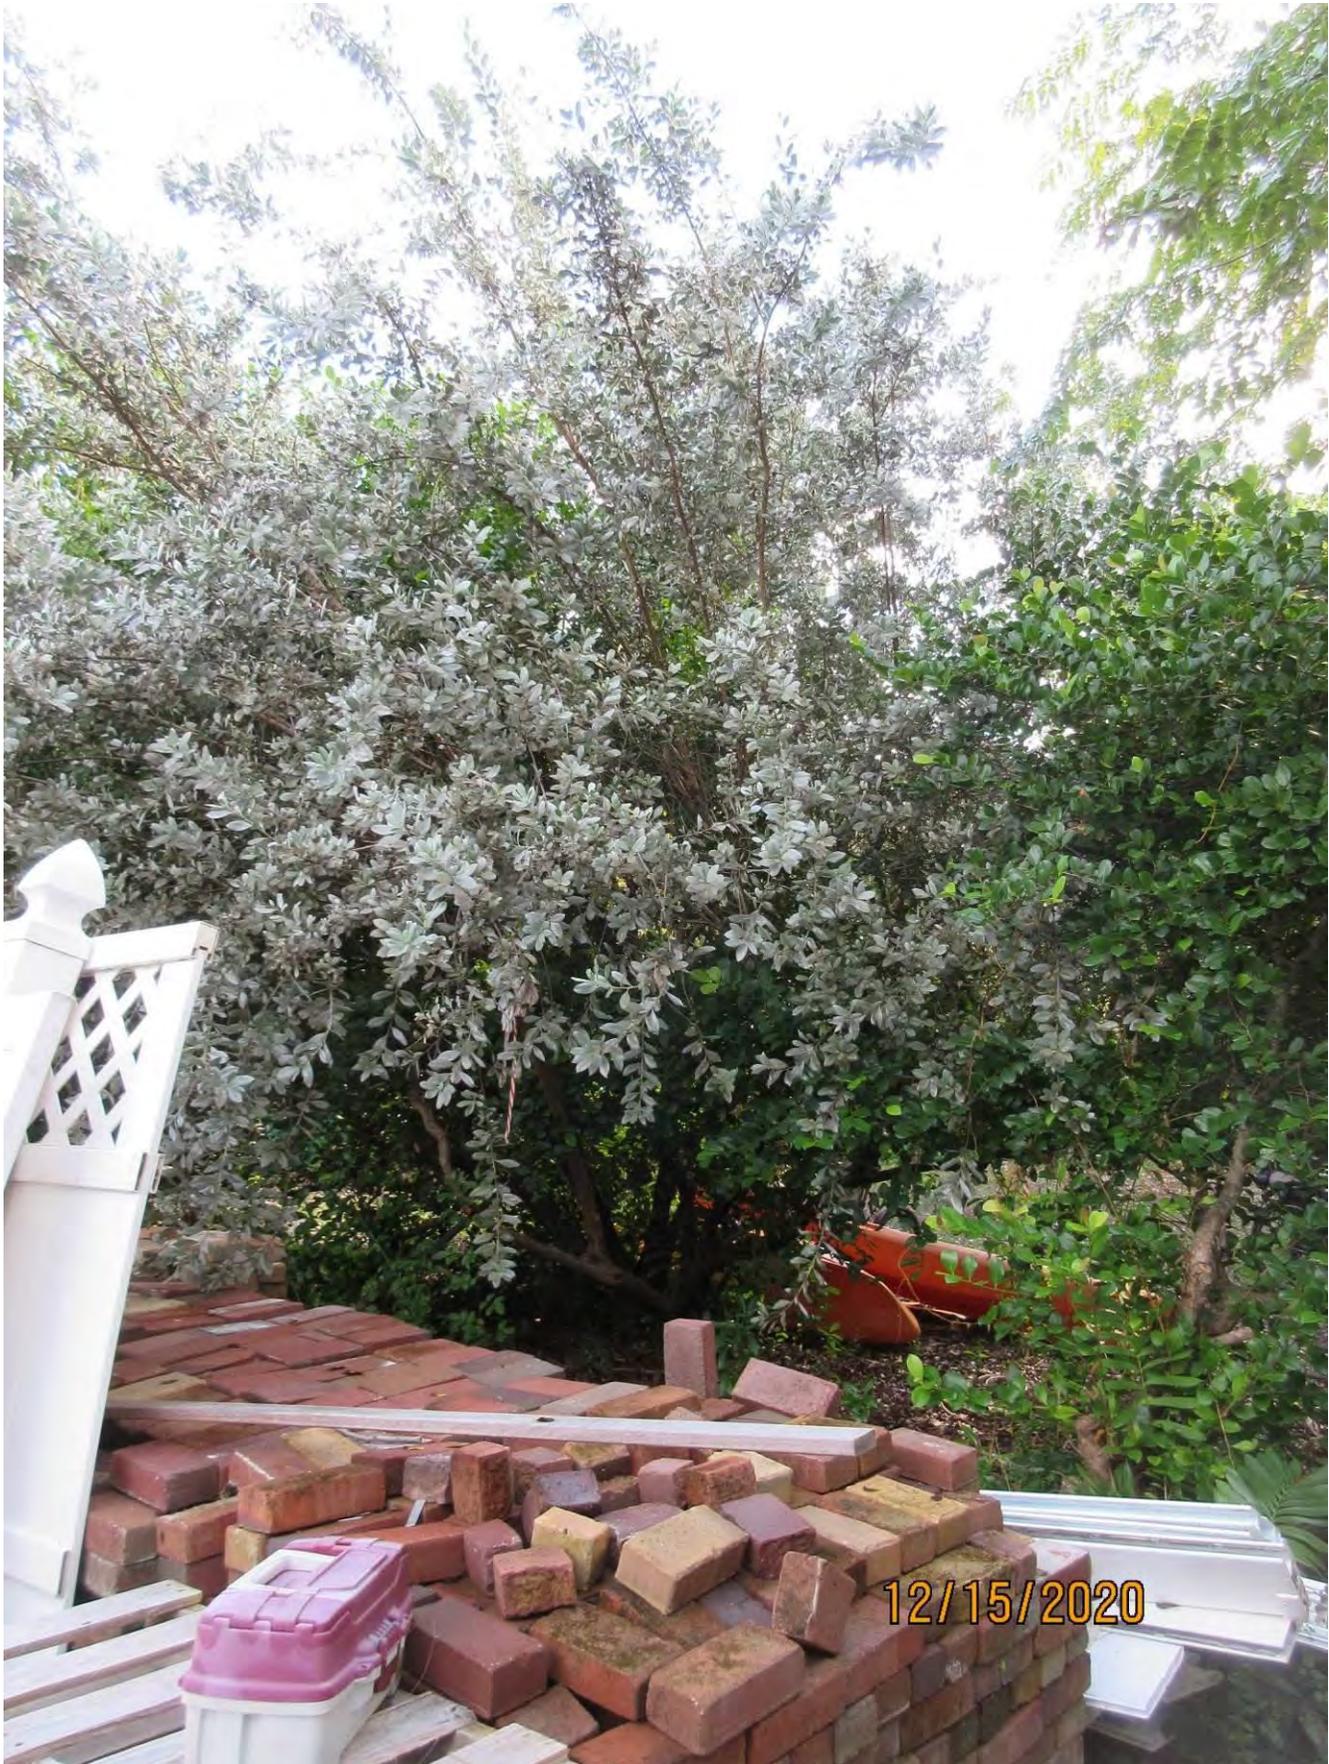
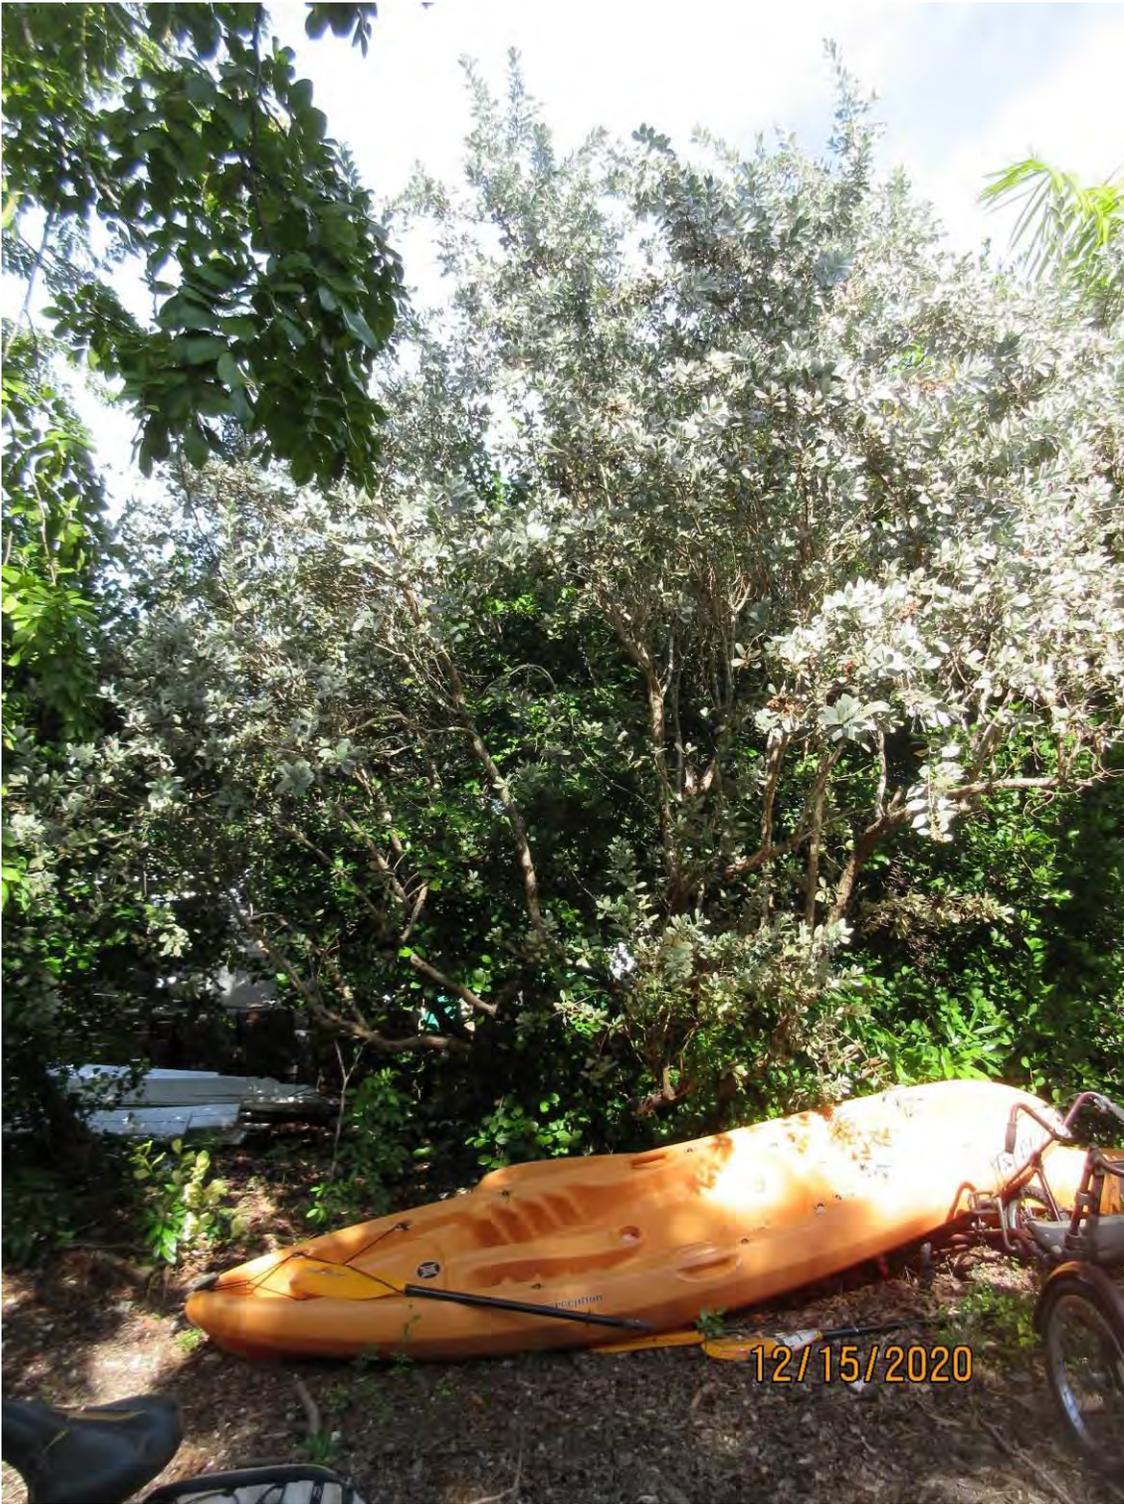
Tree #188

Condition: 60% (overgrown shrub-no maintenance, multi trunked, sprawling tree, healthy, poor structure)

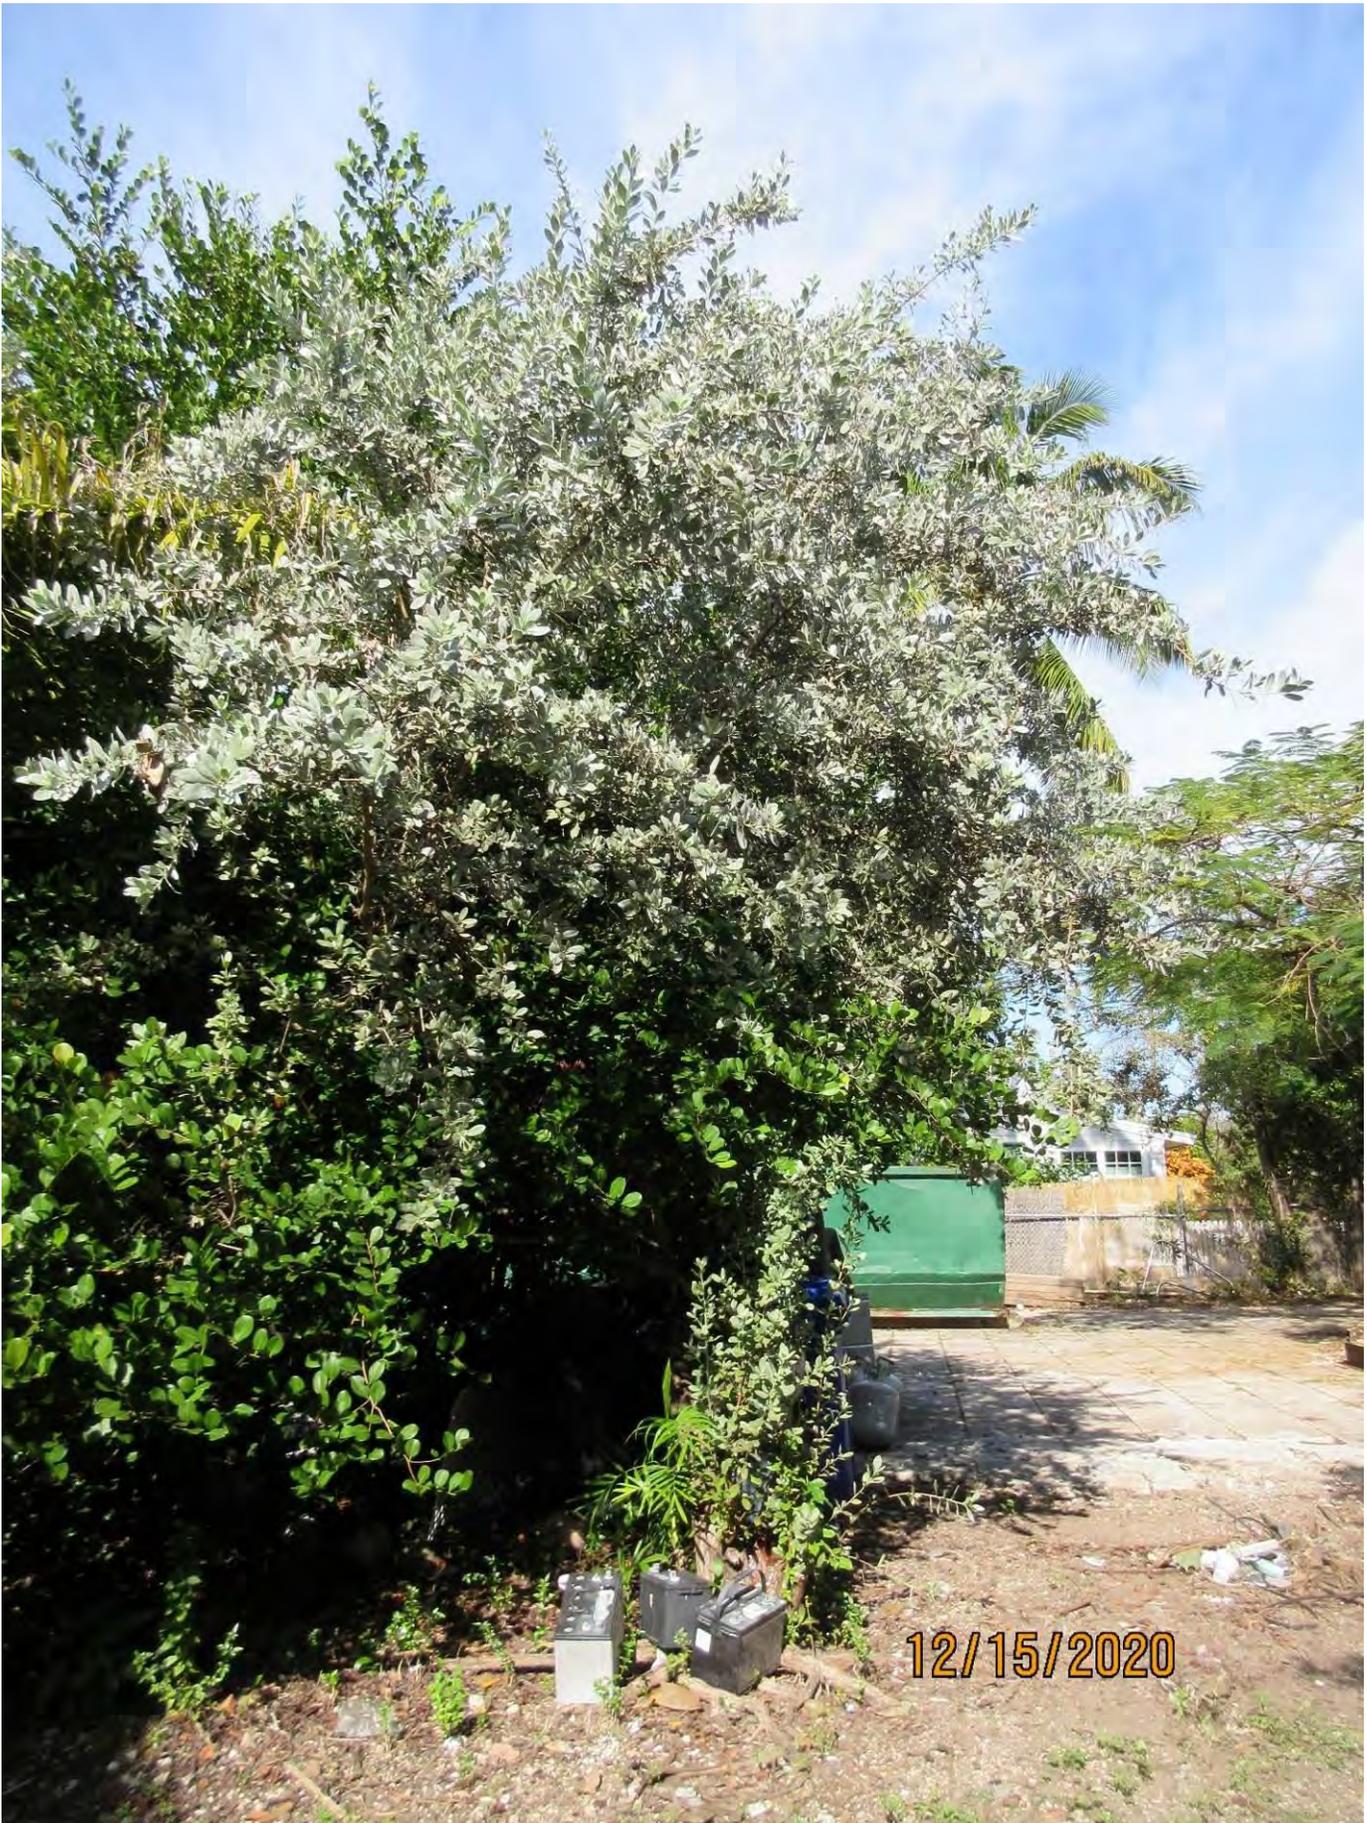
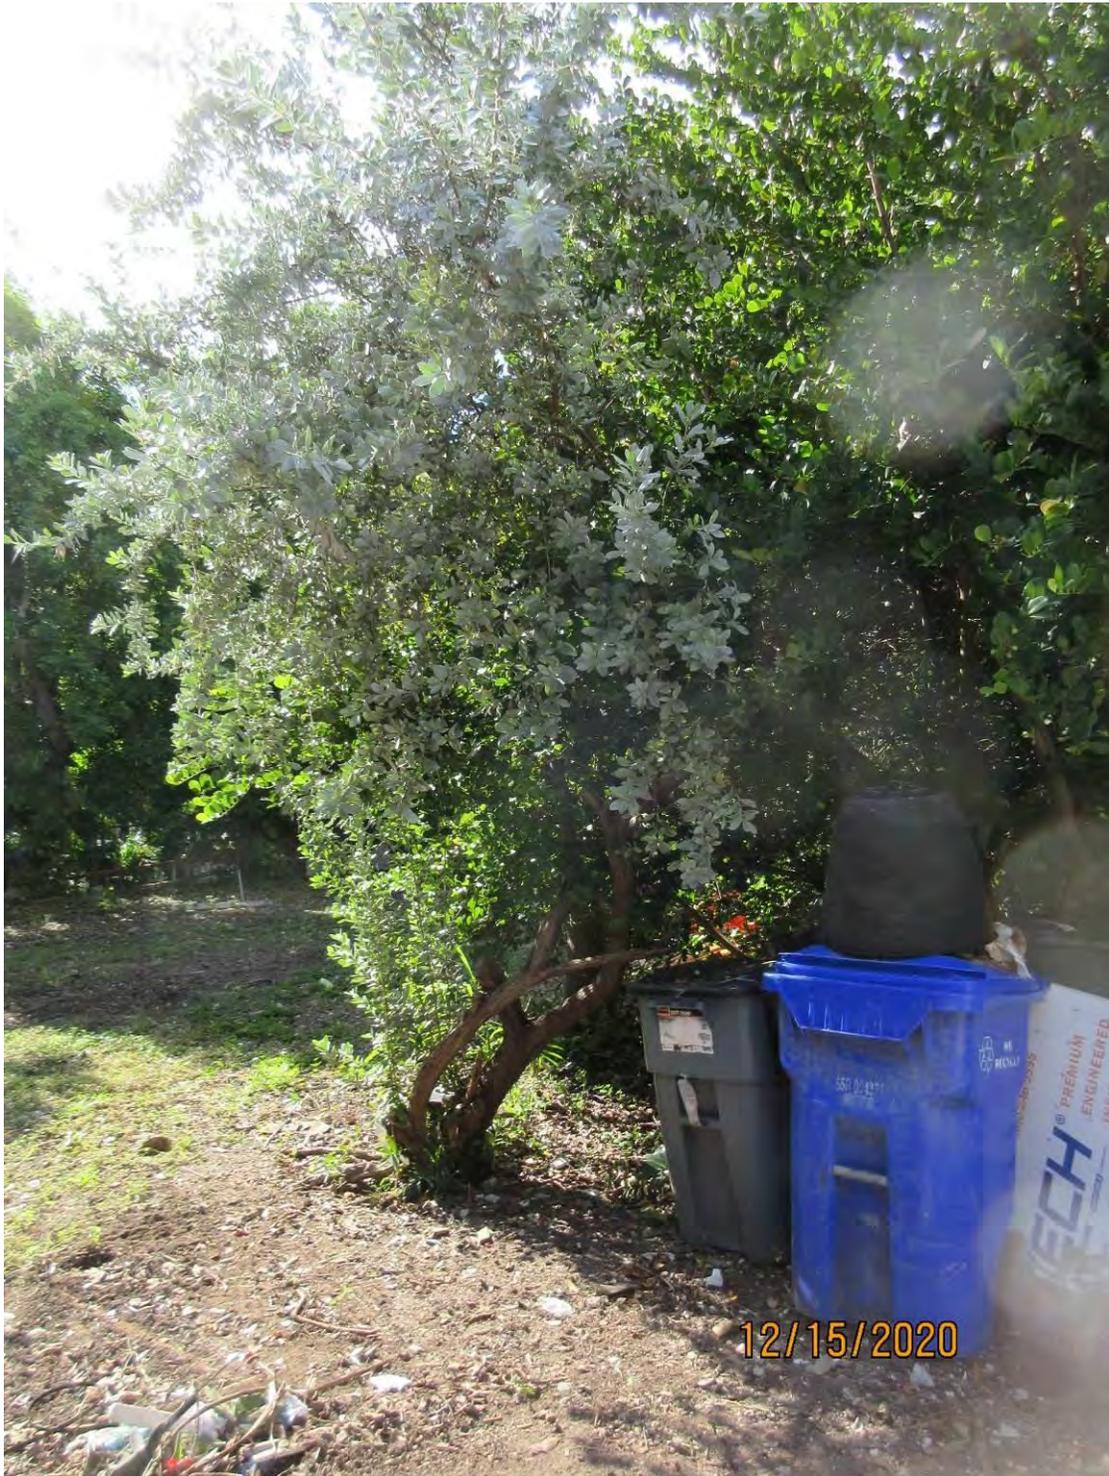
Tree #192

Condition: 50% (fair, overgrown shrub-no maintenance, poor structure)
