Tree Species: Mahogany (Swietenia mahogany)
Tree #172

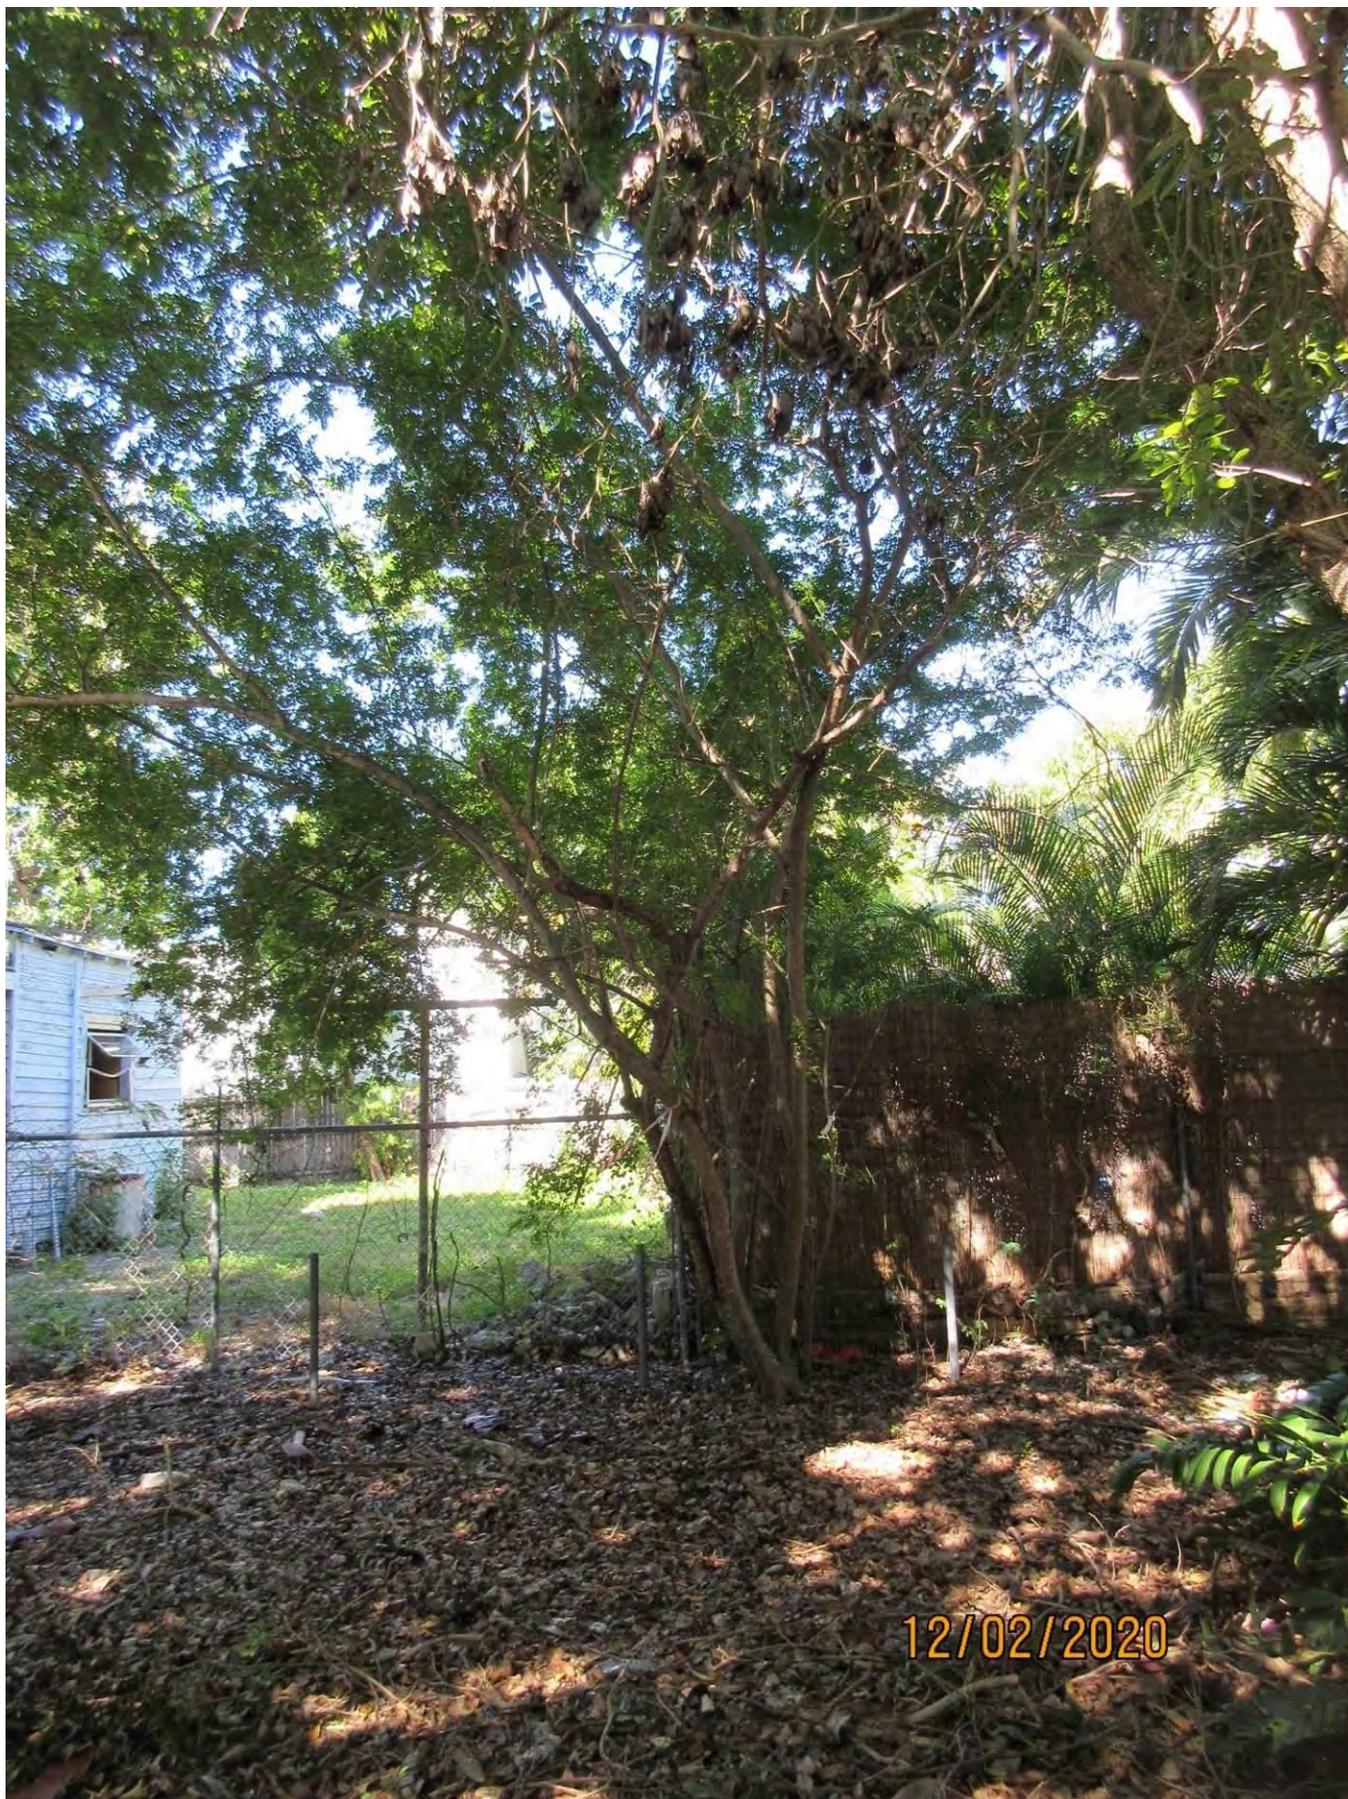
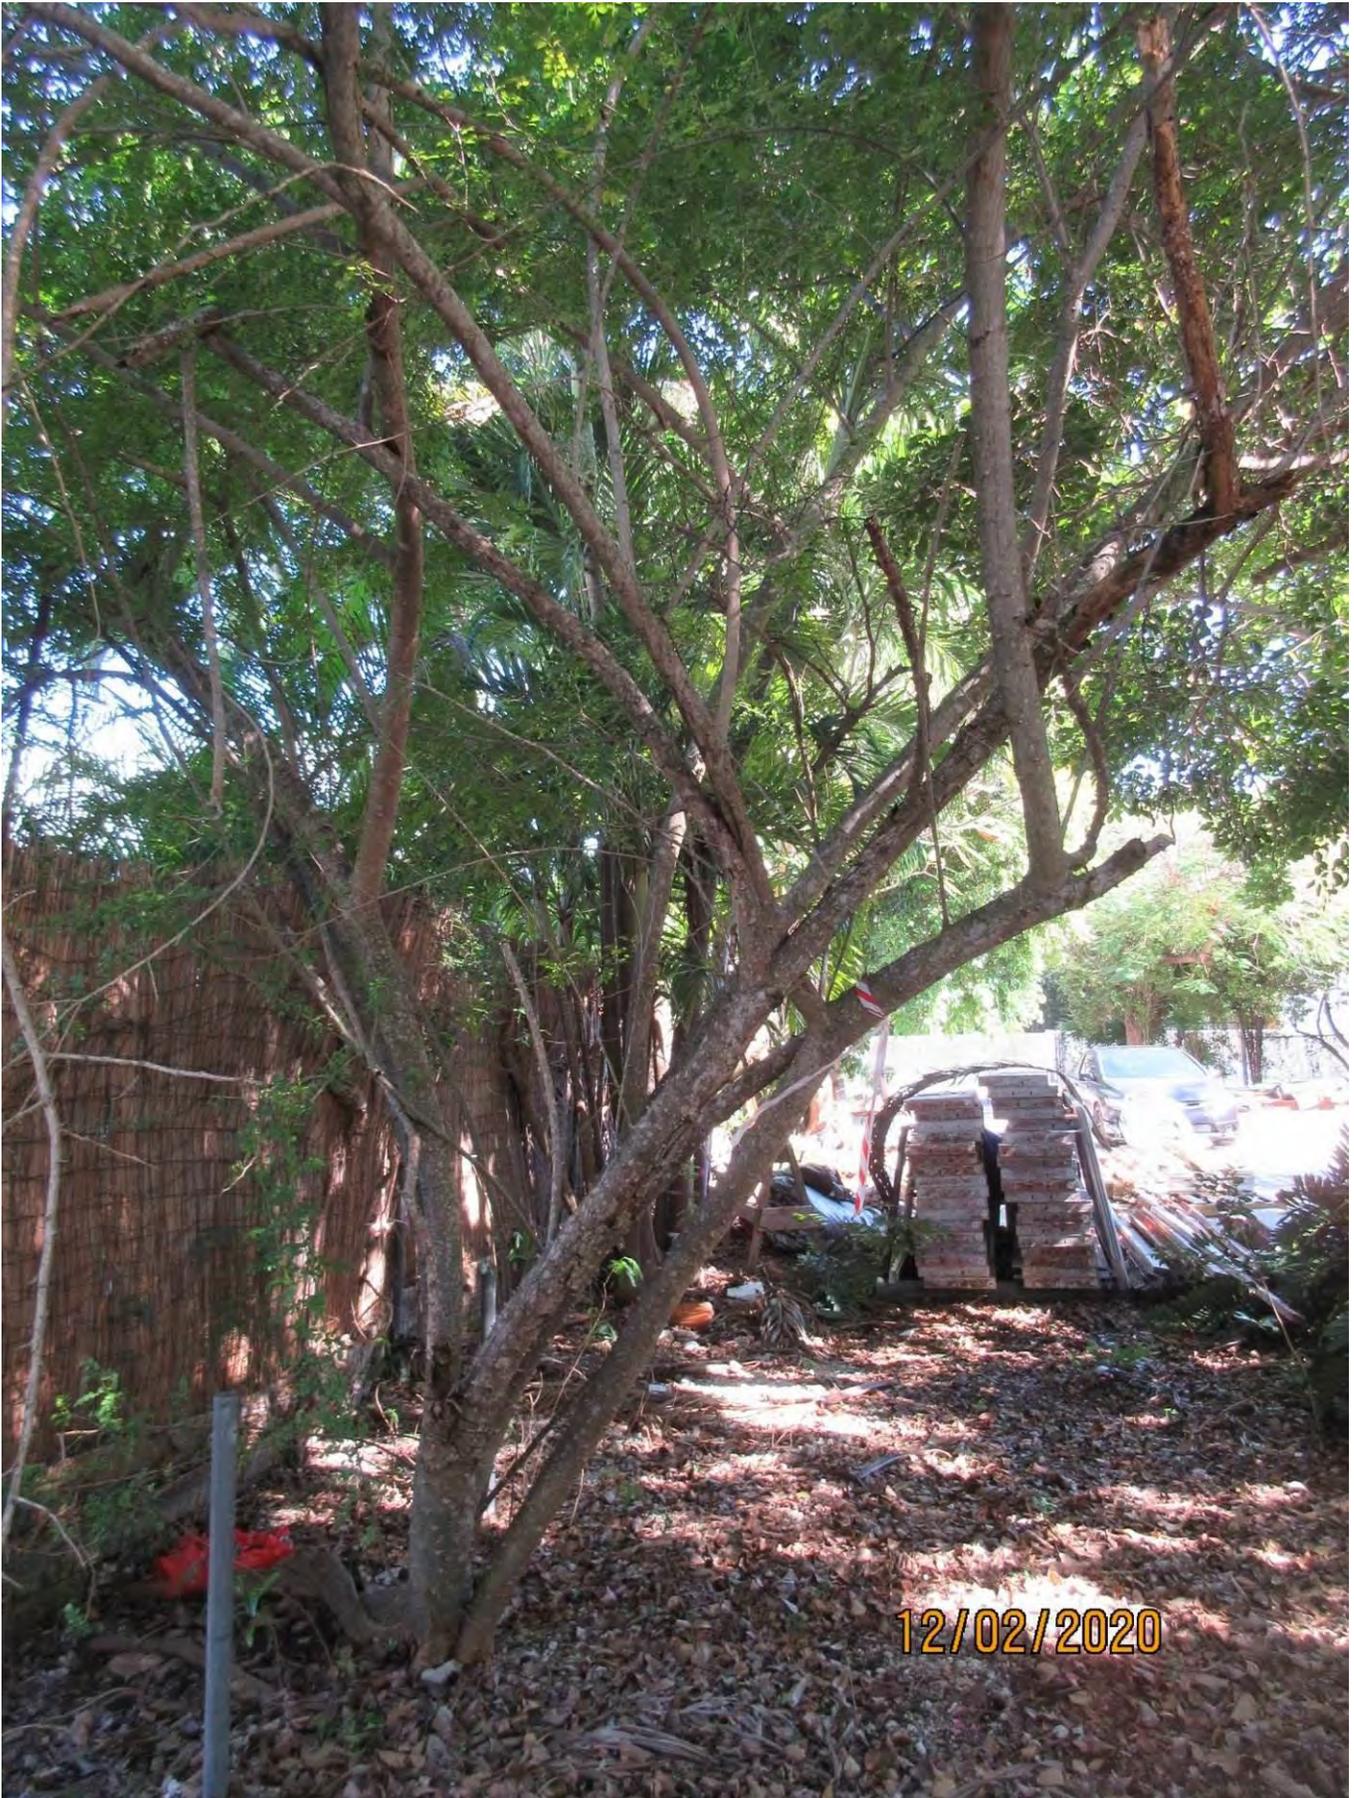
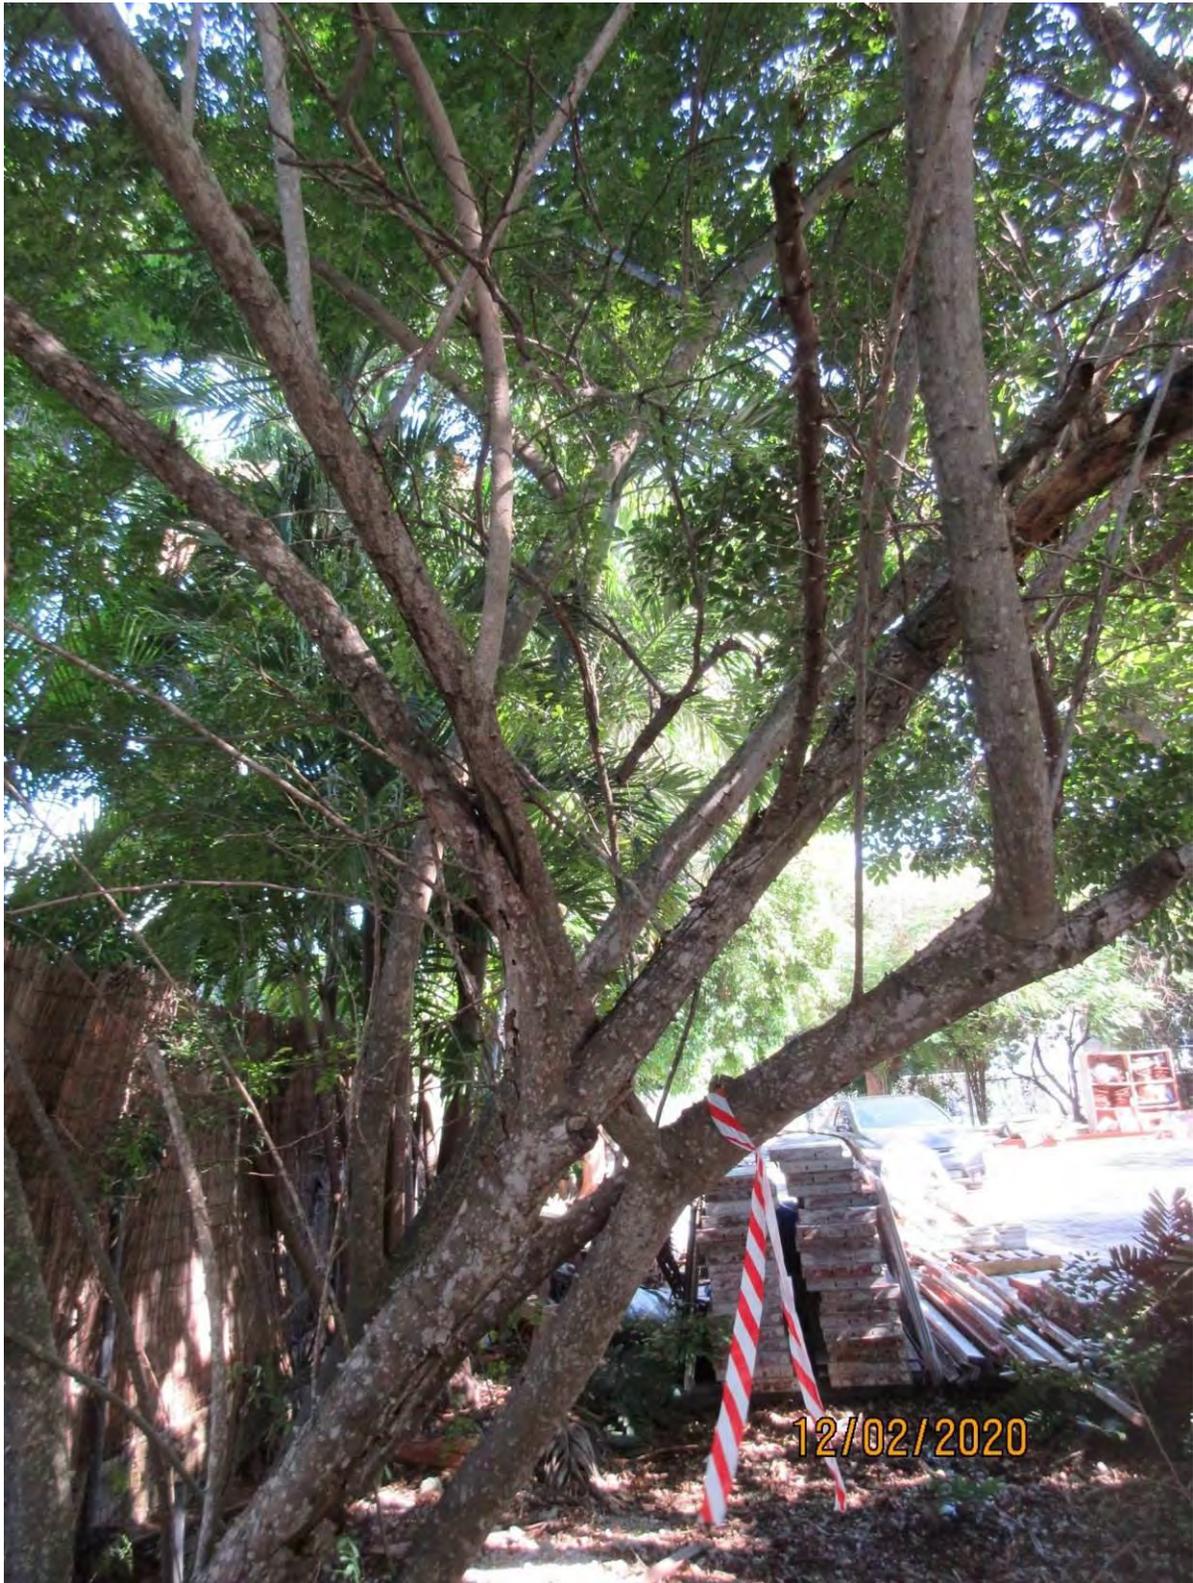
Tree #68

Condition: 40% (poor structure, decay in branches)

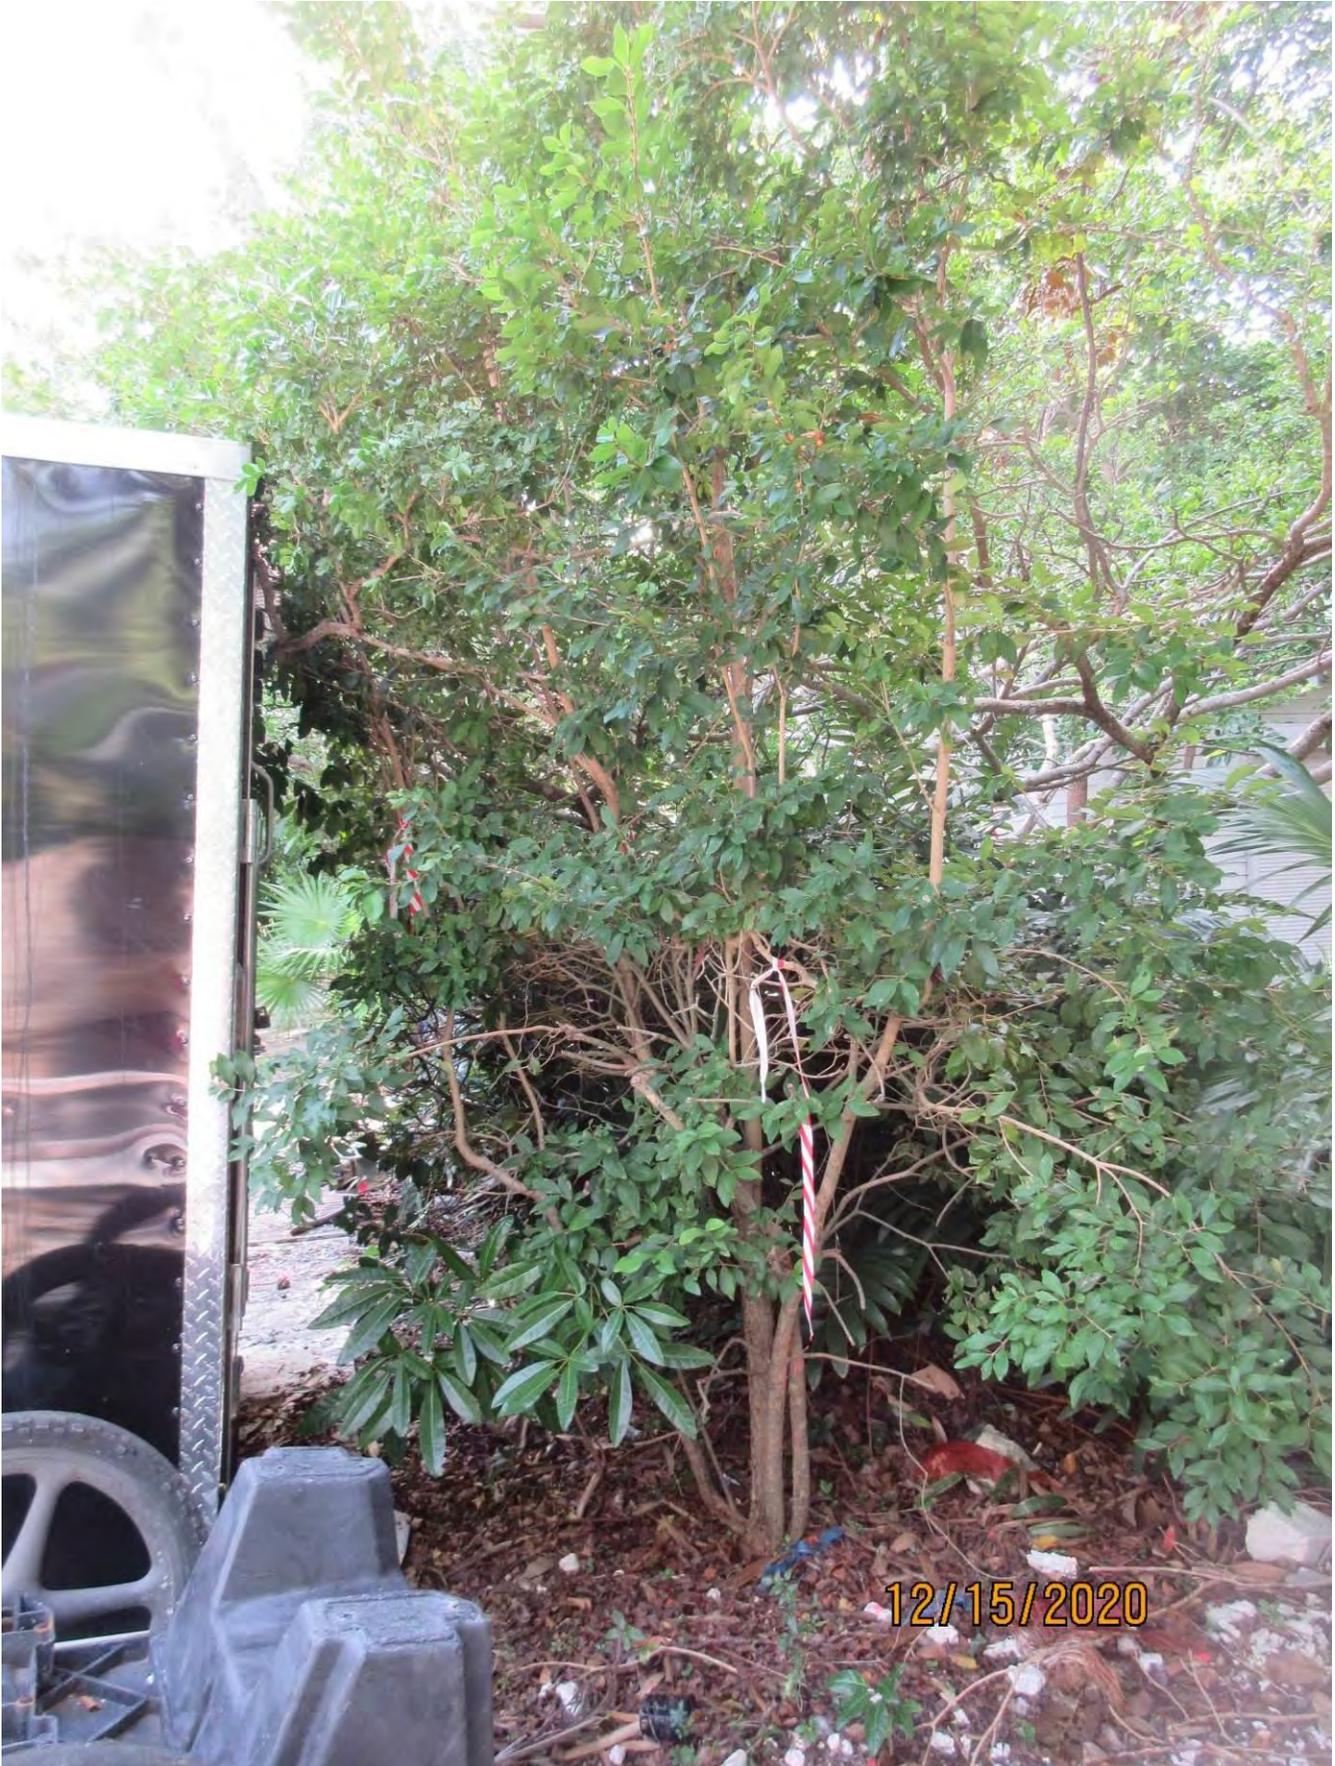
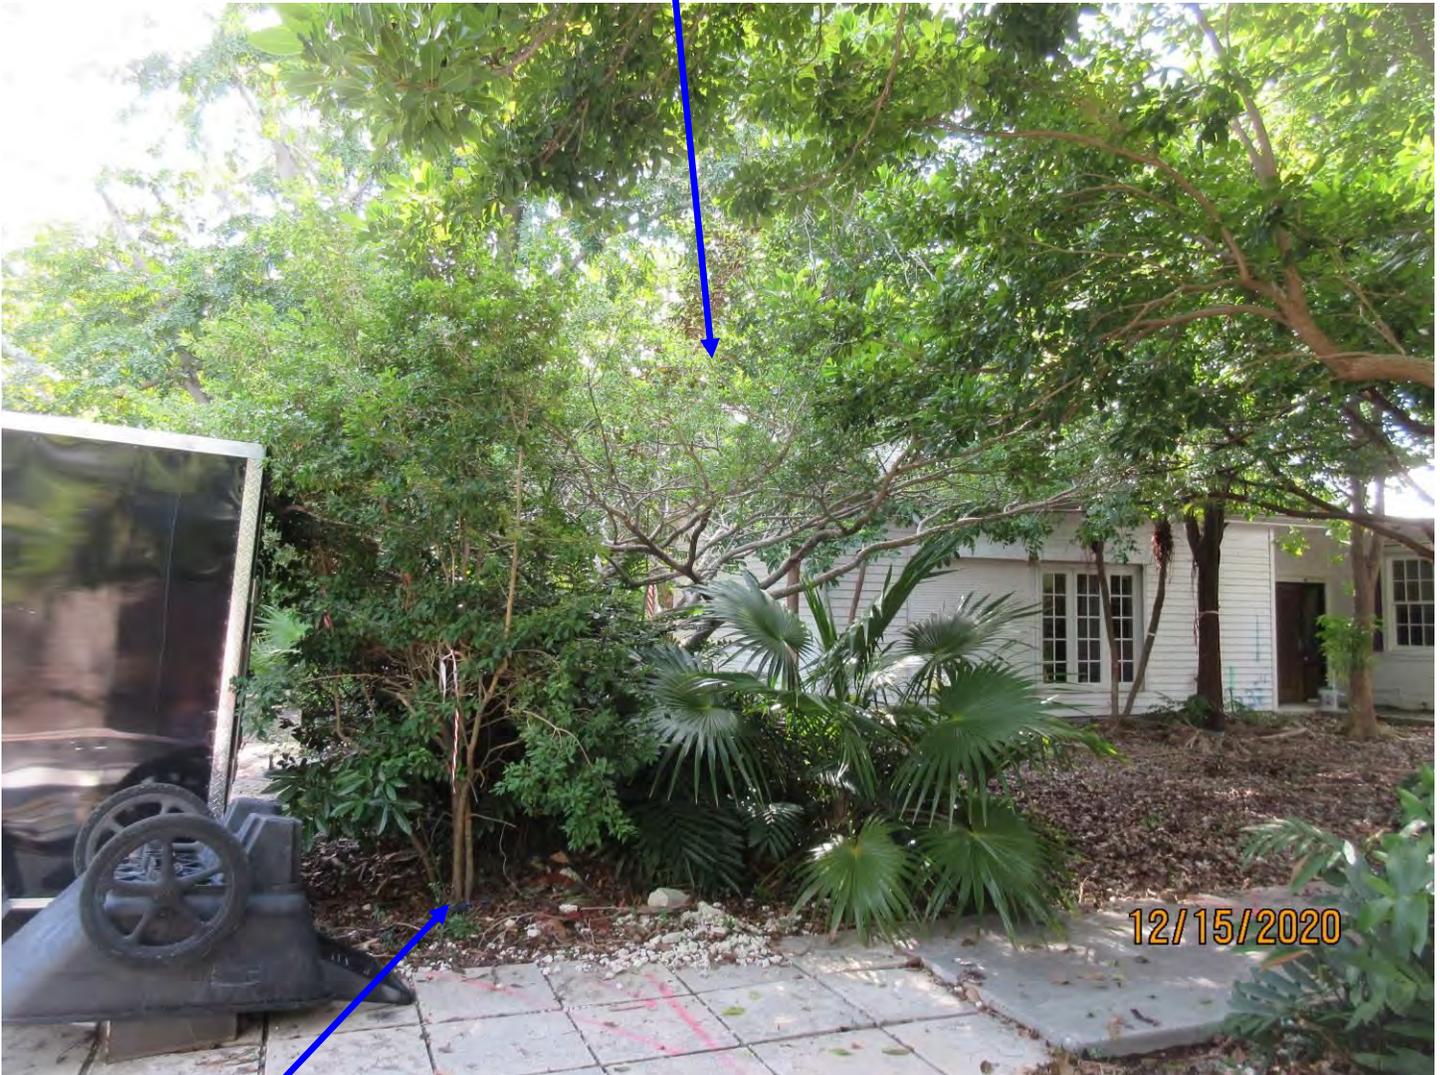
Tree Species: White Stopper (*Eugenia axillarius*) Tree #184

Location: 60% (growing within dripline of lignum vitae tree)

Condition: 60% (fair, multi trunked, young, shrubby tree)
