## STAFF REPORT

RE: 322 and 324 Truman Avenue (file application #TP2021-0003)

FROM: Karen DeMaria, City of Key West Urban Forestry Manager

Re: Conceptual Landscape Plan Review

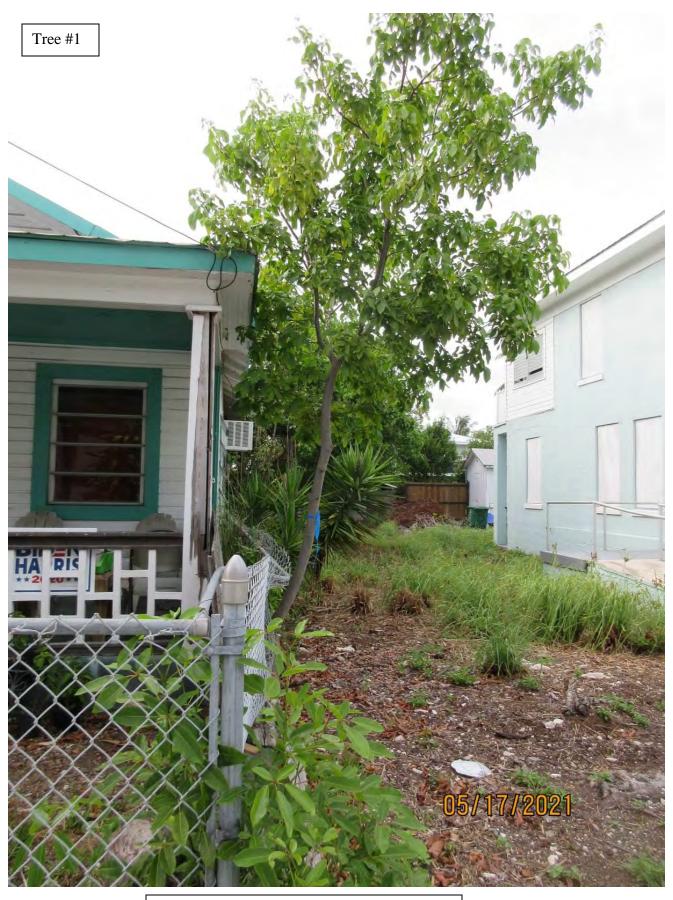
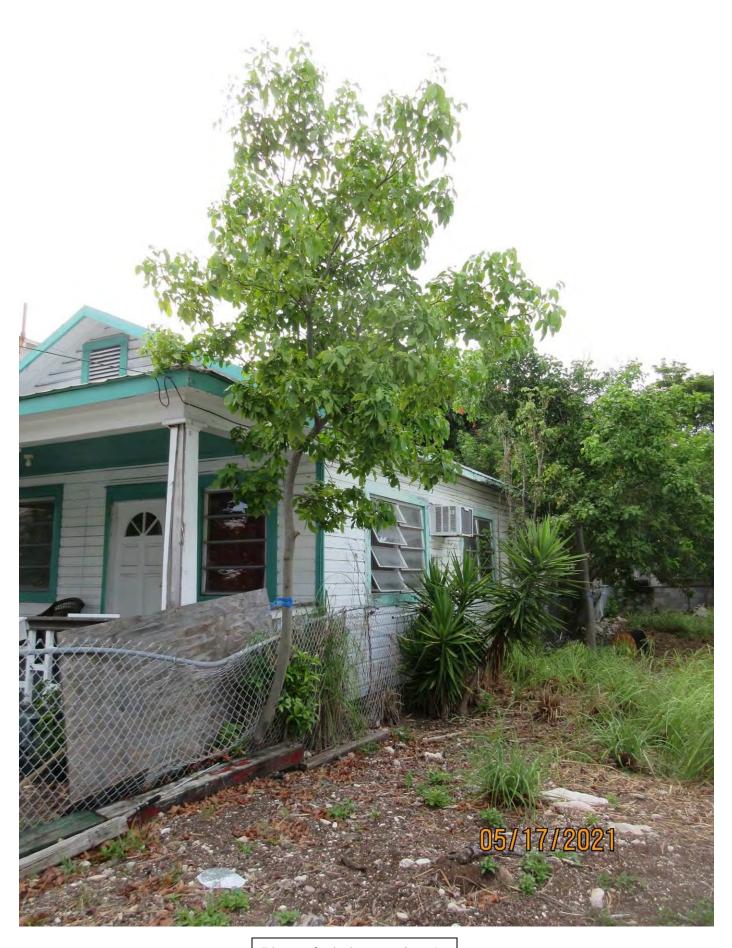
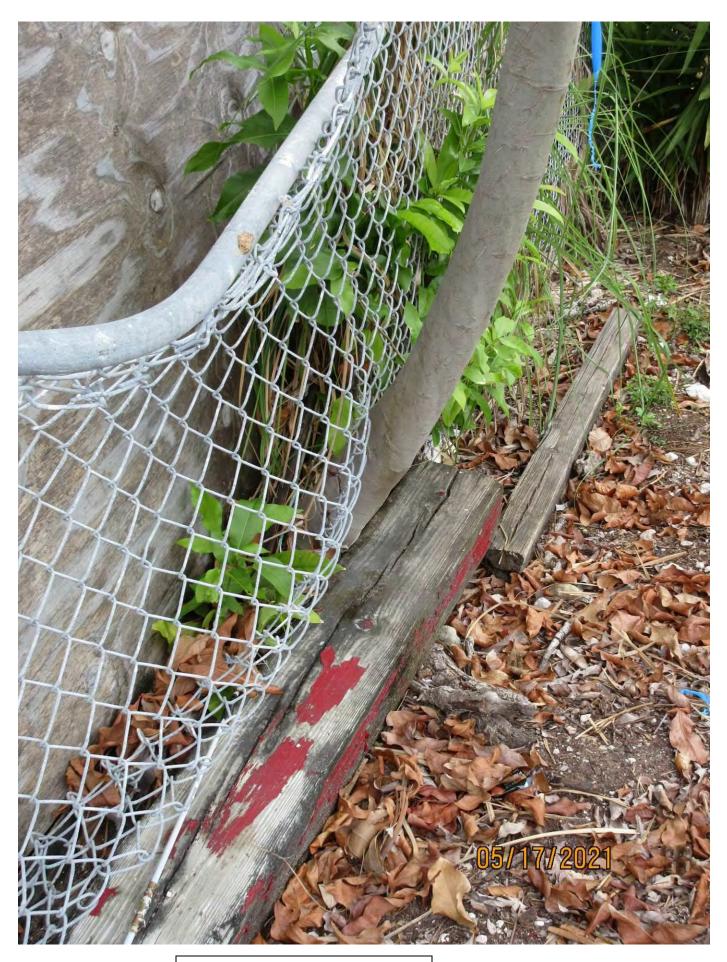
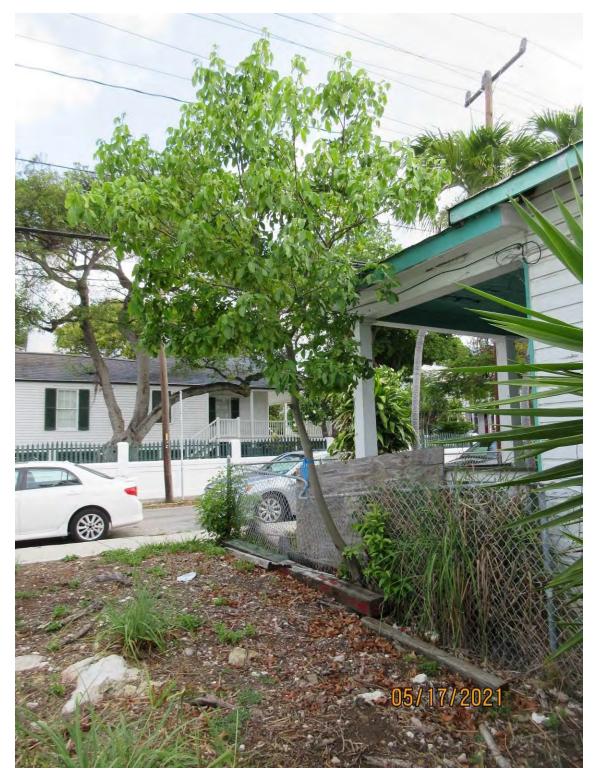
Standing on the property line looking at tree.

Photo of whole tree, view 1.

Photo showing base of tree in fence.

Photo of whole tree, view 2.

Tree #1-Diameter: 3.1"

Location: 40% (base of tree growing in wire fence, close to structure -

wrong tree, wrong place)

Condition: 50% (Fair to poor, canopy healthy, growing in fence immediately

next to neighbor's house-base of tree compromised, trunk growth lean)

Total Average Value = 63%

Value x Diameter = 1.9 replacement caliper inches

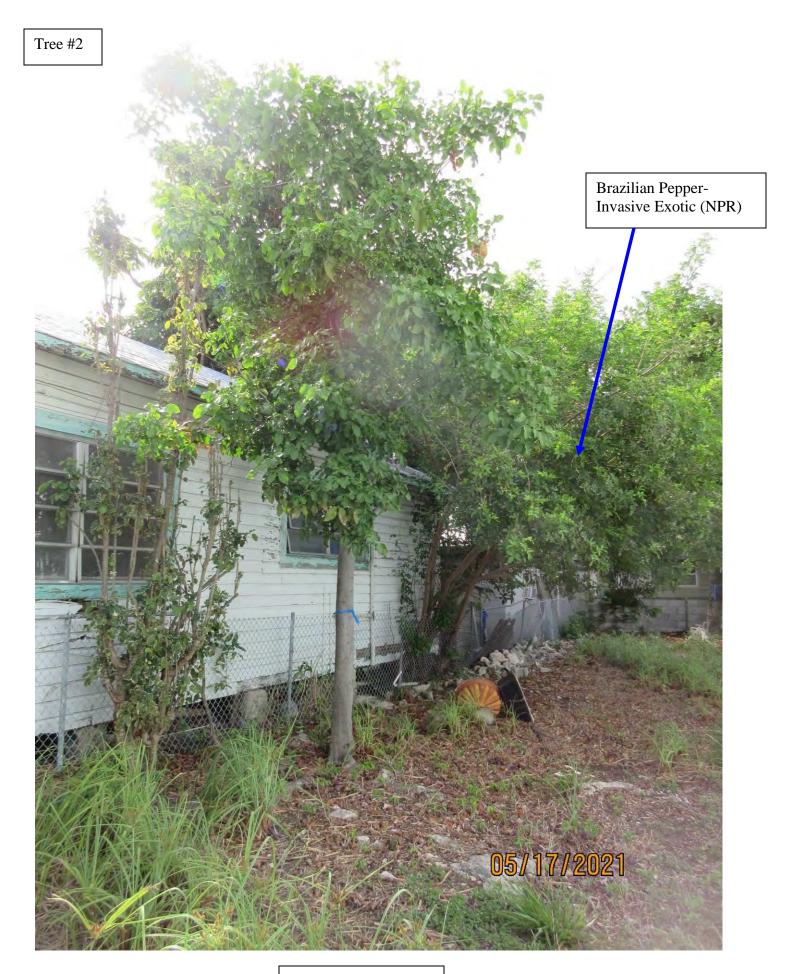
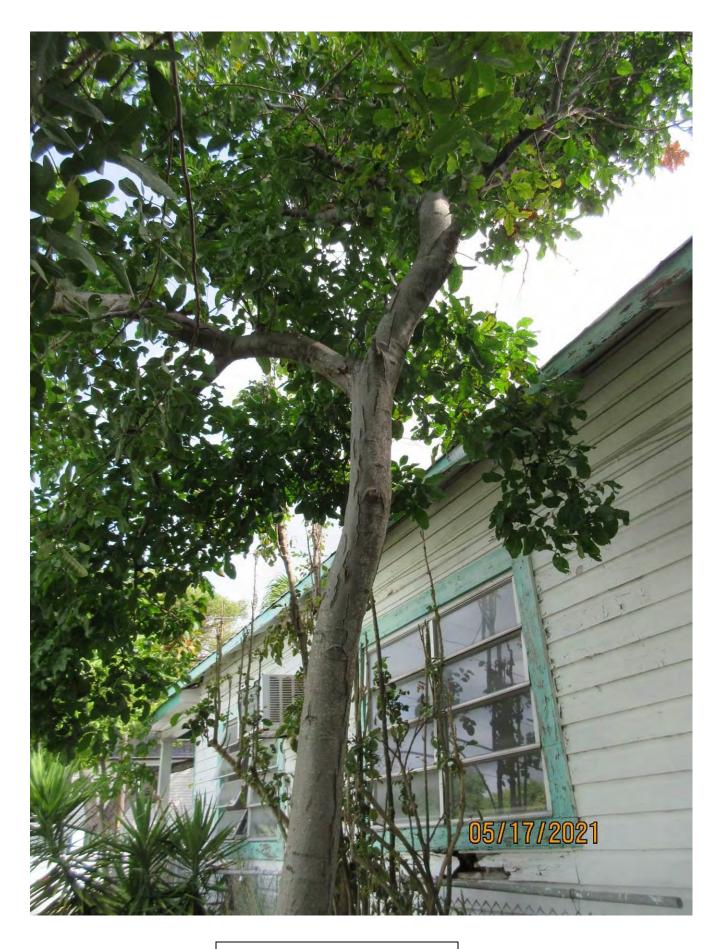
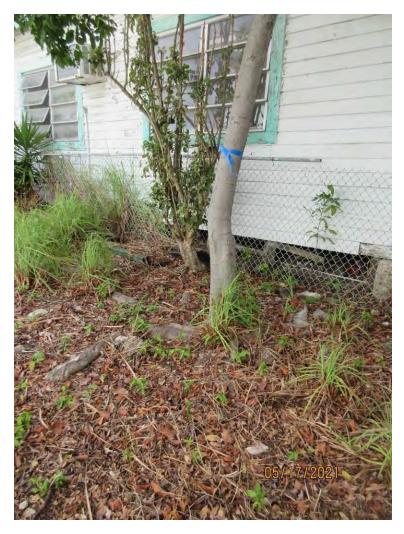
Photo of whole tree.

Photo of tree trunk and canopy.

Tree #2-photos showing tree trunk and base of tree. Lots of surface roots.

Tree #2-Diameter: 6.6"

Location: 70% (side yard near property line. Canopy impacts to

neighboring property.)

Condition: 60% (fair, canopy structure stronger over neighboring property,

lots of surface roots.)

Total Average Value = 76%

Value x Diameter = 5.0 replacement caliper inches

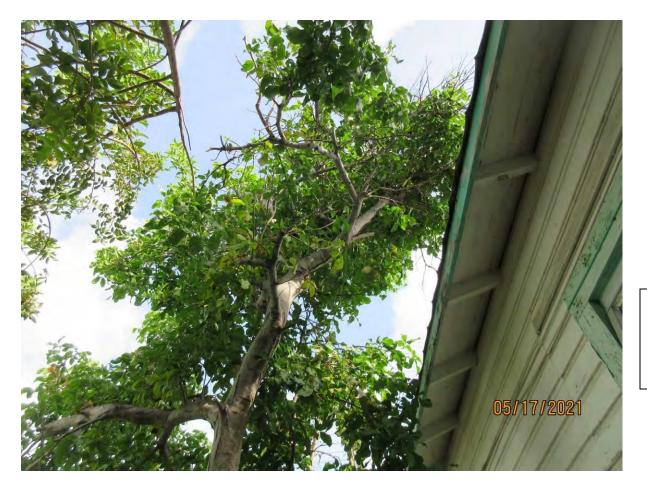
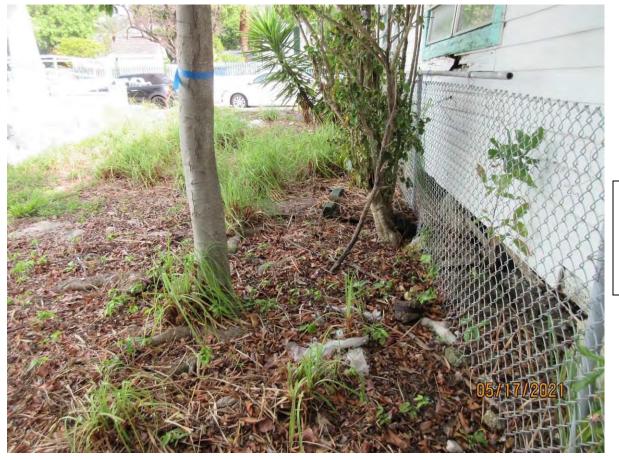
Standing near property line, photo of tree canopy.

Standing near property line, photo showing base of tree location.

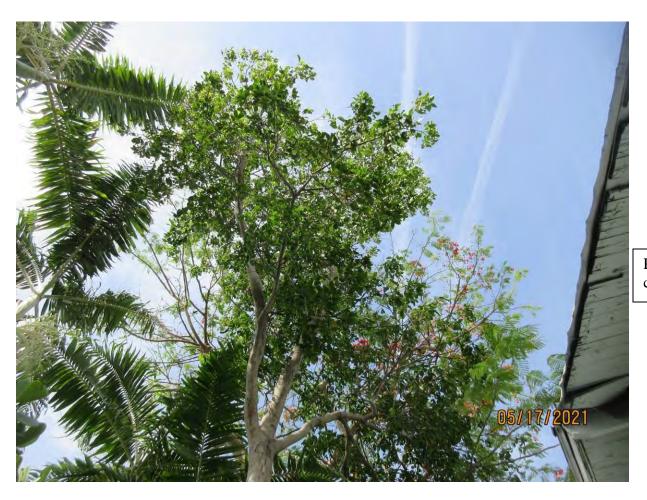
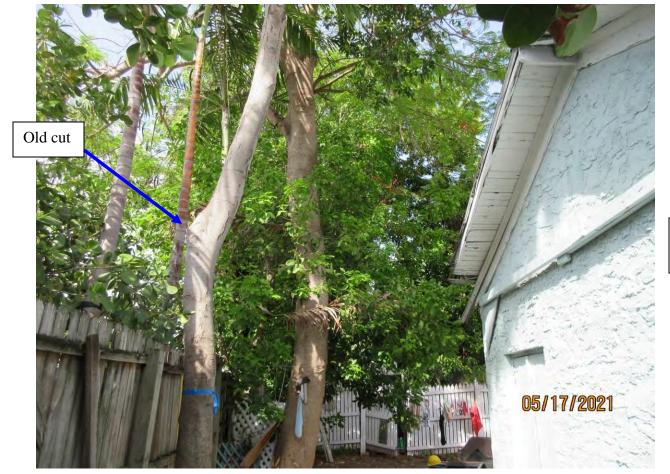
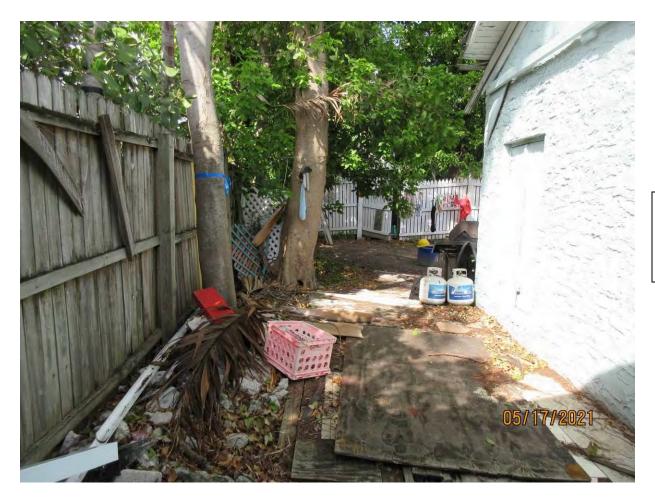
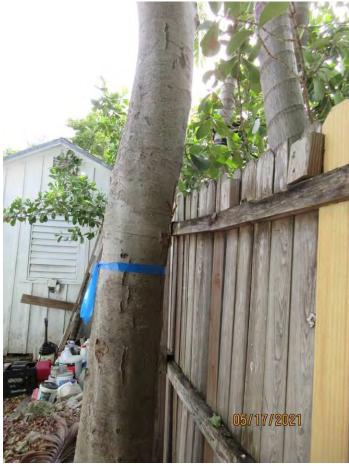
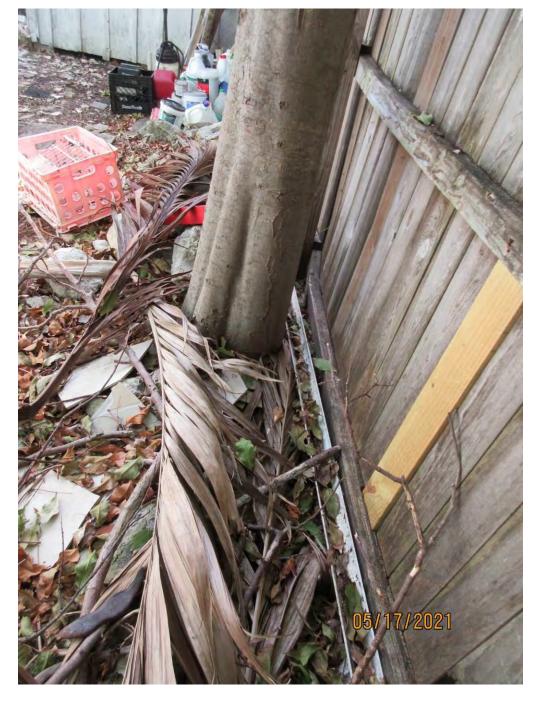
Photo of the canopy of tree #3.

Photo of tree trunk, view 1.

Photo showing trunk and base of tree.

Photo of tree trunk, view 2.

Photo of base of tree.

Tree #3-Diameter: 10.1"

Location: 60% (growing in canopy of Royal Poinciana tree-in future will compete for root and air space with tree, growing close to rear property line).

Condition: 70% (Good to fair condition, elongated trunk growth with no lower branches, appears one section growing toward neighboring property was cut in the past.)

Total Average Value = 76%

Value x Diameter = 7.6 replacement caliper inches

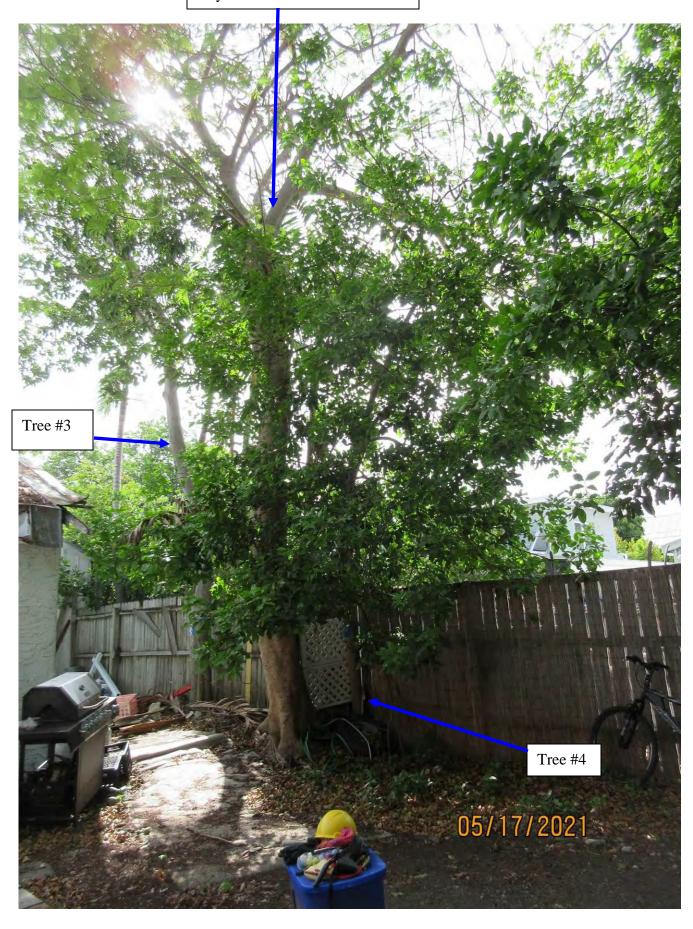
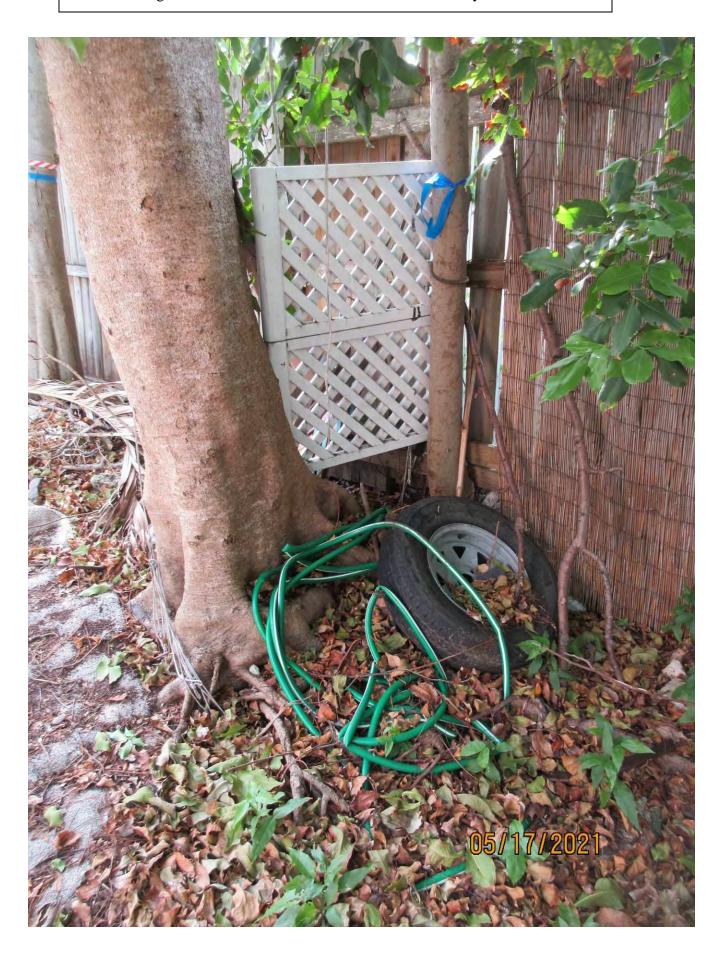
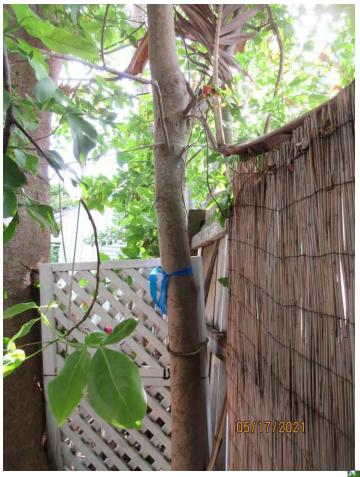
Photo showing location of the base of Tree #4 in relation to Royal Poinciana tree.

View of the trunk of Tree #4.

View of tree canopy.

Tree #4-Diameter: 4.4"

Location: 30% (growing I primary root zone of Royal Poinciana tree

close to rear property line).

Condition: 60% (fair)

Total Average Value = 63% Value x Diameter = 2.7 replacement caliper inches

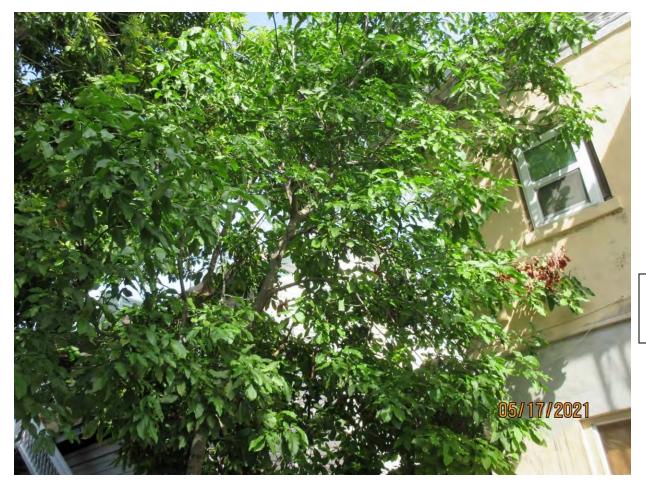
Photo showing canopy of trees 5-8.

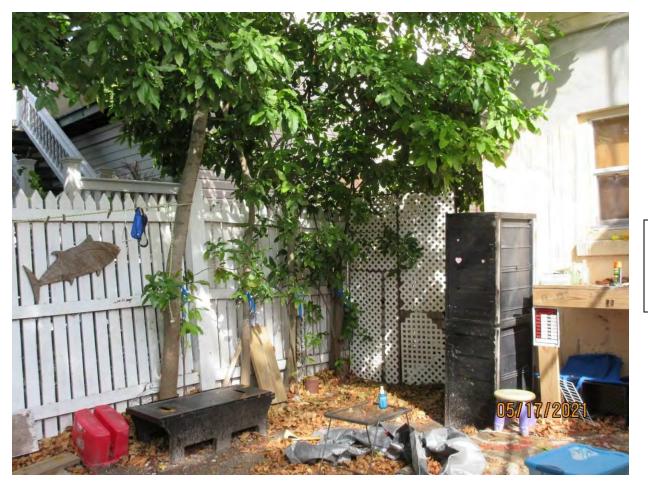
Photo showing trunks of trees 5-8.

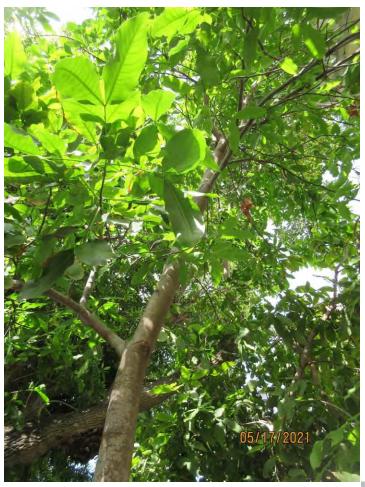
Photo of canopy of tree #5.

Photo showing base of tree #5.

Tree #5-Diameter: 5.0"
Location: 40% (growing at base of fence/property line in root zone with other trees, main portion of canopy over neighbor' house)

Condition: 60% (Fair condition, canopy with lopsided growth

structure)

Total Average Value = 66% Value x Diameter = 3.3 replacement caliper inches

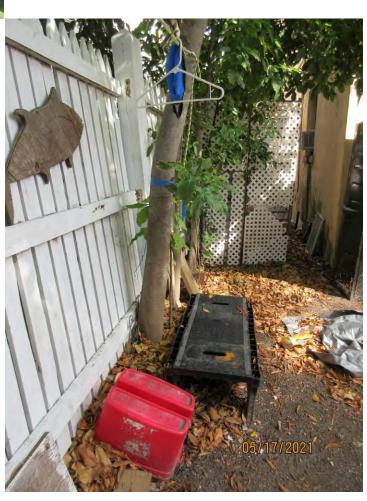
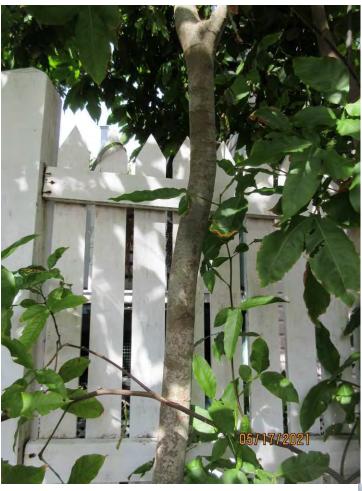
Photo of trunk of tree #6

Photo of base of tree #6.

Tree #6-Diameter: 2.8"

Location: 40% (growing at base of fence/property line in root zone with other trees, competing

canopies)

Condition: 60% (Fair)

Total Average Value = 66% Value x Diameter = 1.8 replacement caliper inches

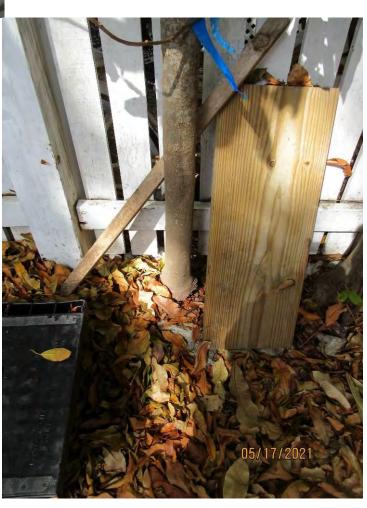
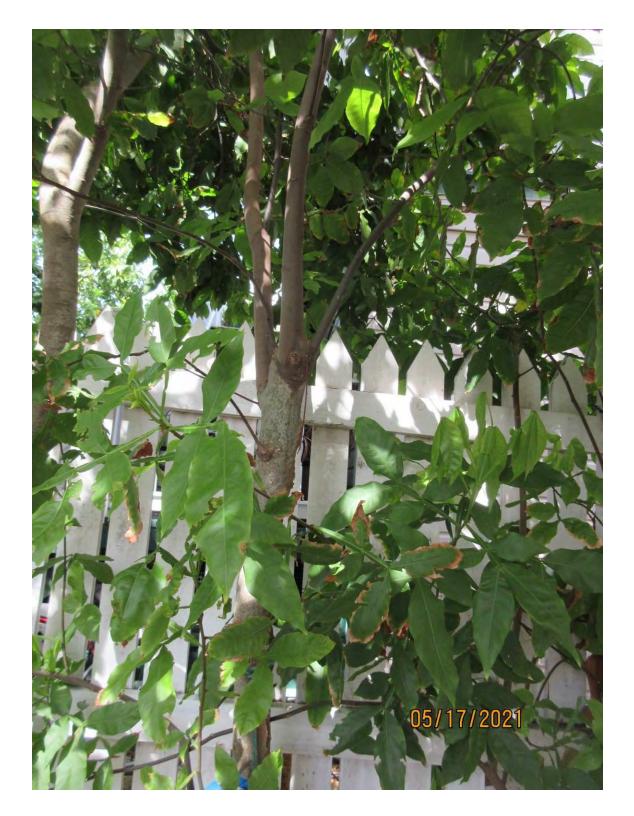
Tree #7-Diameter: 3.1"

Location: 40% (growing at base of fence/property line in root zone with

other trees, competing canopies)

Condition: 40% (Poor condition, top of trunk cut-resprouts)

Total Average Value = 60%

Value x Diameter = 1.8 replacement caliper inches

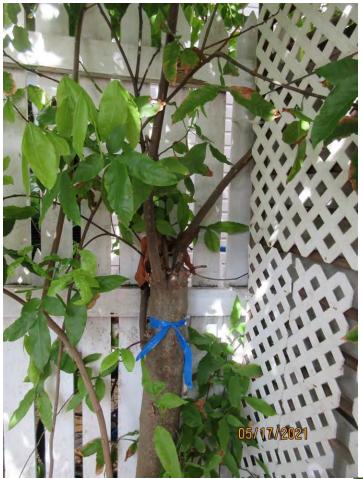
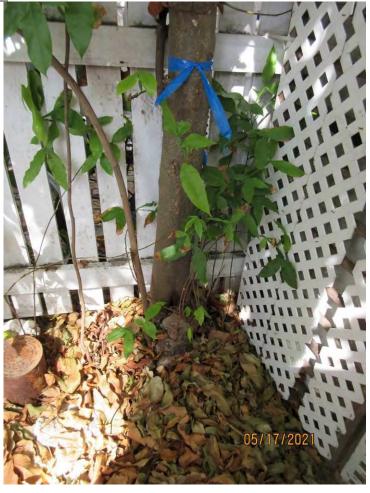
Tree #8-Photo showing top of tree trunk (4 ft from ground)

Photo showing base of tree.

Tree #8-Diameter: 2" (measured 4.5 ft from ground)

Location: 40% (growing at base of fence/property line in root zone with

other trees)

Condition: 40% (top of tree trunk cut, resprouts)

Total Average Value = 60%

Value x Diameter = 1.2 replacement caliper inches

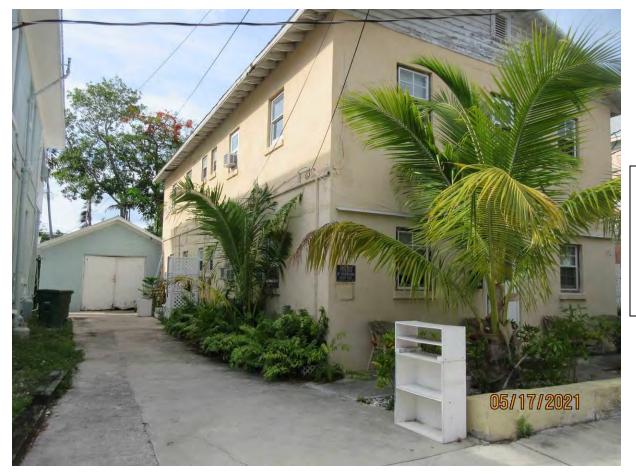
Photo showing old driveway between 322 and 324 Truman. Coconut Palm on side of building to be removed.

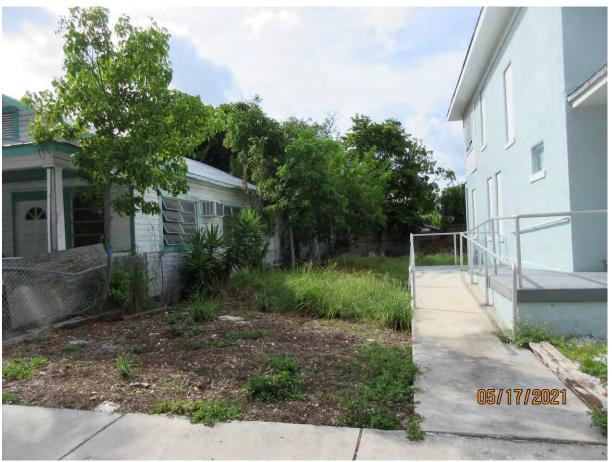
Photo of the side lot next to 324
Truman
Avenue.
Tree #1 and #2 to be removed are located in the area.

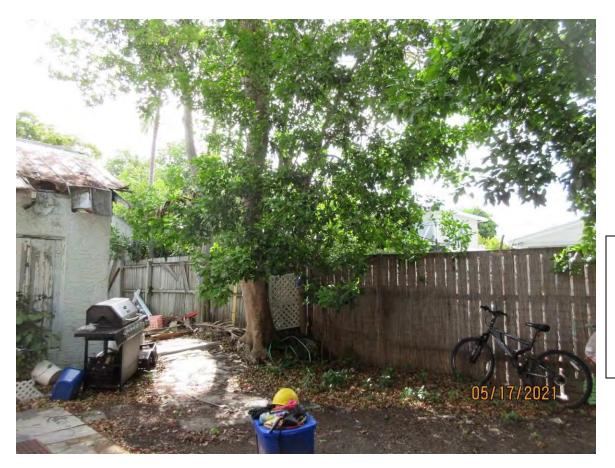
Photo of rear property line behind 322 Truman. Photo shows Tree #3 an #4 to be removed and Royal Poinciana tree to remain.

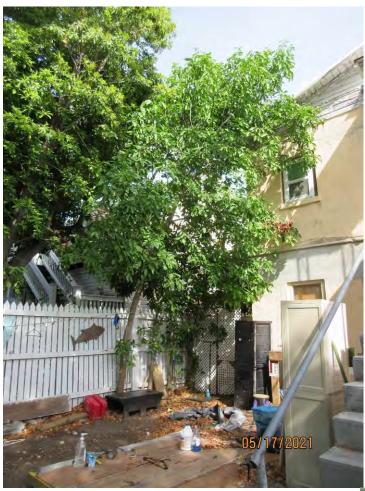
Photo showing side property line of 322 Truman Avenue with 320. Root zone of neighboring large Sapodilla tree is partially in fence area.
