TREE COMMISSION TREE REMOVAL REPORT
CITY of KEY WEST

PROPERTY: 914 Grinnell St.

APPLICATION NUMBER: T2025-0197

REQUEST: Property owner is seeking Tree Commission approval to remove
(1) Avocado Tree

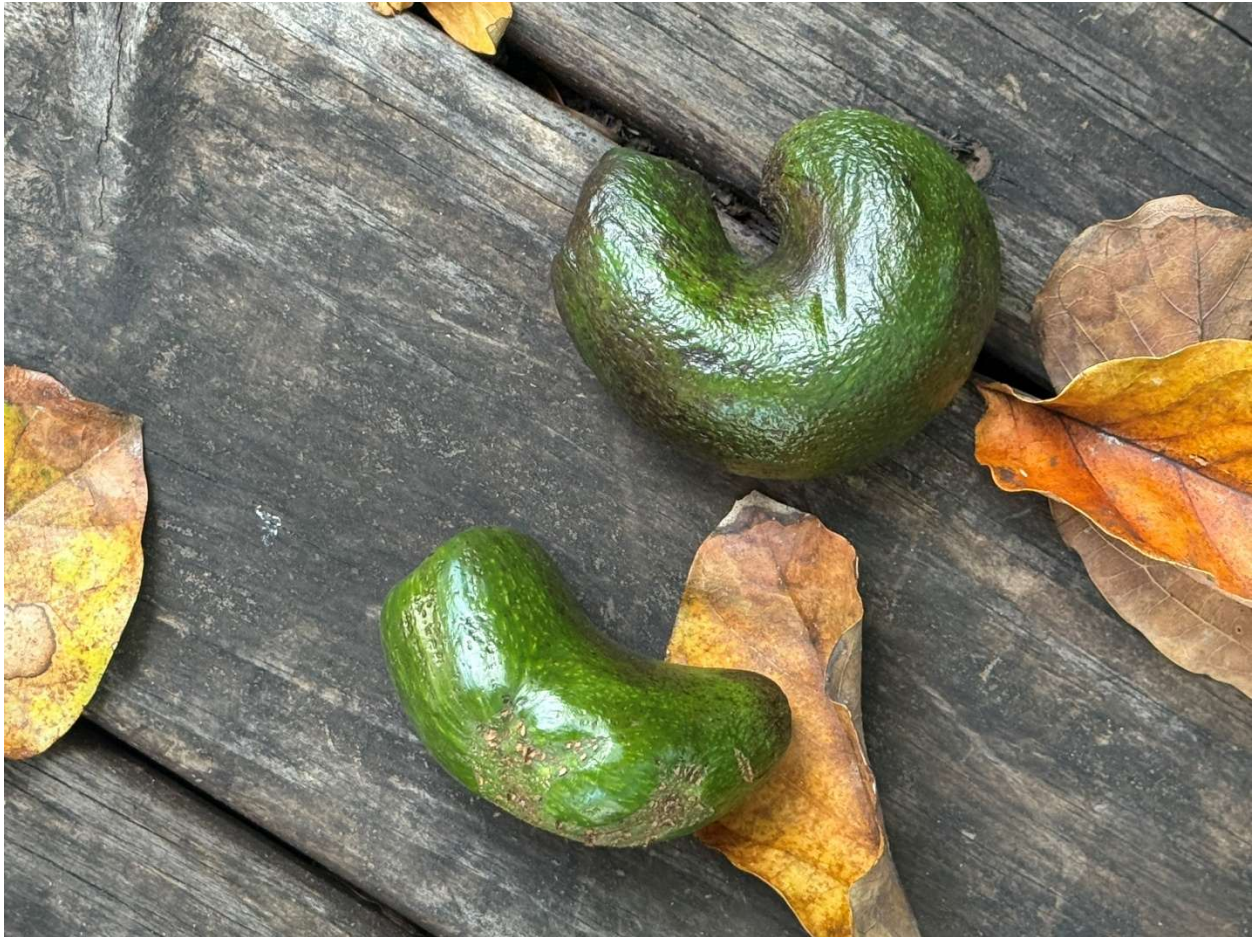
All the fruit on the ground and on the tree is severely stunted and or curved. This is a
sign of stress.

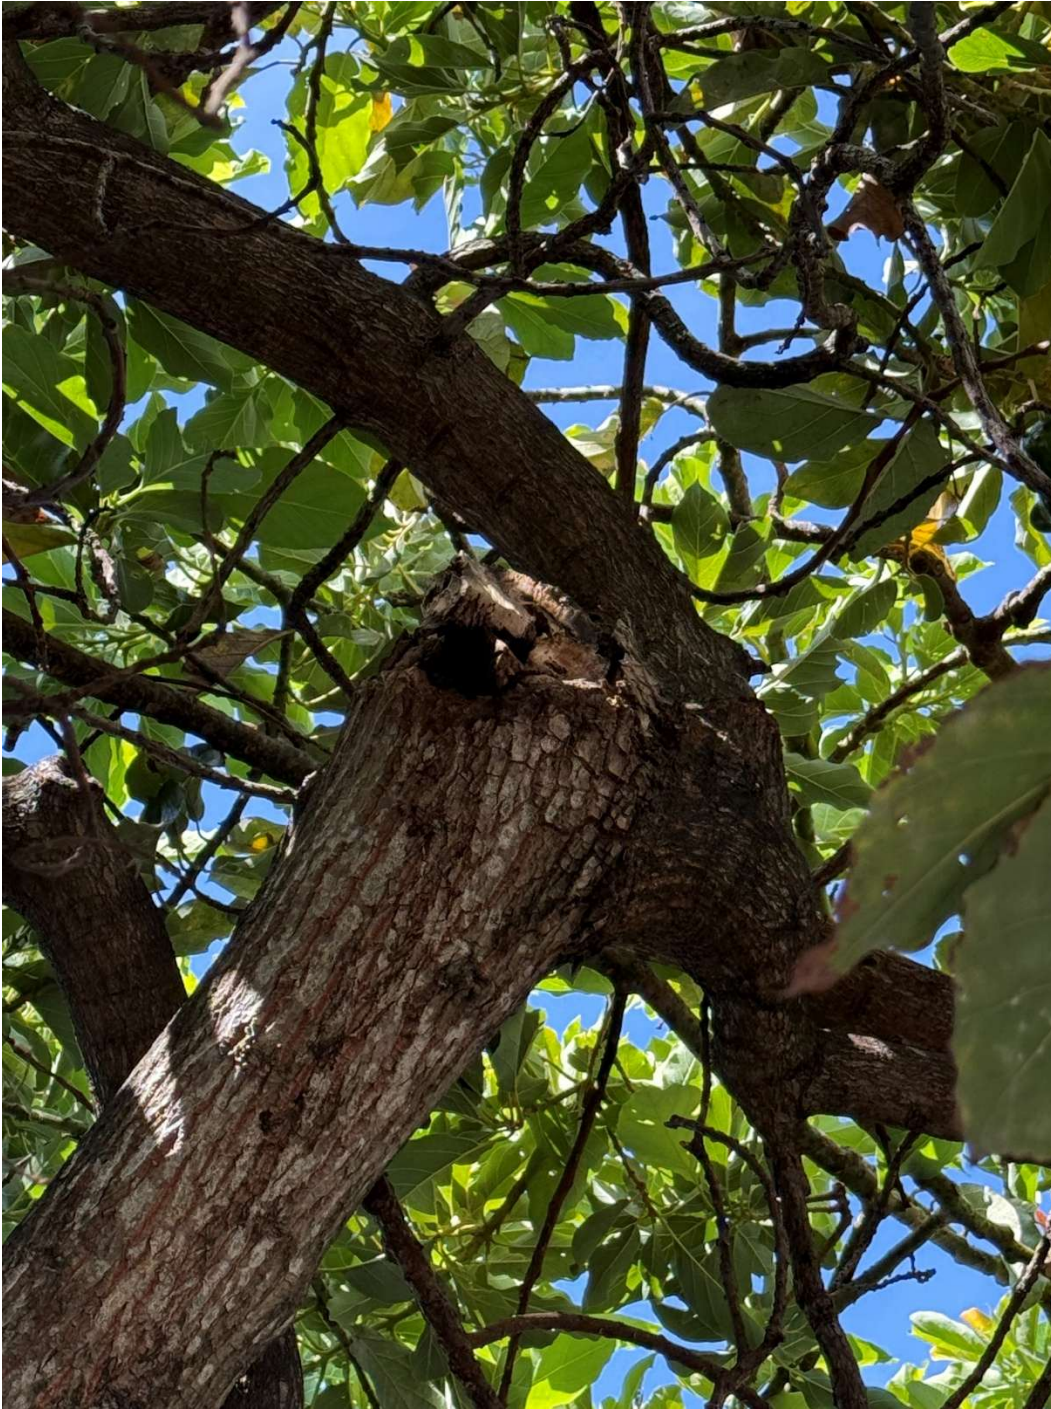
A junction where the tree has been hollowed out possibly by termites.

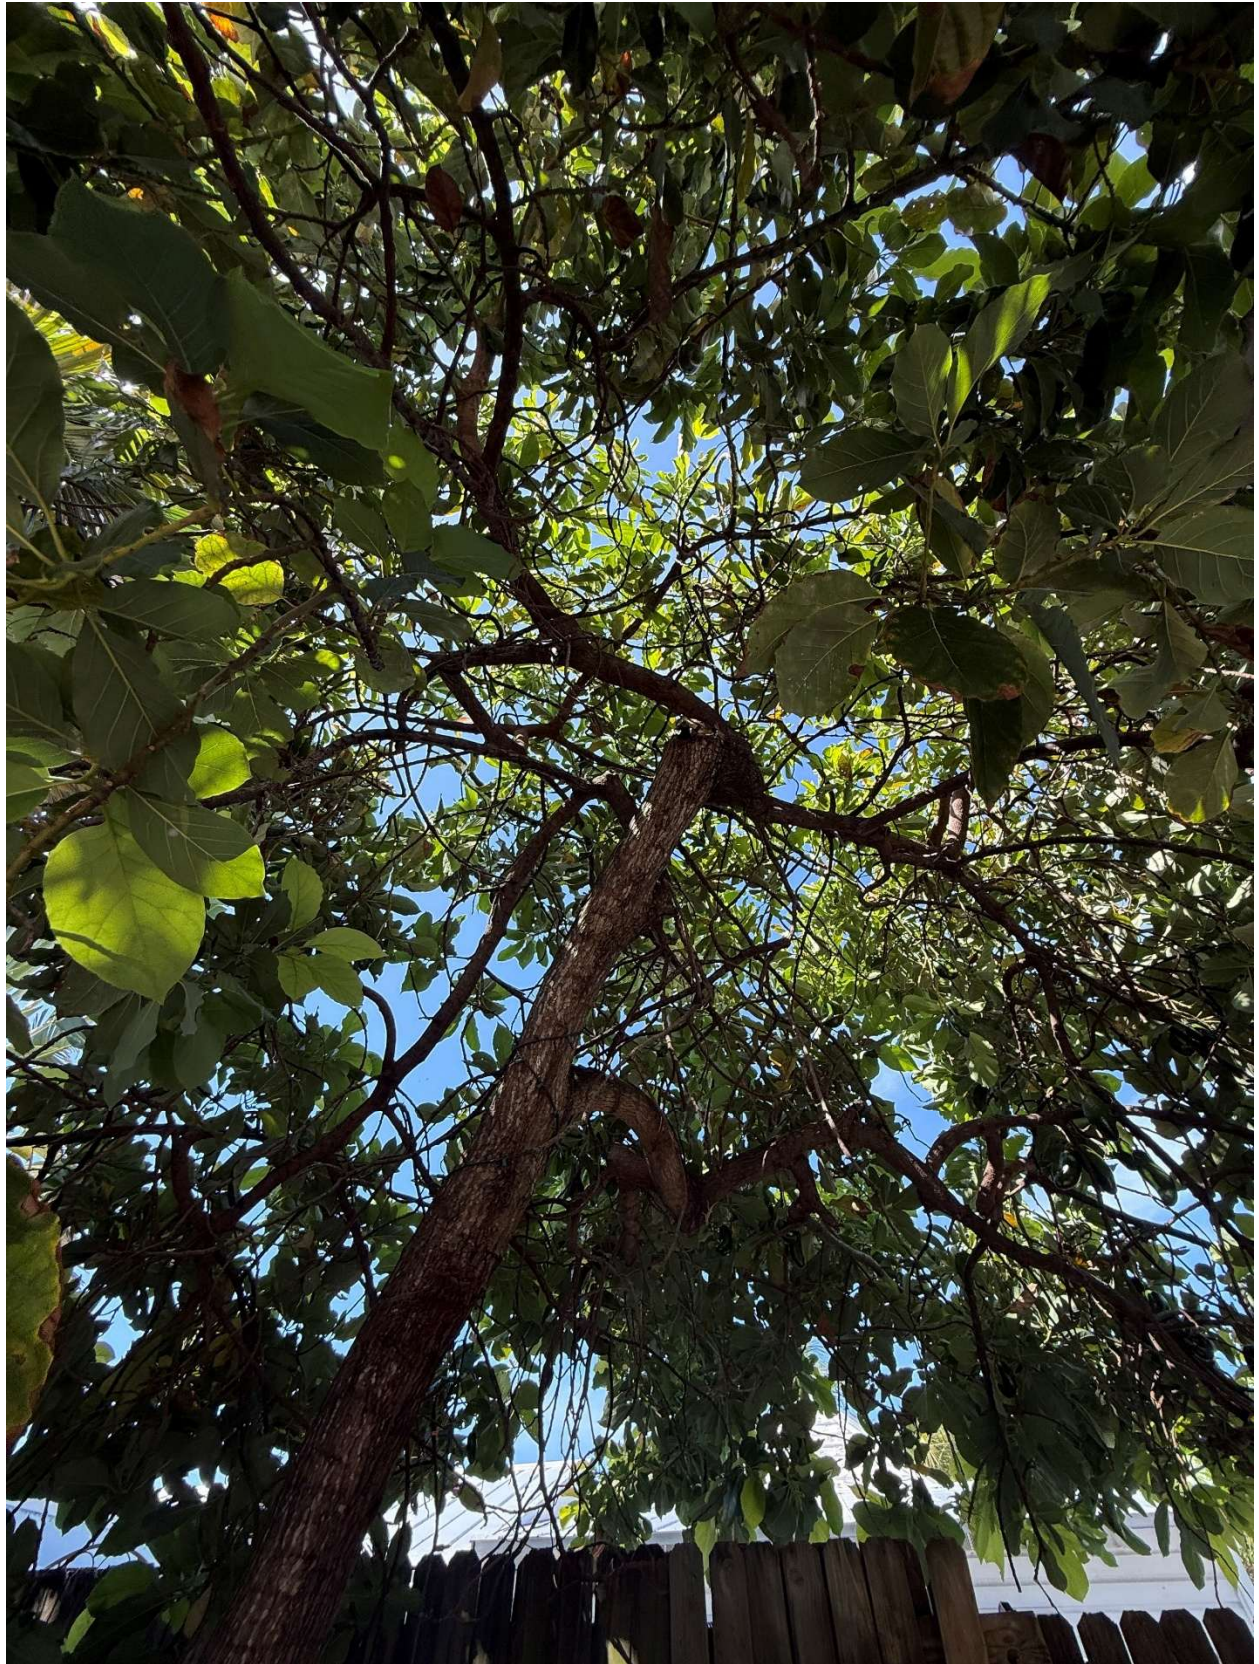
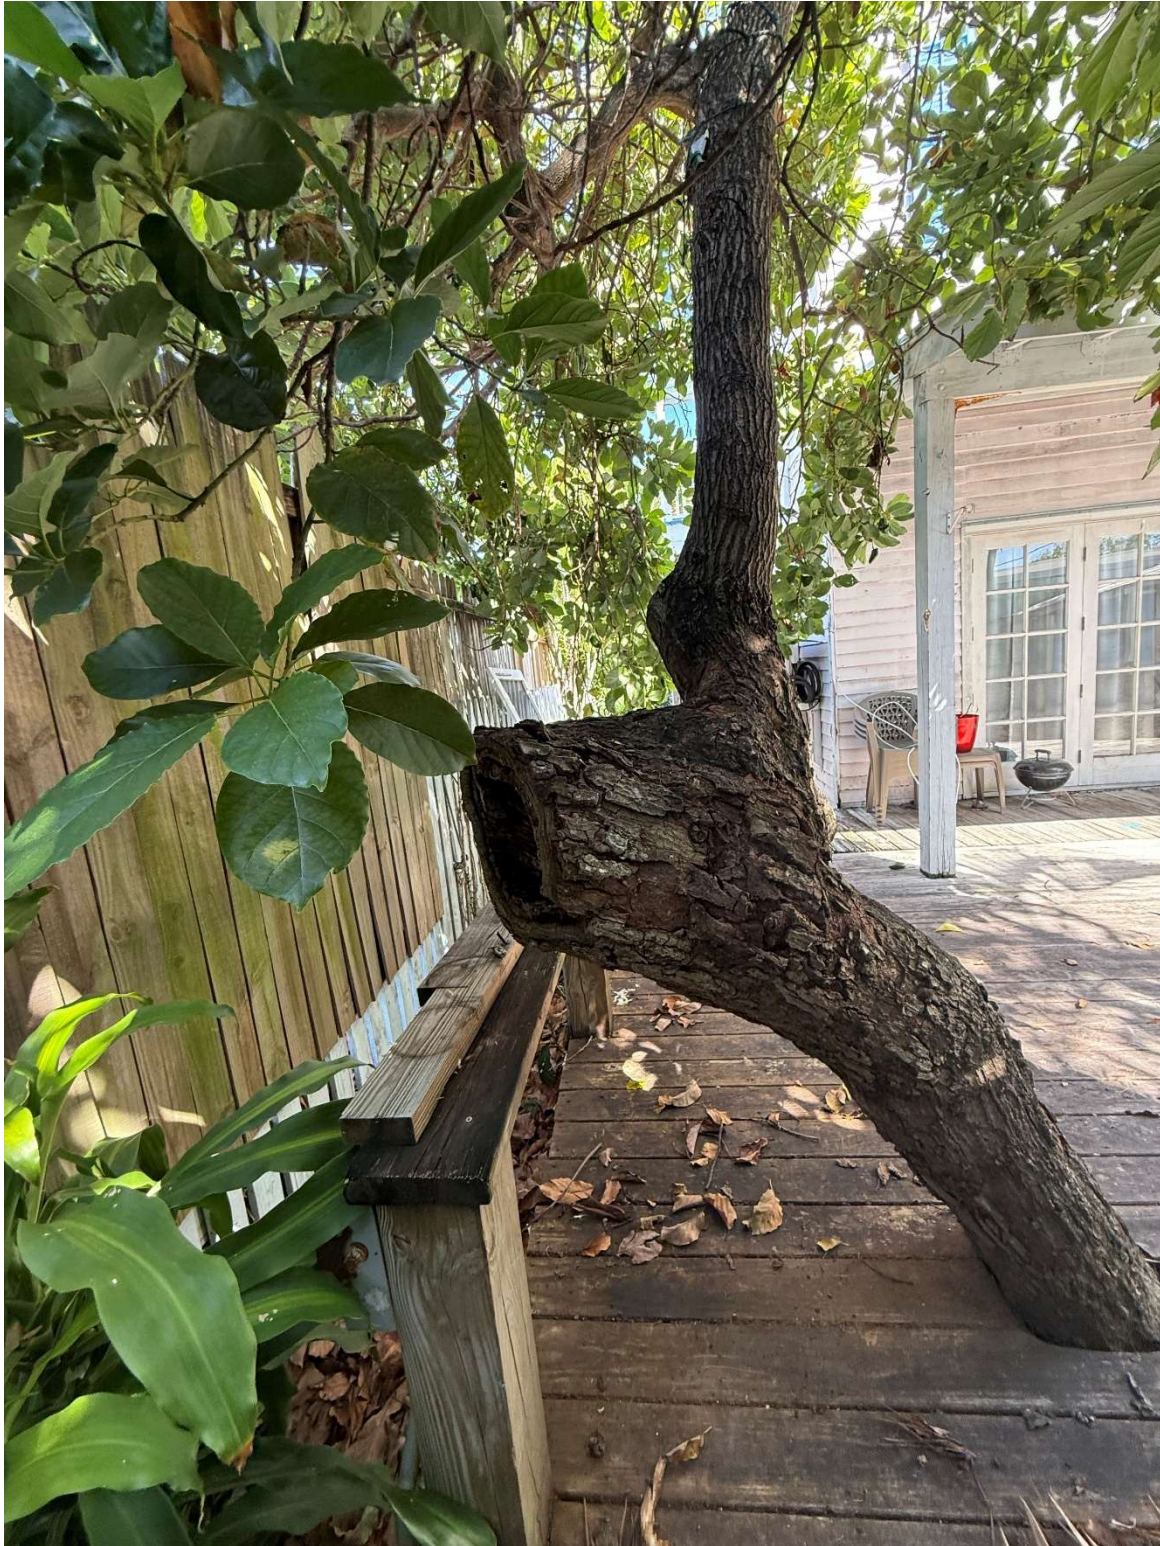
The main trunk has a large hole which was likely caused by termites. Hard to know the order in which the tree suffered various issues. What is certain is that the tree has had a rough go of it.

RECOMMENDATION/NOTES: The tree has visible issues which give merit to an application for removal and mitigation.

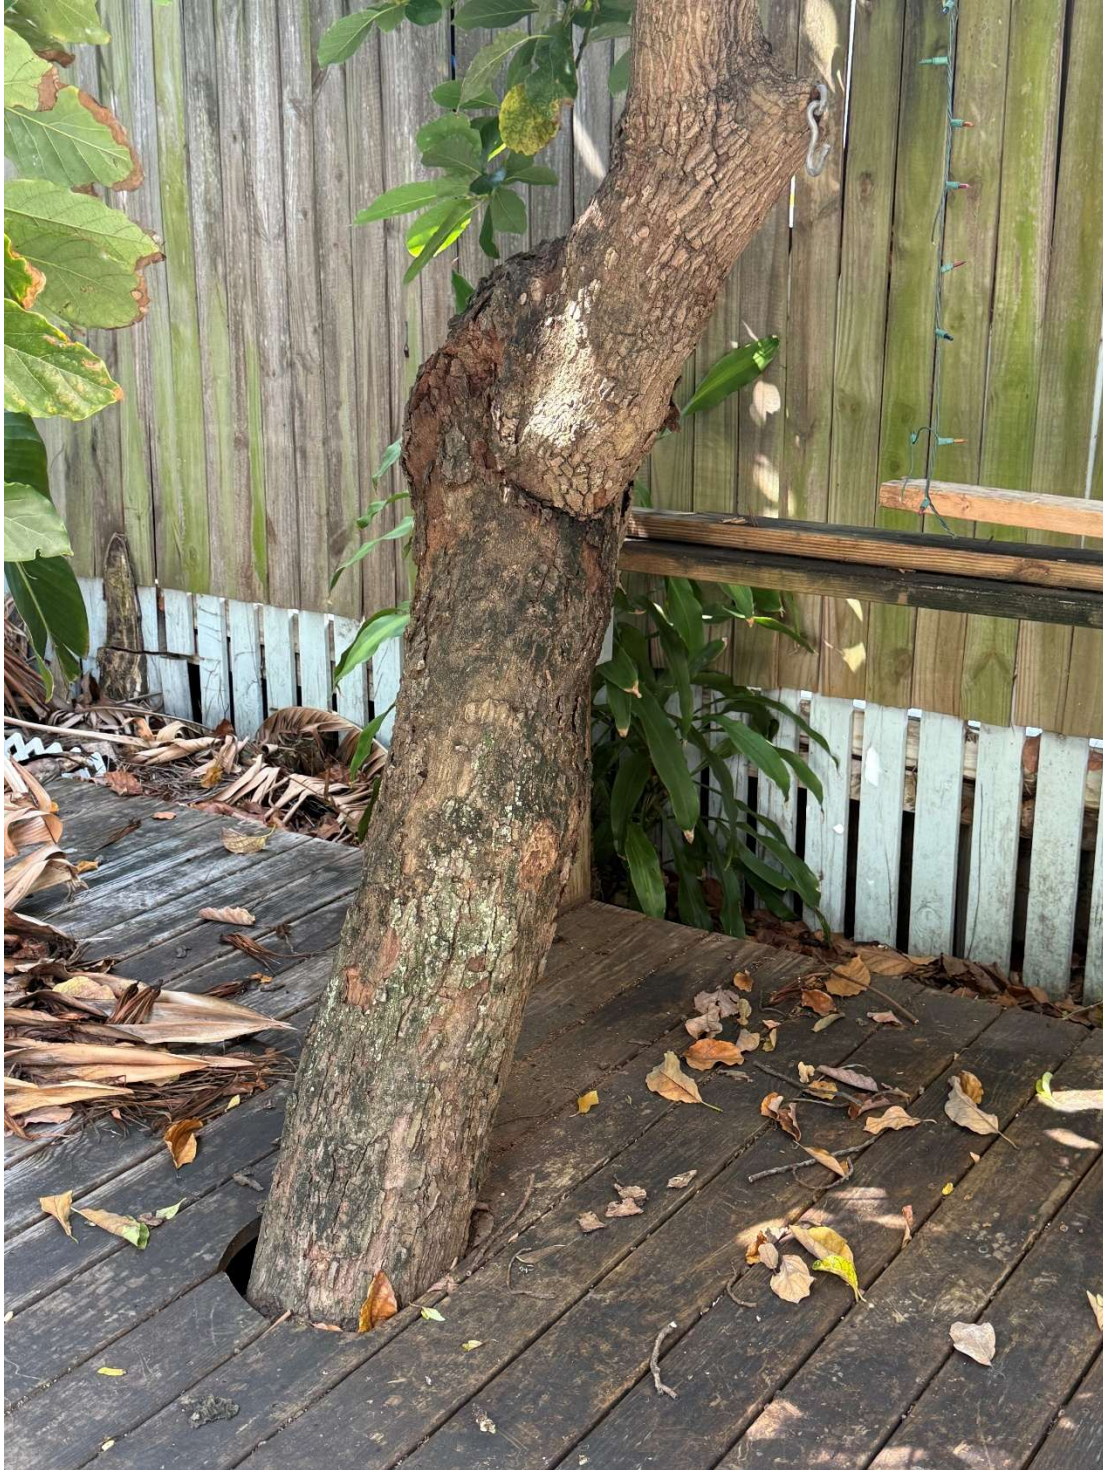
He trunk is discolored and likely harboring unhealthy bacteria. The underlying cause is not clear, but the overall health of the tree is questionable.

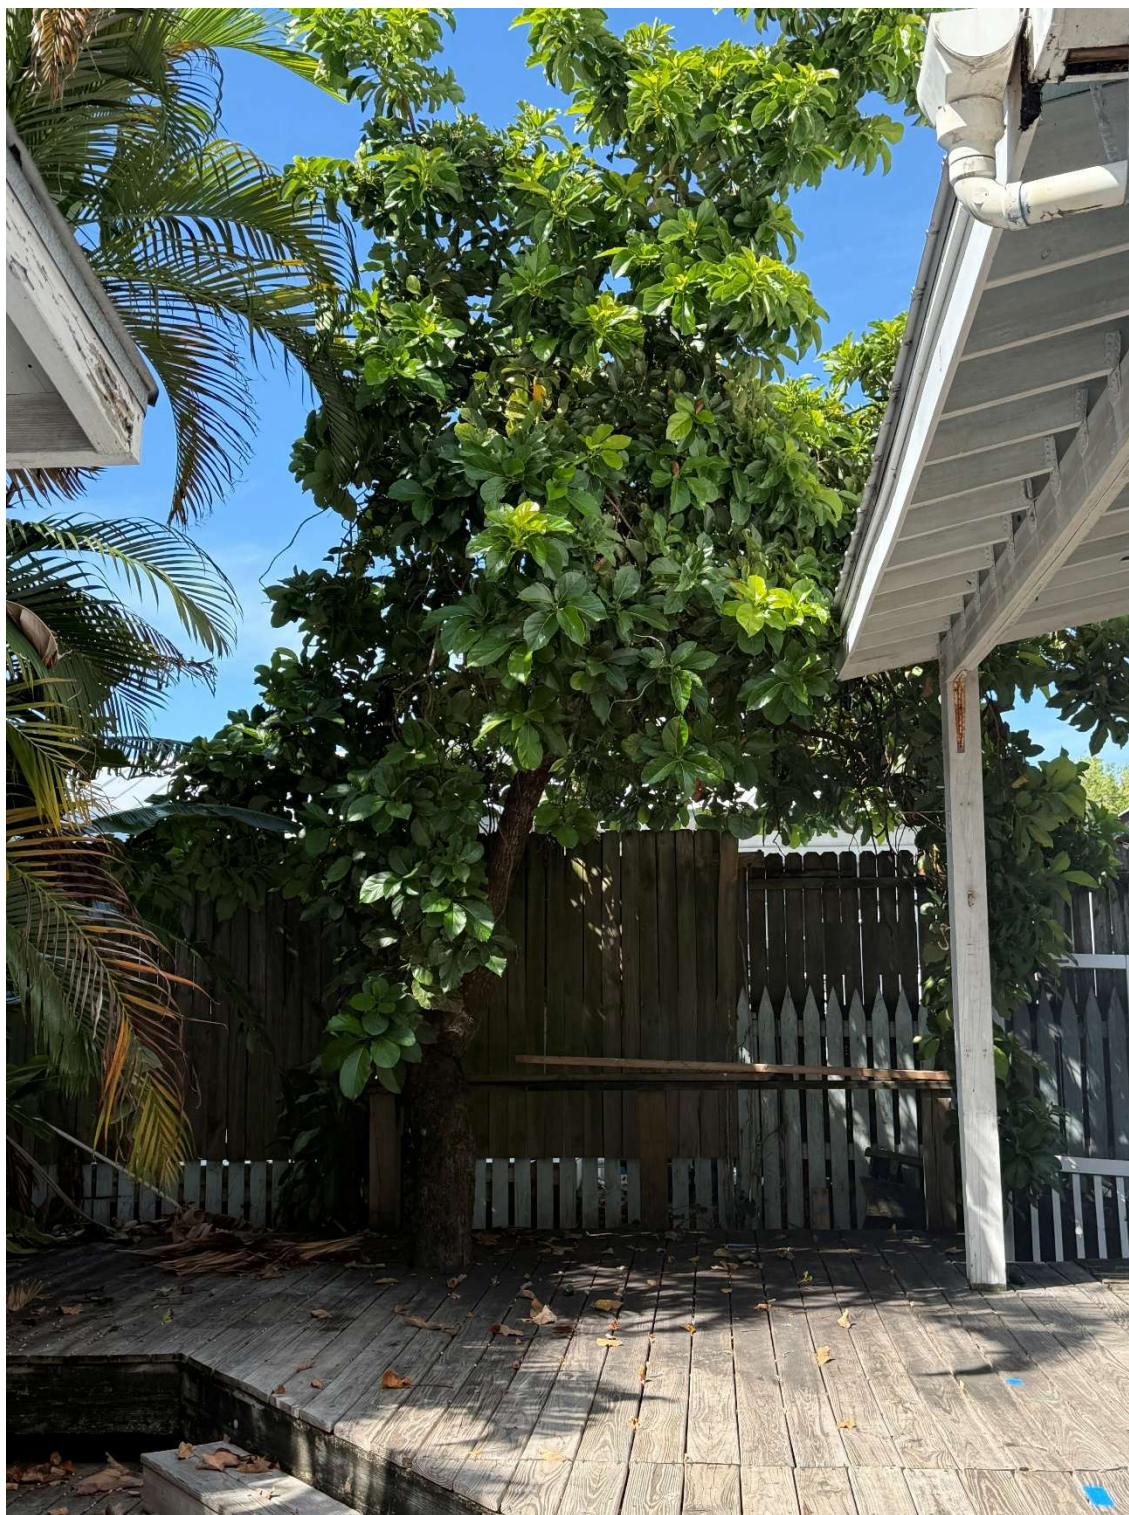
The canopy is in fair shape.
