**TREE COMMISSION TREE REMOVAL REPORT  
CITY of KEY WEST**

**PROPERTY: 729 Truman Ave**

**APPLICATION NUMBER: T2026-0102**

**REQUEST: The applicant is requesting removal of (1) Gumbo Limbo & (1) Poinciana tree.**

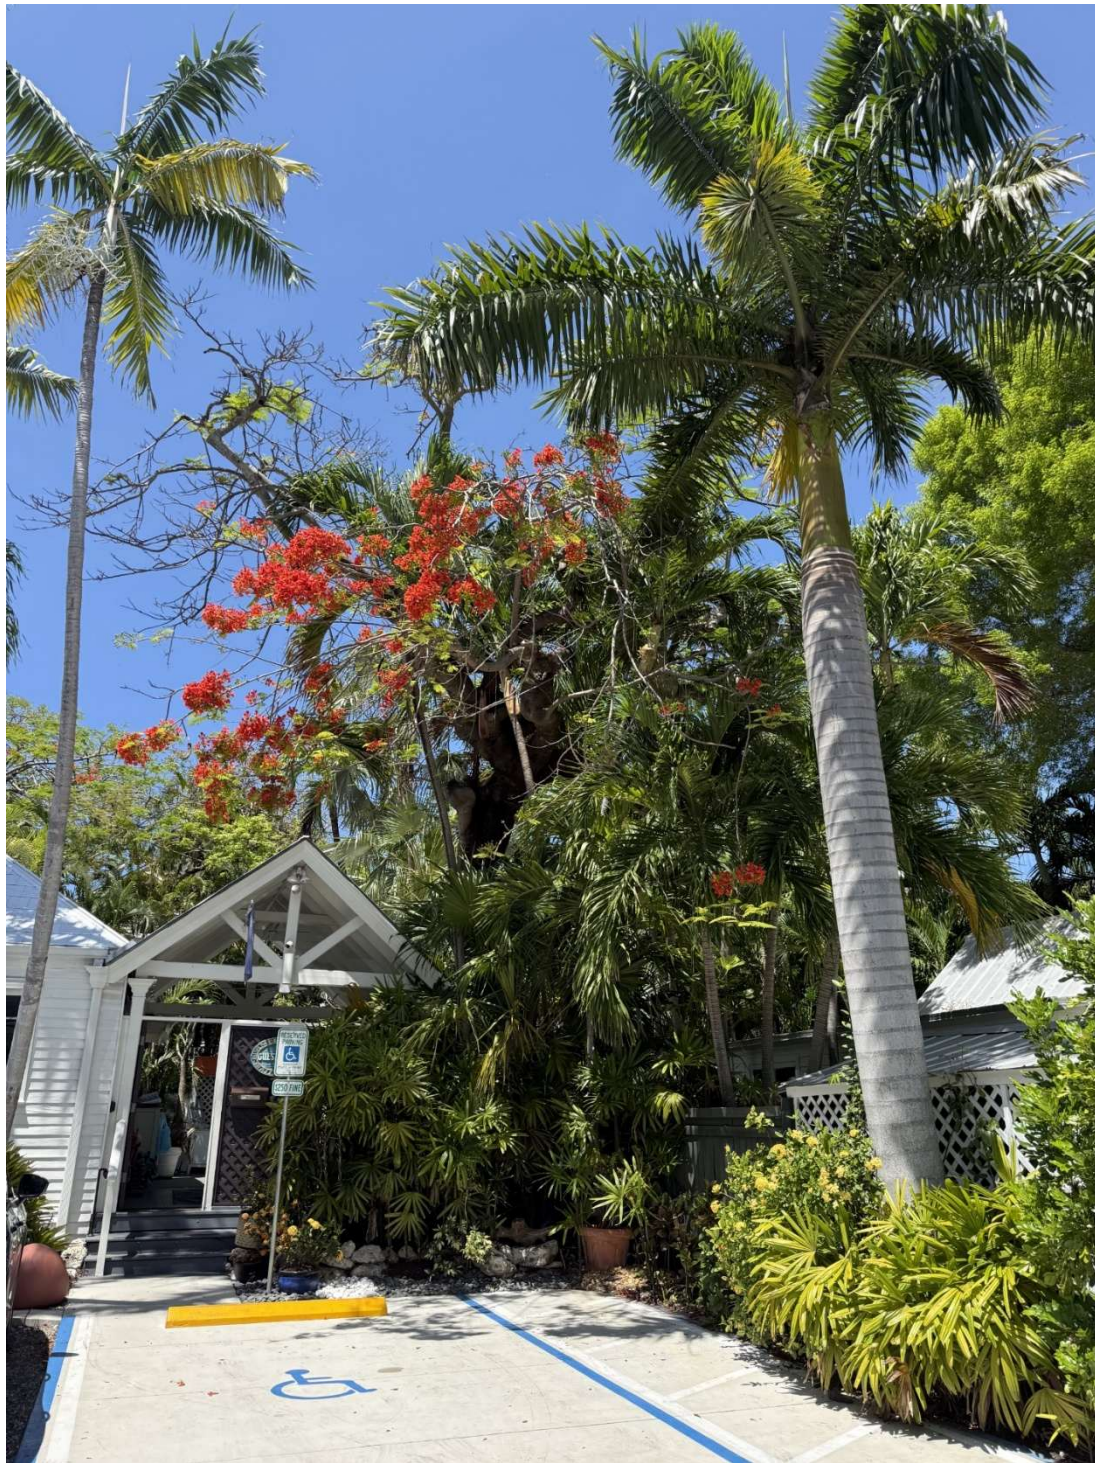
**Poinciana has very little canopy especially for a 28" trunk.**

**The subject tree #2 is a 28-inch DBH Royal Poinciana growing immediately adjacent to a permitted covered deck structure. The base of the trunk is in direct proximity to the deck, nearly contacting the structure, while the main stem at approximately eight feet in height is actively growing into and against the roof system. This ongoing conflict is not only causing physical damage to the roof structure, but is also resulting in abrasion and compression against the tree itself, with the structure beginning to intrude into the bark and cambial layer of the stem. The location of the tree relative to the structure is highly constrained and incompatible with the mature size and growth habit of the species.**

The tree exhibits numerous large historical pruning wounds throughout the canopy and scaffold structure. Nearly all observed pruning cuts display varying degrees of hollowing, decay, and likely infestation. In the local environment of Key West, Royal Poinciana trees commonly demonstrate poor compartmentalization of large pruning wounds, even when cuts are performed in accordance with accepted arboricultural standards and best management practices. As a result, large pruning wounds frequently become long-term points of structural weakness and decay development. The subject tree presently exhibits poor canopy architecture, compromised structure, and overall diminished vitality.

Based upon the structural conflicts with the permitted structure, the extensive decay associated with prior pruning wounds, and the poor overall form and canopy condition, the condition rating of this Royal Poinciana is estimated at no greater than 50%. Given the current defects and ongoing structural impacts to both the tree and adjacent improvements, removal of the tree is worthy of consideration by the Tree Commission.

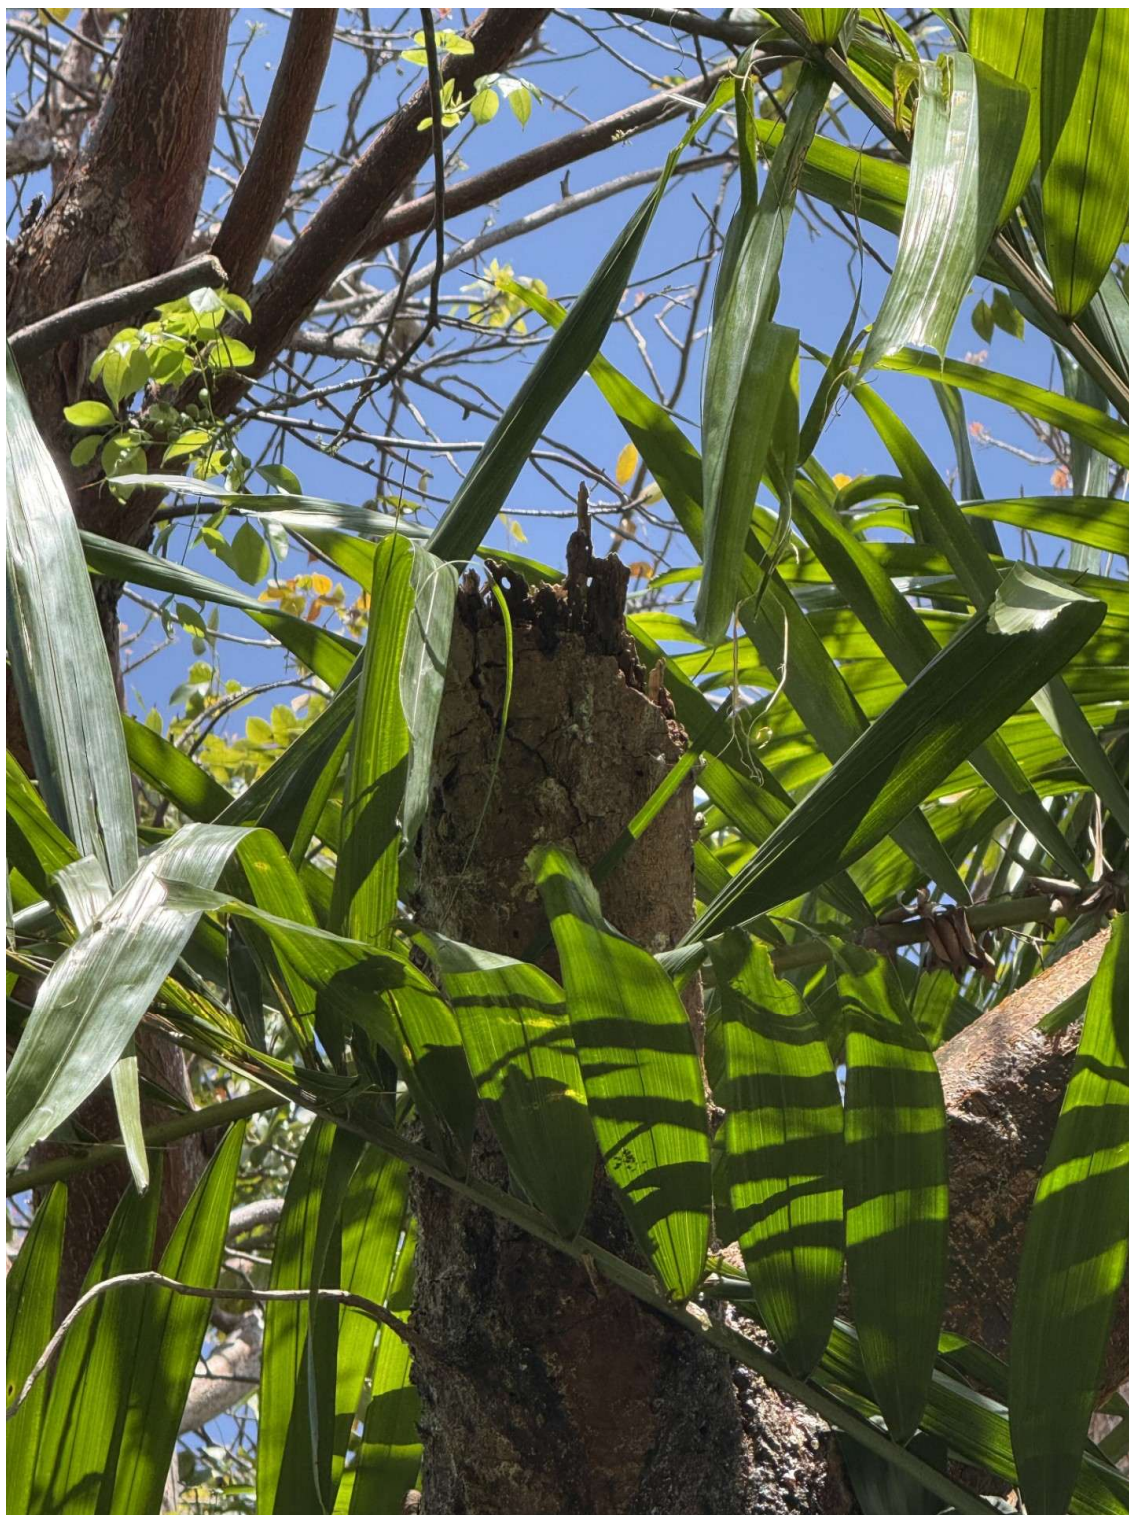
**Gumbo Limbo broken branch**

**The subject tree #1 is a 15-inch DBH Gumbo Limbo tree located on a transient lodging property, growing in close proximity to other mature canopy trees, including another mature Gumbo Limbo less than two feet away. The tree exhibits significant structural and physiological deficiencies which adversely affect both its condition and long-term viability. A pronounced split is present near the base of the trunk, creating openings that are likely facilitating internal infestation and decay. Evidence of chronic stress and internal dysfunction is further**

**demonstrated by the presence of dark and white exudates emerging from the crack, indicative of bacterial activity, decay organisms, or other pathological issues within the trunk structure.**

**The canopy exhibits sparse foliage and poor architectural form, lacking the density and vigor expected of a healthy specimen. Numerous large branches have previously failed or been improperly pruned, leaving behind substantial exposed heartwood and open wounds that have not compartmentalized effectively. These areas now display advanced decay and are likely contributing to continued structural degradation and potential insect infestation. The overall structure of the tree is compromised, and in its current condition, the specimen is approaching the threshold at which emergency mitigation or removal could become necessary.**

**Based upon the observed defects, poor canopy vitality, structural instability, and evidence of ongoing decay, the condition rating of this tree is estimated at no greater than 40%. Given the extent of the defects present and the elevated likelihood of future failure, removal of the tree is worthy of serious consideration by the Tree Commission.**
