Tree Permit Application

EXISTING TREE REPORT and ASSESSMENT

CITY of KEY WEST

PROPERTY: 1621, 1622, and 1623 Spalding Court

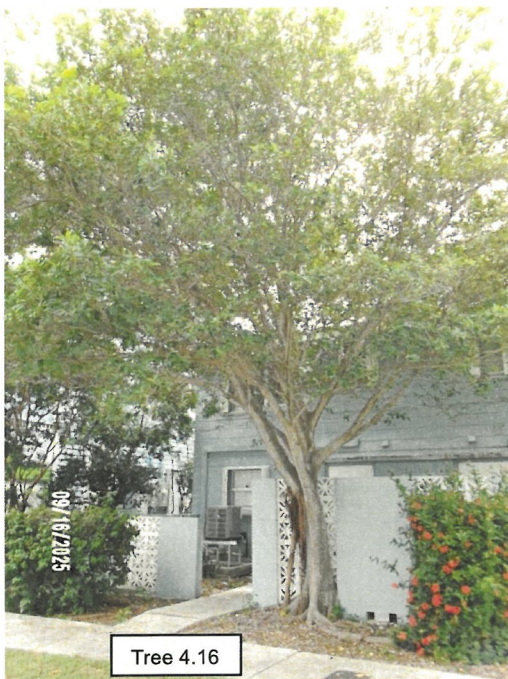
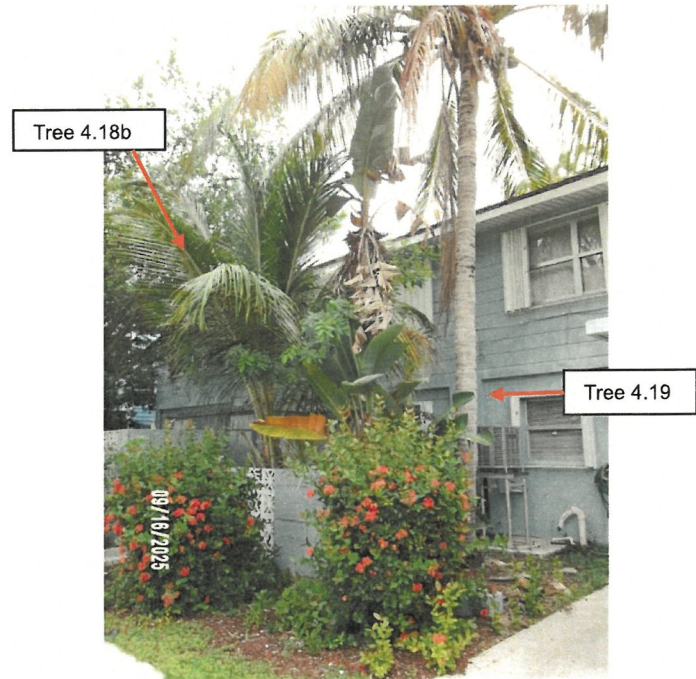
Tree 4.16: Strangler Fig (*Ficus aurea*)

Diameter: 15.6" dbh

Condition: 60% (fair)

Location: 50% (growing immediately against concrete privacy wall, very visible tree)

Approximated Tree Value: 70%

Potential Required Mitigation: 10.9 caliper inches

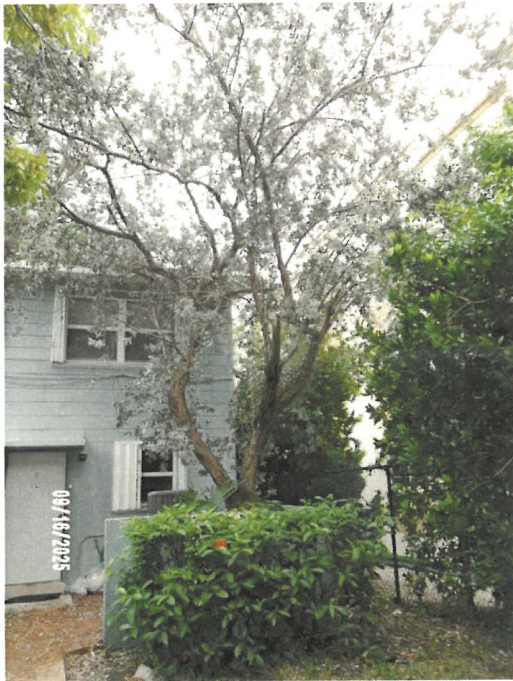
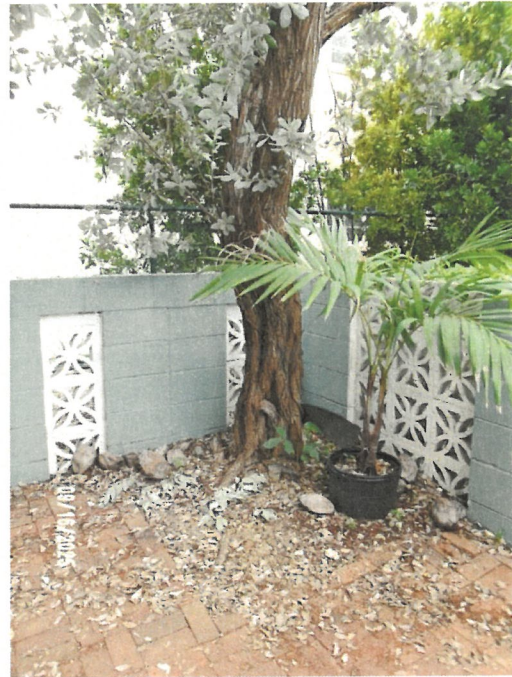
Tree 4.25

Tree 4.25: Silver Buttonwood (*Conocarpus erectus sericeus*)

Diameter: 14.3" dbh

Condition: 50% (fair to poor, some decay from breaks and poor cuts in canopy)

Location: 60% (growing in corner of porch concrete wall, very visible tree)

Potential Required Mitigation: 10 caliper inches

4.25	Silver Buttonwood	Conocarpus erectus var. sericeus	14.3" dbh	Fair to Poor	Protected	Remove	some decay from breaks/poor cuts in canopy, growing in front of bldg 1621

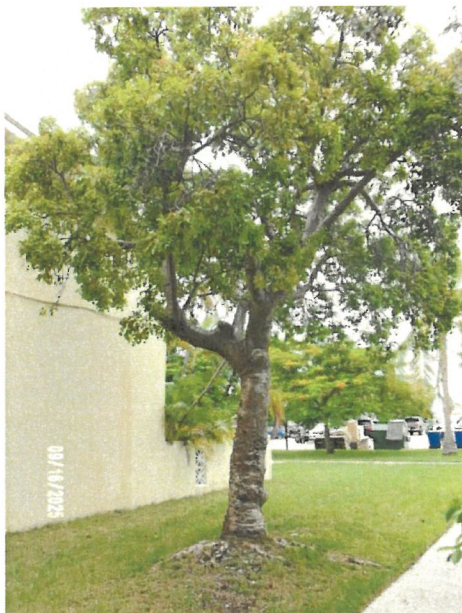
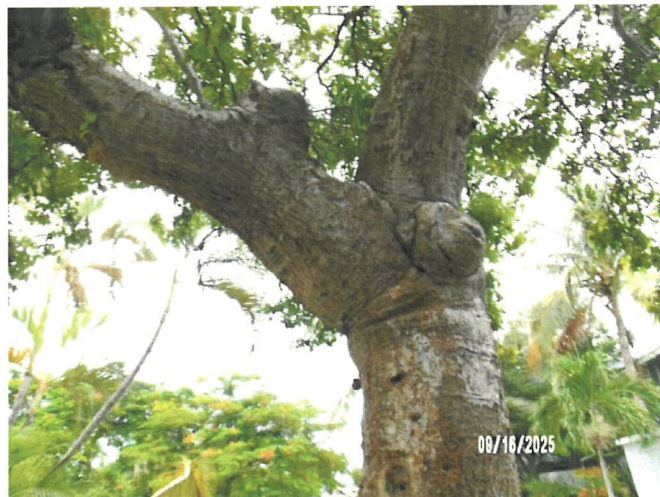
Tree 4.26

Tree 4.26: Gumbo Limbo (*Bursera simaruba*)

Diameter: 16.8" dbh

Condition: 40% (poor, north limb damaged, gummosis in trunk)

Location: 80% (growing in open space area between two buildings, very visible tree)

Potential Required Mitigation: 12.2 caliper inches

4.26	Gumbo Limbo	Bursera simaruba	16.8" dbh	Poor	Protected	Remove	North limb damaged, gummosis, growing between bldgs 1621 & 1622
4.27a	Coconut Palm	Cocos nucifera	>10 ft CT	Fair	Protected	Remove	growing behind bldg 1621

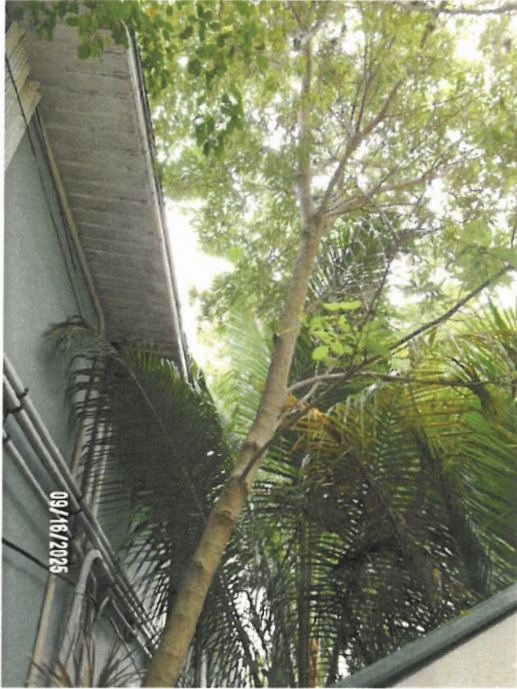
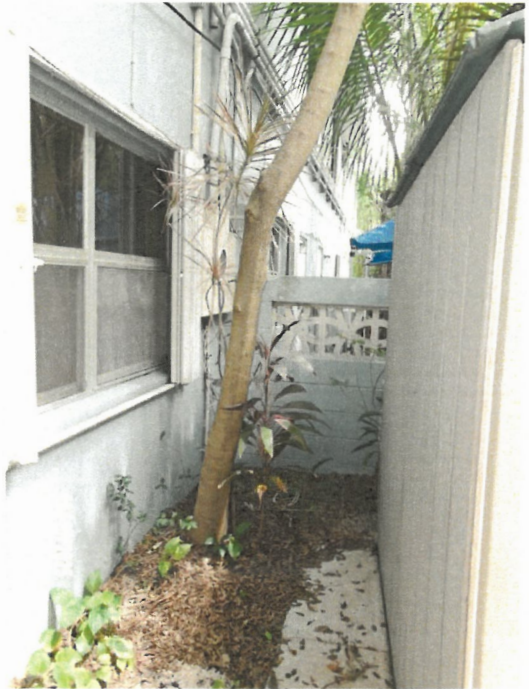
Tree 4.31a

Tree 4.31a: Jamaican Dogwood (*Piscidia piscipula*)

Diameter: est 5" dbh (need access to yard and tree for actual measurement)

Condition: 40% (poor, elongated trunk structure with growth lean due to close, existing structure)

Location: 30% (growing close to structure-no room for future growth)

Potential Required Mitigation: 2.8 caliper inches

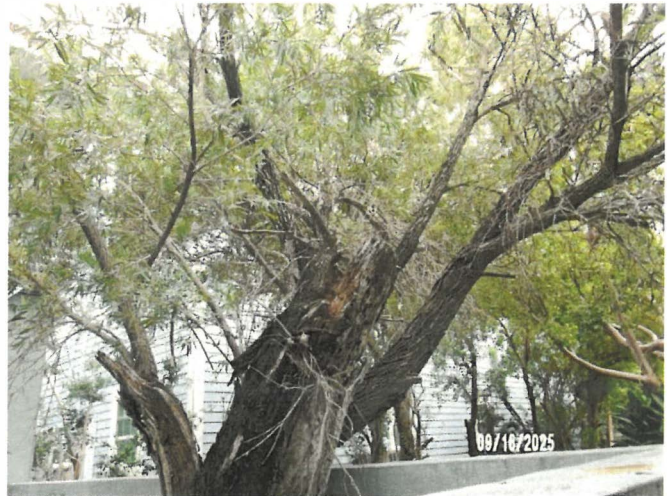
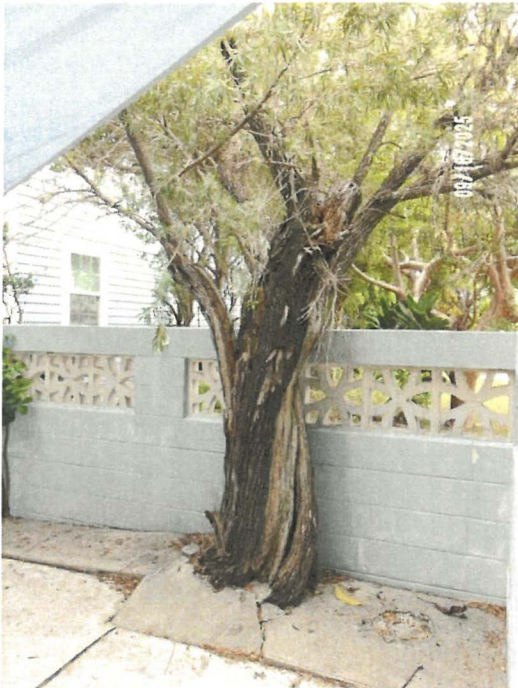
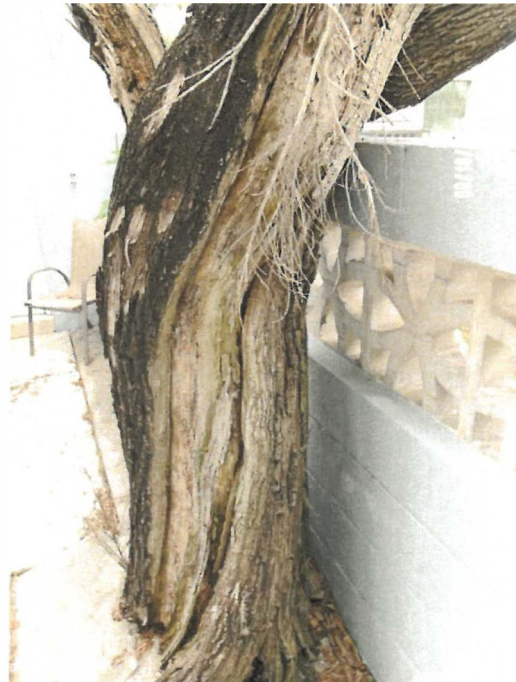
Tree 4.37

Tree 4.37: Bottlebrush (*Callistemon citrinus*)

Diameter: **est 20" dbh (need access to yard and tree for actual measurement)**

Condition: 30% (poor, major trunk decay, root system encased in concrete)

Location: 40% **BM/ZB**(back yard tree growing against concrete porch wall)

Potential Required Mitigation: 8"

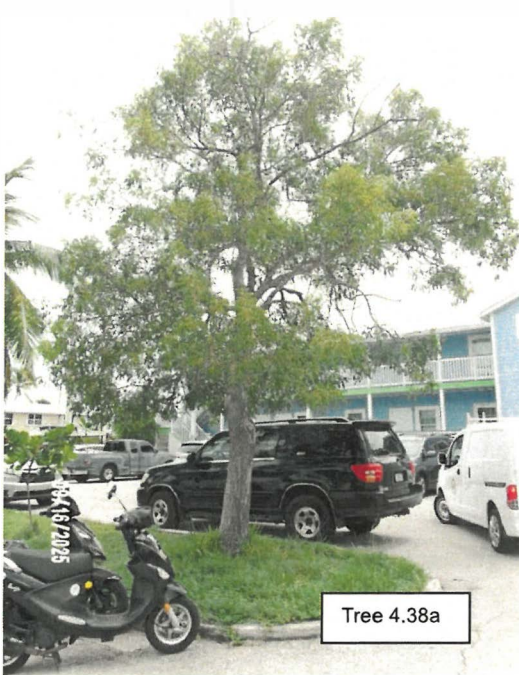
Tree 4.38a

Tree 4.38a: Mahogany (*Swietenia mahagoni*)

Diameter: 11.7 dbh

Condition: 50% **BM/ZB**(fair, some dieback in canopy)

Location: 70% **BM/ZB** (growing in parking lot planter-very visible) Species: 100% (on City of KW protected tree list) Approximated Tree Value: 80%

Potential Required Mitigation: 8.6 caliper inches

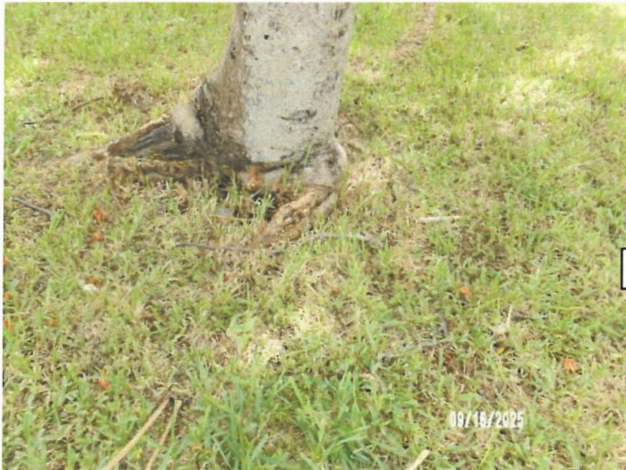
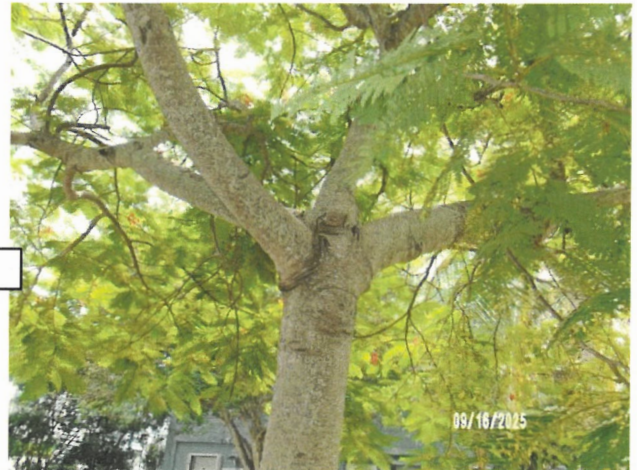
Tree 4.44

Tree 4.44: Royal Poinciana (*Delonix regia*)
 Diameter: 10.8" dbh
 Condition: 50% (fair to poor, poor base structure-circling roots, fair health and canopy structure)
 Location: 90% (growing in open yard area-very visible tree)
 Species: 100% (on City of KW protected tree list)
 Approximated Tree Value: 80%
 Potential Required Mitigation: 8.6 caliper inches

4.44	Royal Poinciana	Delonix regia	10.8" dbh	Poor	Protected	Remove	lawn in front of bldg 1622, circling roots
4.45	Royal Poinciana	Delonix regia	15.9" dbh	Fair	Protected	Remove	lawn in front of bldg 1622, storm damage in canopy

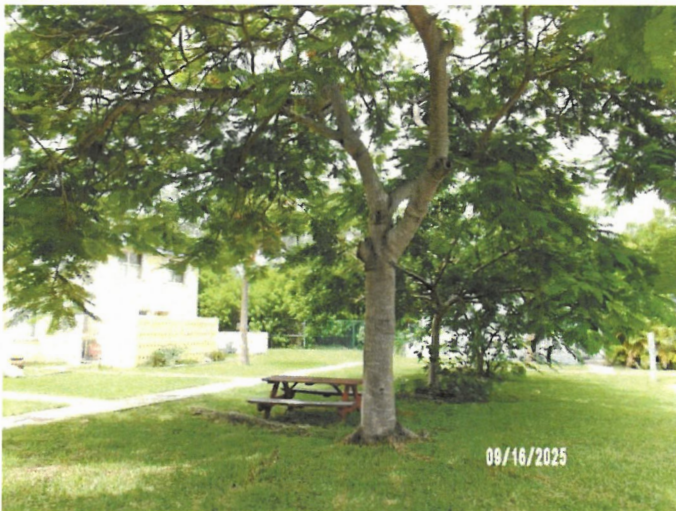
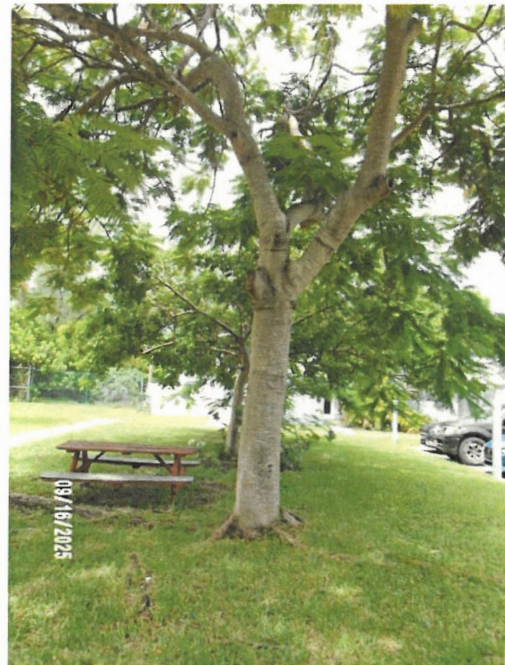
Tree 4.45

Tree 4.45: Royal Poinciana (*Delonix regia*)
 Diameter: 15.9" dbh
 Condition: 60% (overall fair, some old storm damage in canopy, poor canopy structure)
 Location: 90% (growing in open yard area-very visible tree)
 Species: 100% (on City of KW protected tree list)
 Approximated Tree Value: 83%
 Potential Required Mitigation: 13.1 caliper inches

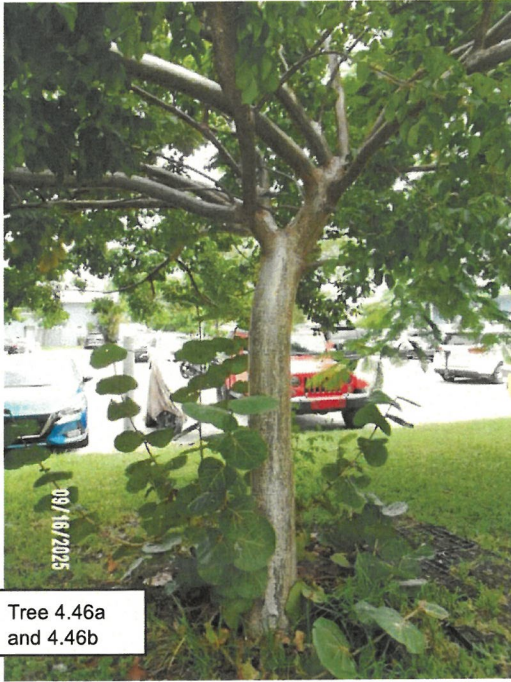
Tree 4.46a
and 4.46b

Tree 4.46a: Gumbo Limbo (*Bursera simaruba*)
 Diameter: 8.9" dbh
 Condition: 60% (Fair overall, good health, poor canopy structure)
 Location: 90% (growing in open yard area-very visible tree)
 Species: 100% (on City of KW protected tree list)
 Approximated Tree Value: 83%
 Potential Required Mitigation: 7.3 caliper inches

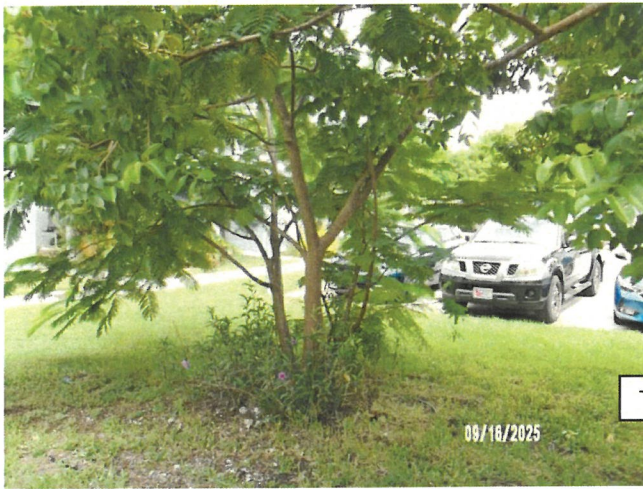
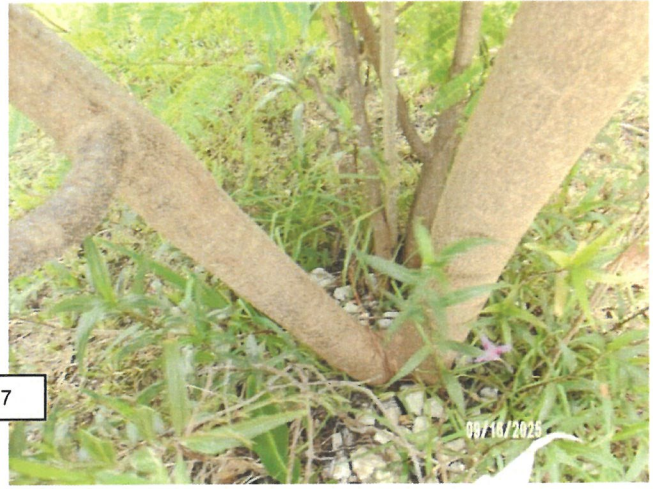
Tree 4.47

Tree 4.47: Royal Poinciana (*Delonix regia*)
 Diameter: 11.7" dbh total (multiple trunks)
 Condition: 50% (fair health, young tree, poor structure)
 Location: 90% (growing in open yard area-very visible tree)
 Species: 100% (on City of KW protected tree list)
 Approximated Tree Value: 80%
 Potential Required Mitigation: 9.3 caliper inches

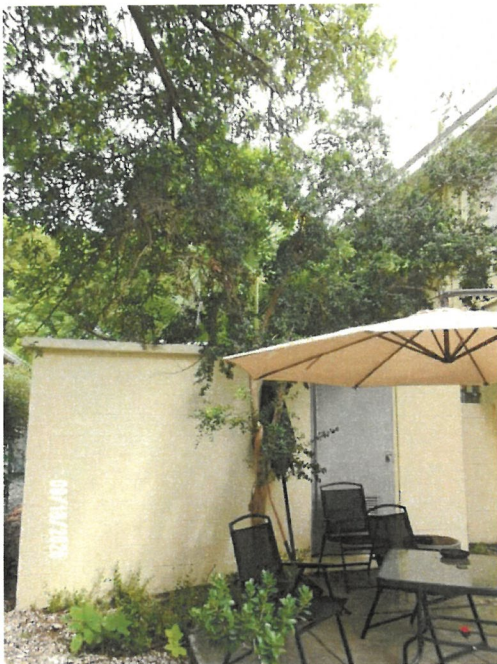
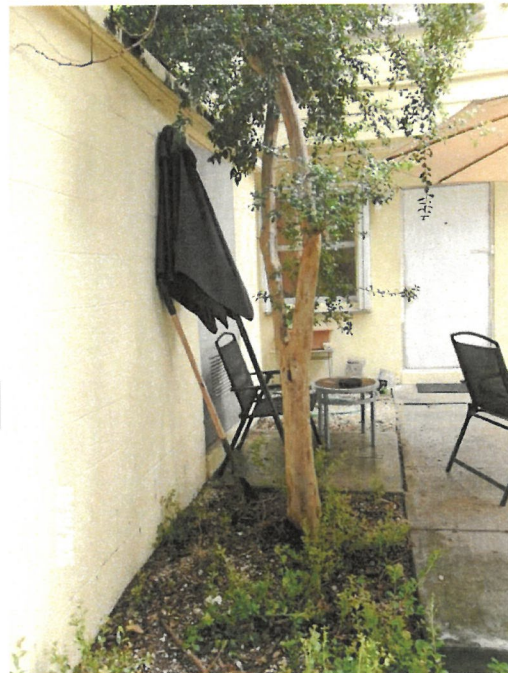
Tree 4.55

Tree 4.55: Simpson Stopper (*Myrcianthes fragans*)

Diameter: 6.3" dbh total

Condition: 60% (fair, two canopy trunks)

Location: 60% (growing behind main building)

Potential Required Mitigation: 3.5 caliper inches

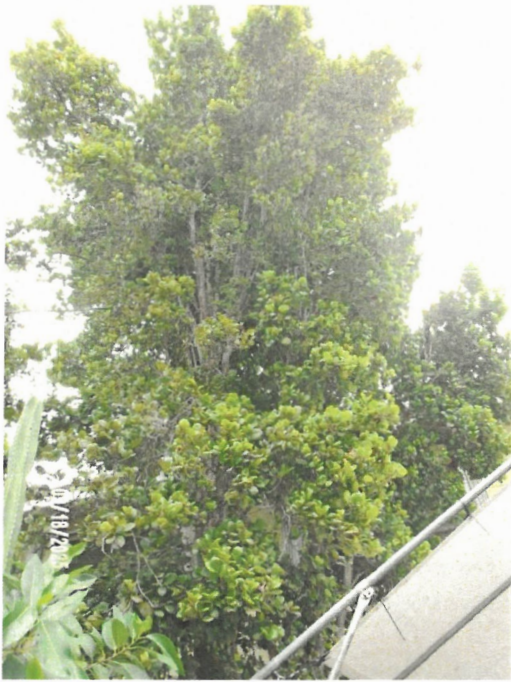
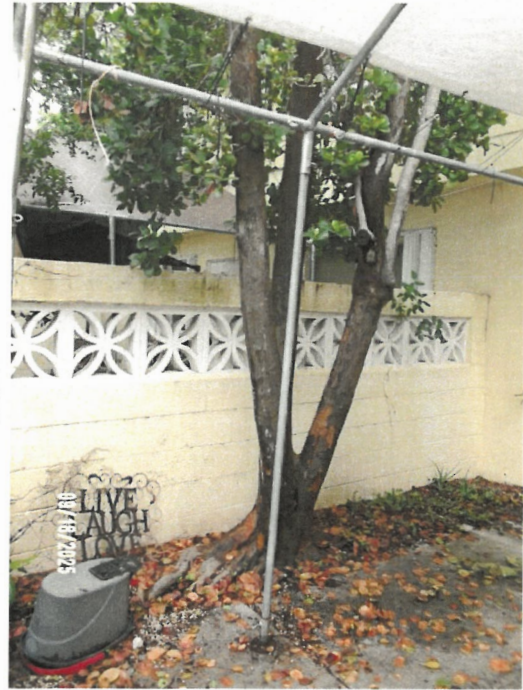
Tree 4.58

Tree 4.58: Pigeon Plum (*Coccoloba diversifolia*)
 Diameter: 18.4" dbh total
 Condition: 60% (fair, very tall tree, three trunks)
 Location: 60% (growing behind main building)
 Species: 100% (on City of KW protected tree list)
 Approximated Tree Value: 73%
 Potential Required Mitigation: 13.4 caliper inches

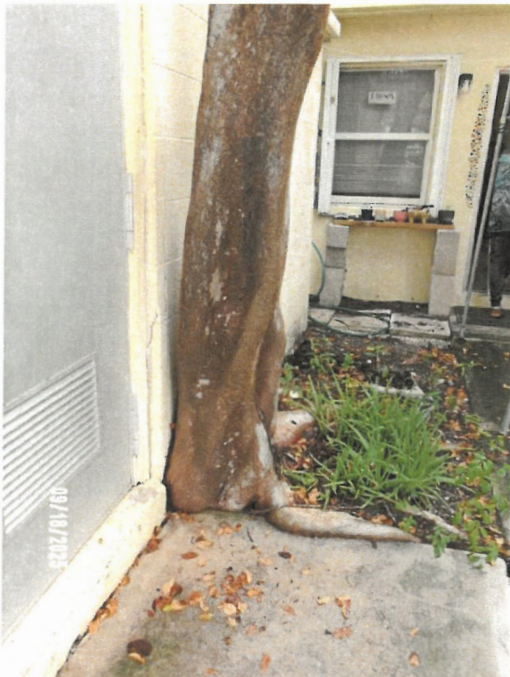
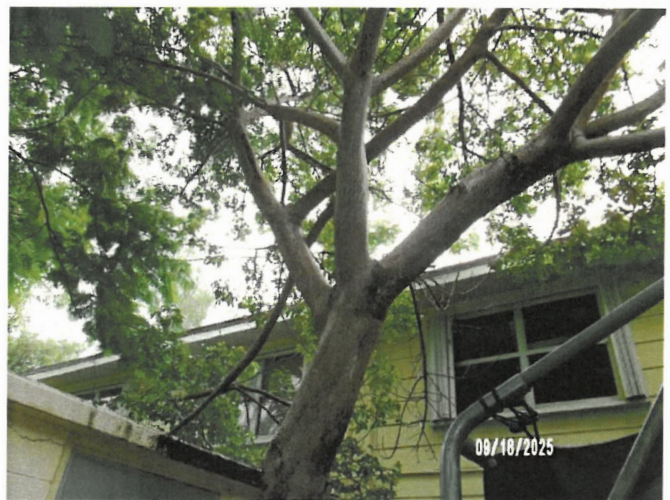
Tree 4.60

Tree 4.60: Gumbo Limbo (*Bursera simaruba*)

Diameter: 14.9" dbh

Condition: 50% (fair health, poor base-root system impacted by concrete pad)

Location: 30% (growing against concrete shed structure and concrete pad)

Potential Required Mitigation: 8.9 caliper inches

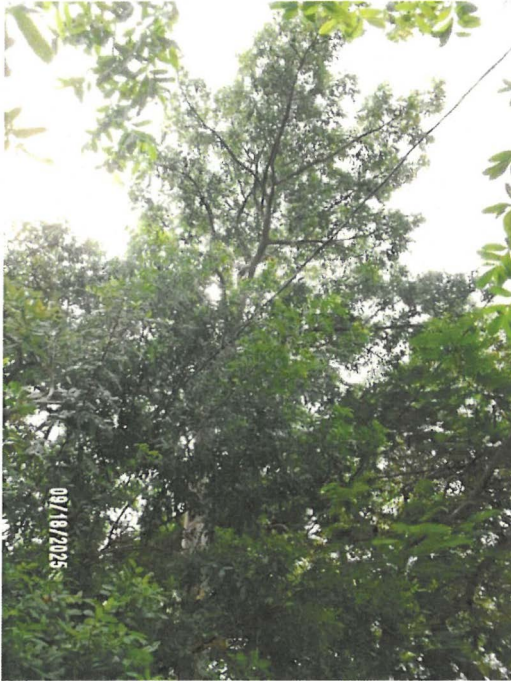
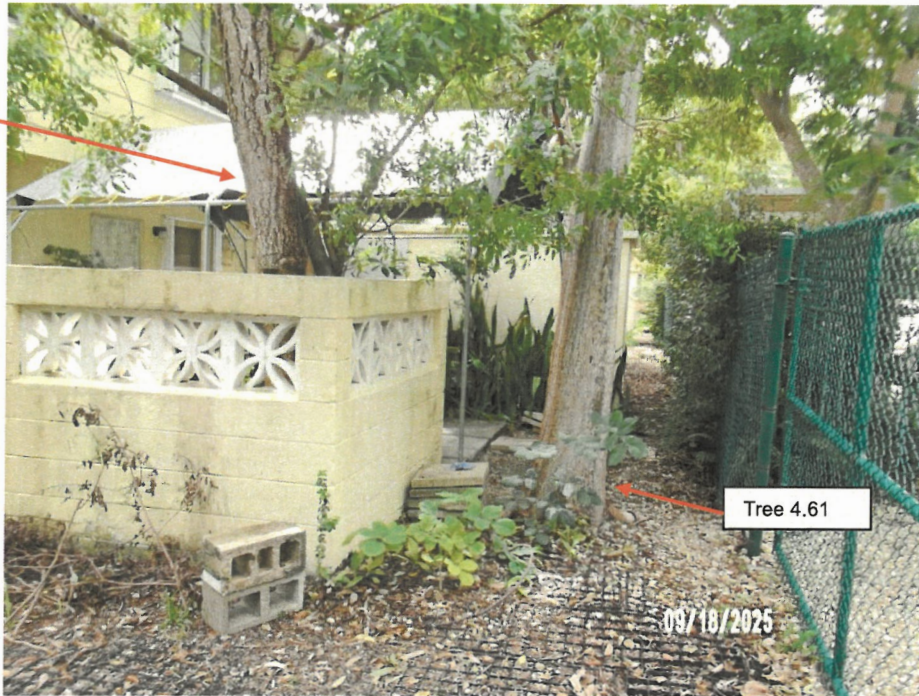
Tree 4.61

Tree 4.61: Gumbo Limbo (*Bursera simaruba*)

Diameter: 15.5" **BM/ZB** dbh

Condition: 60% (fair, very tall tree)

Location: 70% (growing behind main structure)

Potential Required Mitigation: 11.8 caliper inches

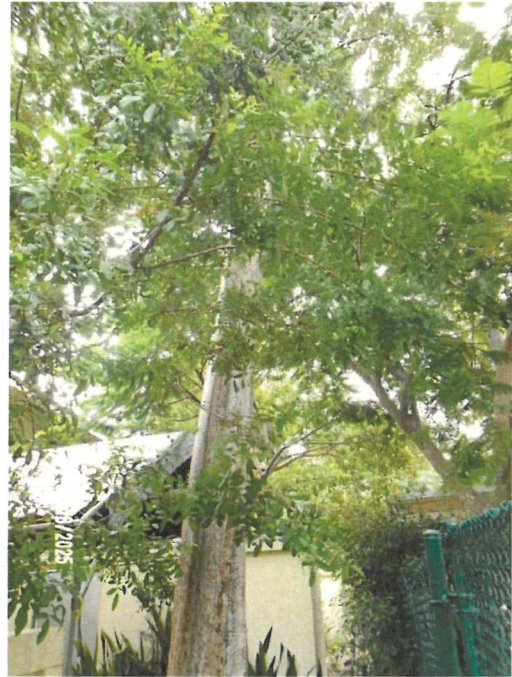
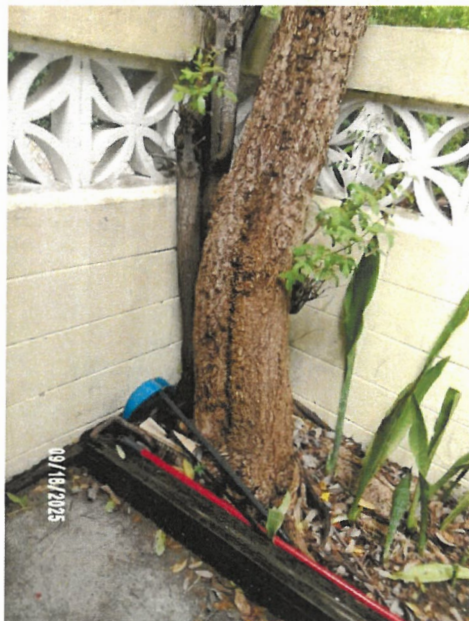
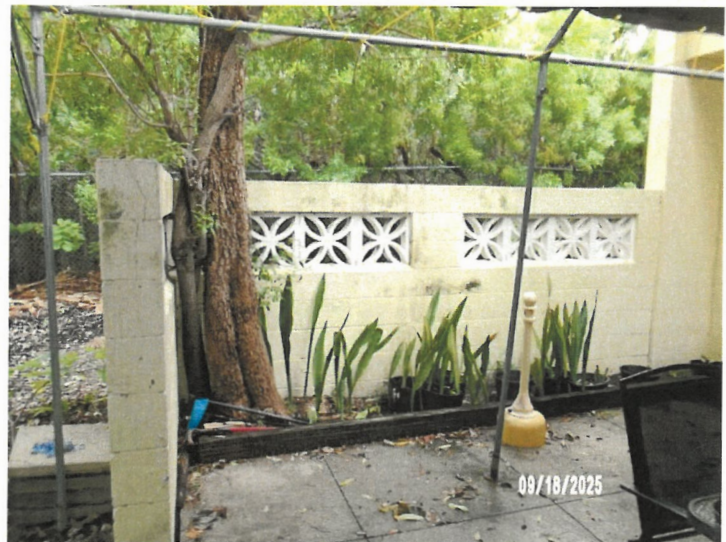
Tree 4.62b and 4.62c

Tree 4.62b: Yellow Tabebuia (*Tabebuia aurea*)

Diameter: 12.4" dbh

Condition: 50% (poor structure, tall tree with old storm damage in canopy)

Location: 60% (growing behind main structure against porch concrete wall corner)

Potential Required Mitigation: 6.5 caliper inches

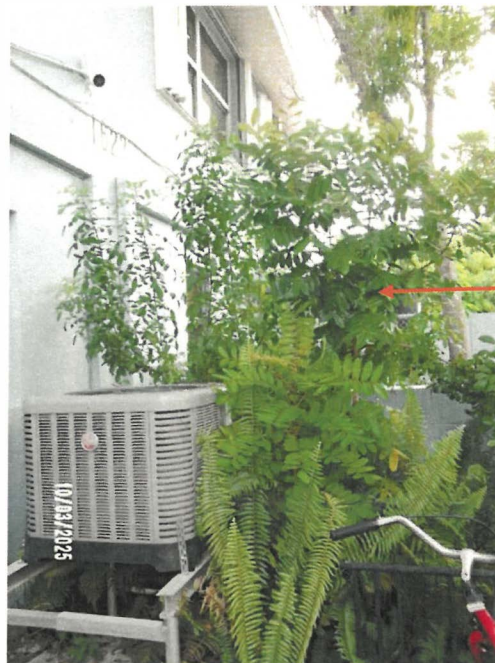
Tree 5.3d

Tree 5.3d: Paradise Tree (*Simarouba glauca*)

Diameter: 1" dbh

Condition: 50% (fair health, poor structure-two trunks, young tree)

Location: 50% (growing in front porch area close to ac unit and concrete wall with Brazilian pepper and ferns)

Potential Required Mitigation: 0.6 caliper inches

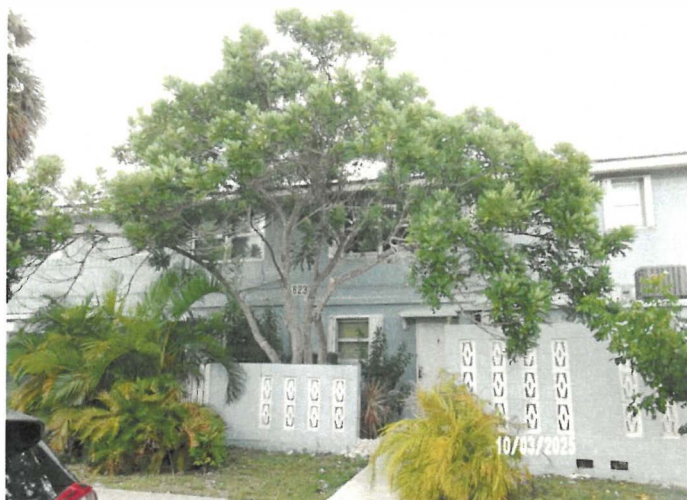
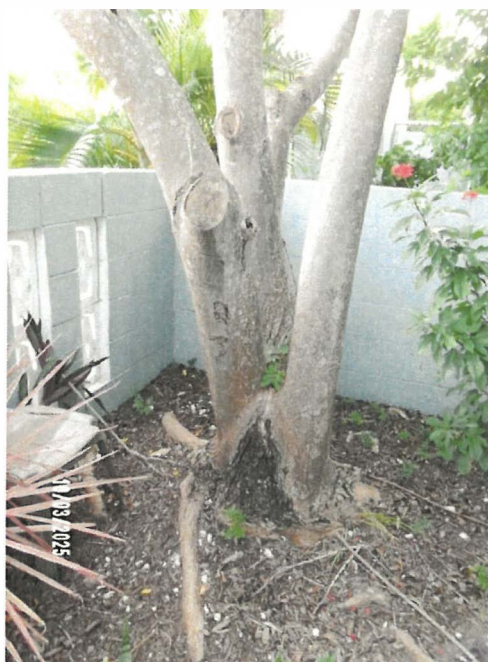
Tree 5.6a

Tree 5.6a: Paradise Tree (*Simarouba glauca*)

Diameter: 25.3" dbh total

Condition: 60% (fair, four trunks)

Location: 60% (growing in front porch area, very visible tree)

Potential Required Mitigation: 18.4 caliper inches

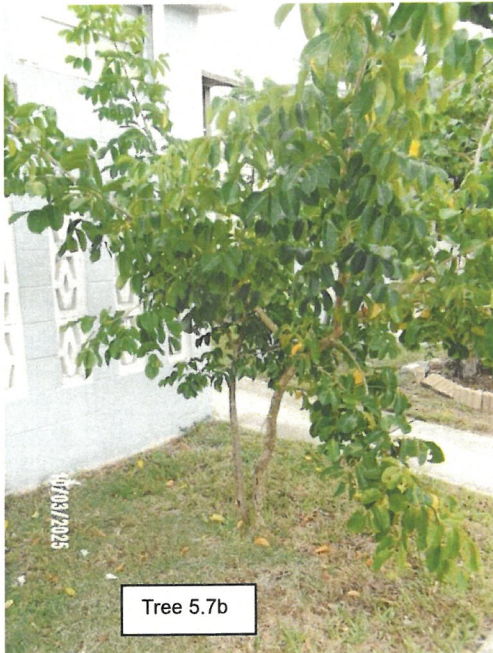
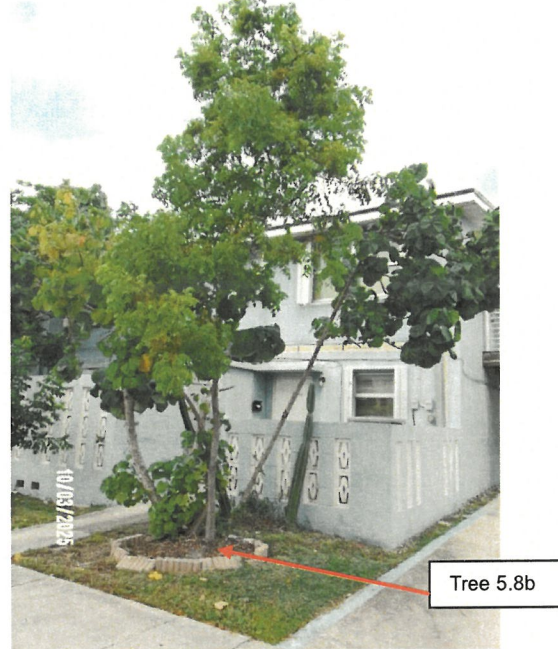
Tree 5.7b: Gumbo Limbo (*Bursera simaruba*)

Diameter: 2.5" dbh total

Condition: 40% (poor structure, two trunks in one rootball, young tree)

Location: 80% (growing in front of main structure, very visible tree)

Potential Required Mitigation: 1.8 caliper inches

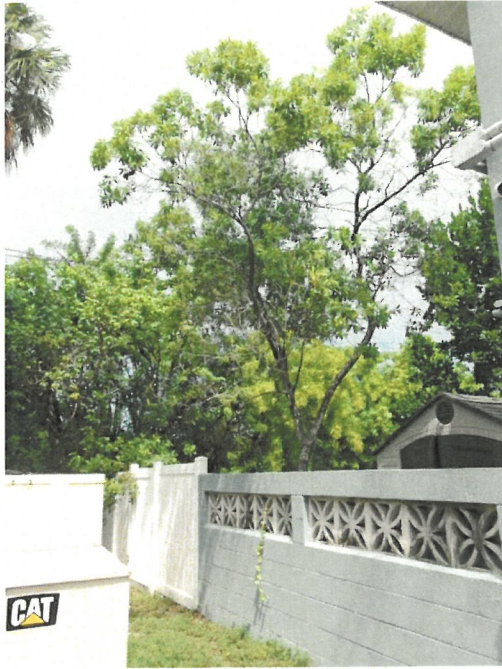
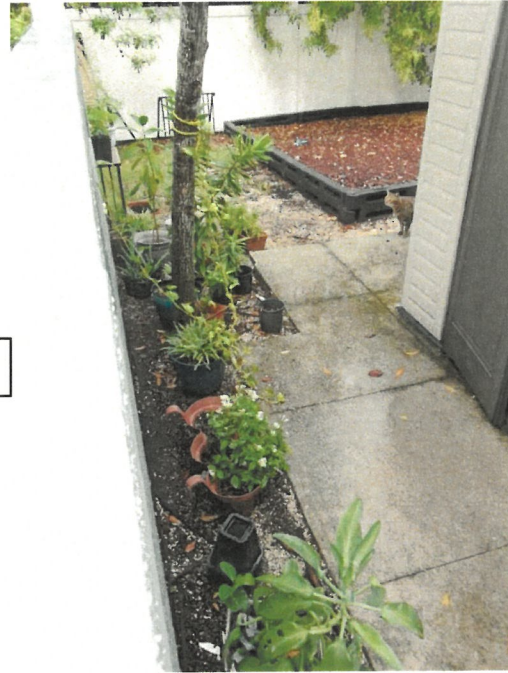
Tree 5.10

Tree 5.10: Willow Busic (*Bumelia salicifolia*)

Diameter: est 4" dbh (need access to yard and tree for actual measurement)

Condition: 40% (poor health-canopy die back)

Location: 60% (growing in back of main structure near concrete wall)

Potential Required Mitigation: 2.6 caliper inches

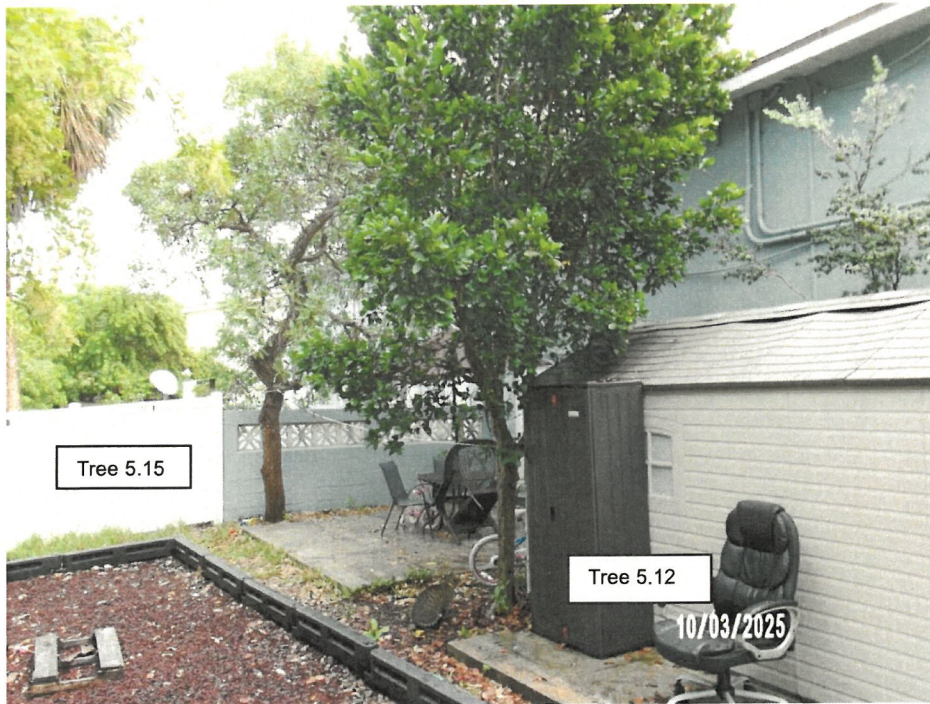
Tree 5.15

Tree 5.15: Yellow Tabebuia (*Tabebuia aurea*)

Diameter: **est 8" dbh (need access to yard and tree for actual measurement)**
 Condition: 50% (fair with poor canopy structure-one sided)
 Location: 60% (growing behind main structure)
 Species: 50% (not on City of KW protected or not protected tree list)
 Approximated Tree Value: 53%
 Potential Required Mitigation: 4.2 caliper inches

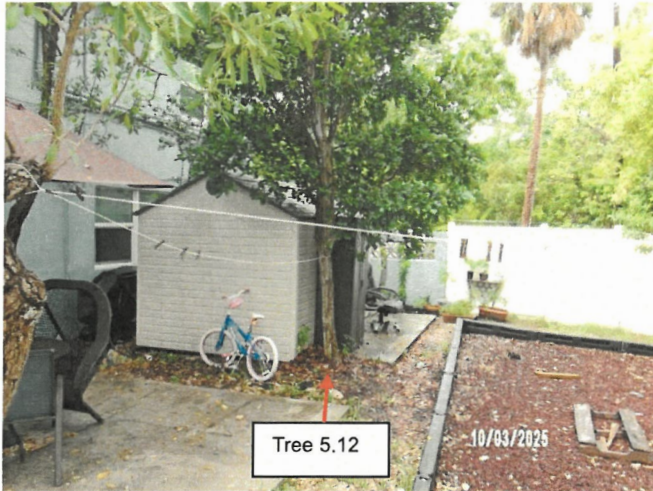
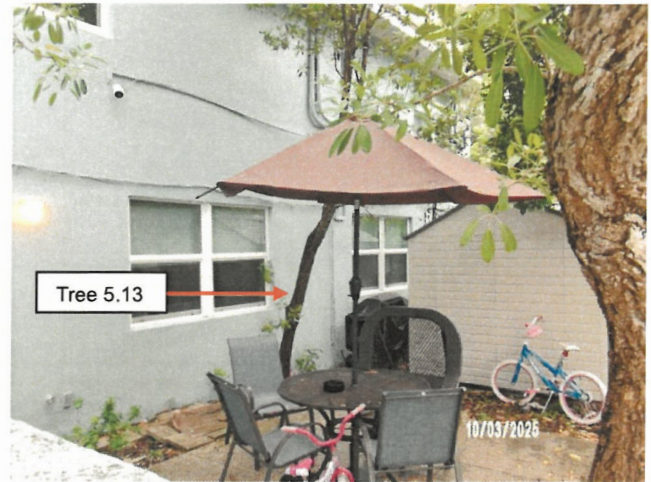
Tree 5.12

Tree 5.12: Pigeon Plum (*Coccoloba diversifolia*)
 Diameter: **est 6" dbh (need access to yard and tree for actual measurement)**
 Condition: 60% (fair)
 Location: 60% (growing behind main structure)
 Species: 100% (on City of KW protected tree list)
 Approximated Tree Value: 73%
Potential Required Mitigation: 4.3 caliper inches
