# UPDATED STAFF REPORT

RE: **1701 Von Phister ROW (permit application # T2022-0462)**

FROM: Karen DeMaria, City of Key West Urban Forestry Manager

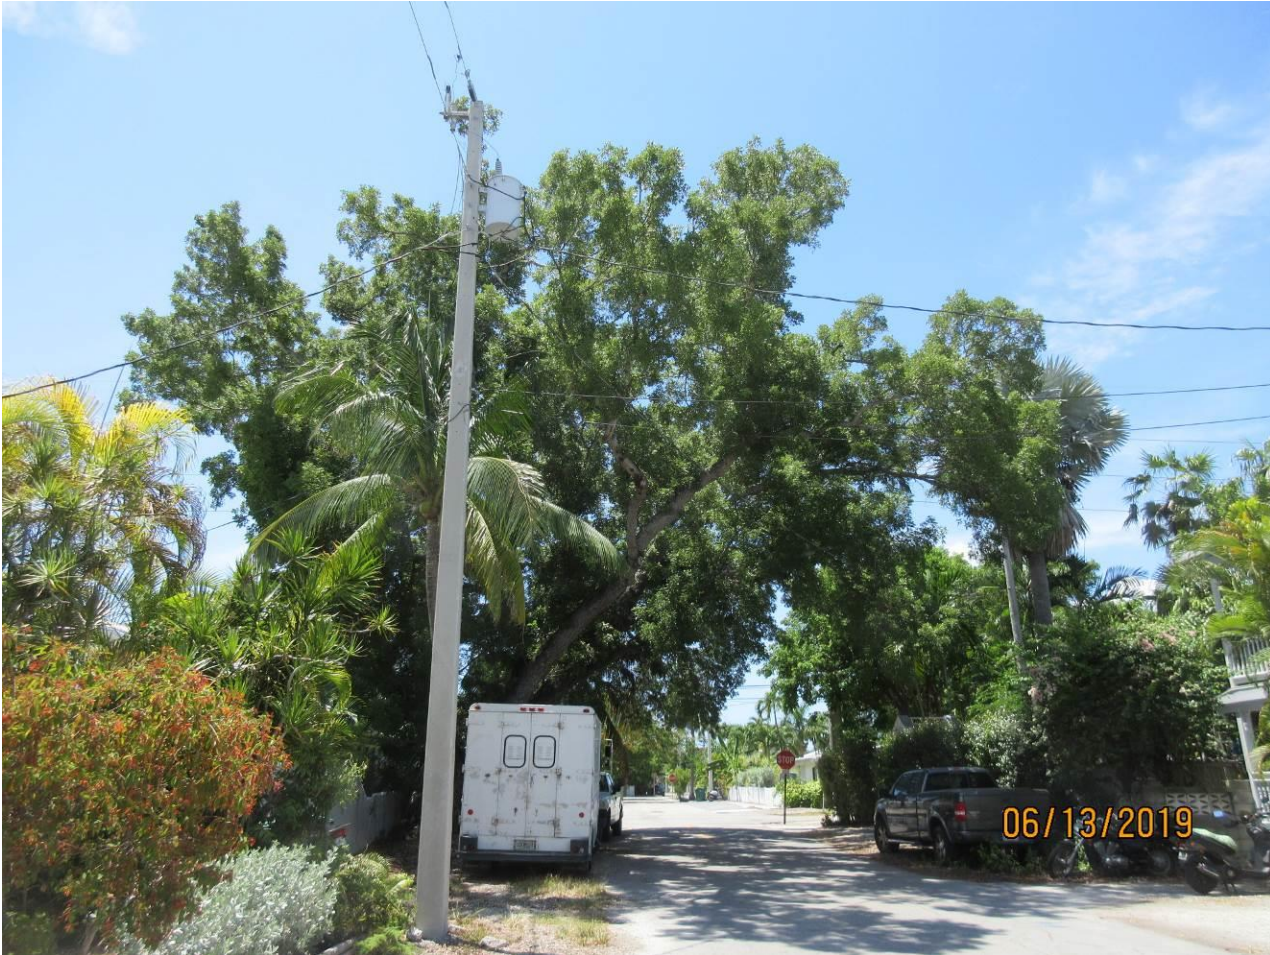
Standing on Ashby Street looking toward Von Phister Street, photo of tree prior to trimming.

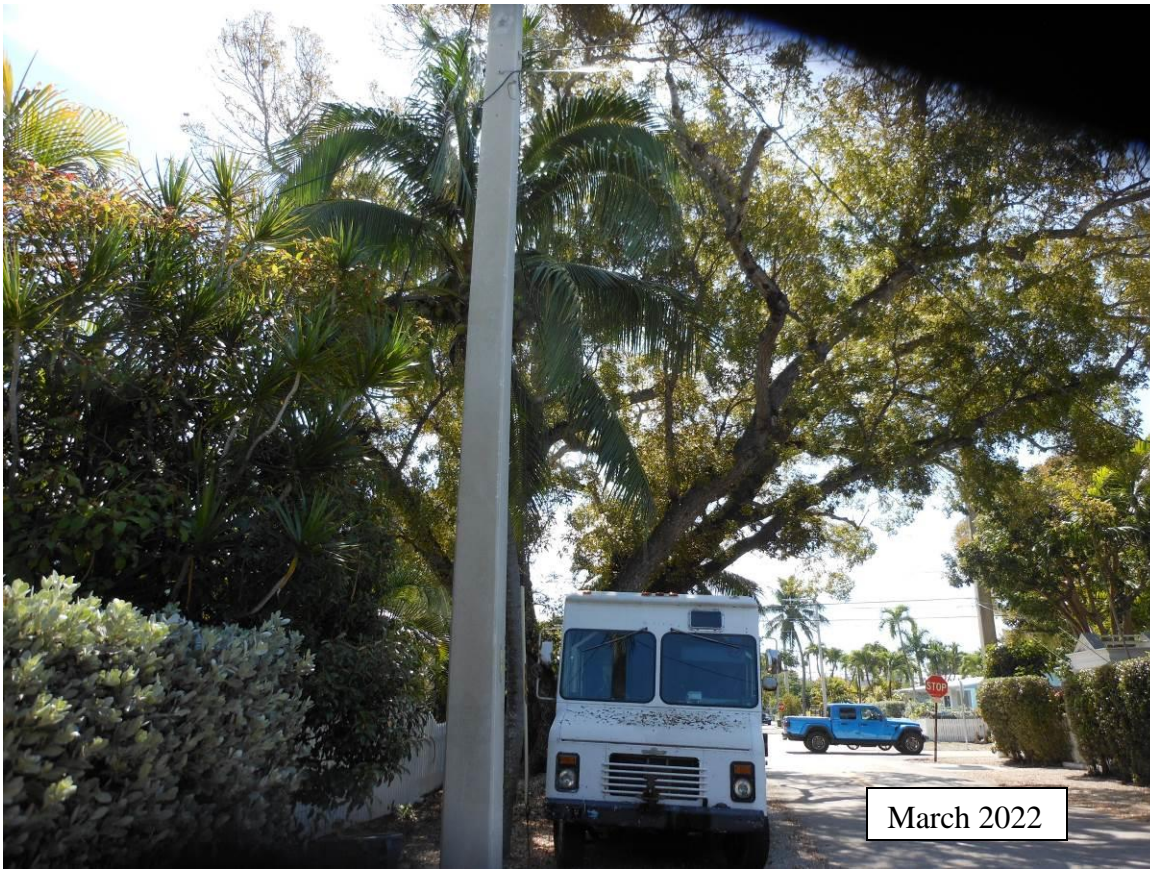
March 2022

Standing on Ashby Street looking toward Von Phister, photo of tree prior to trimming.

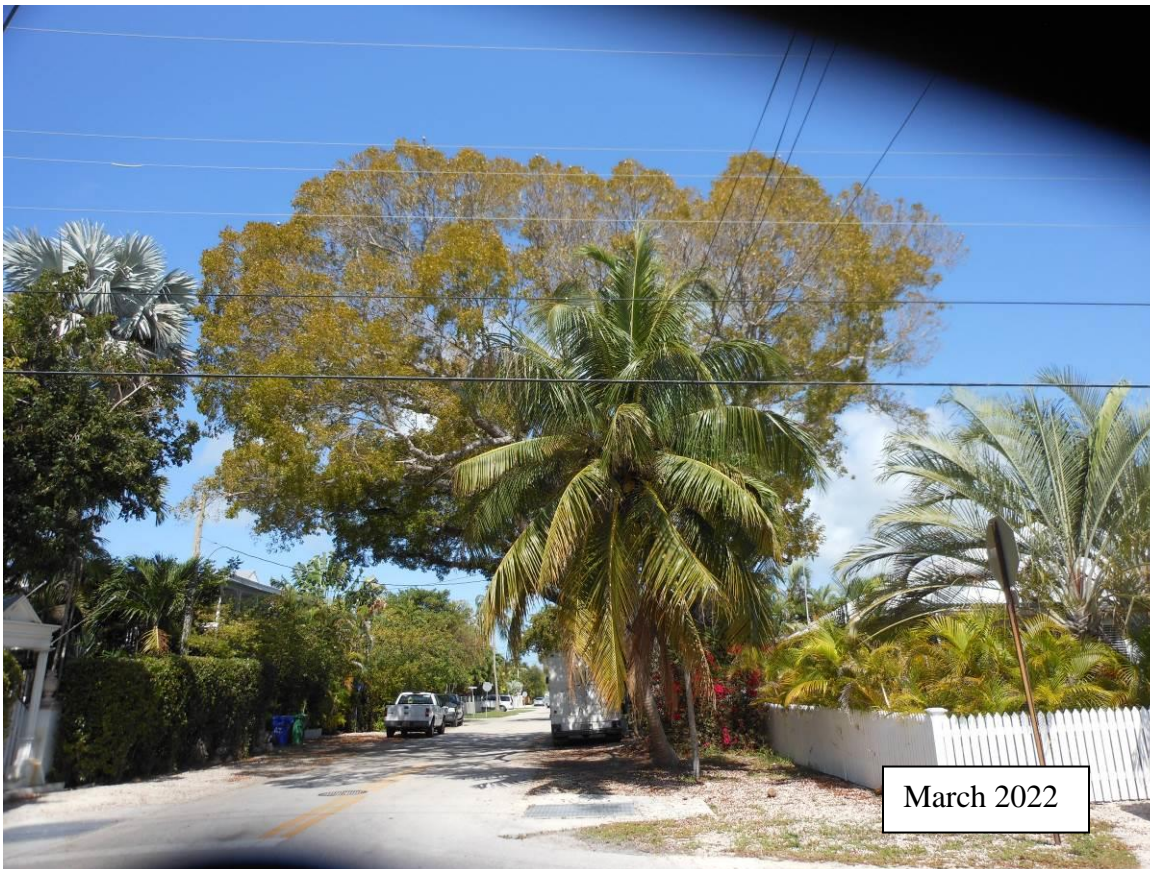
March 2022

Standing at corner of Ashby and Von Phister looking toward Washington Street, photo of tree prior to trimming.

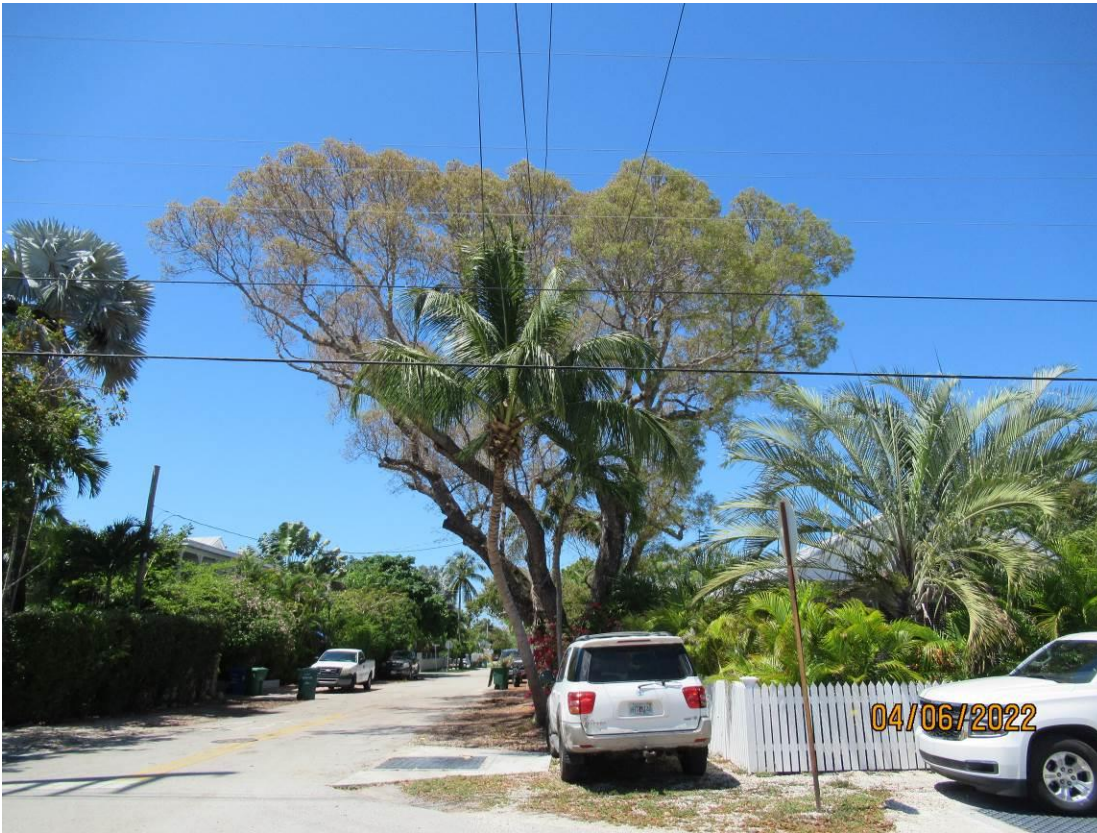
Standing at corner of Ashby and Von Phister looking toward Washington Street, photo of tree after street side trimming by City.

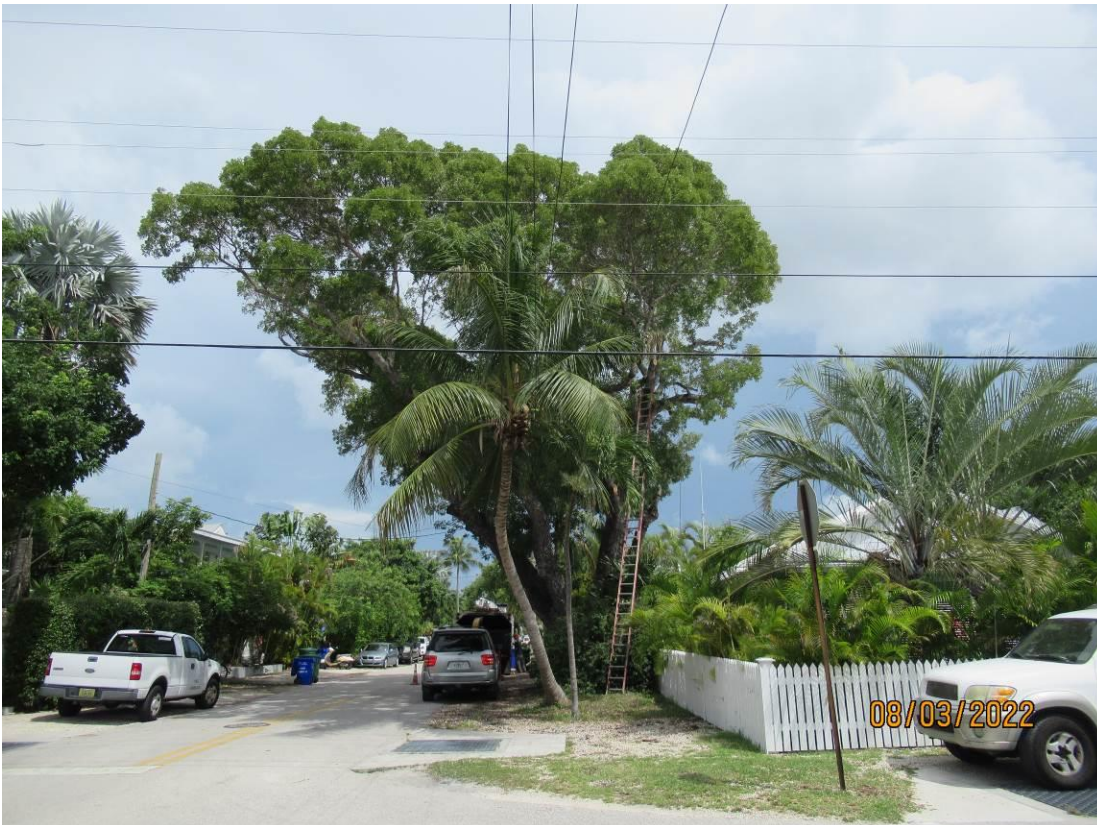
Standing at corner of Ashby and Von Phister looking toward Washington Street, photo of tree after trimming on house side of tree.

The tree canopy is currently in a lopsided shape due to the trimming that has been done in the past year. Standard trimming practices recommend not trimming more than 30% of a canopy in one calendar year. The continued plan is to trim the tree in 2023 to balance and reduce the canopy.
