Mallory Square Berth
Alternatives Analysis 2nd Revision

The City of Key West

Mallory Square Berth

Project No: D3334102
Document Title: Updated Improvements Study
Document No.: D3334102-003
Revision: 3
Date: April 22, 2024
Client Name: The City of Key West
Project Manager: Jim Moore
Author: Melynne Chiariello

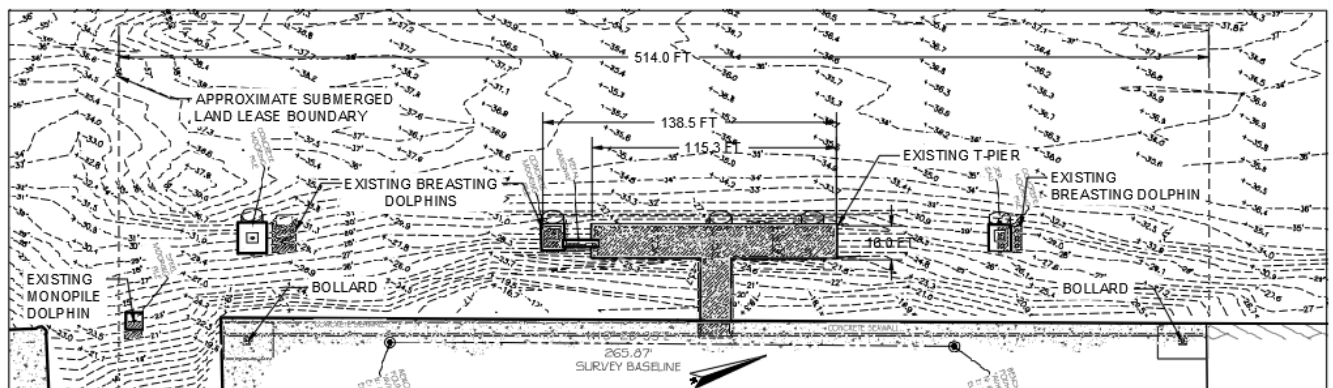
Figure 2: Existing Conditions

The existing structures at the Mallory Square Berth are shown in Figure 2 and consist of a variety of distinct marine structures each serving a specific purpose. The main wharf is a pile supported structure that serves as the interface between the T-Pier and the land. Integrated into this wharf at each waterside end are drilled shaft supported mooring dolphins with a 150-metric ton bollard on each structure. These bollards serve currently as the main bow and stern mooring points for the berth. The ship is accessed via a T-Head pier. Known as the T-Pier, this pile supported structure has an integrated berthing dolphin as well as water and wastewater services. This is the main platform from which passengers embark and debark from the ship.

In line with the outside fender face of the T-Pier are three standalone breasting dolphins. Two of these dolphins were constructed in the mid to late 1990s, while the southern inner most dolphin was constructed in the mid-1980s. In 2018, a vessel collided with the existing southern outer dolphin resulting in a total loss of the dolphin. In 2019, the damaged dolphin was removed, and a new dolphin structure was constructed approximately 25 feet to the north of its original position. Each breasting dolphin is a prestressed concrete pile-supported structure with a foam filled fender and mooring bollard.

The T-pier connects Mallory Square to Mallory Wharf and thus to the City of Key West. As previously stated, the T-pier was originally designed in 1985 when cruise ships were much smaller with fewer passengers. The existing T-pier is 115'-2" long and 16'-0" wide. It is constructed of precast, prestressed deck panels with a topping, supported by cast in place pile caps. The pile caps are supported by 18" square prestressed concrete piles. The northern 28'-4" portion of the T-pier was replaced in 2016 with a steel pipe pile supported breasting dolphin. The remainder of the T-pier had spot repairs to fix spalls and cracks in the concrete in 2018; however, the overall structure is 36-years old and nearing the end of its useful life.

The T-pier design was problematic in that as cruise ships increased in size, the forces transmitted into the T-pier from the fenders caused some damage to the caps and deck of the T-pier. The 2016 dolphin project moved the main fender forces off of the remaining portion of the T-pier which has helped with these damaging forces.

The improvements begin with selective demolition. As the T-pier and approach trestle are nearing the end of their useful lives, it is recommended that the original structures be demolished as opposed to retrofitted. The proposed demolition is shown in Figure 4. The existing approach trestle and the T-Pier with the exception of the integral dolphin section on the northern end of the structure will be demolished. It is possible that the existing T-pier could be widened and extended; however, the existing pier and concrete pile supported dolphin are likely to have structural issues due to age and usage by vessels larger than the original design vessels. Integrating a long-life structure with it would not be cost-efficient and may exacerbate any hidden structural damage; therefore, we do not recommend that approach. Demolition of these concrete pile support sections is therefore recommended as shown in Figure 4. All of the existing dolphins will remain except for the southern inner dolphin.

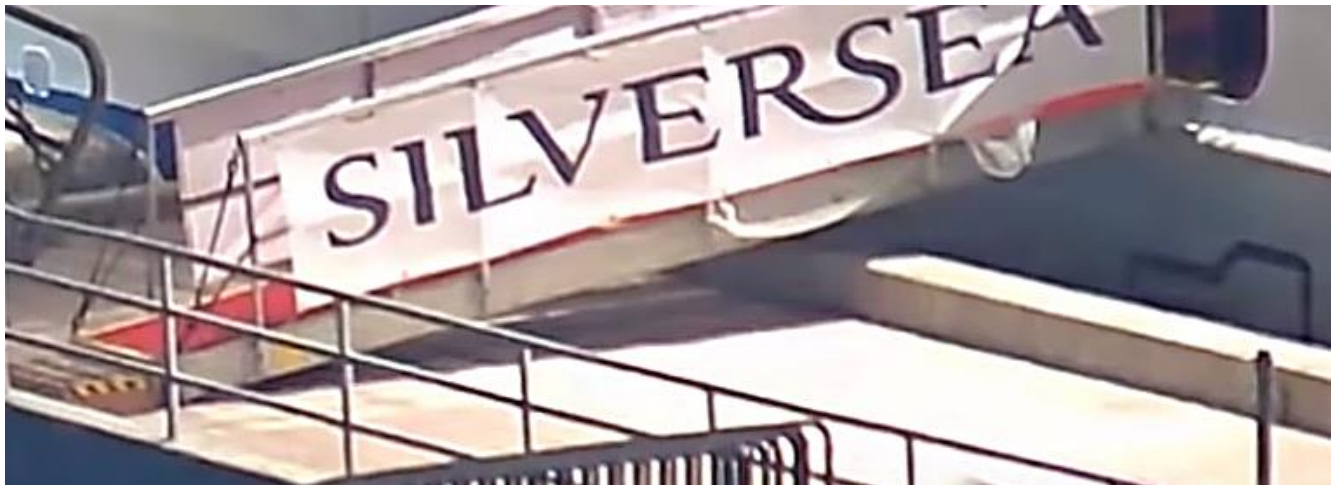
Figure 3: Silversea Gangway at Mallory Square

The narrowness of the pier may cause the gangway's landing ramp to extend to or beyond the landward edge of the T-pier (Figure 3). This configuration leads to a dangerous condition when debarking the vessel with a steep downward walkway without a suitable landing clearance at the pier deck surface. To comply with the Americans with Disabilities Act, a level landing of a least 60" is required. The pier is currently 16 feet wide with a usable area of 14 feet due to the required curbs on either side of the pier.

In addition to the safety issues this situation causes, it also slows the embarkation and debarkation processes. Furthermore, while in port, the ships may need to take on provisions. The provisions may be brought via forklift or utility vehicle. Widening the T-pier to 25 feet will improve passenger safety during embark/debark to meet ADA requirements and will facilitate any provisioning that might take place.

The pier is proposed to be widened from 16 feet to 25 feet. The additional width will improve accessibility and safety so that the conditions as shown in Figure 3 no longer occur.

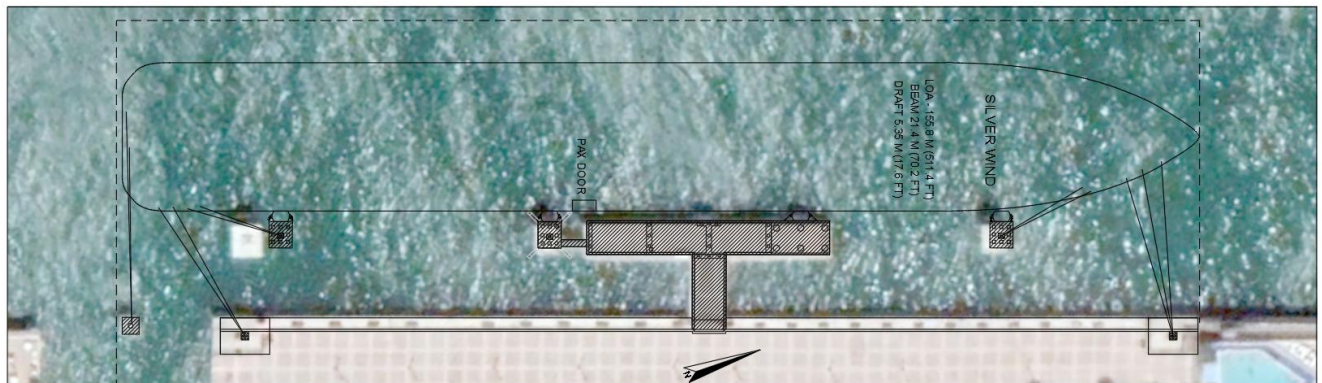
Figure 7: Silver Wind Existing Arrangement

As stated in Sections 3 and 4, the current limited footprint of the T-Pier negatively impacts the gangway operations and mooring conditions. Figures 7 through 12 illustrate “before and after” conditions for the Silver Wind, the Fram and the American Glory. In Figure 7, the passenger door of the Silver Wind is positioned in between the T-pier and the inner southern dolphin. To position the door on the T-pier would cause the ship to encroach on the submerged land lease to the north. Figure 8 depicts the changed condition with the proposed improvements. The ship is centered within the lease area and the passenger door is located on the pier. Furthermore, the widened pier would allow for a safe operation at the pier-gangway interface.

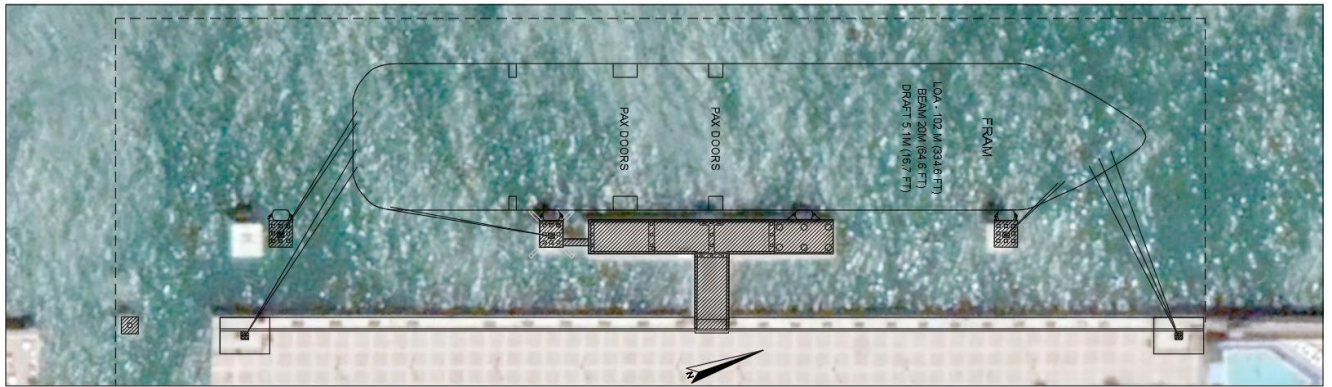
Figure 9: Fram Existing Arrangement

In Figure 9, the Fram is positioned to enable the vessel to embark and disembark passengers from their two passenger doors. The proposed improvements of the pier will not affect the mooring of the Fram as shown in Figure 10, although it will provide a larger pier area for embarkation/debarkation and supply operations.

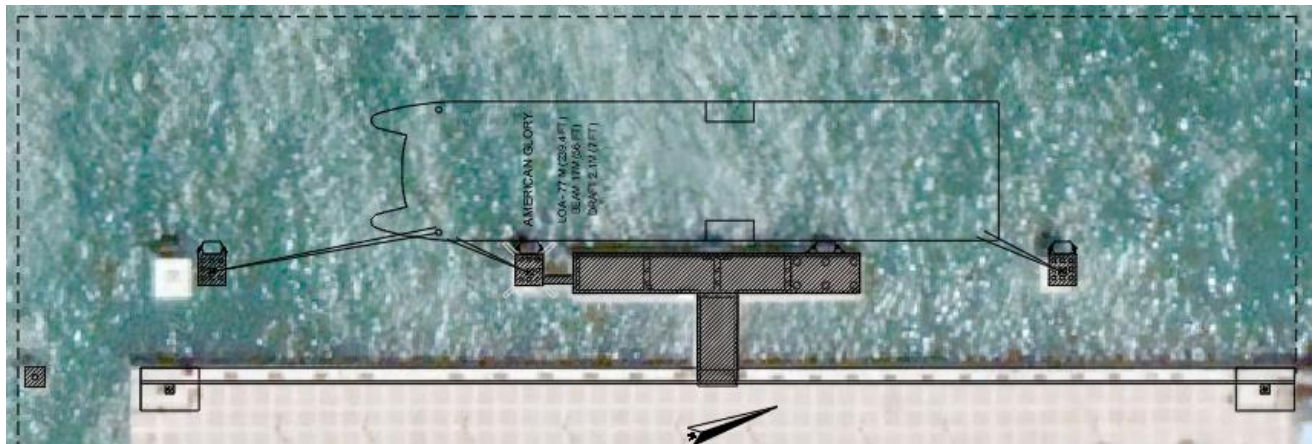
Figure 11: American Glory Existing Arrangement

In Figure 11, the American Glory is positioned to enable the vessel to embark and debark passengers from their passenger door. The proposed improvements of the pier will not affect the mooring of the American Glory as shown in Figure 12. For either arrangement, cleats will need to be provided along the T-pier.
