THE CITY OF KEY WEST  
Urban Forestry  
1300 White Street  
Key West, FL 33040

## Tree Removal Report

**PROPERTY:** 1812 Flagler Ave

**APPLICATION NUMBER:** T2026-0120

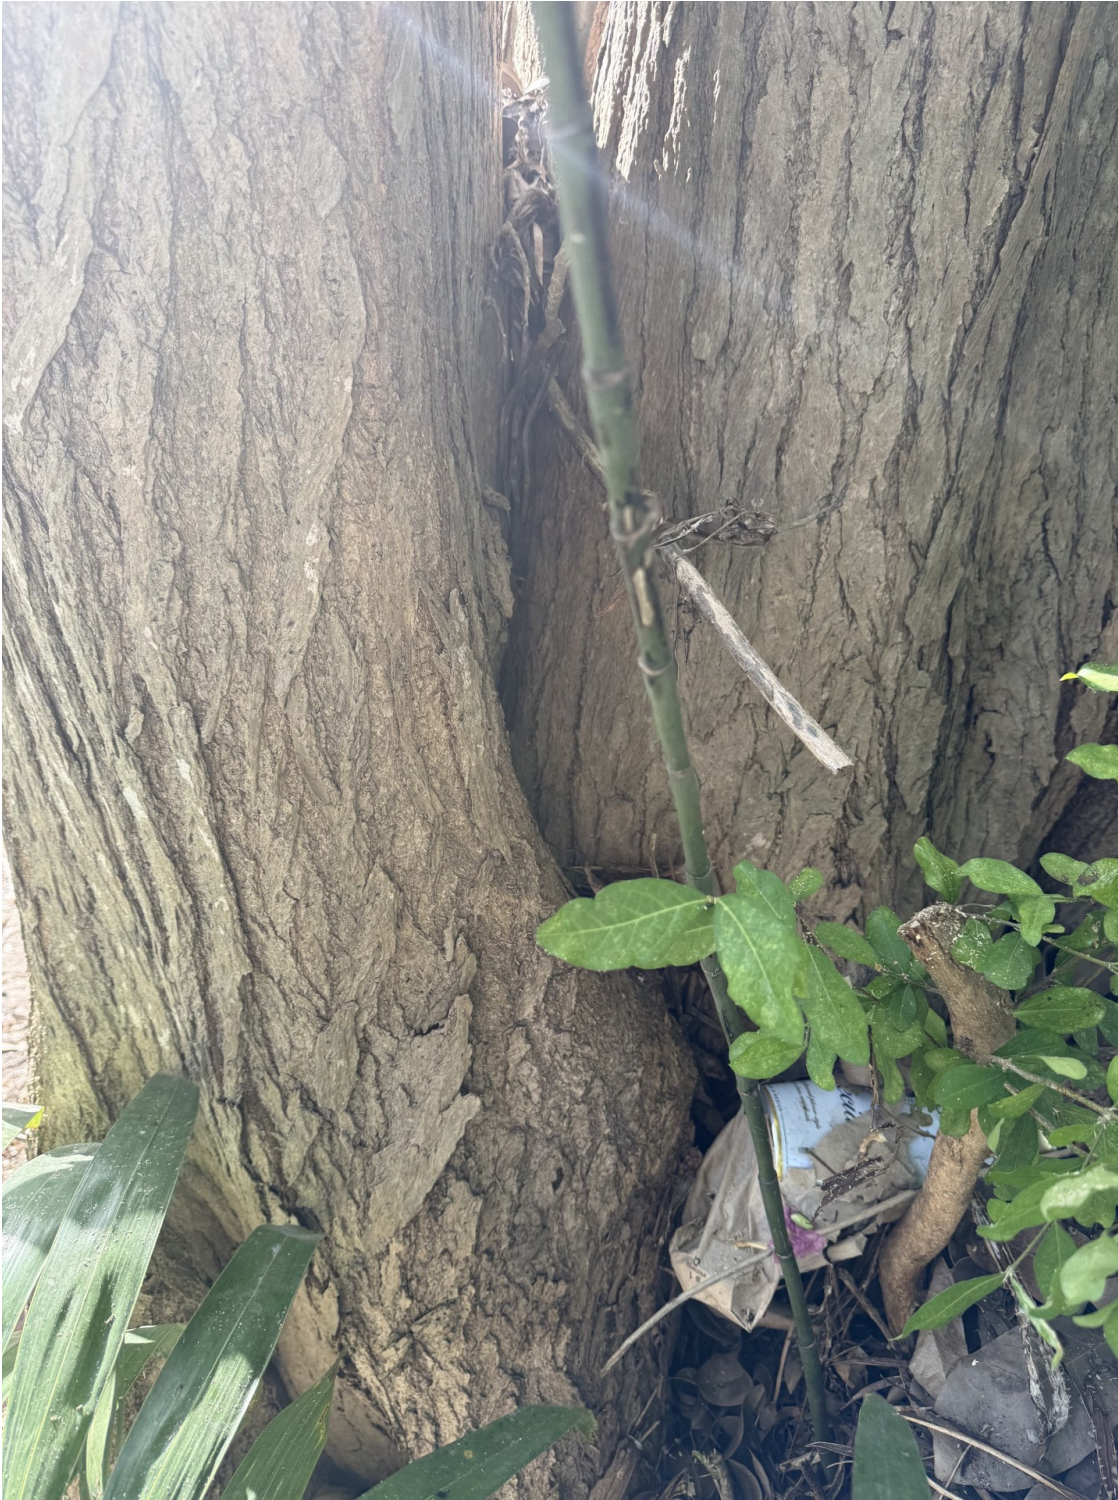
**TREE #1 Pink Tabebuia**

**Codominant Stems with included bark.**

**Condition: 70% Codominant Stems with included bark**

The primary structural concern is the presence of codominant stems with included bark at the base of the tree. Included bark reduces the strength of stem attachments by preventing the formation of normal connective wood, thereby increasing the potential for stem separation as the tree matures.

**Recommended Mitigation: 19 Caliper Inches**

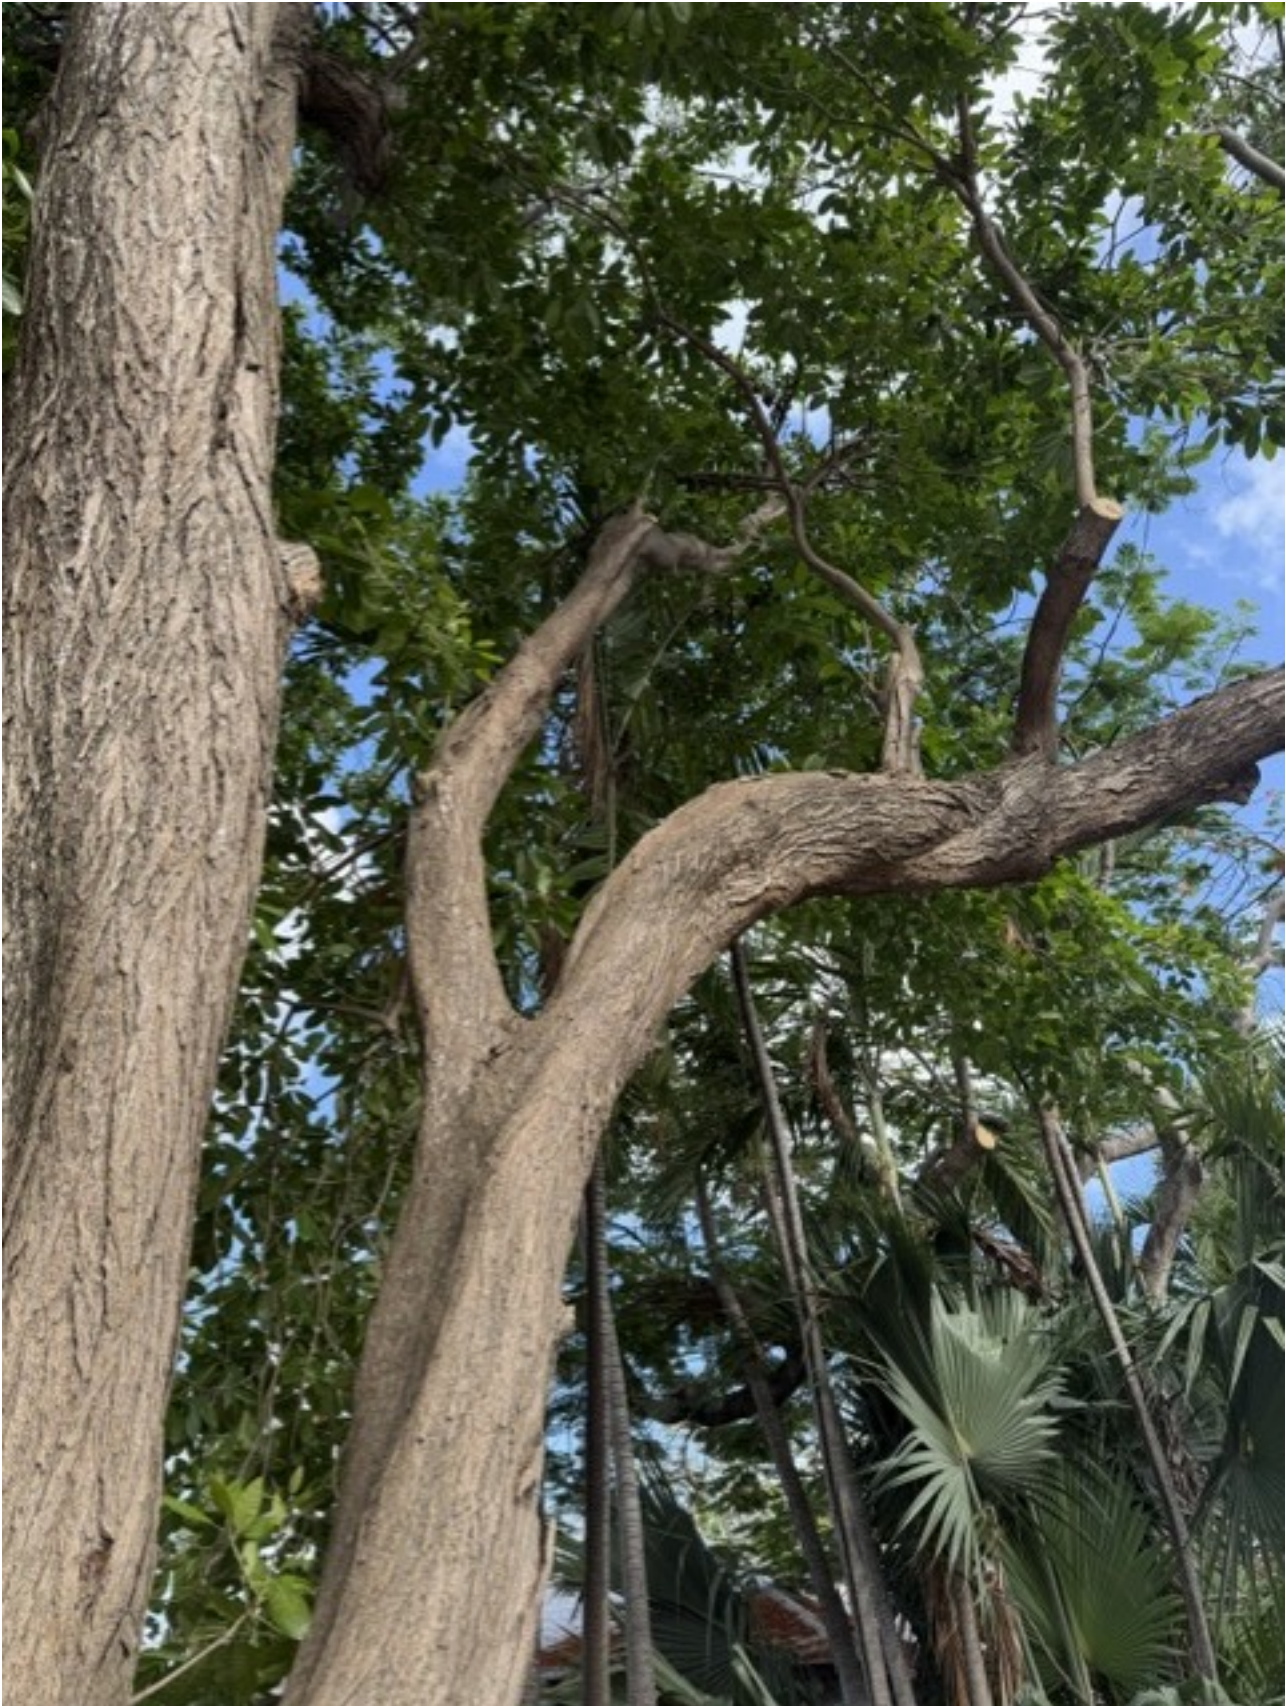
**Unfavorable Stem Bifurcation**

One of the primary stems extends approximately 12 feet before bifurcating into two secondary stems. At this union, the larger diameter stem assumes a pronounced horizontal orientation while the smaller stem continues vertically. This represents less favorable branch architecture, as the dominant stem ideally remains vertical with subordinate lateral growth. The existing configuration increases mechanical loading and bending forces at the attachment point.

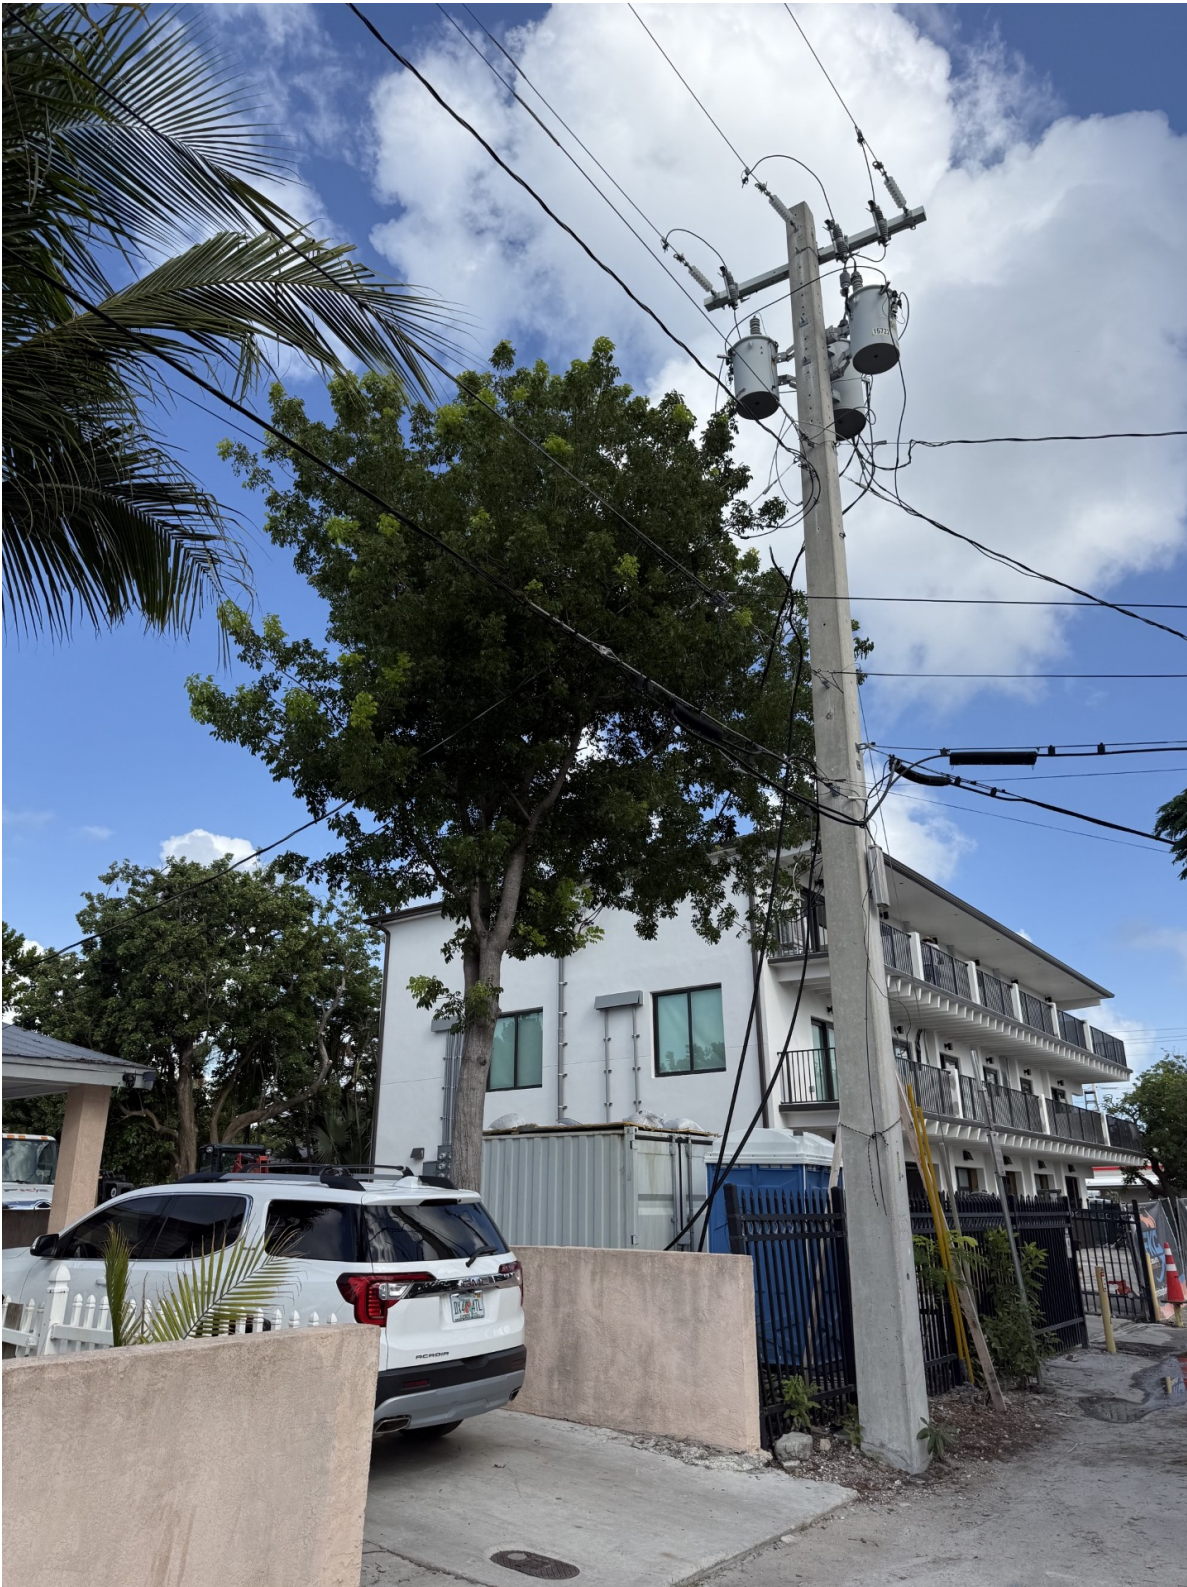
**TREE #2 Cuban Mahogany**

The tree is located in a highly constrained growing environment. It is situated approximately 10 feet from a utility pole supporting three pole-mounted electrical transformers and is directly intersecting the electrical service conductors supplying a commercial building containing a laundromat, multiple apartment units, and an adjacent single-family residence.

Additionally, the trunk is located less than one foot from a concrete masonry wall defining the property boundary. The planting location is inconsistent with recommended species selection and spacing guidelines for a large-maturing canopy tree and appears more indicative of a volunteer tree than an intentionally planted landscape specimen.

The canopy has been raised considerably through previous pruning, resulting in a pronounced lion's-tail effect. Consequently, the tree exhibits a lollipop-shaped canopy architecture, likely attributable to repeated clearance pruning. While no significant structural defects such as decay, cracking, or included bark were observed, the altered canopy structure may increase end-weight loading on scaffold limbs and reduce the tree's natural wind resistance over time.

### **Recommended Mitigation: 9.1 Caliper Inches**
