**TREE COMMISSION TREE REMOVAL REPORT  
CITY of KEY WEST**

**PROPERTY: 1430 Grinnell St.**

**APPLICATION NUMBER: T2026-0103**

**REQUEST: The applicant is requesting removal of (2) Tropical Almond trees.**

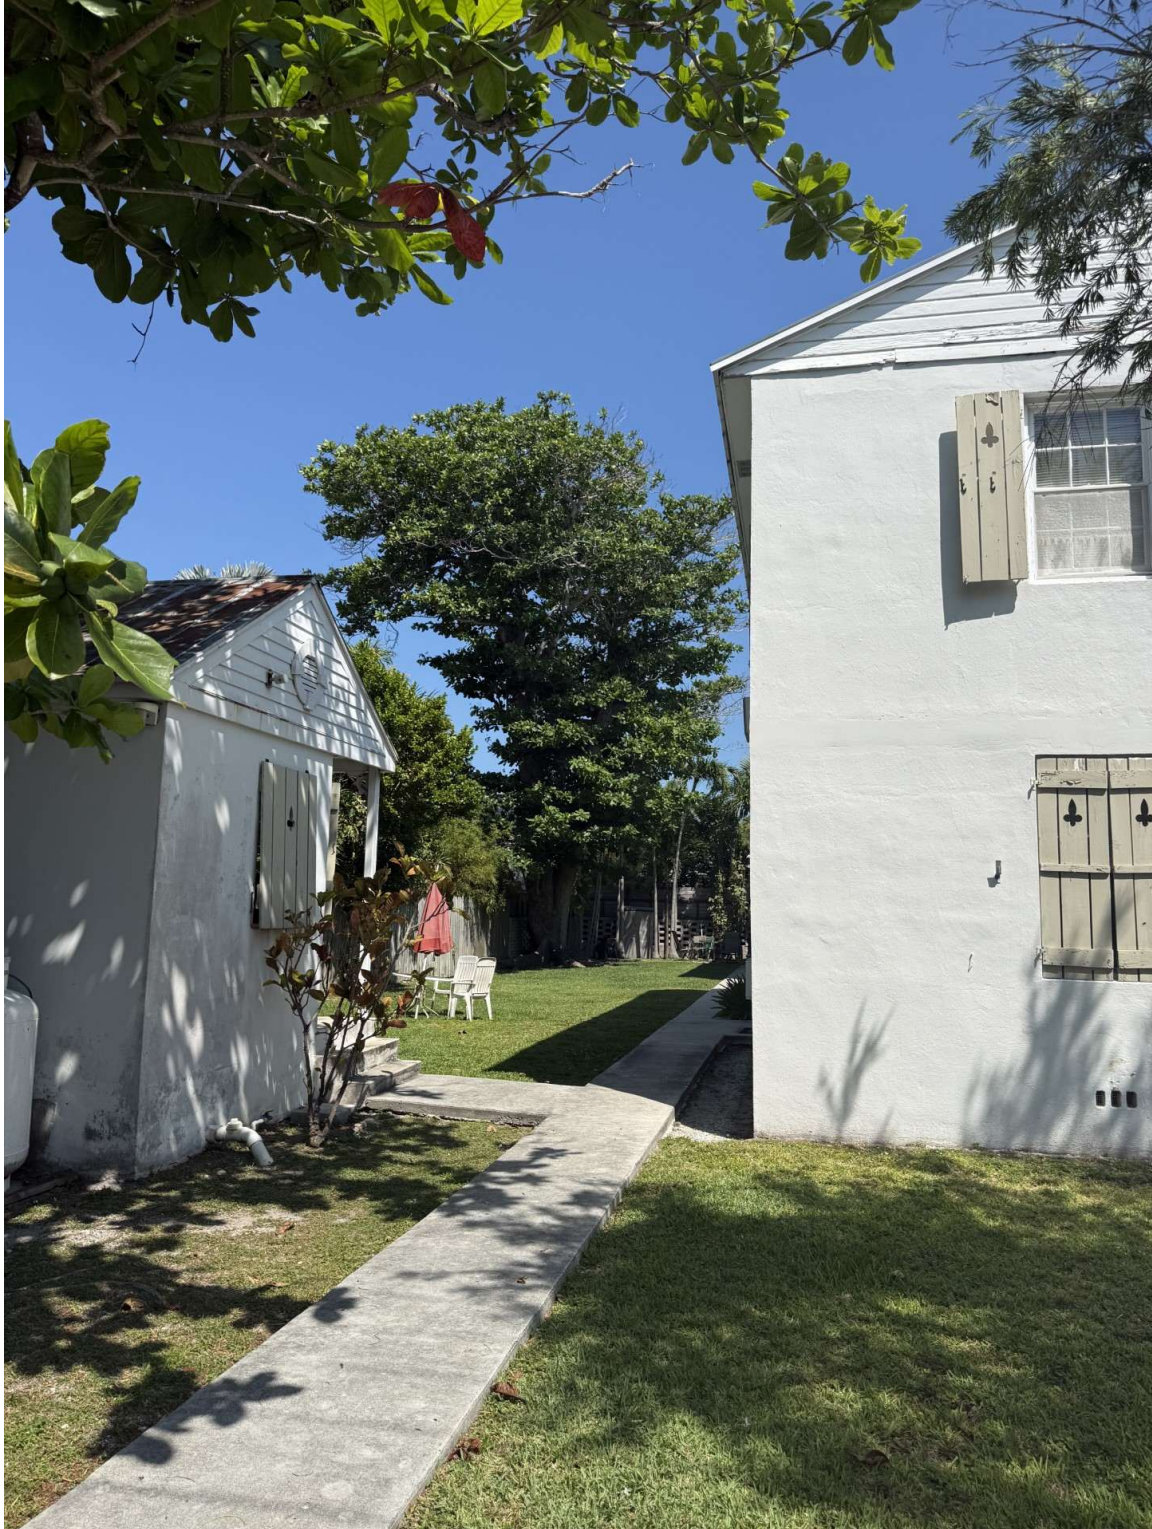
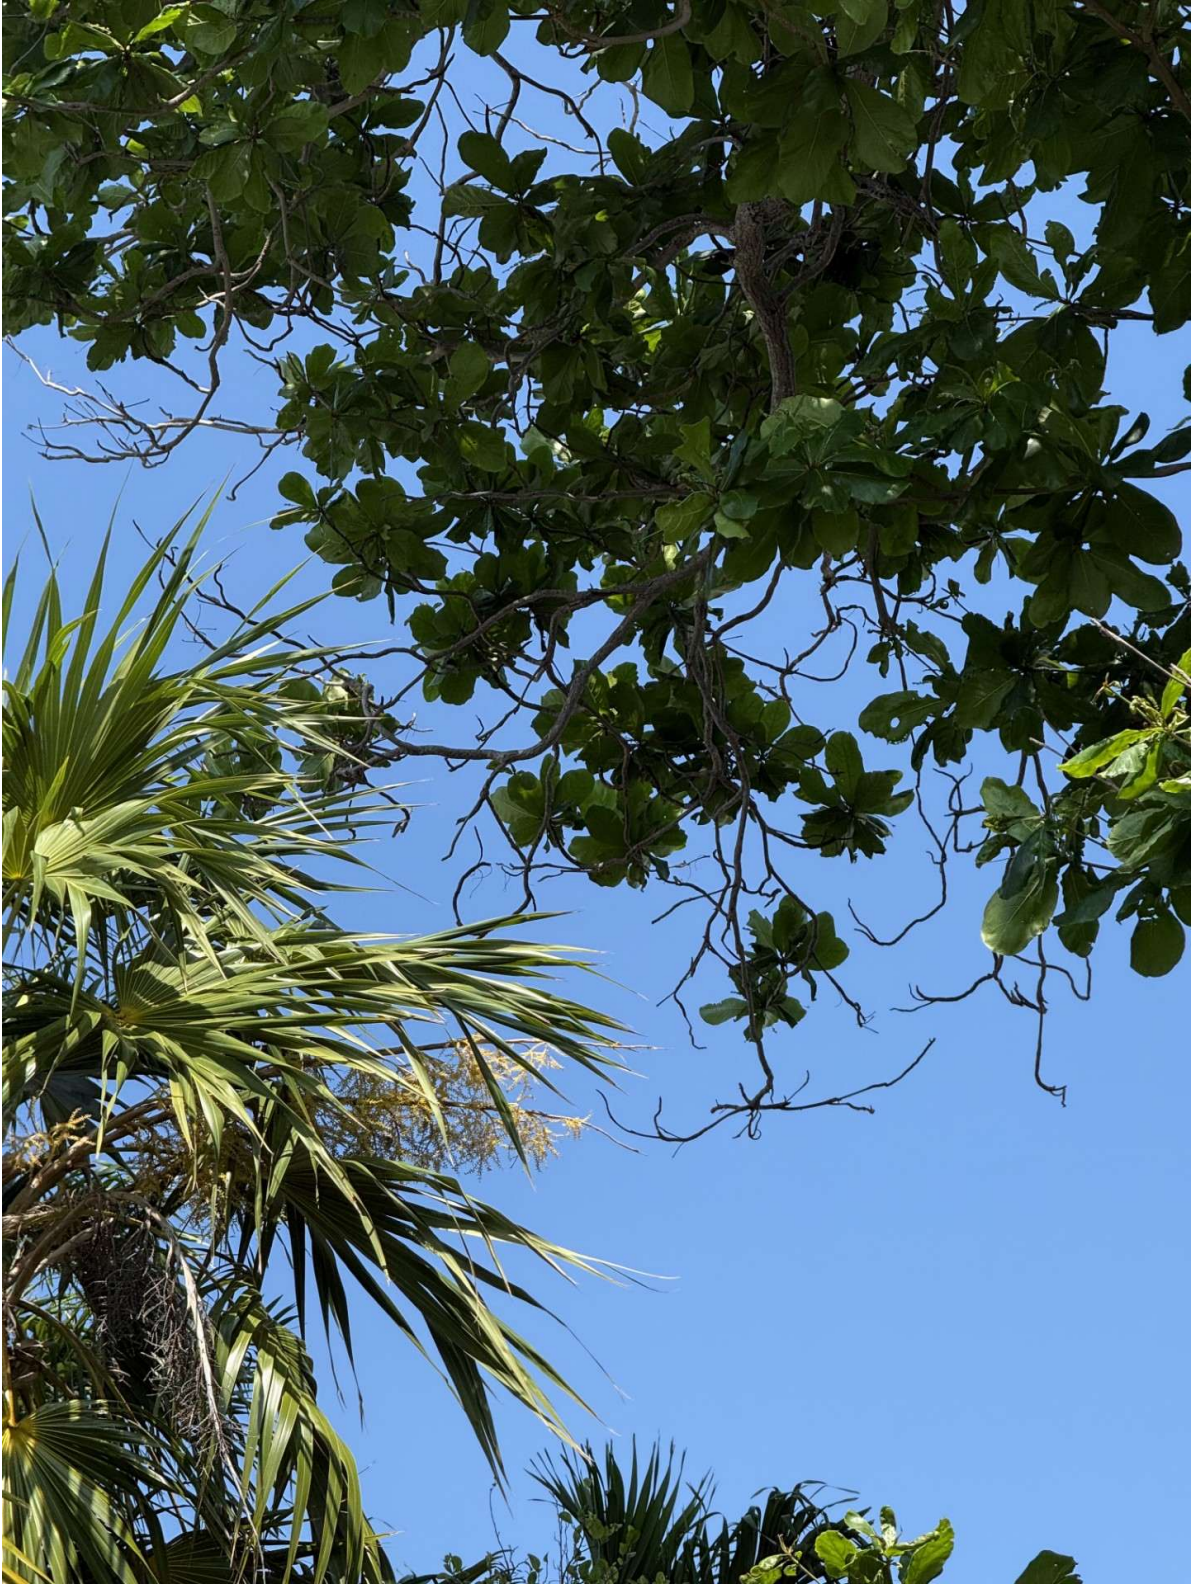
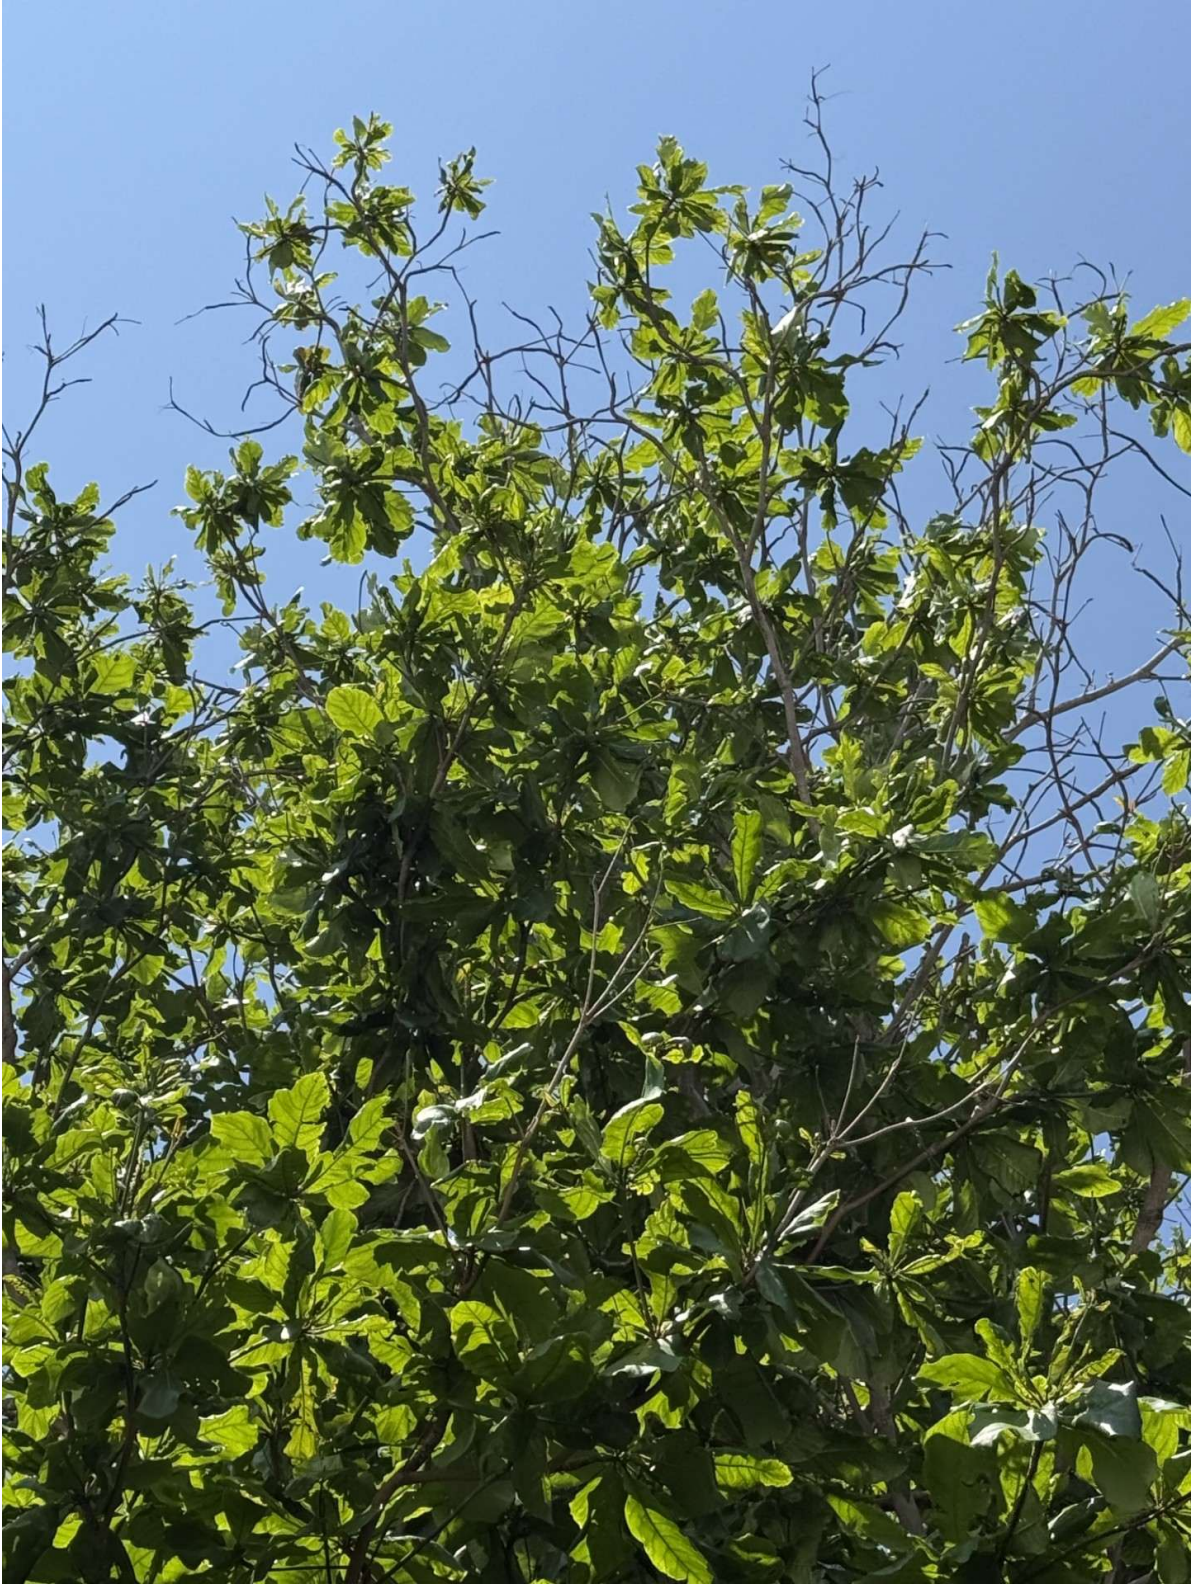
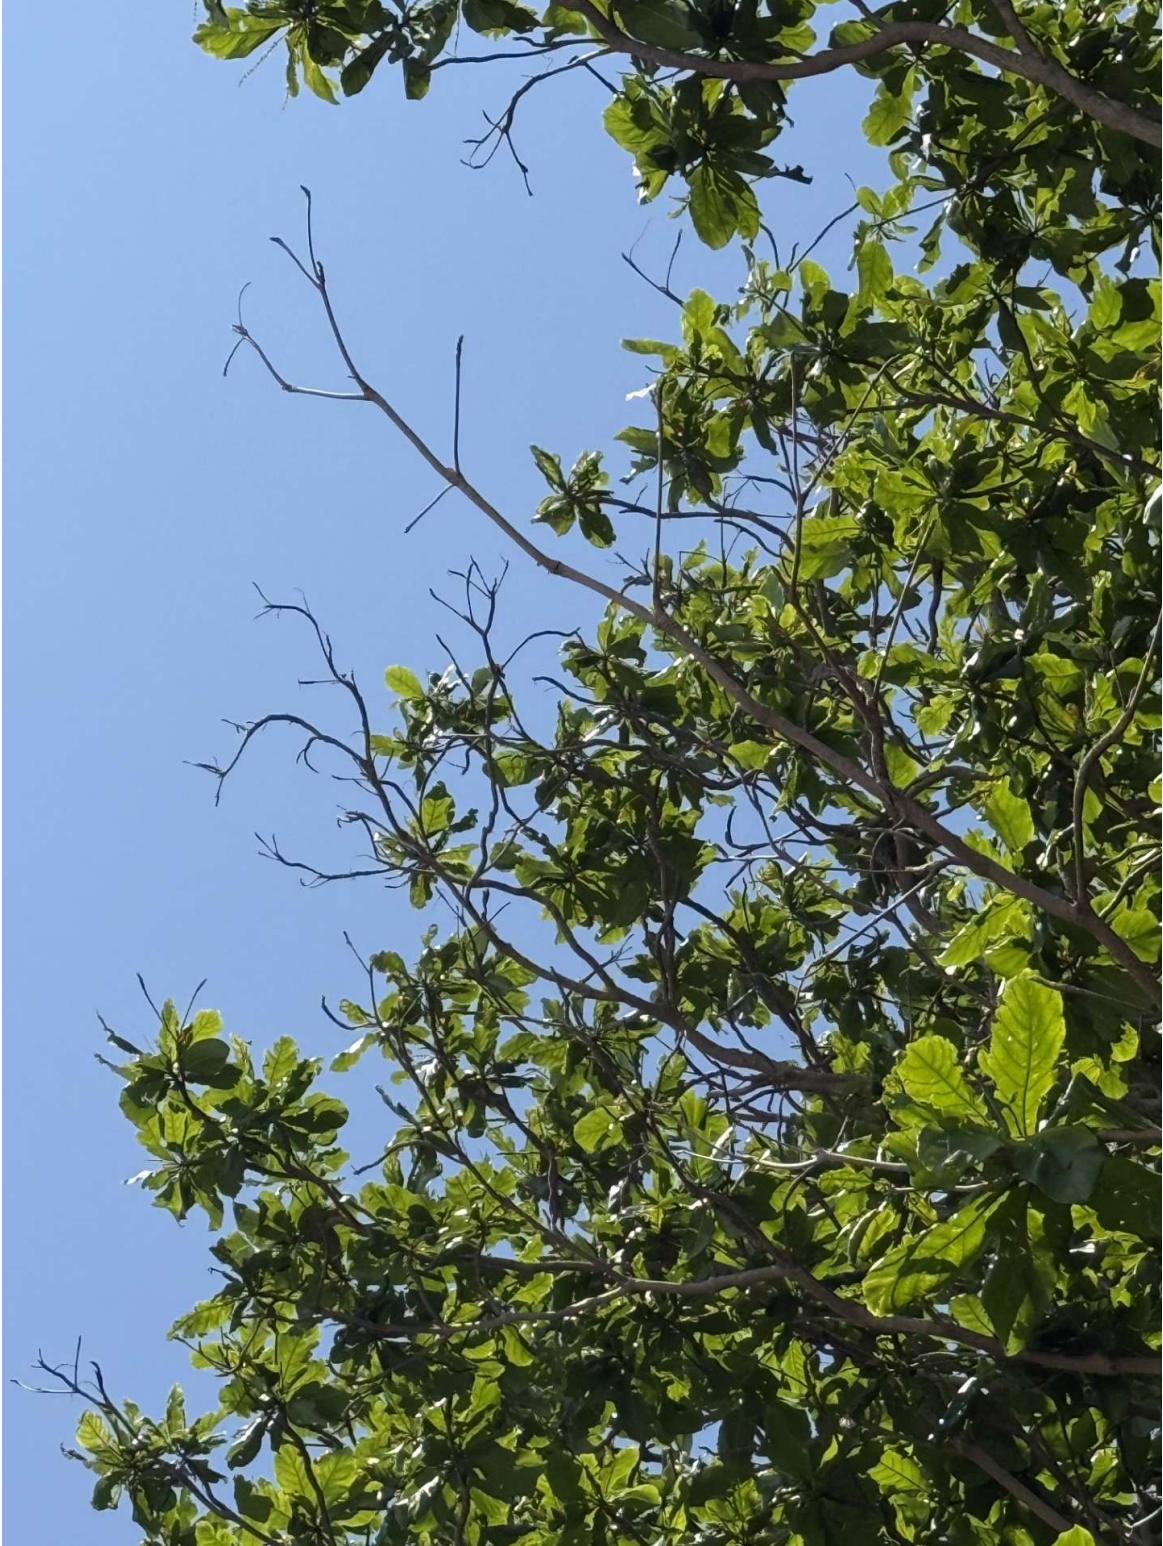
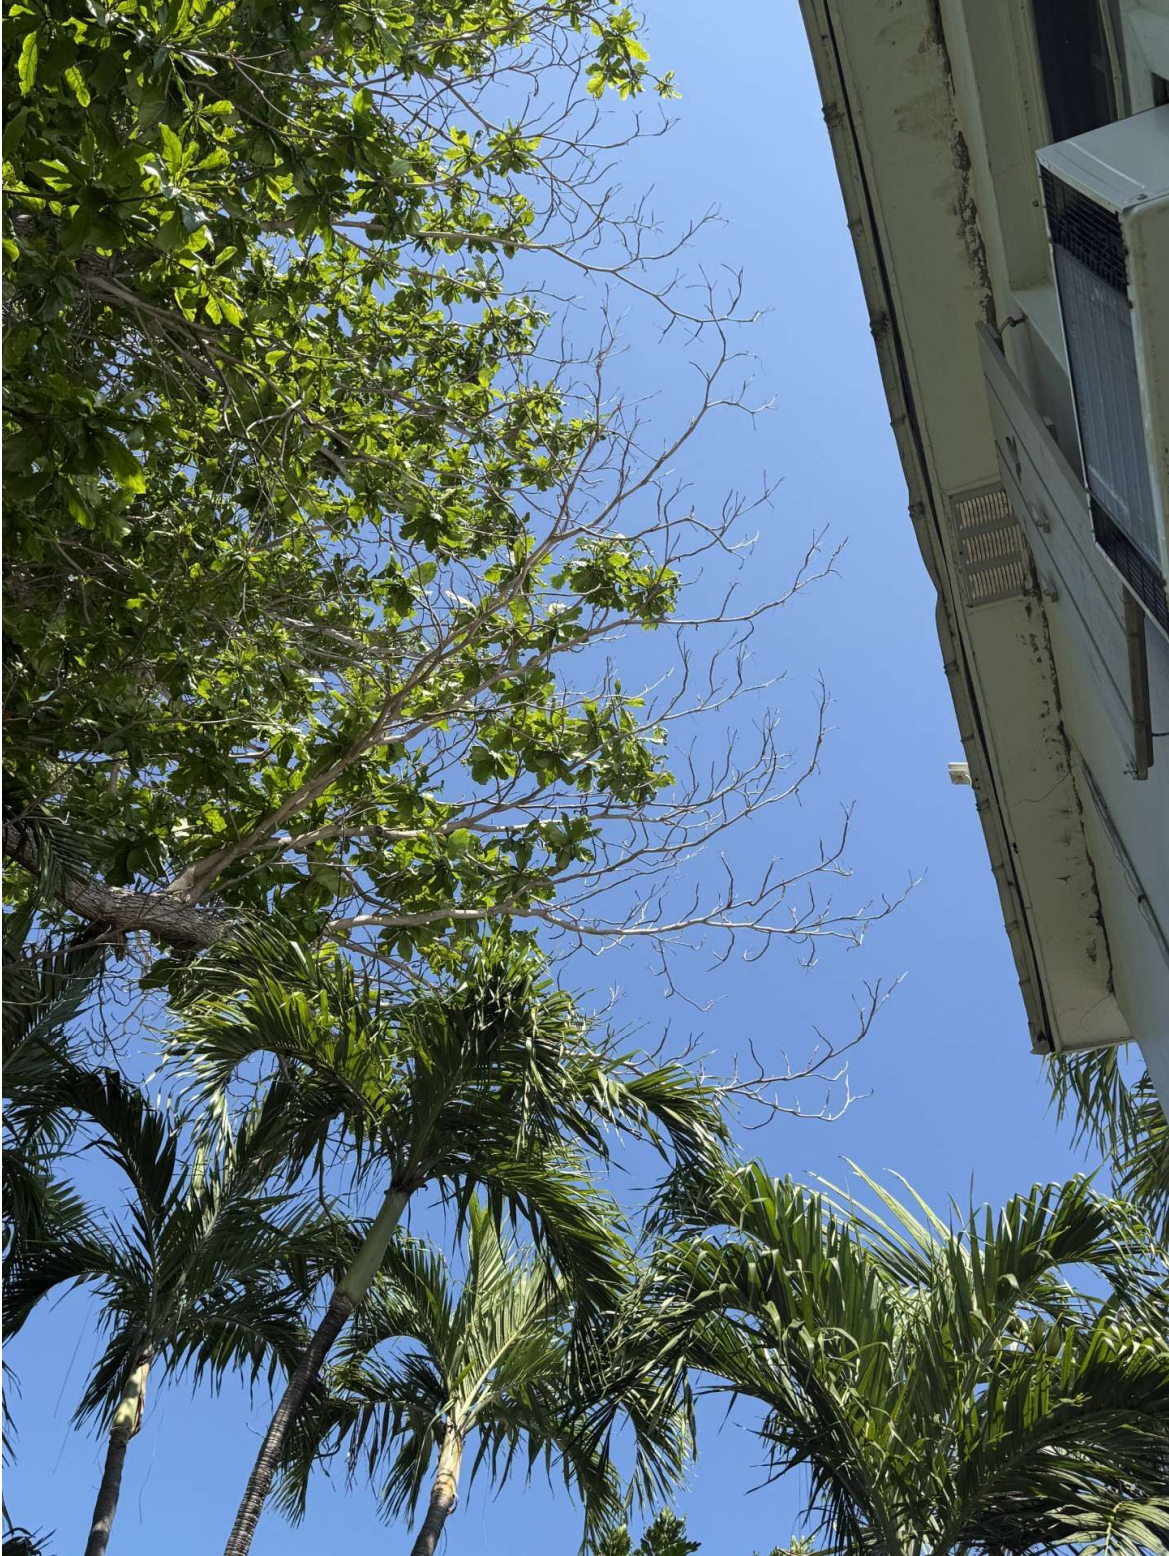
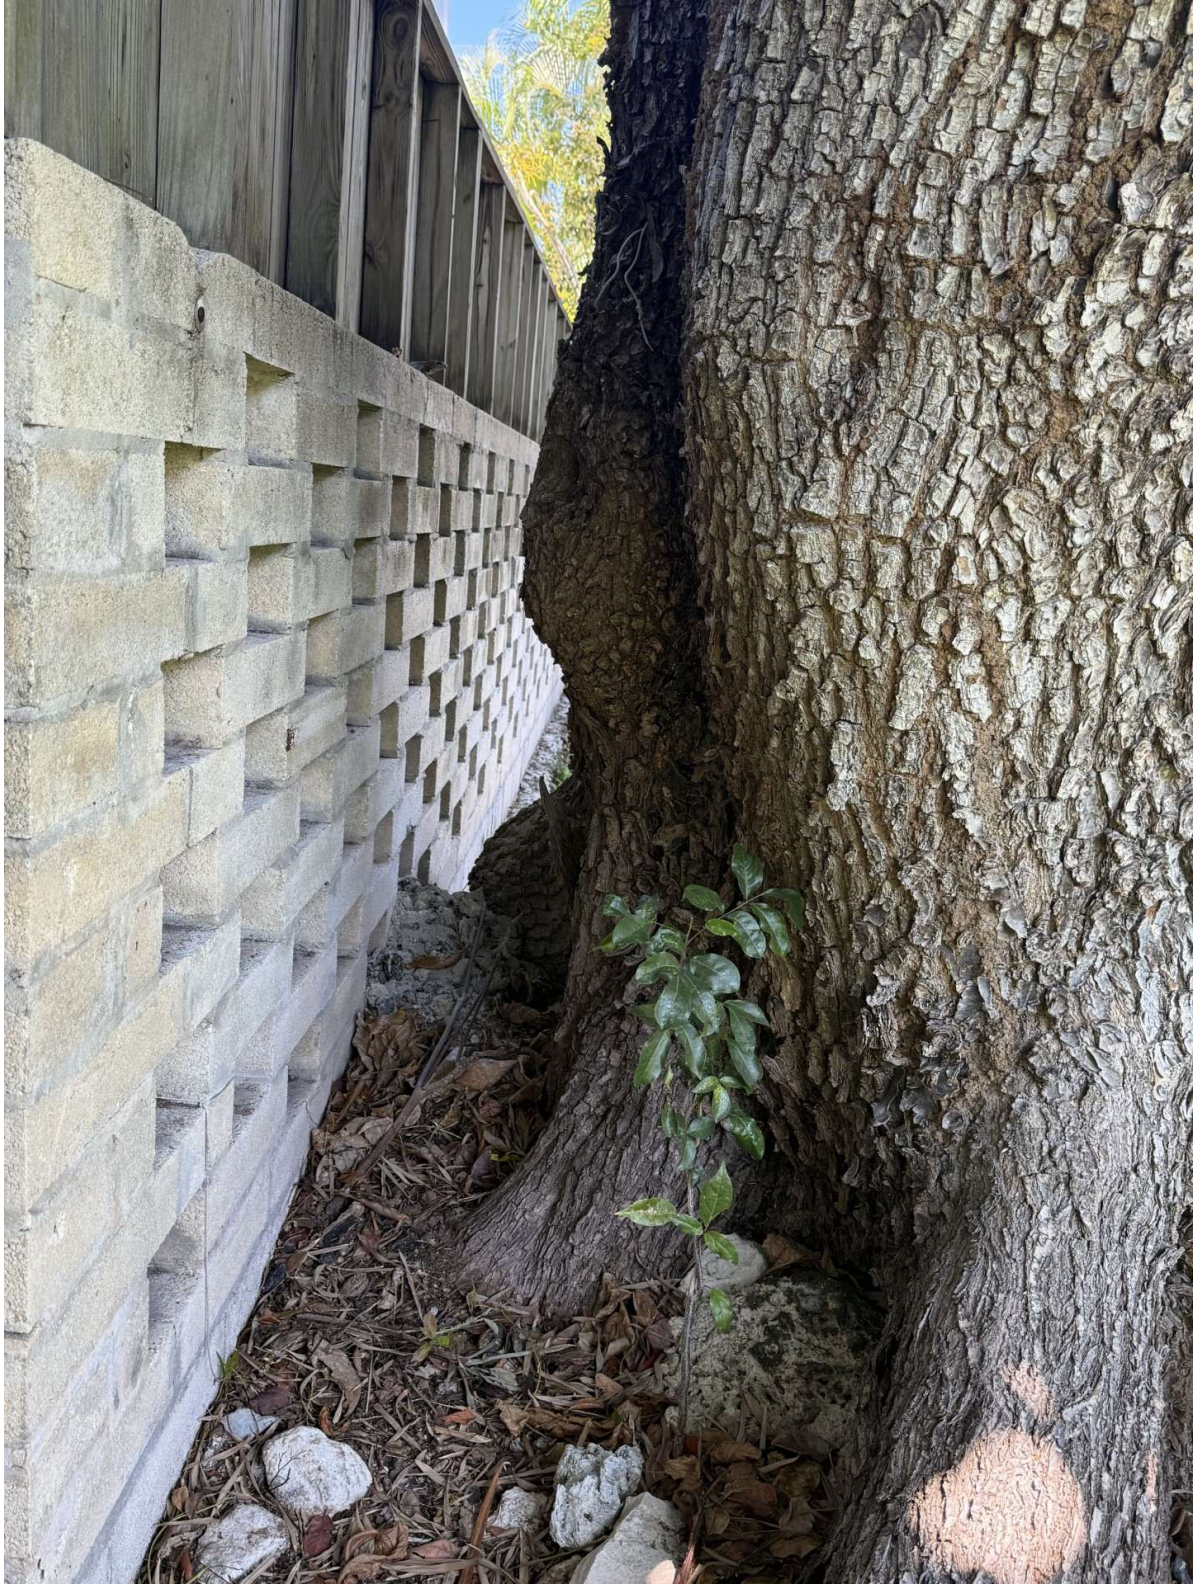
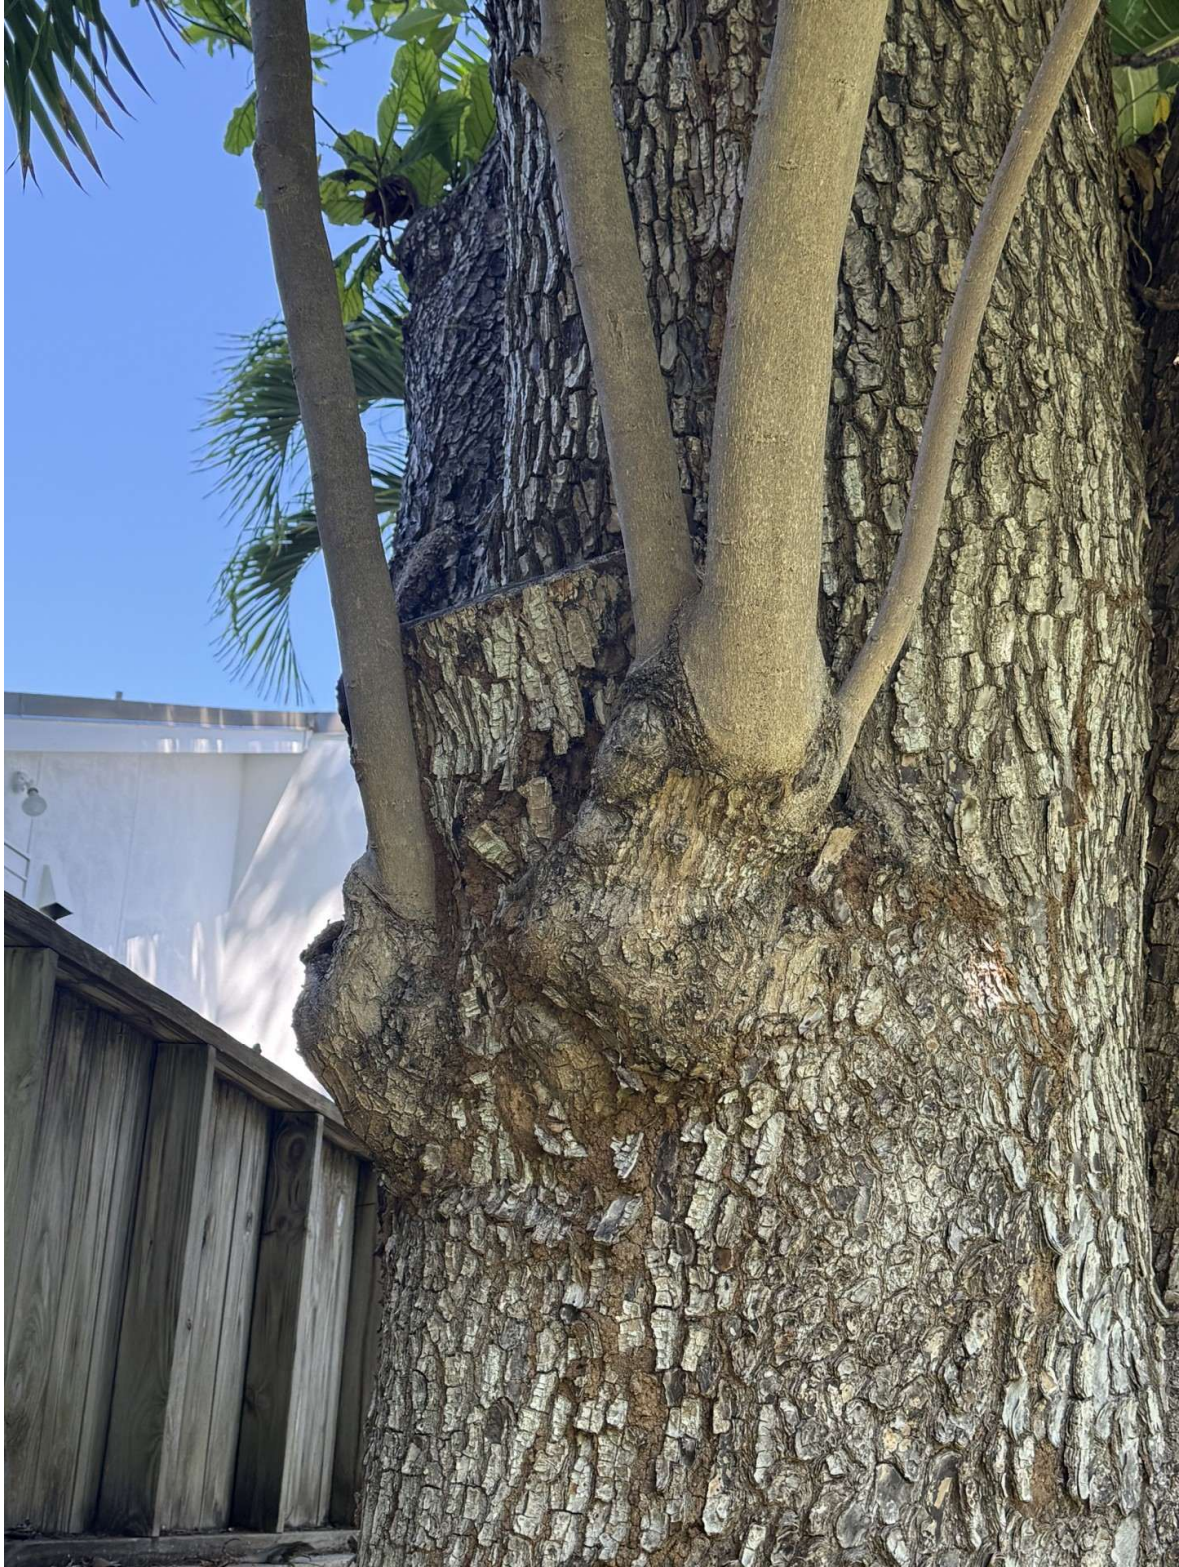
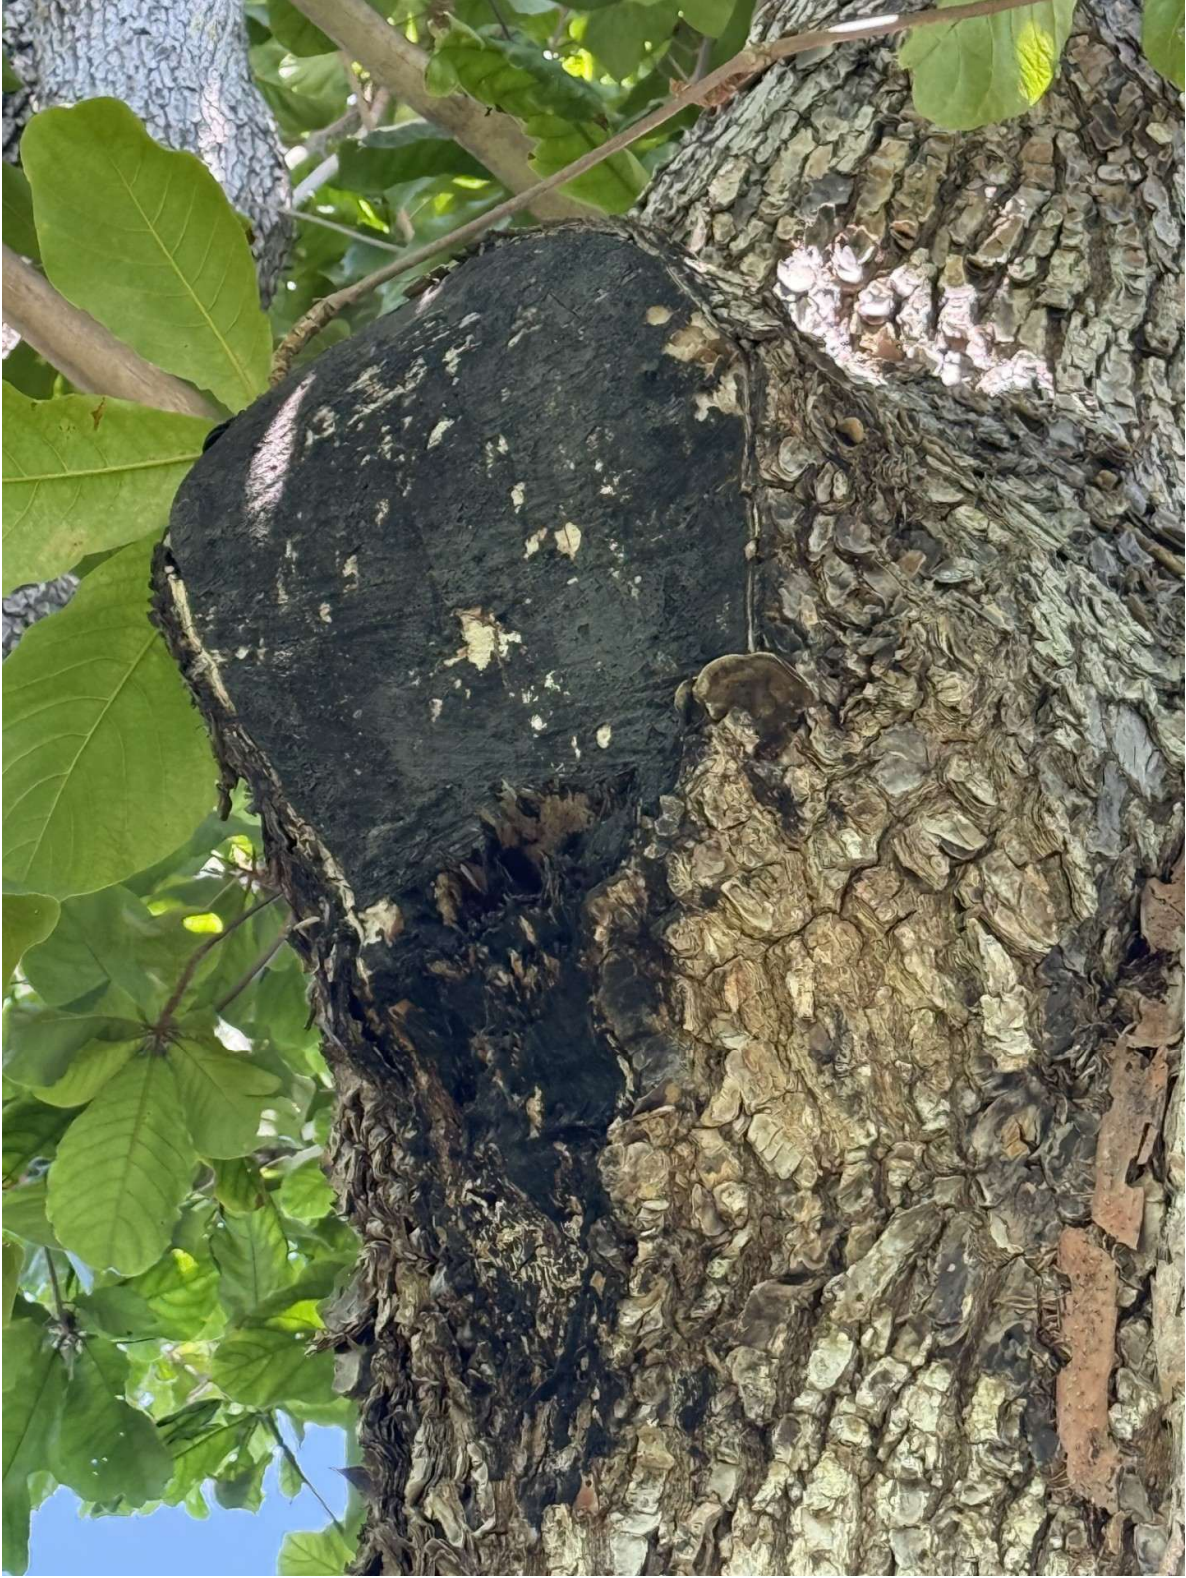
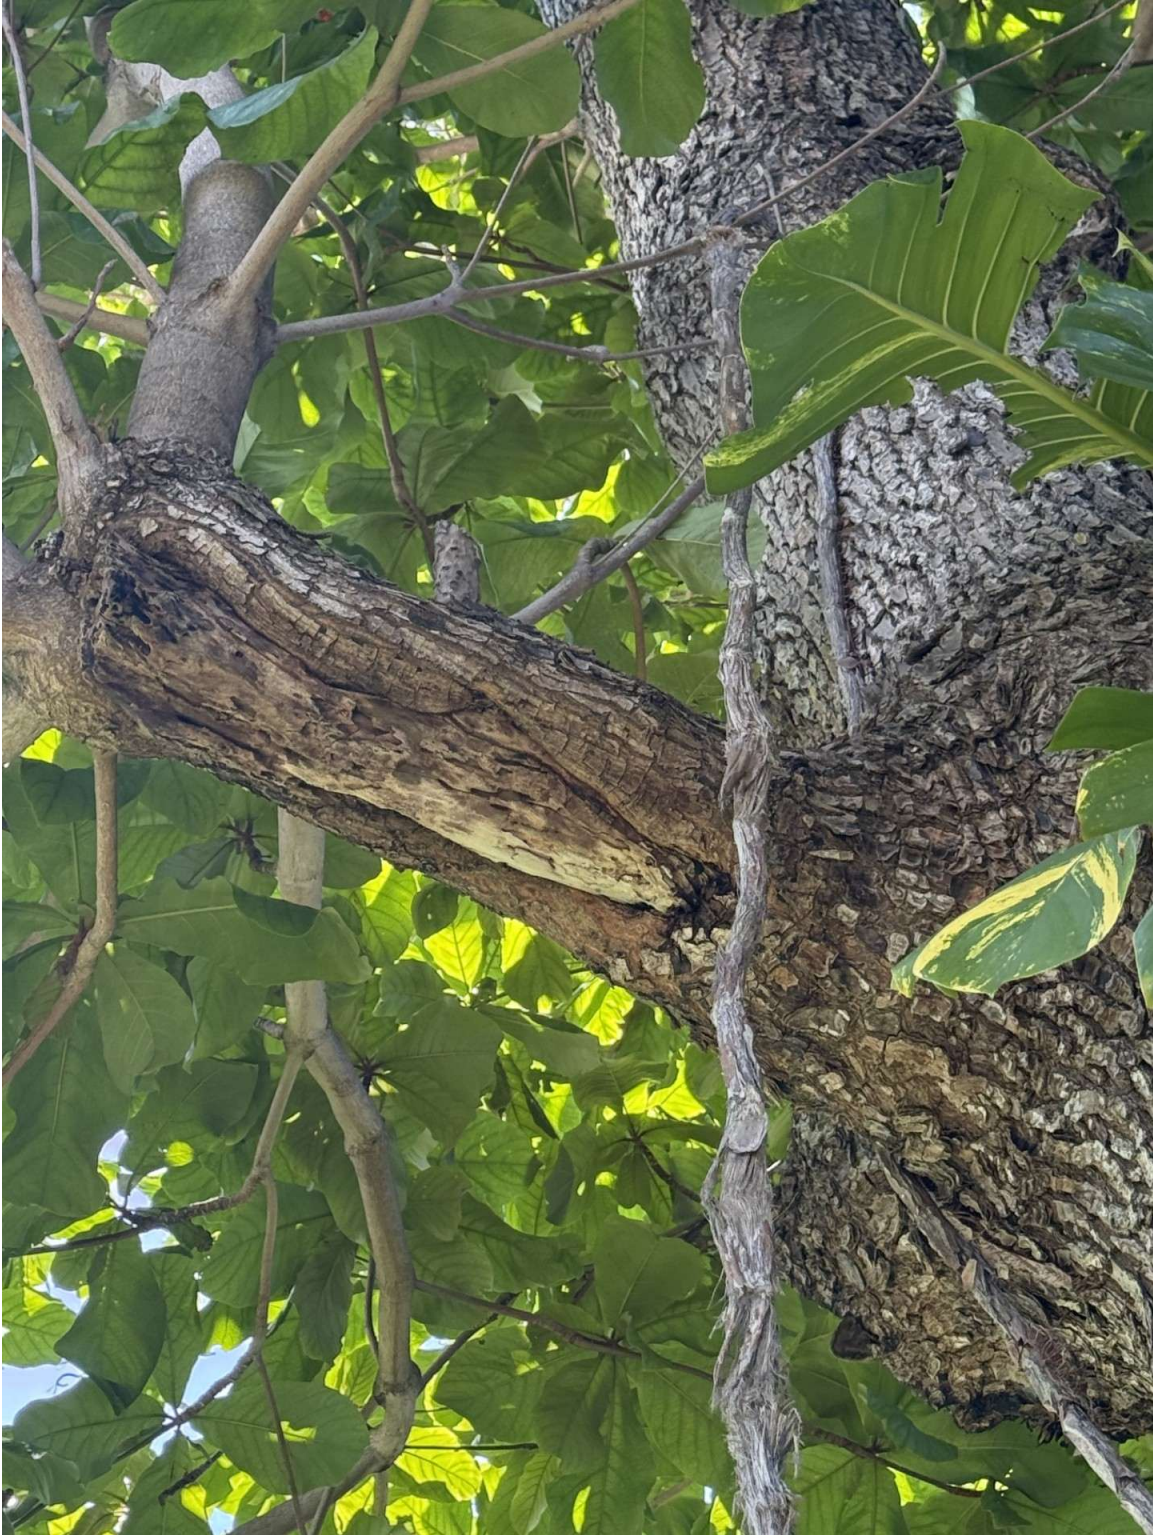
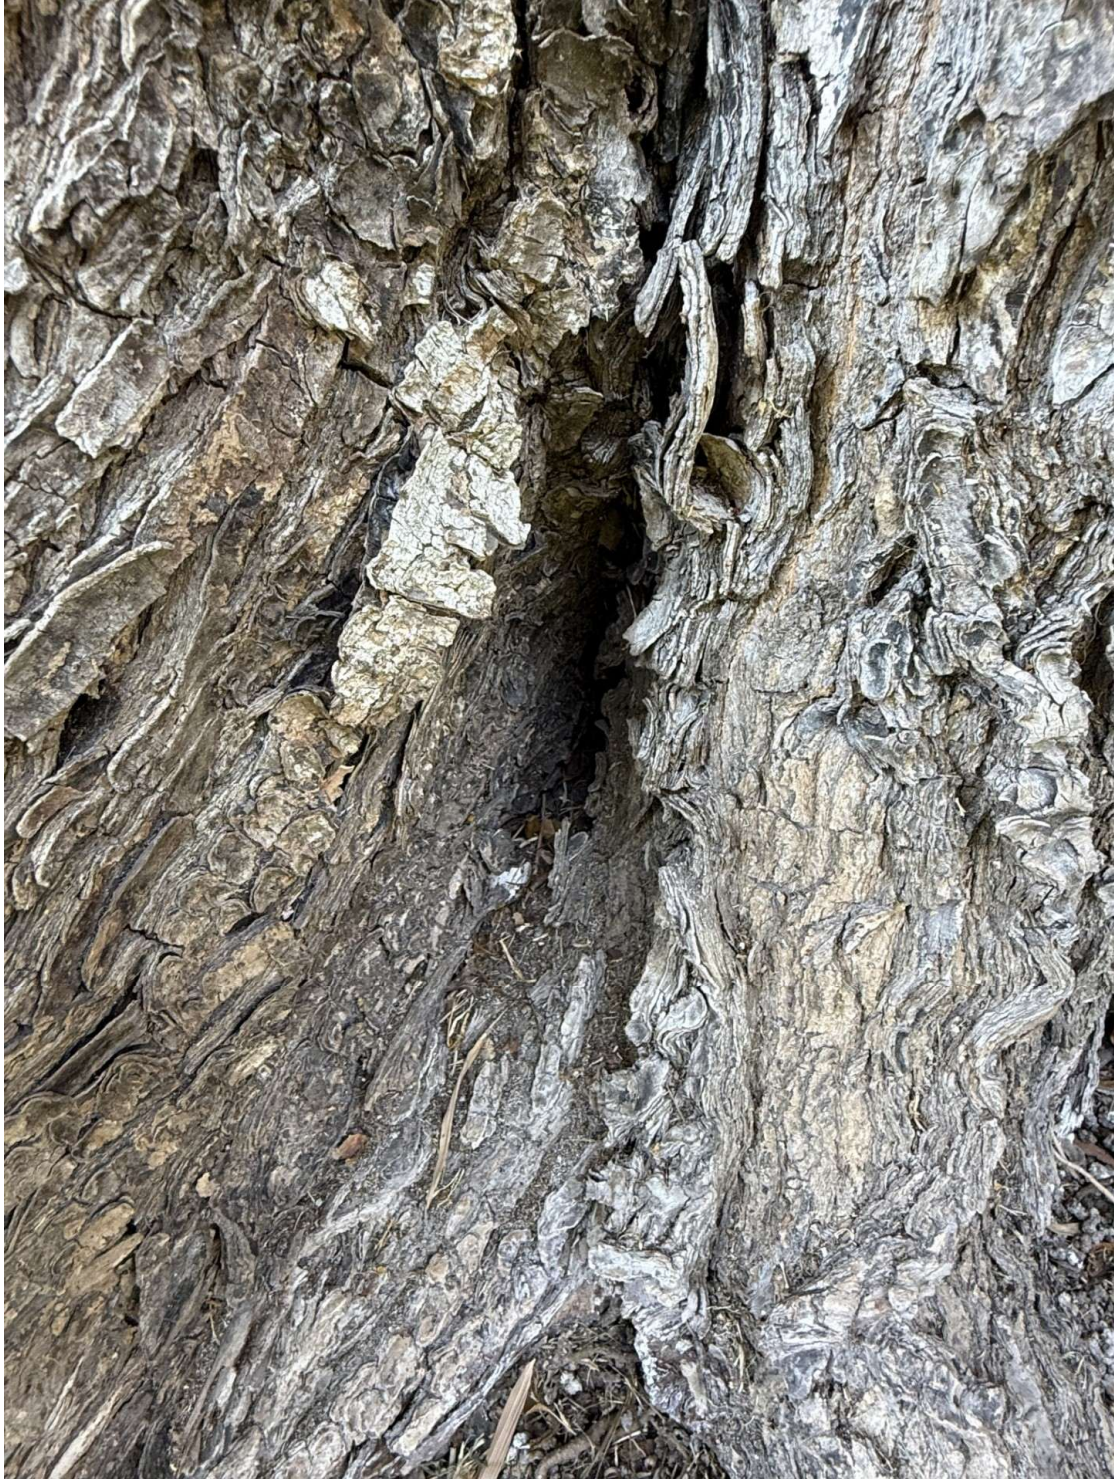
**Tree #2**

**Condition: 60%**

**Tree number two is located within the backyard and is growing directly adjacent to a brick and wooden fence system. The tree possesses a large buttressing root system and codominant stems, both of which contribute to structural concerns within the confined growing area. The canopy structure is highly atypical for a healthy Tropical Almond tree, displaying excessive vertical growth and evidence of repeated**

**pruning from neighboring properties. Significant dieback is present throughout the canopy, suggesting chronic stress and the possibility of systemic decline or pathogenic involvement. Small cavities near the base of the trunk further increase the potential for infestation and internal decay and may help explain the reduced vigor observed throughout the canopy. Based upon the cumulative structural defects, site conflicts, and indicators of decline present in both trees, mitigation and removal warrant consideration.**

**Recommended Mitigation: 14.7 Caliper Inches**
