**TREE COMMISSION TREE REMOVAL REPORT  
CITY of KEY WEST**

**PROPERTY: 1430 Grinnell St.**

**APPLICATION NUMBER: T2026-0103**

**REQUEST: The applicant is requesting removal of (2) Tropical Almond trees.**

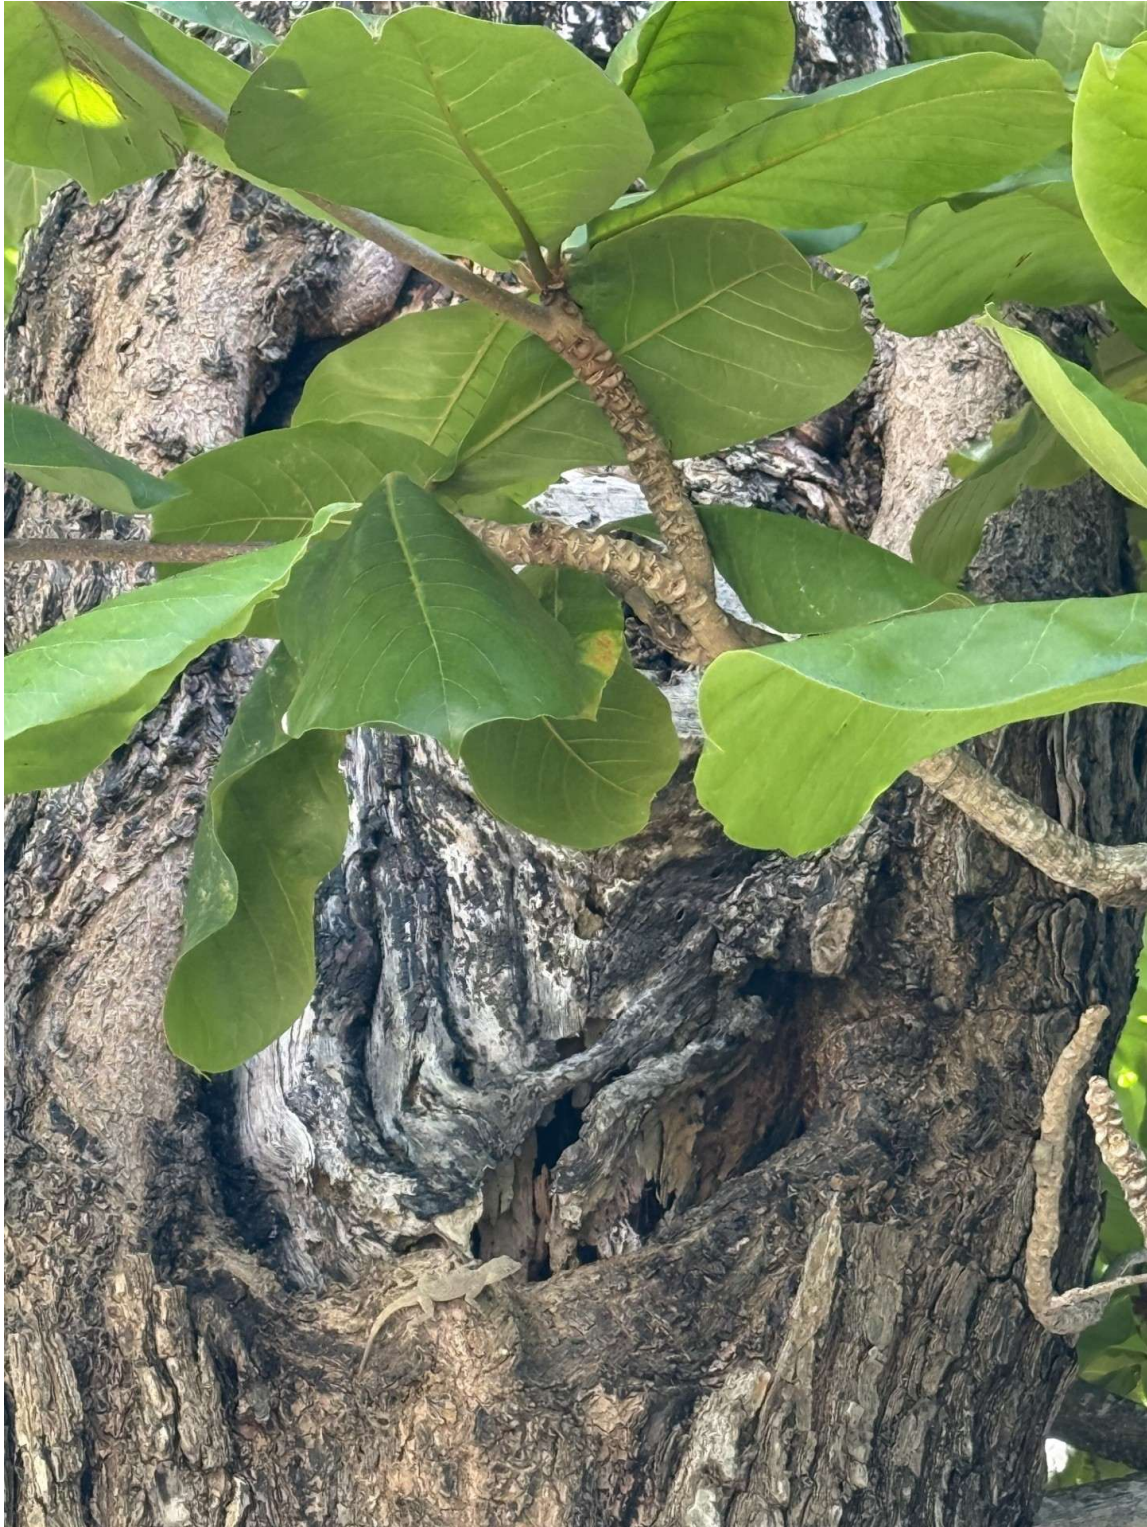
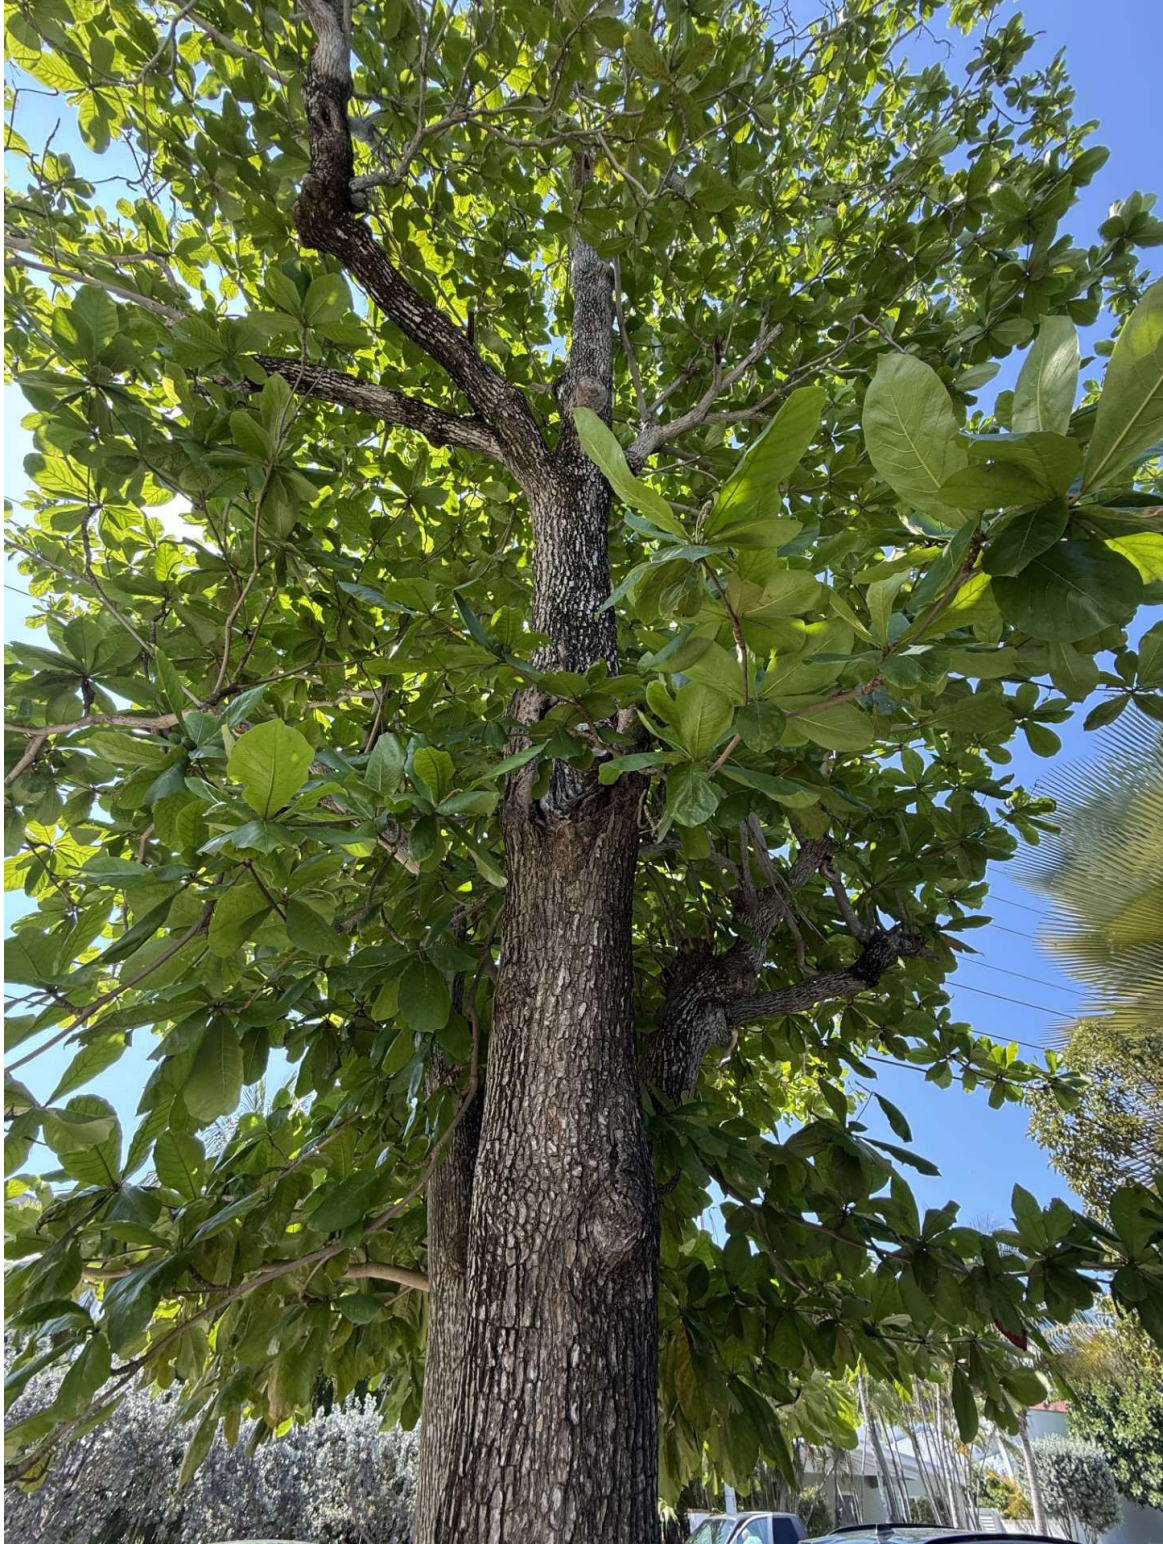
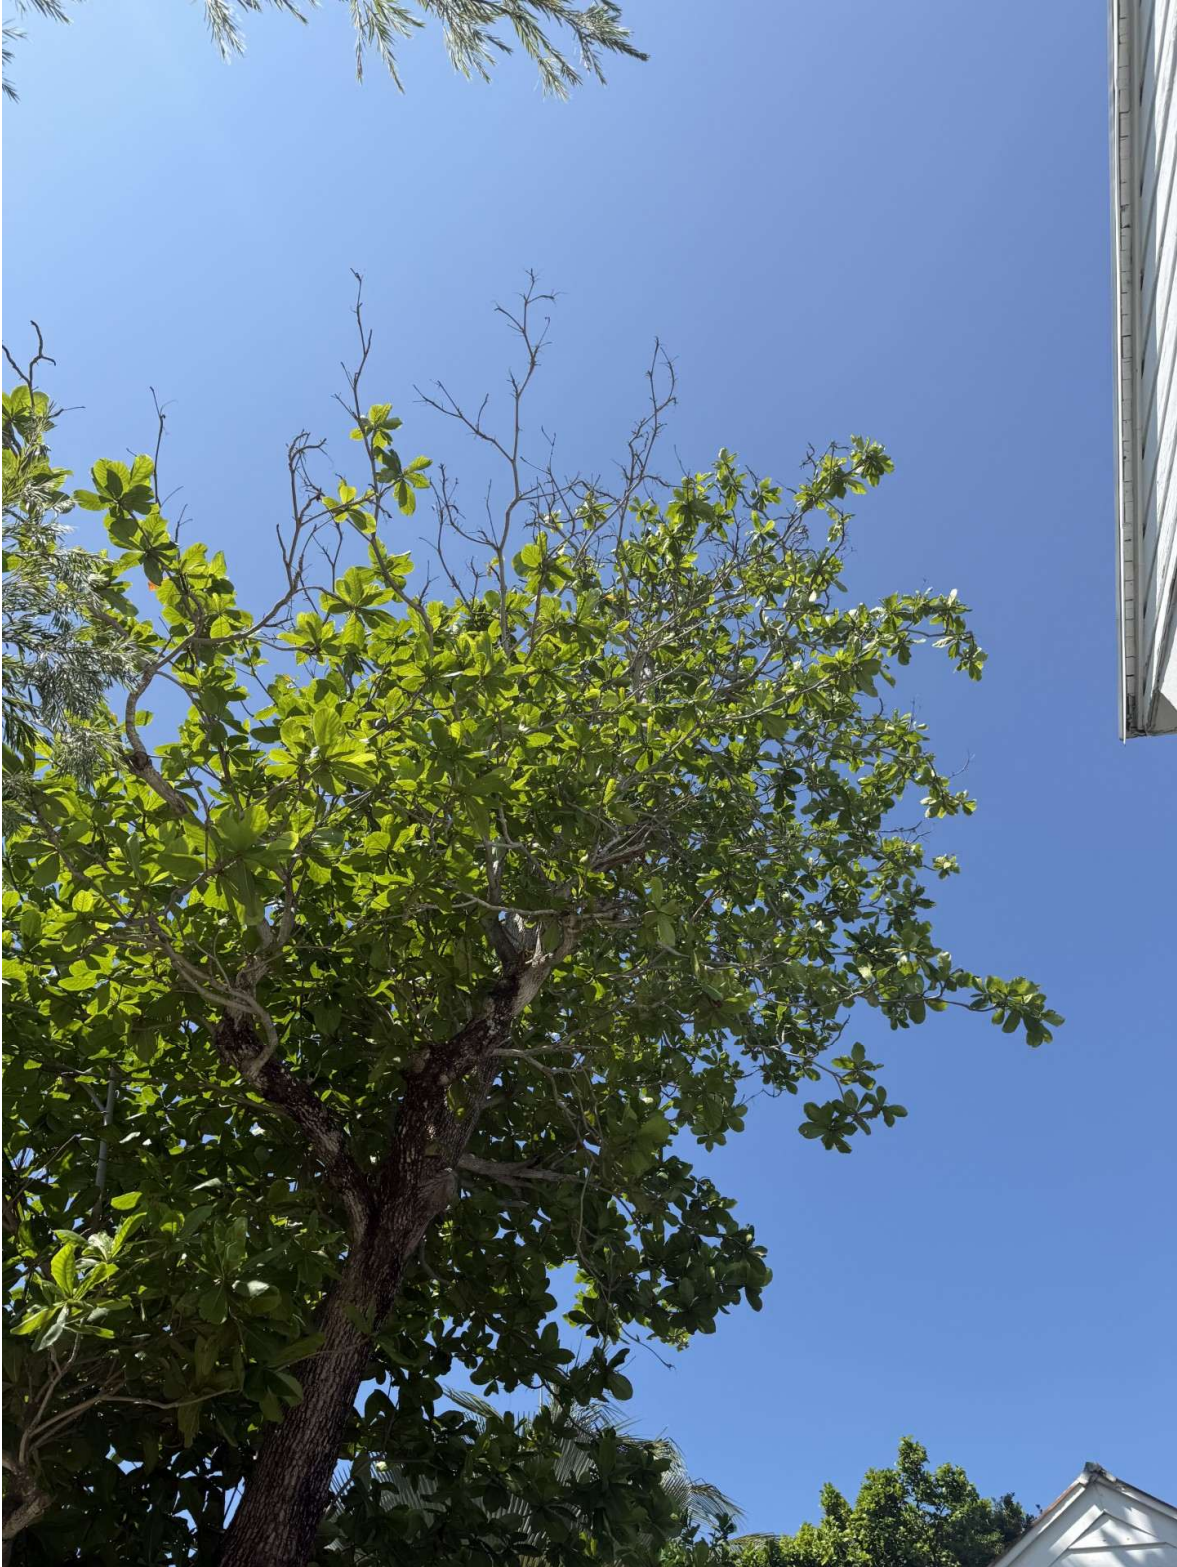
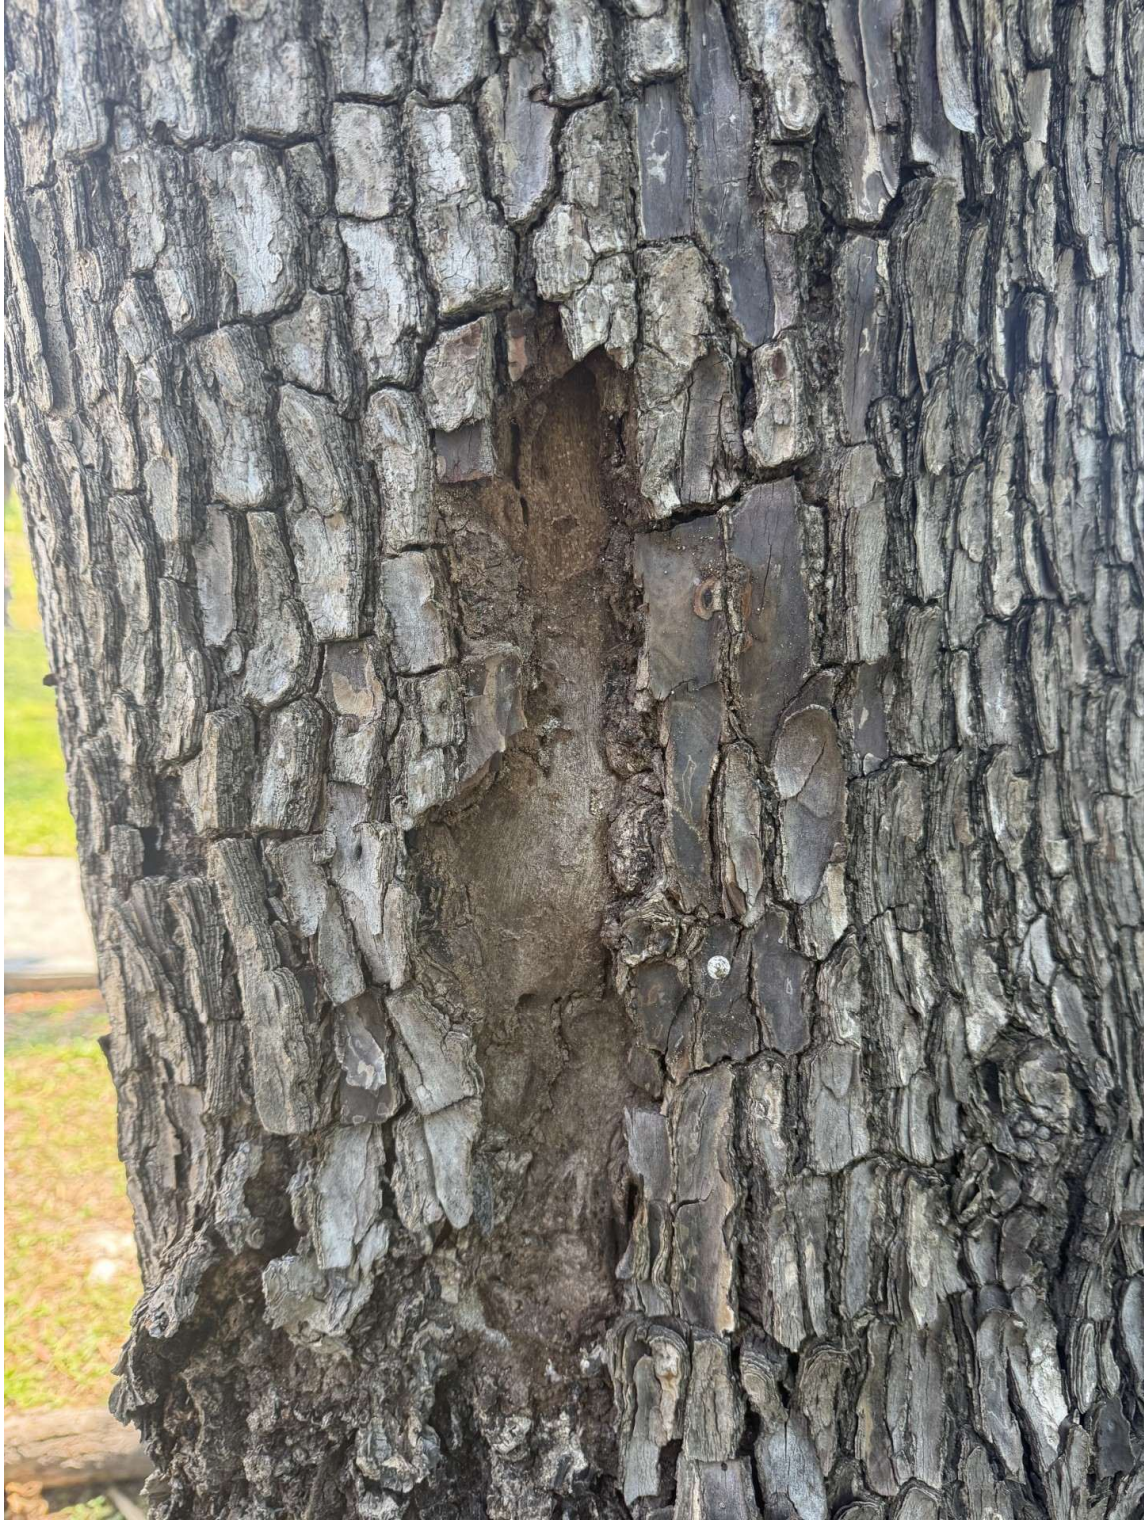
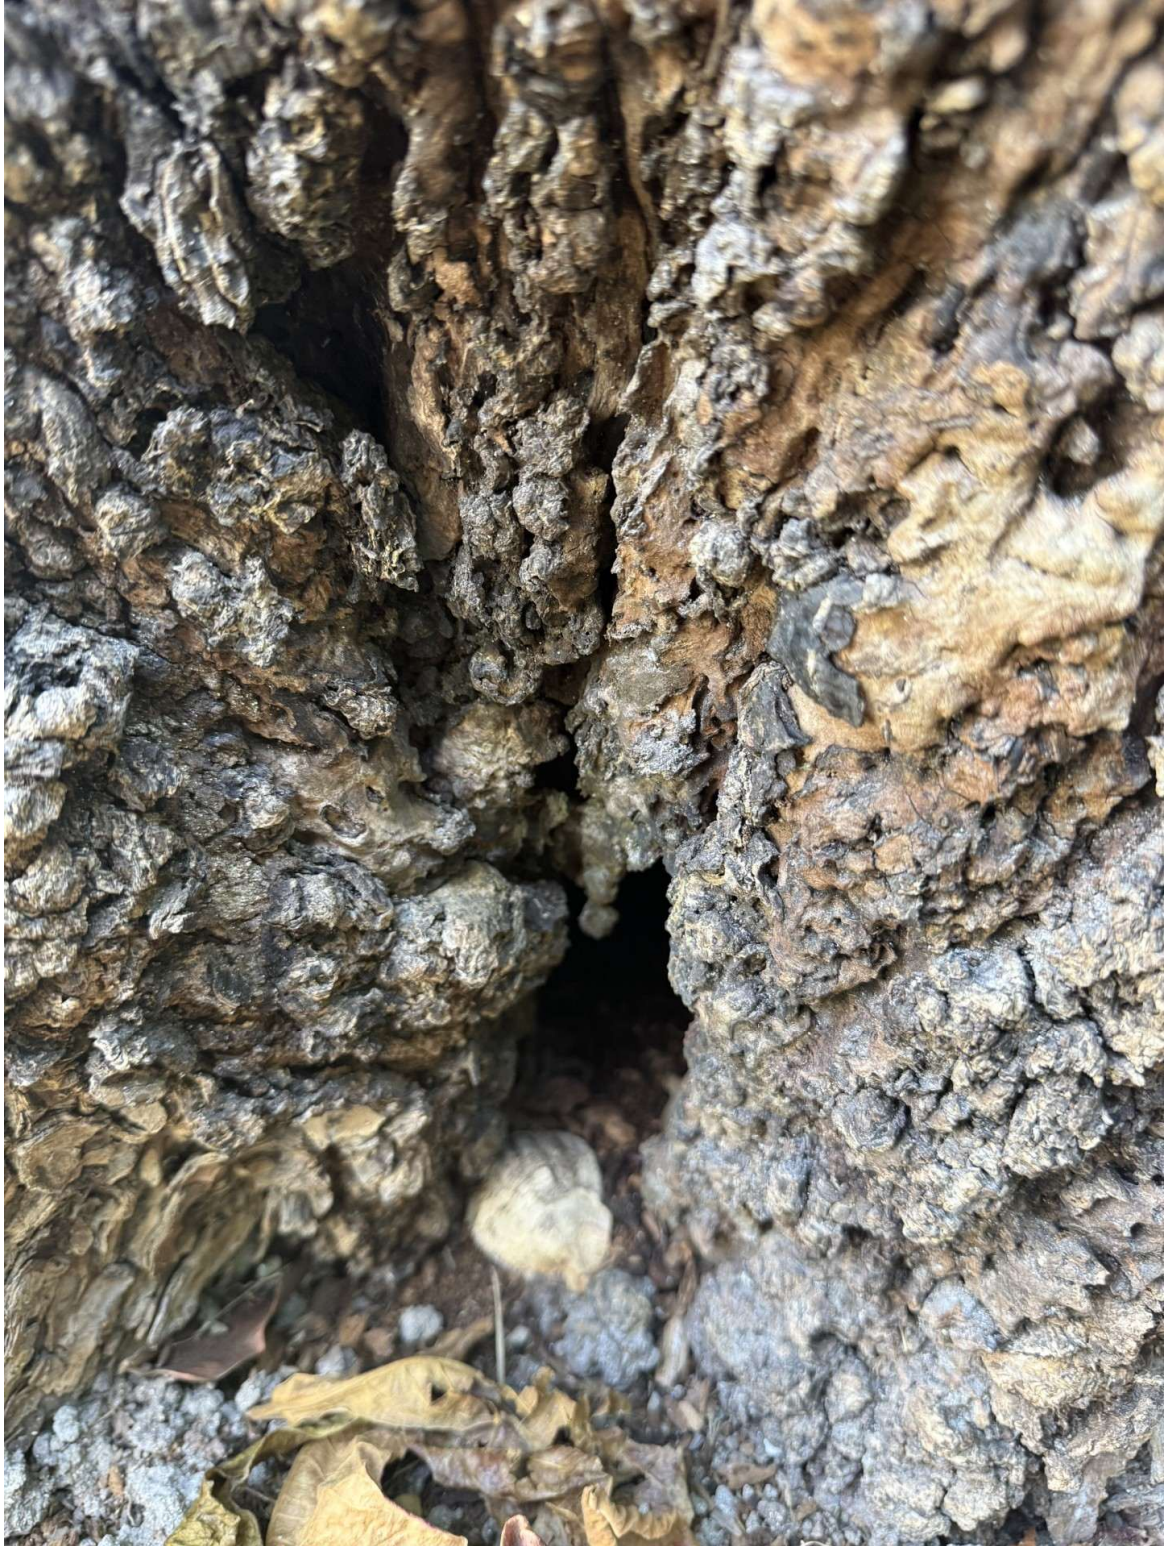
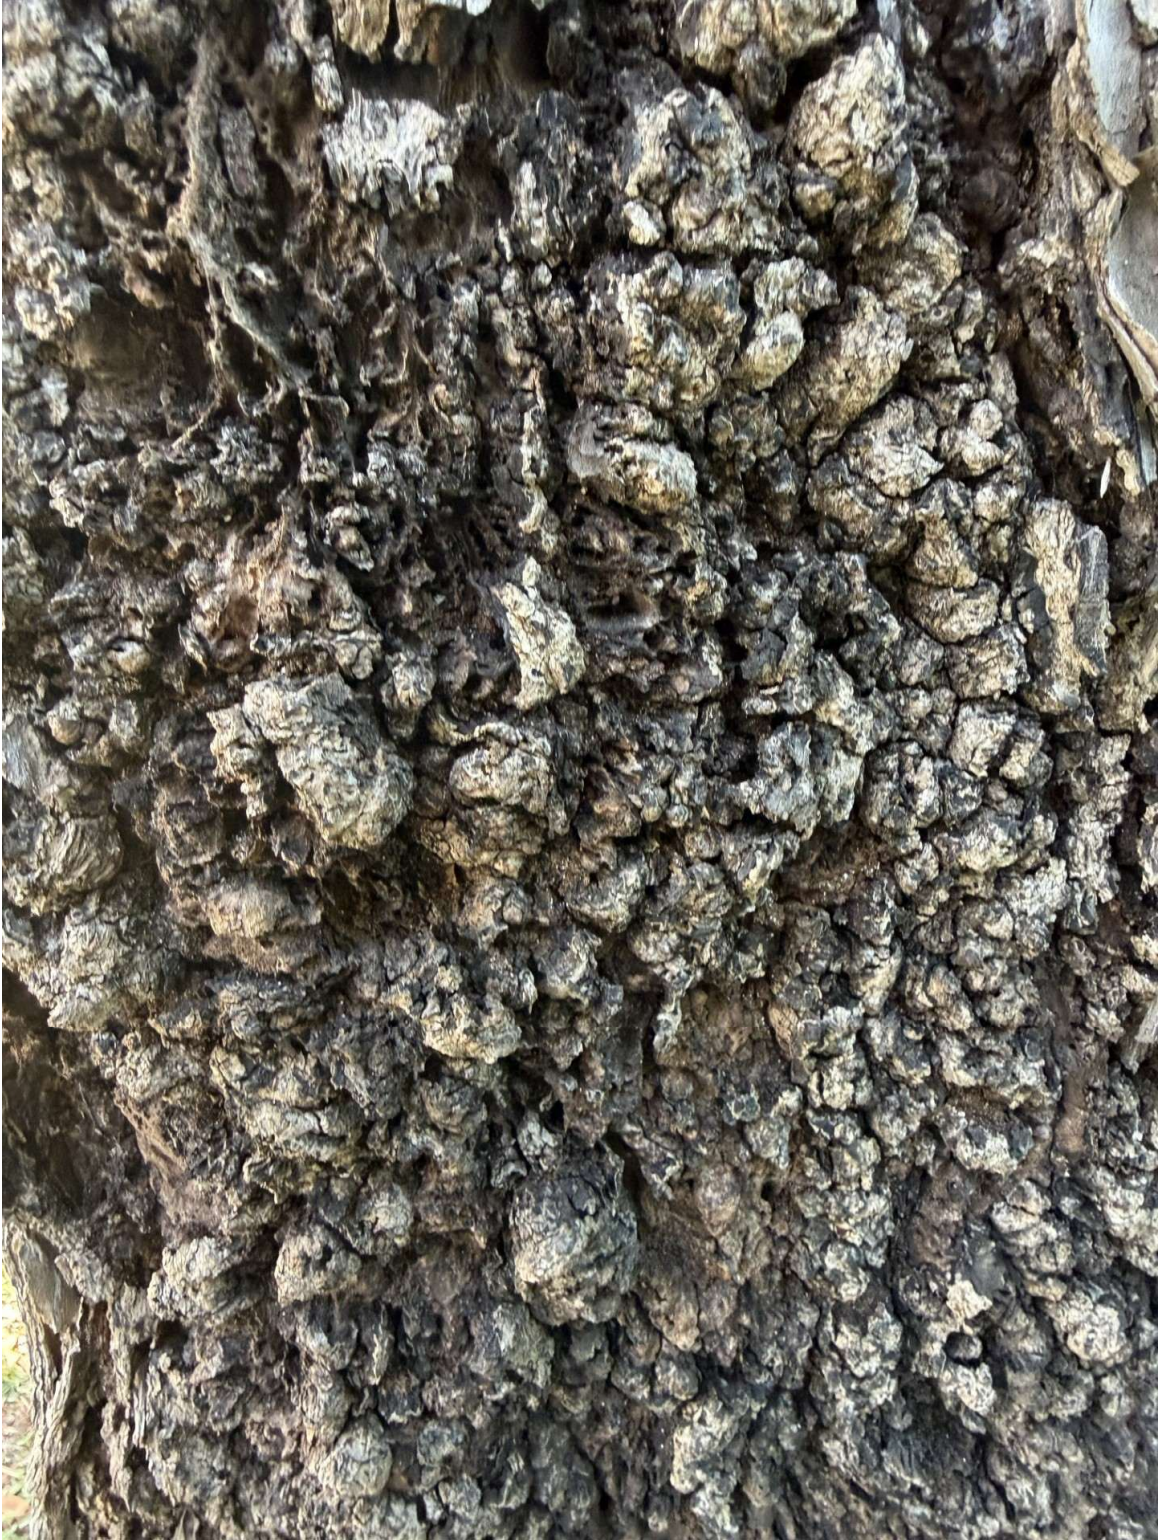
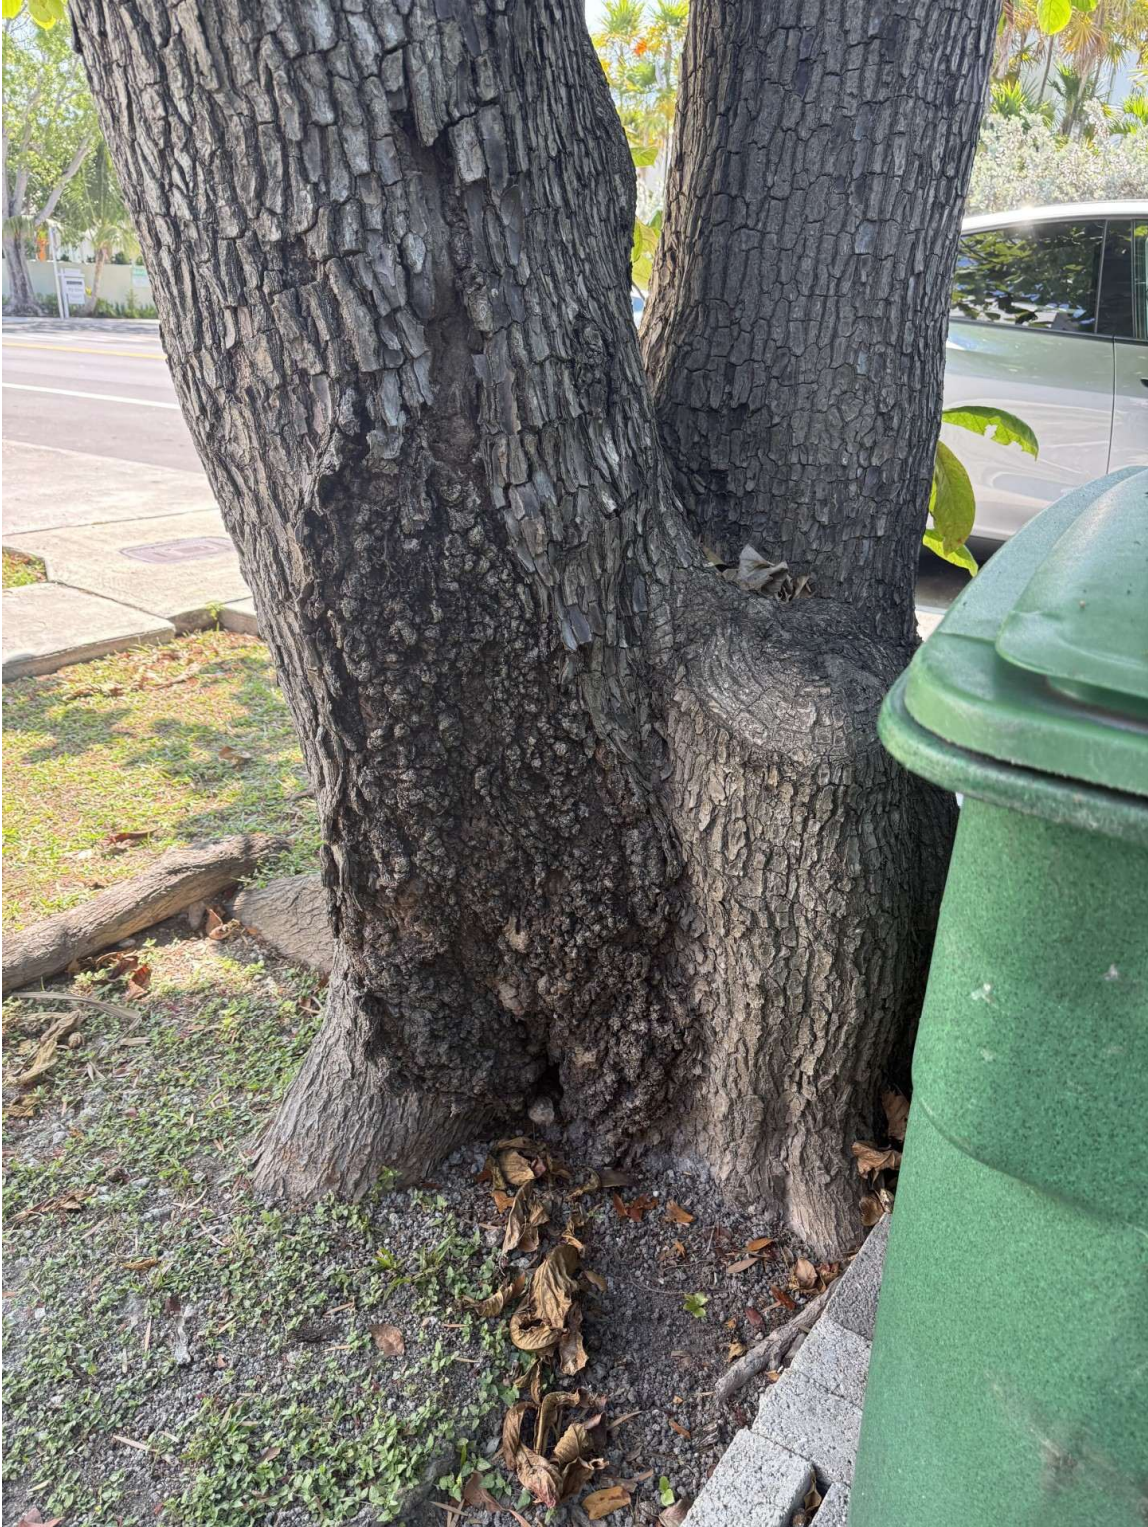
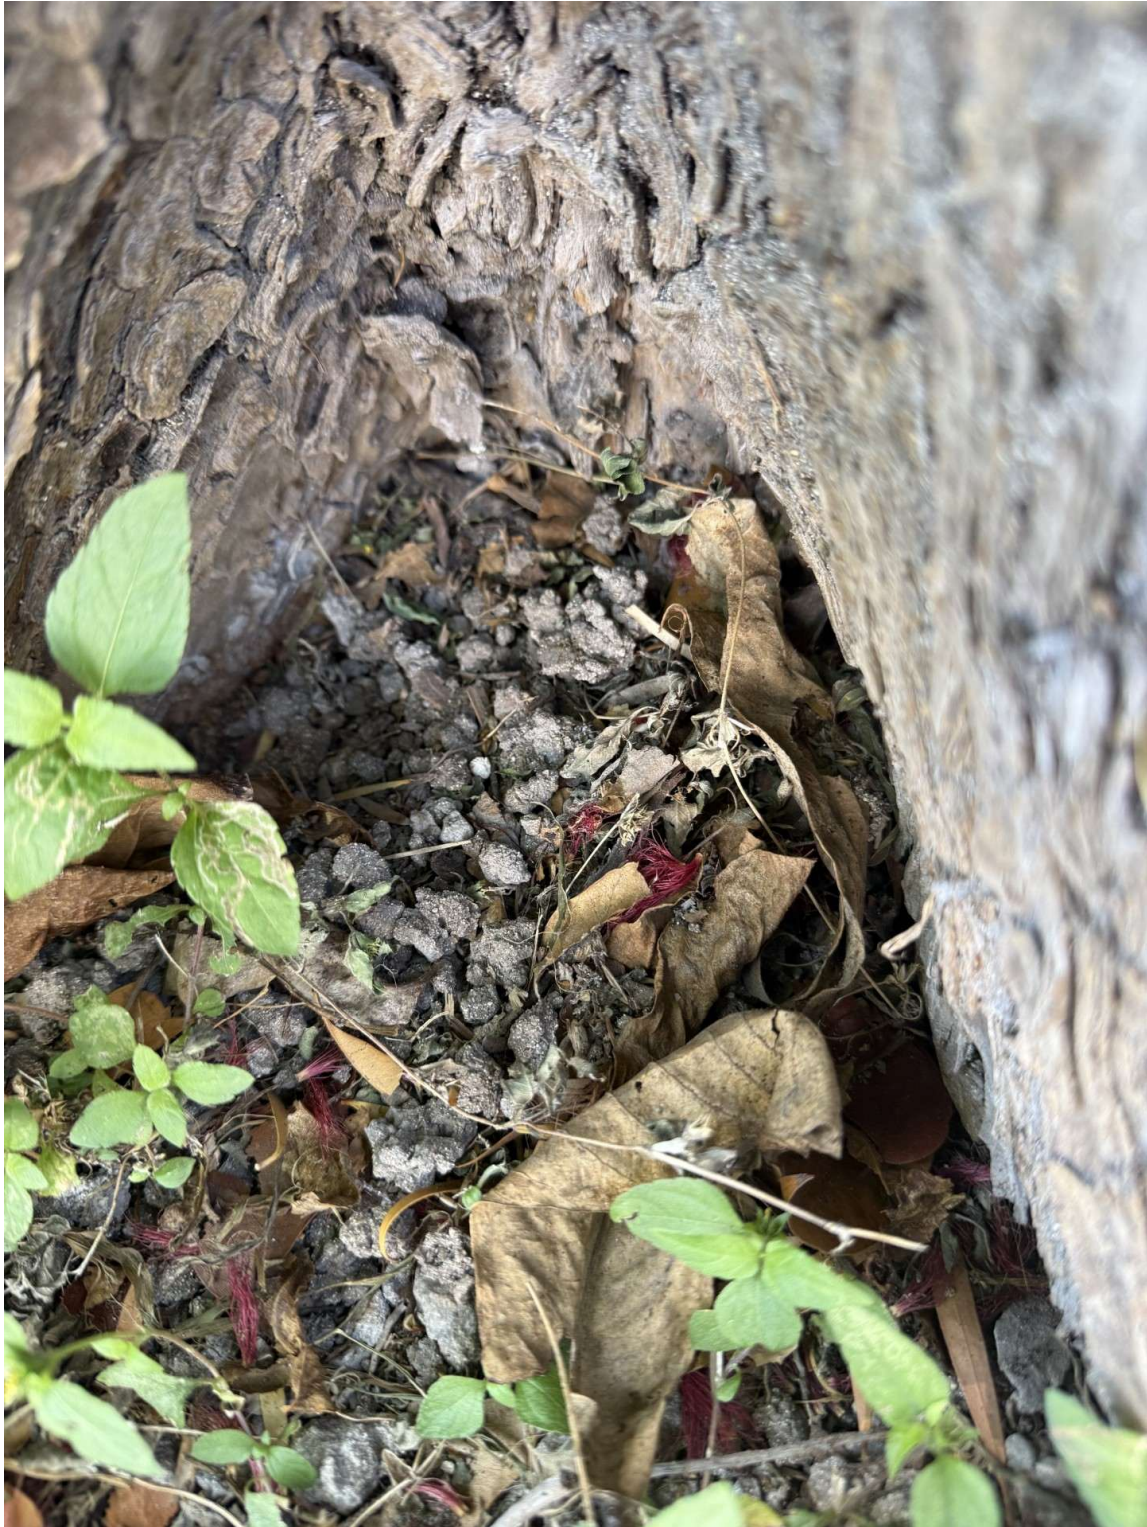
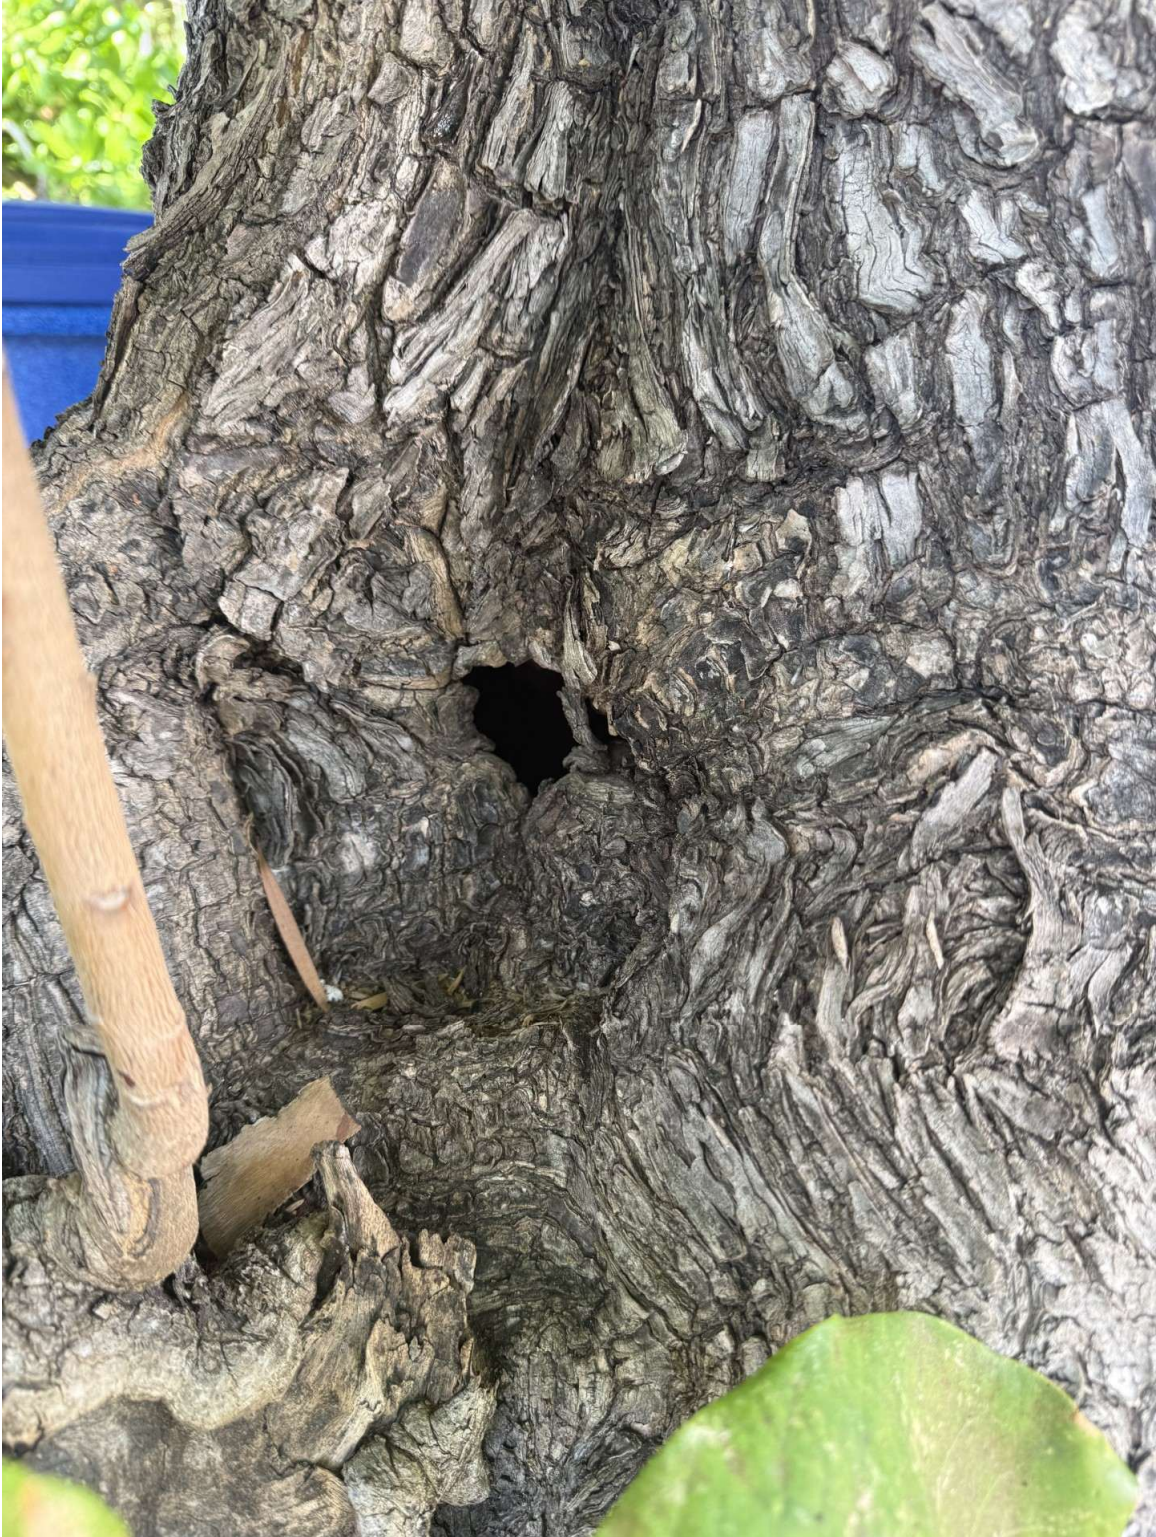
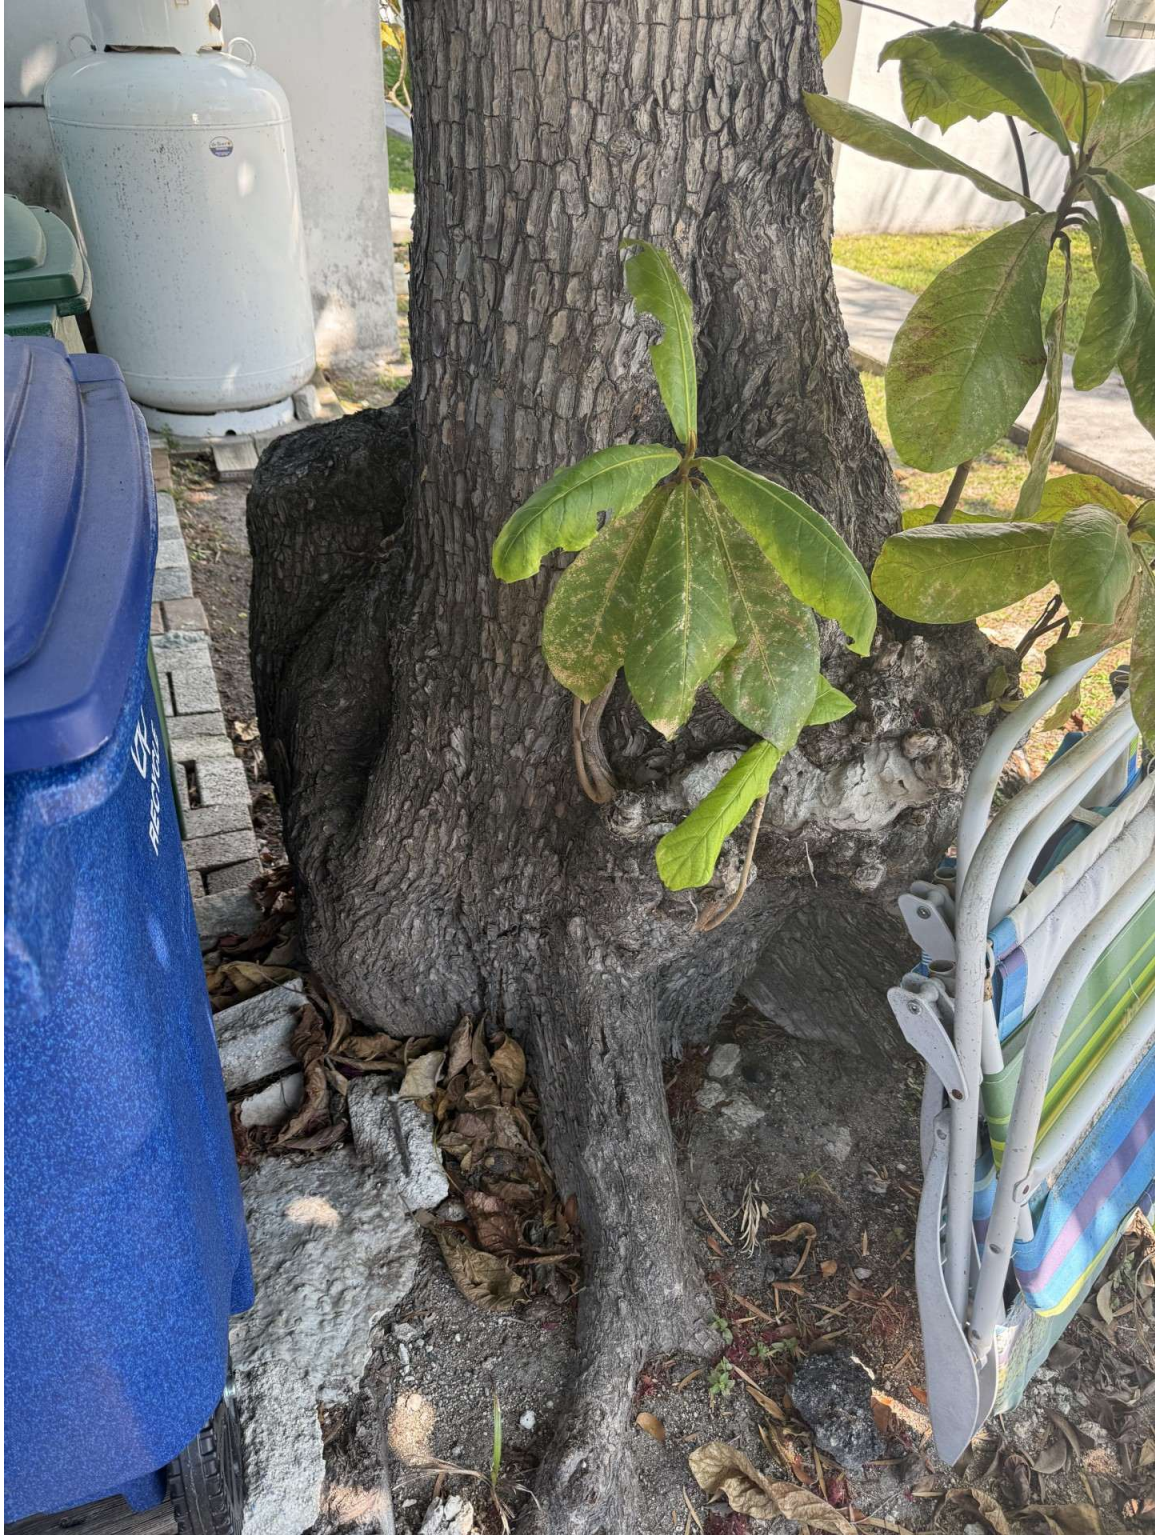
**Tree #1**

**Condition: 60%**

**The subject trees consist of two mature Tropical Almond trees (Terminalia catappa) measuring approximately 31 inches and 50 inches DBH respectively. Both trees are estimated to have a location rating of 60% and a condition rating of 60% due to multiple structural and environmental deficiencies. Tree number one is located in a highly visible area along Flagler Avenue but is positioned unacceptably close to overhead communication and primary electrical service lines. Repeated utility pruning has resulted in poor pruning cuts and compromised canopy development, conditions commonly associated with long-term structural decline. The tree also exhibits codominant stems at the base and appears to have an abnormal root structure due to severe site restrictions caused by adjacent sidewalks and a concrete driveway.**

**Several indicators of possible infestation and internal decay are present on Tree number one. Near the base of the trunk is a cavity exhibiting signs consistent with insect activity and/or wood decay, including suspected termite or insect frass outside the opening. Adjacent bark tissue above the cavity appears blistered and is actively sloughing away from the trunk. Additional areas of bark loss elsewhere on the tree expose underlying tissue that appears compromised by decay or infestation. These symptoms collectively raise concern regarding the long-term structural integrity and health of the tree.**

**Recommended Mitigation: 4 Caliper Inches**
