TREE COMMISSION TREE REMOVAL REPORT CITY of KEY WEST

PROPERTY: 2400 N Roosevelt BLVD

APPLICATION NUMBER: T2025-0265

REQUEST: The applicant is requesting removal of (3) Gumbo Limbo Trees & (1)

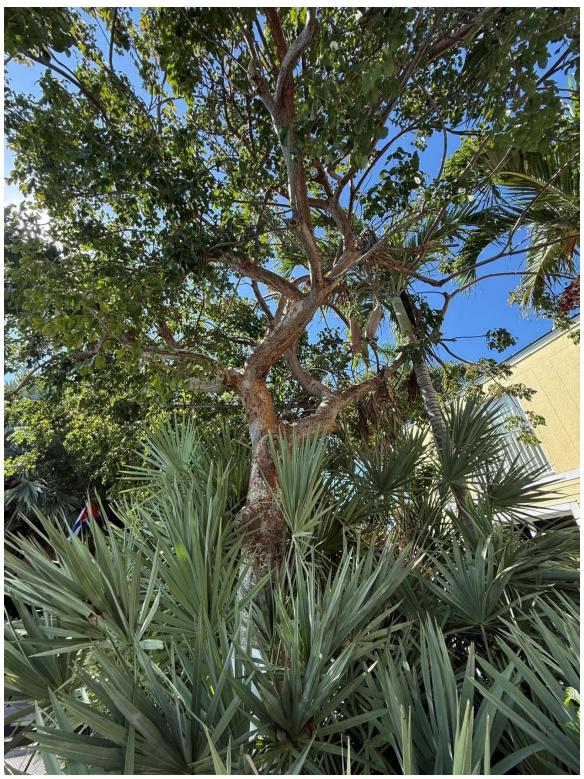
Clear views of Gumbo Limbo #4 are obscured by landscaping

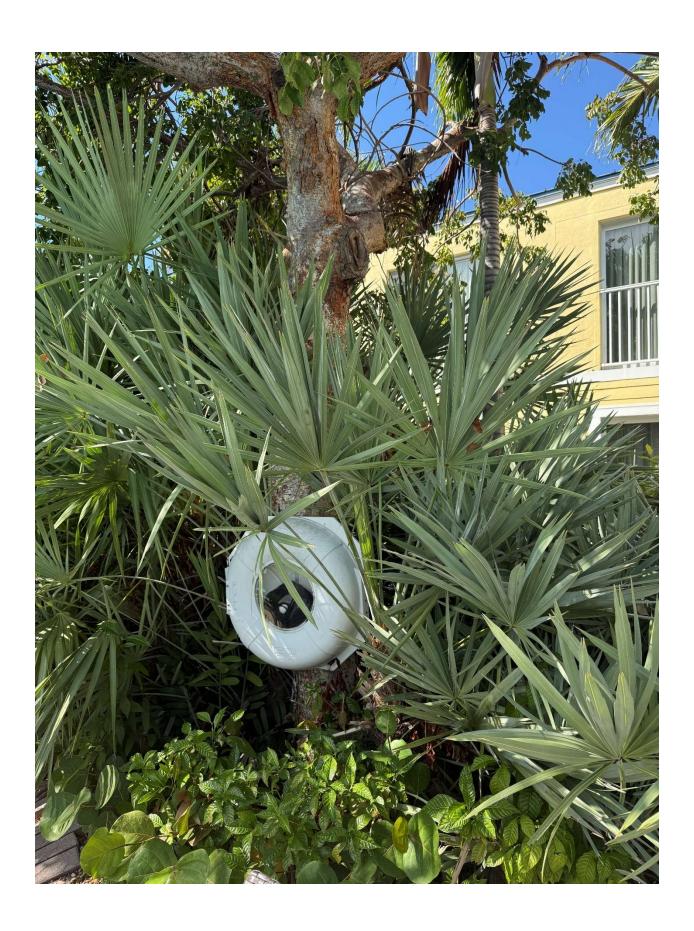
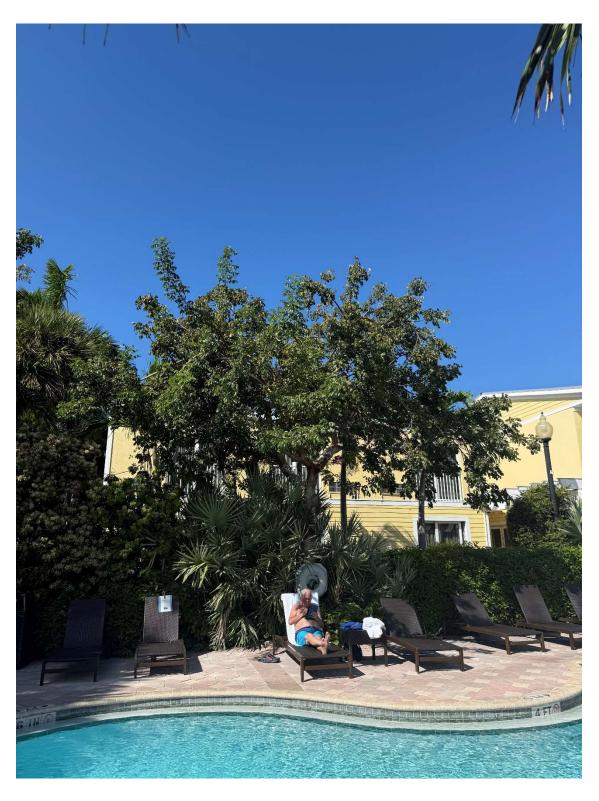
Gumbo Limbo #4 another canopy tree crammed into an insufficient planter bed with root compaction on both sides.

Diameter: 13"

Location: 50%

Species: 100%

Condition: 50%

Value: 66.6%

Recommended Mitigation: 8.5 Caliper Inches

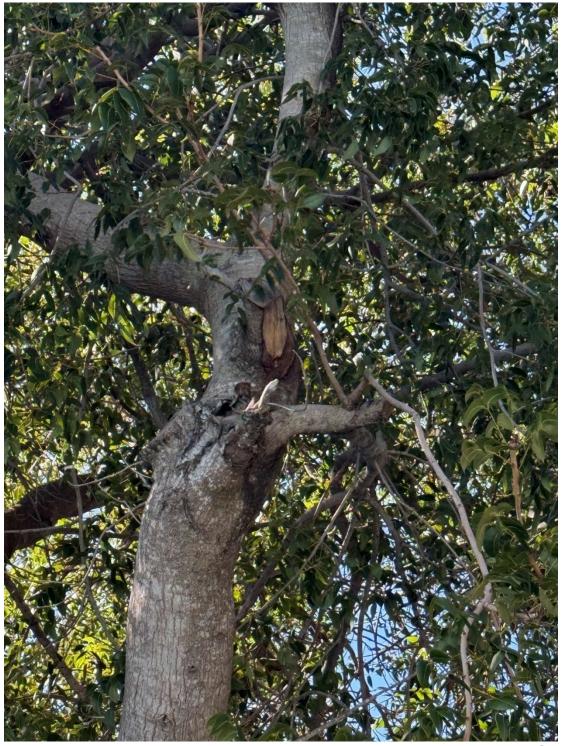
Mahogany Tree #3 has not been given proper bed space nor air space for healthy canopy development and branch structure.

Diameter: 12"

Location: 50%

Species: 100%

Condition: 50%

Value: 66.6%

Recommended Mitigation: 8 Caliper Inches

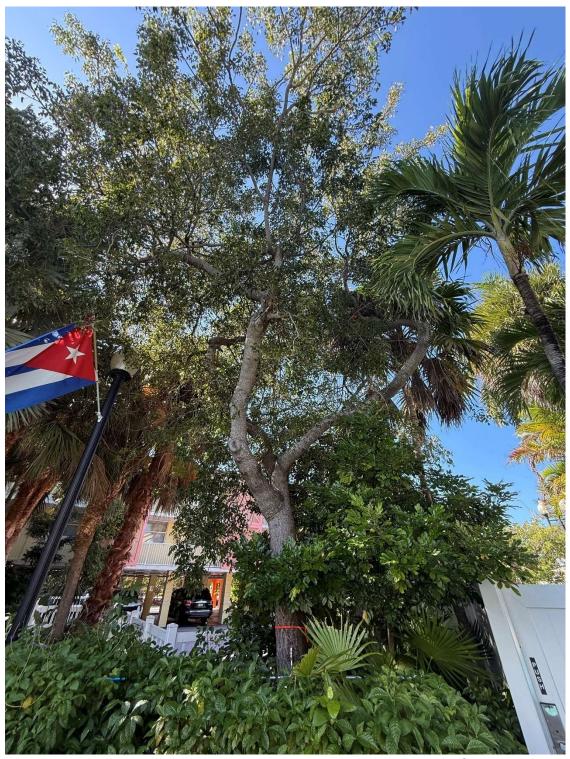
Mahogany #3 has a stunted canopy and poor growth habits for same reasons.

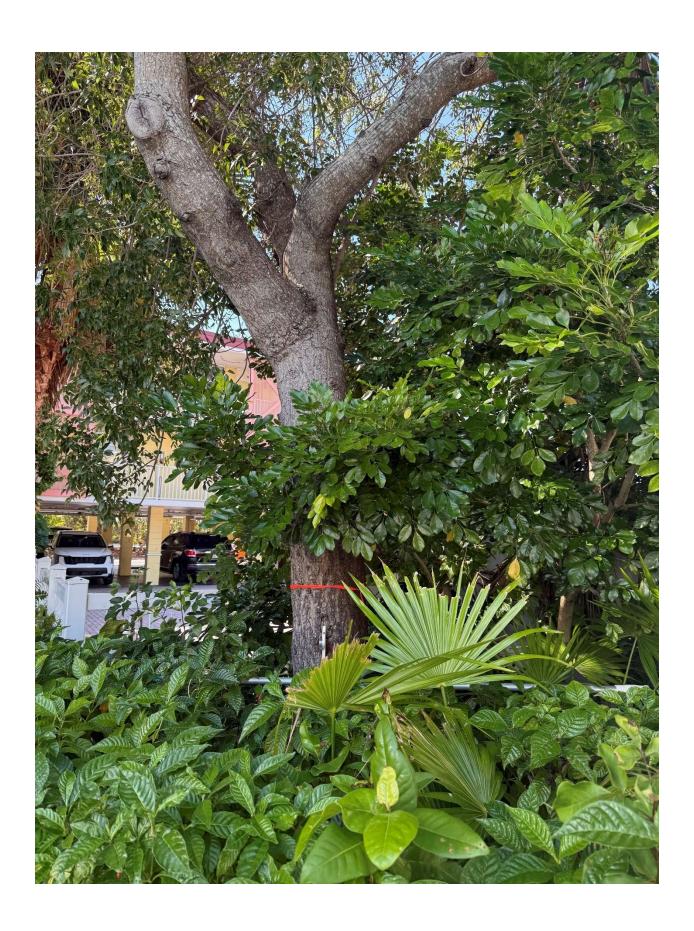
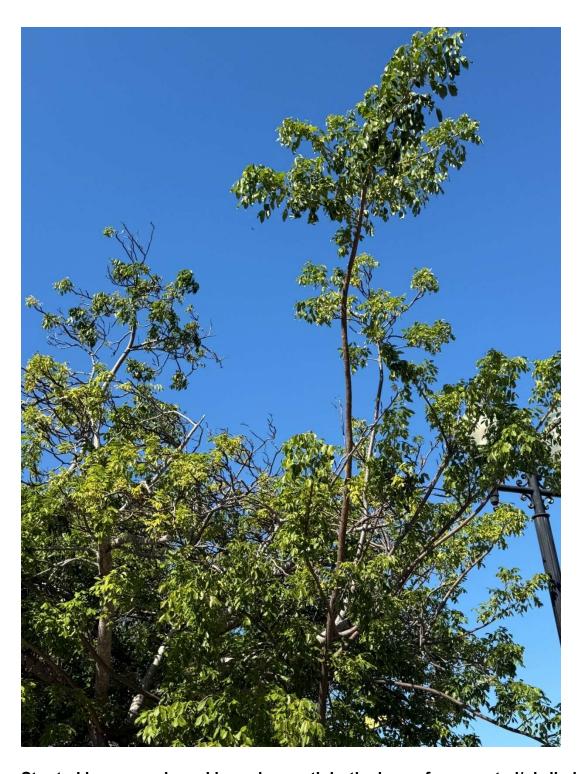
Stunted leaves, awkward branch growth both signs of compacted/girdled roots.

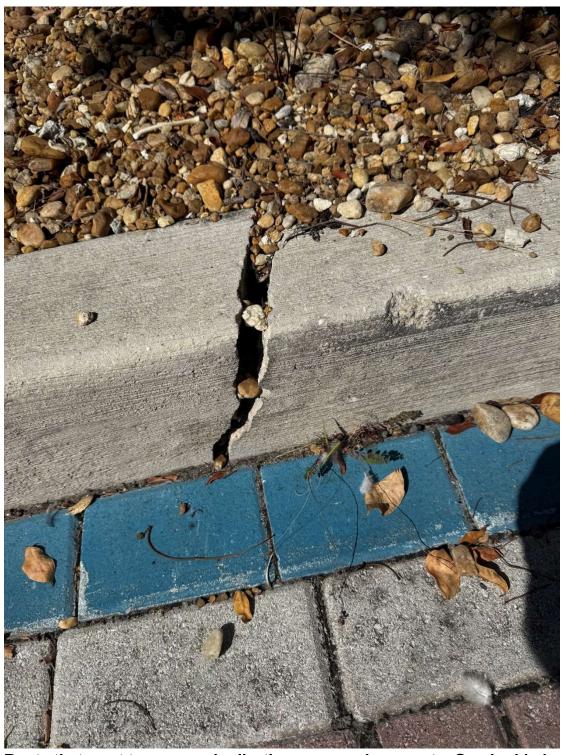
Roots that want to grow so badly, they can crack concrete. Gumbo Limbo #2

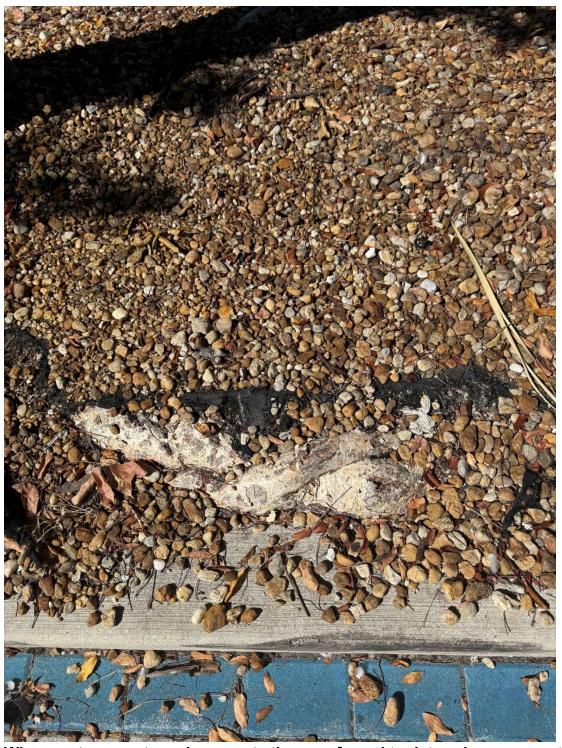
When roots cannot crack concrete they are forced to detour in a manner that is harmful to the tree's health.

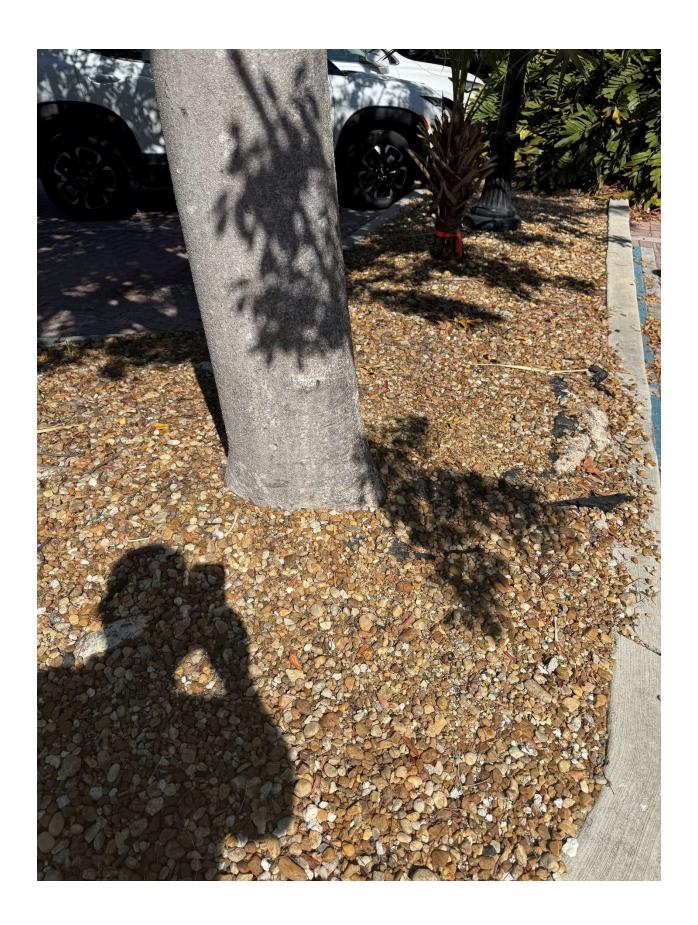
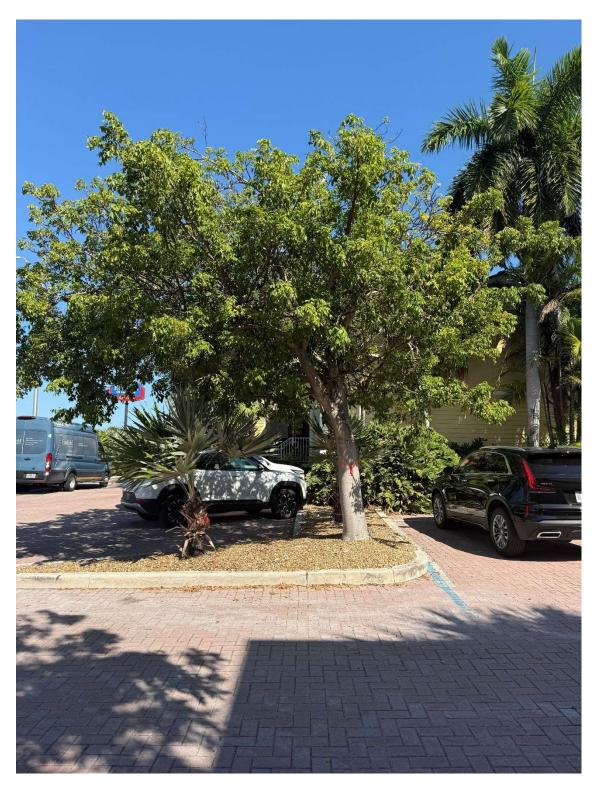
Gumbo Limbo #2 cannot grow a balanced healthy canopy due to compaction of roots and insufficient rhizosphere.

Diameter: 12"

Location: 50%

Species: 100%

Condition: 50%

Value: 66.6%

Recommended Mitigation: 8 Caliper Inches

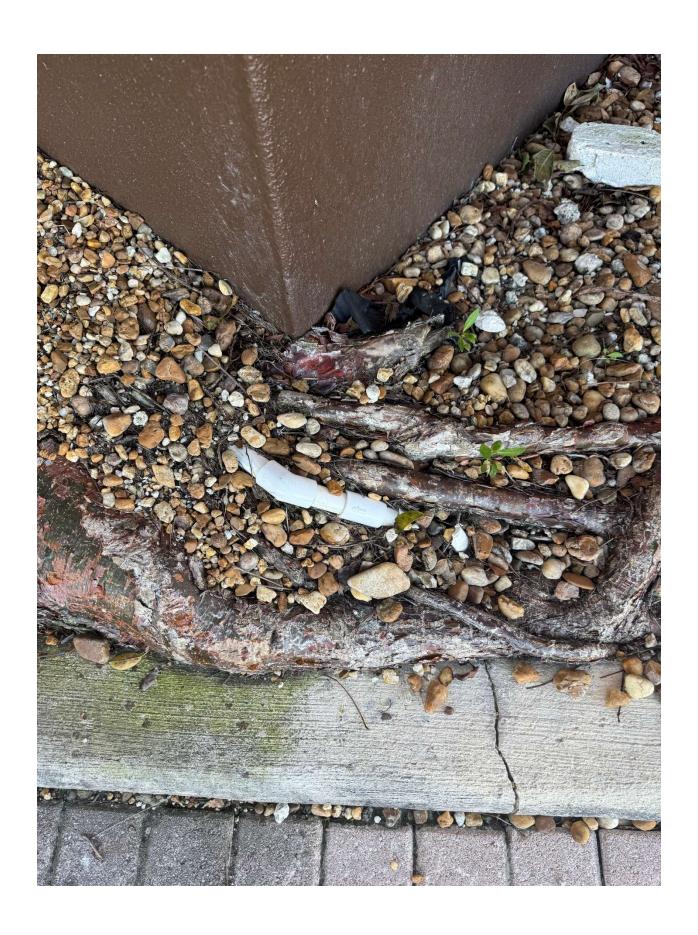
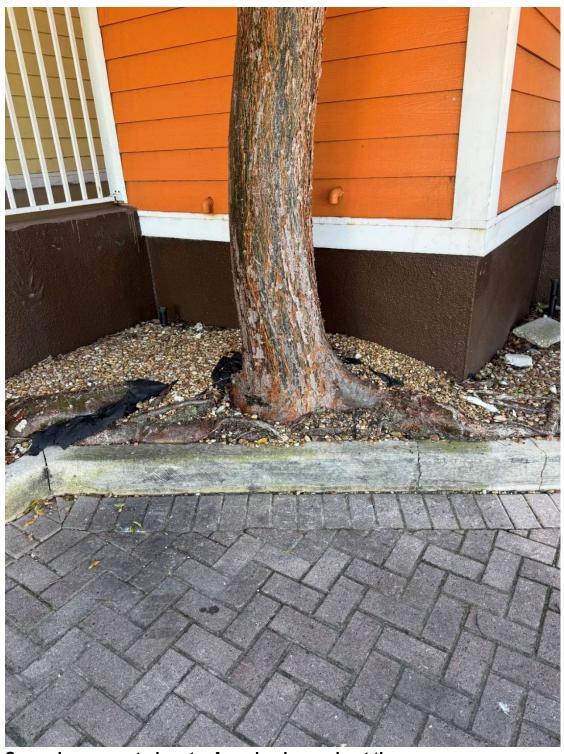
Severely compacted roots. Amazing how robust they appear.

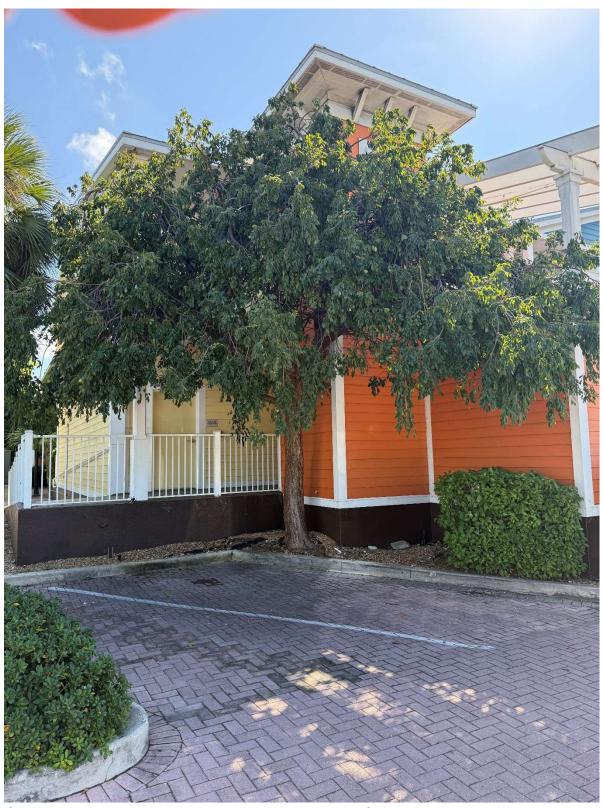
Gumbo Limbo #1 has a lovely canopy in spite of its severely compromised position.

Diameter: 16"

Location: 30%

Species: 100%

Condition: 70%

Value: 66.6%

Recommended Mitigation: 10.6 Caliper Inches
