MEMORANDUM FOR THE FILE

DATE: October 29, 2012

RE: **1332 Duncan Street**

An application was received for the removal of **two (2) Spanish Lime trees**. A site inspection was done on October 29, 2012 and documented the following:

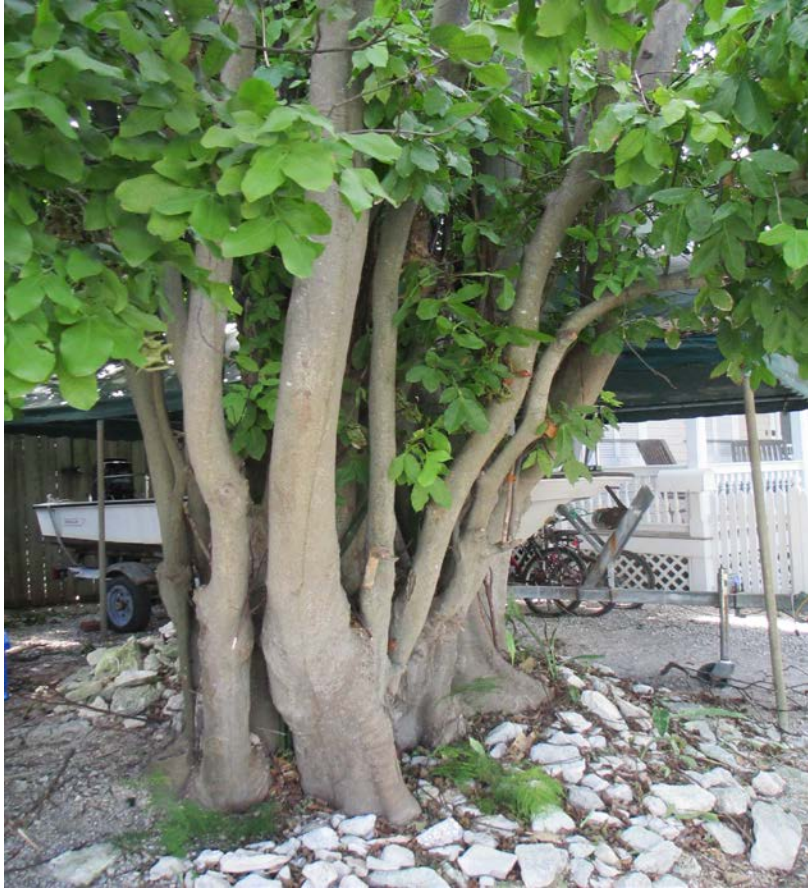
Tree # 1

Diameter: Tree# 1 - 40 inches DBH  
Tree# 2 - 7 inches DBH  
**Total Diameter 47 inches DBH**

Location: 60% - utility lines  
Species: 100% - on protected tree list  
Condition: 60% - fair health

Recommendations: **Staff recommends approval of the permit.**
