# **Staff Report**

Remove asbestos roof tiles and replace with new synthetic slate roofing. Remove windows and replace with impact resistant mahogany units matching the original ones. Repair spalling stucco and repaint exterior-  
**#924 Flagler Avenue – Bender and Associates (H11-01-1140)**

924 FLAGLER AVENUE    EXISTING CONDITIONS

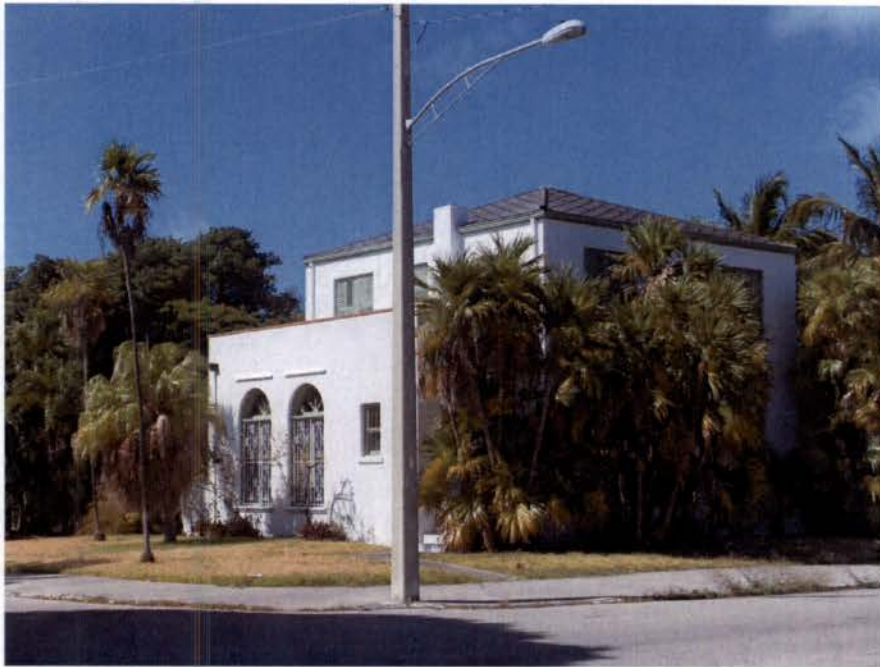
View of house from corner of Flagler and Grinnell Streets. Both the main house and the garage are roofed with asbestos shingles laid in a diamond pattern. Proposed shingles for both house and garage will be synthetic slate in a diamond pattern. All hurricane shutters and burglar bars will be removed from the facades.

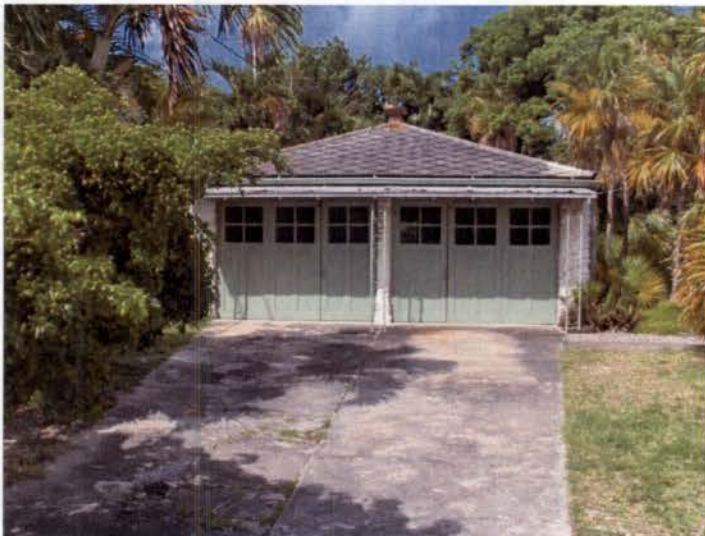
Garage building from Grinnell Street. The garage roof will be replaced with synthetic slate shingles in a diamond pattern. Historic garage doors will remain.

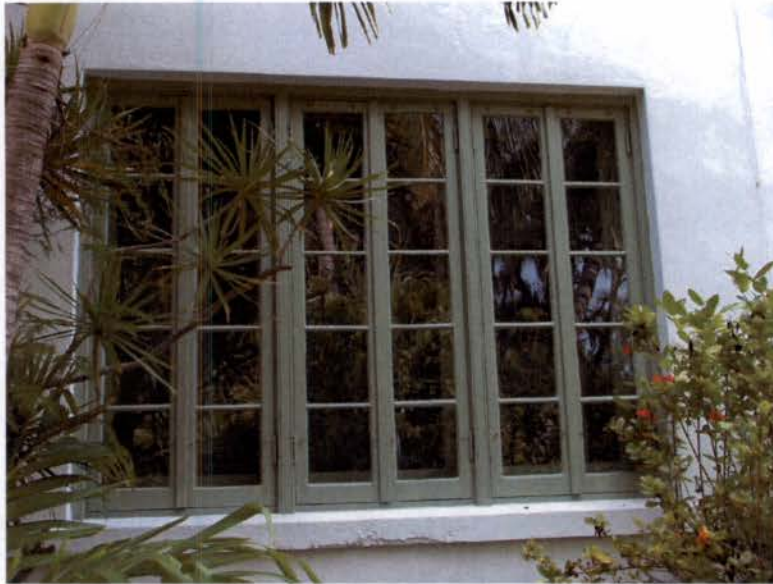
Typical first floor casement window. The windows are termite damaged, and will be replaced with new mahogany impact-resistant casement windows. Profiles will match exactly.

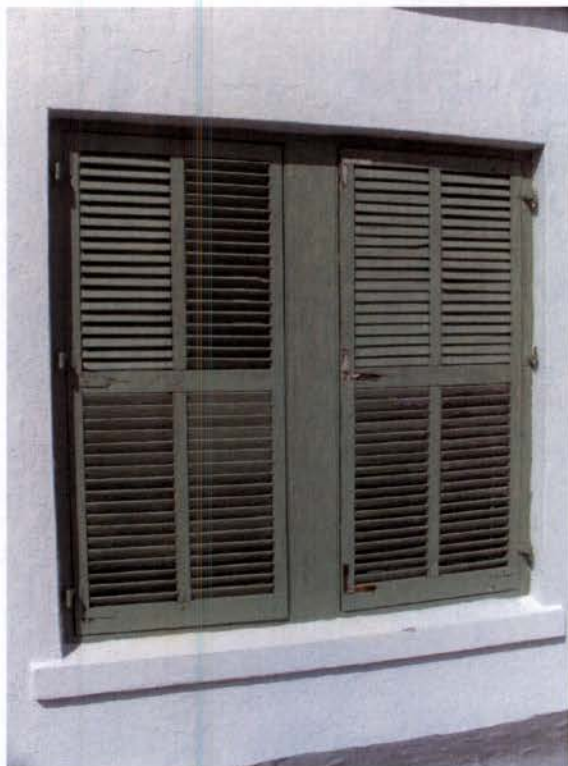
Typical second floor window (shuttered). Both windows and shutters have structural damage from termites.

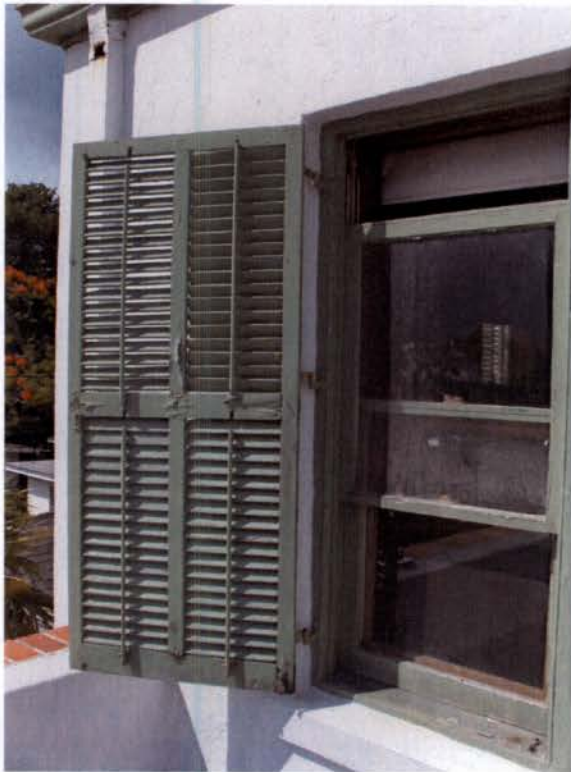
Typical second floor double hung window. The windows will be removed and replaced with mahogany impact-resistant double hung windows matching the profile. The shutters will be replaced with exact matching shutters.

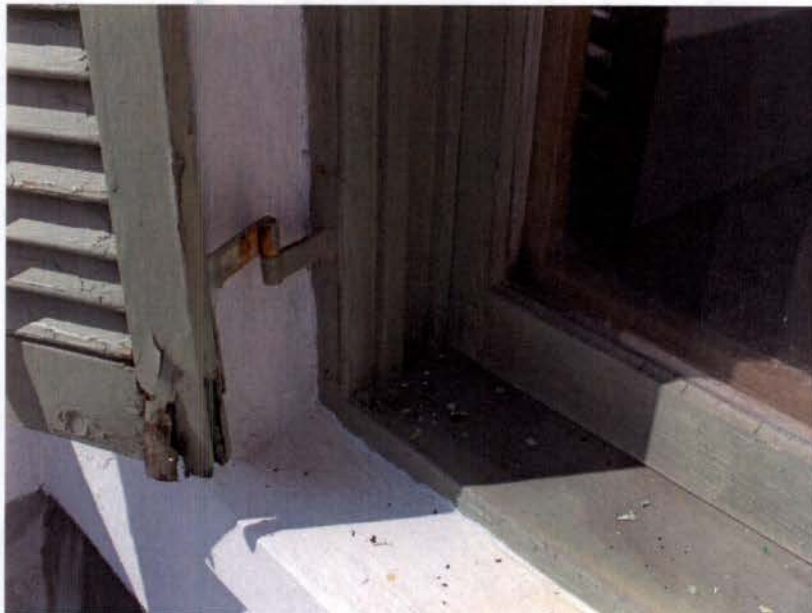
Damage at typical second floor shutter.

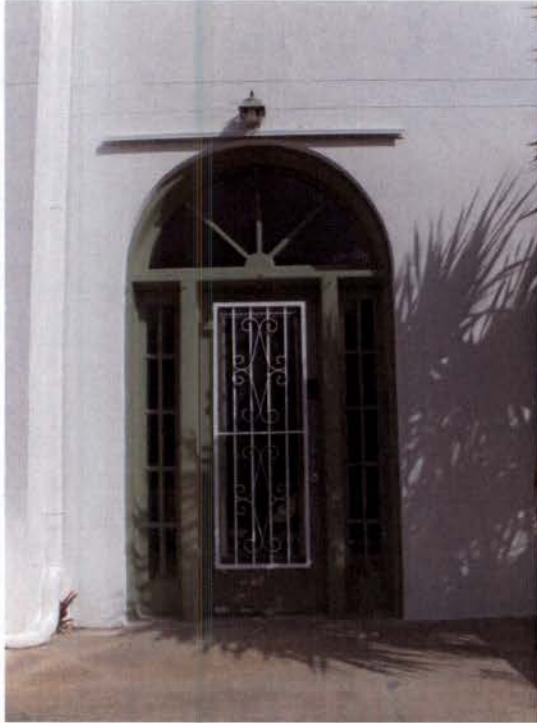
Entry door #1. The door and sidelites are damaged by termites and rot from water infiltration. They will be replaced with new mahogany doors, sidelites and transoms. Hurricane shutter tracks and burglar bars will be removed.

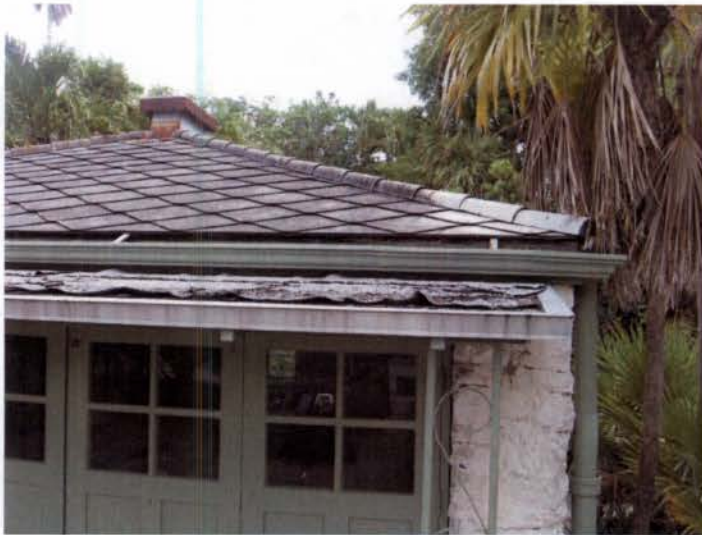
Detail photo of garage. Existing asbestos roofing will be removed and replaced with synthetic slate shingles in a diamond pattern. Gutters will be removed and replaced with copper gutters in a matching profile. The ventilator at top of roof will be repaired and repainted. Sliding garage doors will be repainted. The garage walls are sheathed in historic painted coral stone. The walls will be repainted.

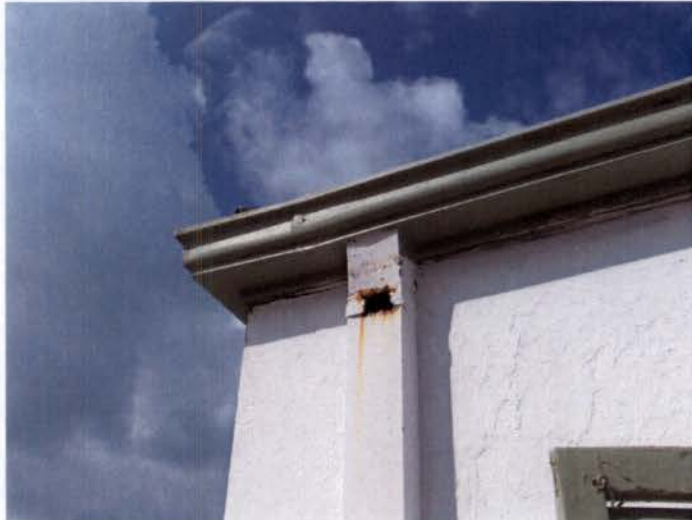
Detail of damaged gutters and downspouts at main house. Gutters and downspouts will be replaced with new copper units matching the historic profile. All of the gutters are piped into the historic cistern located under the Florida Room of the house.

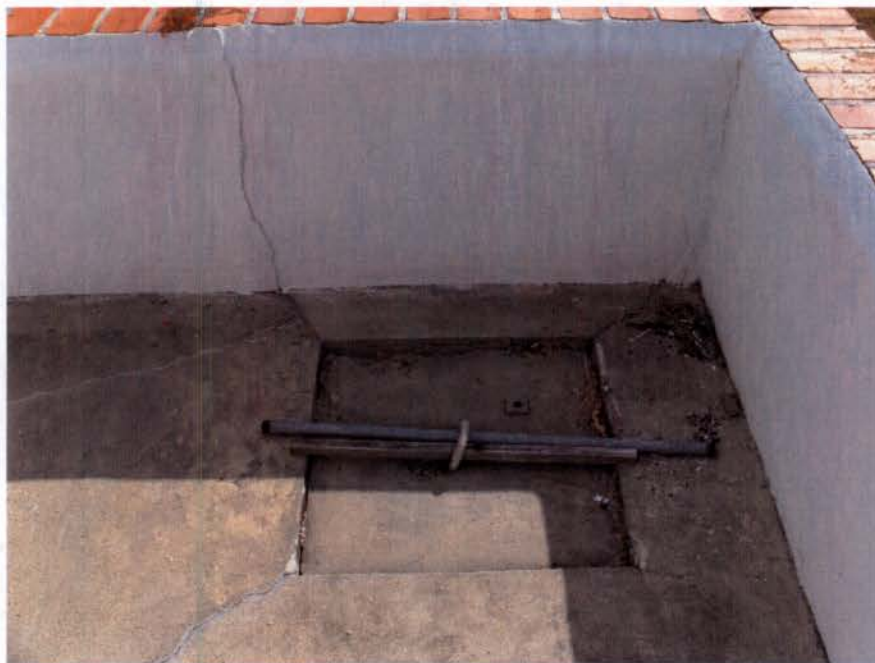
The cover to the historic cistern is located on the porch. The cistern is functional, and will remain so.
