# EXISTING TREE REPORT and ASSESSMENT

## CITY of KEY WEST

PROPERTY: 1621, 1622, and 1623 Spalding Court

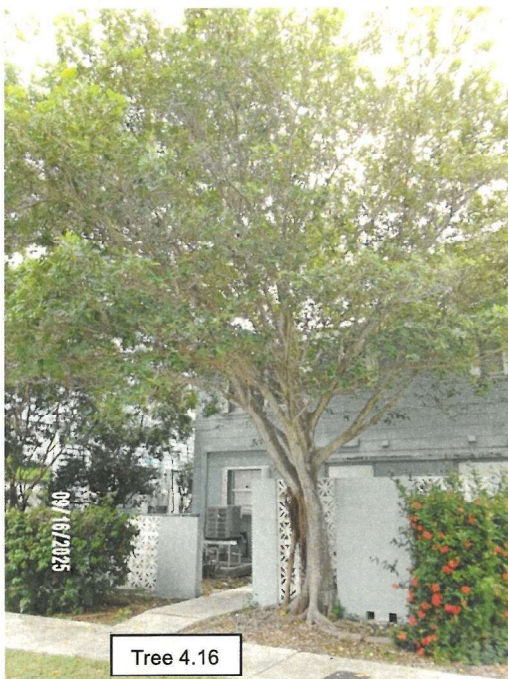
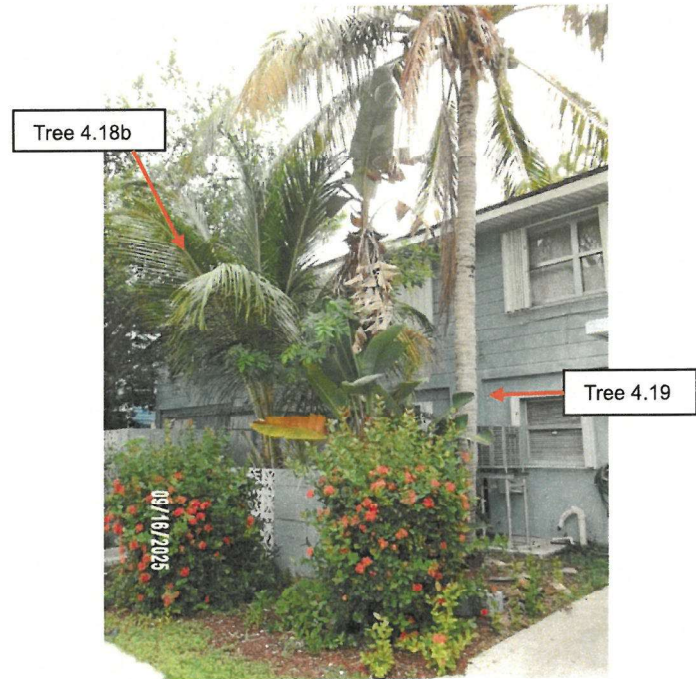
Tree 4.16

**Tree 4.16: Strangler Fig (*Ficus aurea*)**

Diameter: 15.6" dbh

Condition: 60% (fair)

Location: 50% (growing immediately against concrete privacy wall, very visible tree)

Potential Required Mitigation: 10.9 caliper inches

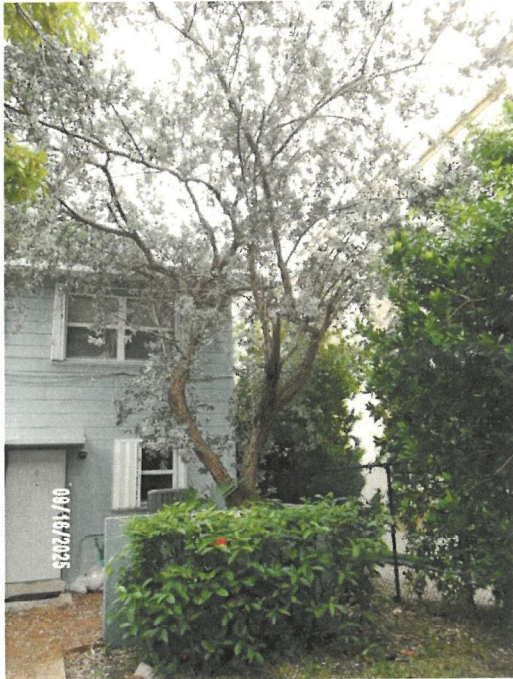
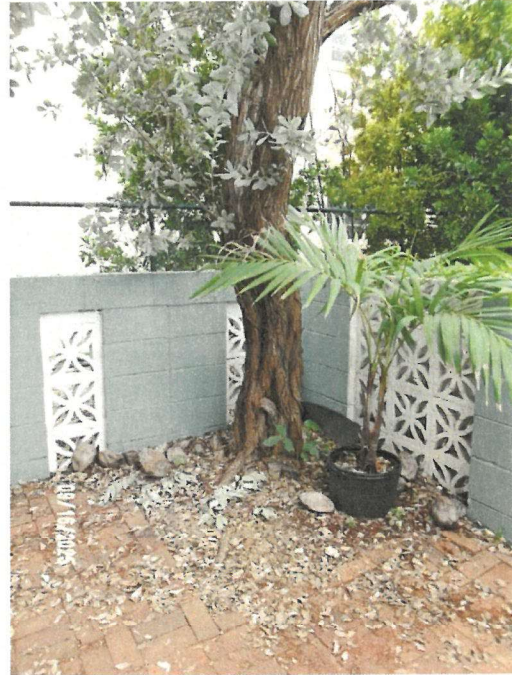
Tree 4.25

Tree 4.25: Silver Buttonwood (*Conocarpus erectus sericeus*)

Diameter: 14.3" dbh

Condition: 50% (fair to poor, some decay from breaks and poor cuts in canopy)

Location: 60% (growing in corner of porch concrete wall, very visible tree)

Potential Required Mitigation: 10 caliper inches

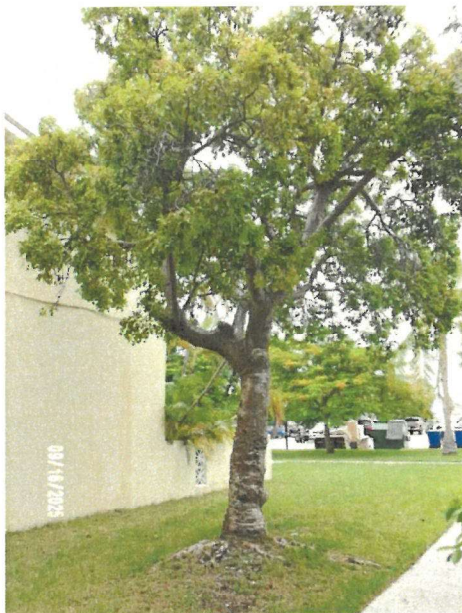
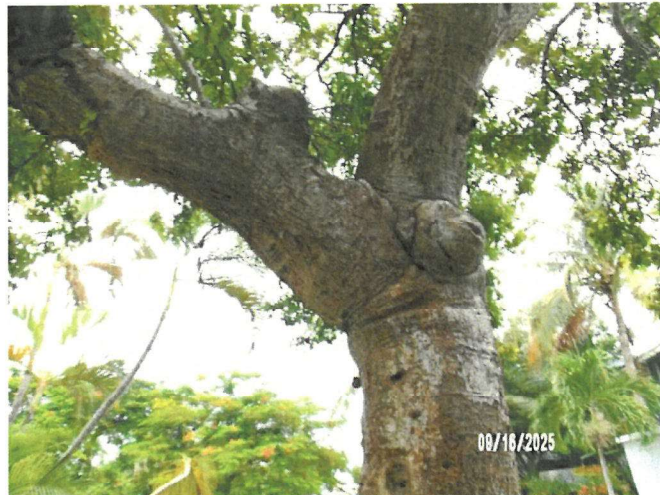
Tree 4.26

Tree 4.26: Gumbo Limbo (*Bursera simaruba*)

Diameter: 16.8" dbh

Condition: 40% (poor, north limb damaged, gummosis in trunk)

Location: 80% (growing in open space area between two buildings, very visible tree)

Potential Required Mitigation: 12.2 caliper inches

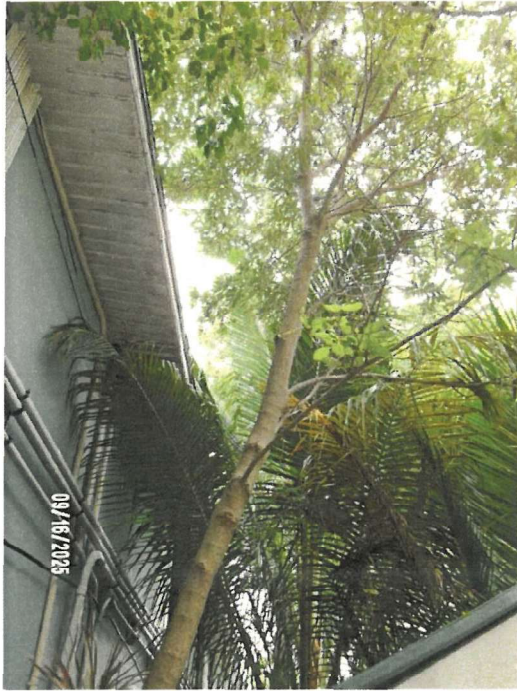
Tree 4.31a

Tree 4.31a: Jamaican Dogwood (*Piscidia piscipula*)

Diameter: est 5" dbh (need access to yard and tree for actual measurement)

Condition: 40% (poor, elongated trunk structure with growth lean due to close, existing structure)

Location: 30% (growing close to structure-no room for future growth)

Potential Required Mitigation: 2.8 caliper inches

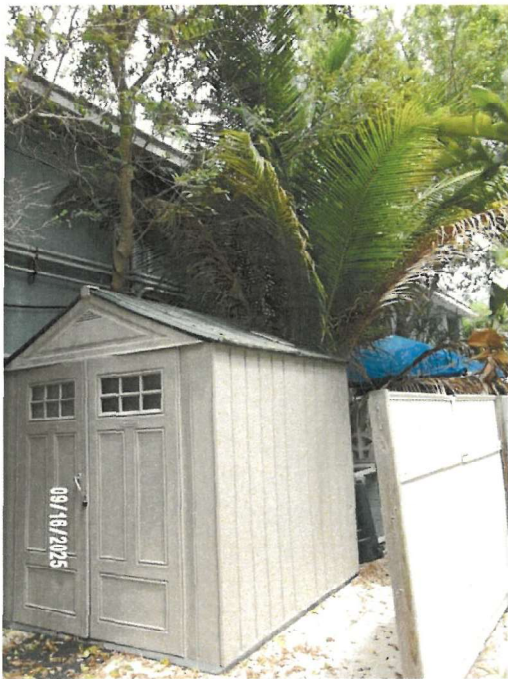
Tree 4.31b

Tree 4.31b: Coconut Palm (*Cocos nucifera*)  
Required Mitigation: 1-native palm, 4 ft tall OH minimum

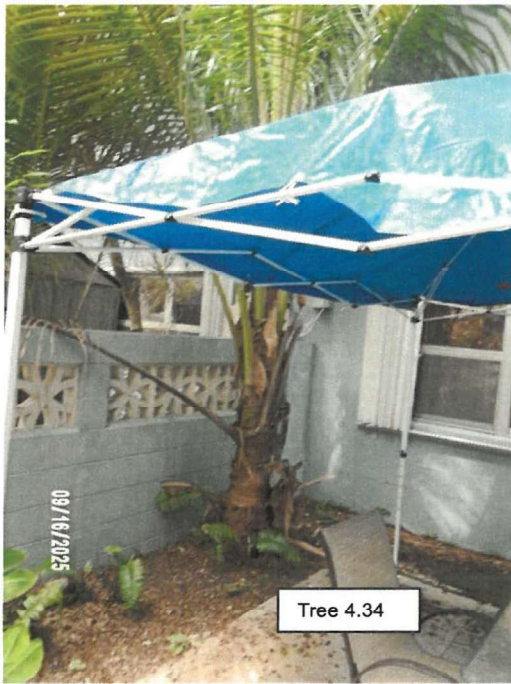
Tree 4.34

Tree 4.34: Coconut Palm (*Cocos nucifera*)  
Required Mitigation: 1-native palm, 4 ft tall OH minimum

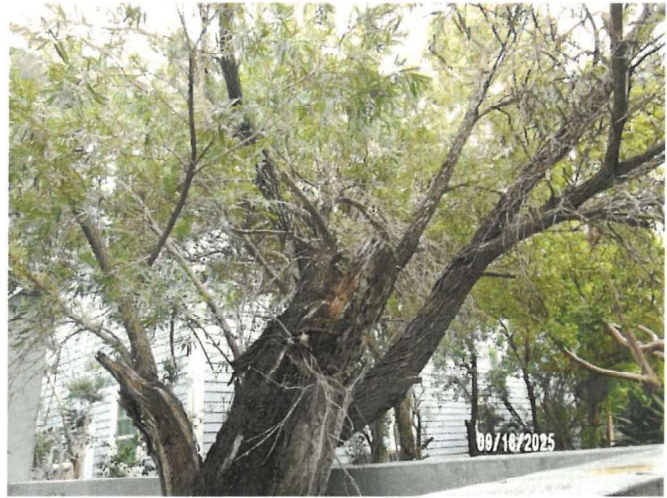
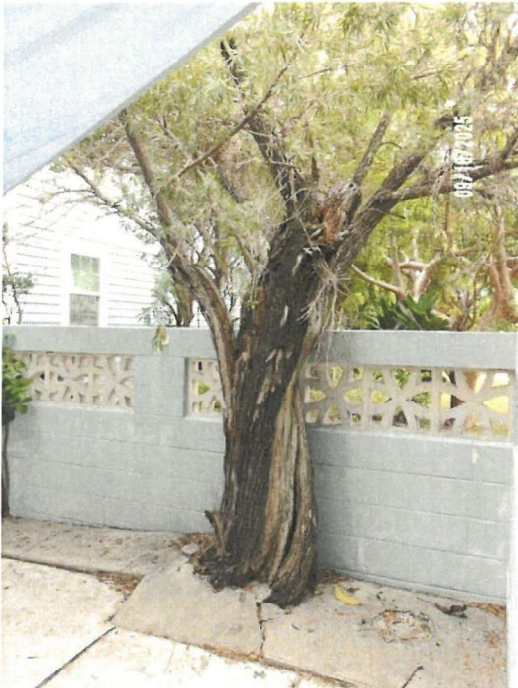
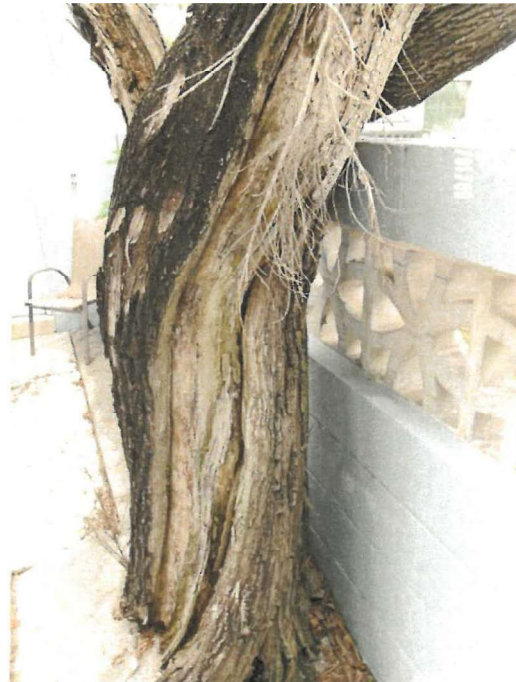
Tree 4.37

Tree 4.37: Bottlebrush (*Callistemon citrinus*)

Diameter: **est 20" dbh (need access to yard and tree for actual measurement)**

Condition: 30% (poor, major trunk decay, root system encased in concrete)

Location: 40% **BM/ZB**(back yard tree growing against concrete porch wall)

**Potential Required Mitigation: 8"**

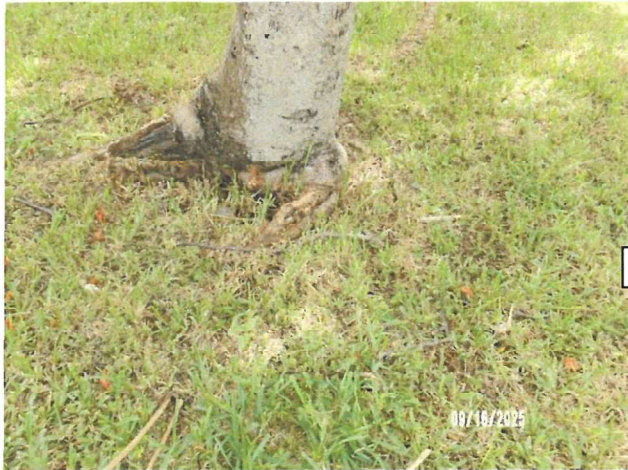
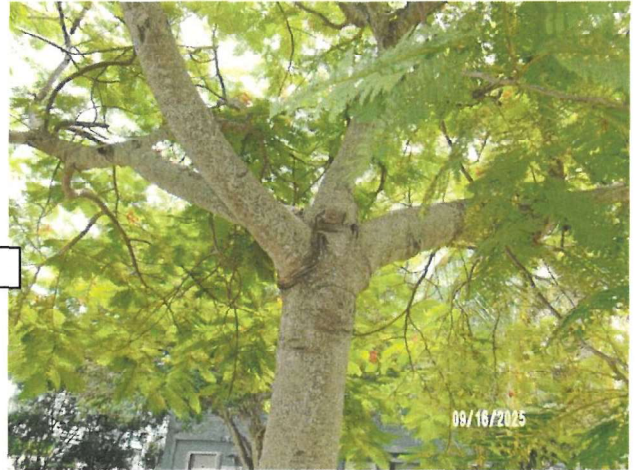
Tree 4.44

Tree 4.44: Royal Poinciana (*Delonix regia*)  
 Diameter: 10.8" dbh  
 Condition: 50% (fair to poor, poor base structure-circling roots, fair health and canopy structure)  
 Location: 90% (growing in open yard area-very visible tree)  
 Species: 100% (on City of KW protected tree list)  
 Approximated Tree Value: 80%  
 Potential Required Mitigation: 8.6 caliper inches

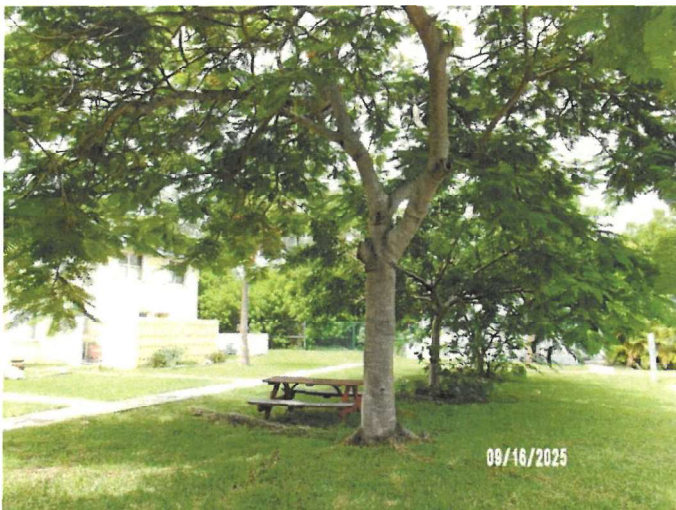
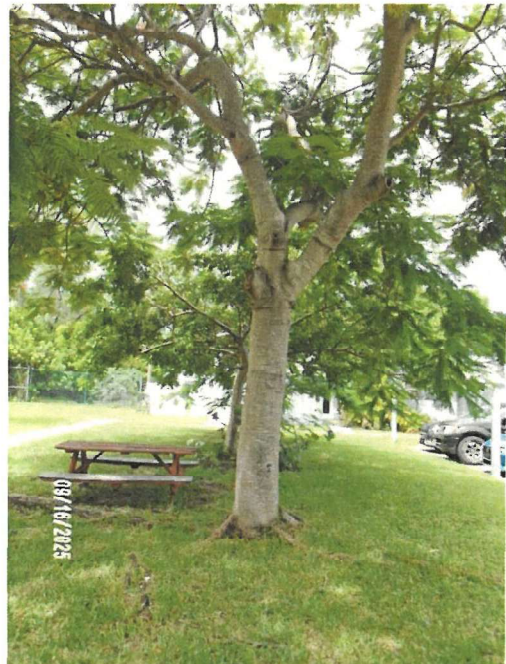
Tree 4.45

Tree 4.45: Royal Poinciana (*Delonix regia*)  
 Diameter: 15.9" dbh  
 Condition: 60% (overall fair, some old storm damage in canopy, poor canopy structure)  
 Location: 90% (growing in open yard area-very visible tree)  
 Species: 100% (on City of KW protected tree list)  
 Approximated Tree Value: 83%  
 Potential Required Mitigation: 13.1 caliper inches

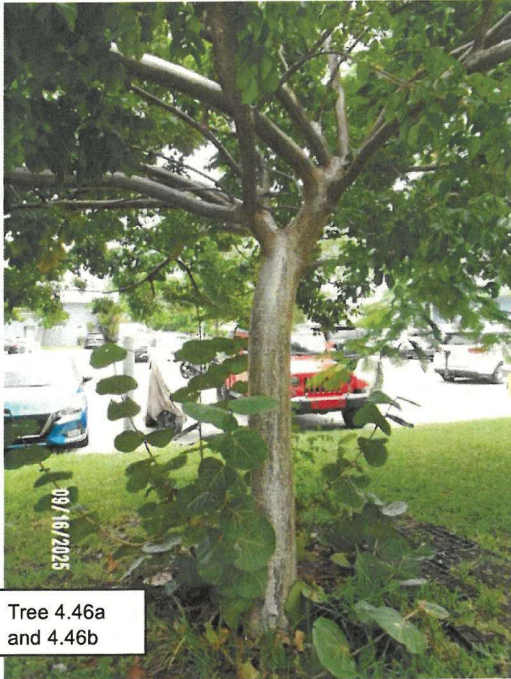
Tree 4.46a  
and 4.46b

Tree 4.46a: Gumbo Limbo (*Bursera simaruba*)  
 Diameter: 8.9" dbh  
 Condition: 60% (Fair overall, good health, poor canopy structure)  
 Location: 90% (growing in open yard area-very visible tree)  
 Species: 100% (on City of KW protected tree list)  
 Approximated Tree Value: 83%  
 Potential Required Mitigation: 7.3 caliper inches

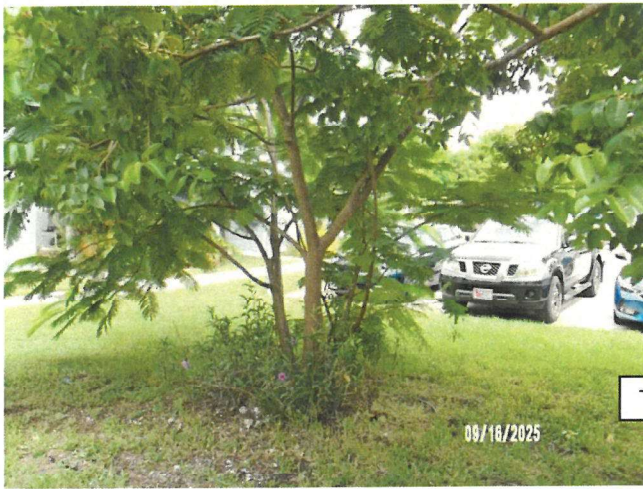
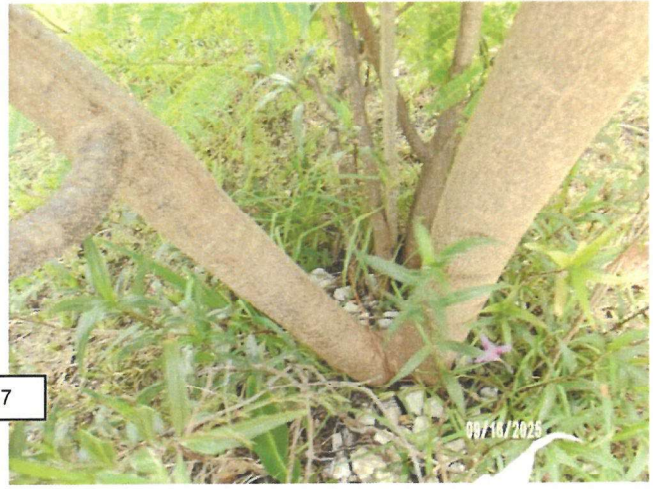
Tree 4.47

Tree 4.47: Royal Poinciana (*Delonix regia*)  
 Diameter: 11.7" dbh total (multiple trunks)  
 Condition: 50% (fair health, young tree, poor structure)  
 Location: 90% (growing in open yard area-very visible tree)  
 Species: 100% (on City of KW protected tree list)  
 Approximated Tree Value: 80%  
 Potential Required Mitigation: 9.3 caliper inches

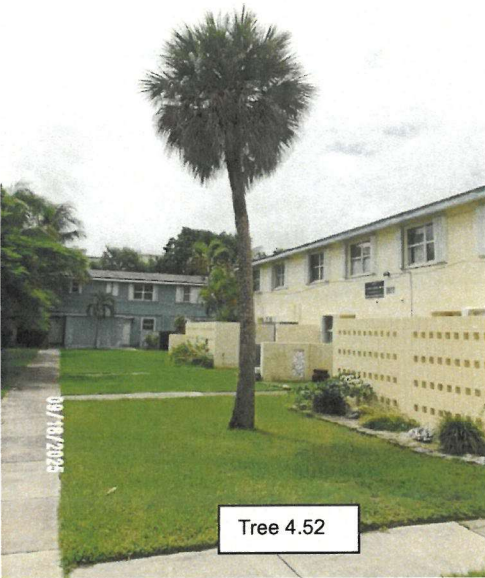
Tree 4.52

Tree 4.52: Sabal Palm (*Sabal palmetto*)  
 Required Mitigation: 1-native palm, 4 ft tall OH minimum

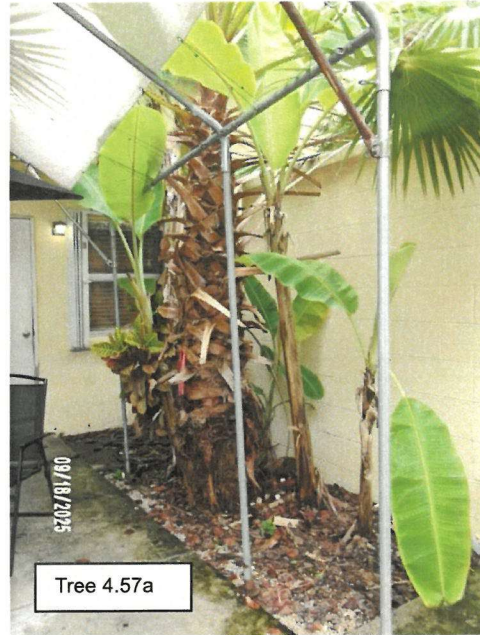
Tree 4.57a

Tree 4.57a: Washingtonian Palm (*Washingtonia robusta*)

Required Mitigation: 1-native palm, 4 ft tall OH minimum

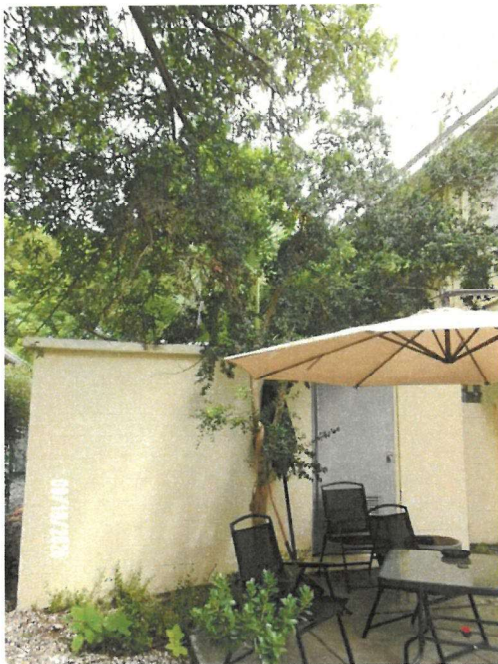
Tree 4.55

Tree 4.55: Simpson Stopper (*Myrcianthes fragans*)

Diameter: 6.3" dbh total

Condition: 60% (fair, two canopy trunks)

Location: 60% (growing behind main building)

Potential Required Mitigation: 3.5 caliper inches

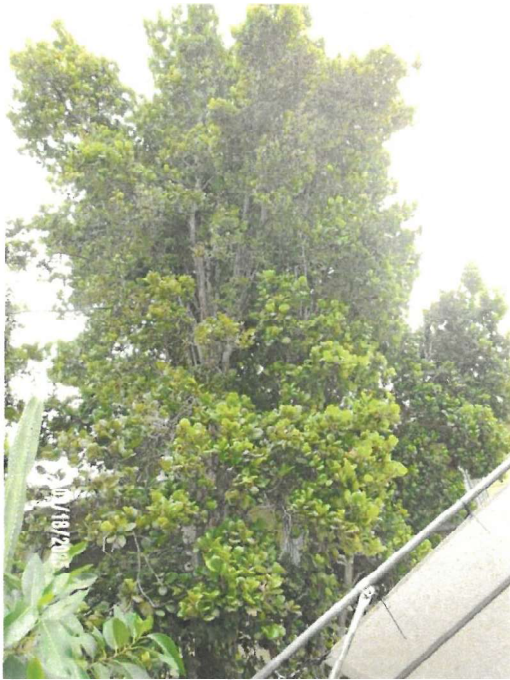
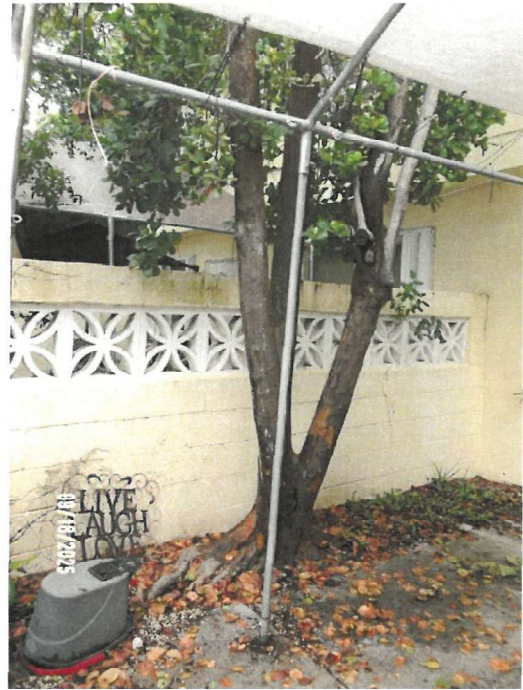
Tree 4.58

Tree 4.58: Pigeon Plum (*Coccoloba diversifolia*)  
 Diameter: 18.4" dbh total  
 Condition: 60% (fair, very tall tree, three trunks)  
 Location: 60% (growing behind main building)  
 Species: 100% (on City of KW protected tree list)  
 Approximated Tree Value: 73%  
 Potential Required Mitigation: 13.4 caliper inches

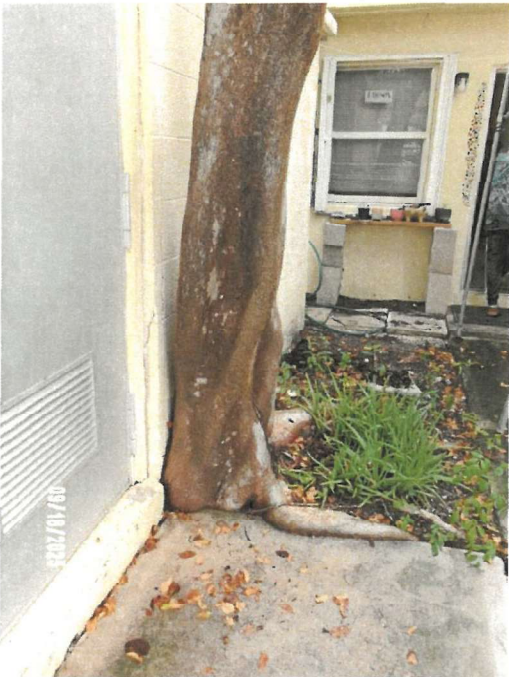
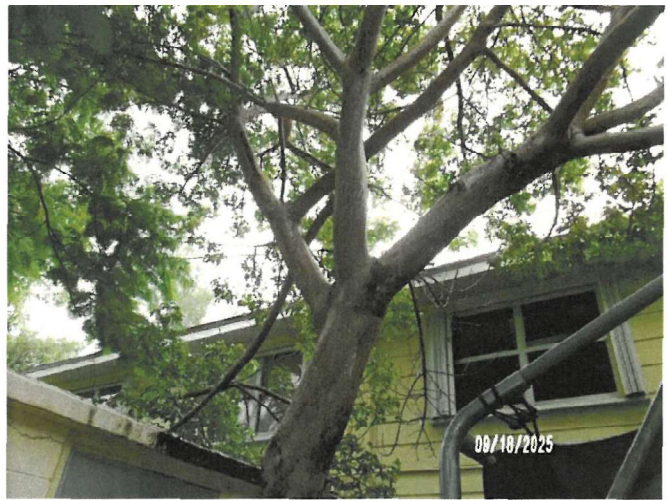
Tree 4.60

Tree 4.60: Gumbo Limbo (*Bursera simaruba*)

Diameter: 14.9" dbh

Condition: 50% (fair health, poor base-root system impacted by concrete pad)

Location: 30% (growing against concrete shed structure and concrete pad)

Potential Required Mitigation: 8.9 caliper inches

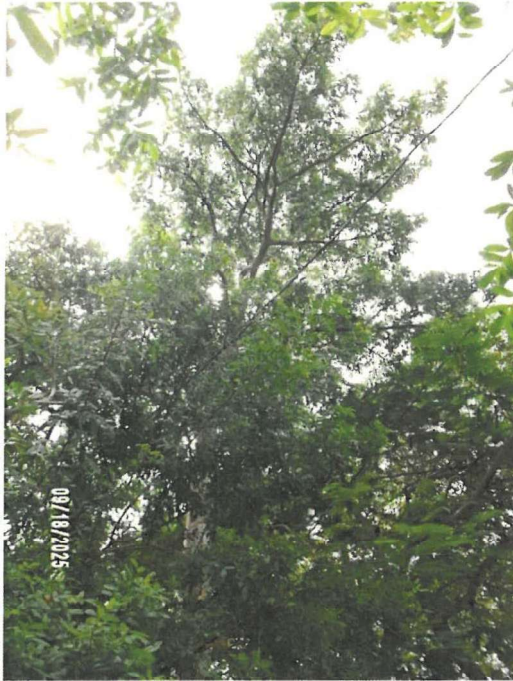
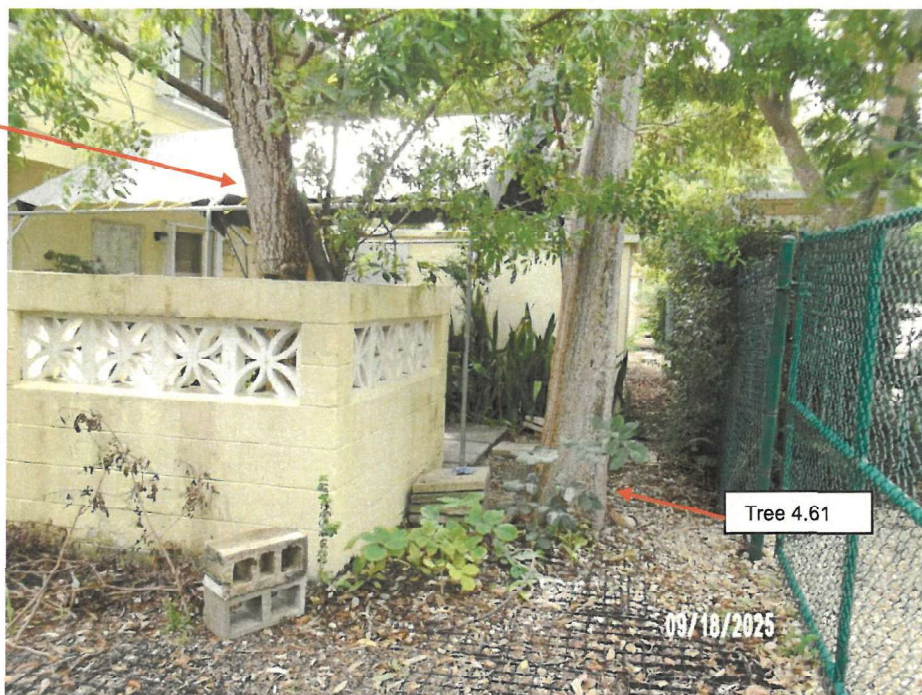
Tree 4.61

Tree 4.61: Gumbo Limbo (*Bursera simaruba*)

Diameter: 15.5" **BM/ZB** dbh

Condition: 60% (fair, very tall tree)

Location: 70% (growing behind main structure )

Potential Required Mitigation: 11.8 caliper inches

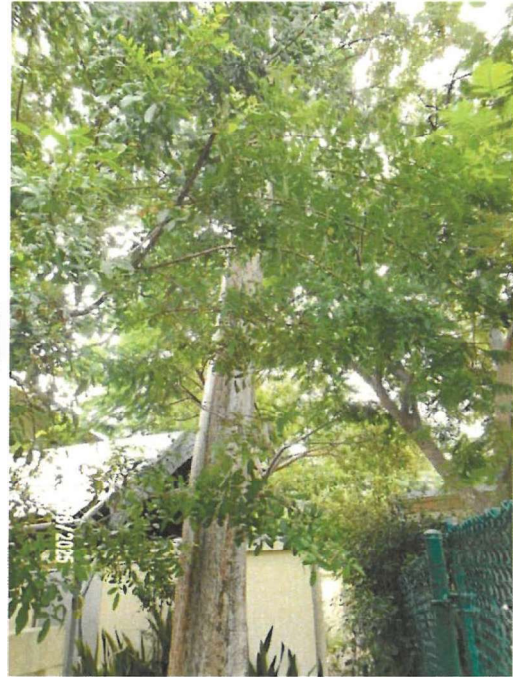
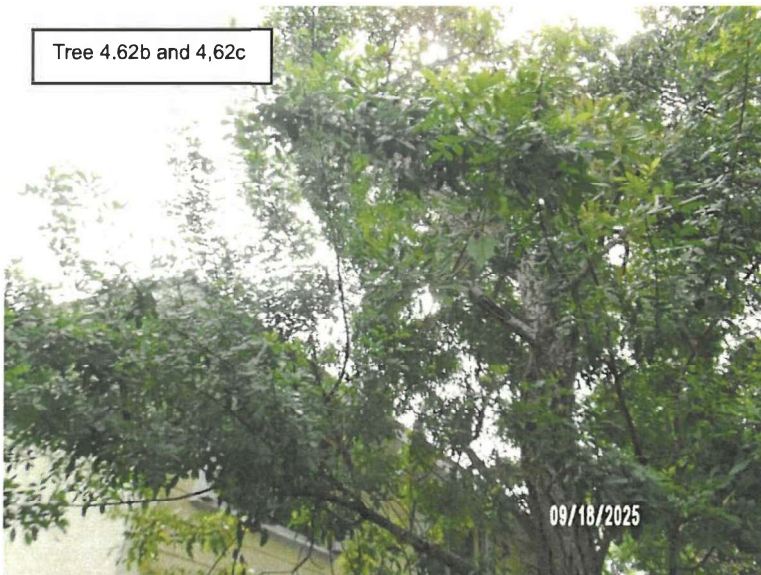
Tree 4.62b and 4.62c

Tree 4.62b: Yellow Tabebuia (*Tabebuia aurea*)

Diameter: 12.4" dbh

Condition: 50% (poor structure, tall tree with old storm damage in canopy)

Location: 60% (growing behind main structure against porch concrete wall corner)

Potential Required Mitigation: 6.5 caliper inches

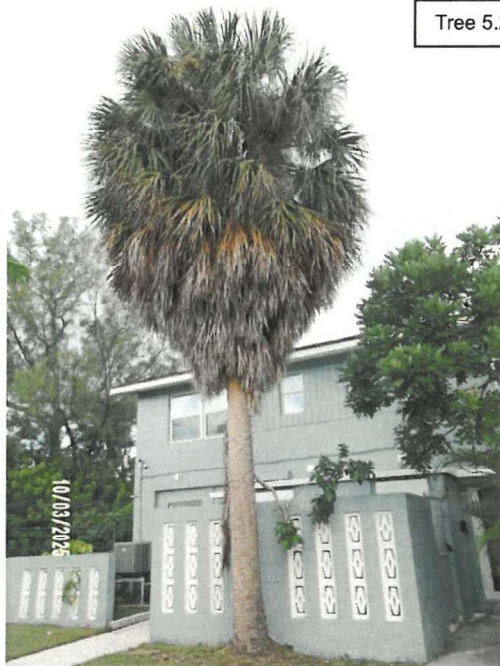
Tree 5.2b

Tree 5.2b: Sabal Palm (*Sabal palmetto*)

Required Mitigation: 1-native palm, 4 ft tall OH minimum

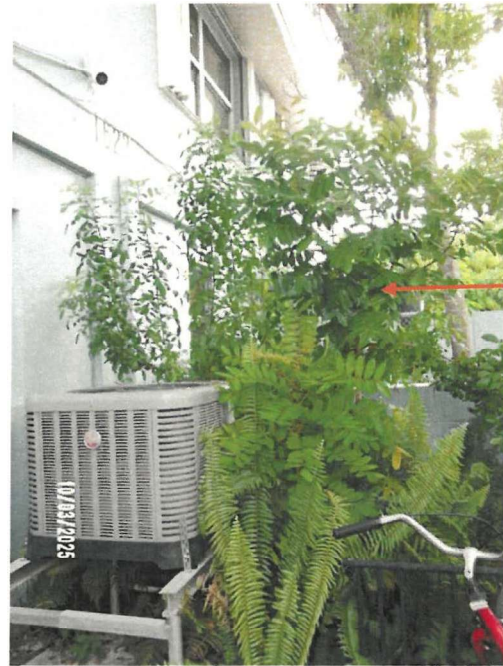
Tree 5.3d

Tree 5.3d: Paradise Tree (*Simarouba glauca*)

Diameter: 1" dbh

Condition: 50% (fair health, poor structure-two trunks, young tree)

Location: 50% (growing in front porch area close to ac unit and concrete wall with Brazilian pepper and ferns)

Potential Required Mitigation: 0.6 caliper inches

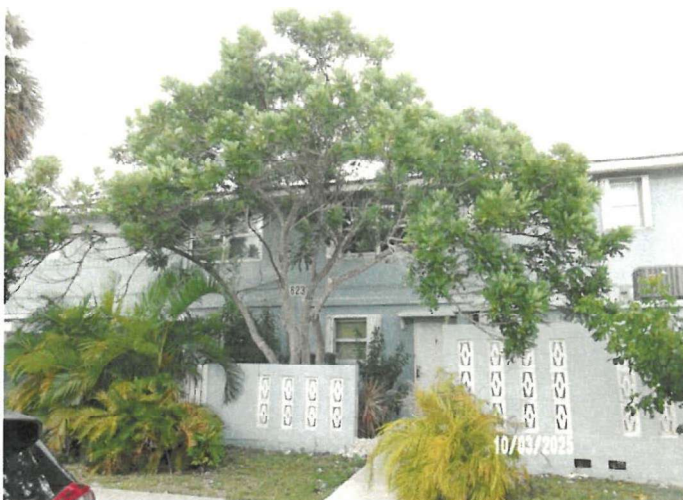
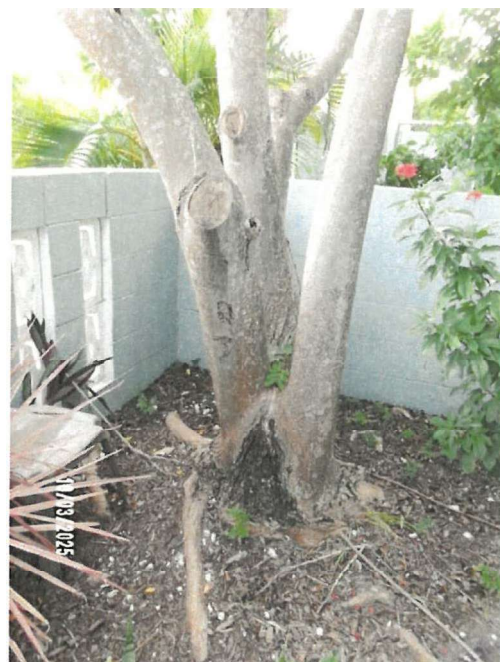
Tree 5.6a

Tree 5.6a: Paradise Tree (*Simarouba glauca*)

Diameter: 25.3" dbh total

Condition: 60% (fair, four trunks)

Location: 60% (growing in front porch area, very visible tree)

Potential Required Mitigation: 18.4 caliper inches

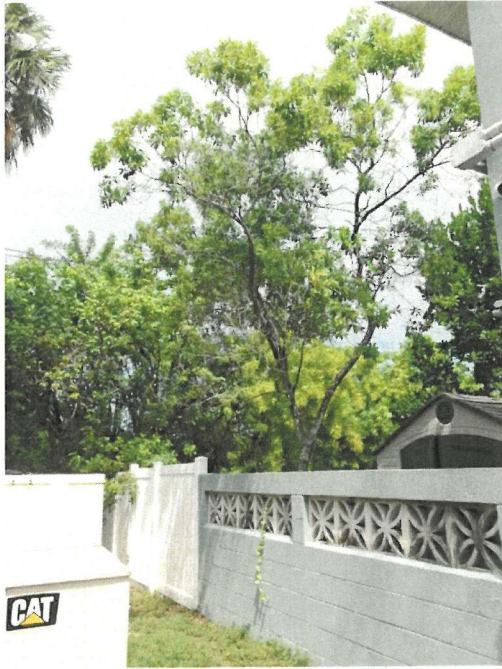
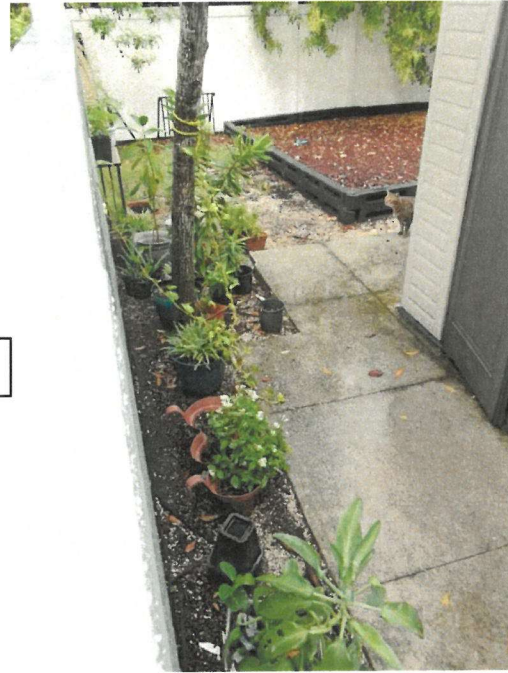
Tree 5.10

**Tree 5.10: Willow Busic (*Bumelia salicifolia*)**

Diameter: **est 4" dbh (need access to yard and tree for actual measurement)**

Condition: 40% (poor health-canopy die back)

Location: 60% (growing in back of main structure near concrete wall)

**Potential Required Mitigation: 2.6 caliper inches**

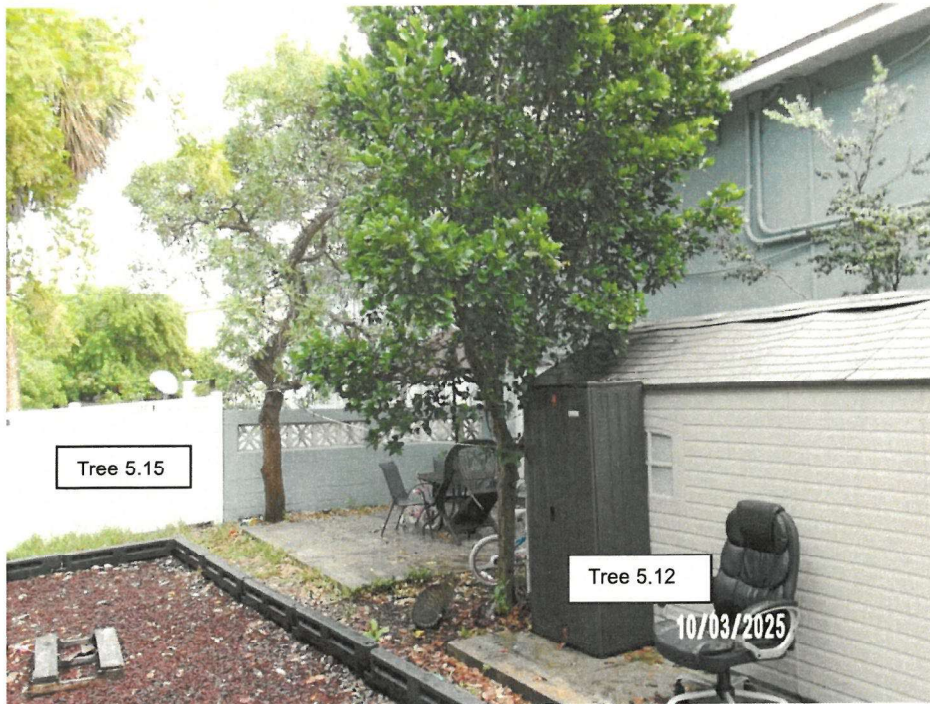
Tree 5.15

Tree 5.15: Yellow Tabebuia (*Tabebuia aurea*)

Diameter: **est 8" dbh (need access to yard and tree for actual measurement)**  
 Condition: 50% (fair with poor canopy structure-one sided)  
 Location: 60% (growing behind main structure )  
 Species: 50% (not on City of KW protected or not protected tree list)  
 Approximated Tree Value: 53%  
 Potential Required Mitigation: 4.2 caliper inches
