**TREE COMMISSION TREE REMOVAL REPORT  
CITY of KEY WEST**

**PROPERTY: 1903-1905 Flagler Ave**

**APPLICATION NUMBER: T2025-0261**

**REQUEST: The applicant is requesting removal of (1) Jamaican Dogwood Tree, (1) Royal Poinciana Tree, (1) Spanish Lime Tree, (1) Sapodilla Tree, (2) Strangler Fig Trees, (2) Gumbo Limbo Trees, (1) Barbados Cherry Tree**

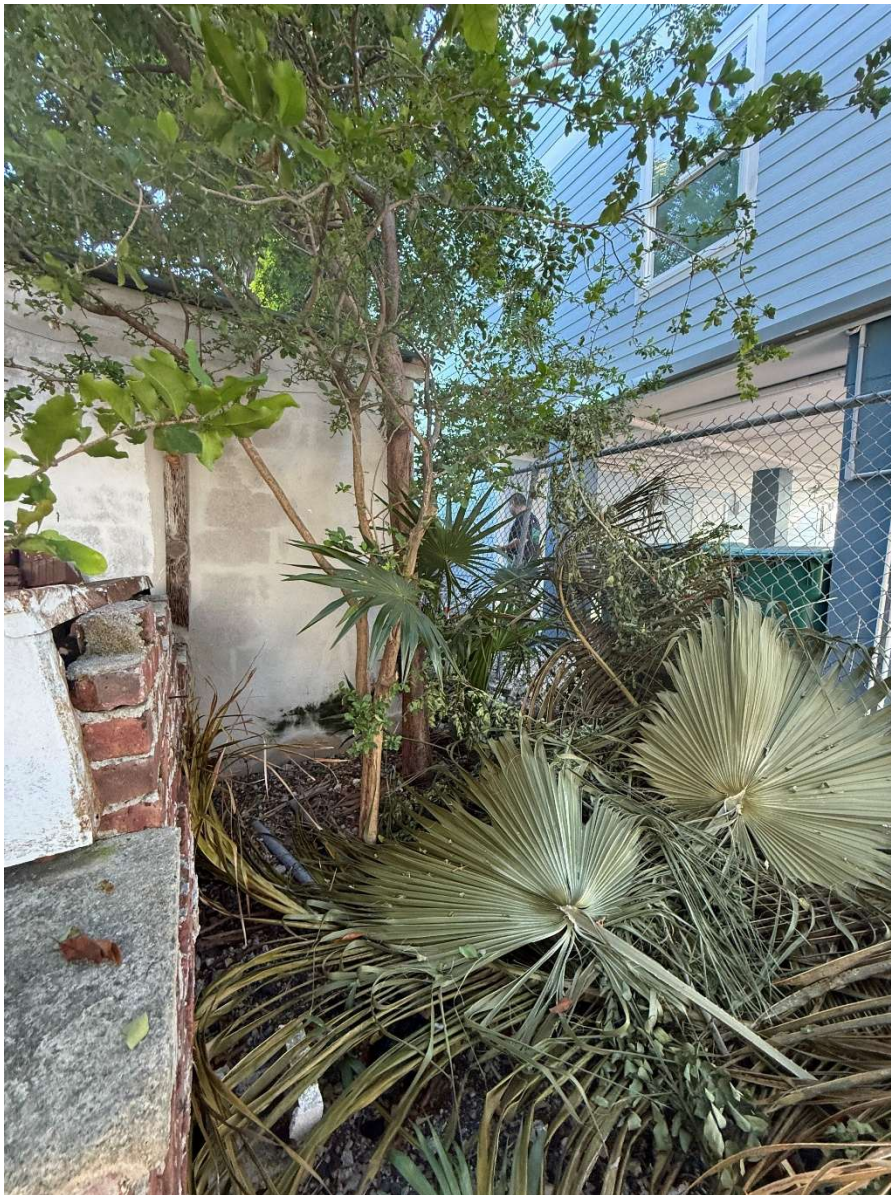
**Barbados Cherry # 8 and Gumbo Limbo #9**

**Barbados Cherry Tree #8**

**Diameter: 4.4"**

**Location: 50%**

**Species: 50%**

**Condition: 60%**

**Value: 53%**

**Gumbo Limbo Tree #9**

**Diameter: 4.7"**

**Location: 60%**

**Species: 100%**

**Condition: 70%**

**Value: 76%**

**Recommended Mitigation: 2.3 Caliper Inches**

**Recommended Mitigation: 3.5 Caliper Inches**

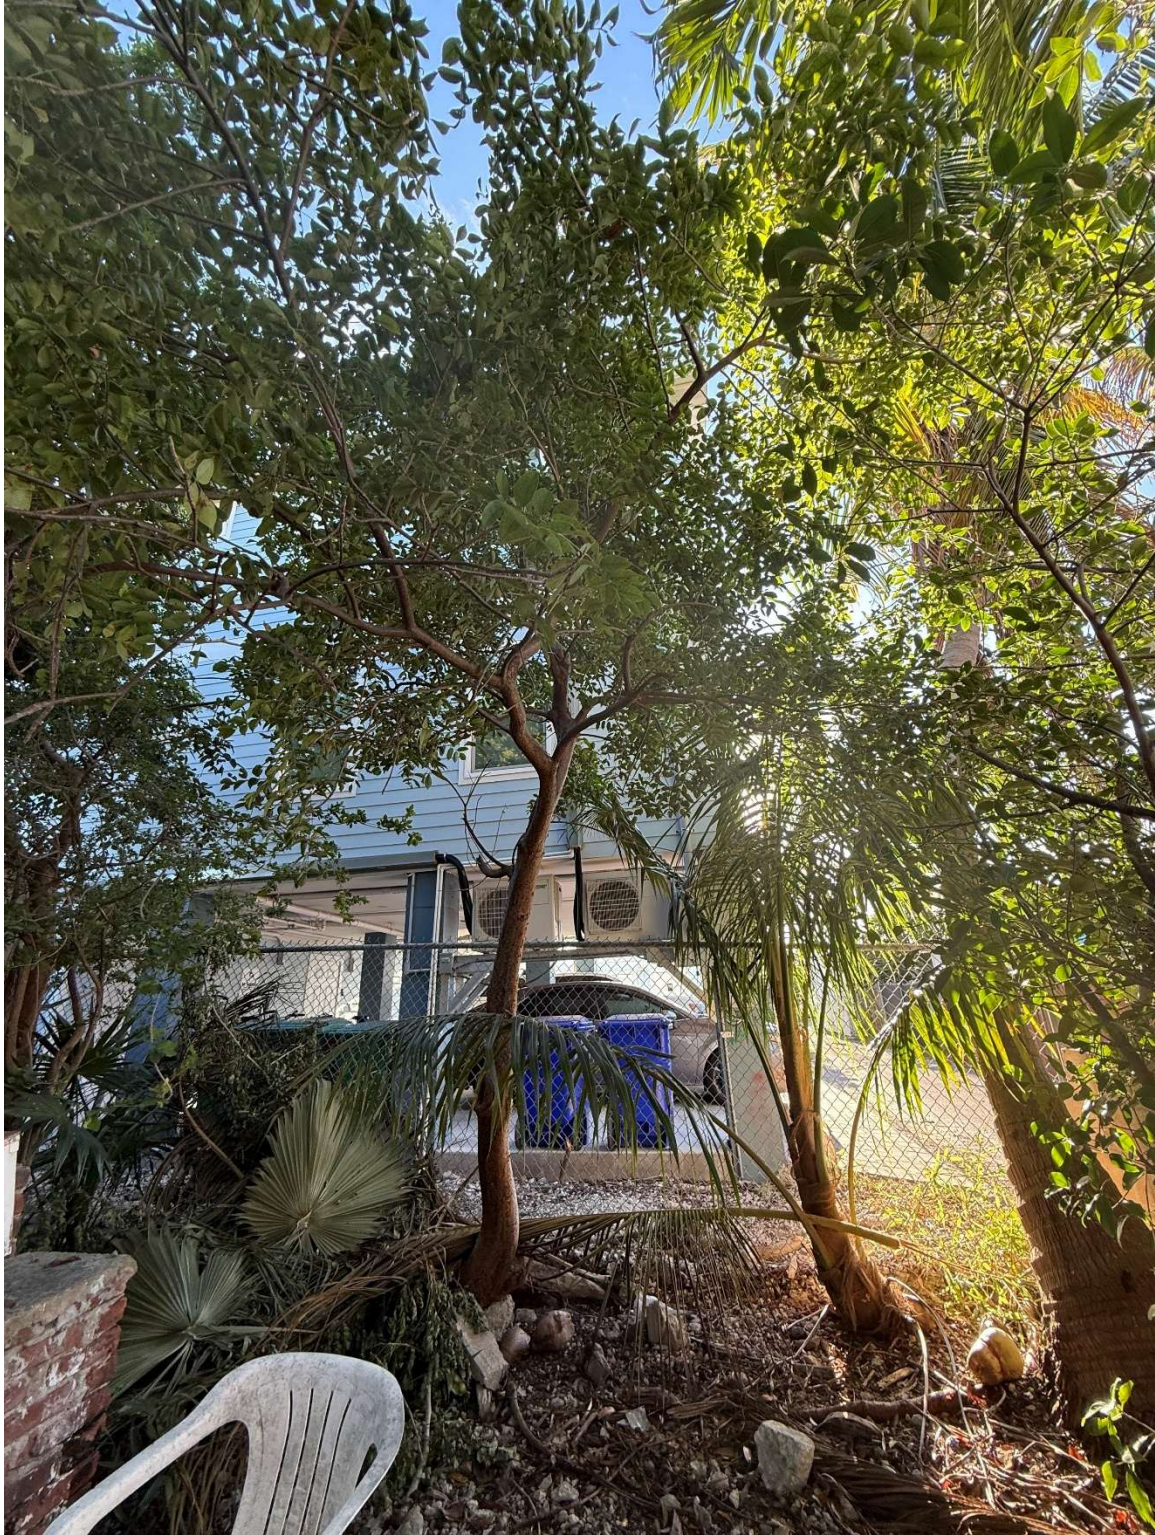
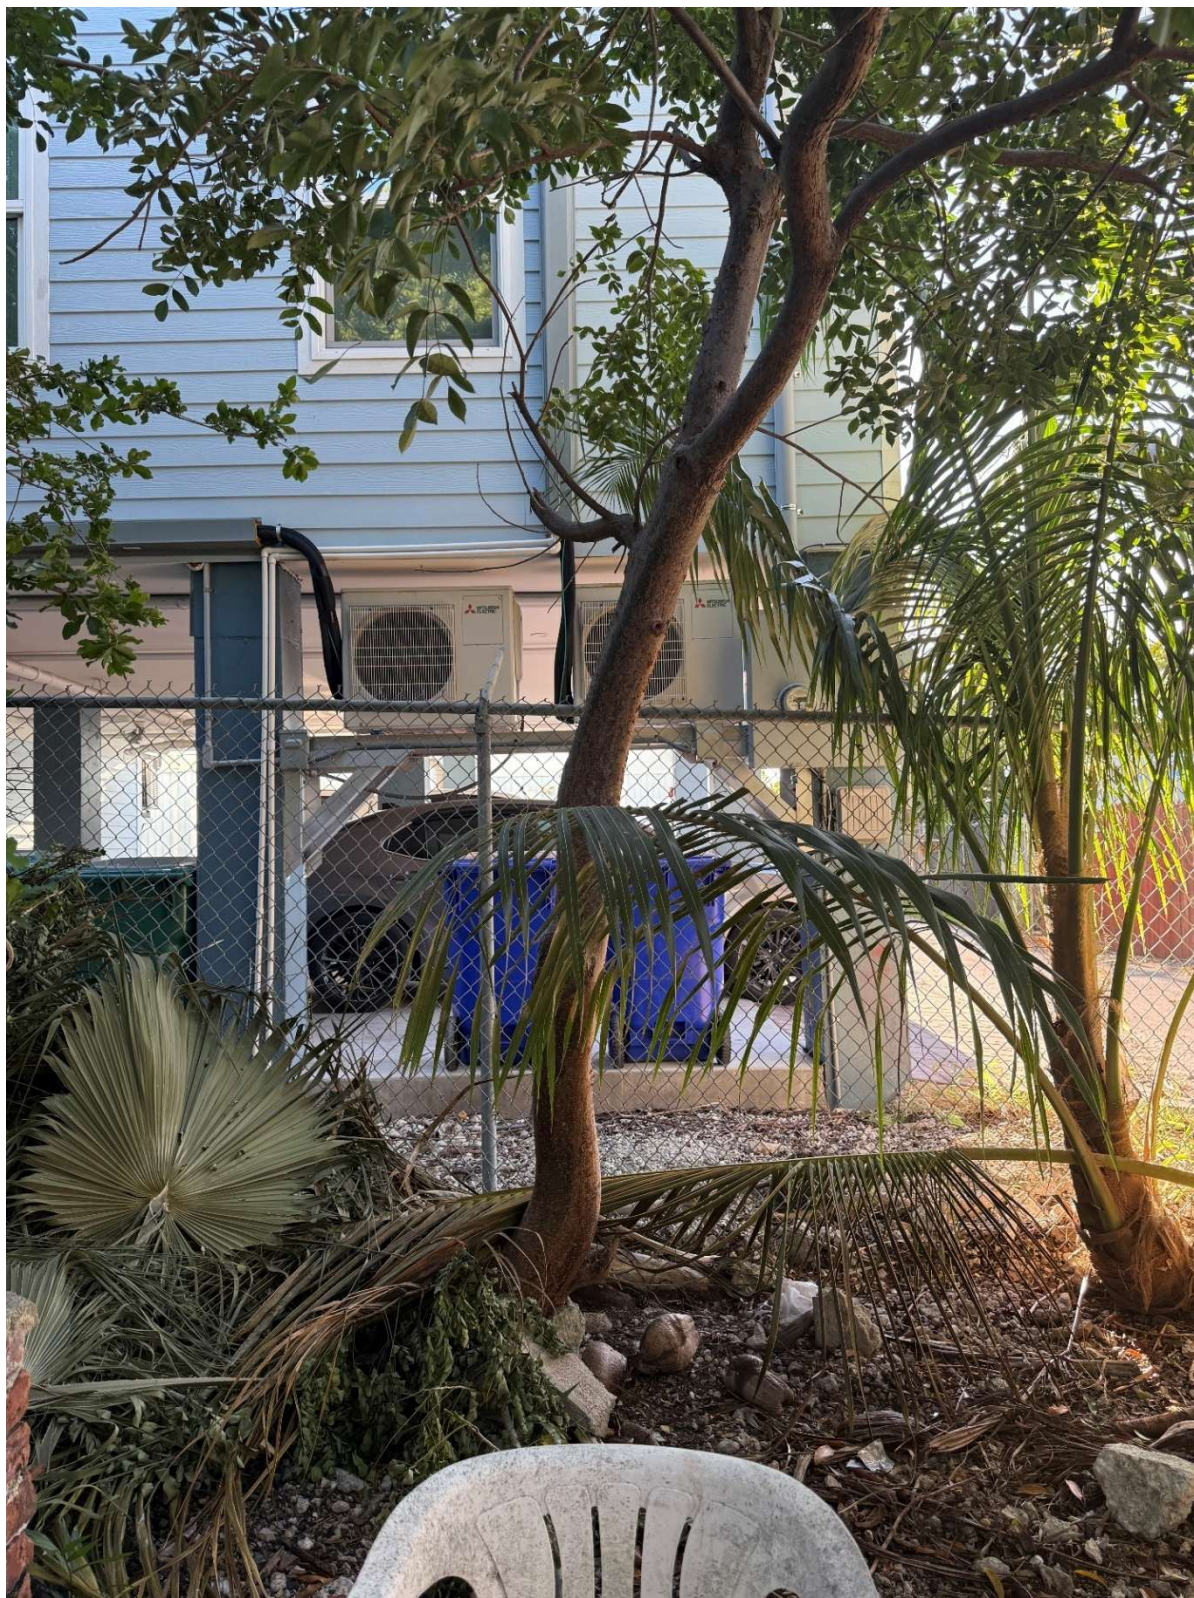
**Gumbo Limbo #7**

**Diameter: 6"**

**Location: 50%**

**Species: 100%**

**Condition: 40%**

**Value: 63%**

**Recommended Mitigation: 3.7 Caliper Inches**

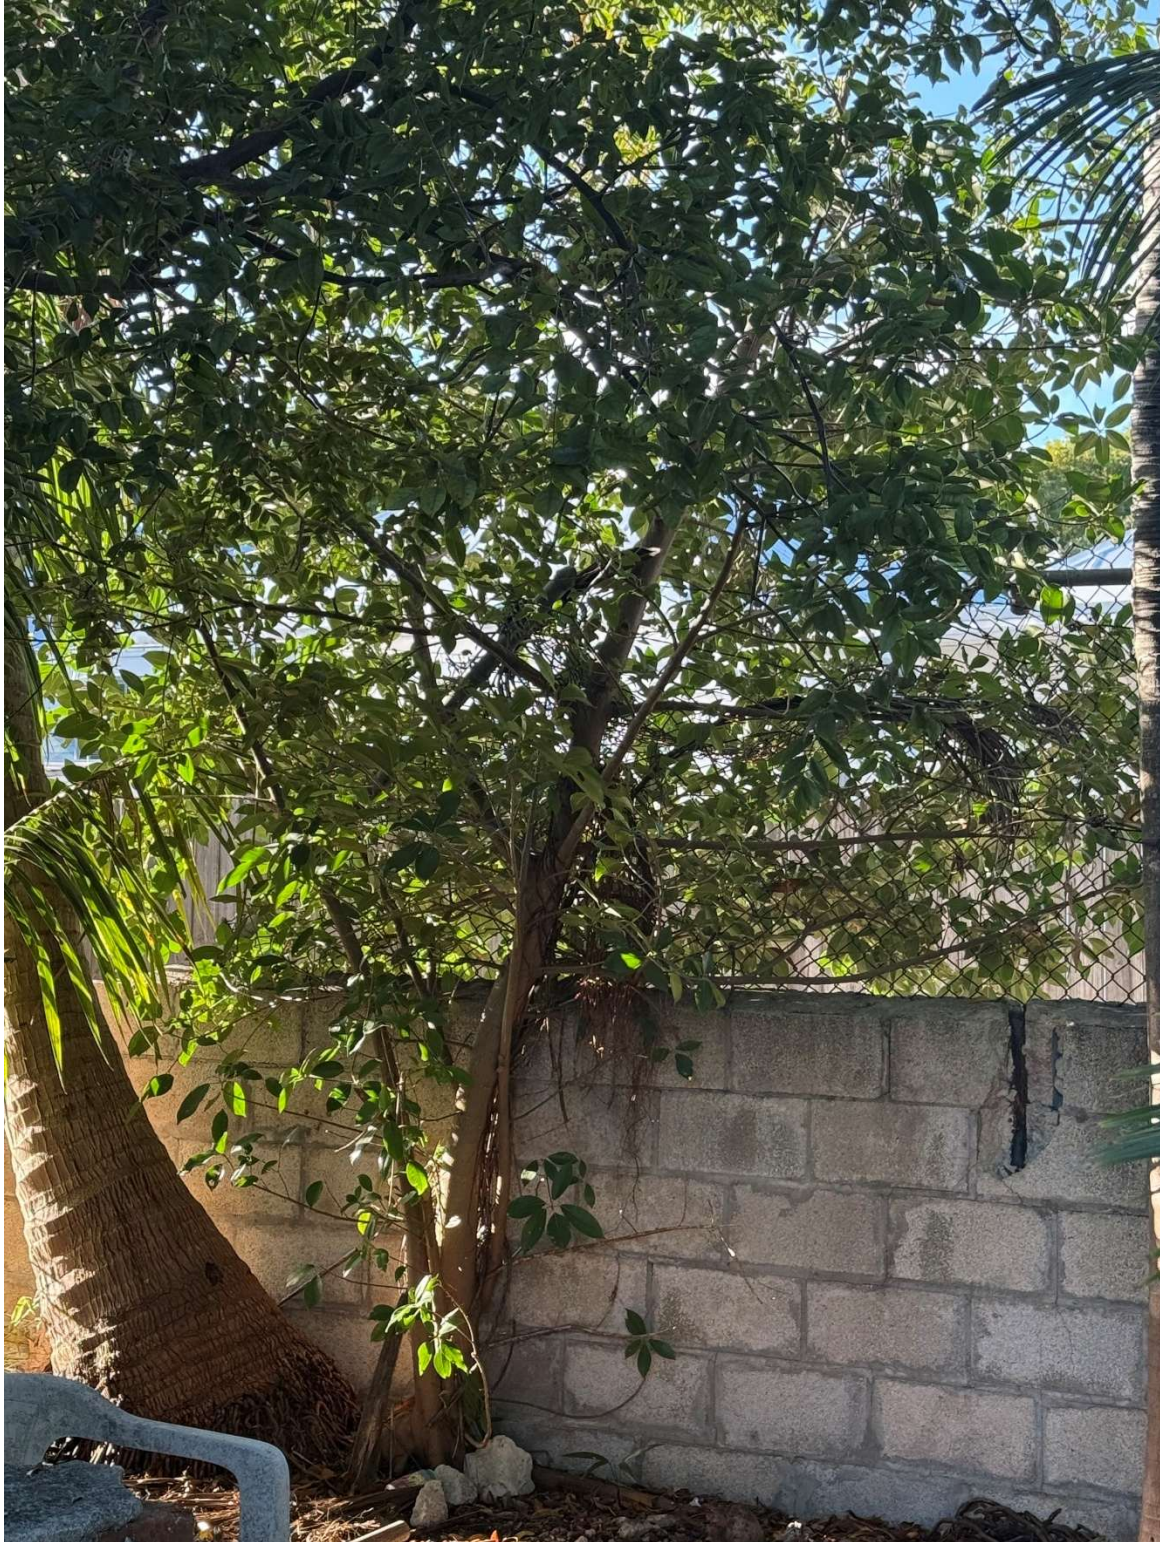
**Strangler Fig #6**

**Diameter: 6.3"**

**Location: 40%**

**Species: 100%**

**Condition: 40%**

**Value: 60%**

**Recommended Mitigation: 3.7 Caliper Inches**

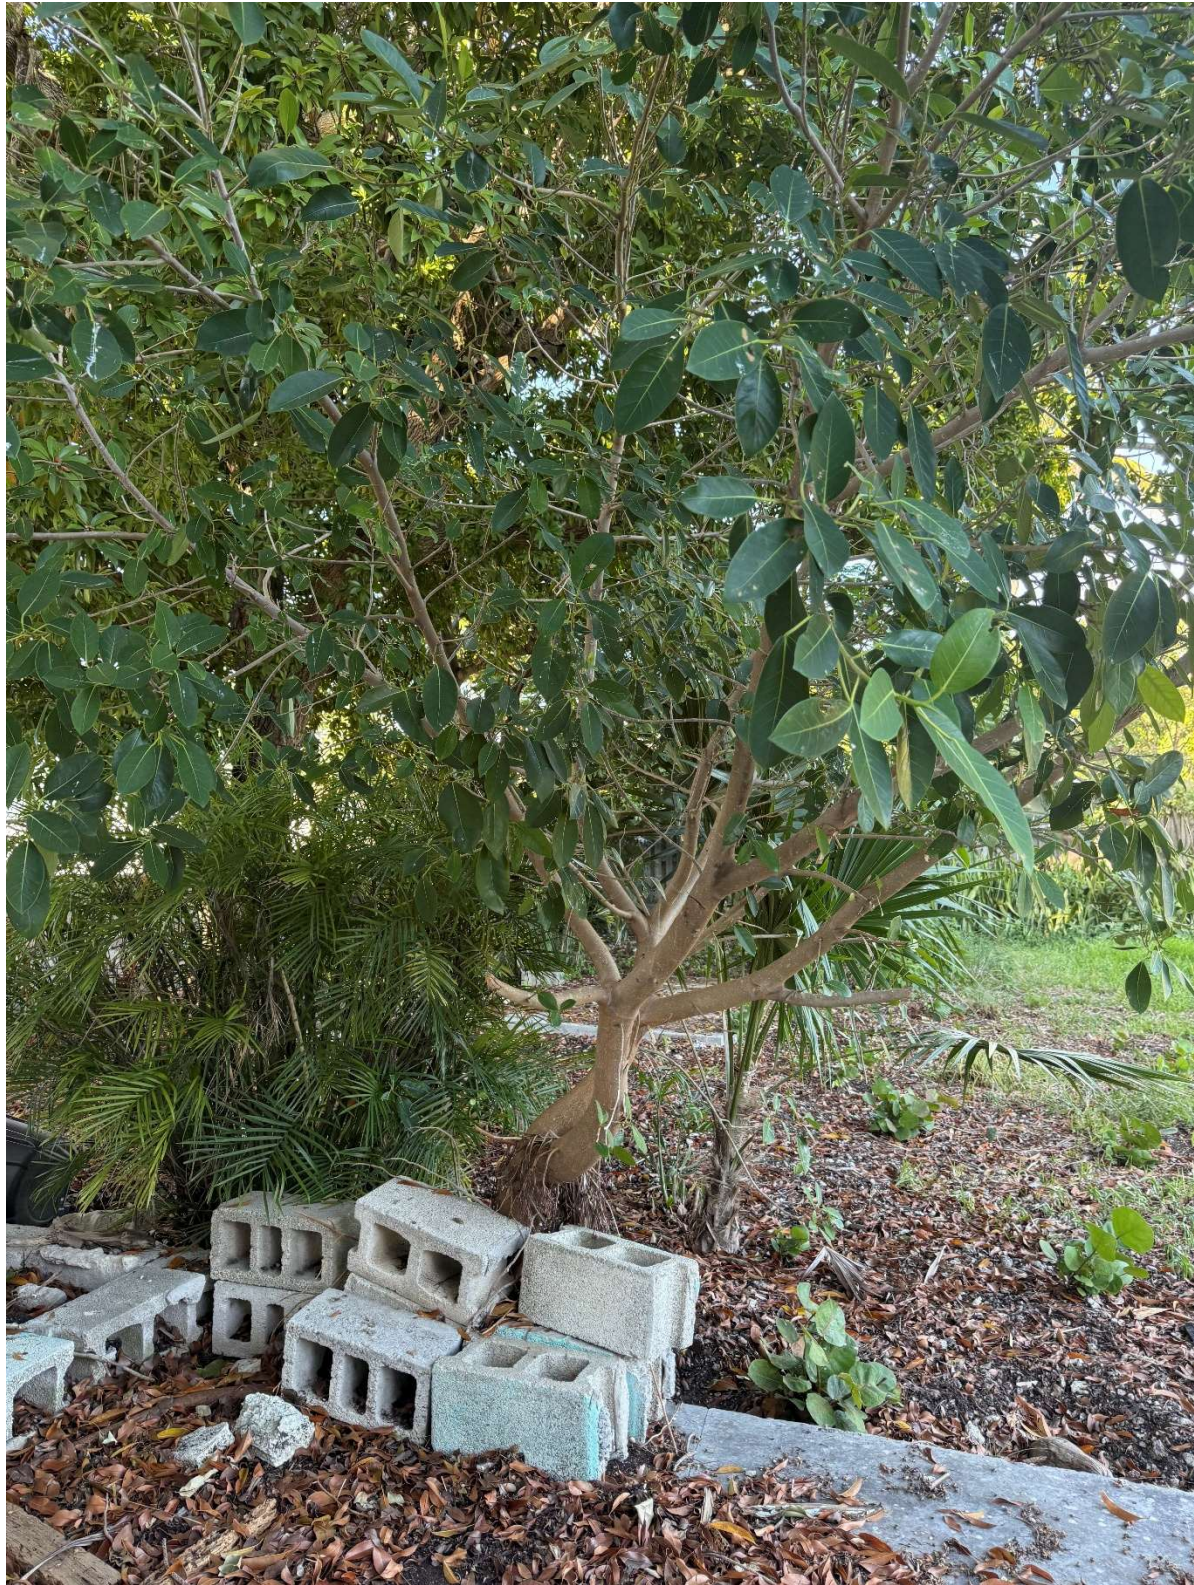
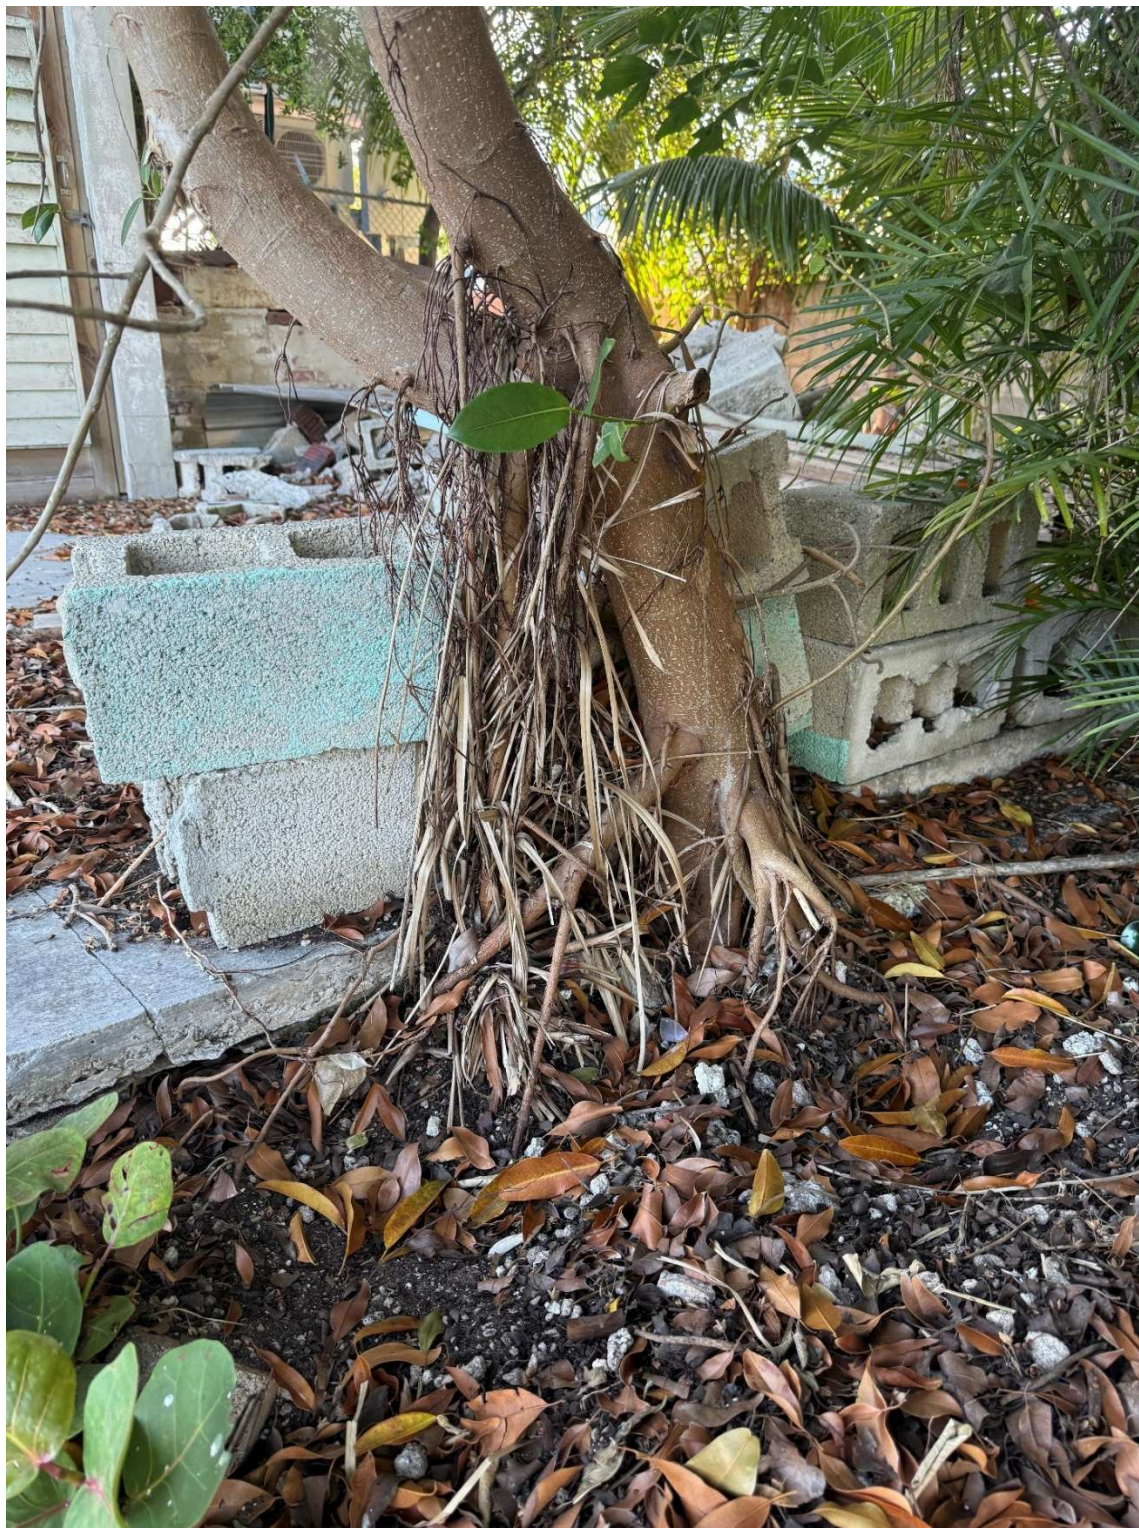
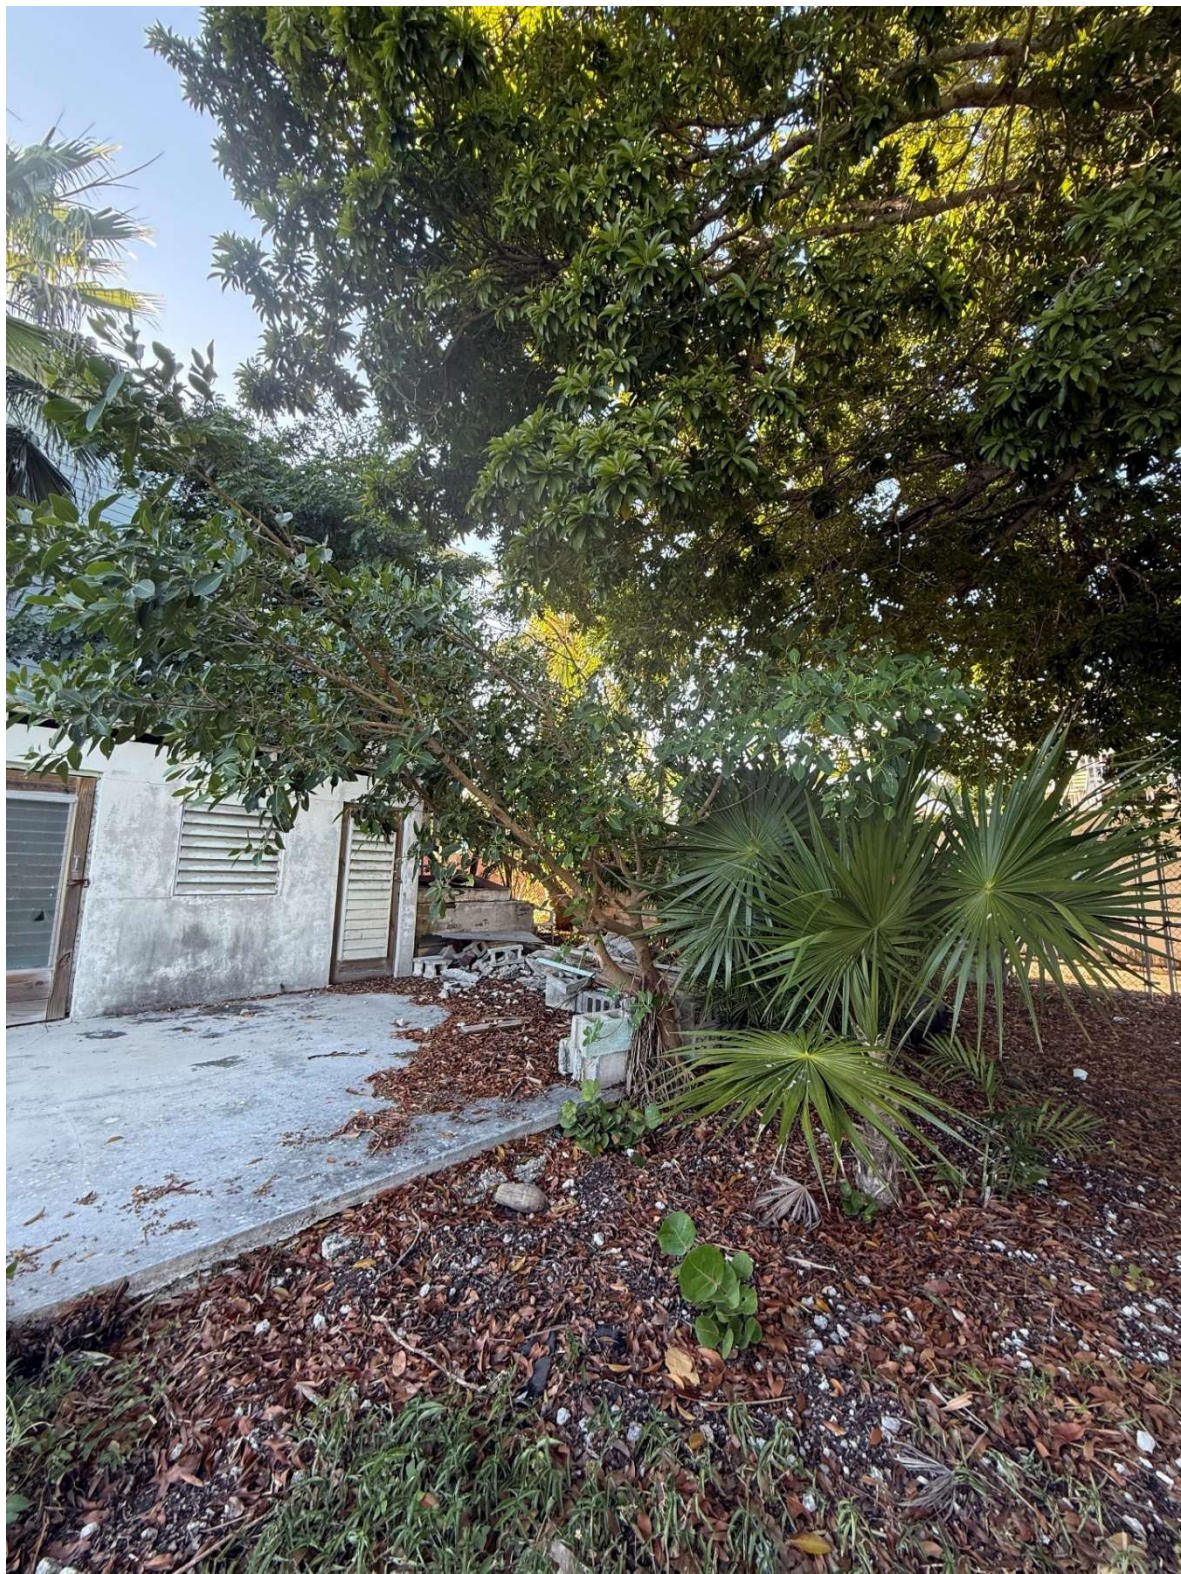
**Strangler Fig #5**

**Diameter: 7.6"**

**Location: 30%**

**Species: 100%**

**Condition: 40%**

**Value: 56%**

**Recommended Mitigation: 4.2 Caliper Inches**

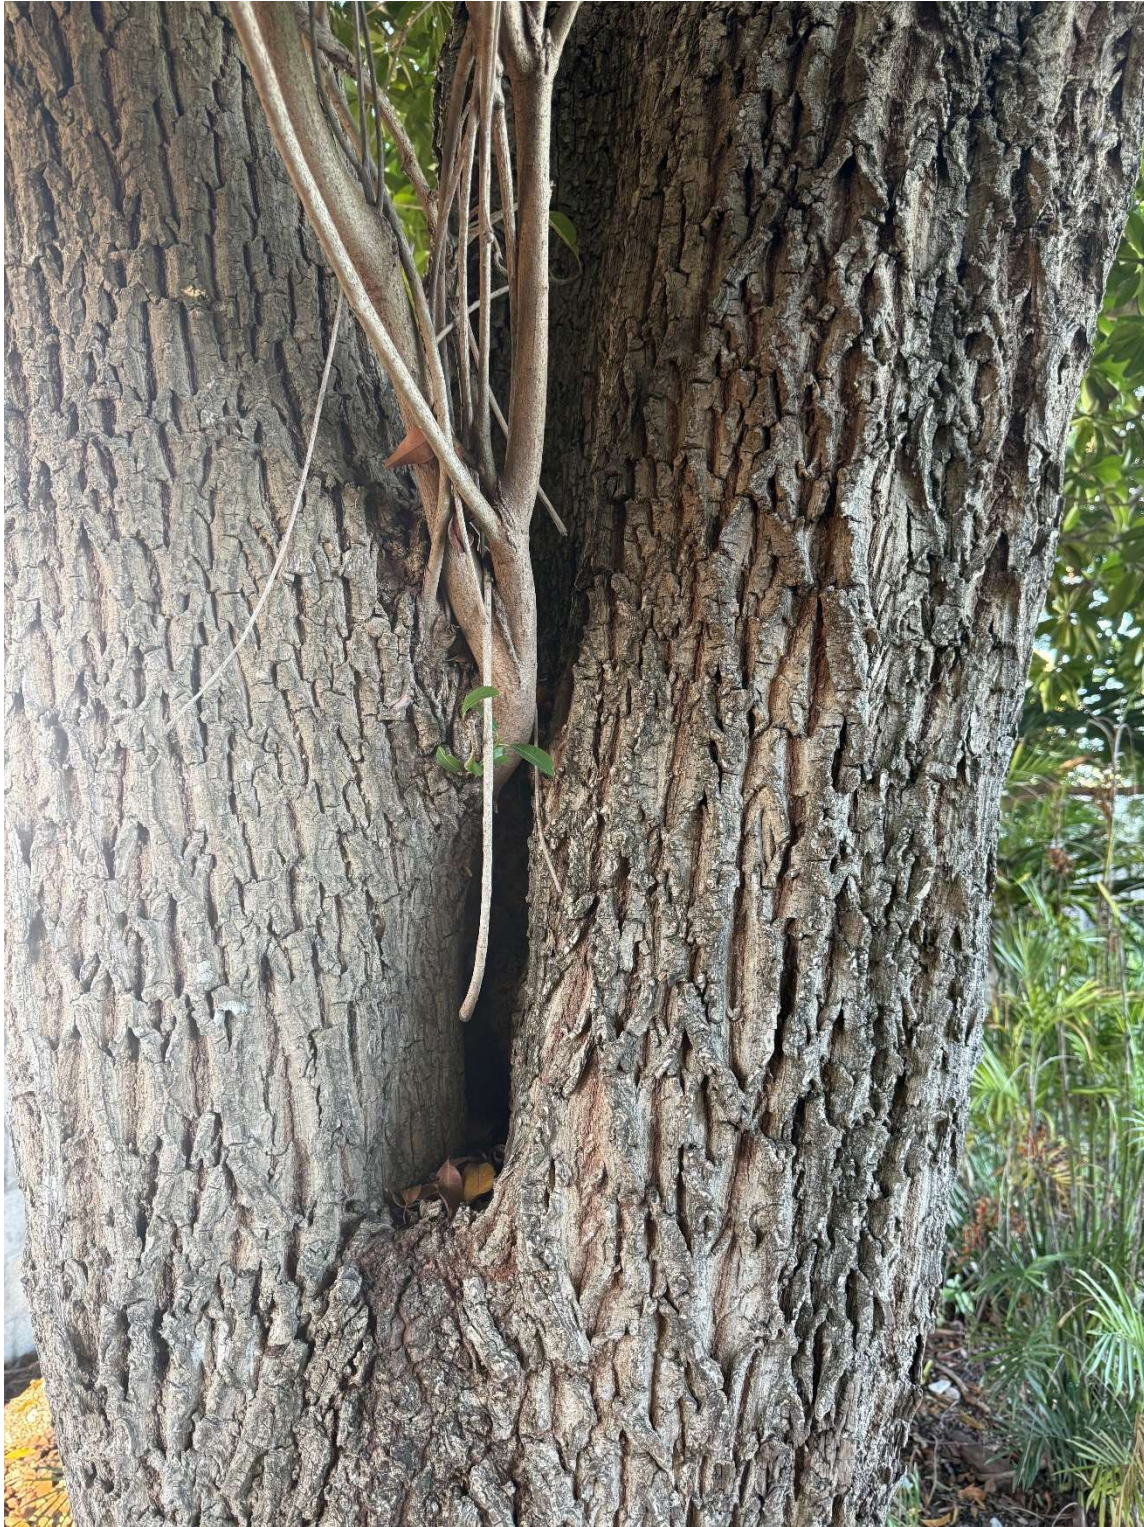
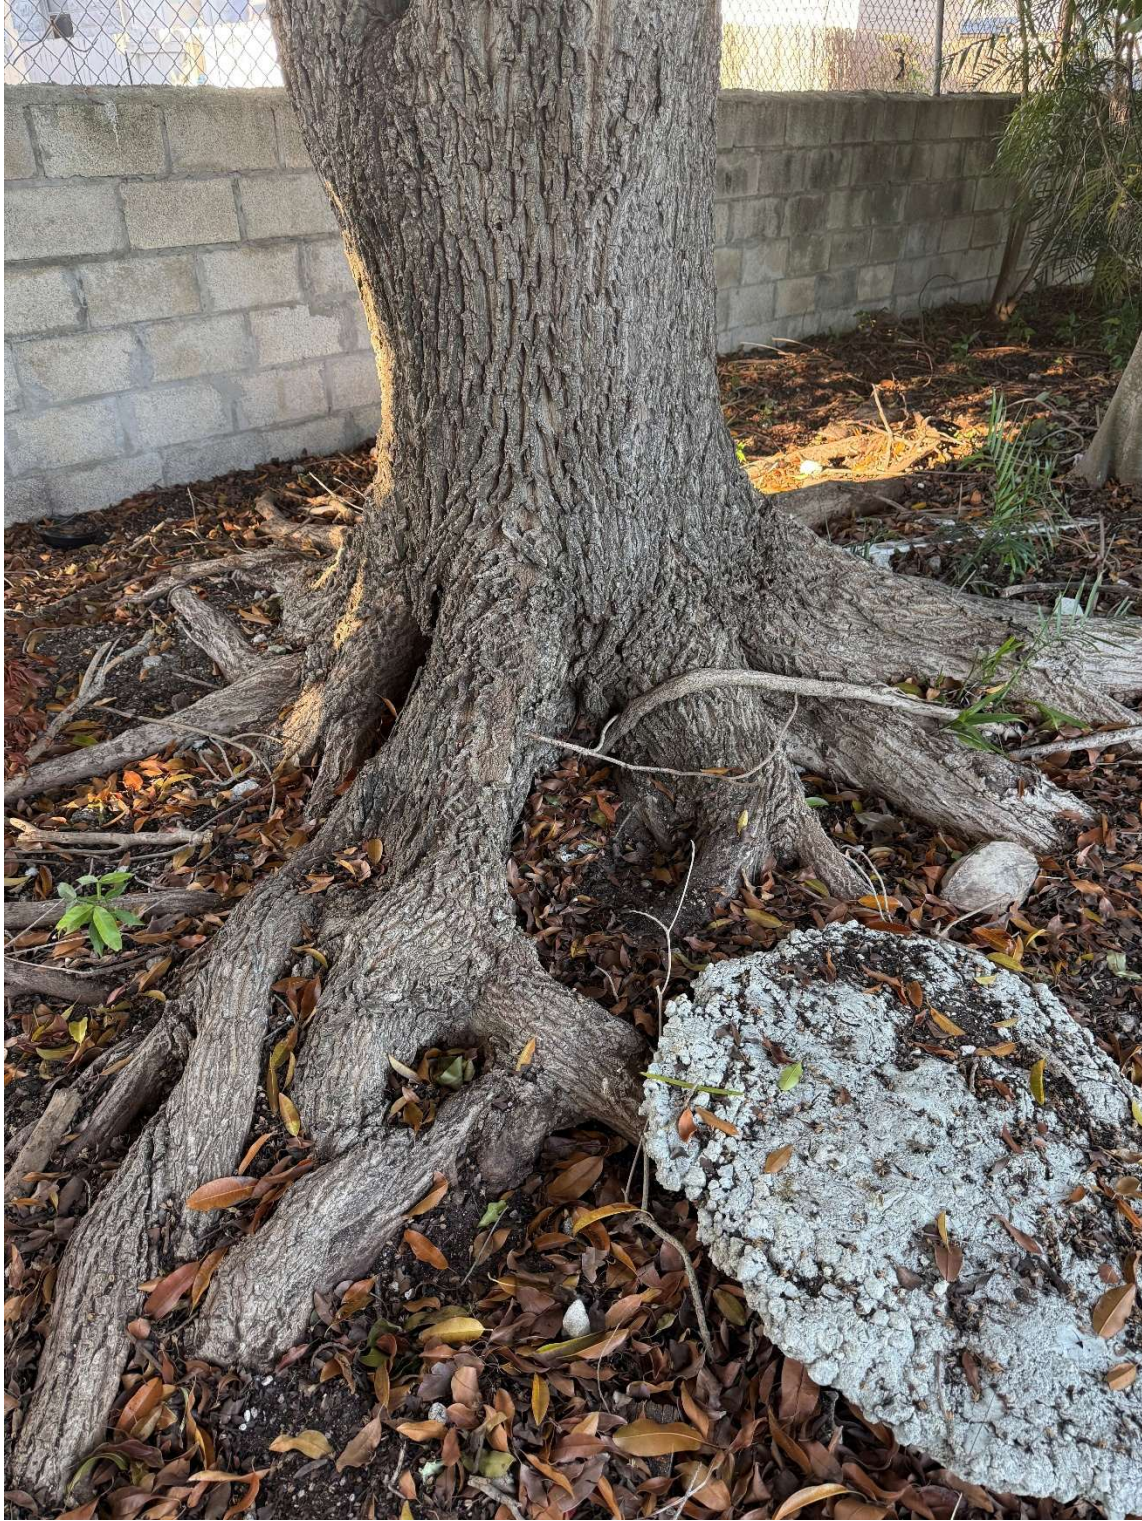
**Sapodilla stem splitting into codominant stems**

**Sapodilla Tree #4 root flare and healthy aerial roots**

**Sapodilla Tree #4**

**Diameter: 27"**

**Location: 80%**

**Species: 100%**

**Condition: 60%**

**Value: 80%**

**Recommended Mitigation: 21.6 Caliper Inches**

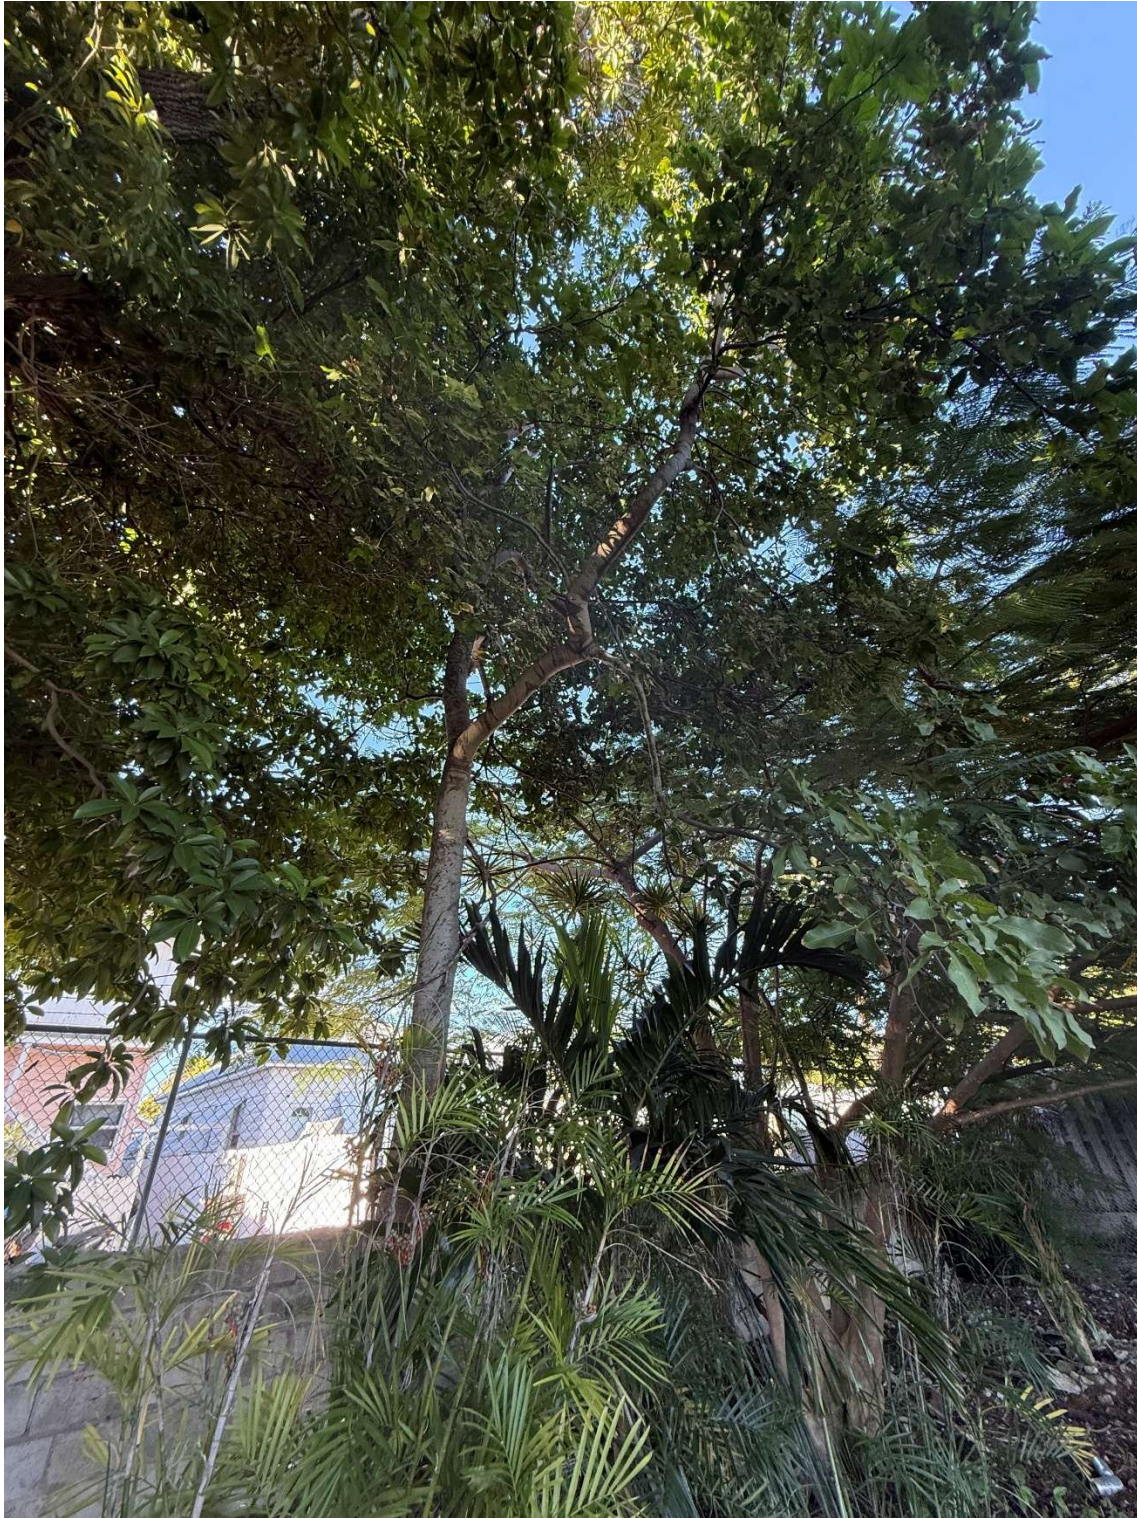
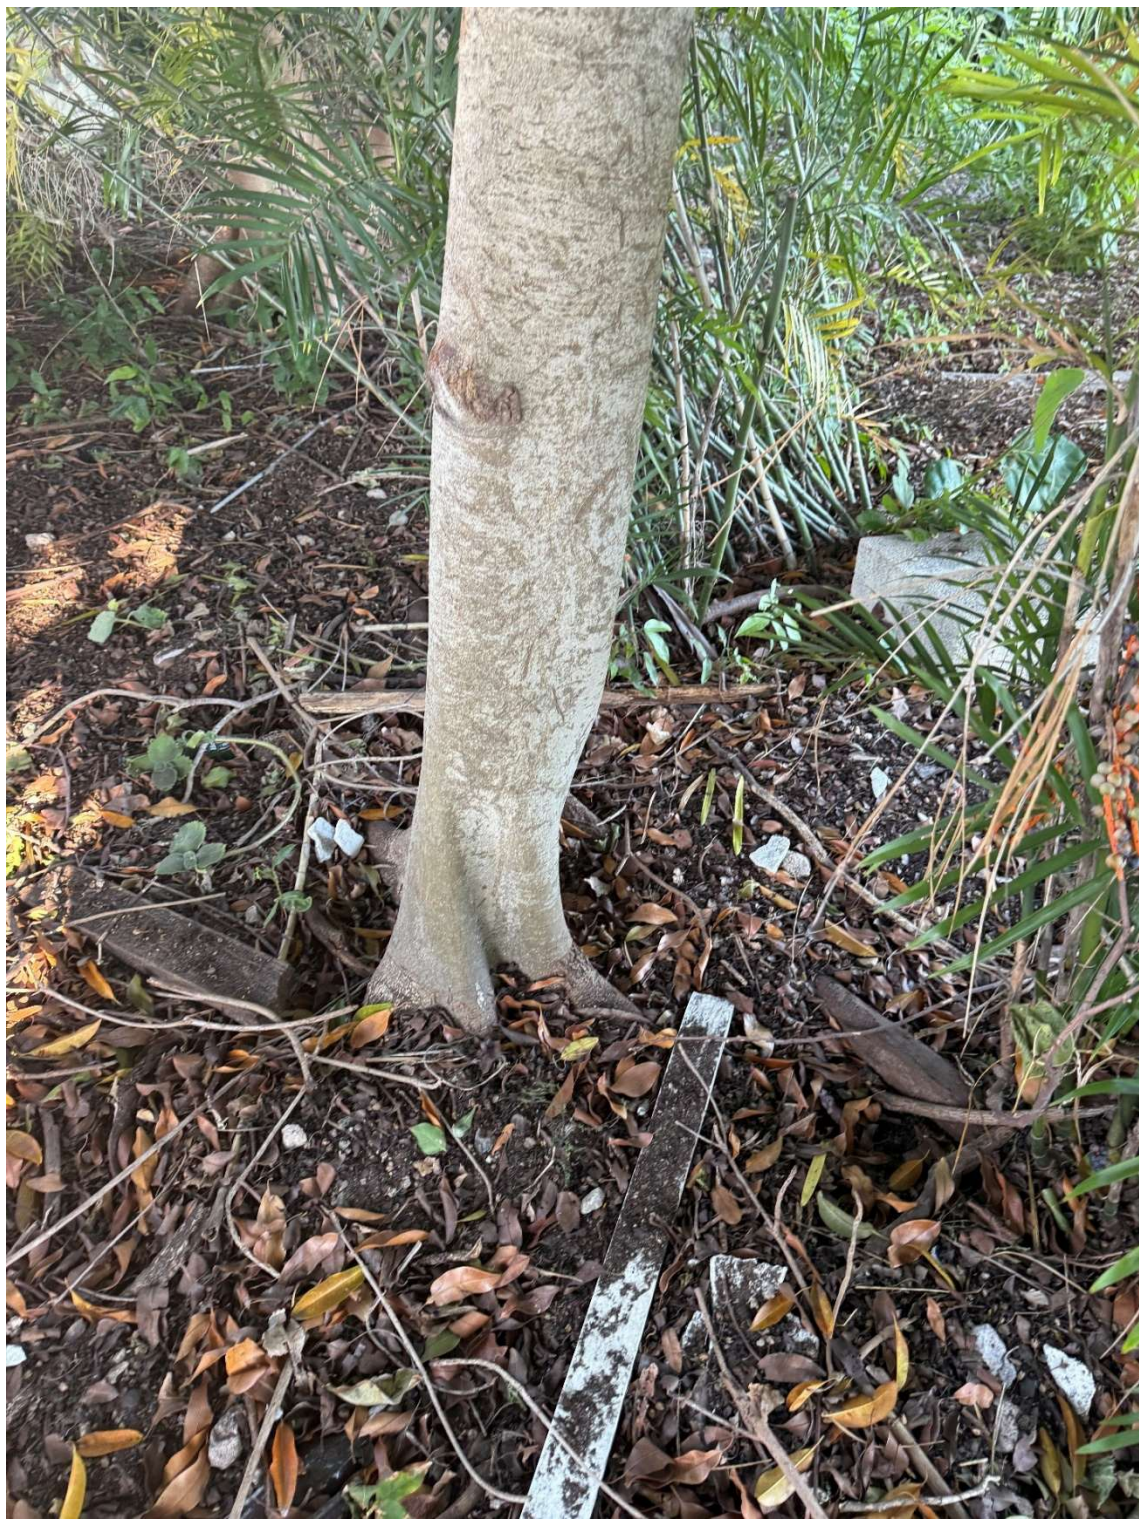
**Spanish Lime Tree #3**

**Spanish Lime Tree #3 smothered by Sapodilla and Royal Poinciana Tree**

**Spanish Lime #3**

**Diameter: 7.3"**

**Location: 40%**

**Species: 100%**

**Condition: 60%**

**Value: 66.6%**

**Recommended Mitigation: 4.9 Caliper Inches**
