**TREE COMMISSION TREE REMOVAL REPORT  
CITY of KEY WEST**

**PROPERTY: 1903-1905 Flagler Ave**

**APPLICATION NUMBER: T2025-0261**

**REQUEST: The applicant is requesting removal of (1) Jamaican Dogwood Tree, (1) Royal Poinciana Tree, (1) Spanish Lime Tree, (1) Sapodilla Tree, (2) Strangler Fig Trees, (2) Gumbo Limbo Trees, (1) Barbados Cherry Tree**

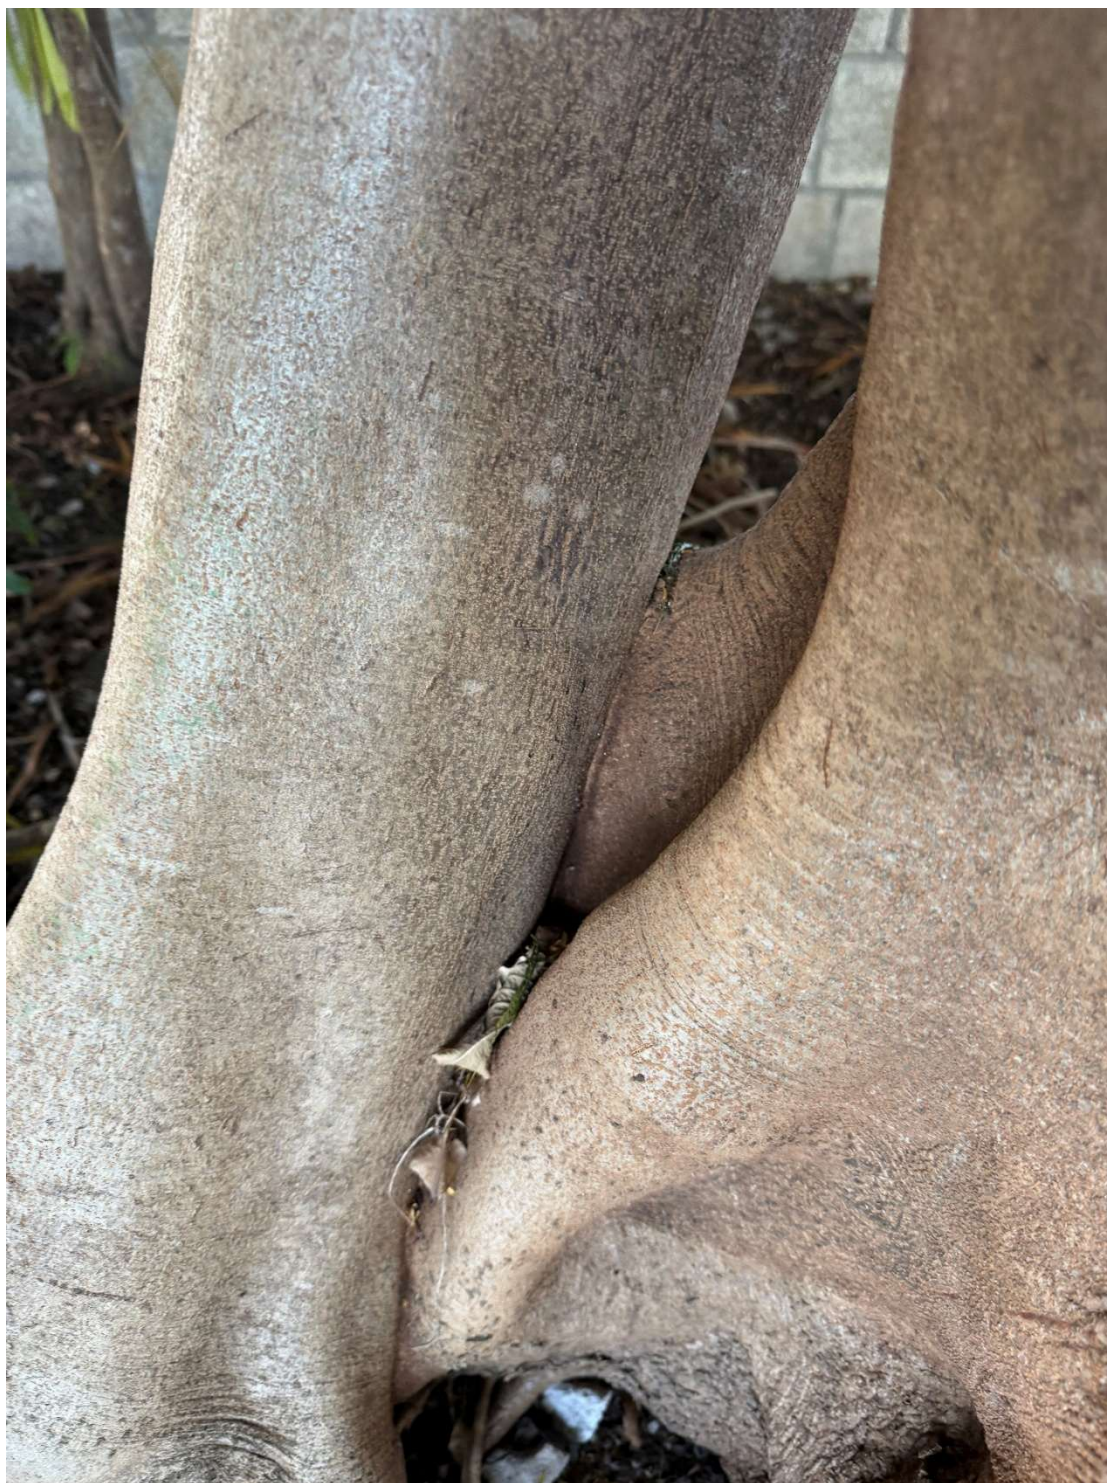
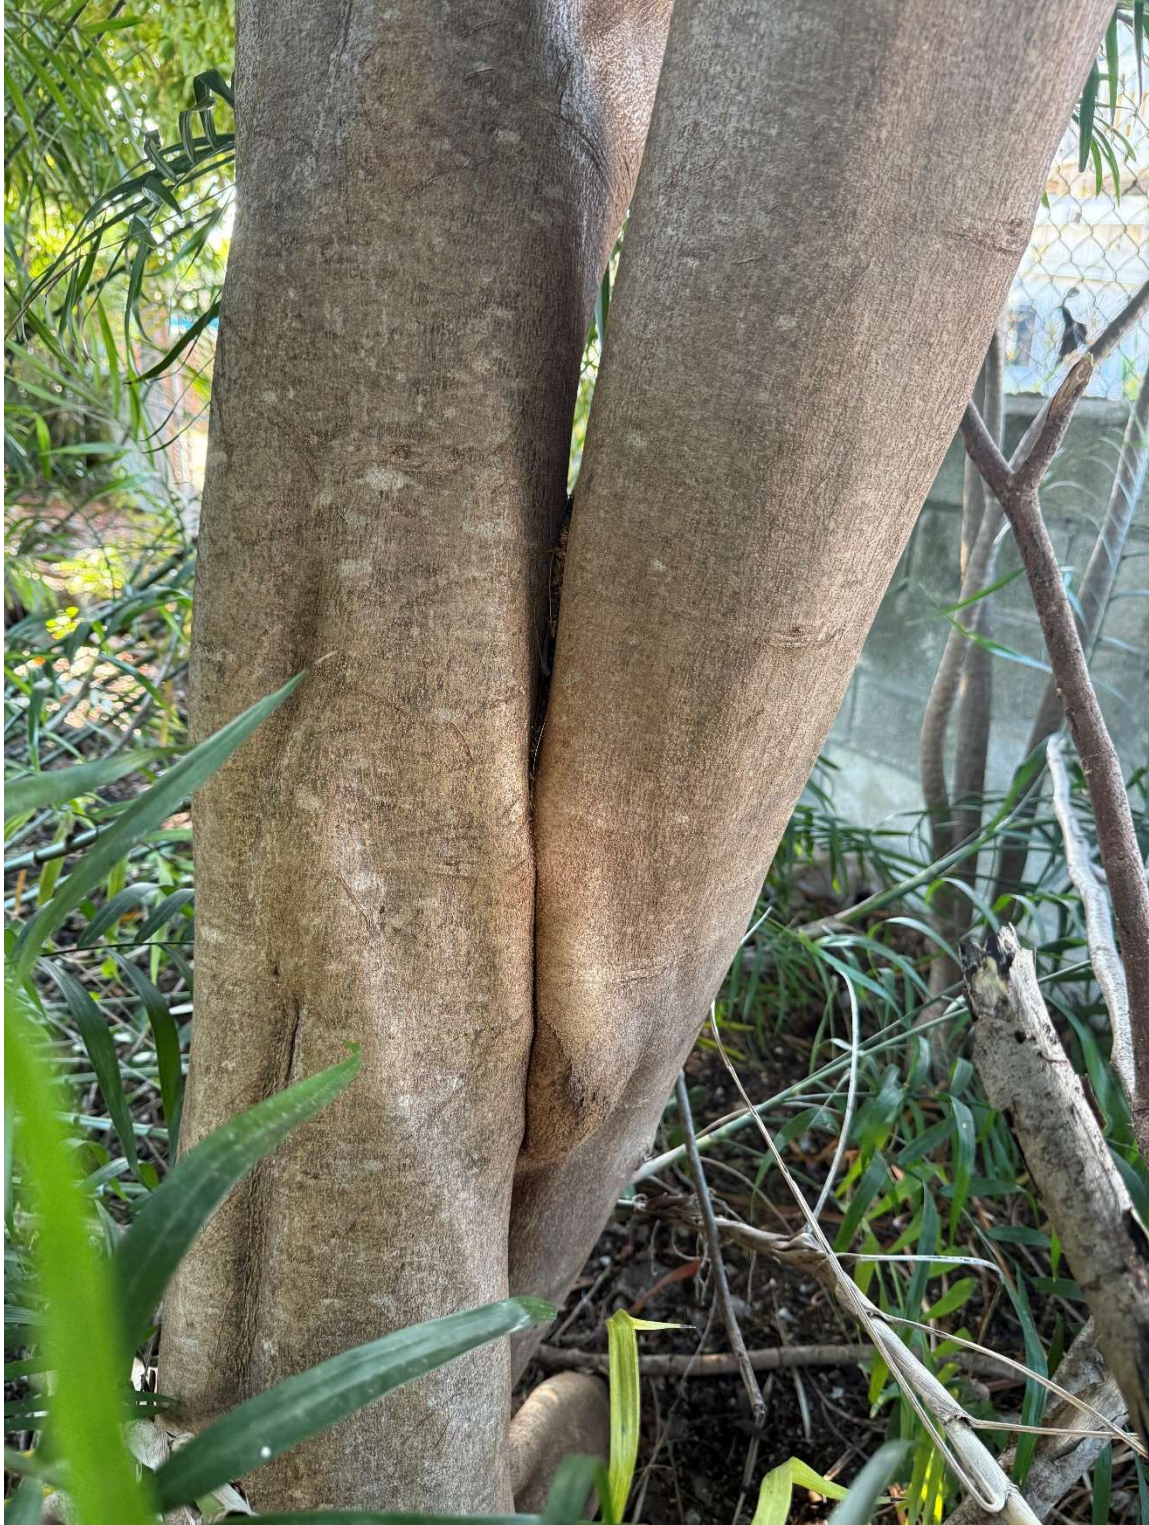
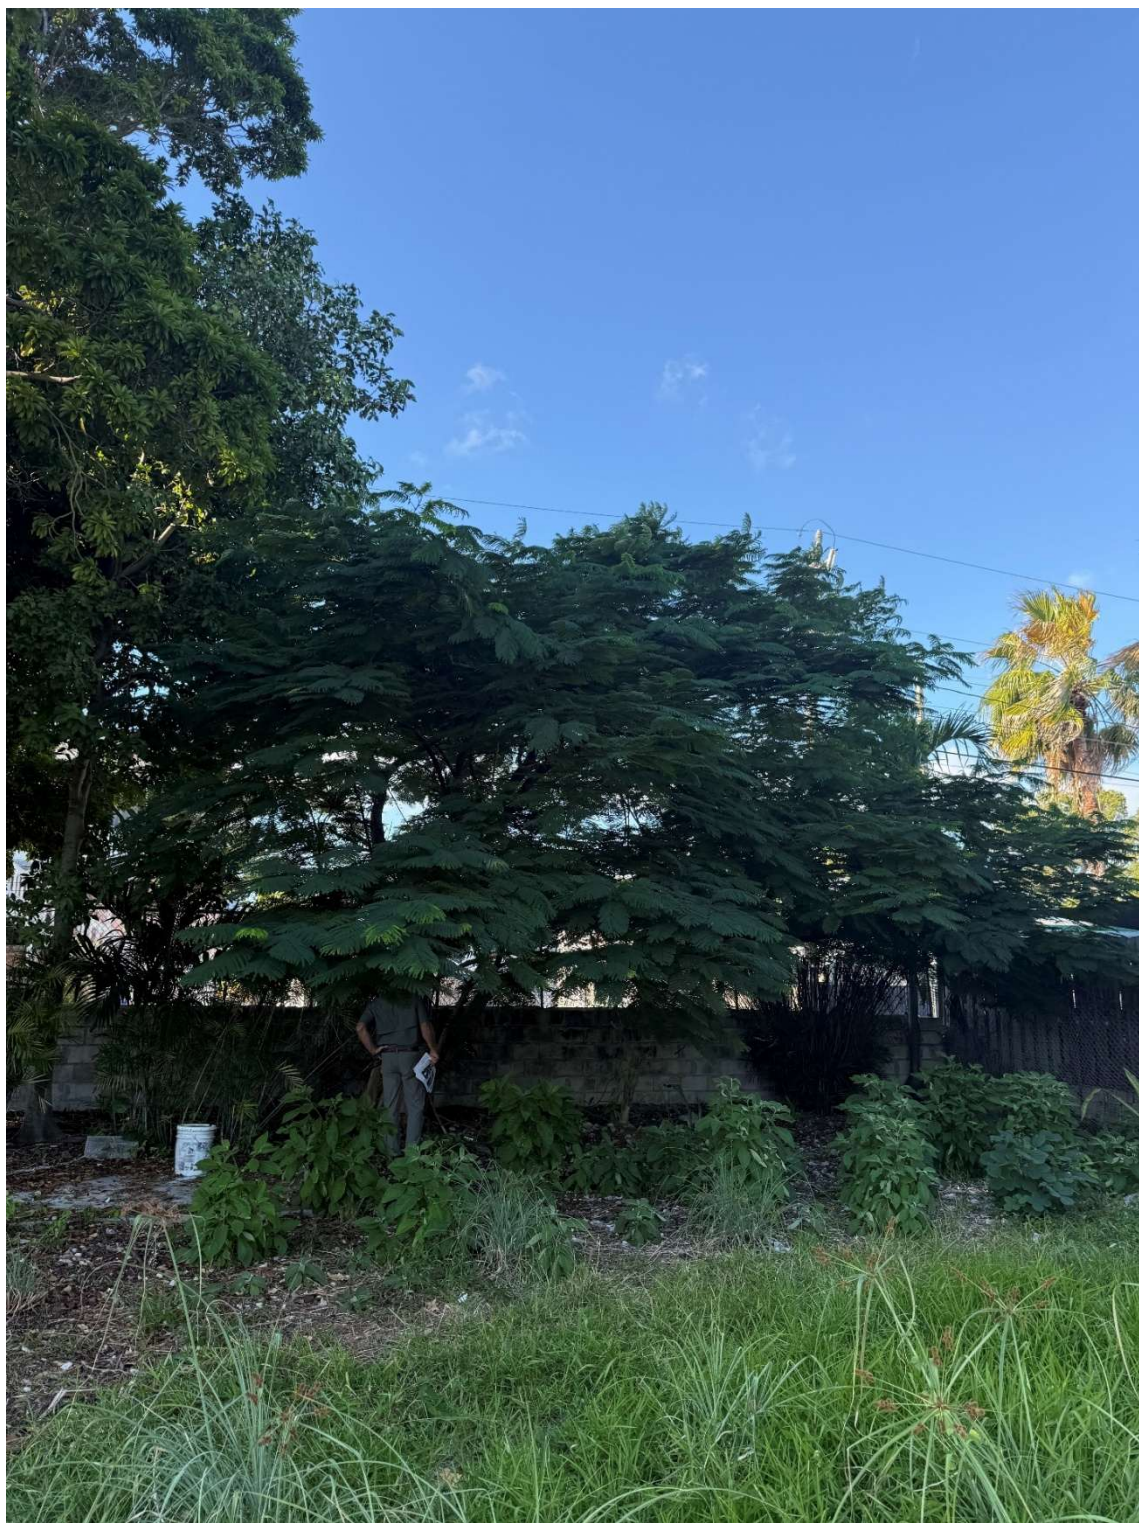
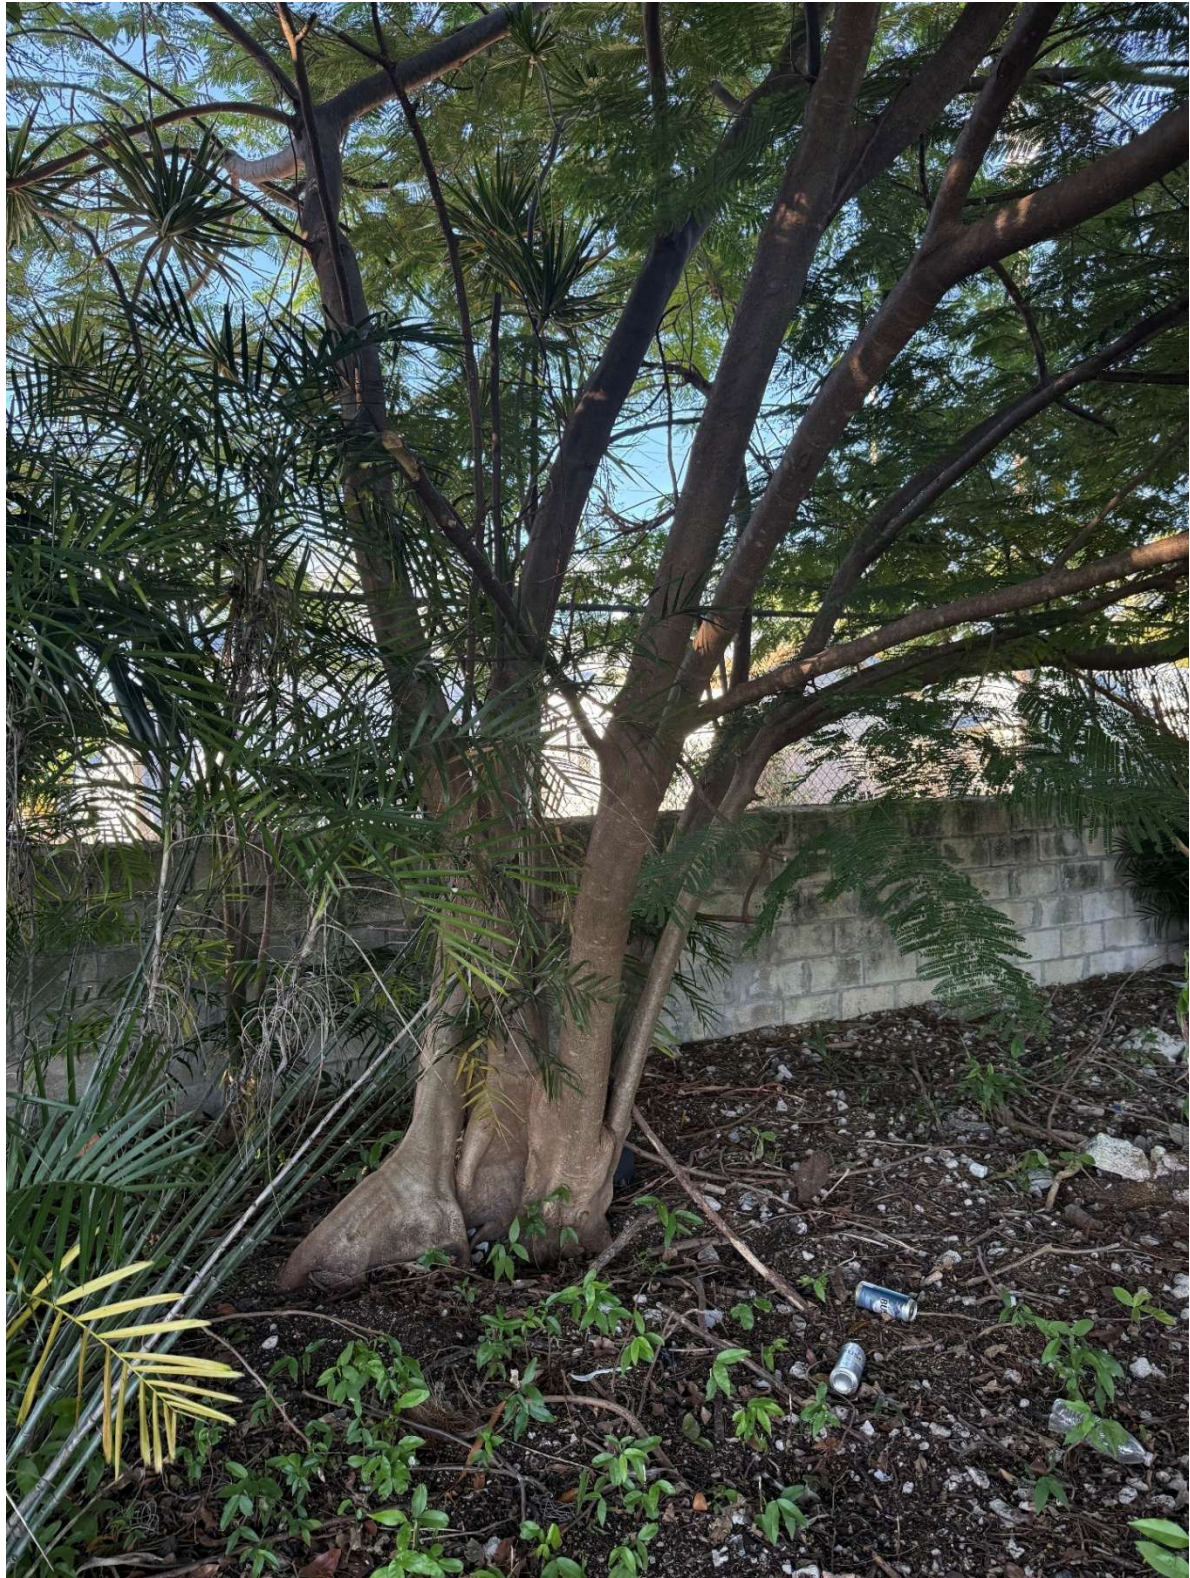
**Poinciana Tree #2**

**Royal Poinciana Tree #2 has compromised stems with included bark**

**#2 Royal Poinciana Tree**

**Diameter: 29.2"**

**Location: 80%**

**Species: 100%**

**Condition: 50%**

**Value: 76%**

**Recommended Mitigation: 22.1 Caliper Inches**

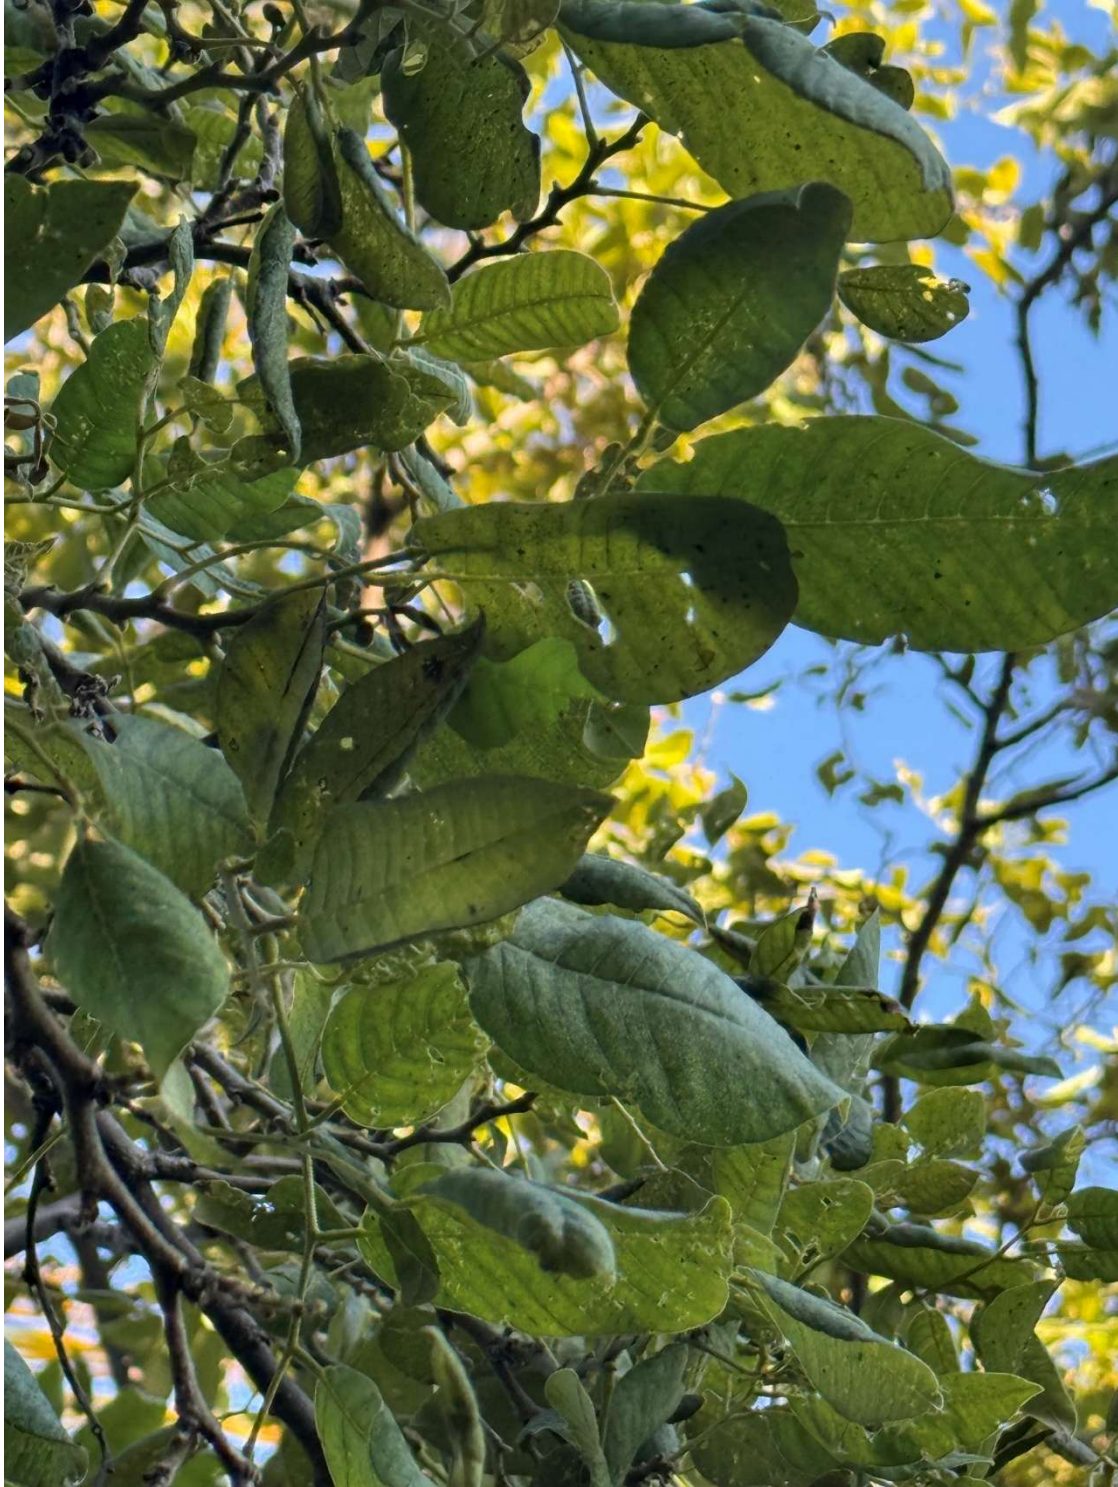
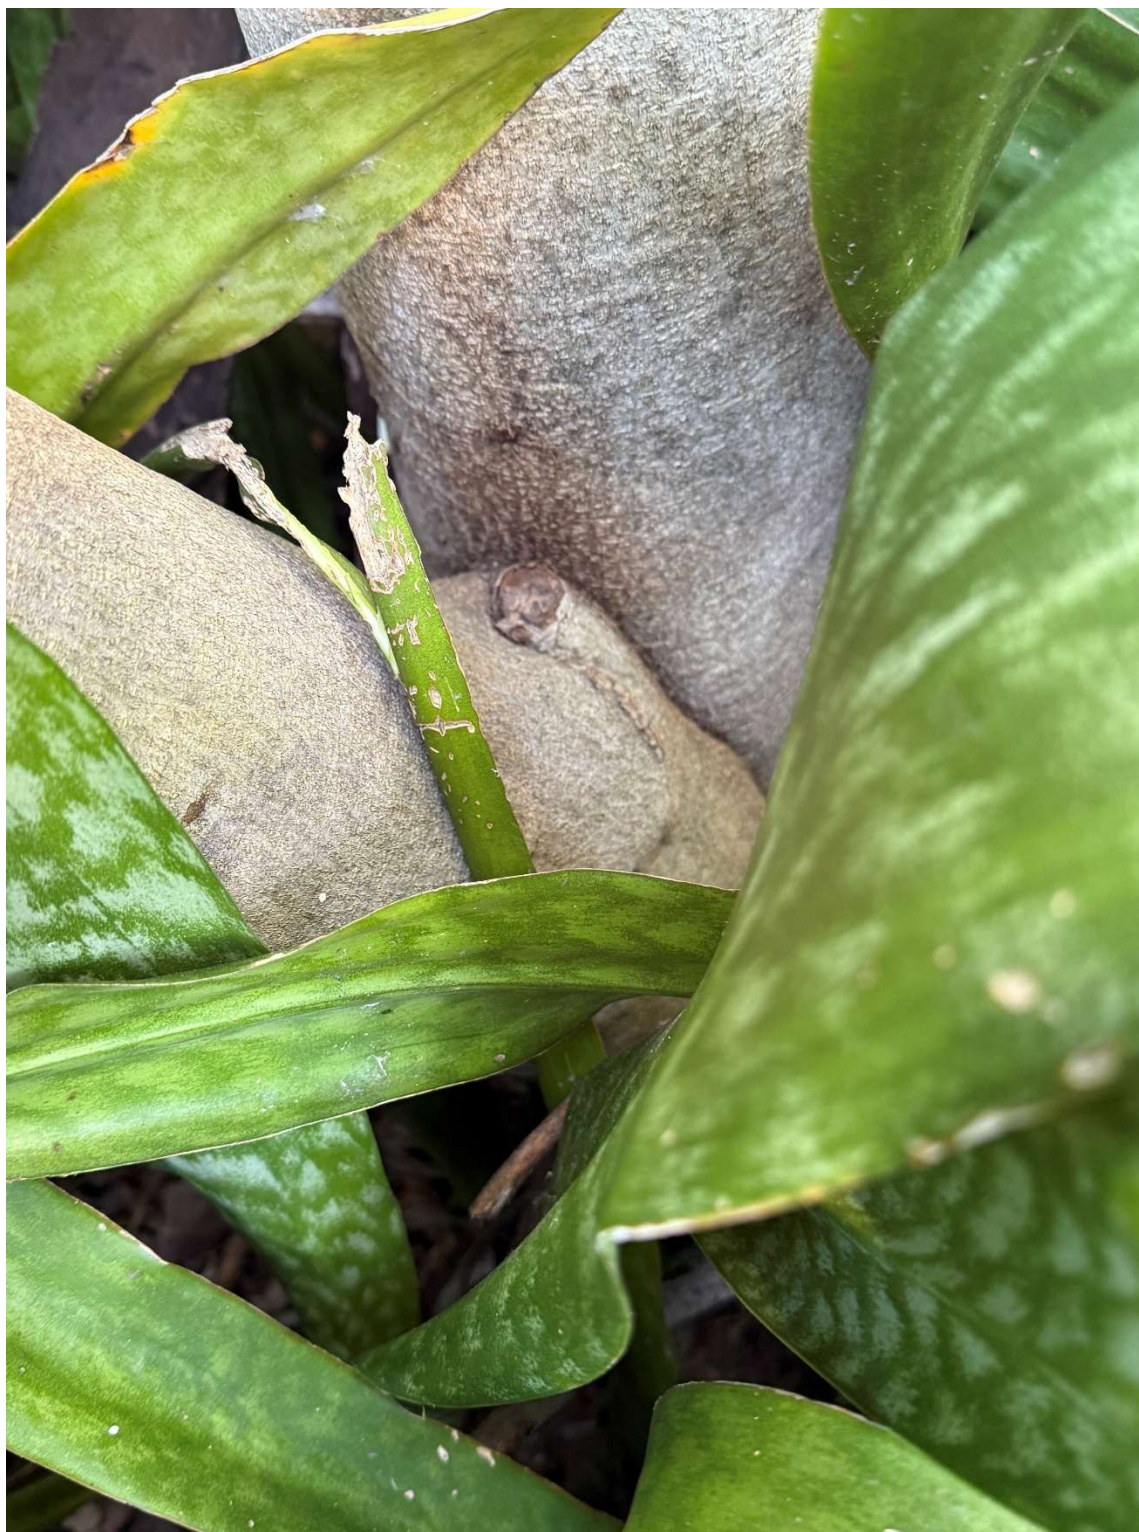
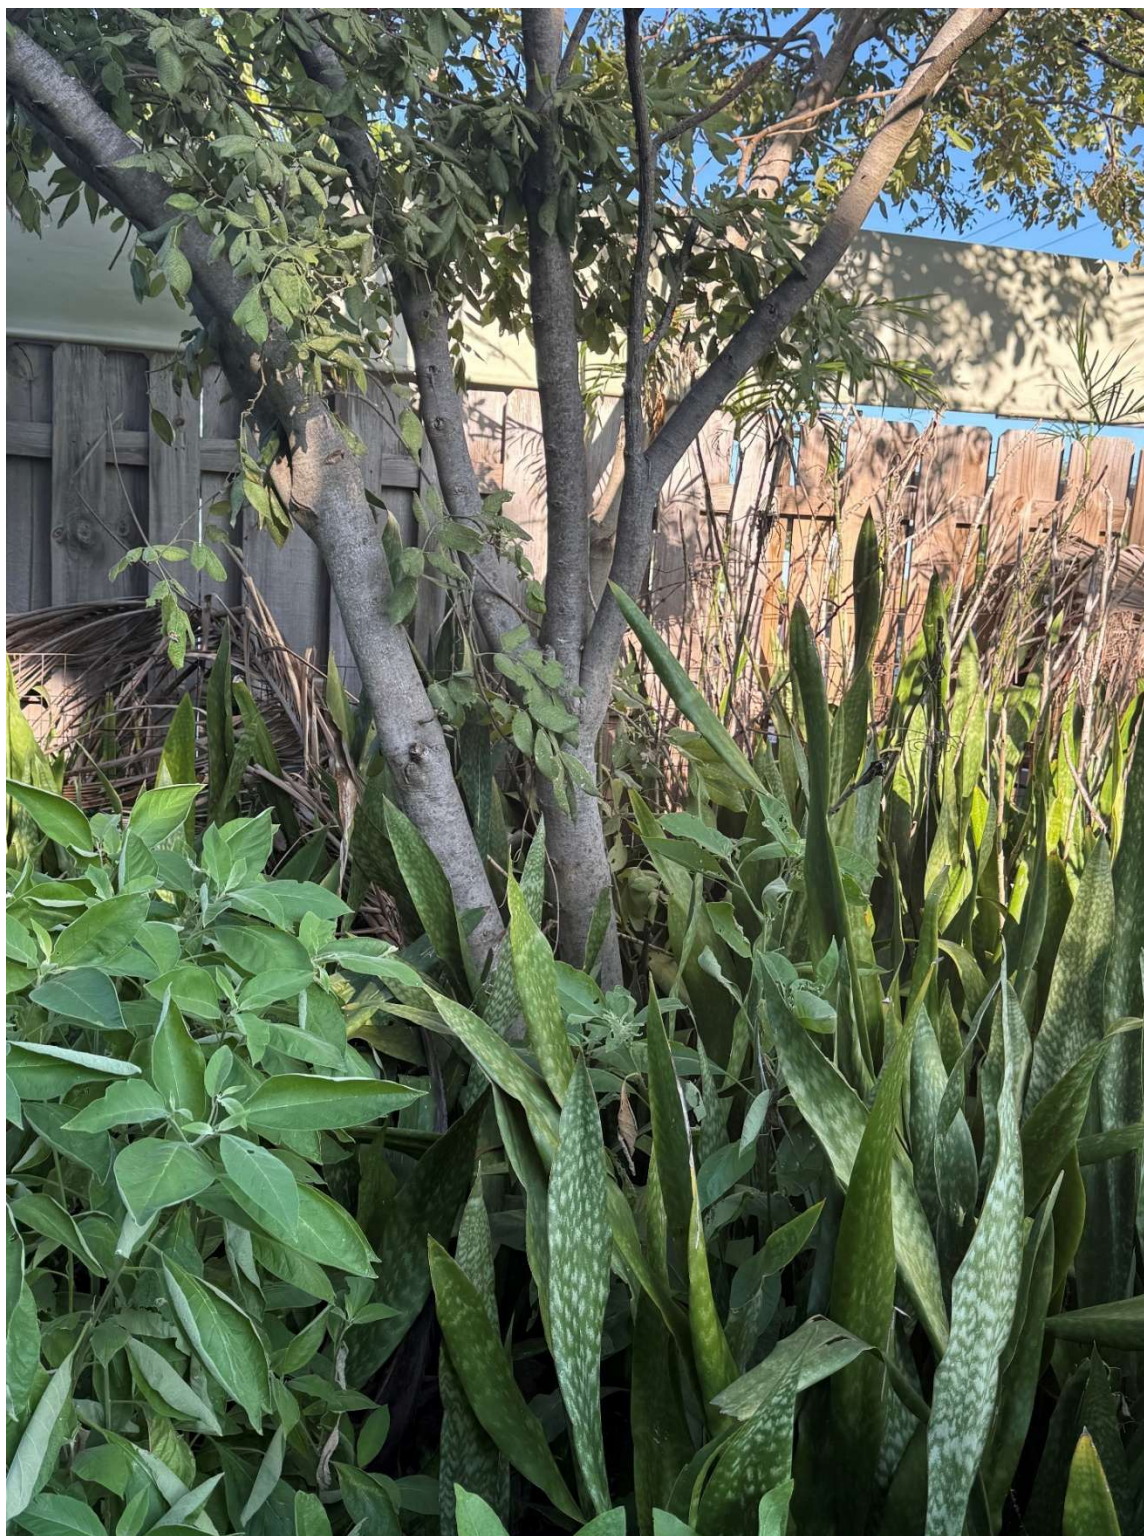
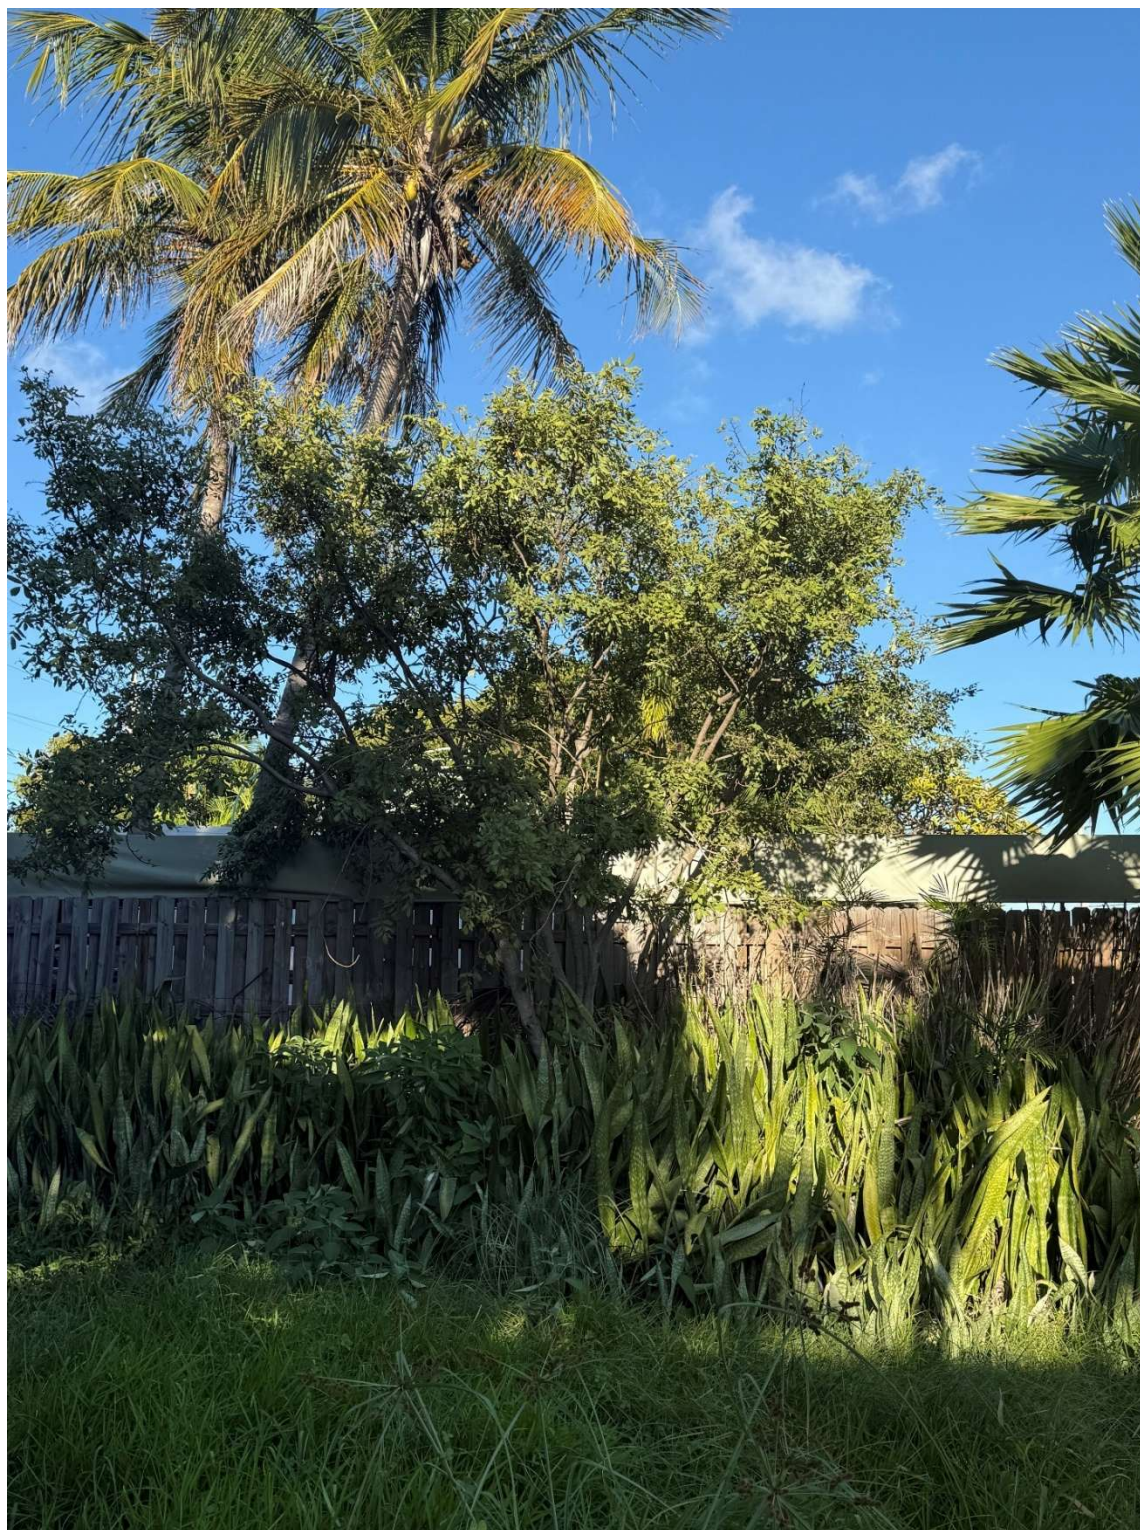
**Jamaican Dogwood #1**

**Jamaican Dogwood leaves and canopy are chlorotic and defoliated from pests.**

**Jamaican Dogwood #1 stem also has included bark.**

**#1 Jamaican Dogwood Tree**

**Diameter: 10.1"**

**Location: 80%**

**Species: 100%**

**Condition: 40%**

**Value: 73%**

**Recommended Mitigation: 7.3 Caliper Inches**
