# Stock Island Landfill

5701 West Junior College Road, Stock Island

Overview of current status, obligations and future possibilities.

Utilities Department City of Key West

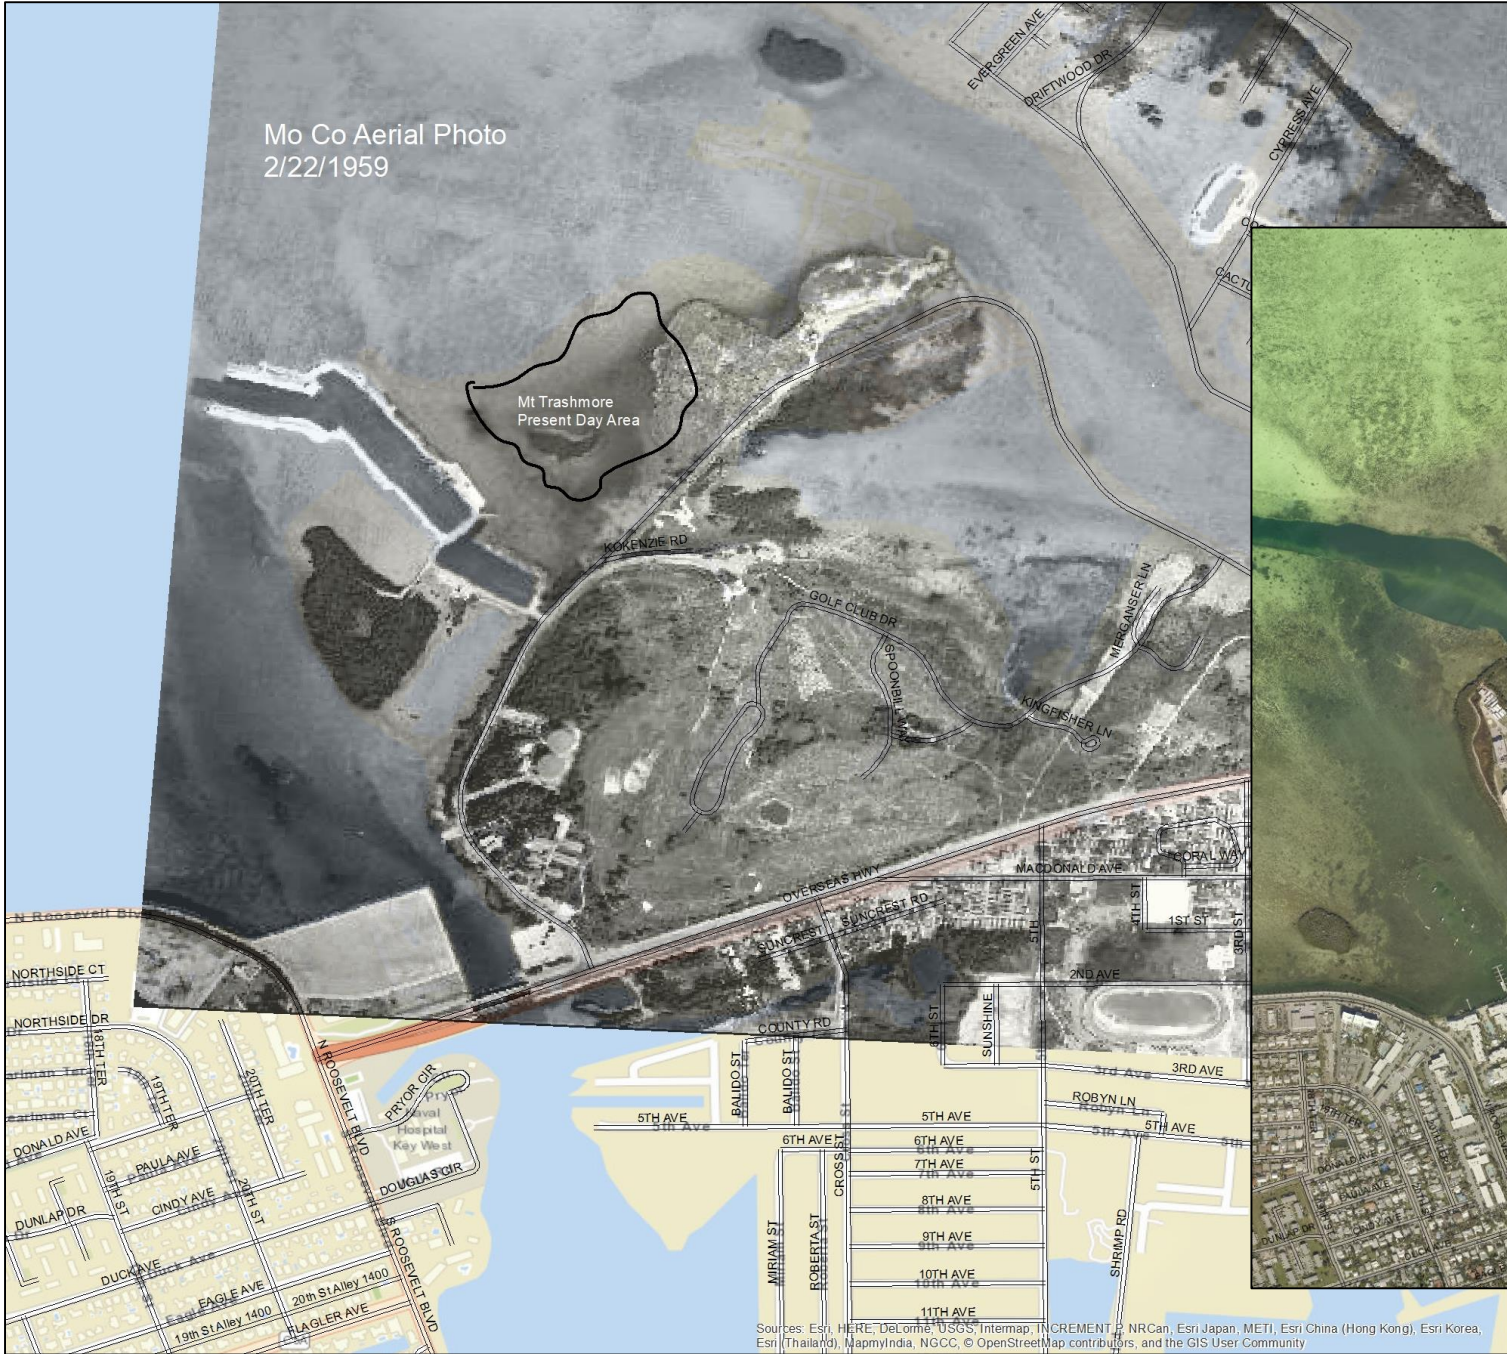
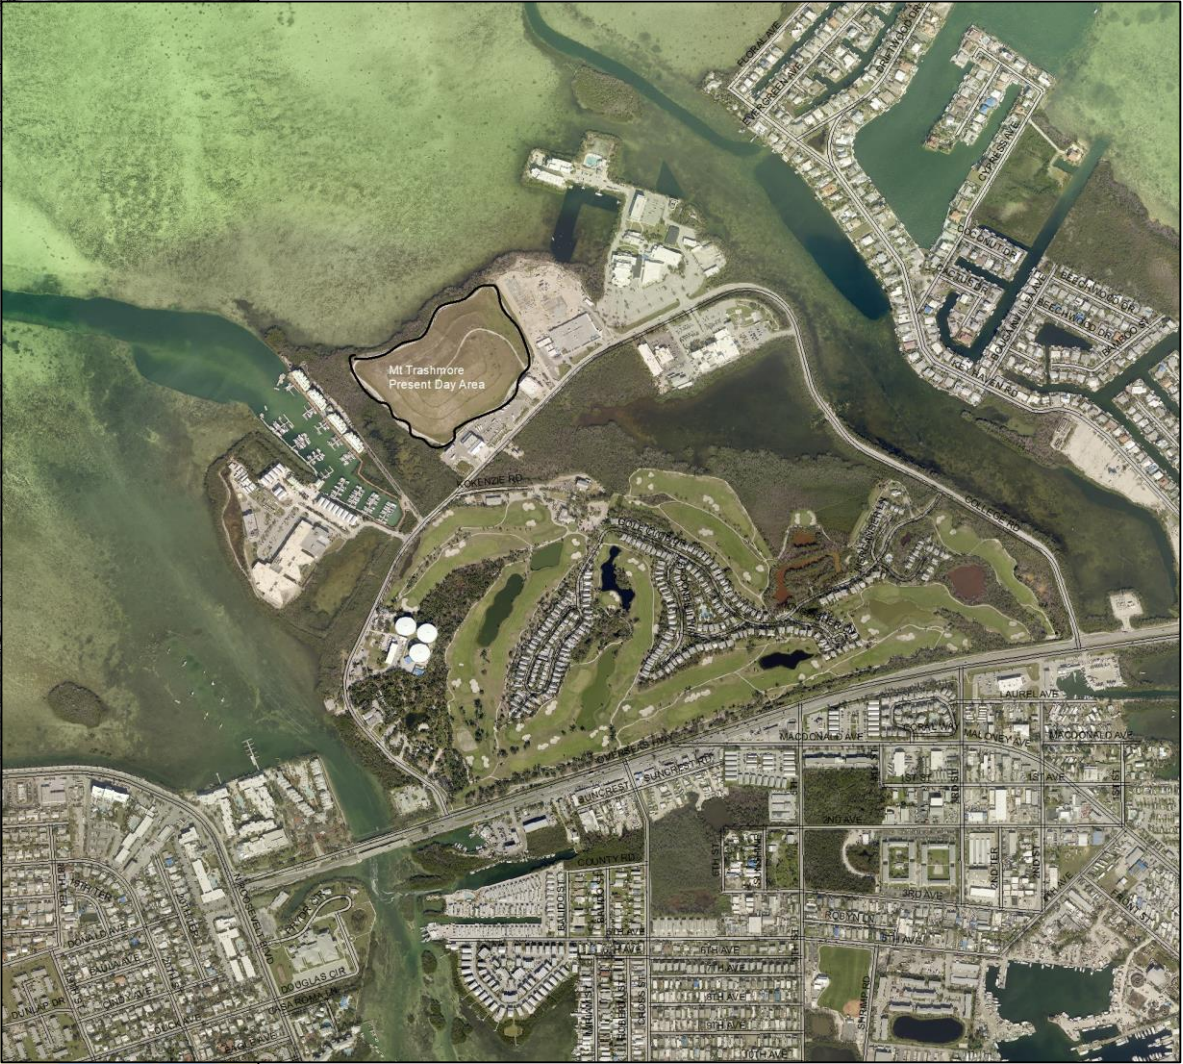
Mo Co Aerial Photo  
2/22/1959

# Comparison Aerials of Stock Island Landfill 1959 and 2015.

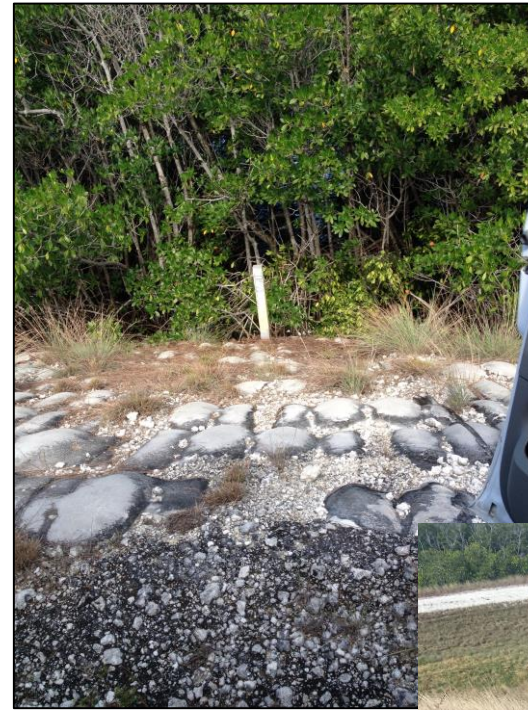
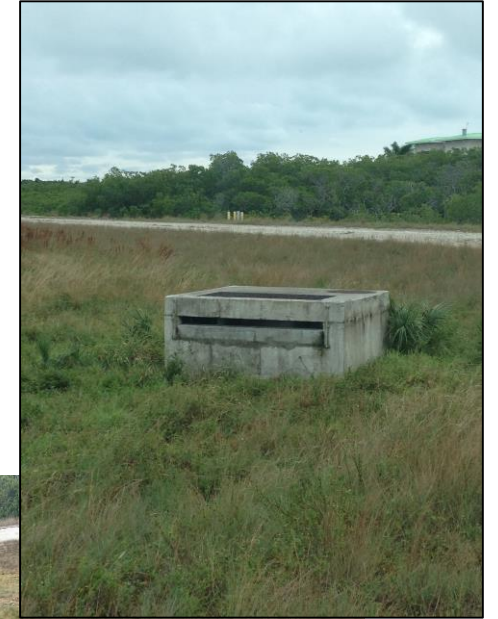
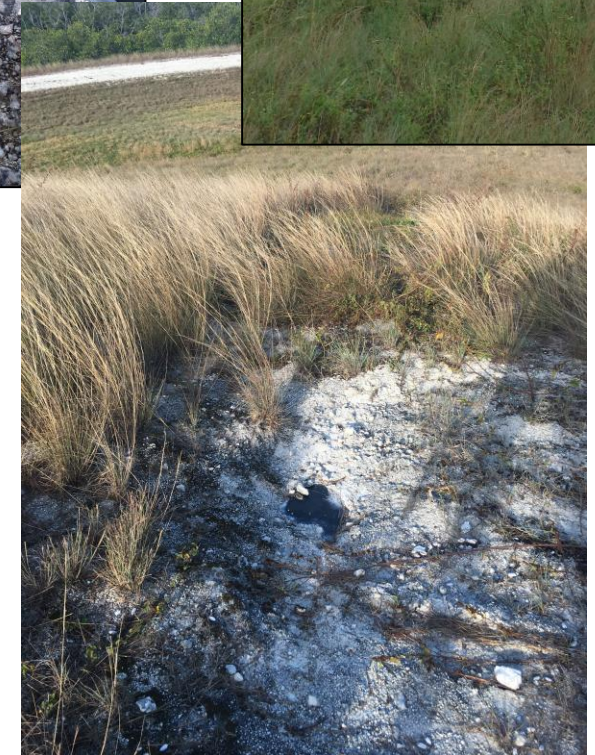
- Engineer reviewed in 2016 and no subsidence when comparing to 2007 topo survey.
- Minimal erosion and stormwater systems are clear and working. Erosion is addressed when noticed and repaired.

- 7 of the gas vents in the deepest areas on the top shelf of the landfill still have a presence of methane and hydrogen sulfide. A slow production.
- Groundwater monitoring from 2011-2015 reviewed. Only parameter to occasionally exceed Groundwater Cleanup Target Levels is TDS (turbidity), at Well #2 and #3. These wells are between the landfill and the Gulf of Mexico, therefore not a sign of leachate leaks.

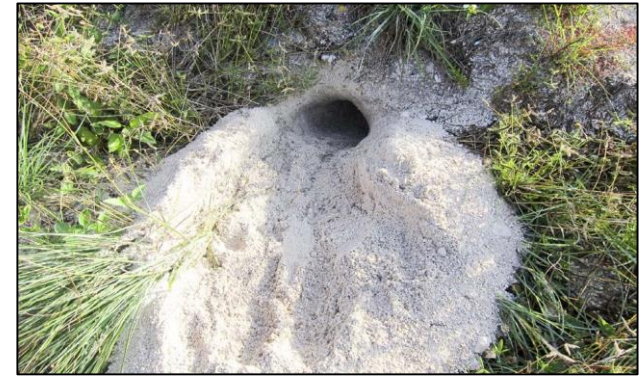
- Mowing 4-6 times per year. Public Works sends employees. Takes 2-3 days. Also maintaining 2 mowers.
- Iguana control. 2019 will cost between \$9,000 and \$14,000. This includes iguana capture and removal and filling in holes and damage caused by iguanas.
- Water sampling. \$1385 annually.
- Repairs to landscaping as needed. 2018 approximately \$24,000.
- We make repairs when areas become bare, soil thins from erosion or liner is showing.
- Repairs needed in future if no changes. New road or road repair and a few landscaping repairs.
