Re: 12 Hilton Haven - Permit Application No T2022-0445

## Cynthia's Blue Palms, LLC

Location: 12 Hilton Haven, Key West, Florida

Purpose for Evaluation: Opinion concerning Tree Condition, Root Growth and Longevity

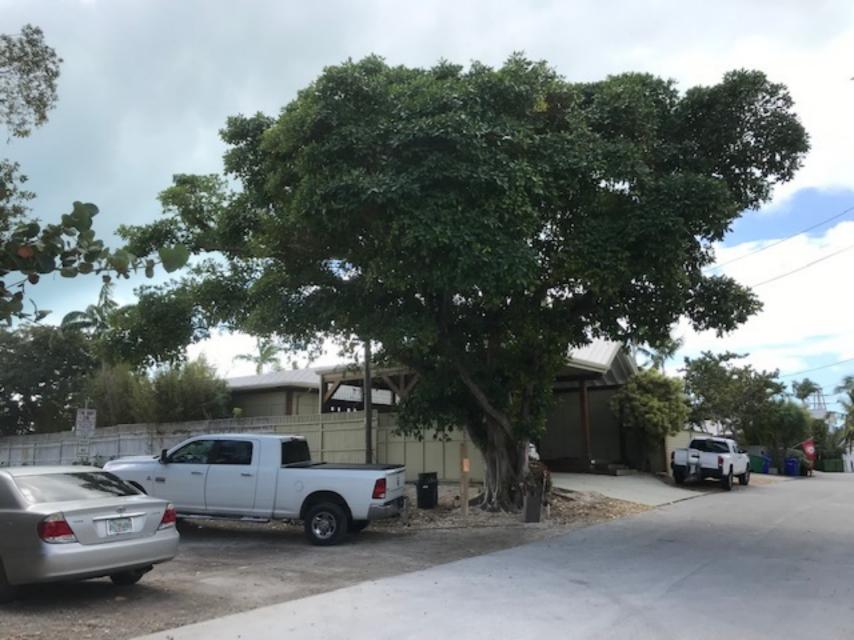
The Ficus tree is located at 12 Hilton Haven, Key West, Florida, at the front north northwestern portion of property (photo 1). Also adjacent and approximately 2' from northwest property line, 4' from water meter, and 8' to the road bed (photo 2). The condition of the Ficus tree is considered Fair/Poor due to the utility pruning and sun-scald on the upper sides of main stems and branches and root pruning at west side of the tree (photos 3 and 4). The Ficus tree is approximately 47.3" or 3.9' in diameter. Canopy or crown is approximately 30'-35' in height and 30'-35' width east to west and 60', north to south. The reduced width from east to west is a result of the utility pruning. The tree has multiple (5) co-dominate trunks or stems. The root system appears to be intact with the exception of the west side of the tree. One large above ground severed root was observed 20' from the canopy dripline to the southwest property line wrapped around the utility pole (photo 5). Roots can grow approximately 5 times the width of the canopy in all directions.

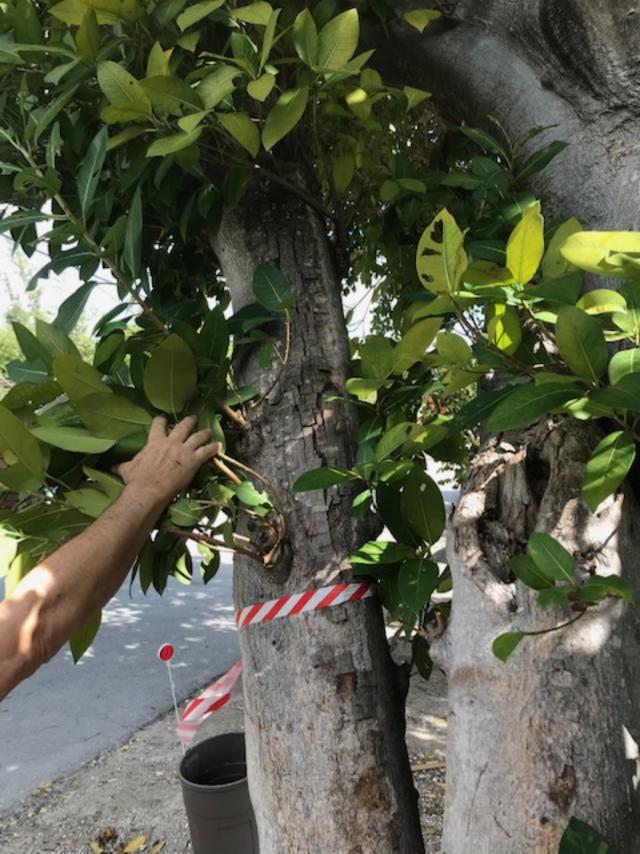
Pruning history of this tree has been minor on all sides except the west side which has been significantly reduced, by half or 50%, by utility pruning. The root system appears to be intact on all sides except the west side which was root pruned prior to accommodate the apron and carport at the adjacent west property, 13 Hilton Haven, 4' from the tree trunk. The past root pruning appears to have been shallow root removal due to the amount of damage currently taking place at the adjacent west property. Due to half the canopy being removed the root reaction has produced rapid growth of remaining roots and regrowth of severed roots to accommodate the heavy pull of the remaining canopy to the east of being one-sided. The roots growth are lifting and damaging the apron and carport to the west..

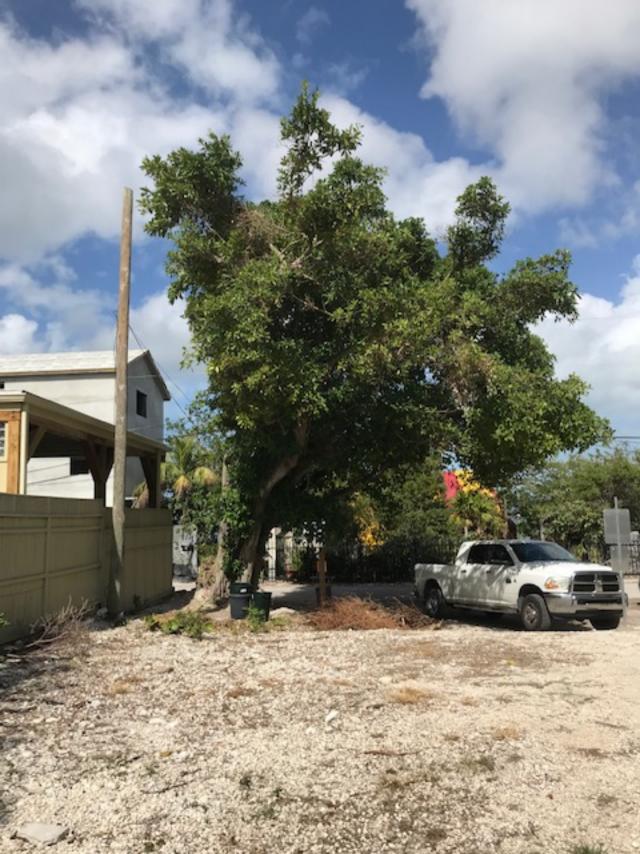
My opinion and findings considering the stability and longevity of this ficus tree are: currently, that the tree is injured due to the root pruning and canopy reduction such that it has become a hazard to the structure immediately adjacent to the west, 13 Hilton Haven. The roots will continue to grow/regrow in the direction of, and under, the structures at 13

Hilton Haven. Any structures built at 12 Hilton Haven will remove additional tree roots to accommodate water, sewer and home. Stability and longevity of discussed tree is at risk of topple during a wind event. Further root pruning at the property line would increase probability of topple (photo 6).
