STAFF REPORT

DATE: August 1, 2017

RE: 1300 Atlantic Boulevard (C.B. Harvey Rest Beach Park) (permit application # T17-8522)

FROM: Karen DeMaria, City of Key West Urban Forestry Manager

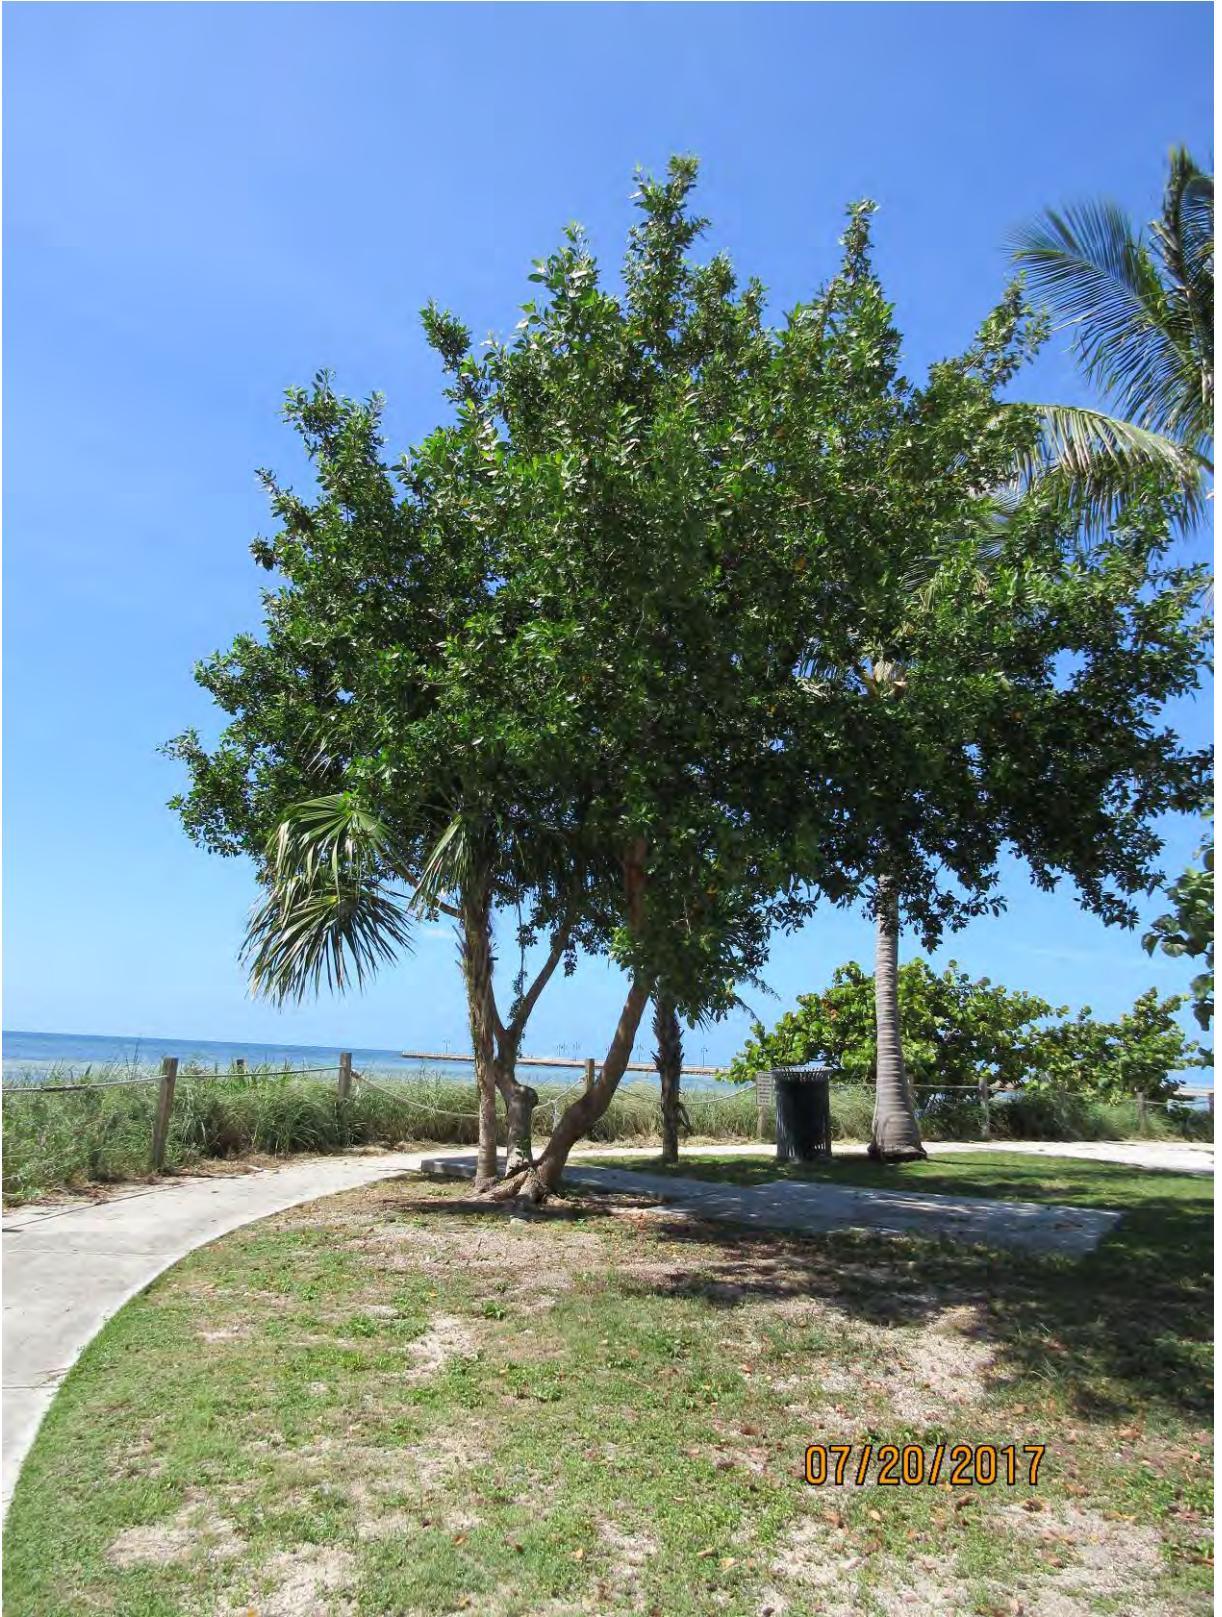
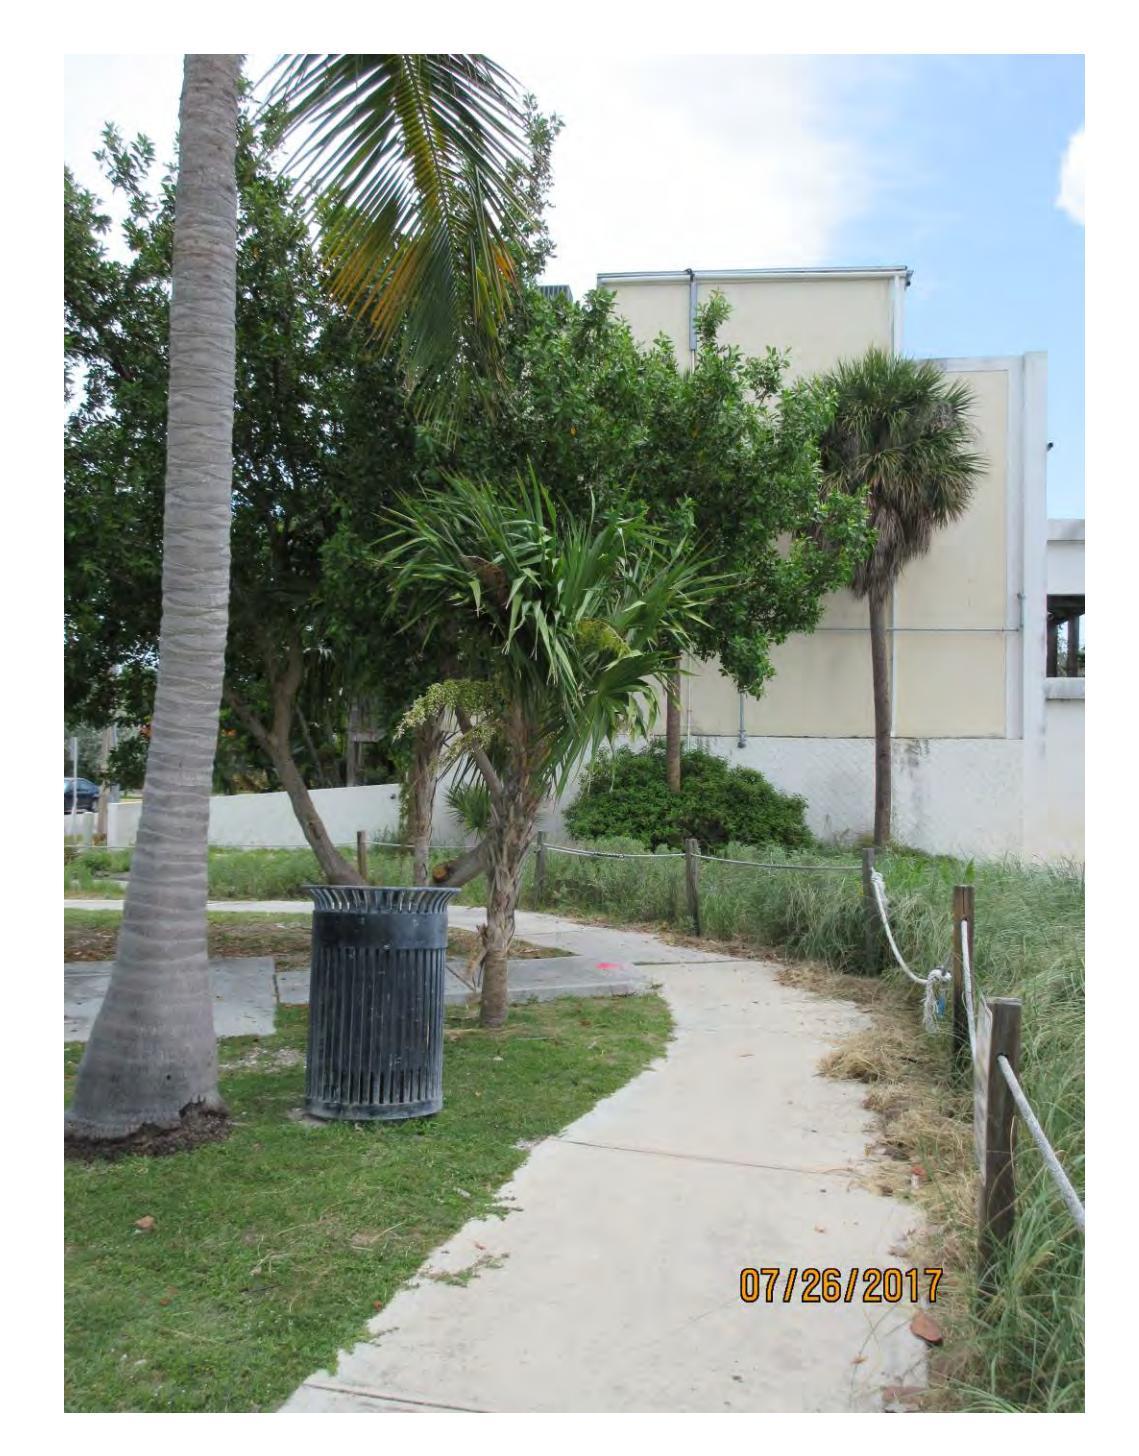
Tree #2A:

Diameter: 14.9" Location: 90% Species: 100% (on protected tree list) Condition: 60% (fair, co-dominant trunks) Total Average Value = 83% Value x Diameter = 12.3 replacement caliper inches

NOTE: It might be possible to do a heavy maintenance trim on this tree to remove one of the main branches. A final decision will be made once site is staged for work.

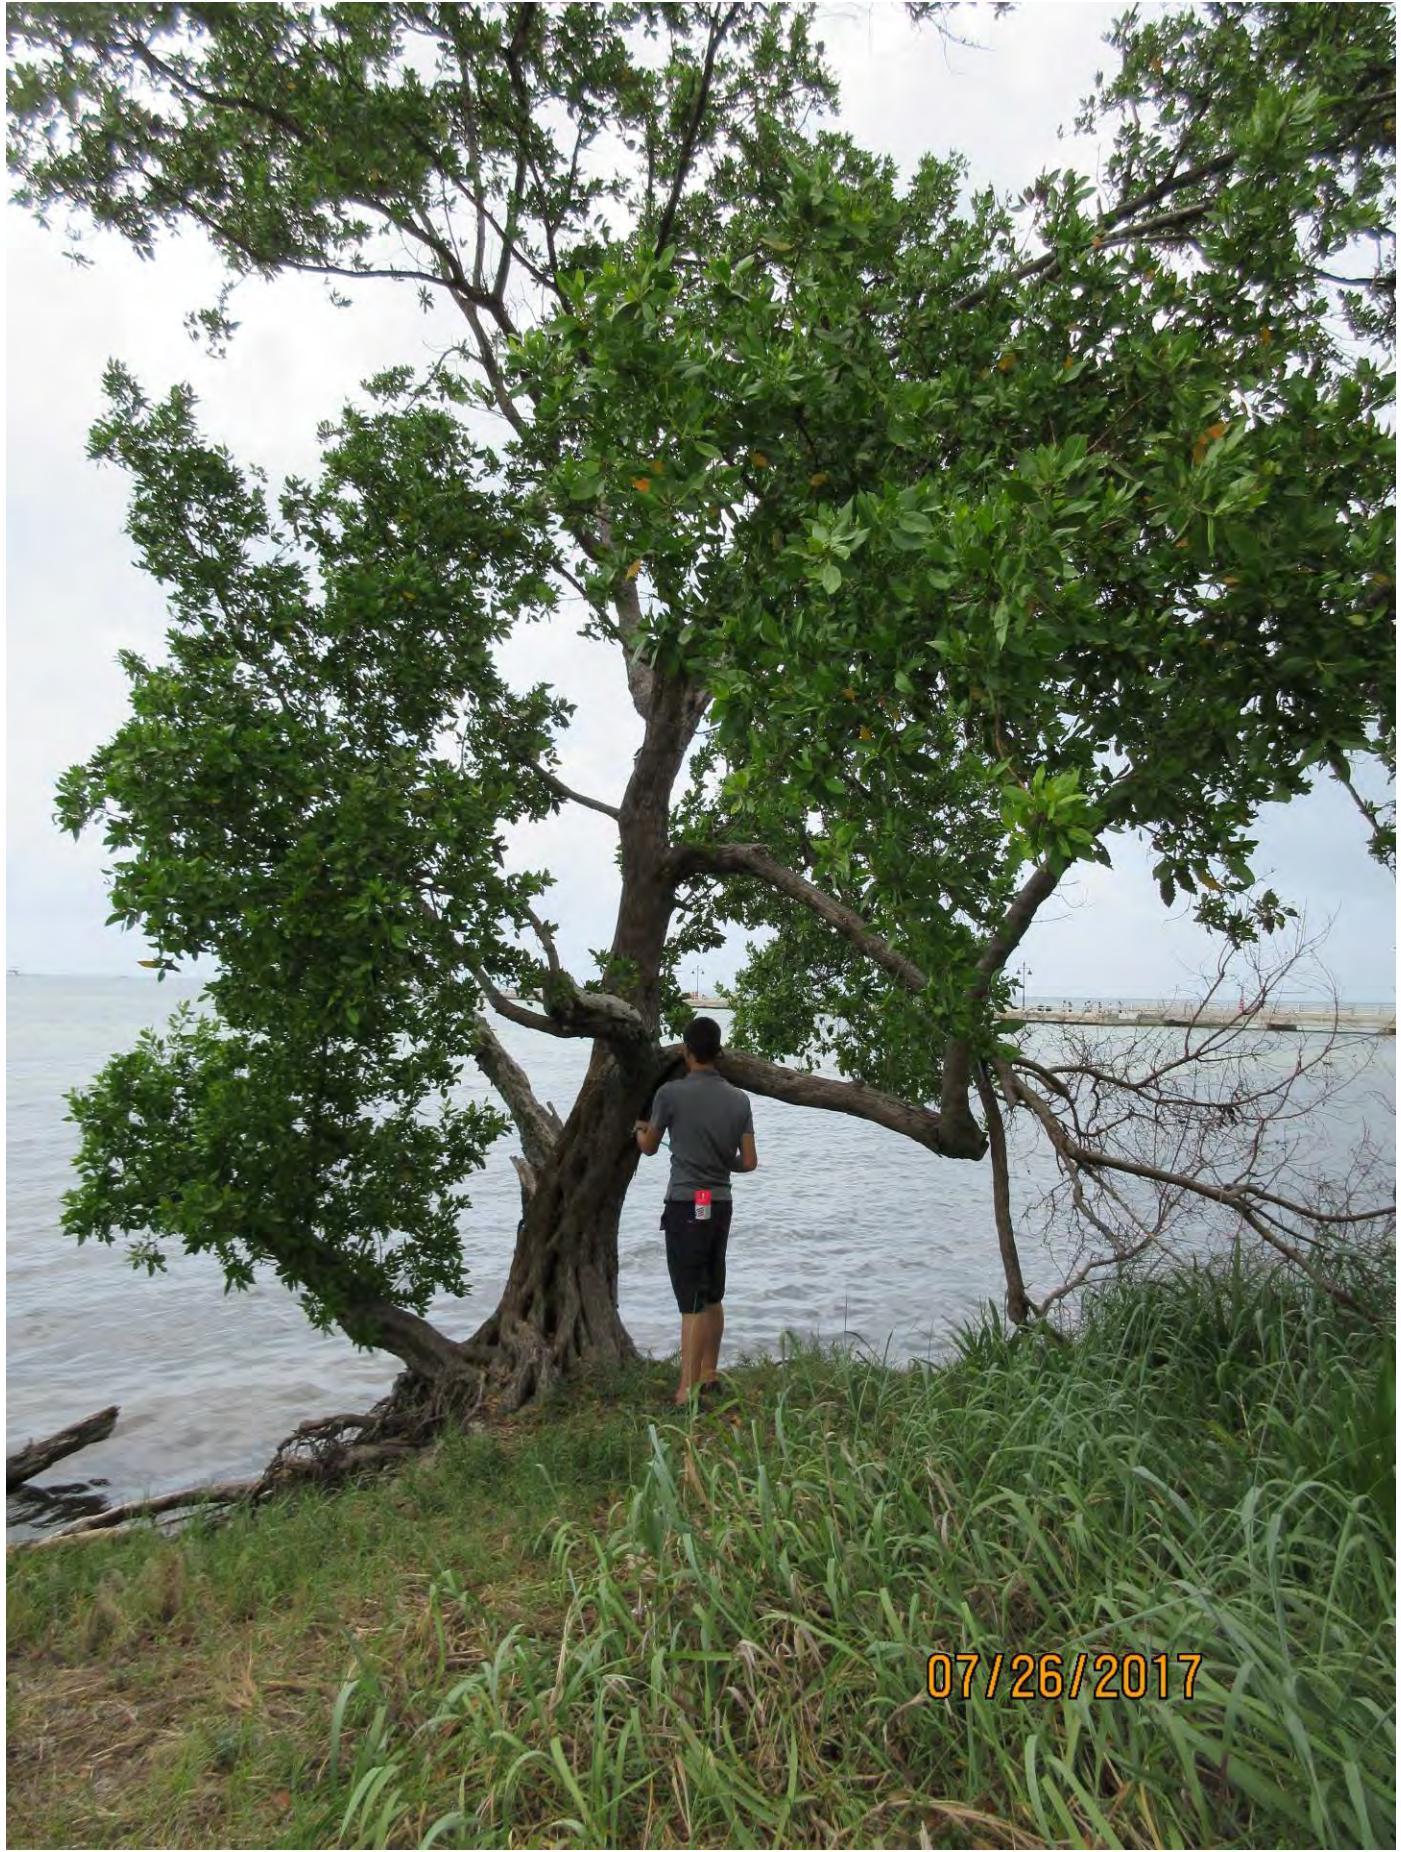
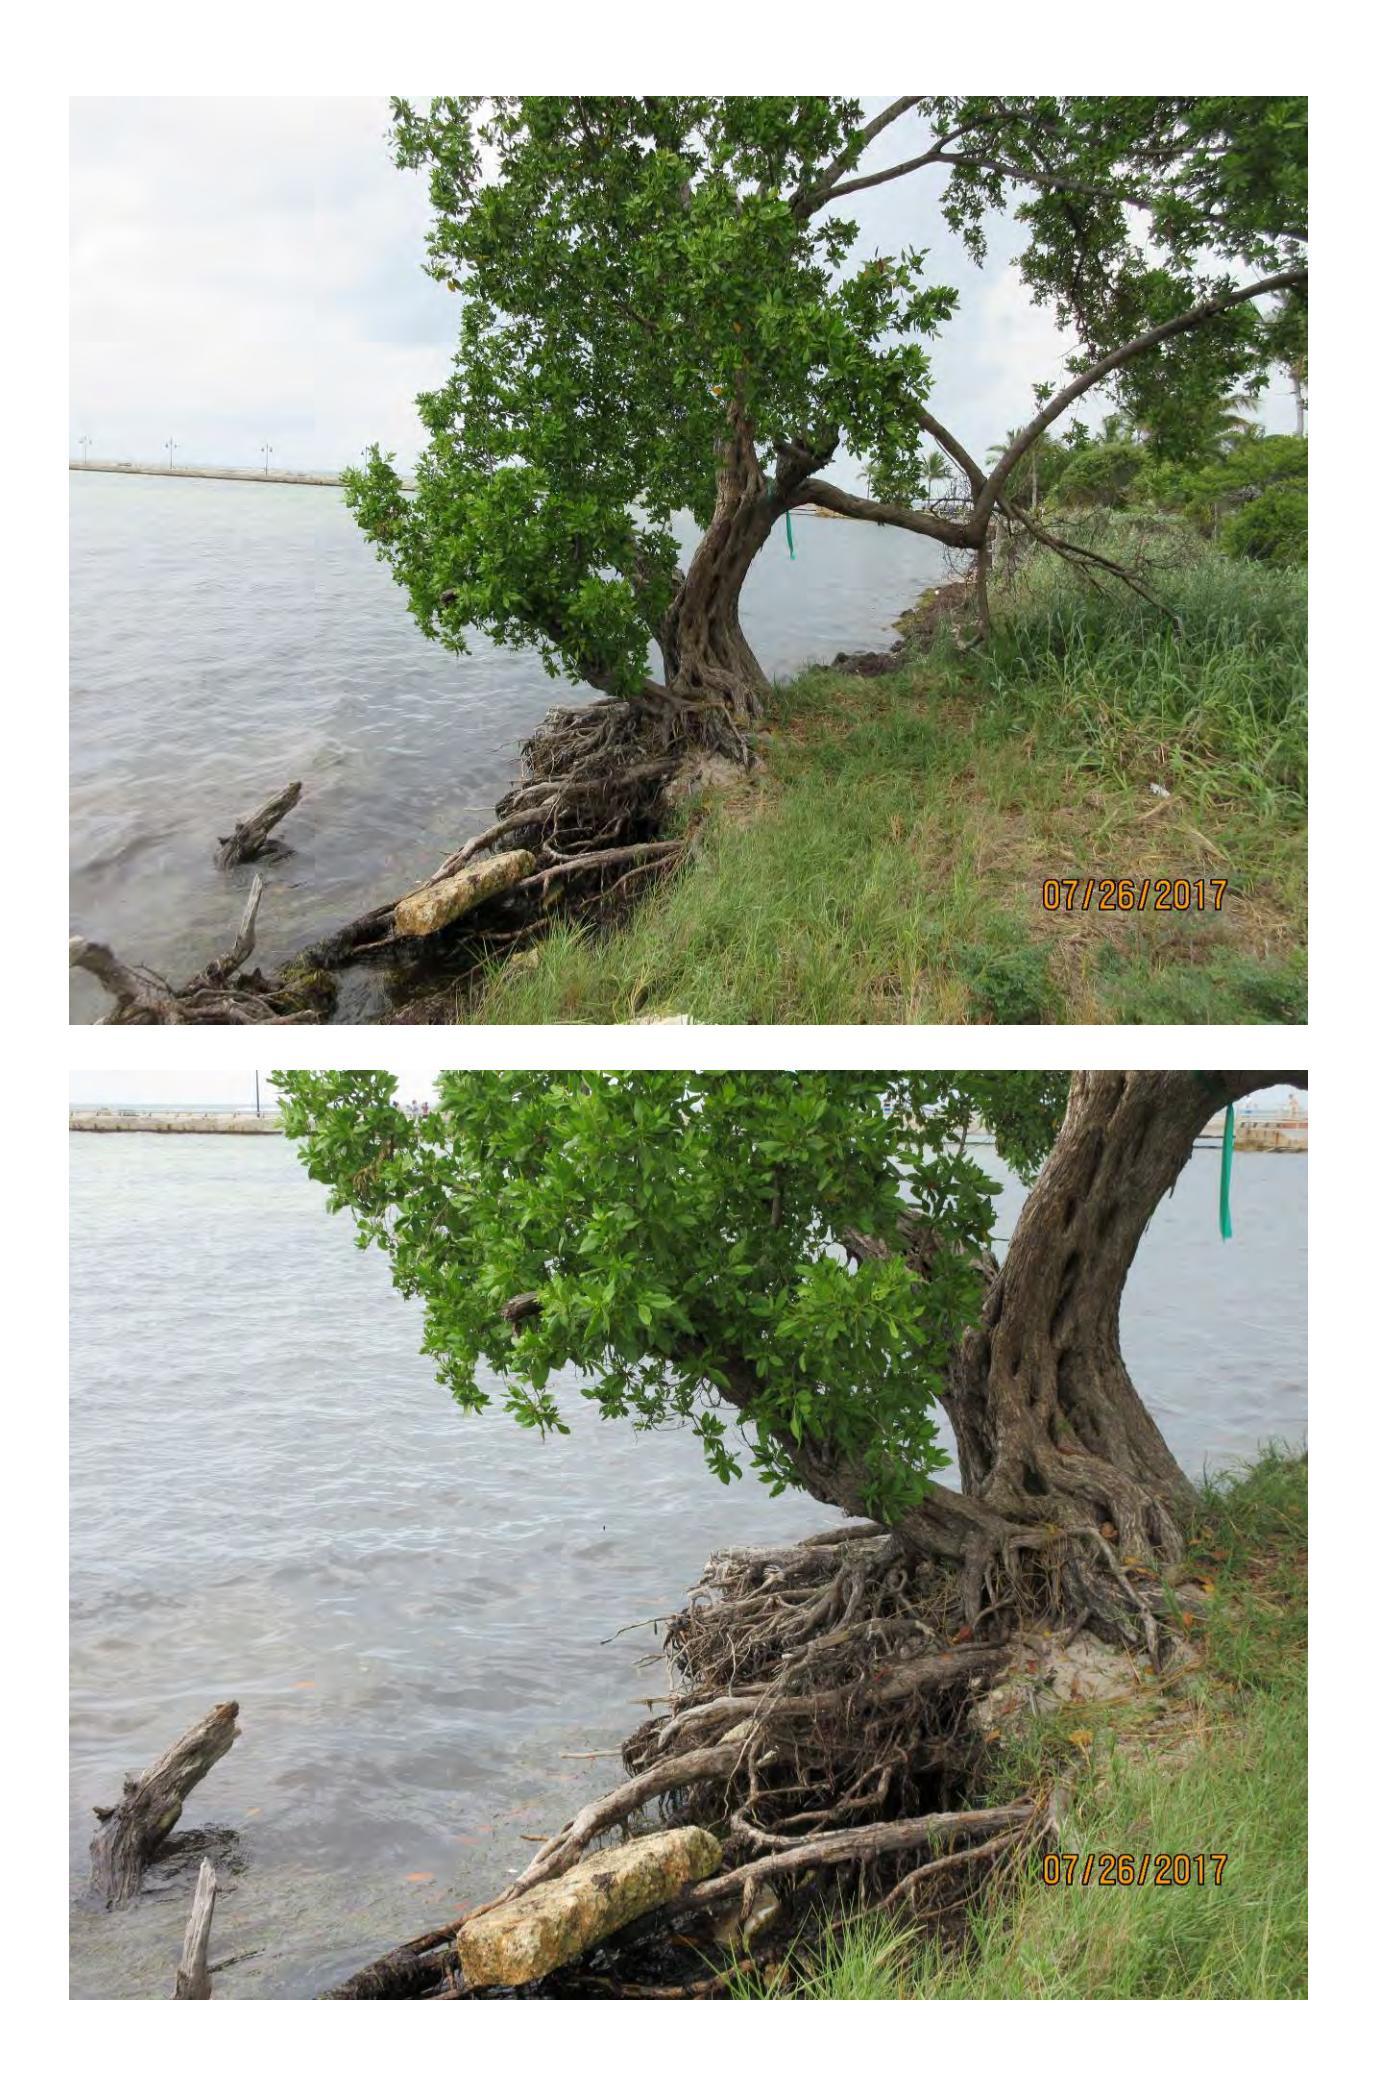
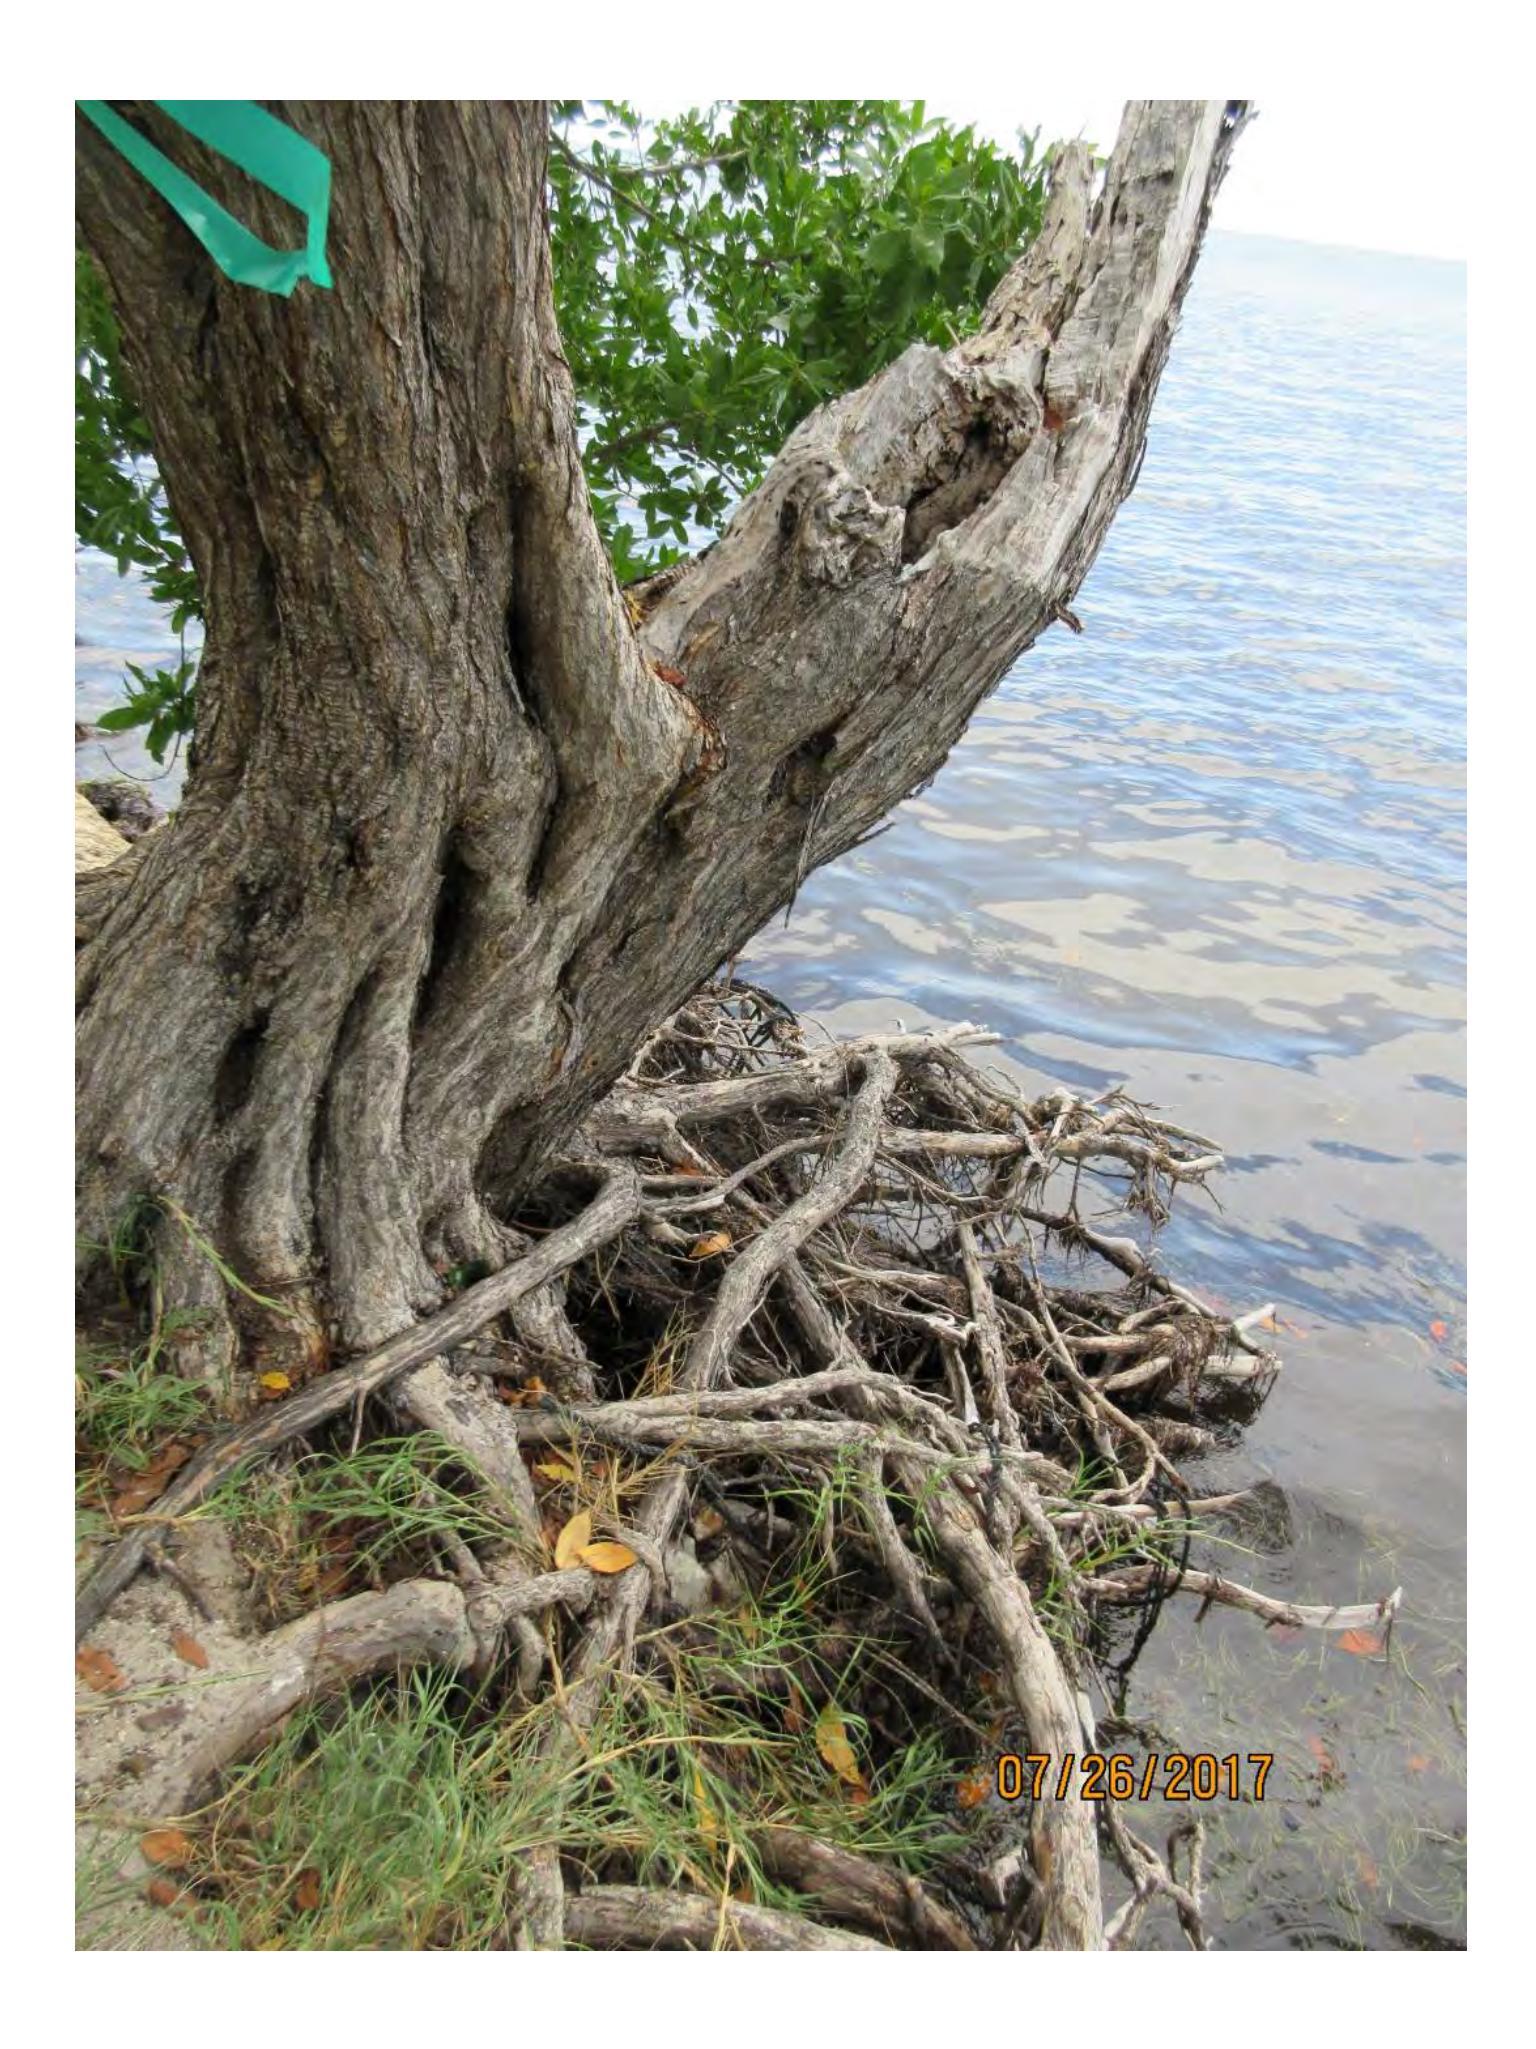
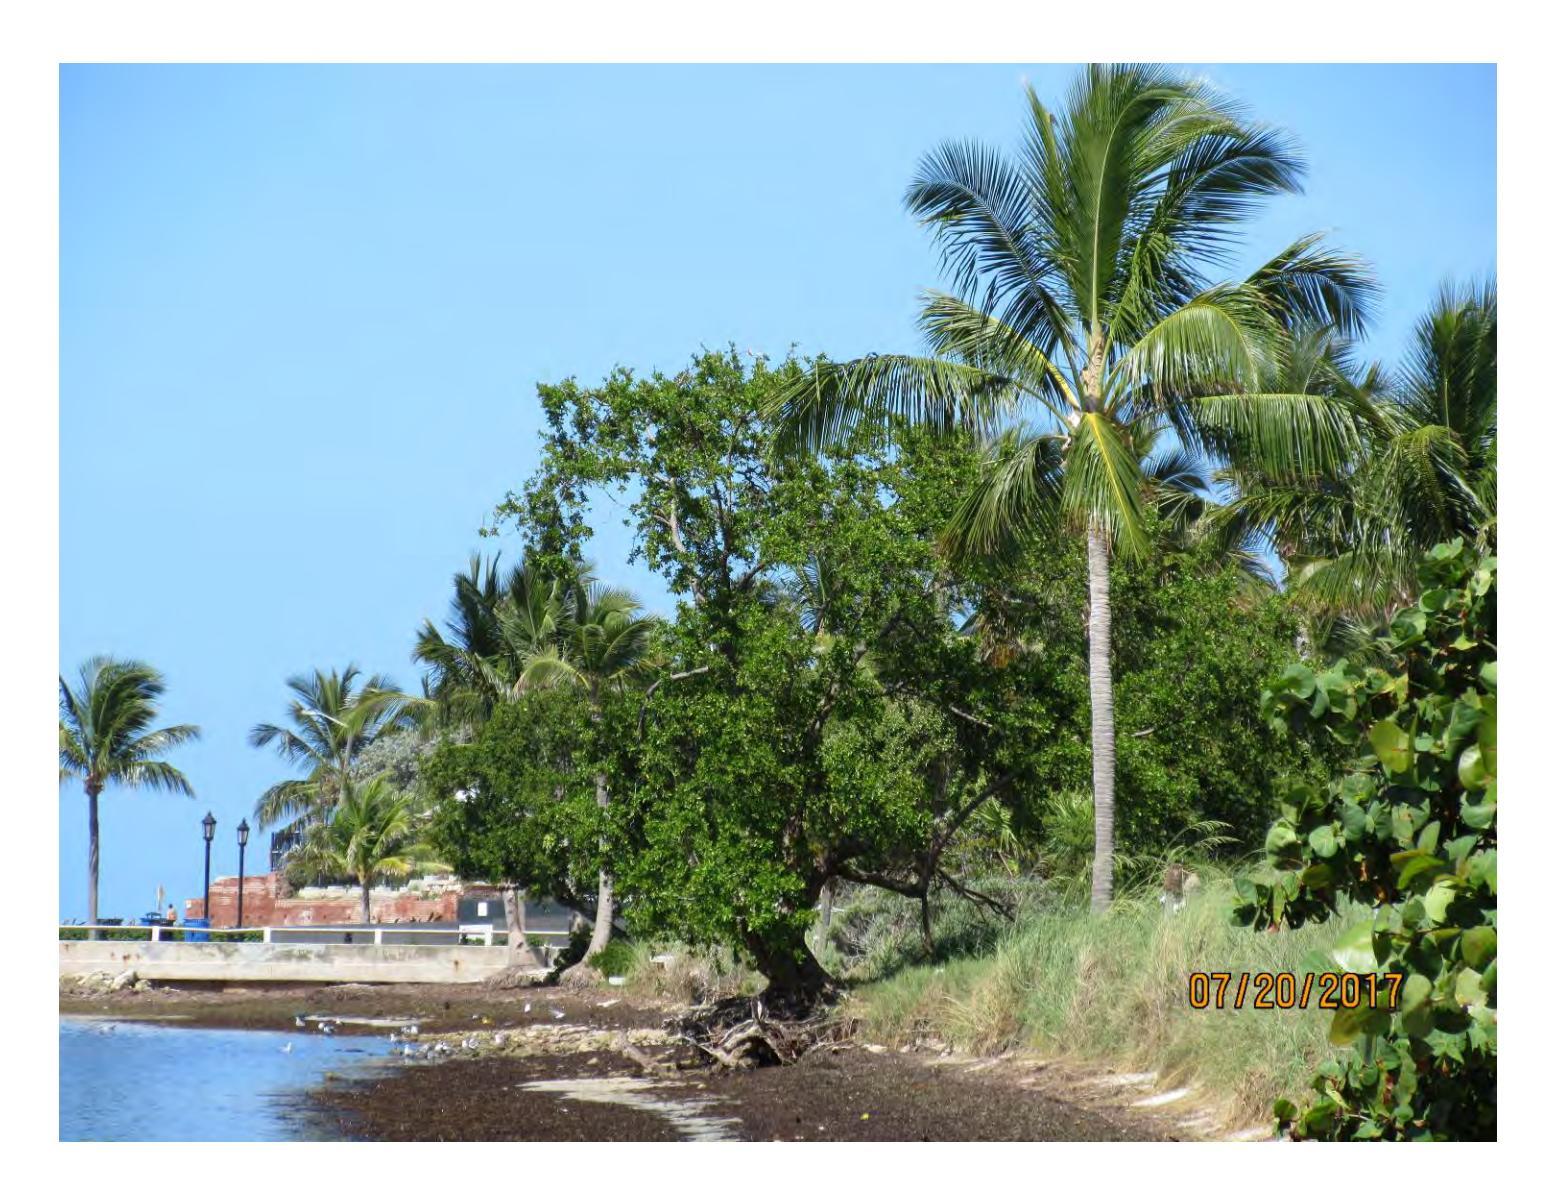
Tree#40:

Diameter: 20.3" Location: 20% (on edge of mean high water line-in a year tree will be dead and in the water) Species: 100% (on protected tree list) Condition: 40% (poor, part of tree already dead due to salt water intrusion and bare root system) Total Average Value = 53% Value x Diameter = 10.7 replacement caliper inches

Recommend removal of tree.

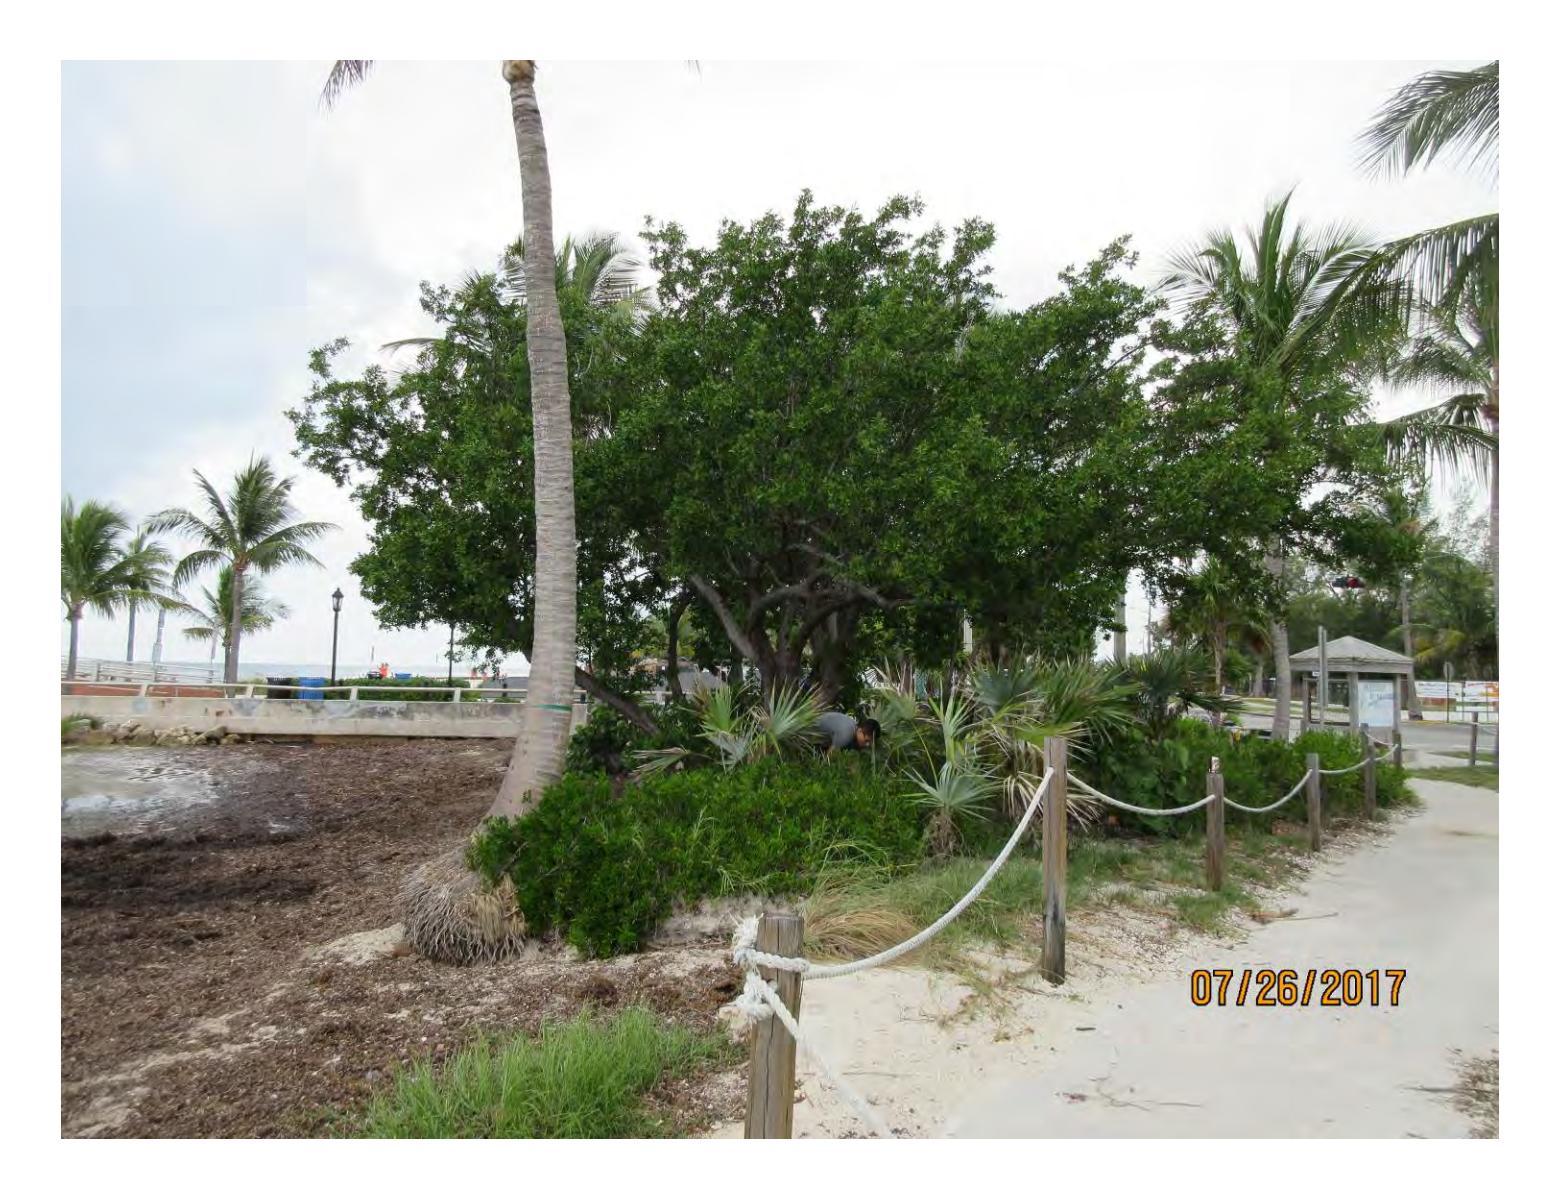
Tree #106

Diameter: 45.2" Location: 90% Species: 100% (on protected tree list) Condition: 80% (multi trunked tree, typical dune shaped buttonwood) Total Average Value = 90% Value x Diameter = 40.6 replacement caliper inches

At the present time it appears that this tree is in the middle of the work area. It is not known at this time whether the tree can successfully be transplanted.
