STAFF REPORT

DATE: August 1, 2017

RE: 1300 Atlantic Boulevard (C.B. Harvey Rest Beach Park) (permit application # T17-8522)

FROM: Karen DeMaria, City of Key West Urban Forestry Manager

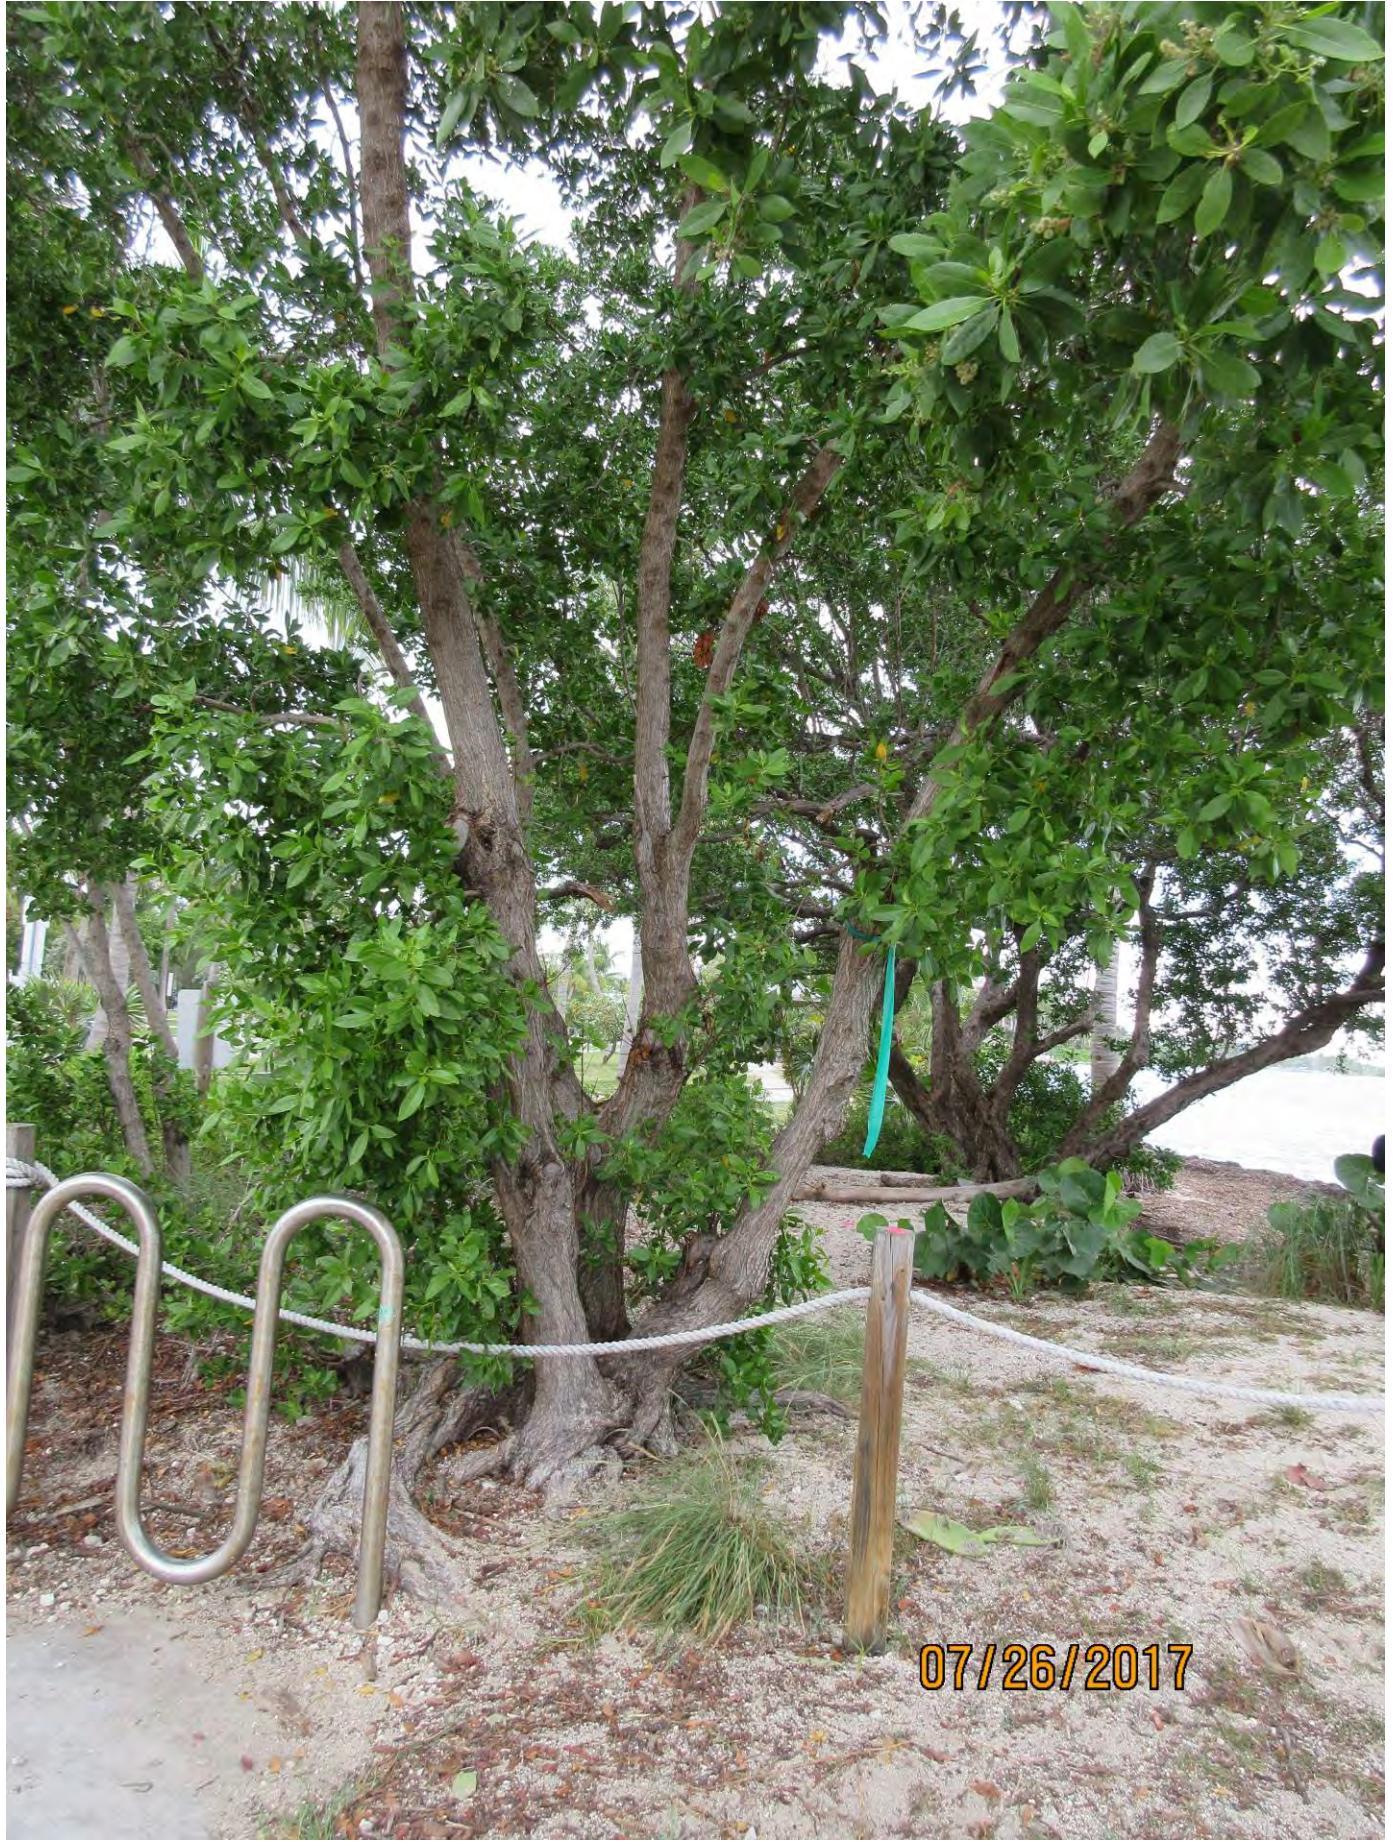
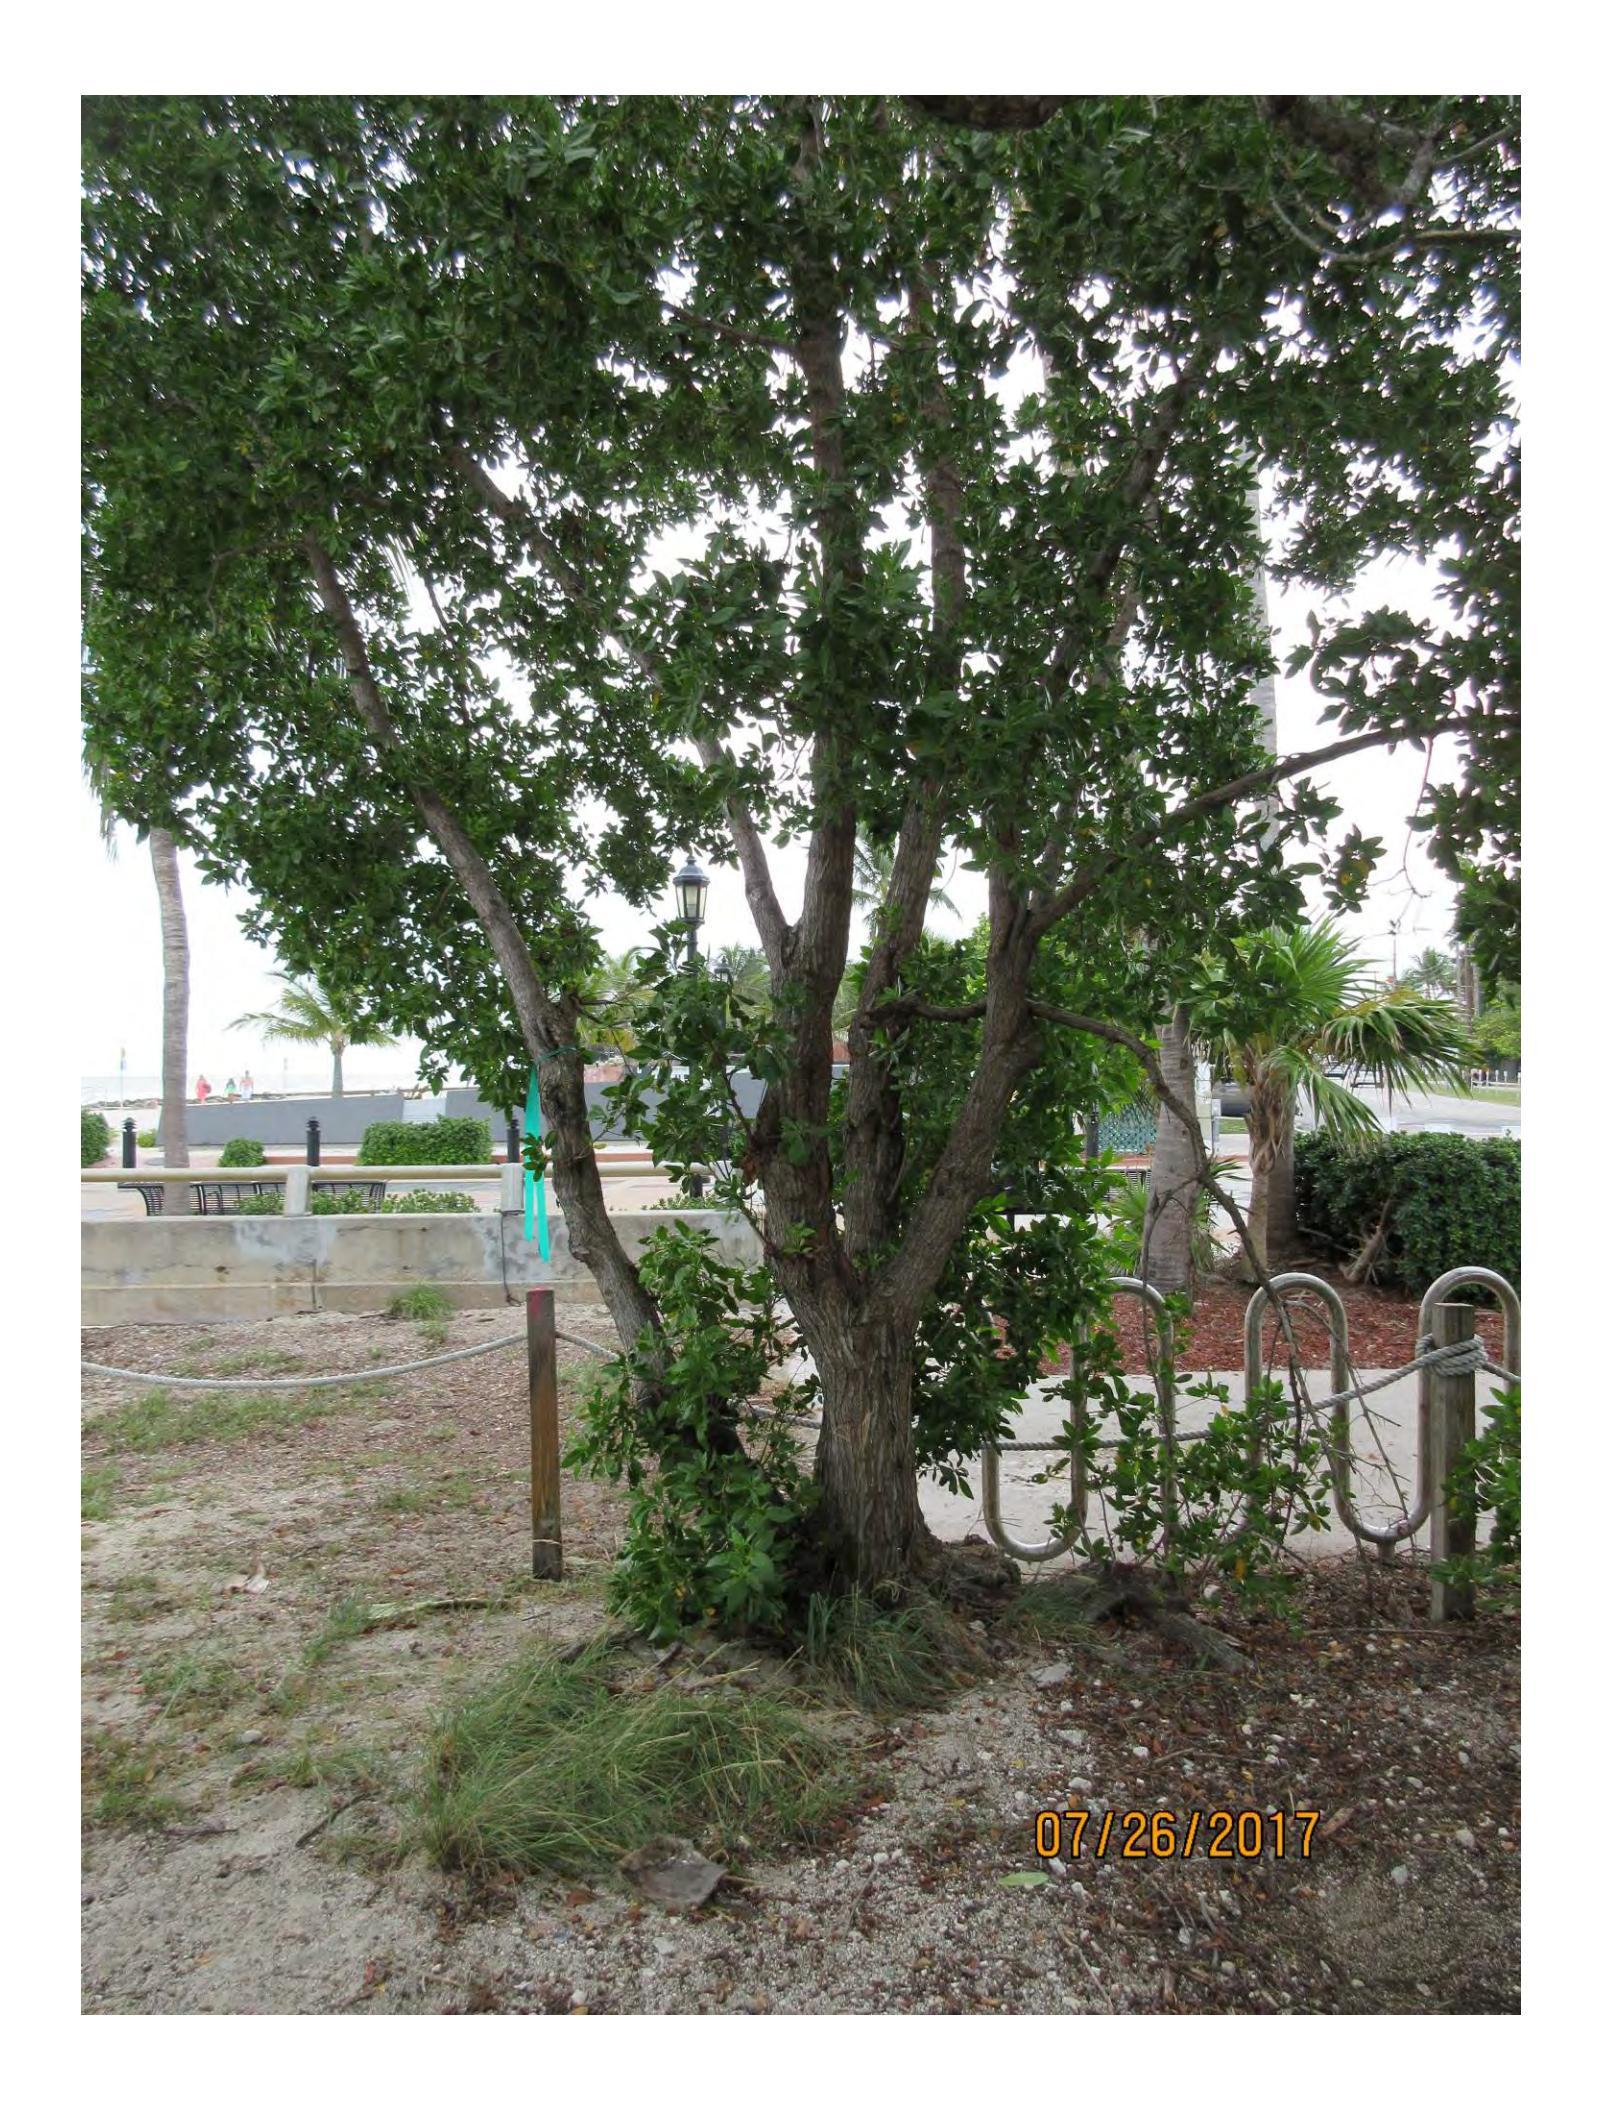
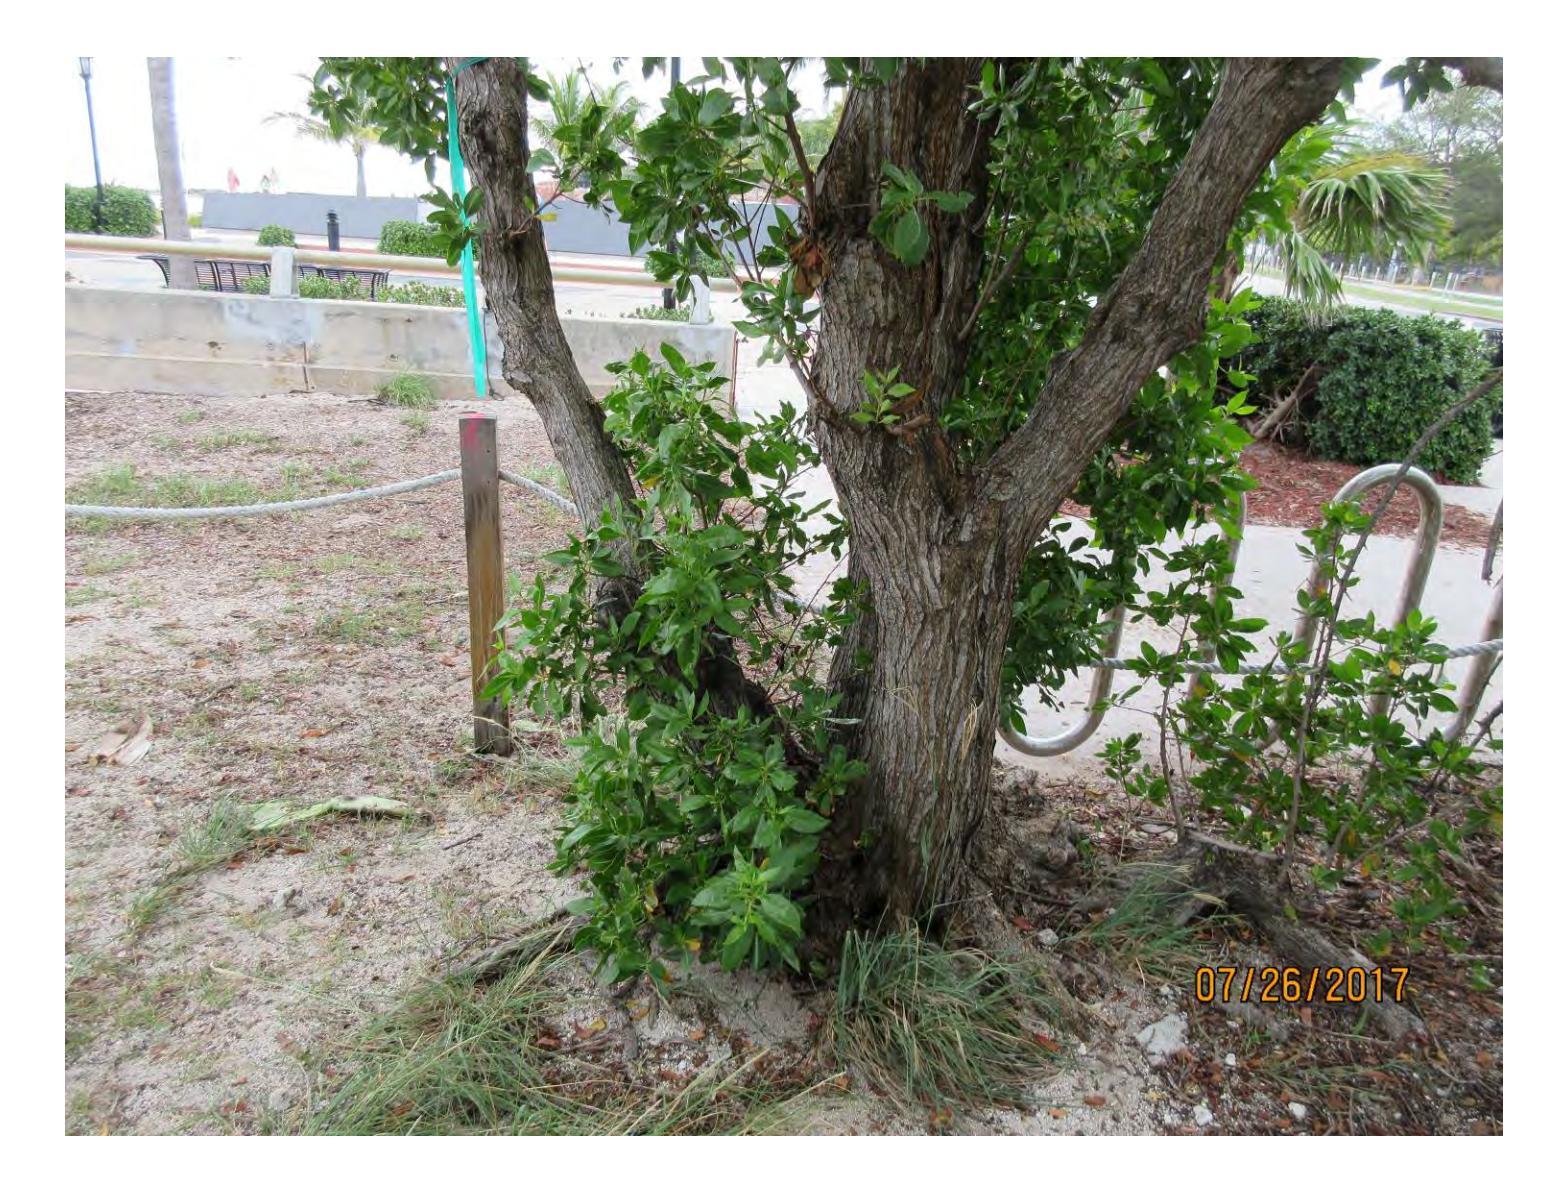
Tree #106:

Diameter: 22.9" Location: 90% Species: 100% (on protected tree list) Condition: 80% (good, multitrunked tree) Total Average Value = 90% Value x Diameter = 20.6 replacement caliper inches

NOTE: It might be possible to do a heavy maintenance trim on the tree to remove one of the trunks. A decision will be made once site is staged for work.

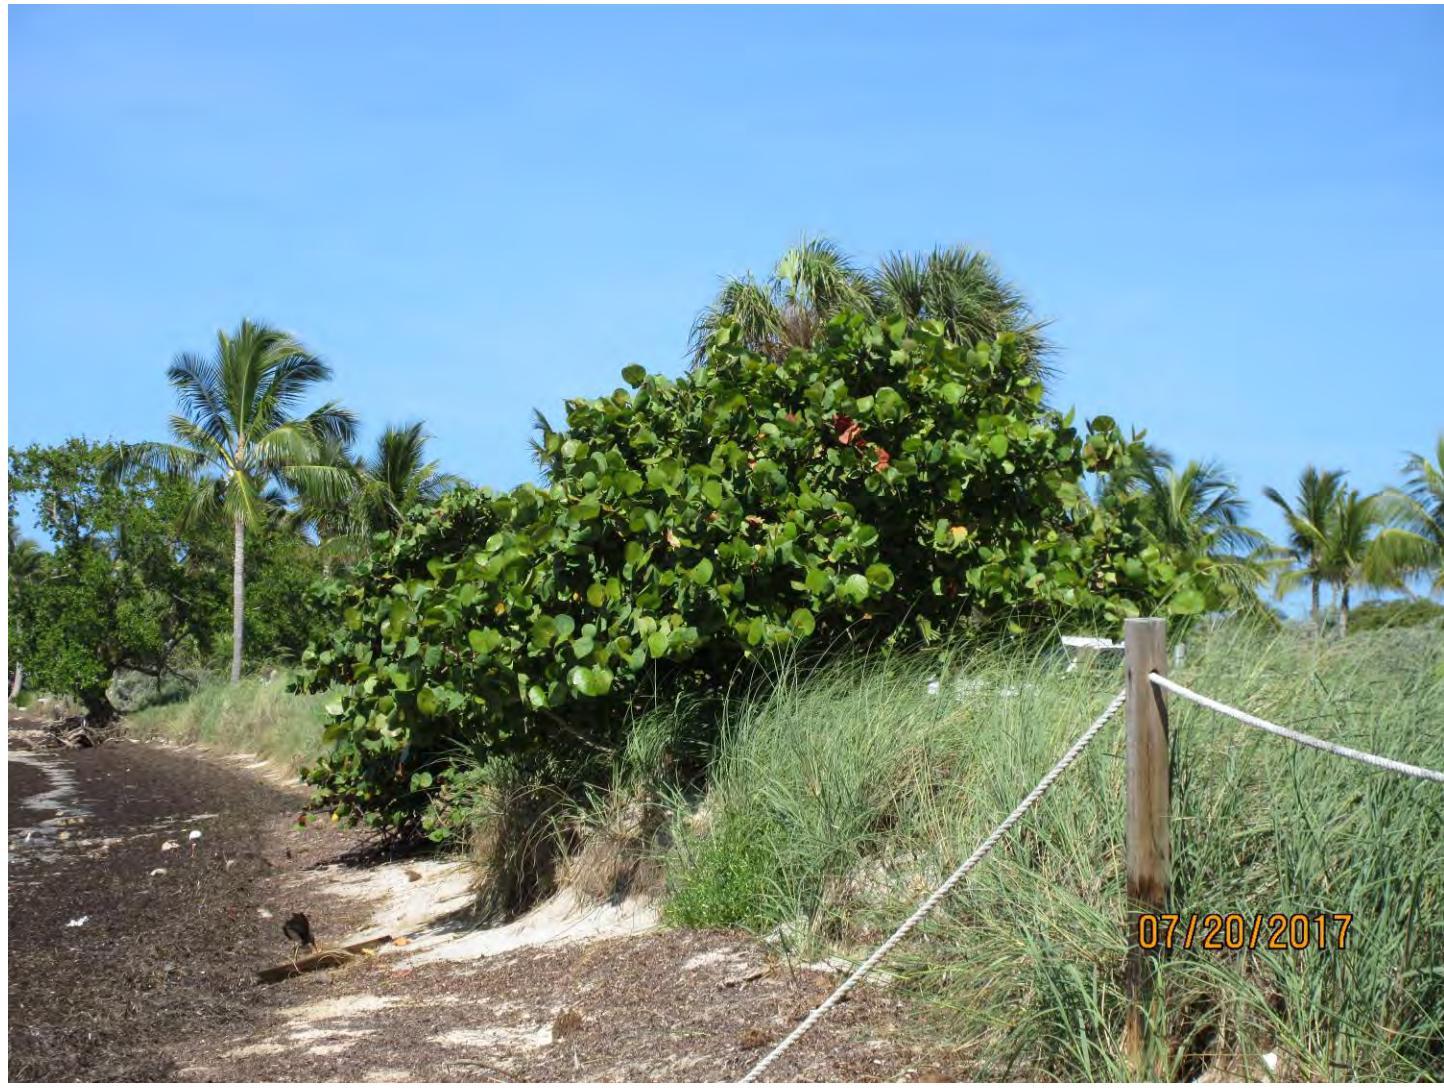
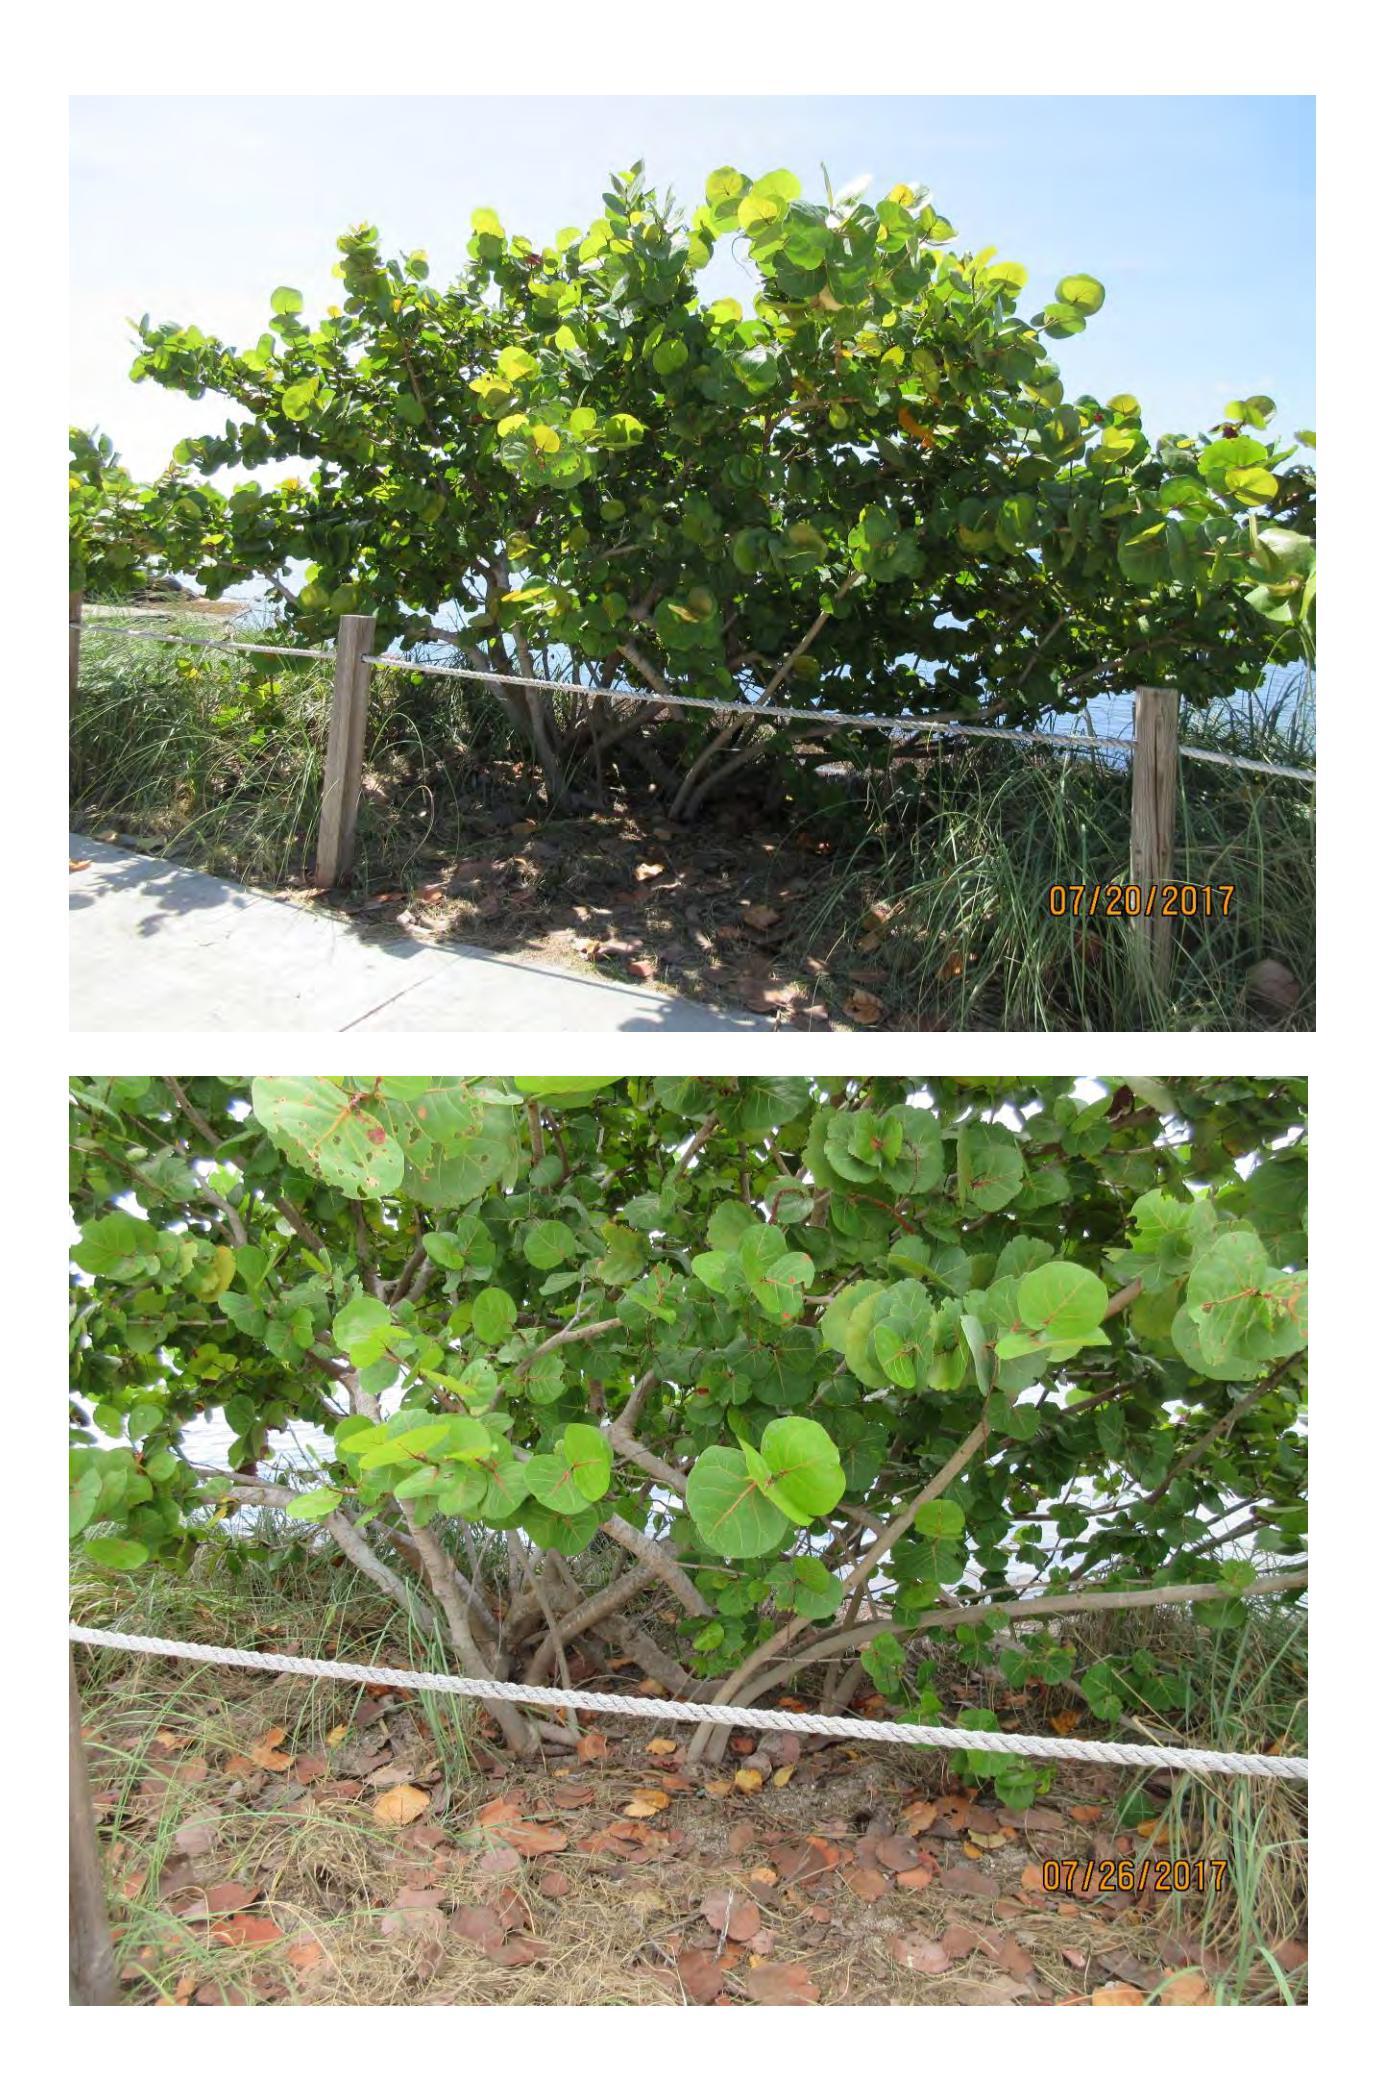
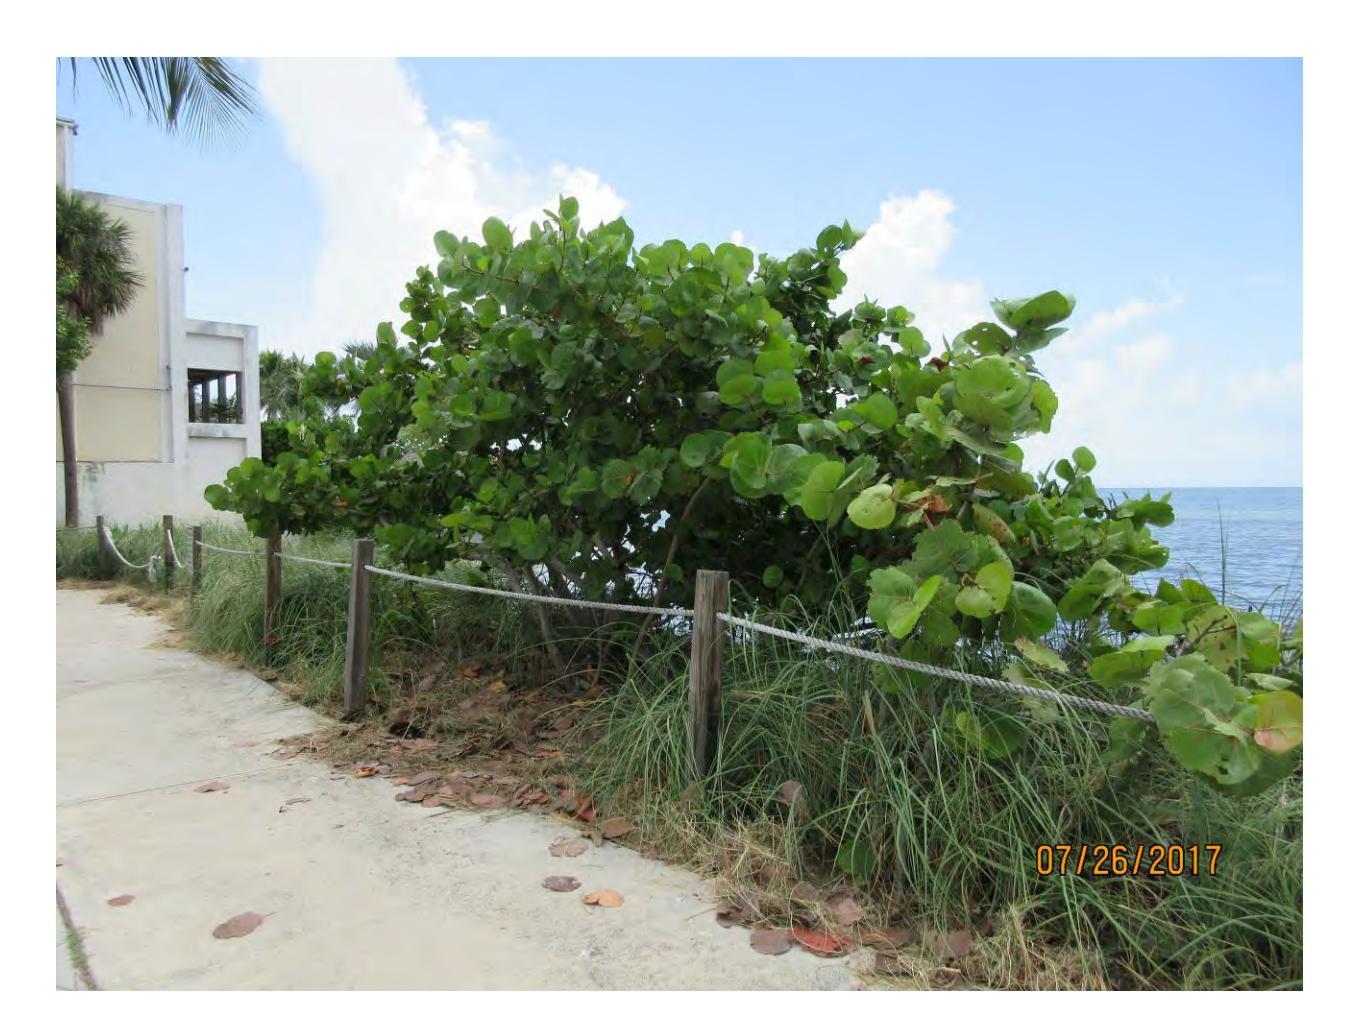
Tree #9:

Diameter: 16.5" Location: 60% (on dune edge, continual erosion will expose roots and cause death of tree) Species: 100% (on protected tree list) Condition: 80% (good, sprawling tree structure-typical dune/beach tree) Total Average Value = 80% Value x Diameter = 13.2 replacement caliper inches

It appears that this tree is in the middle of the work area. It is not known at this time whether the tree can successfully be transplanted.

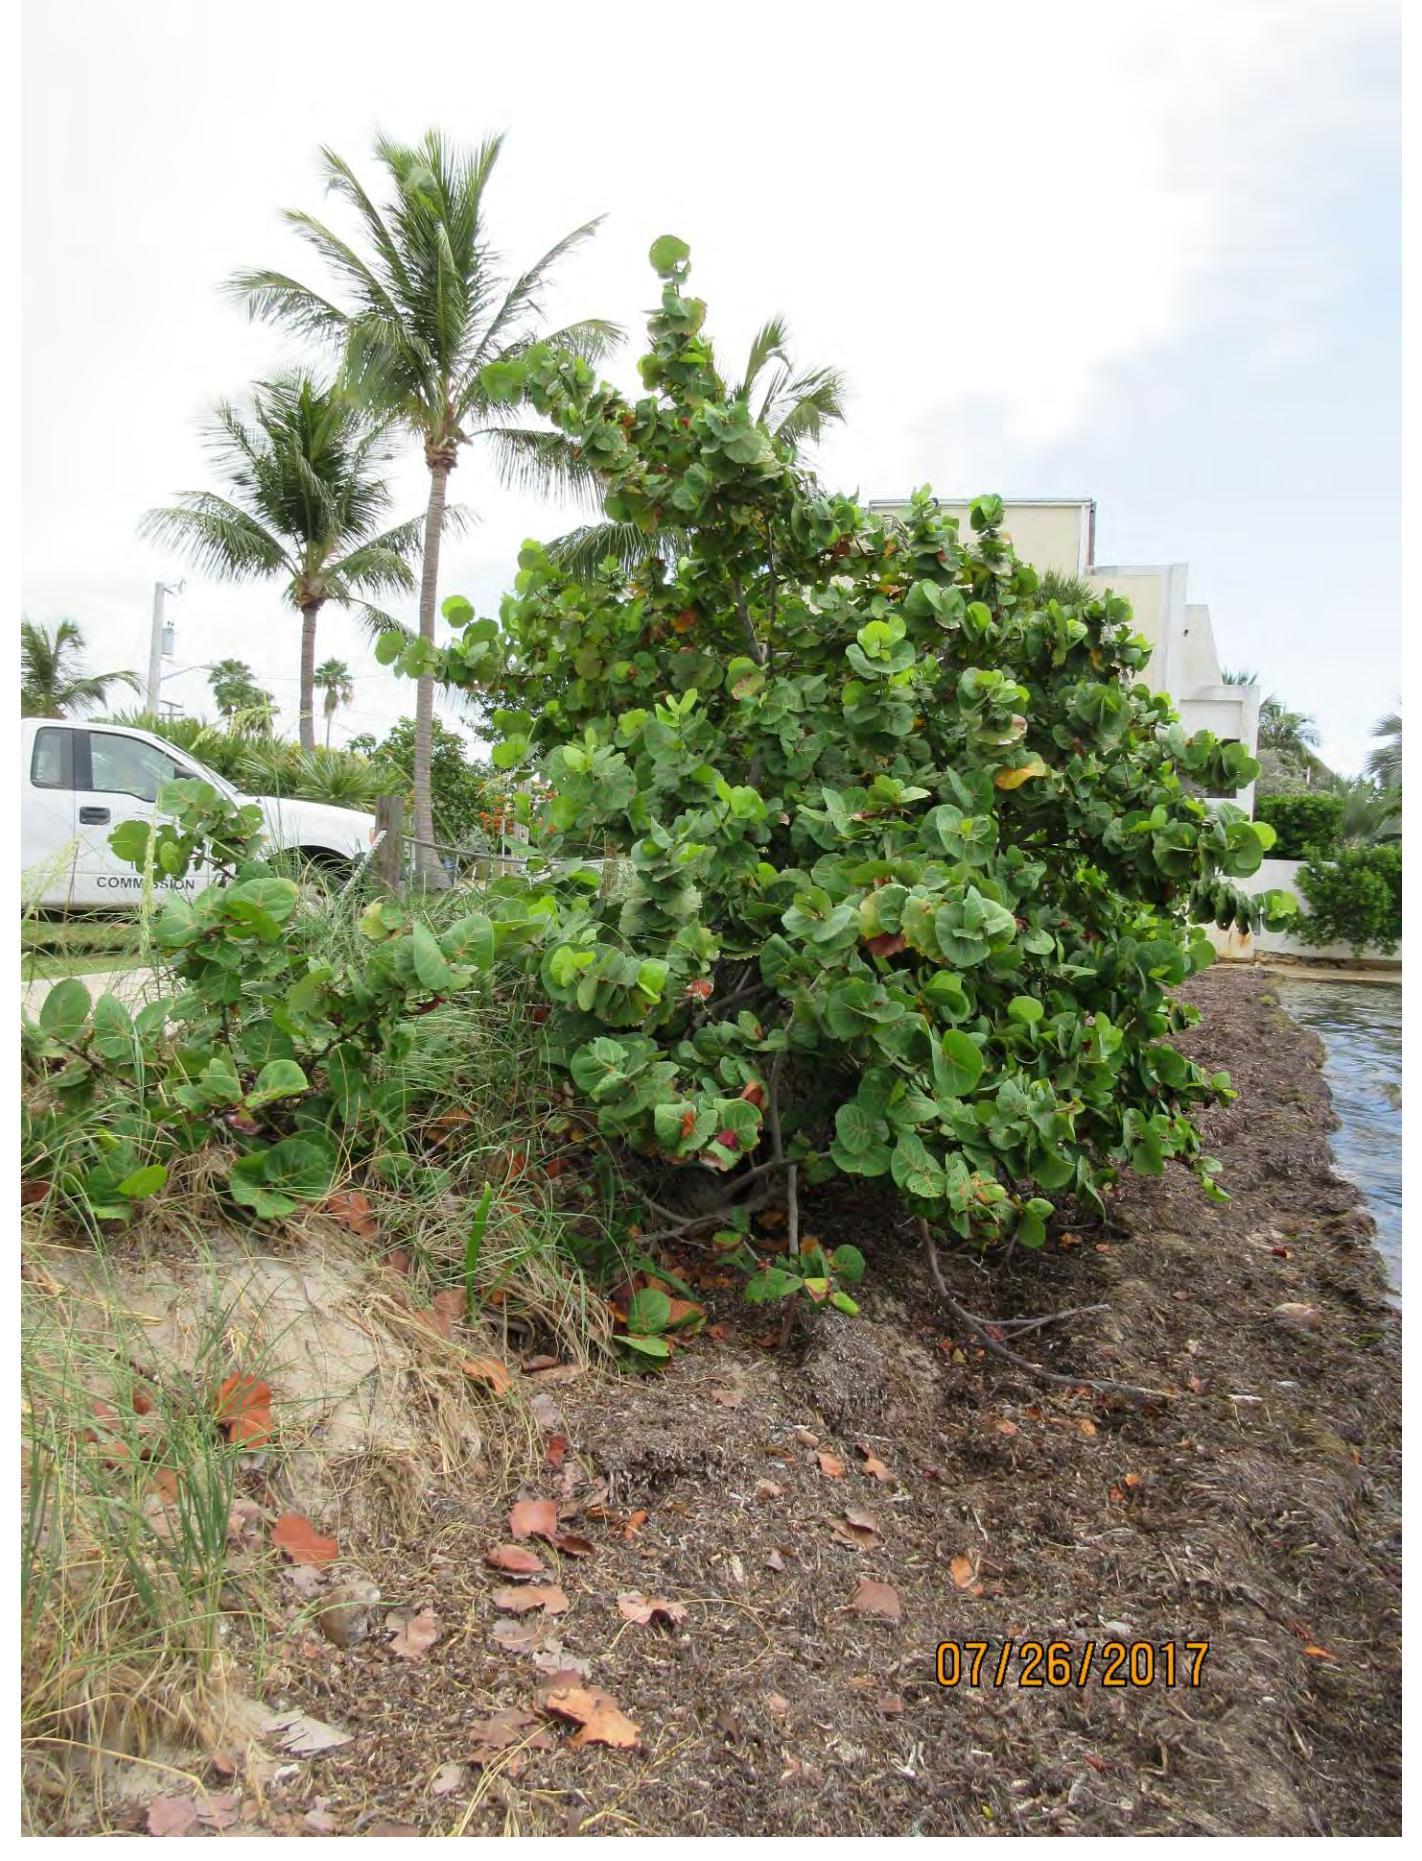
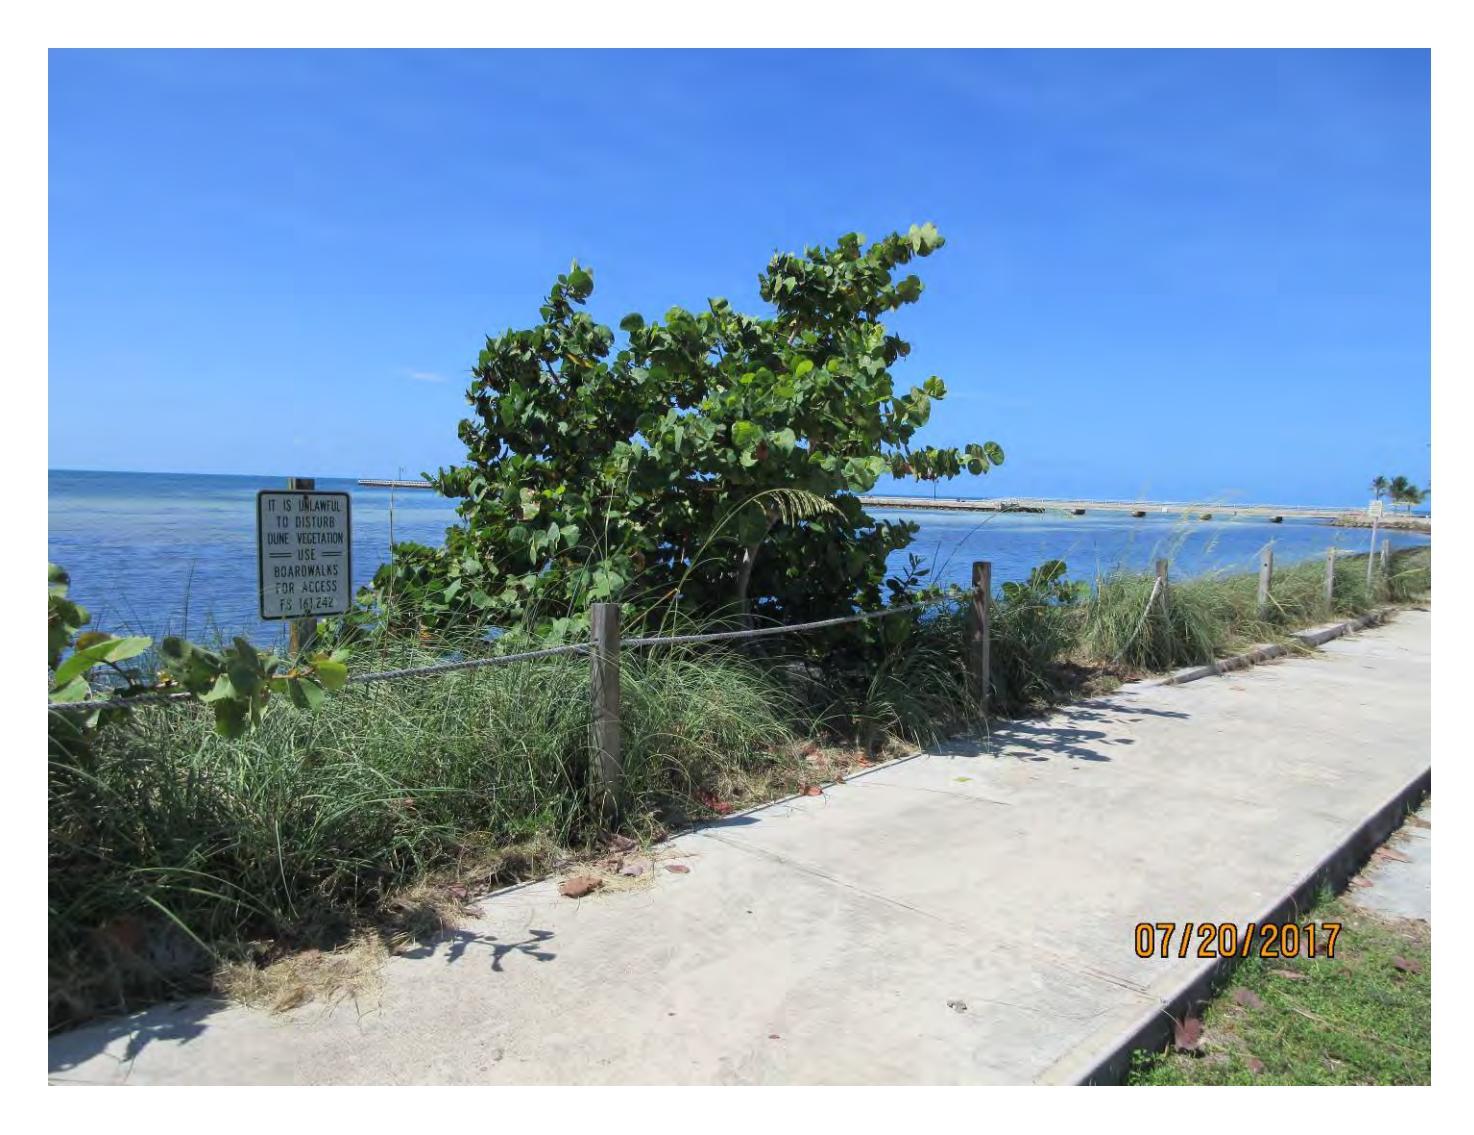
Diameter: 12.7"

Location: 60% (on dune edge, continual erosion will expose roots and cause death of tree)

Condition: 60% (fair, sprawling tree structure-typical dune/beach tree) Total Average Value = 73%

It appears that this tree is in the middle of the work area. It is not known at this time whether the tree can successfully be transplanted.

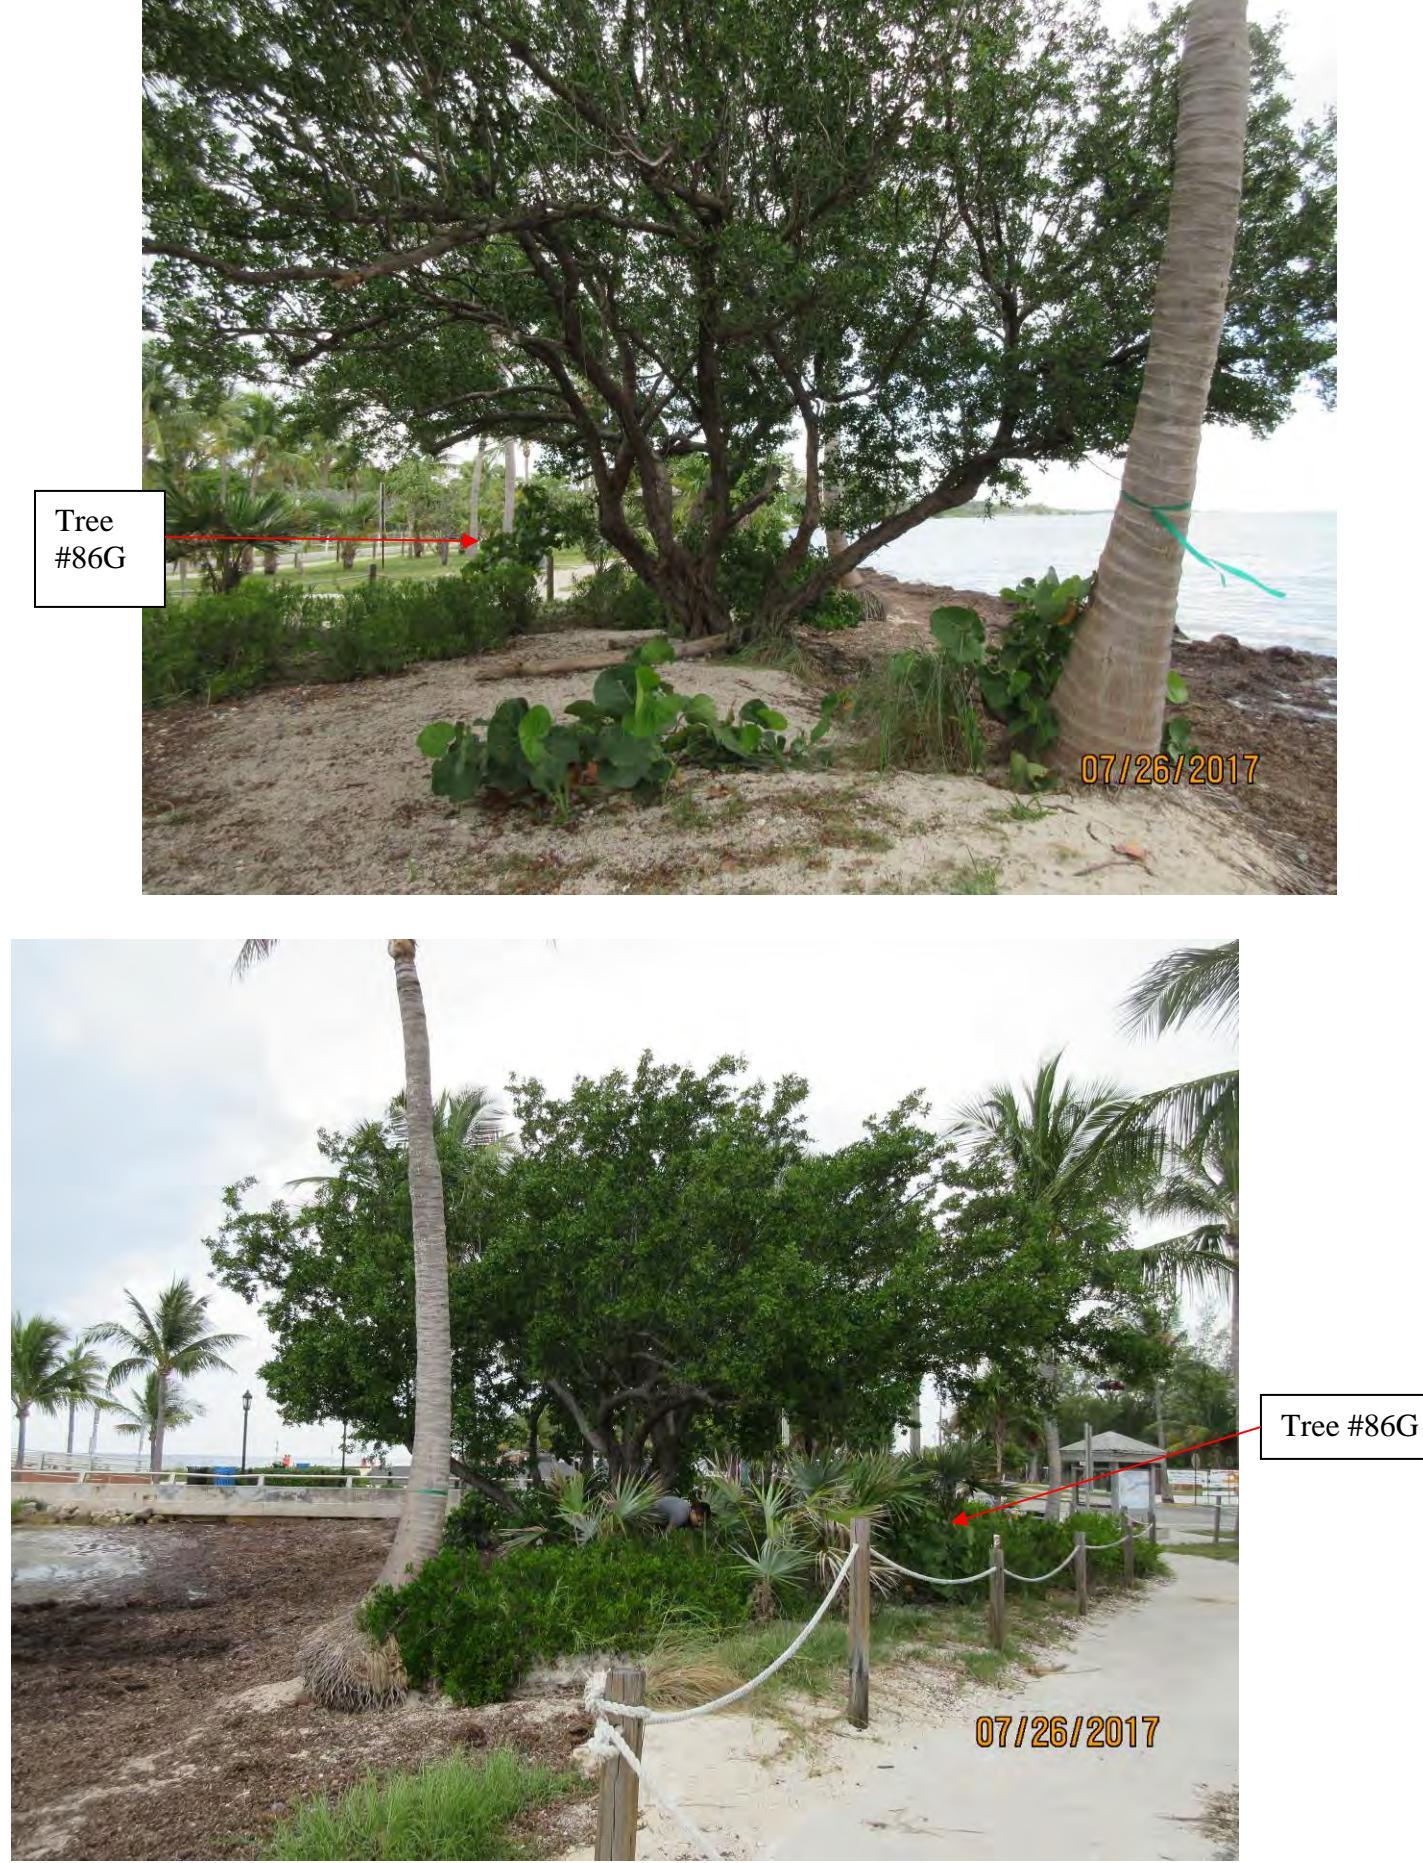
Tree #86G:

Diameter: 1" Location: 90% Species: 100% (on protected tree list) Condition: 60% (fair, young tree) Total Average Value = 83% Value x Diameter = 0.83 replacement caliper inches

It appears that this tree is in the middle of the work area. It is not known at this time whether the tree can successfully be transplanted.
