STAFF REPORT

DATE: August 1, 2017

RE: 1300 Atlantic Boulevard (C.B. Harvey Rest Beach Park) (permit application # T17-8522)

FROM: Karen DeMaria, City of Key West Urban Forestry Manager

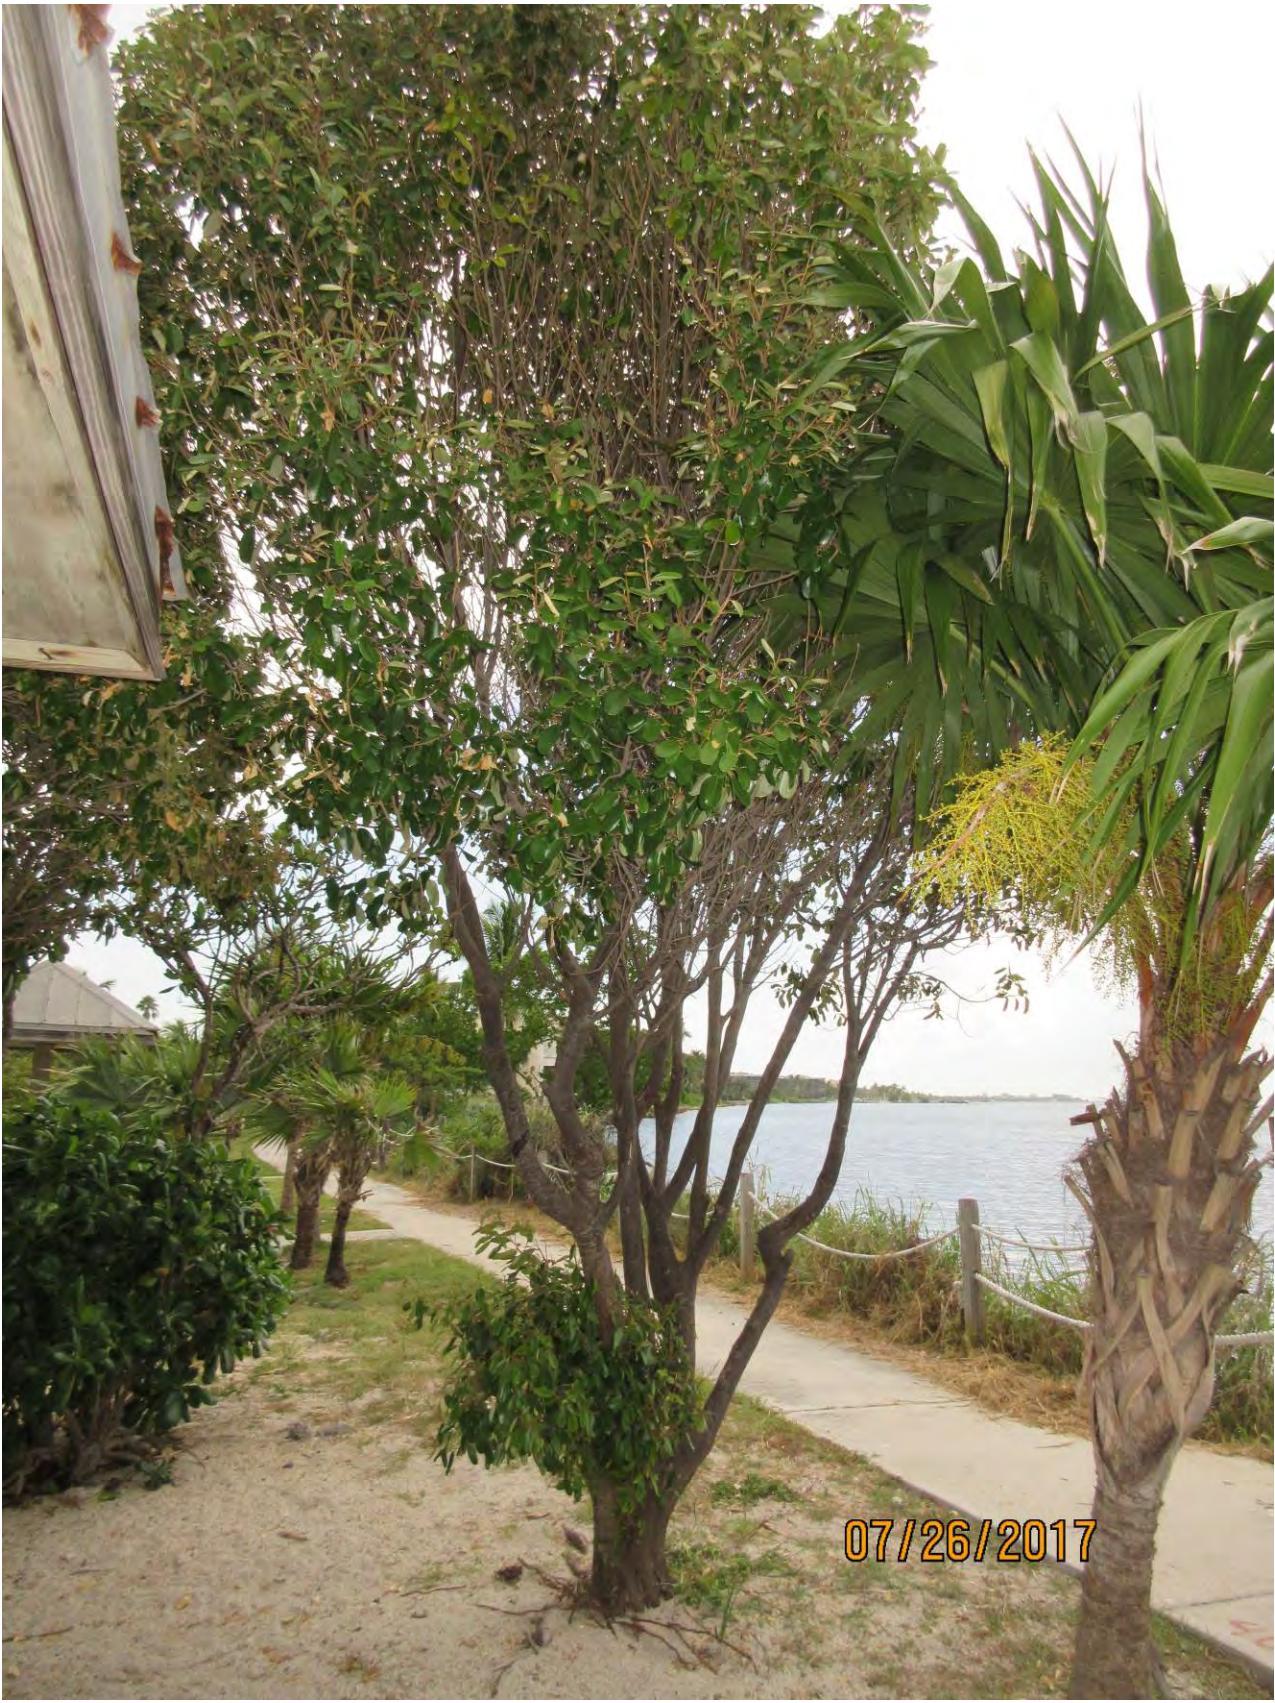
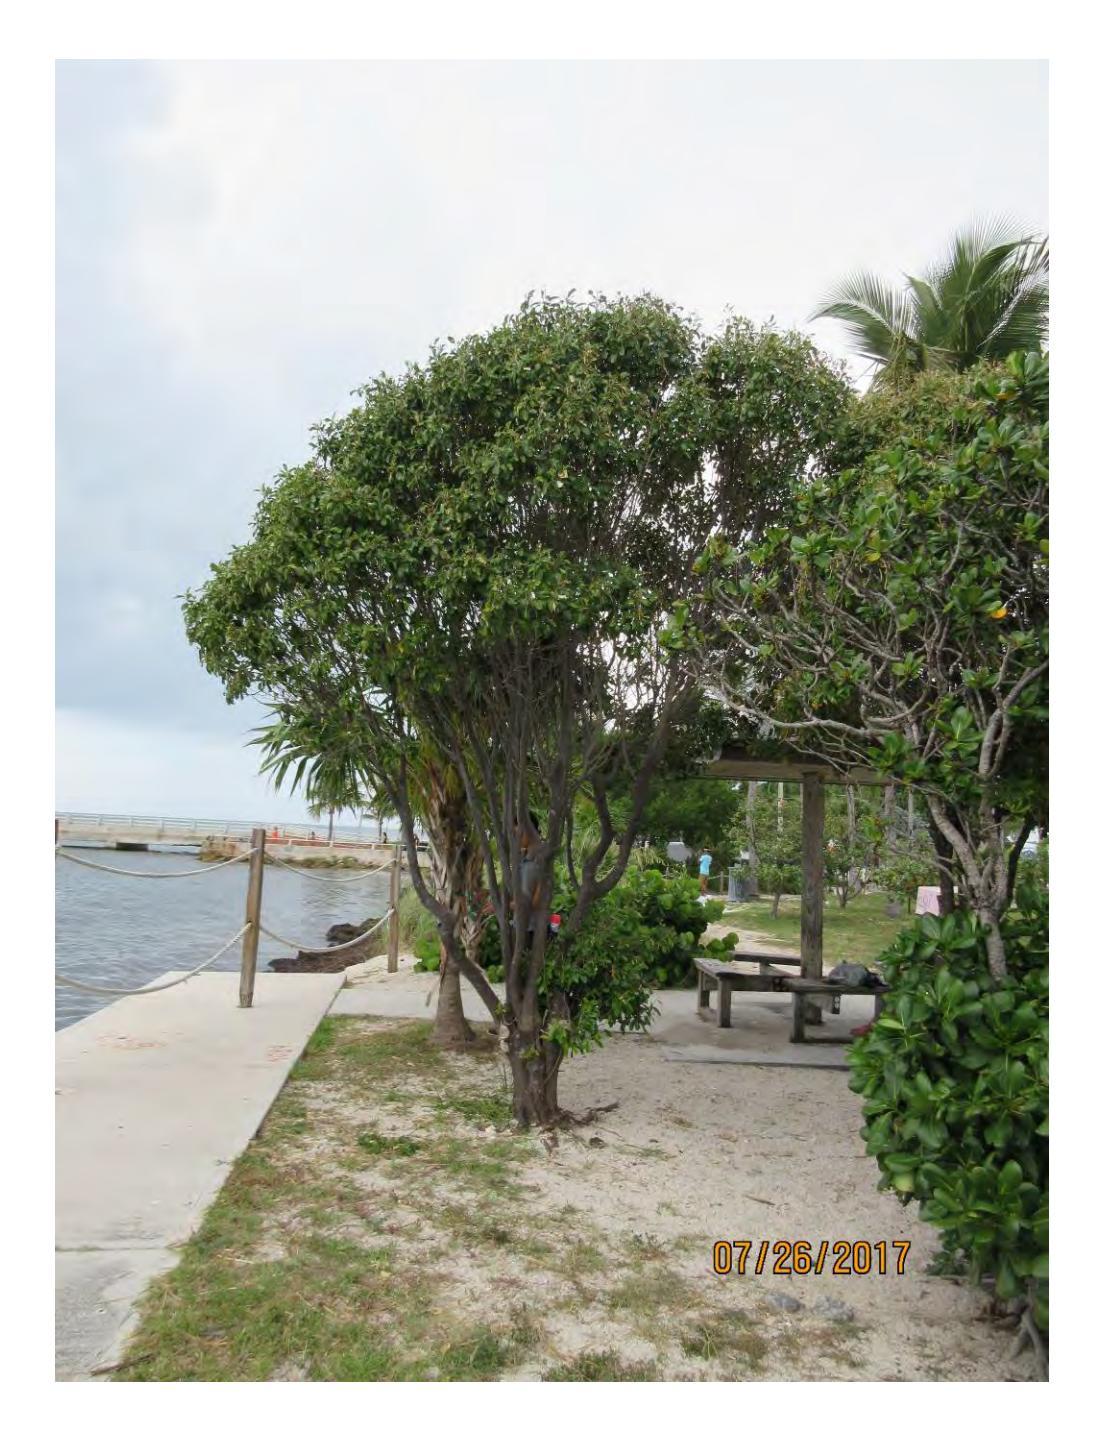
Diameter: 21" Location: 90% Species: 100% (on protected tree list) Condition: 80% (good) Total Average Value = 90% Value x Diameter = 11.3 replacement caliper inches

It appears that this tree is in the middle of the work area. It is not known at this time whether the tree can successfully be transplanted. Tree #68:

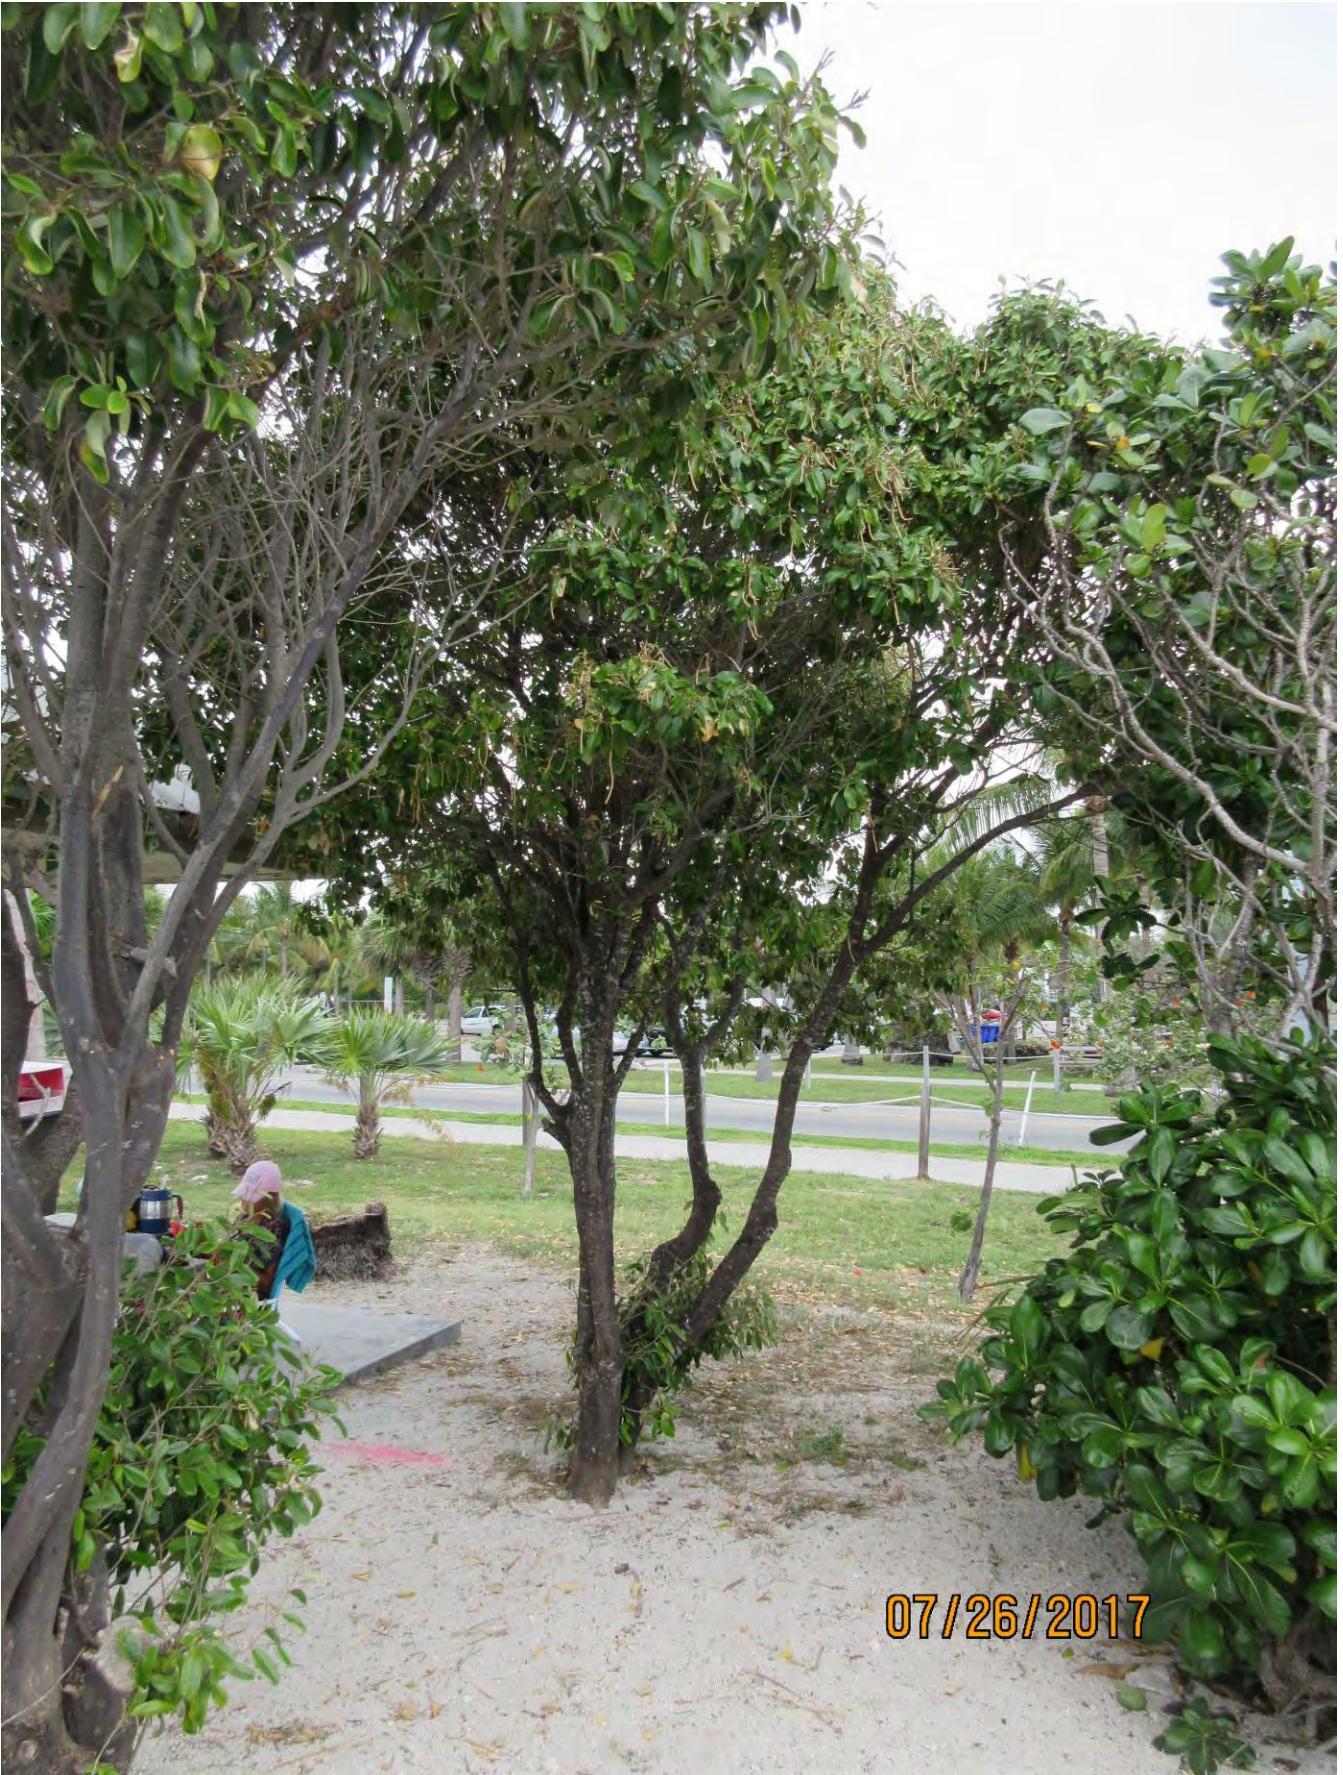
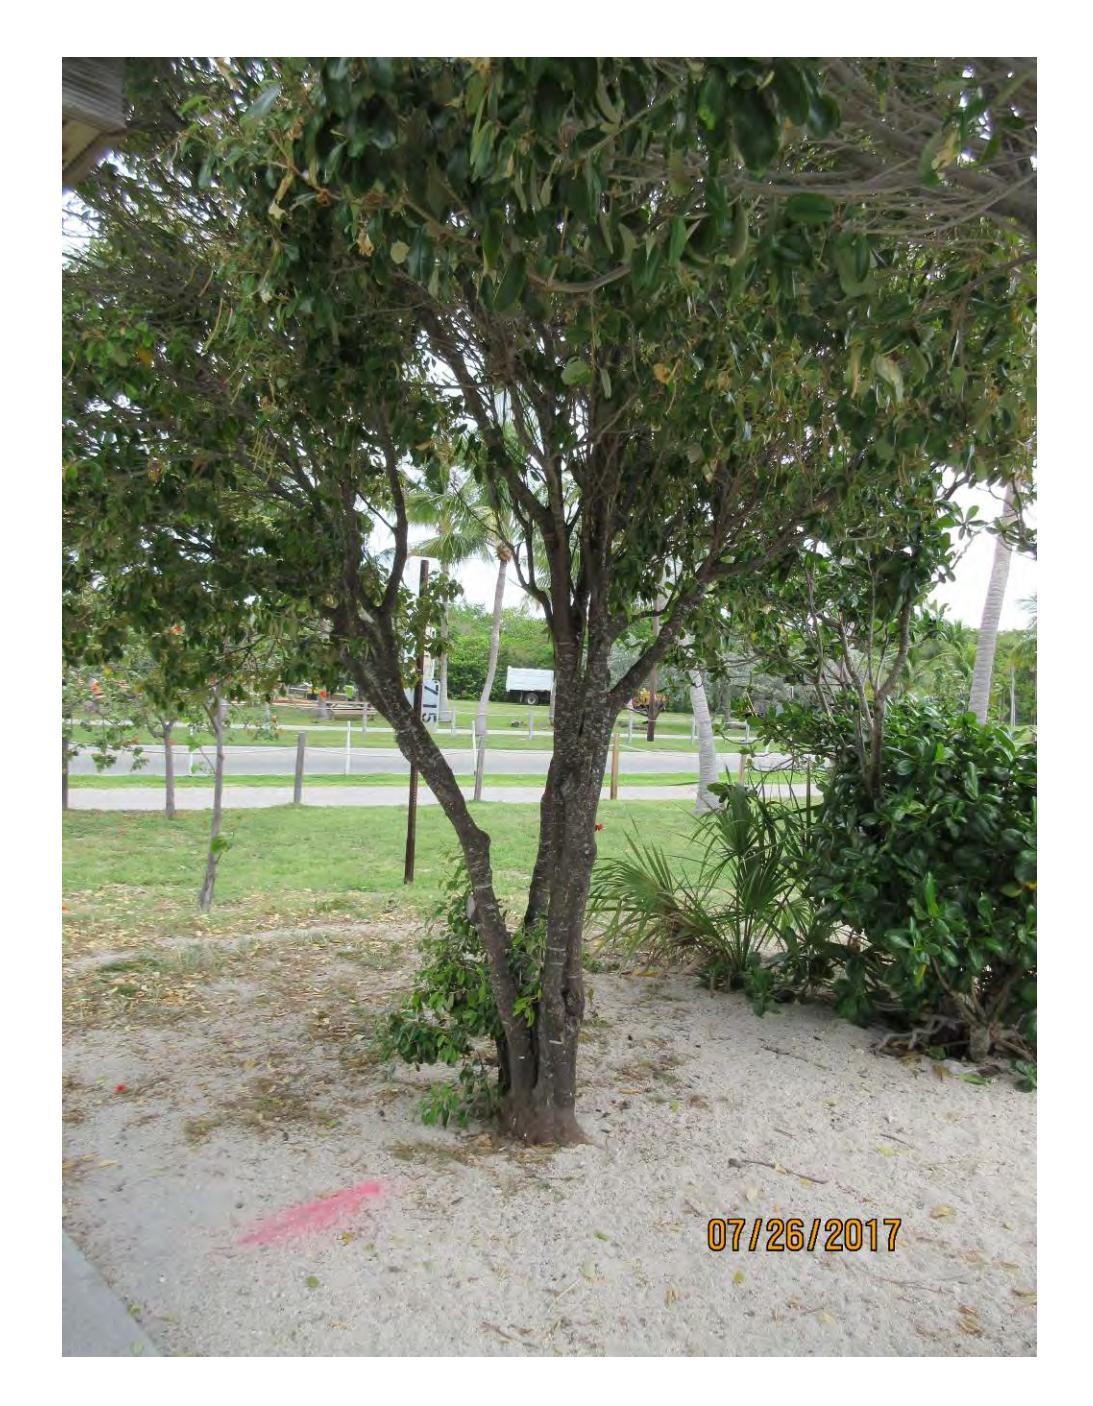
Diameter: 15.6" Location: 90% Species: 100% (on protected tree list) Condition: 70% (good) Total Average Value =86% Value x Diameter = 13.4 replacement caliper inches

It appears that this tree is on the edge of the work area. It is not known at this time whether the tree can successfully be transplanted. Tree Species: Seven Year Apple (Casasia clusiifolia) Tree #66:

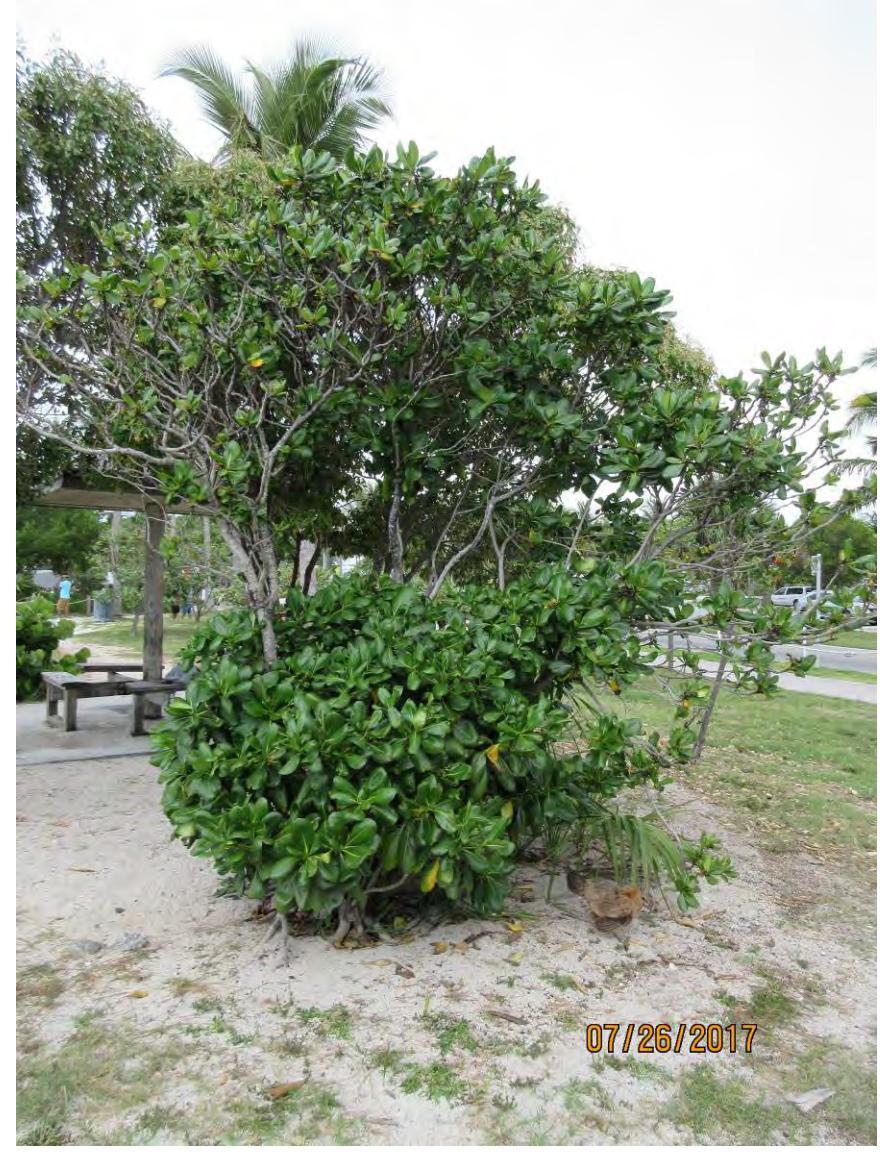
Diameter: 8.5" Location: 90% Species: 100% (on protected tree list) Condition: 70% (fair, sprawling tree) Total Average Value = 86% Value x Diameter = 7.3 replacement caliper inches

It appears that this tree is on the edge of the work area. It is not known at this time whether the tree can successfully be transplanted. Tree Species: Bay Cedar (Suriana maritima) Tree #48:

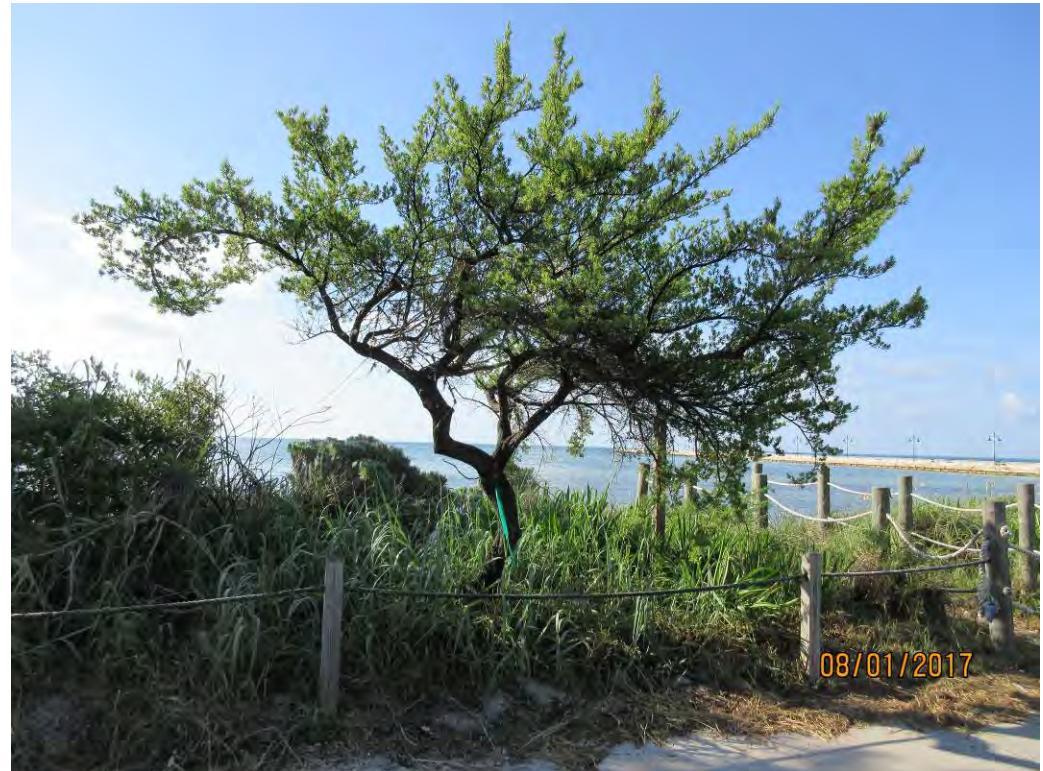
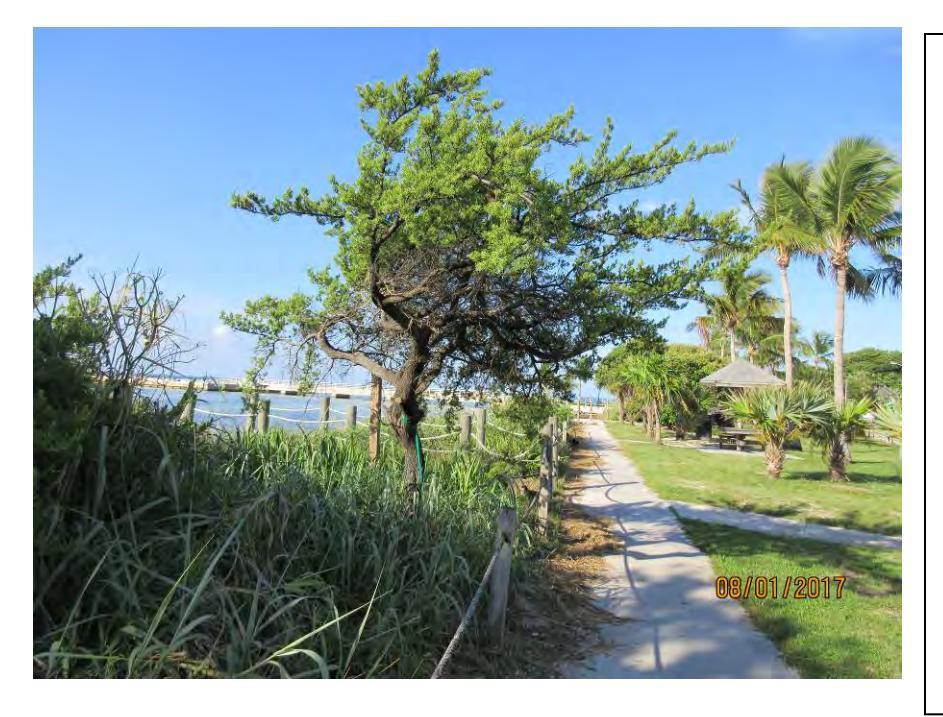
Diameter: 7.3" Location: 90% Species: 100% (on protected tree list) Condition: 70% (old specimen, some dead branches, single trunk with typical dune canopy structure) Total Average Value = 86% Value x Diameter = 6.2 replacement caliper inches

At the present time it appears that this tree is in the work area. It is not known at this time whether the tree can successfully be transplanted.
