## Marty's Place, Affordable Housing Community of Independent Living

Located at the corners of Bertha Street, Venetia Street and Dennis Street, Key West, Florida

### Landscape Overview of Project

## TREE MITIGATION PLAN

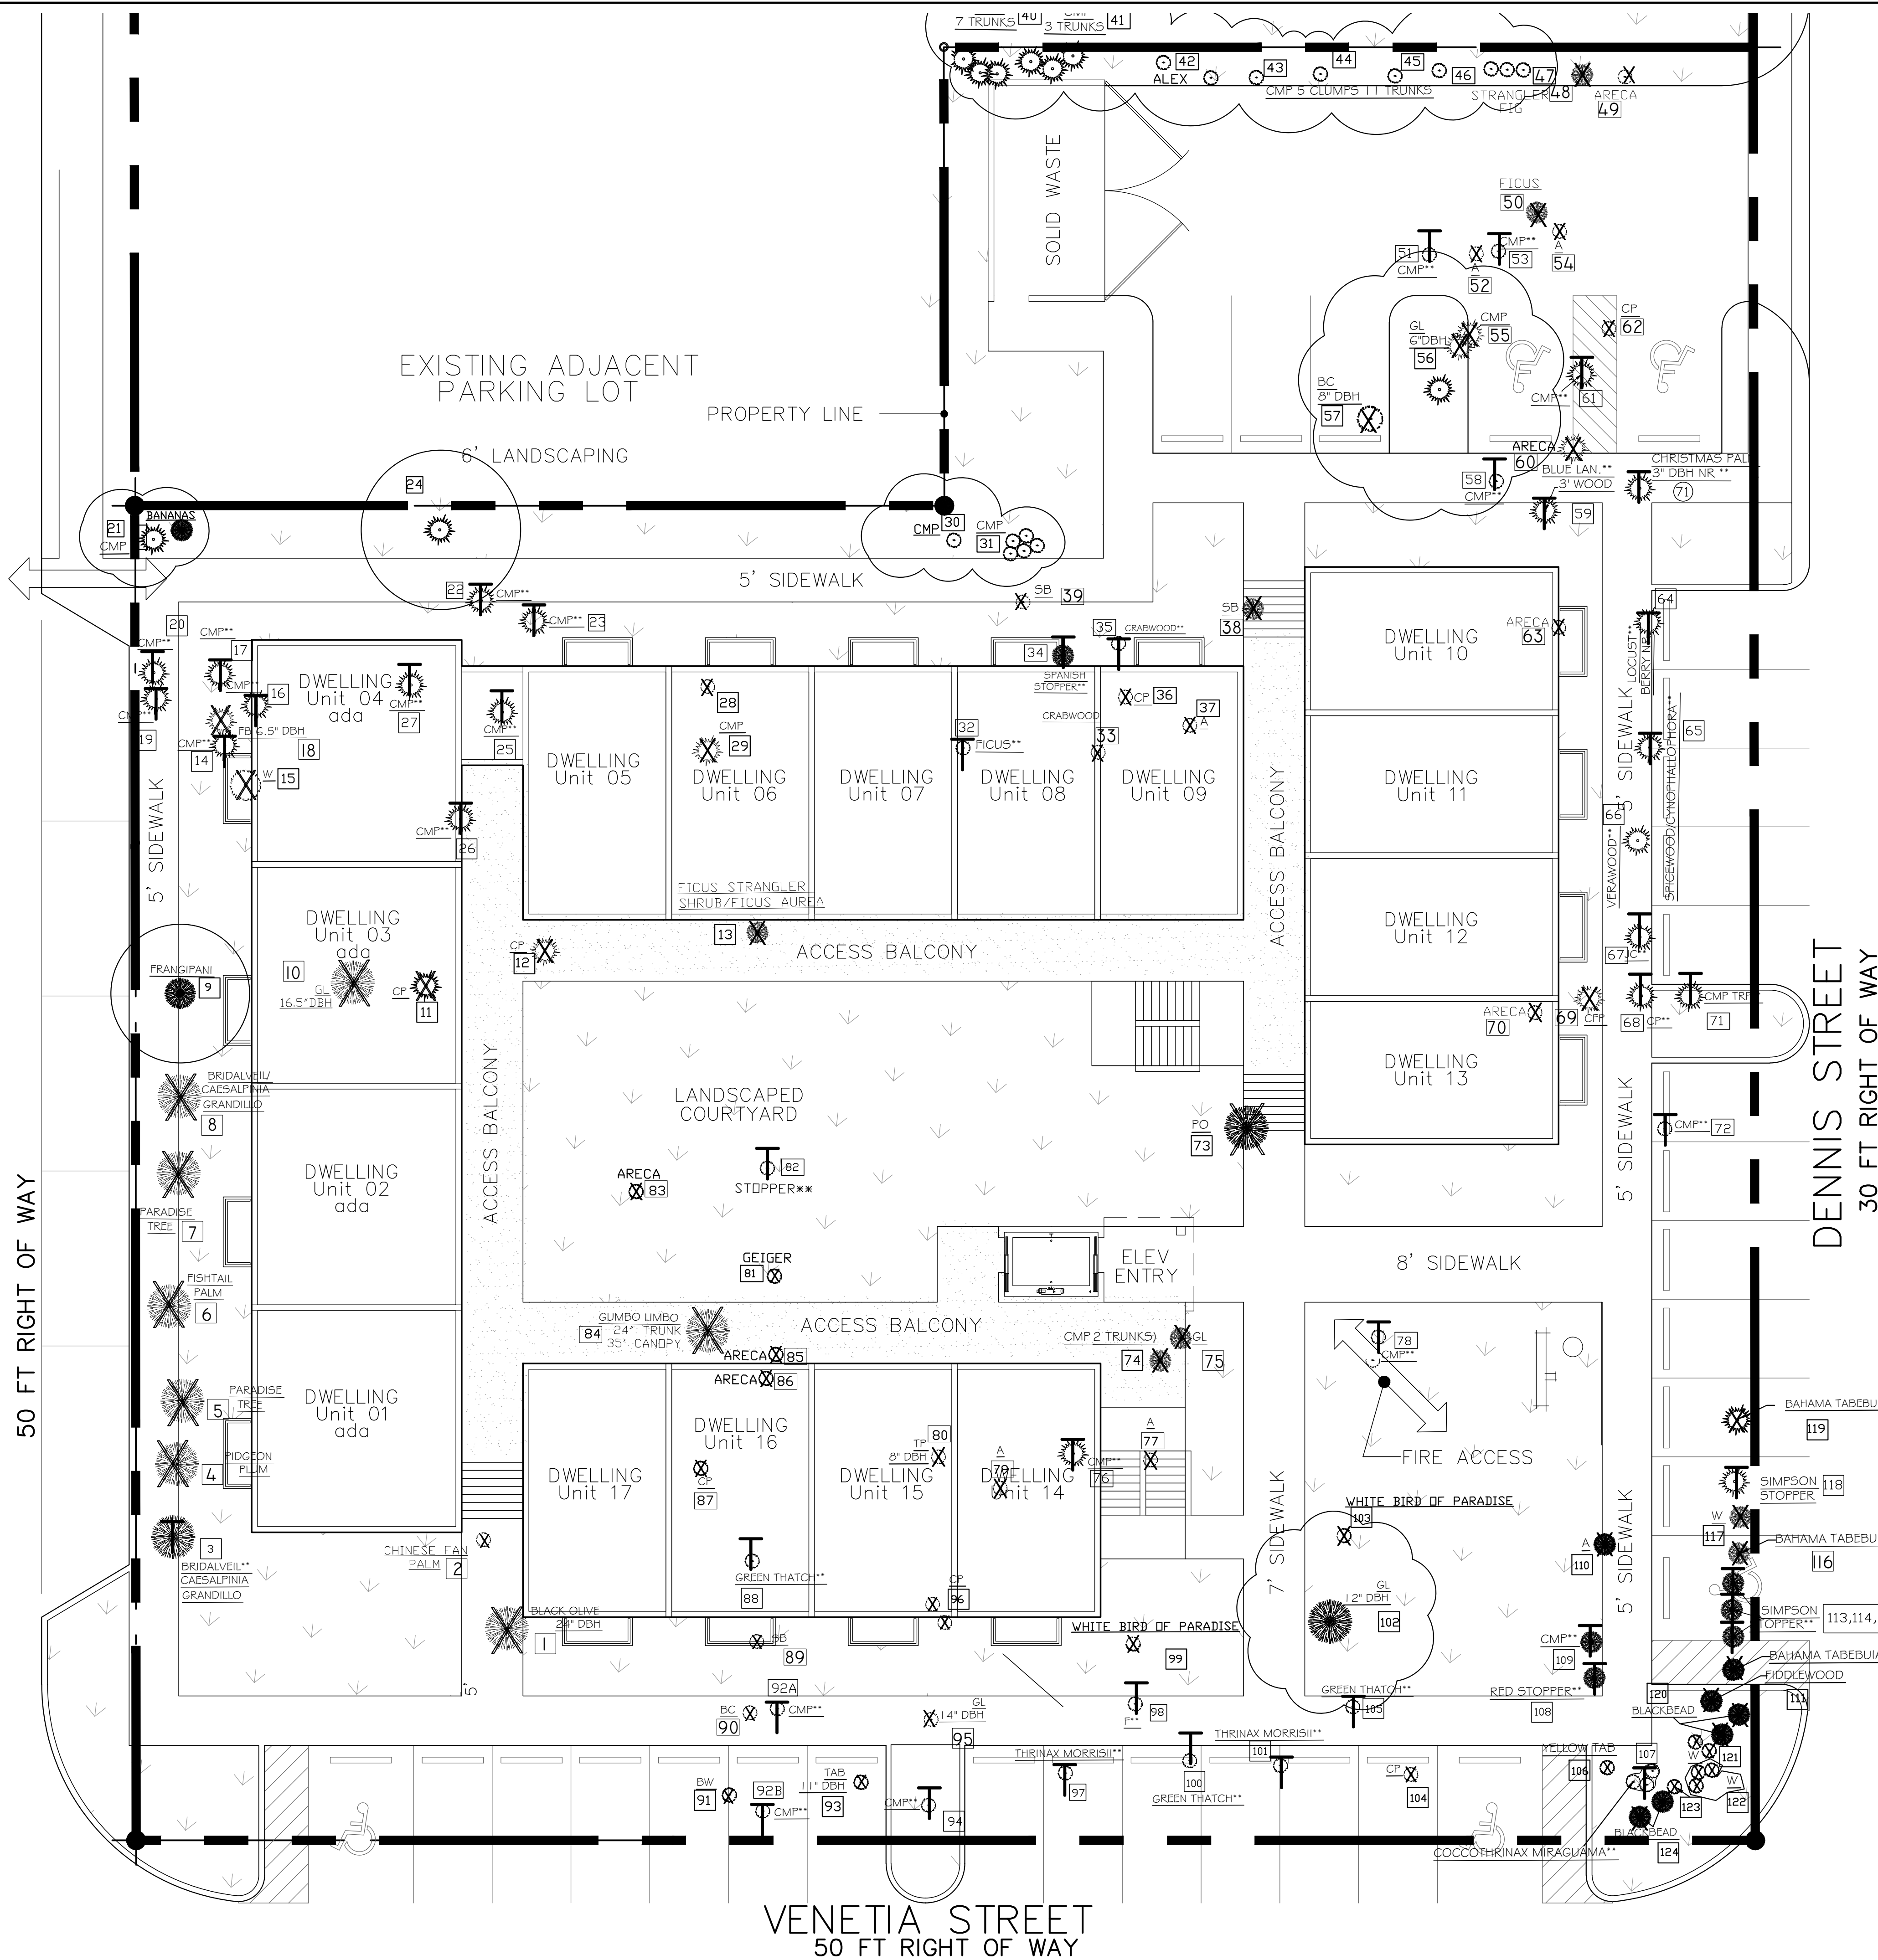
24. Ficus/Ficus aurea -Retain/Protect 4 ½ - 5’ diameter, fair, storm and utility pruning damage

29. Christmas Palm/Adonidia merrillii -Remove 10’-12’ wood, trunk damage-mechanical

33. Crabwood/Gymnanthes lucida -Remove Poor, 1 ¾ “, storm damage, shrub

104. Coconut Palm/Cocos nucifera -Remove 25’-30’ wood
105. Green Thatch/Thrinax radiata -Transplant Good, 8’ over-all
106. Yellow Tab.-Silver Trumpet/Tabebuia caraiba -Remove Poor, 12 ½”, storm damage with decay, very few leaves

110. Alexander Palm/Ptychosperma elegans -Remove 4’-10’ wood
111. Fiddlewood/Citharexylum spinosum -Remove Poor, 3 ¾”, storm damage, very few leaves, mostly dead

118. Simpson Stopper/Myrcianthes fragrans -Transplant, Poor, ¾”, topped
119. Bahama Tab/Tabebuia bahamensis -Remove, Poor, 3 ¾”, tip die-back, major mechanical damage

57. Barbados Cherry/Malpighia glabra -Remove Poor, 7 ½ “, dieback, multi trunked with trunk damage
58. Christmas Palm/Adonidia merrillii -Transplant, 5 ½’ wood

73. Poinciana/Delonix regia -Remove Poor, 14 ¾ “, large west codominant removed-with wound wood closure and decay evident, included bark evident east side of tree, canopy storm damaged with tip dieback, decay and flushing, decay at old pruning cuts, 30-40% of root system compromised by in-ground cistern. Support roots on north side of tree are non-existent around cistern

83. Areca/Dypsis lutescens -Remove
84. Gumbo Limbo/Bursea simaruba -Remove, Poor, 20 ¾ “, codominant with multiple areas of included bark, decay evident, active subterranean termites, damage throughout tree including main area of branch unions

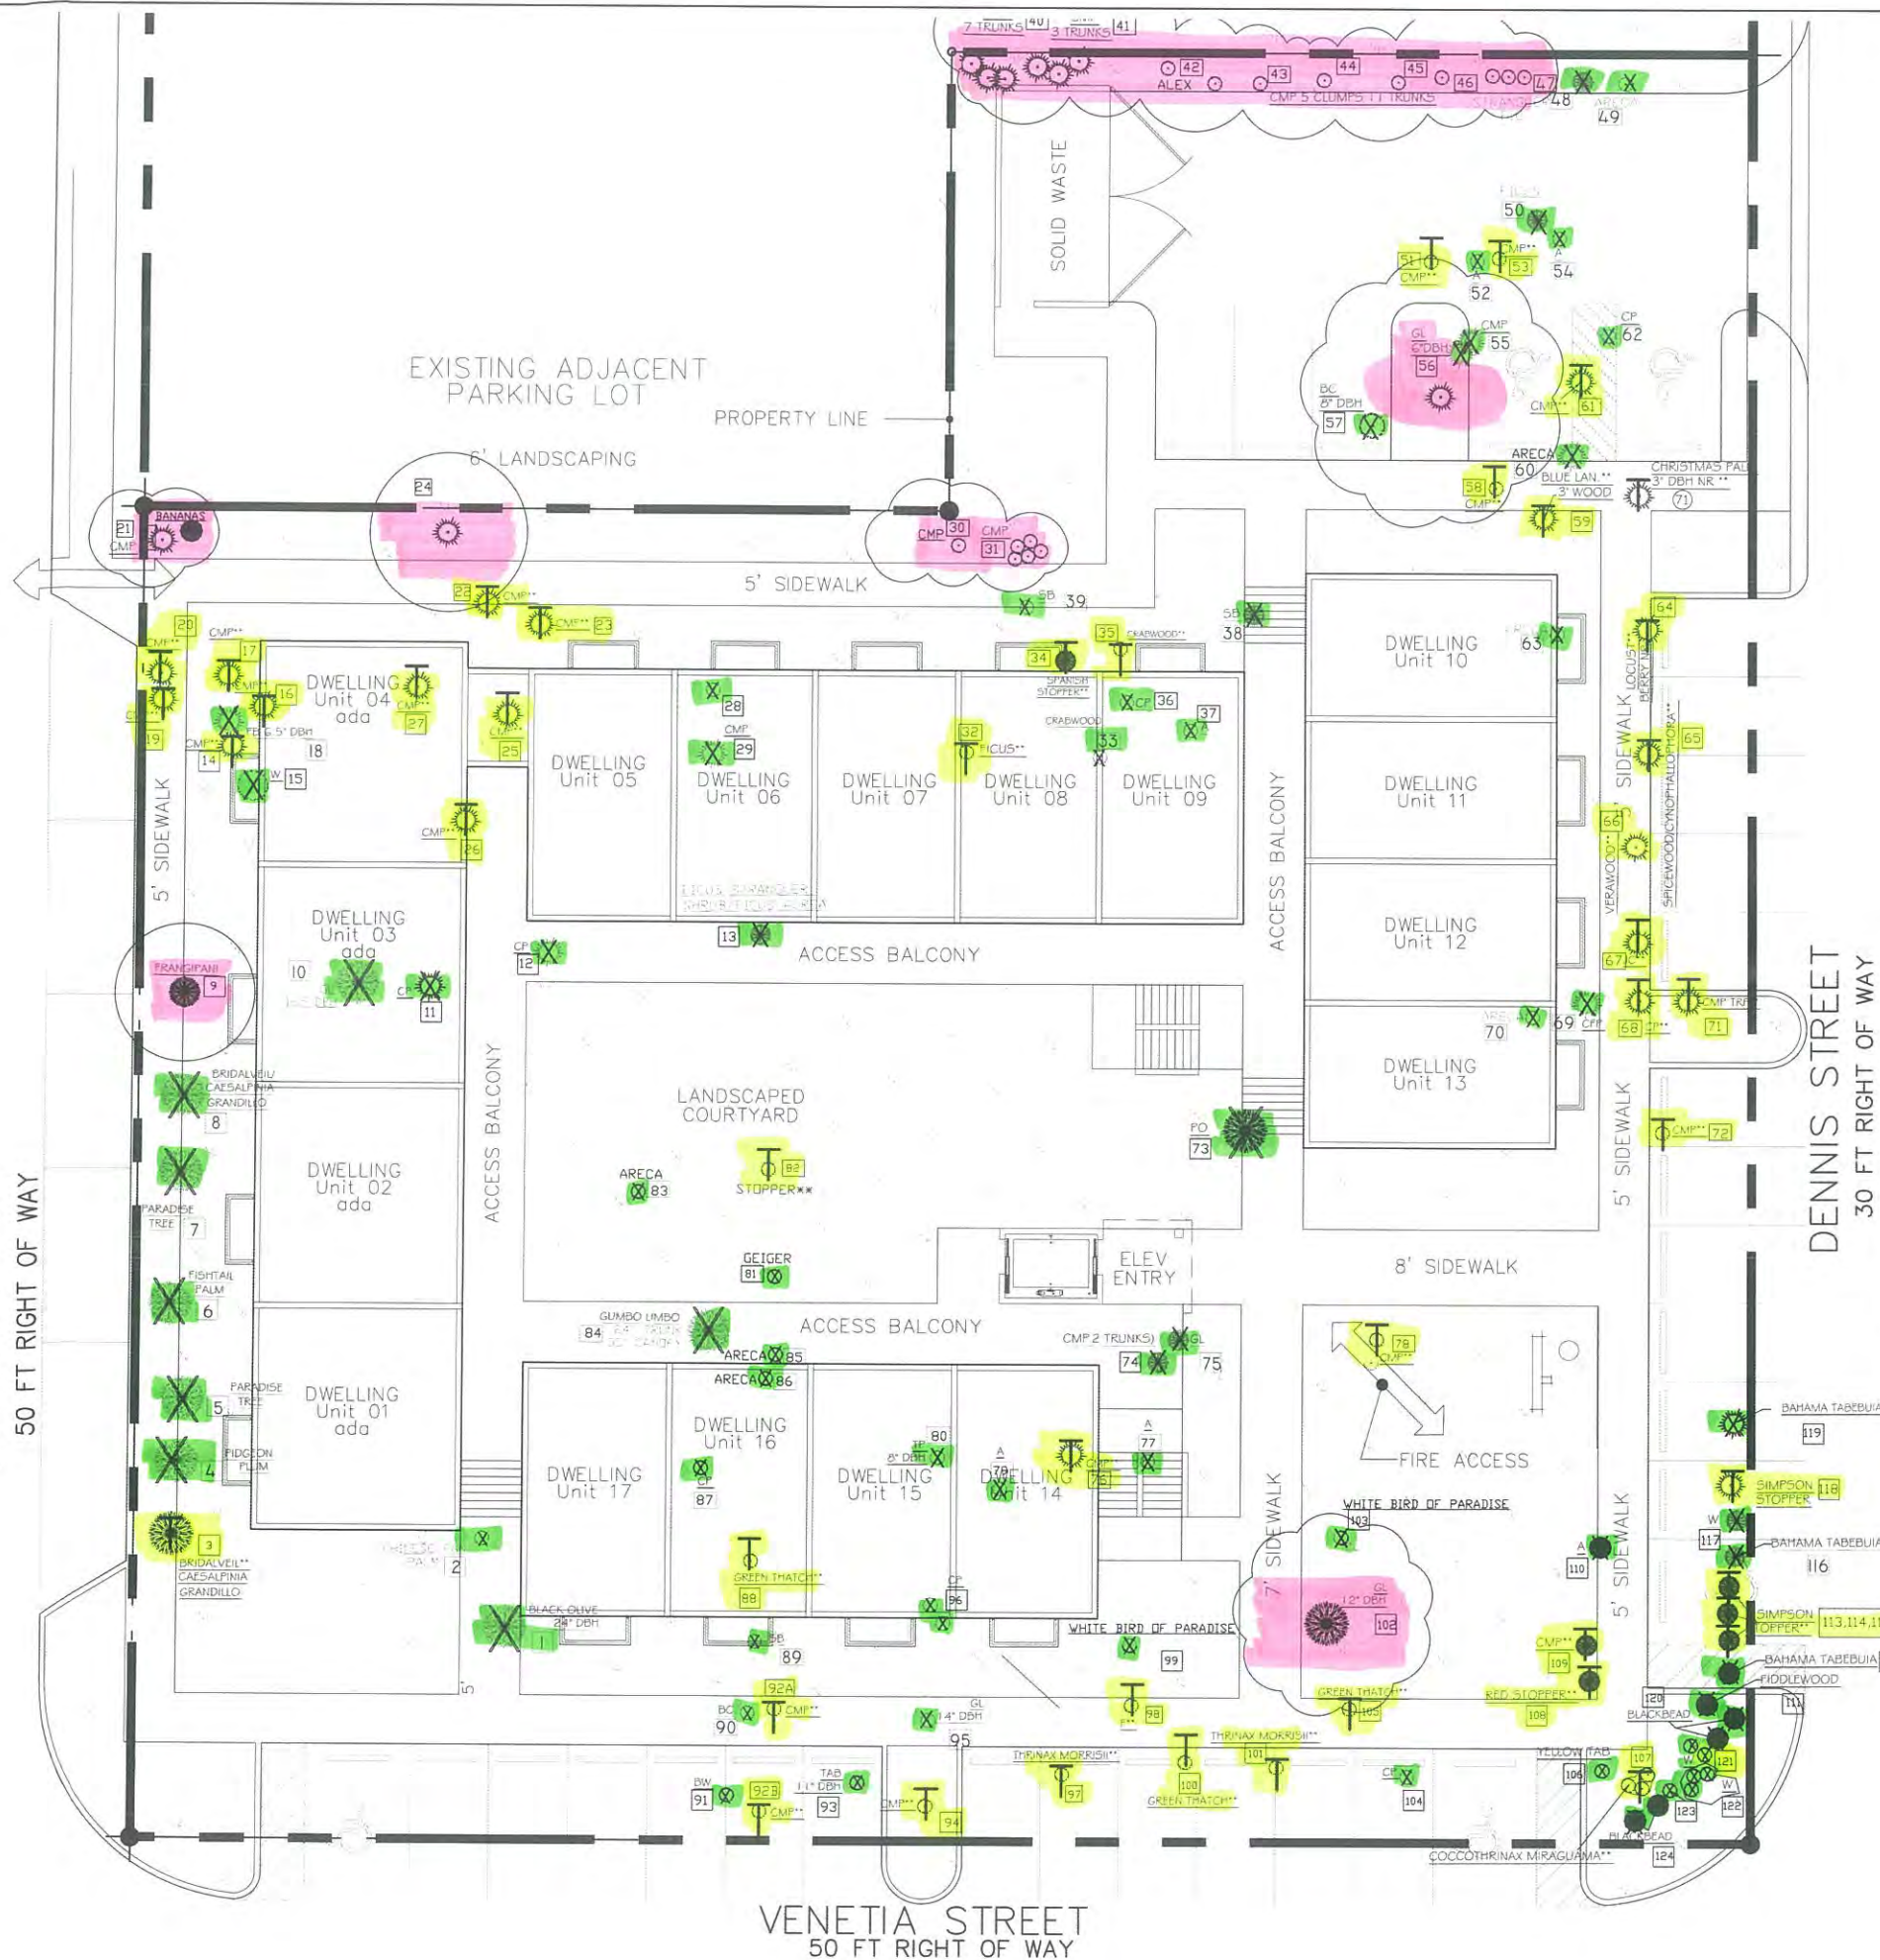
23. Christmas Palm/Adonidia merrillii -Transplant, 10'-13' wood
24. Ficus/Ficus aurea -Retain/Protect 4 ½ - 5' diameter, fair, storm and utility pruning damage

28. Spanish Stopper/Eugenia foetida -Remove Fair, 3 stems total 1", half root system under building
29. Christmas Palm/Adonidia merrillii -Remove 10'-12' wood, trunk damage-mechanical

33. Crabwood/Gymnanthes lucida -Remove Poor, 1 ¾ ", storm damage, shrub
34. Spanish Stopper/Eugenia foetida -Transplant Fair, 1"
35. Crabwood/Gymnanthes lucida -Transplant Good, standard 1 ½ "

57. Barbados Cherry/Malpighia glabra -Remove Poor, 7 ½ ", dieback, multi trunked with trunk  
damage
58. Christmas Palm/Adonidia merrillii -Transplant, 5 ½' wood

73. Poinciana/Delonix regia -Remove Poor, 14 ¾ ", large west codominant removed-with wound wood closure and decay evident, included bark evident east side of tree, canopy storm damaged with tip dieback, decay and flushing, decay at old pruning cuts, 30-40% of root system compromised by in-ground cistern. Support roots on north side of tree are non-existent around cistern

83. Areca/Dypsis lutescens -Remove
84. Gumbo Limbo/Bursea simaruba -Remove, Poor, 20 ¾ ", codominant with multiple areas of included bark, decay evident, active subterranean termites, damage throughout tree including main area of branch unions

104. Coconut Palm/Cocos nucifera -Remove 25'-30' wood
105. Green Thatch/Thrinax radiata -Transplant Good, 8' over-all
106. Yellow Tab.-Silver Trumpet/Tabebuia caraiba -Remove Poor, 12 ½", storm damage with decay, very few leaves

110. Alexander Palm/Ptychosperma elegans -Remove 4'-10' wood
111. Fiddlewood/Citharexylum spinosum -Remove Poor, 3 ¾", storm damage, very few leaves, mostly dead

118. Simpson Stopper/Myrcianthes fragrans -Transplant, Poor, ¾", topped
119. Bahama Tab/Tabebuia bahamensis -Remove, Poor, 3 ¼", tip die-back, major mechanical damage
