Stock Island Landfill

Overview of current status, obligations and future possibilities.

Utilities Department City of Key West

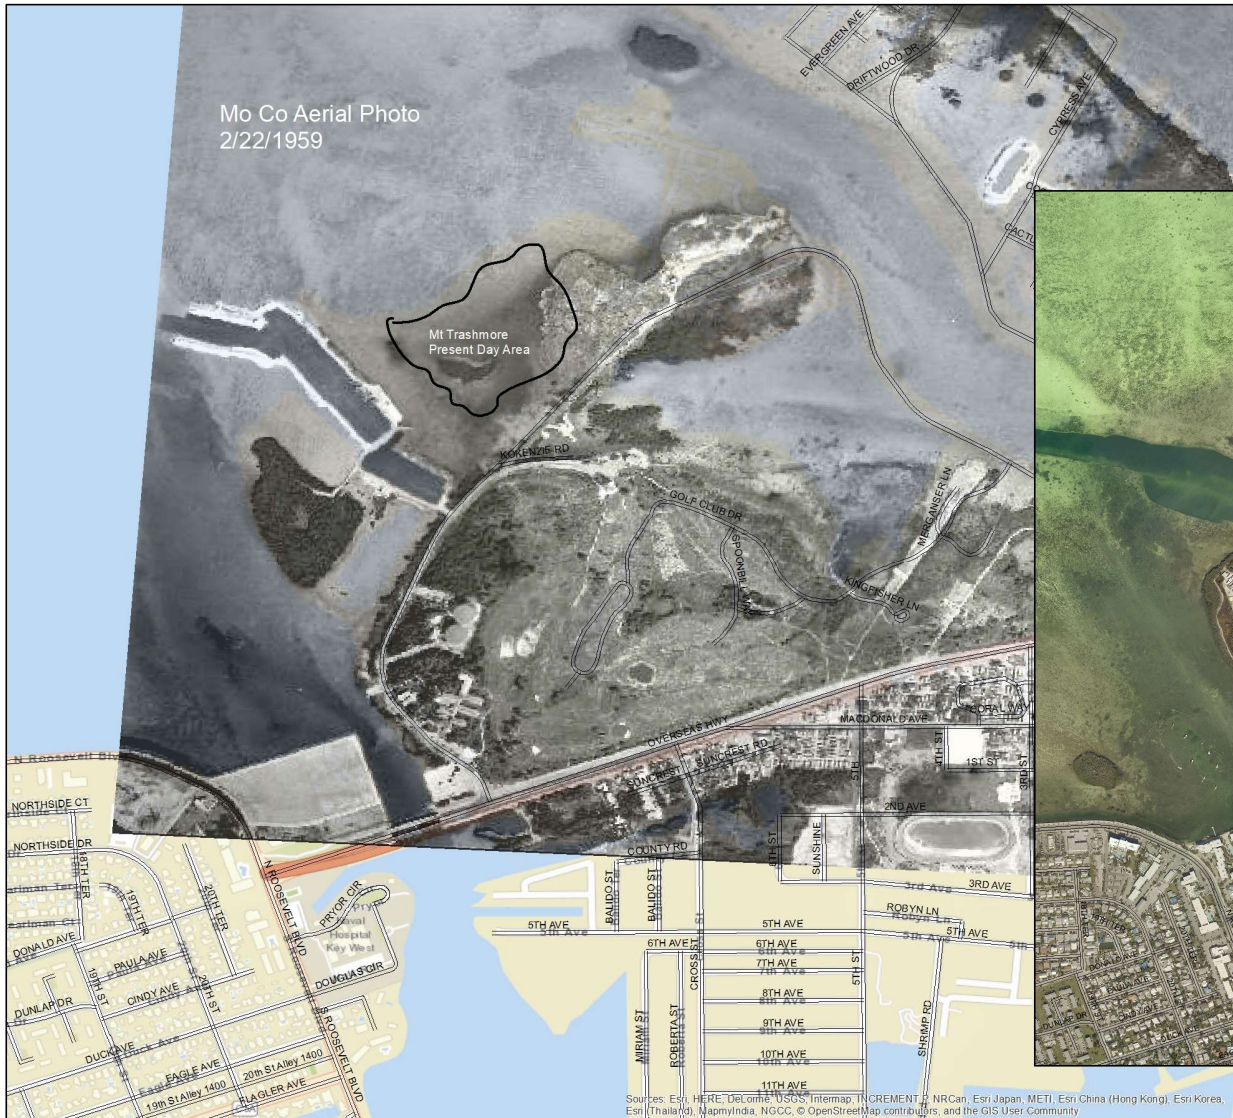
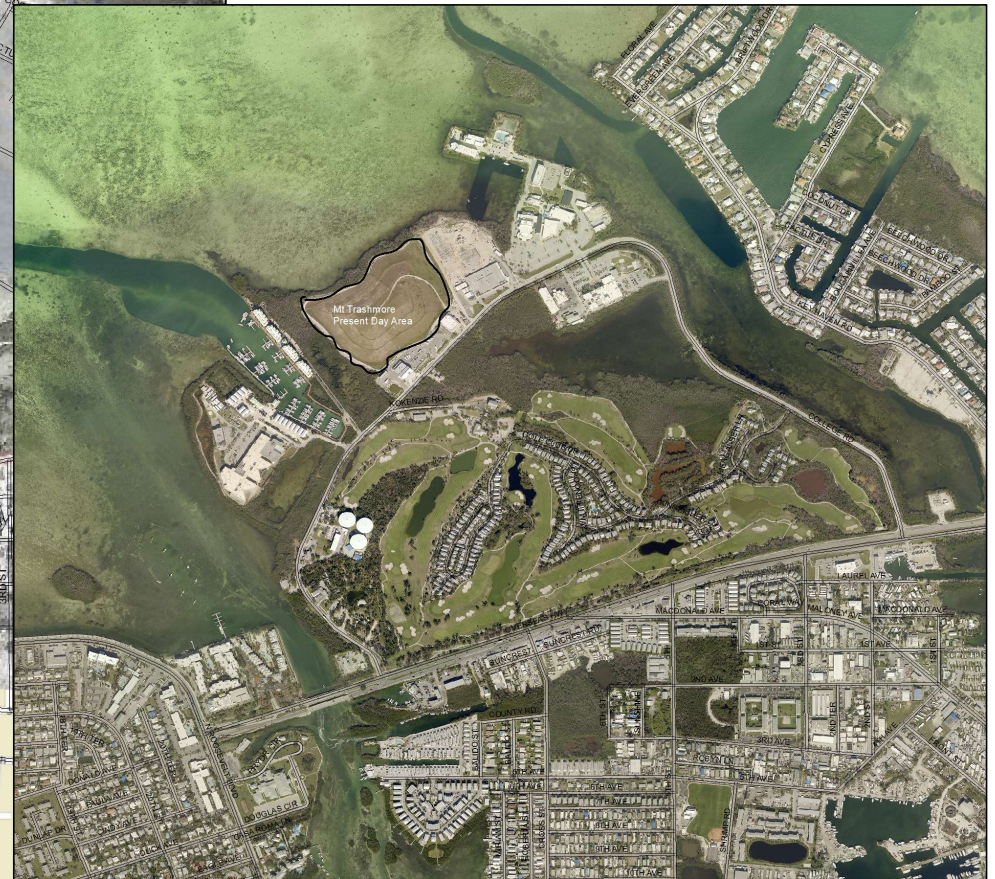
Comparison Aerials of Stock Island Landfill
1959 and 2015.

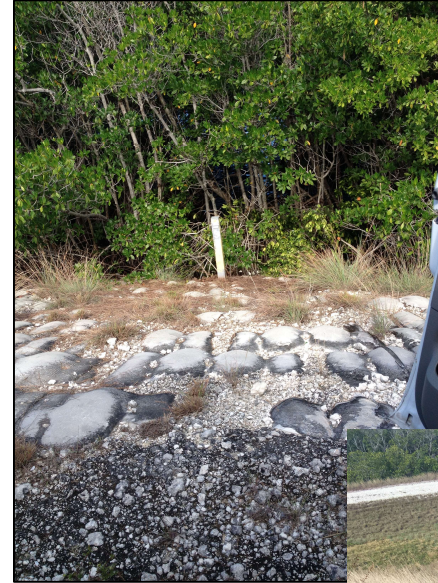
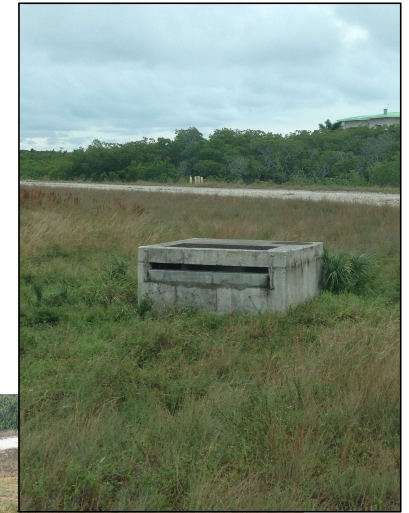
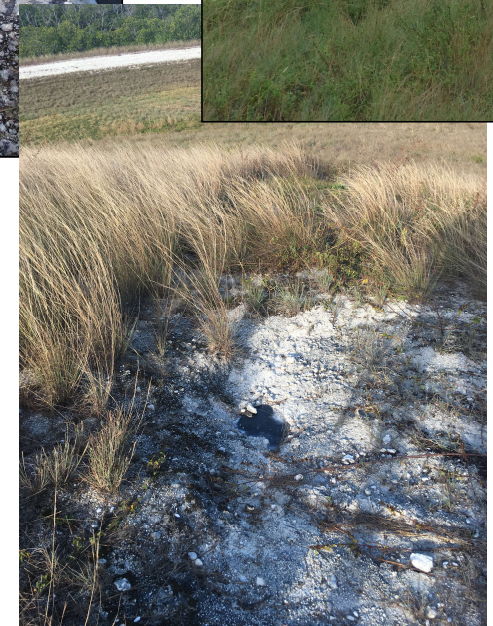
- Elevation approximately 90 feet
- Footprint 16 acres
- No bottom liner or leachate collection. Gas vents installed approximately 20 years ago.
- Upon closure started in 1990, 18 inches of screening sand over one layer of 30-mil PVC geomembrane and covered with 6 inches of bedding sand. This was completed in 2 phases, Phase 1 1990 and Phase 2 1992.

- Engineer reviewed in 2016 and no subsidence when comparing to 2007 topo survey.
- Minimal erosion and stormwater systems are clear and working. Erosion is addressed when noticed and repaired.

- 7 of the gas vents in the deepest areas on the top shelf of the landfill still have a presence of methane and hydrogen sulfide. A slow production.
- Groundwater monitoring from 2011-2015 reviewed. Only parameter to occasionally exceed Groundwater Cleanup Target Levels is TDS (turbidity), at Well #2 and #3. These wells are between the landfill and the Gulf of Mexico, therefore not a sign of leachate leaks.

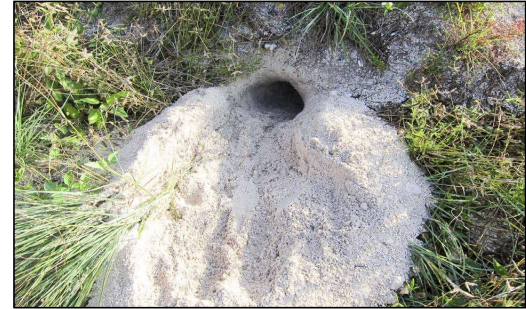
- Mowing 4-6 times per year. Public Works sends employees. Takes 2-3 days. Also maintaining 2 mowers.
- Iguana control. 2019 will cost between \$9,000 and \$14,000. This includes iguana capture and removal and filling in holes and damage caused by iguanas.
- Water sampling. \$1385 annually.
- Repairs to landscaping as needed. 2018 approximately \$24,000.
- We make repairs when areas become bare, soil thins from erosion or liner is showing.
- Repairs needed in future if no changes. New road or road repair and a few landscaping repairs.
