STAFF REPORT

RE: **5220, 5224, 5228, & 5230 College Road**
(permit application # T2019-0135)

FROM: Karen DeMaria, City of Key West Urban Forestry Manager

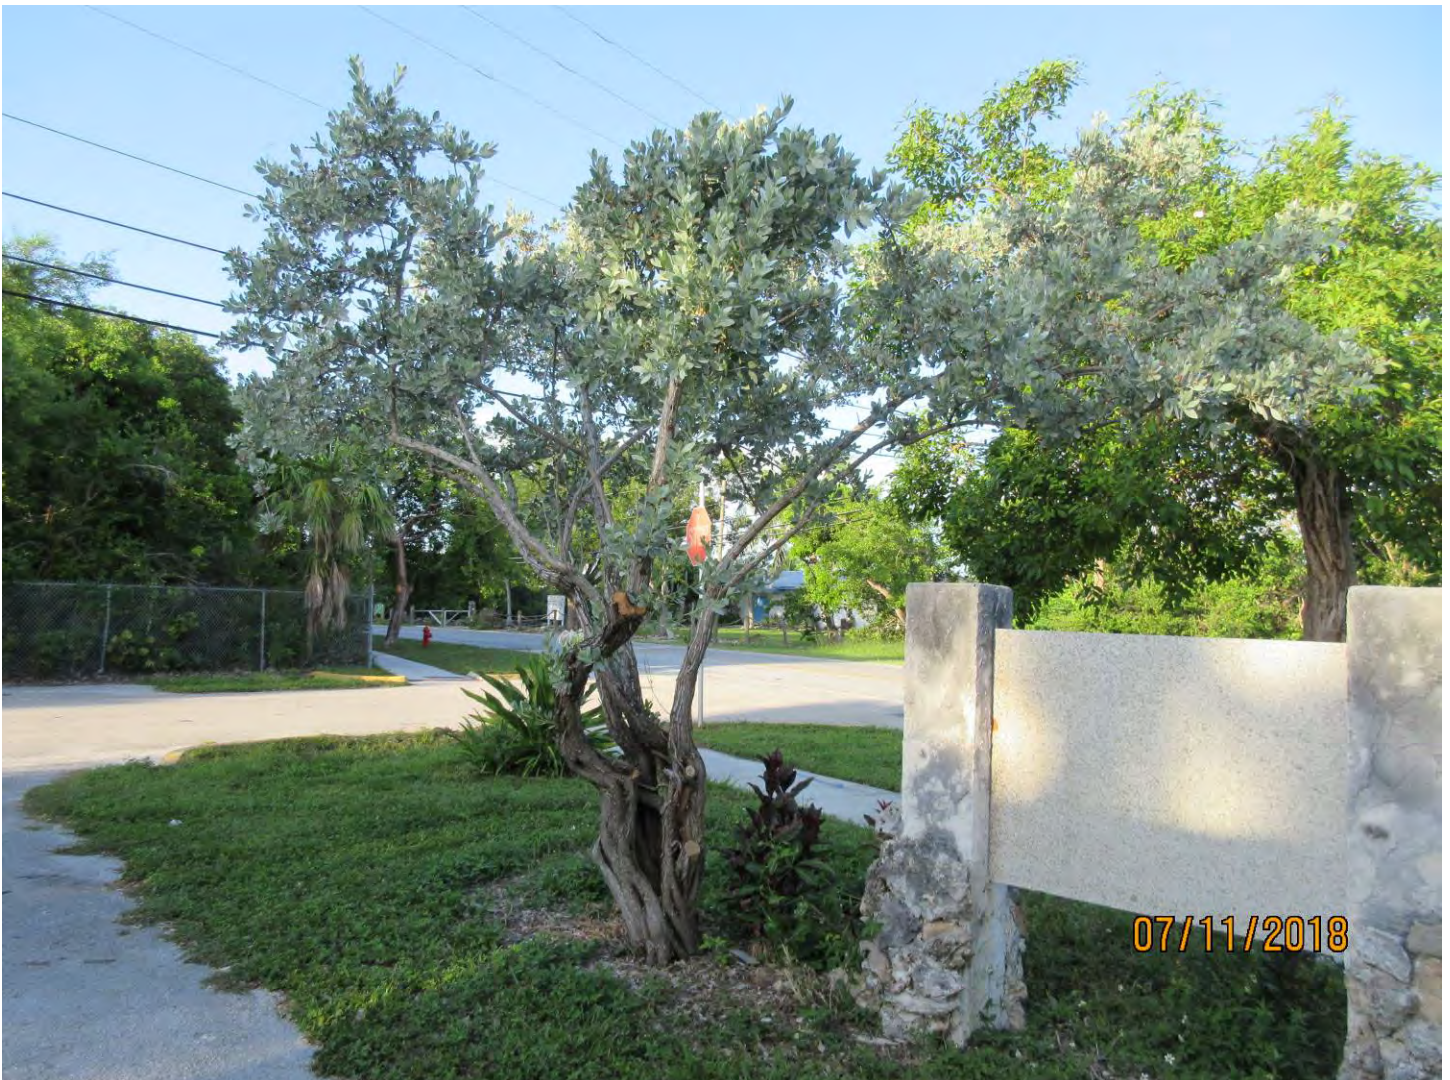
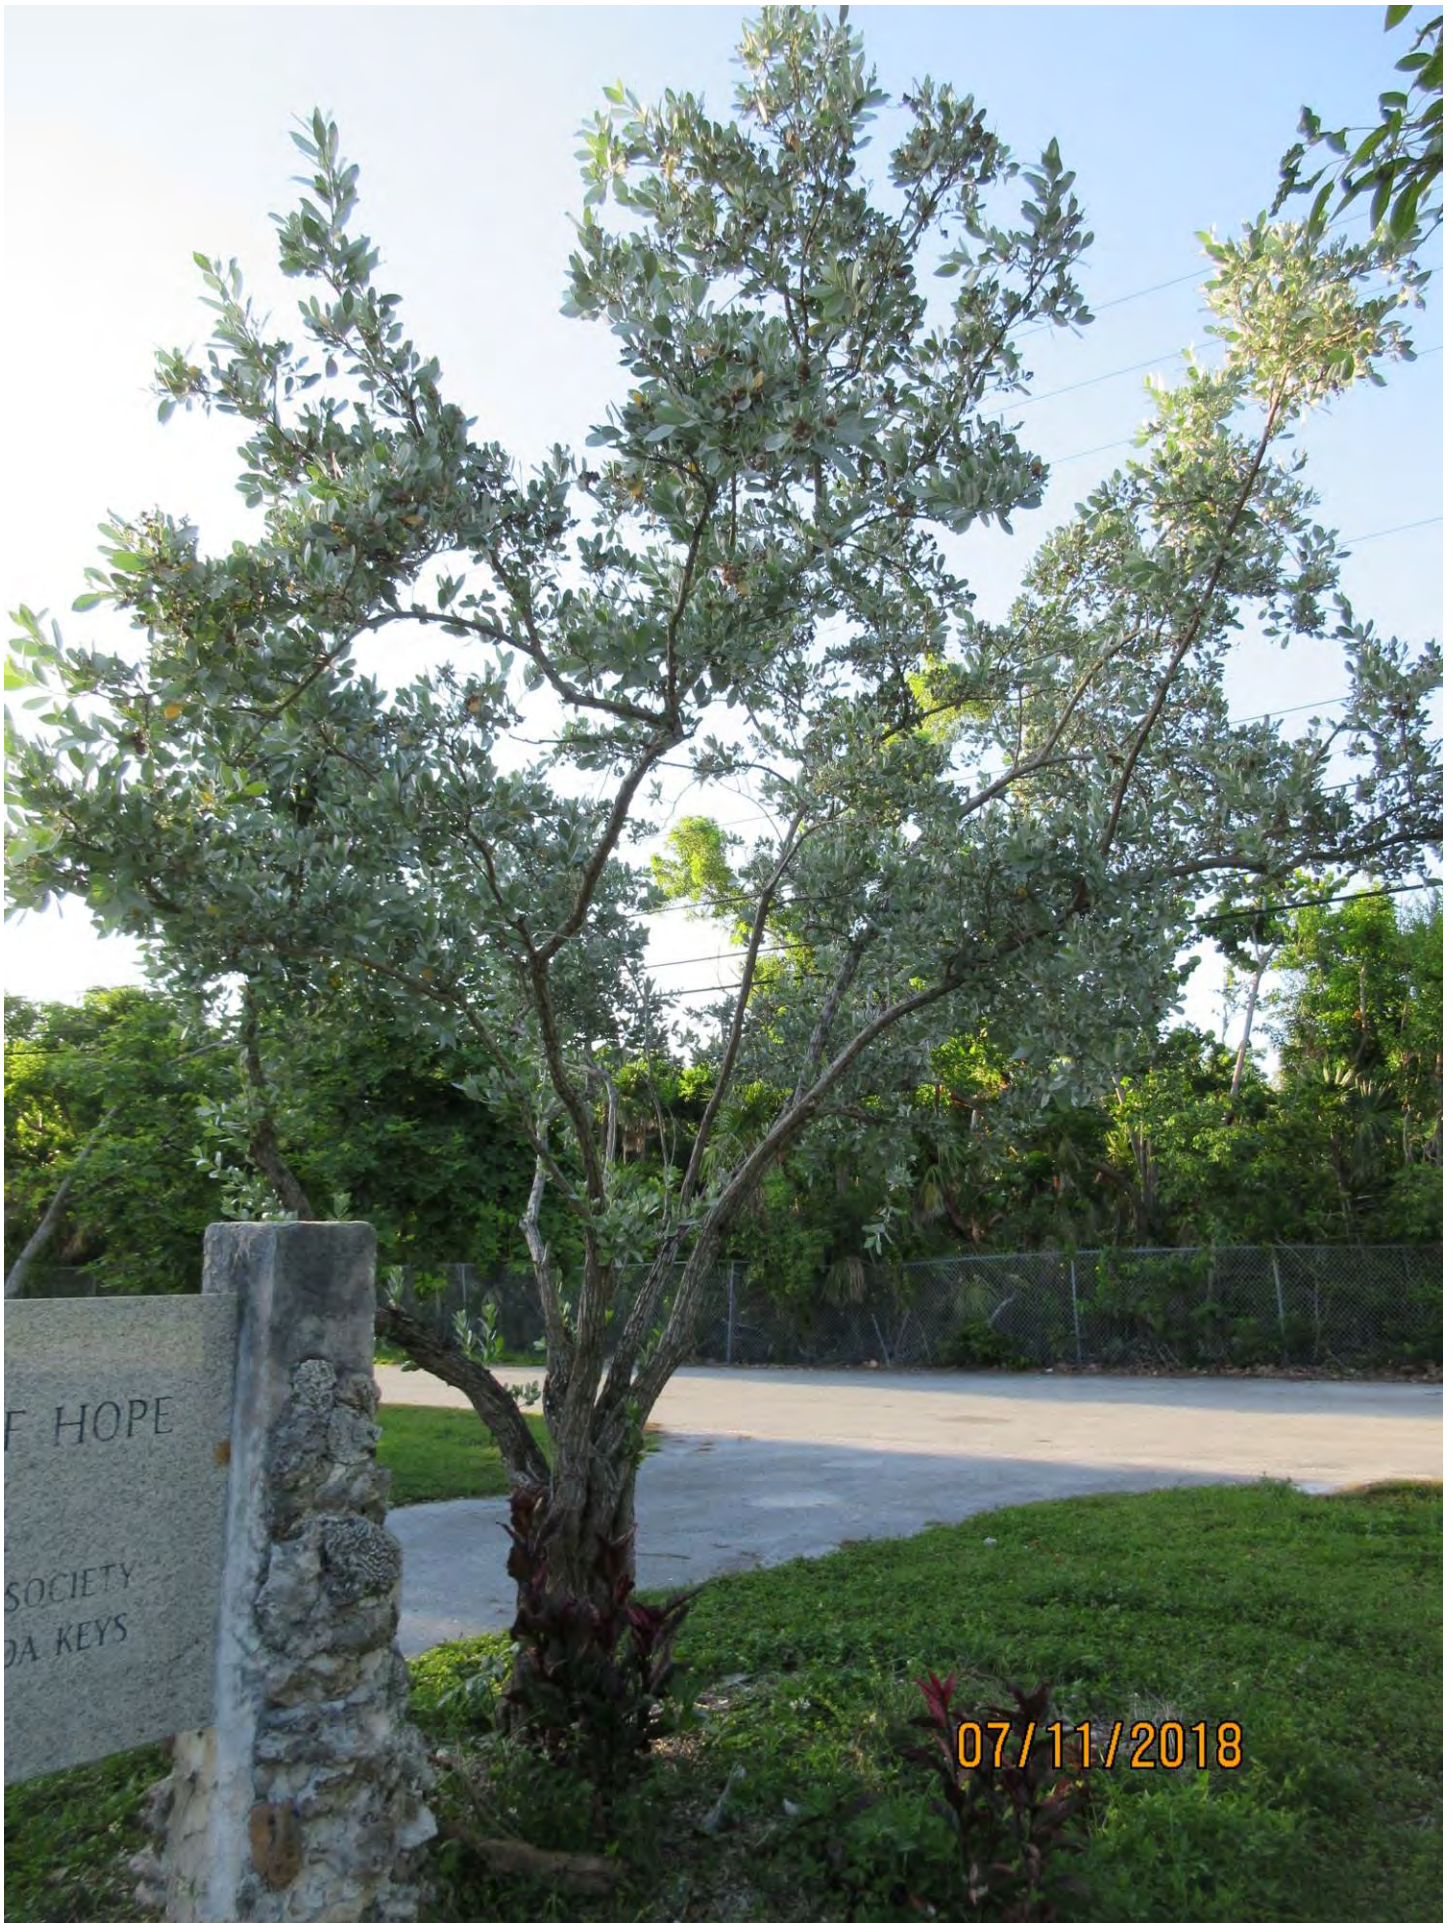
Tree #2:

Diameter: 19.1"

Location: 80% (next to sidewalk)

Species: 100% (on protected tree list)

Condition: 60% (fair, low multitrunked, codominant trunks)

Total Average Value = 80%

Value x Diameter = 15.2 replacement caliper inches

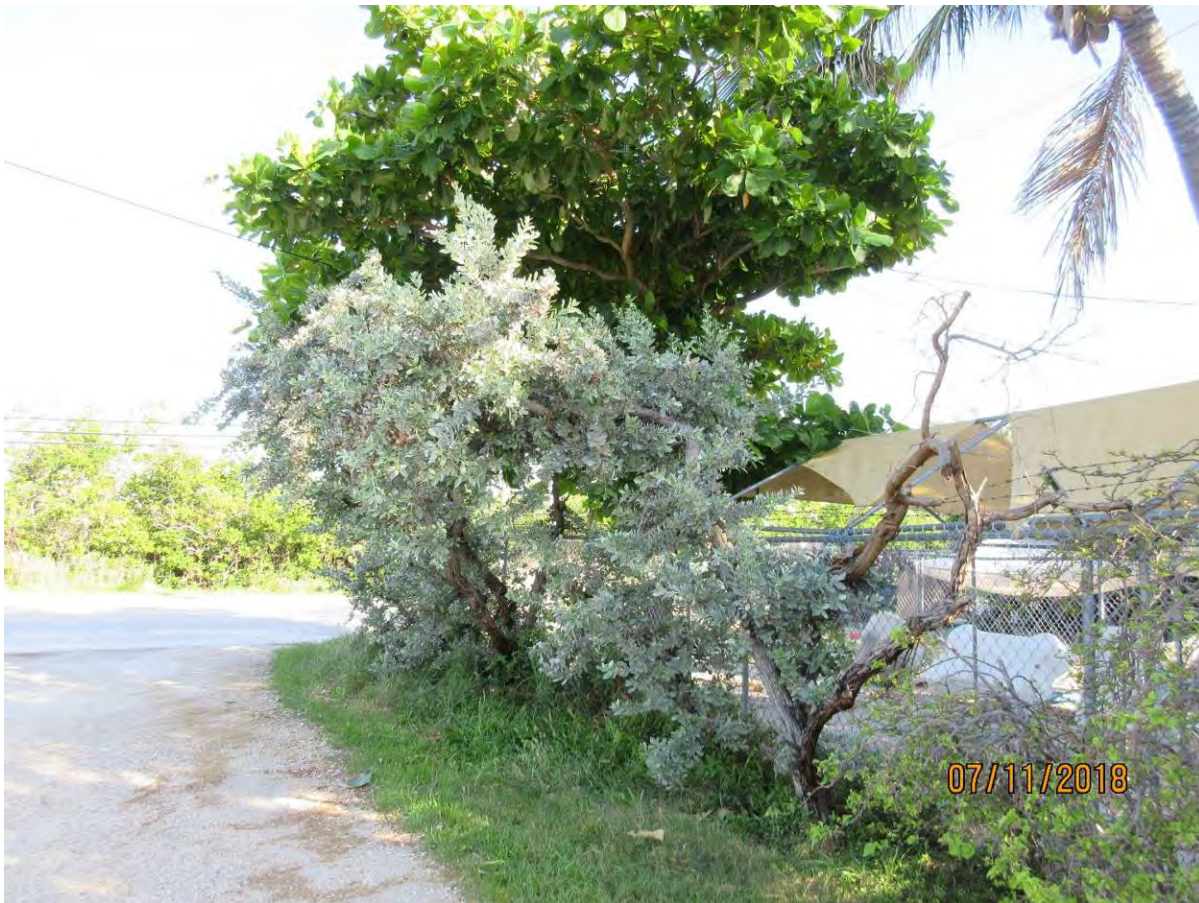
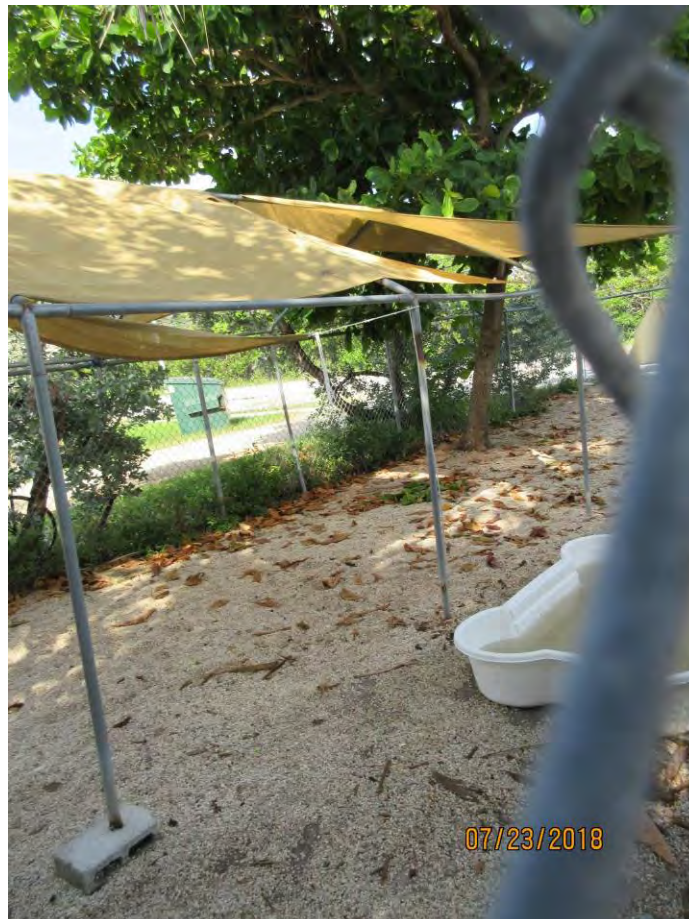
Tree #25:

Diameter: 9"

Location: 80% (growing along fenceline)

Condition: 40% (poor, overgrown shrub/hedge, part of canopy dead)

Diameter: 25"

Condition: 60% (fair, overgrown shrub/hedge)

Diameter: 4"

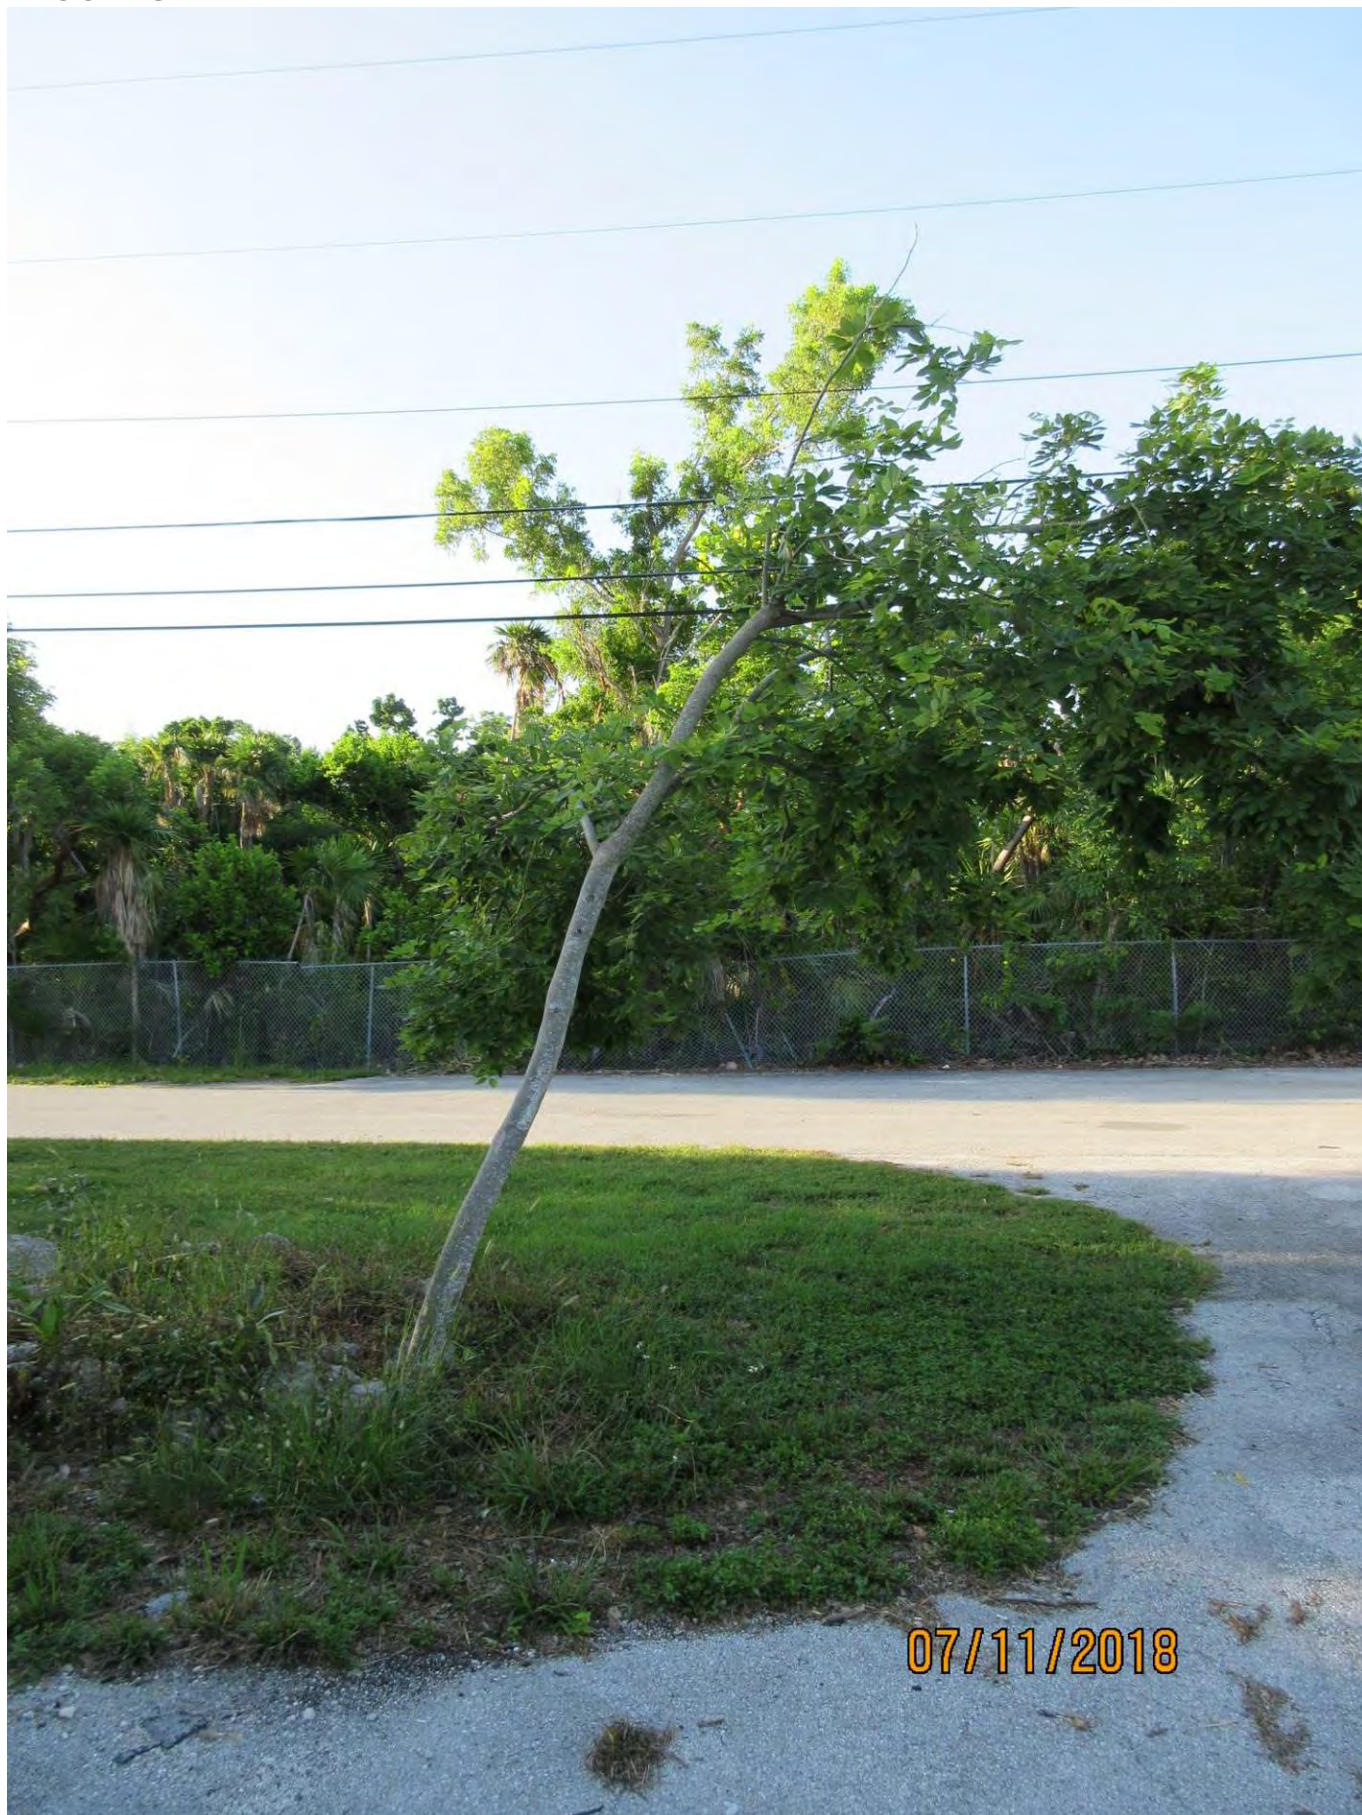
Tree #5:

Diameter: 3.5"

Condition: 40% (poor, strong lean, one codominant trunk previously removed)

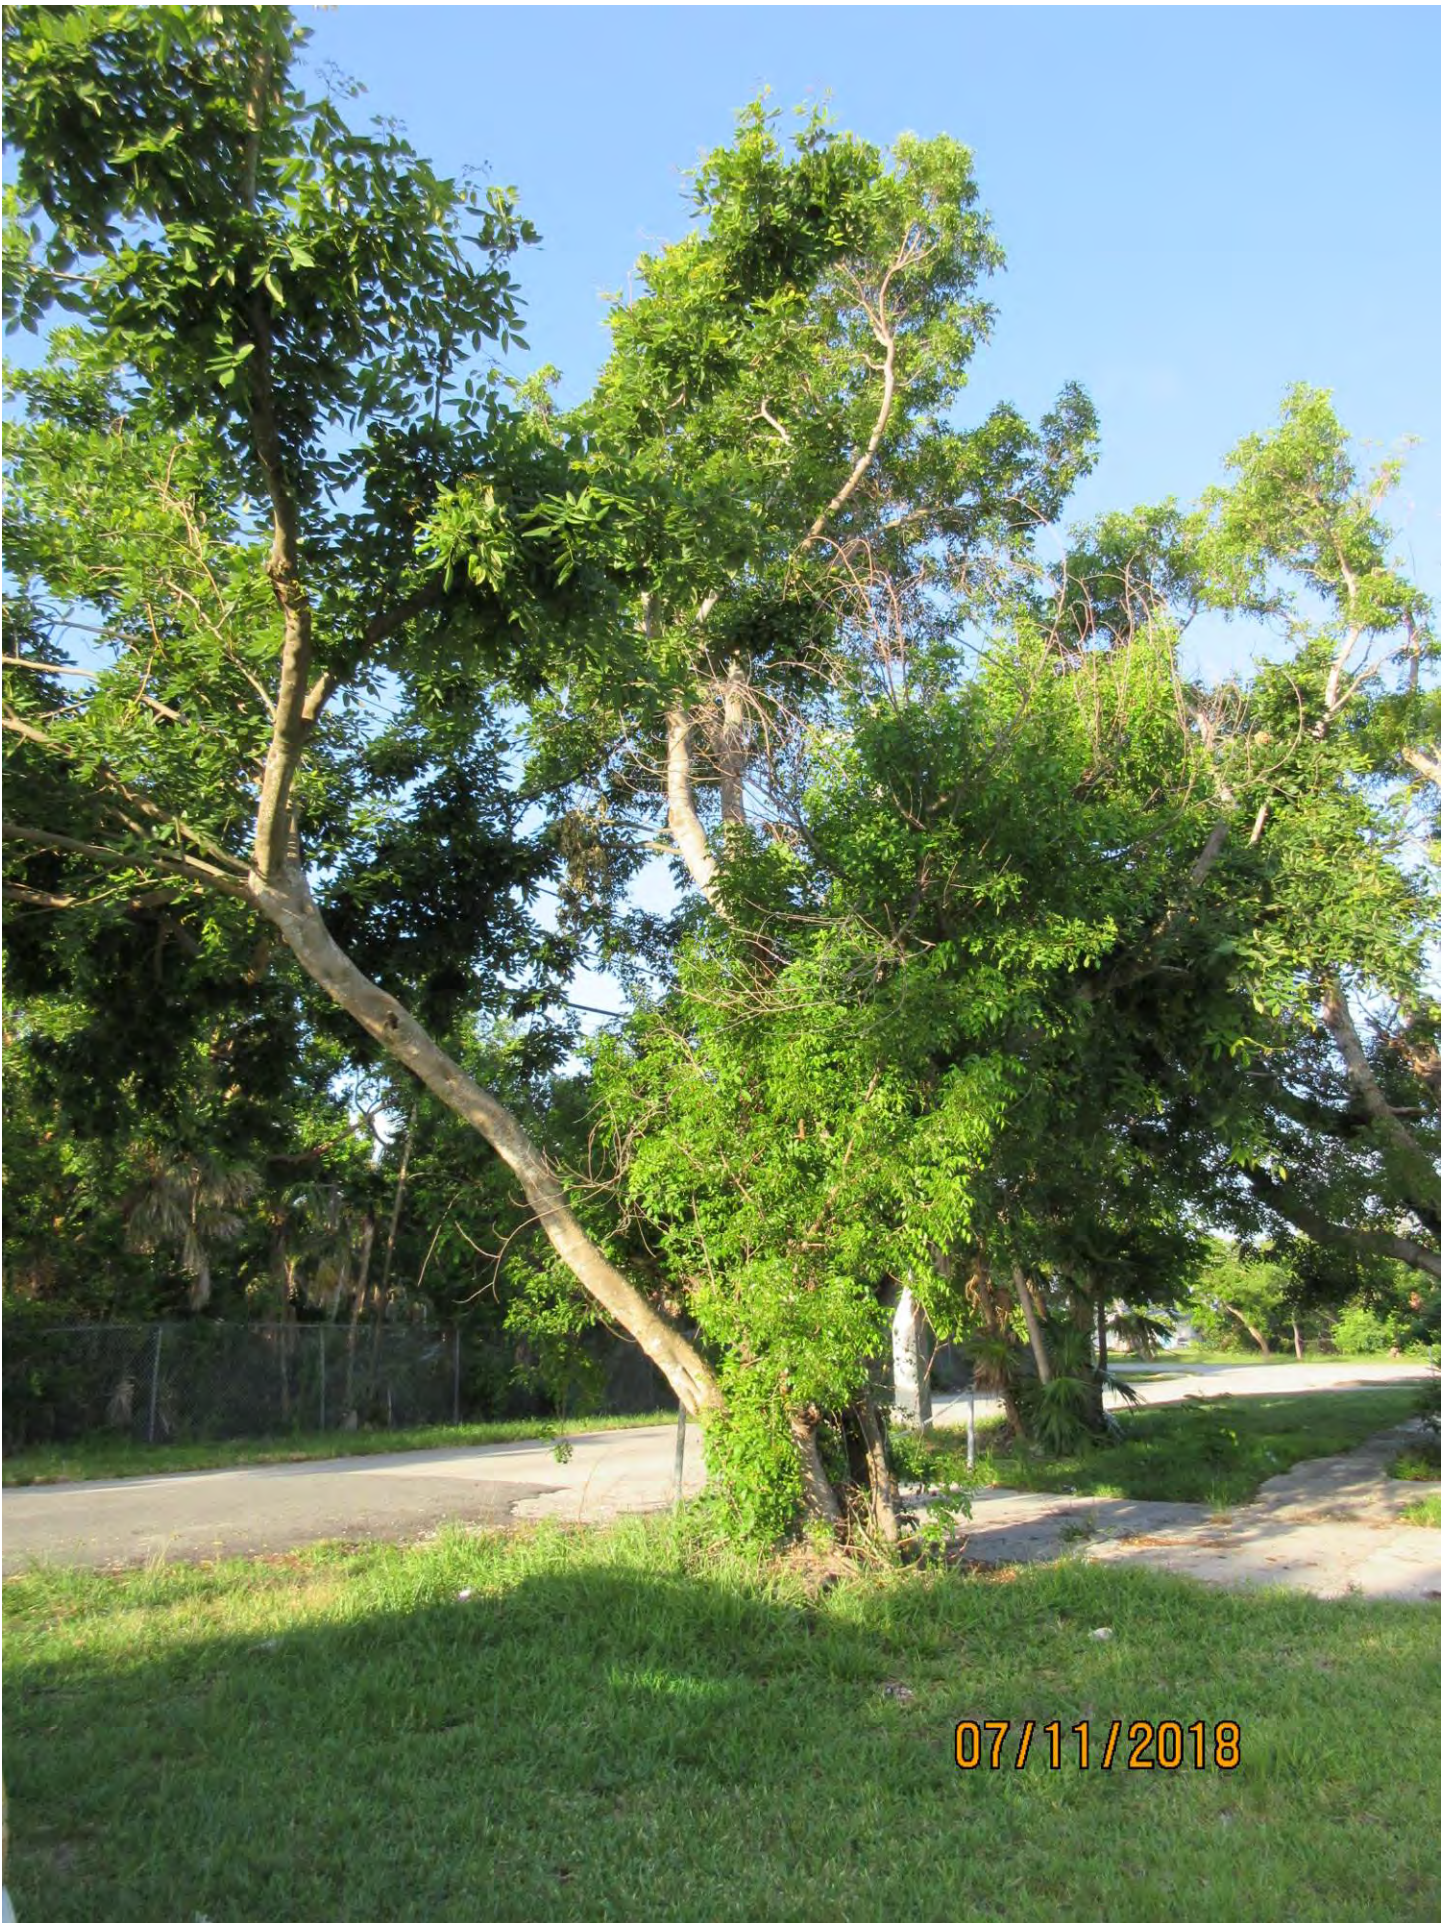
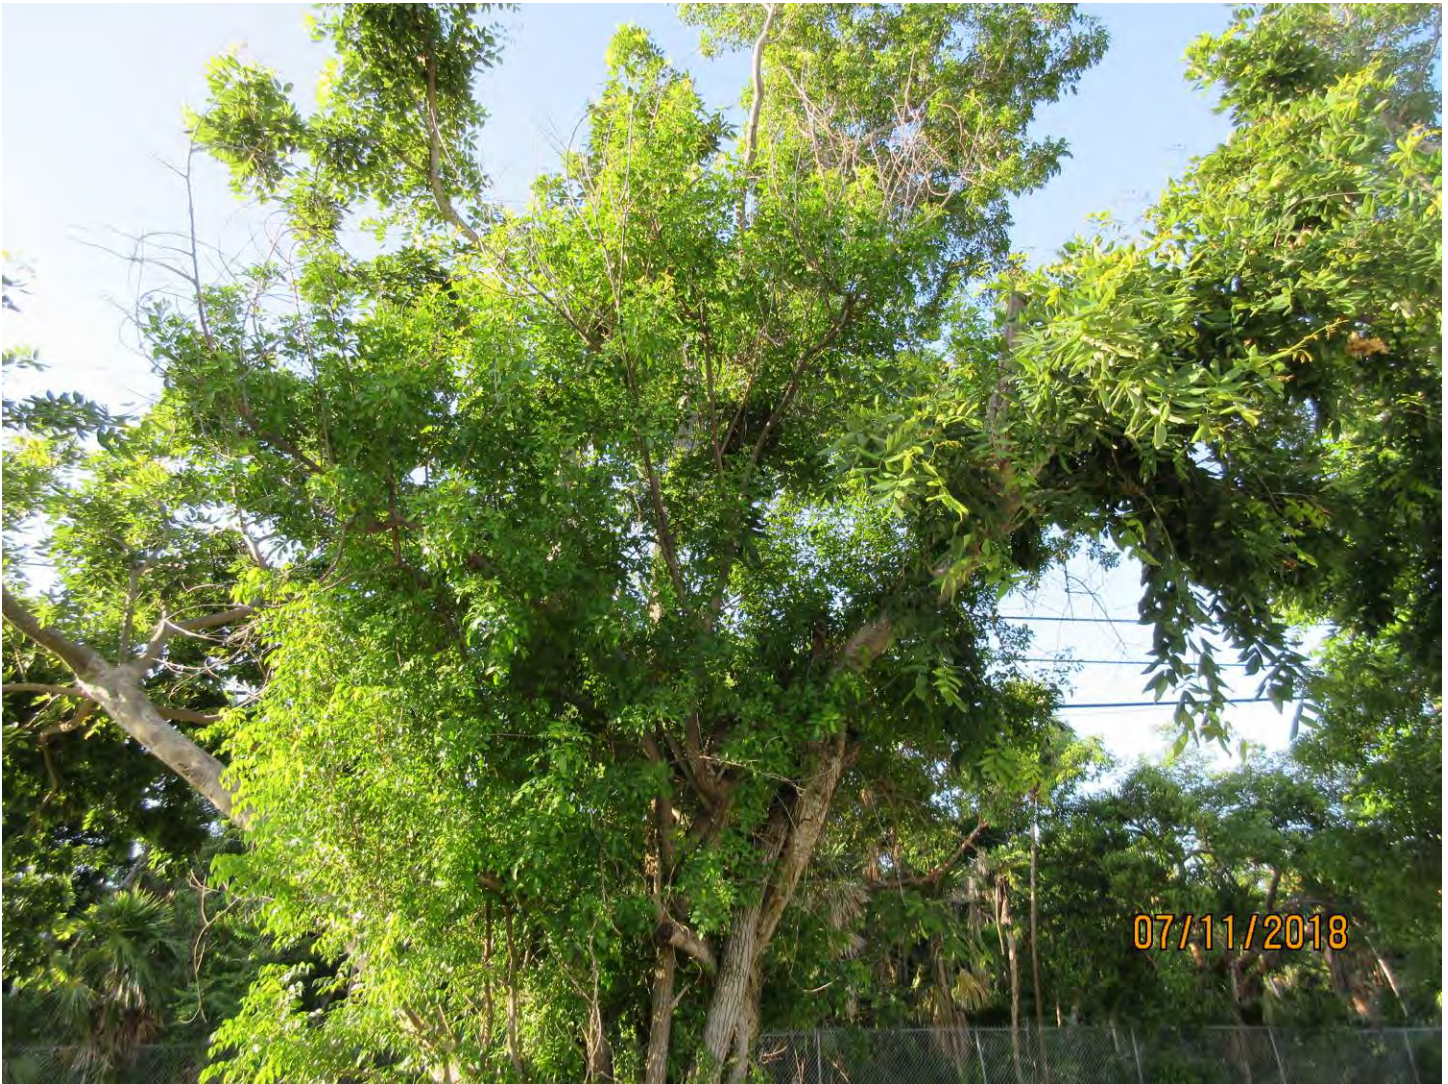
Tree #8a:

Tree lump 8 consists of a large Jamaican Dogwood tree with a Mahogany (tree #8c) and Brazilian pepper tree (invasive exotic) growing with it.

Diameter: 21.9"

Location: 60% (growing intertwined with two other trees species)

Condition: 40% (poor, decay in canopy branches and main trunks, poor structure)

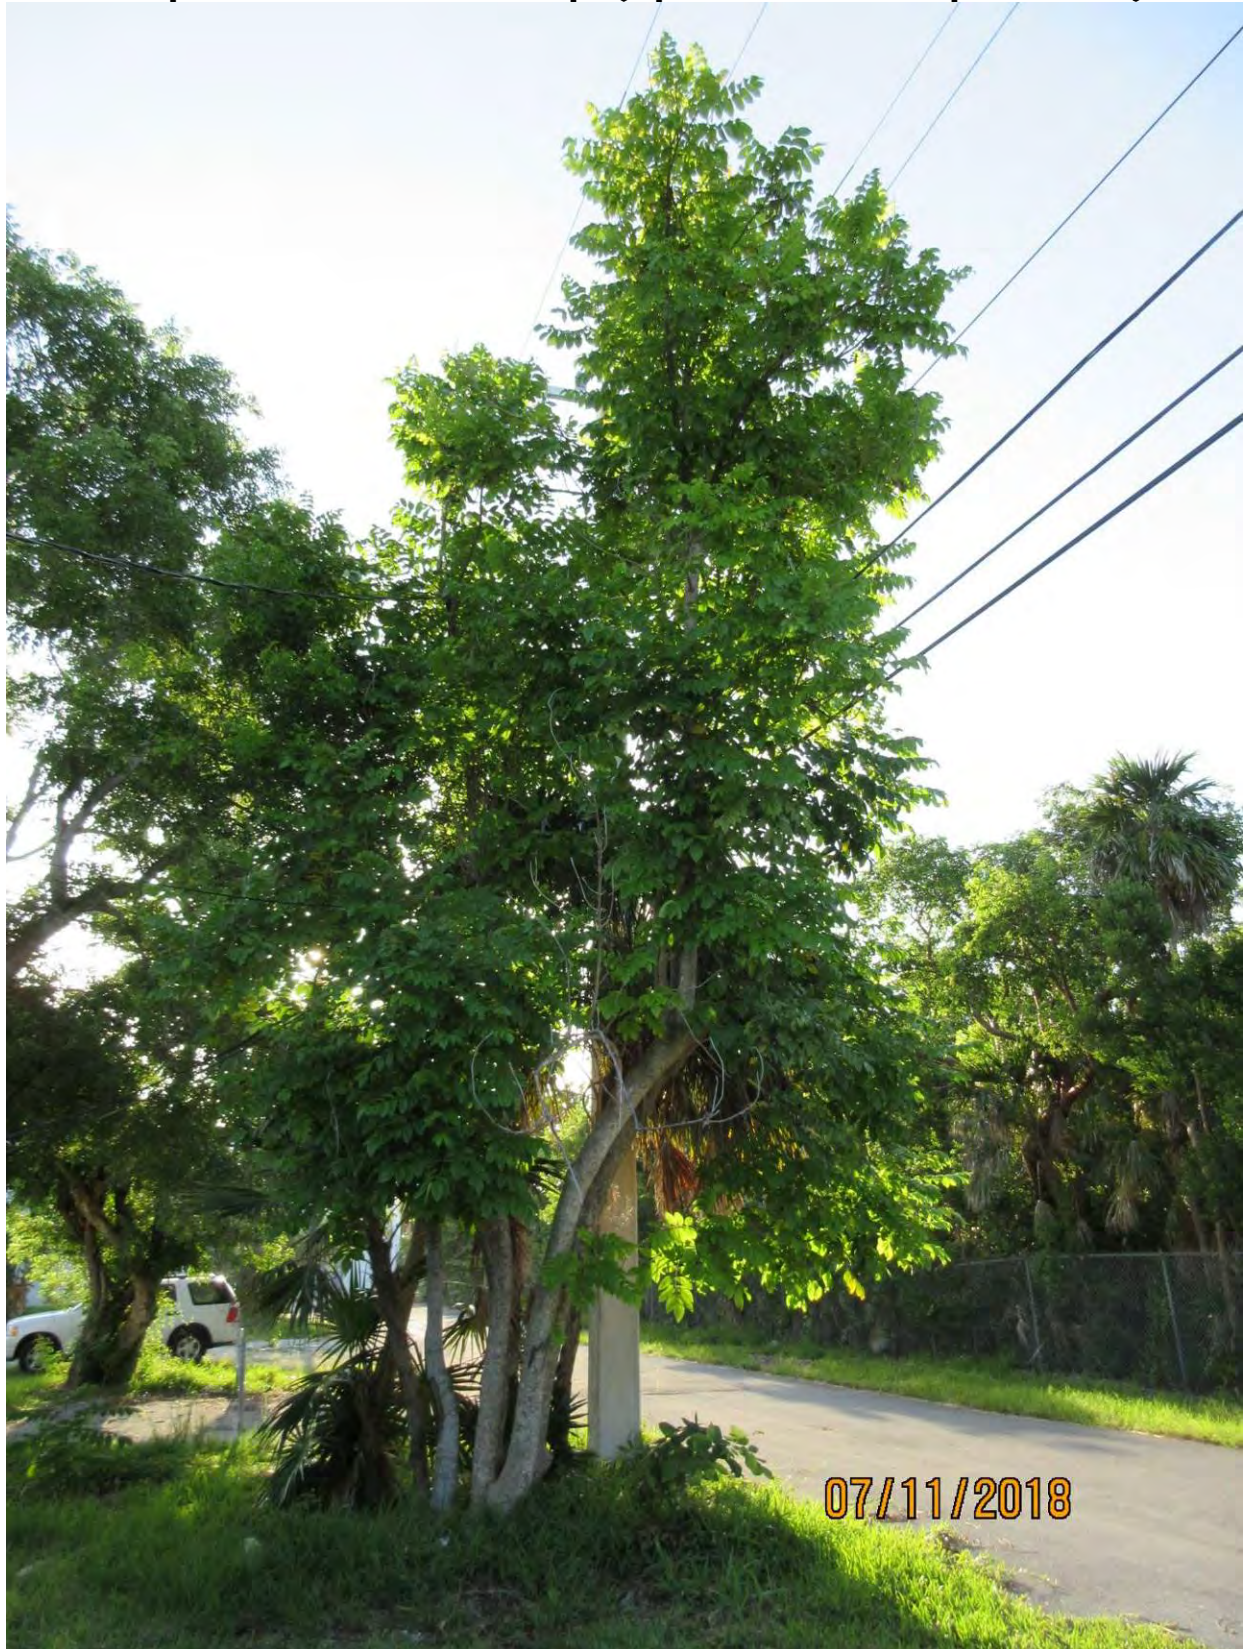
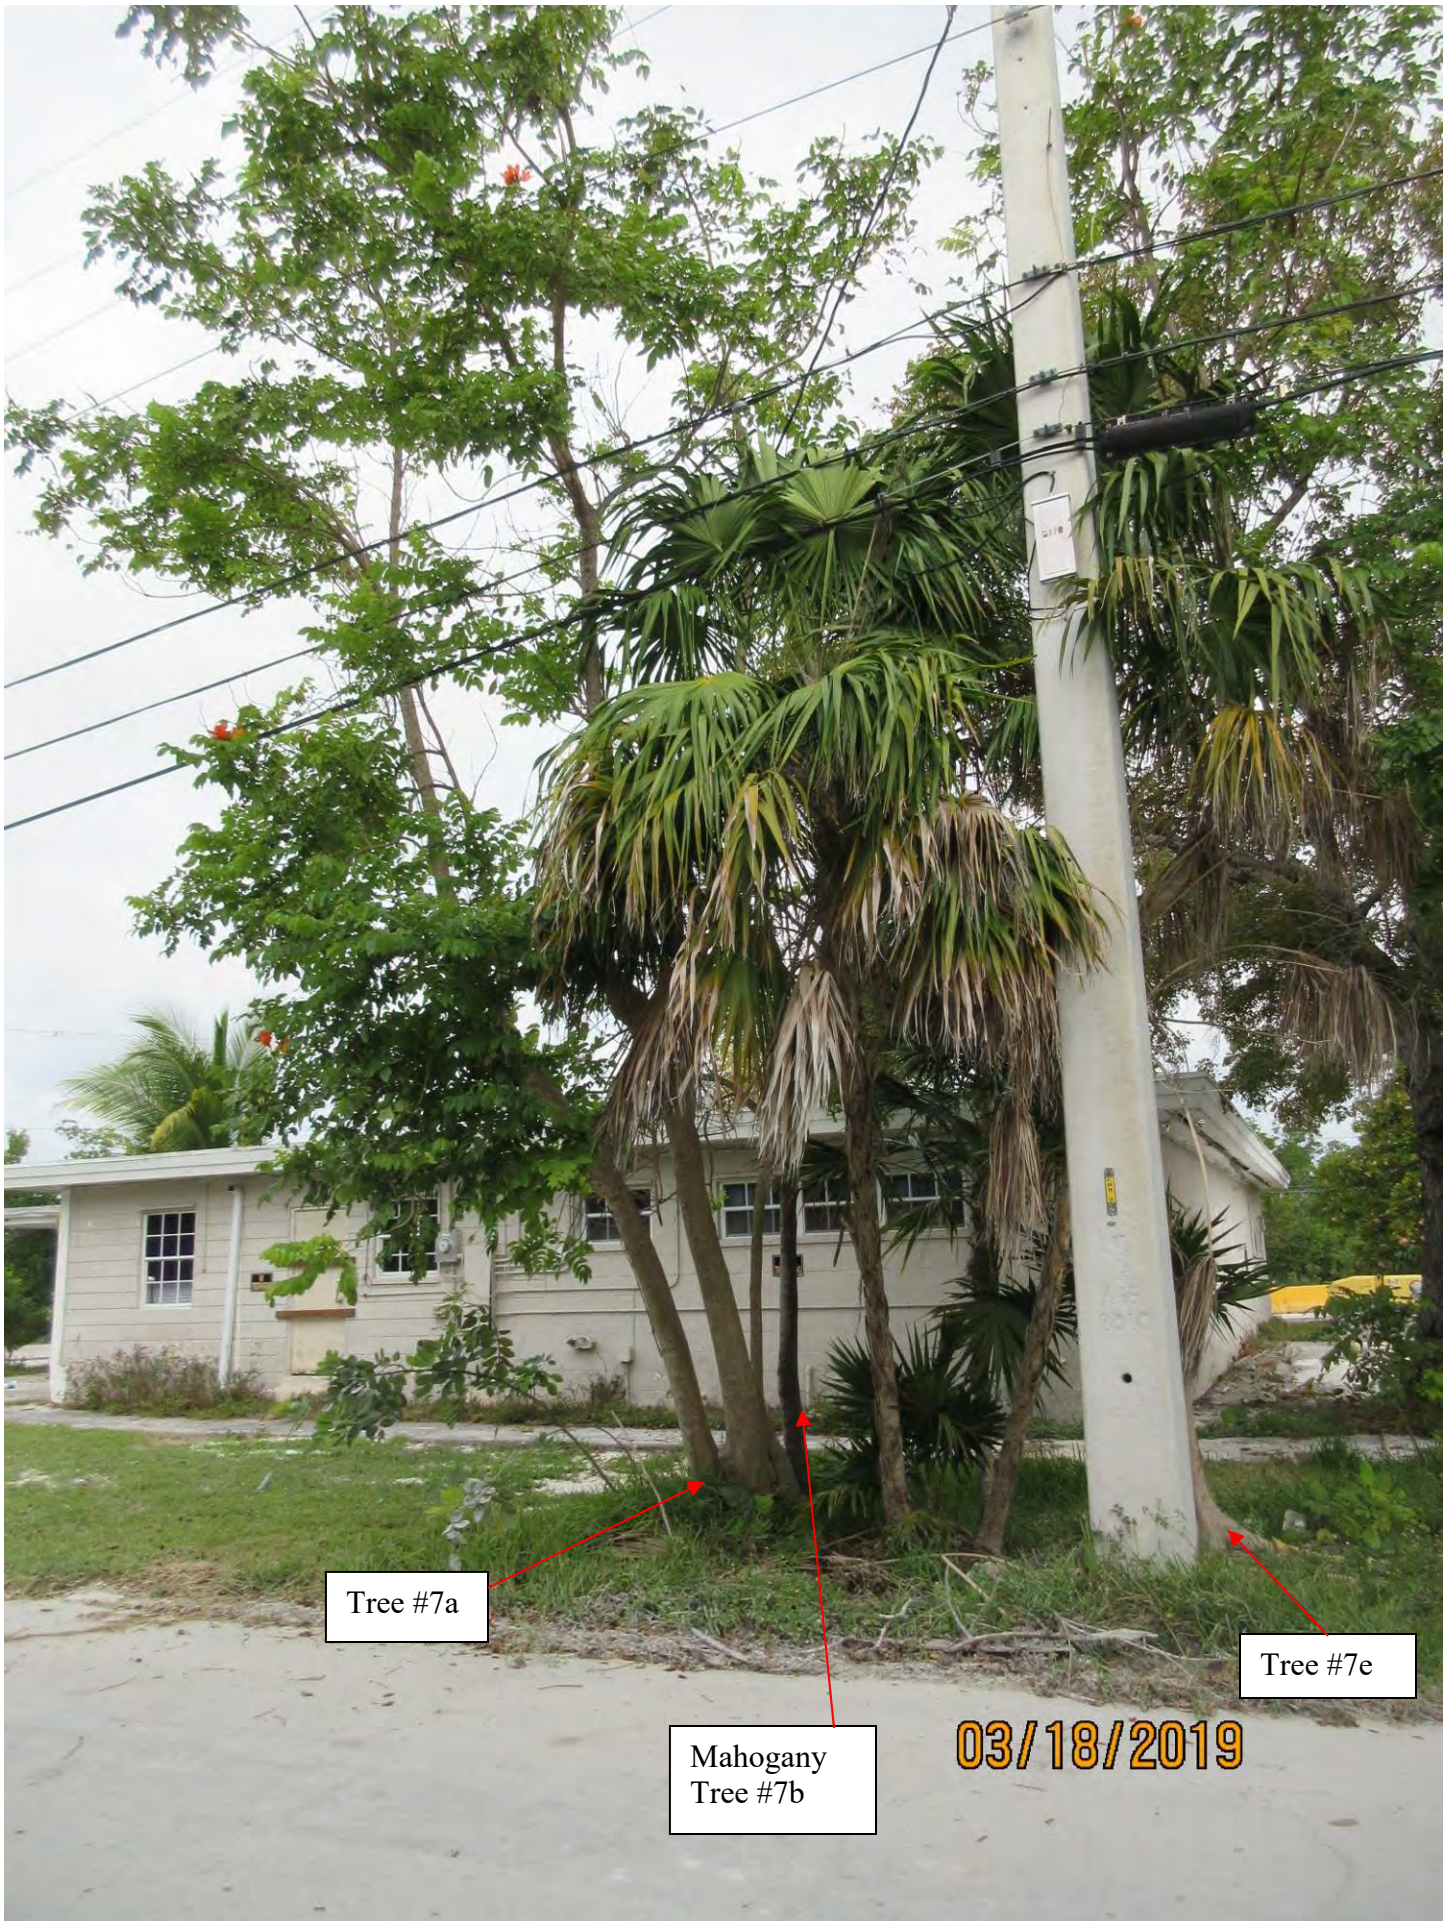
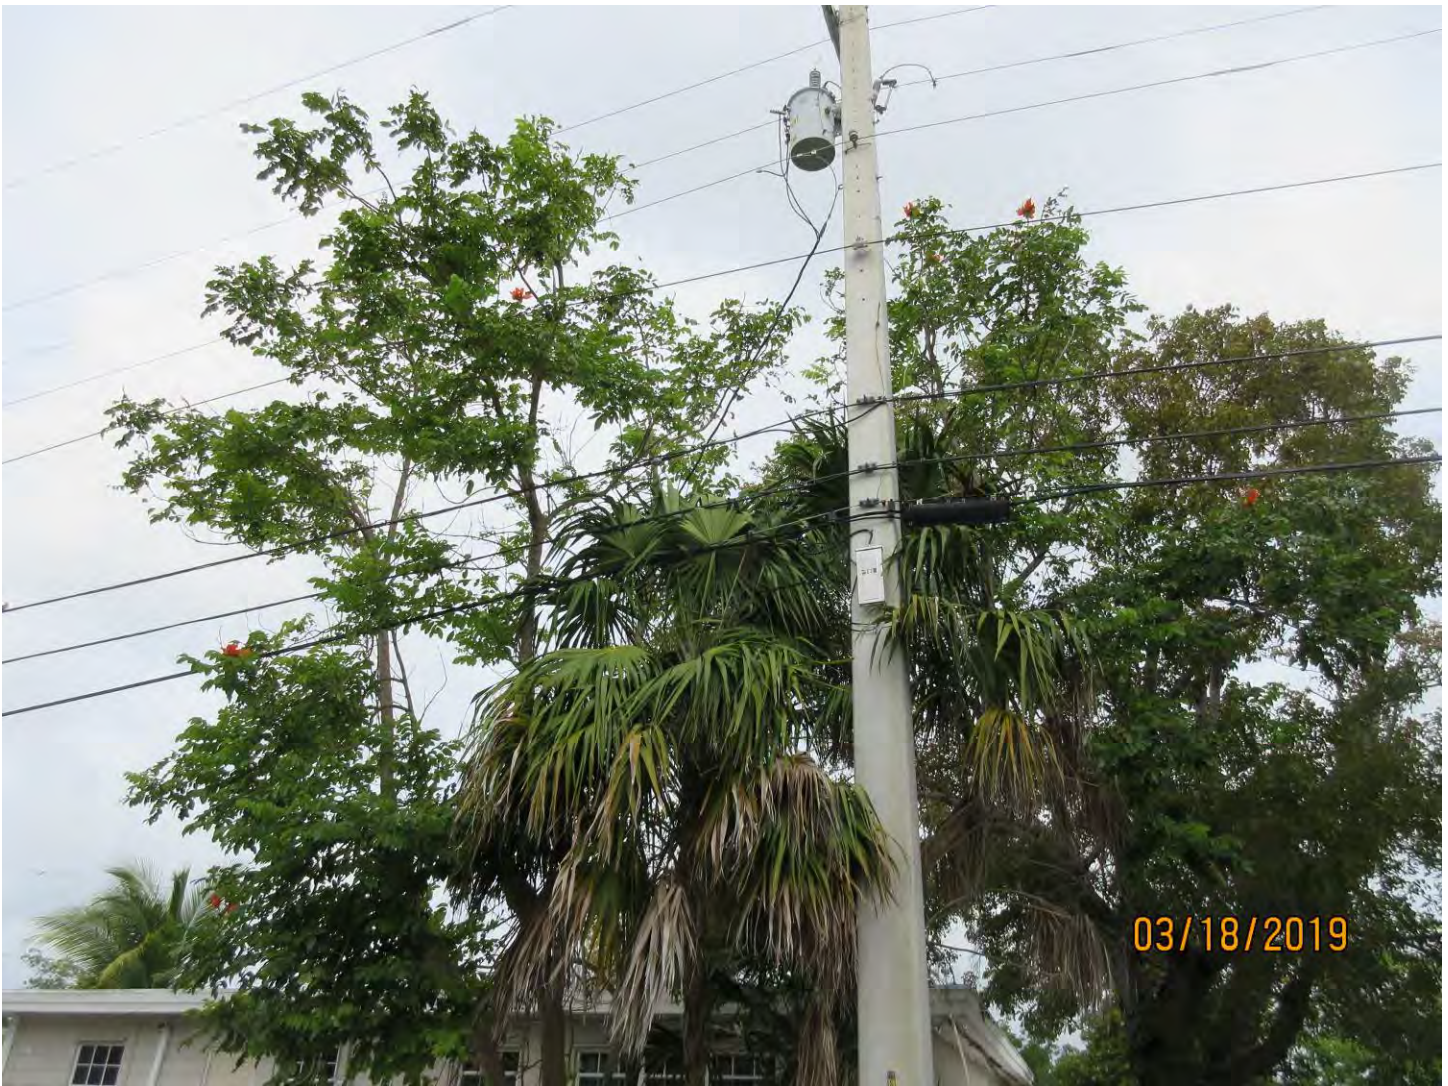
Tree Clump #7 consists of a large multi trunked African Tulip tree, a young mahogany tree and a clump of thatch palms. The Thatch Palms will be transplanted.

Diameter: 22.6"

Location: 50% (in utility lines, roots intertwined with mahogany tree and thatch palms)

Condition: 50% (several trunks, poor structure)

Diameter: 6.3"

Location: 40% (in utility lines and growing at base of pole, roots intertwined with mahogany tree and thatch palms)

Condition: 60% (fair)

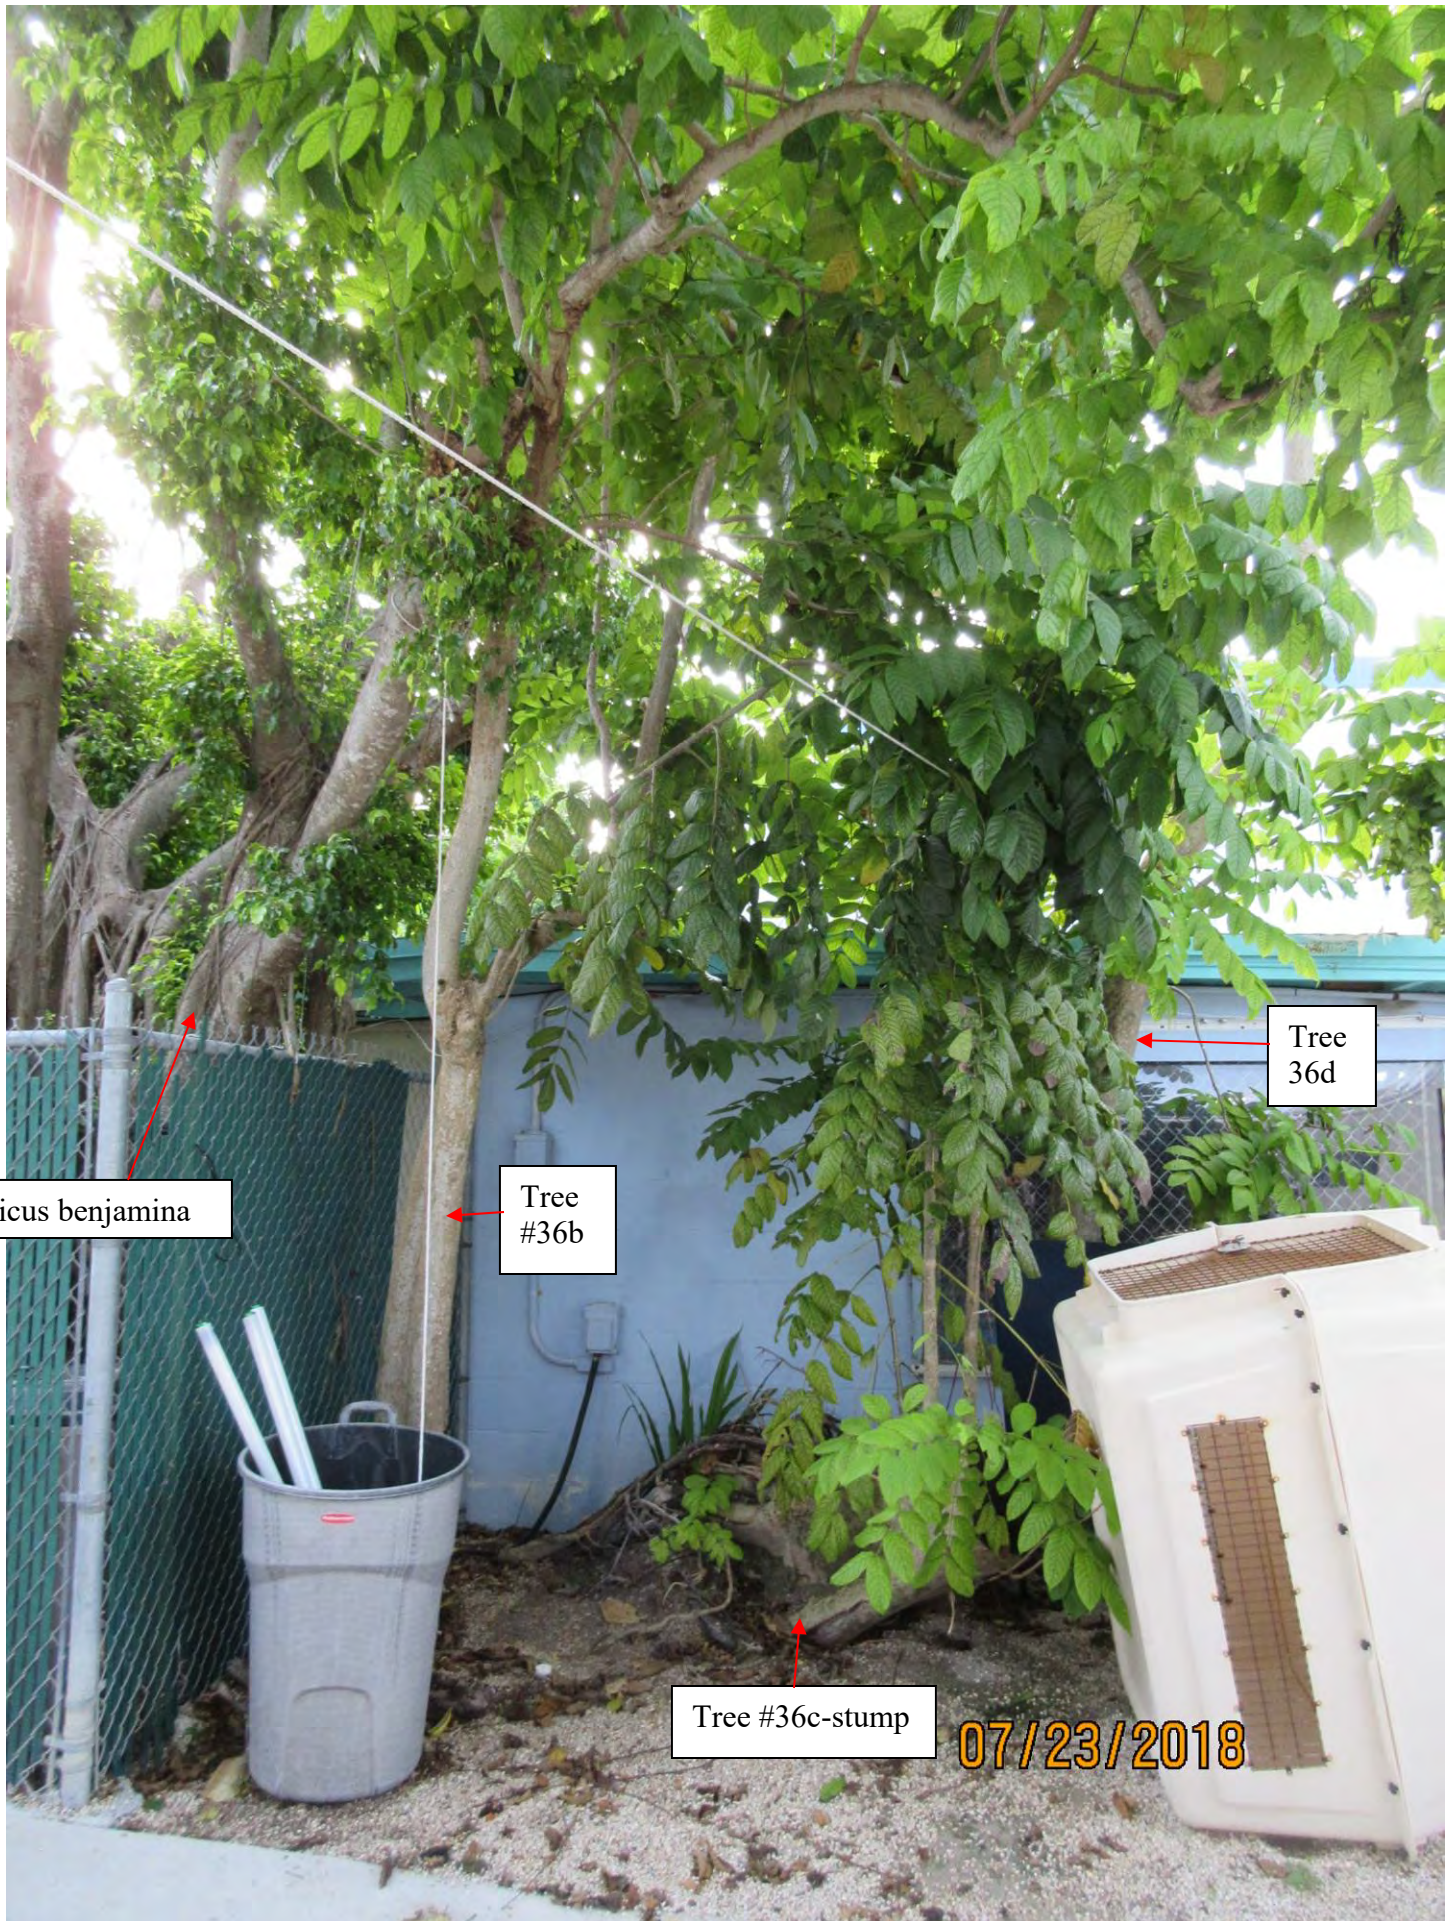
Tree clump #36 consists of (2) African Tulip trees, (1) African Tulip stump that has resprouted (not regulated), and (1) Ficus benjaminia (not regulated).
