STAFF REPORT

RE: **5220, 5224, 5228, & 5230 College Road**
(permit application # T2019-0135)

FROM: Karen DeMaria, City of Key West Urban Forestry Manager

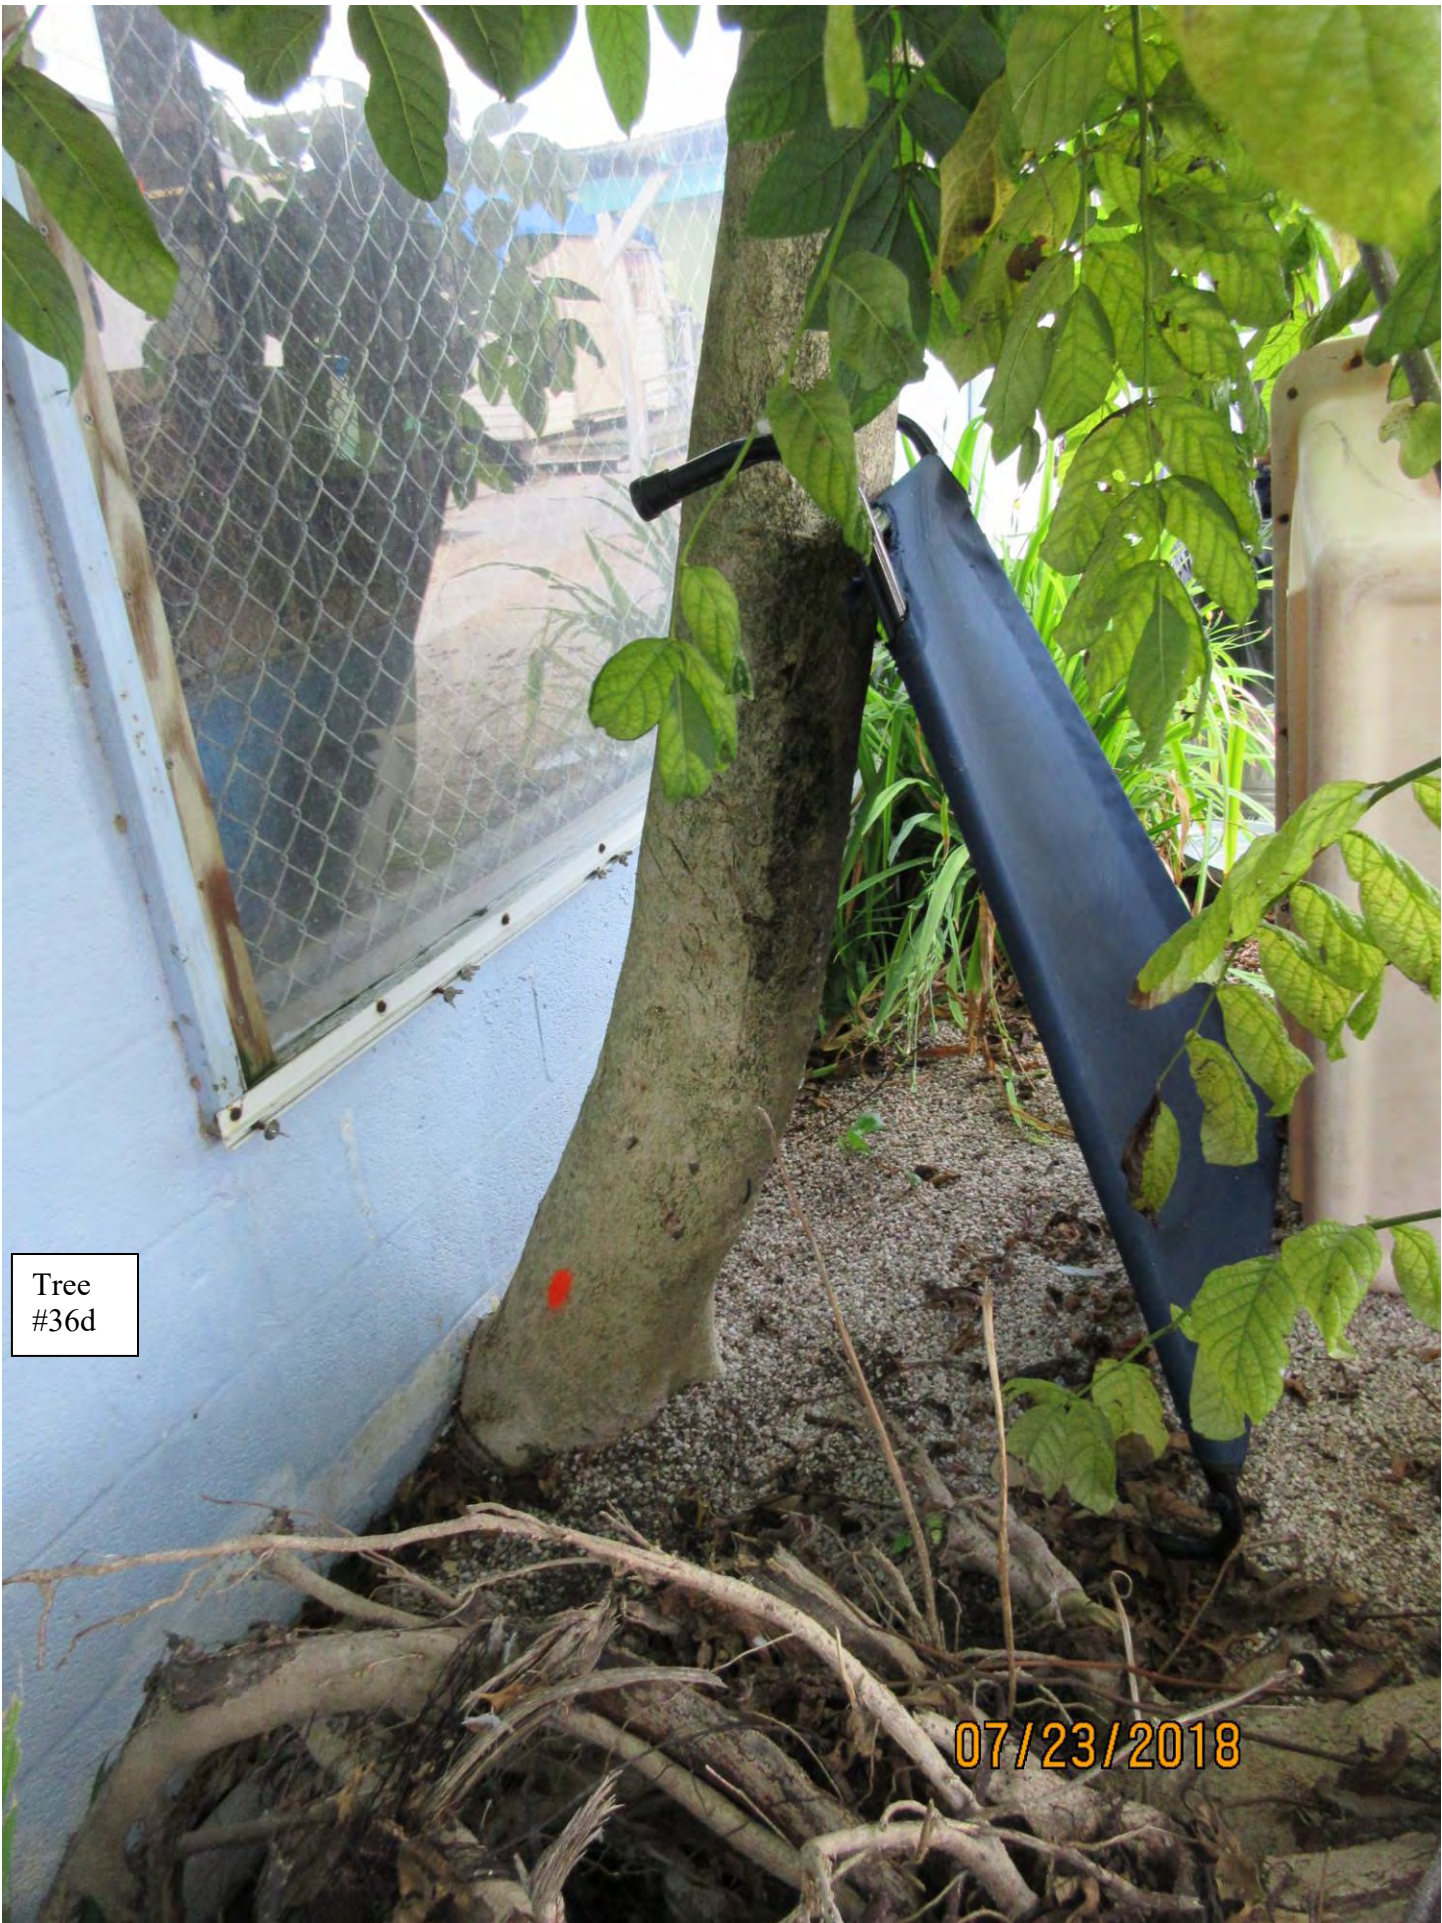
Tree
#36d

Diameter: 7.3"

Location: 40% (growing at base of structure)

Condition: 40% (poor structure)

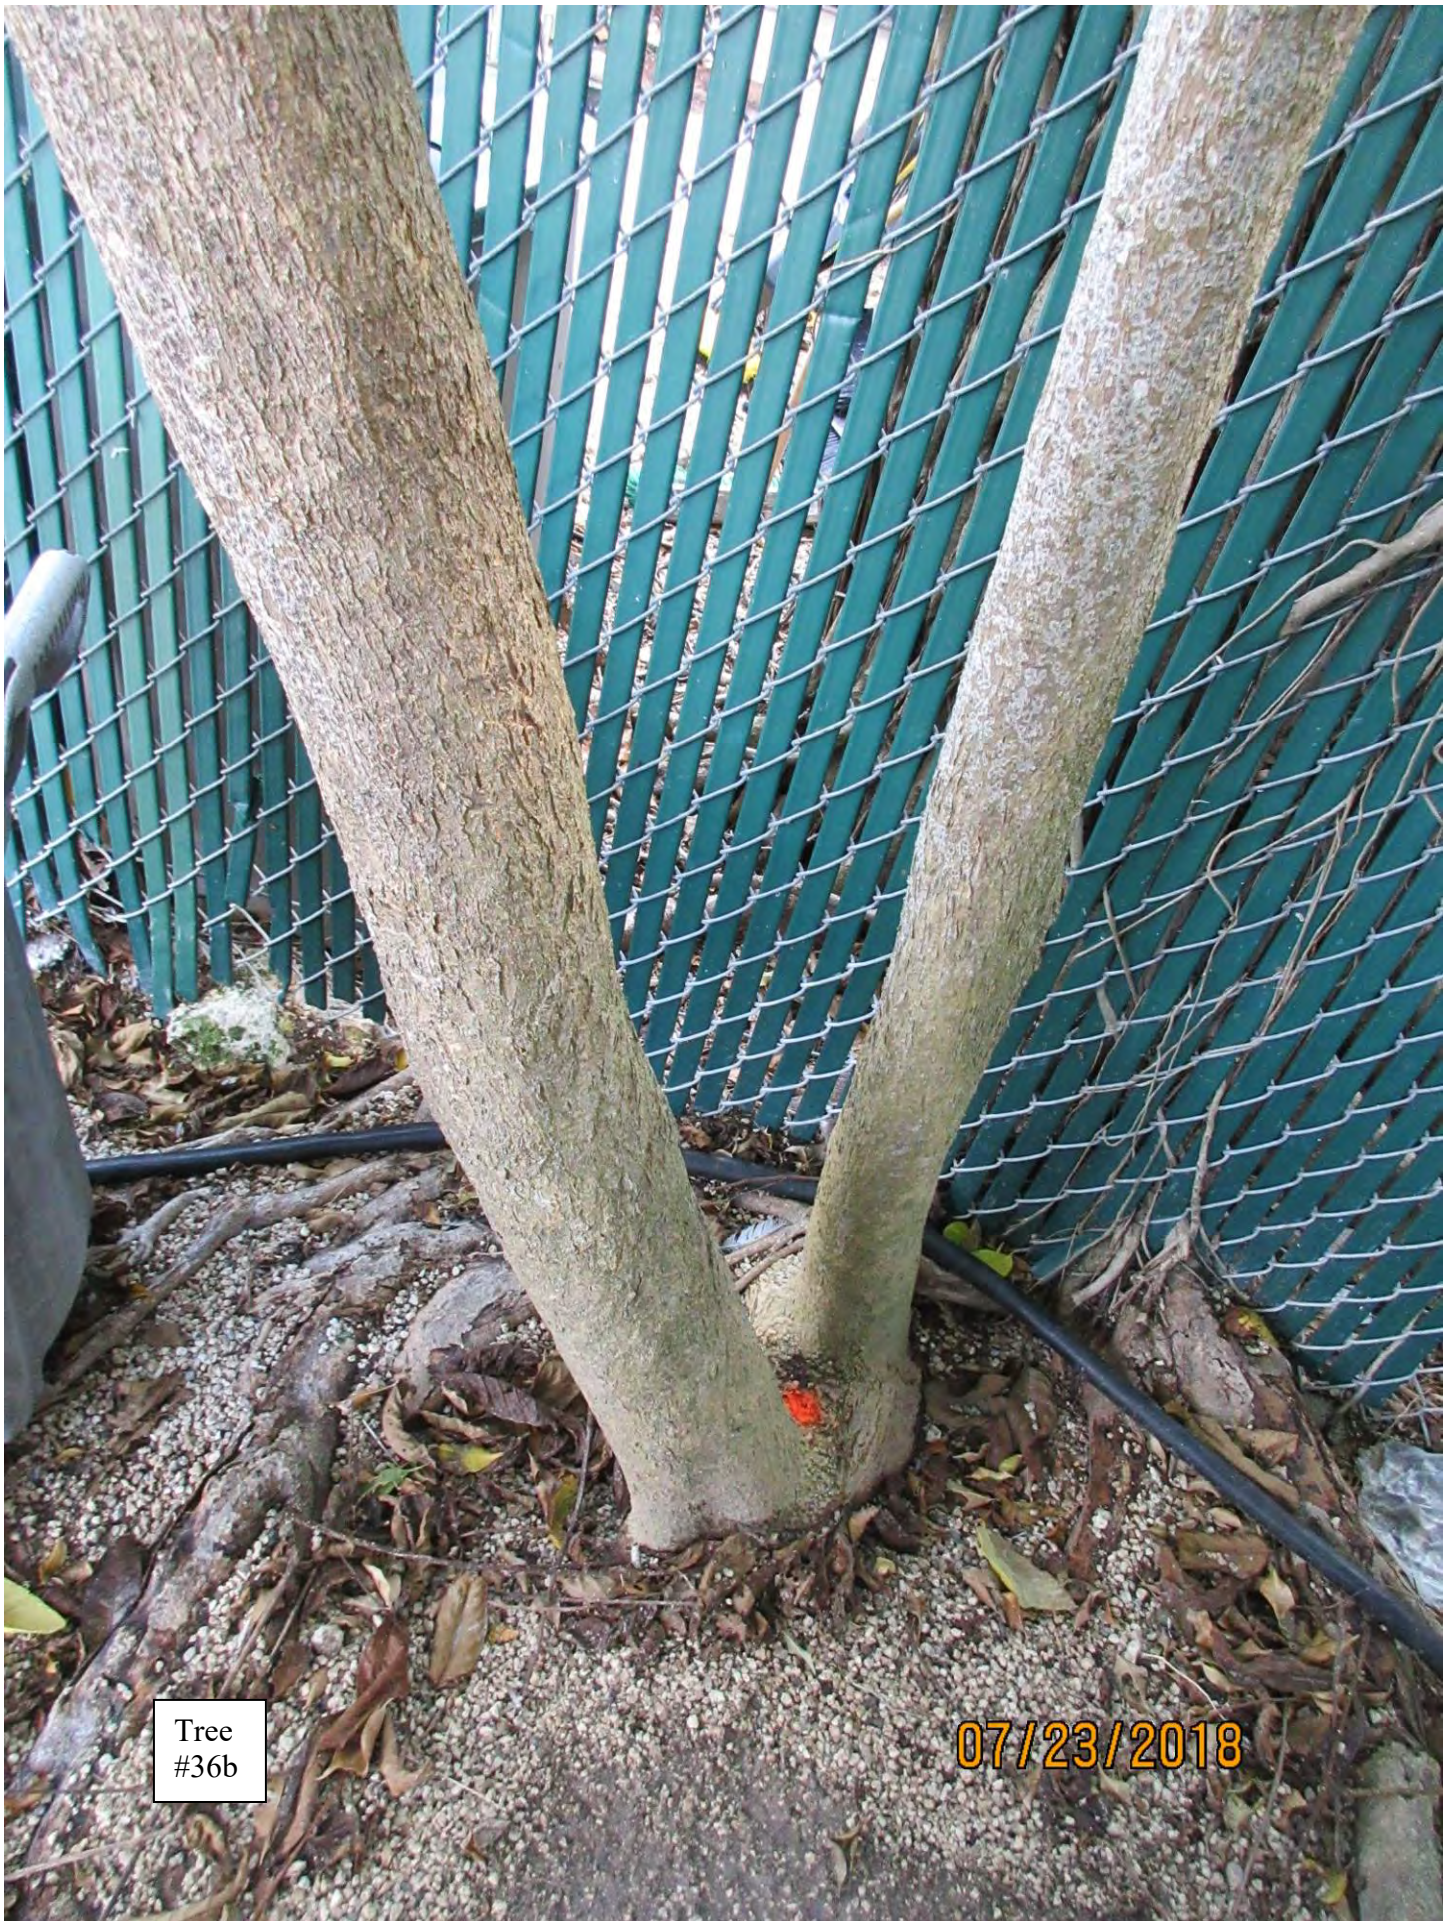
Tree
#36b

Diameter: 7.9" (double trunked)

Location: 60% (canopy impacted by adjacent tree)

Condition: 40% (codominant trunks, poor structure)

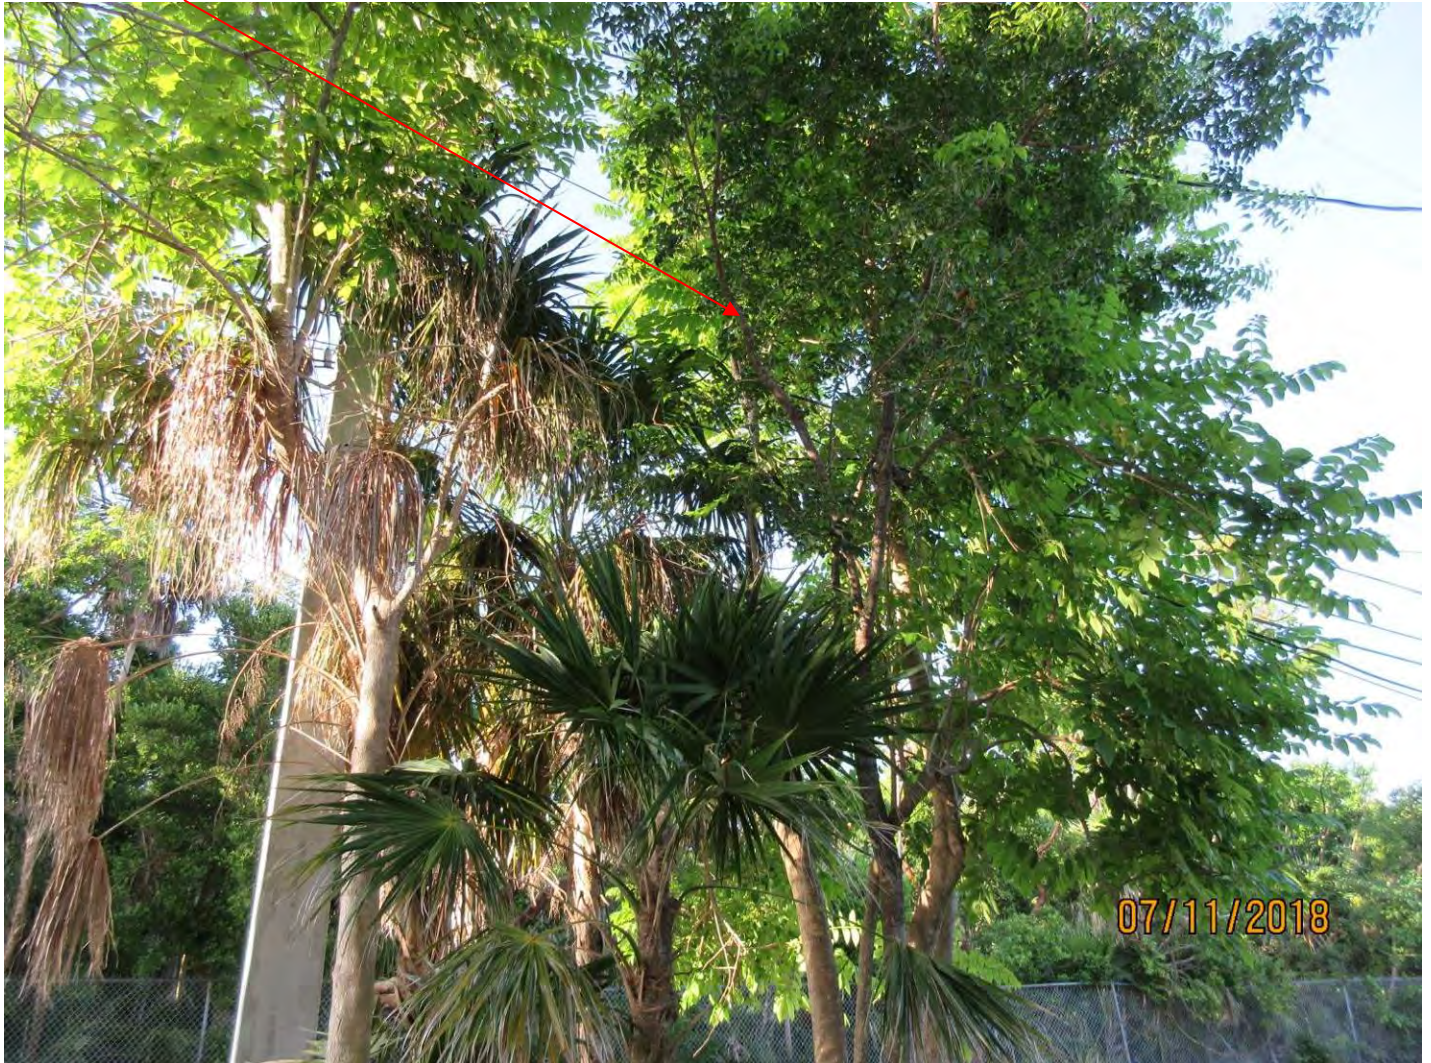
Tree #7b:

Diameter: 5"

Location: 50% (canopy in utility lines, roots intertwined with other trees.)

Condition: 50% (fair)

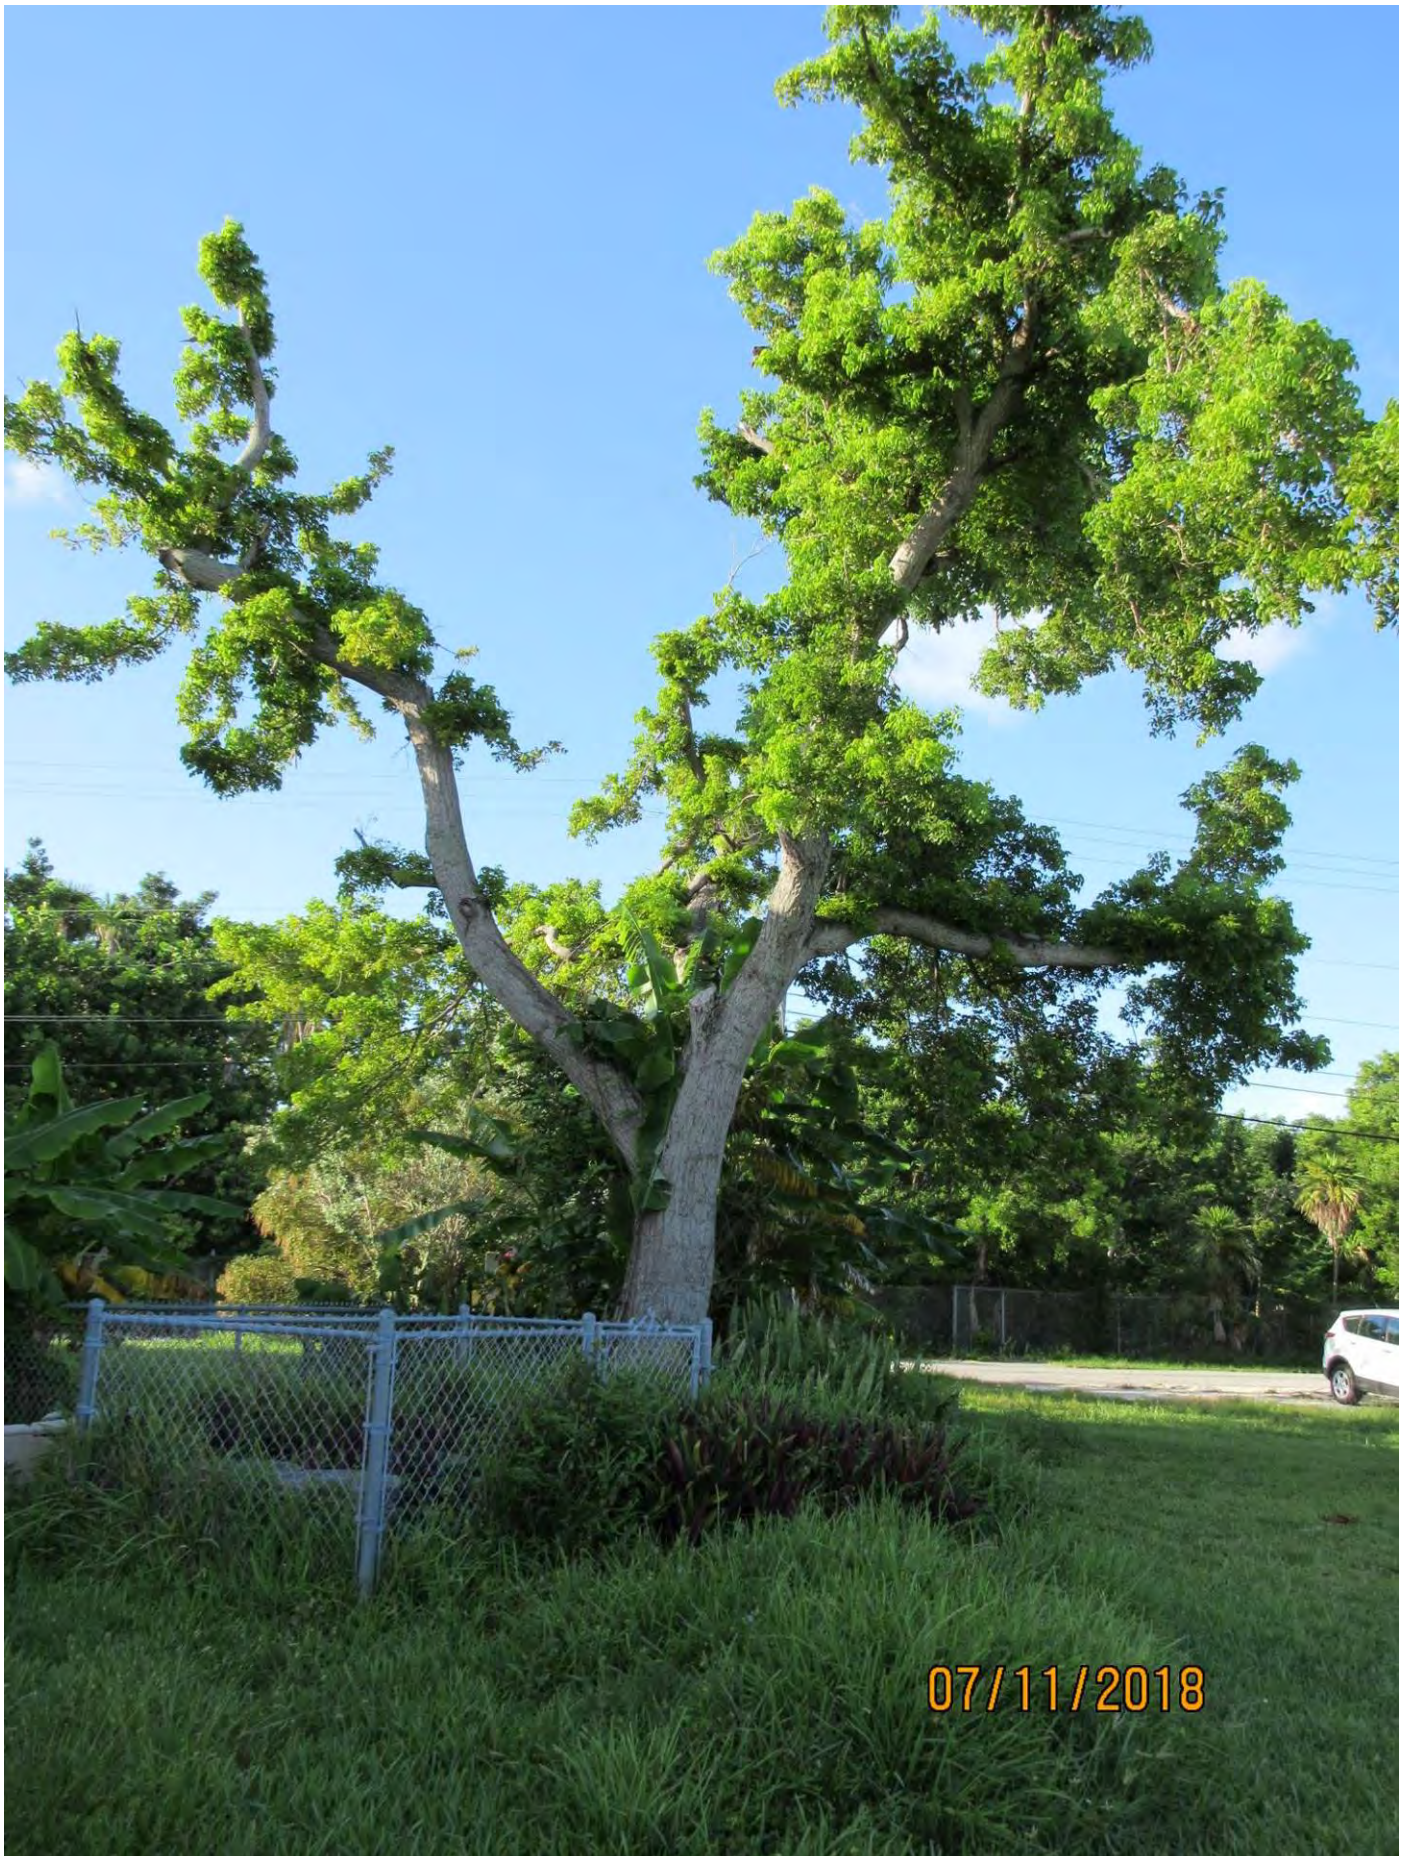
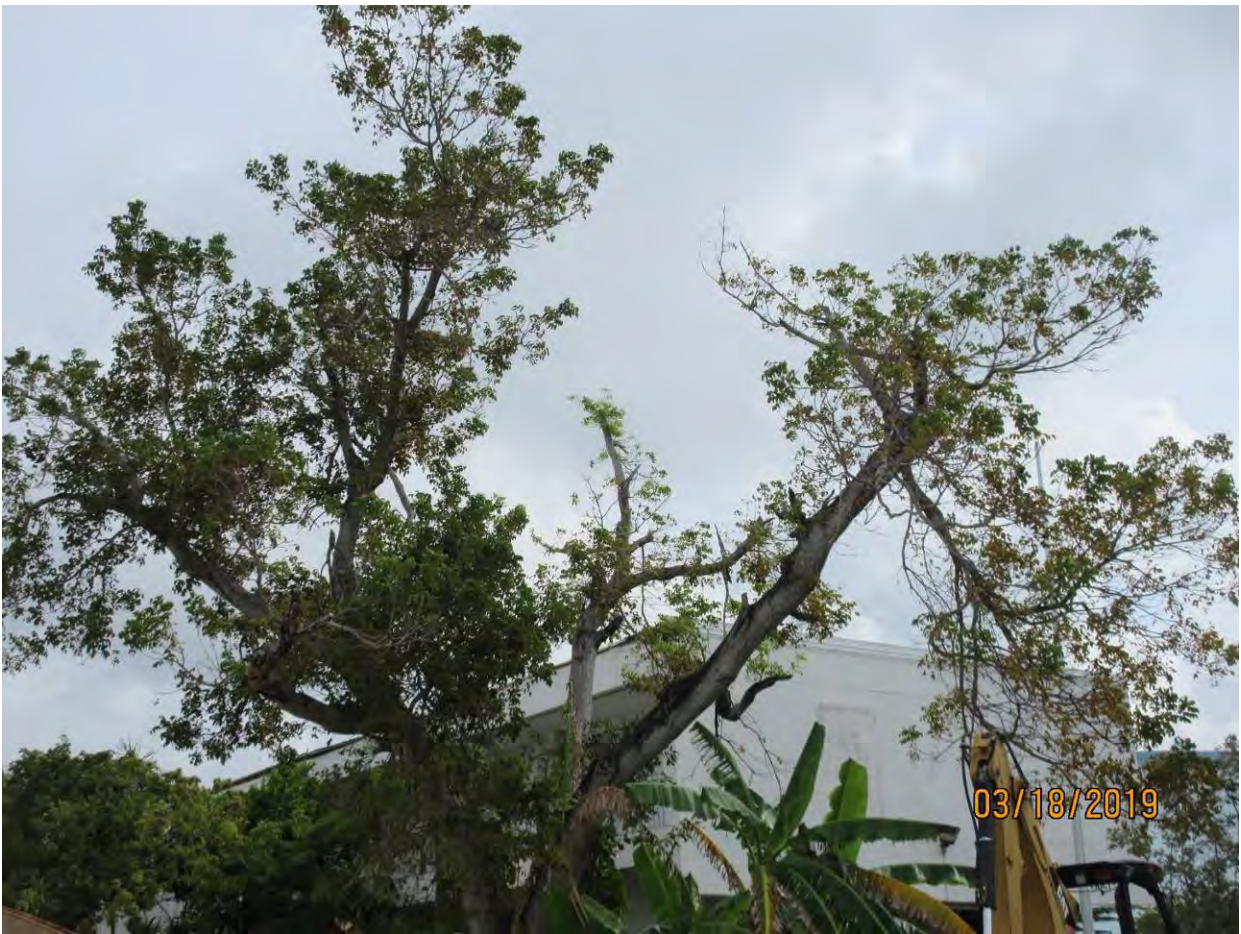
Tree #15a:

Diameter: 31.8"

Condition: 50% (fair, a lot of storm damage in canopy, decay, poor structure)
