STAFF REPORT

RE: **1316 Royal Street-1319 William Street Major Development Plan
(project application #TP2020-00008)**

FROM: Karen DeMaria, City of Key West Urban Forestry Manager

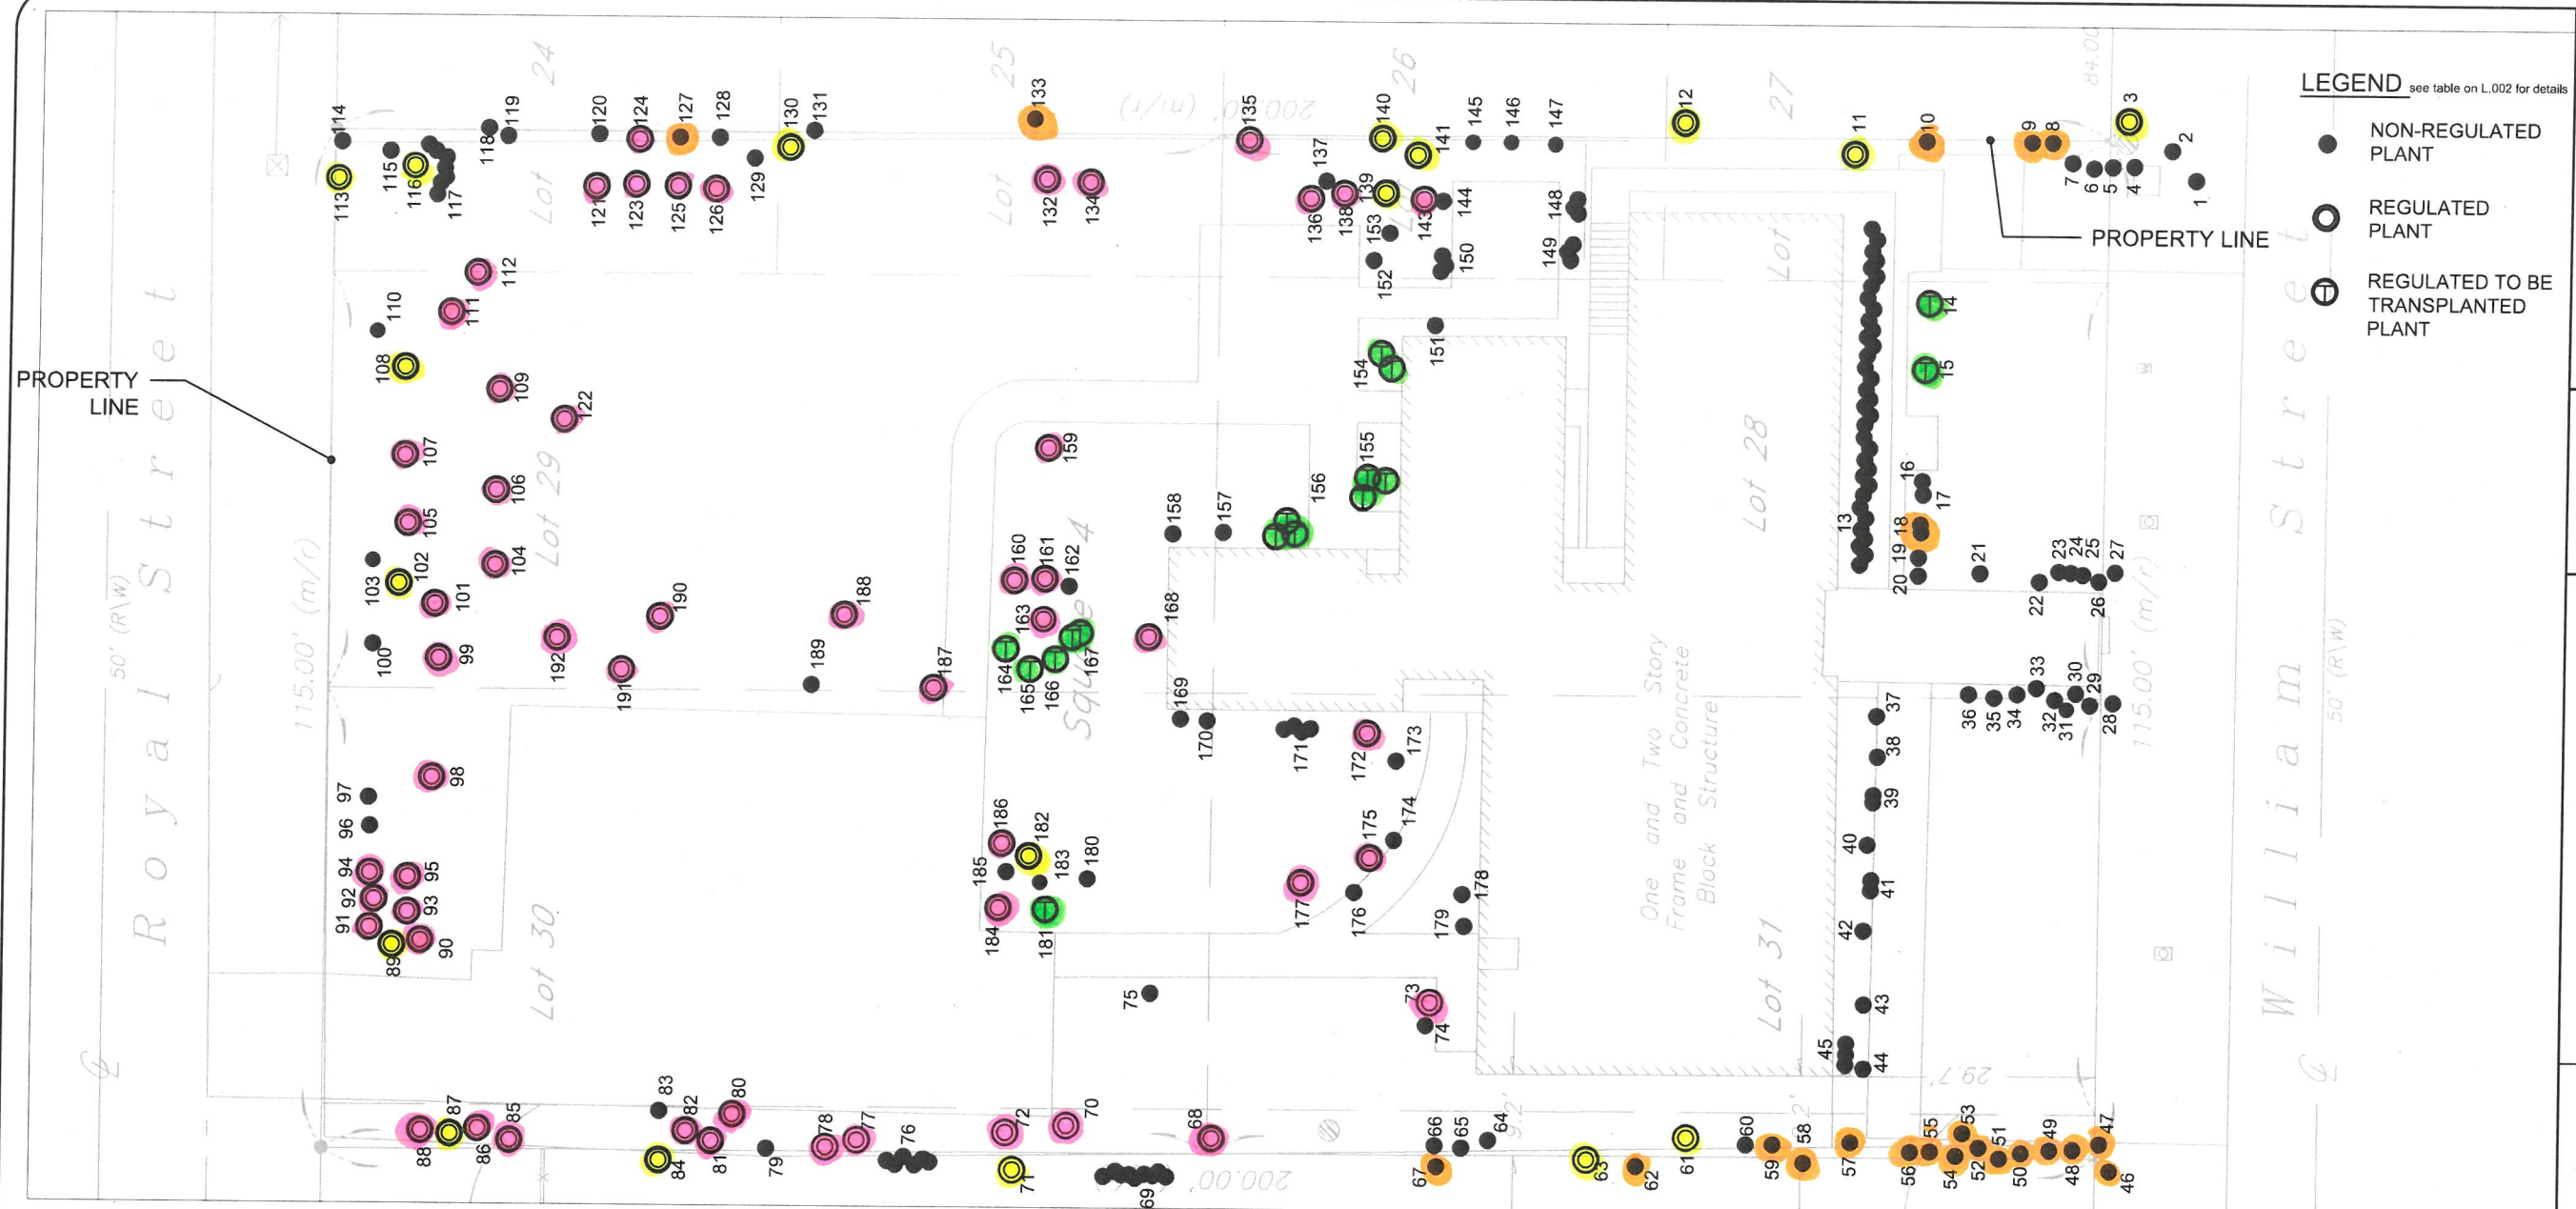
EXISTING VEGETATION MAP

The project requests approval to remove a total of 46 regulated trees and 9 regulated palms and the transplanting of an additional 10-regulated palms on the property. This work is requested in association with a major development plan to construct six new homes and redevelop two existing structures on the property.

Total mitigation requirement for the removal of all the requested trees is 268.2 caliper inches of approved dicot trees, FL#1 from the approved list and 9 approved palms, minimum 4 ft tall each palm, to be planted on site and incorporated into the required landscape plan. The landscape plan is being reviewed under a separate agenda item.
