STAFF REPORT

DATE: December 28, 2020

RE: 1316 Royal Street-1319 William Street Major Development Plan
(project application #TP2020-00008)

FROM: Karen DeMaria, City of Key West Urban Forestry Manager

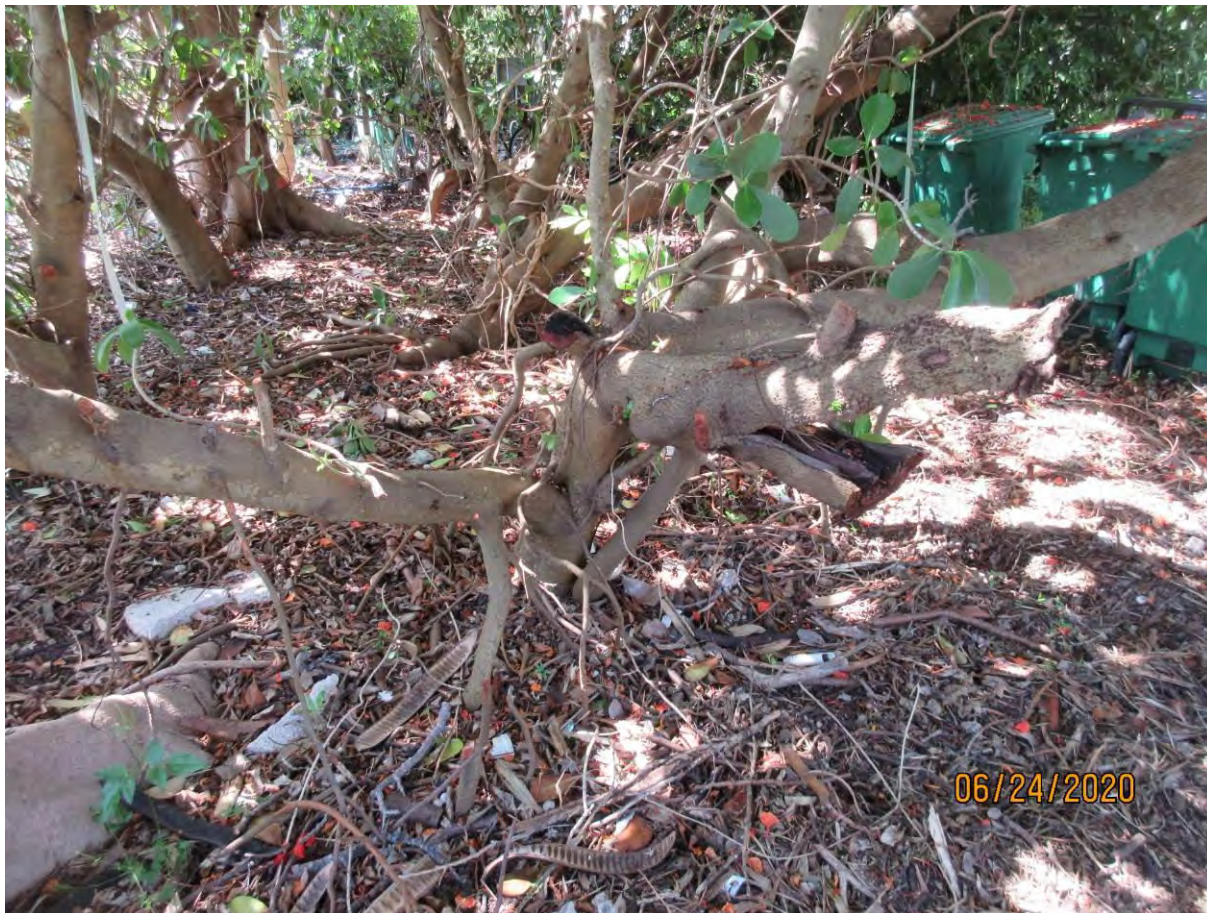
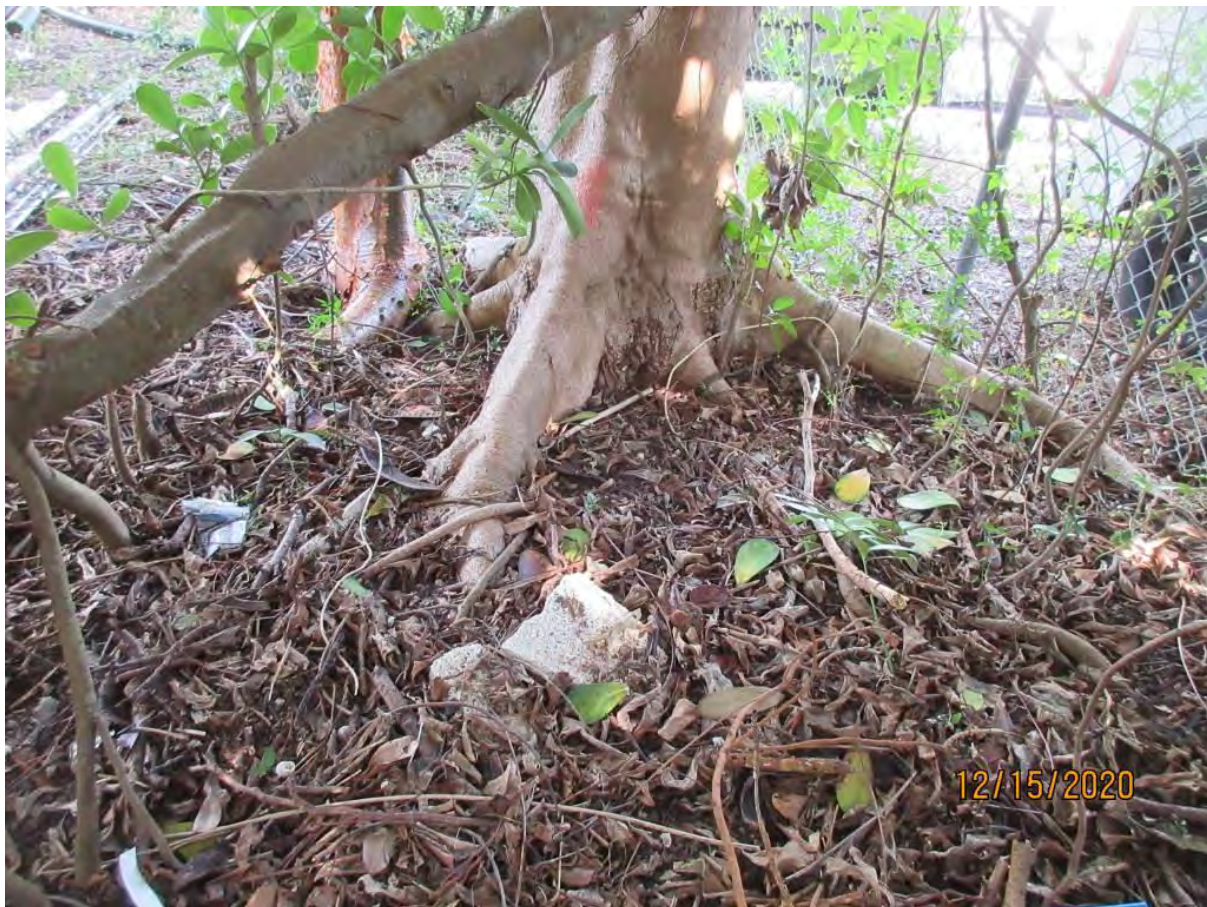
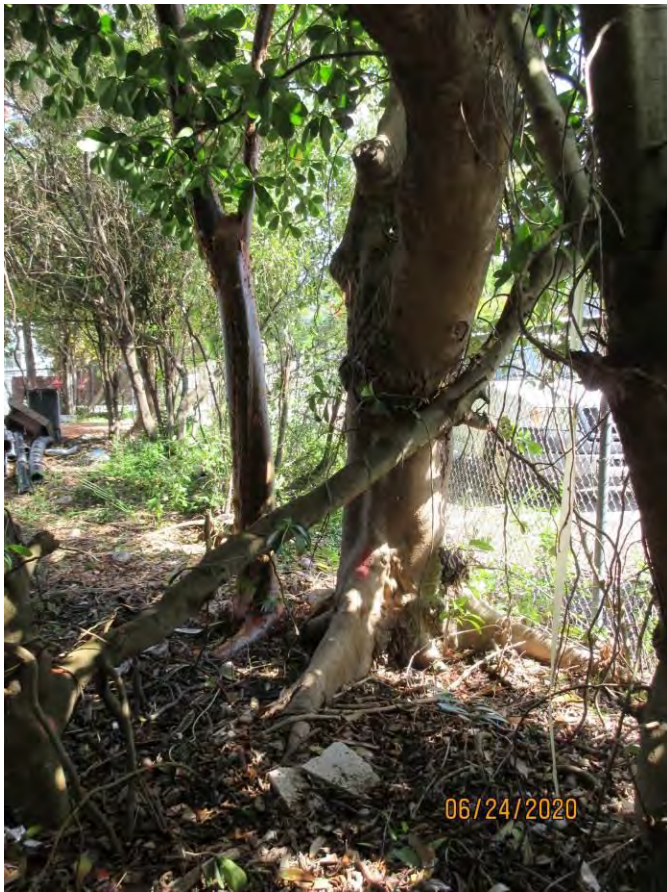
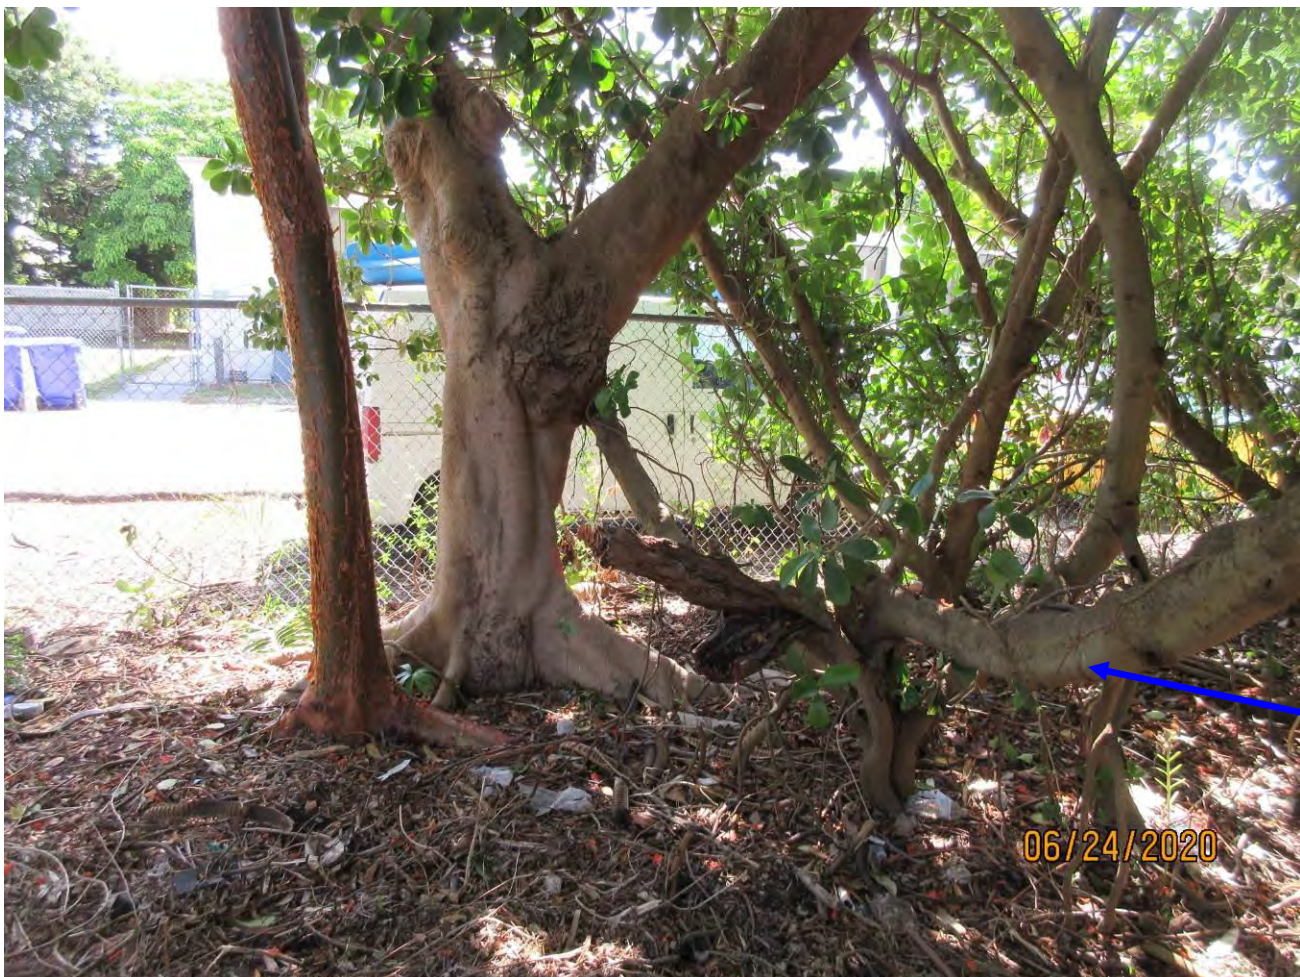
Tree#104

Tree #104 Diameter: 14"
 Location: 80%
 Species: 50% (not on protected or not protected tree list)
 Condition: 40% (poor structure-low sprawling growth with extended branches. Shrub that was not maintained.)
 Total Average Value = 56%
 Value x Diameter = 7.8
 replacement caliper inches

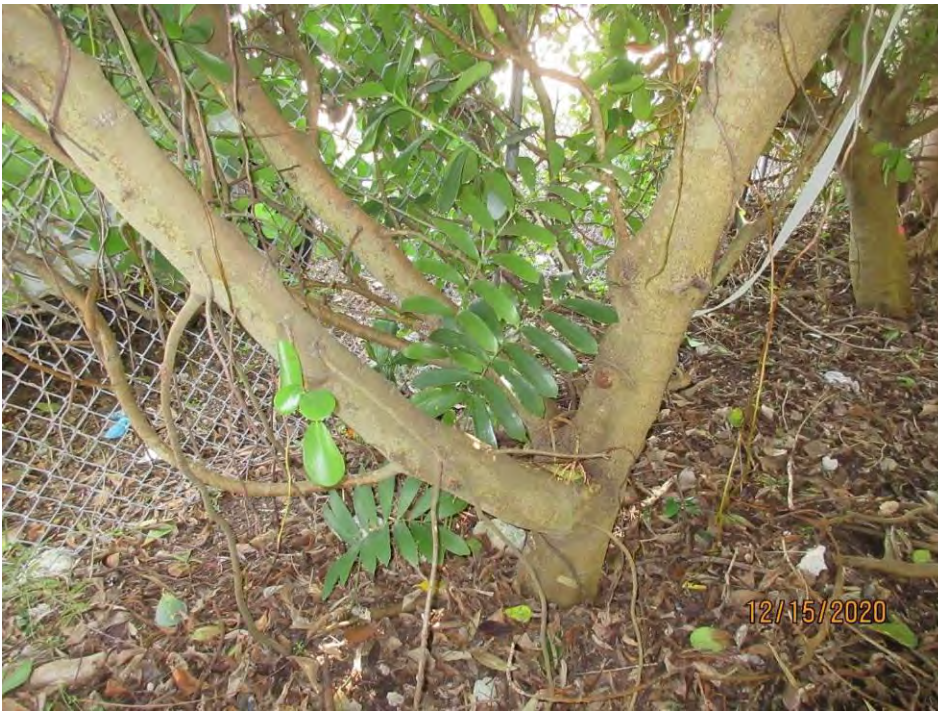
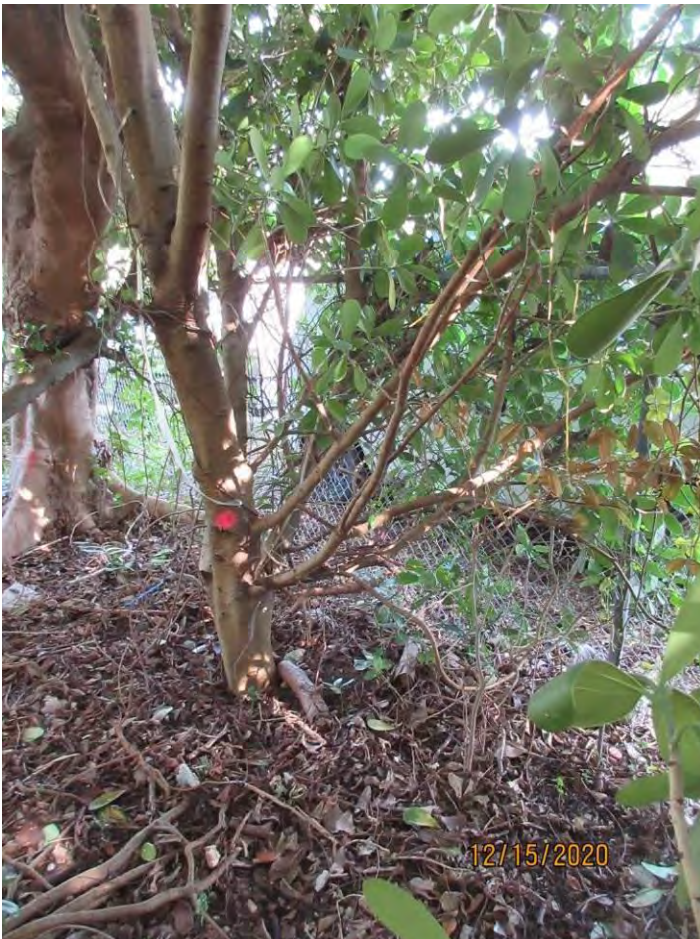
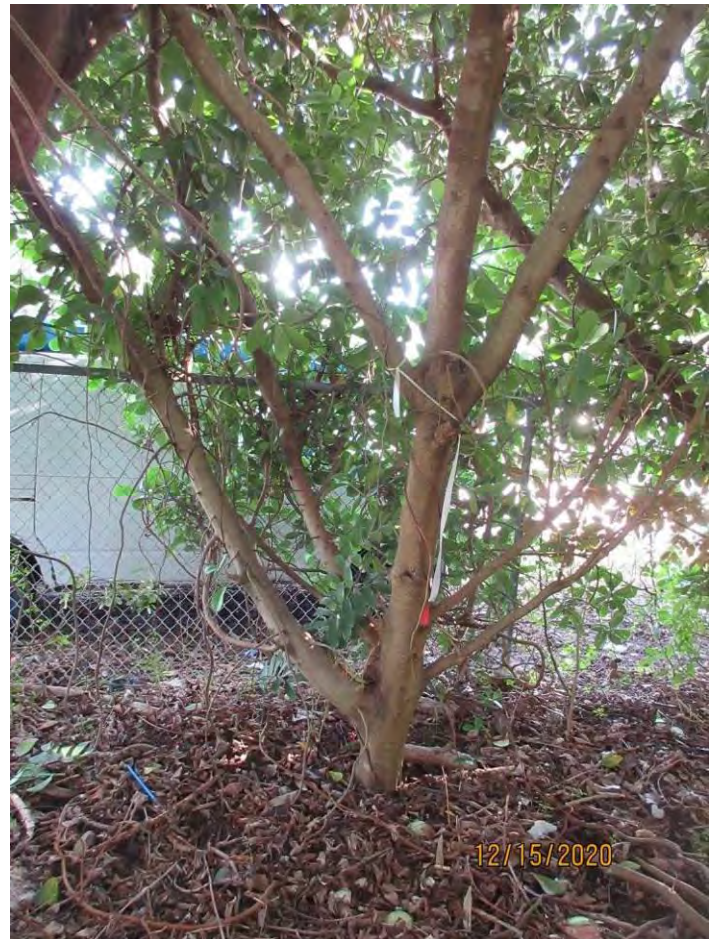
Tree#105

Tree #105 Diameter: 14.3"
Location: 80%
Species: 50% (not on protected or not protected tree list)
Condition: 50% (fair to poor overall, upright trunk structure but no maintenance)
Total Average Value = 60%
Value x Diameter = 8.5 replacement caliper inches

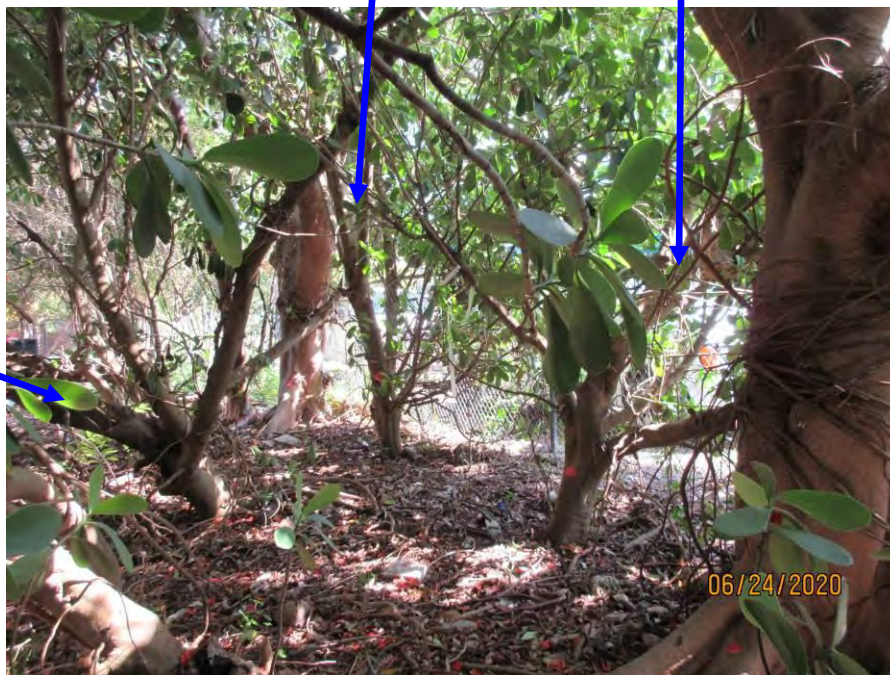
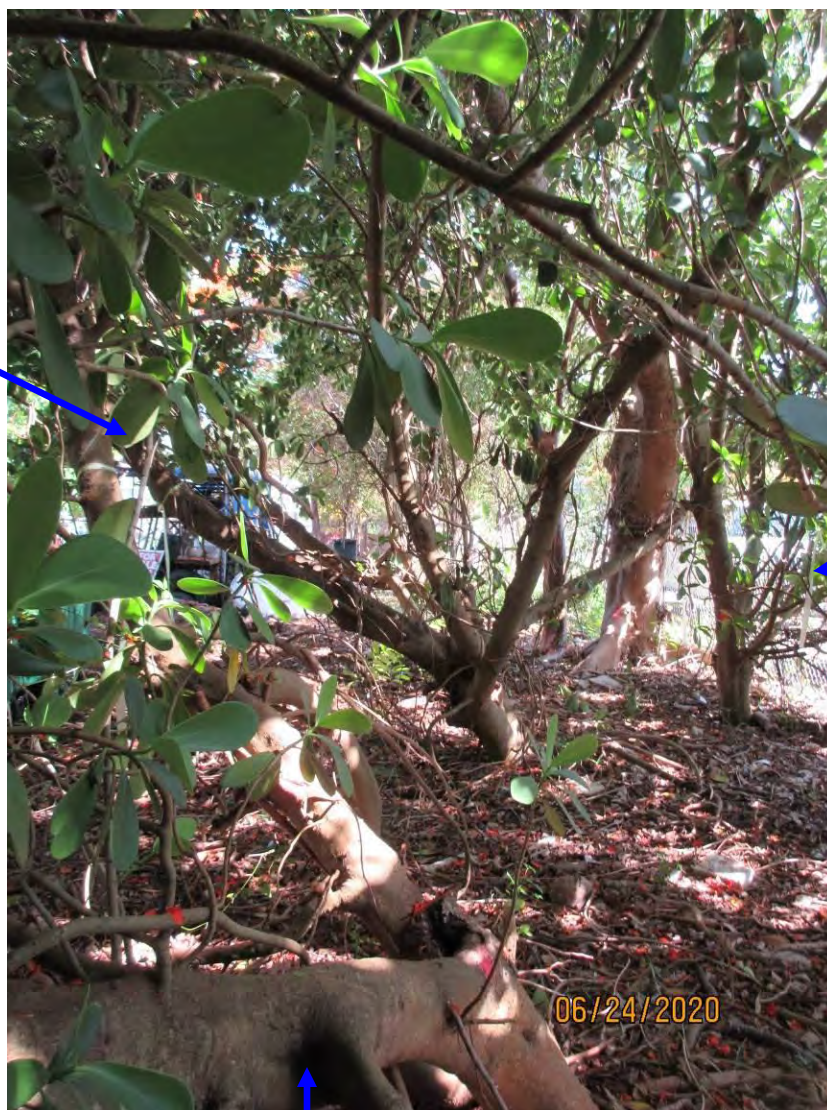
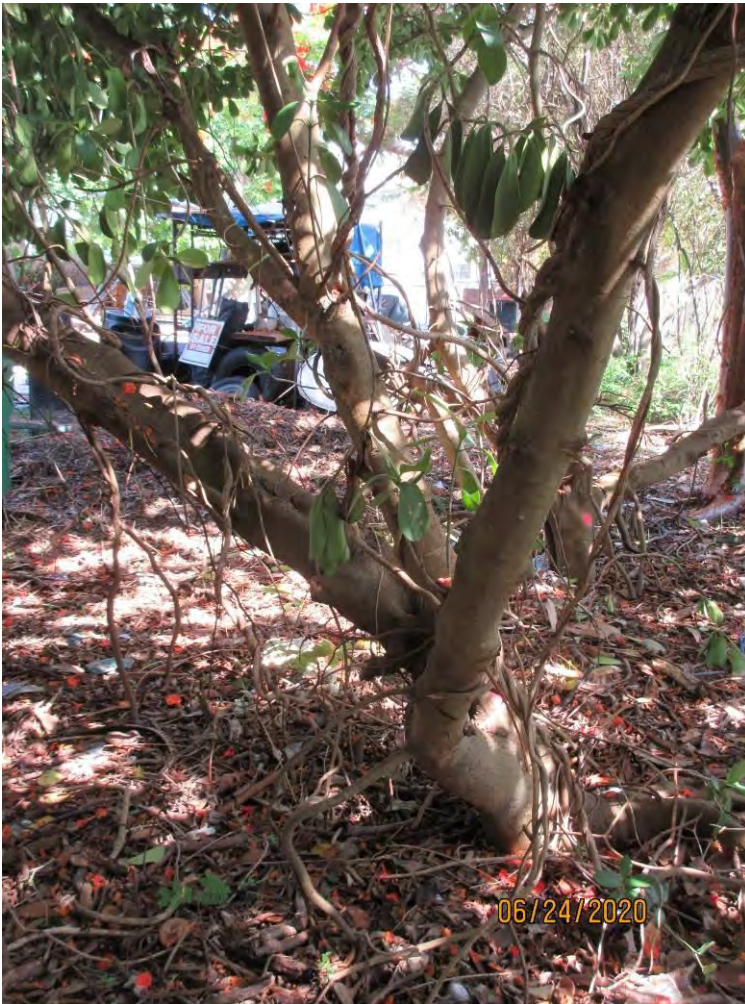
Tree #106 Diameter: 16"
Location: 80%
Species: 50% (not on
protected or not protected
tree list)
Condition: 30% (poor
structure, partial uprooting of
roots)
Total Average Value = 53%
Value x Diameter = 8.4
replacement caliper inches

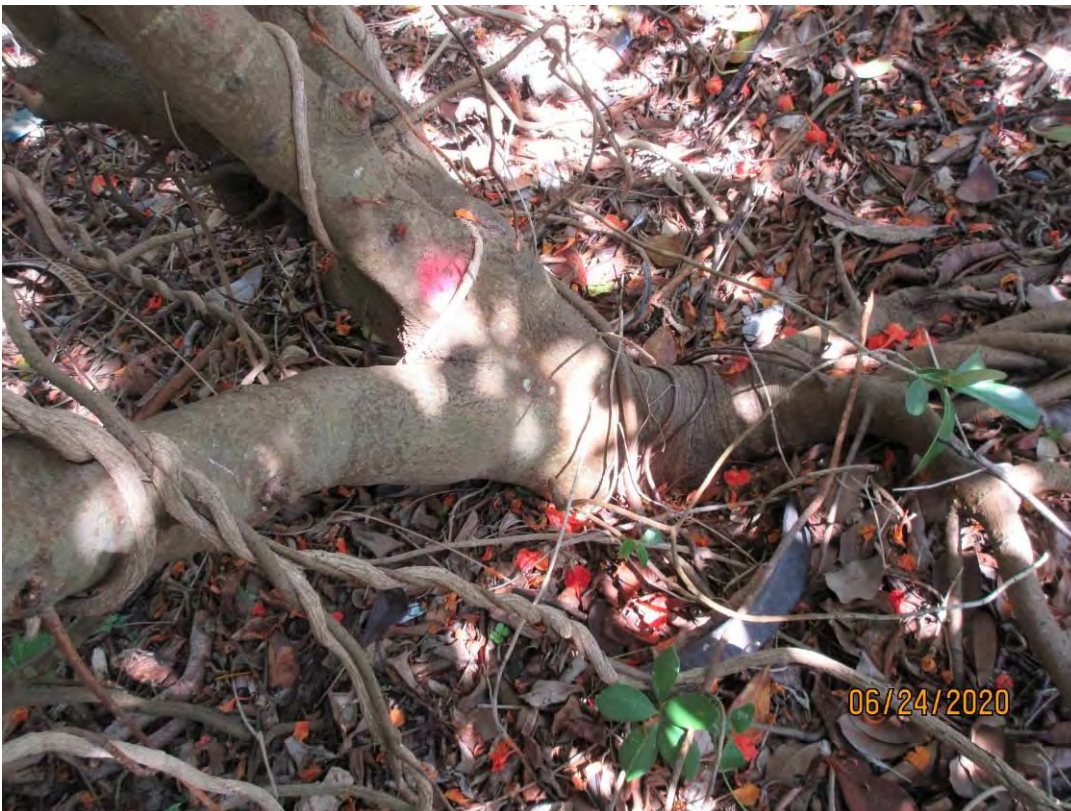
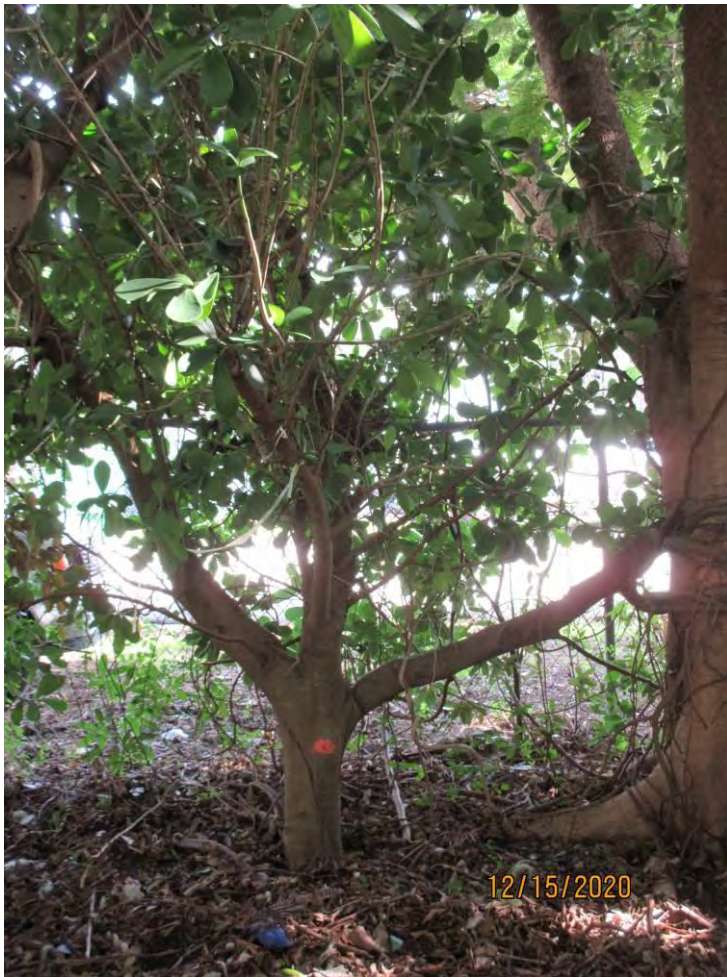
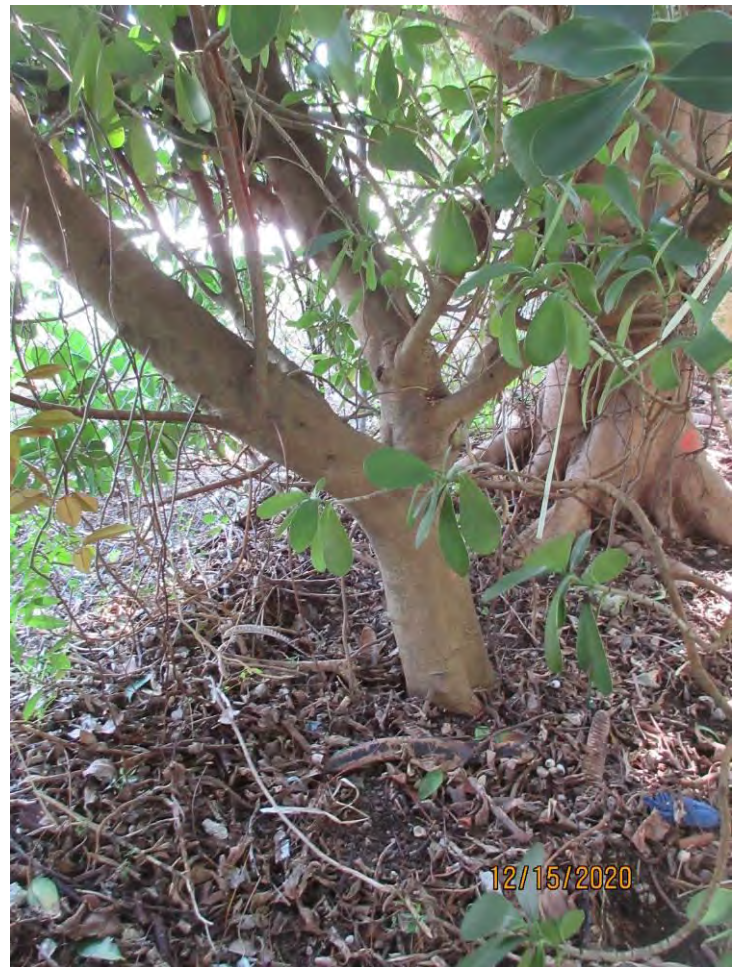
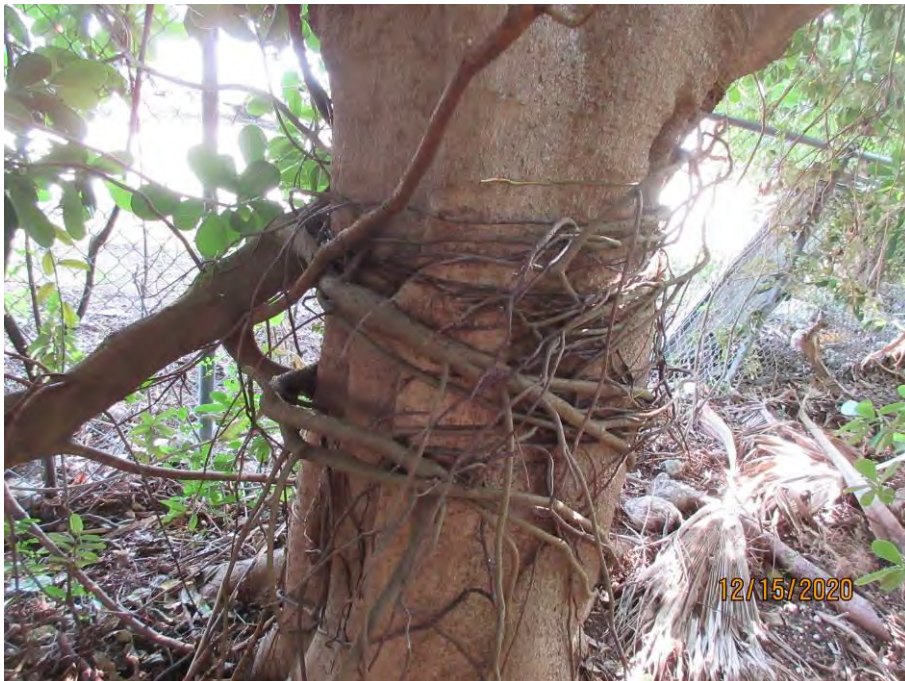
Tree#107

Tree #107 Diameter: 12.7"
Location: 60% (part of tree impacting adjacent Royal Poinciana tree)
Species: 50% (not on protected or not protected tree list)
Condition: 50% (fair overall, poor structure)
Total Average Value = 53%
Value x Diameter = 6.7 replacement caliper inches

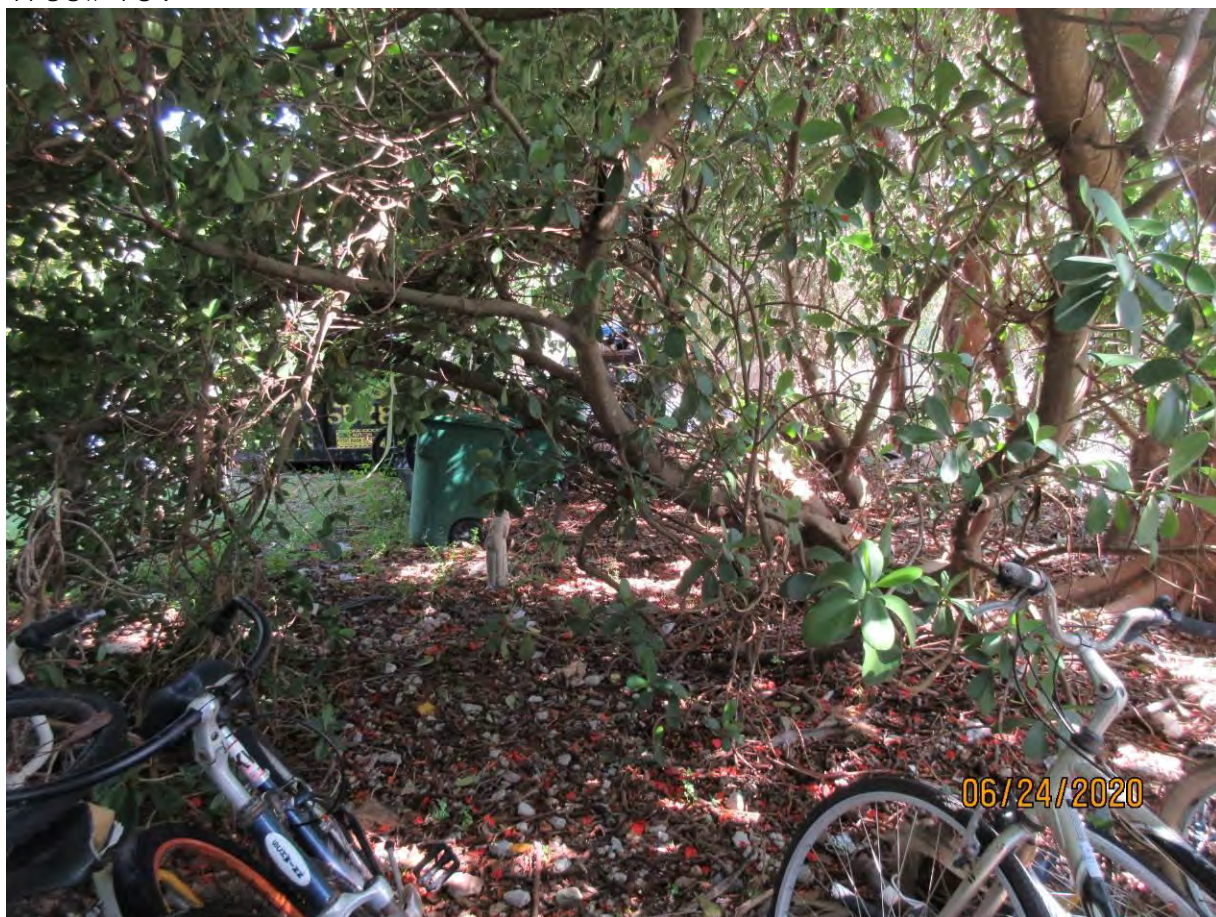
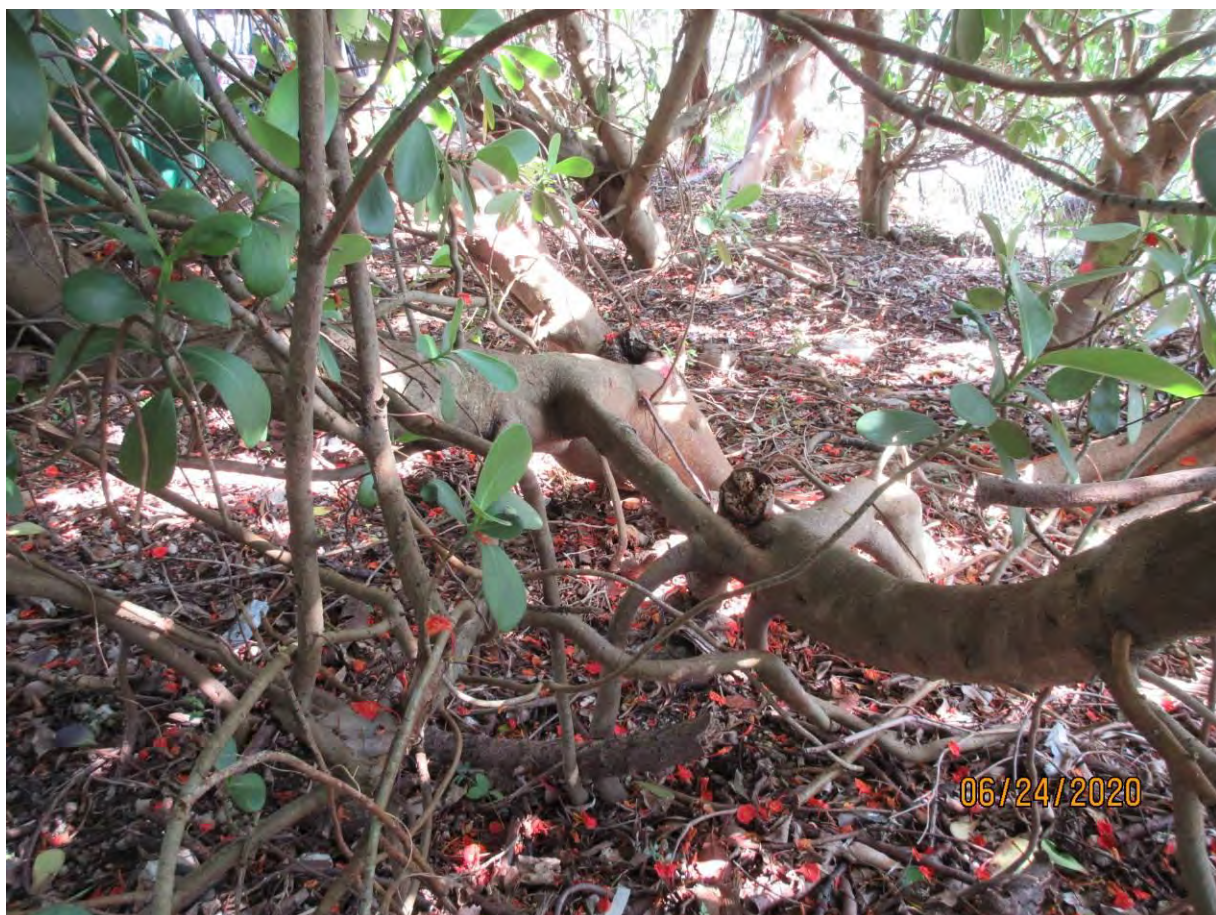
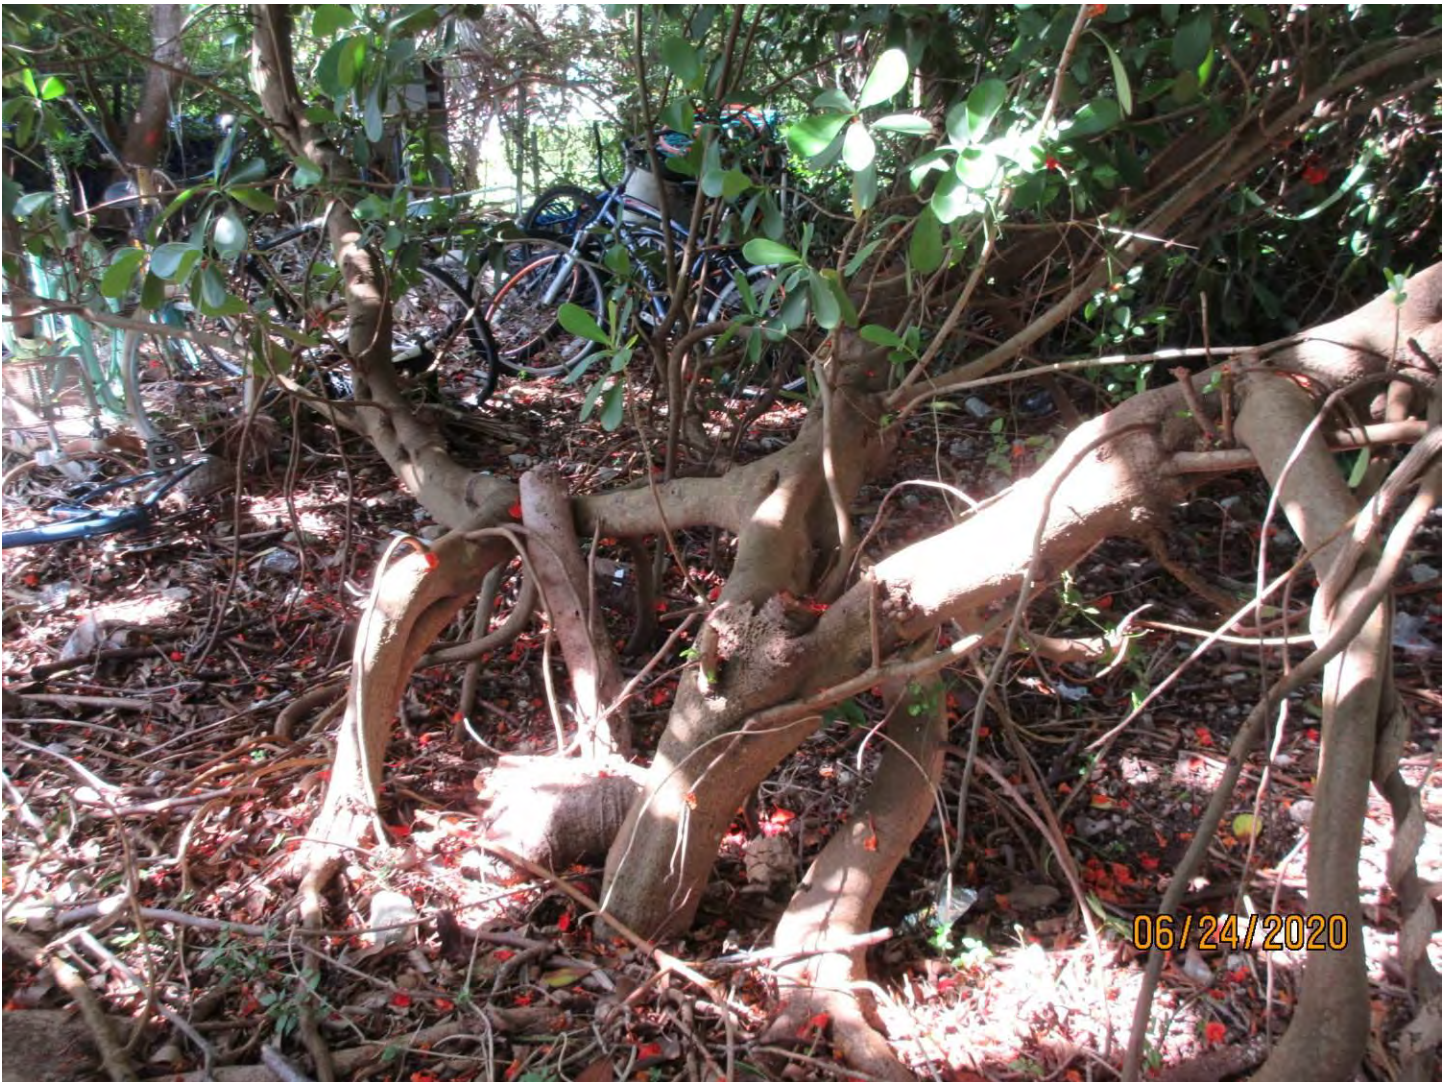
Tree#109

Tree #109 Diameter: 18"

Location: 80%

Species: 50% (not on protected or not protected tree list)

Condition: 30% (overall condition is poor, low sprawling trunk growth, roots partially uplifted)

Total Average Value = 53%

Value x Diameter = 9.5 replacement caliper inches

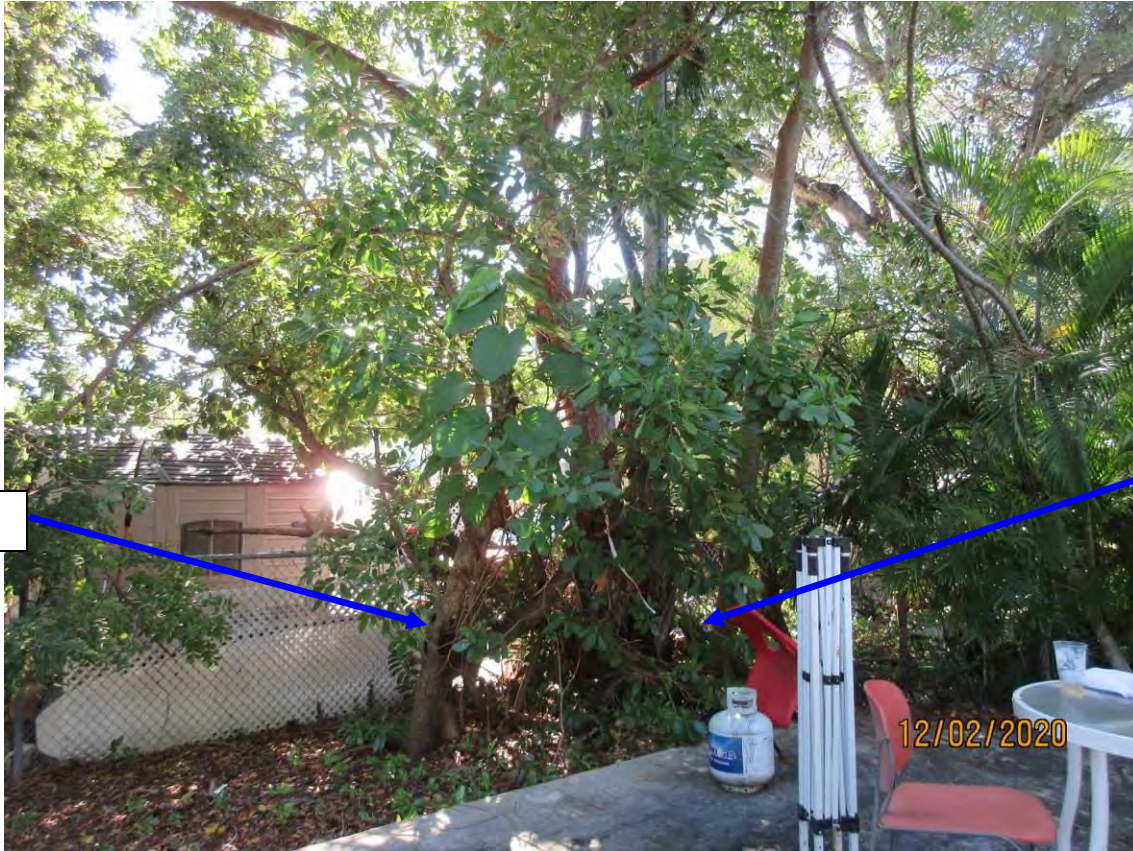
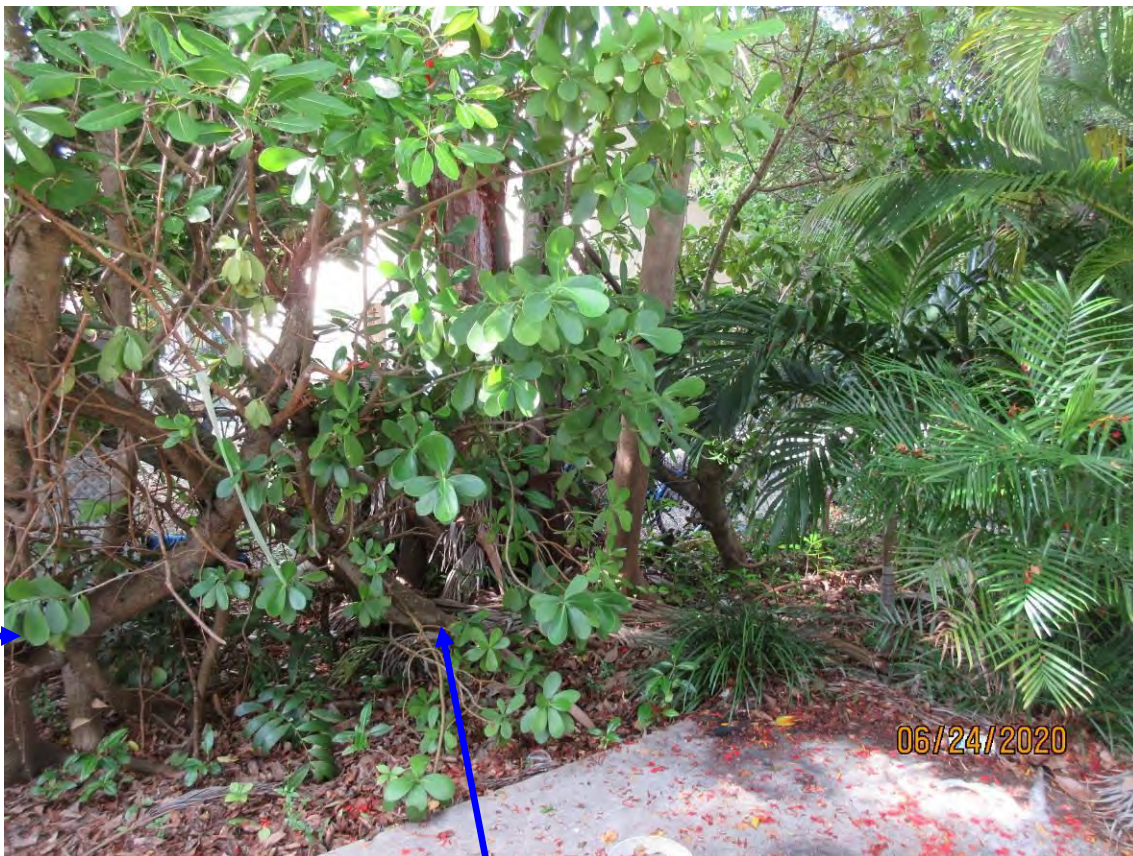
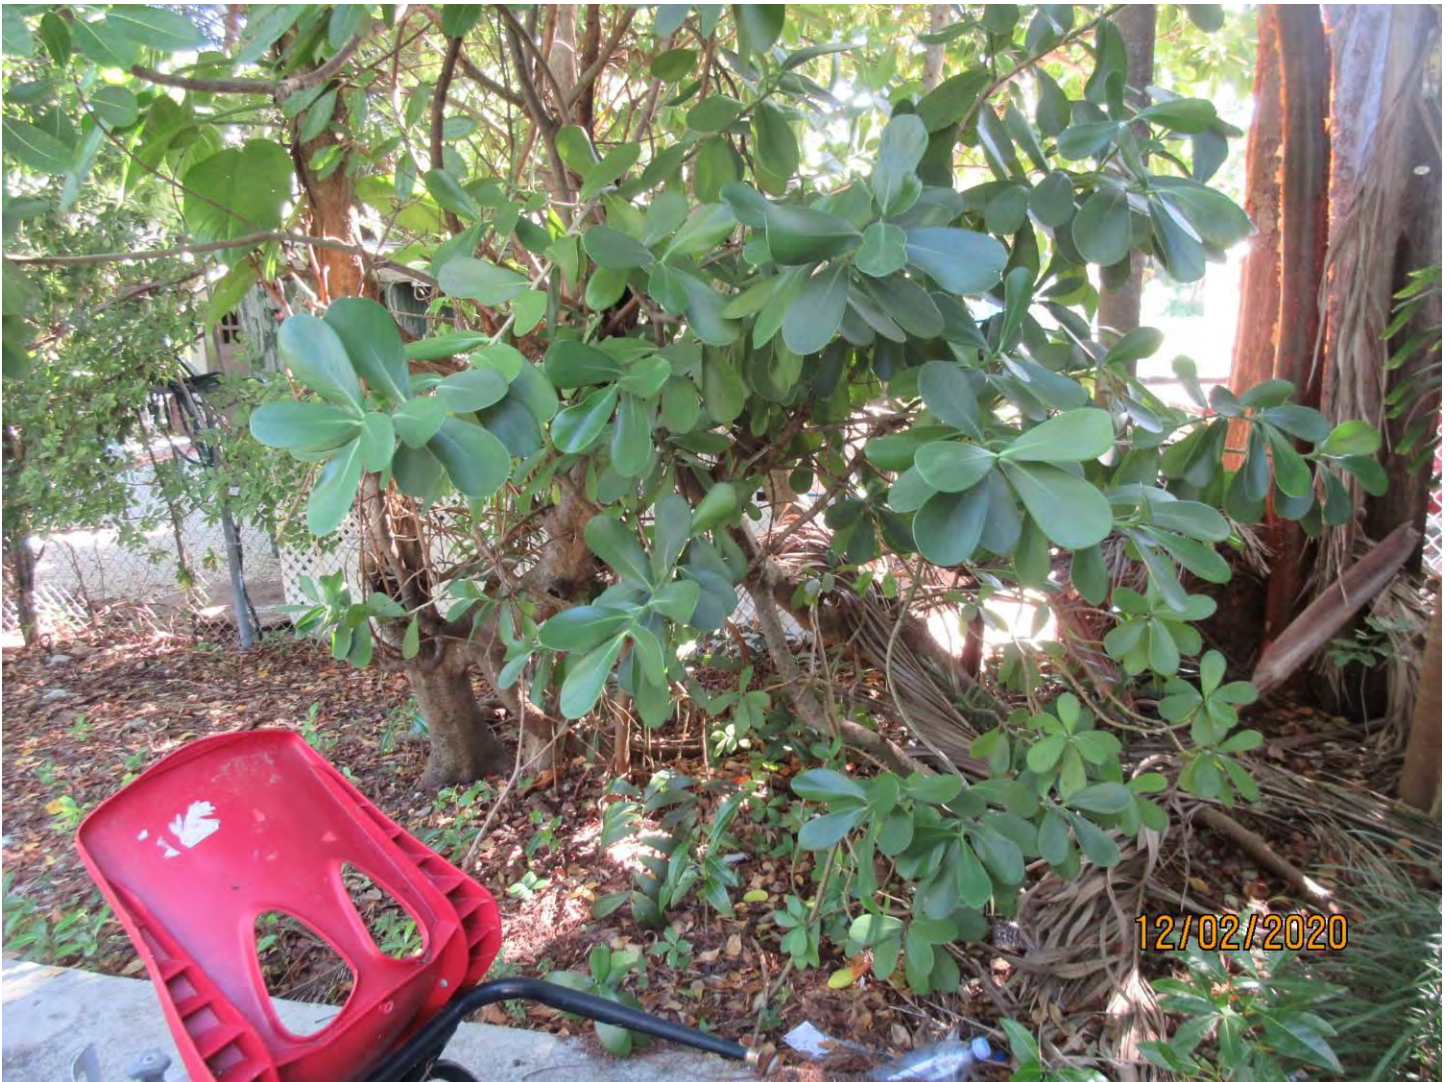
Tree #138 Diameter: 7.5"

Location: 80%

Species: 50% (not on protected or not protected tree list)

Condition: 40% (overall condition is poor, overgrown shrub-no maintenance)

Total Average Value = 56%

Value x Diameter = 4.2 replacement caliper inches

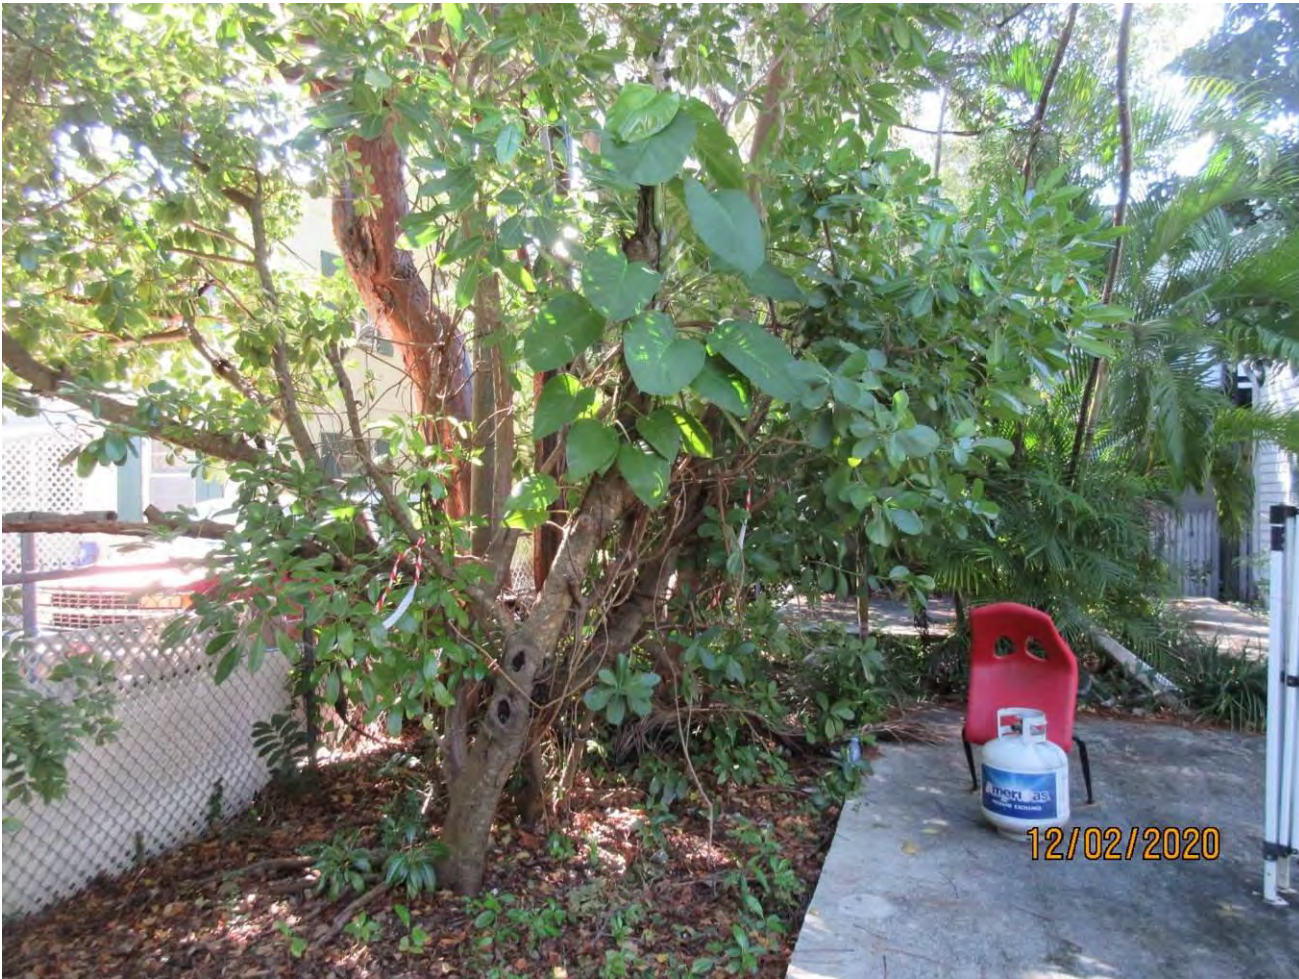
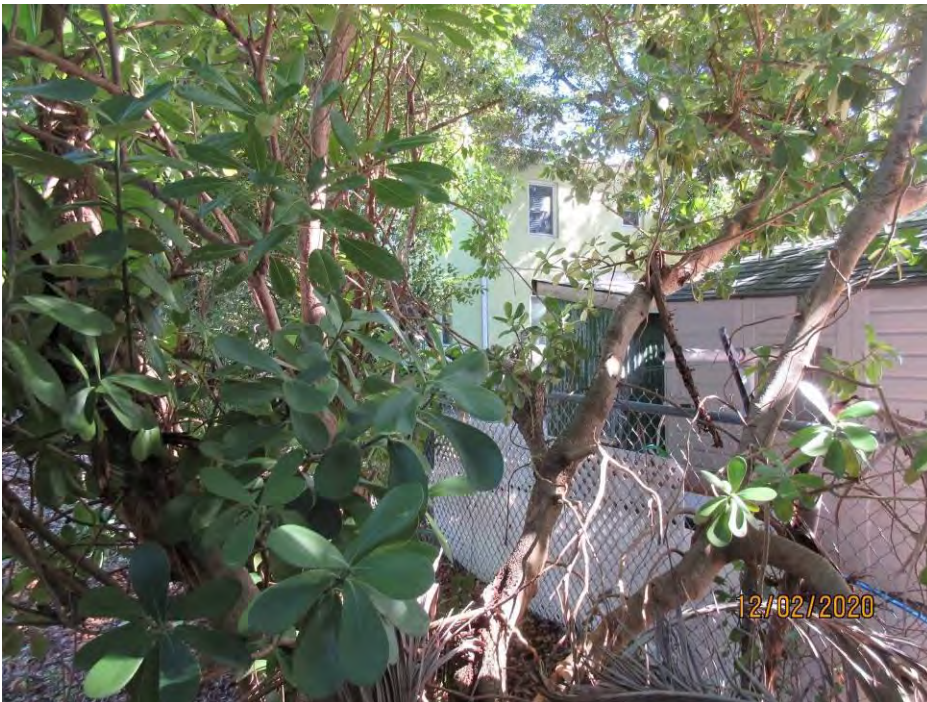
Tree #136

Diameter: 6.7"
Location: 80%
Species: 50% (not on protected or not protected tree list)
Condition: 40% (overall condition is poor, decay in trunk, growth is sprawling-overgrown shrub with no maintenance)
Total Average Value = 56%
Value x Diameter = 3.7 replacement caliper inches
