STAFF REPORT

DATE: December 28, 2020

RE: 1316 Royal Street-1319 William Street Major Development Plan
(project application #TP2020-00008)

FROM: Karen DeMaria, City of Key West Urban Forestry Manager

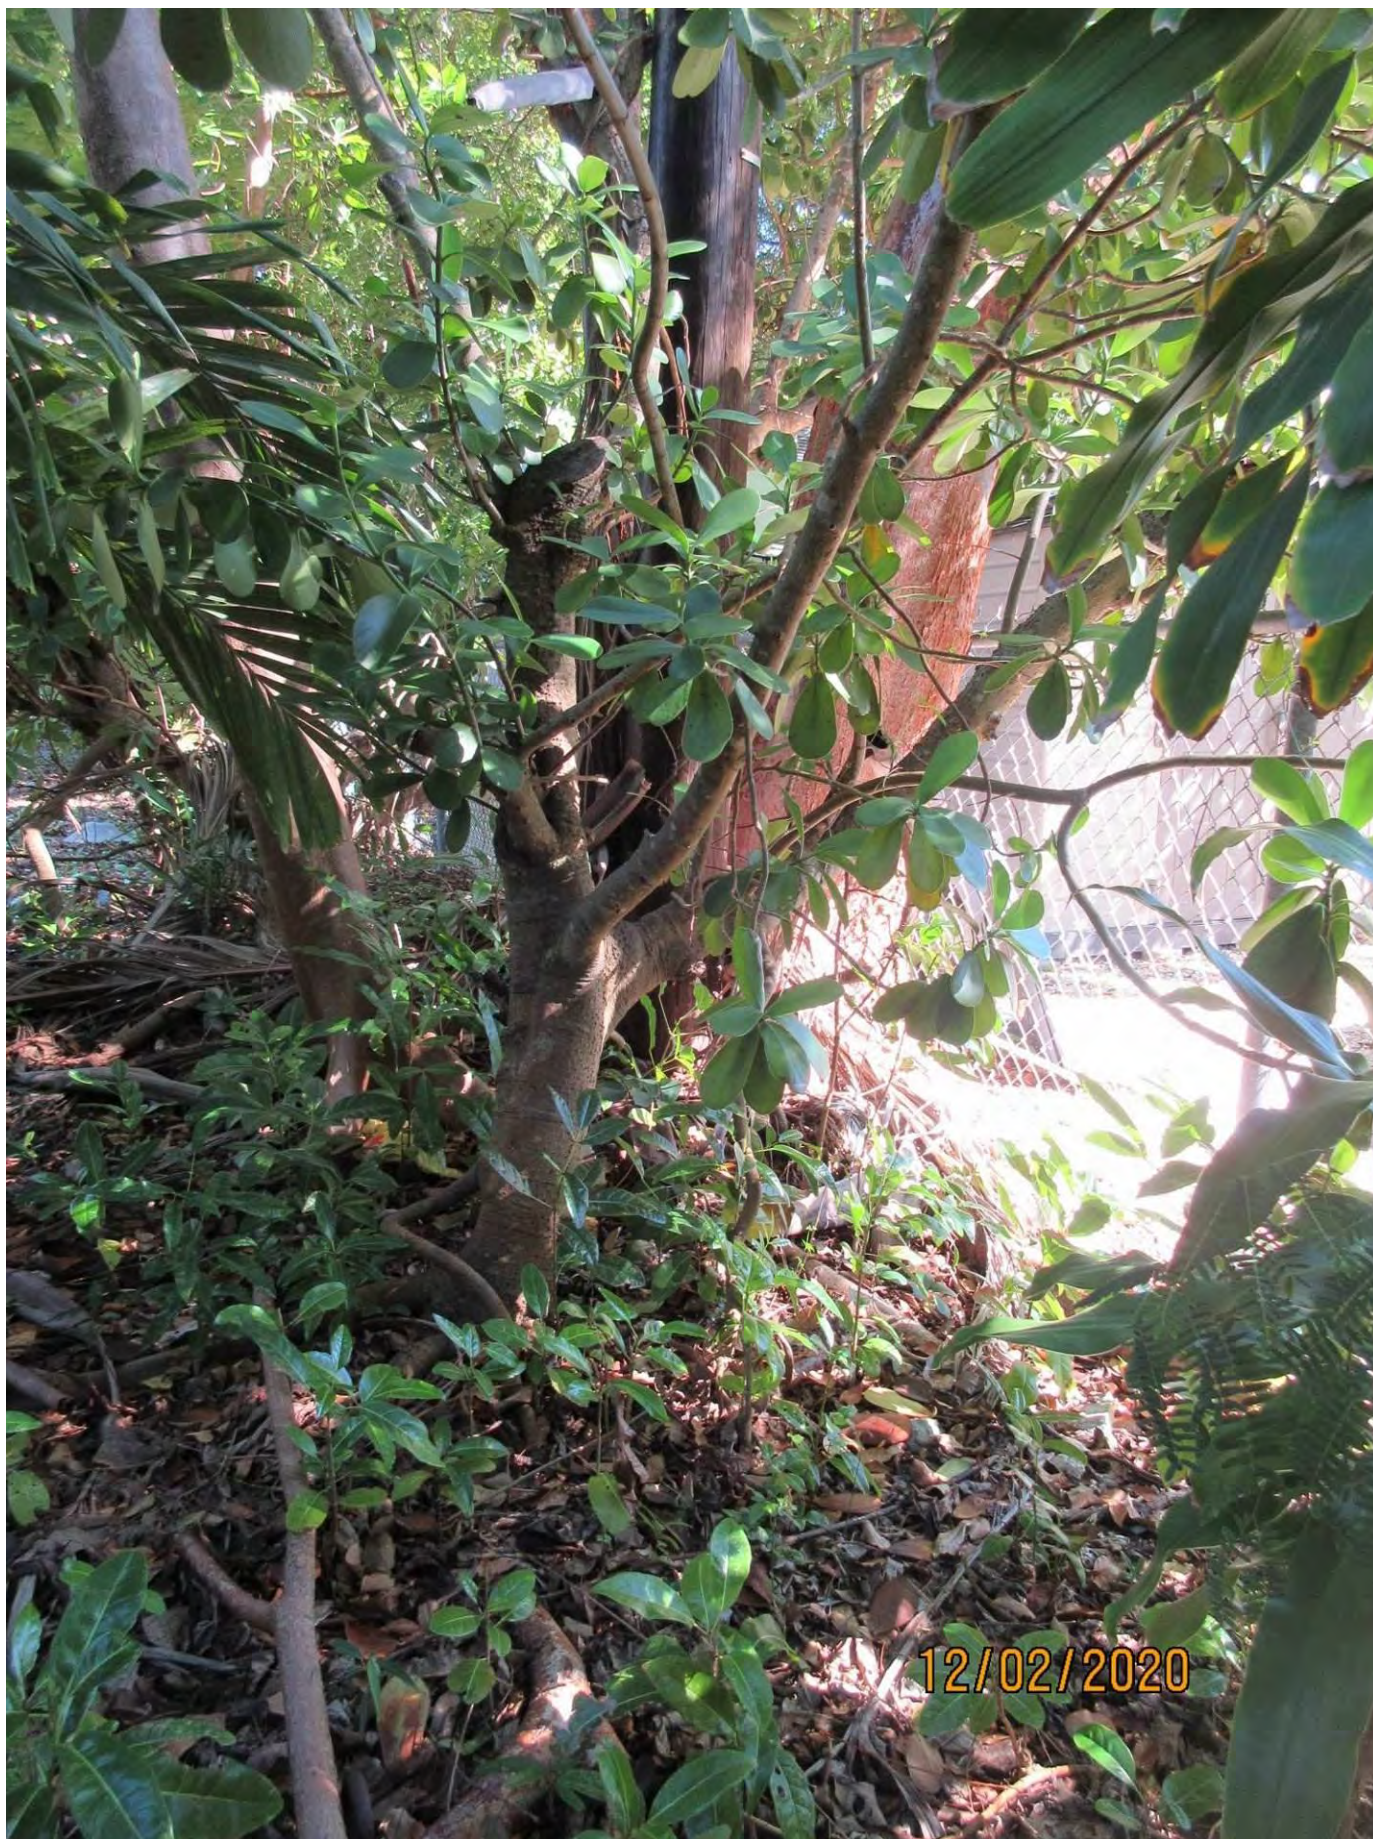
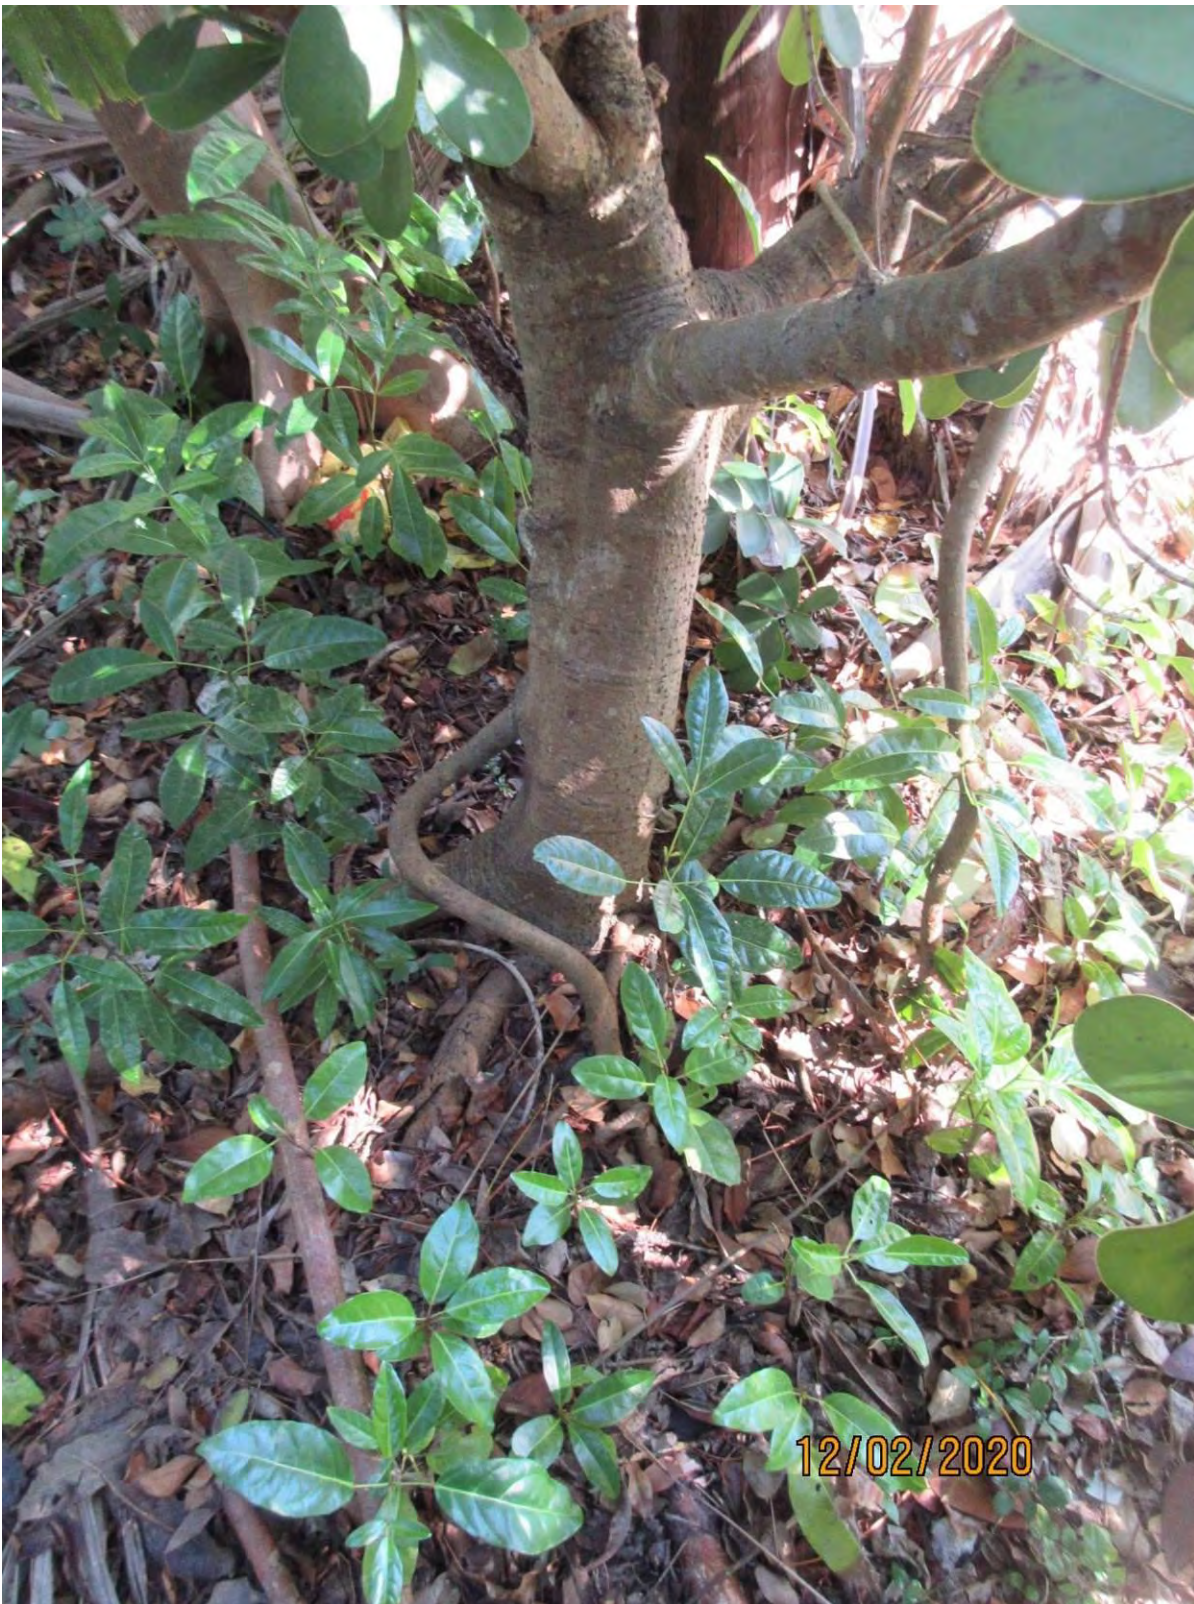
Tree#143

Diameter: 6.2"

Location: 80%

Species: 50% (not on protected or not protected tree list)

Condition: 40% (overall condition is poor, main trunk cut)

Total Average Value = 56%

Value x Diameter = 3.4 replacement caliper inches

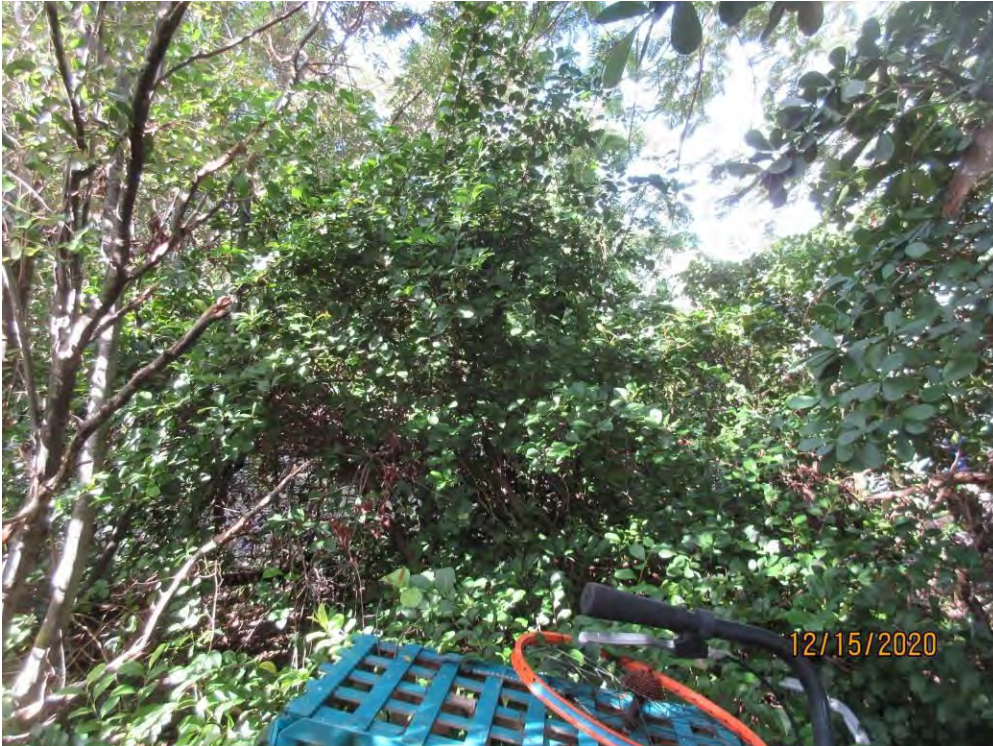
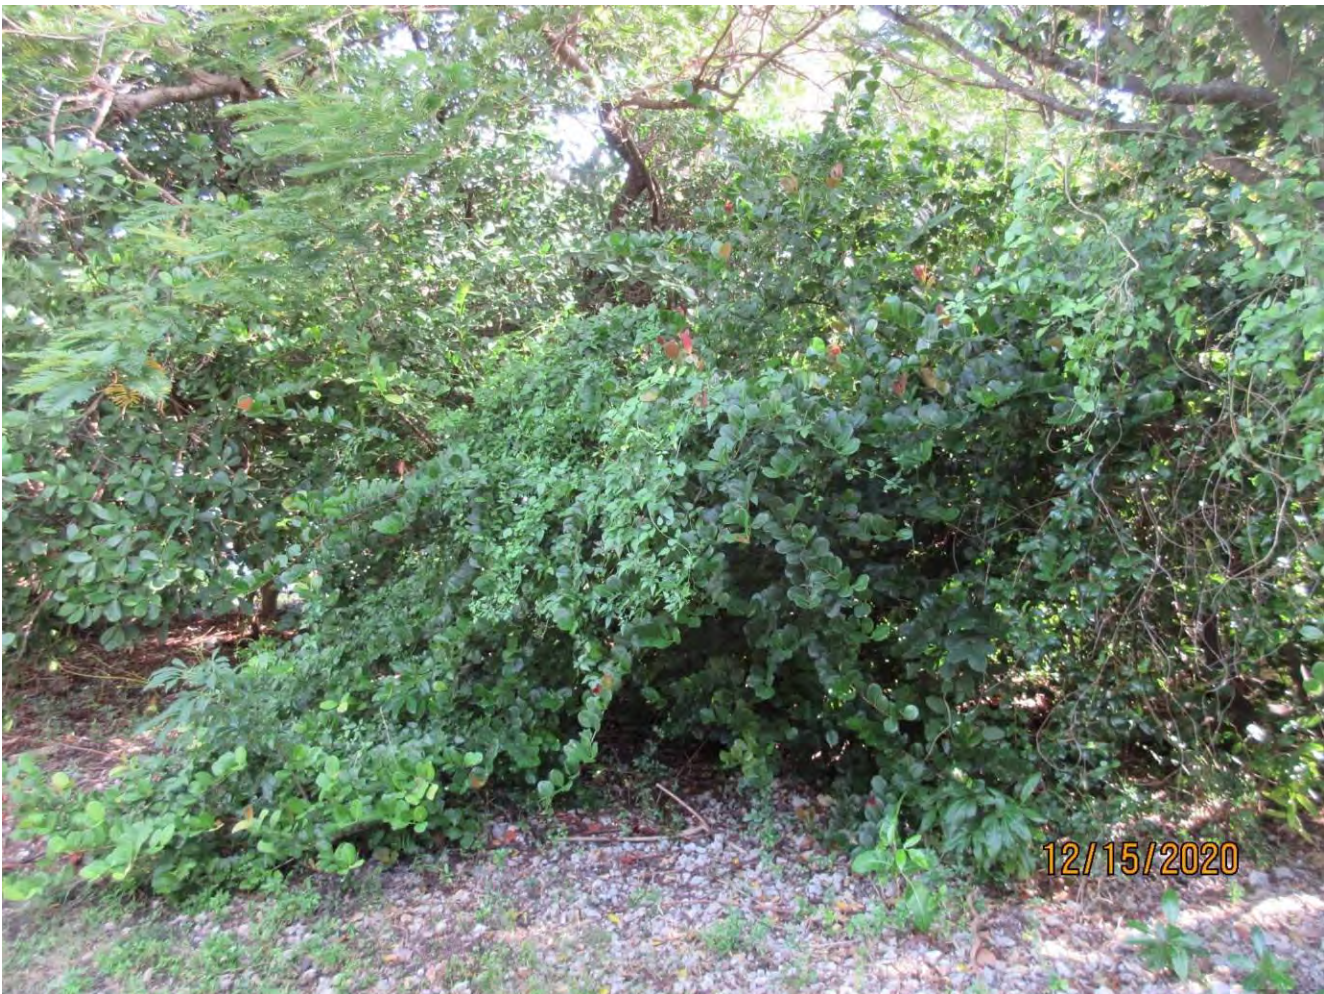
Tree#122

Tree #122 Diameter: 7"
Location: 80%
Species: 100% (on
protected tree list)
Condition: 40% (poor
structure-overgrown
shrub with at least one
main trunk growing
upright due to lack of
maintenance)
Total Average Value =
73%
Value x Diameter =
5.1 replacement
caliper inches

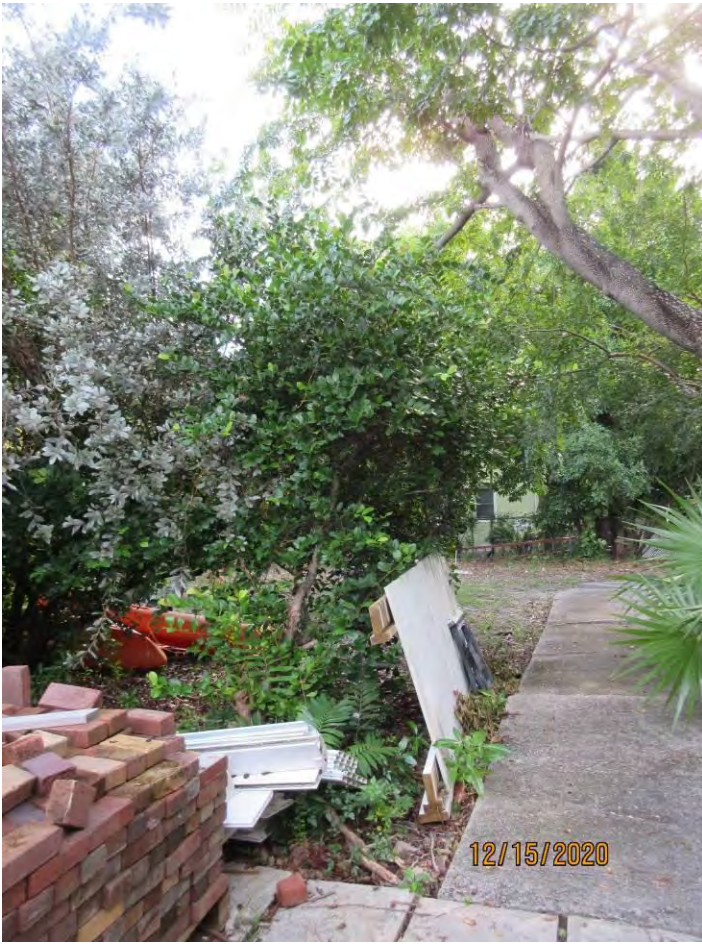
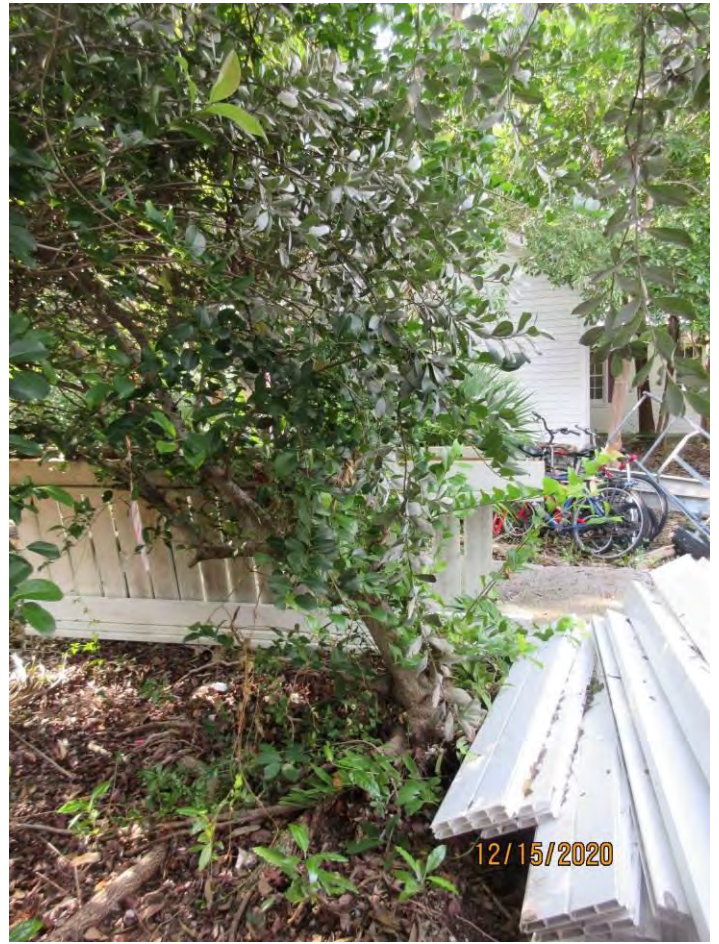
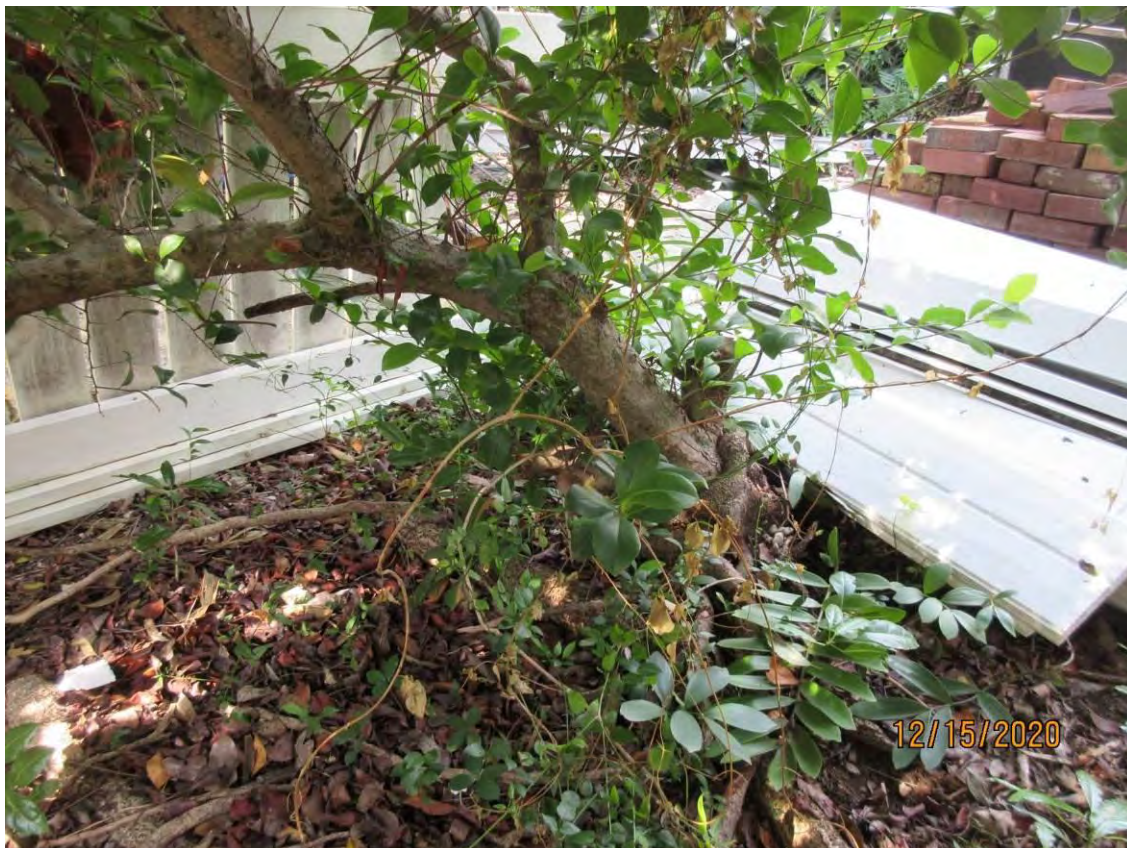
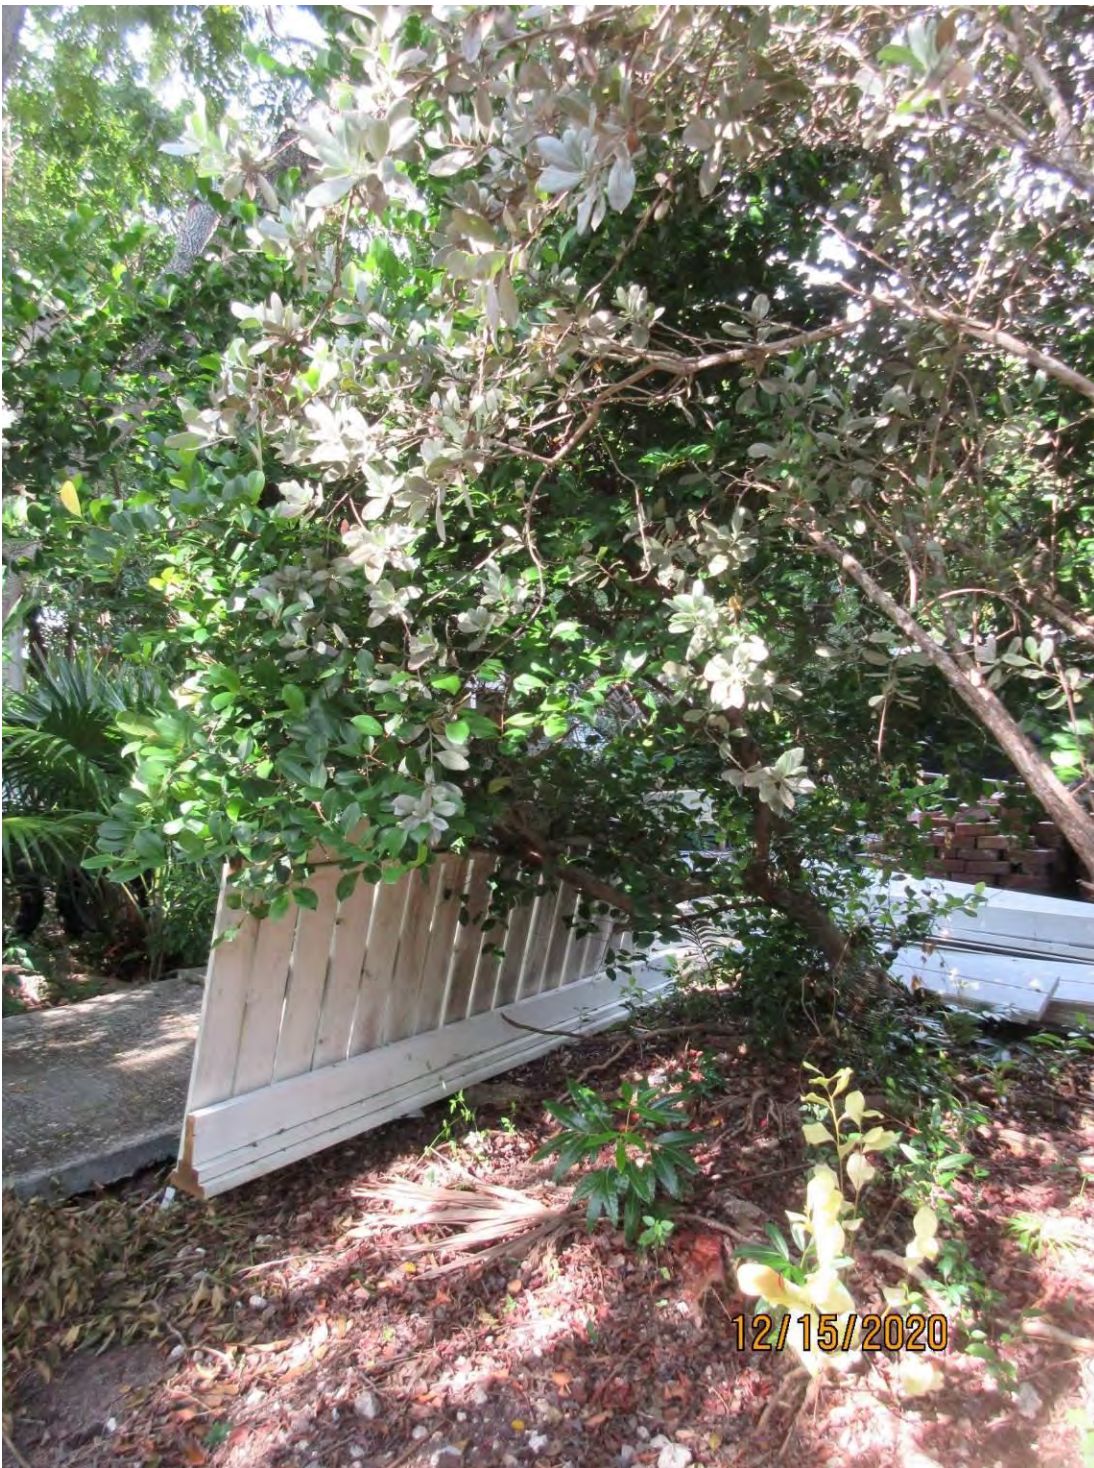
Tree#187

Tree #187 Diameter: 7"

Location: 80%

Species: 100% (on protected tree list)

Condition: 40% (poor, surface roots with some partial uplifting, growth primarily to one side, overgrown shrub that became a tree shape due to lack of maintenance)

Total Average Value = 73%

Value x Diameter = 5.1 replacement caliper inches

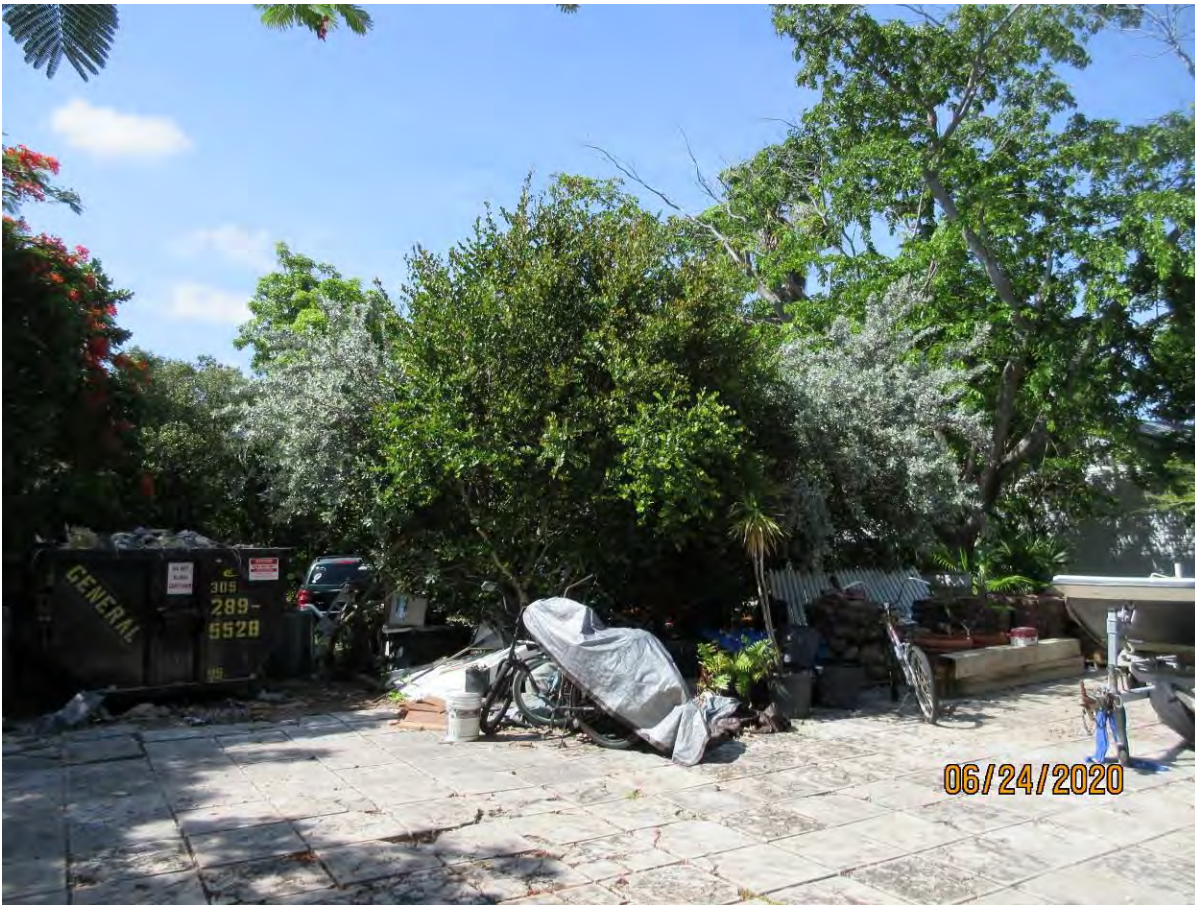
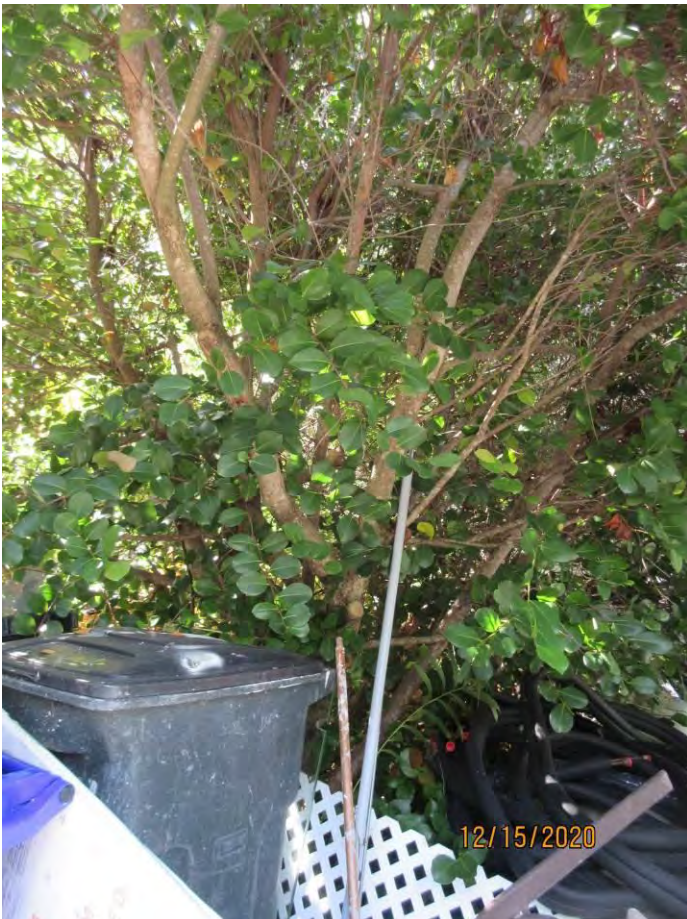
Tree #191 Diameter: 7"
Location: 80%
Species: 100% (on protected tree list)
Condition: 50% (overall condition is fair, several upright trunks)
Total Average Value = 76%
Value x Diameter = 5.3 replacement caliper inches

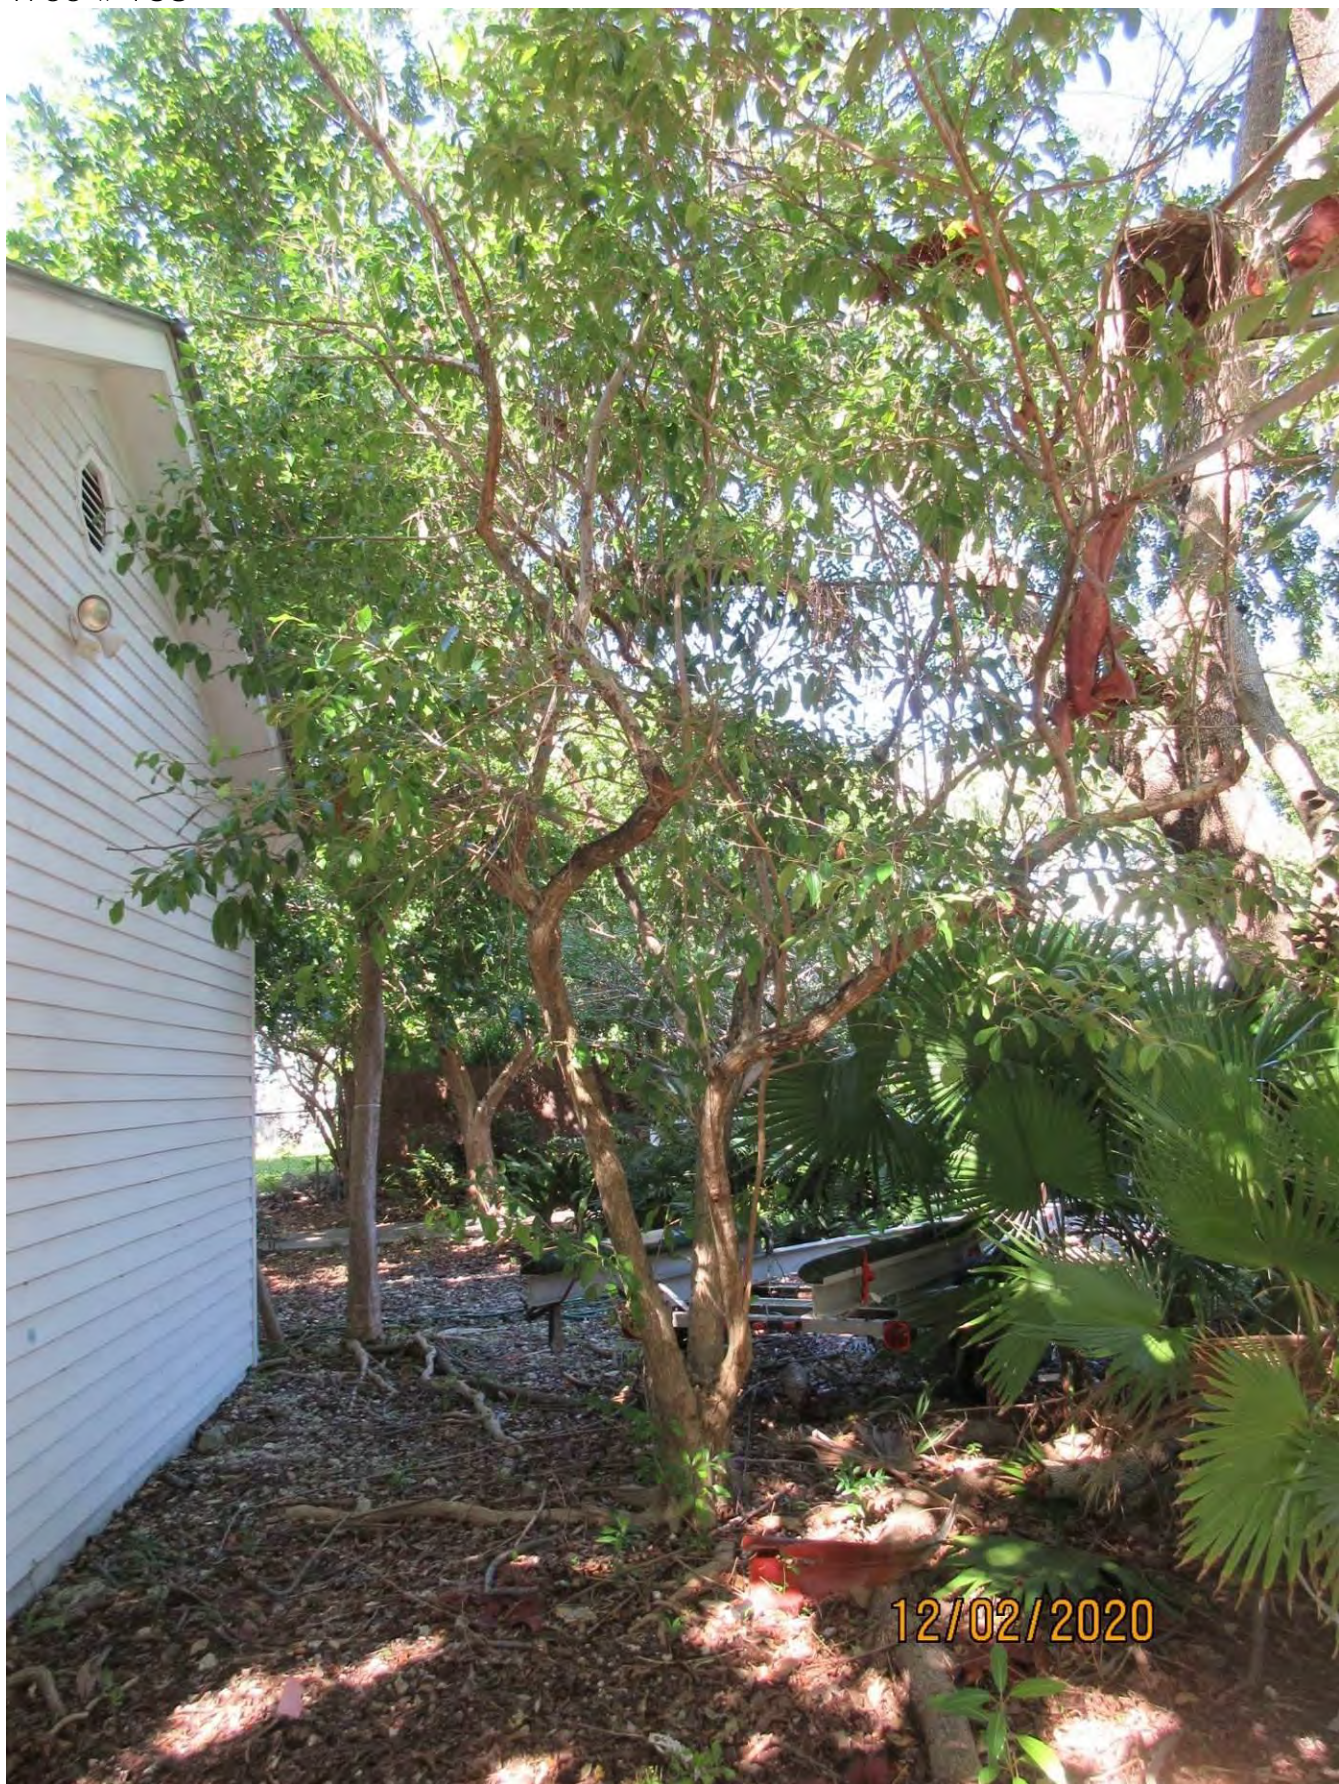
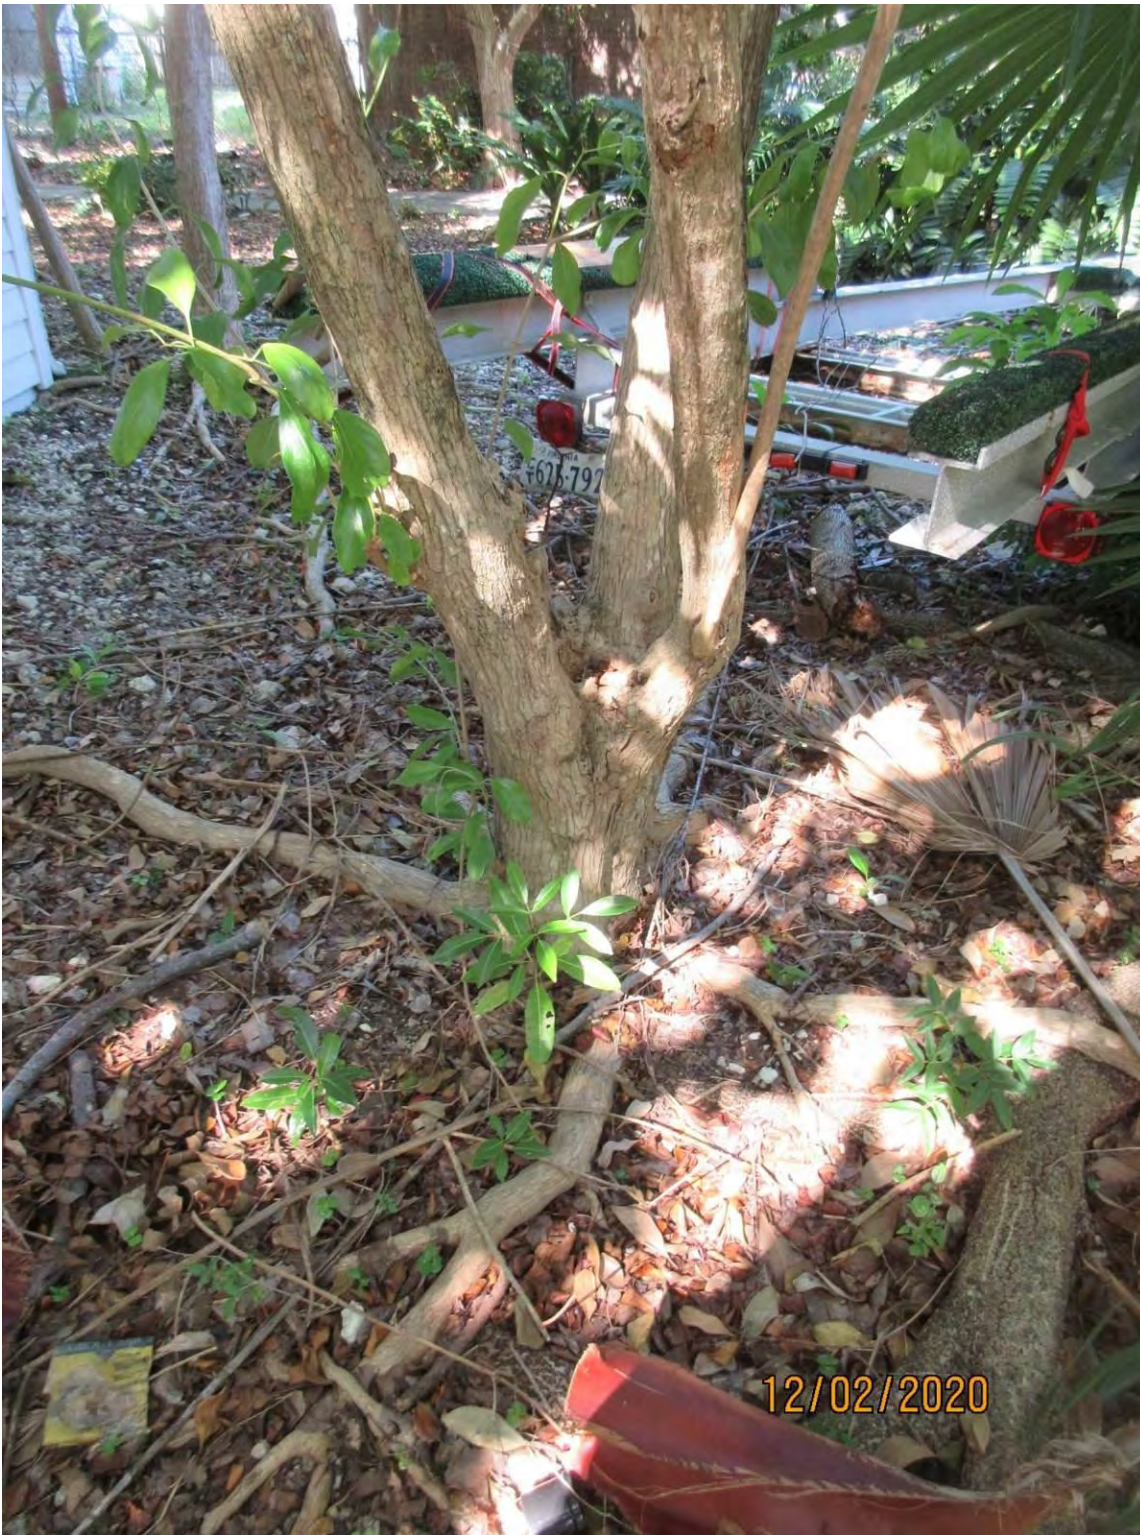
Tree #168 Diameter: 7.3"

Location: 60% (growing in root system of larger tree)

Species: 100% (on protected tree list)

Condition: 40% (overall condition is fair to poor, codominant trunks with sprawling growth, exposed surface roots)

Total Average Value = 66%

Value x Diameter = 4.8 replacement caliper inches

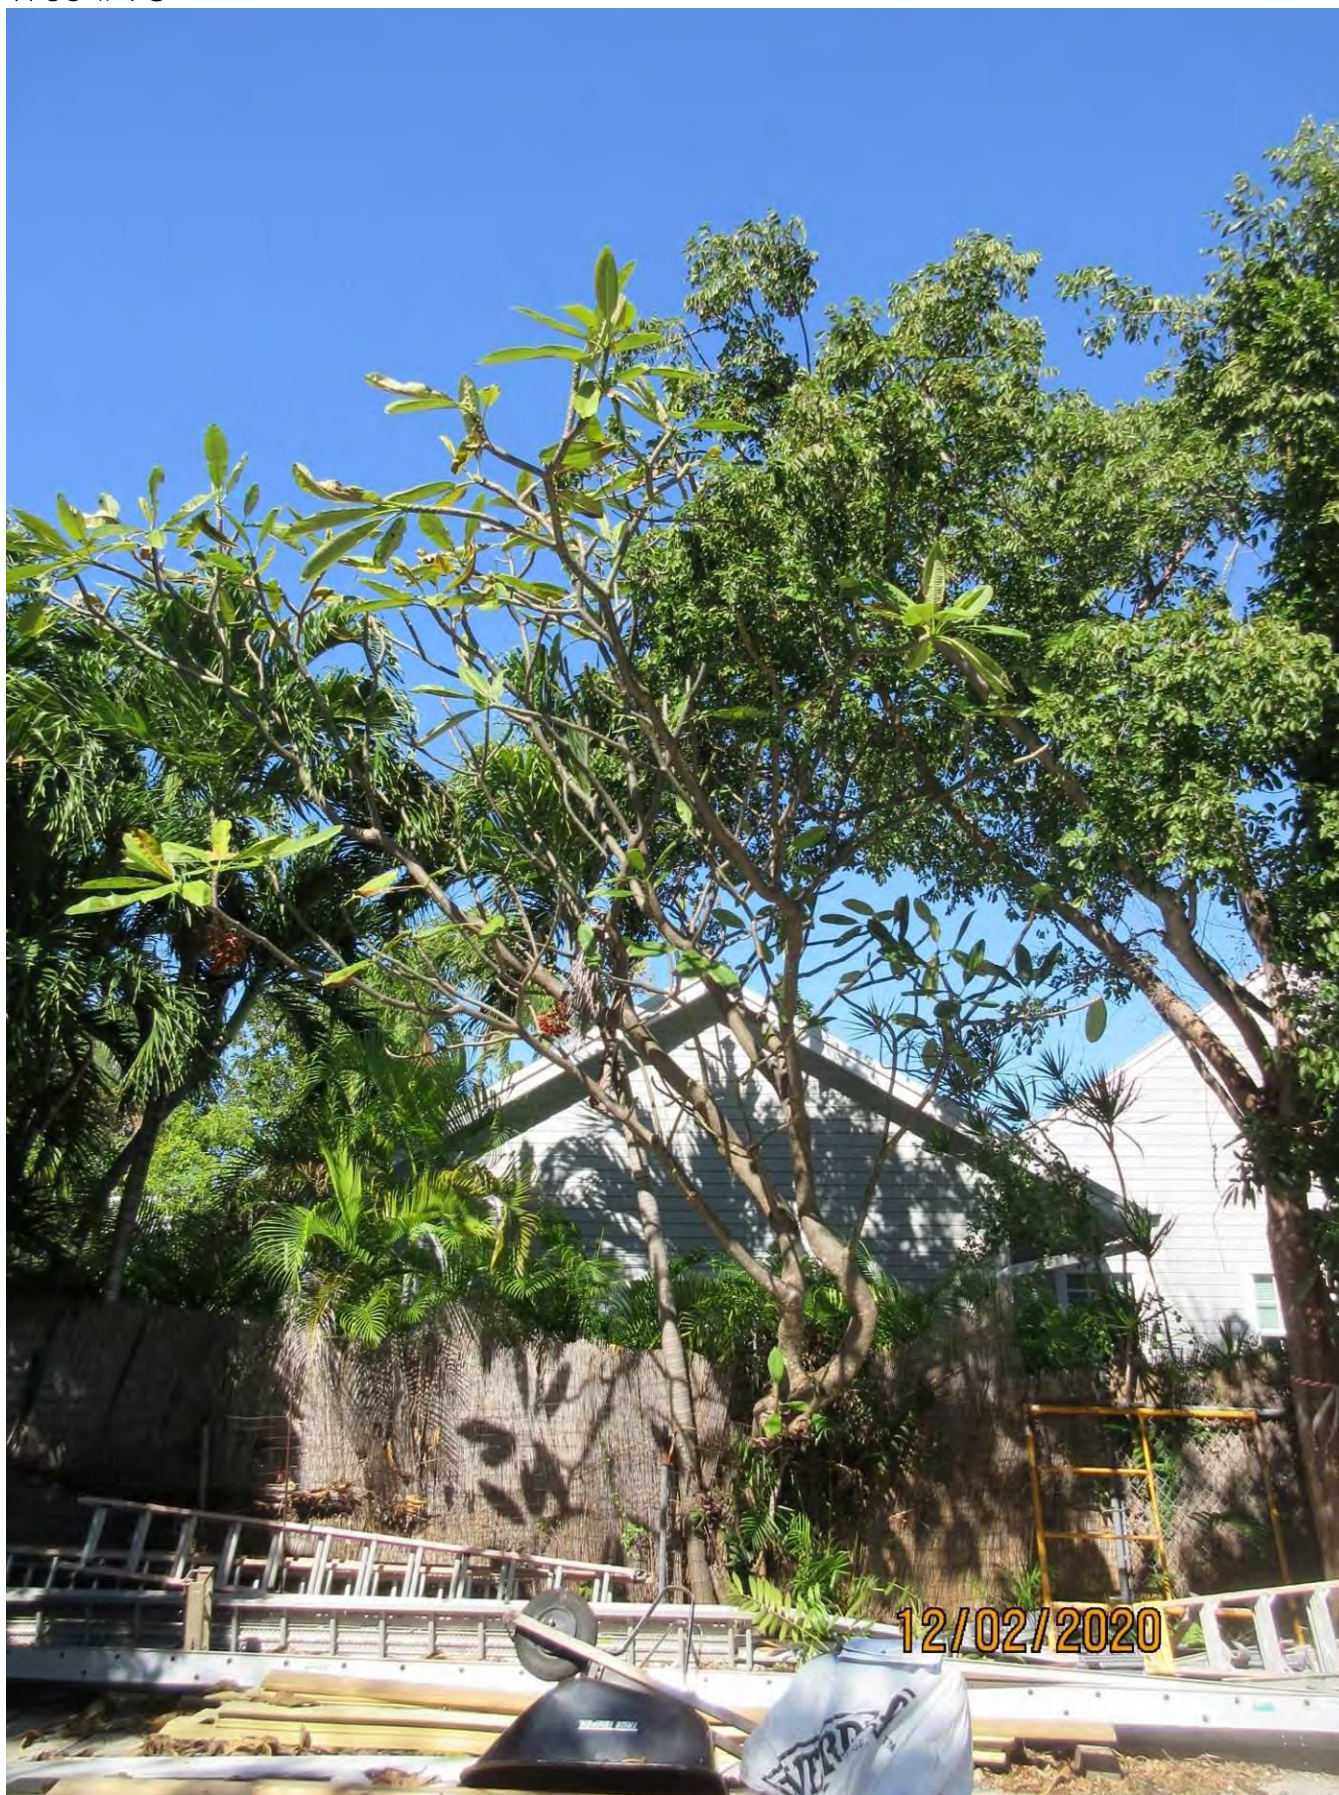
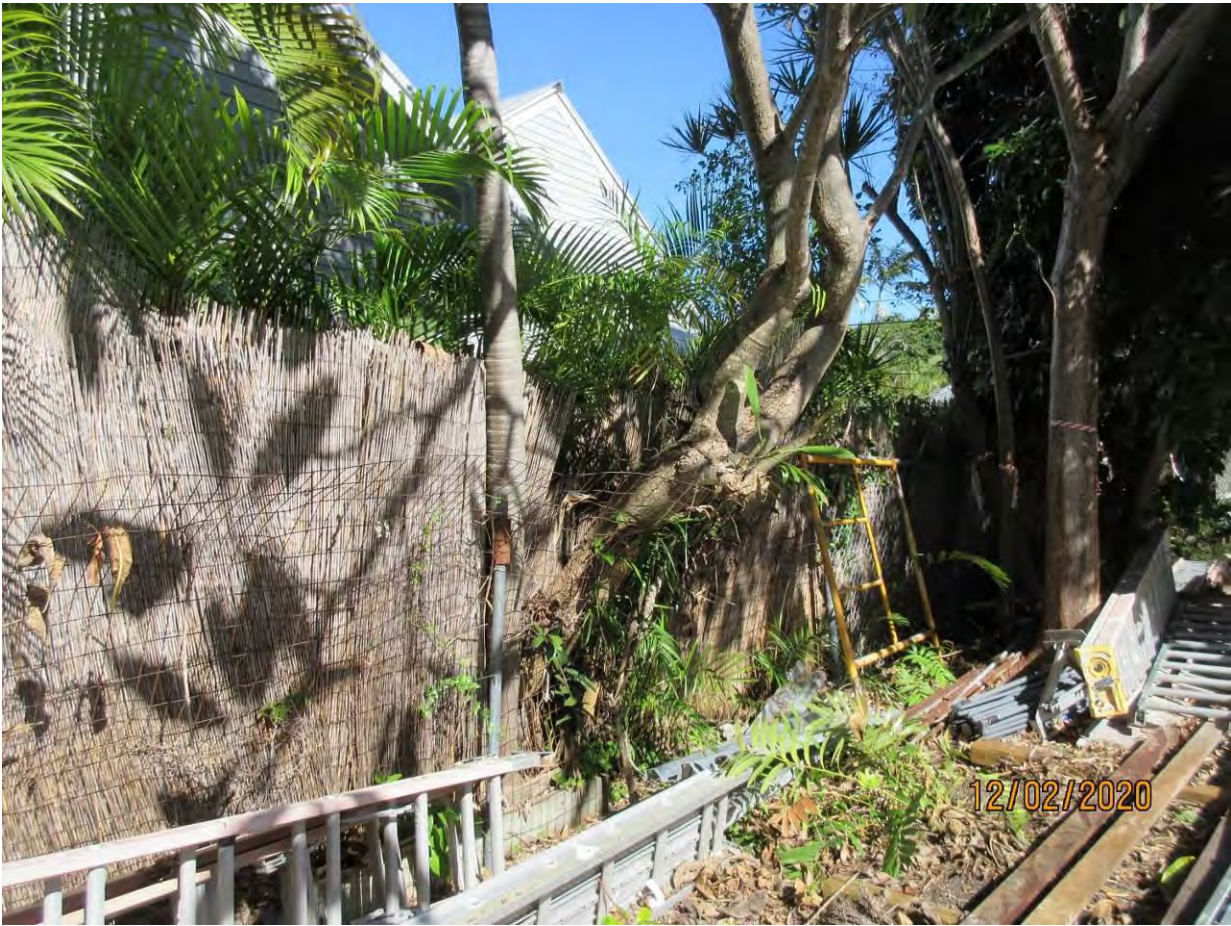
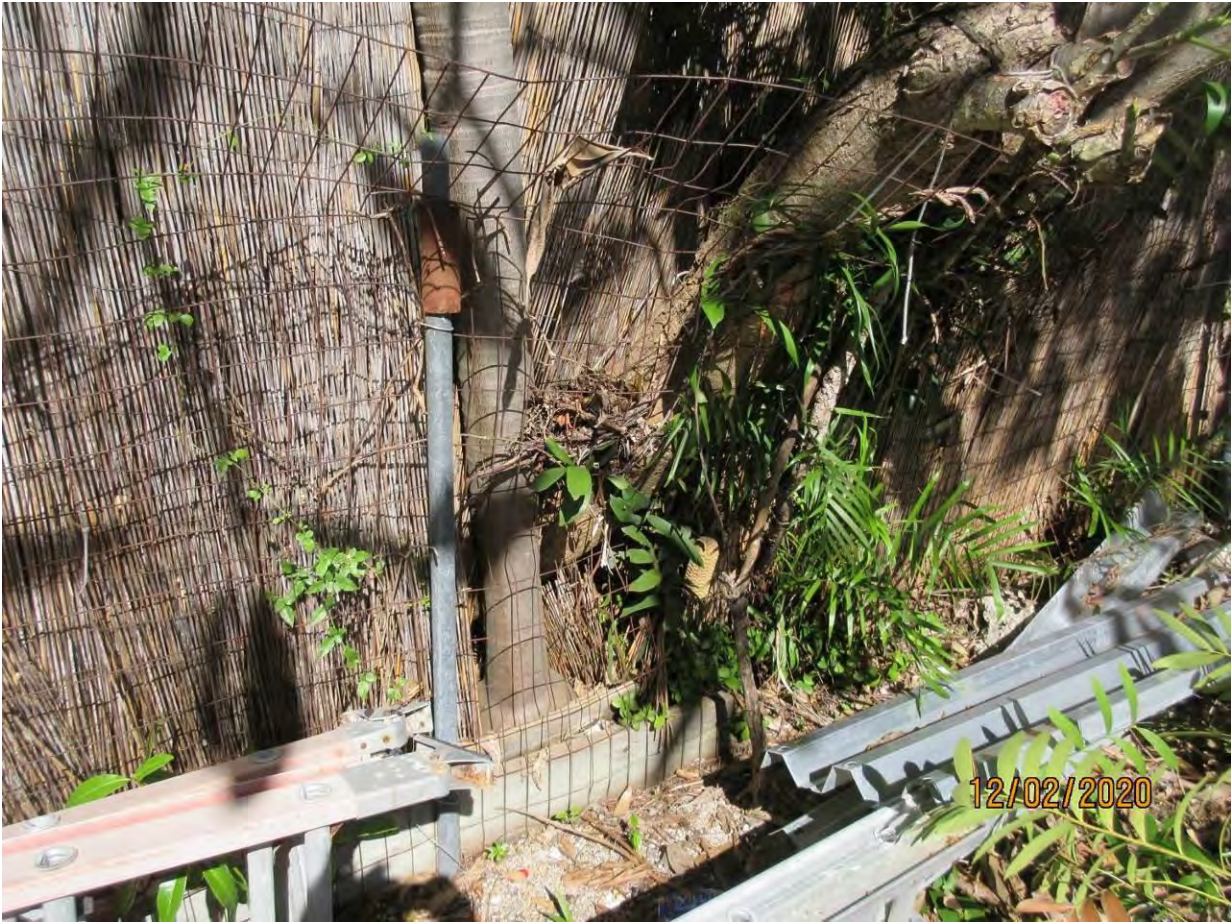
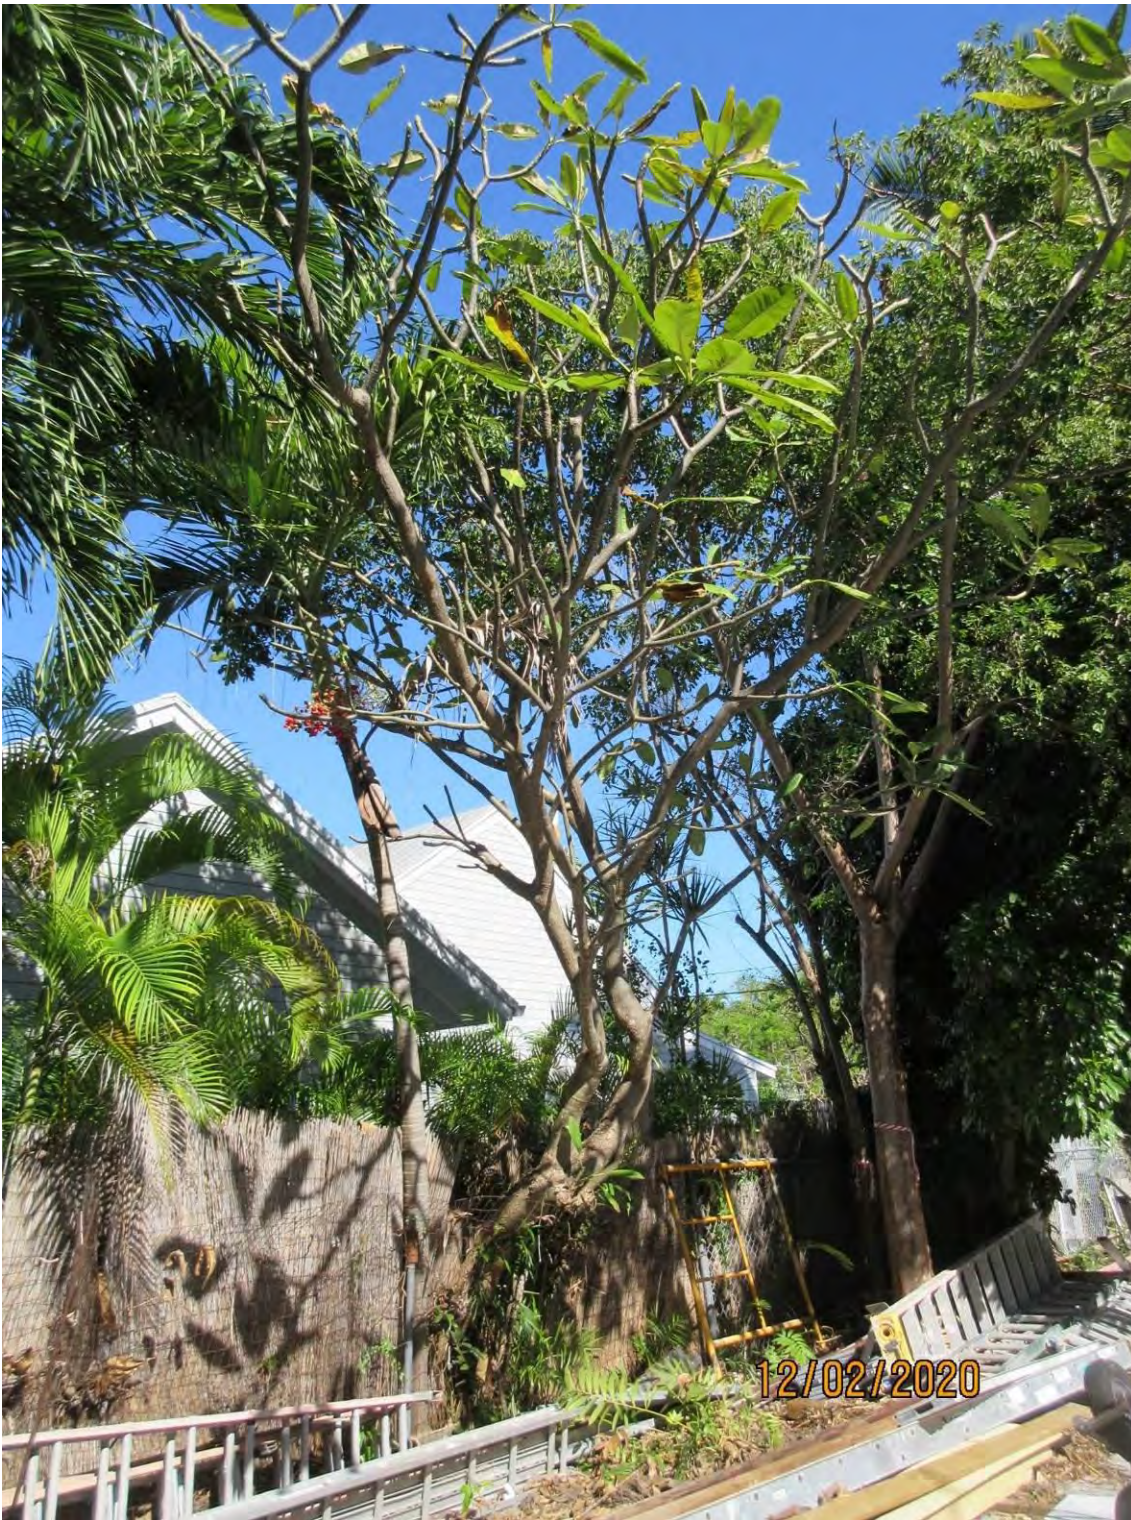
Tree #78 Diameter: 10.5"

Location: 40% (growing through a chain link fence on/near property line)

Species: 50% (not on protected or not protected tree list)

Condition: 40% (overall condition is fair to poor, trunk has growth lean and lopsided canopy with damage from fence. Could not see base of tree)

Total Average Value = 43%

Value x Diameter = 4.5 replacement caliper inches
