Tree Species: Gumbo Limbo (*Bursera simaruba*)
Tree #80 and #81

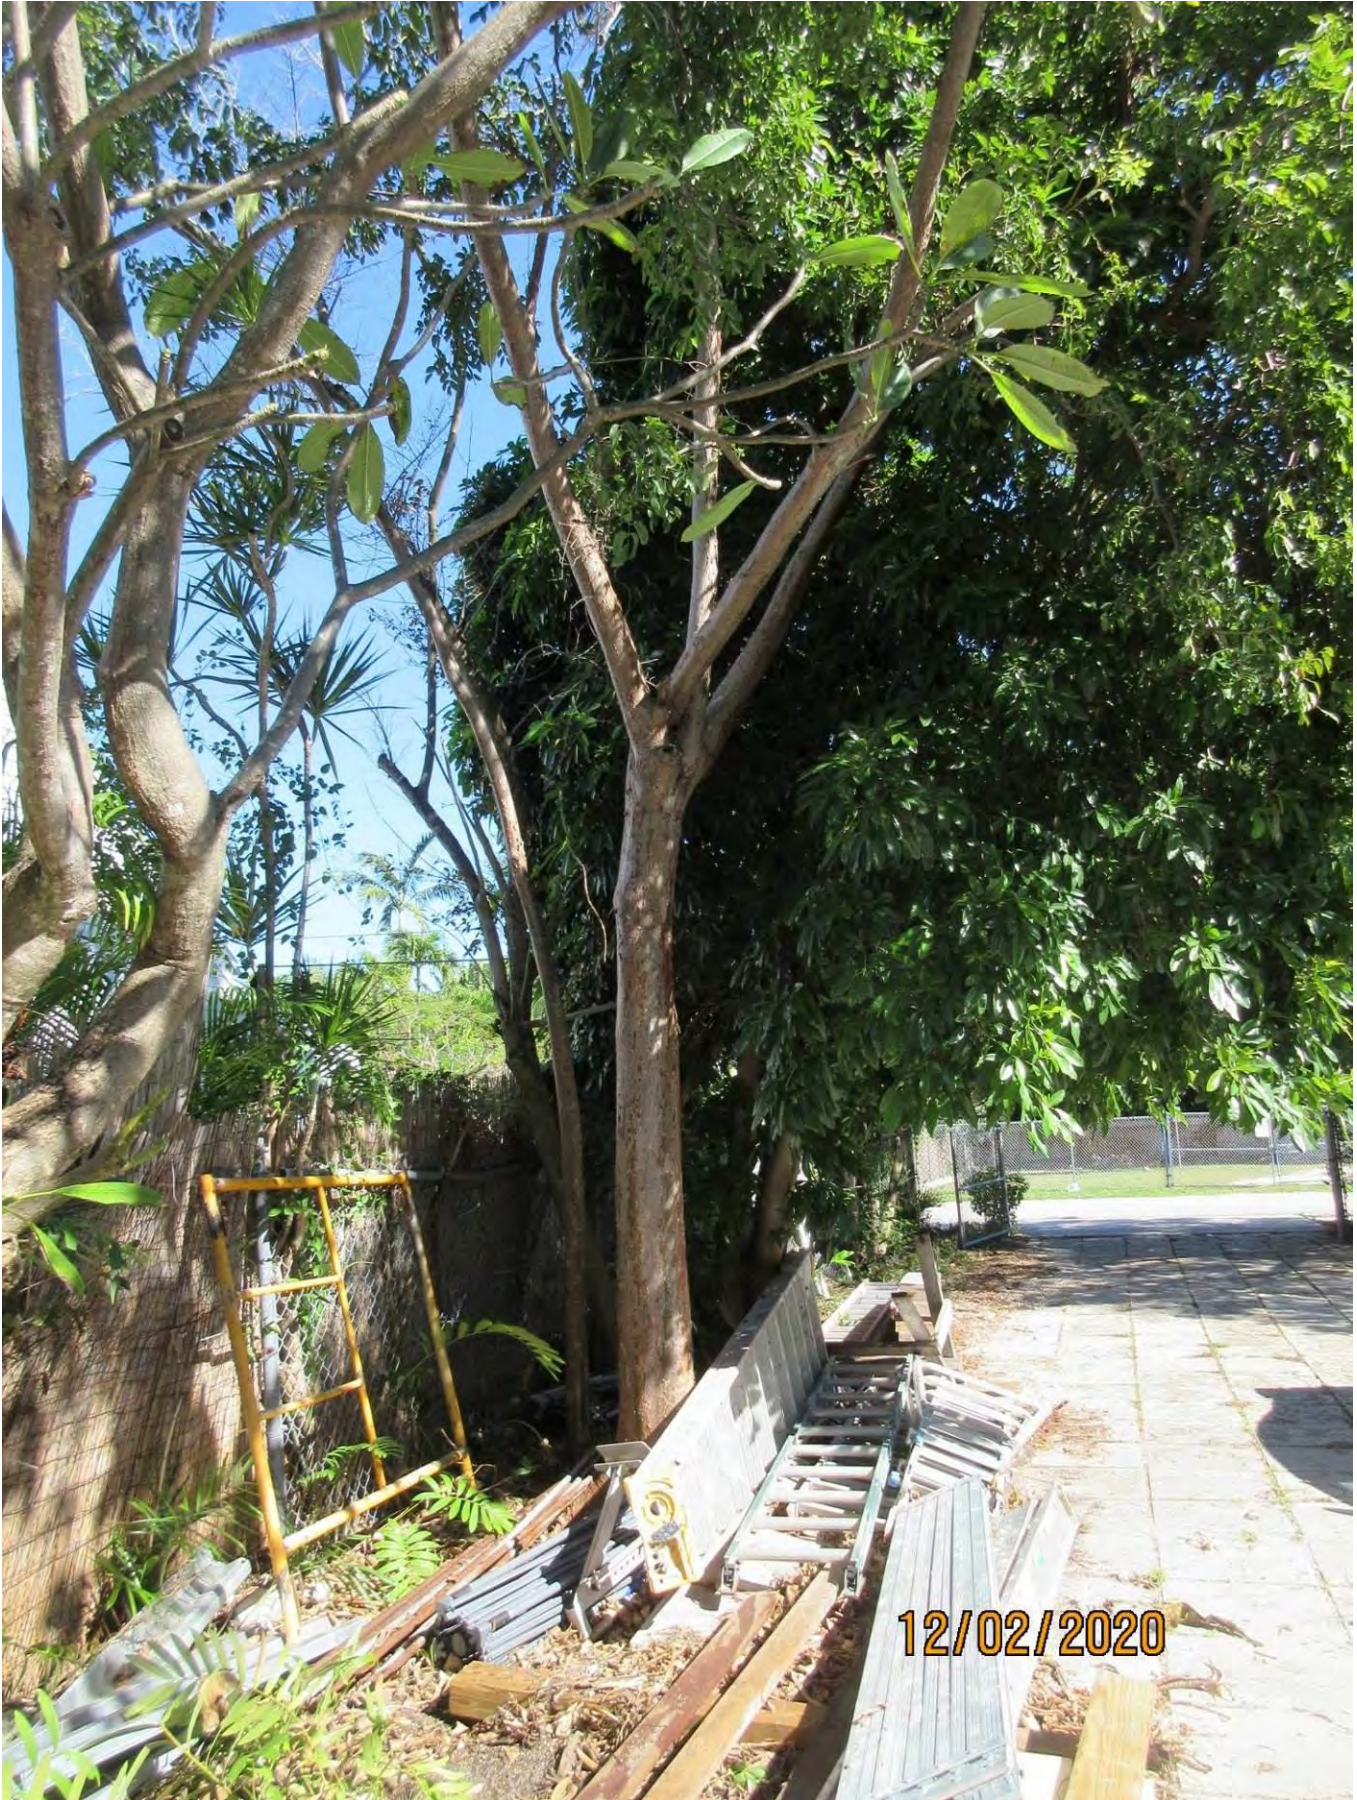
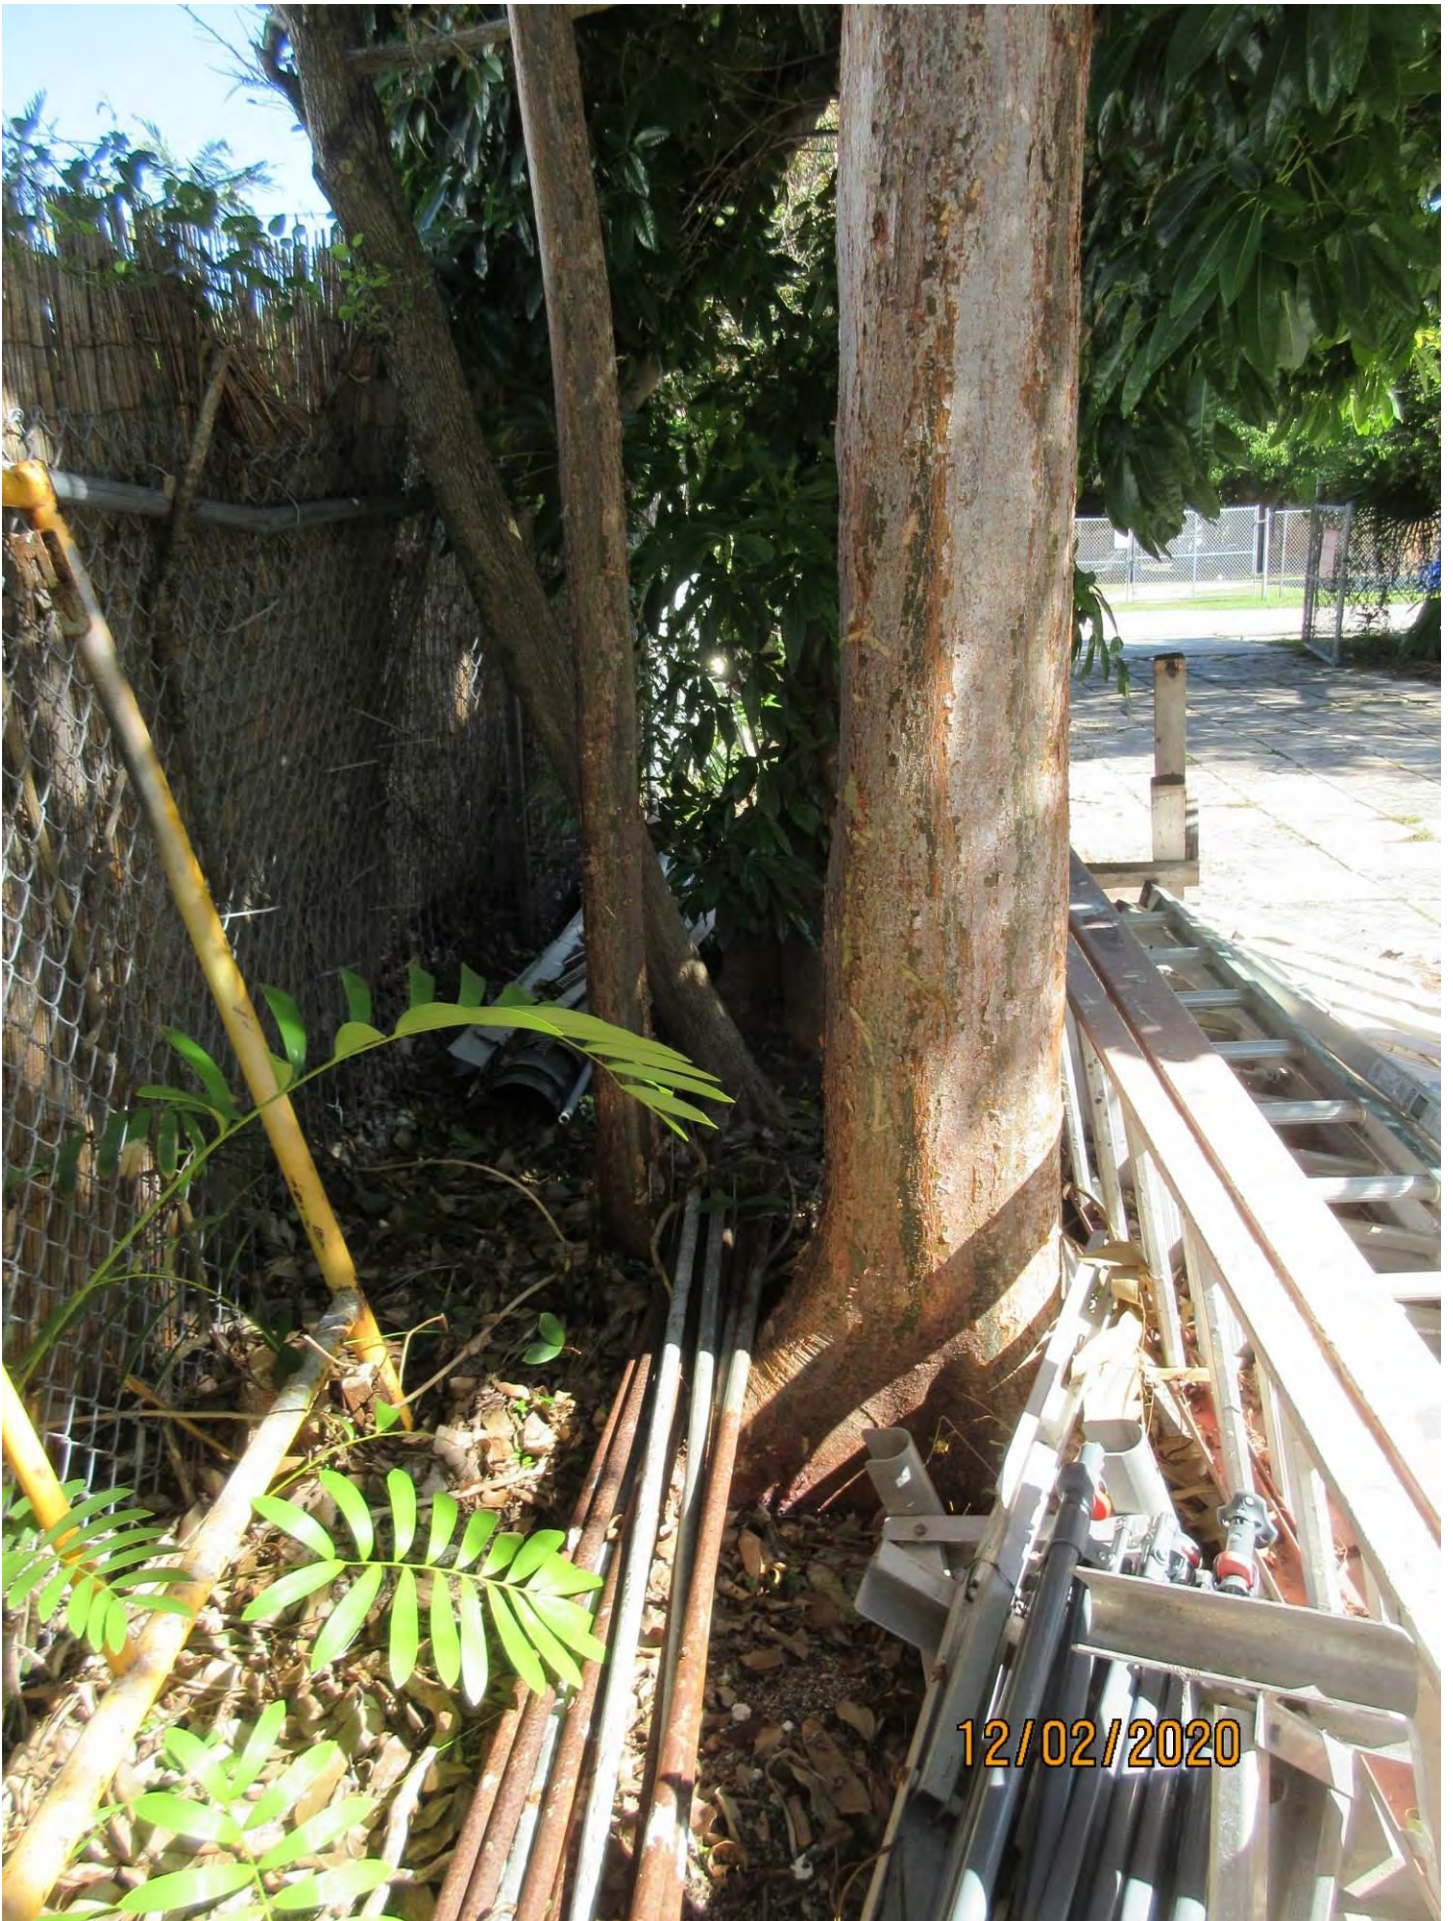
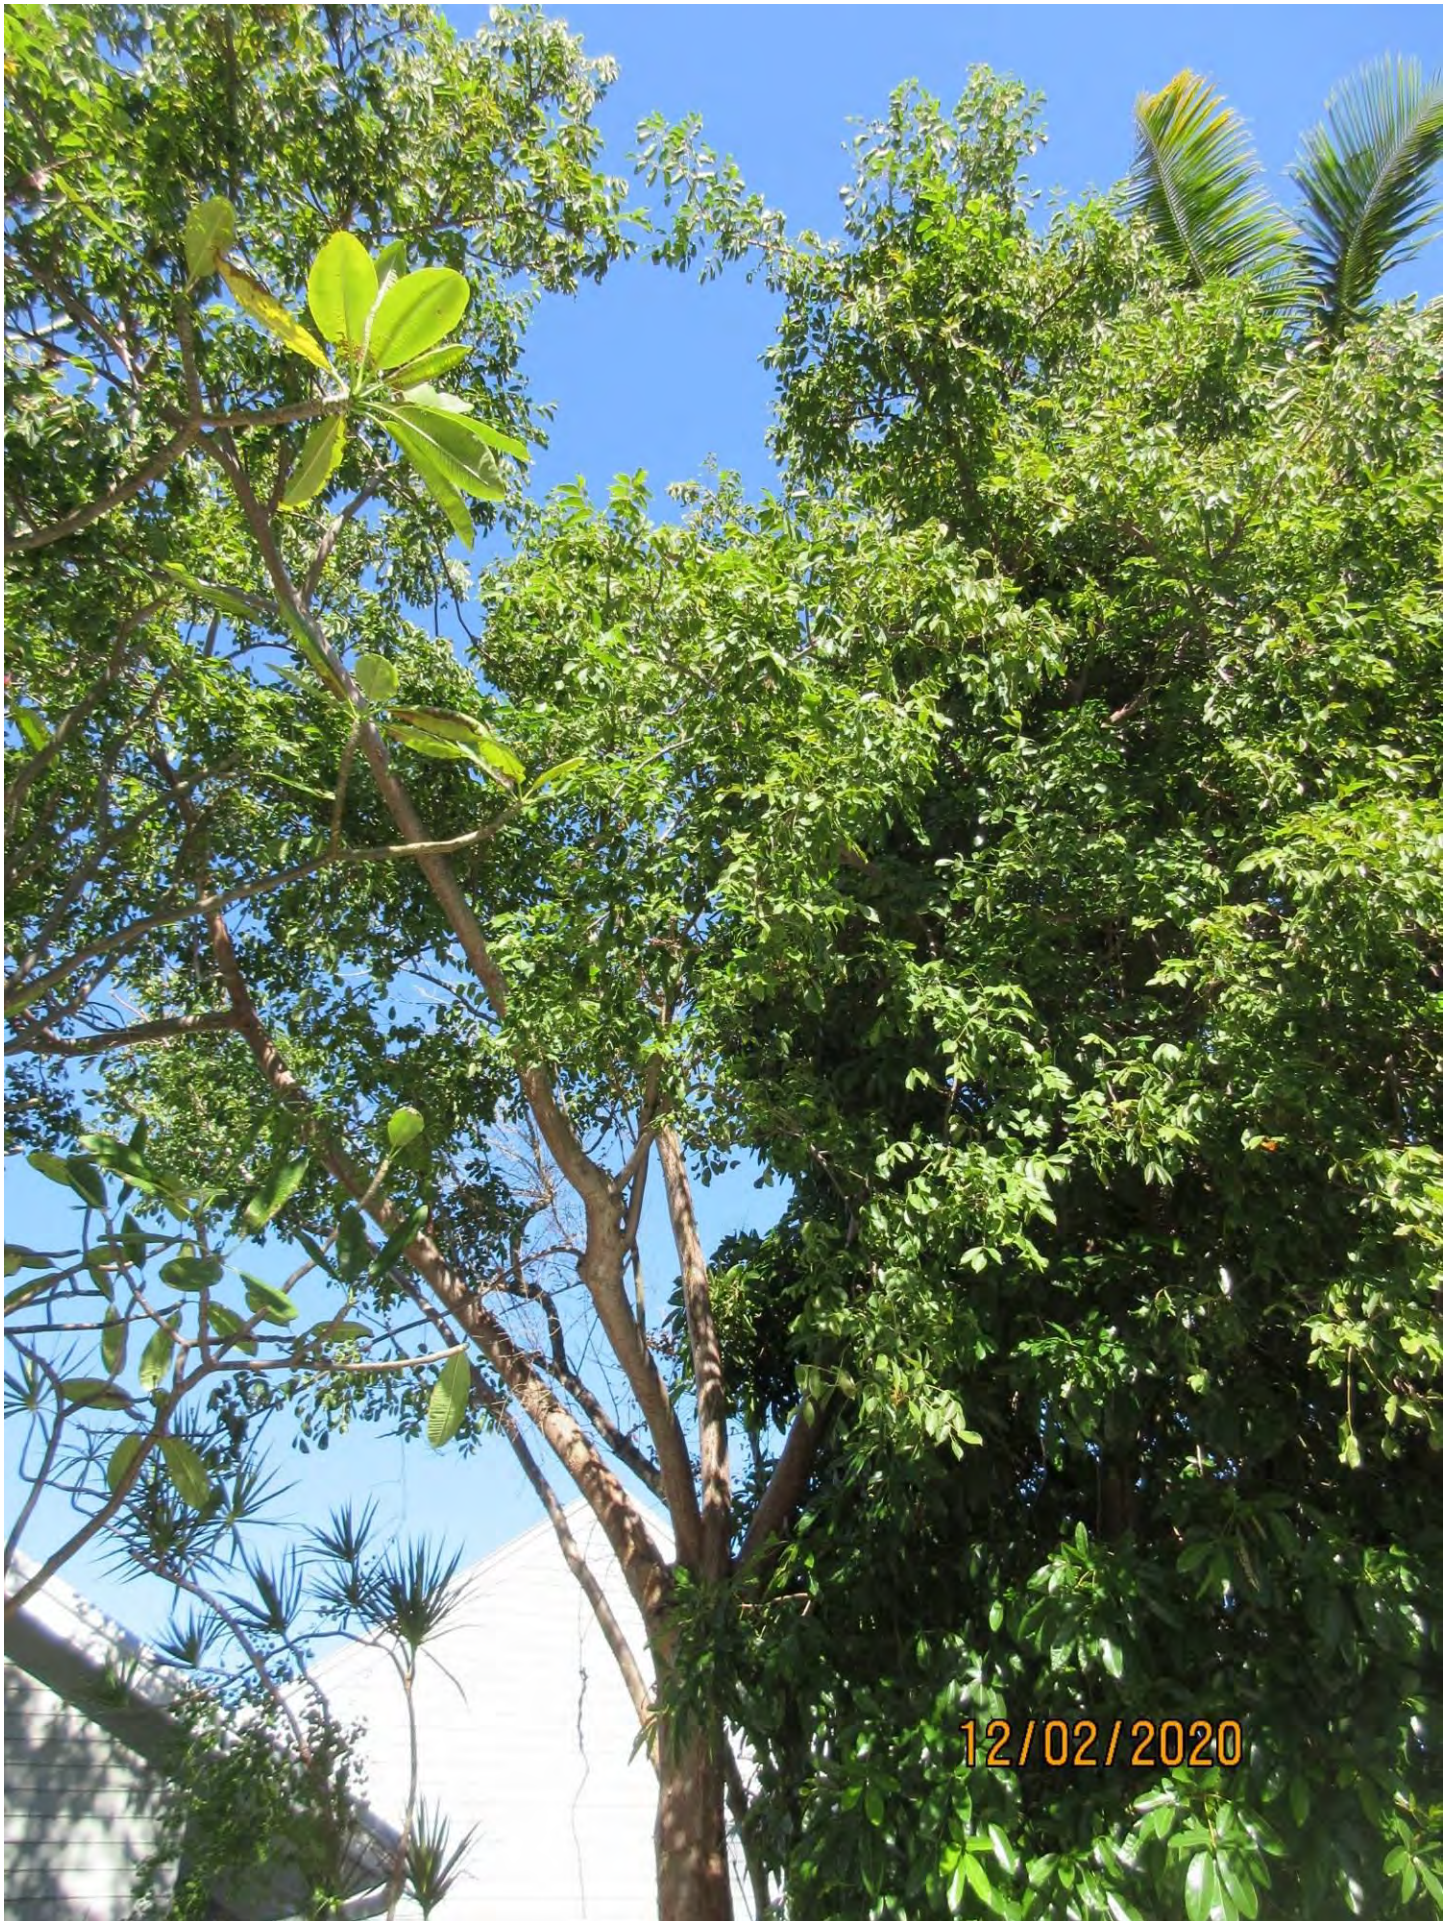
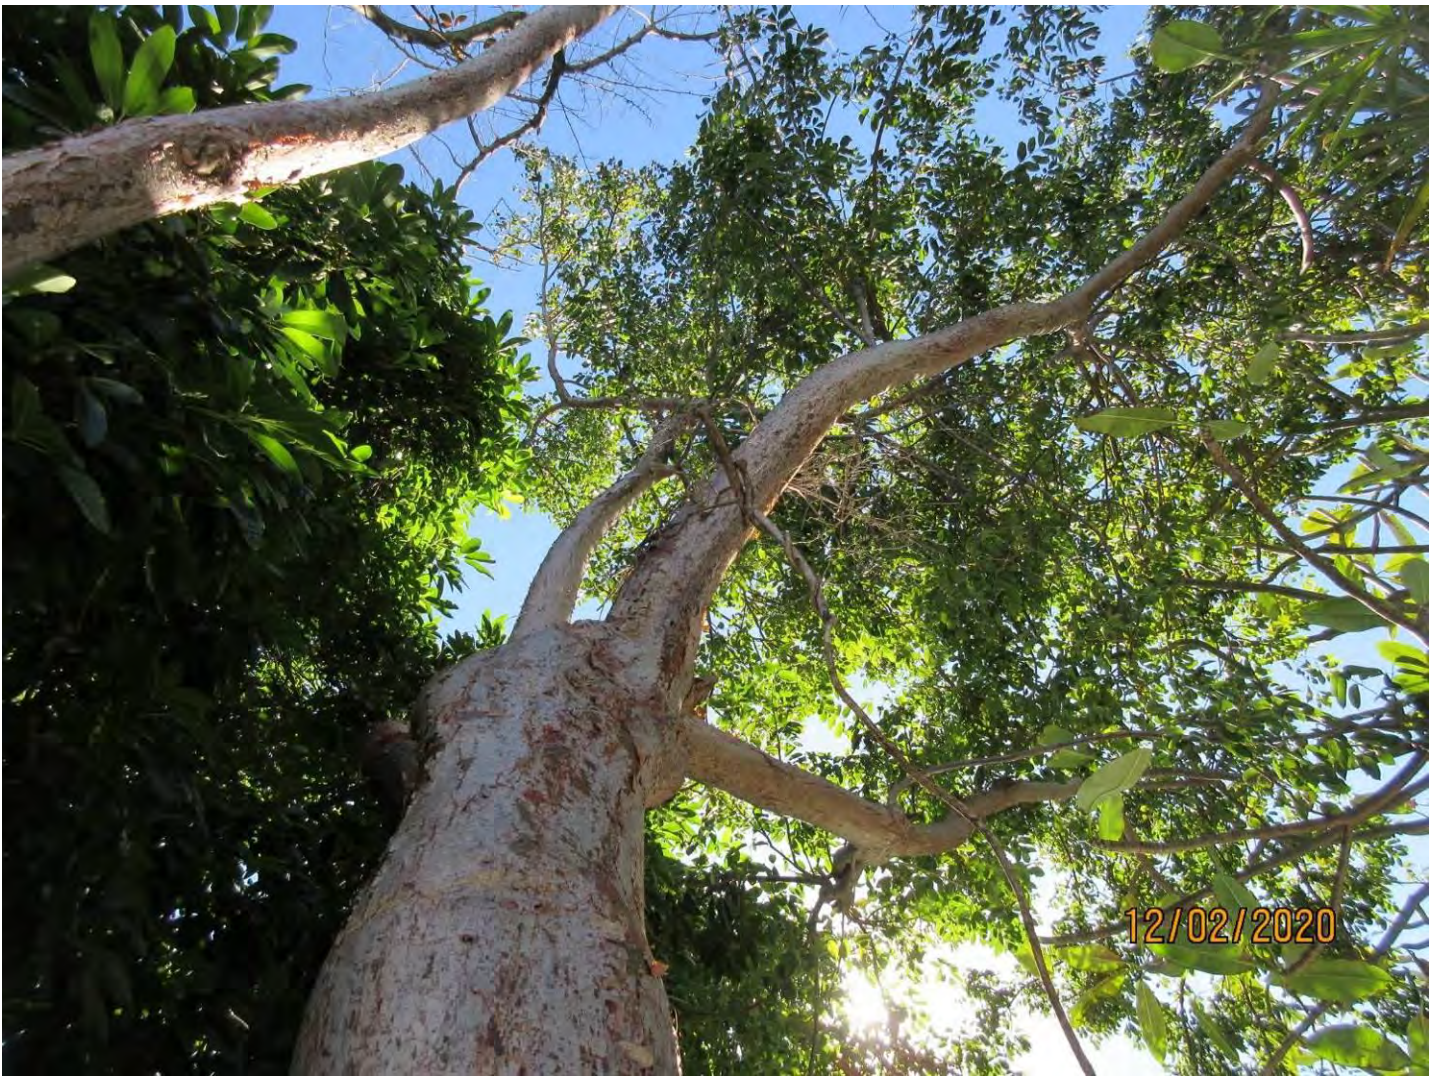
Tree #80 Diameter: 10.6"

Location: 80%

Condition: 50% (overall condition is fair to poor, poor canopy branch structure)

Value x Diameter = 8 replacement caliper inches

Tree #81 Diameter: 3.3"

Location: 60% (growing close to larger tree)

Condition: 40% (overall condition is poor, limited canopy growth)

Value x Diameter = 2.1 replacement caliper inches

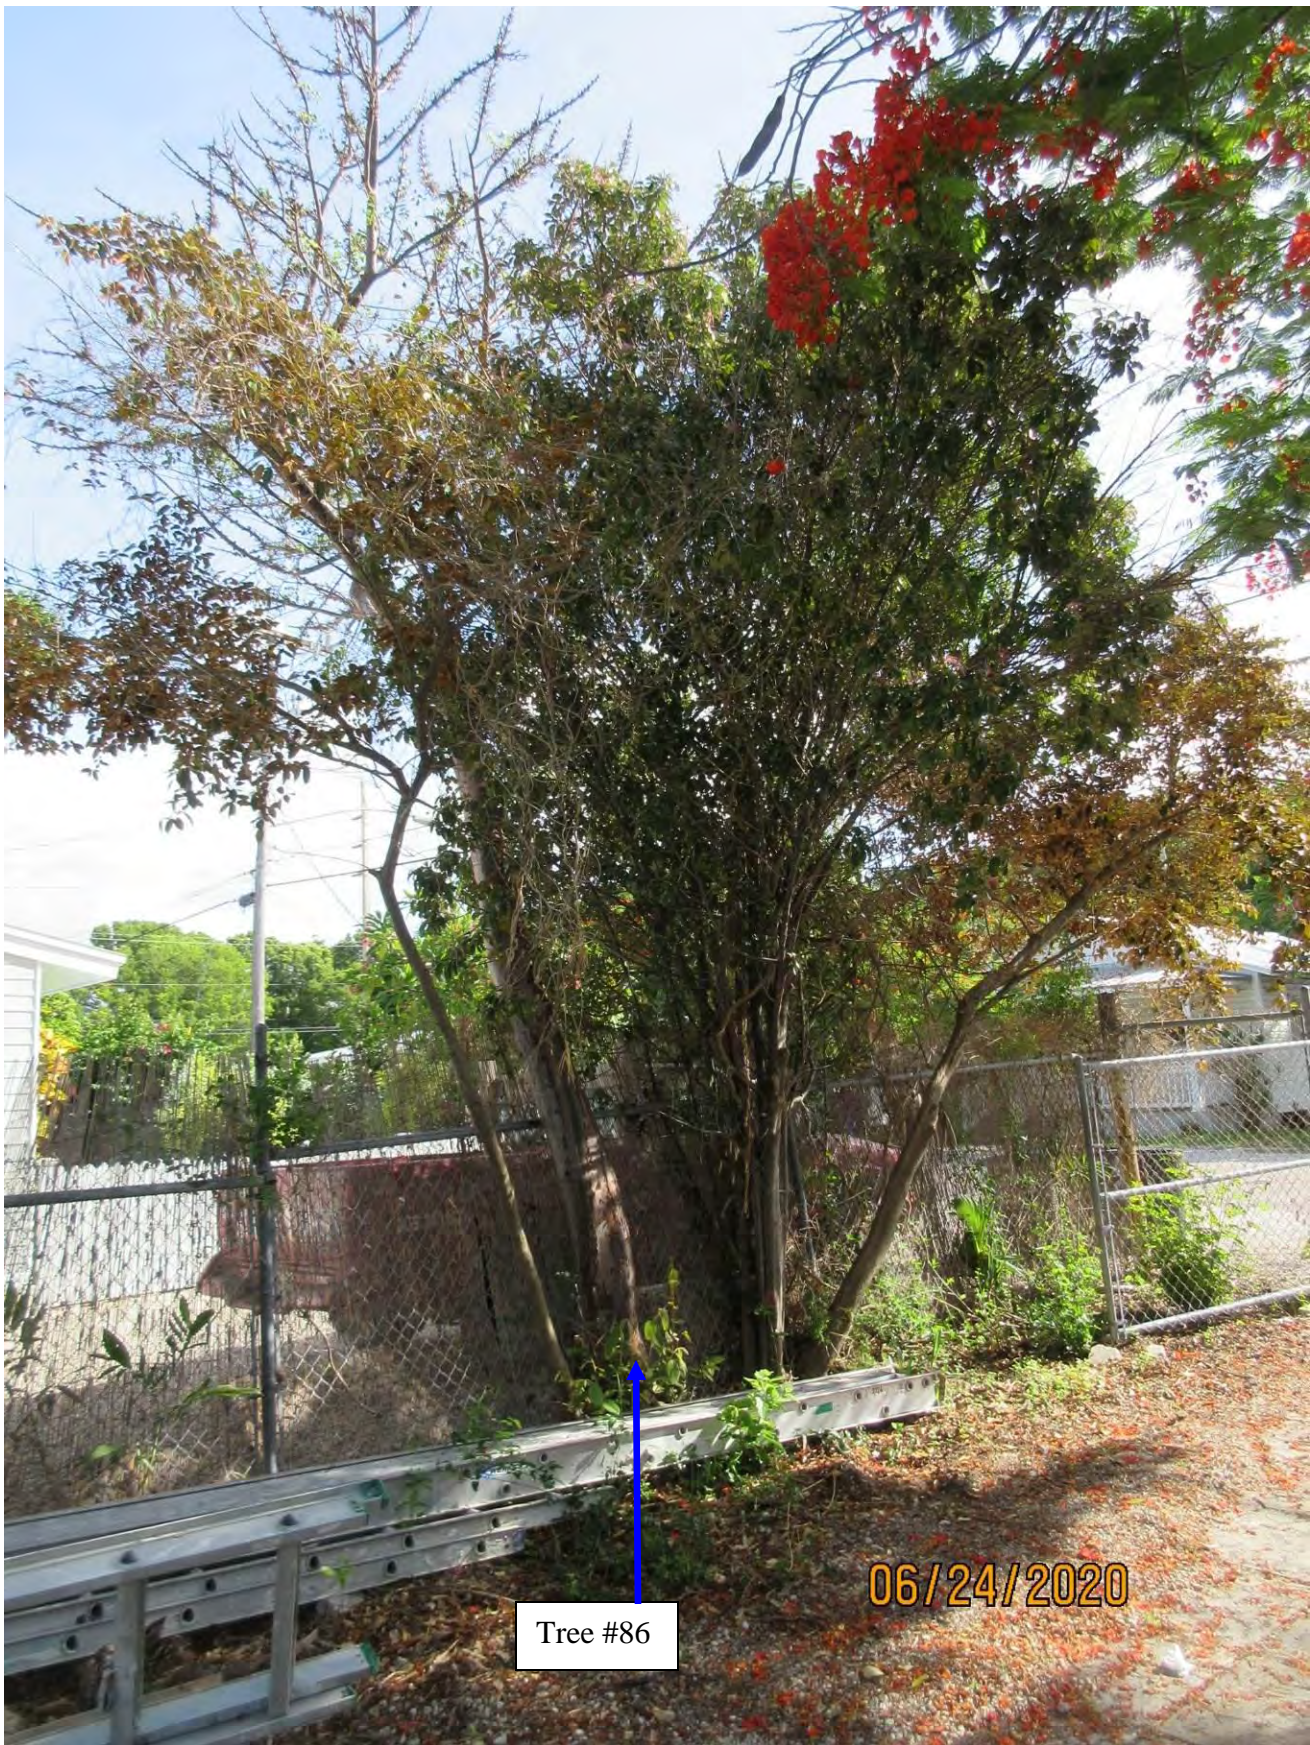
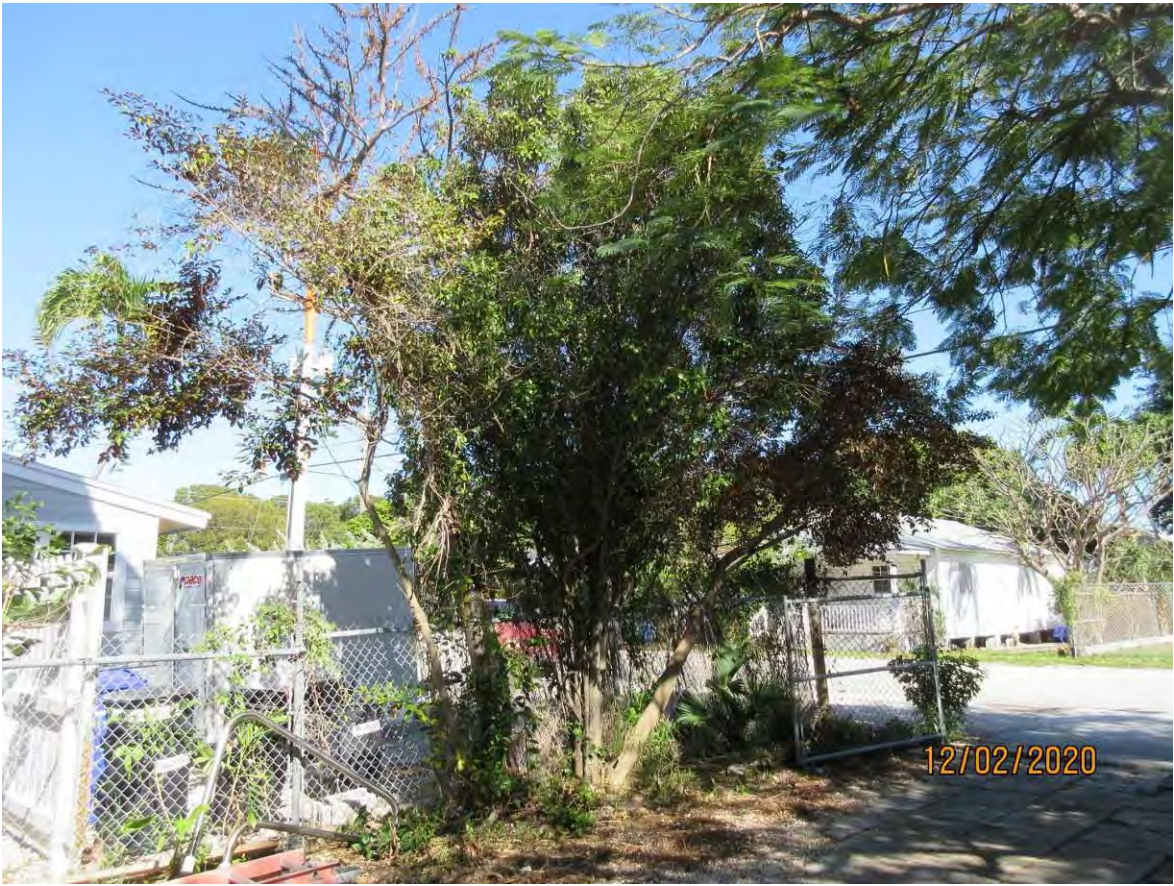
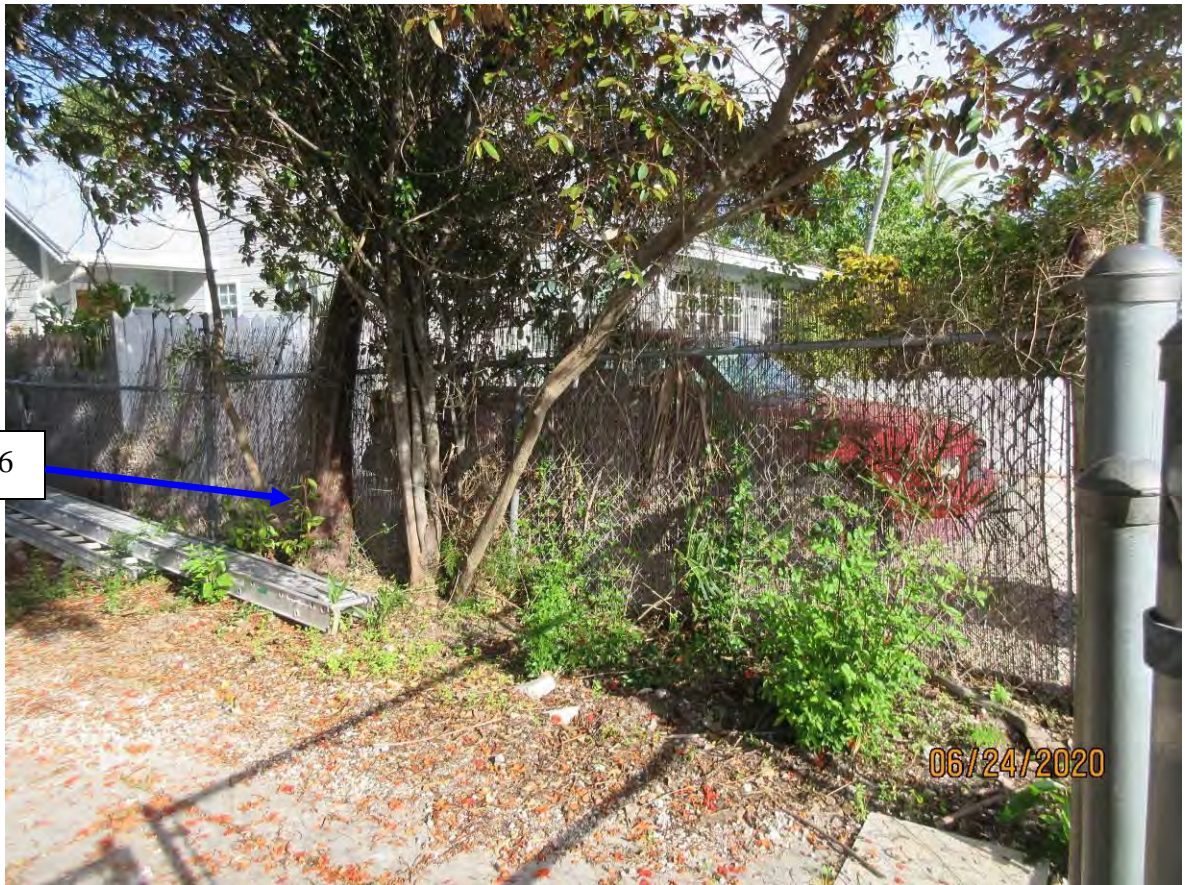
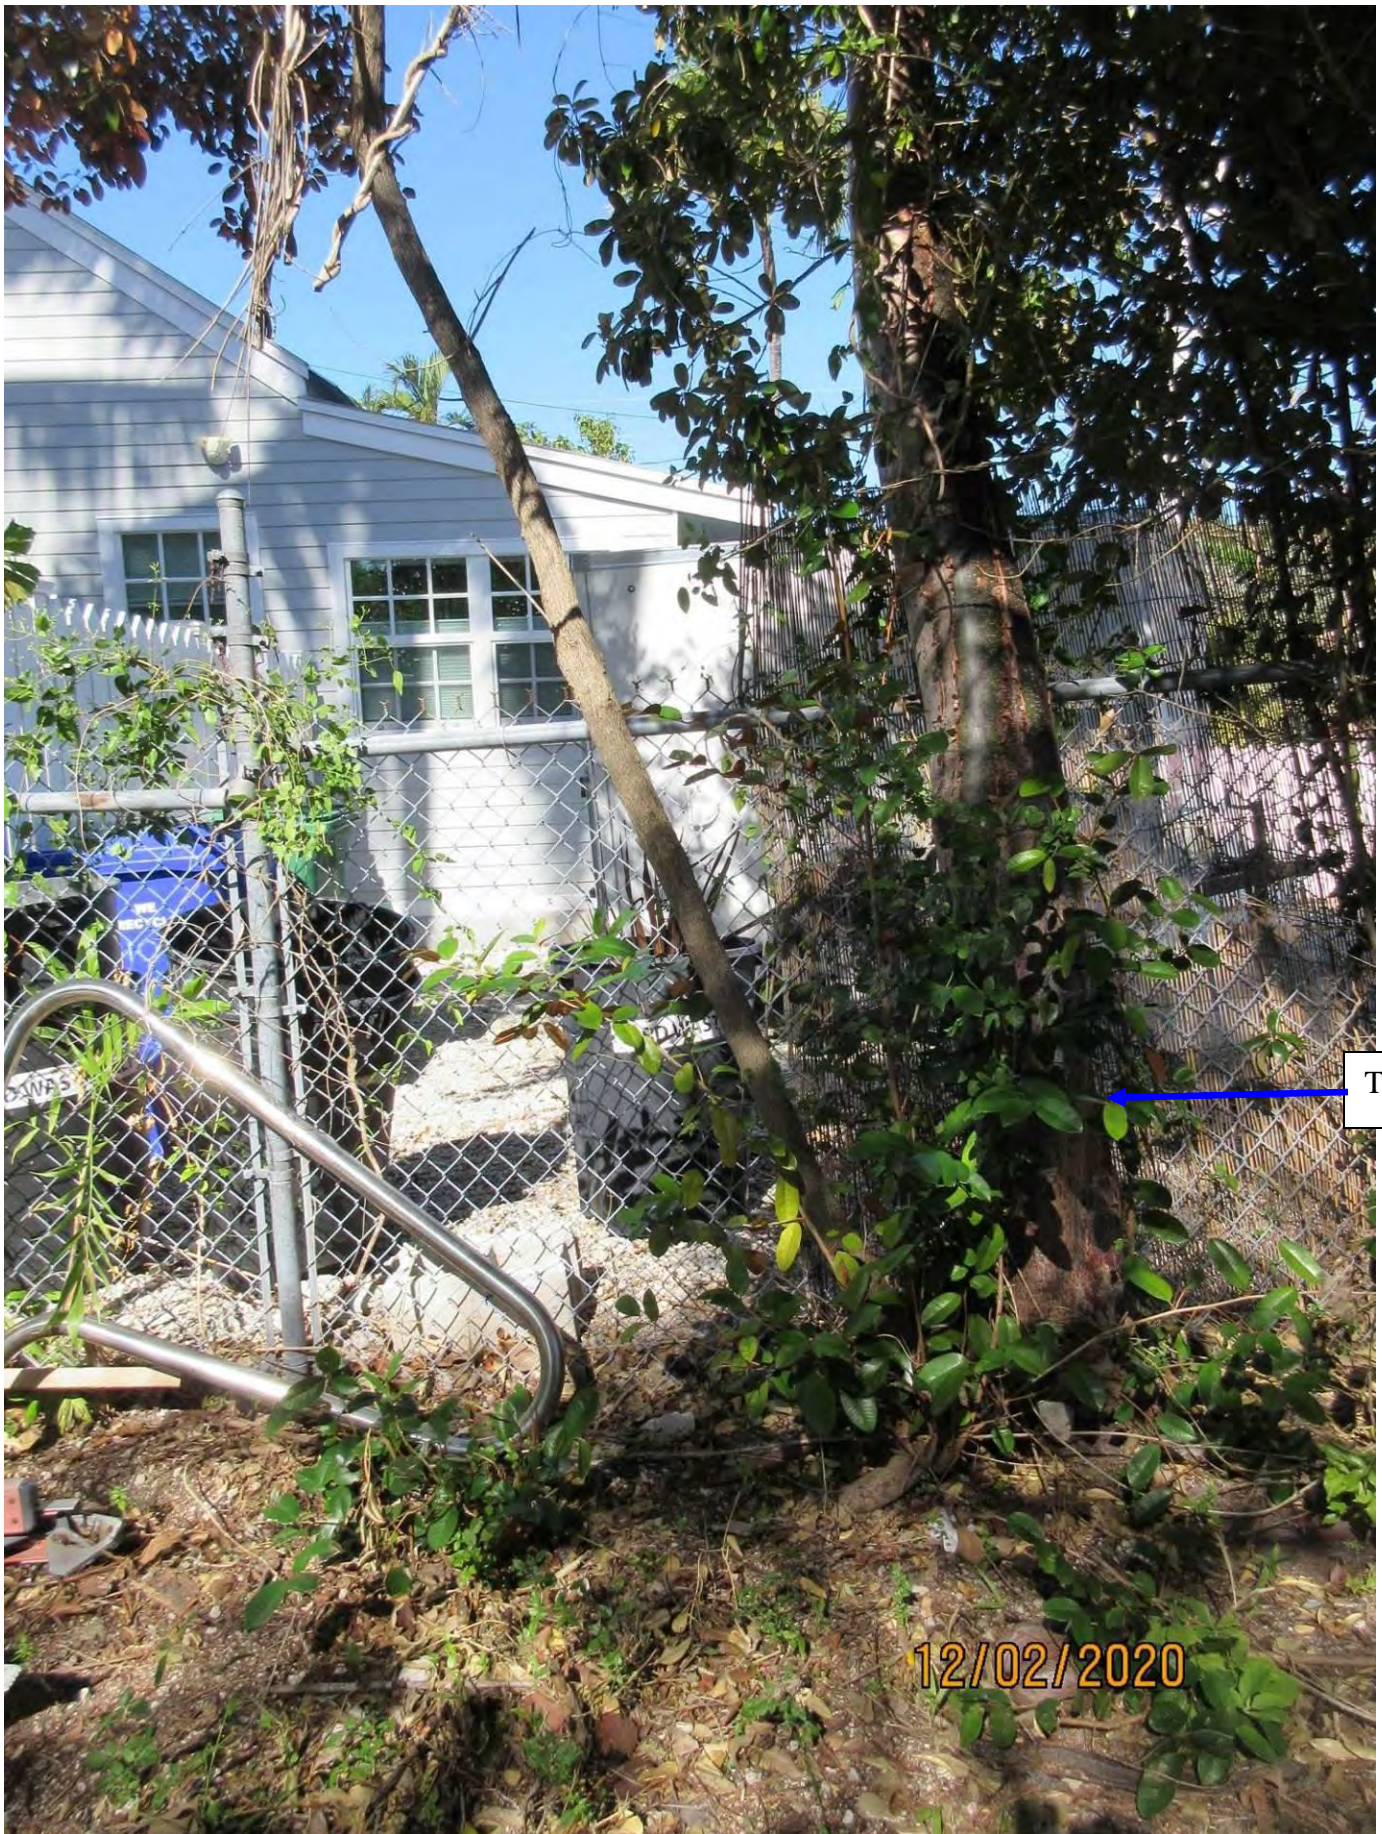
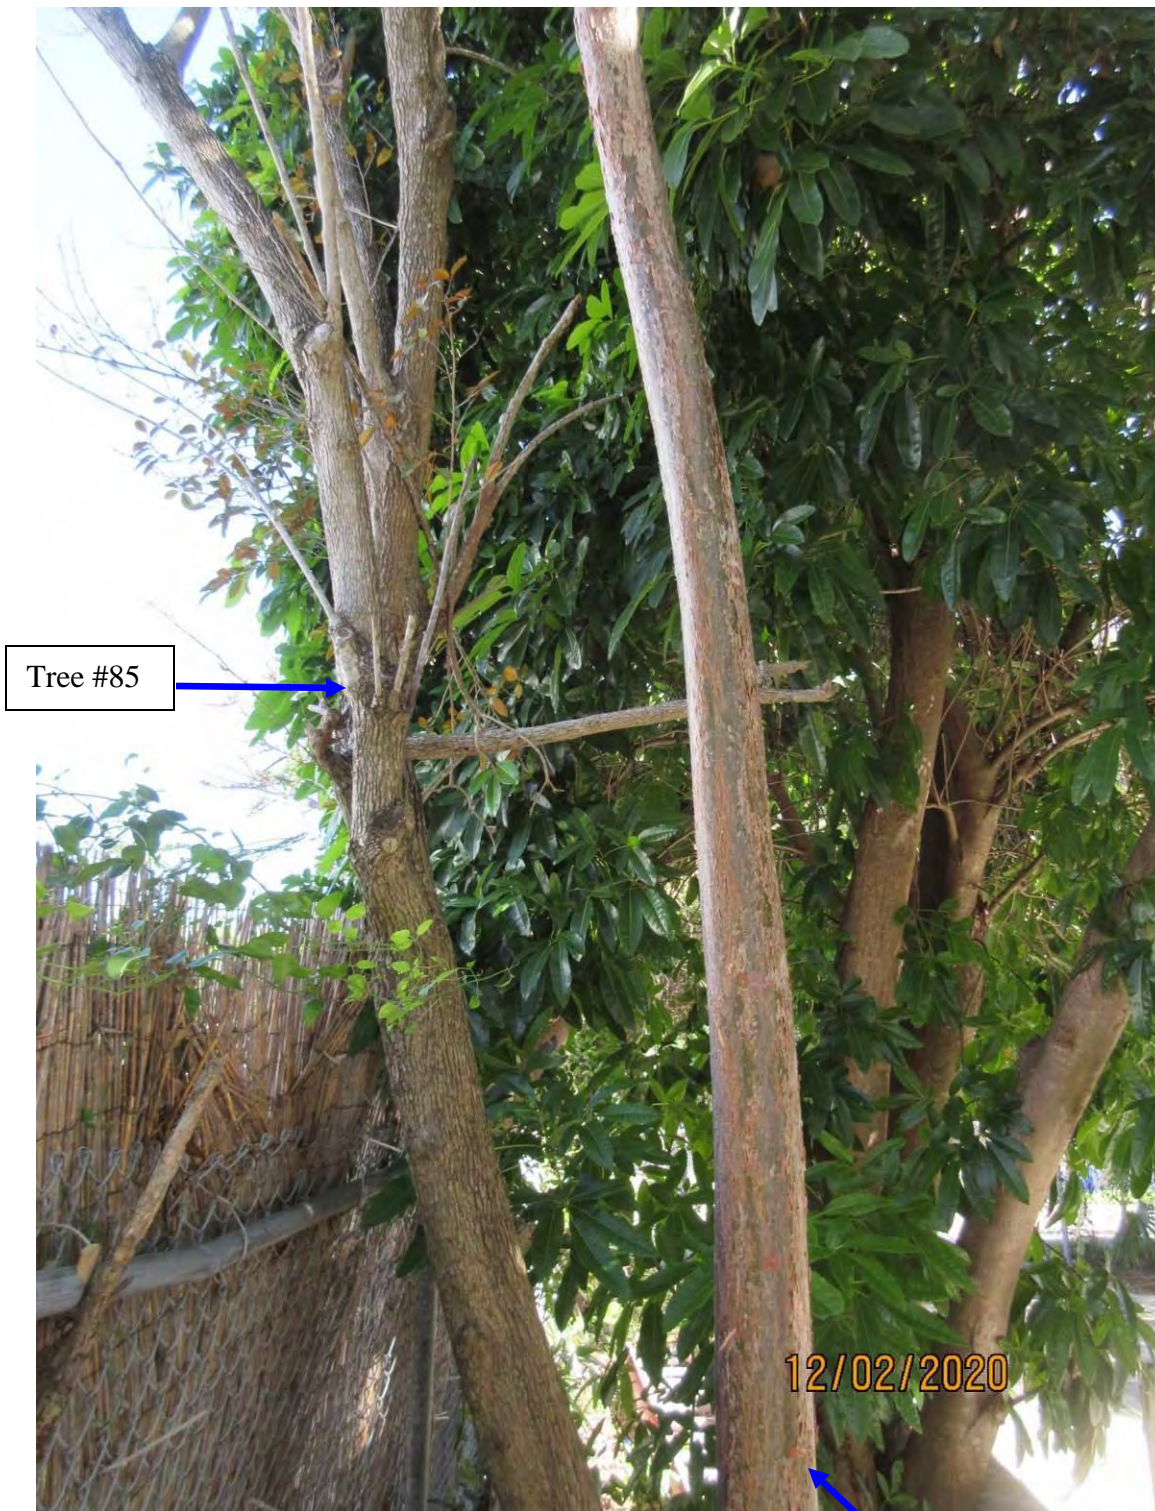
Tree #86 Diameter: 9.5"

Location: 60% (growing with other canopy trees, growth impacted by other canopies, appears canopy also has bud mites).

Condition: 40% (overall condition is fair to poor, trunk has growth lean and canopy has a pest issue)

Value x Diameter = 6.2 replacement caliper inches
