Tree Species: Gumbo Limbo (*Bursera simaruba*)
Tree #80 and #81

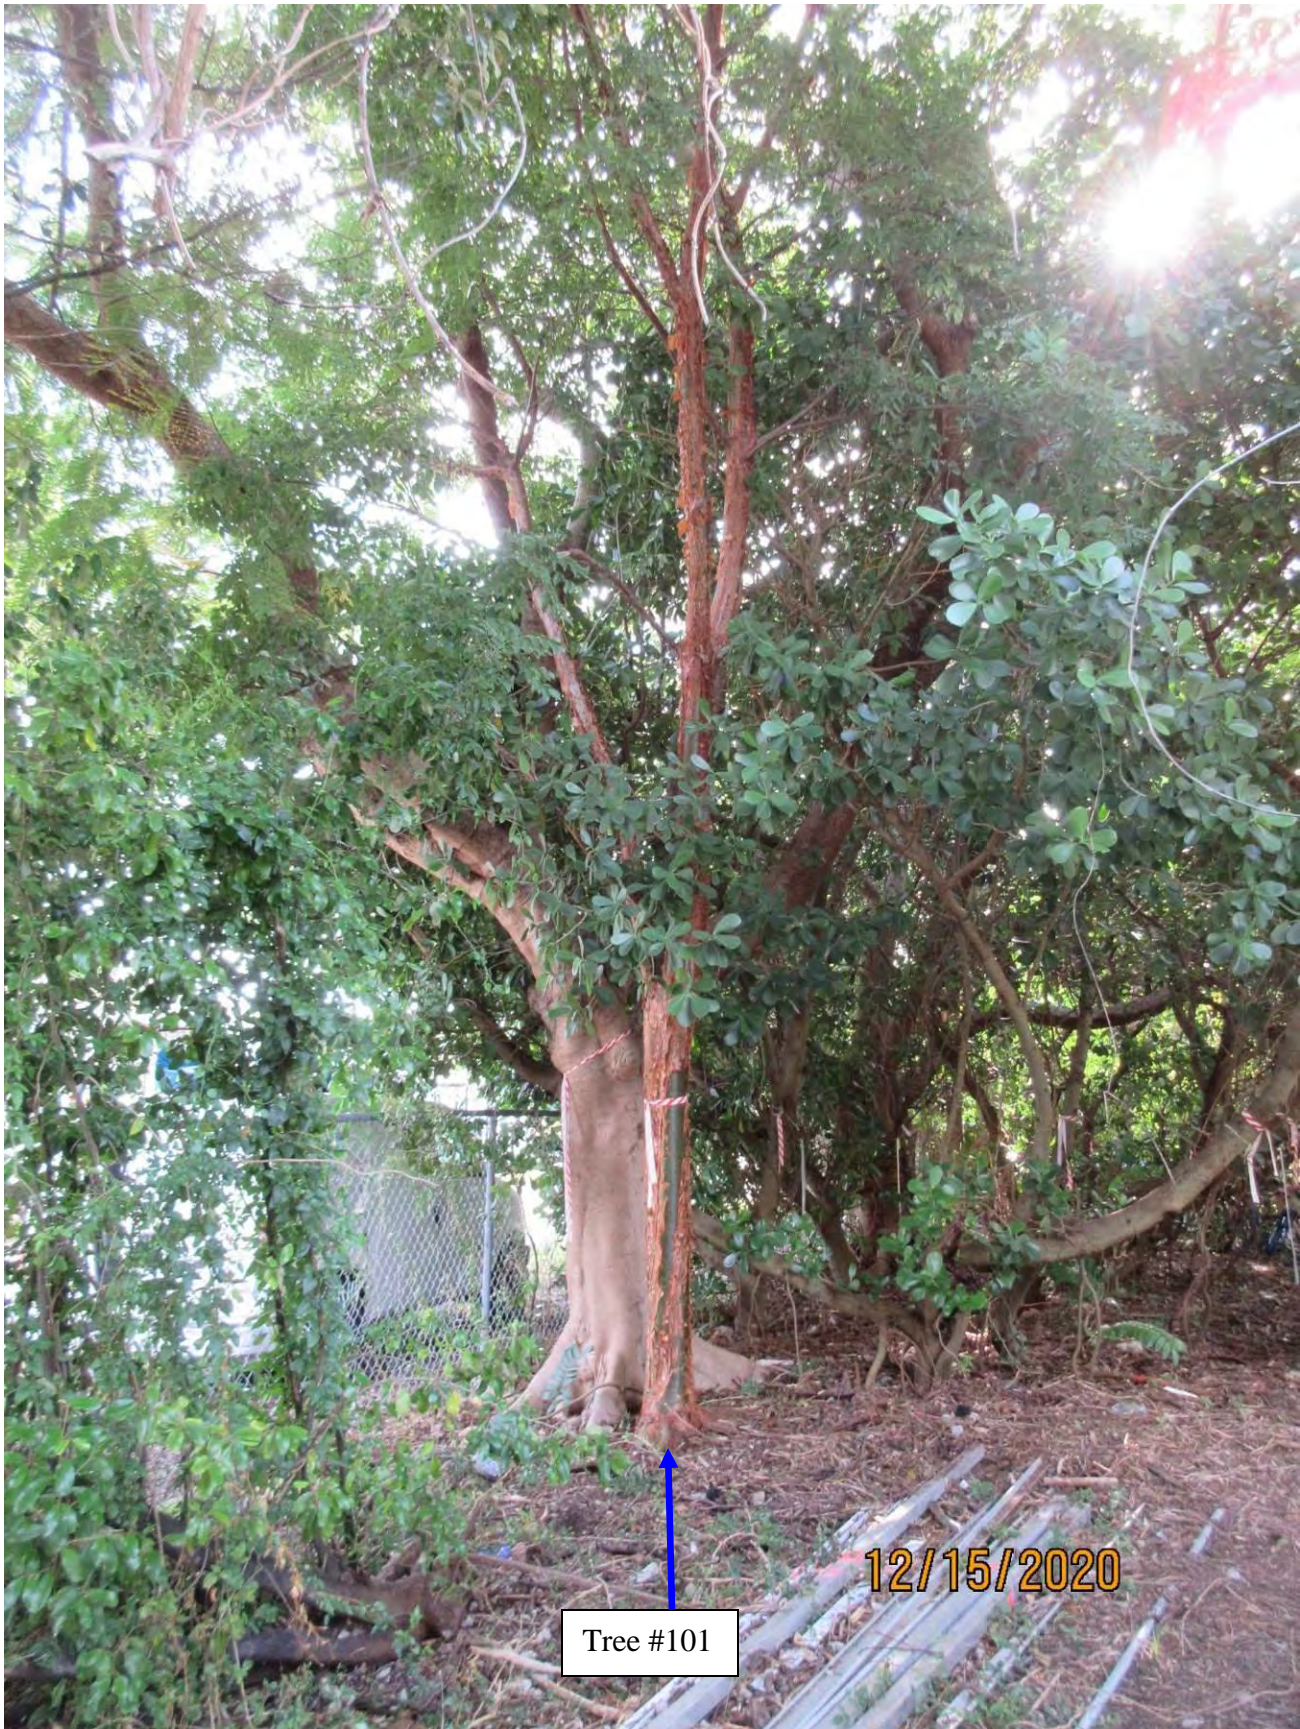
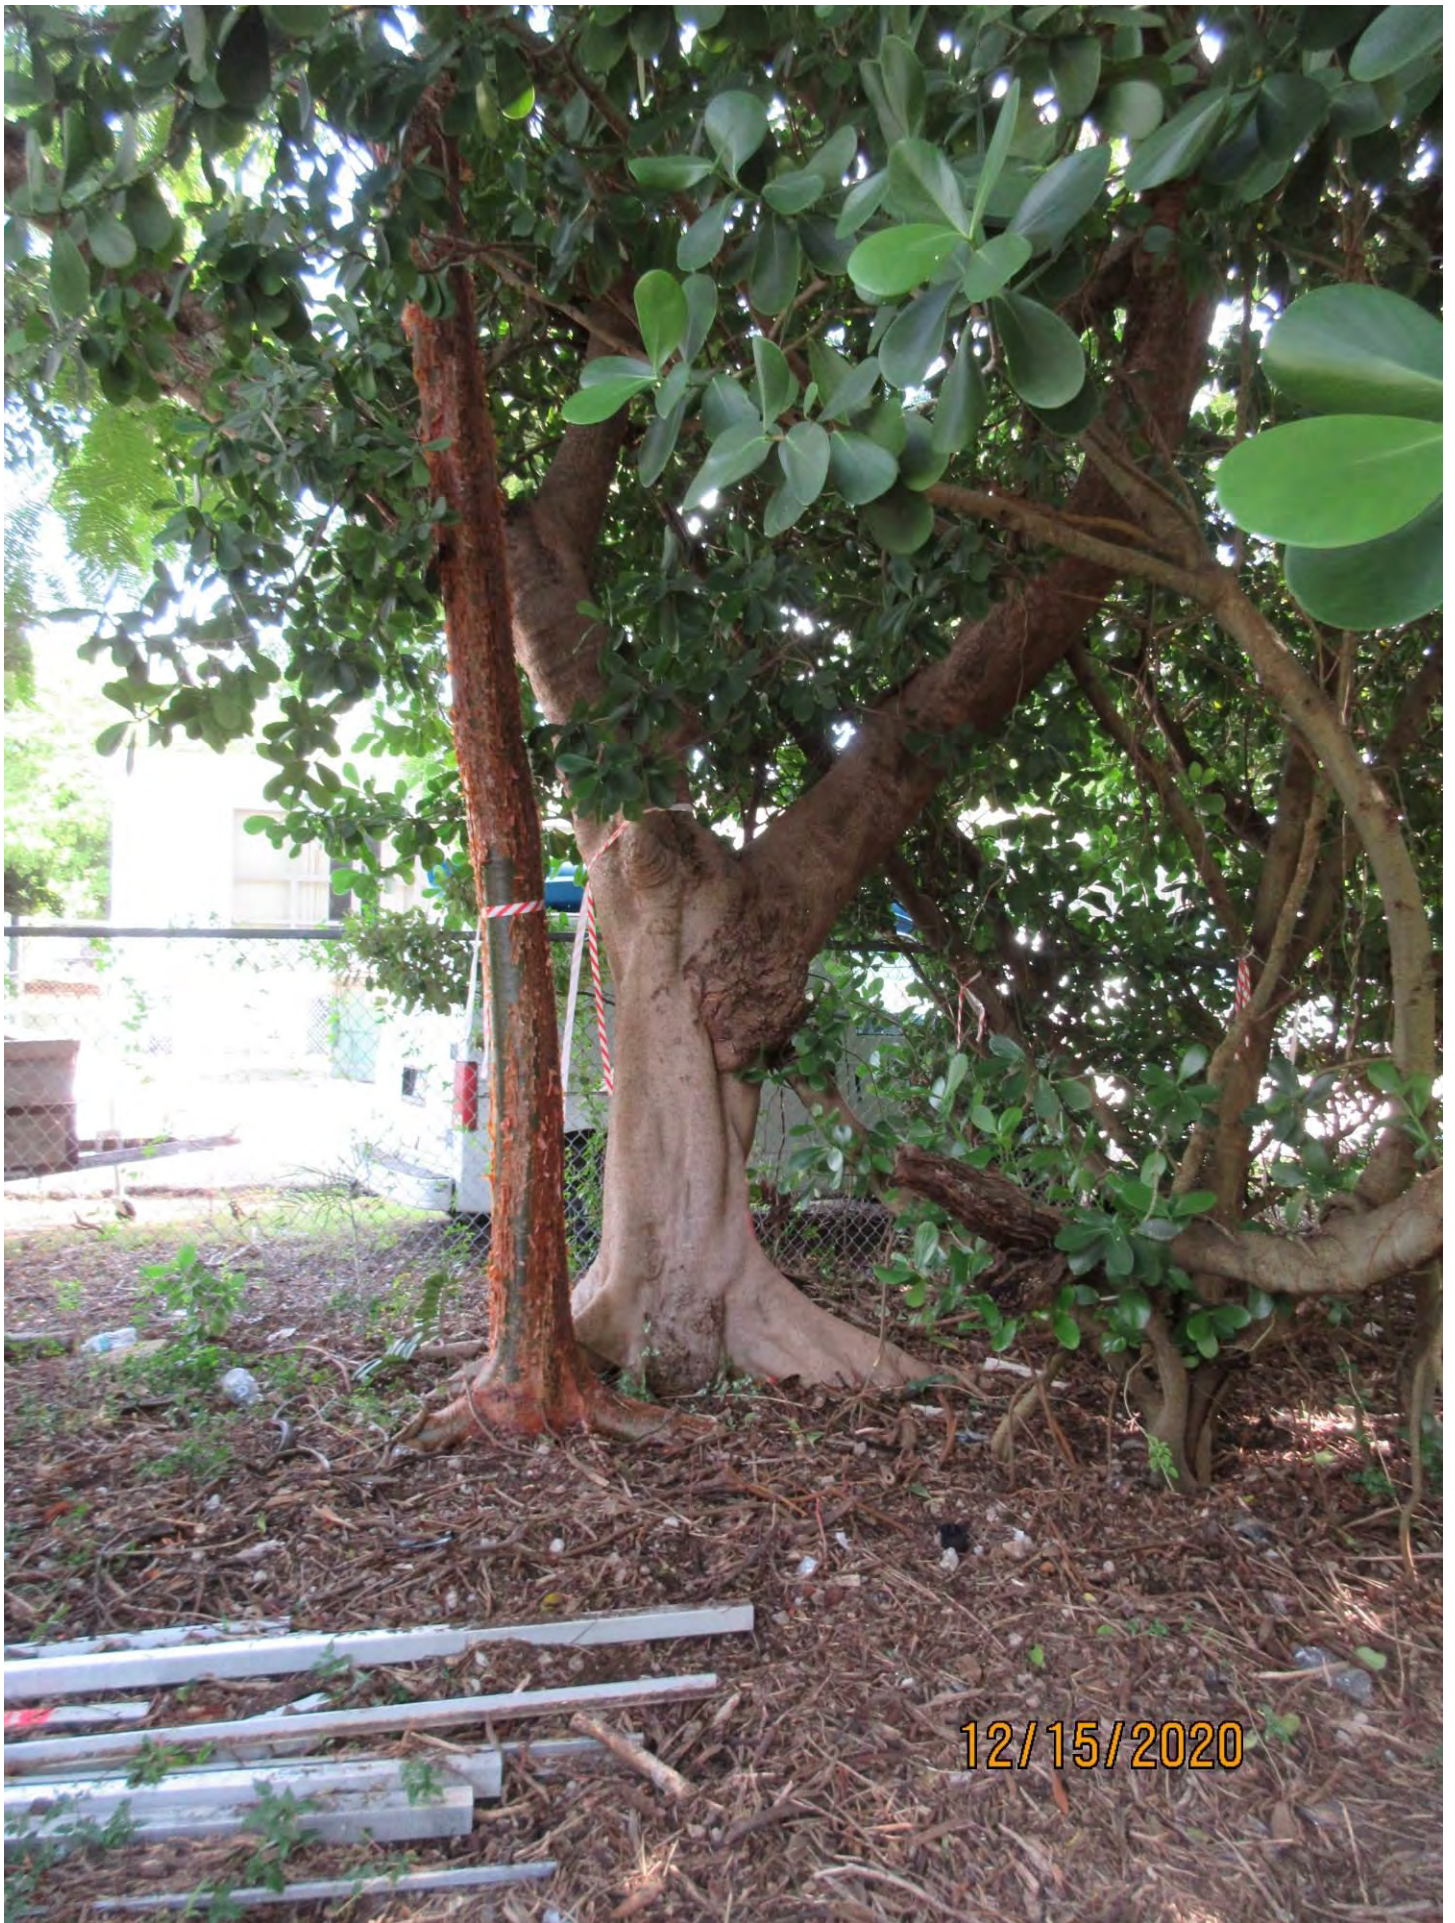
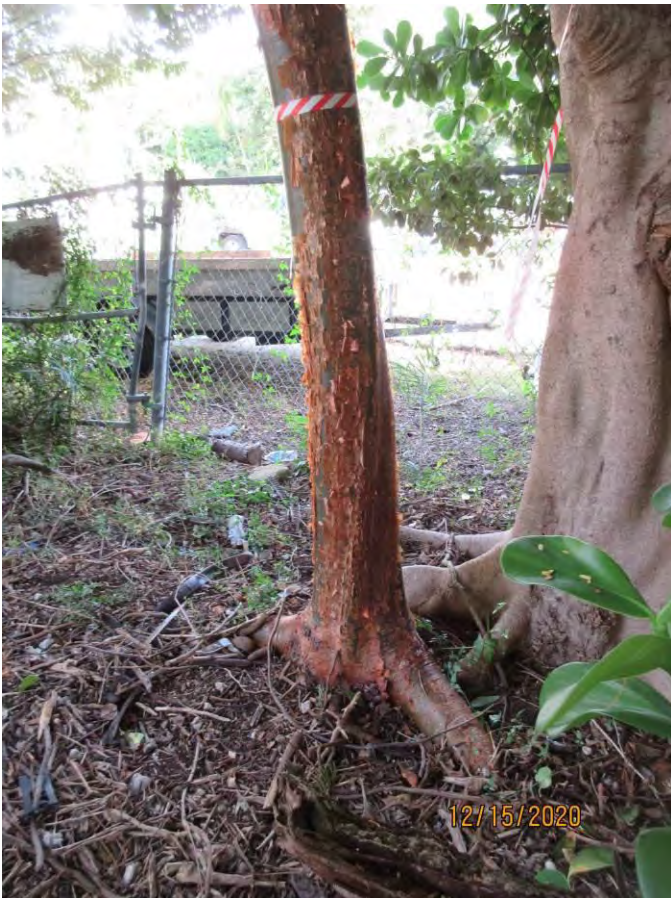
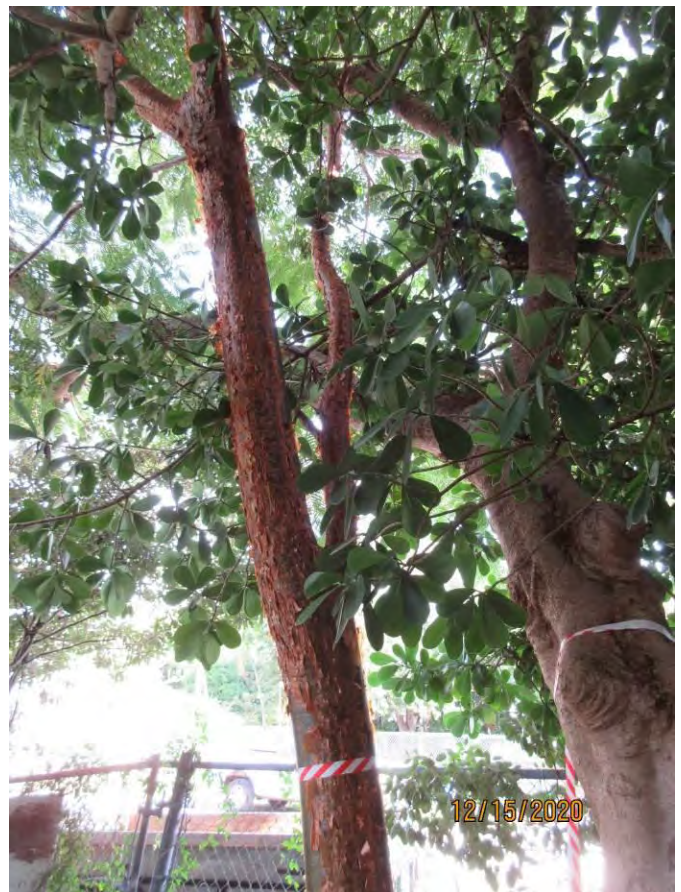
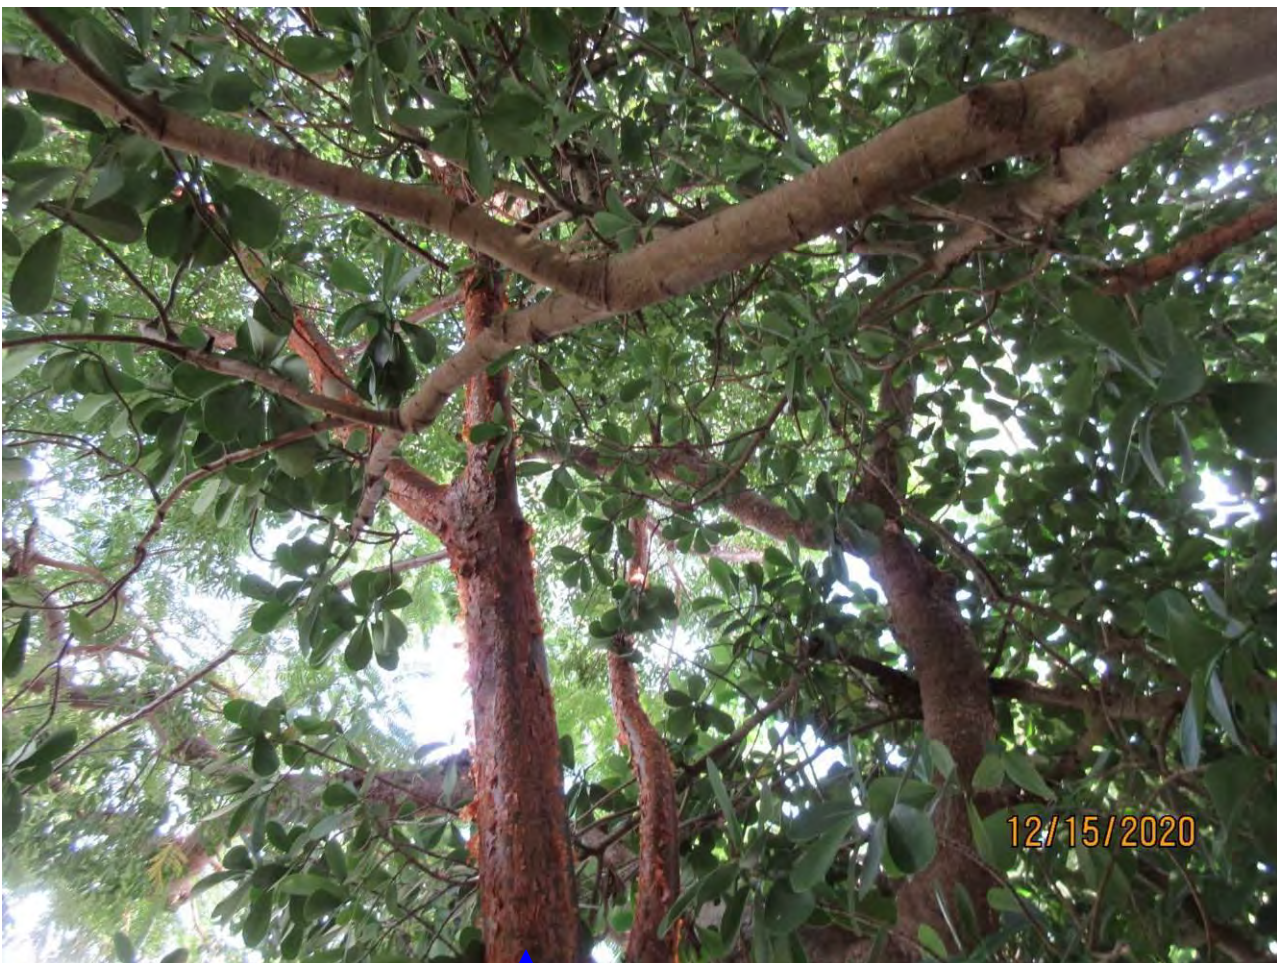
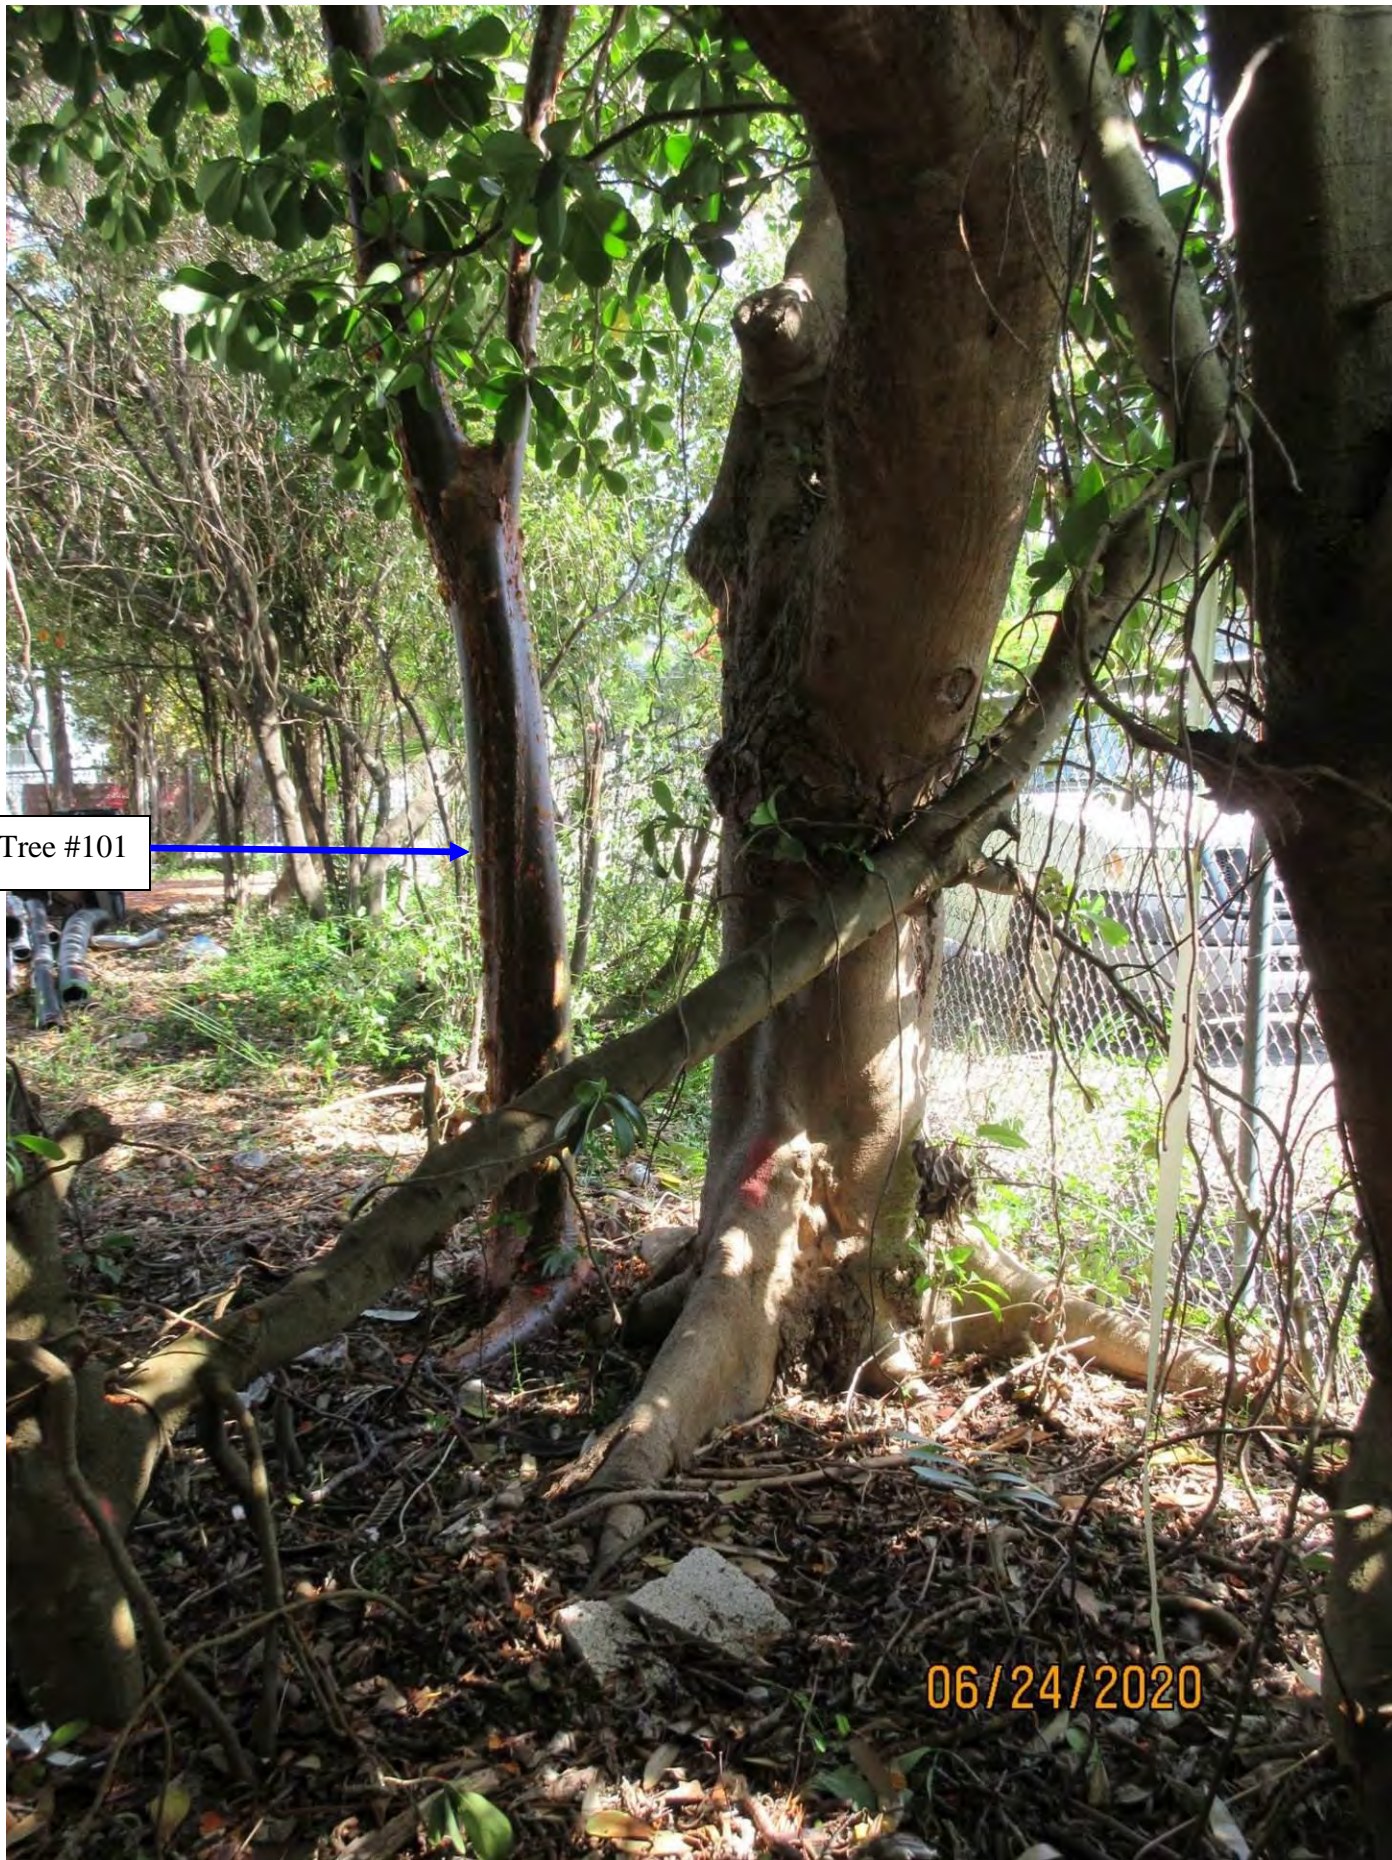
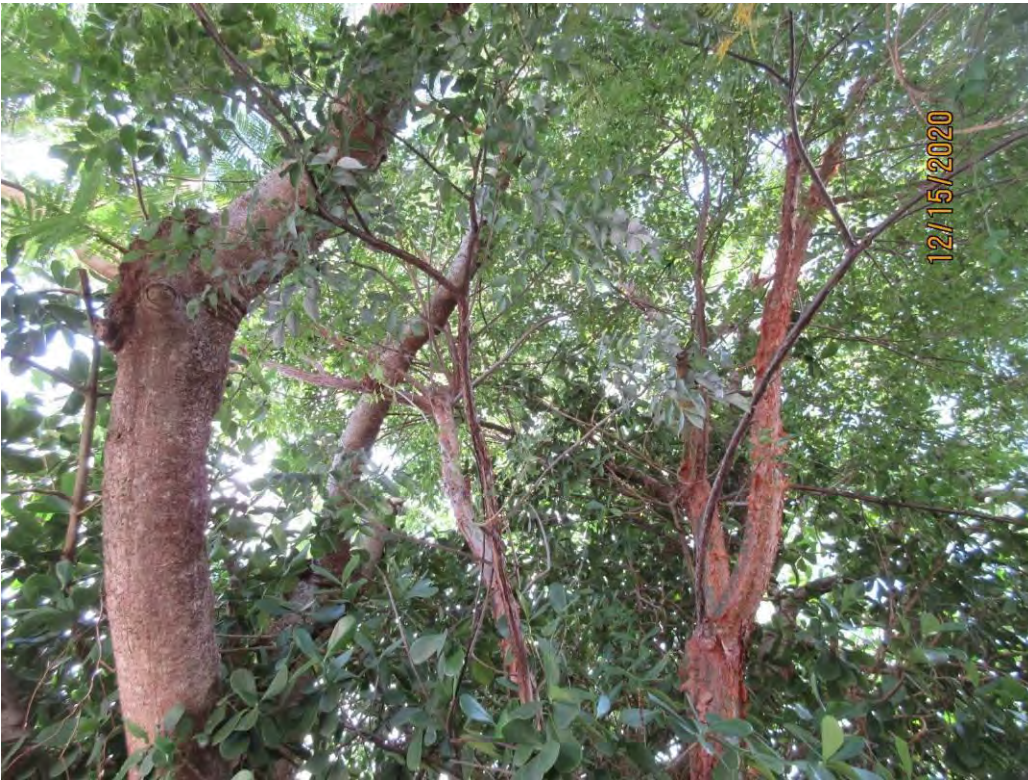
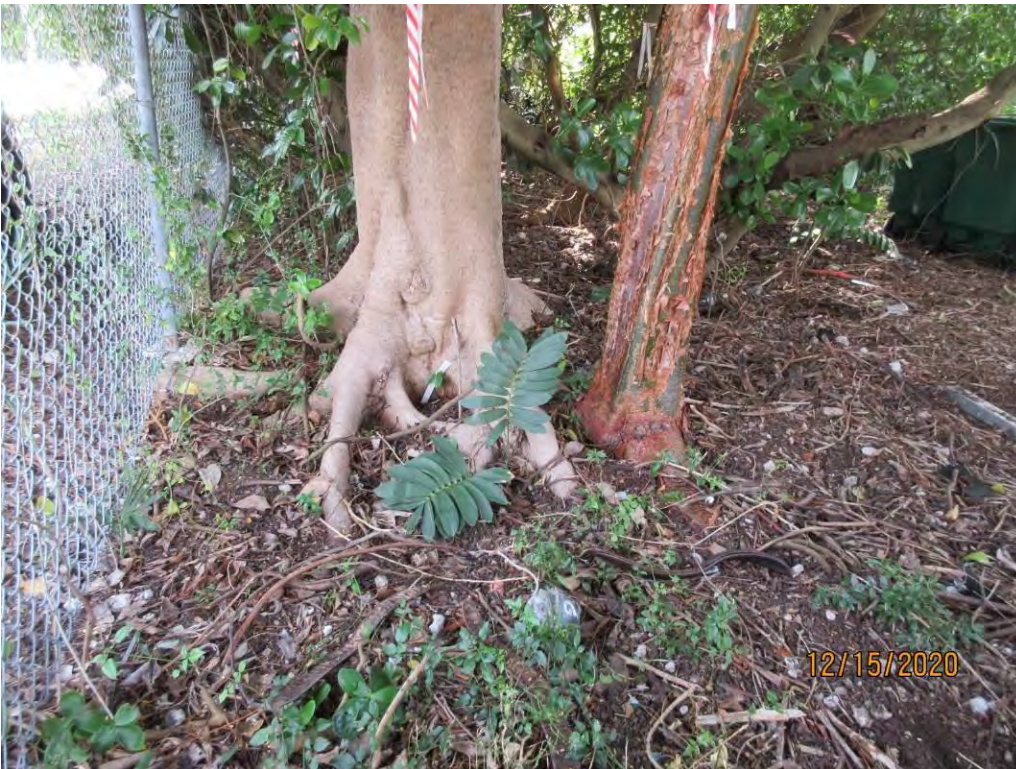
Tree #101

Diameter: 8.5"

Location: 60% (growing at base of Royal Poinciana tree)

Condition: 60% (overall condition is fair)

Value x Diameter = 6.2 replacement caliper inches

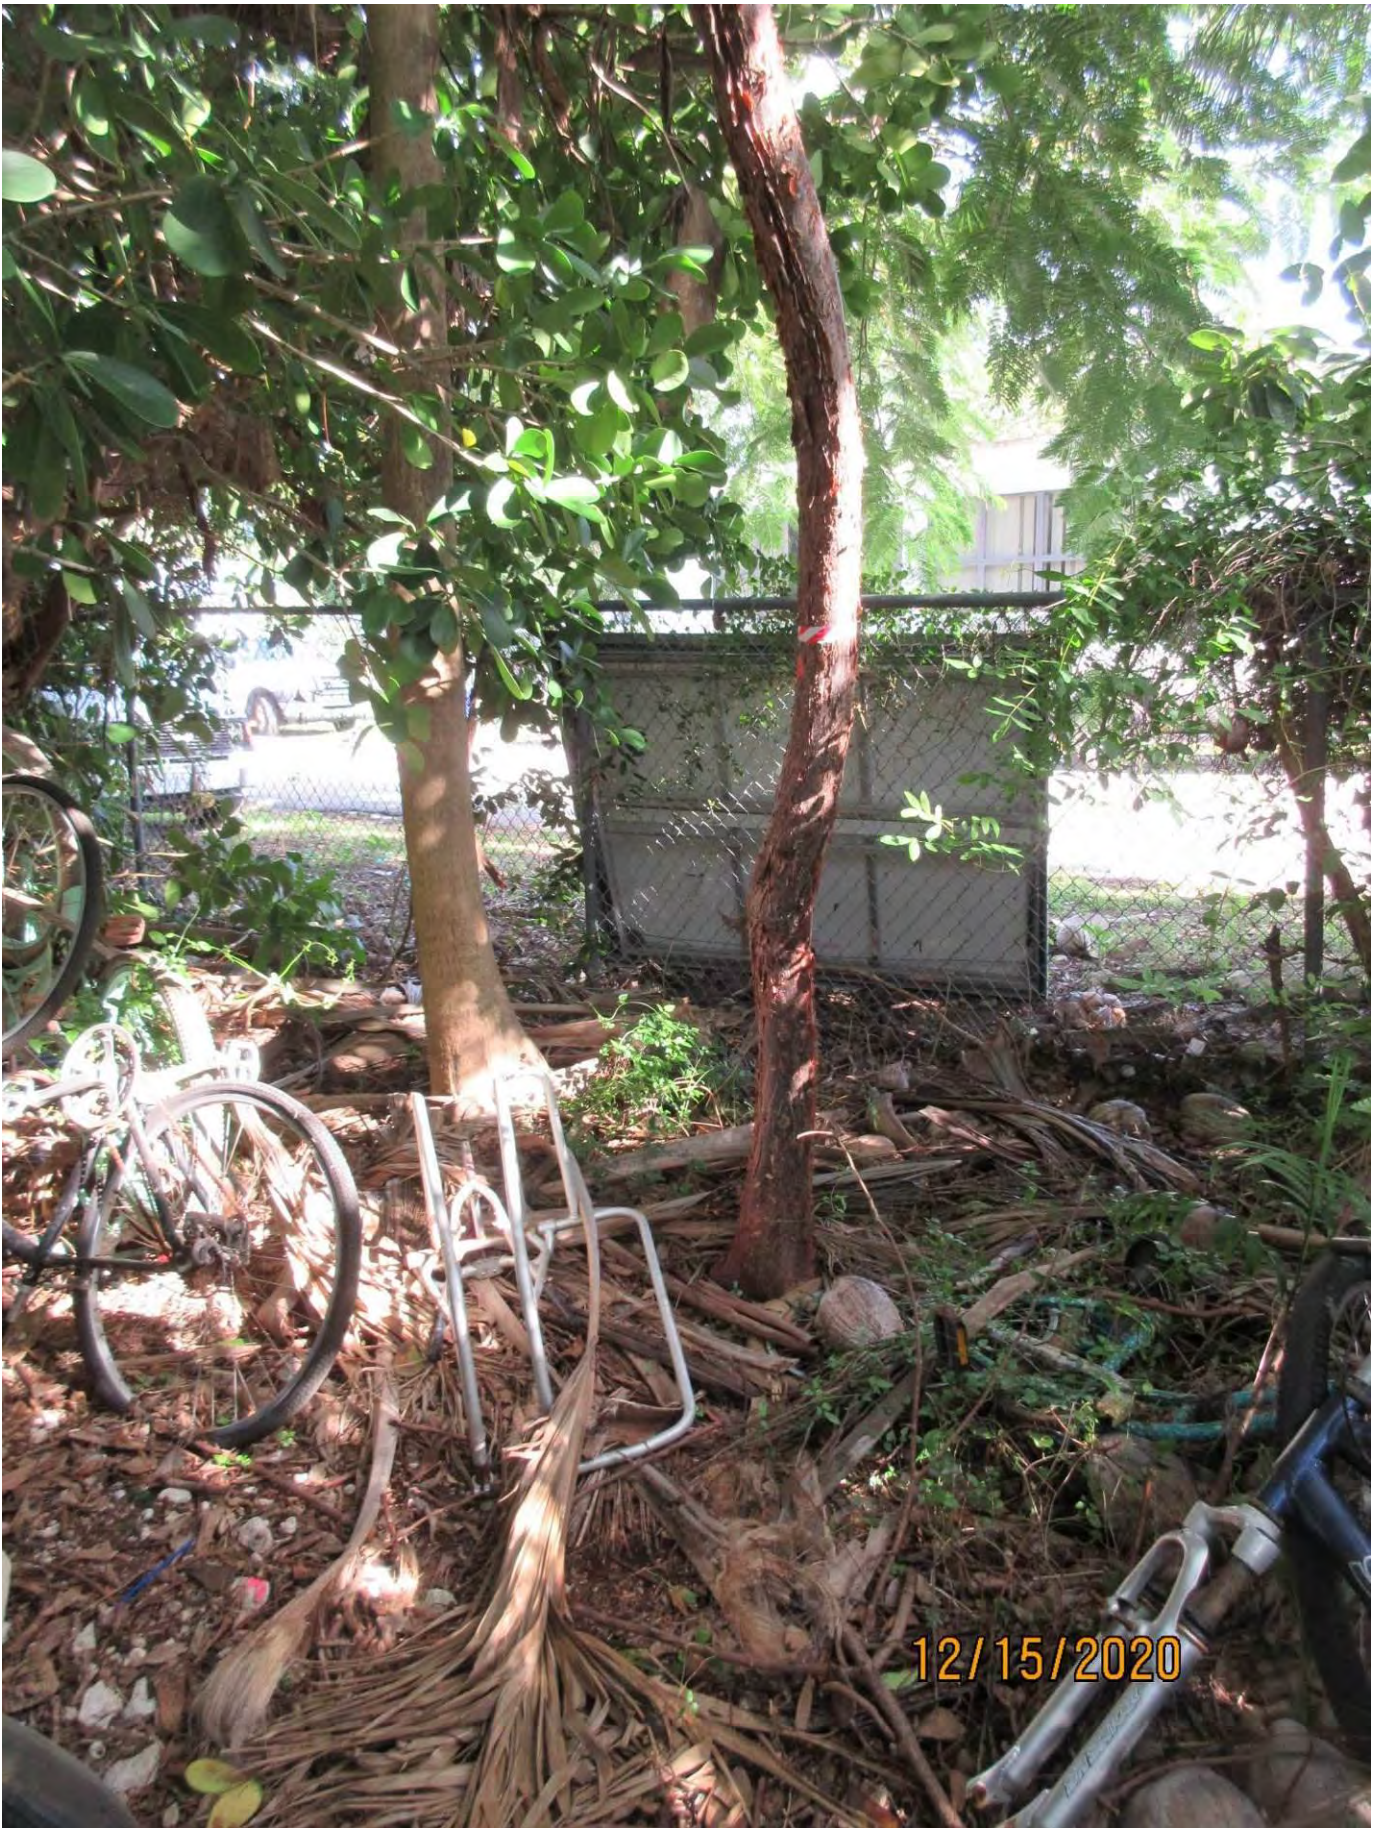
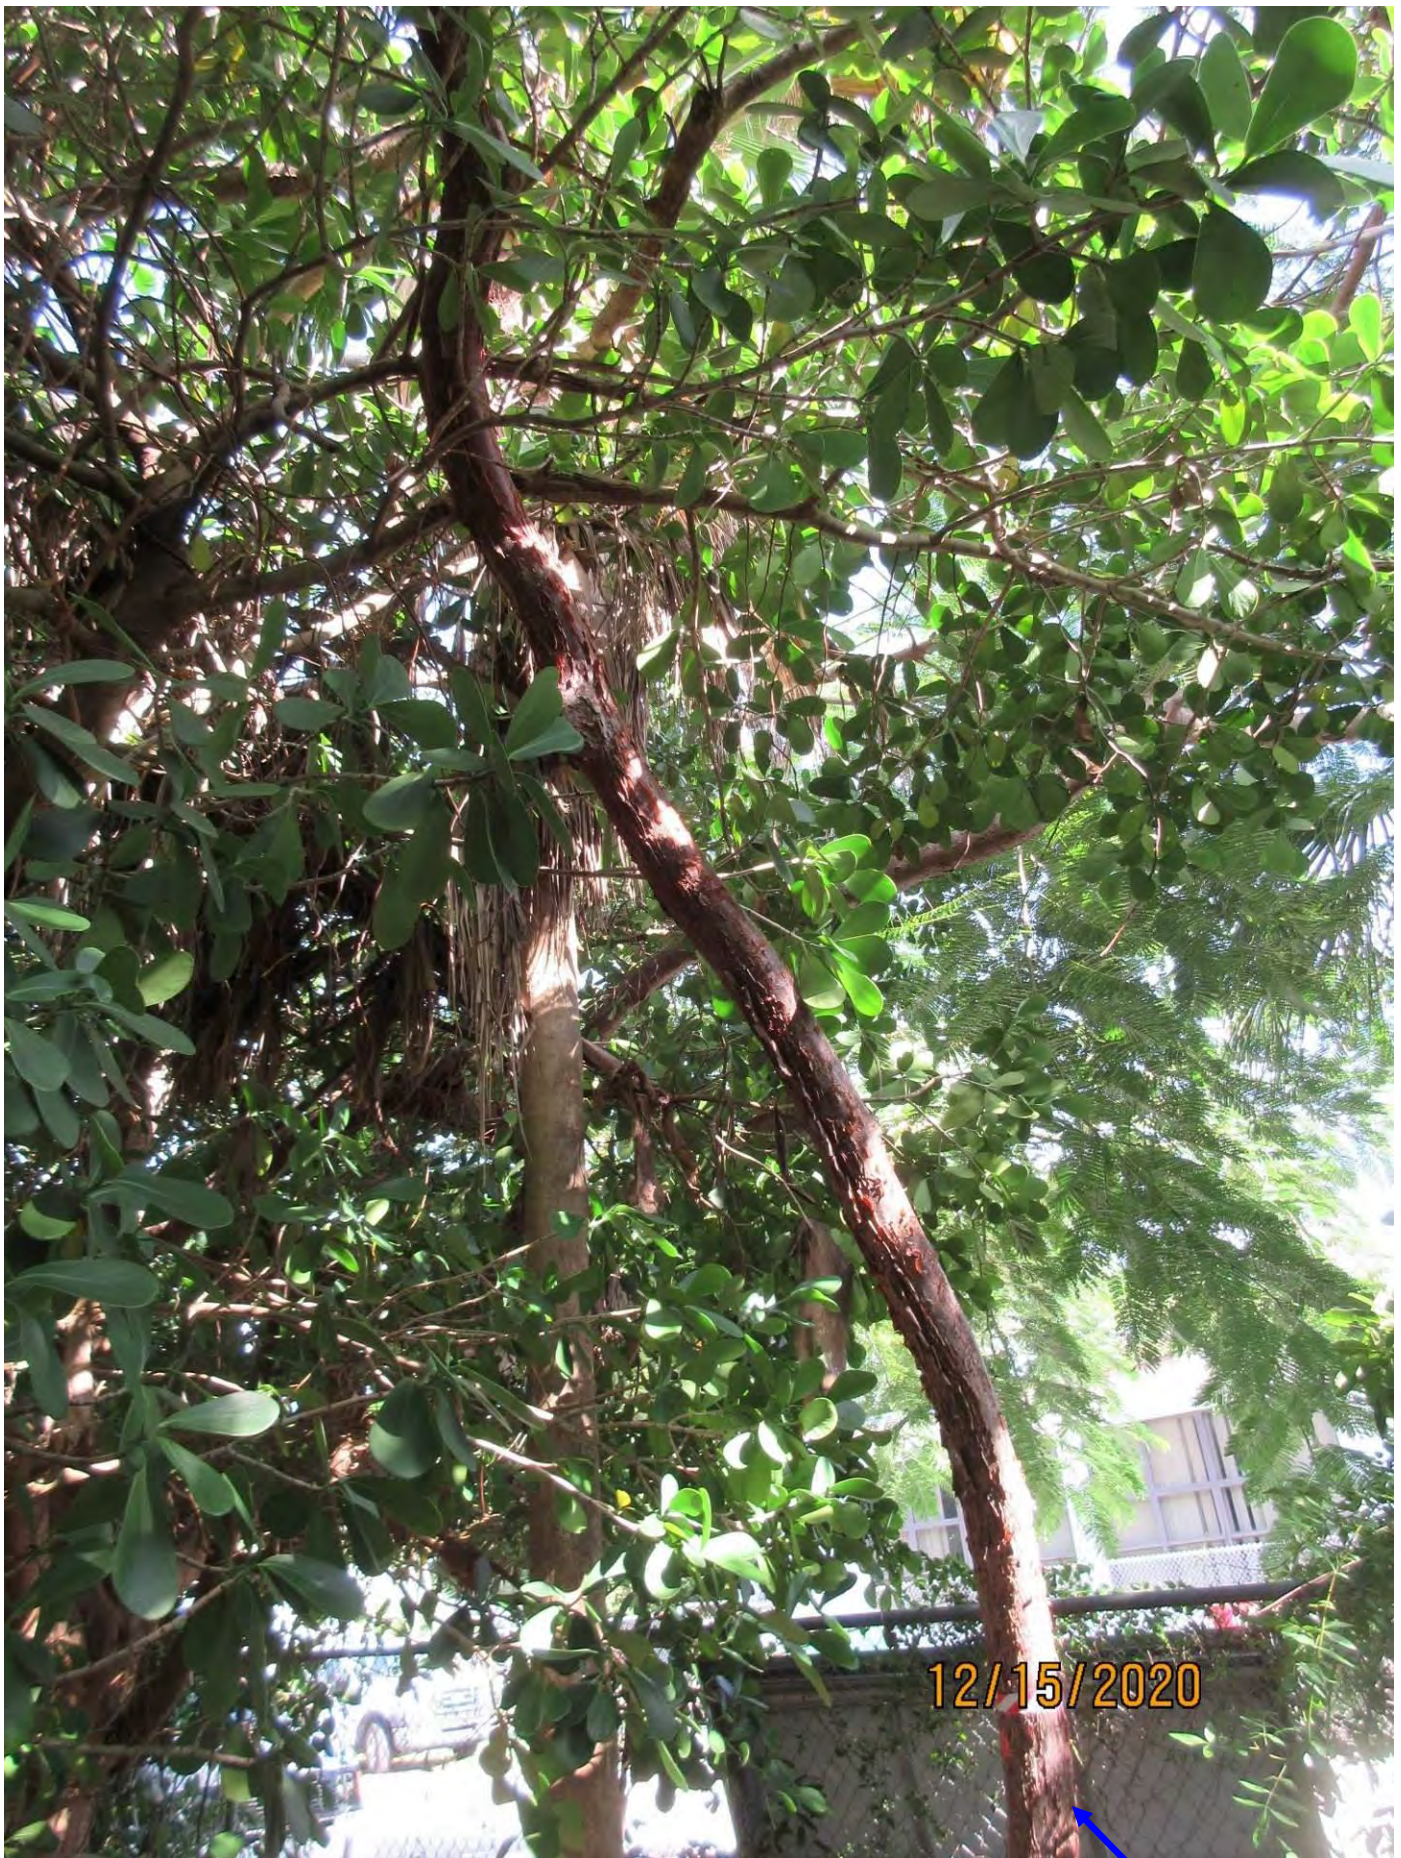
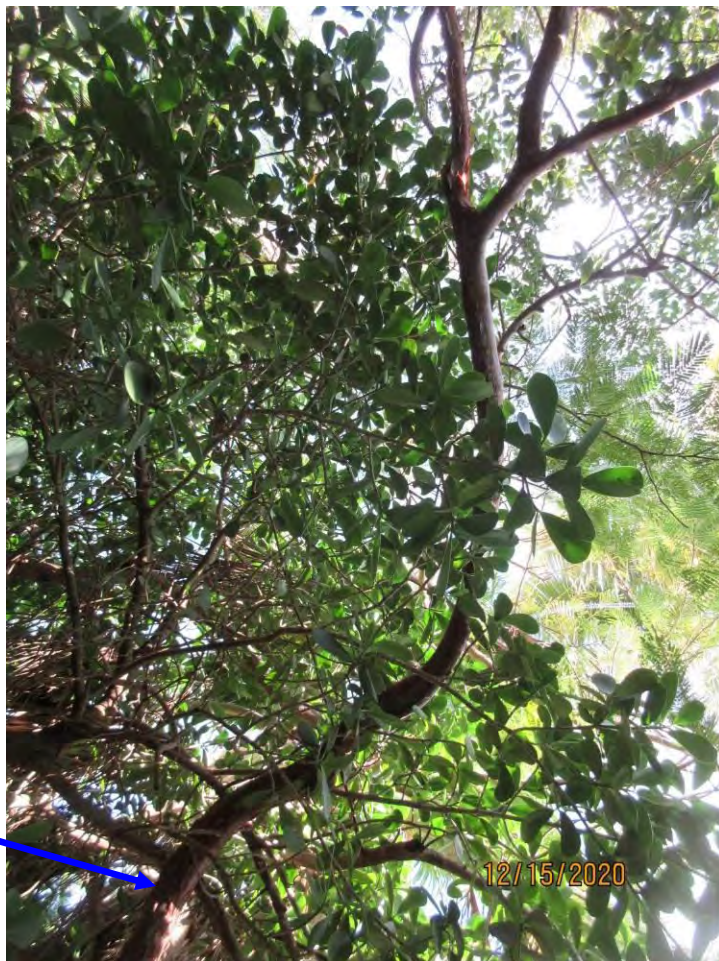
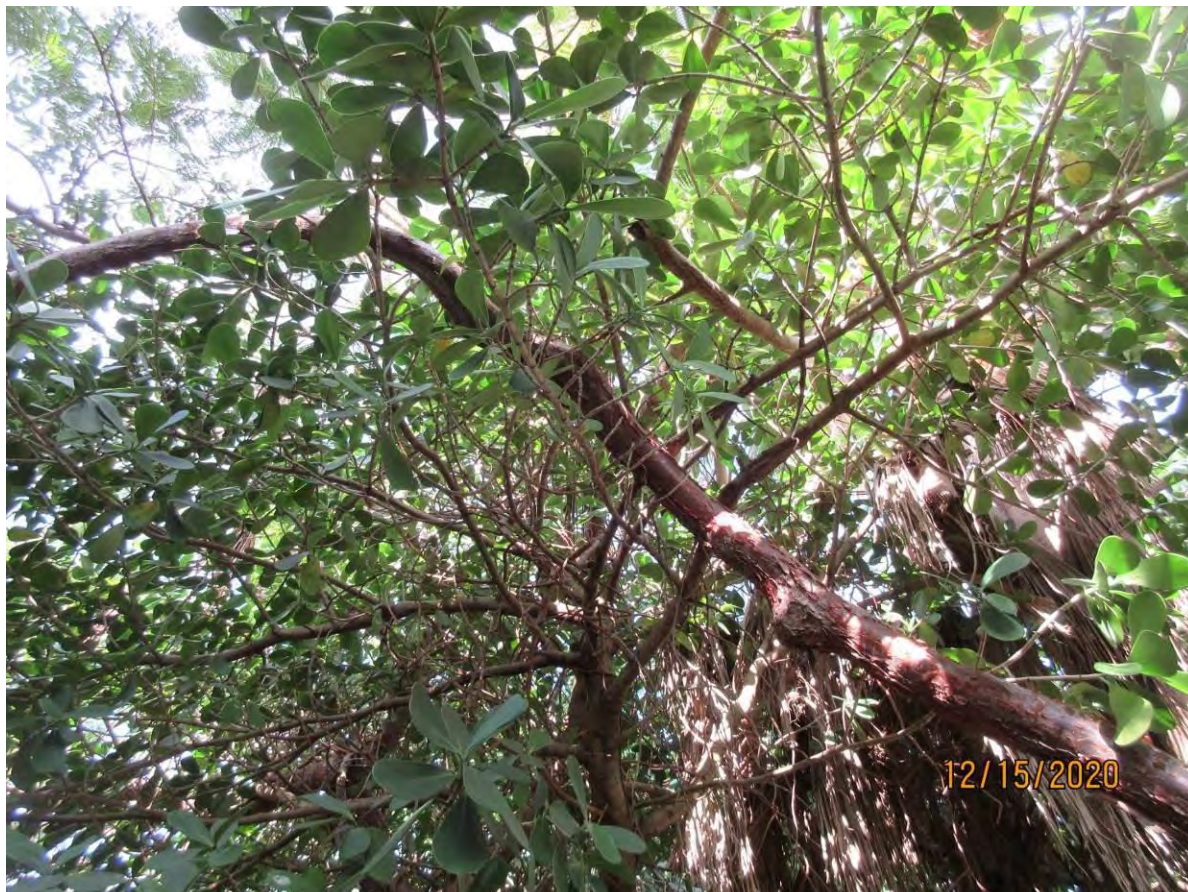
Tree #112 Diameter: 4.7"

Location: 60% (canopy growth impacted by other adjacent trees)

Condition: 40% (overall condition is poor, trunk has growth lean and canopy not properly developed-branch growth sprawling to one side)

Value x Diameter = 3.1
replacement caliper inches

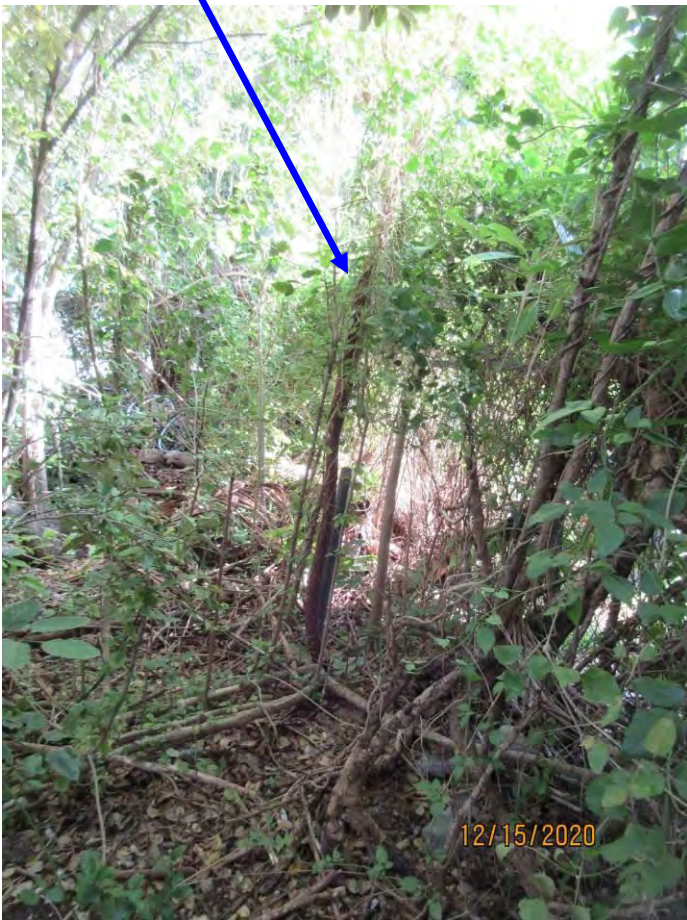
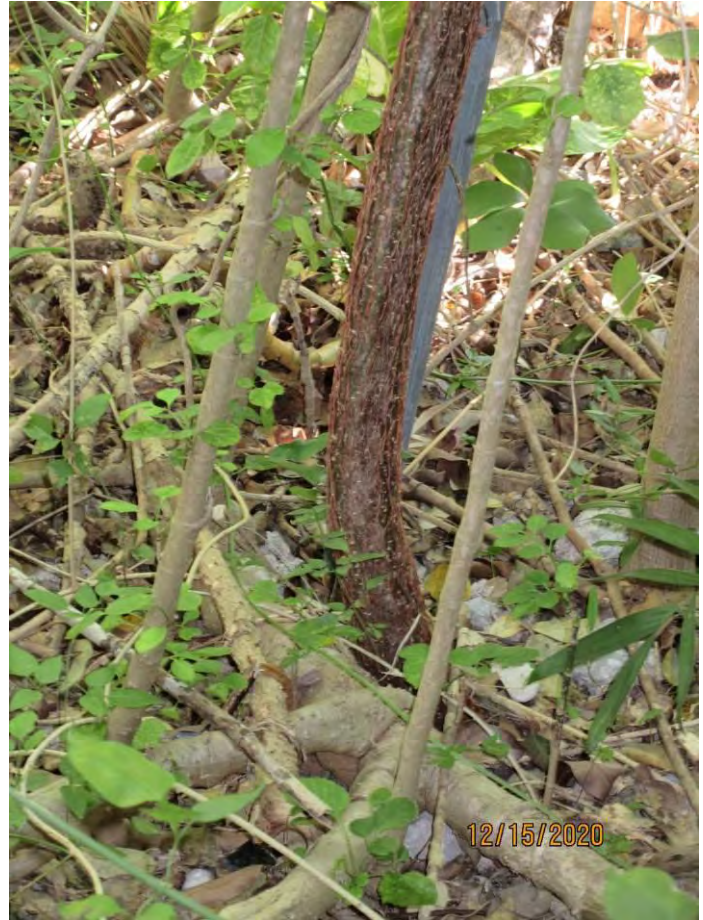
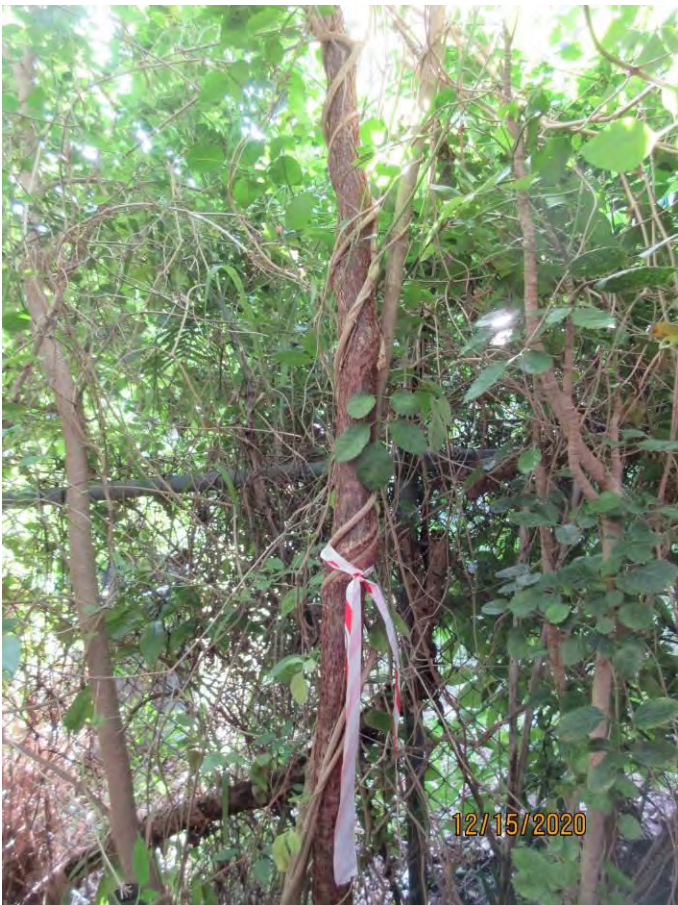
Tree #124 Diameter: 1.3"
Location: 80%
Species: 100% (on protected tree list)
Condition: 40% (poor, trunk impacted and constricted by vines, reduced canopy)
Total Average Value = 73%
Value x Diameter = 0.9
replacement caliper inches
