Tree Species: Gumbo Limbo (*Bursera simaruba*)
Tree #80 and #81

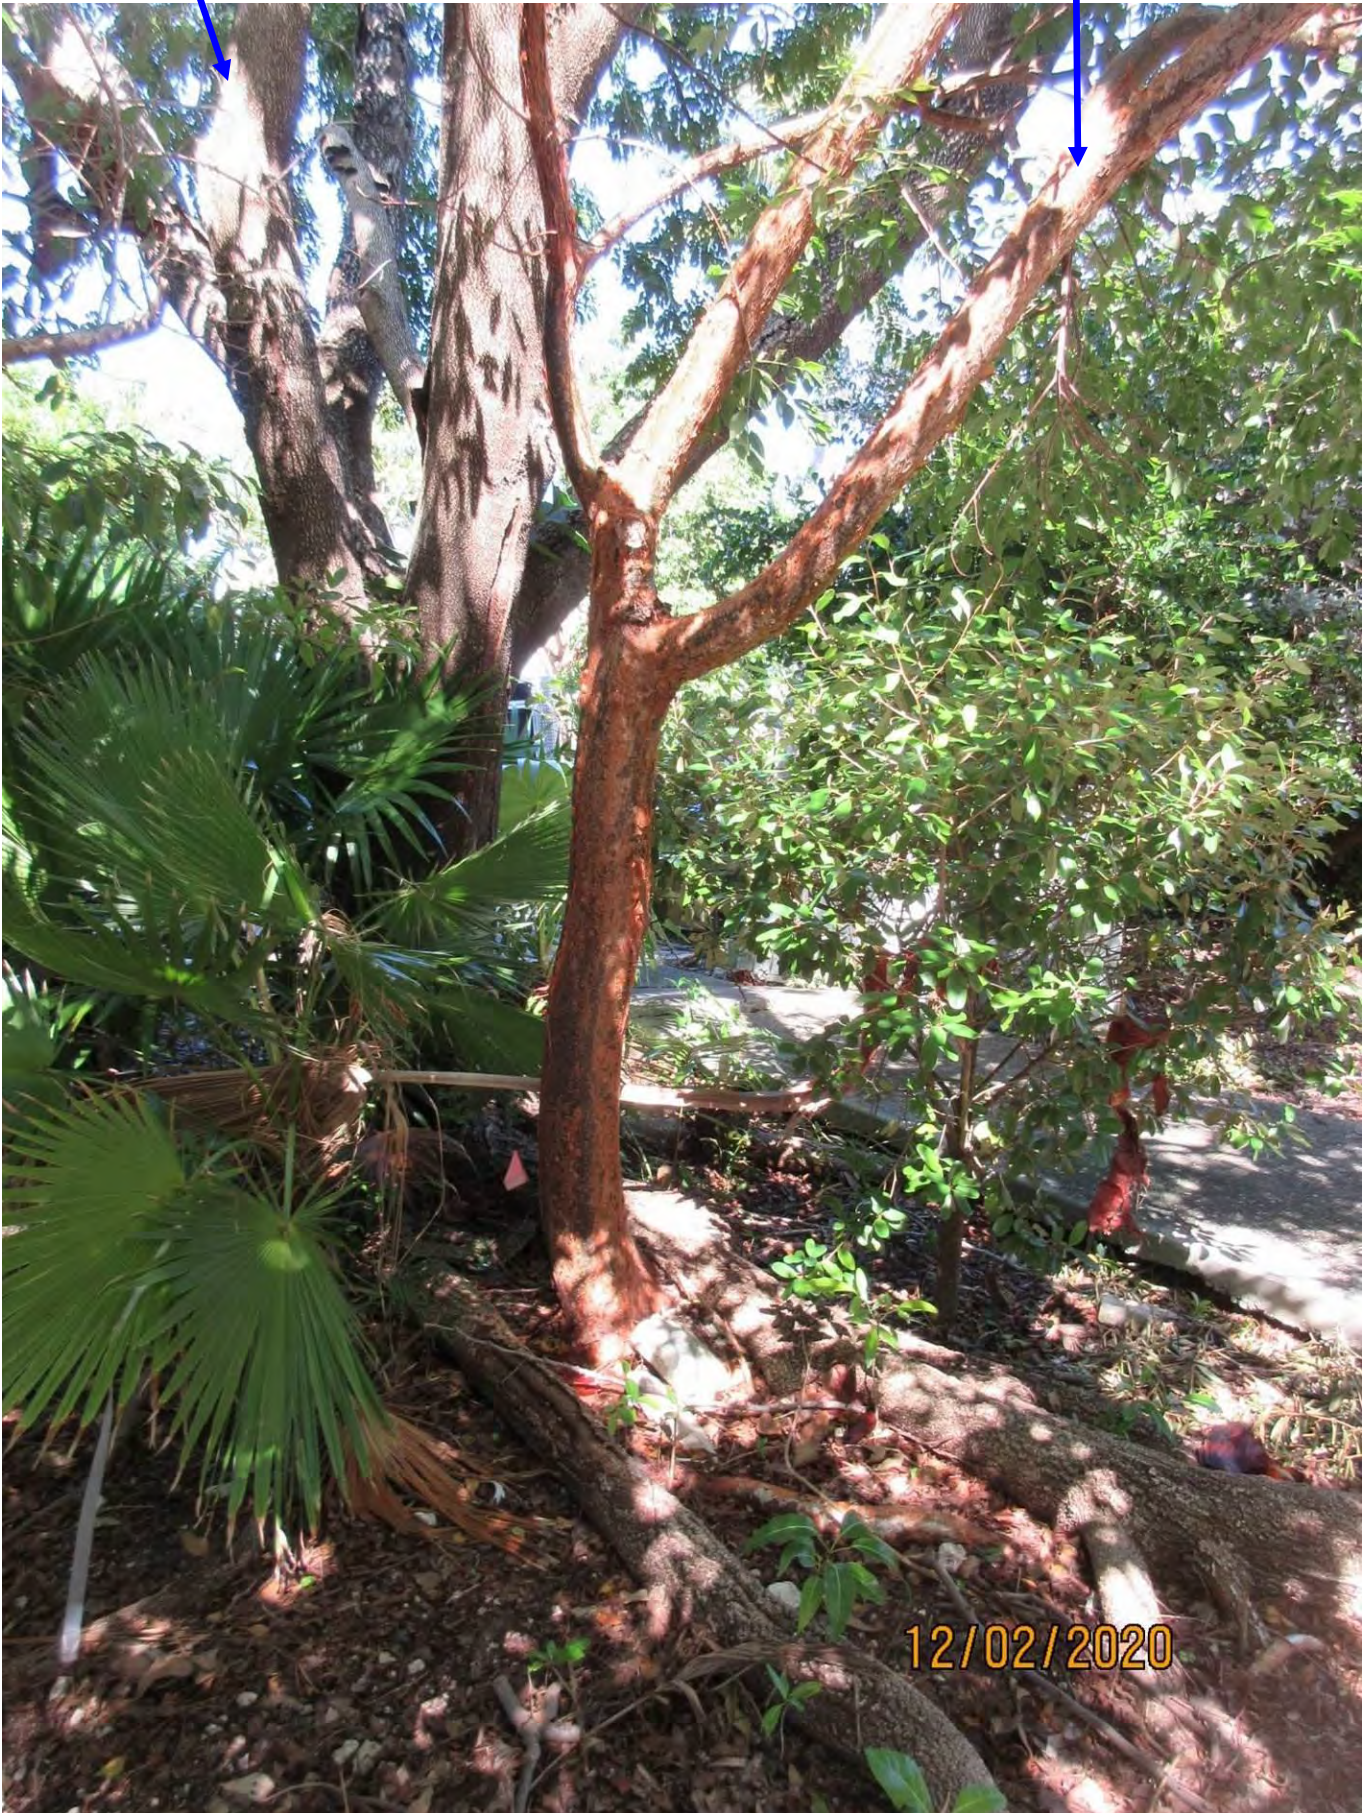
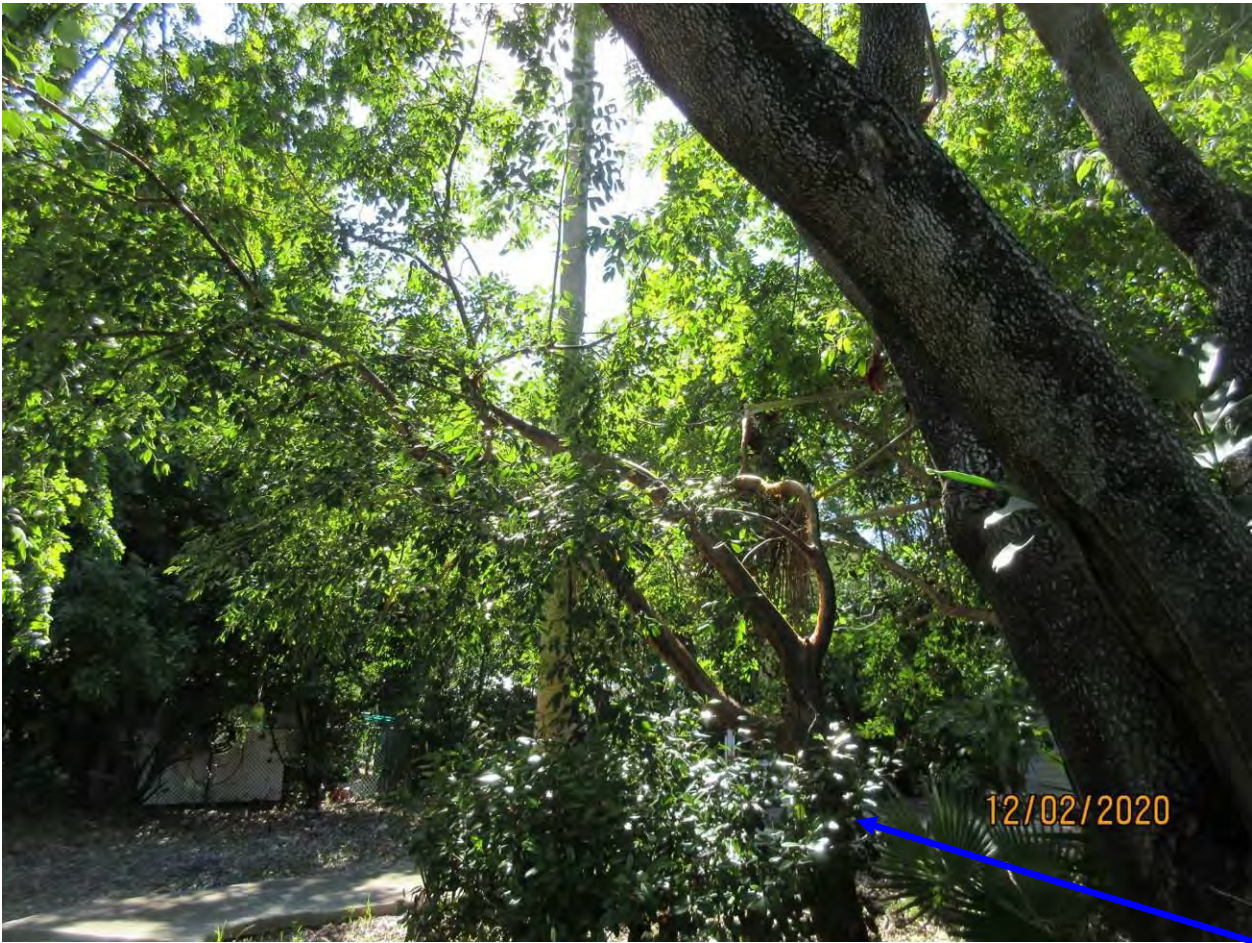
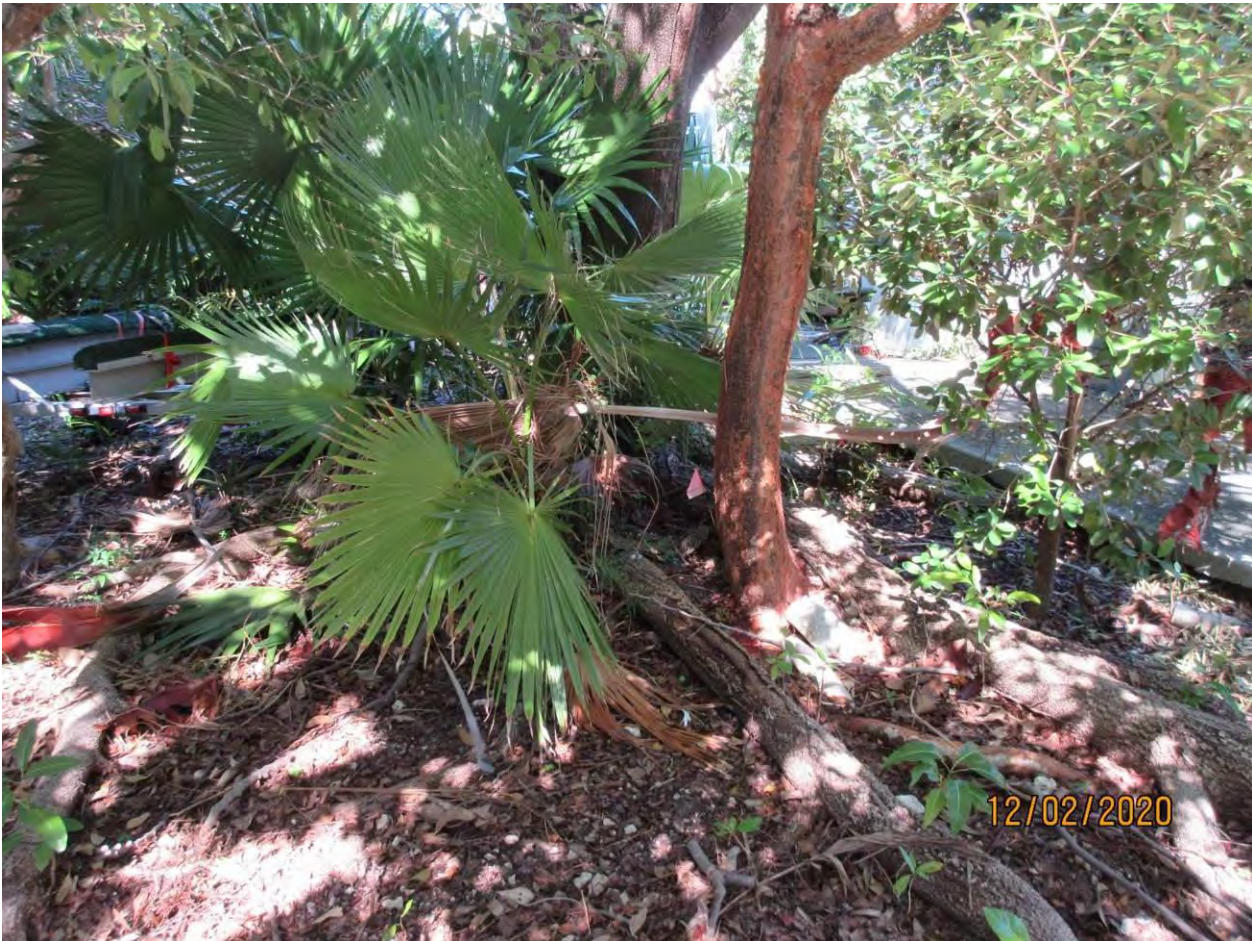
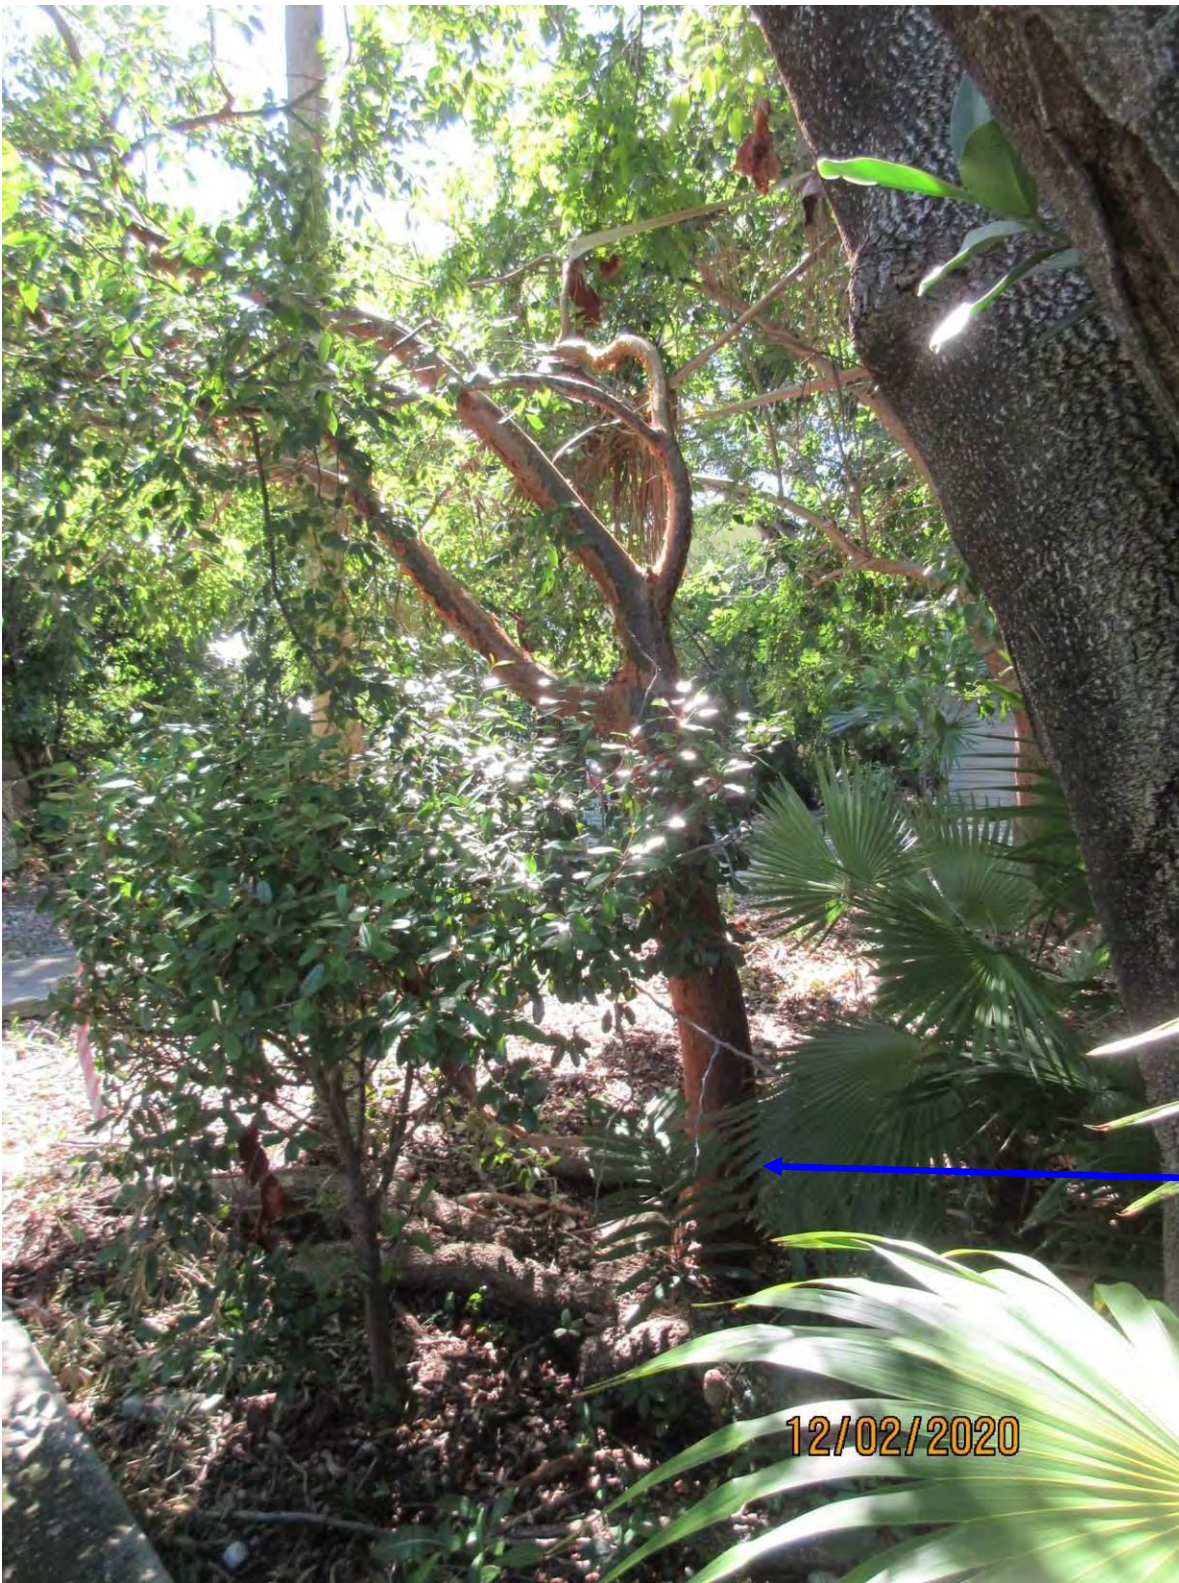
Tree #161 Diameter: 6.5"

Location: 60% (growing at base and in root area of larger tree)

Condition: 50% (fair to poor, canopy with growth lean away from larger tree, overall structure poor)

Value x Diameter = 4.5 replacement caliper inches

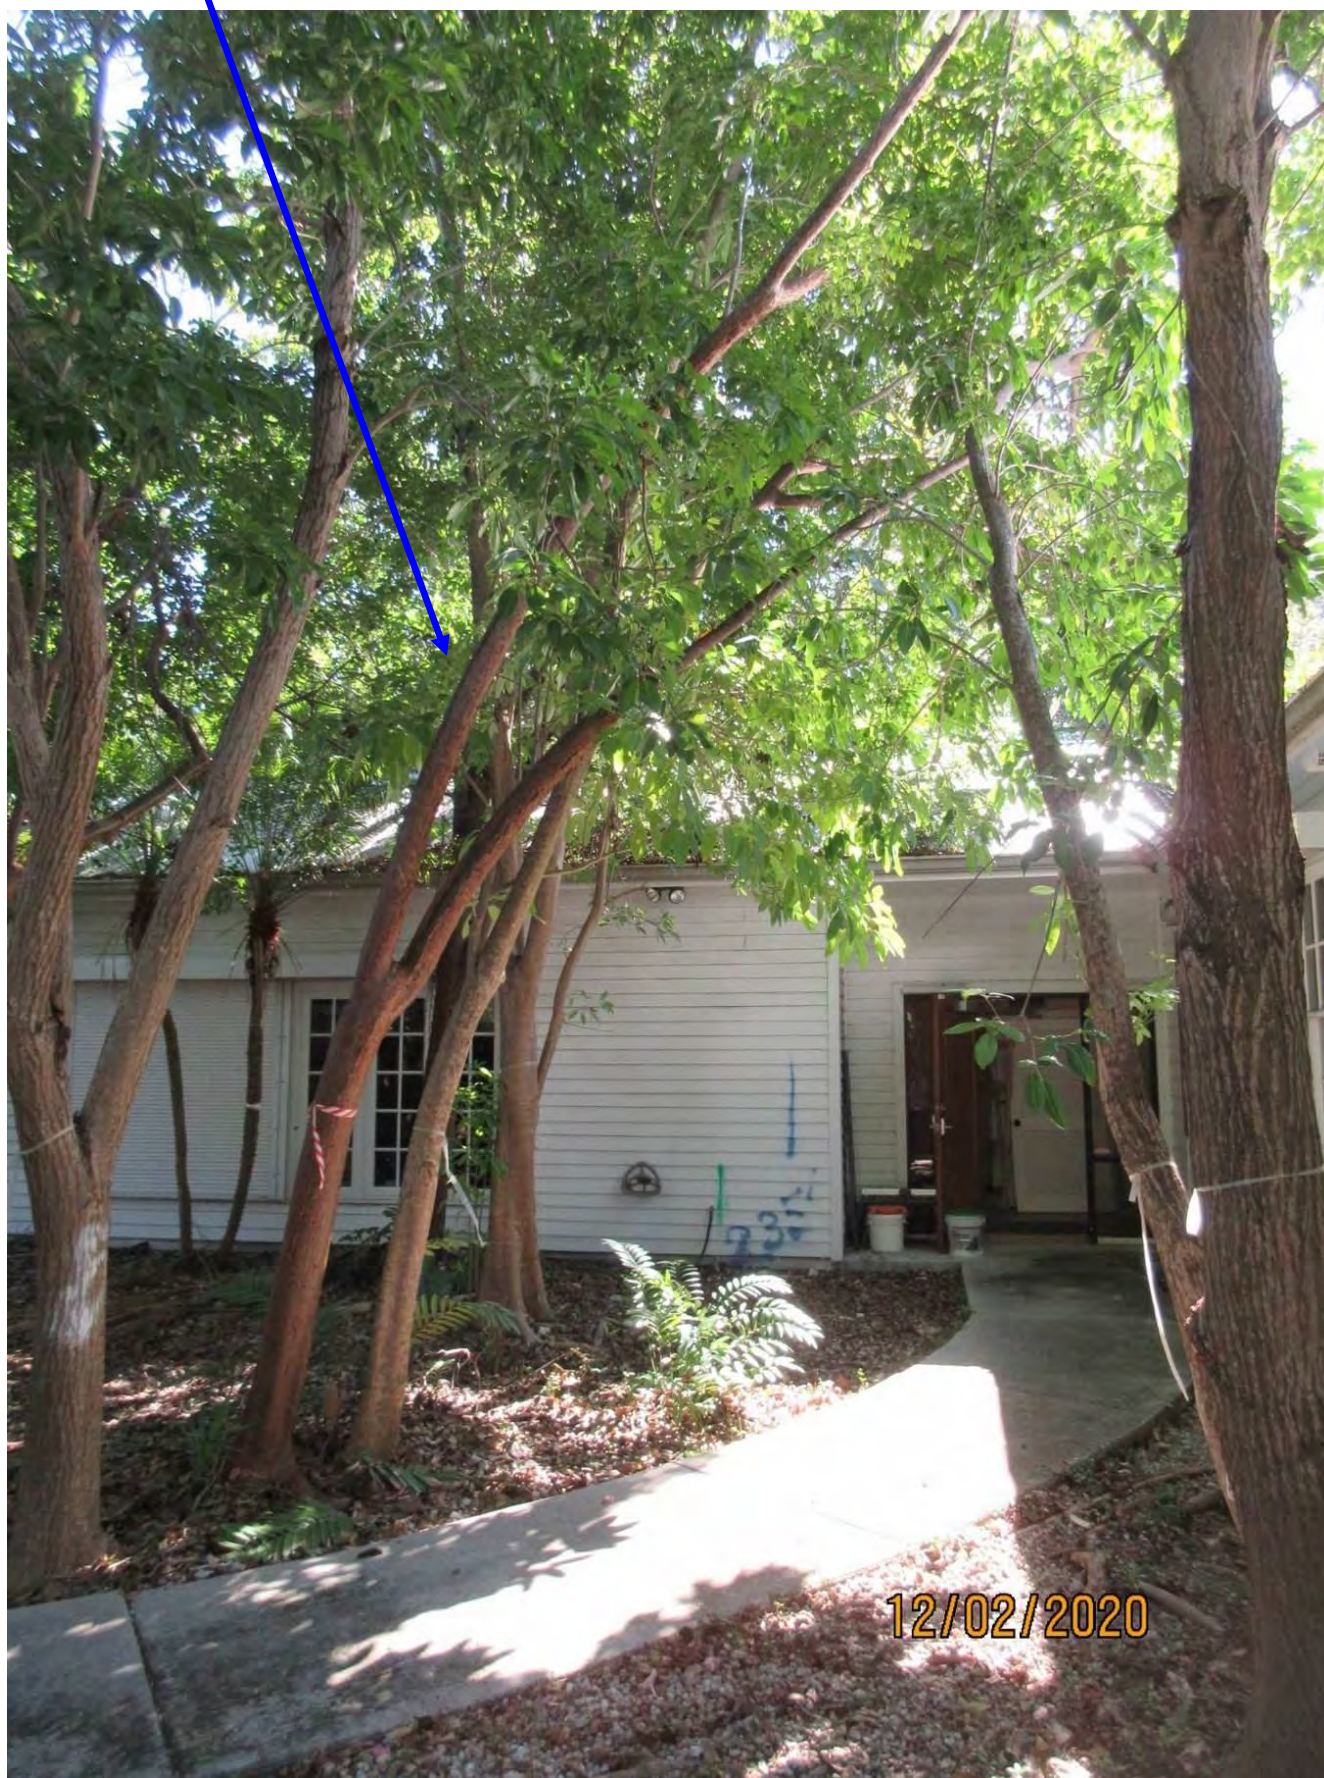
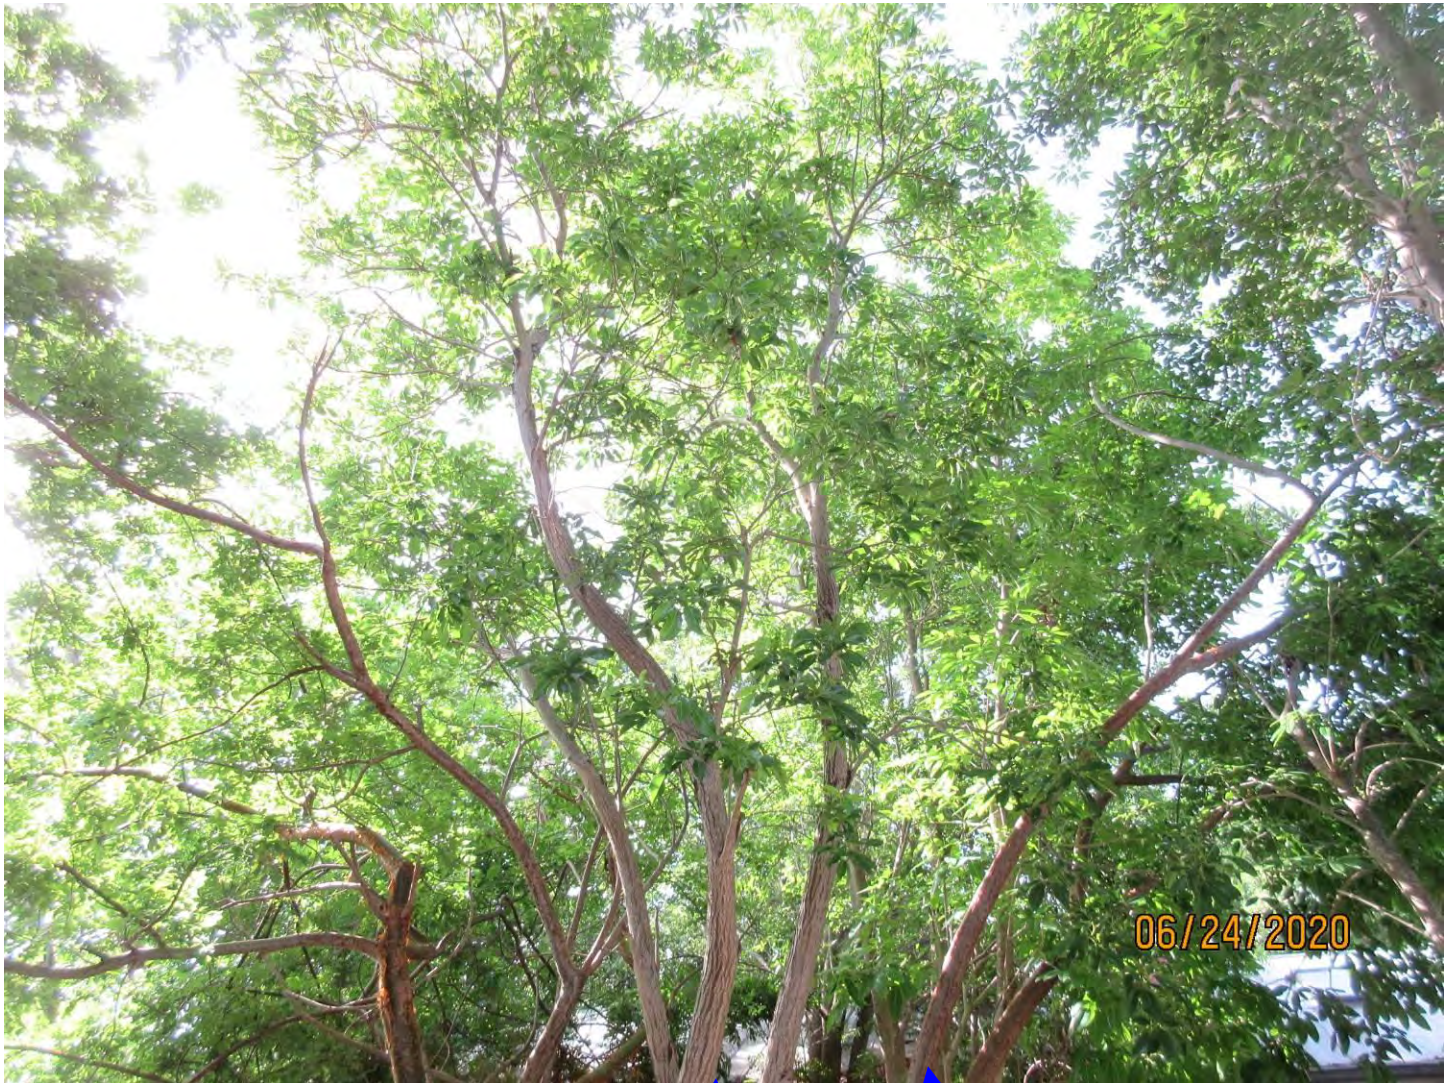
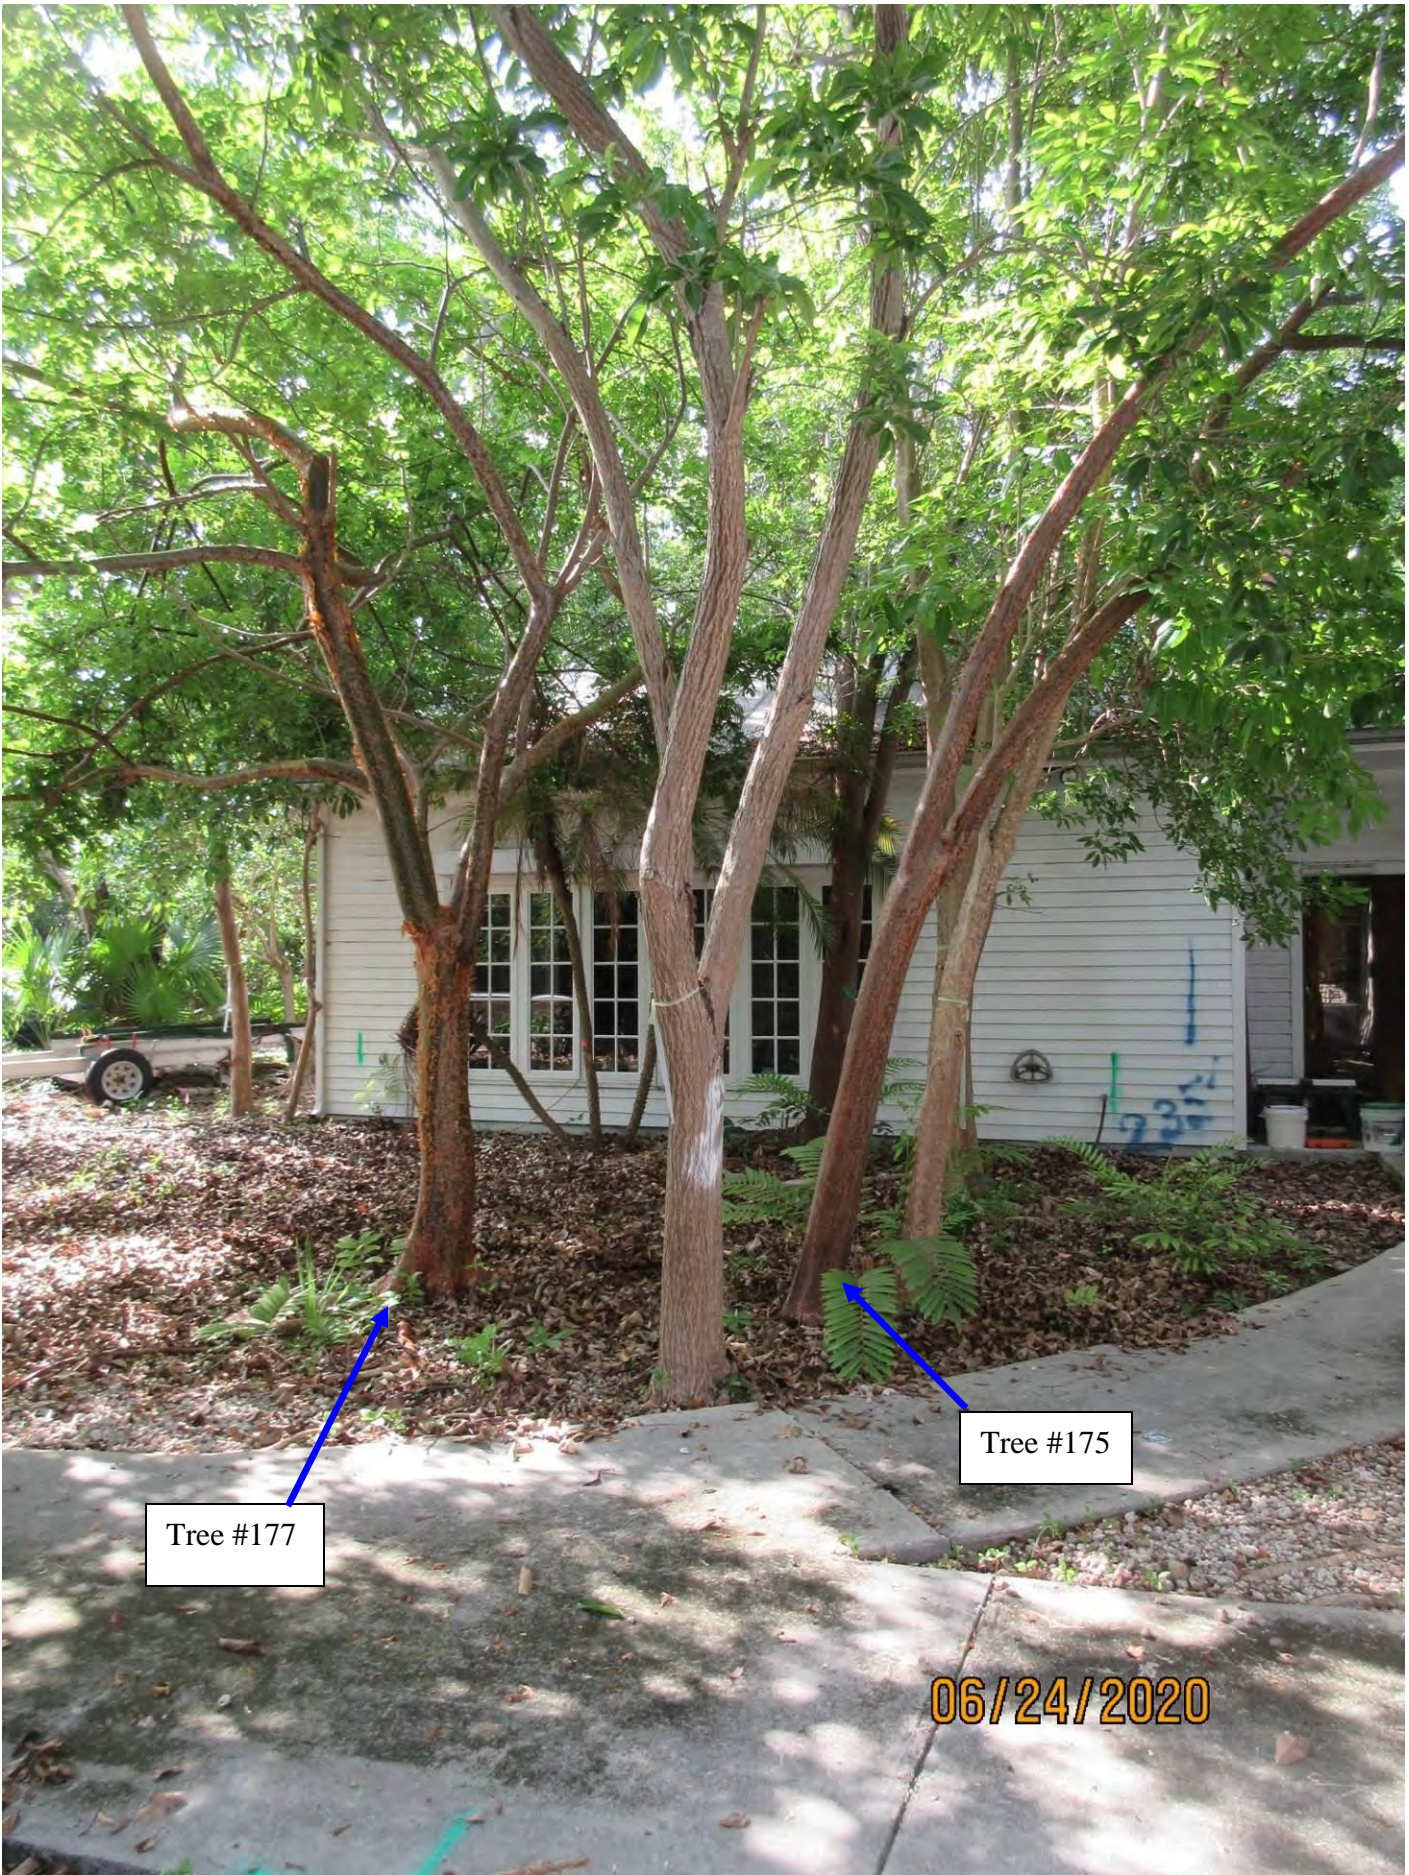
Tree #175.

Tree #175 Diameter: 6.4"

Location: 60% (growth impacted by canopies of adjacent trees)

Condition: 60% (overall condition is fair, tree has a growth lean with codominant branch trunks)

Value x Diameter = 4.6 replacement caliper inches

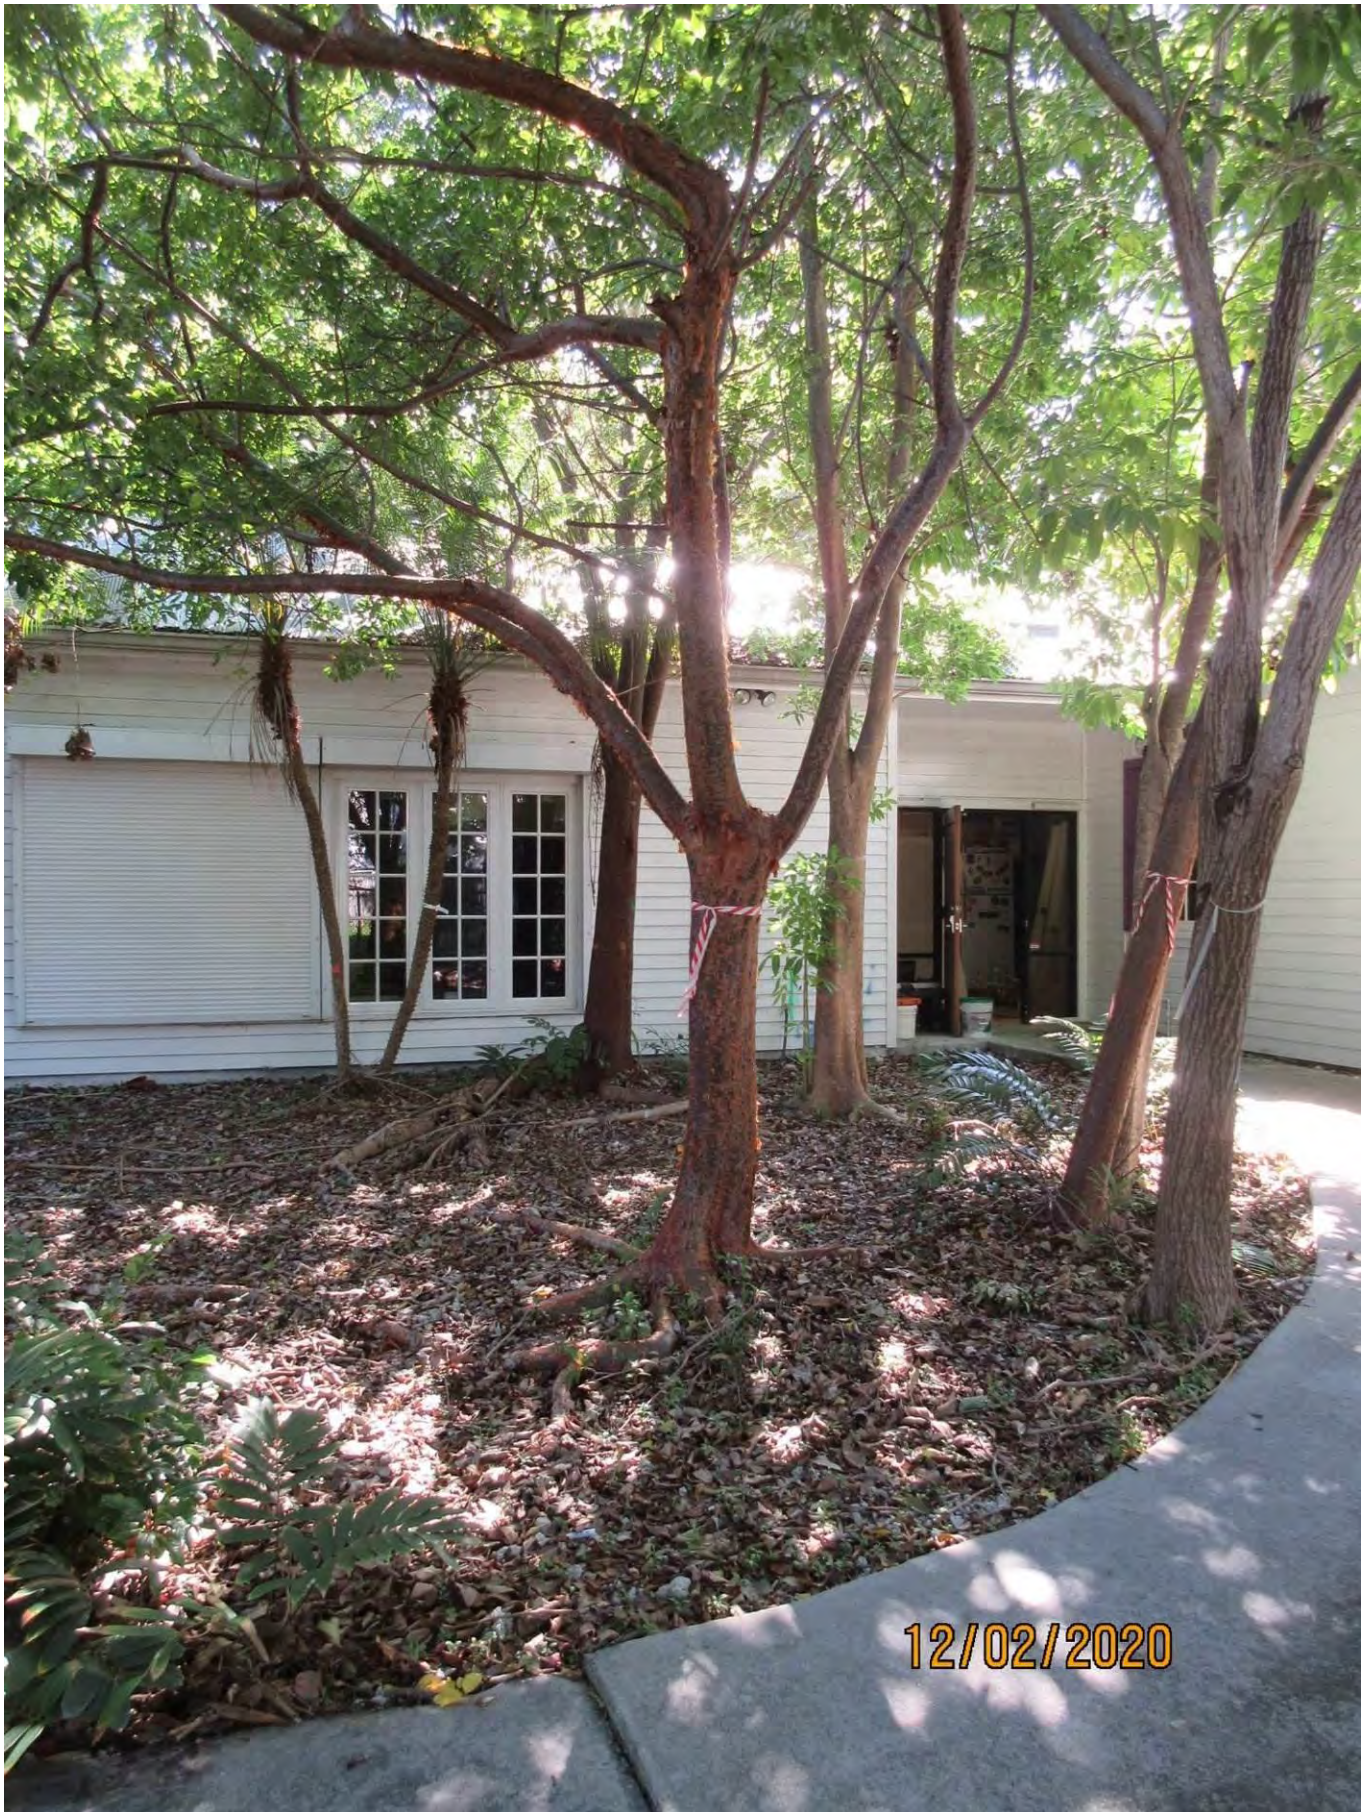
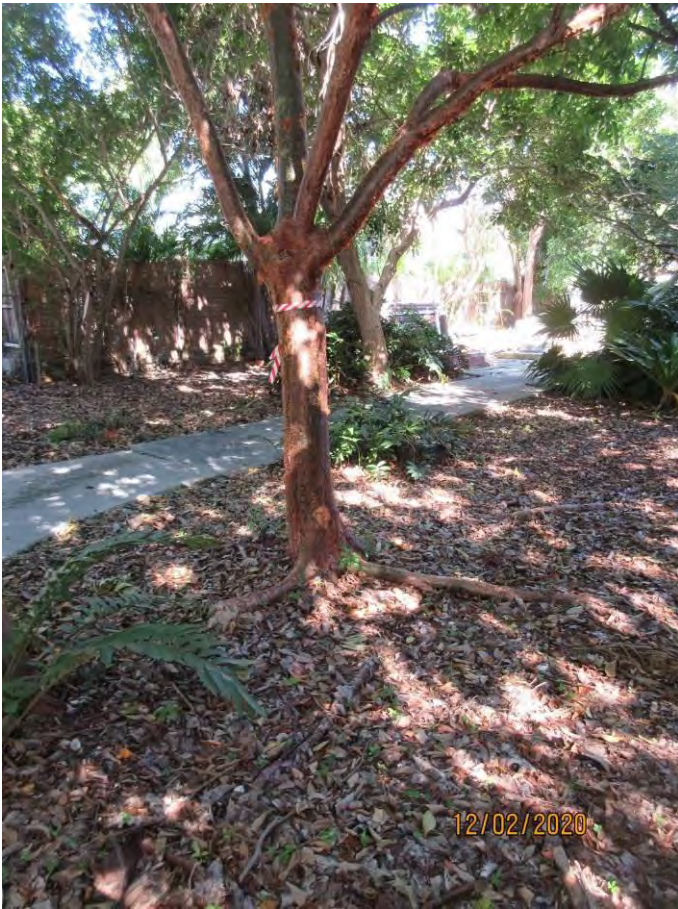
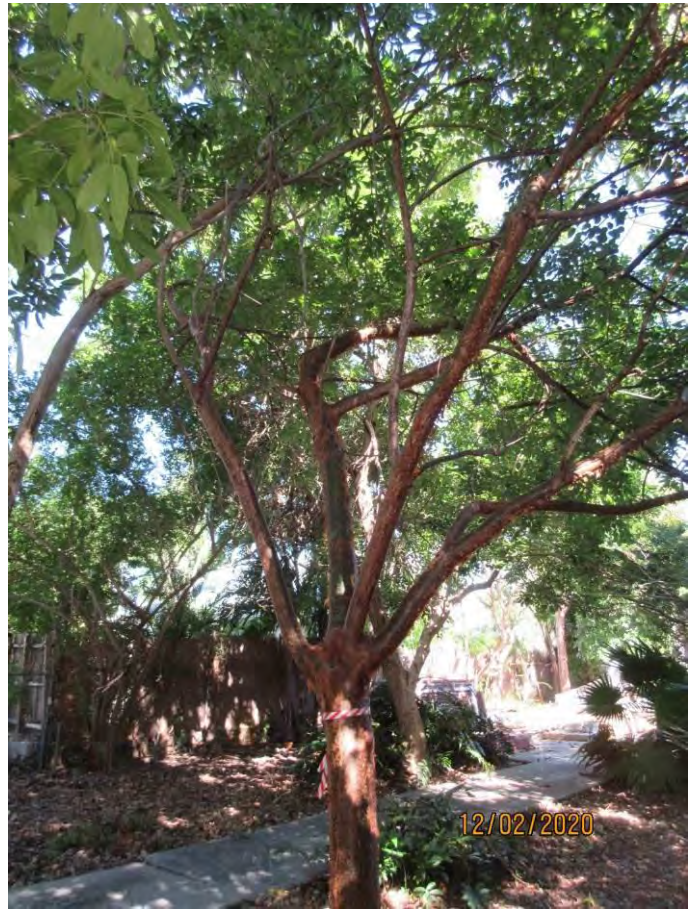
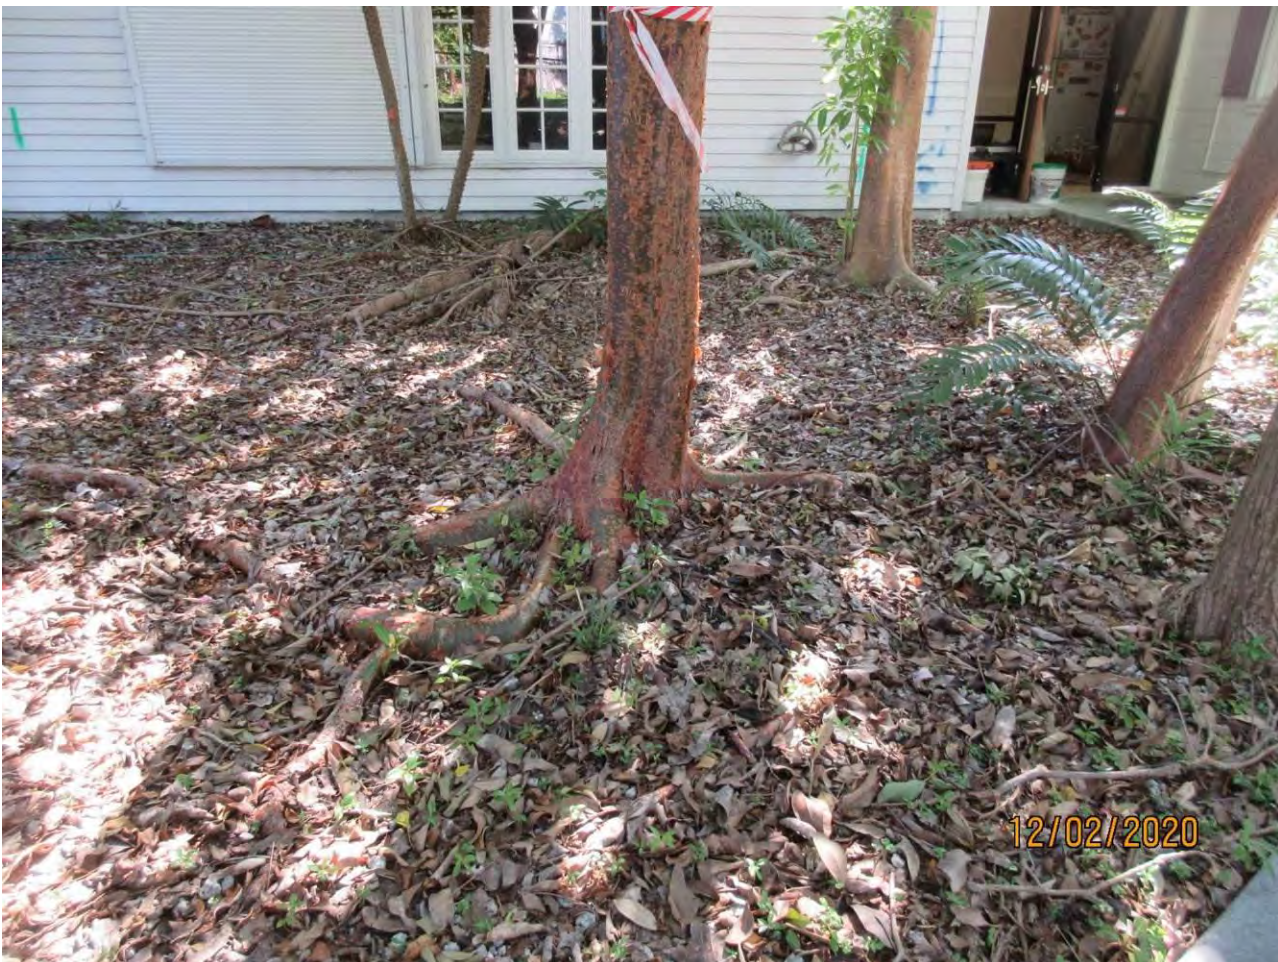
Tree #177 Diameter: 8.5"

Location: 70% (canopy growth impacted by adjacent tree canopies)

Condition: 60% (overall condition is fair)

Value x Diameter = 6.4 replacement caliper inches
