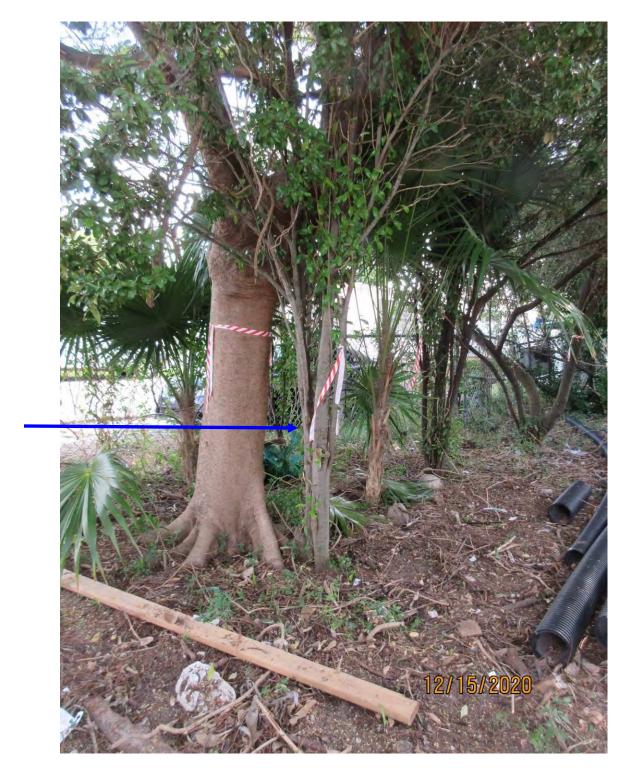
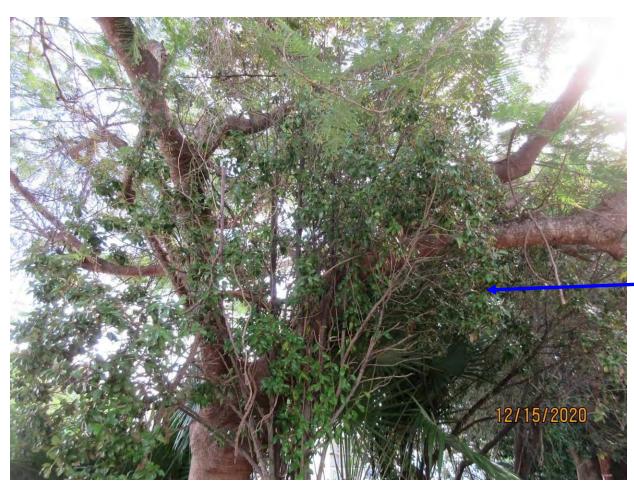
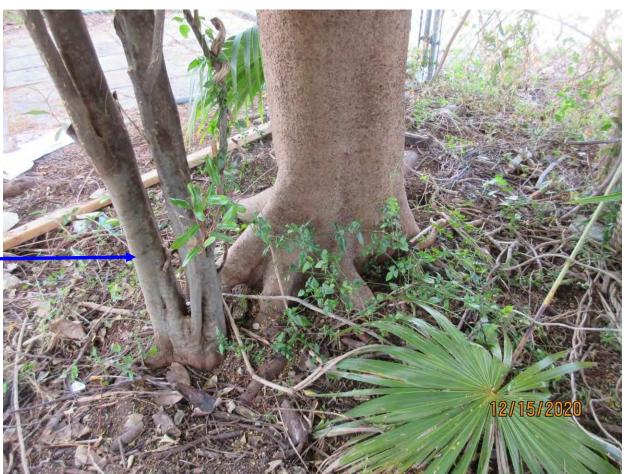
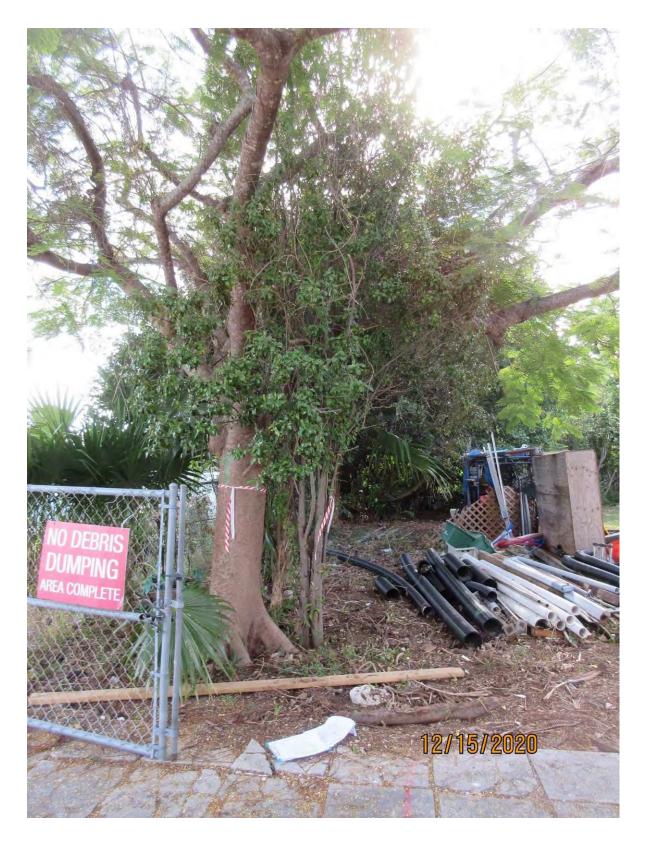
Tree Species: Jamaican Caper (Capparia cynophallophora) Tree #90

Tree #90 Diameter: 7.5"

Location: 60% (growing at the base of a Royal Poinciana tree)

Species: 100% (on protected tree list)

Condition: 60% (fair, shrubby tree with codominant trunks, canopy impacted by

adjacent tree canopy)

Total Average Value = 73%

Value x Diameter = 5.4 replacement caliper inches

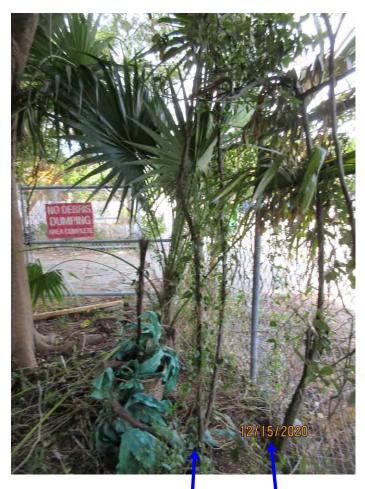
Tree #92 and #94

Tree #92 Diameter: 2"

Location: 80%

Species: 100% (on protected tree list)

Condition: 50% (fair, young shrubby tree with codominant trunks)

Total Average Value = 76%

Value x Diameter = 1.5 replacement caliper inches

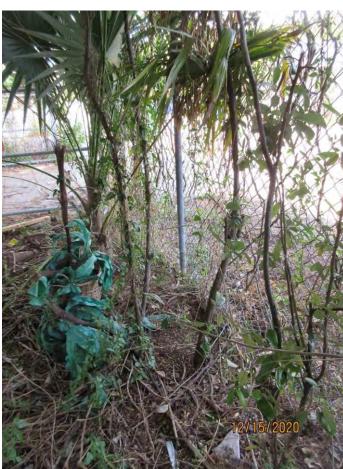
Tree #94 Diameter: 2"

Location: 60% (growing into fence) Species: 100% (on protected tree list)

Condition: 40% (poor)

Total Average Value = 66%

Value x Diameter = 1.3 replacement caliper inches

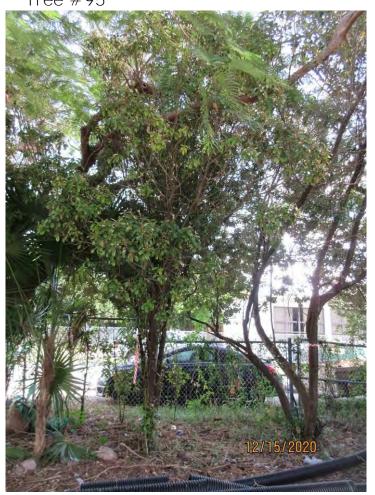
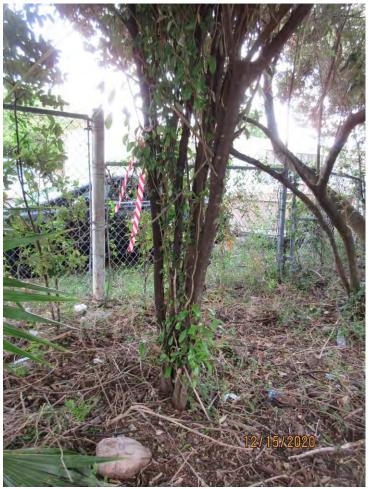
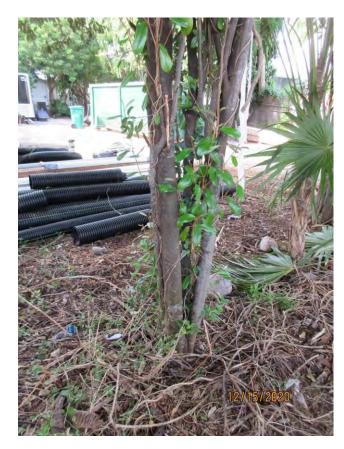
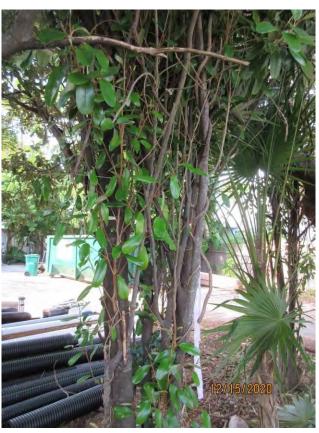
Tree #95 Diameter: 10"

Location: 80%

Species: 100% (on protected tree list)

Condition: 60% (overall condition is fair, multi trunked, shrubby tree, canopy

growth impacts with Royal Poinciana tree, vines wrapped around trunk)

Total Average Value = 80%

Value x Diameter = 8 replacement caliper inches

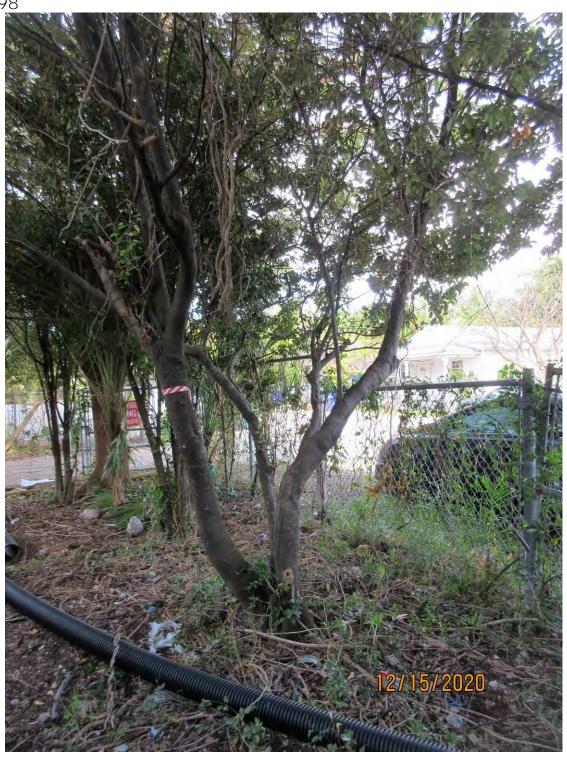
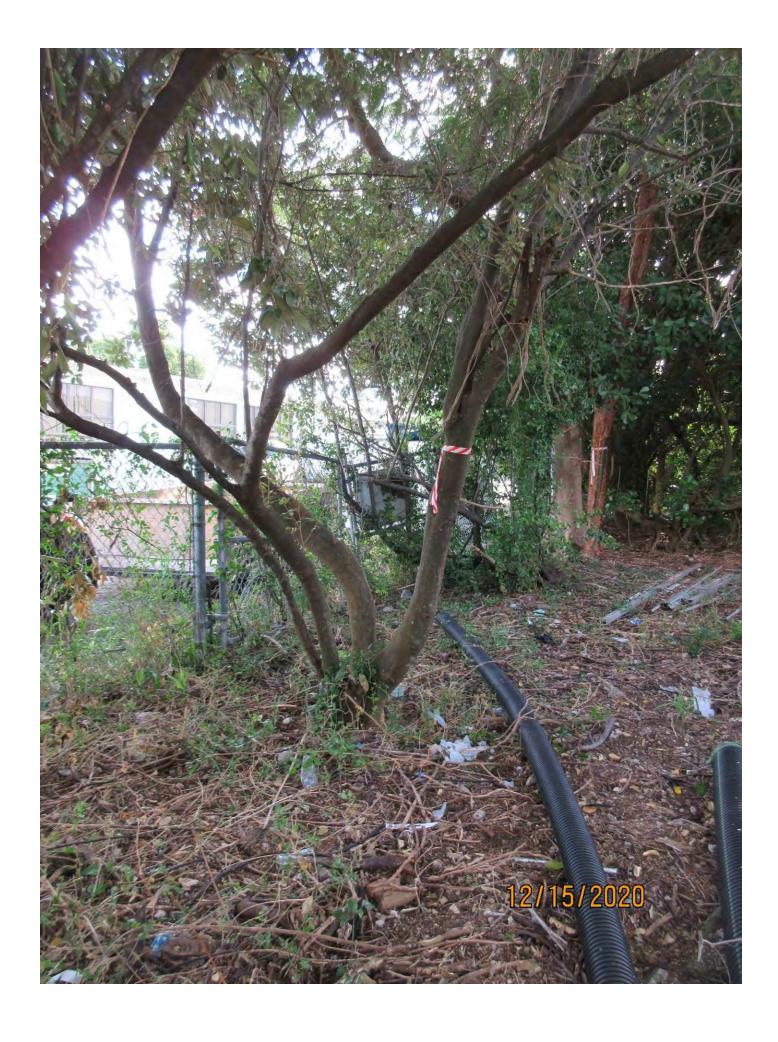
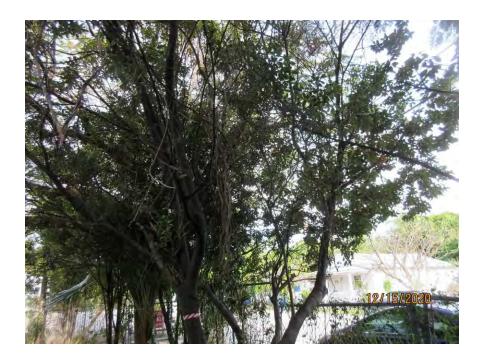
Tree #98 Diameter: 14"

Location: 80%

Species: 100% (on protected tree list)

Condition: 40% (poor, multi trunked, sprawling tree with codominant trunks,

extended limbs)

Total Average Value = 73%

Value x Diameter = 10.2 replacement caliper inches

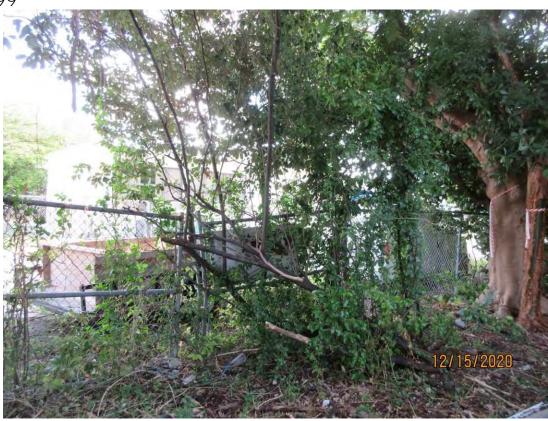
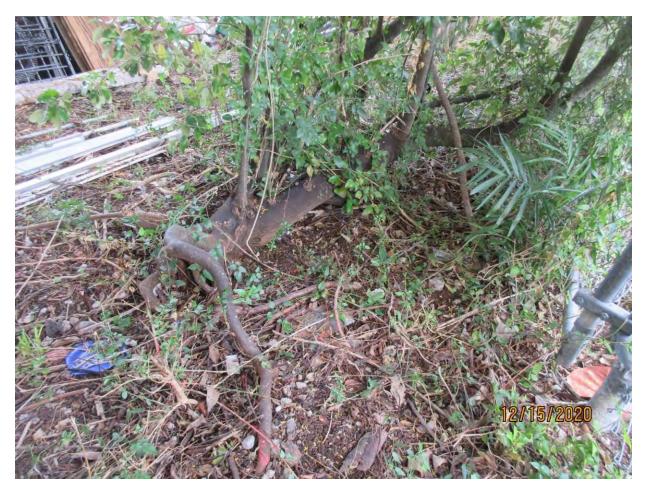
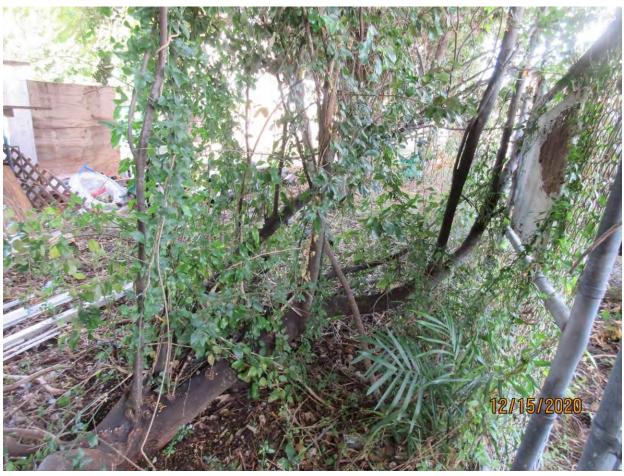
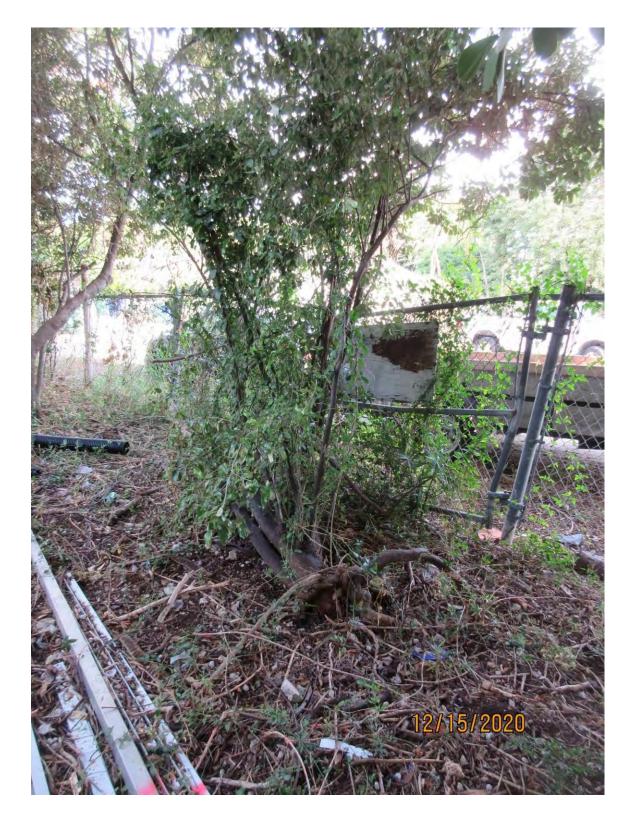
Tree # 99

Tree #99 Diameter: 12"

Location: 80%

Species: 100% (on protected tree list)

Condition: 30% (poor, uplifted roots, multi trunked shrubby tree with regrowth,

poor structure.)

Total Average Value = 70%

Value x Diameter = 8.4 replacement caliper inches

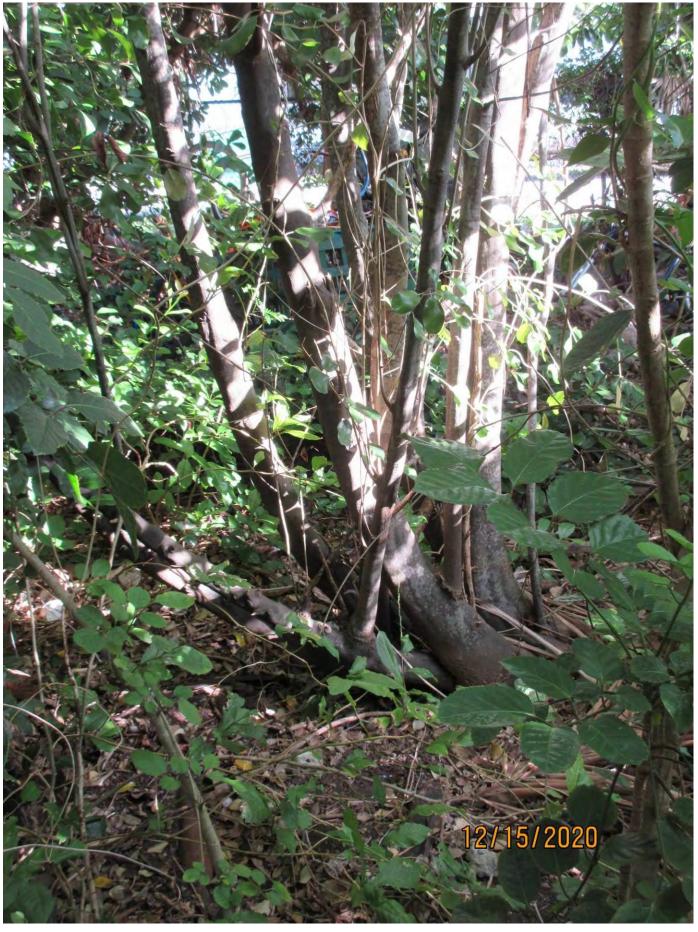
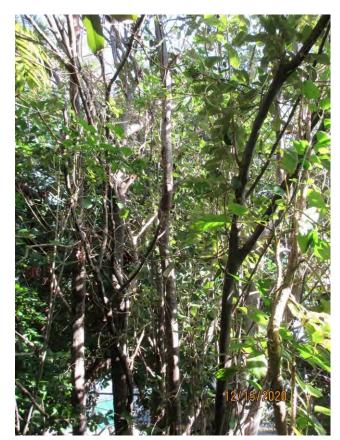
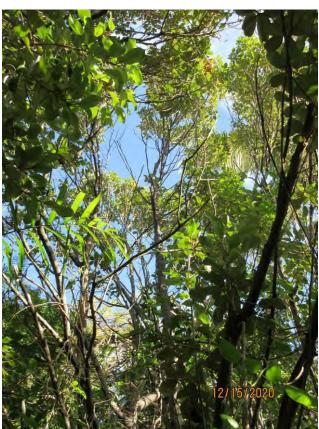
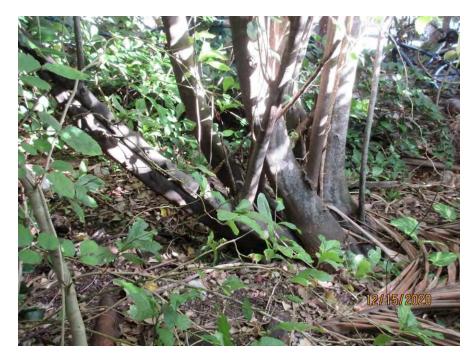
Tree #121 Diameter: 18"

Location: 80%

Species: 100% (on protected tree list)

Condition: 40% (overall condition is poor, multi trunked tree, canopy with die

back)

Total Average Value = 73%

Value x Diameter = 13.1 replacement caliper inches

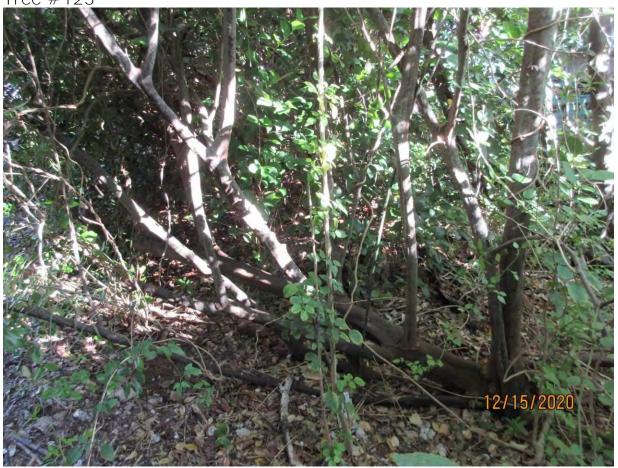
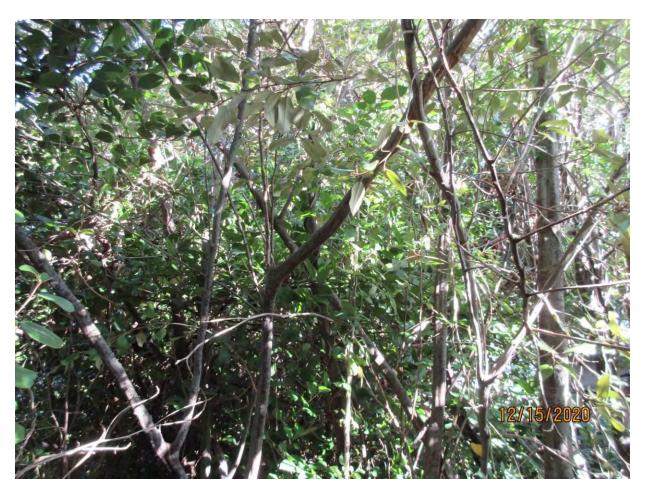
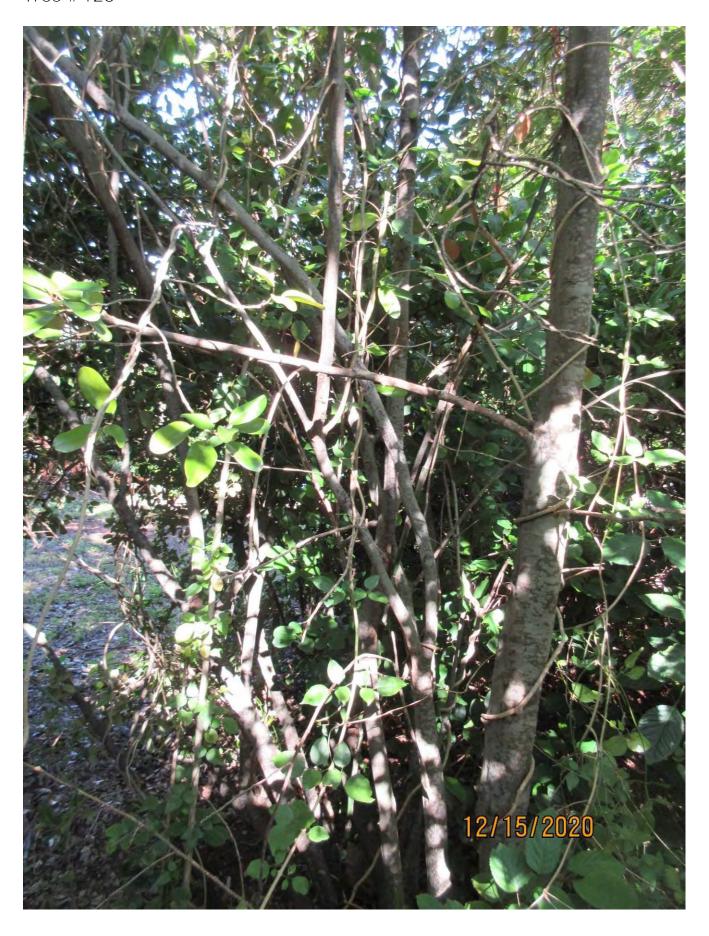
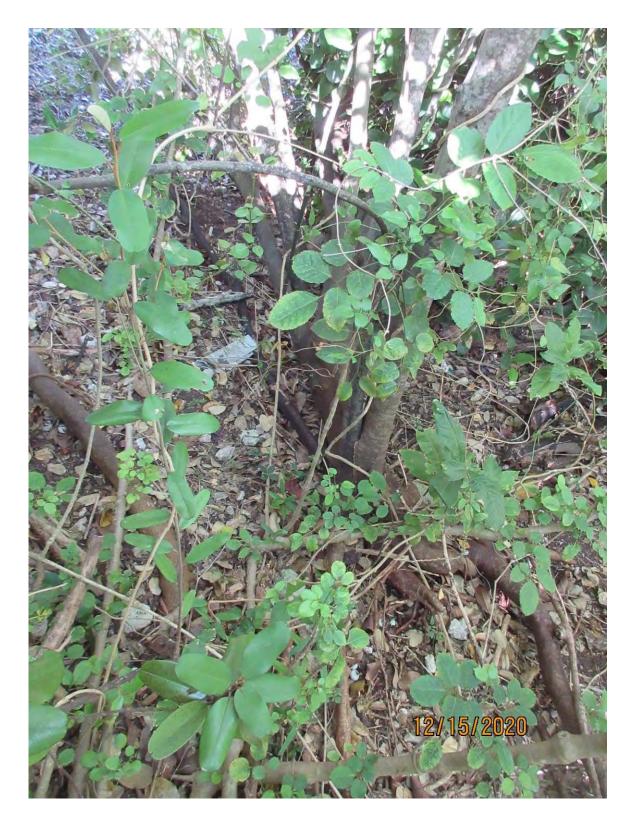
Tree #123 Diameter: 6"

Location: 80%

Species: 100% (on protected tree list)

Condition: 40% (overall condition is poor, uplifted roots, multitrunked with

regrowth).

Total Average Value = 73%

Value x Diameter = 4.3 replacement caliper inches

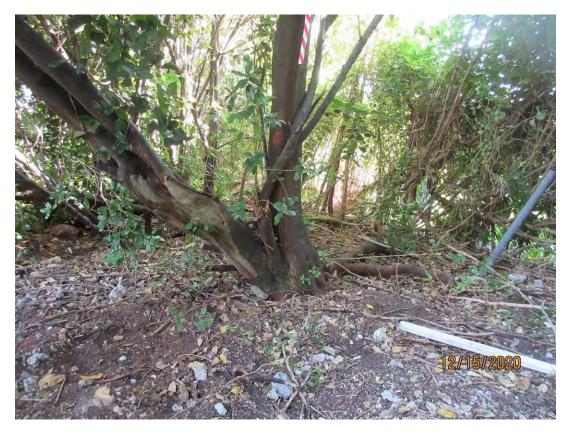
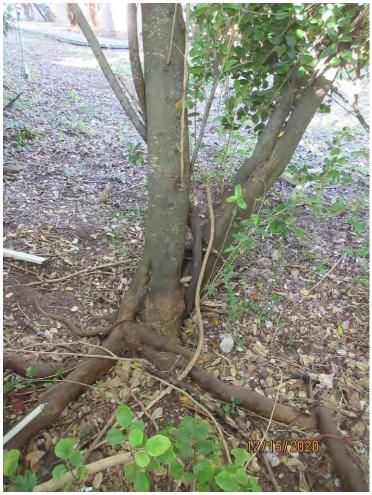
Tree #125 Diameter: 15"

Location: 80%

Species: 100% (on protected tree

list)

Condition: 40% (overall condition is poor, uplifted roots, multitrunked

with regrowth).

Total Average Value: 73% Value x Diameter = 10.9 replacement caliper inches

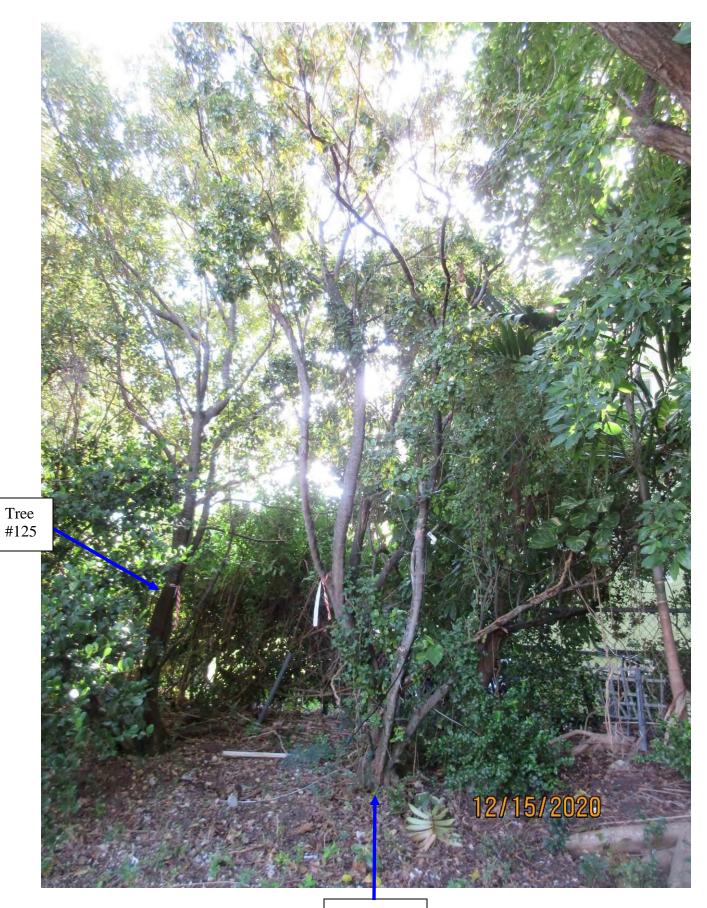
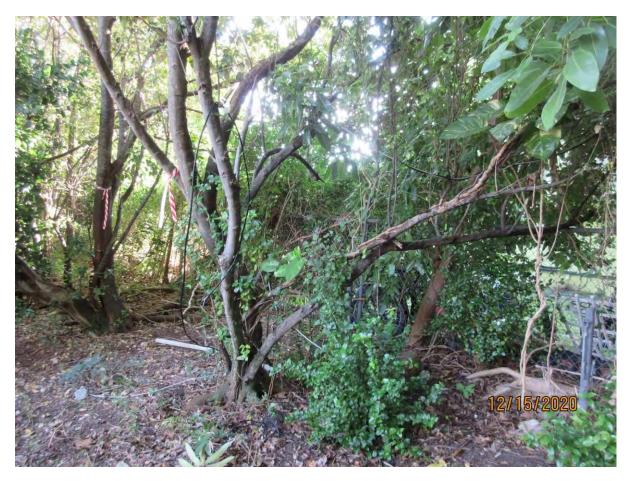
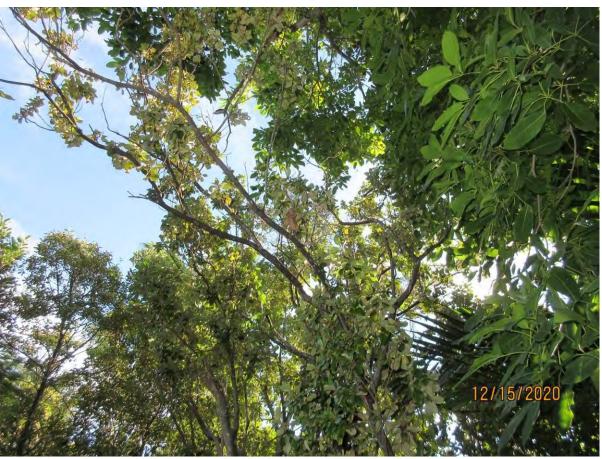
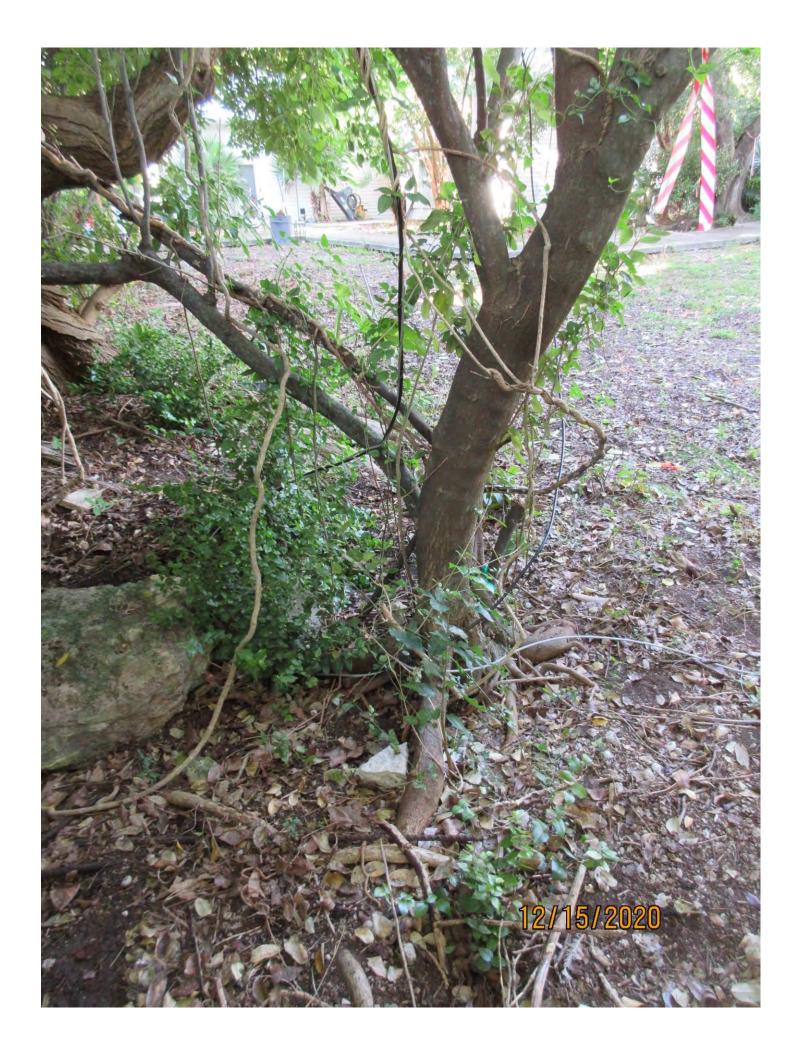
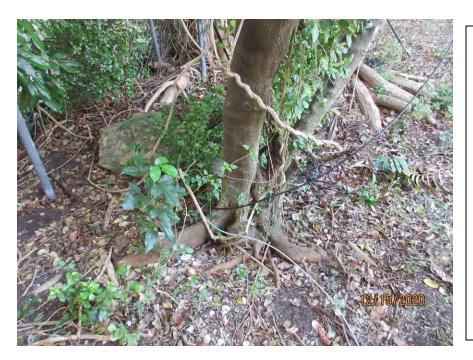
Tree #126 Diameter: 14.6" Location: 60% (growth impacted by adjacent larger tree)

Species: 100% (on protected

tree list)

Condition: 30% (poor, exposed base and root system, crown die back, poor

structure.)

Total Average Value = 63% Value x Diameter = 9.1 replacement caliper inches

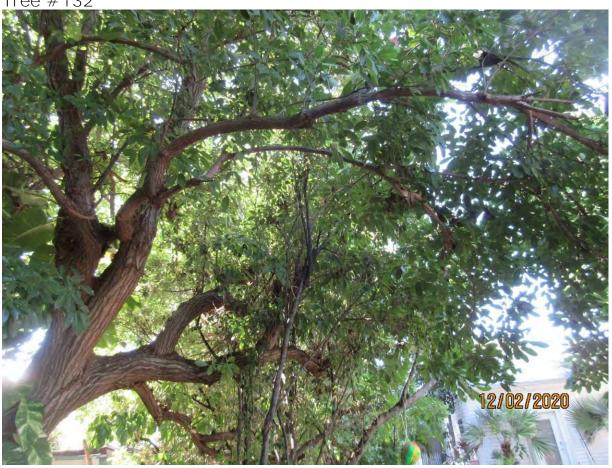
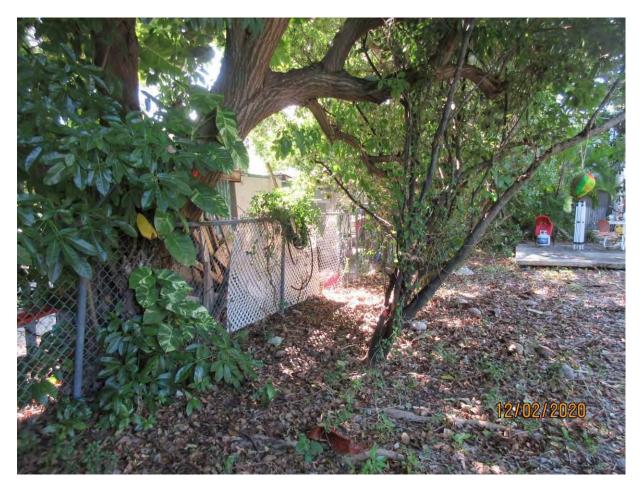
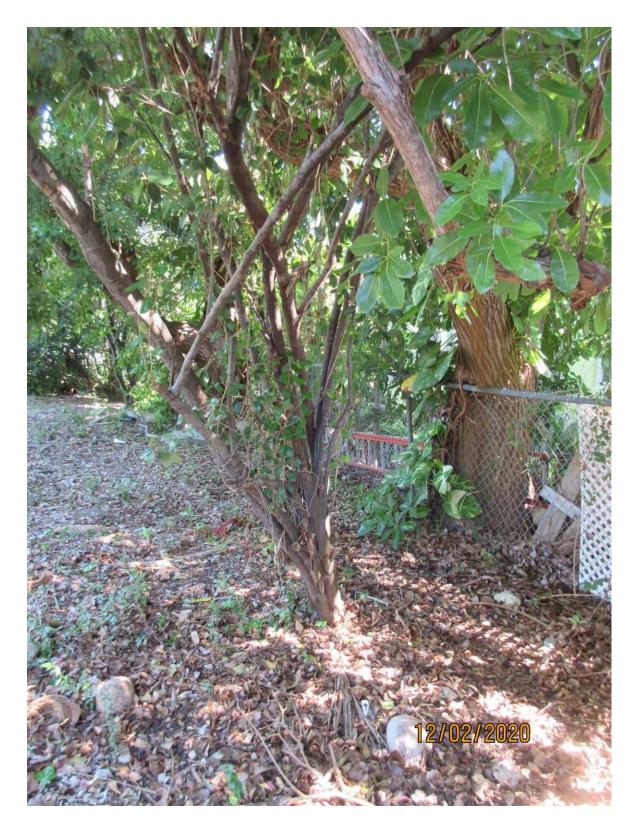
Tree #132 Diameter: 10"

Location: 60% (growing within canopy of larger tree)

Species: 100% (on protected tree list) Condition: 60% (overall condition fair)

Total Average Value = 73%

Value x Diameter = 7.3 replacement caliper inches

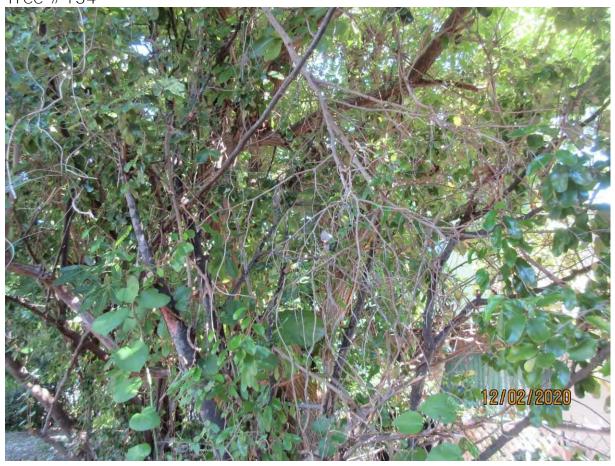
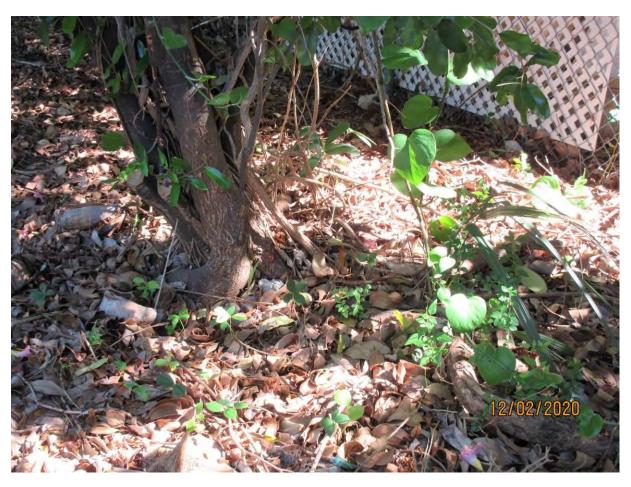
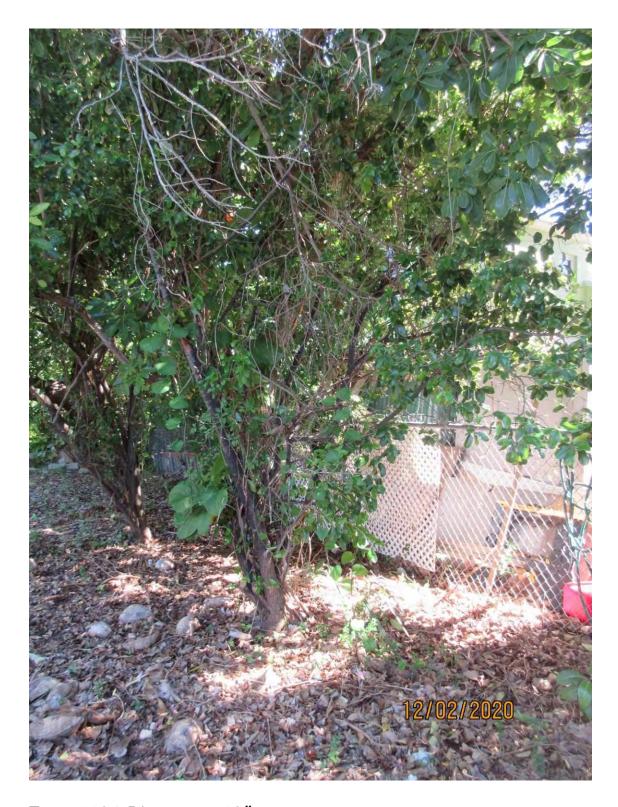
Tree #134 Diameter: 12"

Location: 60% (growth impacted by canopy of adjacent larger tree)

Species: 100% (on protected tree list)

Condition: 50% (overall condition is fair to poor, trunk and canopy impacted by

vines, poor structure)

Total Average Value = 70%

Value x Diameter = 8.4 replacement caliper inches

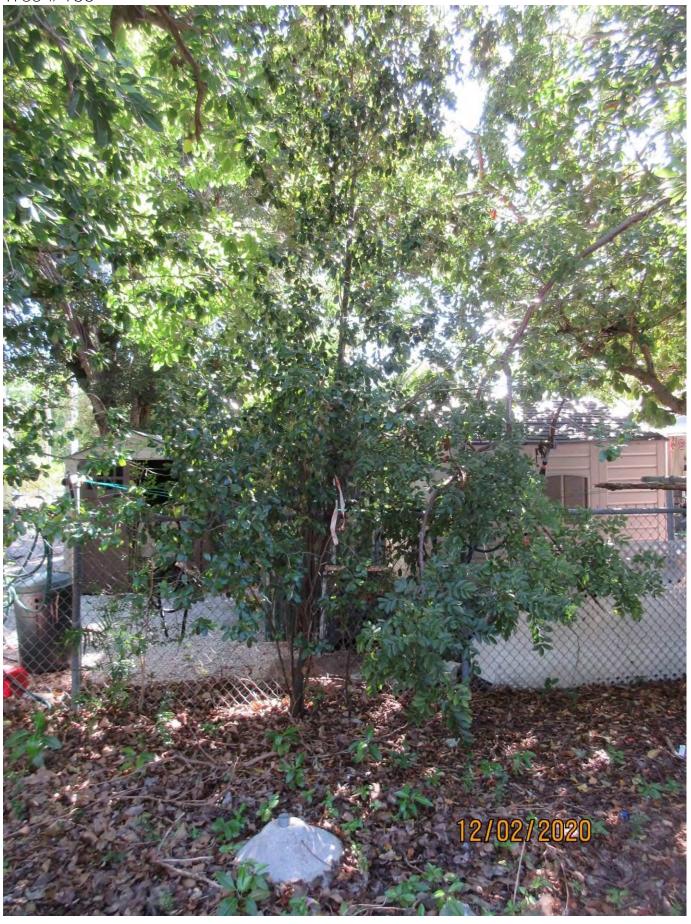
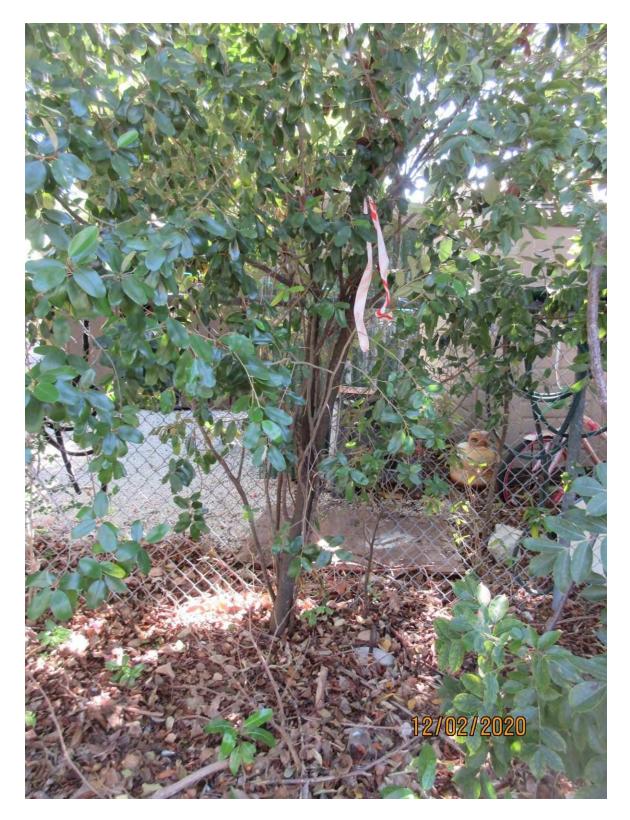
Tree #135 Diameter: 3"

Location: 70% (close to fence)

Species: 100% (on protected tree list)

Condition: 60% (fair-young tree)

Total Average Value = 76%

Value x Diameter = 2.2 replacement caliper inches

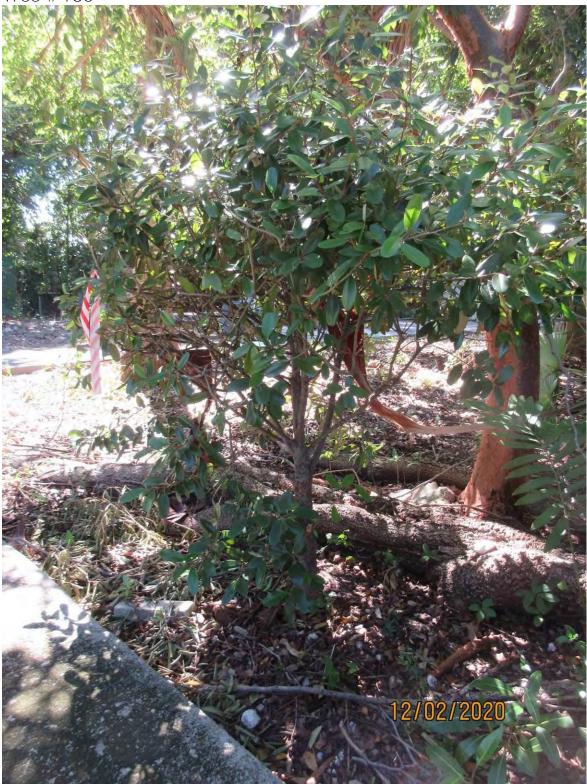
Tree #160 Diameter: 2"

Location: 60% (growing in roots system of larger tree)

Species: 100% (on protected tree list) Condition: 70% (overall nice young tree)

Total Average Value = 76%

Value x Diameter = 1.5 replacement caliper inches

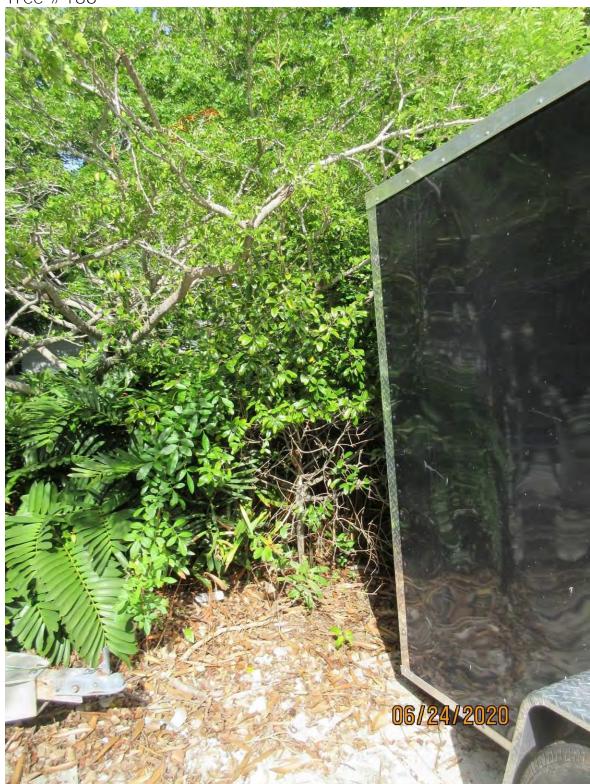
Tree #186 Diameter: 2"

Location: 60% (growing in dripline of lignum vitae tree)

Species: 100% (on protected tree list) Condition: 70% (overall nice young tree)

Total Average Value = 76%

Value x Diameter = 1.5 replacement caliper inches
