STAFF REPORT

RE: **1020 Margaret Street (permit application # TP2020-0005)**

FROM: Karen DeMaria, City of Key West Urban Forestry Manager

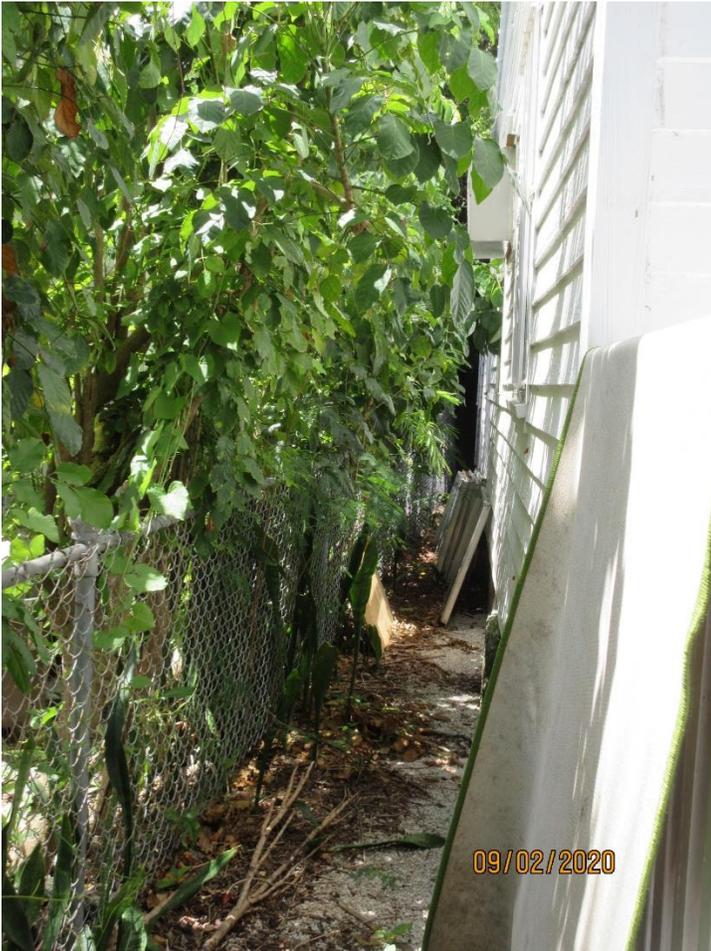
Photo to the left shows the existing condition of the southern property line next to historic structure to be shifted away from property line.

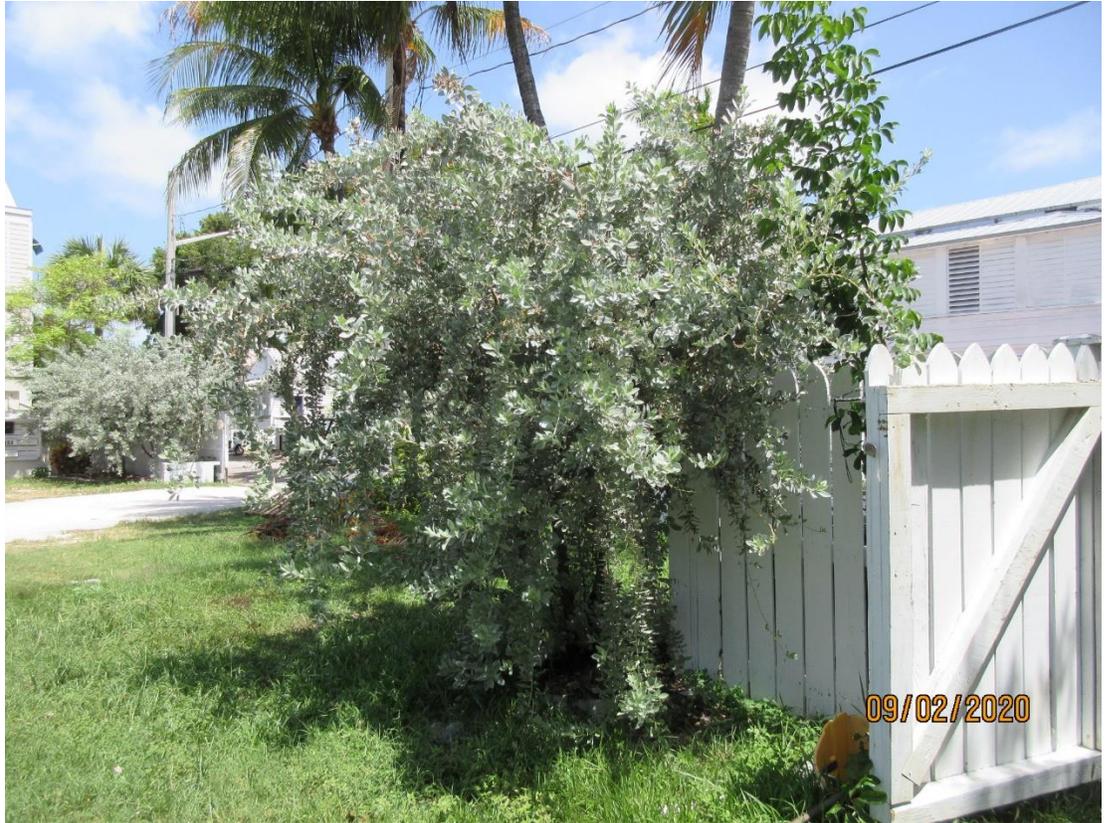
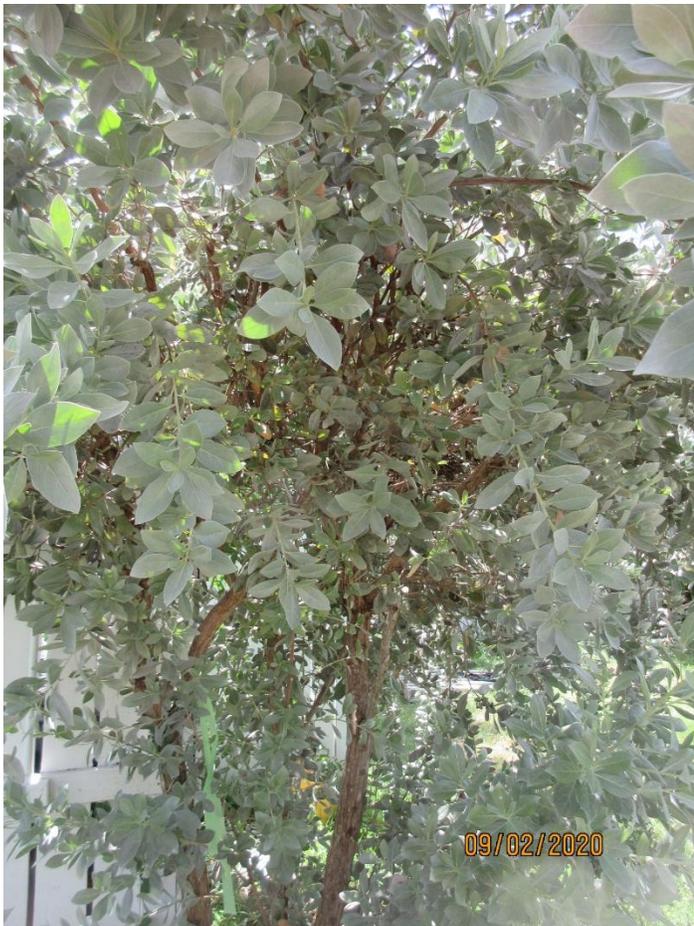
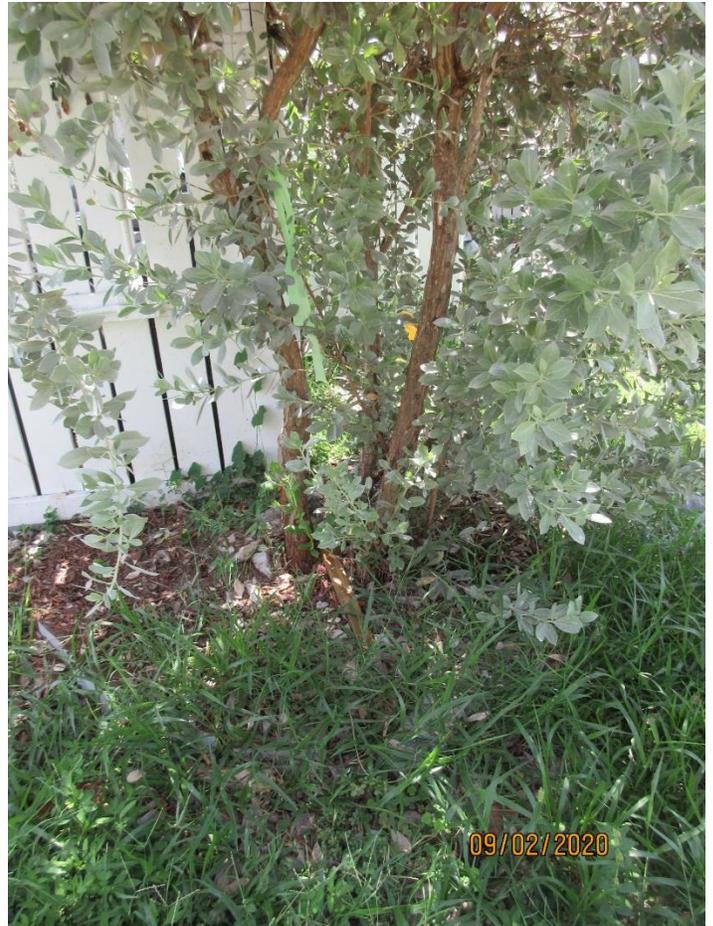
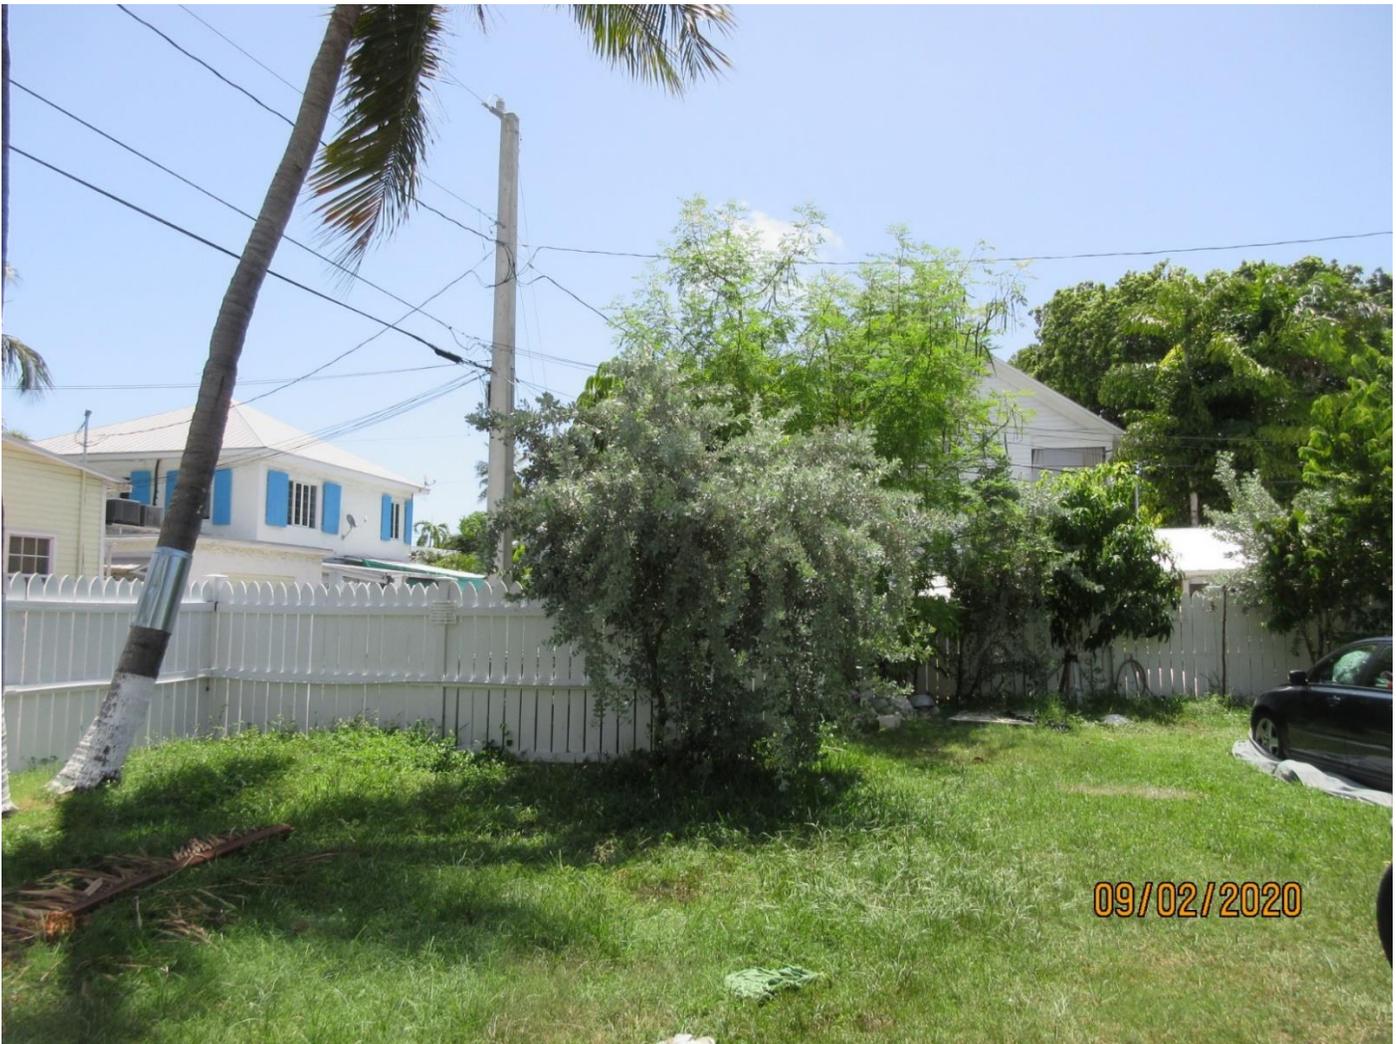
Tree #4:

Photo showing location of tree #4 along eastern property line near Margaret Street.

Diameter: 6"

Location: 80% (growing along fence where garbage is stored)

Species: 100% (on protected tree list)

Condition: 80% (multi trunked young tree)

Total Average Value = 86%

Value x Diameter = 5.1 replacement caliper inches

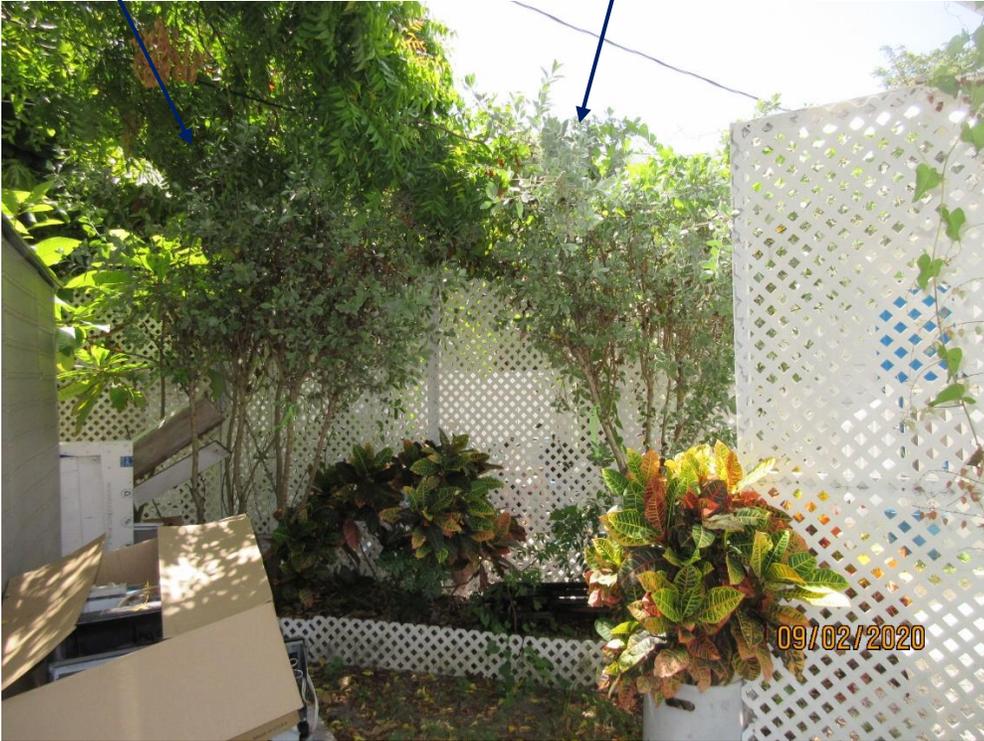
Photo showing location of trees #20 and #21.

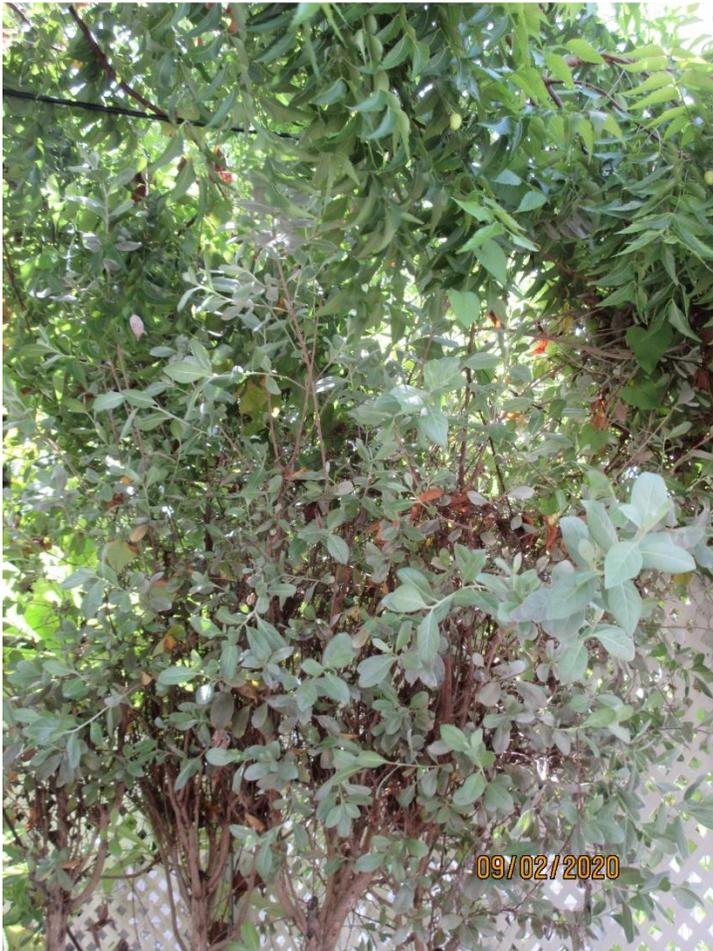
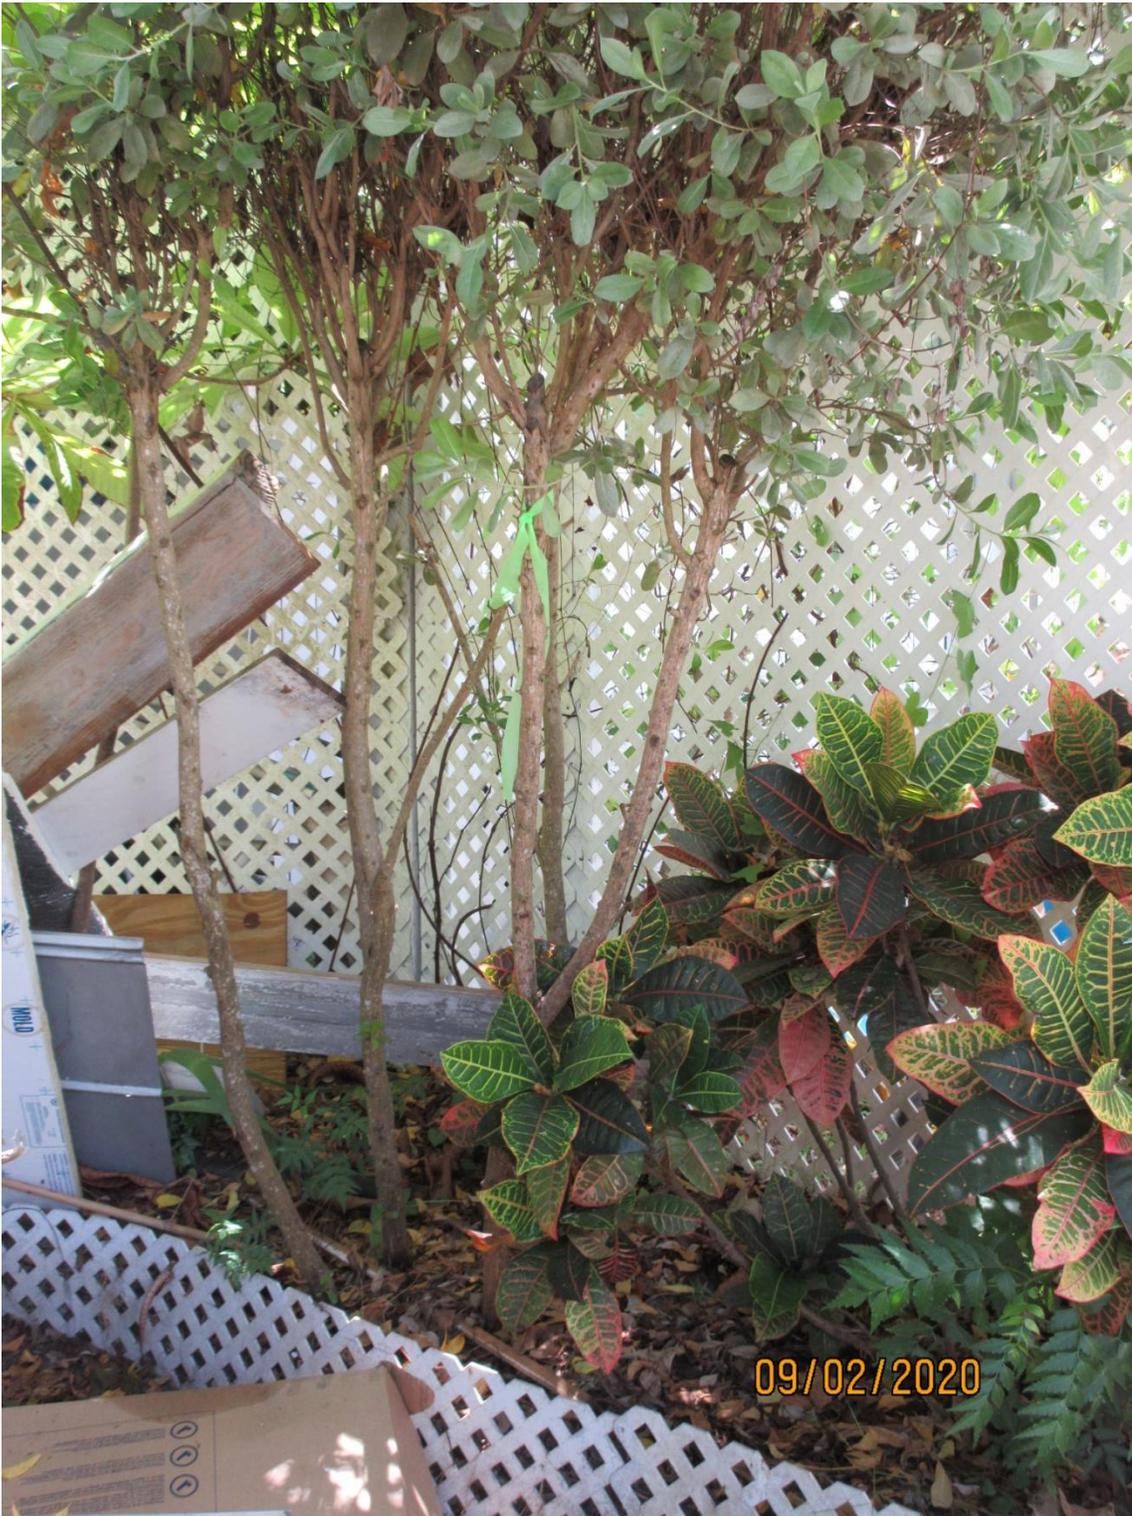
Tree #20:

Close up of canopy of tree #20

Close up photo of the trunks of tree #20.

Diameter: 7"

Location: 60% (growing in a slightly raised planter)

Species: 100% (species is on protected tree list)

Condition: 60% (young multi trunked tree that has been topped in the past- was probably once maintained as a shrub/hedge)

Total Average Value = 73%

Value x Diameter = 5.1 replacement caliper inches

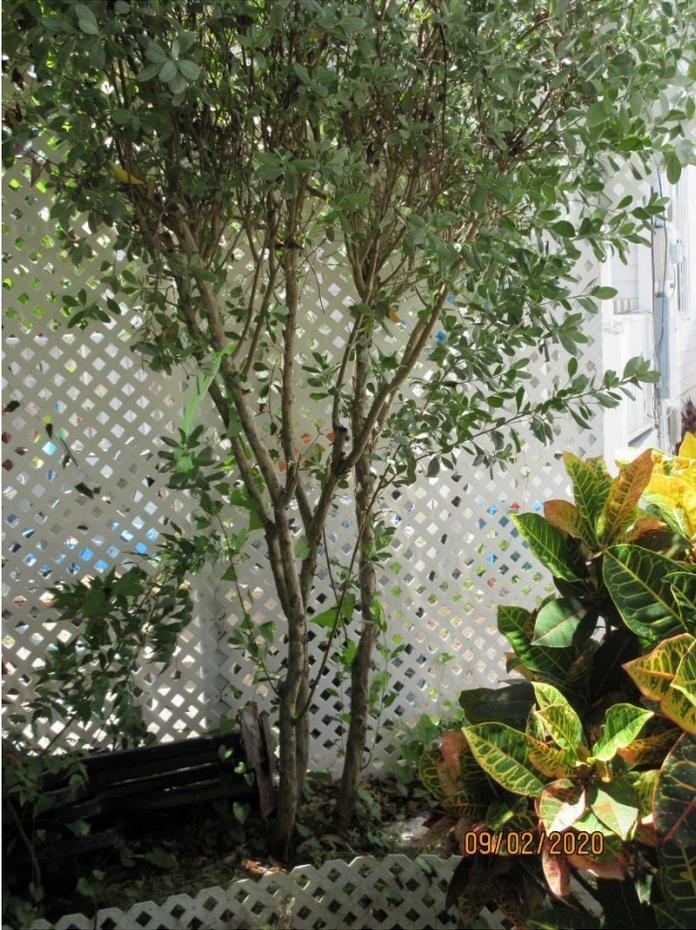
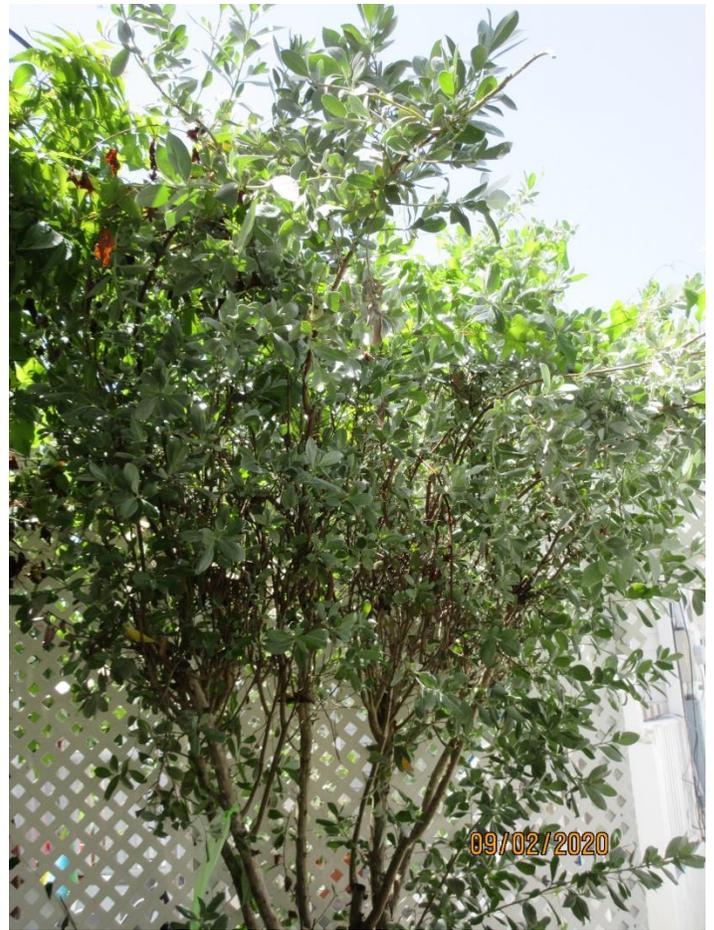
Tree #21:

Diameter: 7"

Location: 60% (growing in a slightly raised planter)

Species: 100% (species on protected tree list)

Condition: 80% (young multi trunked tree)

Total Average Value = 80%

Value x Diameter = 5.6 replacement caliper inches

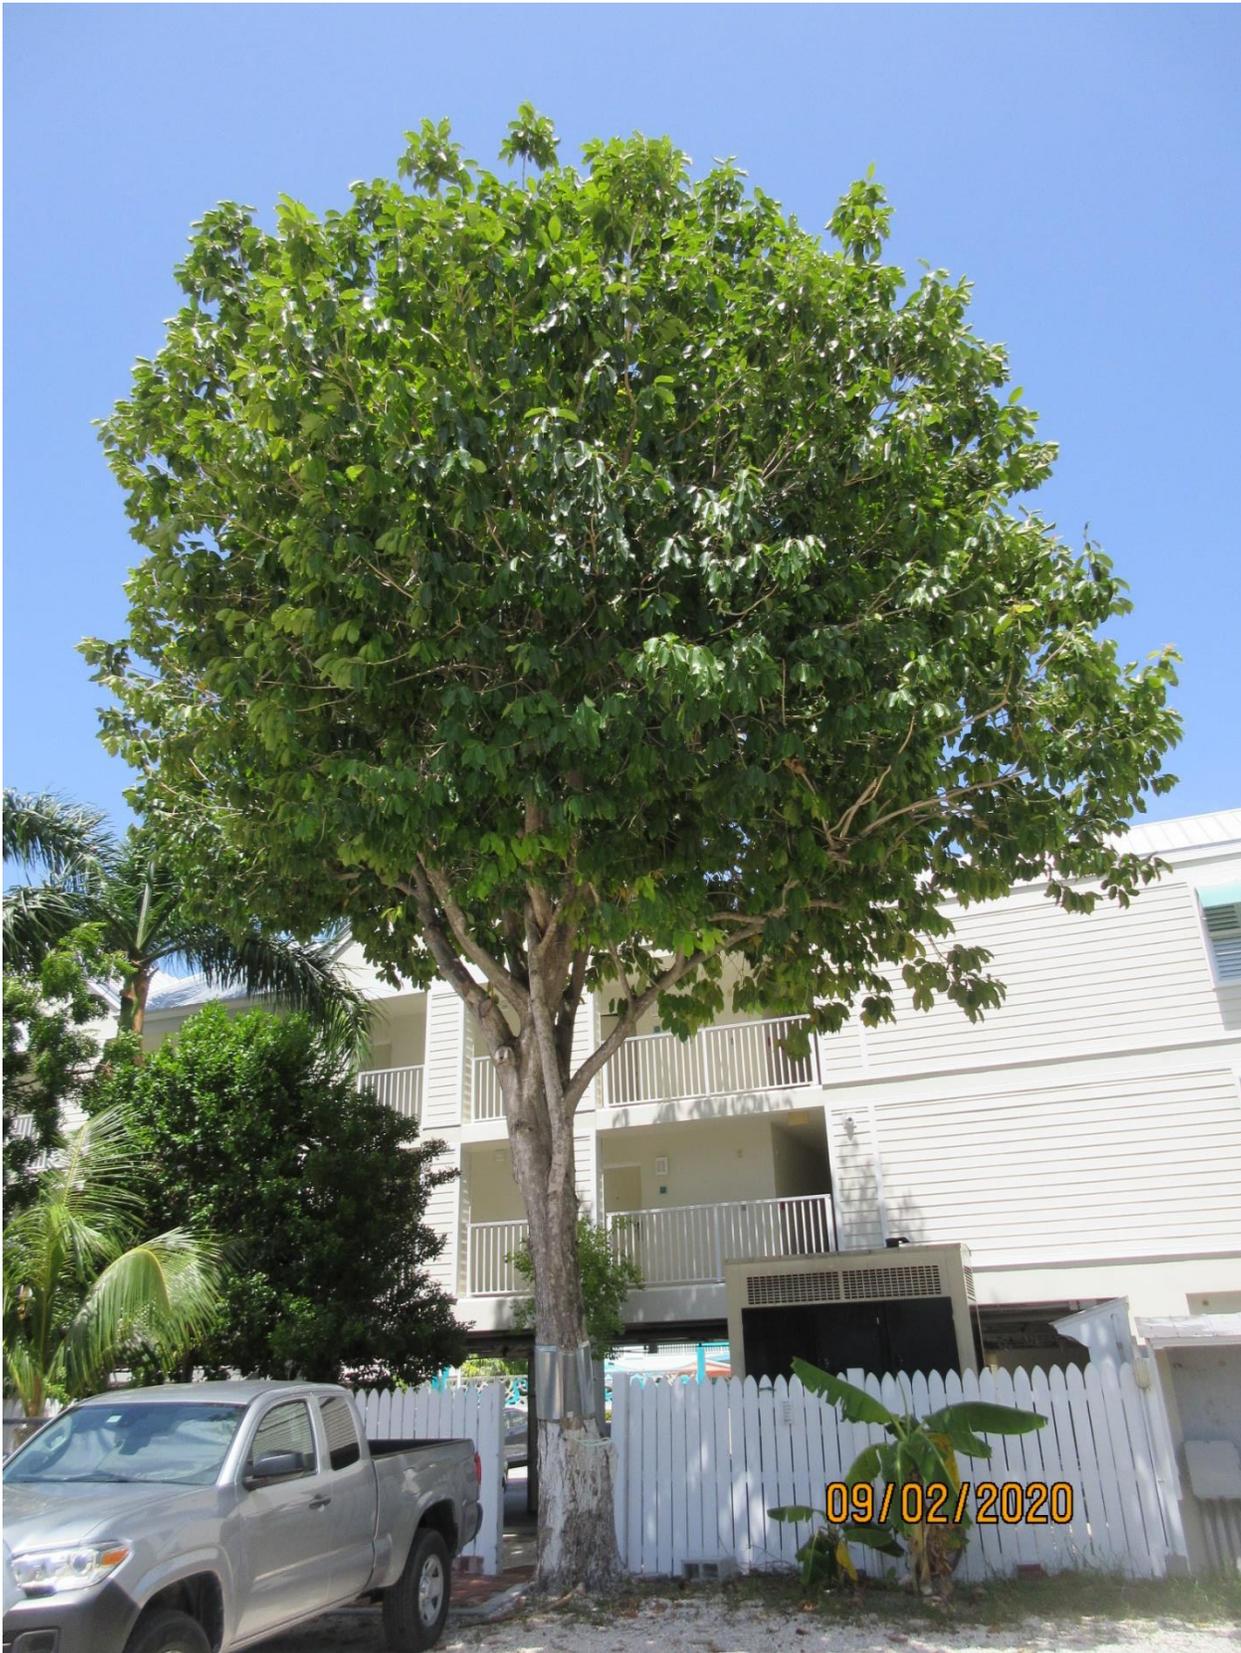
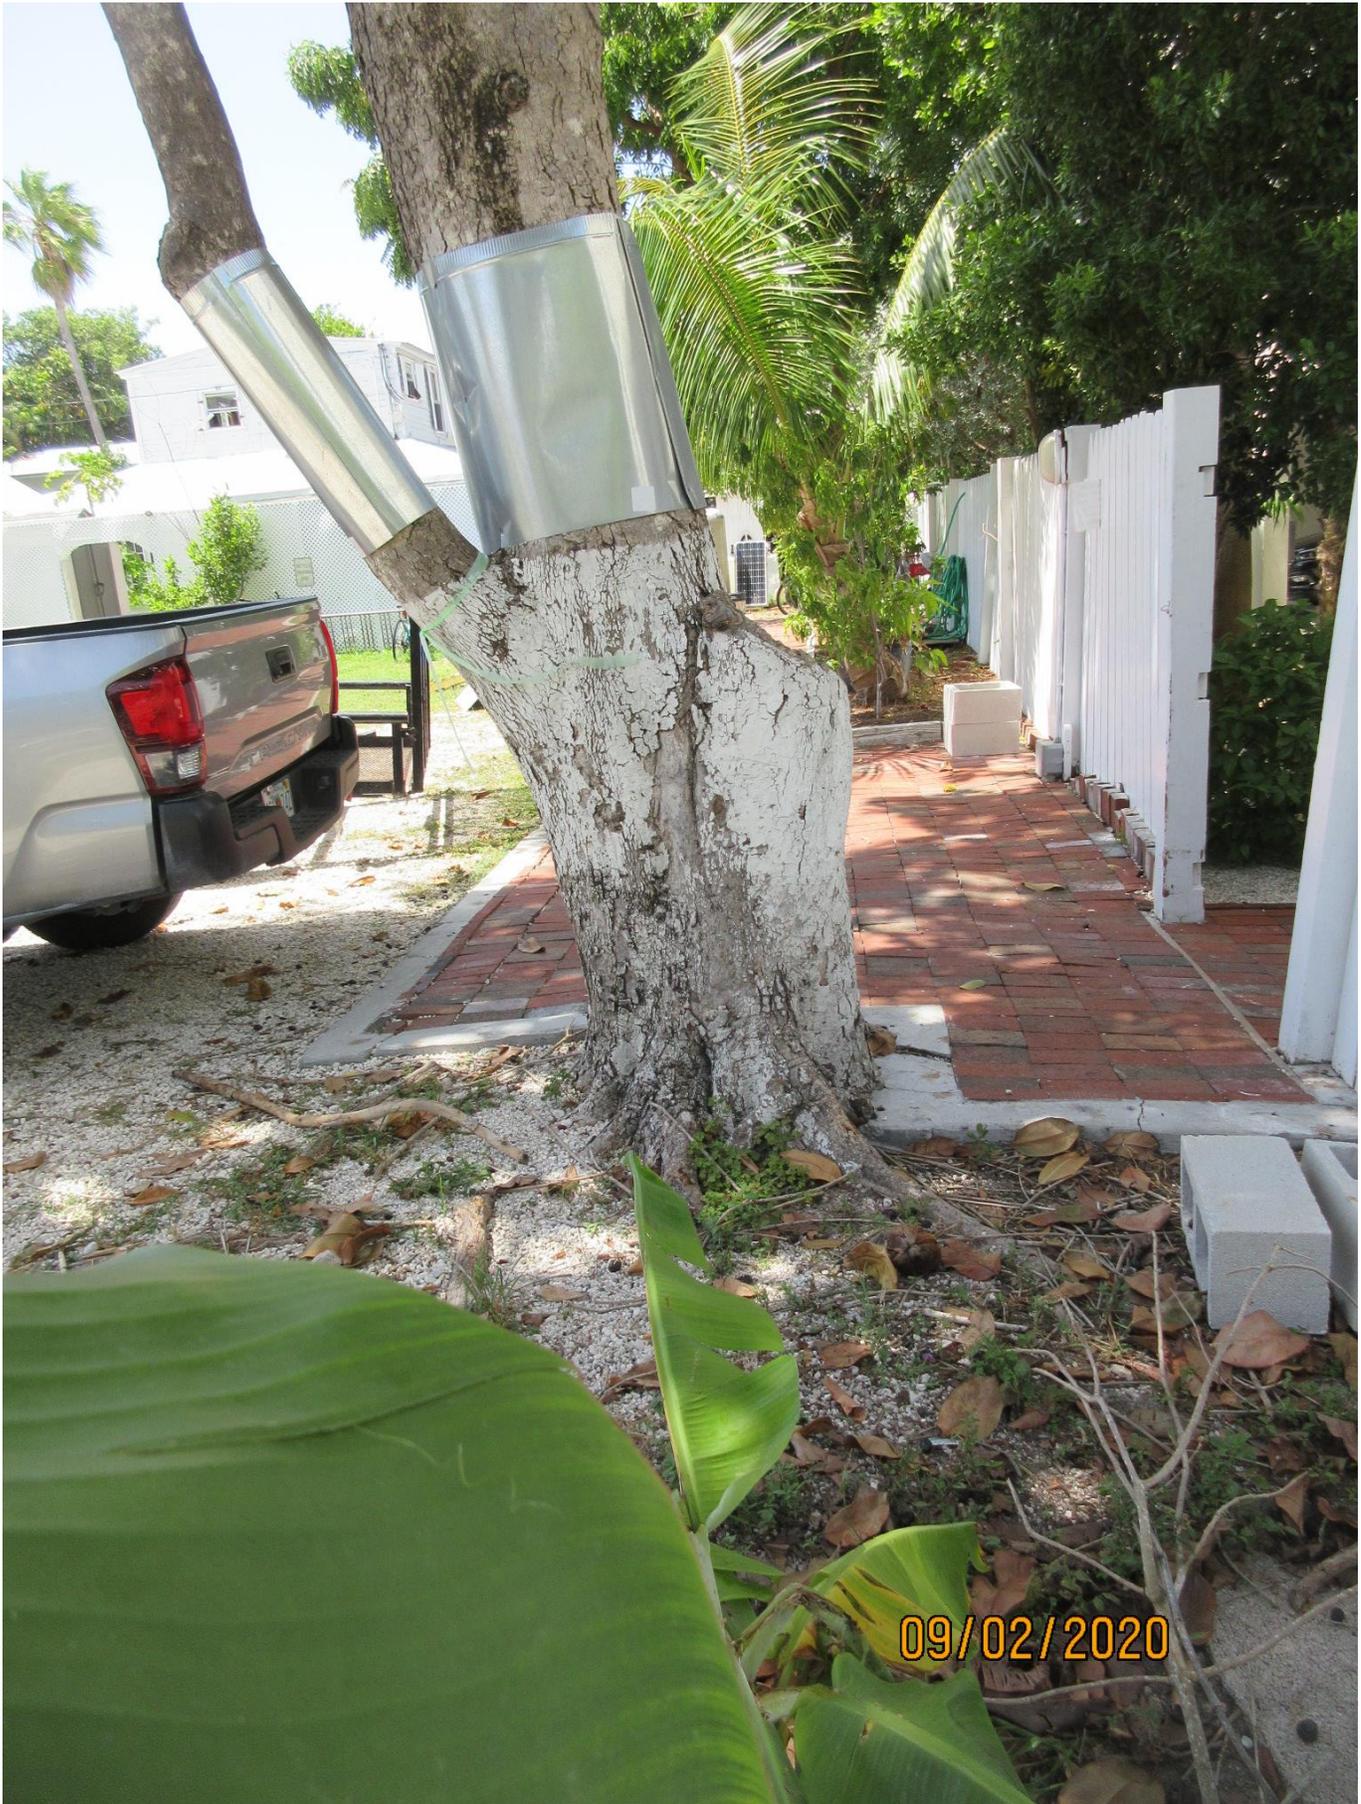
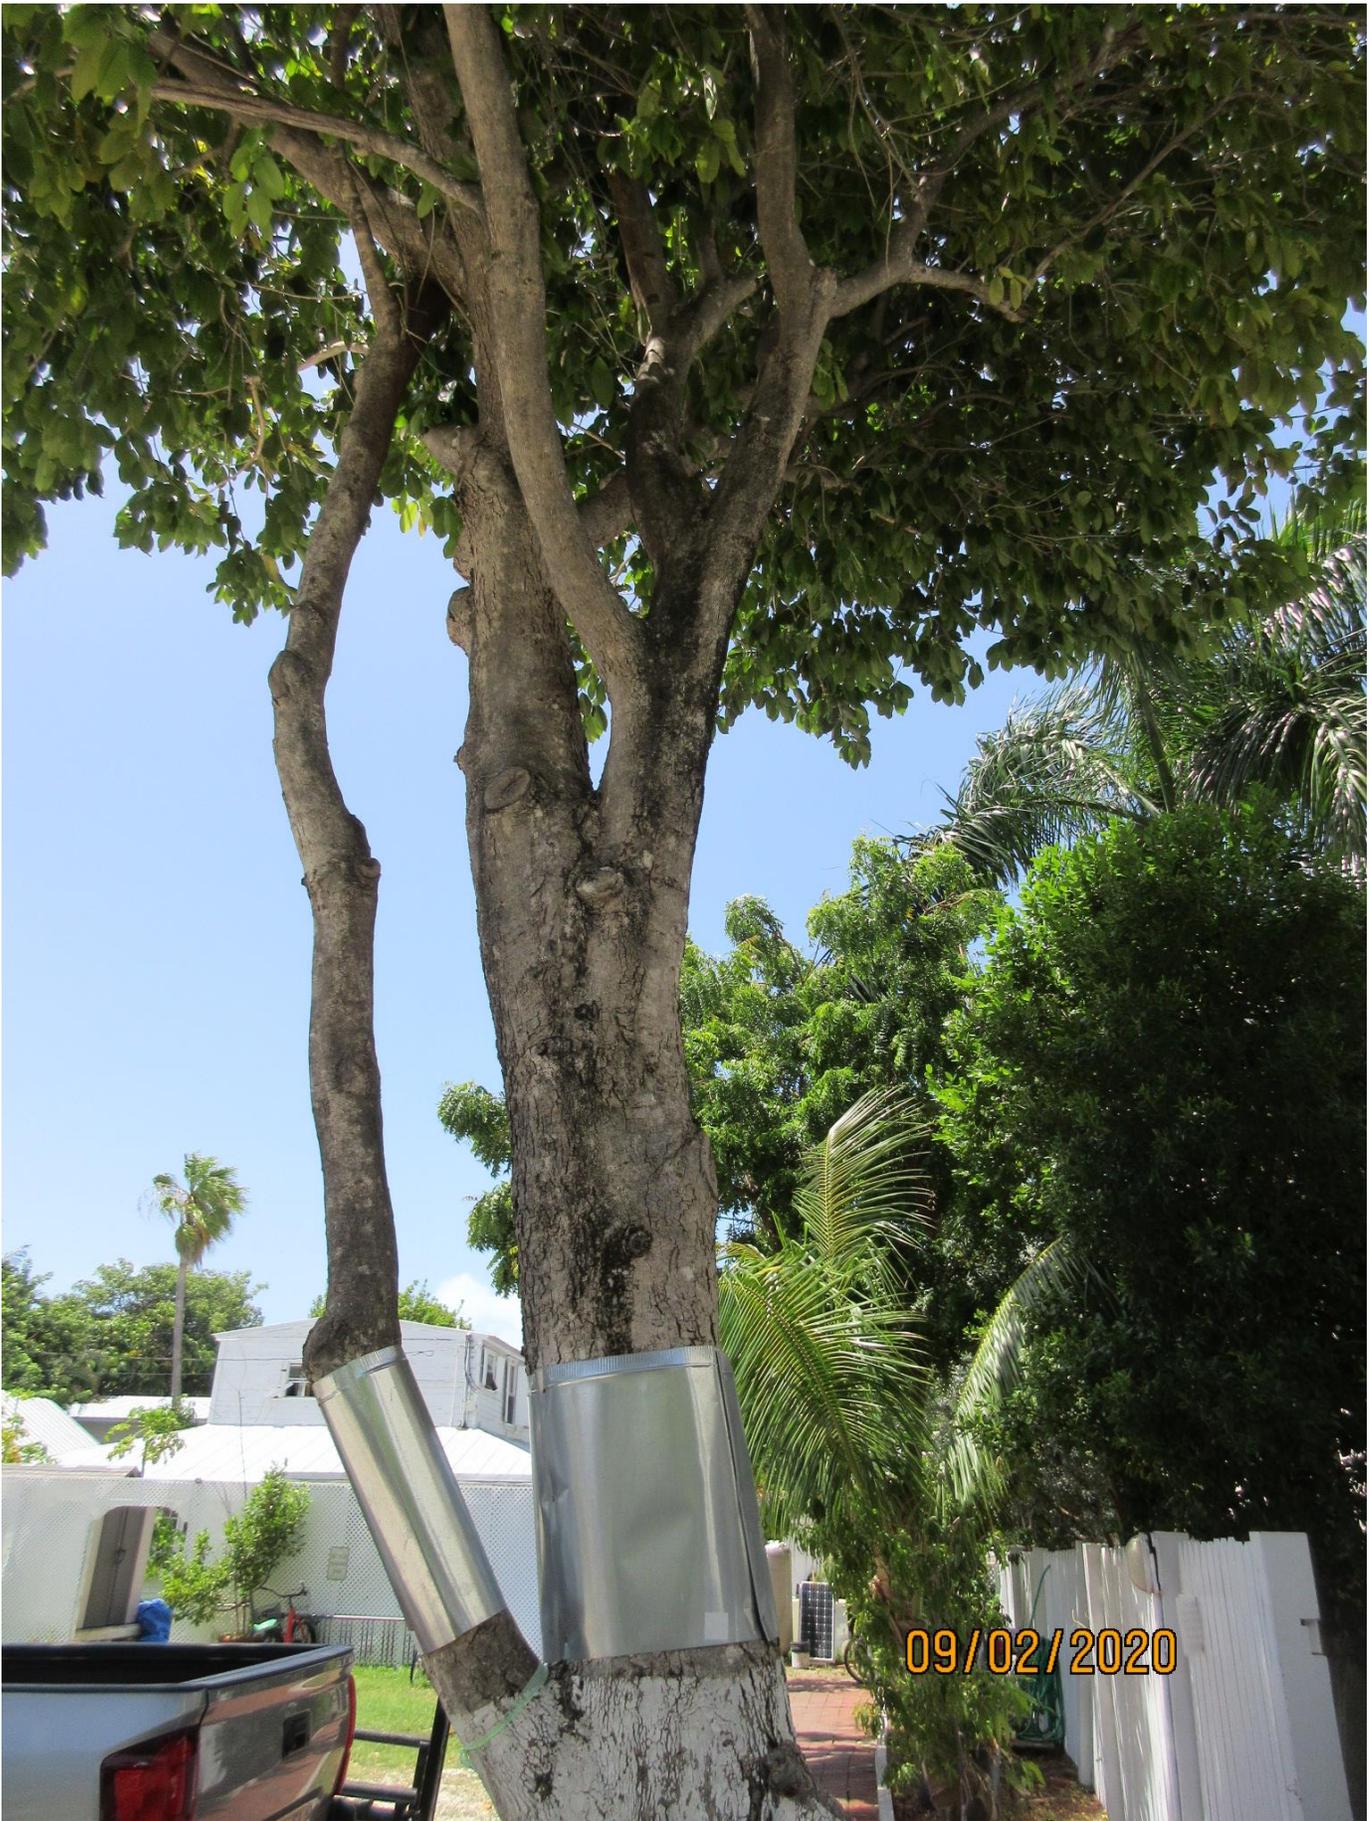
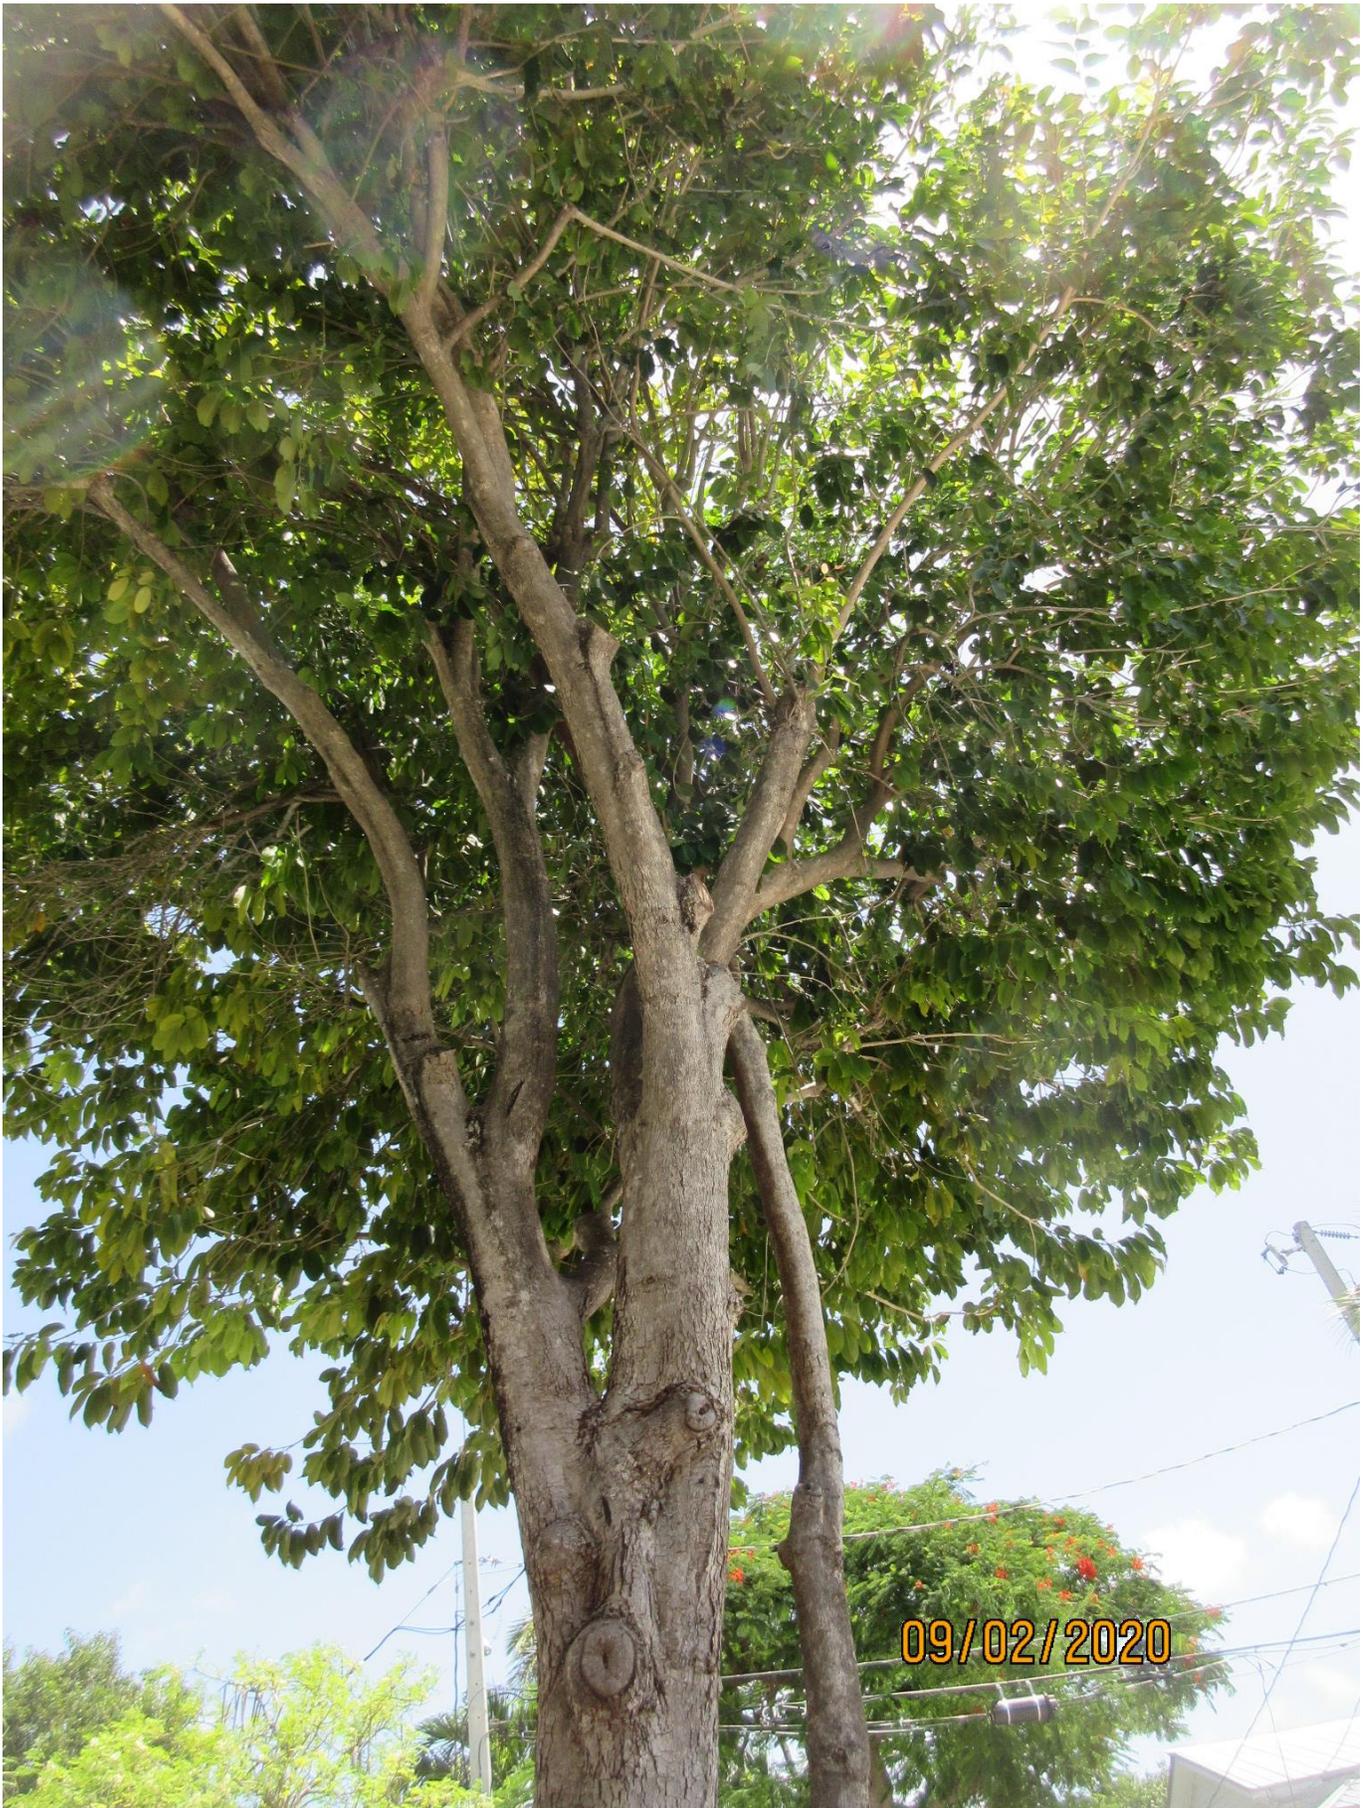
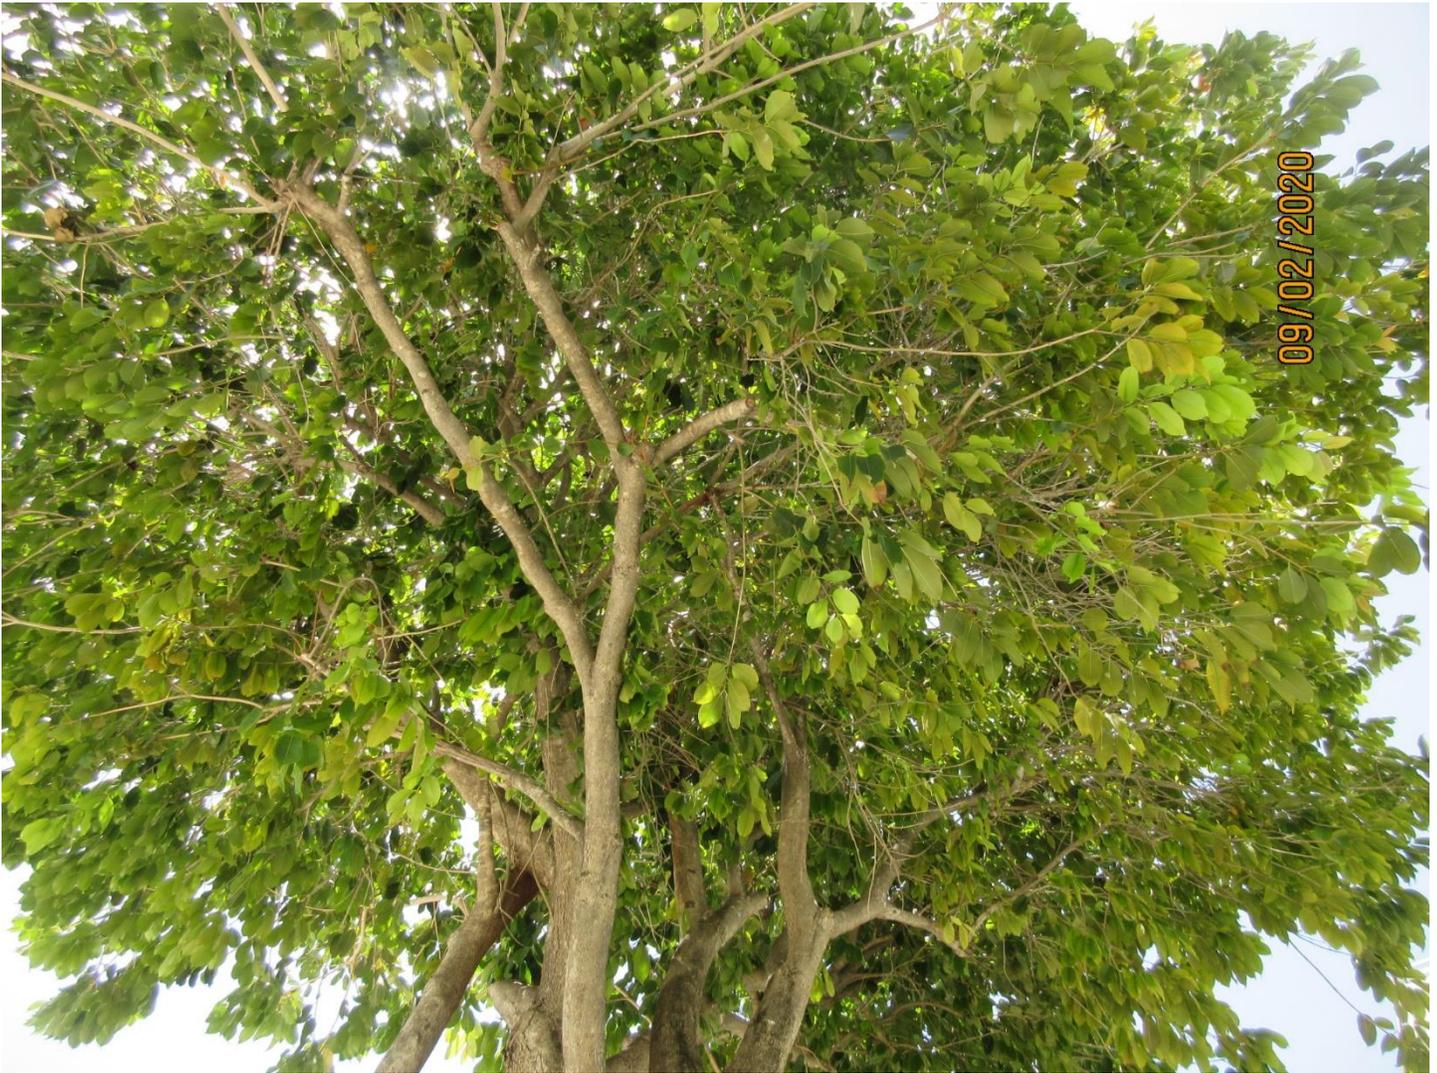
Tree #27:

Photo showing whole tree and its location on the property.

Photo showing base and main trunk of tree.

Photo showing tree trunk and canopy.

Photo of tree canopy.

Diameter: 28"

Location: 90%

Species: 50% (not on protected or not protected tree list)

Condition: 70% (fair to good-tree appears to be healthy, structure is fair)

Total Average Value = 70%

Value x Diameter = 19.6 replacement caliper inches
