BUILDING INSPECTION REPORT

Report Number
822

202 Williams Street

Client Name **Key West Bight City of Key West**

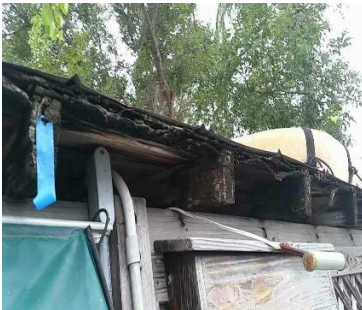
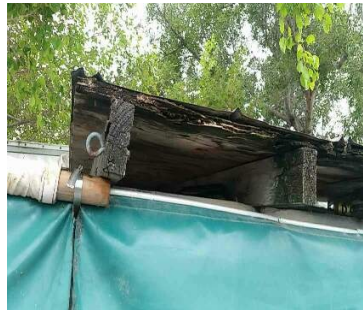
1.

Location: Kitchen **System:** Roof **Condition:** Rot observed on sheathing

Explanation: Our examination of the roof structure has revealed indications that moisture issues at the roof structure has resulted in rotting of the roof sheathing.

Impact Consequences: The design of the roof structure assumes all framing and support members are intact and bearing their contribution of loads and forces. A deteriorated area of roof sheathing can seriously compromise the integrity of the roof structure. A possible outcome of this condition is that the roof may not be capable of bearing heavy loads or forces without broader damage to the roof structure. Immediate investigation by a roof framing specialist is recommended.

Recommended Action: Repair

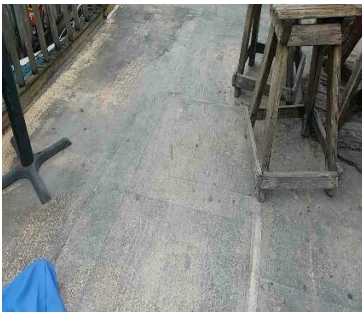
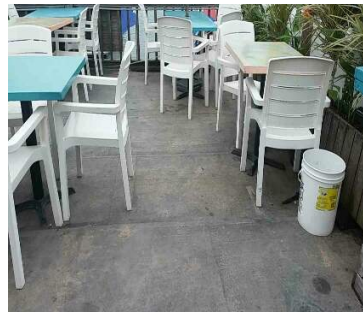
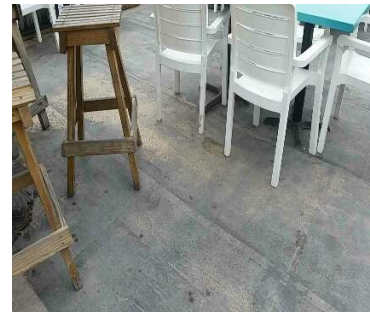
2.

Location: Upper Dining Deck **System:** Roof **Condition:** Roof Covering Deteriorated or Missing

Explanation: The roof surface covering is observed to be missing or deteriorated in the noted location.

Impact Consequences: Missing or deteriorated roof covering poses a risk of moisture penetration as well as acceleration of deterioration of the underlying roof structural components. Install or repair the areas of interest in order to restore the intended function of the roof covering.

Recommended Action: Install or Repair

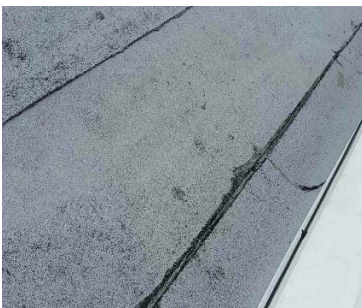
4.

Location: CBS Bldg Roof **System:** Roof **Condition:** Bubbled Roll Roofing

Explanation: Roll roofing is observed to be bubbled.

Impact Consequences: Bubbling of the roll roofing is an indication of deterioration. The raised areas should be reviewed by a qualified roofing contractor for corrective action in order to prevent roof leaks.

Recommended Action: Repair

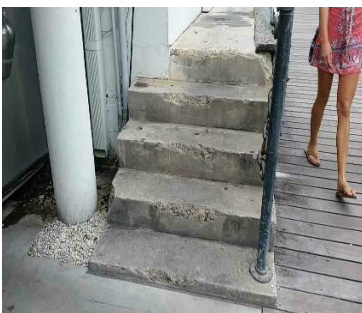
1.

Location: CBS Bldg Exterior Front **System:** Exterior **Condition:** Deteriorated Concrete Components of Exterior Stairs

Explanation: Exterior stairs display deterioration of concrete structural components

Impact Consequences: Repair the areas of deteriorated components on the exterior stairs in order to restore structural integrity and prevent trip hazards.

Recommended Action: Repair

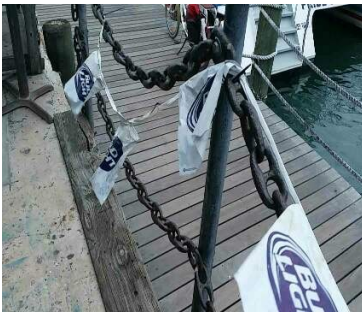
2.

Location: CBS Bldg Exterior Front **System:** Exterior **Condition:** Exterior deck railing is shaky

Explanation: Exterior deck railings should be installed and maintained so as to be sufficiently secured to prevent failure or detachment under normal use. Shaky deck railings are an indication that the railings are deteriorating and in need of corrective repairs or replacement.

Impact Consequences: The primary function of deck railings is to protect people from falling and being injured. Loose or shaky railings are indicators of poor design construction or maintenance. Failure to correct rail support conditions is a safety issue with potential legal consequences.

Recommended Action: Repair or replace

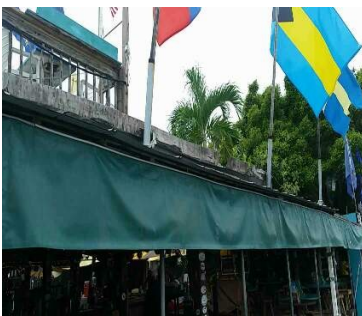
3.

Location: Outdoor Dining **System:** Exterior **Condition:** Decorative Wood Trim Displays Rot and or Deterioration

Explanation: Trims attached to the structure as decorative items are observed to contain wood rot and or are deteriorated.

Impact Consequences: Trims are decorative in nature however condition of the trim may promote mold and or mildew growth on the exterior of the structure and may attract pests if not properly maintained.

Recommended Action: Repair

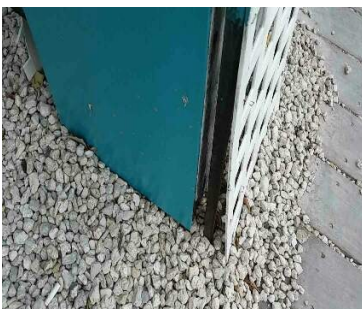
4.

Location: Outdoor Dining **System:** Exterior **Condition:** Decorative Wood Trim Displays Rot and or Deterioration

Explanation: Trims attached to the structure as decorative items are observed to

contain wood rot and or are deteriorated.

Impact Consequences: Trims are decorative in nature however condition of the trim may promote mold and or mildew growth on the exterior of the structure and may attract pests if not properly maintained.

Recommended Action: Repair

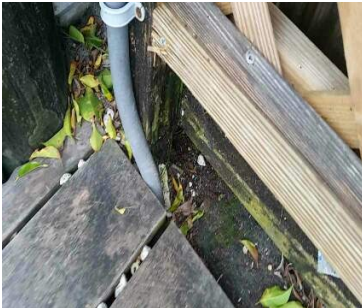
5.

Location: Kitchen **System:** Exterior **Condition:** Porch wood posts are rotted

Explanation: Wood posts are observed to be rotted and deteriorated. The ability of the posts to bear their intended load has been compromised

Impact Consequences: Posts are crucial to the support structure of the porch and structural failure will likely occur when due to deterioration the posts can not bear their intended load. The ability to adequately support the deck structure is a safety concern. Immediate remedial action is recommended. Review by a framing contractor is suggested.

Recommended Action: Repair

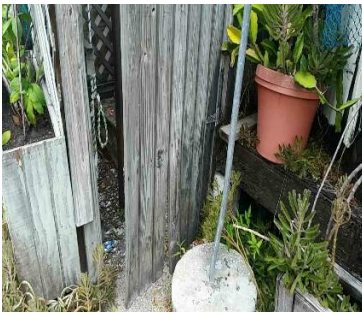
7.

Location: Exterior Left **System:** Exterior **Condition:** Damaged Gate

Explanation: The gate in the noted location is observed to be damaged.

Impact Consequences: A damaged gate may not be able to perform its intended function of securing the property. Repair or replace the gate in order to restore its intended function.

Recommended Action: Repair

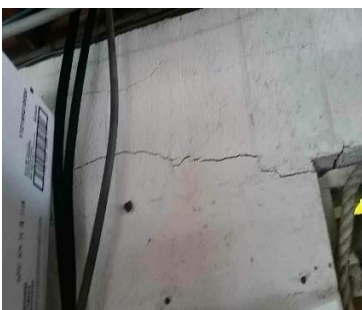
9.

Location: Kitchen **System:** Exterior **Condition:** Exterior masonry wall is cracked; minor

Explanation: Cracks are observed through the mortar and or brick. Cracks may be due to a number of factors; minor cracks are generally due to stress or settlement in the wall and are generally stable. Wider or more extensive cracks generally indicate that there is a problem with the masonry support system examples of which include foundation settlement or loosening of the ties between the brick wall and inner wall

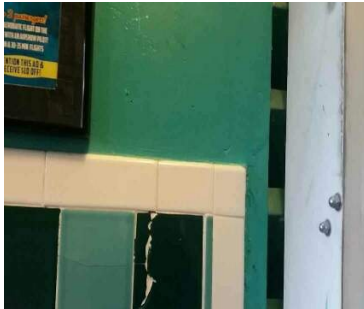
10.

Location: Mens Restroom **System:** Exterior **Condition:** Exterior masonry wall is cracked; minor

Explanation: Cracks are observed through the mortar and or brick. Cracks may be due to a number of factors; minor cracks are generally due to stress or settlement in the wall and are generally stable. Wider or more extensive cracks generally indicate that there is a problem with the masonry support system examples of which include foundation settlement or loosening of the ties between the brick wall and inner wall structures.

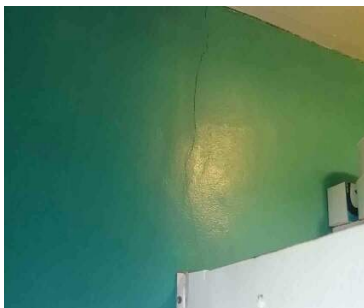
11.

Location: Womens Restroom **System:** Exterior **Condition:** Exterior masonry wall is cracked; minor

Explanation: Cracks are observed through the mortar and or brick. Cracks may be due to a number of factors; minor cracks are generally due to stress or settlement in the wall and are generally stable. Wider or more extensive cracks generally indicate that there is a problem with the masonry support system examples of which include foundation settlement or loosening of the ties between the brick wall and inner wall structures.

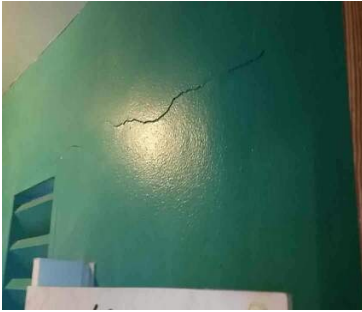
12.

Location: Womens Restroom **System:** Exterior **Condition:** Exterior masonry wall is cracked; minor

Explanation: Cracks are observed through the mortar and or brick. Cracks may be due to a number of factors; minor cracks are generally due to stress or settlement in the wall and are generally stable. Wider or more extensive cracks generally indicate that there is a problem with the masonry support system examples of which include foundation settlement or loosening of the ties between the brick wall and inner wall structures.

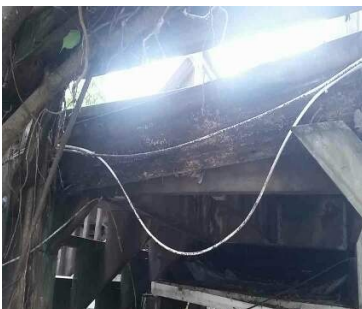
13.

Location: Elevated Porch **System:** Exterior **Condition:** Deteriorated Stairway Components

Explanation: The stairway components are observed to be deteriorated.

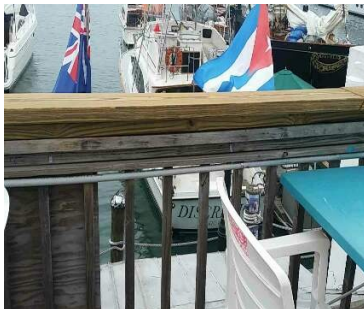
15.

Location: Upper Dining Deck **System:** Exterior **Condition:** Exterior deck railing is shaky

Explanation: Exterior deck railings should be installed and maintained so as to be sufficiently secured to prevent failure or detachment under normal use. Shaky deck railings are an indication that the railings are deteriorating and in need of corrective repairs or replacement.

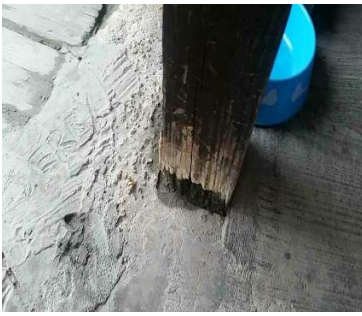
2.

Location: Outdoor Dining **System:** Structure **Condition:** Rot in wood column(s)

Explanation: Support columns are crucial to providing proper transfer of building loads to the footings. Areas of wood rot and deterioration are observed. Selective probing indicates loss of fiber strength and integrity. The current and future ability of the column(s) to bear their intended load is suspect.

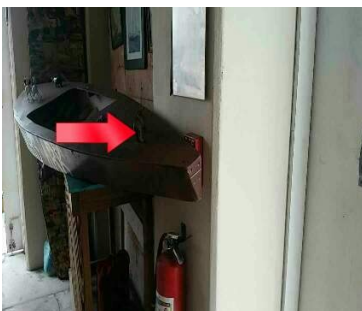
1.

Location: CBS Dining **System:** Interior **Condition:** Restricted Fire Alarm Pull Access

Explanation: The access to the fire alarm pull lever is restricted.

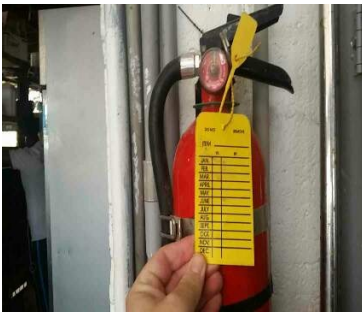
2.

Location: Kitchen **System:** Interior **Condition:** Expired Fire Extinguishing Equipment

Explanation: Fire Extinguisher Inspection Is Expired

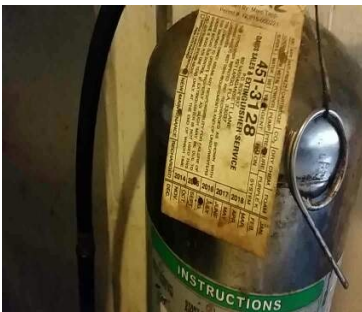
3.

Location: Kitchen **System:** Interior **Condition:** Expired Fire Extinguishing Equipment

Explanation: Fire Extinguisher Inspection Is Expired

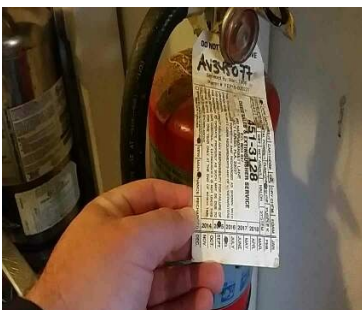
4.

Location: Kitchen **System:** Interior **Condition:** Expired Fire Extinguishing Equipment

Explanation: Fire Extinguisher Inspection Is Expired

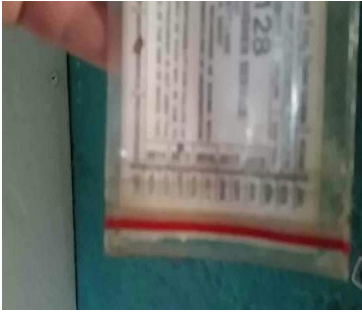
5.

Location: Kitchen **System:** Interior **Condition:** Expired Fire Extinguishing Equipment

Explanation: Fire Extinguisher Inspection Is Expired

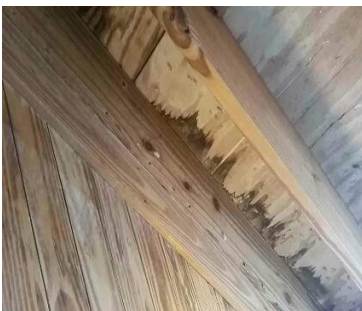
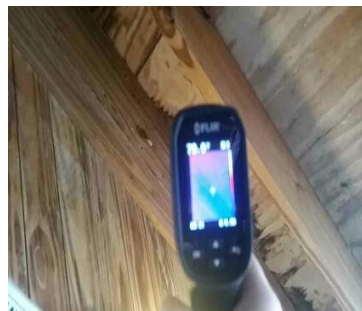
7.

Location: Mens Restroom **System:** Interior **Condition:** WET Ceiling Stain Roof Leak

Explanation: A stain on a ceiling surface is observed to test high for moisture content using moisture meters or thermal imaging camera. The source of the moisture intrusion is suspected to be from an active roof leak.

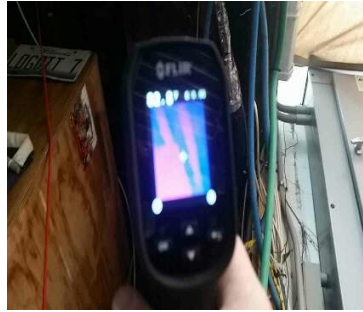
8.

Location: Lounge **System:** Interior **Condition:** WET Ceiling Stain Roof Leak

Explanation: A stain on a ceiling surface is observed to test high for moisture content using moisture meters or thermal imaging camera. The source of the moisture intrusion is suspected to be from an active roof leak.

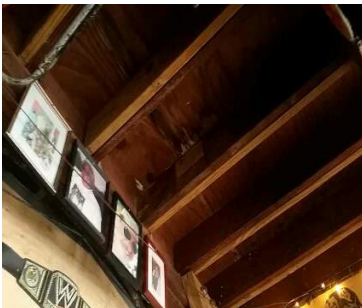
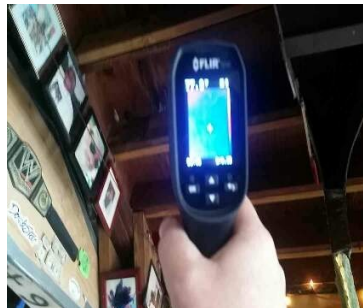
9.

Location: Lounge **System:** Interior **Condition:** WET Ceiling Stain Roof Leak

Explanation: A stain on a ceiling surface is observed to test high for moisture content using moisture meters or thermal imaging camera. The source of the moisture intrusion is suspected to be from an active roof leak.

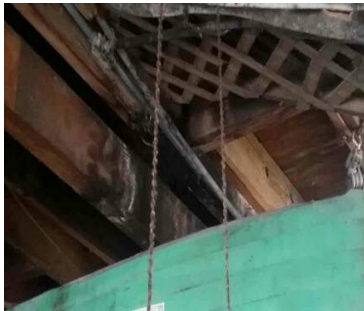
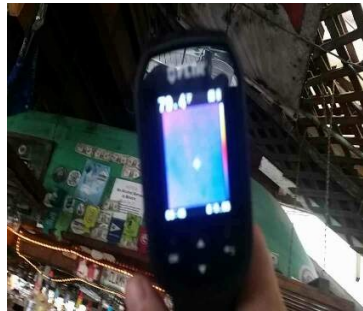
10.

Location: Lounge **System:** Interior **Condition:** WET Ceiling Stain Roof Leak

Explanation: A stain on a ceiling surface is observed to test high for moisture content using moisture meters or thermal imaging camera. The source of the moisture intrusion is suspected to be from an active roof leak.

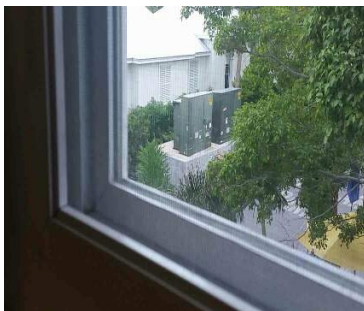
11.

Location: Elevated Office **System:** Interior **Condition:** Window has damaged hardware

Explanation: Hardware required for proper operation and function of the window is damaged. Window operation and performance considerations include: ability to restrict forced entry; ability to open and close with relative ease; ability to securely close and latch; ability to restrict entry of air water and pests.

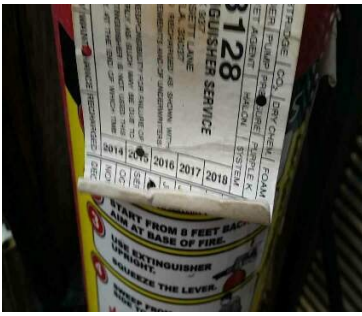
12.

Location: Lounge **System:** Interior **Condition:** Expired Fire Extinguishing Equipment

Explanation: Fire Extinguisher Inspection Is Expired

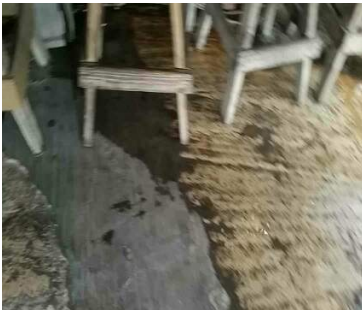
13.

Location: Lounge **System:** Interior **Condition:** Trip hazard in floor surface

Explanation: The floor surface has an abrupt change in height where different floor finishes abut. This condition has a variation that is sufficiently great as to present a potential trip hazard.

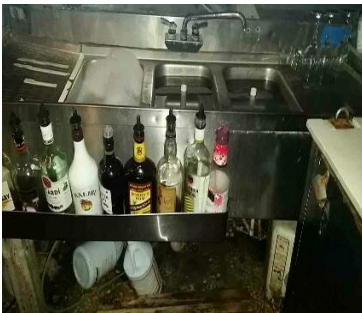
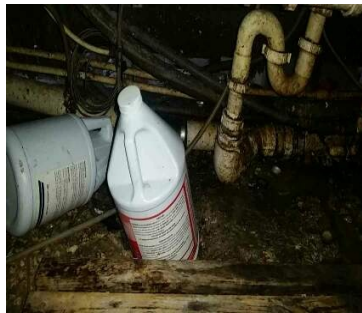
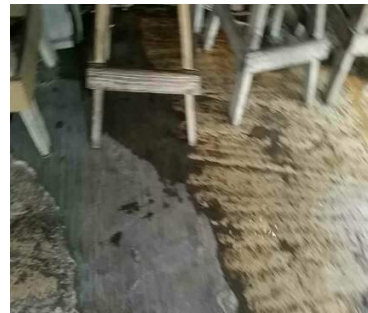
1.

Location: Lounge **System:** Plumbing **Condition:** Fixture Drain Discharges To Exterior Site

Explanation: A plumbing drains discharging to the exterior site may pose environmental hazards and health risks.

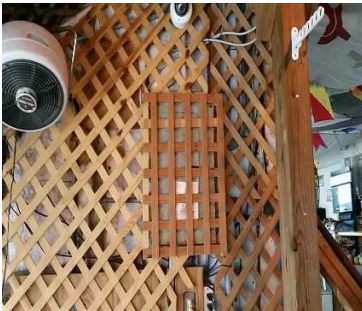
2.

Location: Outdoor Dining **System:** Electrical **Condition:** Restricted Access to Distribution Panel

Explanation: Panel is locked or blocked in a manner which restricts evaluation.

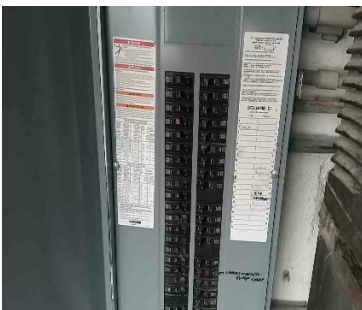
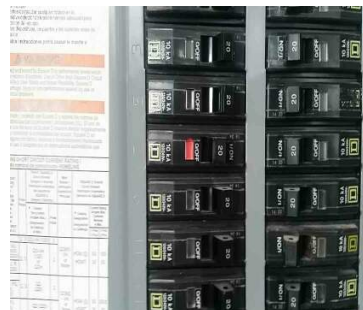
3.

Location: Kitchen **System:** Electrical **Condition:** Breaker Trips

Explanation: A breaker observed to continuously trip at the time of inspection.

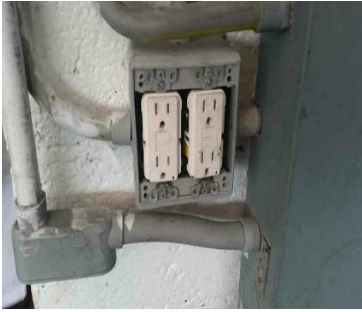
4.

Location: Kitchen **System:** Electrical **Condition:** Electrical outlet does not work

Explanation: An electrical outlet is observed to be inoperative.

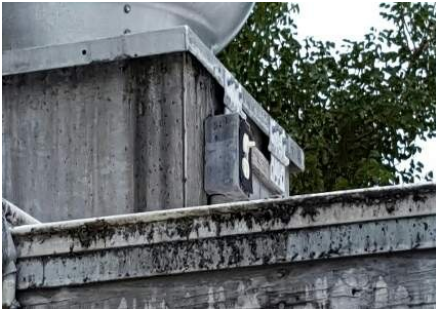
5.

Location: Kitchen **System:** Electrical **Condition:** An exterior switch has a missing cover plate

Explanation: Electrical switches installed in outdoor locations require protection from water entry and contaminants.
