# **Interpreting Resistograph Readings.**

## **A Manual for Users of the Resistograph Decay Detection Instrument**

**Dunster & Associates Environmental Consultants Ltd.**

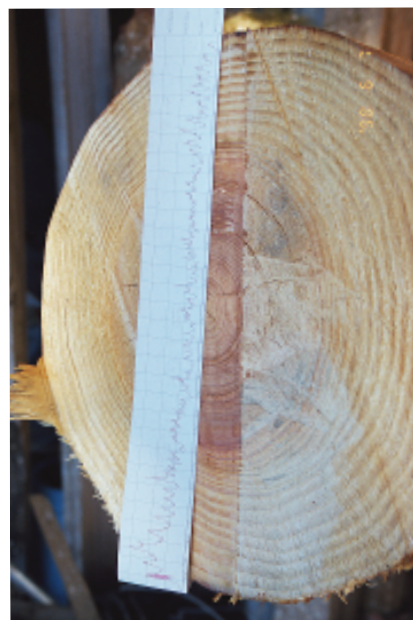
Wider growth rings

Narrower growth rings

The Resistograph reading clearly shows the ring width variation and exactly matches the sampling point.

Chart 2 is a reading taken right through a Douglas-fir stem that had been dead for over two years. In this example the ring width is not so tight in the central area. The photograph shows the original chart laid across the sampling area.

In both cases the wood is sound. Close examination of either chart shows that the lowest point of drilling resistance in the wide rings is similar to the higher point in the narrow ring widths.

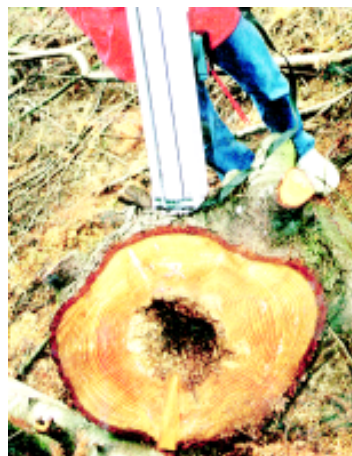
Looking at the cavity just below the original point of topping

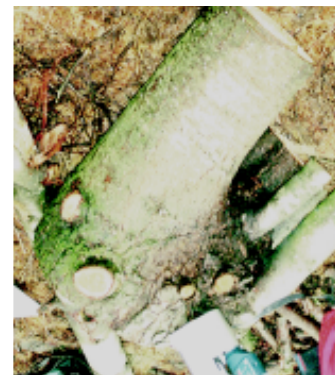
The top of the trunk showing the regrown leaders after the original topping work.

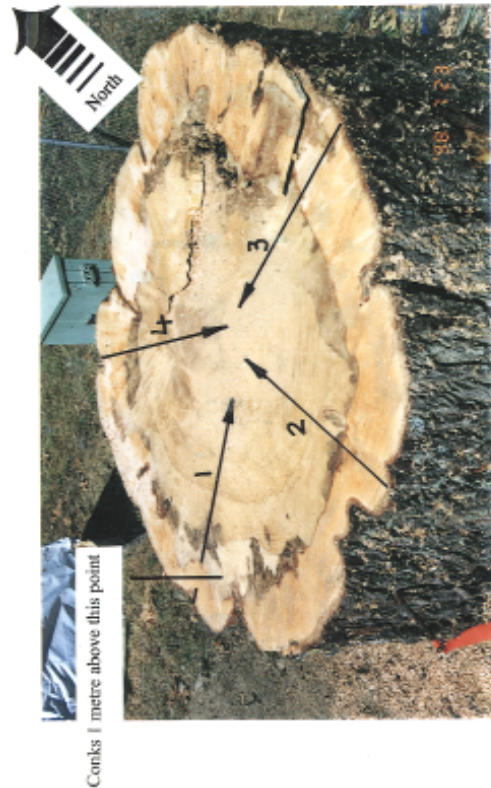
Big leaf maple (*Acer macrophyllum*) 134 cm in diameter. Large conks had been observed on the south face on either side of vertical bark cracks. Resistograph readings were taken at points 1 through 4 to determine shell thickness and the extent of suspected decay due to *Ganoderma applanatum*. The readings revealed very extensive advanced decay with shell thicknesses equating to less than 30% of the trunk radius. The cross section shown in the photograph is right at the plane of sampling. The central part of the trunk in readings 1, 2, and 3 still shows some drilling resistance, but note how the trace line at these central areas shows no "spikes", while the earlier trace in the sound outer wood shows quite distinct spikes as each ring is traversed. This is a typical reading and shows the difference between sound wood, and wood that has incipient decay.

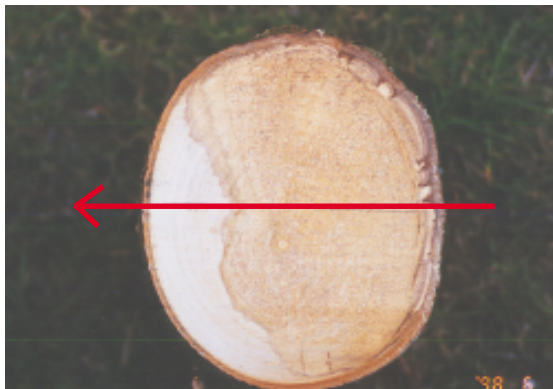
A large branch (6.5 inches in diameter) fell from a big leaf maple without warning, on a calm day. There were no external indicators of defect on the tree at the point of failure. The failed branch exhibited extensive fungal mycelium at the failure point, subsequently analysed to be a saprobe, *Bjerkandera adjusta* (syn. *Polyporous adjustus*). Resistograph testing across the failure zone revealed that there was no structural capacity in most of the branch, with only a small part of sound wood on the upper zone (left of chart).

Top of branch

Underside of branch

Cross section tested showing the small area of sound wood on the left (top) side

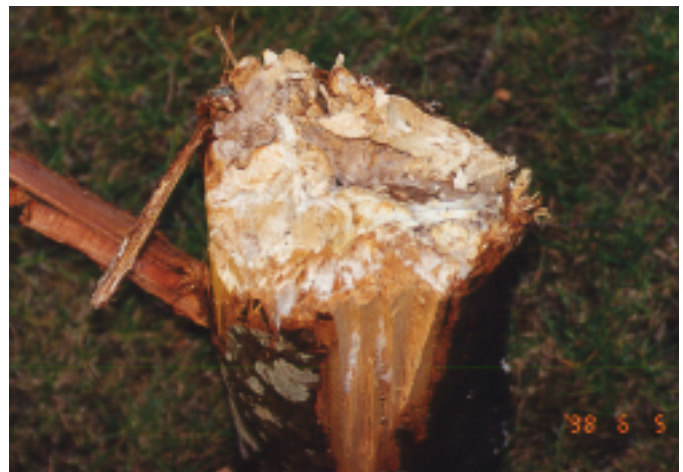
The failed branch at a point about 20 centimetres beyond the testing point. Note the extensive mycelium across the branch.

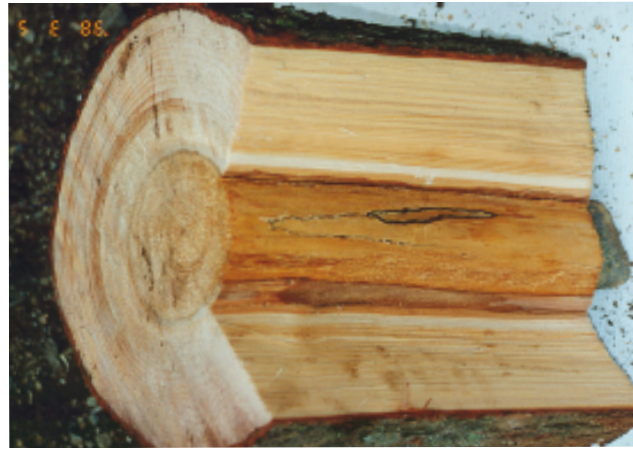
Western hemlock (*Tsuga heterophylla*) showing a reading across the entire trunk right next to a crack in the bark. The Resistograph reading was taken a few weeks after the tree was cut down, by which time the radial crack along the barrier zone (arrow) had dried out and opened up slightly. The photograph at left shows that the tree had been wounded about 18 years ago. The callus tissue closed over the wound leaving a well defined barrier zone. However, the callus tissue did not join together and after a strong winter wind the tree ruptured along the defect to produce a pronounced crack in the outer bark. This crack was weeping sap which then became a well defined black streak down the trunk - the visual indicator that triggered further assessment. The vertical section shows the column of decay which extended for 30 metres up the south face of tree, well beyond the original wound area.

Note that the reading was taken off-centre, so the trace at around 5.5 inches in, is actually traversing along the rings, and not at 90° to them.

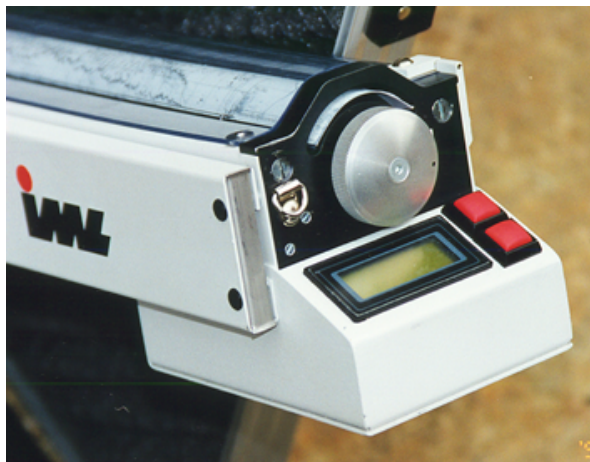
The electronic output option shown here mounted on an F500S Resistograph. Readings can be individually numbered through the keyboard.

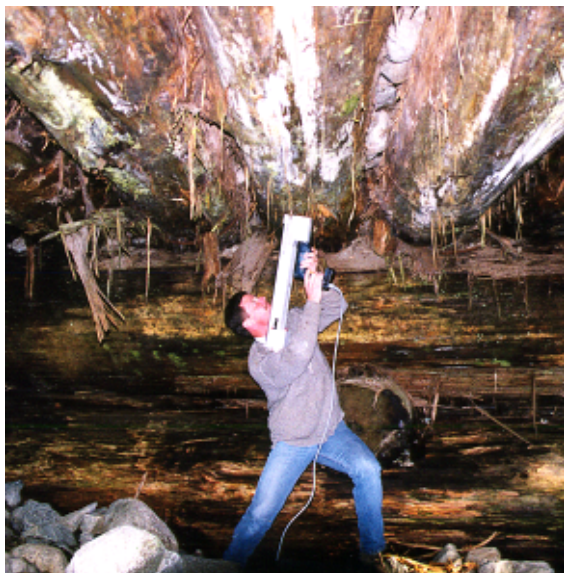
The Resistograph F500se with power pack adapter, seen here in use testing the main stringers on a log bridge. The results show the log to be sound. Use of testing records in this manner greatly facilitates proof of "due diligence" for structures that require proof of inspection.

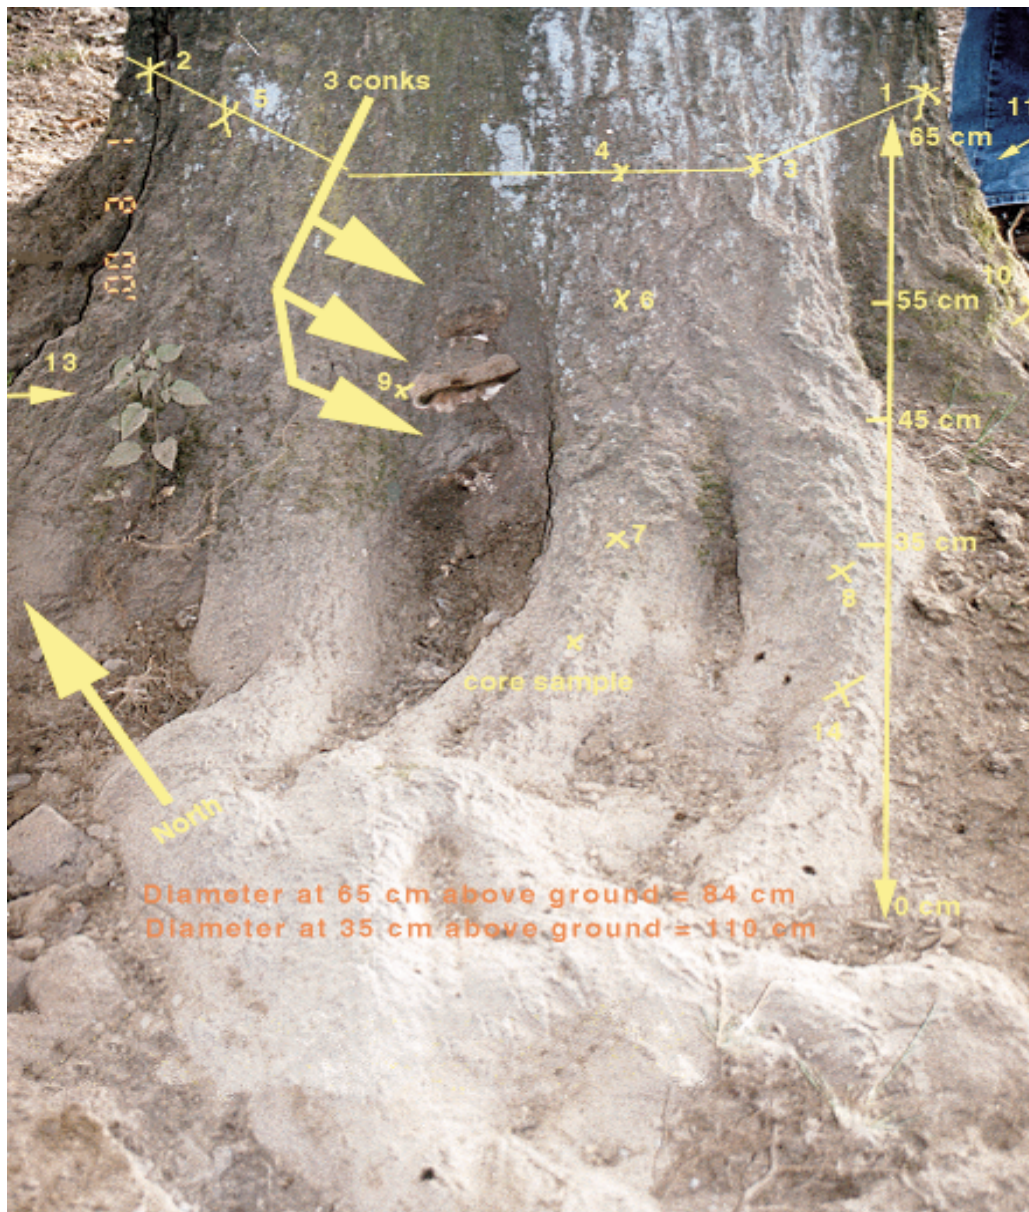
In the previous pages various defects have been shown in an array of species and conditions. In many cases an area of decay may be suspected, but will require more readings before it can be accurately mapped out. In such cases the user should set up a systematic sequence for drilling so that decay can be mapped in a set of horizontal planes, or a vertical sections. The figure shown below illustrates a detailed analysis undertaken on a Red Oak (*Quercus rubra*). Three *Ganoderma applanatum* conks were noted. Initial Resistograph readings were taken at points in the plane 65 centimetres above ground. On the basis of the decay patterns noted in these first readings amore systematic gris was then laid out using drilling direction on a compass bearing at planes 10 centimetres apart. A detailed picture of the decay pattern was then built up in the horizonatl and vertical planes.
