STAFF REPORT

RE: **Key West Historic Seaport (permit application # T18-8977)**

FROM: Karen DeMaria, City of Key West Urban Forestry Manager

An application was received requesting the review of a conceptual landscape plan in association with the proposed renovations at the Key West Historic Seaport area. This review will be discussed in stages.

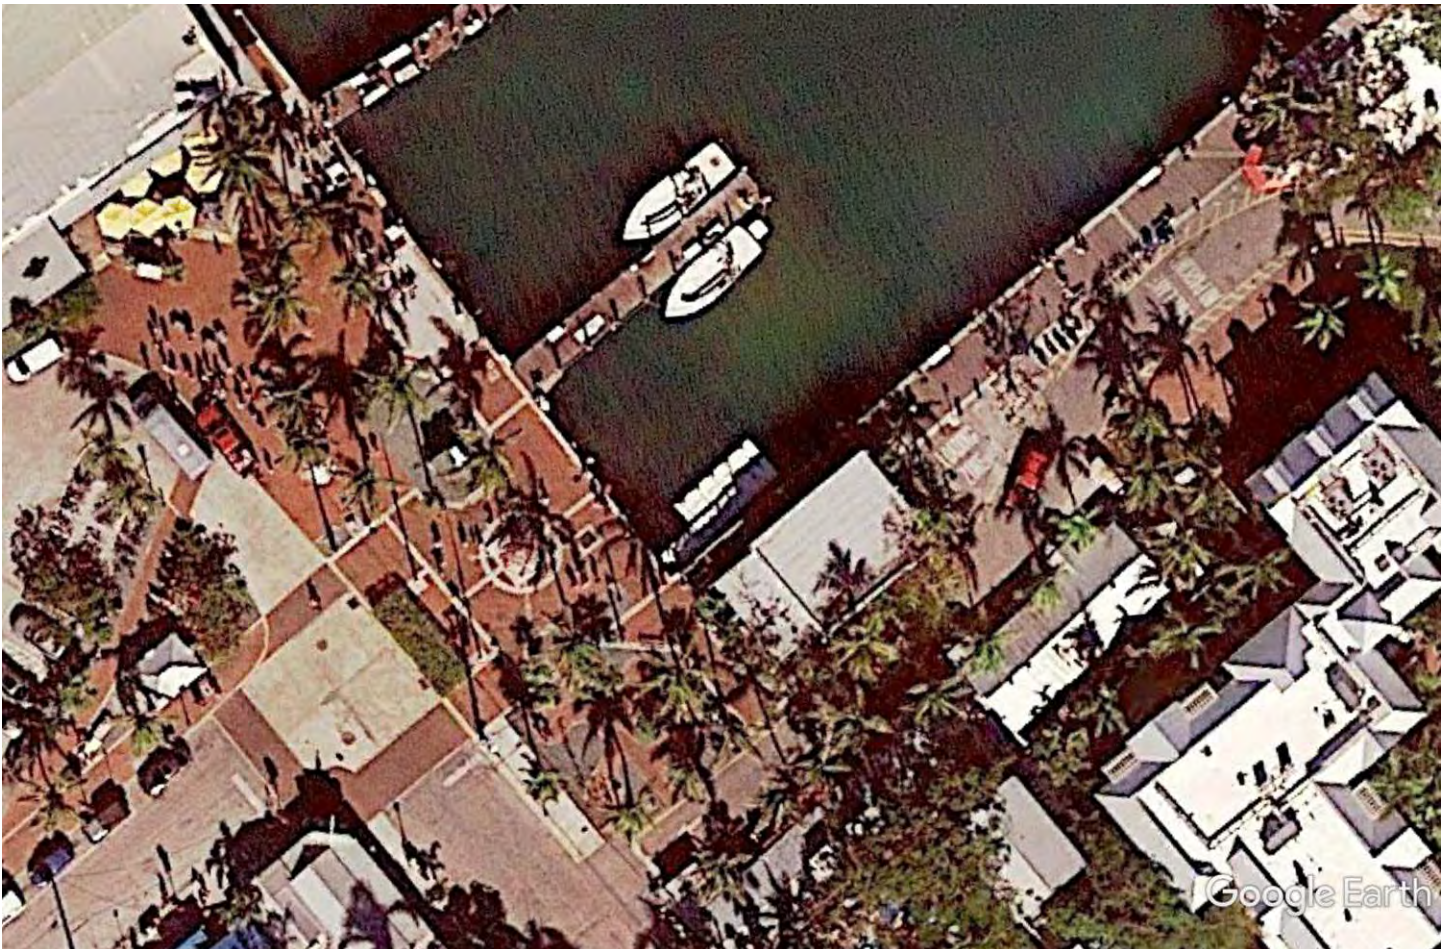
Google aerial photo of proposed work area (December 2017).

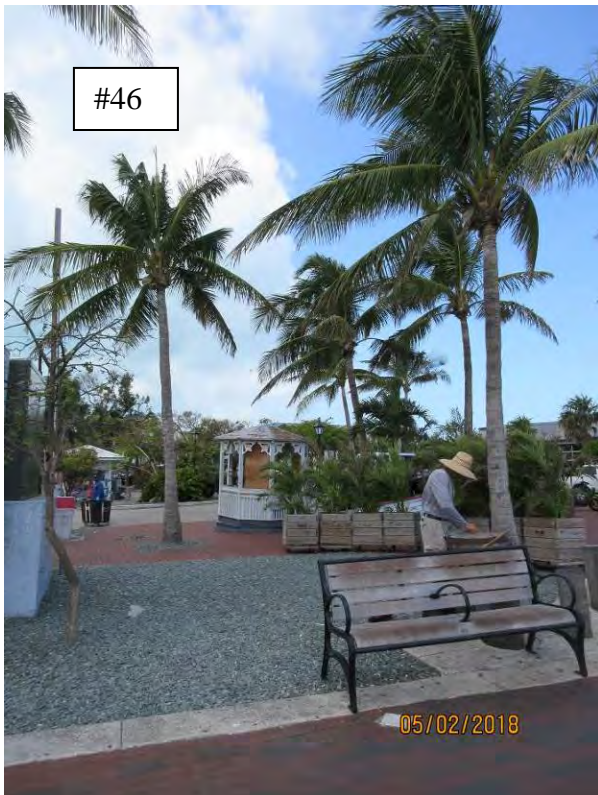
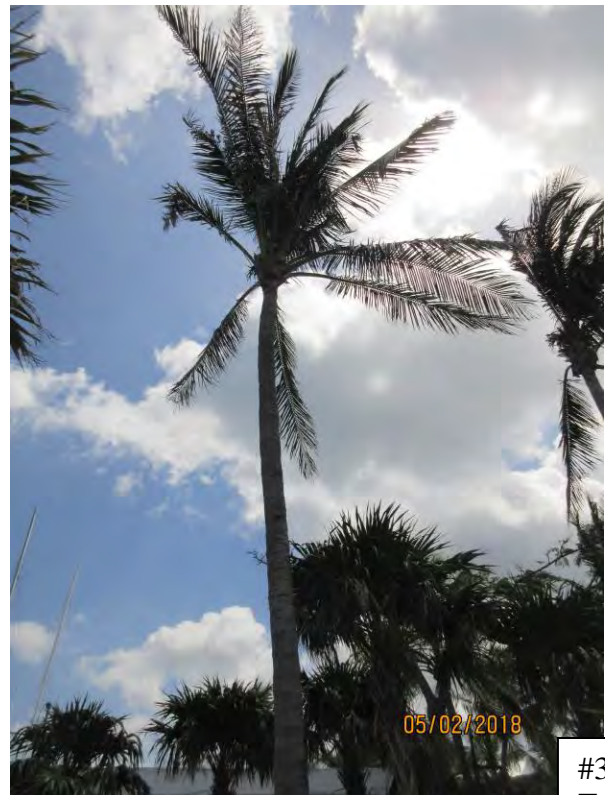
Palms #46 and #48 if they can not remain, should be transplanted.

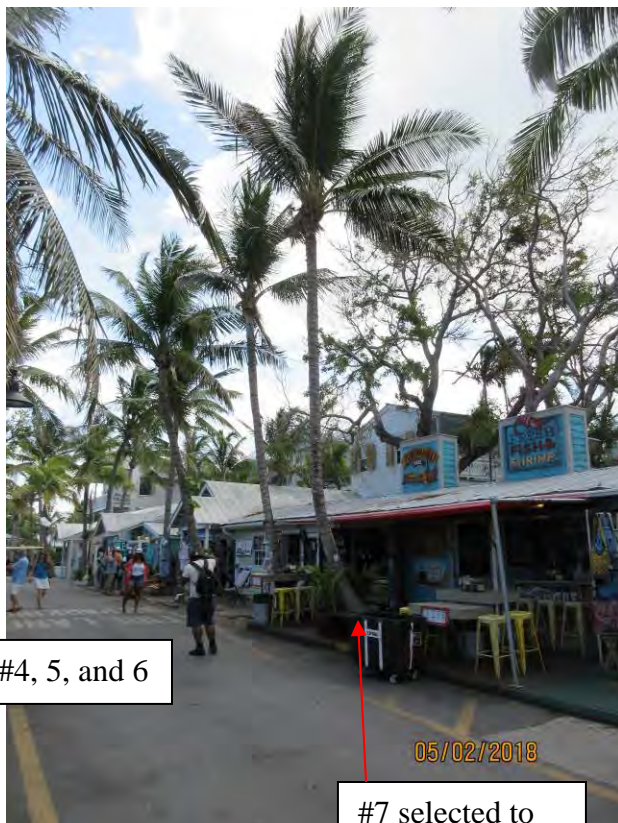
#38
Top and
bottom of
palm

Palm #38 is too tall to be transplanted and due to its condition, would be a candidate for removal.

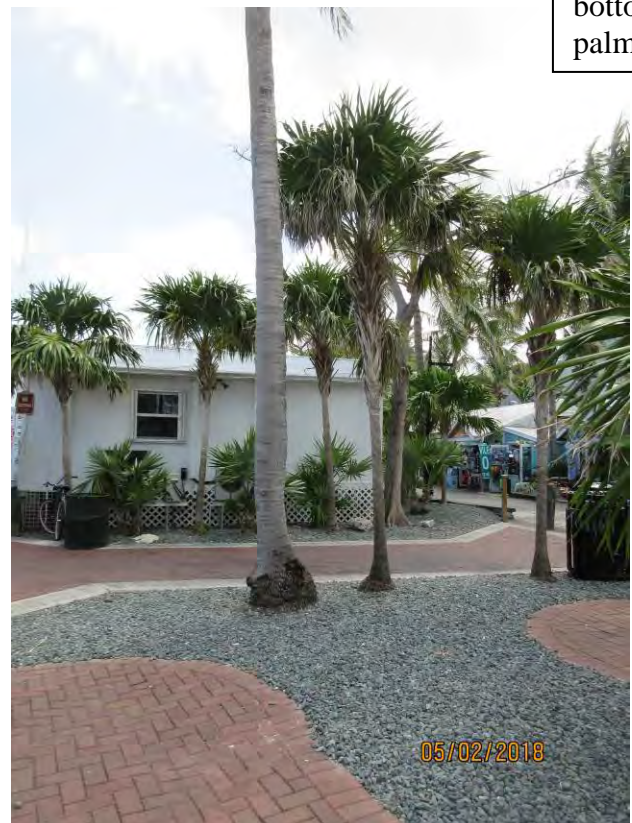
#7 selected to
be removed

Same for why palms #7 and 8 in that same line of palms, are slated for removal?

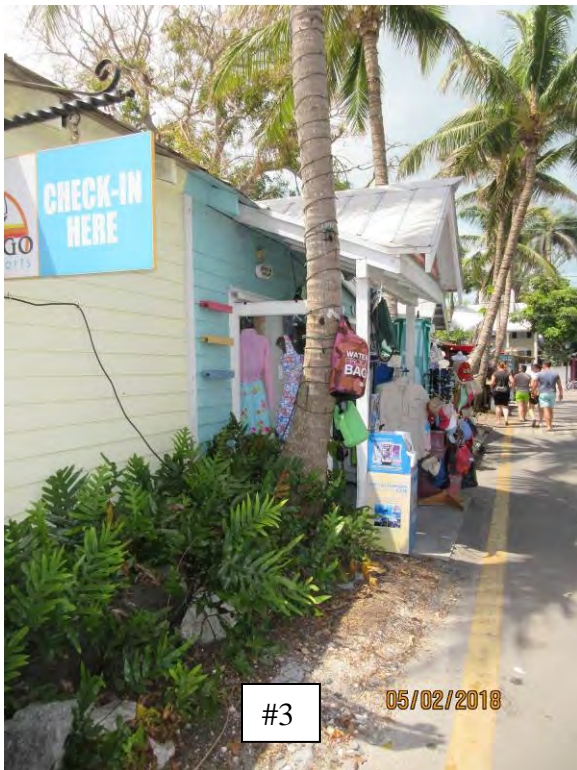
#3

Why do Palms #3, 4, 5, and 6 need to be removed? Transplanting may cause a mess and a great disturbance to the area.

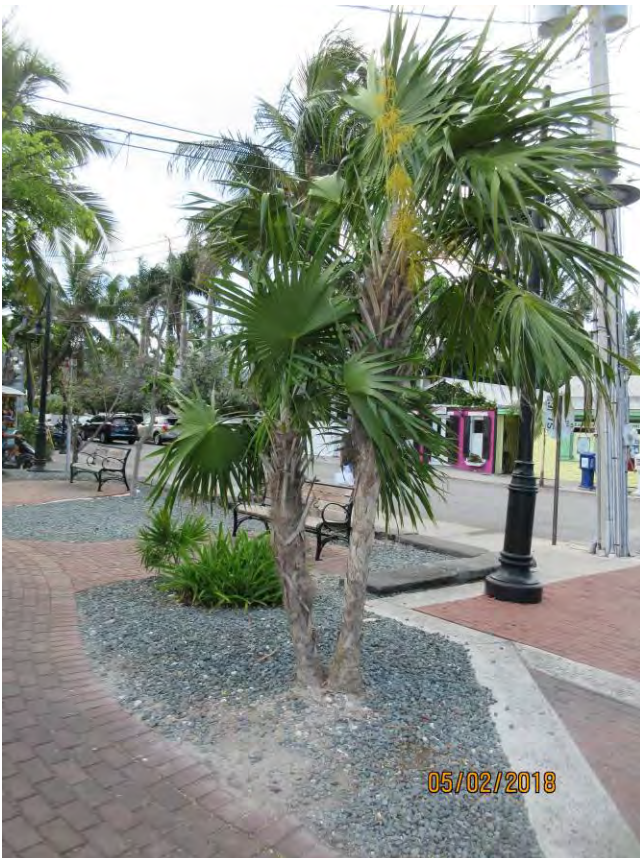
#44

Five Thatch Palms are slated to be transplanted:

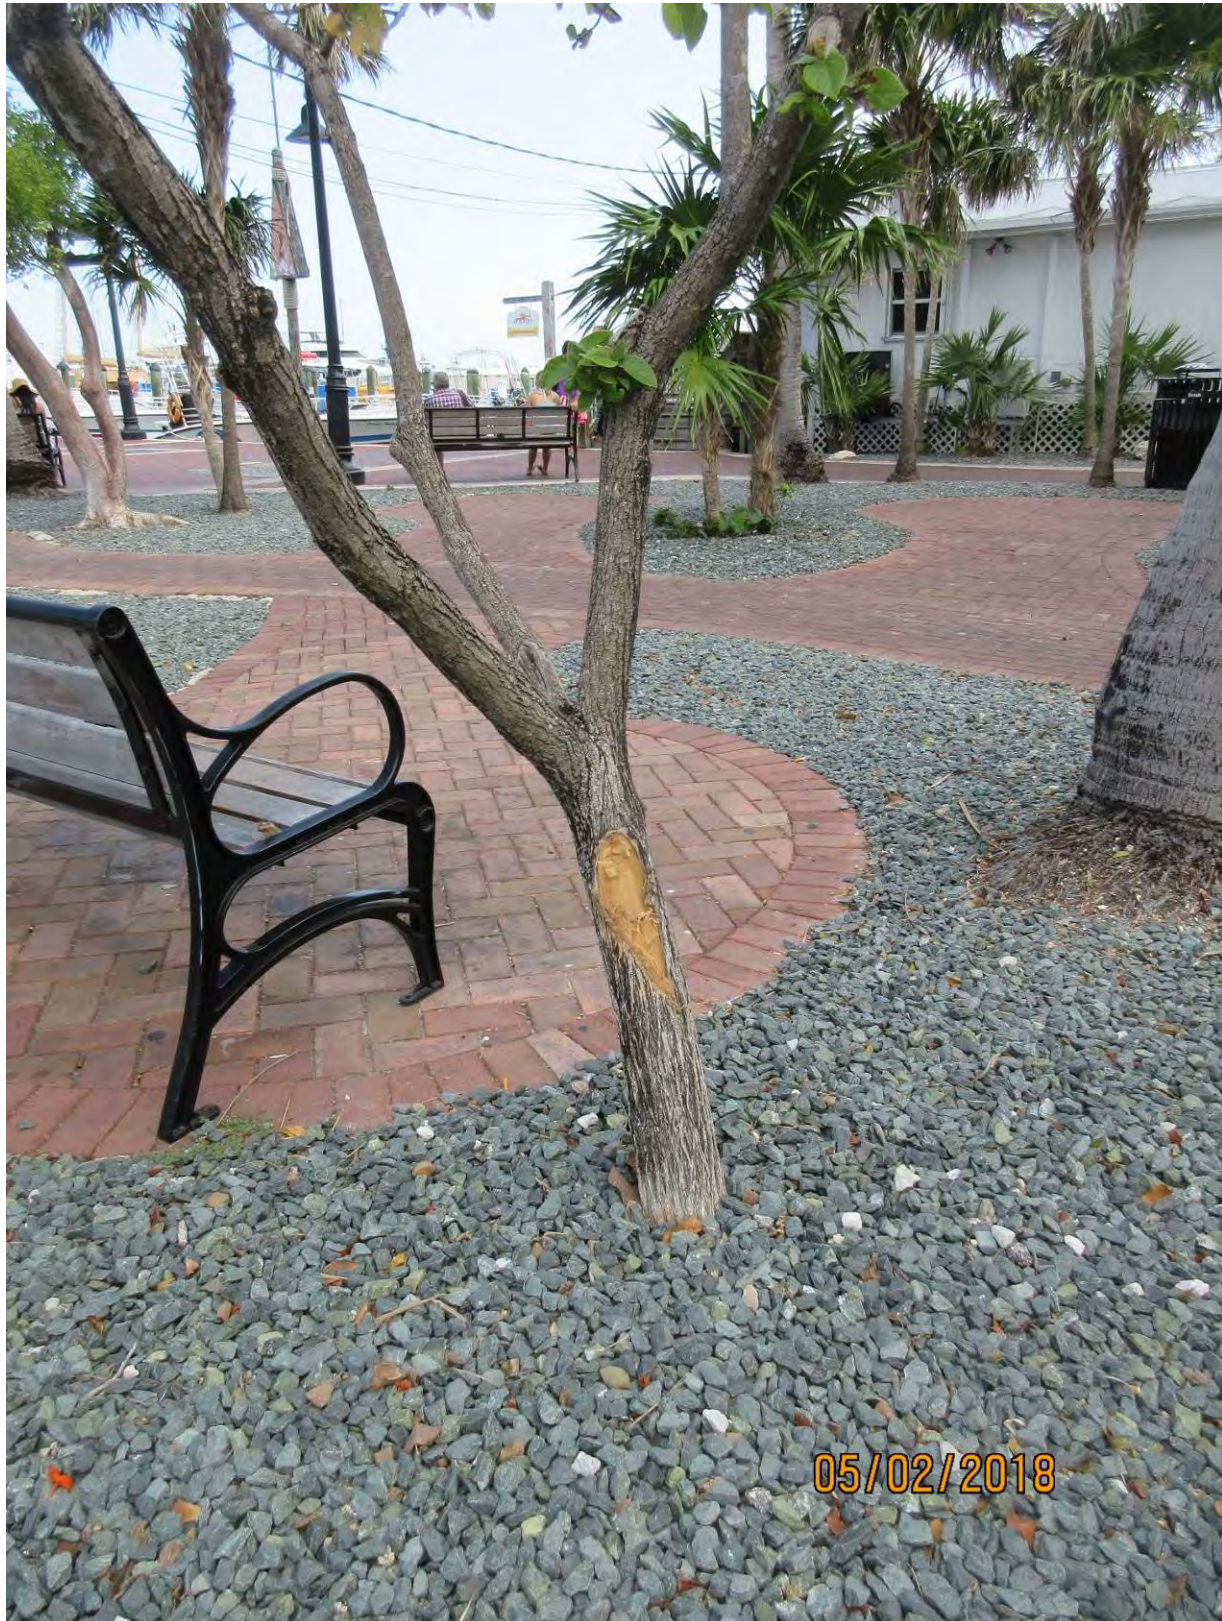
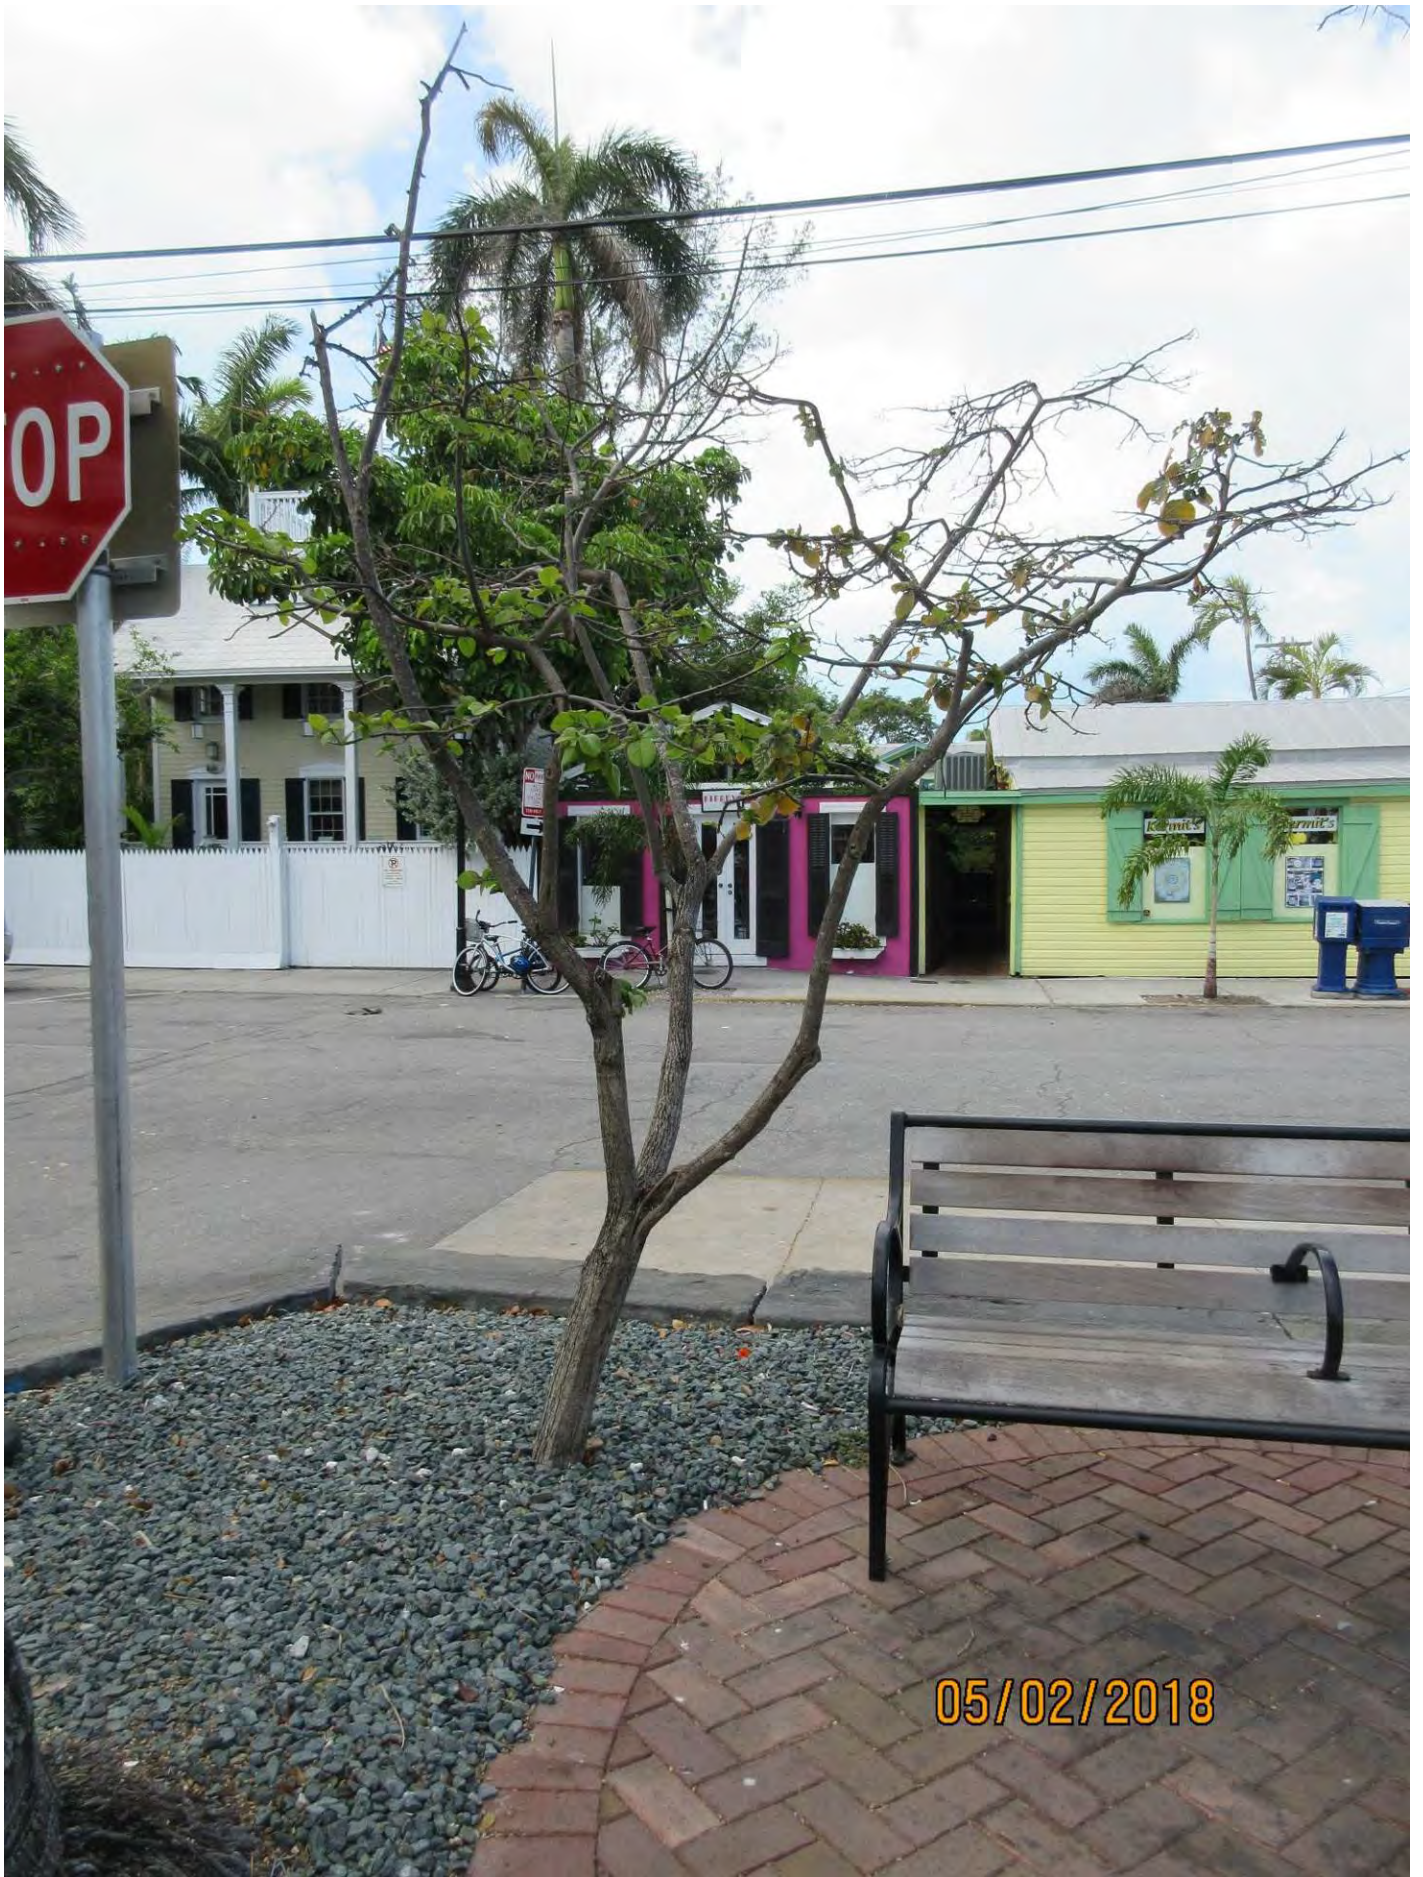
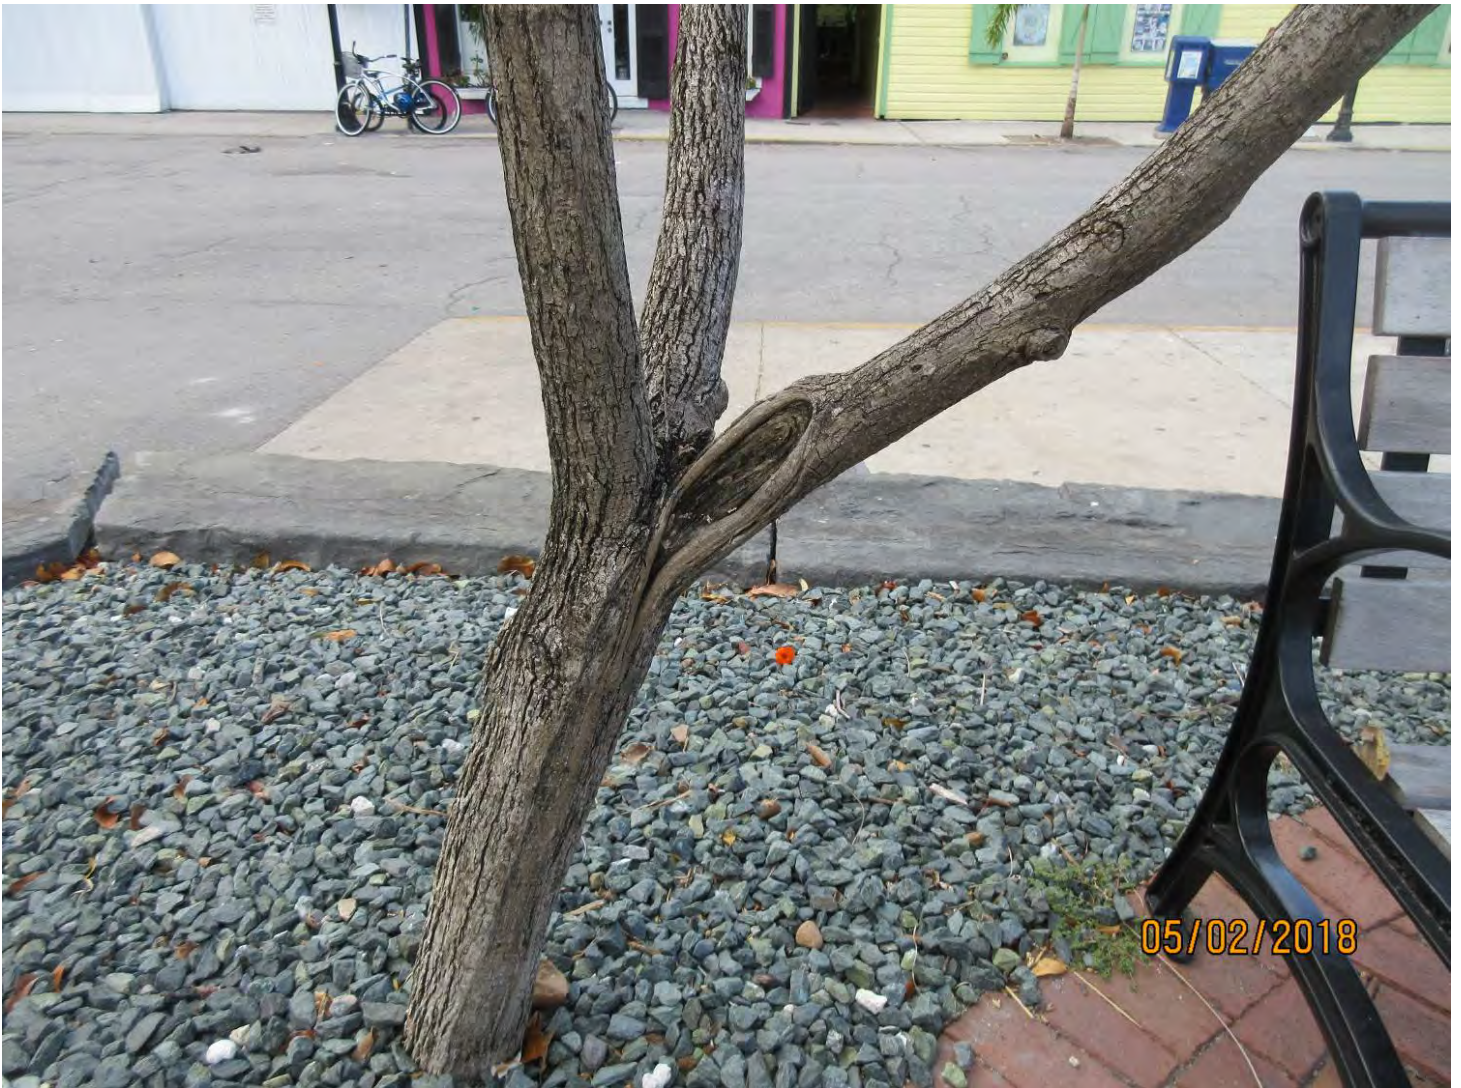
Geiger tree #10

Diameter: 4.7"

Location: 100%

Species: 100% (on protected tree list)

Condition: 50% (fair to poor-poor structure, tear in main trunk)

Total Average Value = 83%

Value x Diameter = 3.9 replacement caliper inches

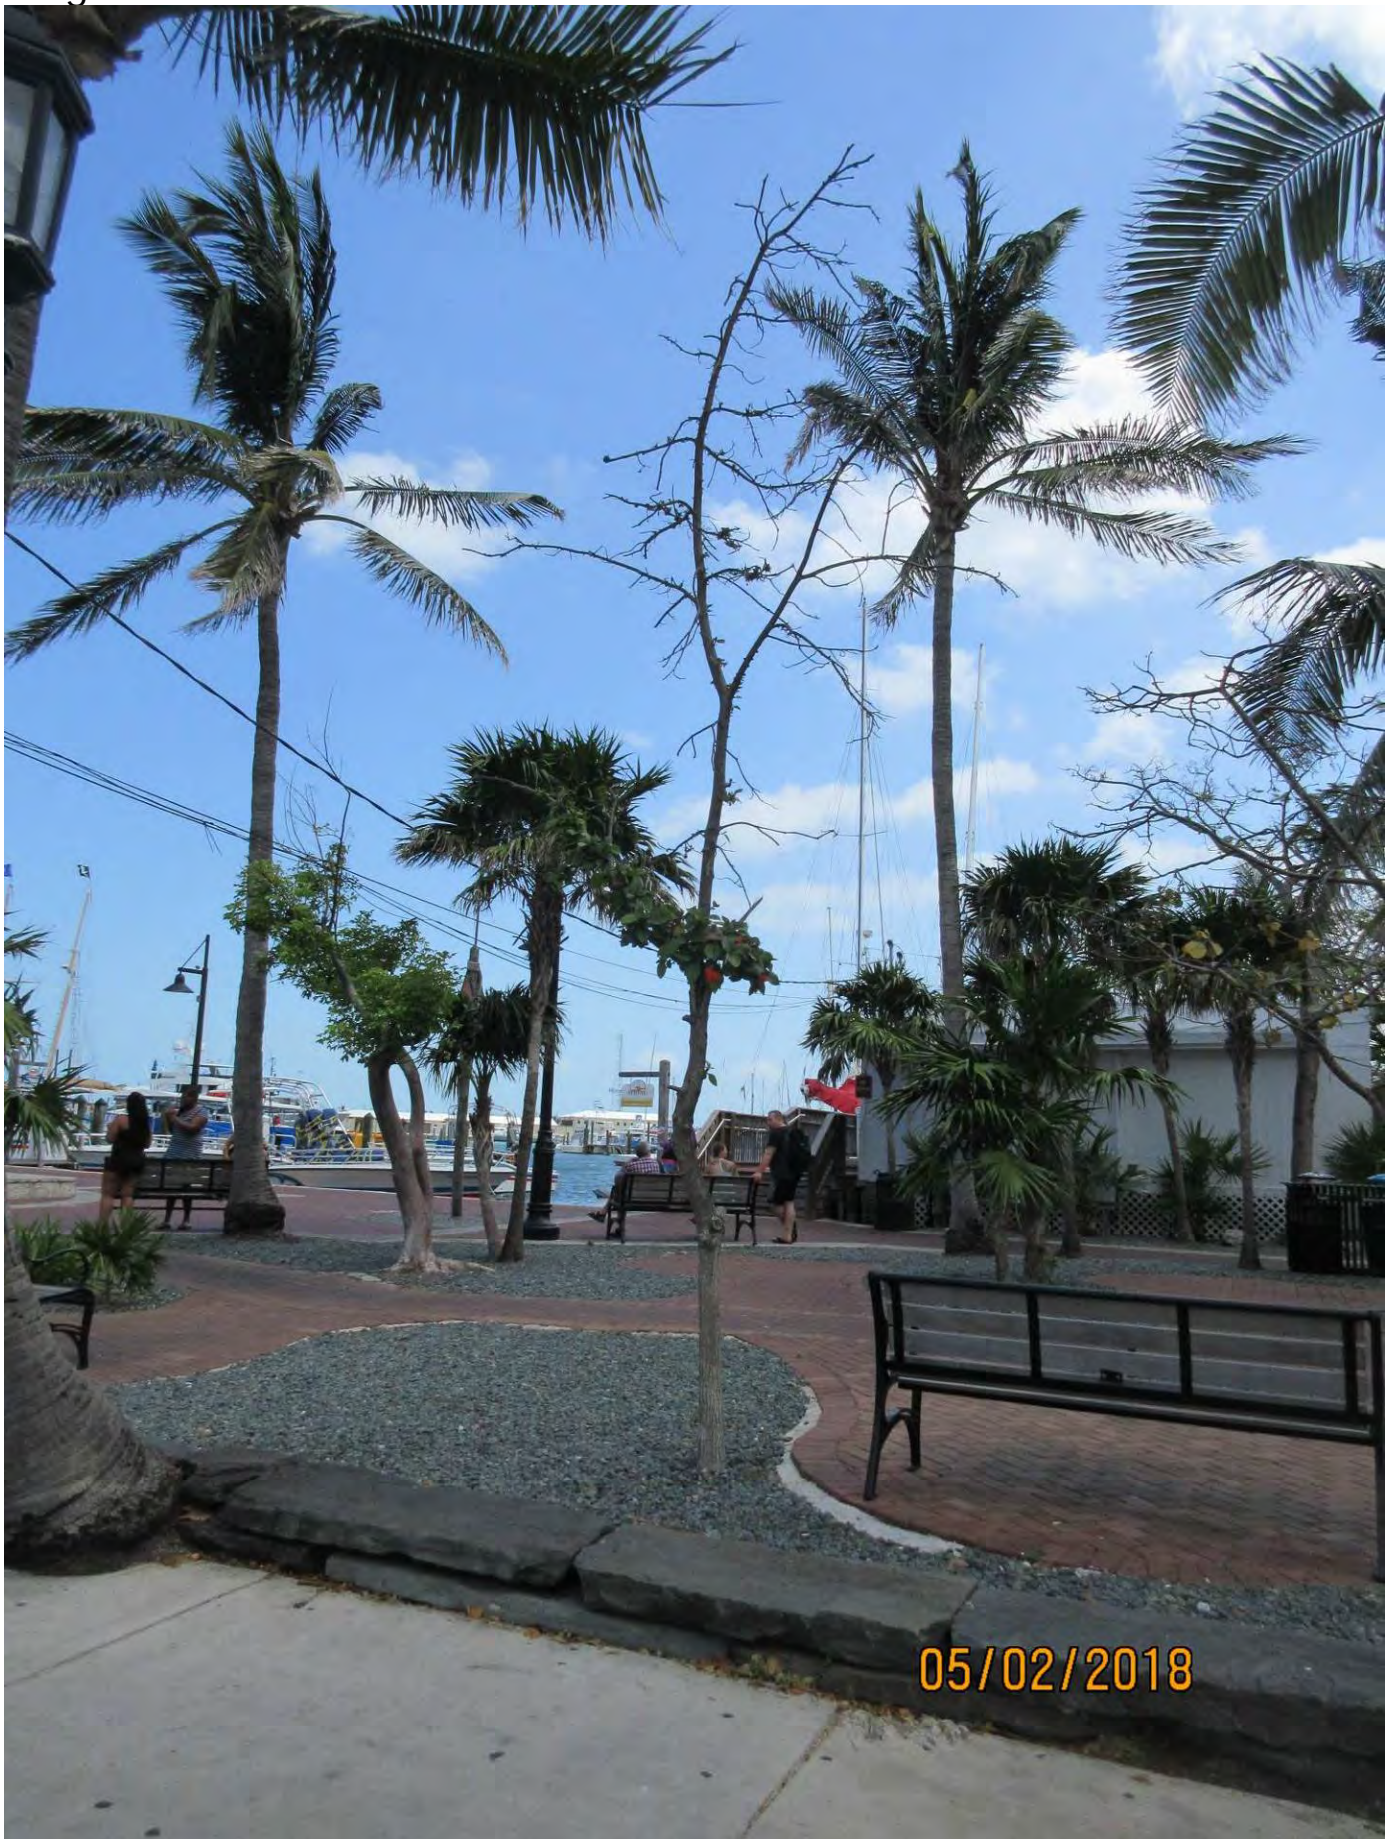
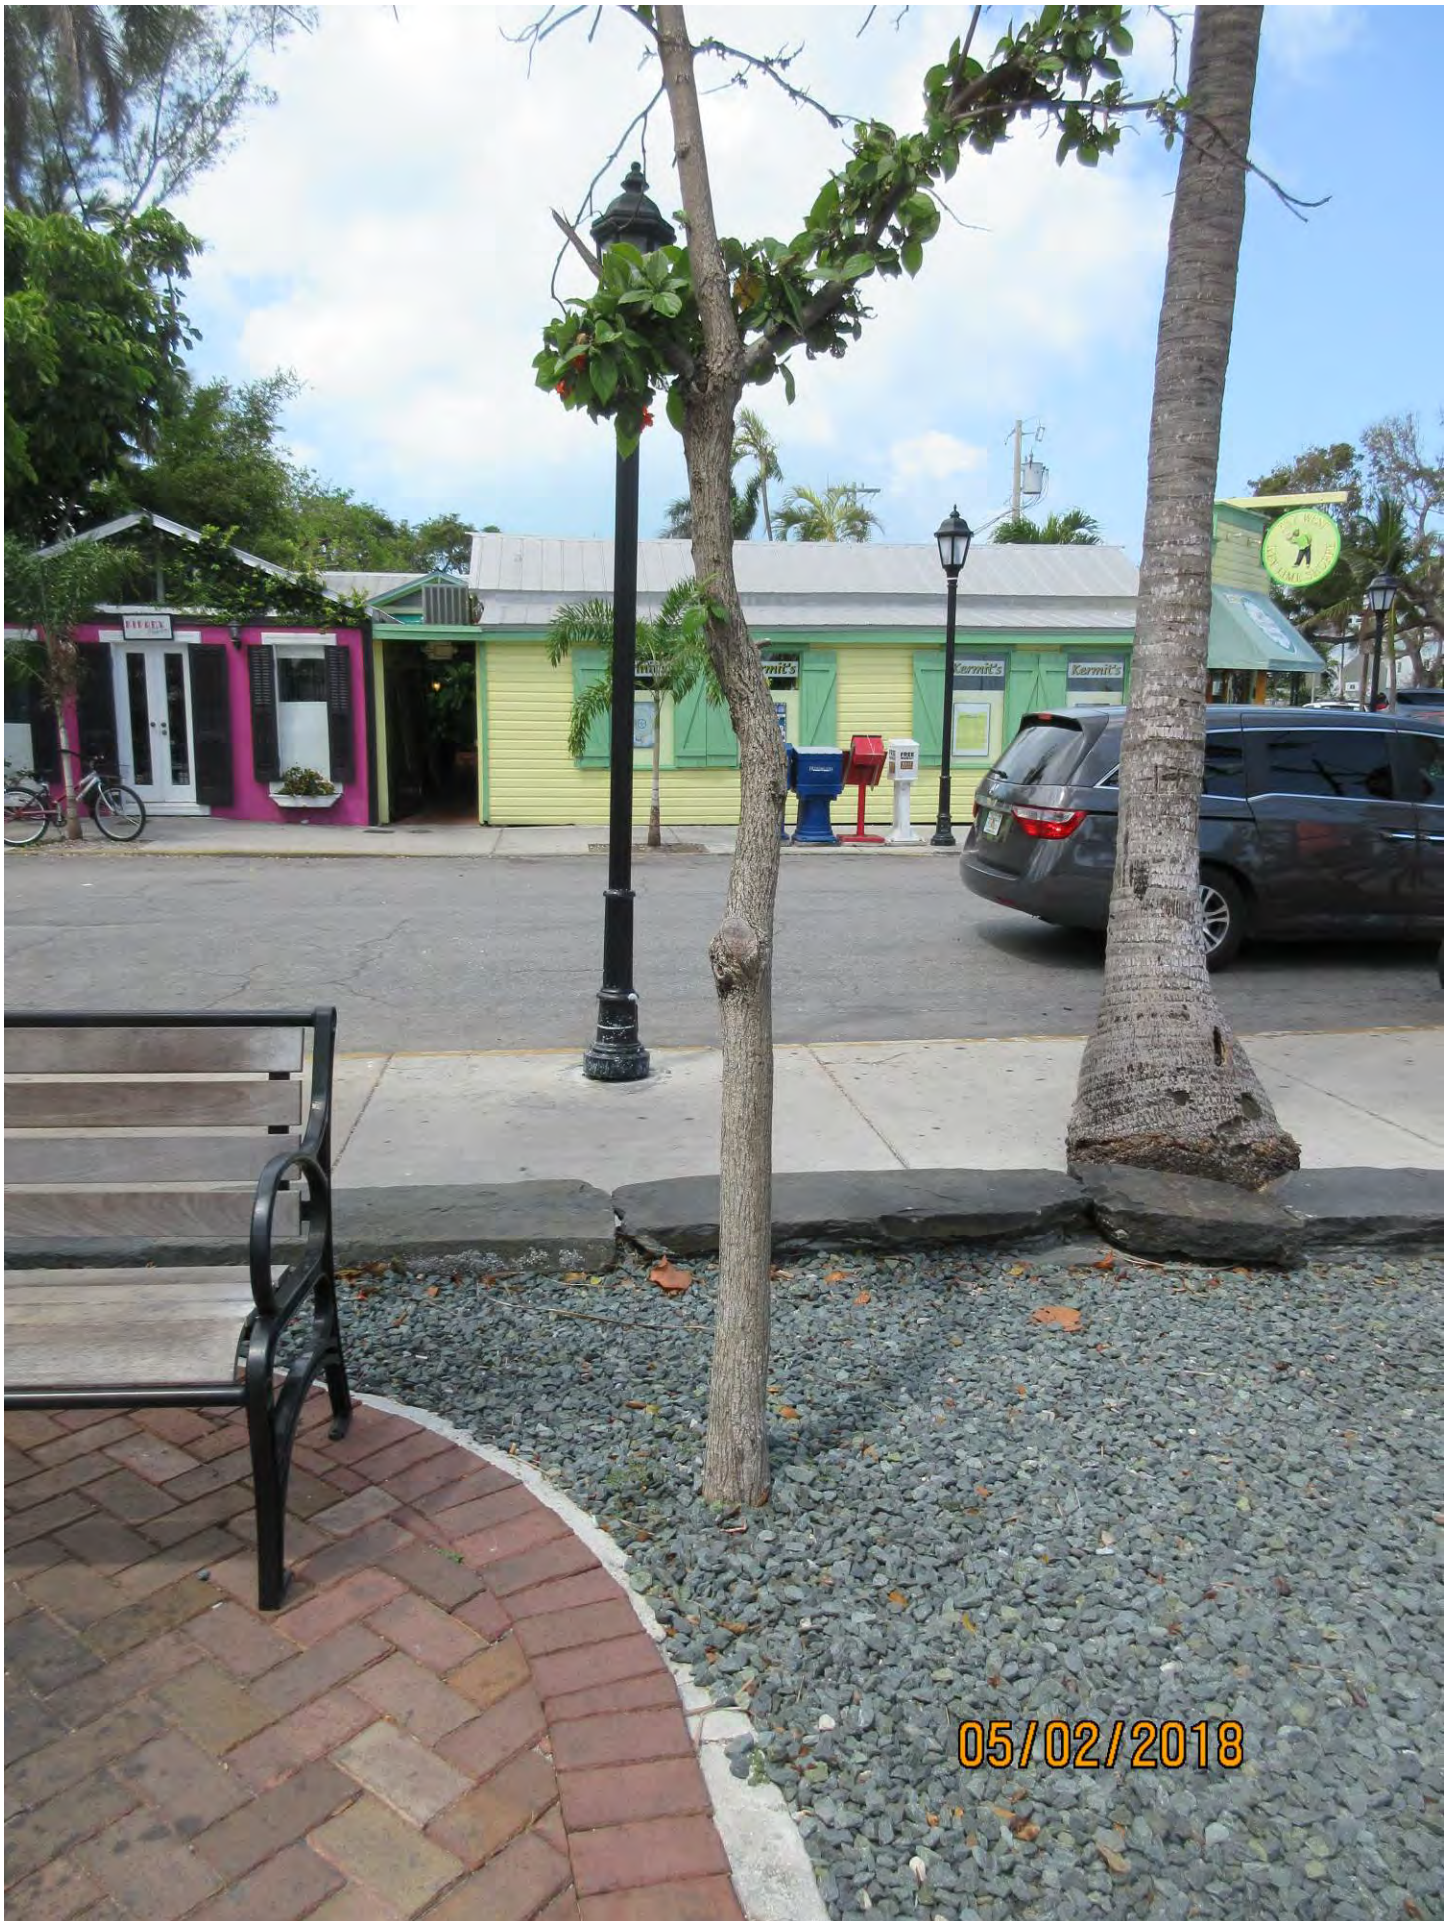
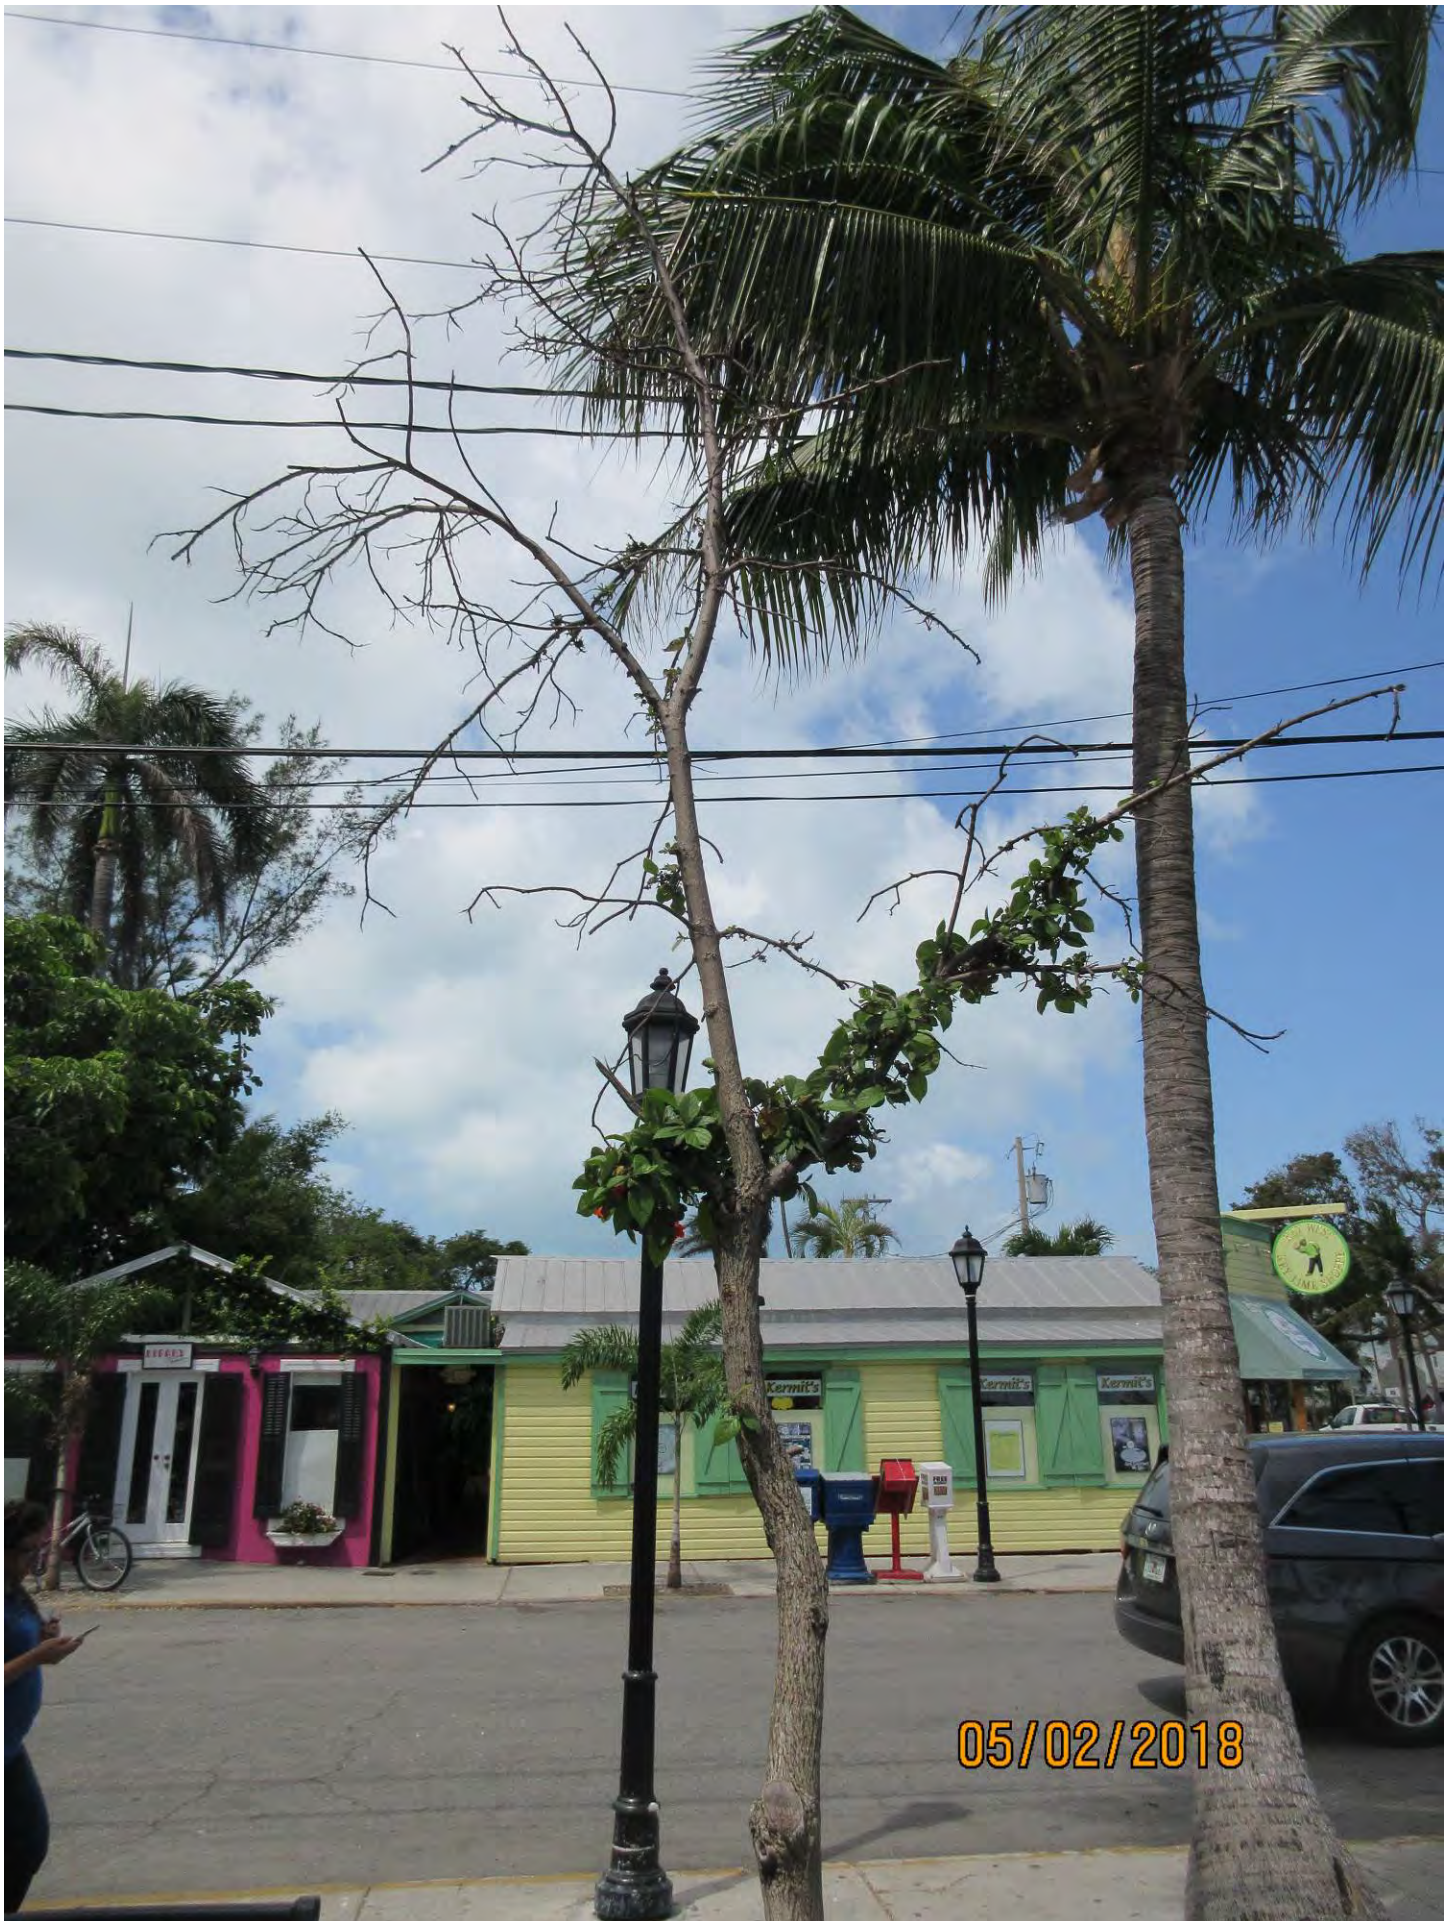
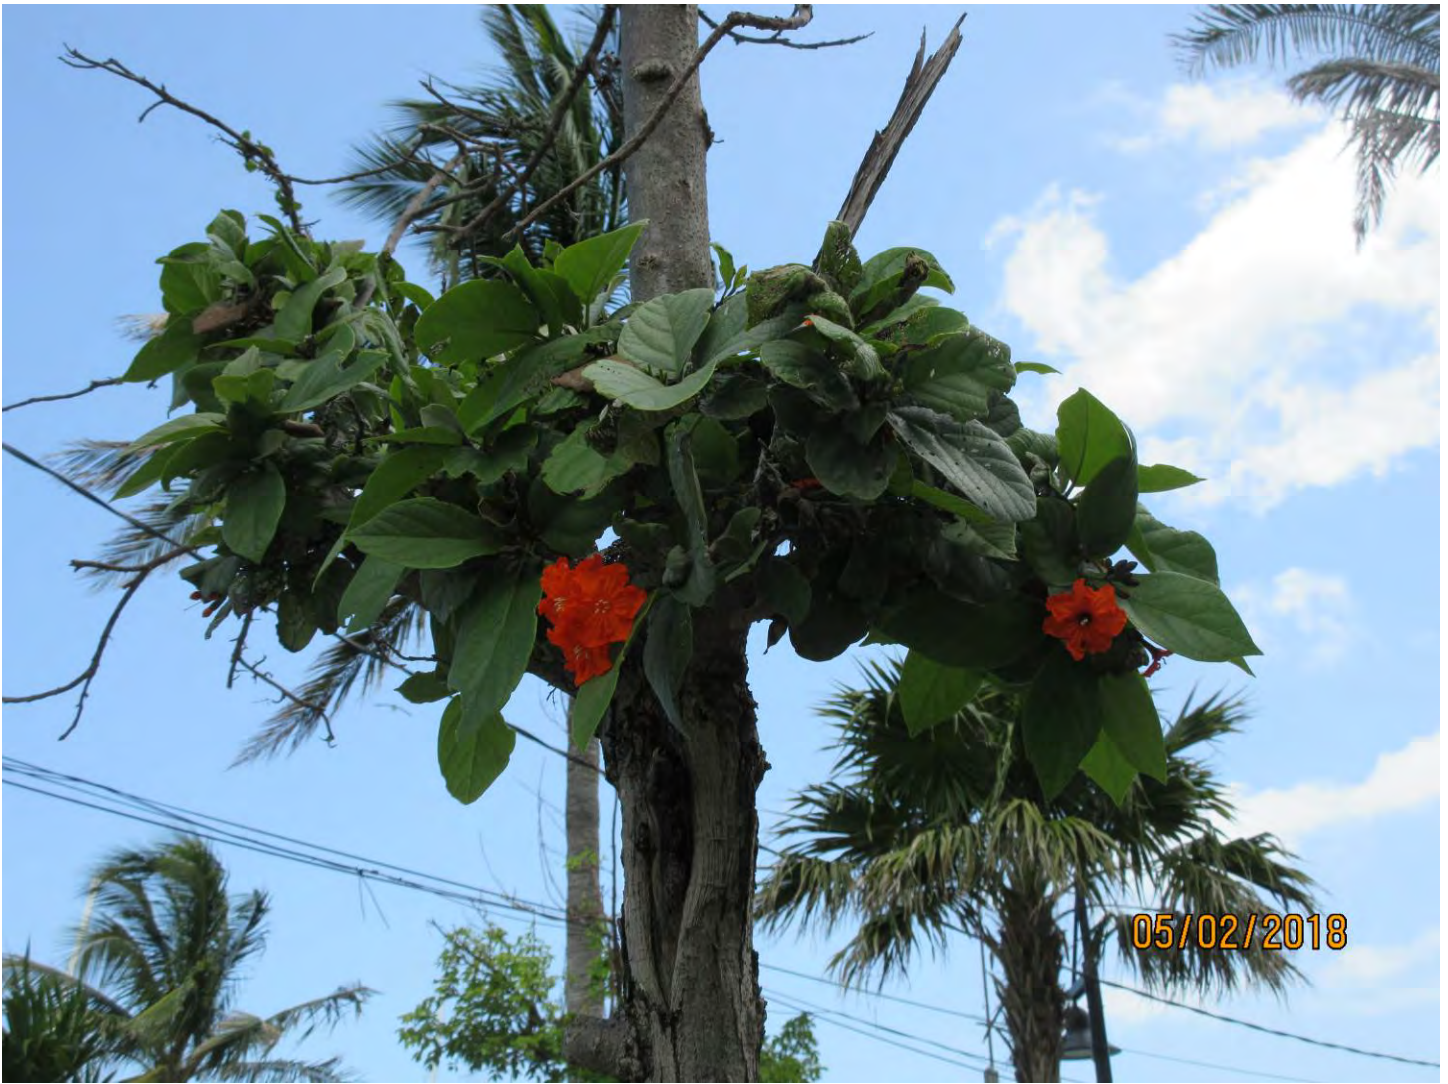
Geiger tree #40

Diameter: 4.1"

Location: 100%

Species: 100% (on protected tree list)

Condition: 40% (poor)

Total Average Value = 80%

Value x Diameter = 3.2 replacement caliper inches
