STAFF REPORT

RE: **Key West Historic Seaport (permit application # T18-8977)**

FROM: Karen DeMaria, City of Key West Urban Forestry Manager

An application was received requesting the review of a conceptual landscape plan in association with the proposed renovations at the Key West Historic Seaport area. This review will be discussed in stages.

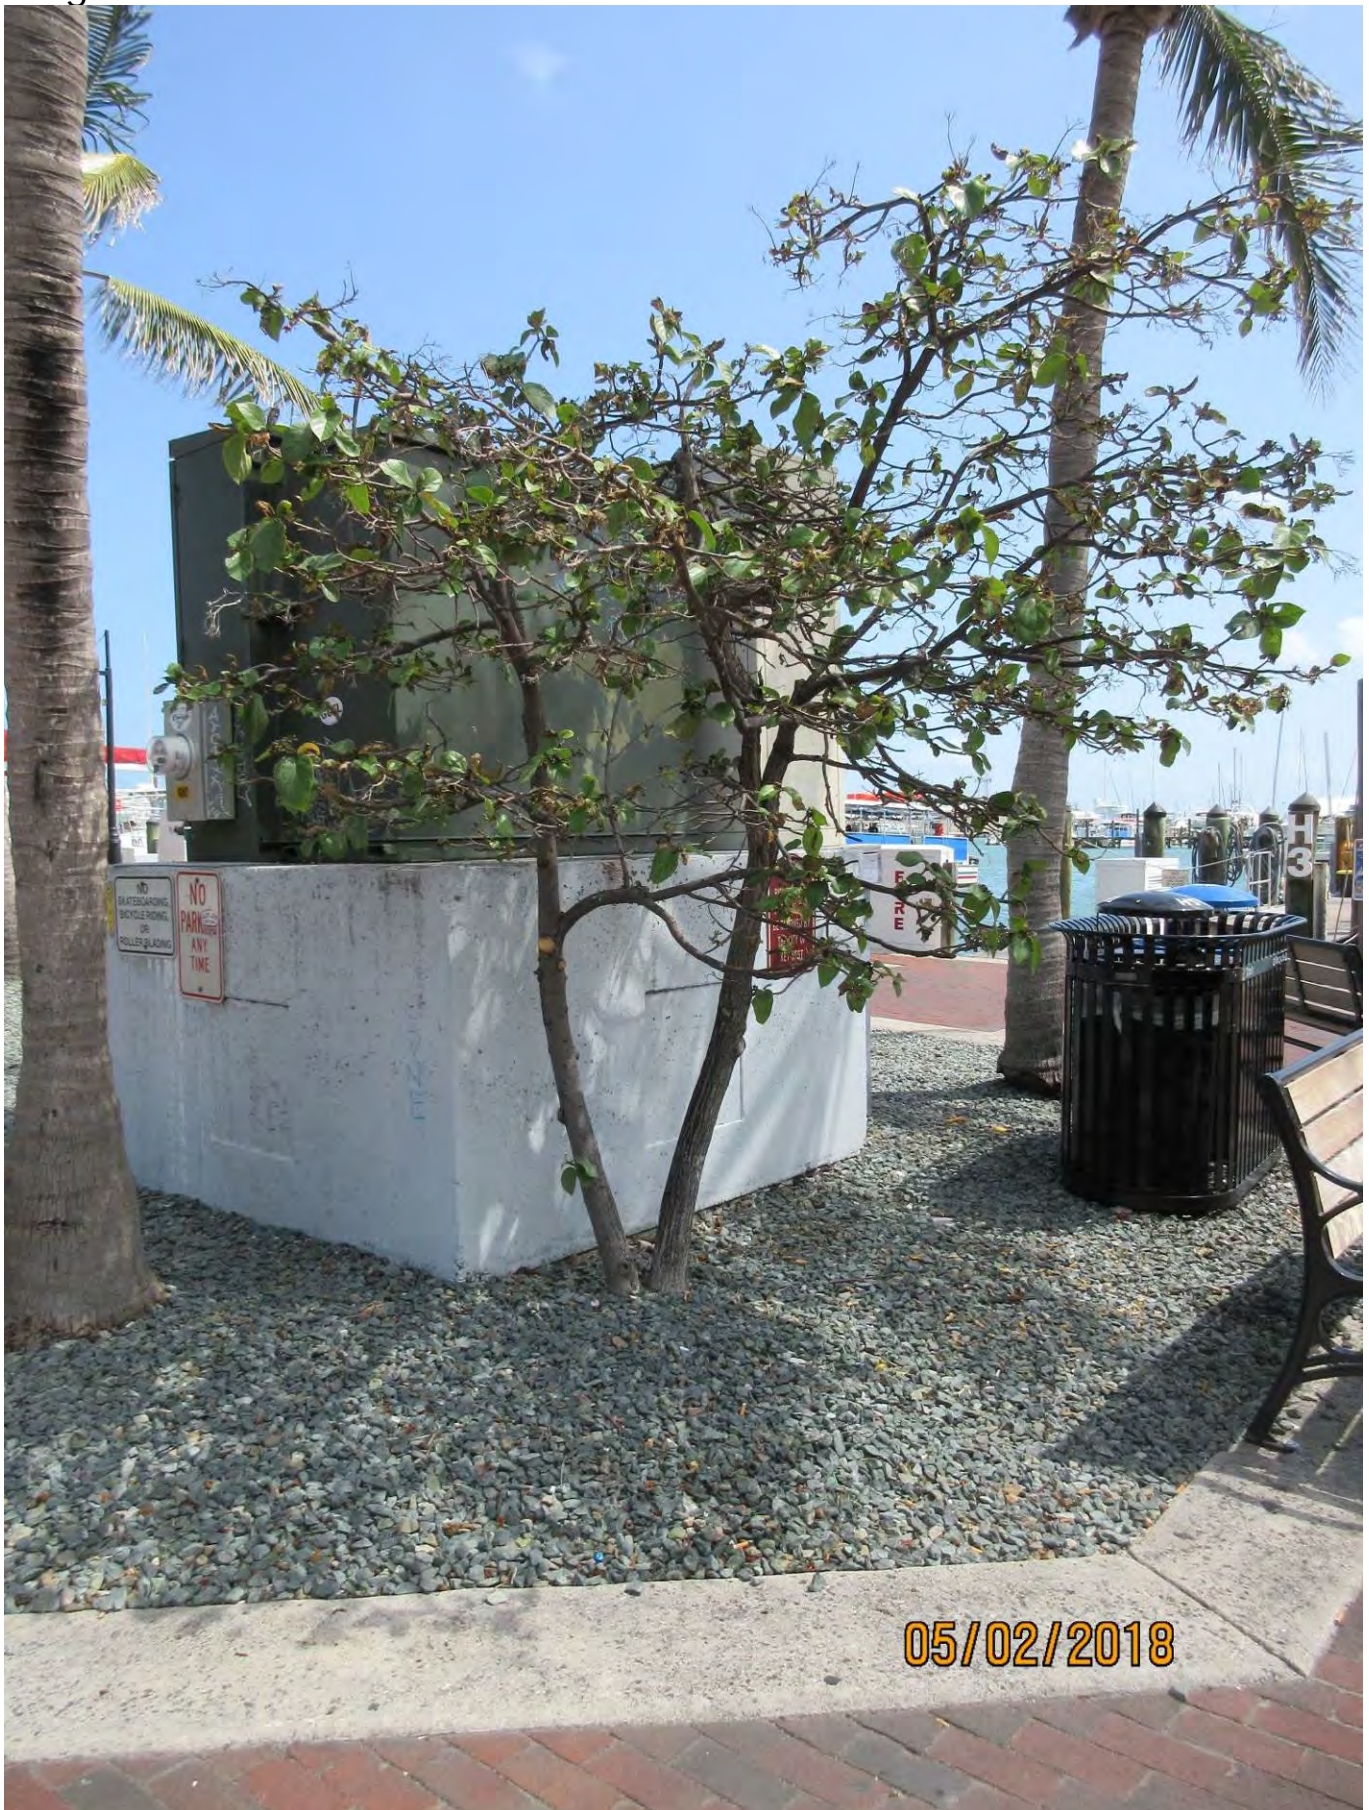
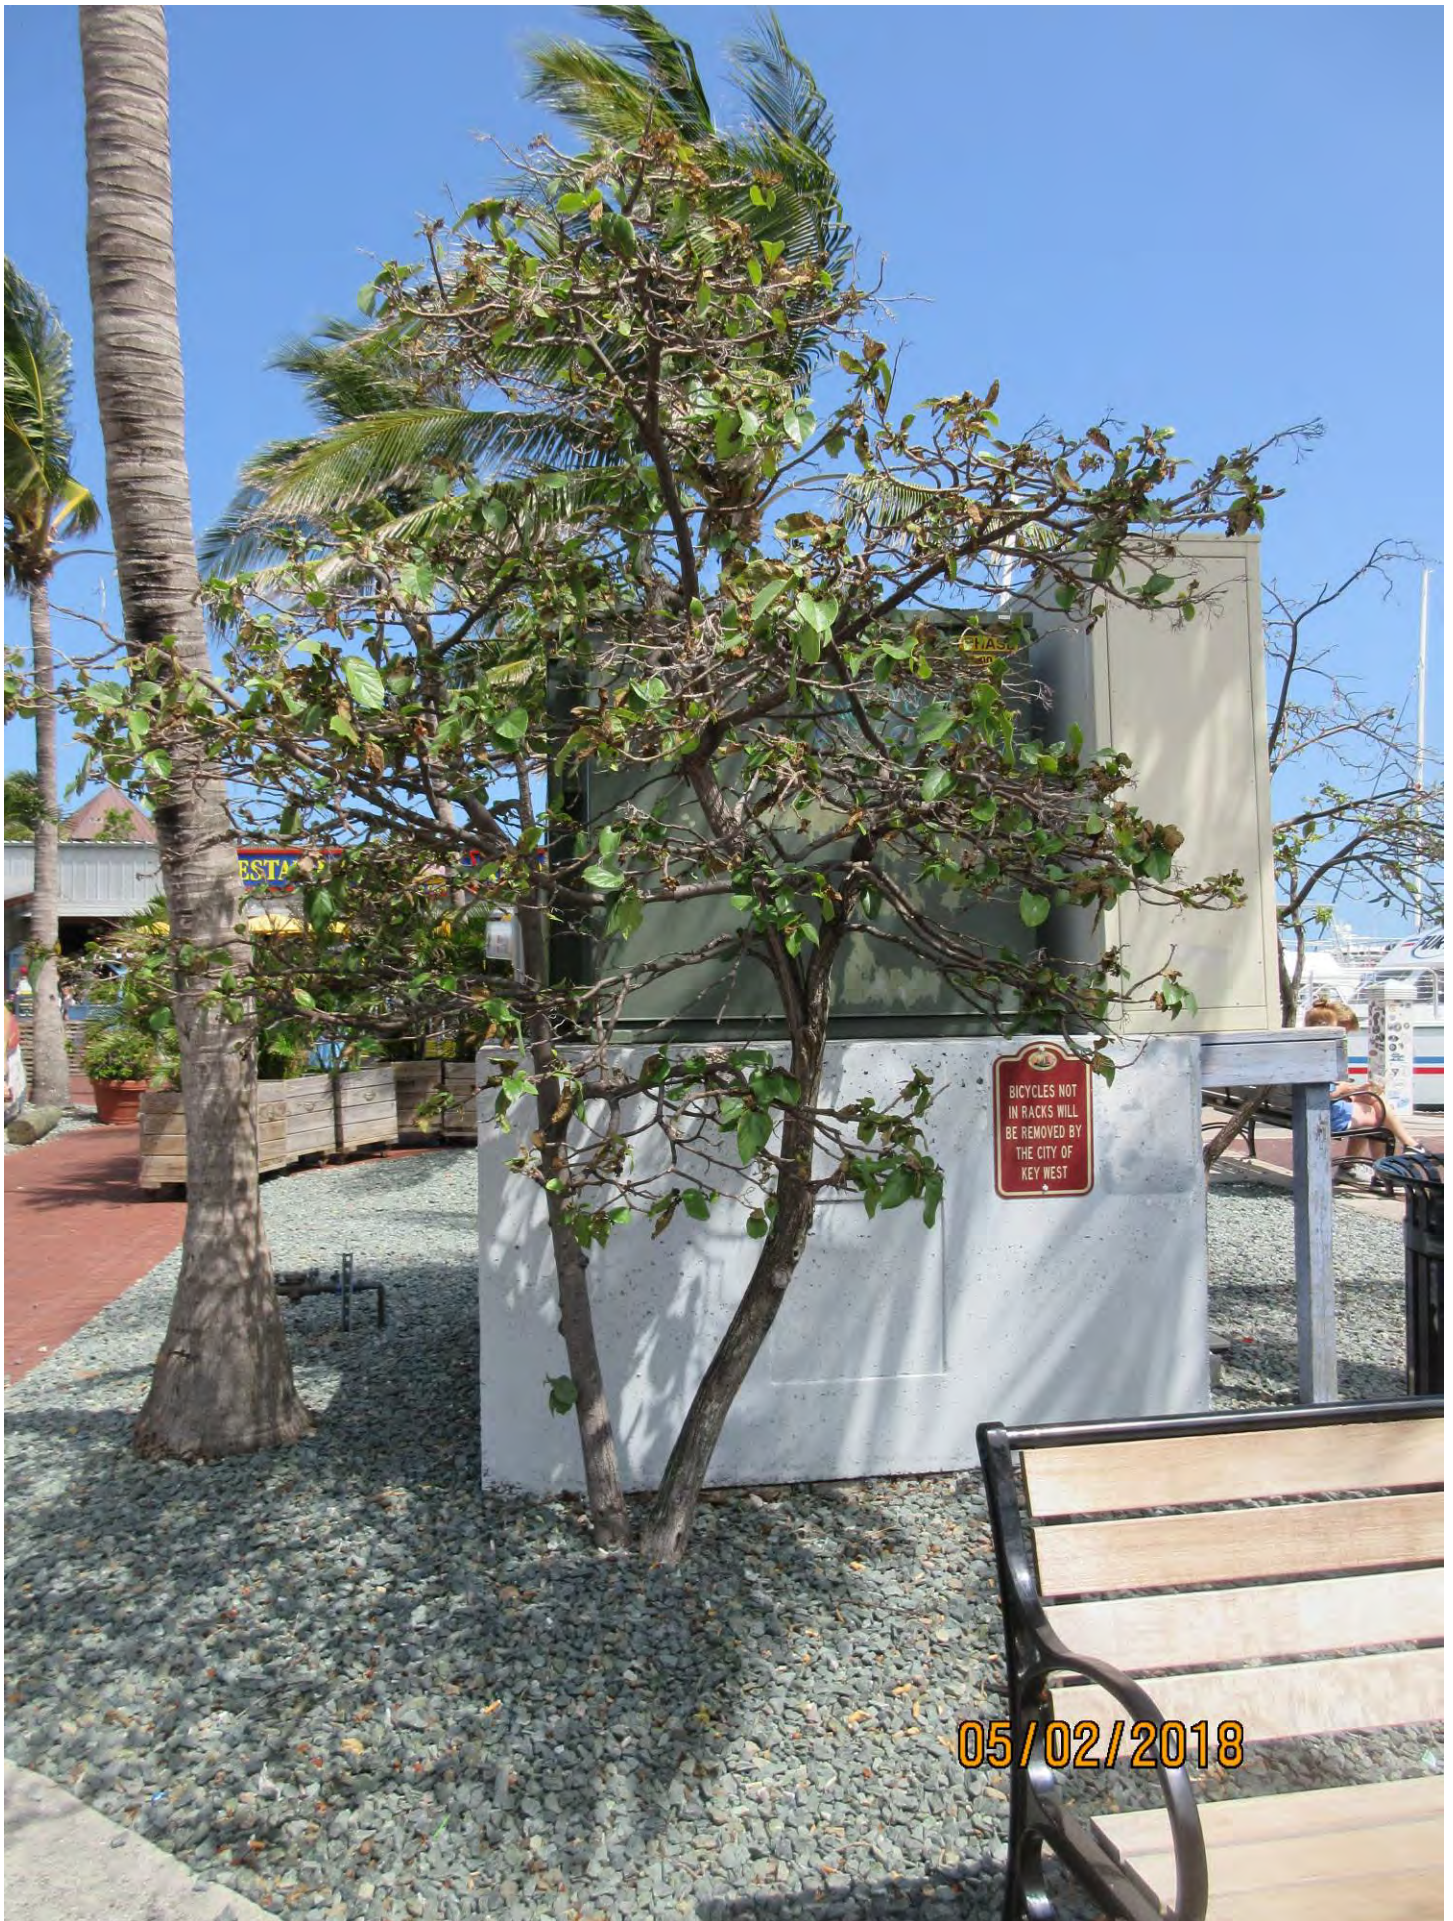
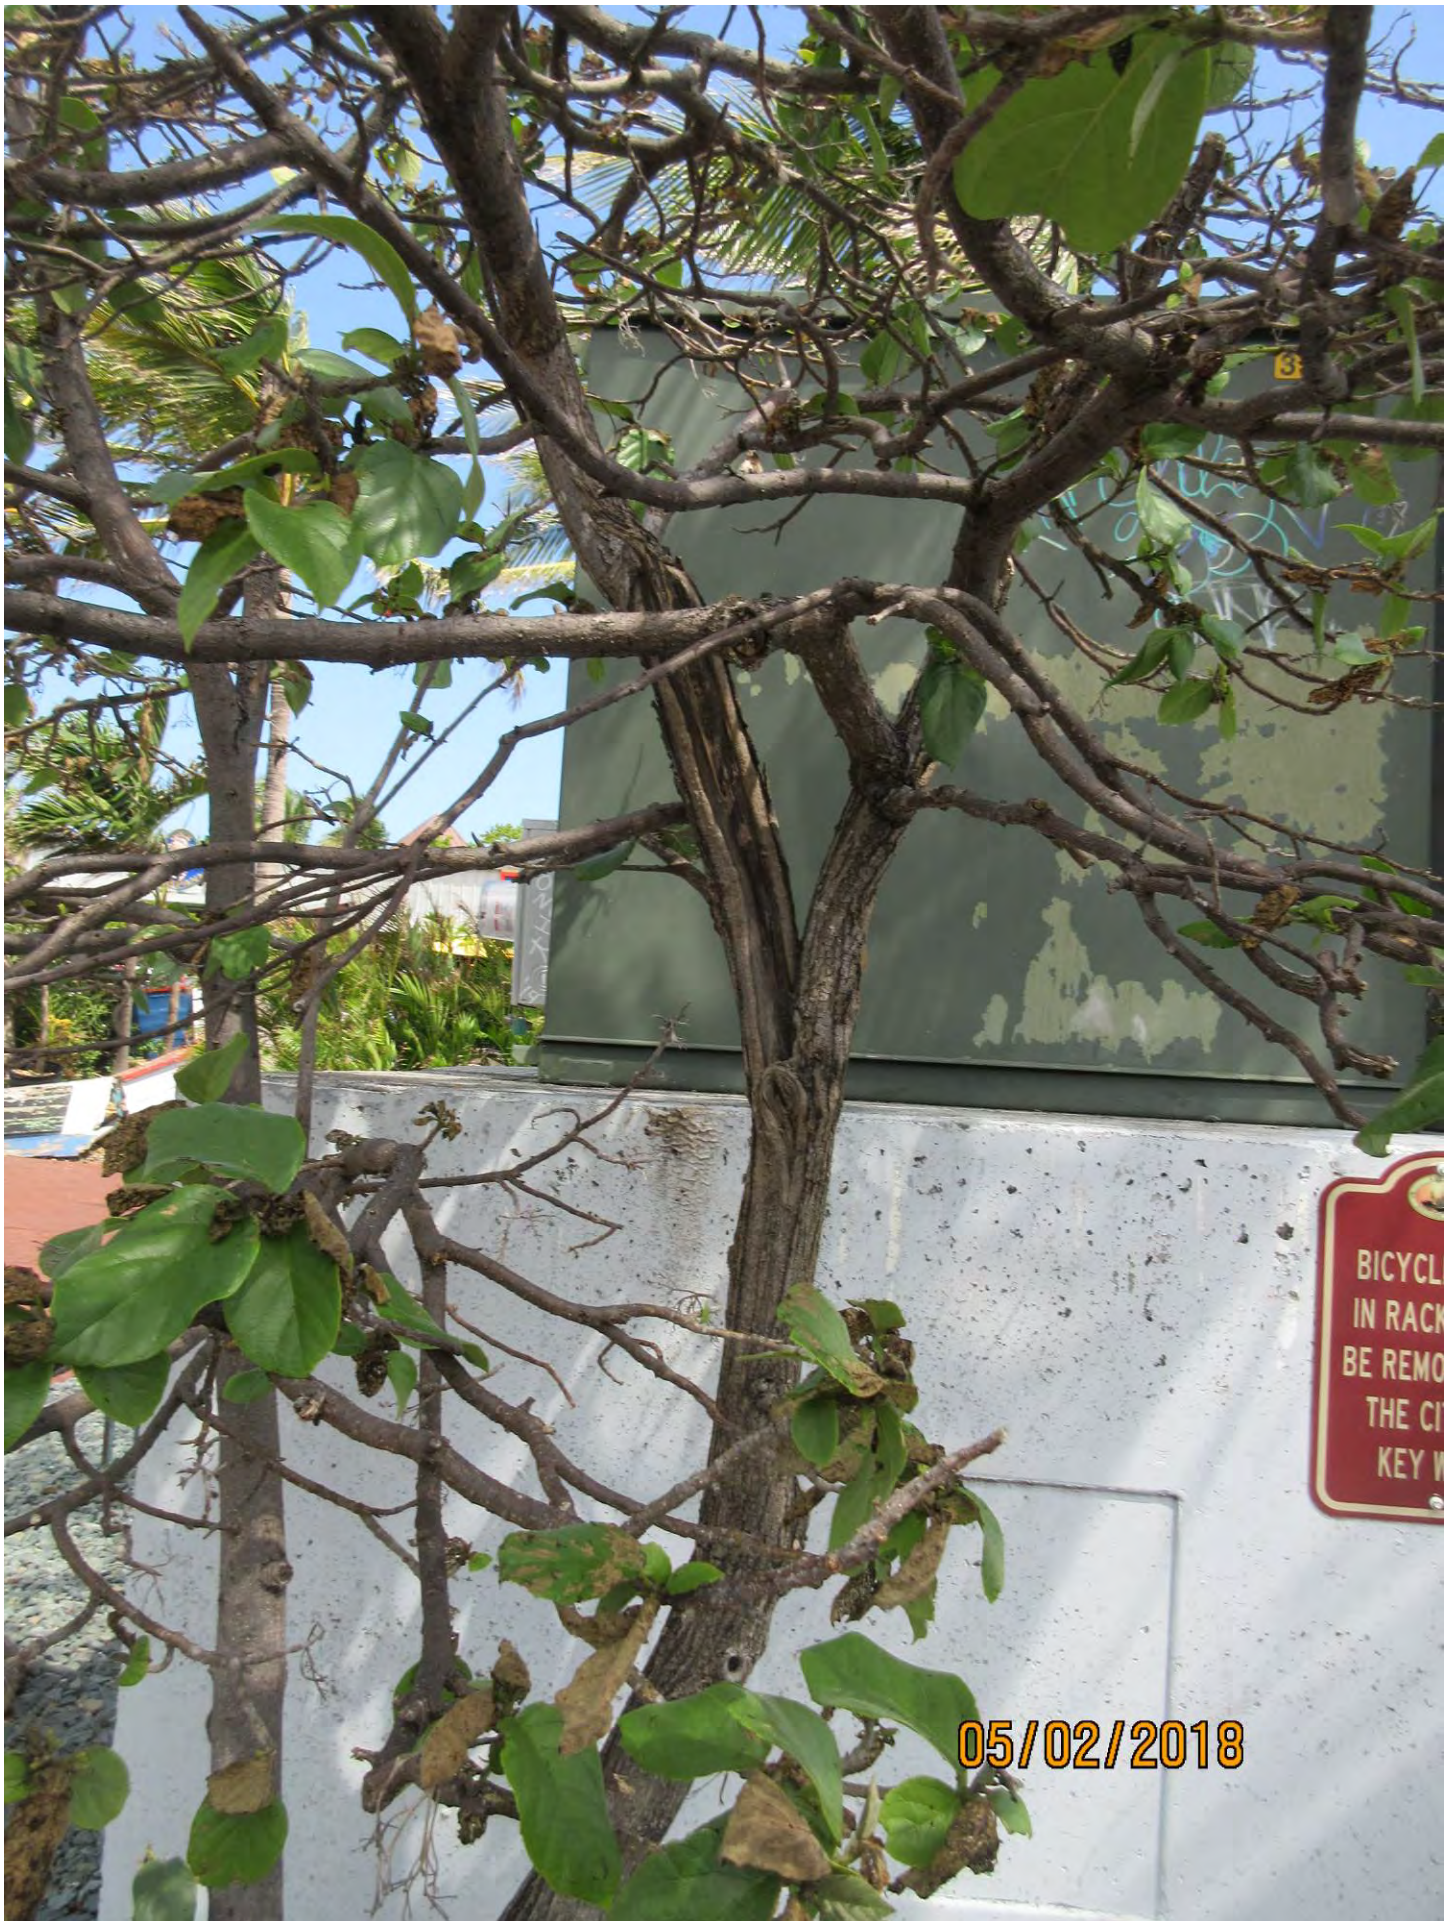
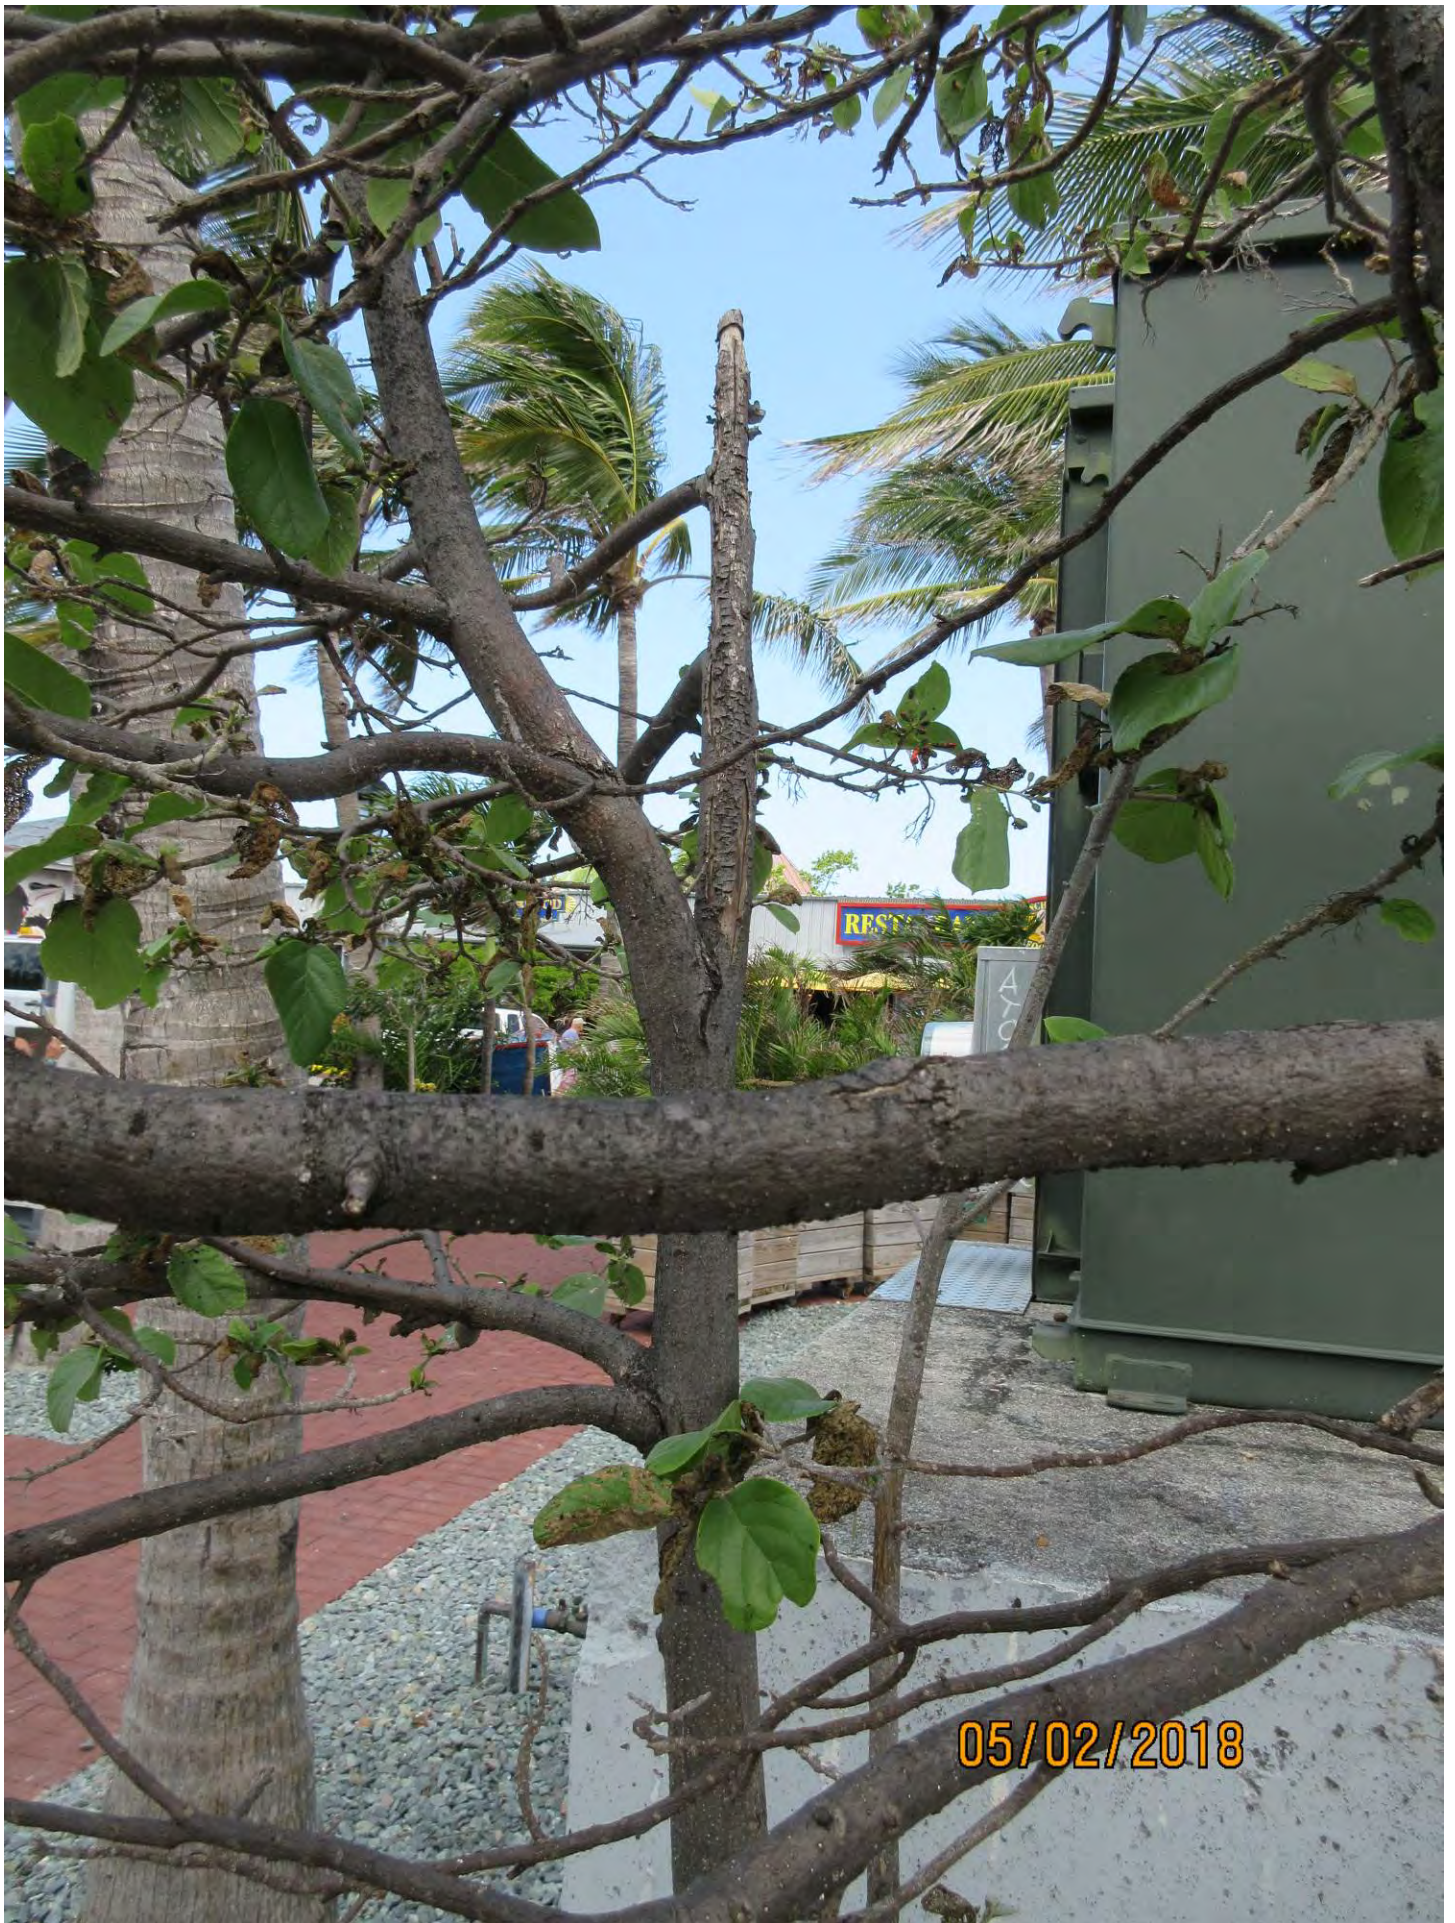
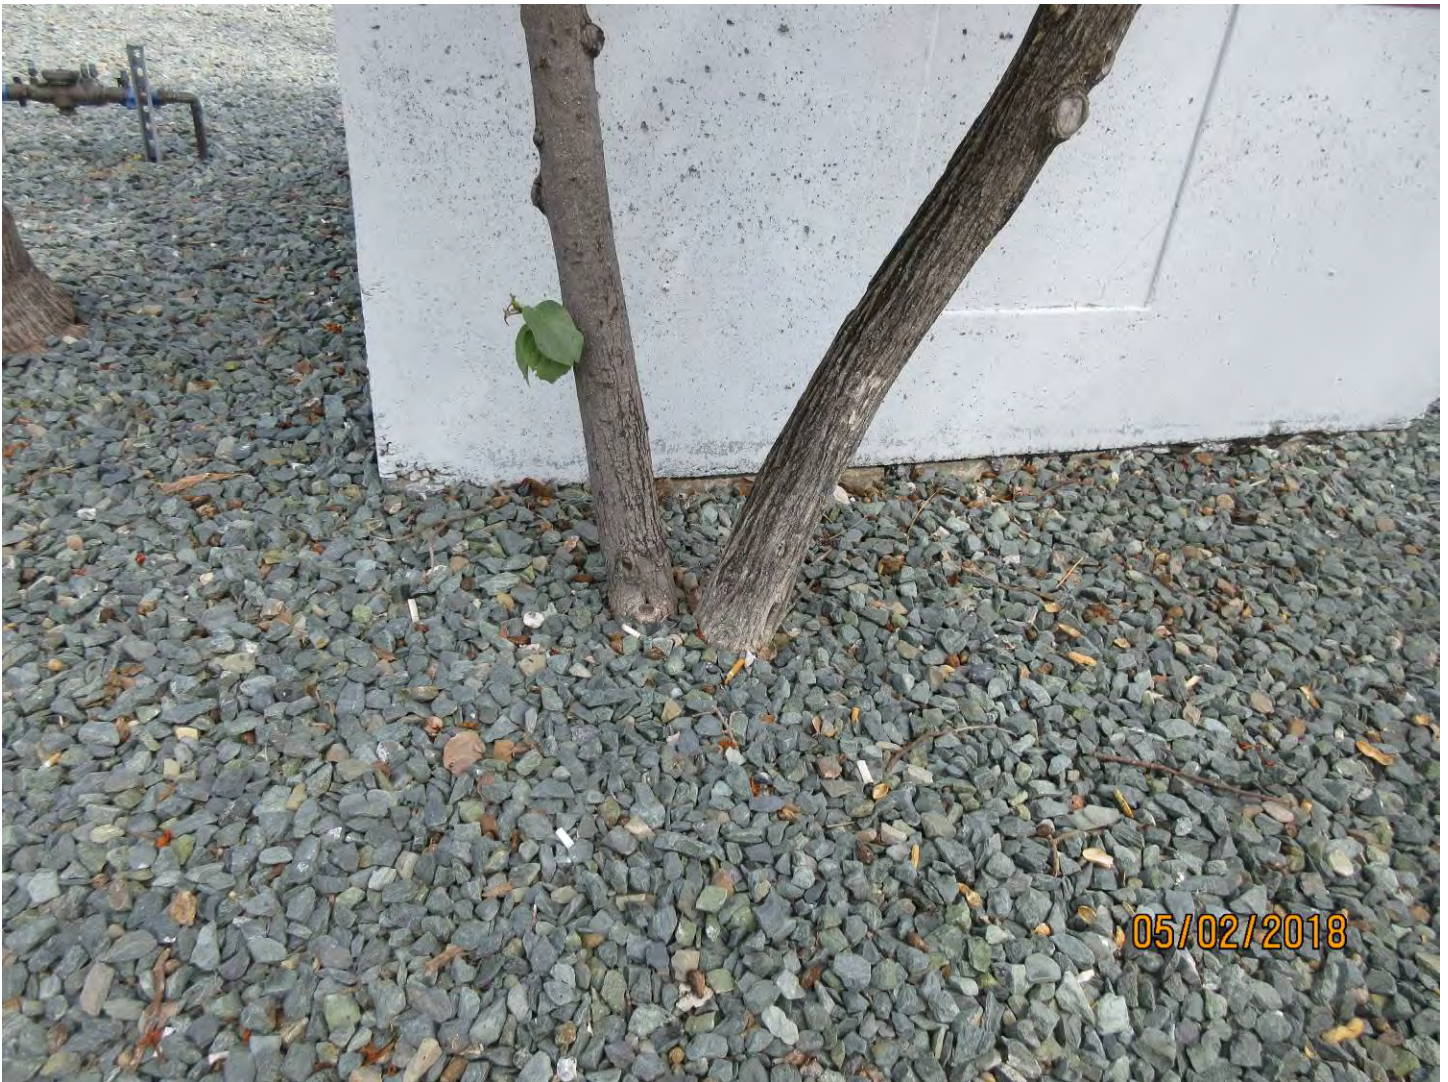
Geiger tree #47

Diameter: 6.2"

Location: 70% (planted close to utility box)

Species: 100% (on protected tree list)

Condition: 50% (fair to poor, poor structure-decay)

Total Average Value = 73%

Value x Diameter = 4.5 replacement caliper inches

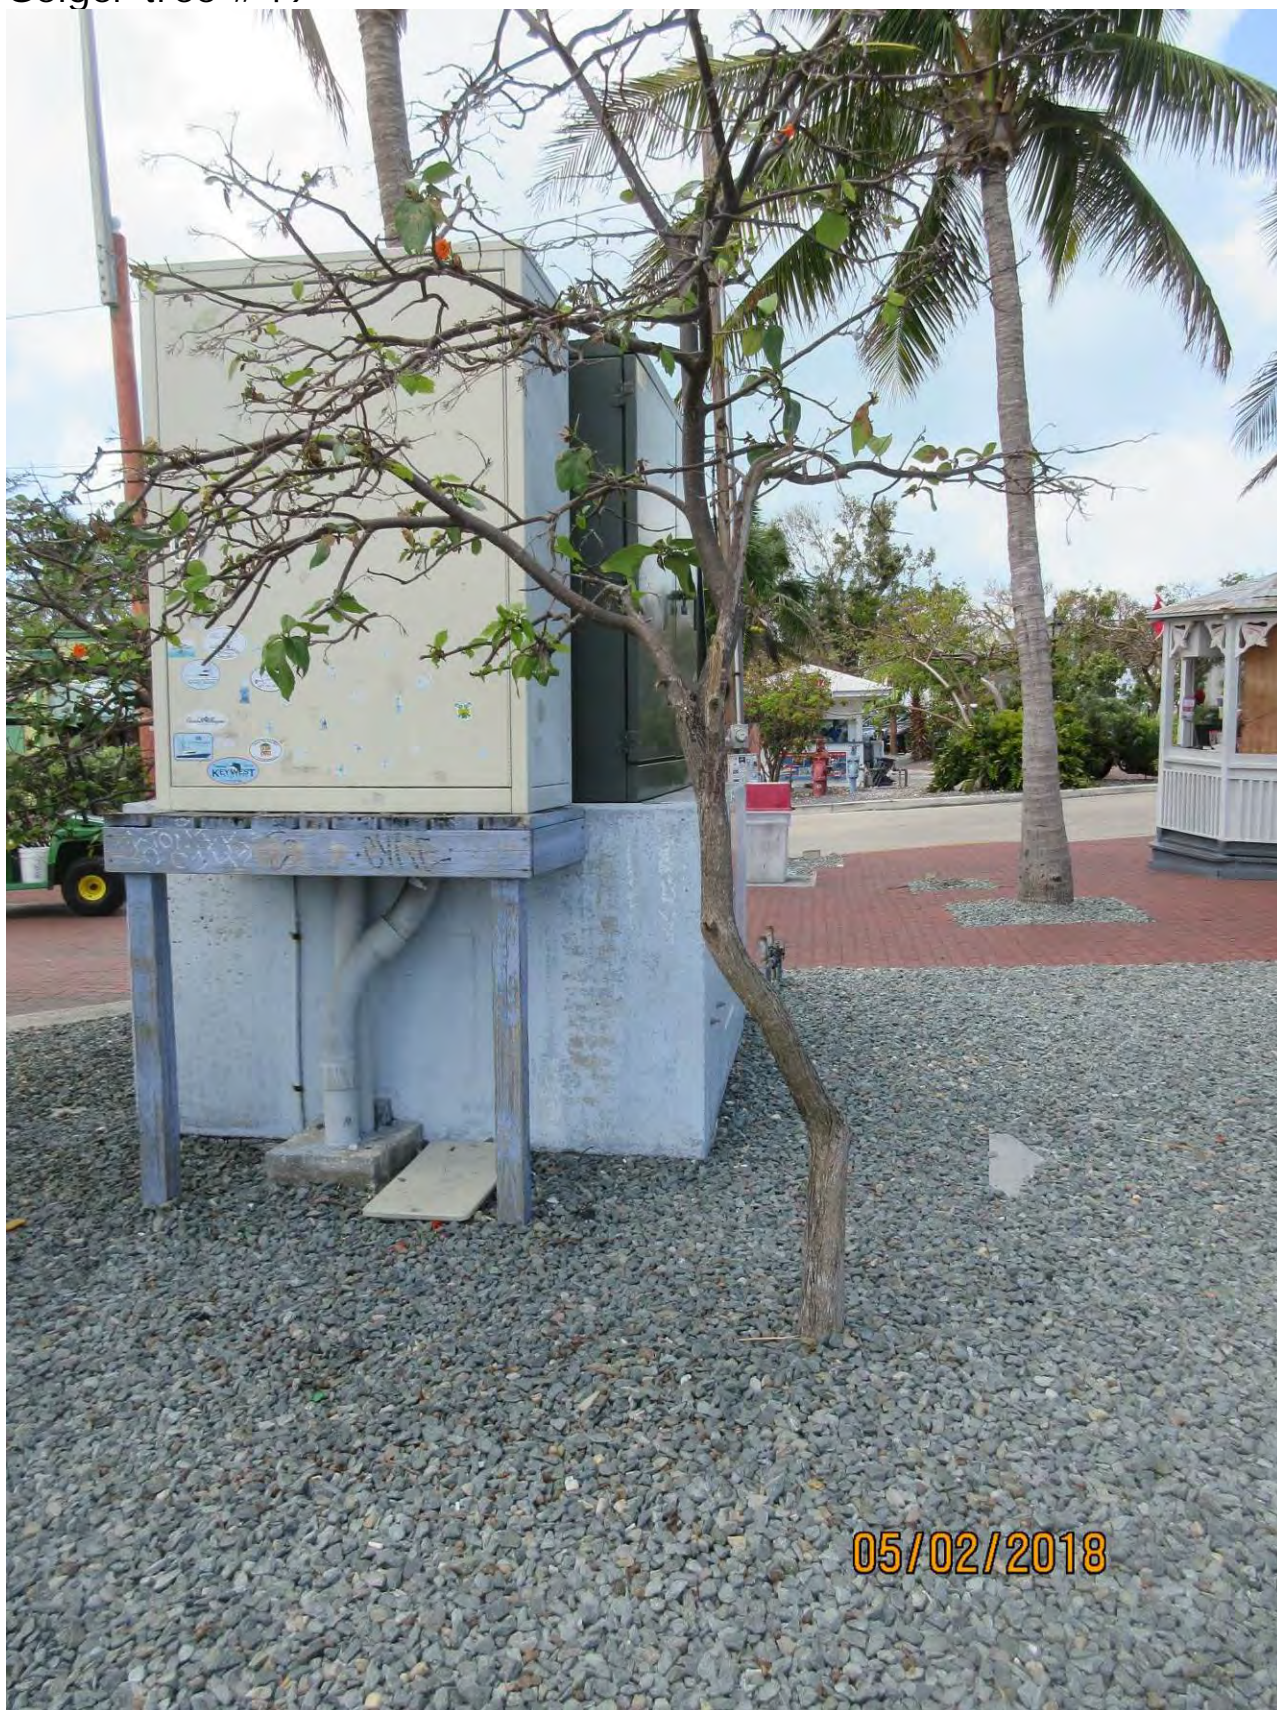
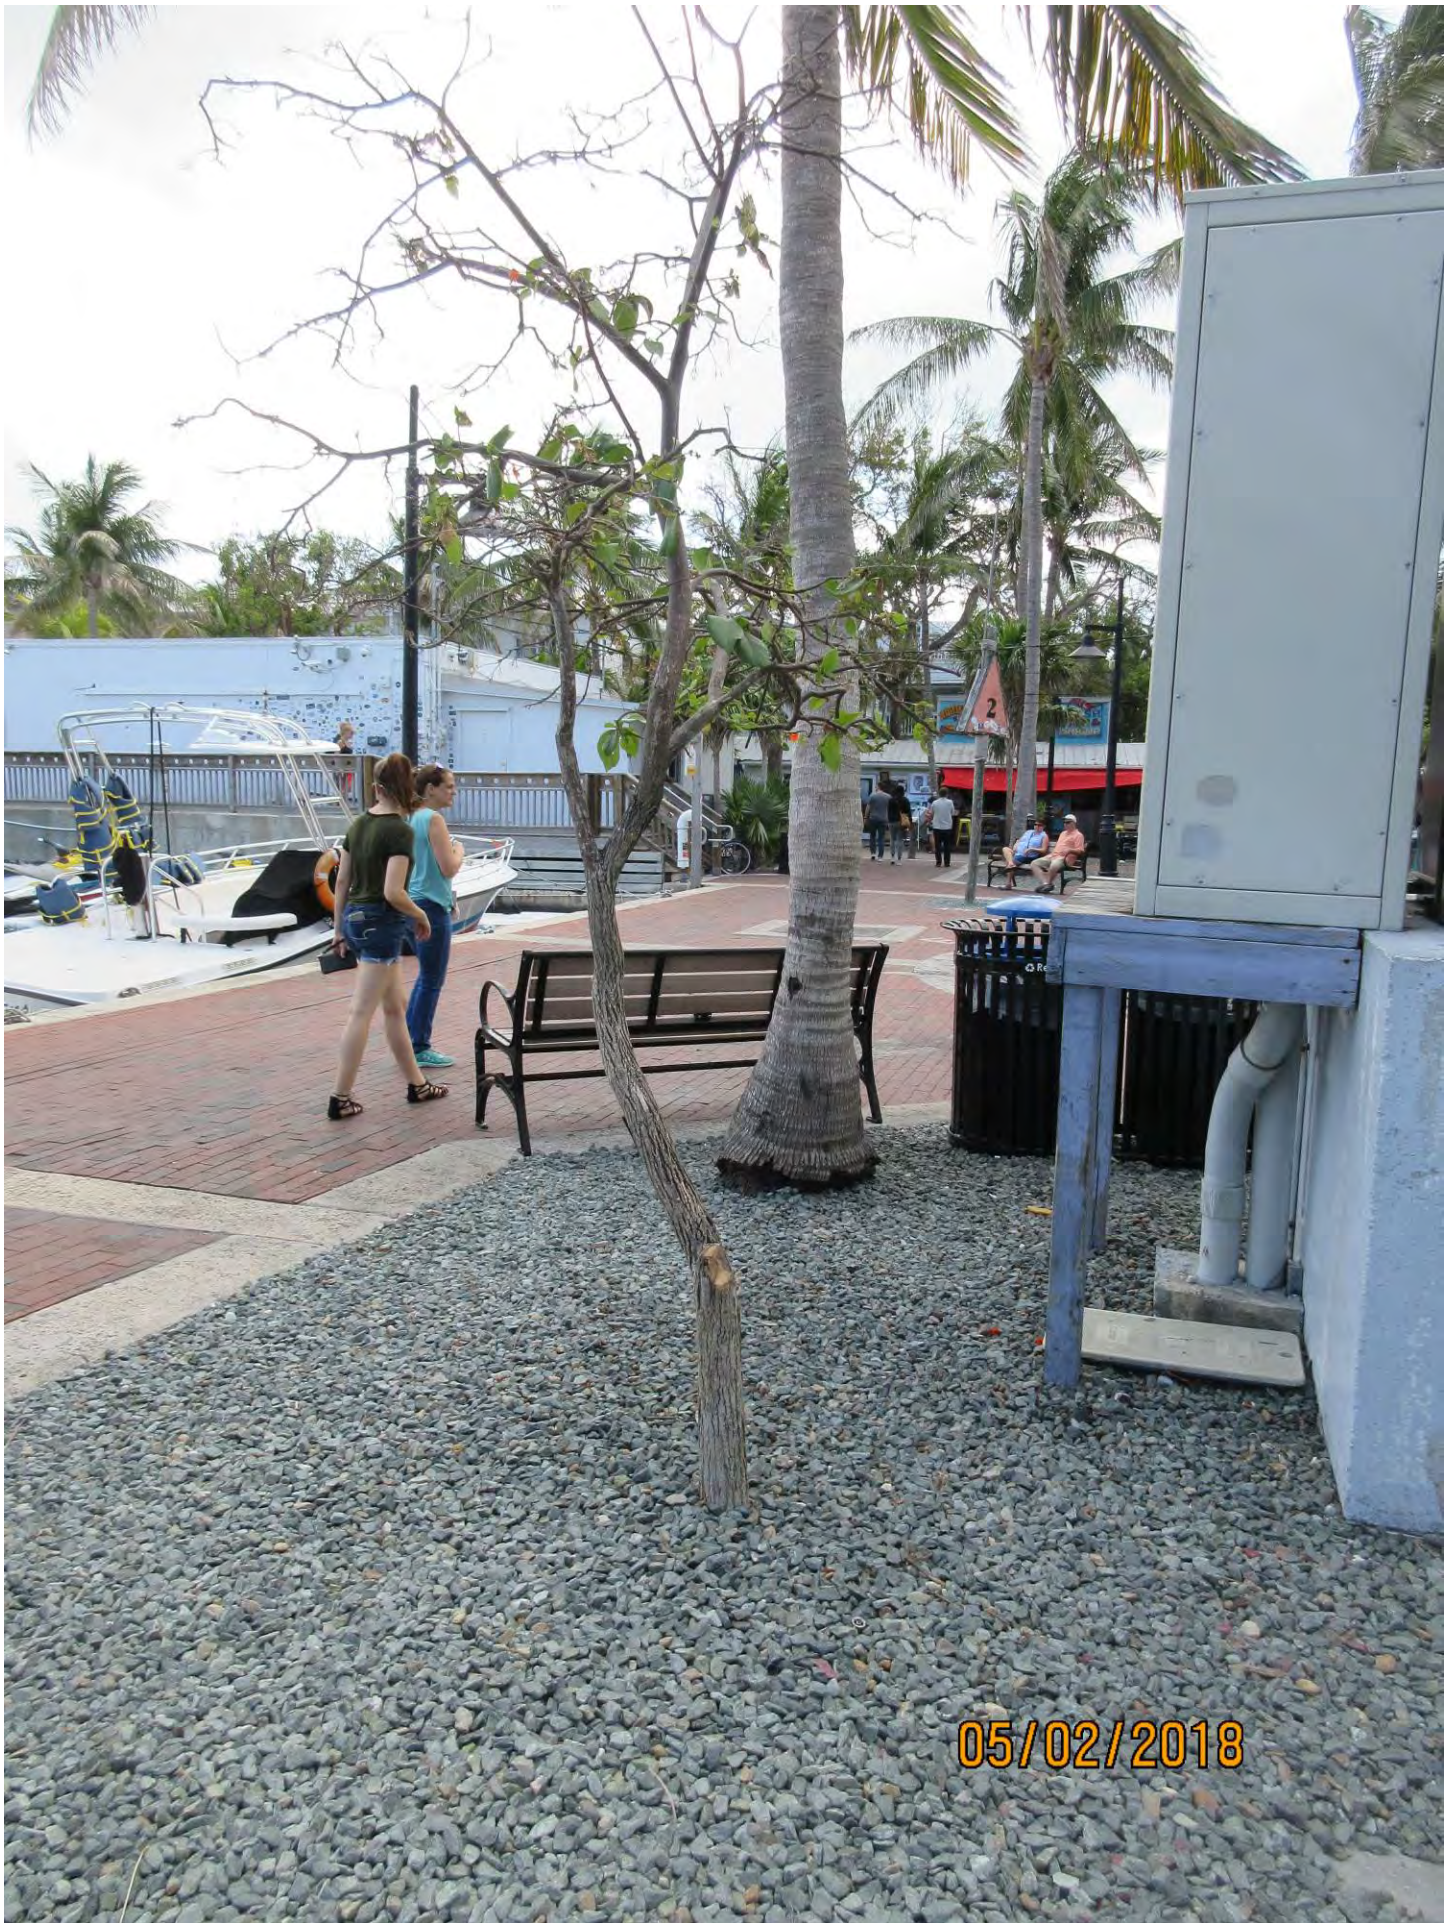
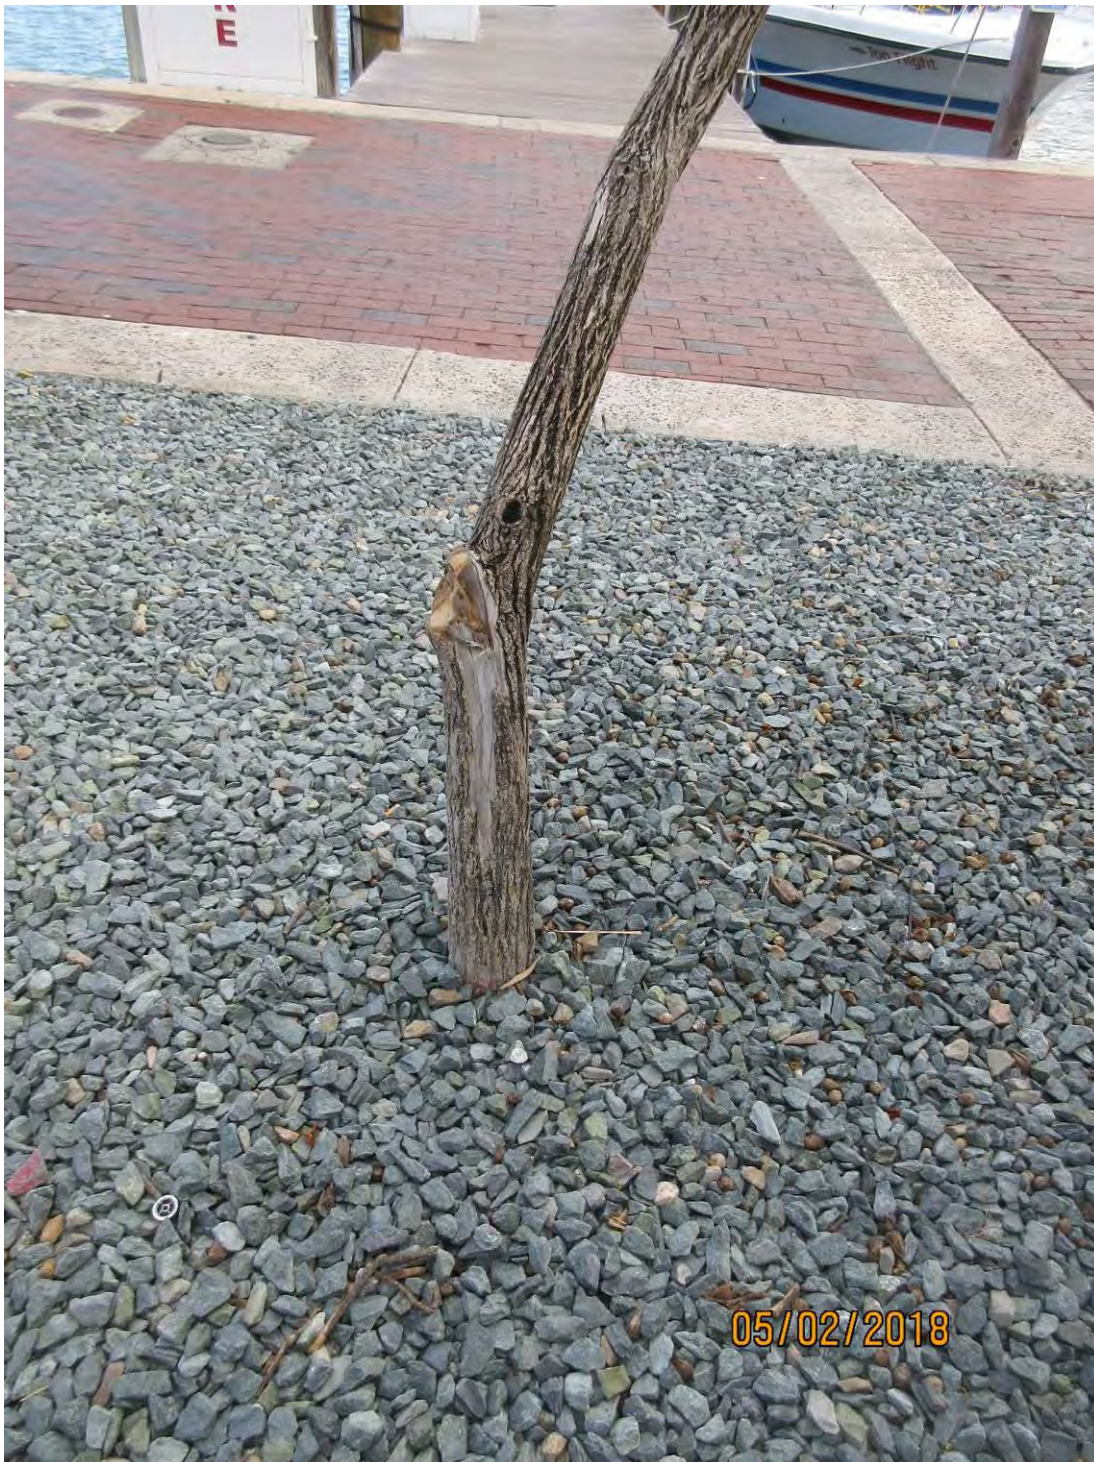
Geiger tree #49

Diameter: 2.8"

Location: 100%

Species: 100% (on protected tree list)

Condition: 50% (fair to poor, poor structure, tear into main trunk of tree)

Total Average Value = 83%

Value x Diameter = 2.3 replacement caliper inches
