STAFF REPORT

RE: **Key West Historic Seaport (permit application # T18-8977)**

FROM: Karen DeMaria, City of Key West Urban Forestry Manager

An application was received requesting the review of a conceptual landscape plan in association with the proposed renovations at the Key West Historic Seaport area. This review will be discussed in stages.

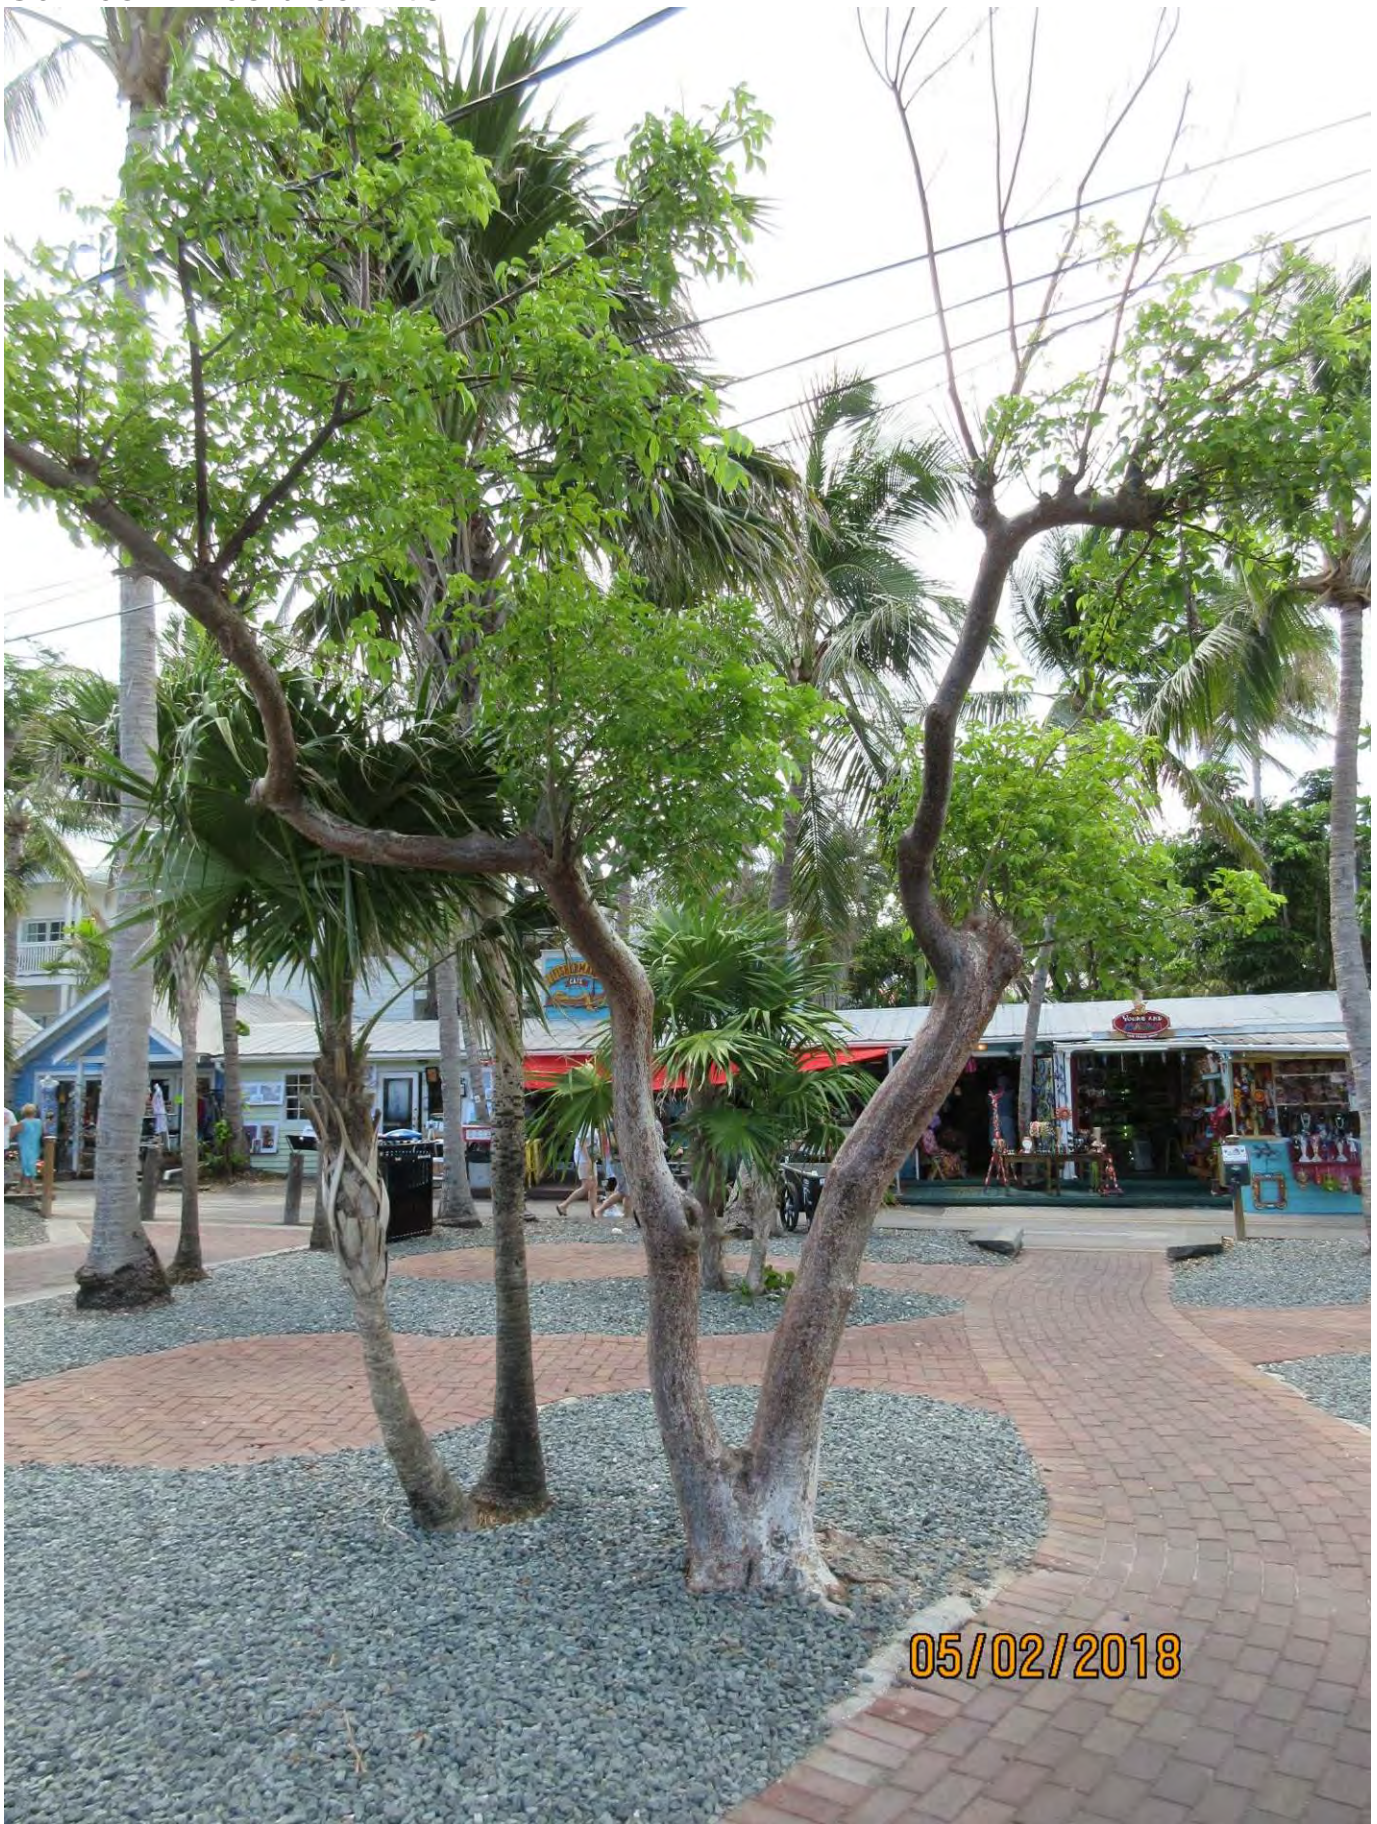
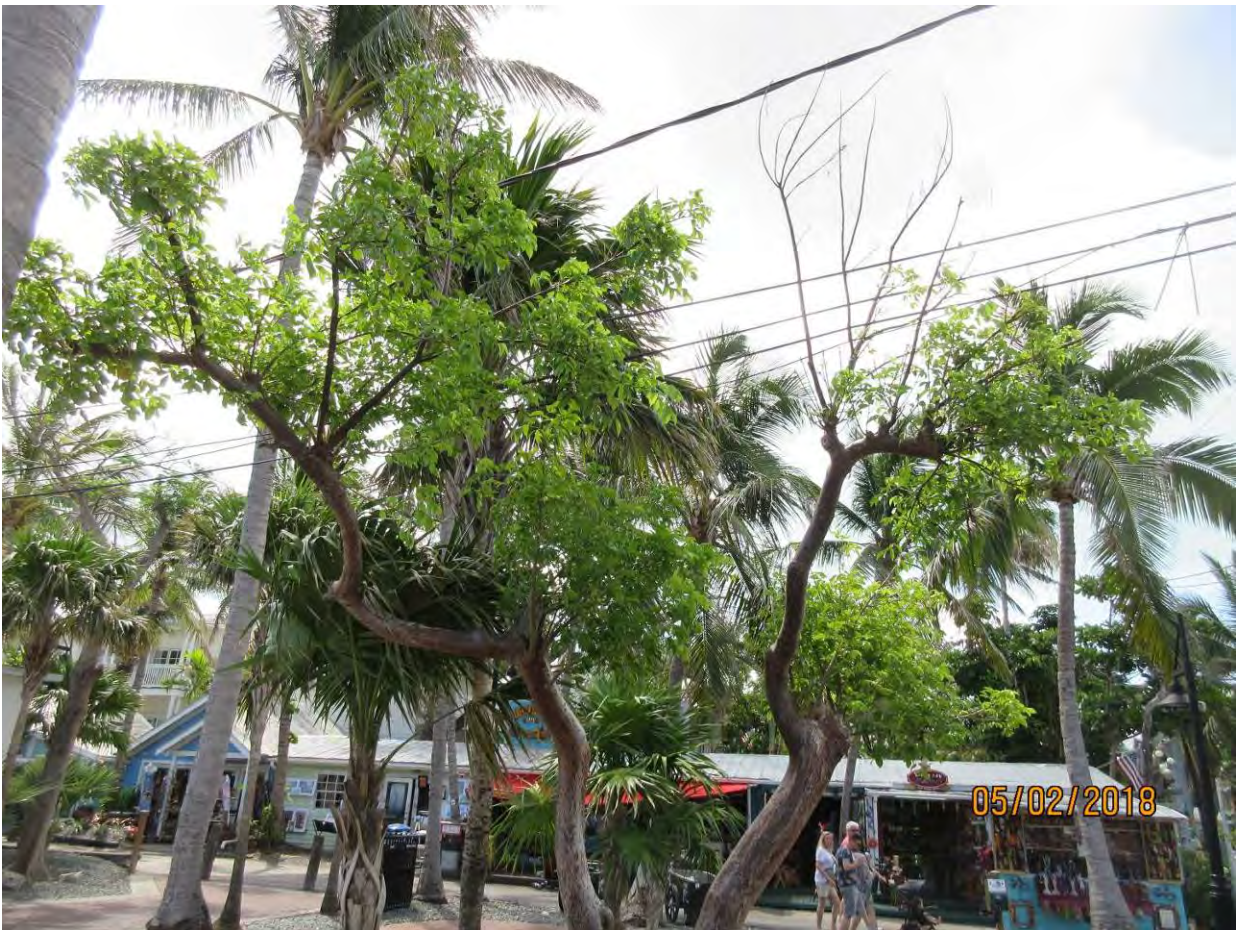
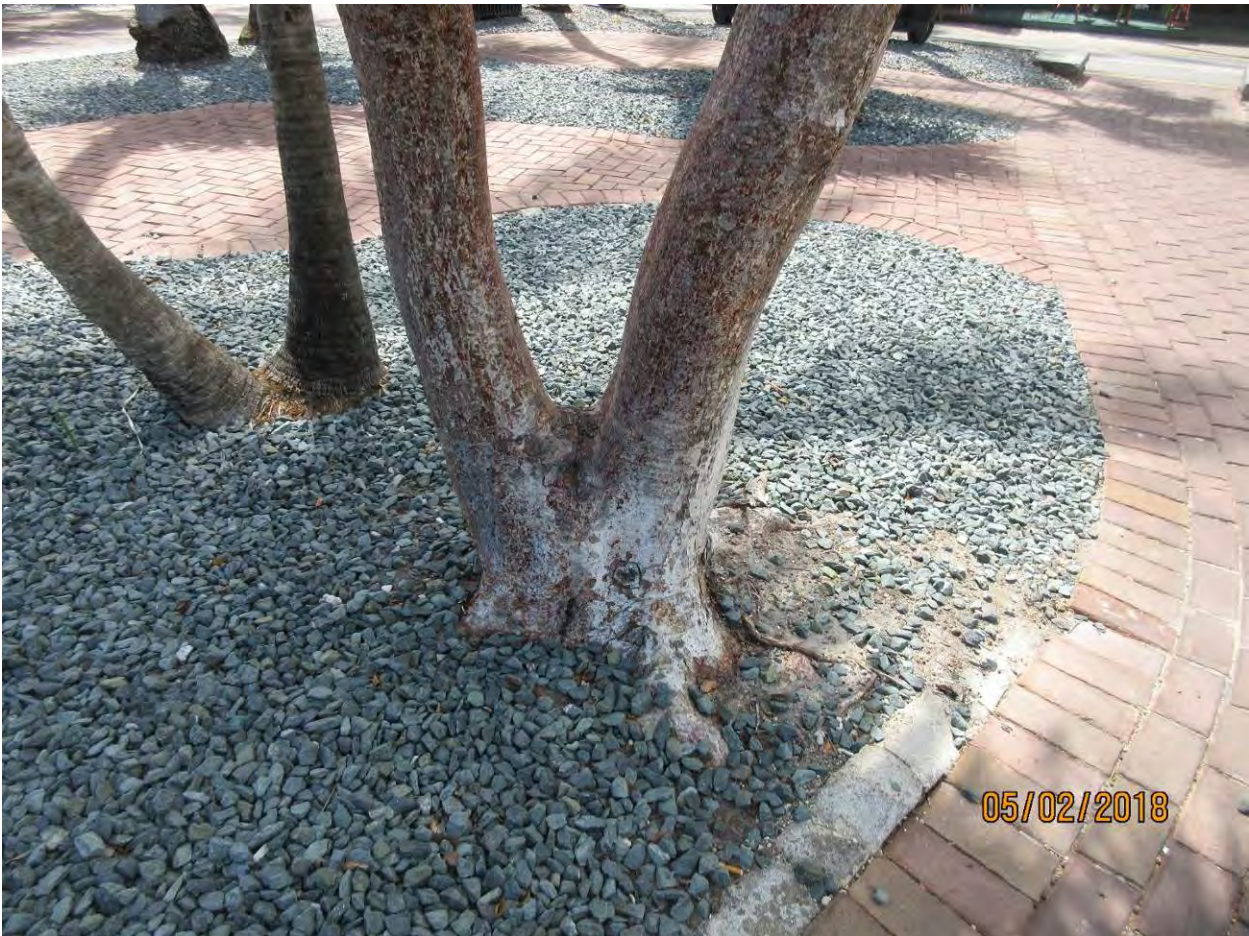
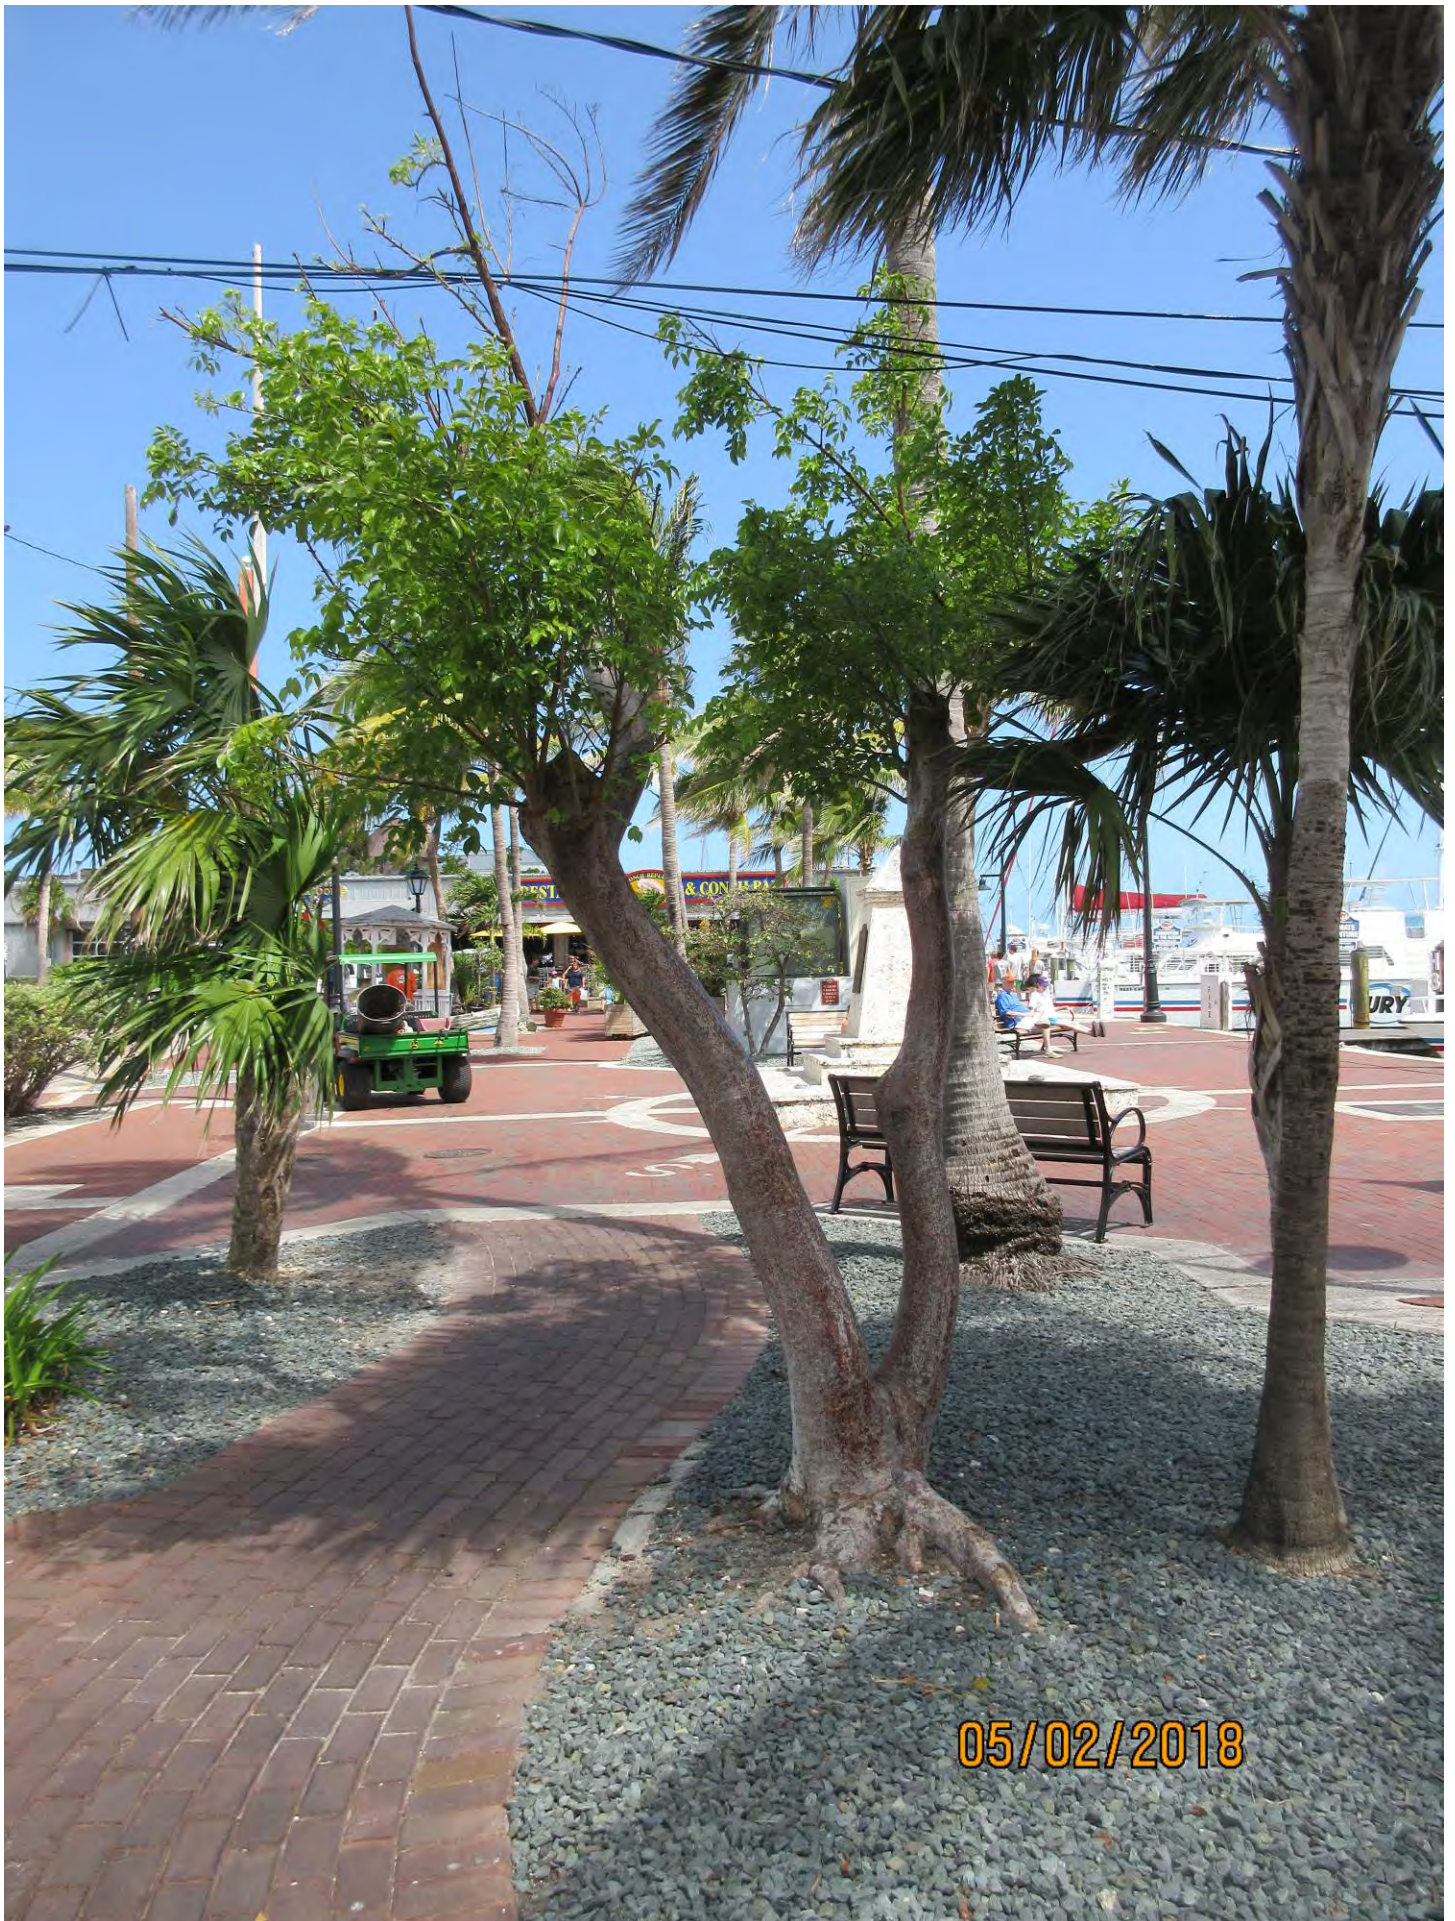
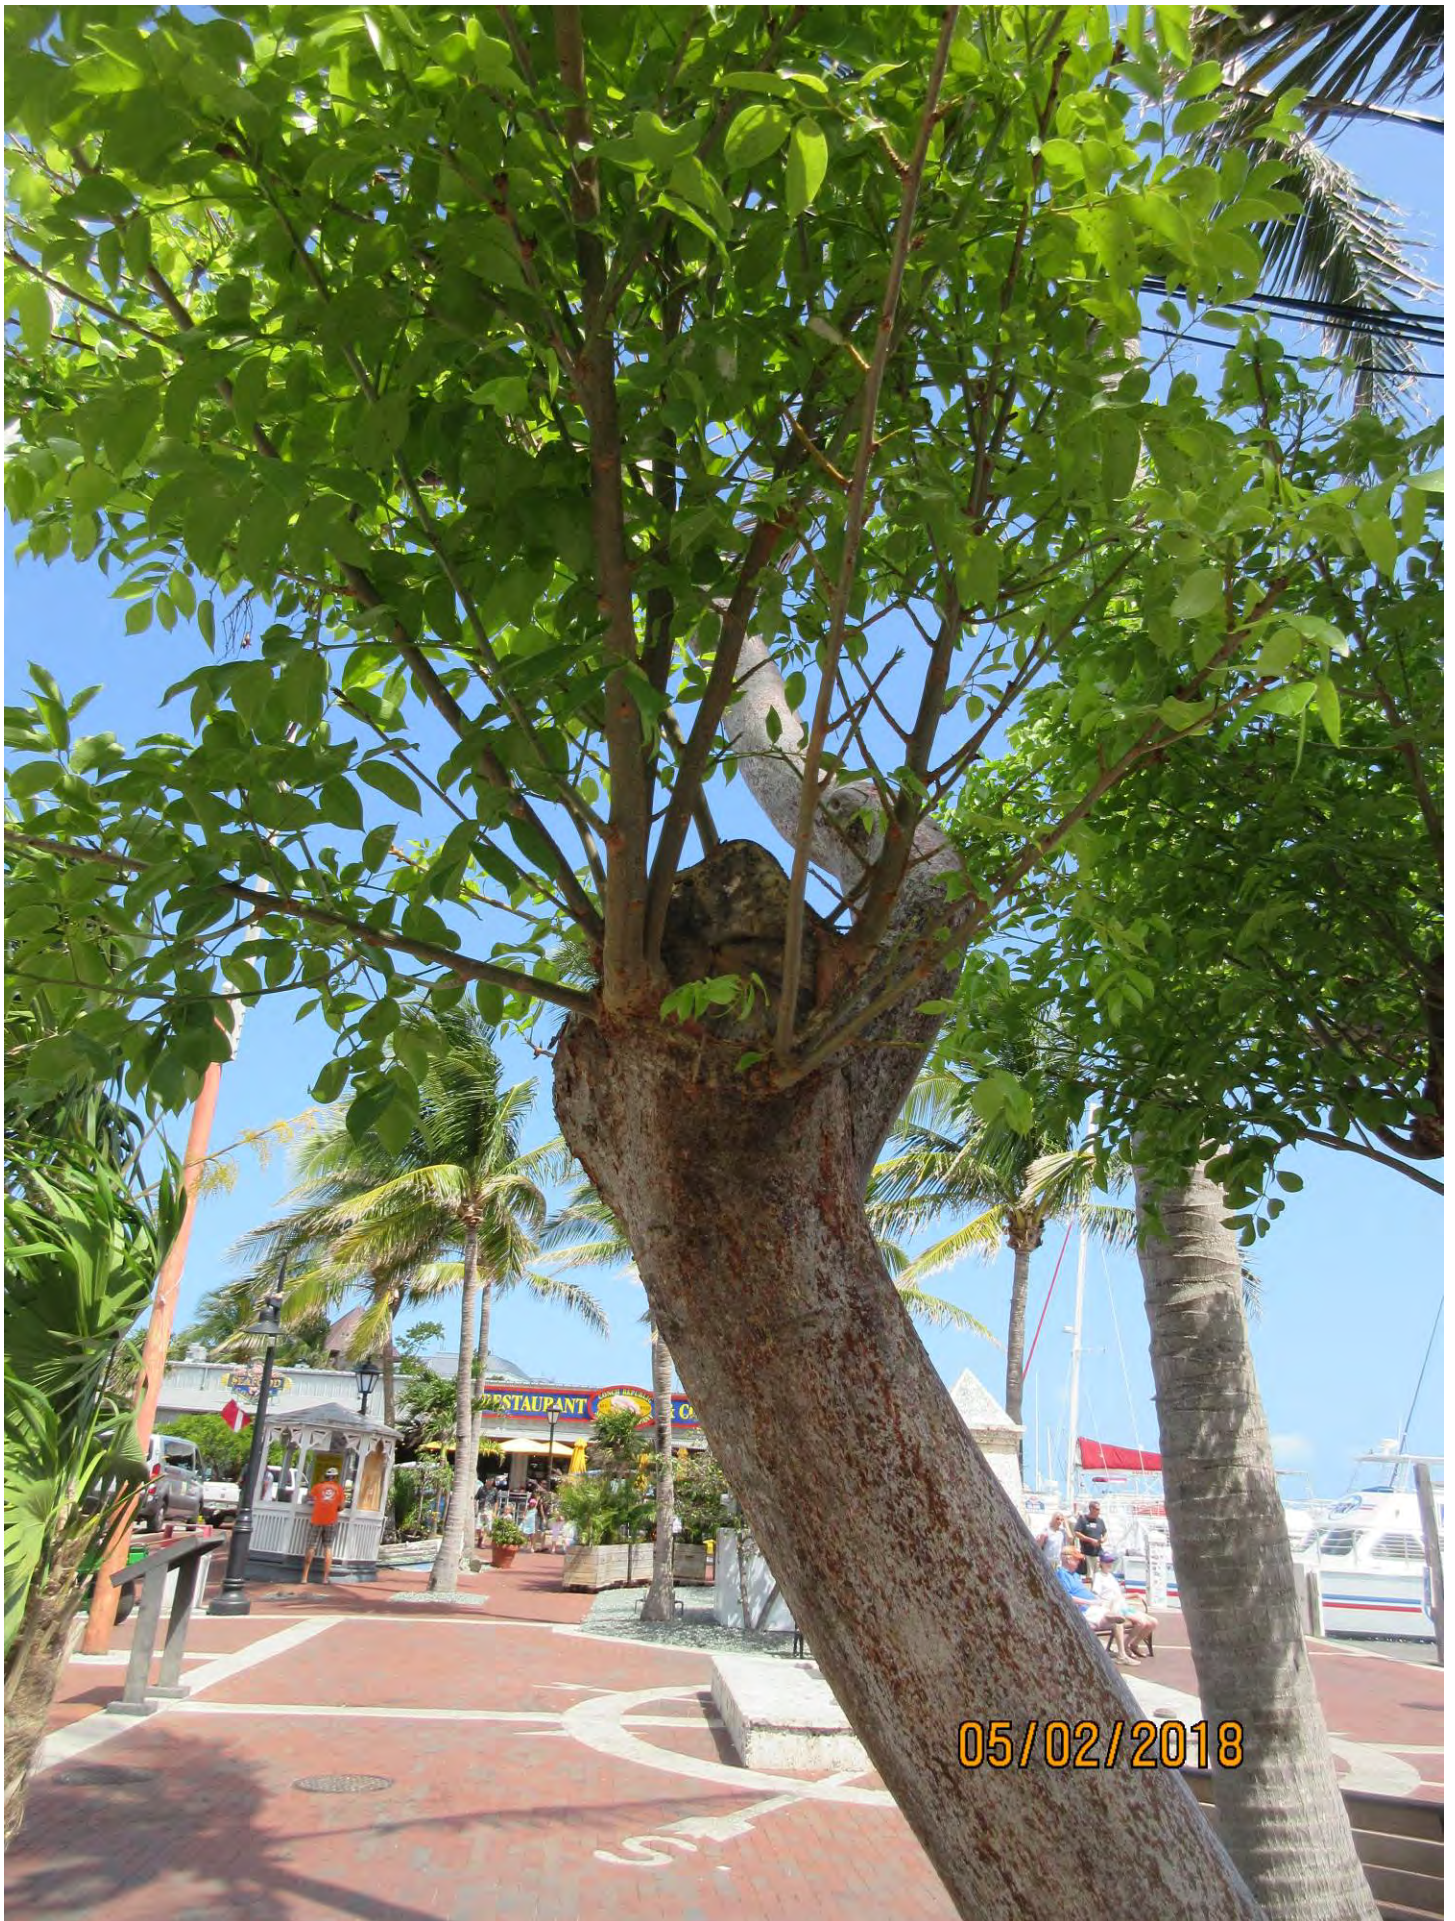
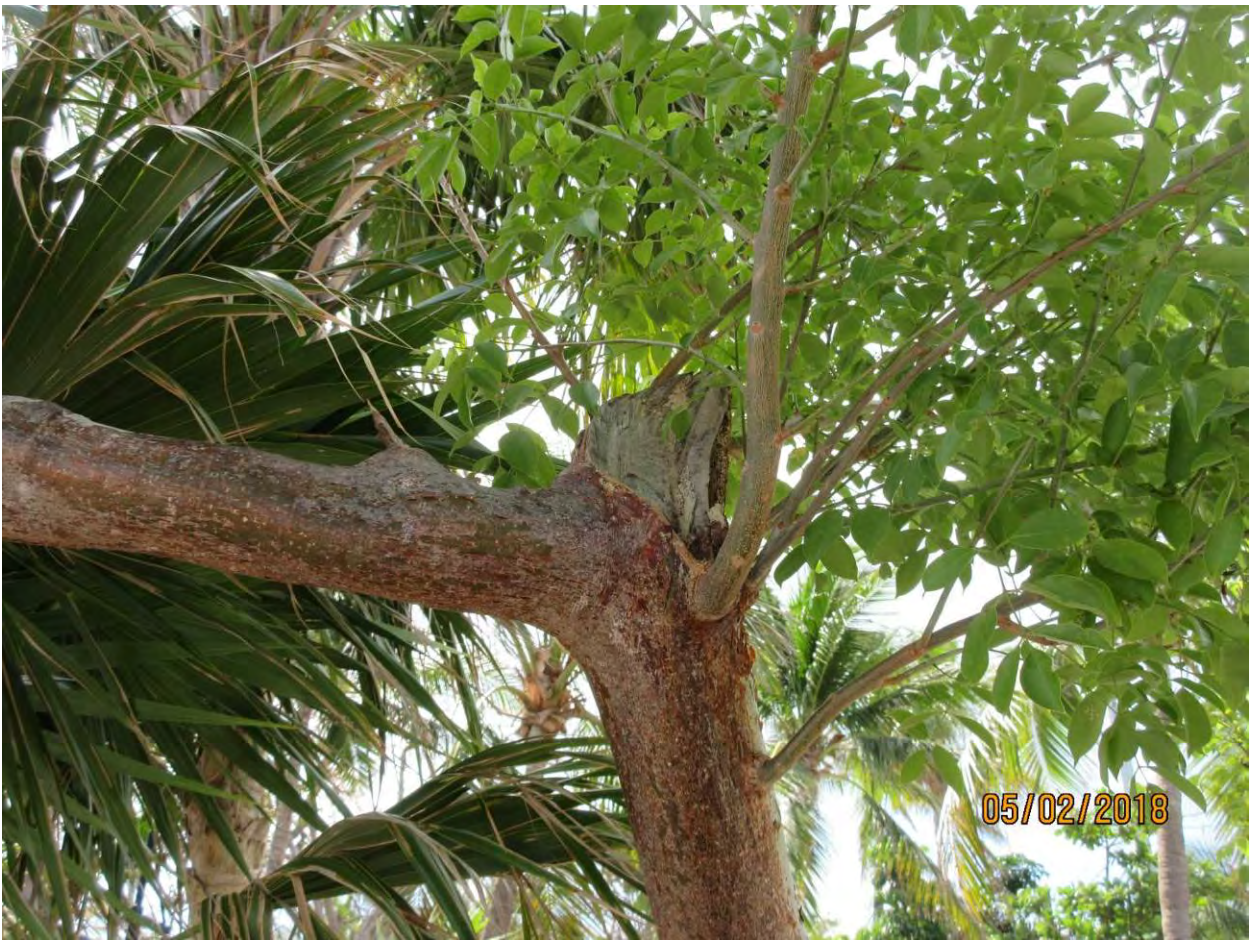
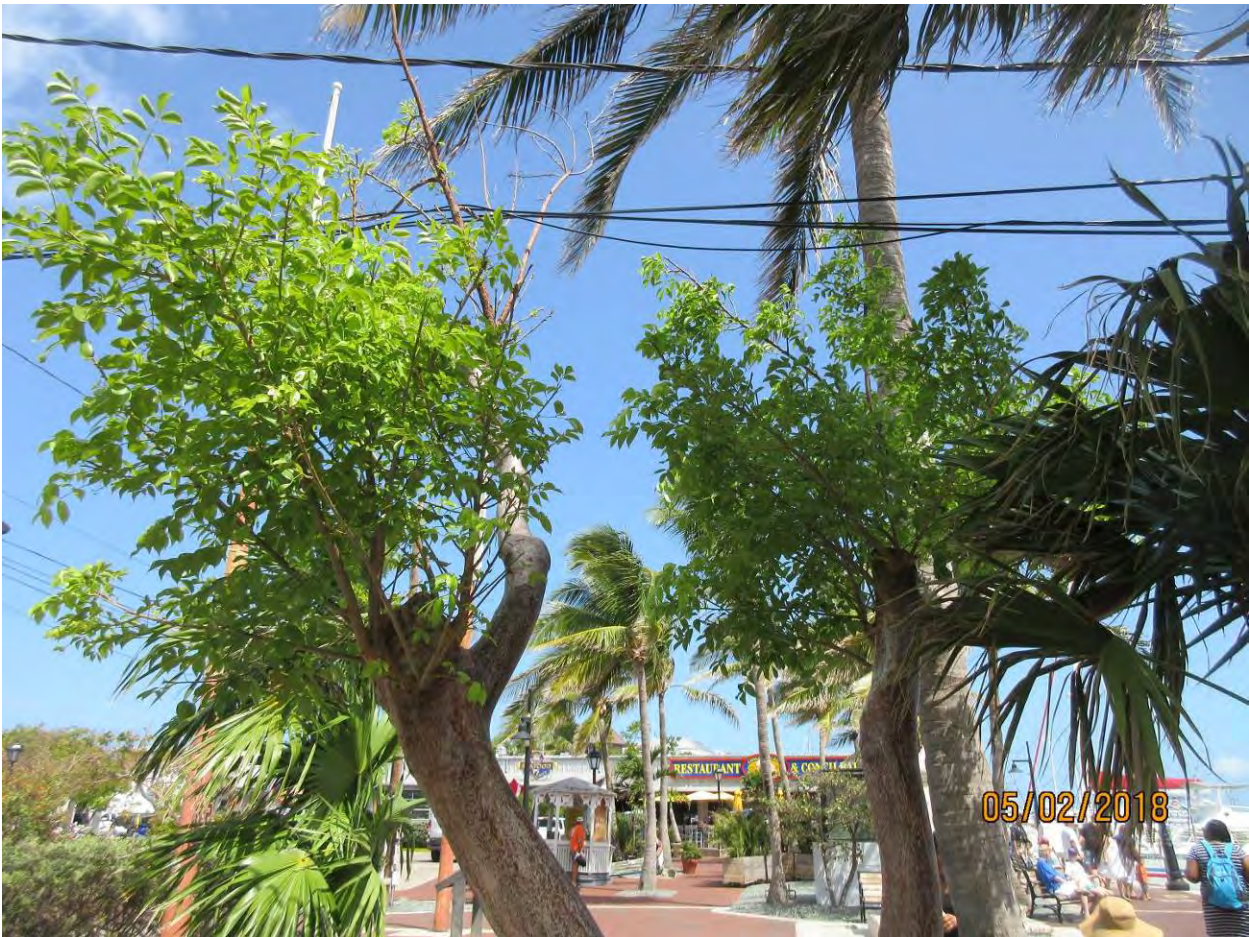
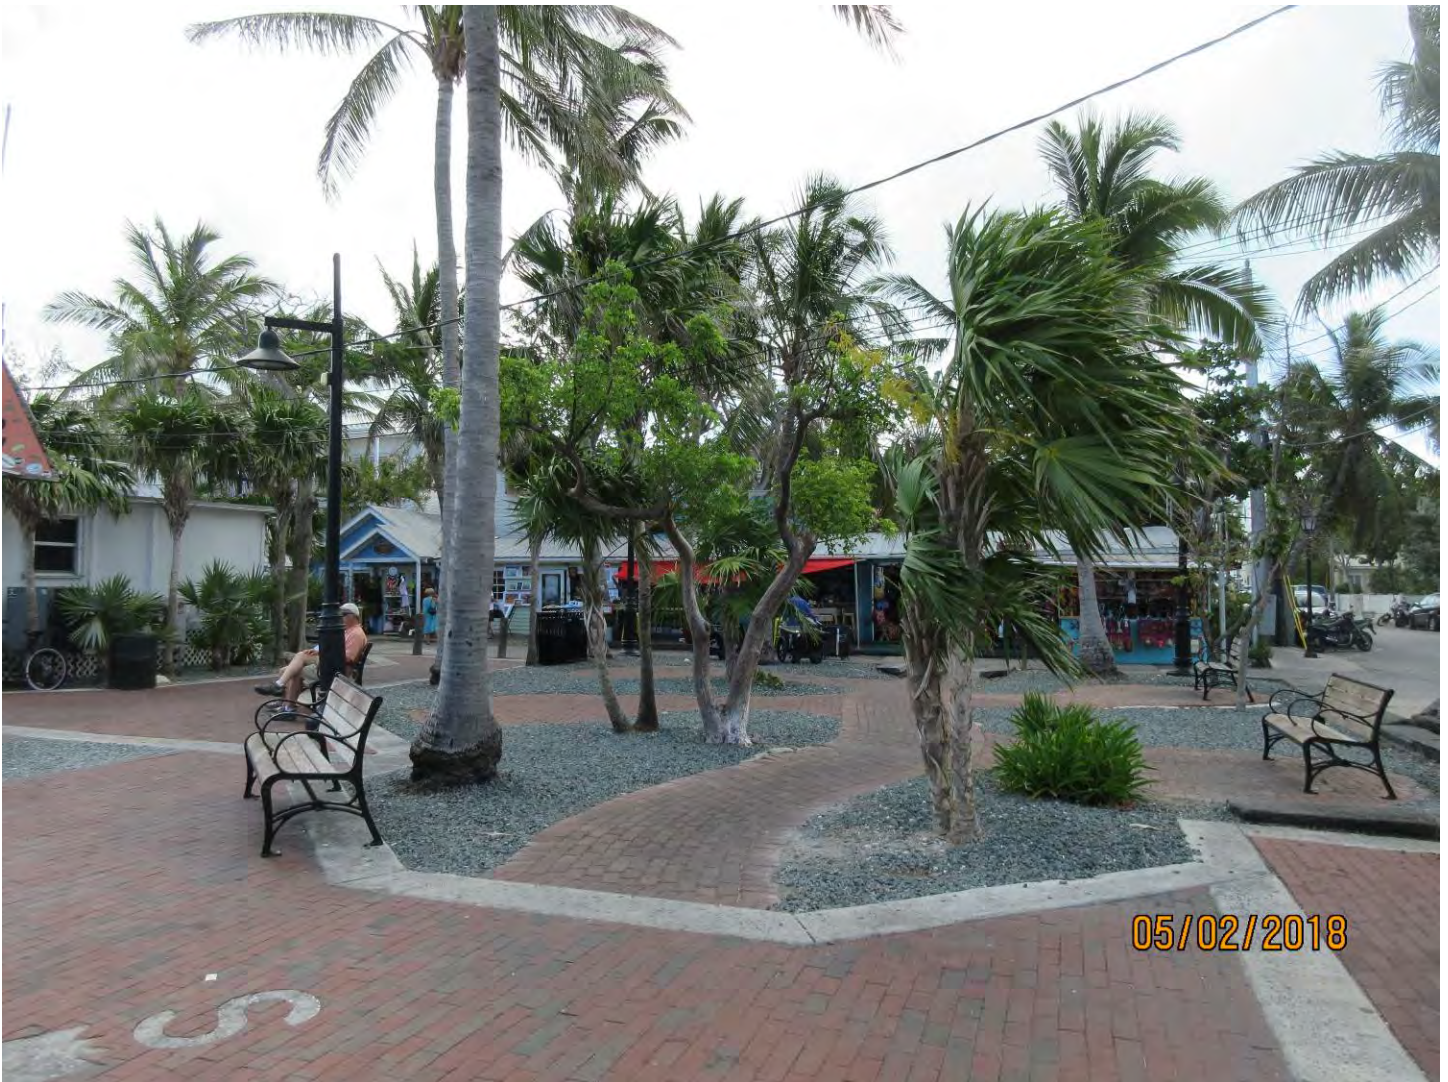
Gumbo Limbo tree #43

Diameter: 14.9" (two trunks)

Location: 60% (canopy impacted by utility lines)

Species: 100% (on protected tree list)

Condition: 50% (fair to poor, old canopy cuts have resprouted, poor canopy structure)

Total Average Value = 70%

Value x Diameter = 10.4 replacement caliper inches

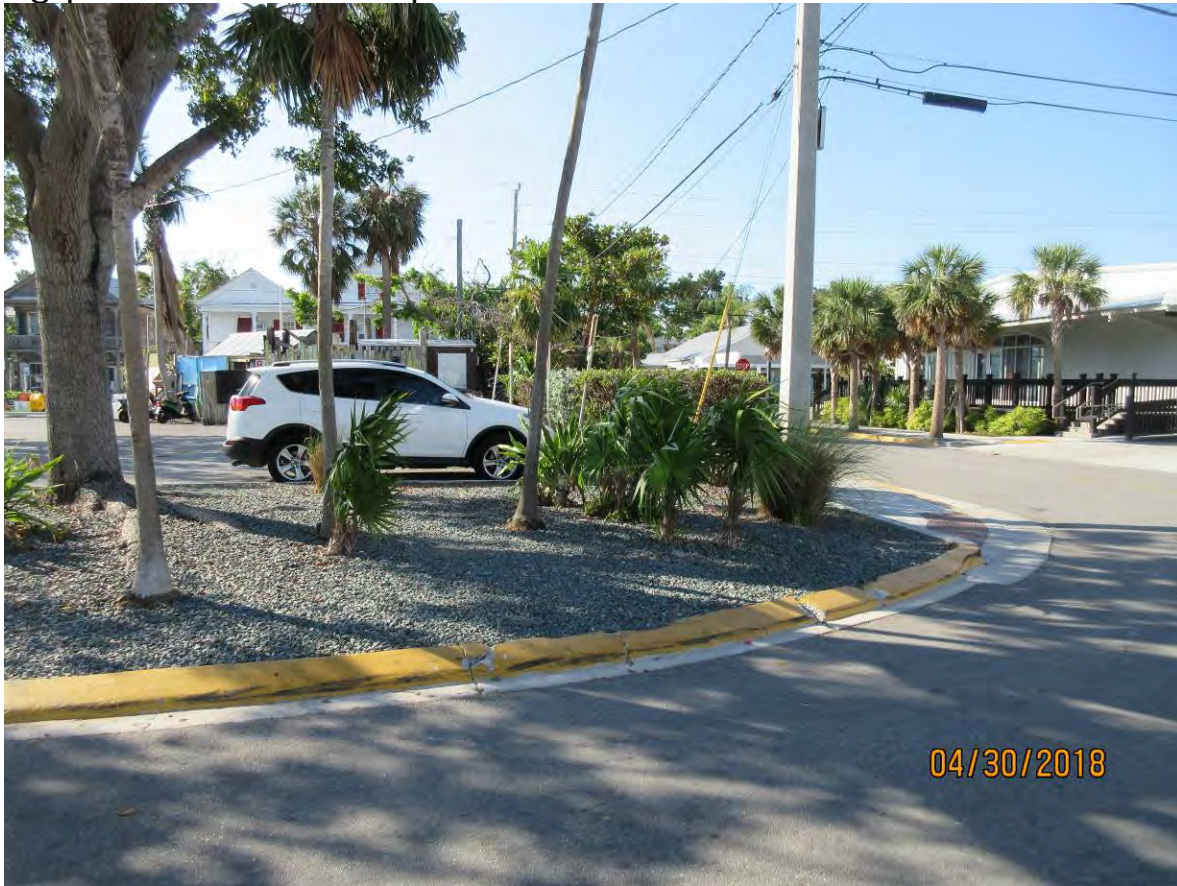
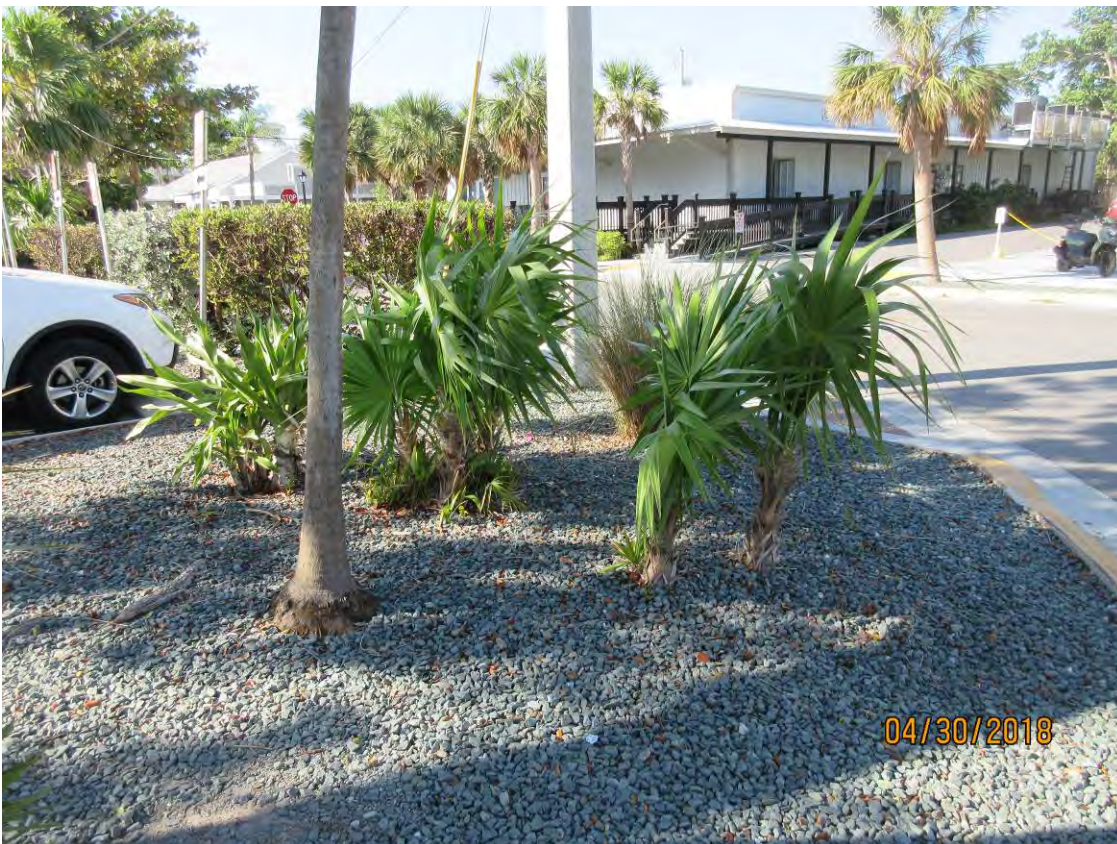
Proposed work in this area includes the removal of three (3) Christmas Palms and the transplanting of three (3) young Thatch palms. The following photos are recent photos of the area.

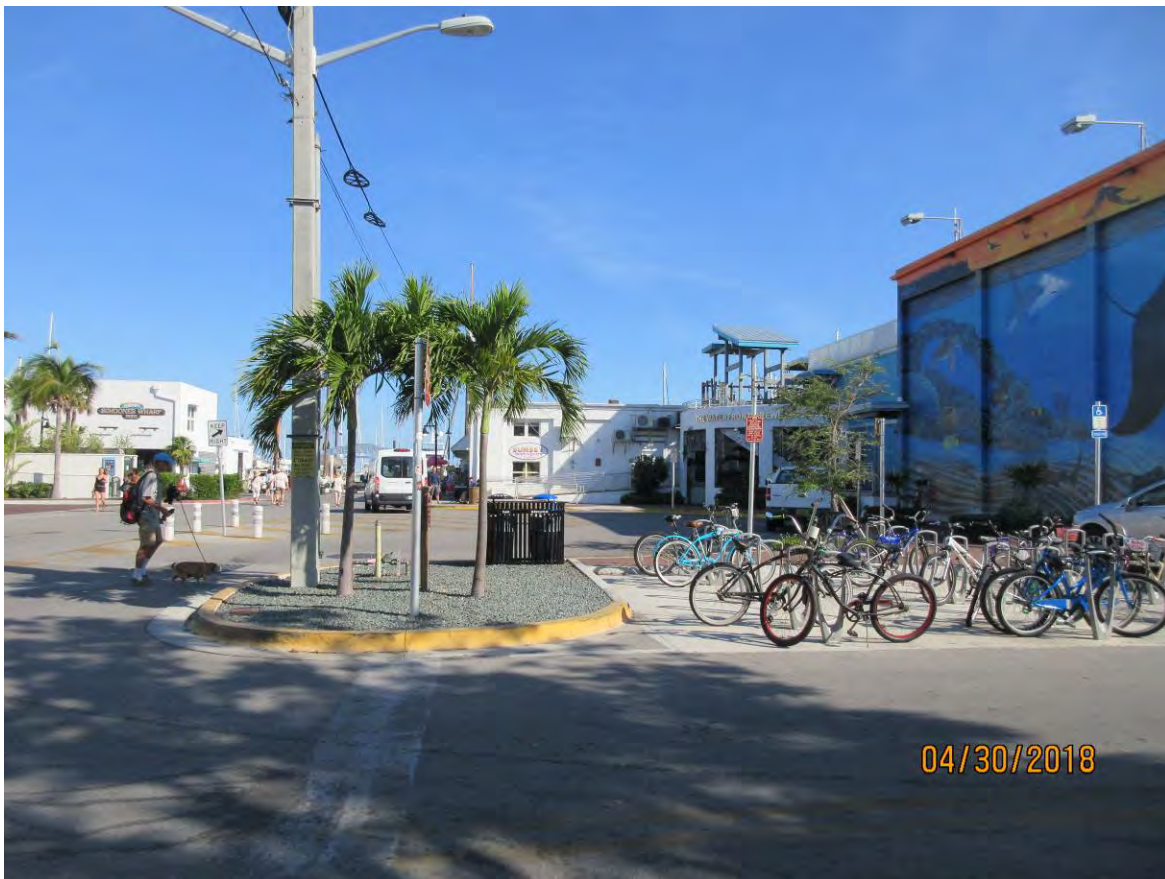
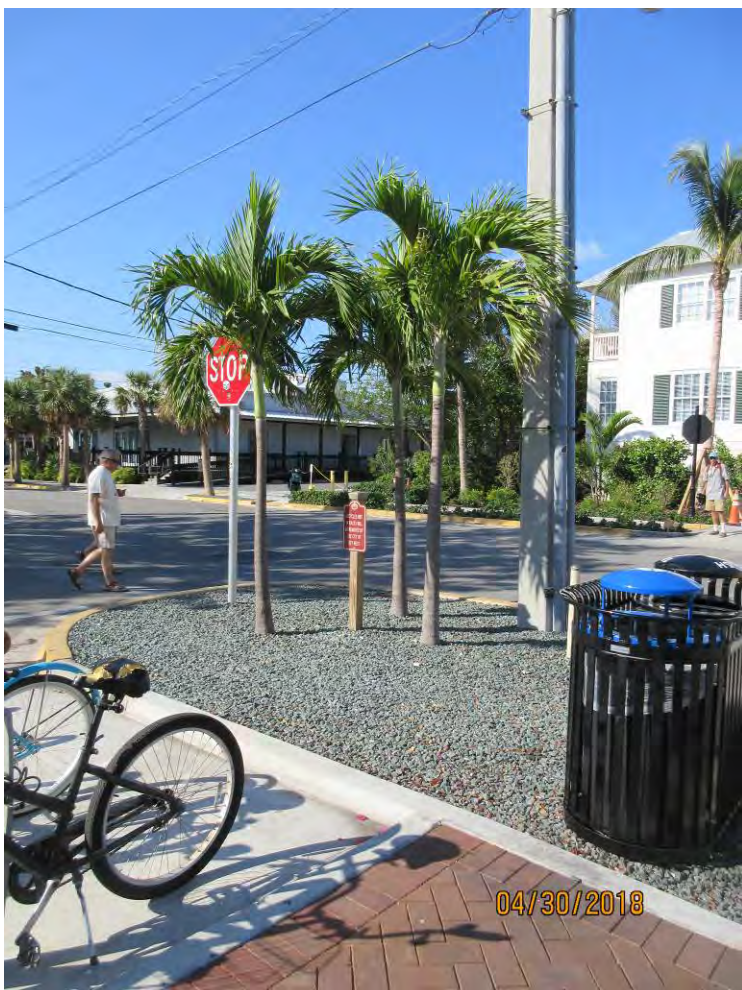
These Christmas Palms are proposed to be removed. It appears that shrubs will be replanted in this area. Do not recommend removal of these palms. Why do they need to be moved from this area? At the very least, transplant these trees to another location, either in the area or a street planter in old town.

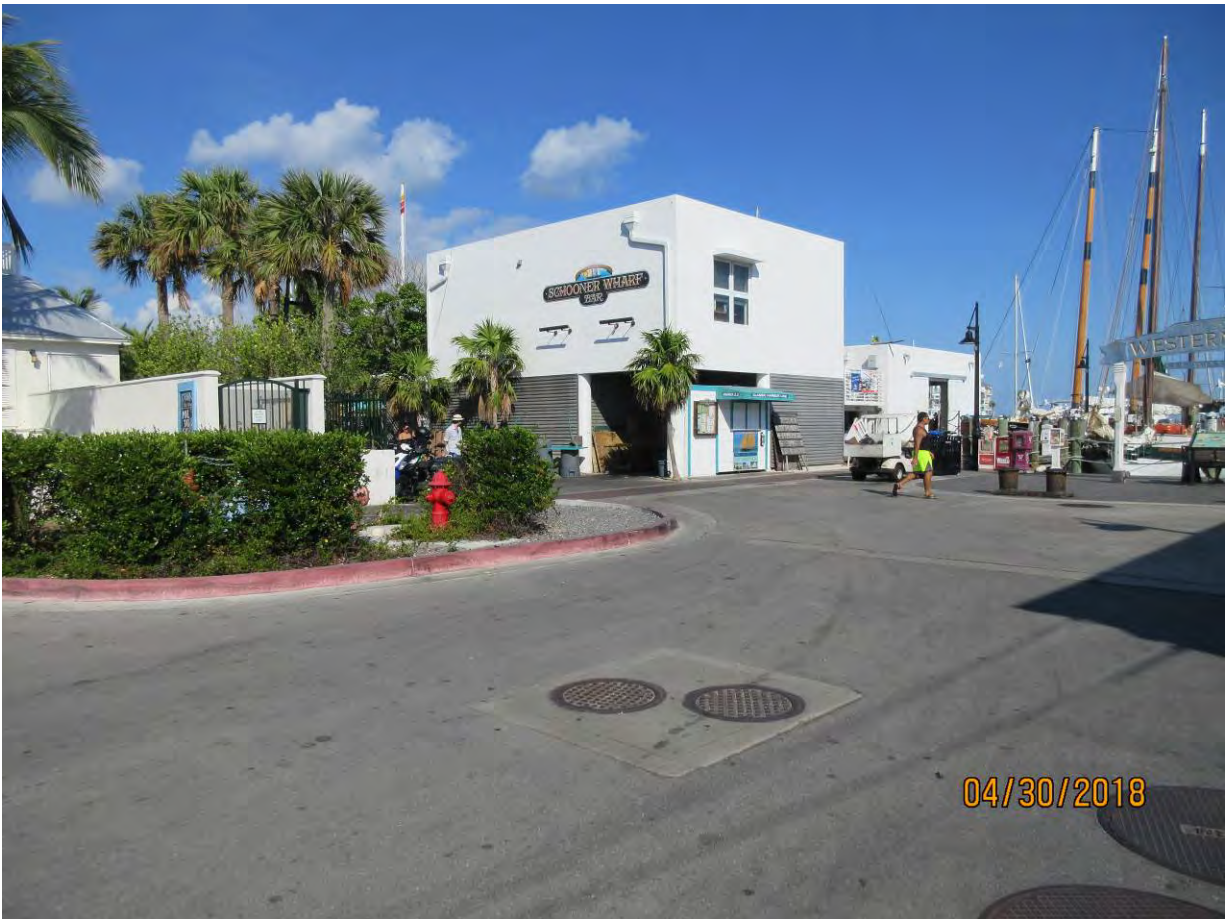
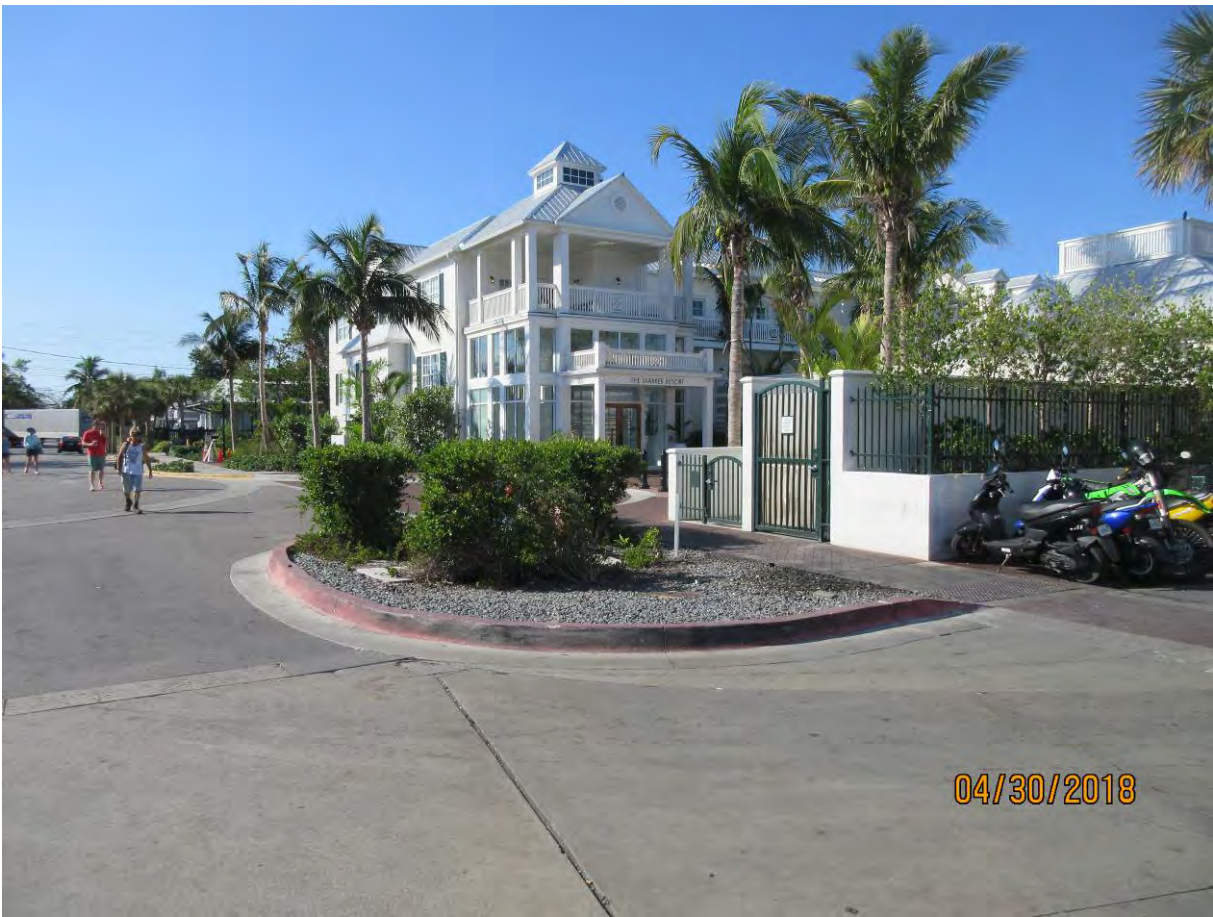
This area to be enhanced with additional landscaping.

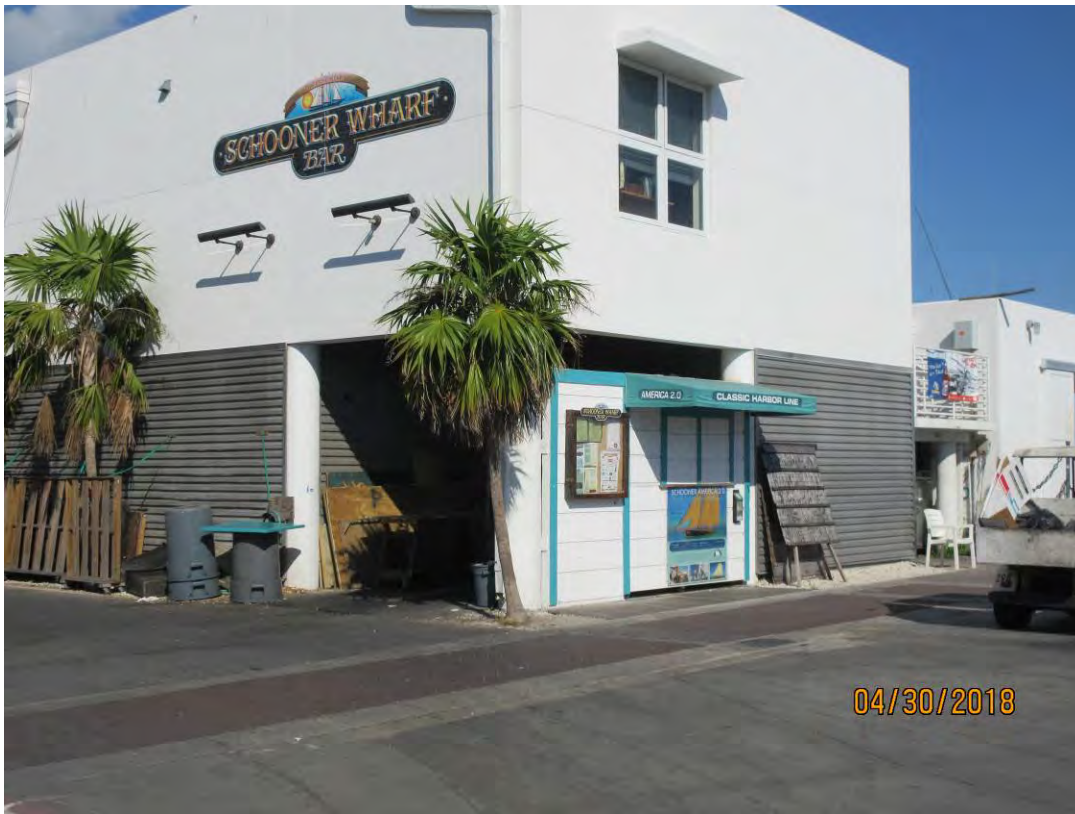
This Thatch Palm is not noted on the plans but is in the project boundaries.
